Condition Assessment Report

491 Auburn Ave. NE,
Fulton County, Atlanta, GA 30312

Jennifer Dixon
HIST 8620
September 29th, 2010

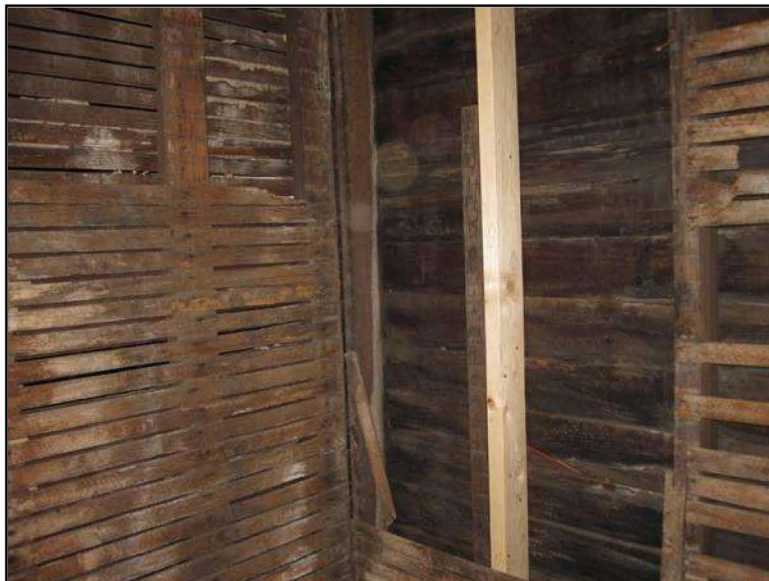
Figure 1 – Clapboard installed without sheathing, room 207, southwest (courtesy of Adam Archual)

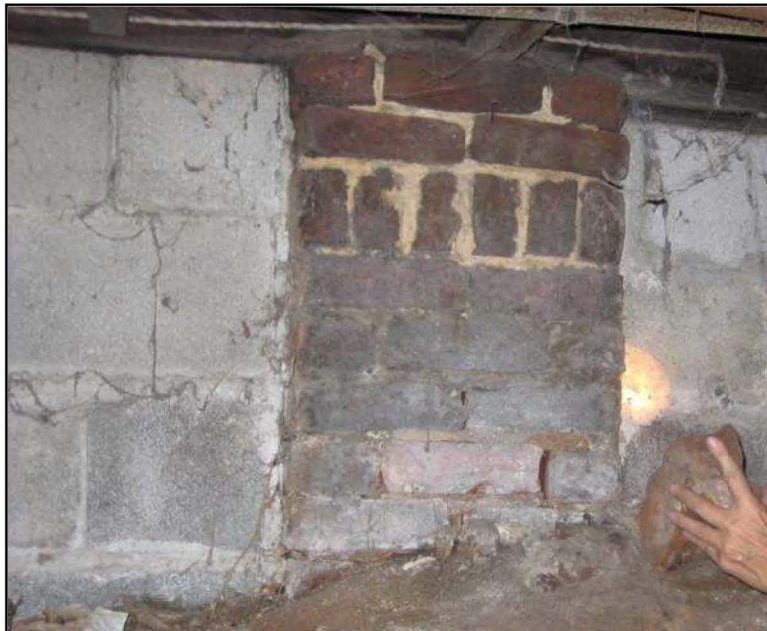
Figure 3 – Brick pilasters and CMU viewed from within crawlspace, looking east

surrounding the crawlspace (Fig. 3). Vents and openings are punched in the CMU on the west and east sides of the building (Appendix A, Figs. 3.1 and 4.1, Drawings 3.1 and 4.1). The two exterior door types and the five window types on the elevations are surrounded by wood trim,

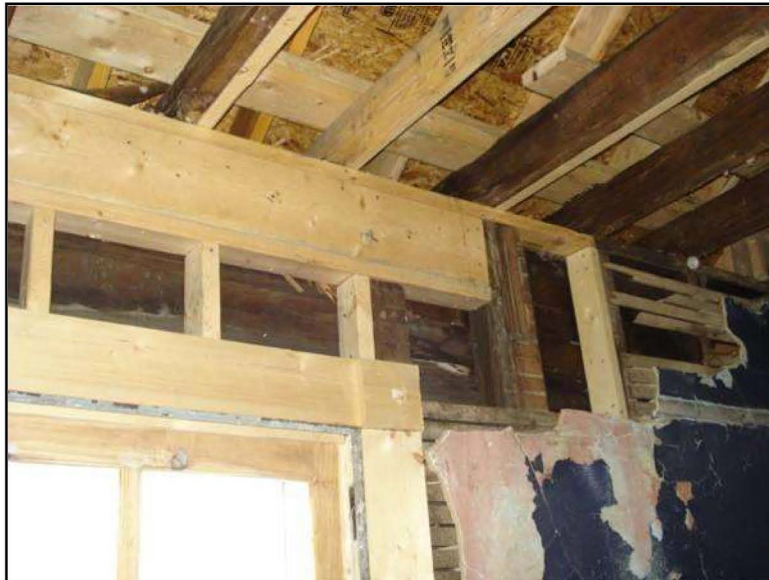
during this stabilization were replaced at a later date with small metal ones. The NPS also repaired or installed canopy screens for all exterior windows and demolished, repaired, or shored framing for large portions of the west and south sides of the building, as well as some on the east and north side (Fig. 5). Installation of a new roofing structure with composition shingles, repair of the porch, and 4” x 4” structural framing support on the west side of the crawlspace were all

Figure 5 – Example of repairs by NPS in room 207, west wall (courtesy of Holly Schwarzmann)

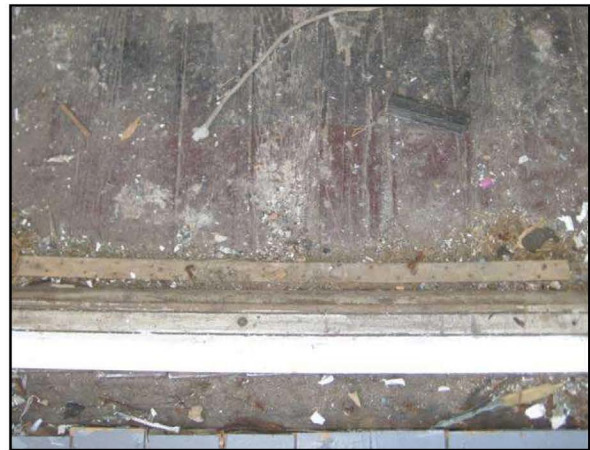
two different types of tongue-and-groove hardwood. A few rooms, such as 101, 109, 201, 207 and 209 have furring strips around the perimeter of the room (Fig. 8), which suggests carpet may have been installed at one point. The majority of the rooms have had a portion of the tongue-

Figure 8 – Detail of furring strip in room 101

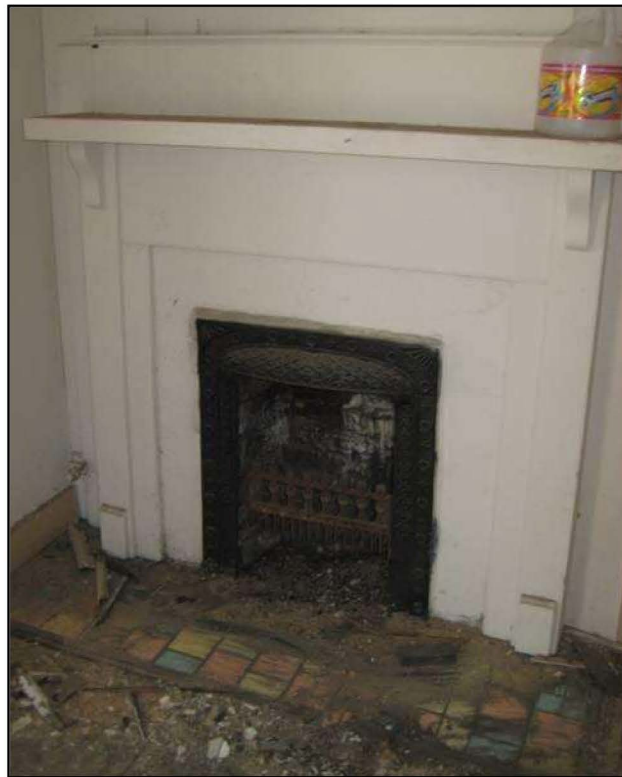
Coal-burning fireplaces are located in some rooms, such as rooms 107 and 209. On the first floor, some fireplaces appear to have been covered with drywall, as in rooms 102, 104 and 108. The fireplaces in rooms 107, 202 and 208 have glazed tile surrounds and hearths, while the fireplace in room 201 appears to have only a replacement tile hearth (Fig. 11). Rooms 101, 203,

Figure 11 – Fireplace in room 201, south wall

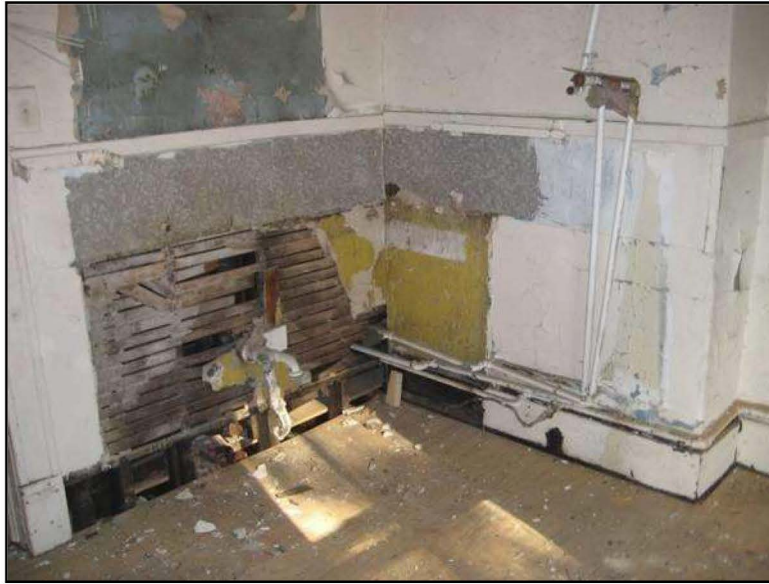
A few unique qualities of particular rooms should be mentioned. Rooms 104, 110, 204 and 210 were used as kitchens as evidenced by the water, gas, and exhaust lines and ghosting where cabinets were probably hung (Figs. 12 and 13). Rooms 106, 112, 206 and 212 were

Figure 12 – Room 204 appliance lines, northwest wall

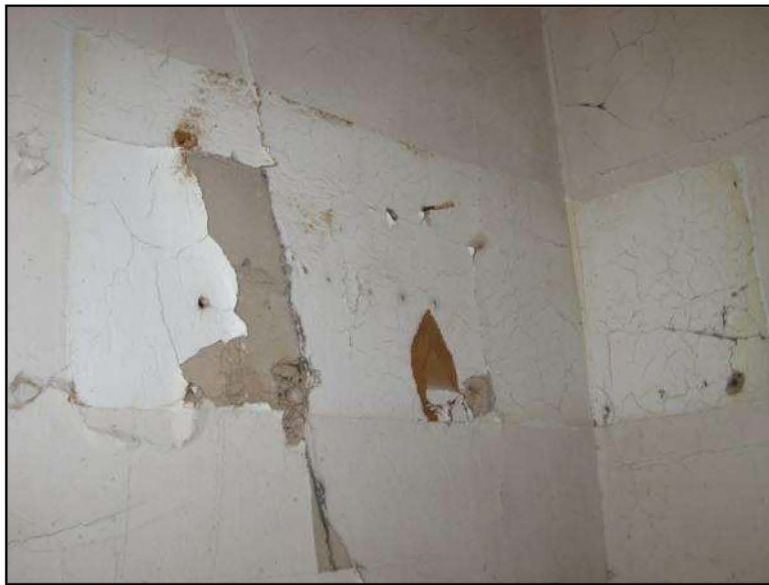
Figure 13 – Room 204 ghosting from cabinets, southeast wall
