54 Howell Street, NE Historic Structure Report

54 Howell Street, NE
Martin Luther King, Jr. National Historical Park
Atlanta, Georgia

Historic Structure Report

August 2019

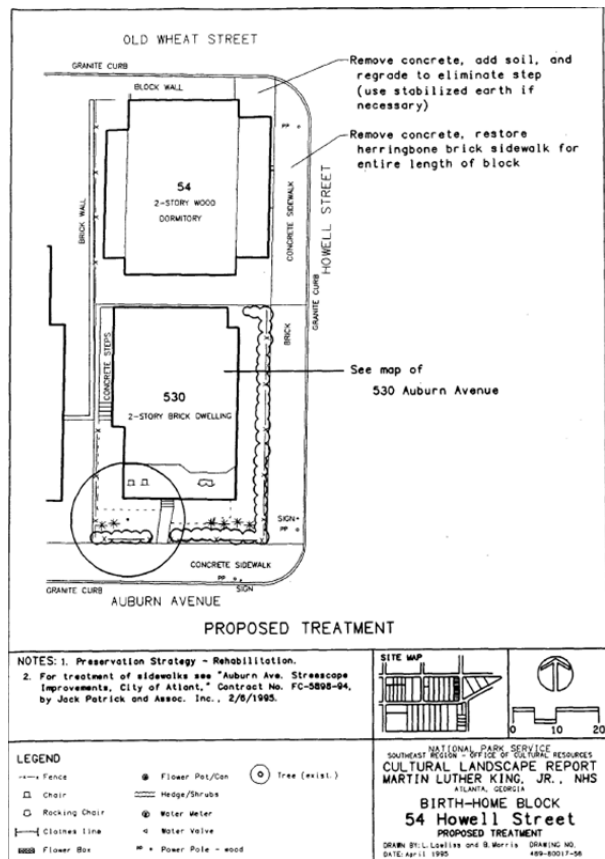
FIGURE 6. 1995 Proposed Landscape Treatment Plan, showing location of house, hedges, walls, fences, and other landscape elements at 54 Howell Street. (Source: Lawliss:182, Figure 101)

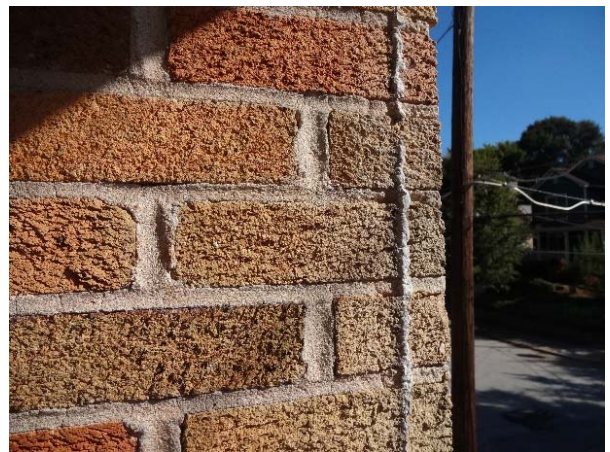
Similar to the second-floor framing, wood box-framed beams are at the top of the brick piers and painted dark yellow. They in turn support the edge of the roof. The first- and second-floor ceilings of the porch have bead board measuring 3 1/2 inches wide and painted light blue. Between the box beam and ceiling is crown molding, painted yellow (Figure 29). Vertical lines of sealant at the brick piers are what remains of a previously existing screen installed outboard of the balustrade at the second floor of the porch (Figure 30).

FIGURE 30. Remaining sealant at brick where previously existing screens had been installed outboard of the balustrade.

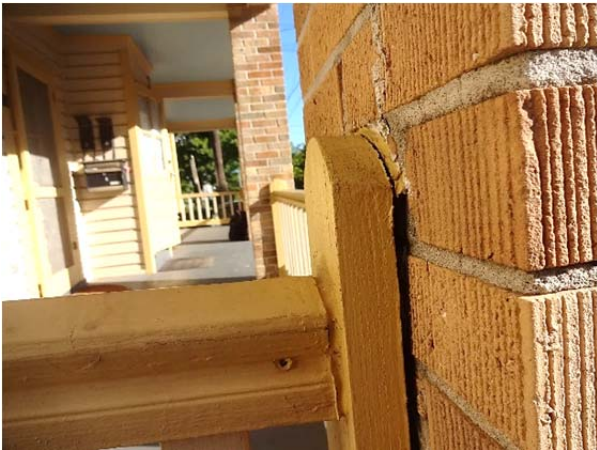
- Displacement was observed at some of the vertical trim boards between the baluster and brick piers (Figure 68). At these locations, the joint between the trim and pier was open, indicating that the vertical trim had shifted or moved.

FIGURE 68. Displacement and open joints at vertical trim boards.

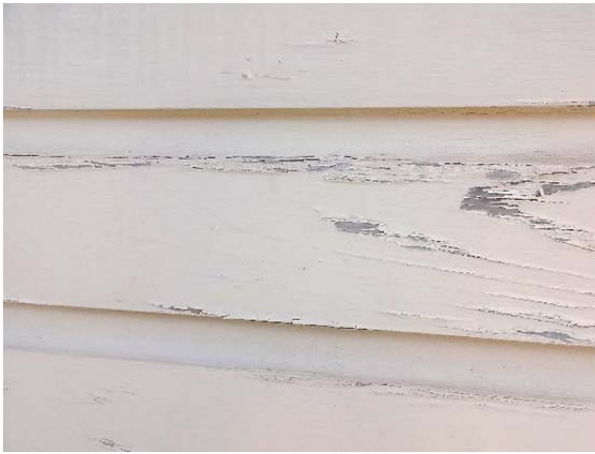
FIGURE 71. Peeling paint at wood siding.

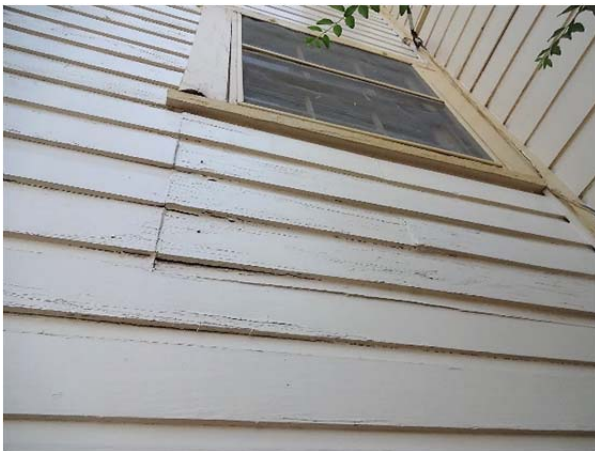
FIGURE 72. Infill siding below kitchen window opening.

- Physical evidence suggests that the siding below the kitchen window at the north end of the west elevation was installed to infill a portion of the wall where a previously existing window was located (Figure 72).

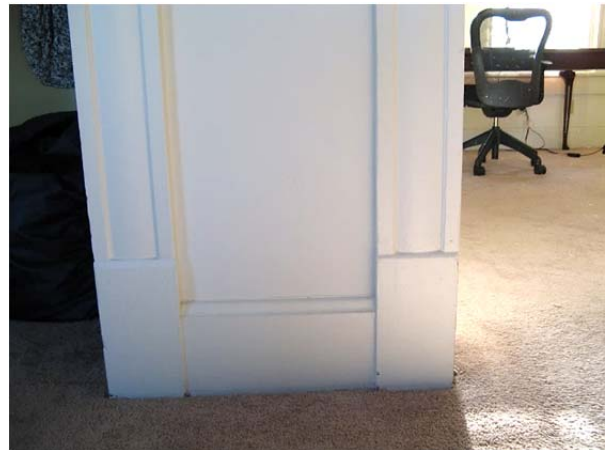
Door and window casings are painted wood and are consistent throughout the units. The interior jamb casings consist of a 5-1/2-inch symmetrical profile trim with a convex panel (Figure 83). Doors have flush 10-1/2-inch by 5/4-inch plinth block with a radiused top edge set in plane with the base

board (Figure 84). Head casings and window aprons are 5-1/2-inch flush boards with no profile or rosette (Figure 85). Window stools are 5/4 inches thick painted wood with a radiused top edge returning to the wall.

FIGURE 84. Typical base and door trim at second floor.

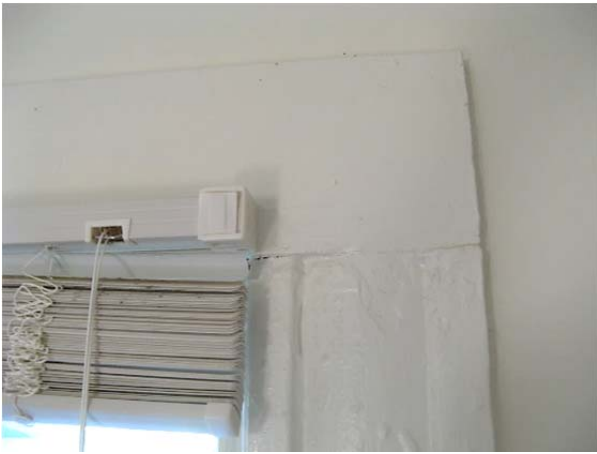
FIGURE 85. Typical window head casing.

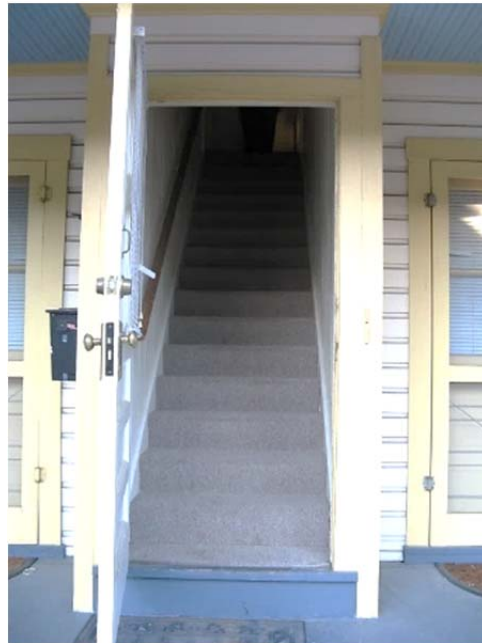
The front (east) stair functions as a public vestibule, providing access to the upper apartments from the second-floor landing (Figure 86). The first tread serves as the threshold for the door with the nosing painted to match the thresholds of the adjacent entry doors. On the interior, the treads and risers and second-floor landing are covered in a contemporary grey-brown carpet (Figure 87).

FIGURE 86. Front stair vestibule.

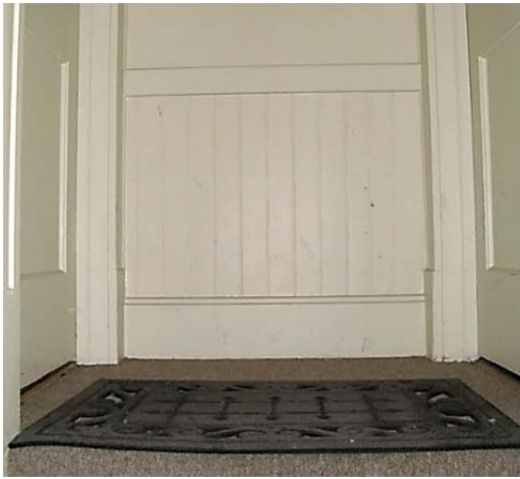
FIGURE 87. Wainscot at upper landing of front stair.

Walls at the front stair are finished with vertical, double-bead wood paneling rising to a wood paneled ceiling at the first floor and terminating at the second floor as a wainscot with a simple rail cap. The wall above the wainscot and the ceiling are painted gypsum board (refer to Figure 87).

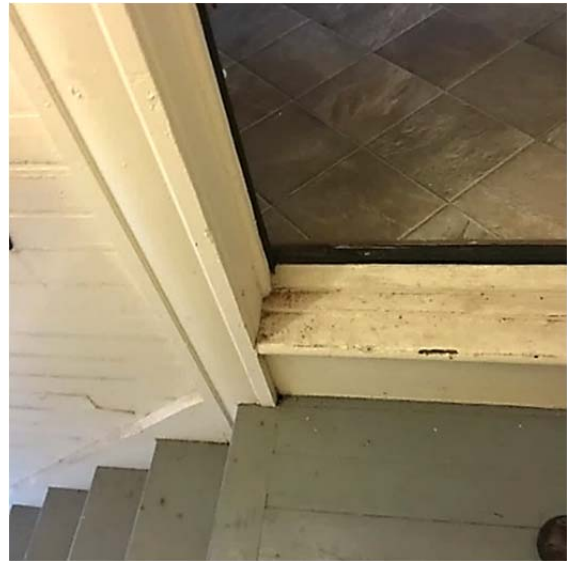
The rear stair provides access from the lower west porch to the second-floor apartments. The stair retains original painted wood treads, risers, and painted tongue-and-groove flooring at each landing (Figure 88). Walls at the first floor are painted a cream color and are horizontal, single-bead wood paneling which continues to wainscot height at the second floor where it is capped with ogee trim (Figure 89). The wall above the wainscot at the second floor is white painted plaster. The ceiling of the stair is finished with painted double-bead wood paneling, and there is an attic access scuttle above the second-floor landing. A pair of doors at the base of the stair has diamond lattice lights above a single raised panel (refer to Figure 89). The doors are a particularly unique feature of the building and appear to be original.

FIGURE 88. Threshold at kitchen door to rear stair.

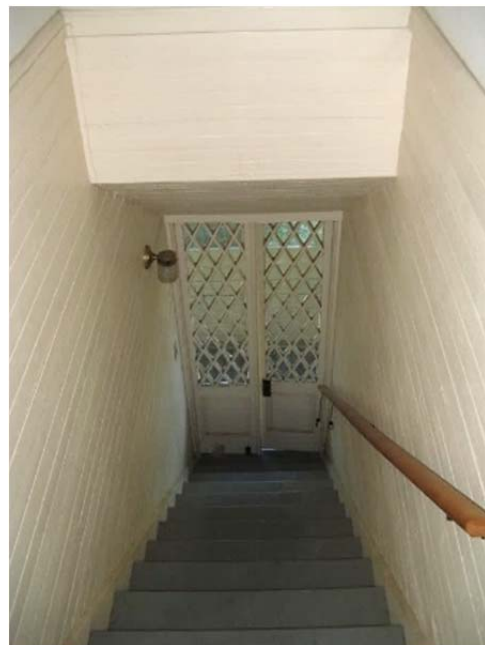
FIGURE 89. Rear stair with horizontal beaded siding and diamond lattice lights at doors below.

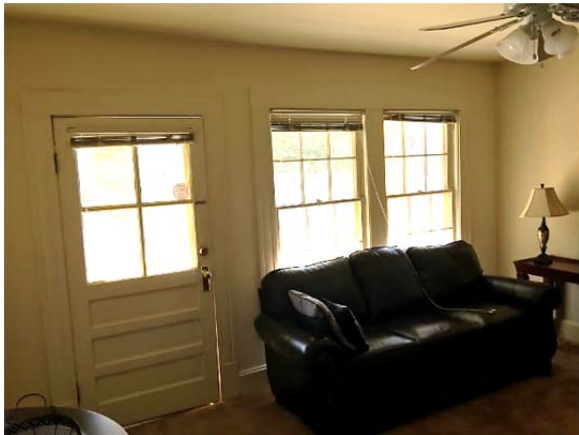
First Floor – Living Rooms. In each unit, living rooms are located on the Howell Street (east) side of the structure and open directly to the common front porch with a single door adjacent to a pair of joined double-hung windows in the original configuration (Figure 90). Under the 1993 rehabilitation project, the two living rooms in the lower apartments were joined by reworking the back-to-back closets below the central stair to

FIGURE 90. Overall view of south living room.

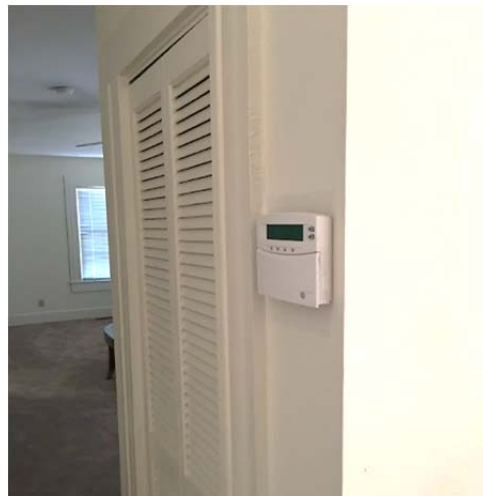
create a narrow passage between the two living rooms (Figure 91). Both living rooms are used as flexible living spaces when temporarily housing NPS employees or visiting guests.

FIGURE 91. Reworked closet below front stair at connection between north and south lower units.

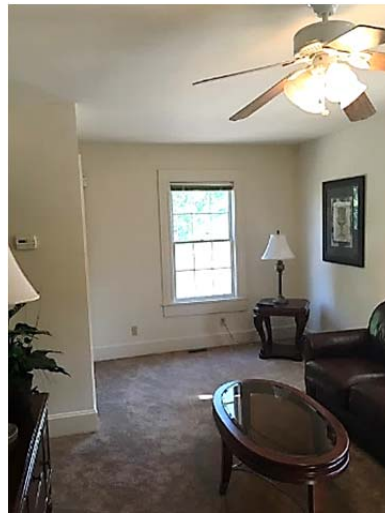
FIGURE 92. The window in the north wall of the living room remains where the bathroom was removed from the northwest corner.

In the north unit, the original bathroom and closet on the north wall was removed, and a contemporary closet with sliding, louvered doors was added on the west wall, adjacent to the kitchen. A double-hung window remains in its original location at the north end of the living area (Figure 92). Also, in the west wall, a single-panel wood door opens into the kitchen, and a cased opening provides access to the dining room.

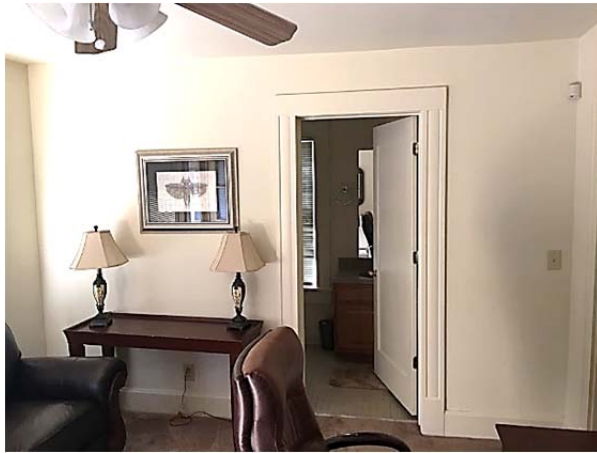
Modifications in 1993 to the living room of the south unit were virtually the same as those made to the second-floor apartments. The bathroom wall was continued west to intersect the bedroom wall in order to enclose a larger closet. The bathroom door was relocated to the south wall of the living

room (Figure 93), and the door to the south bedroom was moved slightly to the north. The door to the north bedroom remains in its original location.

FIGURE 93. Single panel wood door leading to renovated bathroom at the south living room.

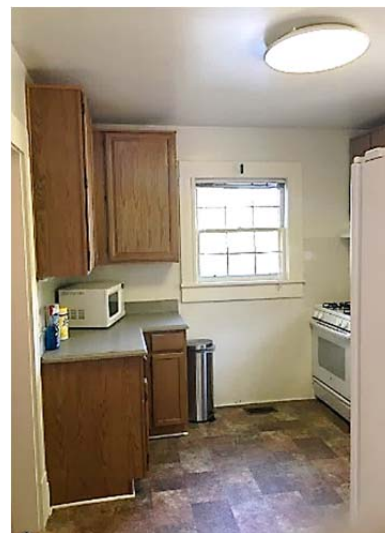
The sills of the two kitchen windows are raised from their original height, apparently to accommodate cabinets below; although there is no cabinet located under the window on the west wall (Figure 94). The north window has weighted counterbalances with sash cords consistent with others in the building. The window in the west wall has vinyl sash guides with coil spring balances indicative of a contemporary window.

FIGURE 94. Overall view of the kitchen at the first-floor apartment.

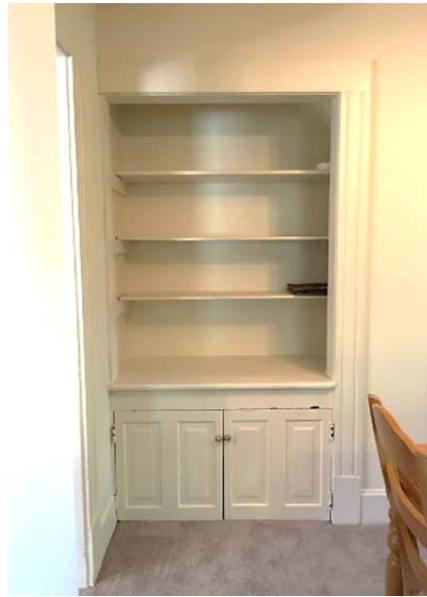
Another feature of the dining room is a cabinet with open shelves above it that is built into the south wall in the space below the rear stair (Figure 95). This cabinet and shelf unit is likely original to the building. Demolition plans from the 1993 rehabilitation project indicate a similar unit existed in the south apartment.¹¹³ The exposed surfaces are painted off-white to match the wall color. Casing on the internal jamb and head matches that of typical door in the unit. A painted wood top consisting of two 12-inch by 5/4-inch boards with a bullnose edge is supported by a 2-inch by 4-inch face rail and perimeter frame. Two flush inset doors have a profiled panel, brass pulls, and butt hinges. Above the countertop, three painted 1-inch by 8-inch wood shelves above mounted on 1-inch supports. Textured and painted plaster walls remain at the back of the cabinet. The underside of the wood top is unfinished with remnants of an earlier green over-paint from the wall (Figure 96). Carpet from the dining room continues under the cabinet doors and into the cabinet's interior. A non-original 12-inch by 12-inch grey VCT below the carpet and quarter-round shoe molding were likely installed prior to the current carpet and kitchen tile (Figure 97). The soffit of this built-in unit consists of beaded tongue-and-groove paneling, which is on the underside of the stair framing.

FIGURE 95. Original built-in shelving and cabinet at dining room.

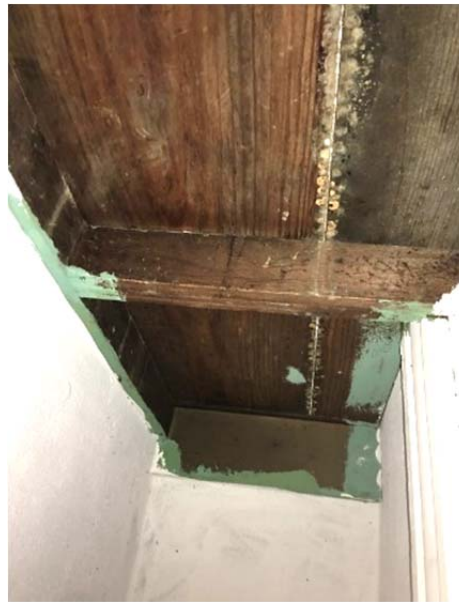
FIGURE 96. Underside of cabinet at dining room.

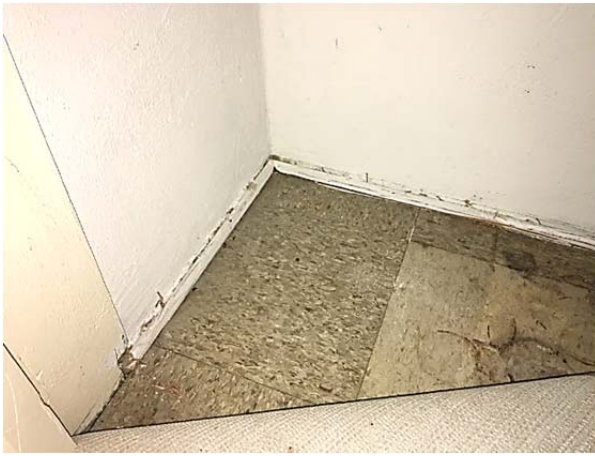
FIGURE 97. Original plaster wall and non-original VCT flooring at cabinet interior.

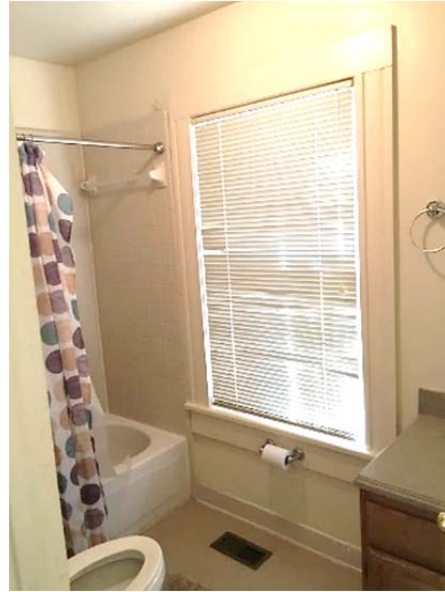
The floor in the bathroom is a 2-inch by 2-inch beige porcelain ceramic tile with a 4-inch beige ceramic cove base. Walls and ceilings are painted gypsum board except at the tub where there are 4-inch by 4-inch glazed ceramic wall tiles on the two end walls and back wall of the tub, extending approximately 5 feet 6 inches above the tub, where they terminate with 2-inch by 6-inch bullnose tiles (Figure 98).

FIGURE 98. Updated and enlarged bathroom at the first-floor apartment.

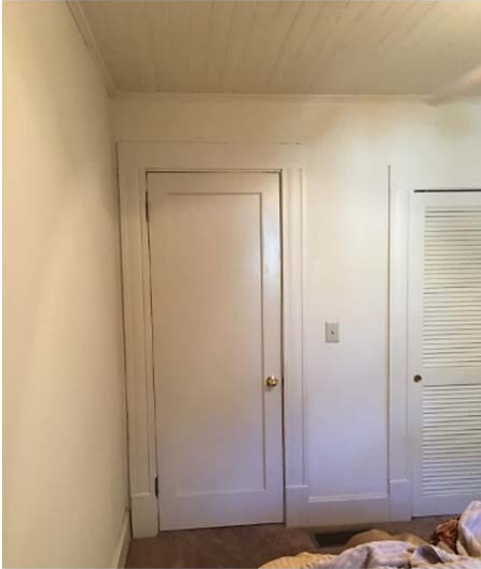
FIGURE 99. The relocated bedroom door (left) and remodeled closet (right) at south bedroom.

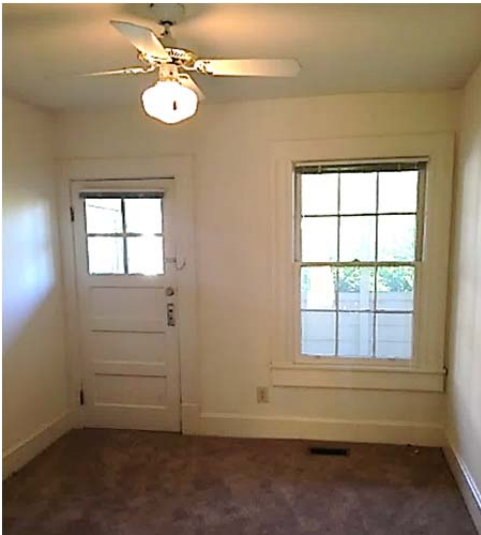
FIGURE 100. The internal bedroom at the lower unit was a kitchen for the south unit prior to its rehabilitation in 1993.

The second bedroom, adjacent to the stair, was formerly the kitchen for the south apartment prior to 1993.¹¹⁶ A door and one double-hung window in the west wall open to the porch (Figure 100). On the north wall, the original built-in millwork was removed and replaced by a closet with sliding,

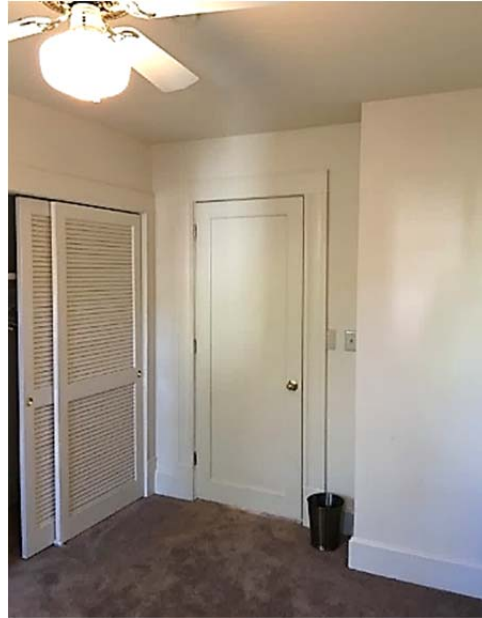
louvered doors, a single painted wood shelf, and a clothes rod (Figure 101).

FIGURE 101. Interior bedroom door to living room (center) and sliding closet doors (left).

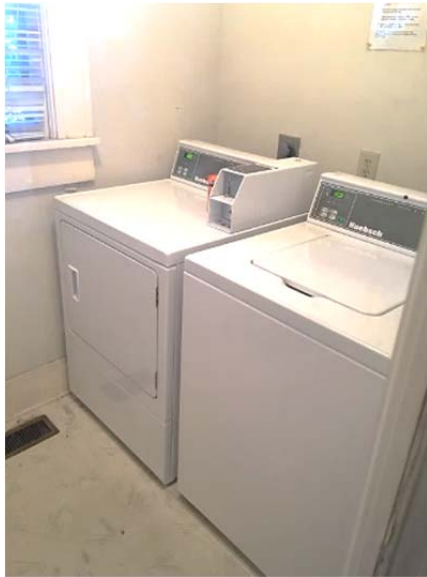
A coin-operated commercial washer and electric dryer are located on the north wall (Figure 102). The vent from the dryer runs below the floor and out through the brick skirt wall of the crawl space. In the southwest corner of the laundry is a gas water heater, which serves the first-floor living unit. Water and gas piping serving the heater penetrates the floor from the crawl space below. A vent flue rises through the wood-framed, screened porch above to a flue cap on the roof. The only light in the laundry is a single porcelain fixture with an exposed bulb and a pull string switch.

FIGURE 102. Coin-operated washer and dryer in the shared laundry.

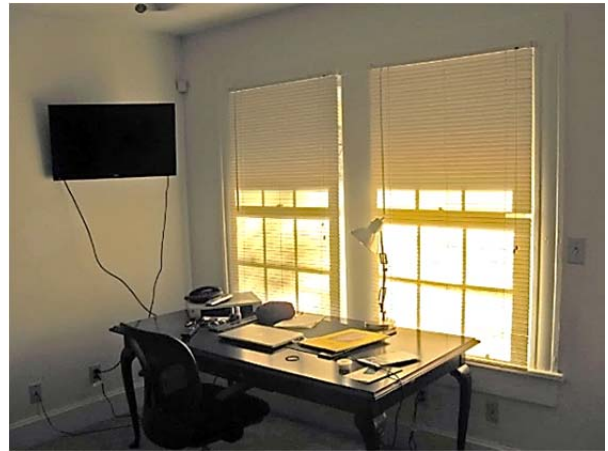
FIGURE 103. Joined double-hung windows at living room of the north apartment.

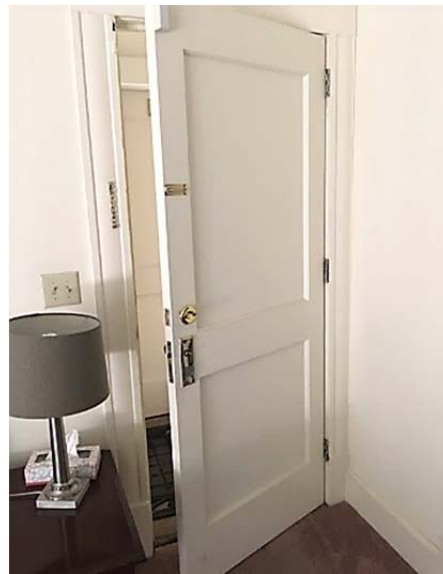
Second Floor – Living Rooms. The two apartments on the second floor of the building at 54 Howell Street are currently rented to National Park Service employees. Both units were occupied at the time of the site visit. The layouts and finishes of the two second-floor units are nearly identical and retain the arrangement of the original construction. The living rooms are located on the street (east) side and have access directly to a shared porch overlooking Howell Street (refer to Figure 75). A pair of joined, six-over-six double-hung windows and an exterior door open to the porch the same as the units below (Figure 103). The primary entrance to each apartment is directly into the living room from the central stair vestibule (Figure 104).

FIGURE 104. Two-panel door at entry to north apartment from the central stair.

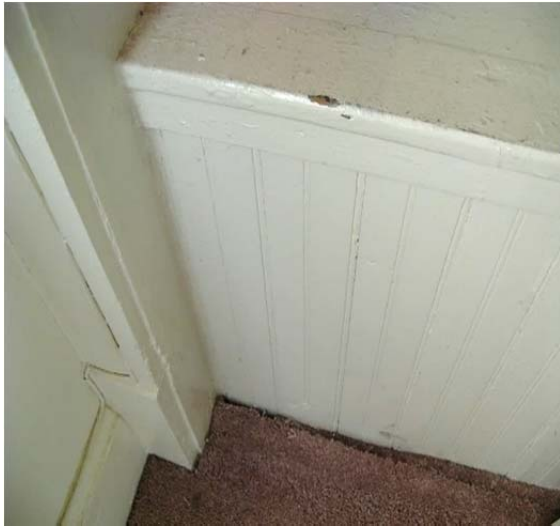
A coat closet in the living room of each apartment appears to be original. Textured plaster walls and beaded panel ceilings remain at each of the back-to-back closets. Furred enclosures built above the stair retain original vertical beaded panels and a solid wood top (Figure 105). A single shelf is supported by a wood ledge with several bent wire coat hooks (Figure 106). These hooks were noted in other buildings in the district. They are likely

FIGURE 105. Beaded wood paneling in the closet above the north stair appears original.

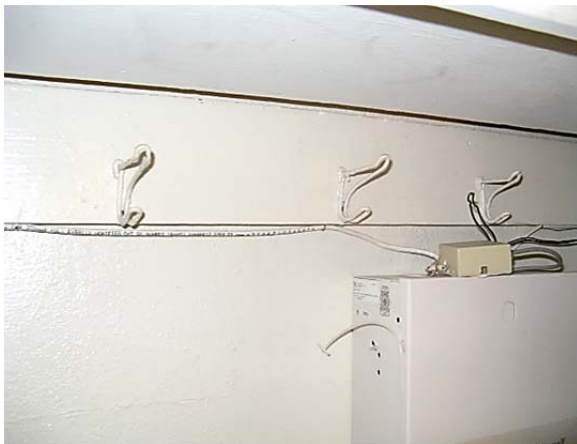
FIGURE 106. Bent wire coat hooks consistent with homes of the period.

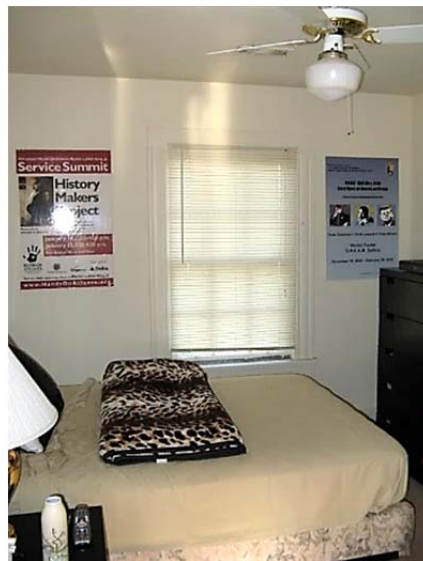
Second Floor – Bedrooms. Bedrooms in the second-floor apartments remain in their original locations along the outside corners of the rear (west) elevation. A single 6-over-6 double-hung window is in the center of each exterior wall (Figure 107). When the building was rehabilitated in 1993, bedroom doors were relocated when bedroom closets were enlarged. The closets are non-original with a single painted wood shelf and sliding louvered doors with round brass pulls. Finishes in the bedrooms are also non-original. Door and window casings and baseboards are consistent with other rooms in the building, and carpet is continuous from the living rooms into the bedrooms.

FIGURE 107. Overall view of the bedroom at the north apartment.

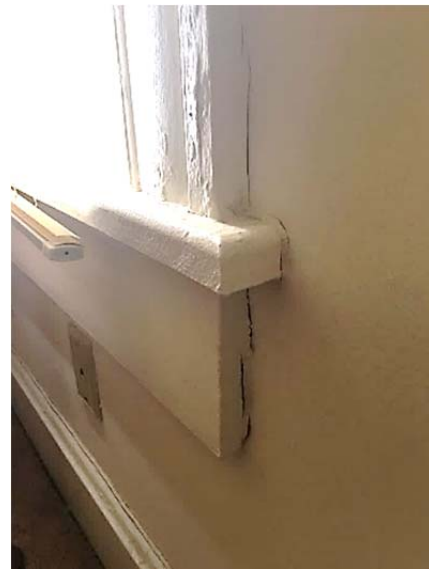
- There are separations between trim elements and the gypsum wall at the wood baseboards, door and window casings, and window aprons (Figure 115). These appear to be related to contraction or warping of the wood members after installation. It is not known if the trim is back primed.
- There is a linear crack in the plaster on the west side of the second-floor landing of the rear stair (Figure 116).
- A hole in the gypsum board at the north wall of the north second-floor apartment is patched with a thick gypsum patch material. The patch is crudely installed and appears not to have been sanded or painted (Figure 117).

FIGURE 115. Typical separation between trim elements and gypsum board.

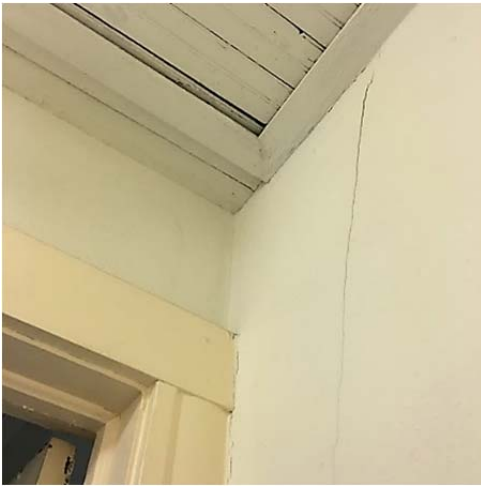
FIGURE 116. Linear crack in plaster at rear stair.

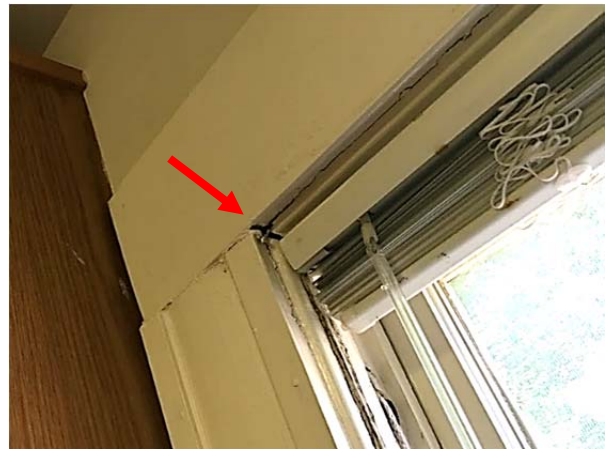
- At some locations, the interiors of windows exhibit signs of decay due to moisture infiltration at the glazing pocket and / or condensation (Figure 121 and Figure 122).

FIGURE 122. Separation of components at interior of window.

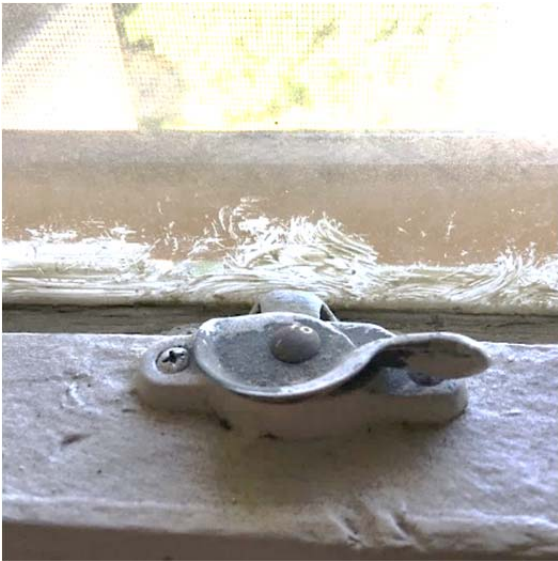
- Paint was delaminating at some interior muntins (Figure 123).
- Windows appeared operable at some locations. Others were painted shut and inoperable. At some, the sash locks did not align at the meeting rail and could not be secured (Figure 124). Several lifts were missing.

FIGURE 124. Alignment of meeting rail does not allow sash lock to close.

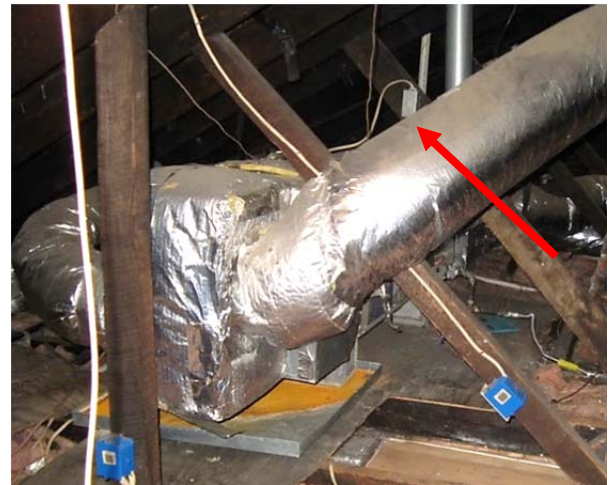
- During the site visit, the mechanical system at the second floor north was not cooling. Fans were being used by the occupant to control temperature.
- Electrical cut-off for HVAC units is a toggle switch located in a junction box near the unit (Figure 135).

FIGURE 135. Toggle switch for HVAC unit.

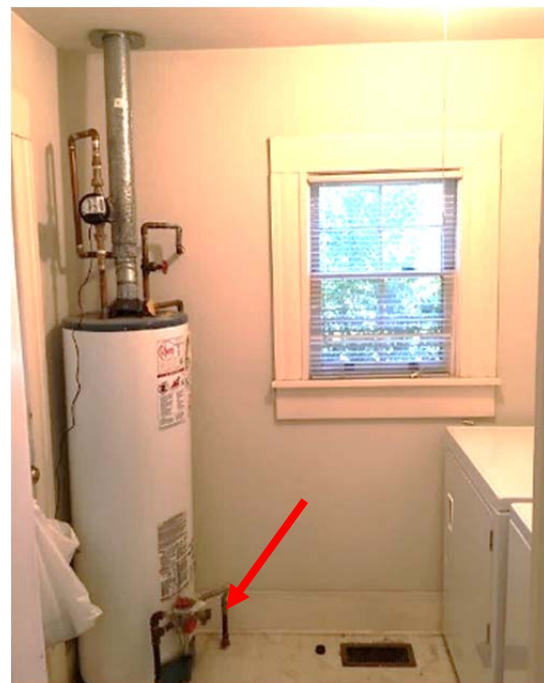
- Several issues were noted for comment at hot water heaters. Water heaters were mounted directly on the floor level with no overflow pans. Water lines typically penetrated gypsum walls with no insulation or escutcheons to protect and seal the wall cavity. The gas line serving the unit penetrates the floor in front of the unit with a valve at the floor and a flexible gas line above. This valve location is unprotected and vulnerable to traffic or in the working space in front of the dryer (Figure 136). At the second-floor water heater, gypsum wall board had been removed at the water and electric line penetrations the wall had not been patched (Figure 137).

FIGURE 136. Floor penetration of gas service line at laundry hot water heater. Water supply piping entering wall is uninsulated.

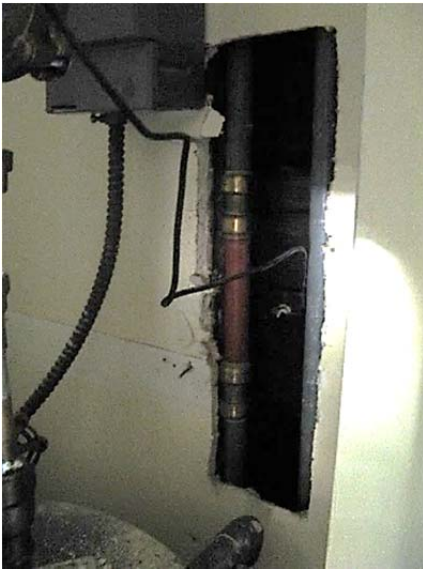
FIGURE 137. Opening in gypsum wall board at hot water heater, north second-floor apartment.

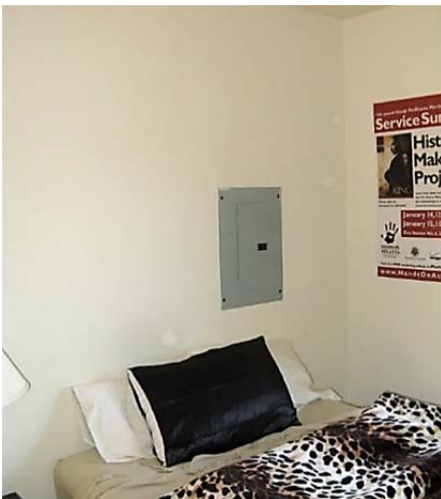
- Electrical panels at the second-floor apartments are installed in the interior wall of the bedrooms (Figure 139). This location is problematic as the space in front of the panel is the most convenient location for the beds. The National Electrical Code (NEC) requires 36-inch minimum clear floor space in front of an electrical panel.

FIGURE 139. Electrical panel above bed at north apartment.

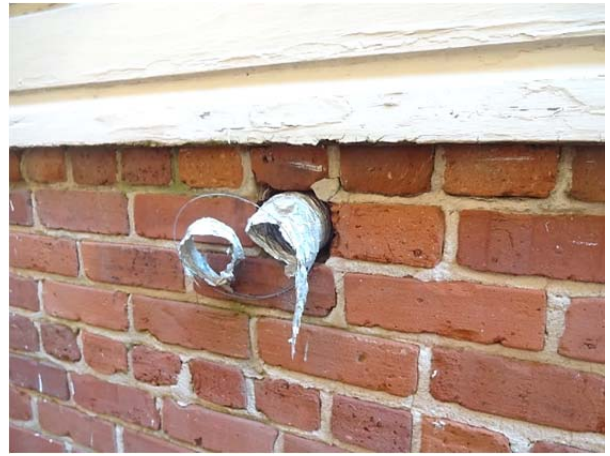
A power exhaust vent is installed in the ceiling of each bathroom. Vents from the second-floor bathrooms are ducted through flexible foil connections to metal vent caps on the east side of the roof. A similar flexible foil connection leads from the first-floor bathroom to the crawlspace, exiting through the brick skirt wall. No cap or screen protection was present at this location (Figure 143).

FIGURE 143. Flexible foil exhaust vent from first-floor bathroom at penetration of south skirt wall.

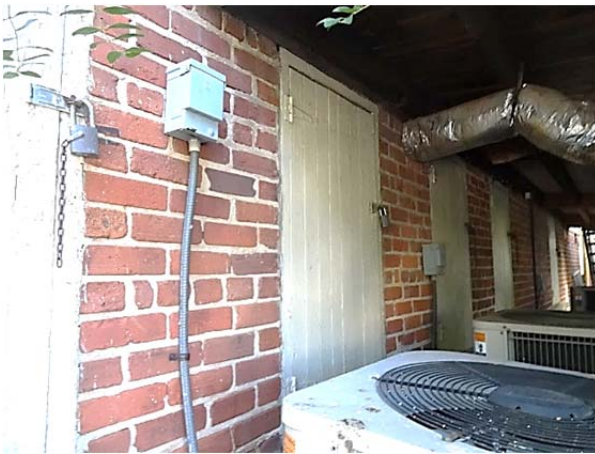
Condensing units for the three systems are located under the rear (west) porch (Figure 142). Electrical disconnects are mounted on the crawlspace wall. Refrigerant lines are routed through the crawlspace and internal walls and did not appear to be insulated between the unit and the crawlspace wall.

FIGURE 142. A/C condensing units under the rear porch.

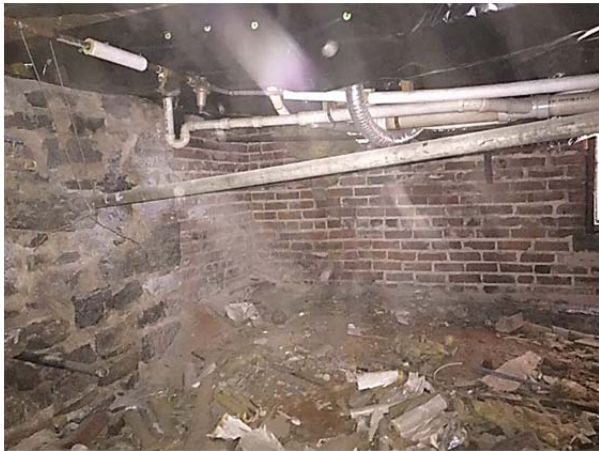
Plumbing. Plumbing fixtures and piping throughout the building appear to have been replaced in the recent rehabilitation project. Water and gas service enter the crawl space from Howell Street, on the west elevation (Figure 144). Water piping appears to be copper where exposed to view in attics, crawl spaces, and at lines serving hot water heaters. Insulation was not consistently present on exposed-to-view water lines (Figure 145).

FIGURE 145. Drain and supply piping at crawl space.

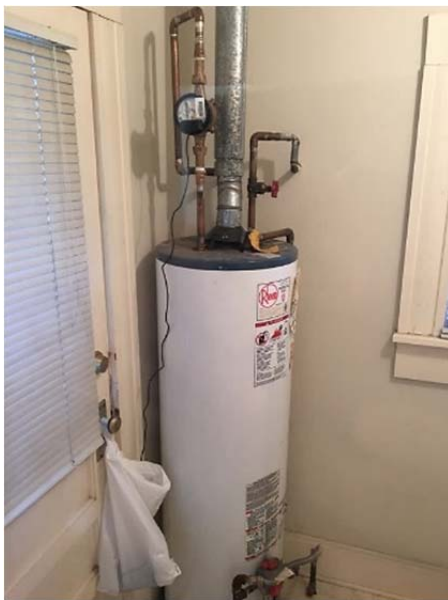
A natural gas, tank-type hot water heater serves the lower unit from the common laundry space (Figure 146). The flue for the unit extends vertically through the porch flooring and screened porch roof above with a vent mounted on the roof. Tank-type water heaters serving the second-floor apartments are 40-gallon (north) and 65-gallon (south) 240 volt electric units located in the

kitchen pantry closets (Figure 147). All water heaters are metered where pipes exit the water heater. Exposed to view hot and cold pipes were not insulated. Drain pans with secondary drains were not noted to be present at units. The gas water heater in the laundry did not appear to be elevated above the floor. The gas connection to this unit is through a valve in the floor (refer to Figure 136). The valve and gas line are vulnerable to traffic in the workspace in front of the dryer. Gas-fired appliances are vented to caps on the west side of the roof.

FIGURE 146. Gas hot water heater at first-floor apartment (located in laundry).

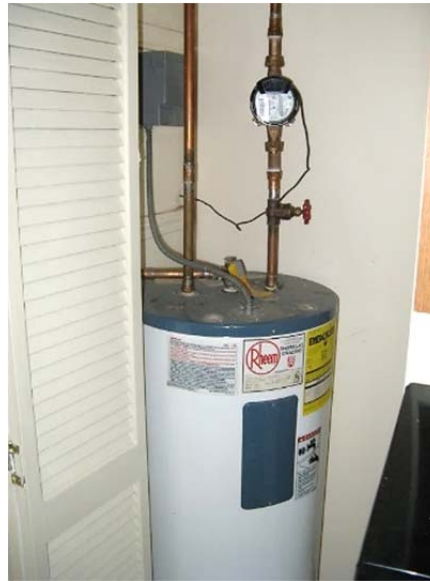
FIGURE 147. Typical electric hot water heater at second-floor apartment.
