historic structure report
architectural data section
volume 1
june 1985

HISTORIC STRUCTURE REPORT

LINDENWALD

MARTIN VAN BUREN NATIONAL HISTORIC SITE

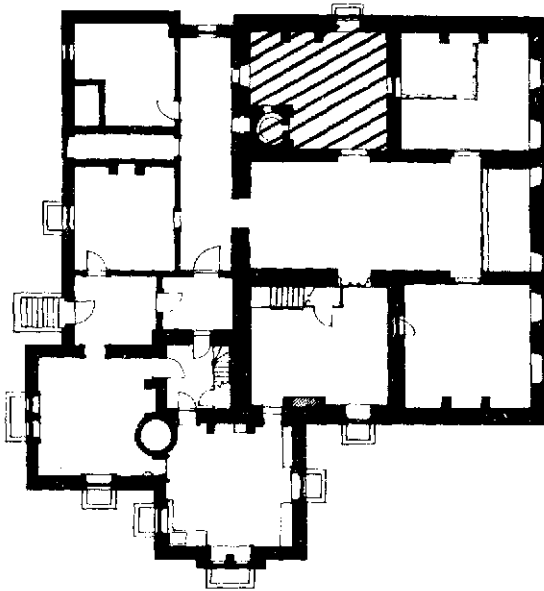
a. Room 001 - Furnace

Room 001 occupies the northwest corner of the 1797 house. To the best of our knowledge, there is no documentary or photographic evidence concerning the earliest appearance or uses of this room. The historic hot-air furnace and the modern oil-fired boiler in this room provide eloquent proof of its use from the last years of Van Buren's life to the present. (The furnace is dated to Van Buren's lifetime by the patent date "August 22, 1854" on its cast-iron firebox door and by the inscription on its sheet metal access door, "Hon. M. Van Buren/Kinderhook, N.Y.") See section IV.C.2. for a full description of the historic heating system.

Walls are unpainted stone rubble except for the white-painted brick furnace enclosure in the southwest corner and the unpainted arched brick chimney foundation on the north wall. High on the north wall west of the chimney foundation is an area of loose stonework. Near the base of all walls and especially on the furnace, mortar is powdery or has fallen out of the joints because of "rising damp." The floor is a lime mortar wash, roughly $\frac{1}{2}$ " thick, over sand. In the middle of the room, the lime mortar has been destroyed by moisture and wear. The lime mortar is intact near the walls and extends roughly 10" up the wall surface. The floor level is lower than that of any other room in the 1797 portion of the basement. This level coincides with the bottom of the ash clean-out door of the furnace, and the furnace occupies the full height of the room, so it is assumed that the floor of this room was excavated to accommodate the furnace. (For further discussion of this point, see NPS, Fiero 1983.)

Restore the bell pull system.

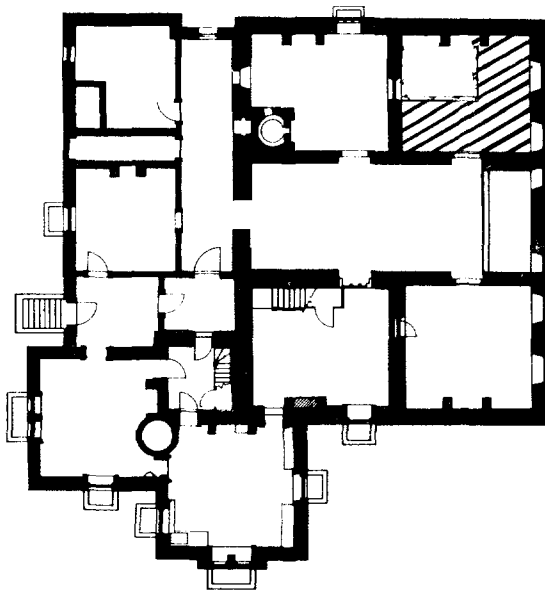
b. Room 002 - Storage

Room 002 occupies the northeast corner of the 1797 house. The northwest corner of this room was separated by a wood stud and board partition creating room 002A (discussed below). No documentary or photographic evidence relating to the historic use and appearance of this room survives. However, wrought-iron hooks in the ceiling, a "cistern" in the floor, and shelves in room 002A suggest that its primary function was food storage of some sort.

The original walls of this room are whitewashed rubble masonry with lime mortar except for the arched chimney foundation on the north wall, which is whitewashed brick, and the whitewashed board-on-studs partition, which separates room 002A from room 002. The boards in this partition are sash-sawn, and they are attached to the studs with cut nails. The plates and some of the studs used in this partition have empty mortises with no associated evidence of missing members, suggesting that they are reused. Because of the way the different materials meet, it is clear that the partition predates both the floor and ceiling finishes.

- Repoint the walls as necessary.
- Remove the steam-heating pipes.
- Repair the ceiling.
- Repair the partition.
- Replace the doors.
- Repair or reconstruct the windows.
- Whitewash the wall and ceiling surfaces.
- Restore the floor.

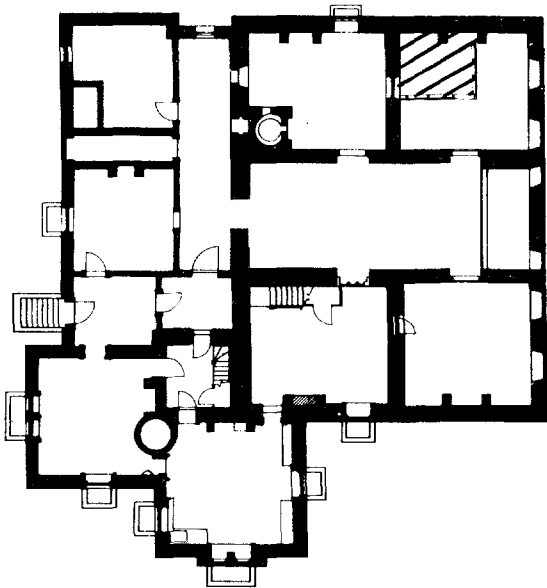
c. Room 002A - Storage

Room 002A is the space that was partitioned off in the northwest corner of room 002. It is apparent from the shelving, the lock evidence on the door, and the jars and bottles still on the floor and shelves that the room was used for food storage.

The walls of room 002A are the same as those of room 002 except that the stone walls are the north and west walls and the board partition forms the south and east walls.

Repair the shelves.

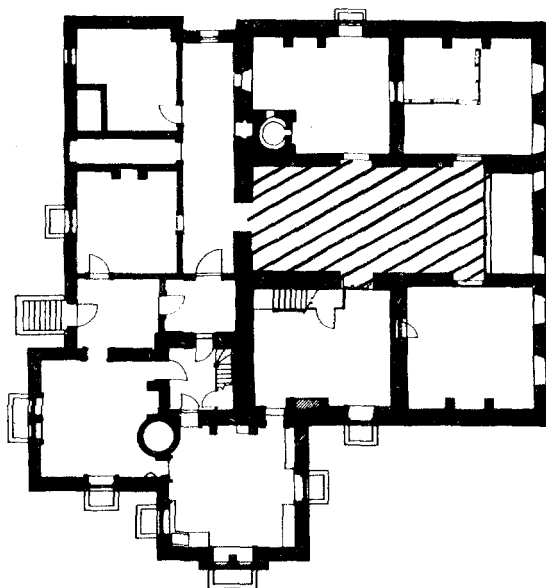
d. Room 003 - Hall

Room 003 is the central hall of the 1797 part of the basement. It provides access to rooms 001, 002, 003A, 004, and (originally but not during the historic period, 1850-62) 005. It is entered from room 012. Access was its primary function, but it may also have been used as a nonsecure storage area.

The north, south, and west walls are rubble masonry, parged and whitewashed. Crumbling mortar and peeling whitewash at the base of these walls indicate a "rising damp" problem. The east wall is a board partition, which was installed before the floor and ceiling finishes because the ends

- Improve structural reinforcement, with better footings and columns.

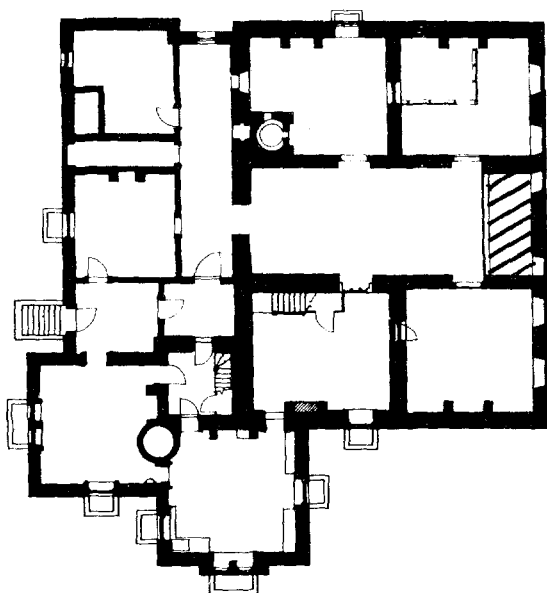
e. Room 003A - Vegetable Bin

Room 003A is at the east end of room 003. Archeological investigation seems to confirm the tradition that this room was used for vegetable storage. It may be the storeroom mentioned by Harriet Butler in her letter of May 17, 1841: "I am glad to hear from Smith that your store room is made. It will need a good lock and the key always in the hands of a trusty person" (Van Buren Papers, CCHS).

The east and south walls are parged and whitewashed rubble masonry. The north wall is two wythes of brick laid in American bond, with headers every fourth or fifth course, and whitewashed

Whitewash the walls.

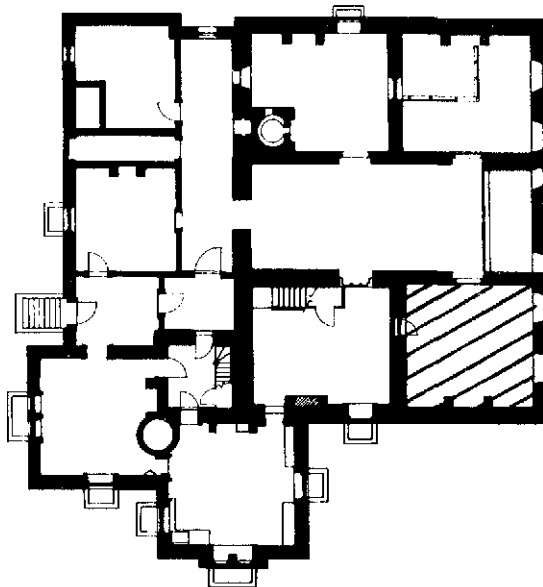
f. Room 004 - Wine Storage

Room 004 occupies the southeast corner of the 1797 basement. The surviving racks and barrels suggest that the room was used for storage of beverages. Evidence below leads to the conclusion that these fixtures are historic.

The walls are whitewashed rubble masonry with heavily mortared joints. The arched brick chimney foundation against the south wall is also whitewashed. Due to "rising damp" or infiltration of rainwater, the mortar at the base of the walls is slightly deteriorated.

Restore the bell pull system.

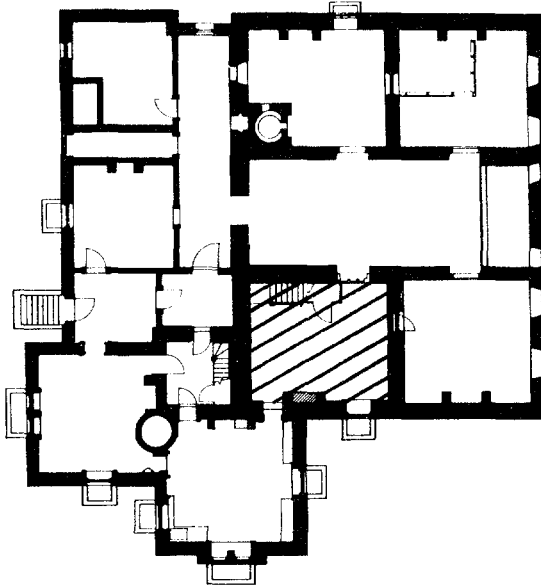
g. Room 005 - Servants' Dining and Stair

Room 005 is in the southwest corner of the 1797 part of the house. According to tradition, it was used as the servants' dining room during the historic period. The evidence of call bells, the stairs, the wallpaper, and the proximity to the kitchen (room 006) combine to add credence to the tradition.

The walls of room 005 are a two-coat plaster on wood lath attached to furring strips with ca. 1850 nails. Behind the furring strips, the rubble masonry walls are whitewashed. The plaster is covered with a striped floral wallpaper. Analysis of this wallpaper is presented in section VI.C.

Paint all woodwork (cream, Munsell 5Y 9/2, Benjamin Moore GB-60).

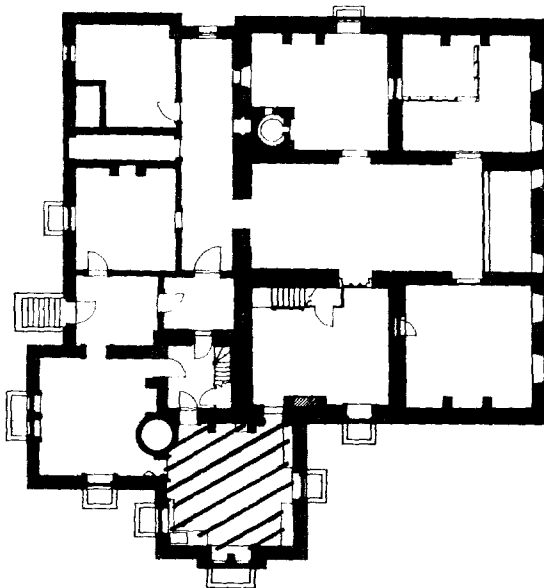
h. Room 006 - Kitchen

Room 006 is in the south bay of the ca. 1850 addition. It was the kitchen for the Van Buren household during the historic period. The evidence for this use consists of the cast-iron range and ovens in the north wall, the water supply, the cupboards, and the circular brick oven in the northwest corner of the room.

All of the plaster, lath, and furring strips are completely gone from the walls of this room. The exterior walls (east, south, and west) are of coursed rubble masonry with horizontal wood nailers incorporated into the construction for attachment of

- Return the shelving in room 114 to room 006.

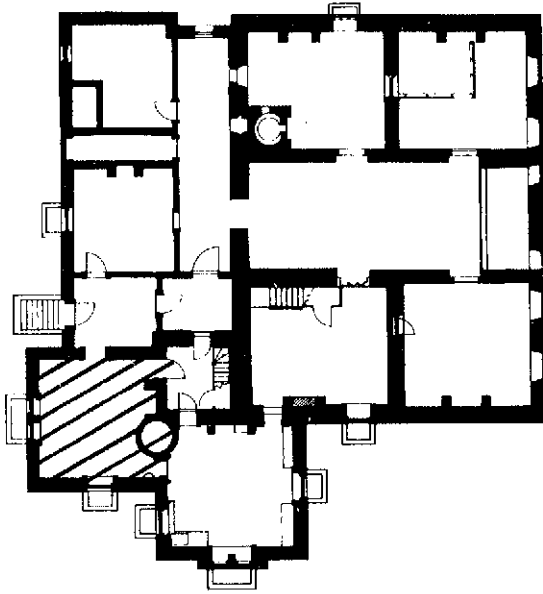
i. Room 007 - Laundry

Room 007 is in the southwest corner of the ca. 1850 addition. It was apparently the "wash room" referred to in Upjohn's specification for basement floors. This hypothesis is drawn from the survival of a hand pump and lead-lined wood sink on the south wall of the room. Also the uses of the other rooms in the ca. 1850 portion of the basement have already been determined, or the rooms do not have the water supply required for a washroom.

The south, west, and north walls of room 007 are coursed rubble masonry with built-in wood nailers for the attachment of furring strips. The east wall is brick

Restore all woodwork to a cream color (Munsell 5Y 9/2, Benjamin Moore GB-60).

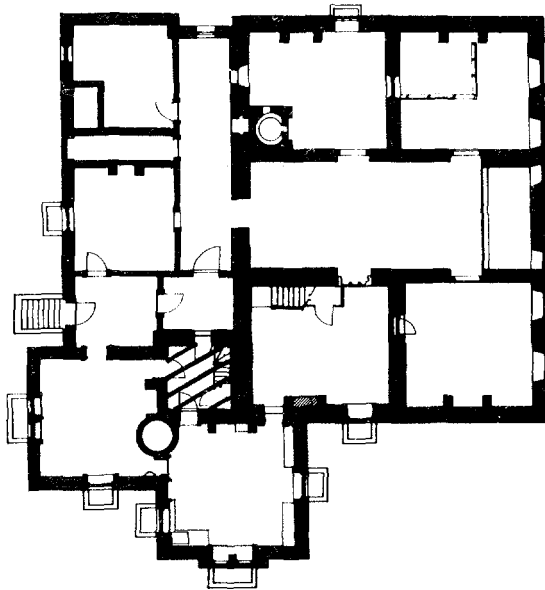
j. Room 008 - Stair Hall

Room 008 is the lowest level of the tower stair and the primary interior access to the basement. The walls of the room are whitewashed, two-coat plaster directly on masonry walls. The north and east walls are rubble stone construction; the south and west walls are brick. Aside from minor damage to the south wall (caused by rising damp) and to the northwest corner (probably caused by leaking pipes), the plaster and masonry are in good condition. The east wall under the stair consists of a board partition with a board-and-batten door, both of which have a painted wood-grain finish. The underside of the stair and the

east and south walls behind this board partition are finished with plaster and whitewash. Typical ca. 1850 baseboard for secondary spaces is found in the main part of the room and around the south and east walls under the stair, but not on the board partition. Thus, this partition is considered nonhistoric, as are similar partitions in room 005 and between rooms 113 and 117.

- Restore all woodwork to a cream color (Munsell 5Y 9/2, Benjamin Moore GB-60).

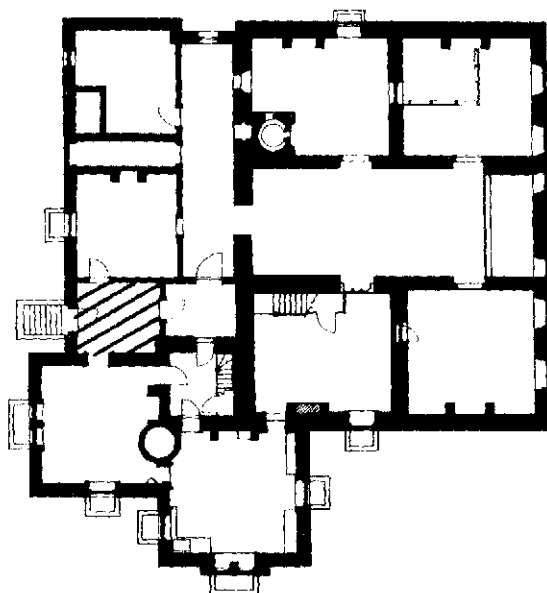
k. Room 009 - Basement Entry

Room 009 is a vestibule/entry space. Door 012 in the west wall of the room gives access to the bulkhead stair. The historic cesspool is under the floor of this room. There is also evidence that suggests the brick platform in the southeast corner may have supported a water heater.

The walls are masonry covered with two-coat plaster and light gray whitewash. The south and west walls are coursed rubble stonework, and the east and north walls are brick. At the southeast corner the stone foundation of the tower projects into the room. On the south wall just west of the tower foundation

Restore all woodwork to a cream color (Munsell 5Y 9/2, Benjamin Moore GB-60).

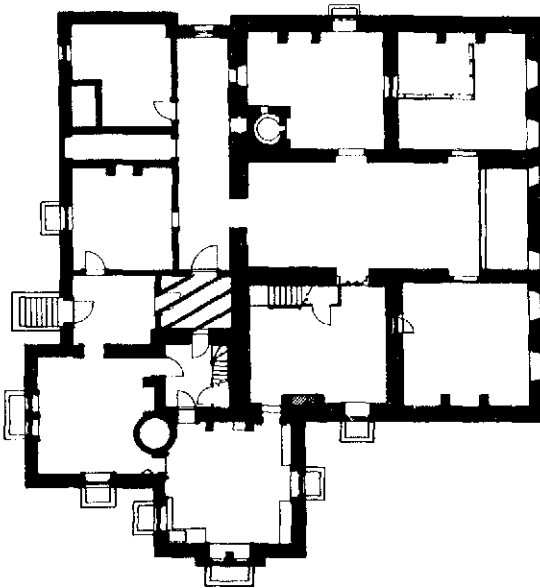
1. Room 010 - Transitional Space

Room 010 is east of room 009 and north of room 008. It is a small rectangular space 10' by 7'6" whose only apparent use is as a transitional space between rooms 008, 009, and 012.

The walls are covered with a two-coat plaster and whitewash. Except for minor cracks, a large area of missing plaster in the southwest corner, and a small area of missing plaster near the floor in the northwest corner, the plaster is in good condition. In the east wall there are two straight vertical cracks, extending from floor to ceiling, indicating an infilled door. The north jamb of this door was about

- Restore all woodwork to a cream color (Munsell 5Y 9/2, Benjamin Moore, GB-60).

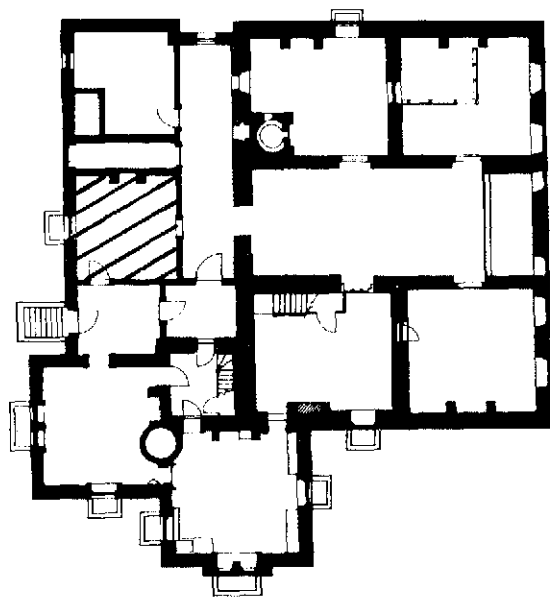
m. Room 011 - Chamber

Room 011 is along the west wall of the ca. 1850 portion of the basement, just north of room 009. There is no documentary evidence of its use, but the presence of a fireplace suggests that it was used for human habitation--possibly a servants' bedroom.

The walls of room 011 were covered with a whitewashed two-coat plaster. Plaster was applied directly to the brick on the north, east, and south walls and to wood lath over furring strips attached to wood nailers that were incorporated into the construction of the coursed rubble stone west wall. Plaster, lath, and furring strips are all

Restore all woodwork to a cream color (Munsell 5Y 9/2, Benjamin Moore GB-60).

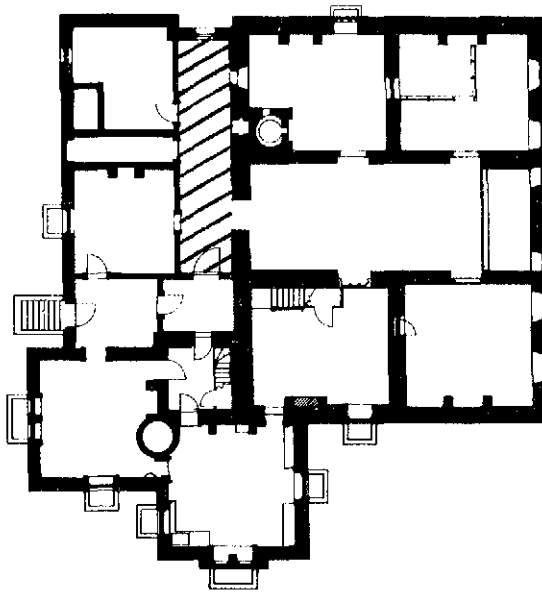
n. Room 012 - Back Hall

Room 012 is the back hall of the basement. It provides access from room 010 to rooms 003, 013, and 015. In recent years (and possibly earlier) it has been used as a storage area.

The south and west walls of room 012 are of brick construction with two-coat plaster applied directly to the brick. The plaster on the south wall is in good condition. On the west wall, plaster has deteriorated to a greater or lesser extent because of rising damp of variable intensity. The north wall is of coursed rubble stone construction similar to that of other exterior walls built ca. 1849. There is no evidence to

- Restore all woodwork to a cream color (Munsell 5Y 9/2, Benjamin Moore GB-60).

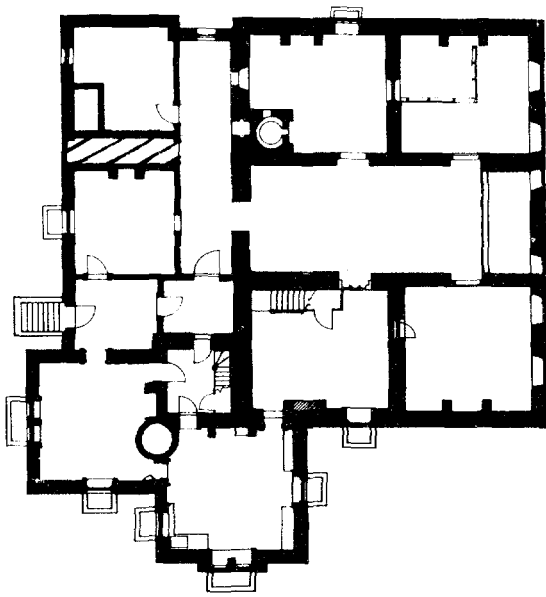
o. Room 013 - Vaulted Tunnel

Room 013 is a long, narrow room, 3'6" by 14'6", between rooms 011 and 015 (see IP024). It is bounded on the east by room 012 and on the west by the exterior foundation wall. Its historic and subsequent uses are a subject of considerable interest. The most plausible hypothesis is that this room and an adjacent small chamber to the west were used for cold food storage and ice storage respectively. The evidence supporting this hypothesis is presented in the following paragraphs.

The north and south walls of room 013 are of solid brick construction, three wythes (13") thick (compared to two wythes for adjacent walls). There is no structural reason for greater thickness, suggesting that insulation may have been the object of the thicker walls. The bond used in the brick work is American bond, with header courses at spacings ranging from three to six courses. There is no plaster on the walls and no evidence that there ever was. The end walls are completely dominated by door openings.

It is recommended that this room be preserved as is. If the room is to be interpreted to the public, door 010 should be opened and the room beyond should be reconstructed.

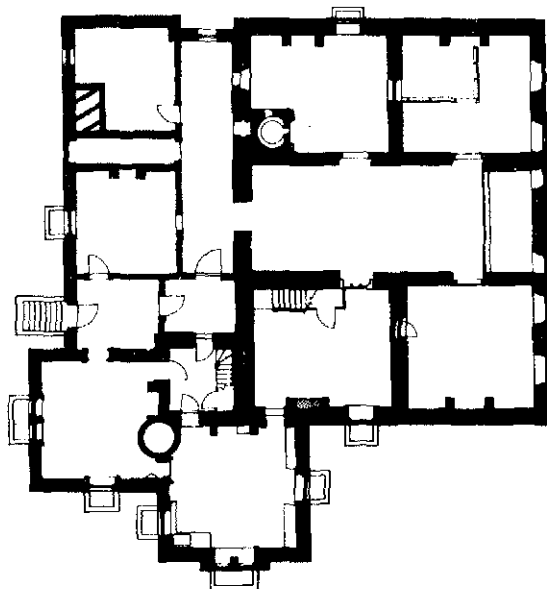
p. Room 014 - Privy Pit

Room 014 is not really a room at all. It is the interim repository for human wastes from room 121 pending their ultimate disposal in another place. It is along the west wall of the basement, adjacent to room 013 and seemingly carved out of the southwest corner of room 015. Interior dimensions are approximately 3'6" by 6'0". Its proximity to the ice and food storage areas seems unsanitary, but as demonstrated by the presence of the cesspool in room 009, either sanitation was not well understood by the architect and owner or it was not a matter of great concern.

The north, east, and south walls are of solid brick construction with a badly constructed stone lining that has partially collapsed and appears to be unstable. The west wall is the coursed rubble stone construction typical of ca. 1849 exterior foundation walls. The lower portion of the interior walls is covered with fill, which was partially excavated by Denver Service Center archeologists in the summer of 1978 (see NPS, Fiero 1983). A portion of the north wall either collapsed or was taken down. The resulting 3' radius hole is roughly the shape of a quadrant, with its center at the intersection of the floor of room 015 and the west wall.

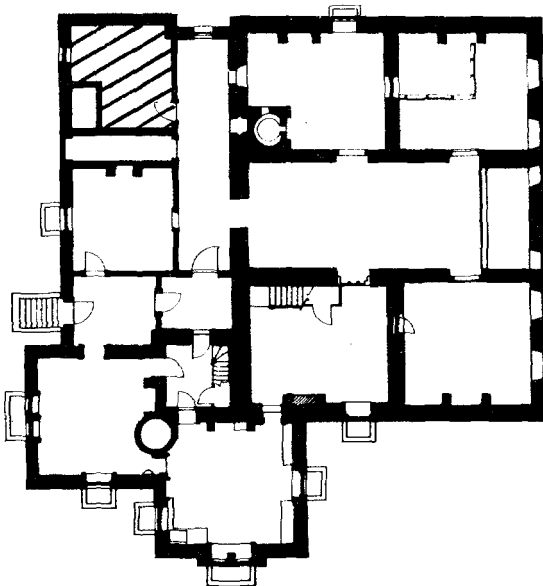
q. Room 015 - Coal Storage

Room 015 is at the northwest corner of the ca. 1850 addition to Lindenwald. The remaining piles of coal in the room, the bricked-in opening on the north wall (which appears to have been a coal chute), and its proximity to room 001 suggest that this room may have been used for coal storage during the historic period.

The floor of room 015 is paved with brick, and areas of the brick are covered with a lime mortar wash approximately 1/2" thick. The broken edges of this wash and the dispersed locations of the surviving areas suggest that at one time the entire floor was covered with this material. The floor is 7" to 8" lower than the floor in room 012.

The preservation and restoration work recommended for room 015 includes the following items:

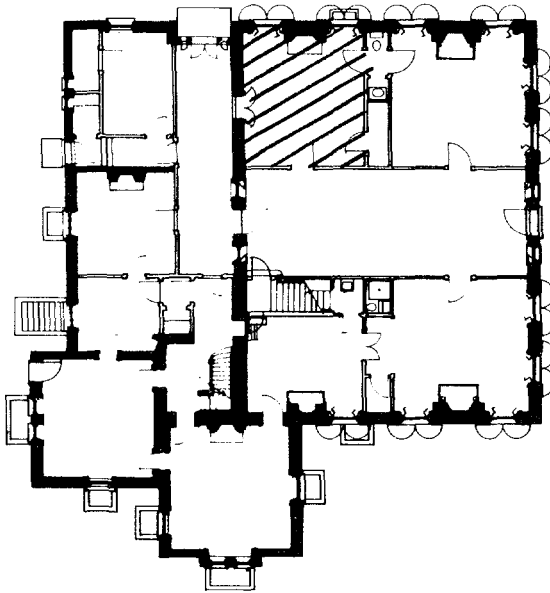
a. Room 101 - Bedroom

Room 101 is in the northwest corner of the 1797 house. Direct access is from the 1797 central hall, room 105, on the south wall (D101). Door 104 at the north end of the east wall opens into a small closet, room 102, and allows one to pass into the northeast room 104. Originally room 102 was connected to a larger closet, room 103. A door opening in the west wall has functioned as a closet since 1849 (D105). The north wall has a central chimney breast and windows (W109, 110) at either side.

Van Buren, as in other 1797 rooms, also removed the chair rail in room 101. Its location is evidenced by plaster infill and irregularity. This change is assigned to Van Buren work of the early 1840s because of conclusive evidence found in rooms 105 and 109. Van Buren, in ca. 1854, installed a floor register for hot-air heat in the southwest corner. A stovepipe hole also was cut in the chimney breast, probably after the historic period.

The following preservation and restoration work is recommended to return room 101 to a bedroom:

Make miscellaneous plaster repairs, including plumbing and stovepipe hole patching.

Repair window shutters and replace hardware for all pulls, several butt hinges, and sash locks; repair jamb stops.

Restore the ceiling using a calcimine finish.

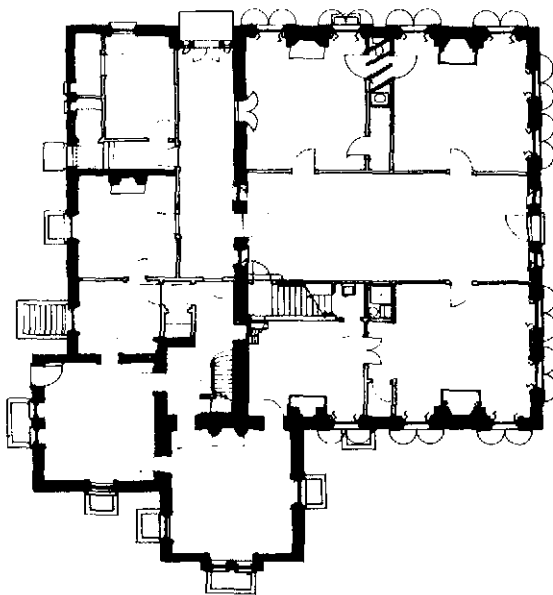
b. Room 102 - Bathroom

Room 102 is a small space between the two north rooms of the 1797 house. The space is formed by two parallel walls dating to 1797 that run in a north-south direction between rooms 101 and 104. A larger space, room 103, shares this enclosure south of room 102.

construction of a short partition wall to enlarge the closet. The 1936 Weig report (NPS, Weig 1936) and the oral history of the DeProsse family do indicate that toilet facilities were installed ca. 1920. In this instance, the 1938 drawing may be regarded as a record of existing conditions.

The preservation and restoration work recommended for room 102 includes the following items:

Restore the north wall door and casing to a cream color (Munsell 5Y 9/2).

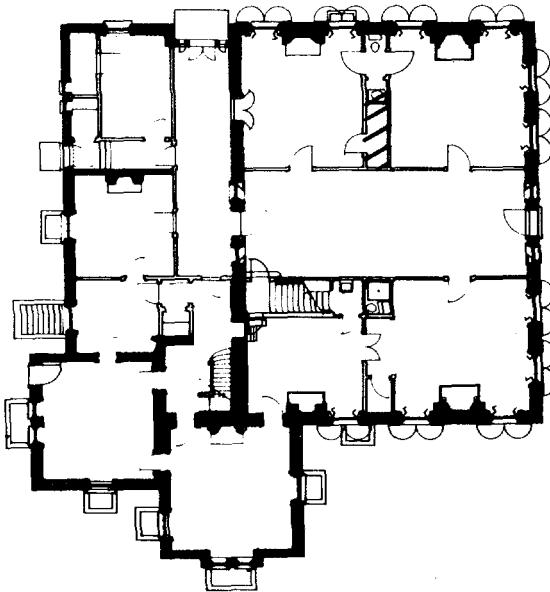
c. Room 103 - Closet

This room is a companion closet to room 102. It is a larger space that was originally constructed with its door opening on the south of room 102. Markings on the east wall indicate that it was originally lined with shelves. The shelves were 9'7" long, 7'4" high, and 1'½" wide and were placed approximately 1'5" apart. On the west wall there was a pegboard set into the plaster brown coat.

This space was altered sometime during the DeProse residency to accommodate modern plumbing fixtures. The north end of this closet was converted into a sink alcove using a board partition to

The following preservation and restoration work is recommended to restore this closet:

- Restore the north wall door and casing to a cream color (Munsel 5Y 9/2).

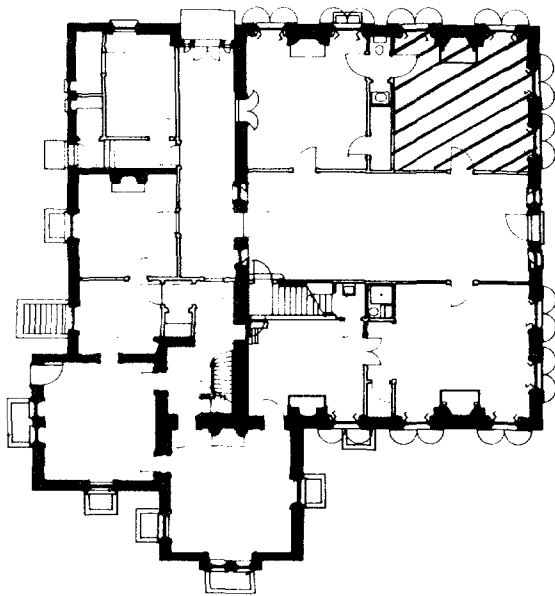
d. Room 104 - Parlor

This room occupies the northeast corner of the 1797 house. It is entered from the central hall, room 105 (D102), and also has access to closets 102 and 103 and through to room 101. The east (front) wall has two window openings (W105, 106), and the north wall has a central chimney breast flanked by window openings (W107, 108).

Changes in the decorative wall finishes in room 104, beginning with the ca. 1840 Van Buren period, are supported by both physical and documentary evidence. In 1978, when a large pier mirror was removed from between the east wall windows of room 104, a large section of early wallpaper, extending from the baseboard to several inches above the window casing, was found. This wallpaper is composed of black star motifs on a gray ground (005). In areas where the chair rail was removed, it is lined with the green paper associated with Van Buren's work in room 105 and therefore has been dated to 1841. This black star wallpaper is described in the 1936 Weig report as an "original wallpaper [star design-green border]" (NPS, Weig 1936, 47). Two photographs dating to ca. 1930 (HP19 and HP34) confirm that the paper was still on the walls, with small portions missing on the chimney breast. The mirror, behind which the wallpaper was found, was probably installed during Van Buren's residency. It required removal of the 1797 baseboard and chair rail and chiseling of the floorboard to half its depth to receive it.

Other changes in room 104 include the ca. 1854 introduction of a hot-air register in the south end of the west wall (see IP026 and section IV.C.), radiators on the east and north walls, and varnishing of the wood floor ca. 1960.* Previous insect damage, from wood bores and silverfish, may be found on the floors and the east wallpaper.

The following preservation and restoration work is recommended for room 104:

- Replace the plaster cornice astragal molding.

- Make miscellaneous plaster fills and repairs.

- Remove the cast-iron backing and investigate the masonry condition.

- Reconstruct the missing shutter leaf.

Replace the missing hardware: four shutter pulls, two butt hinges, and the shutter bar.

Remove the wood floor varnish.

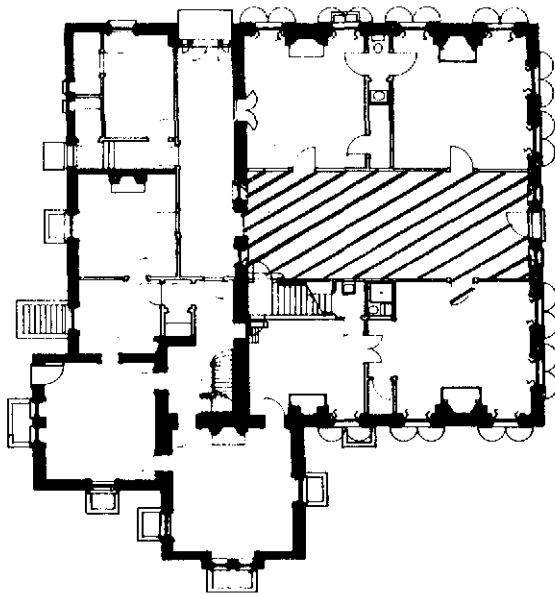
e. Room 105 - Banquet Hall

This room occupies the entire depth of the central portion of the first floor within the 1797 structure. Its original function was as an entrance hall both from the front (east-D101) and the back (west-D108) into rooms on the north and south and as a stair hall to the second floor.

Subsequent intrusions include hot-air heating system registers ca. 1854, one midway in the north wall baseboard and one in the northwest corner of the floor. A later register (ca. 1840), 3'4" square, associated with a kerosene burner, was also installed in the northwest area of the floor. There is a hot-water radiator in the southeast corner. Recent plaster patching around the east entry door may relate to the ca. 1849 porch and its deterioration.

The preservation and restoration work recommended to restore room 105 includes the following:

- Repair the plaster cornice.

- Consolidate and repair the plaster walls.

- Restore the hot-air registers (ca. 1854) in the north wall baseboard and northwest corner of the floor.

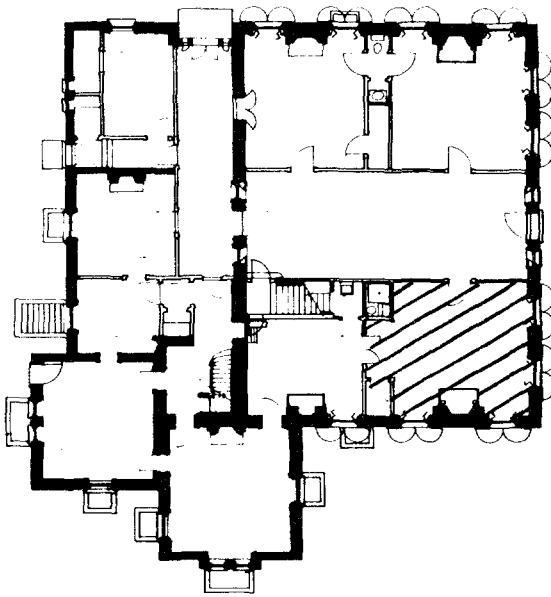
f. Room 106 - Parlor

Room 106 occupies the southeast corner of the 1797 house. It is entered through a door opening in the north wall (136) from the central hall, room 105. Two window openings are in the east or front wall (101, 102), and a chimney breast flanked by two windows (126, 127) is in the south wall. An ogee arch in the west wall frames an alcove with double doors (133) leading into room 109 and includes side doors (135, 134) into two small closets, rooms 107 and 108, respectively.

- Repair the plaster, including patching holes and creating a smooth surface over the chimney breast stovepipe openings.

- Replace one shutter pull.

Reproduce the missing knobs for door 134.

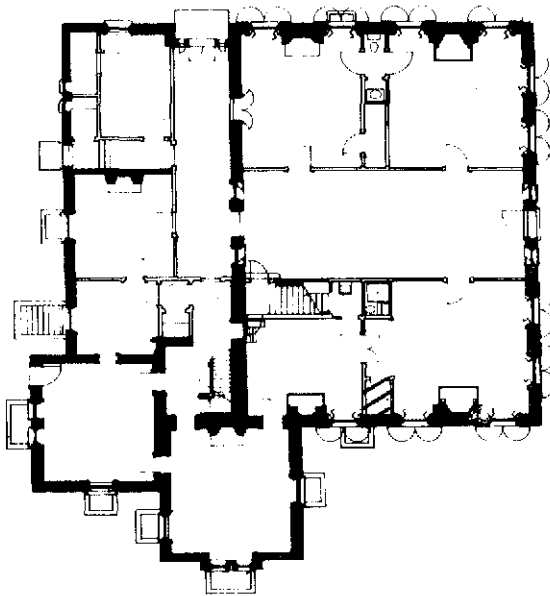
g. Room 107 - Storage

Room 107 is a small closet on the south side of the 1797 house between rooms 106 and 109. This closet is entered through a door opening (135) in the north wall from an alcove in room 106, the drawing room. Rooms 107 and 108 maintain a symmetrical relationship with rooms 102 and 103 on the north side of the central hall, room 105. The treatment of the four closets is different, however.

Changes in room 107 include a reworking of shelves and holes in wood and plaster to accommodate heat and water supply pipes. All remaining fabric in this closet is from the 1797 period of construction.

Restore all woodwork to a cream color (Munsell 5Y 9/2, Benjamin Moore GB-60).

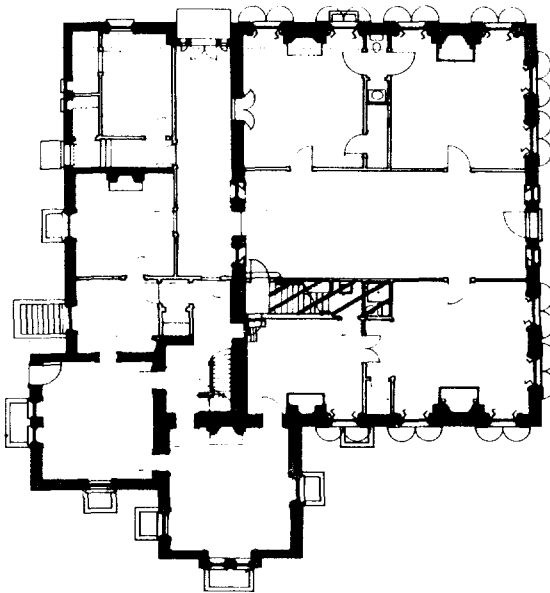
h. Room 108 - Closet/Stair/Bath

Room 108 is a small closet between rooms 106 and 109 on the north. There are three door openings into this closet, including a door from the room 106 alcove (D134), a door from room 109 (D132), and a door on the west wall into a stair hall leading to the basement room 005 (D131).

The major change in this closet appears to have occurred when the central hall stair was relocated by Martin Van Buren in the early 1840s. The physical evidence suggests that the stair access into the basement was relocated to maintain the parallel relationship between both sets of stairs.

Reproduce the gold-striped wallpaper (006) and its border.

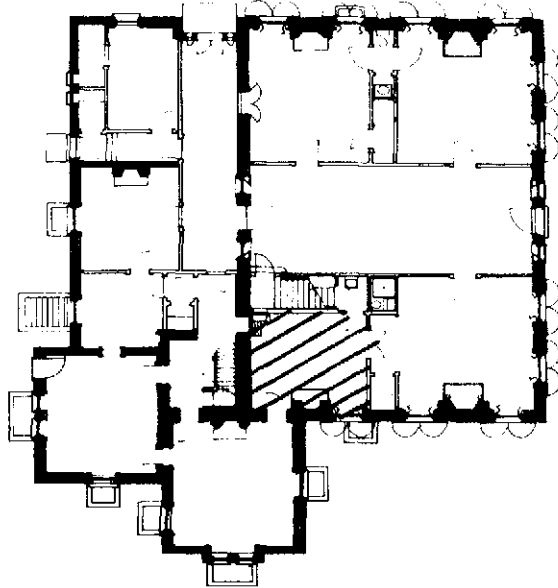
i. Room 109 - Library/Den

Room 109 is in the southwest corner of the 1797 house. In plan it is symmetrically opposite to room 101, a Van Buren bedroom. Although their functions appear to have differed, the decorative treatments for rooms 101 and 109 were similar. These rooms were secondary to the more formal front rooms (104 and 106) and central hall (105).

- Reproduce the gold-striped wallpaper (006) and its border; restore the fireboard and reproduce the scenic panel.

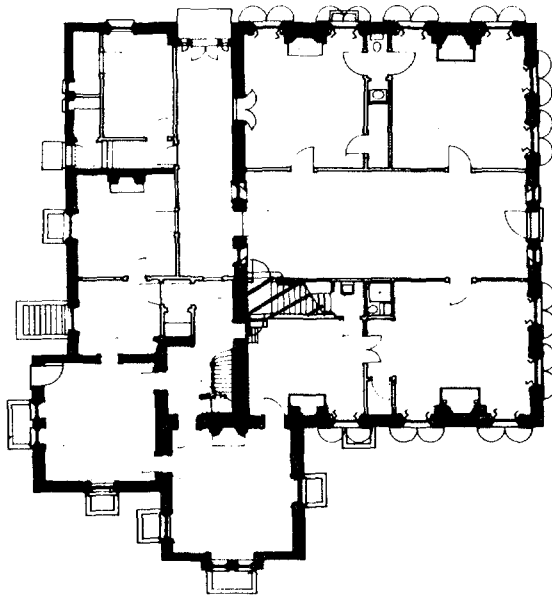
j. Room 110 - Stair

Room 110 is the number that has been assigned to the stairs that run from room 105 up to room 206. These stairs are located between rooms 105 and 109 in an area that was originally part of room 109. The north wall of the stairs is the 1797 north wall of room 109. Access on the first floor is from rooms 105 and 109; on the second floor it is only from room 206.

The stairs were first built in this location in 1840, when the staircase was removed from room 105. (See discussion of room 105 for the dating of this alteration.)

Restore the ceiling to a finish plaster white coat.

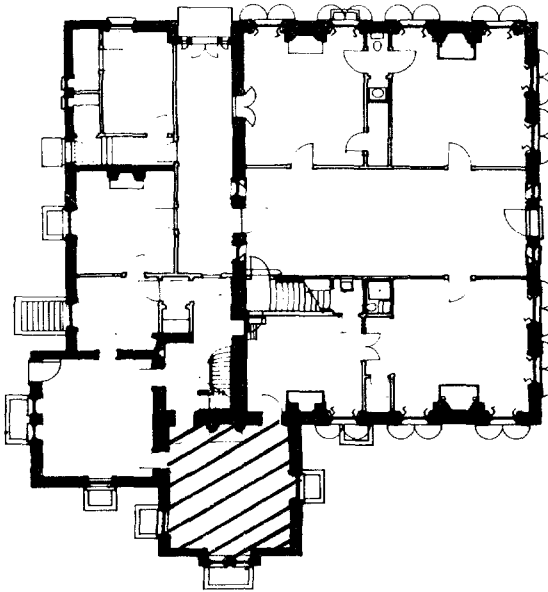
k. Room 111 - Library

As part of the 1849 additions designed by Upjohn, this room is assumed to have been the library. The plan records of Upjohn's office include details for the bay window of the library (Upjohn Planbook), and room 111 is the only first-floor room with a bay window. This room adjoins the south side of the 1797 house so that access is not only from room 113 (D126), the tower stair hall, and the bedroom, but also from room 109 (D128), the breakfast room.

Restore all plaster wall surfaces with a brown paint (Munsell 10YR 6/4, Benjamin Moore CB-9).

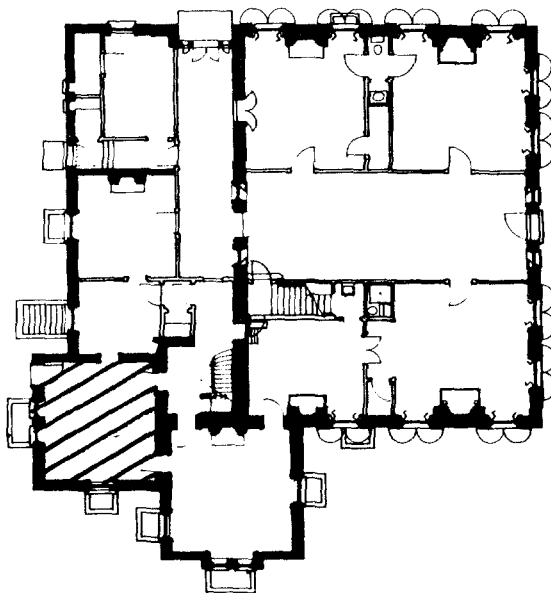
I. Room 112 - Bedroom

This room projects farther west than the other portions of the one-story 1849 addition. It is under its own batten-seam terneplate gable roof immediately to the west of the tower. The room may be entered from the tower stair hall, room 113 (D125); the library, room 111 (D127); the bathroom, room 114 (D122); and from an exterior door in the west wall (D124). There is one window in the south wall, a double-arched window in the west wall, and a fireplace in the east wall.

The records of Upjohn plans refer to details for a bedroom double window and a cornice for a bedroom. There is no other room that meets both criteria. A letter of October 4, 1849, from Barney McGuire to Richard M. Upjohn confirms the bedroom designation: "The Bedroom fire place has no projection. The opening of the fire place is 2'-5-3/4" (Upjohn Papers). Although this room probably functioned as a bedroom for Smith Thompson Van Buren, its later uses have varied considerably. In fact, no other space designed by Upjohn experienced to as much fabric alteration and deterioration as this room.

Patch all stovepipe openings in the ceiling.

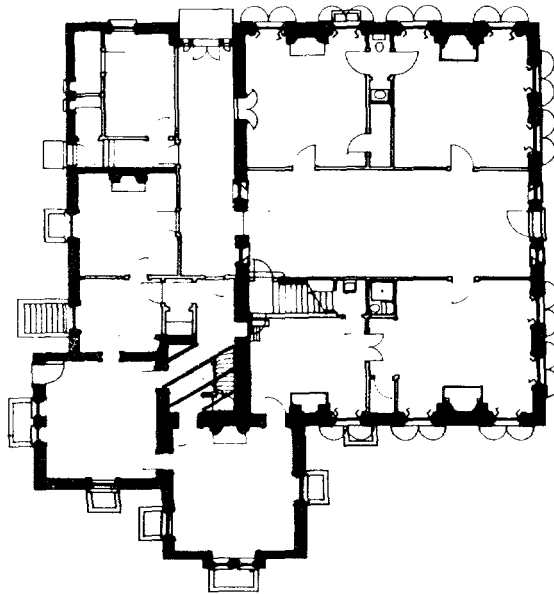
m. Room 113 - Tower Stair

This room originally joined room 117. A board partition (see IP035) divides the space and is described here as a separate room. It functions as the tower stair hall that provides access to the basement and upper floors--room 111 (D126), the library, and room 112 (D125), a bedroom.

Correspondence from Smith Thompson Van Buren to Upjohn documents the staircase design problems that can be seen today (Van Slyck to Richard Upjohn, October 23, 1849, and Smith Thompson Van Buren to Richard Upjohn, November 22, 1849, April 20, 1850, and May 17, 1850,

Restore the stair tread and risers to a light brown color (Munsell 10YR 6/2, Benjamin Moore ET-45).

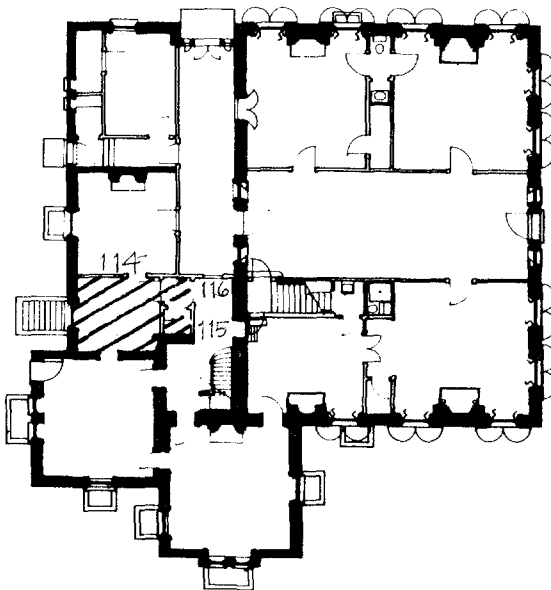
n. Rooms 114/115/116 - Bathroom/Water Closet/Access

Rooms 114, 115, and 116 are the three rooms that comprised the bathroom. (How the bathroom functioned is described in section IV.C.3.). They are roughly at the center of the west side of the one-story 1849 addition.

Room 114 contained a sink, bathtub, and dressing area. At present, the room may be entered from the bedroom, room 112 (D122); a small access hall, room 116 (D117); the nursery, room 118 (D116); and an exterior door in the west wall (D123). Room 114 has a window in its west wall and a fireplace in its southeast corner.

Restore the plaster ceiling and cornice using a finish plaster white coat.

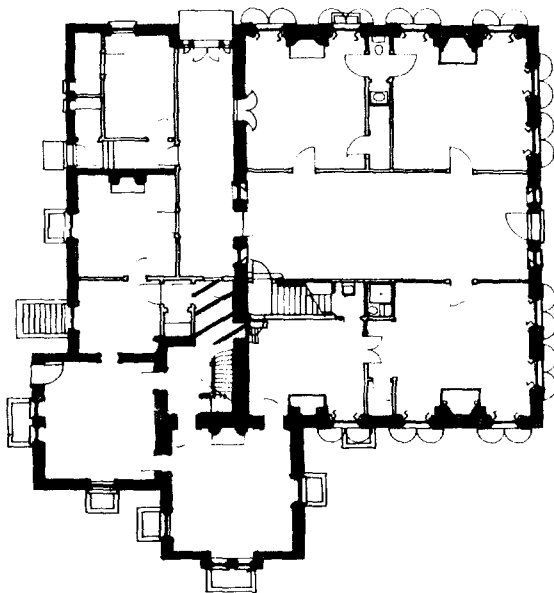
o. Room 117 - Hall

This hall was added as part of the 1849 additions, and although it is currently divided from the tower stair hall, room 113, they were originally connected. The arched opening between rooms 113 and 117 was filled in with a vertical board partition, probably by the Wagoner family in the last quarter of the 19th century. The date of this alteration is supported by paint, hardware, and molding evidence.

The paint samples taken from the partition and door separating rooms 113 and 117 do not contain the first two tan paint layers found on the baseboards in room 117 and on door 119 (compare

Check the floor joists in relation to downward movement, and monitor cracks.

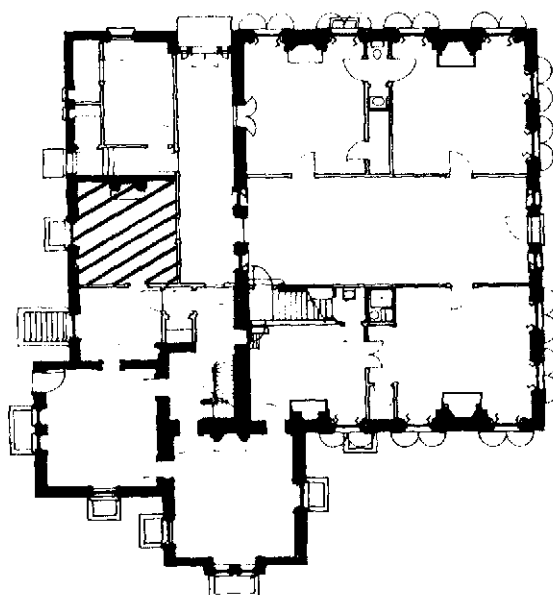
p. Room 118 - Nursery

Room 118 is directly to the west of the 1797 central hall, room 105, and between the small hallway, room 120, on the north and the bathroom, room 114, on the south. The entry for May 30, 1849, in Upjohn's planbook lists "cornices of hall, nursery, bedroom and bathroom." Having identified the hall, bedroom, and bathroom, Room 118 is the only remaining space with a cornice molding. Barney McGuire stated in a letter of October 4, 1849, to Richard Upjohn that the width of the chimney breast in the nursery was 5'4". This corresponds to the present condition in room 118.

- Study further to determine the southwest furniture piece and the floor markings in the northeast corner.

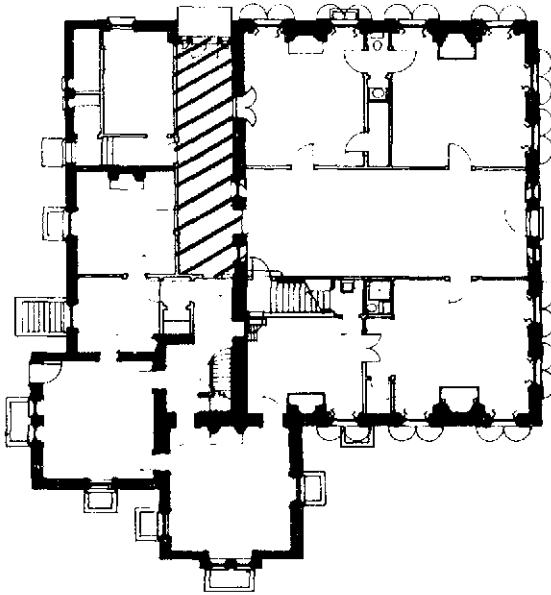
q. Room 119 - Hall

Room 119 is an entrance hall approximately 33' in length along the northern portion of the west wall of the 1797 house. This hall was added as part of the 1849 work. Entry from the exterior is through a double-door opening in the north wall (D109). Access from this hall is provided by two doors in the west wall--one to room 120, a hall (D114), one to room 118, nursery (D115)--and by a former exterior door opening in the east wall (D108) leading into the central hall, room 105.

Remove the varnish from the wood floor.

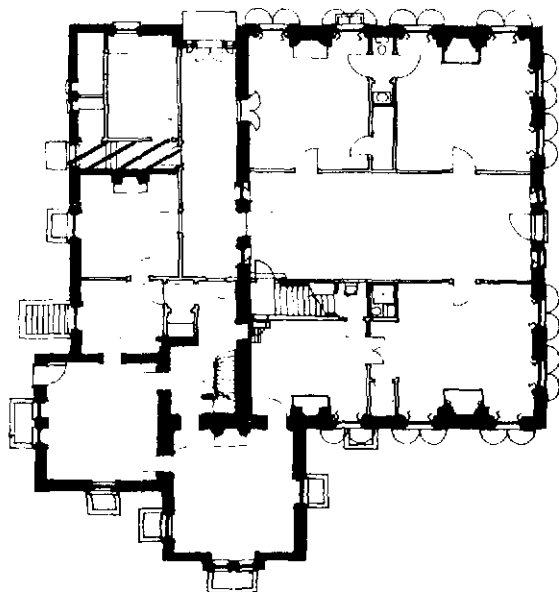
r. Room 120 - Hall

This hallway in the 1849 addition runs in an east-west direction. Before other door openings were added in the latter part of the 19th century, this hallway provided the only exit from the first floor to the west, or back, side of the house. The space is perpendicular to and midway along the west wall of the large Upjohn entry hall (room 119). Access from other parts of the house is through room 119 only (D114). This small hallway, in addition to providing an exit to the exterior, provides access to room 123, a bedroom (D113), and room 121, a privy (D121).

Changes in this hallway are primarily a result of roof deterioration. More than 50 percent of the plaster ceiling is missing because of water damage. Drainage problems along the west wall gutter system also caused masonry settlement. The diagonal cracks in the west wall plaster can attest to this problem.

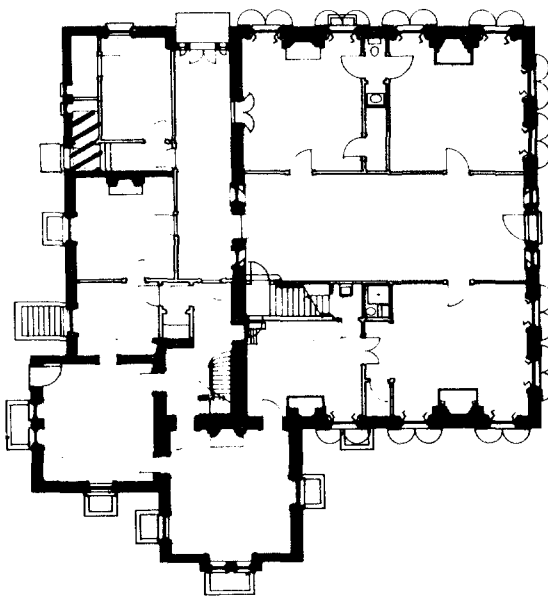
s. Room 121 - Privy

This privy has remained in its original form since ca. 1849 (see IP041). It has a wood-encased seat above a stone-lined privy well. The built-in seat is composed of one horizontal, recessed panel with molding on the vertical front and four similar panels with the cyma recta molding on the top or horizontal surface. One larger panel on the top is butt-hinged for the seat opening.

Remove a board with hooks on the east wall, if it is found to be nonhistoric.

Replace the door (111).

Restore the painted wood surfaces to a cream color (Munsell 2.5Y 9/2 Benjamin Moore GB-30).

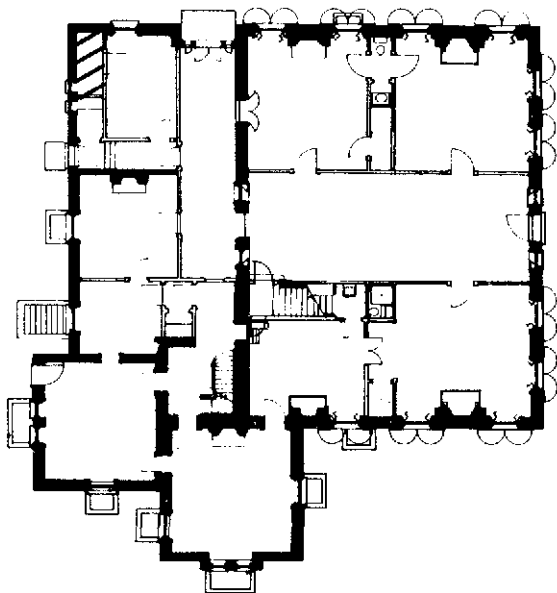
t. Room 122 - Storage

This closet occupies the northwest corner of the ca. 1849 addition. It is entered from a small bedroom, room 123 (D110).

There does not appear to be a built-in or attached system for hanging clothes or for storage except for one shelf at the north end. Neither the shelf nor several ledger strips appear to be original.

Remove molded ledger strips secured to the north and west walls for further investigation; replace these ledger strips with strips matching those on the east wall.

Remove the metal patch along the west wall; assess and repair any deterioration to which it may be related.

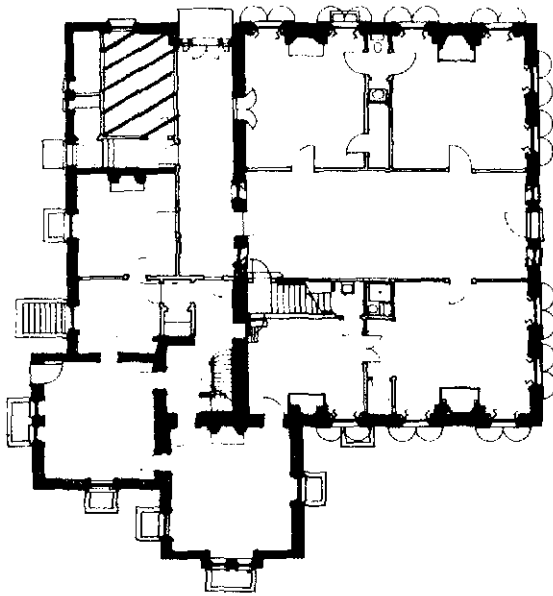
u. Room 123 - Chamber

Except for several minor repairs that are needed, room 123 is in its original form. There is no fireplace or cornice molding. The finish woodwork for two door openings, one north wall window opening, and the baseboards is

- Repair the sliding shutter.

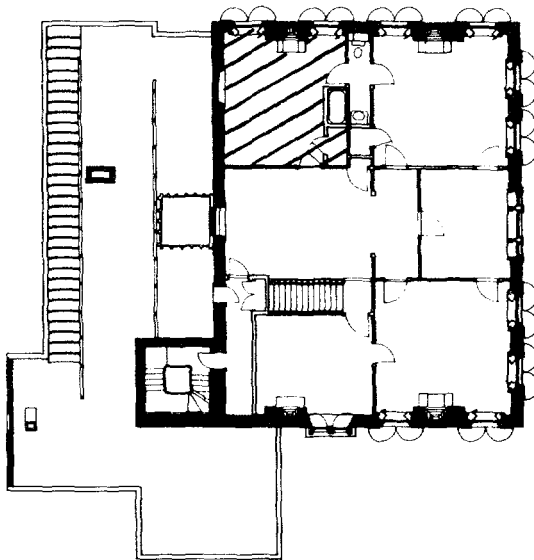
a. Room 201 - Guest Chamber

The earliest change that has been noted in room 201 was the removal of all chair rails. The evidence consists of horizontal plaster infill at an approximate height of 35". This change occurred in all major rooms of the ca. 1797 house and has been associated with ca. 1840 work of Martin Van Buren. The case supporting this date and the association with Van Buren is well documented in rooms 101, 105, and 109 (see section IV.B.2).

Repair and stabilize the plaster wall and ceiling in areas where the ca. 1960 lowered ceiling intervened and above window 212 where roof deterioration caused water leakage.

Replace missing butt hinge parts, and hang window 212 doors.

Remove the 20th century sash locks, and replace them with reproductions.

Install a bell system wire and reproduction crank on the east face of the chimney breast.

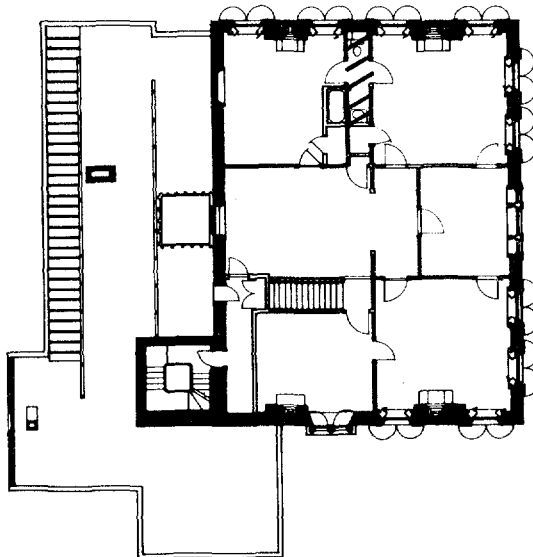
b. Rooms 202/203/204 - Closet/Bathroom/Closet

Rooms 203 and 204 are secondary spaces between the major north bedrooms, rooms 201 and 205. Room 203 (north of room 204) was enlarged to receive a bathtub by relocating a portion of the west wall farther west. This ca. 1960 work included the closet construction that created room 202. Plumbing for the toilet and sink fixtures in room 203 has been attributed to the DeProsse family through oral history and the 1938 DeProsse drawings.

Replace the floorboards.

Replace several baseboards.

Restore the woodwork to a cream color (Munsell 2.5Y 9/2, Benjamin Moore GB-30).
