historic structure report
architectural data section
volume 1
june 1985

HISTORIC STRUCTURE REPORT

LINDENWALD

MARTIN VAN BUREN NATIONAL HISTORIC SITE

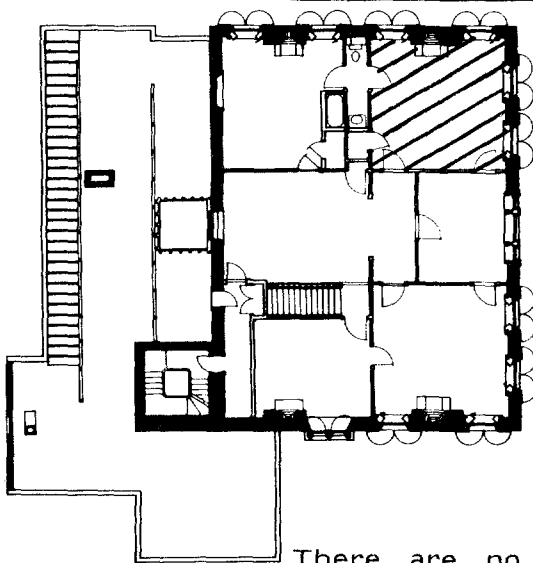
c. Room 205 - Guest Chamber

Wallpaper was removed in 1978 by the park maintenance staff to reveal areas of beige paint, the chair rail infill, and a finish plaster white coat above the chair rail and a brown coat below the chair rail. A sample of the ca. 1841 wallpaper for this room (WP018) was found under the casing of door 206. It is a machine-made paper with a white ground and large brown, green, and yellow flowers and leaves. The earliest layer of fireboard paper is a scenic of undetermined design with a border matching the border of the fireboard in room 101 (also a bedroom during the Van Buren residency).

Make miscellaneous plaster repairs and stabilize, particularly at the south end ceiling along the east wall where the ca. 1960 lowered ceiling contacted the walls; fill the small south wall opening.

Repair (and replace) the nonhistoric masonry work at the rear wall of the firebox, and mortar fill between the stone lintel veneer and brick.

Remove the 20th century sash locks and replace with ca. 1840 reproductions; replace the window 207 stop; replace the HL hinges on windows 206 and 209.

Install a bell system wire and reproduction crank on the west face of the chimney breast.

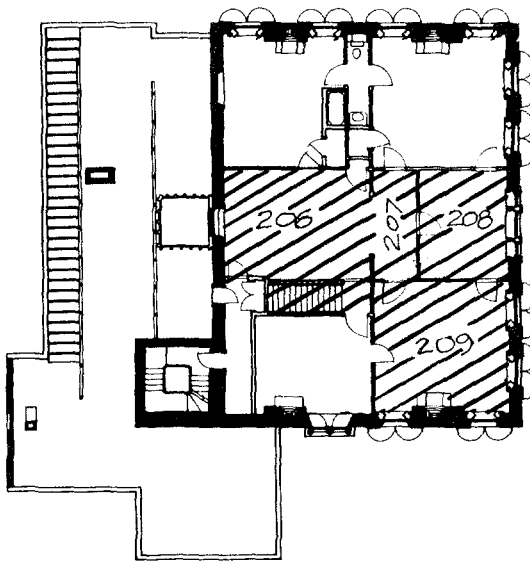
d. Rooms 206/207/208/209 - Stair Hall/Game Room/
Entry/Two Chambers

In rooms 207/208/209 the alterations were much more extensive. The walls that created the present room plan were erected, transforming the one large room into three smaller rooms. Evidence supporting this date includes the gray-green paint on the plaster walls (P762, 763). This paint is different from the green paint found on the original walls of the room. It is not found in the area of the chair rail, indicating that it was applied to the walls before 1840.

Install a bell system wire and reproduction crank on the west side of the chimney breast.

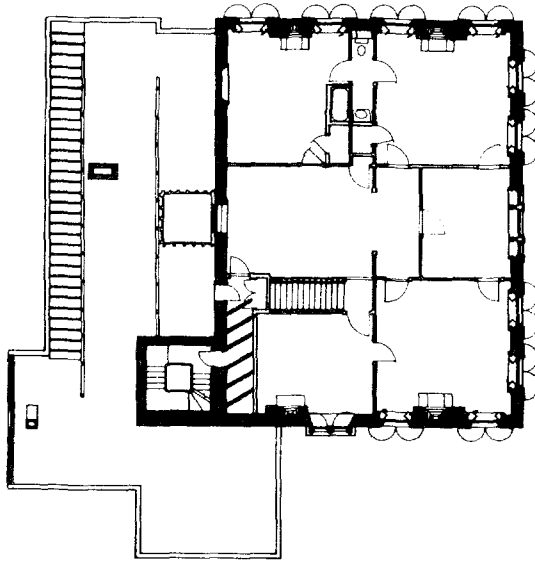
f. Room 211 - Hall

The ca. 1797 to 1849 use of this space was as part of the bedroom, room 210. The location of the west wall window was approximately 5' 4" from the south plaster wall. Infill masonry is currently exposed south of door 214, the probable location of a window in the ca. 1797 house.

- Restore all woodwork to a tan color (Munsell 10YR 8/2, Benjamin Moore GB-60).

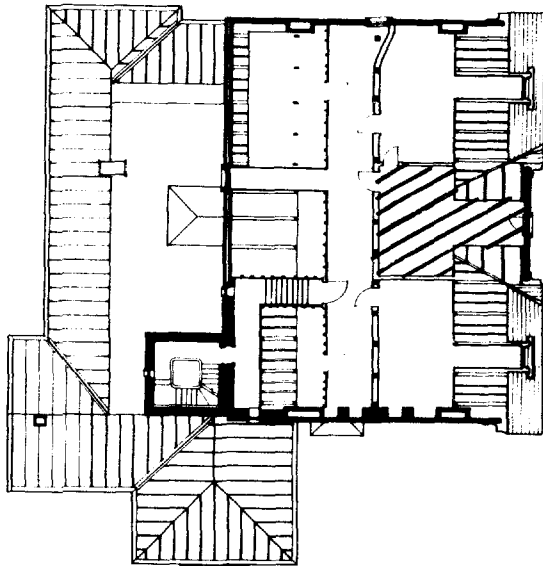
e. Room 304 - Servant's Chamber

Walls, floor, and ceiling are identical to those in room 303 with the following exceptions: In the north wall of the gable extension, a hole was cut to allow access to the former roof surface now covered by the ca. 1850 gable roof. In the south portion of the east wall, a hole was cut for

Lay fiberglass batt insulation, 10" to 12" thick, on the floor.

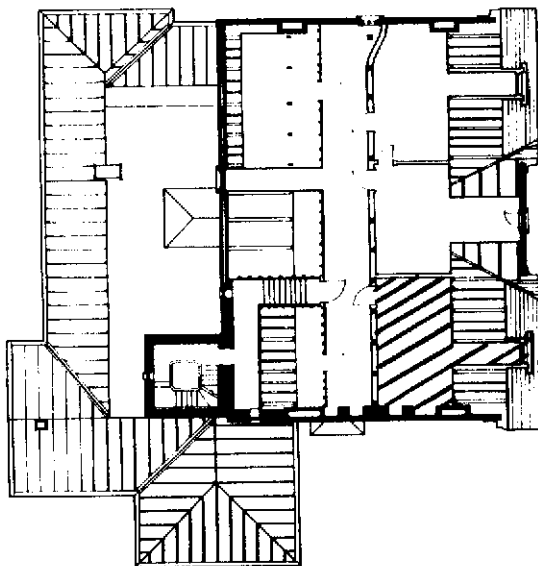
f. Room 305 - Servant's Chamber

The walls, floor, and ceiling are identical to those in room 303 with the following exceptions: There is an access hole cut in the south portion of the east wall for access to room 313. The south wall contains two arched niches that support the rerouted flues. Plaster is missing from most of the ceiling in the south half of

Lay fiberglass batt insulation, 10" to 12" thick, on the floor.

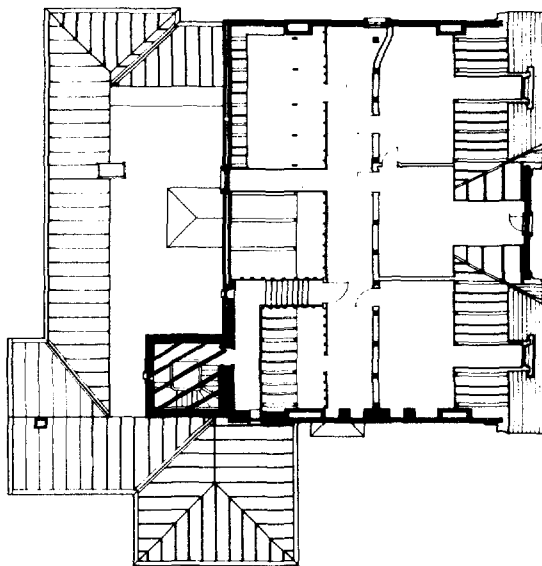
i. Room 308 - Tower Stair

Room 308 is the third-floor level of the tower stair. It is a square room approximately 9'8" by 9'10" whose only function was to provide vertical access to all the floors in the house.

The walls are a whitewashed three-coat plaster on wood lath on furring strips attached to the brick walls of the tower. The baseboard at the landing along the north wall and along the stairs below is the typical profile used in the more formal areas of the Upjohn (ca. 1849) addition. Along the east wall, above door 309 and all the way to the belvedere, the baseboard is the simple cavetto type found in the

The ceilings of this space are whitewashed two-coat plaster on wood lath attached to irregular nailers on the underside of the stair structure. The finished plaster follows the landings, straight runs, and winder portions of the stair in one smooth continuous surface with gradual transitions between areas of different slope and around corners. Some of this plaster has been damaged by water that penetrated through the tower deck. One already damaged area of plaster and lath was completely removed to allow an inspection of the stair structure (see IP-068, 069, and 070).

The preservation and restoration work recommended for room 308 includes the following items:

- Repair or replace all damaged or missing plaster or lath.

- Install a transparent barrier (of acrylic sheet) at the third-floor level to reduce heat loss through the tower, while maintaining visual continuity for visitors observing the tower stair from the first floor.

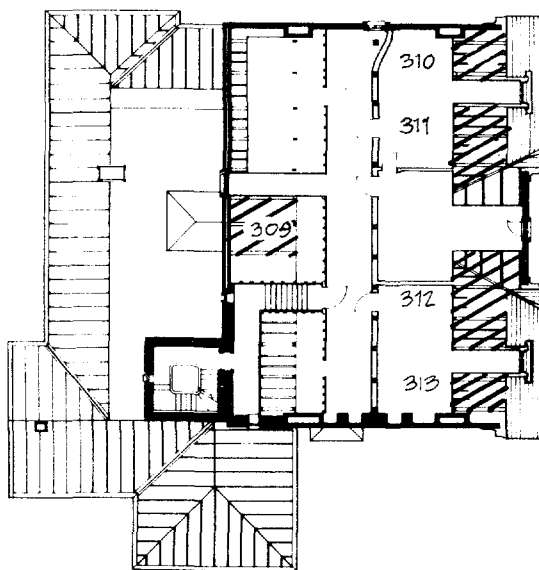
j. Rooms 309/310/311/312/313 - Attic

These rooms are not really rooms at all inasmuch as they were not intended for regular access. In fact, access was not possible until access holes (generally 1'6" by 2'0") were cut in the lath and plaster walls of the adjoining rooms.

The walls of these rooms were the unfinished back side of the lath and plaster walls of the adjoining rooms, except for the north wall of room 310 and the south wall of room 313, which were the exposed brick of the north and south gables, respectively (see IP066).

The following items of work are recommended for rooms 309, 310, 311, 312, and 313:

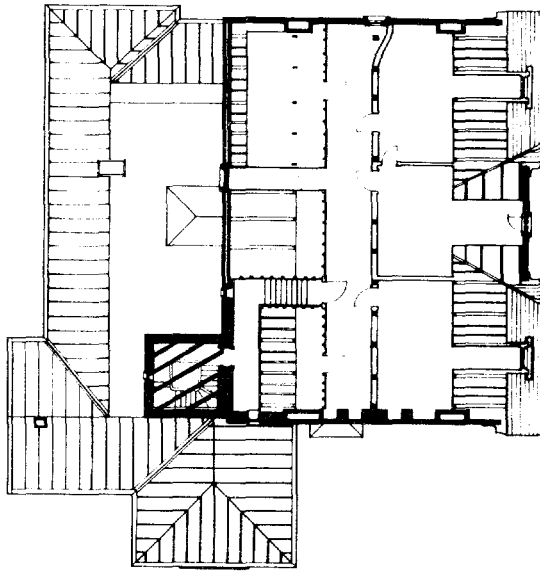
6. Fifth Floor - Belvedere

Room 501 is the open-air belvedere at the top of the ca. 1850 Italianate tower. The term "belvedere" is used because the only apparent historic function of the space was as a vantage point from which to enjoy the view of the Hudson River valley and the Catskill and Berkshire mountains.

The north and south walls are of solid brick construction with painted wood paneling as the interior finish. These walls carry roof loads down to the stronger, four-walled section of the tower below. The east and west walls are open with nonload-bearing columns at the middle of two arched openings and handrails

The preservation and restoration work recommended for room 501 includes the following items:

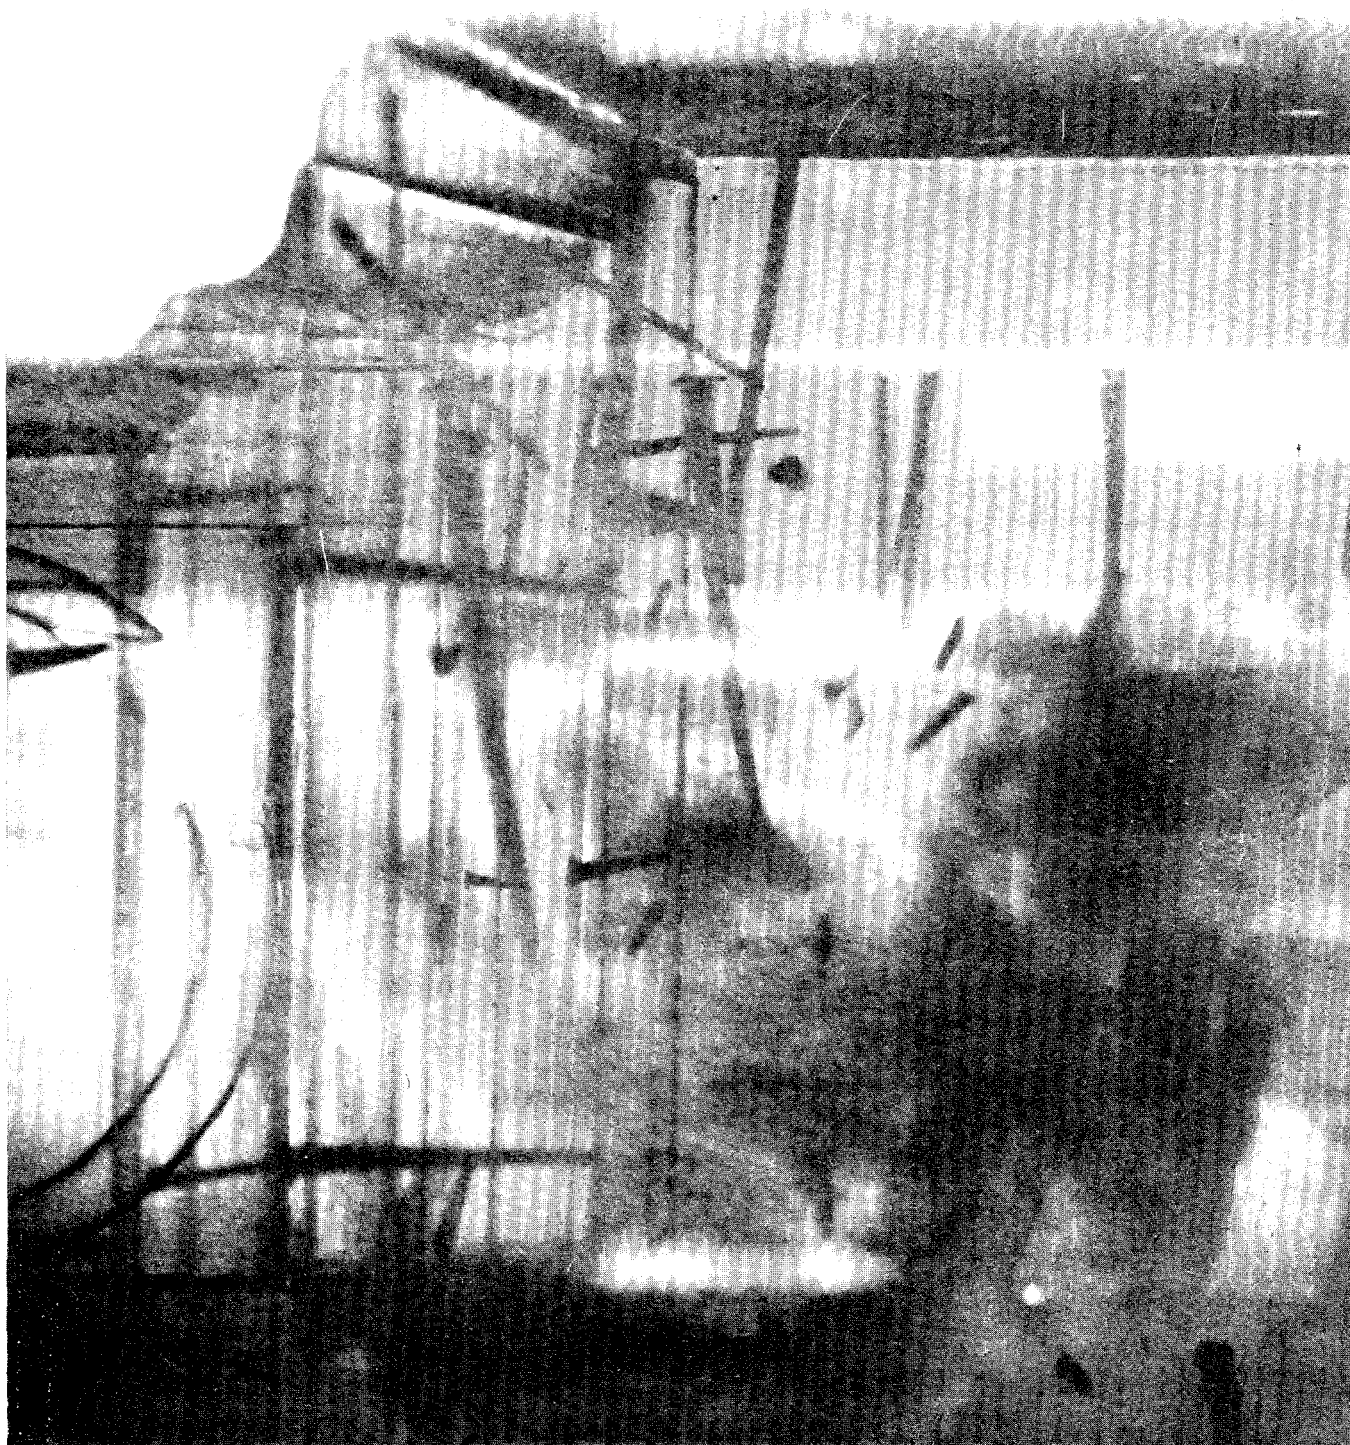
MAVA 01 X008

Room 206/207, door 218, south pilaster, looking west at floor level.

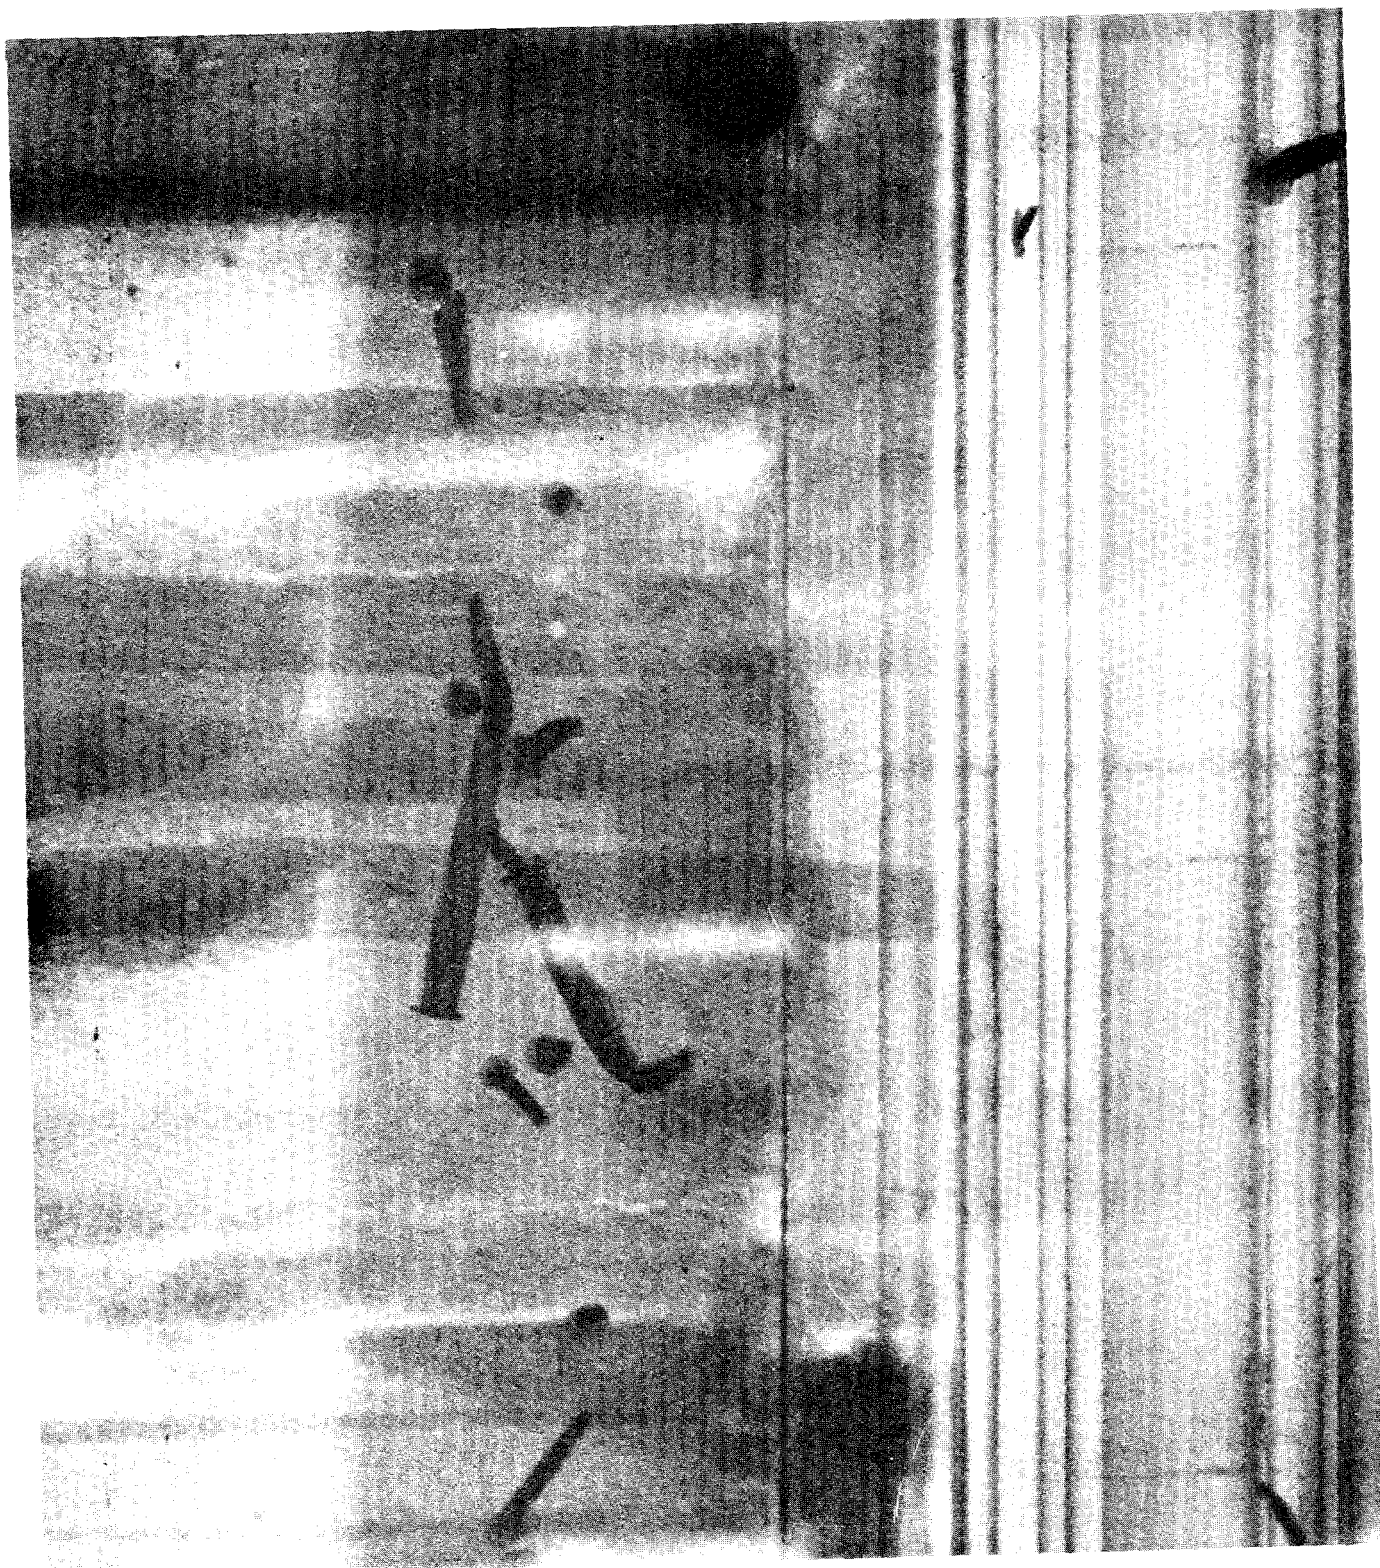
MAVA 01 X009

Room 206/207, door 218, south pilaster, looking west at floor level.

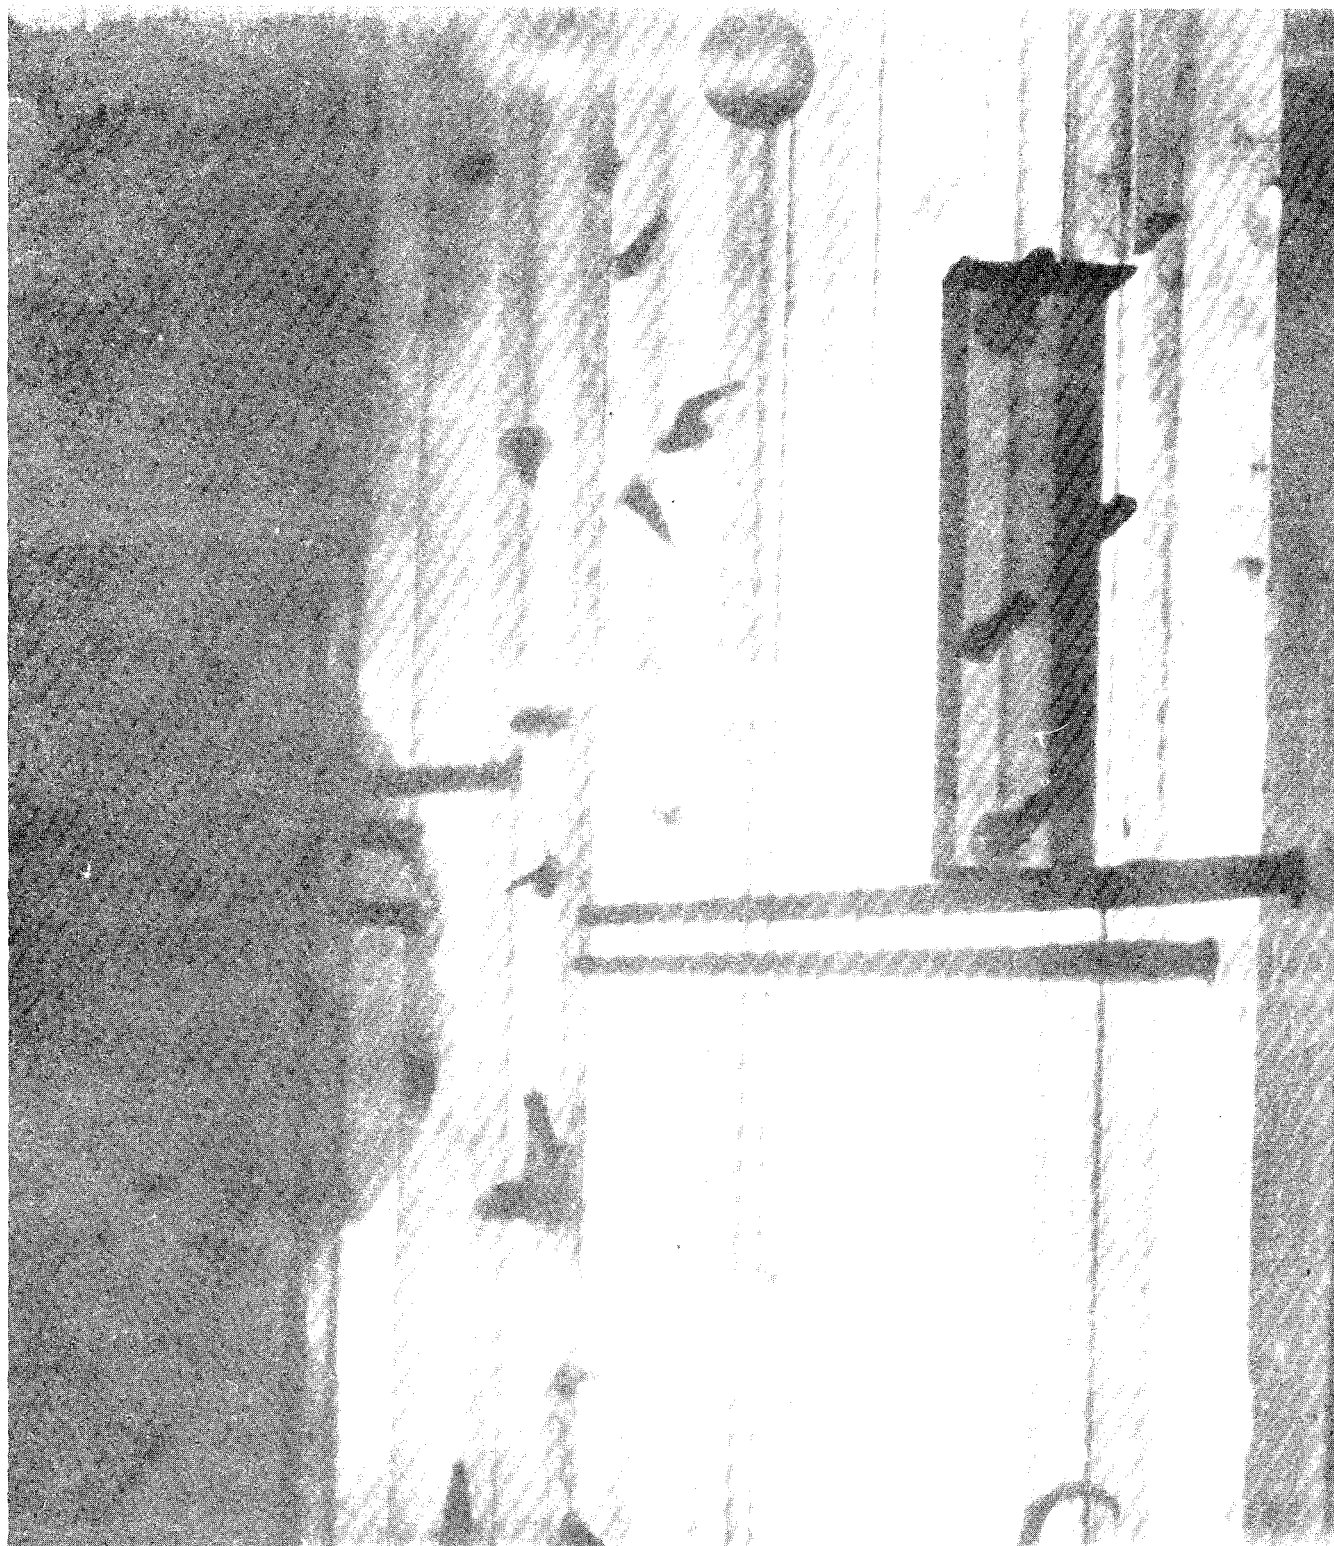
MAVA 01 X014

X-rays taken in the area of the north wall "ghost" showed a more evenly cut lath that may be sawn lath. This lath is in the area of the previous chair rail. The lath nails are not readily distinguishable. In the areas of split lath, the two-facet handmade head is visible. The large nails in the chair rail area are the same as those found in room 207--a handwrought nail with a short taper at the upper end (see MAVA 01 X013-014).

Room 208, north wall, ghost of door opening, looking down, 315° above
the floor.

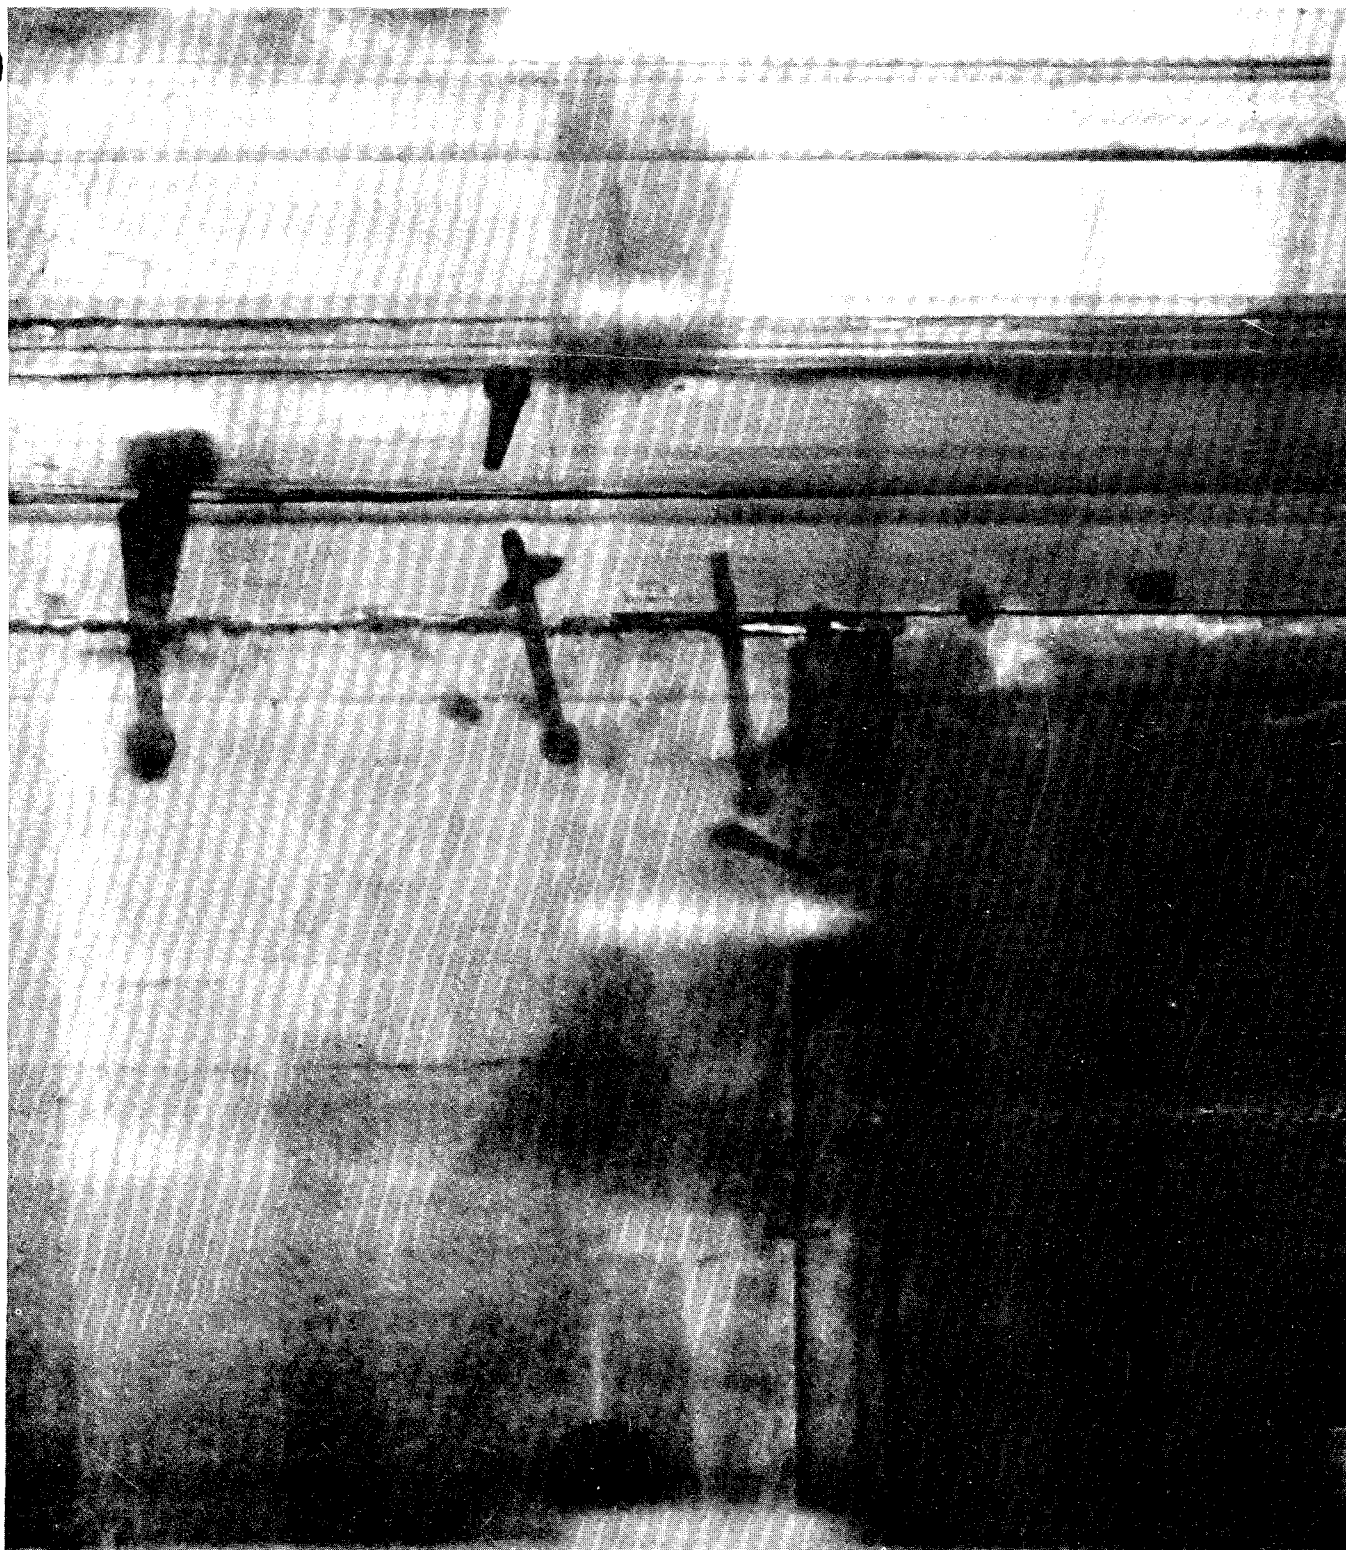
MAVA 01 X018

Room 209, west wall, door 216, north jamb, looking west 2'10" above the floor.
