# SAGAMORE HILL HOME OF THEODORE ROOSEVELT

Sagamore Hill National Historic Site  
Oyster Bay, New York

Historic Structure Report

Marie L. Carden  
with  
Richard C. Crisson

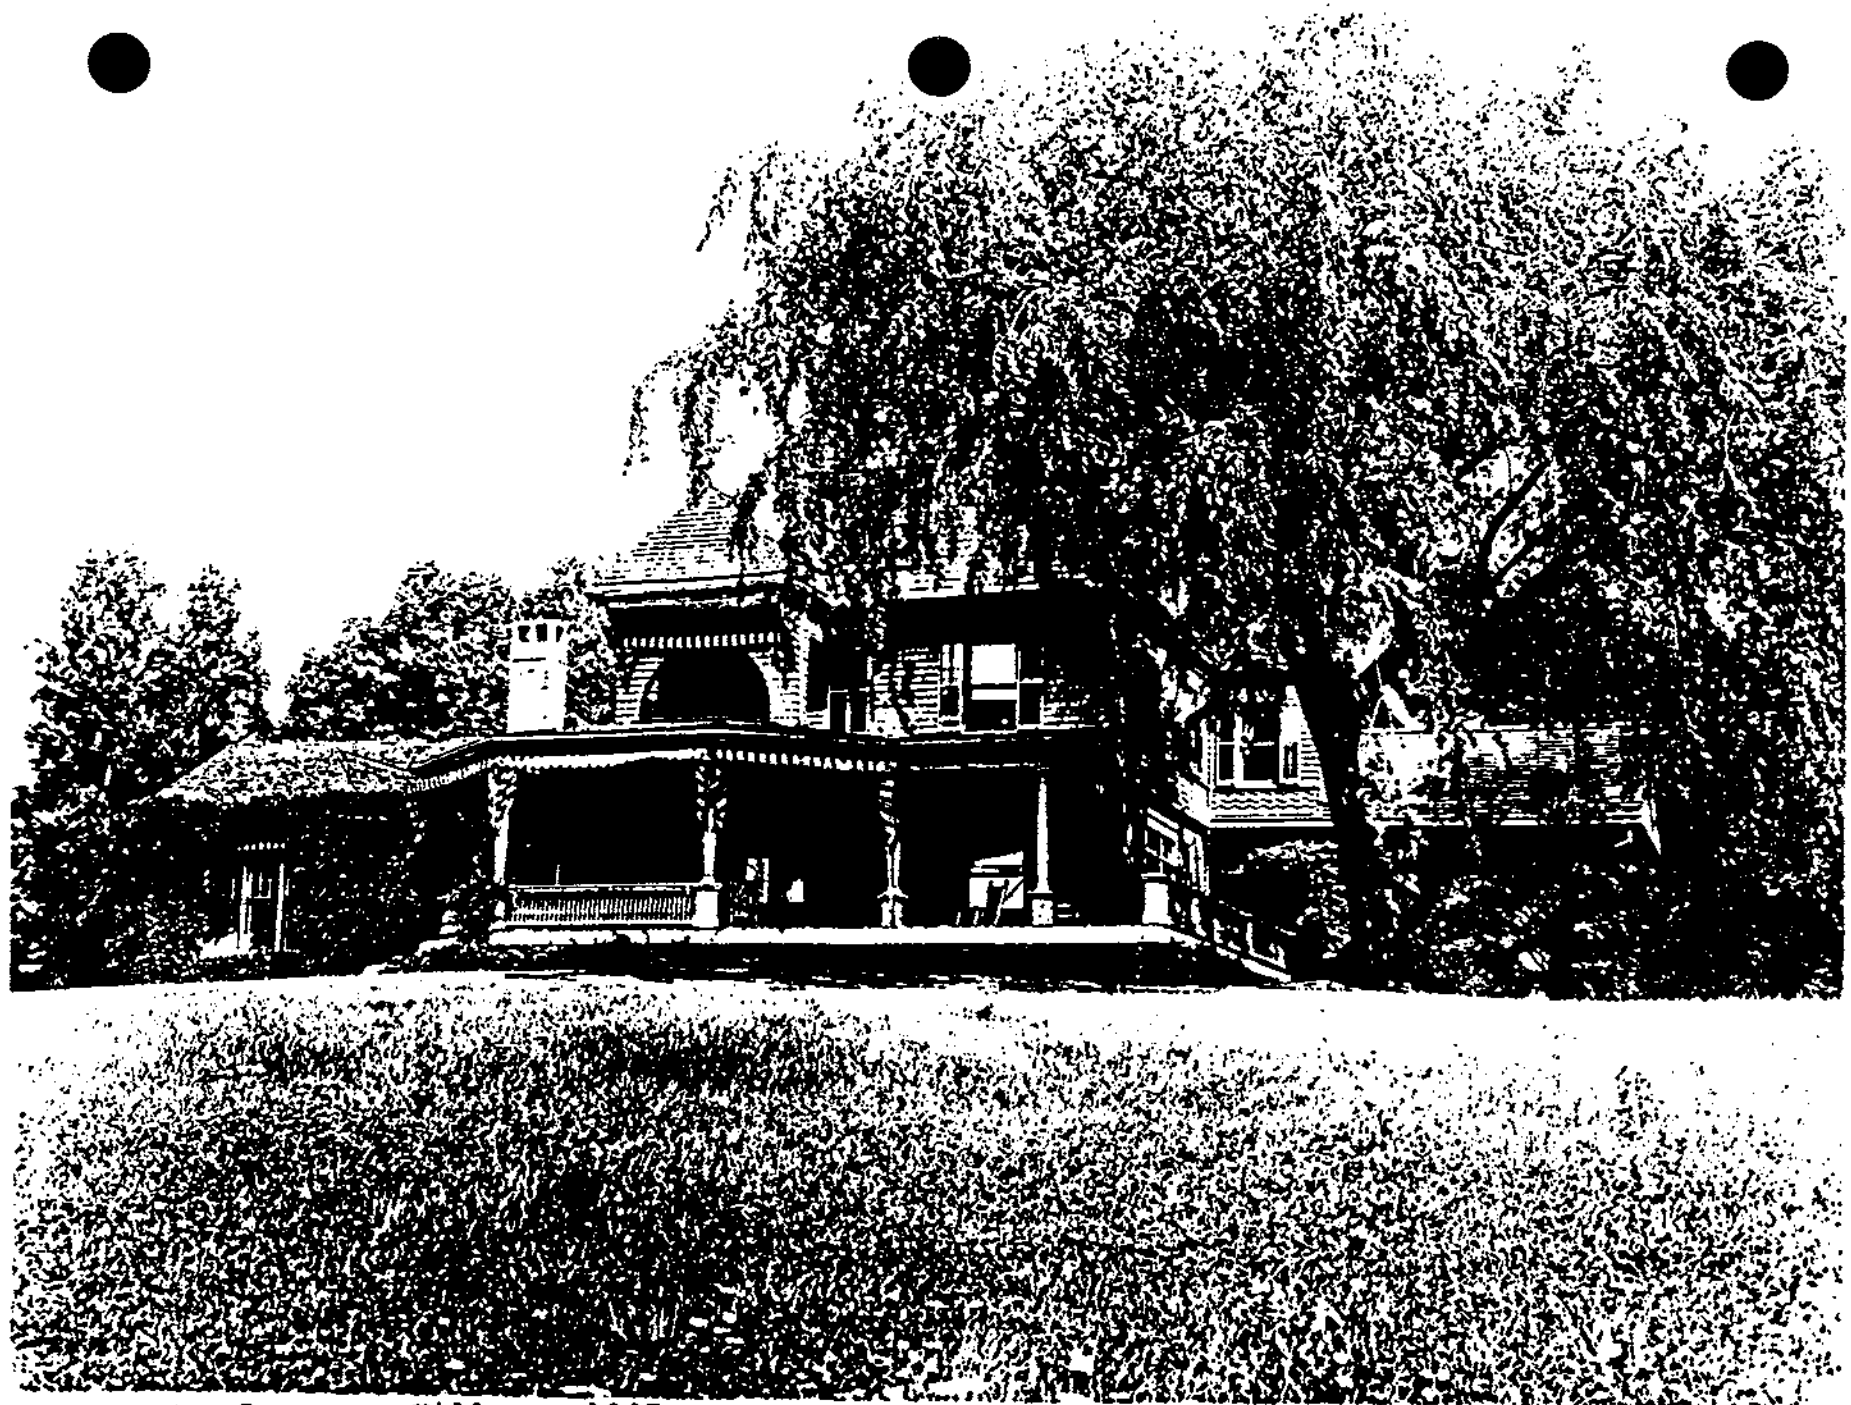
5. Sagamore Hill - c.1907  
House appears to have the monochromatic gray color scheme.

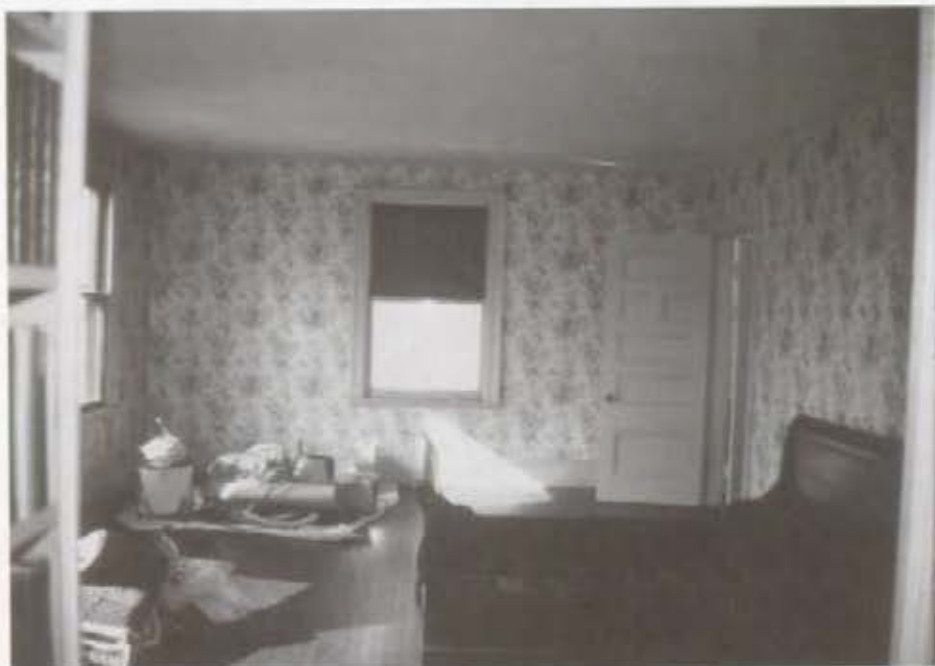
Gate Room: Before Restoration

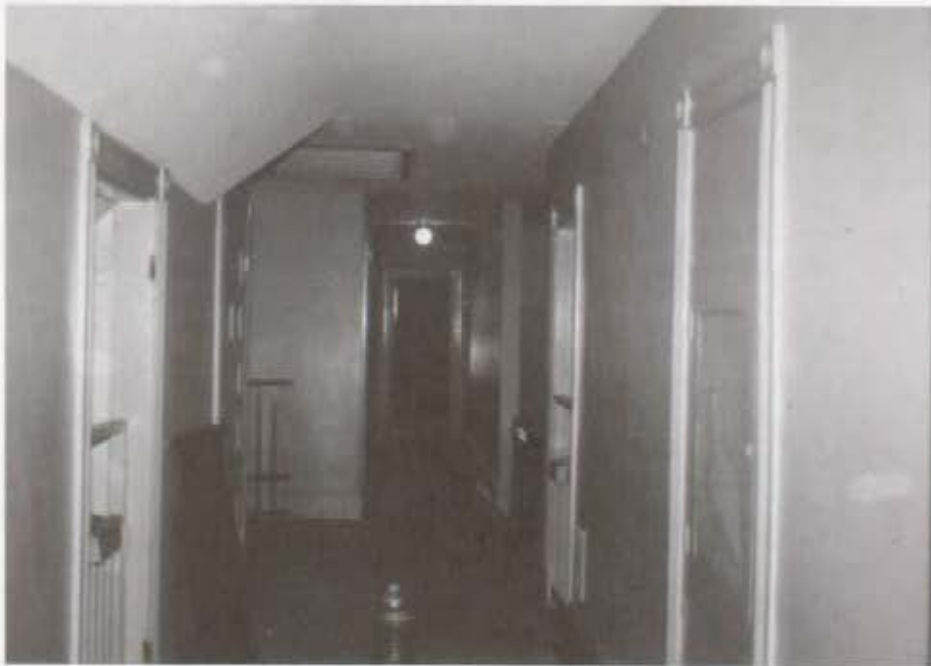
**Third Floor Hall: Before Restoration**

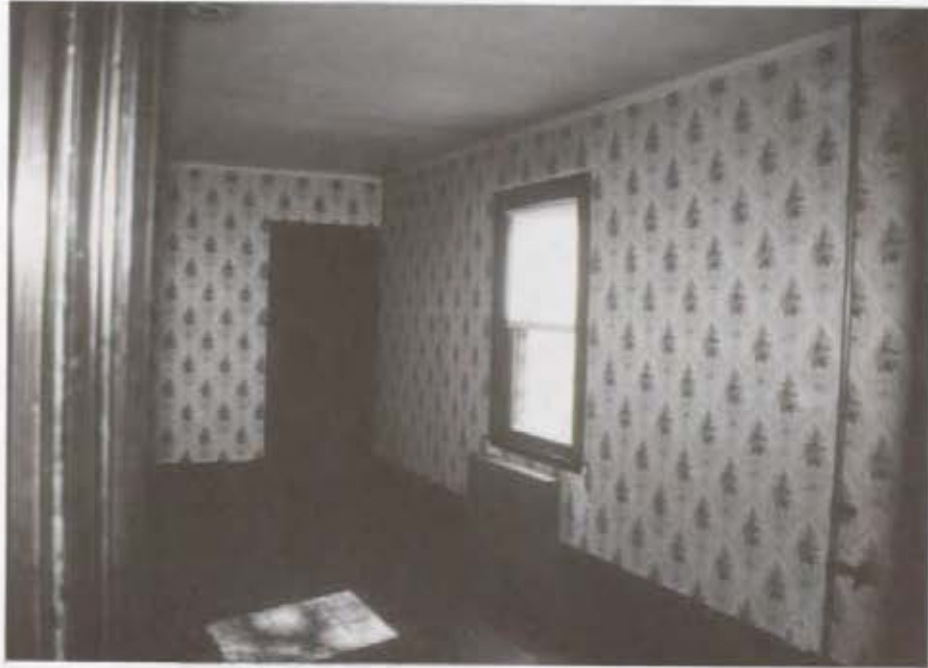
Alice's Room: Before Restoration

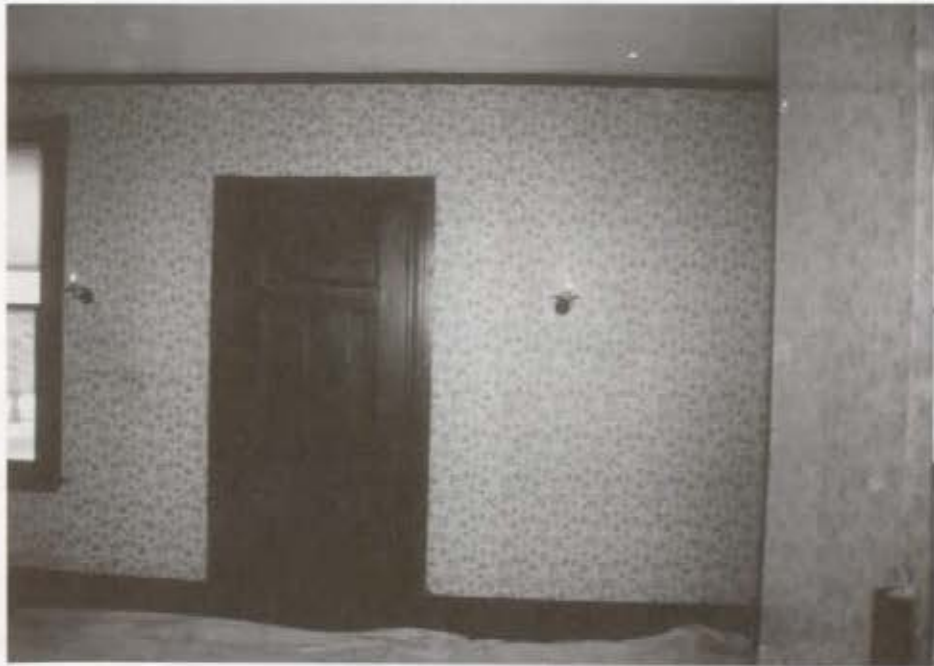
Nursery: Before Restoration

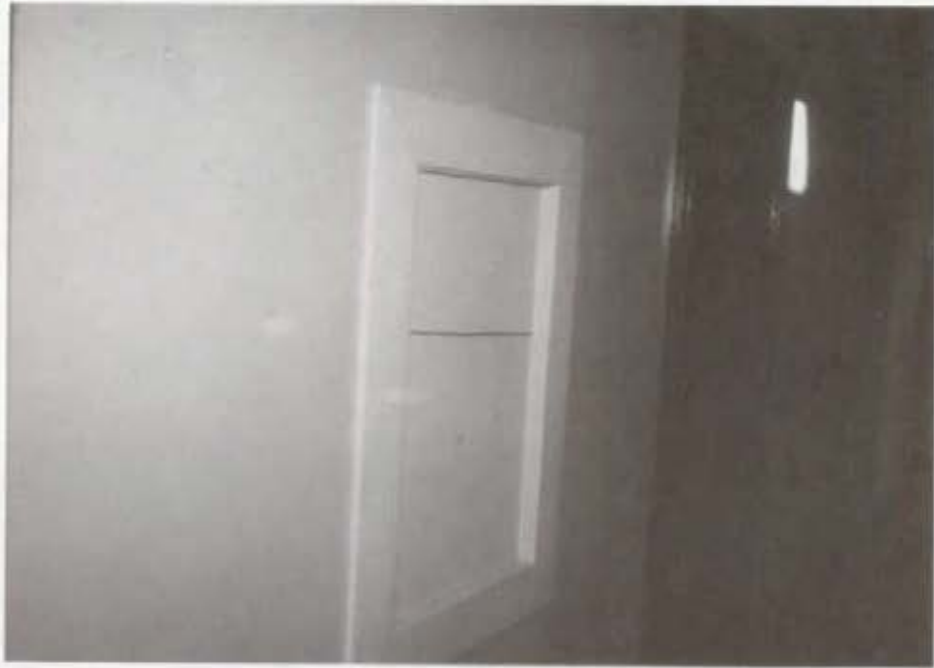
**Typical Firebox Location in Hallway: Before Restoration**
