THE FORTIFICATIONS OF SAN JUAN NATIONAL HISTORIC SITE

HISTORIC STRUCTURE REPORT

Summaries
Conditions Survey
Recommendations
Glossary
Bibliography
Selected Historic Drawings
Appendices

1991

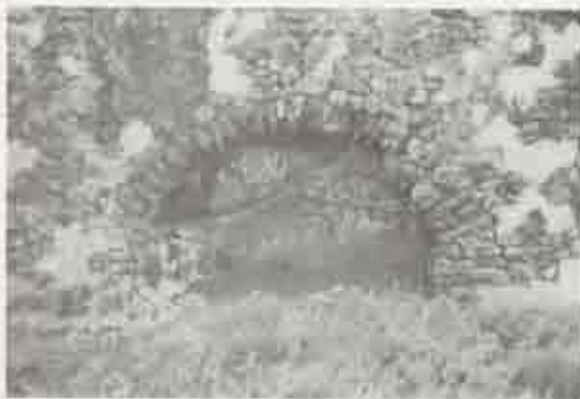
Figure 7. Water Battery, former oven. (Photo by W. Sedovic, 1988.)

Weathering will erode surfaces and materials at different rates; softer (or less cohesive) and more porous materials are generally eroded faster than harder (or more cohesive), denser materials. Differential erosion is apparent throughout the fortifications. One example is the former oven on the Water Battery of el Morro (fig. 7). The mortar, being less cohesive than its associated brick and stone, has eroded at a faster rate and is now recessed in the wall. It is possible that these joints were never flush with the masonry units and were originally slightly recessed, in which case, weathering has simply augmented the condition. Weathering has also affected masonry units, but to a lesser extent. Both brick and stone have acquired the rounded edges characteristic of erosion.

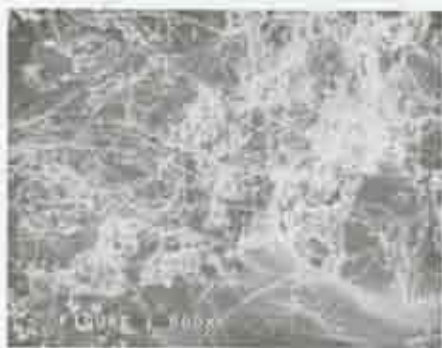
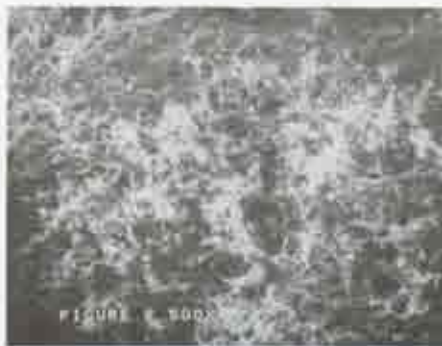
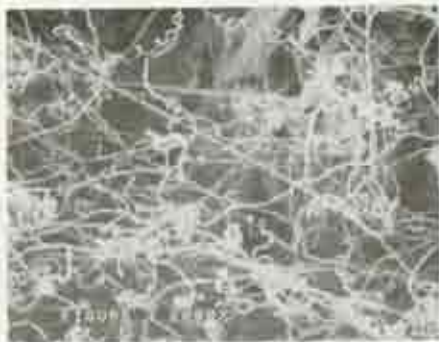
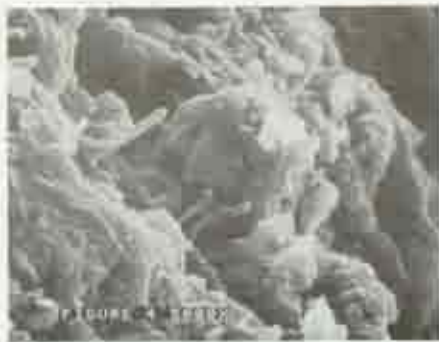
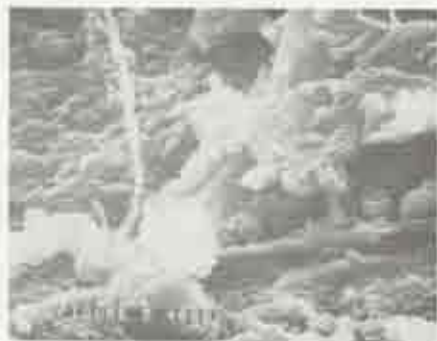
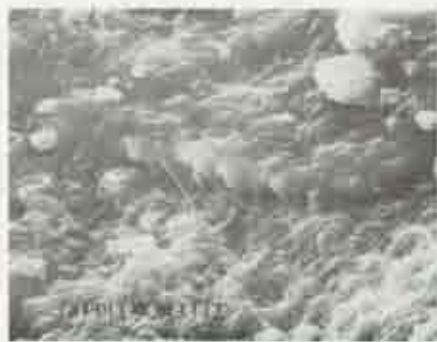
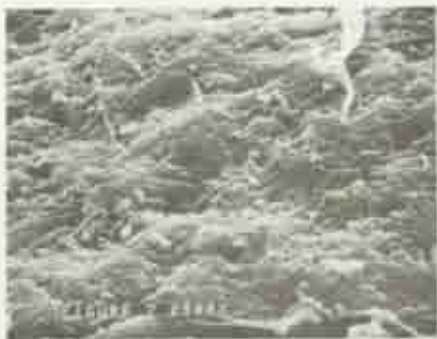
Scanning electron micrographs taken from samples of el Abanico are presented in figures 1 through 7. The surface of the stone was extensively covered with microbiological growths. Figures 1-3 show the extensive network of fungal hyphae that covers large parts of the samples. Even in apparently microbiologically-clear areas, at higher magnifications fungal hyphae and other microorganisms can be found, figs. 4 and 5. In other samples, the microorganisms had completely covered the surface of the stone with a biological "mat," figs. 6 and 7. Figure 6 shows an apparent layer of microbial exudate covering the upper half of the image. One long fungal hypha is visible in the center bottom, coming out of the layer. Figure 7 shows what look like rod-shaped bacteria in a layer of microbial exudate.

Figure 2. Scanning electron micrograph taken at 500x. Another sample of el Abanico stone showing extensive fungal-hyphal network.

Figure 3. Scanning electron micrograph taken at 2000x. Higher magnification view of fungal colony.

Figure 4. Scanning electron micrograph taken at 5000x. Relatively poorly colonized area of el Abanico stone. Note the presence though of some fungal growth tips.

Figure 5. Scanning electron micrograph taken at 4000x. Relatively poorly colonized area of el Abanico stone. The white mass in the lower half of the micrograph is associated with the fungal hyphae. Upper right shows a coccolith shell.

Figure 6. Scanning electron micrograph taken at 2000x. Biological secretions or "mat" in upper half of the figure. Exudate probably from a mixture of algae, bacteria and fungal.

Figure 7. Scanning electron micrograph taken at 2500x. Biological "mat" on surface of stone. Rod-like bacteria are apparent as are fungal growth tips.

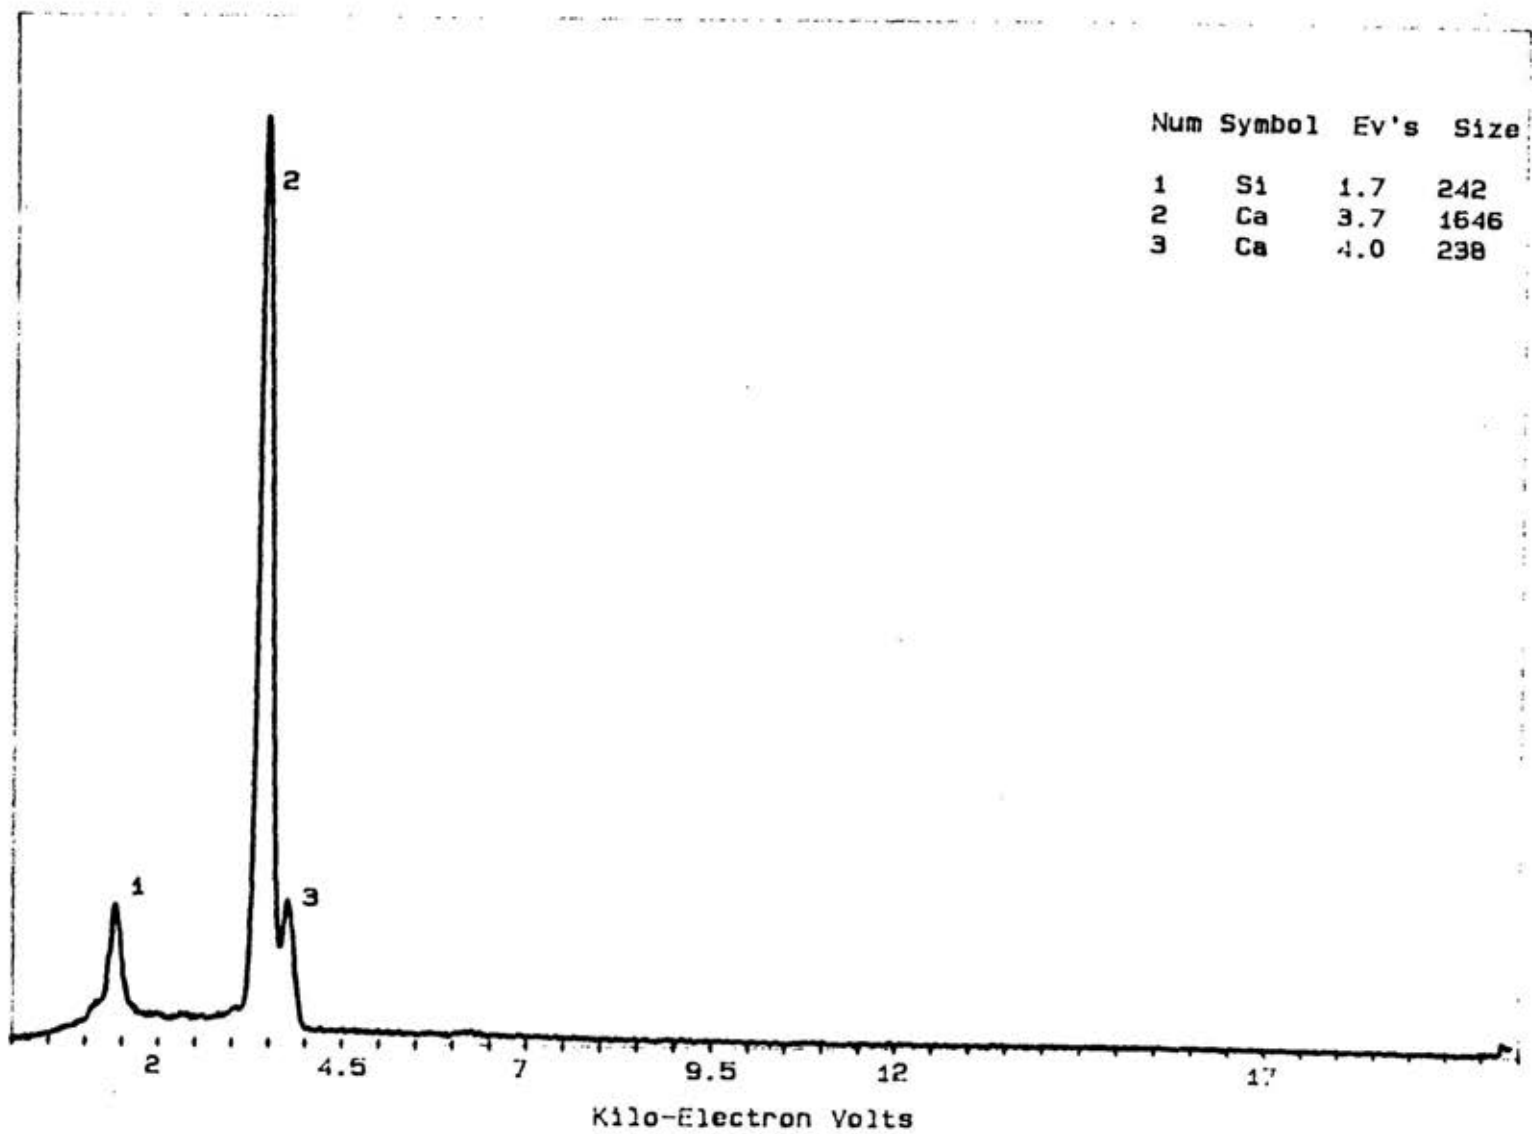
The X-ray spectrum from the clean interior (obtained by fracturing the sample) is in Figure 1. Silicon (Si) and Calcium (Ca) are the only elements (in addition to oxygen and other elements with low atomic numbers (less than 9), which are not detected by the energy dispersive X-ray technique utilized). In contrast, the spectrum in Figure 2 from a dirty area on the surface of a sample indicates the presence of many other elements and a much higher relative amount of Si, possibly from pickup of silicate (i.e., fine sand). In particular, there was a high concentration of sulfur (S), as you postulated in your letter.

Figure 1. X-ray Spectrum from the clean interior of a piece of stucco (obtained by fracturing a sample).

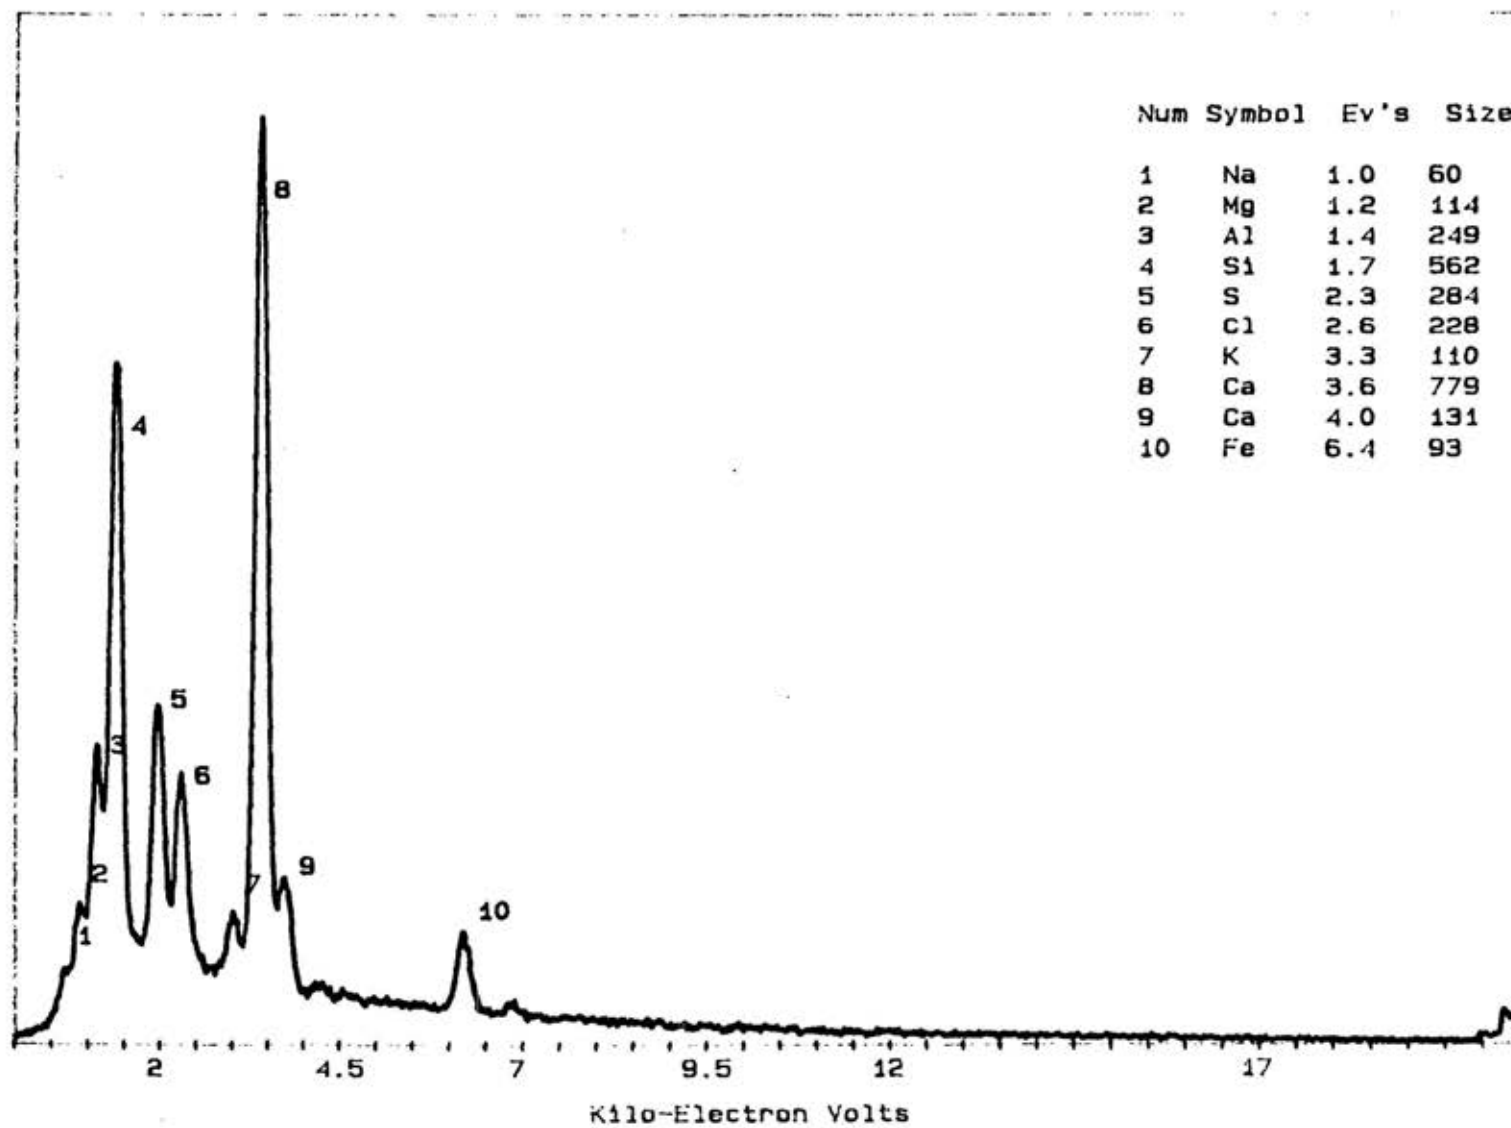
Figure 2. X-ray spectrum from the da... surface of a stucco sample.

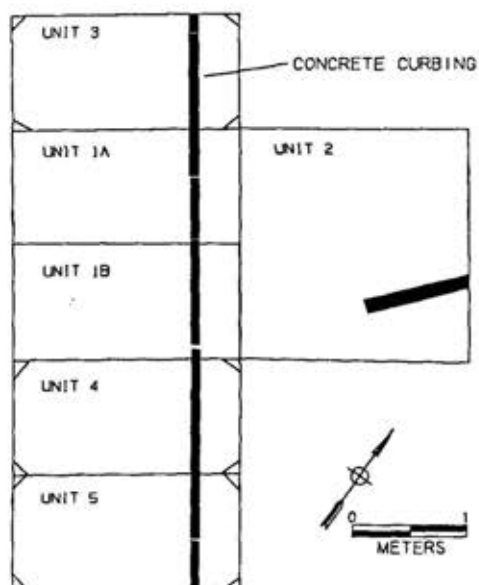
A sketch drawing of the fort made in the 1930s depicted a tennis court in the immediate vicinity of the excavation. During the 1961 investigations Smith found remains of this tennis court which he notes was of concrete and was present in the area in 1926. Evidence for the tennis court during the 1990 project was found in the form of concrete curbing underlaid with a red clay stratum. The red clay stratum was identified by Smith (1962) as the base for the tennis court. The curbing was found 1.4-1.5 meters out from the fort wall at 40-60 cmbs. The curbing runs parallel to the flanking battery wall. Four connecting sections of the curbing extended across units 3, 1, 4, and 5. A discarded section of the curbing was also removed from unit 2 (Figure 9). A footer was located adjacent to the curbing in unit 4 that initially was

Figure 9. Location of Concrete Curbing in Units 1 through 5.

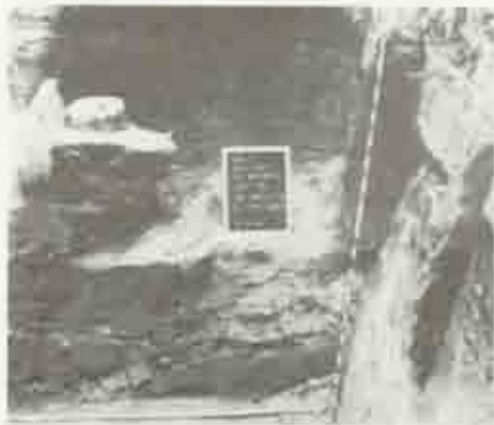
thought to be for the tennis net post (Figure 10). The footer was of concrete and apparently set in a bucket. Continued excavation in unit 4, below the footer, revealed

a midden deposit of 20th century trash. This deposit extended to a depth of 1.70 meters (Figure 11). The majority of diagnostic materials recovered from the midden dated to the 1940s suggesting that the footer was not for the tennis court but for another function required in the 1940s.

Figure 10. Concrete Footer Located in Unit 4.

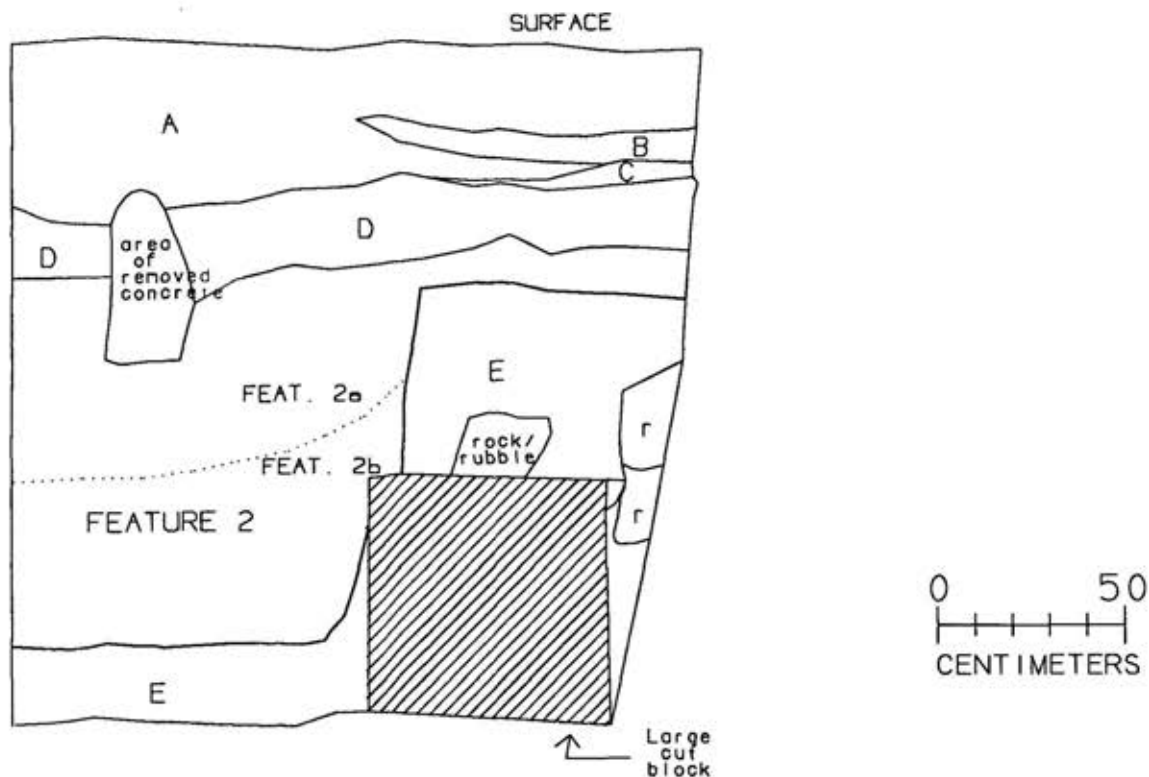
Figure 11. Feature 2 as Shown in the Southeast Profile of Unit 4 as Excavated to a Depth of 1.8 Meters Below the Surface.

At 1.15 meters below the surface in unit 4 a large stone was encountered that altered the course of the investigations (Figure 11). After consultation with the Historic Architect it was decided that excavations be shifted in order that the deepest point reached in the excavation be located adjacent to this stone. The stones horizontal angle suggested that it was the corner of the orillon as it was identical to the angle depicted in the 1742 drawing of the fort (Figures 1, 15 and 17). Excavation down along the southeast edge of the stone revealed a vertical wall of solid construction consisting of five stones laid without batter or scarp on any exposed sides. It was obvious that this vertical stone wall had been constructed at a different date than the battered wall of dressed stone and the rubble stone wall (Figures 18 and 19).

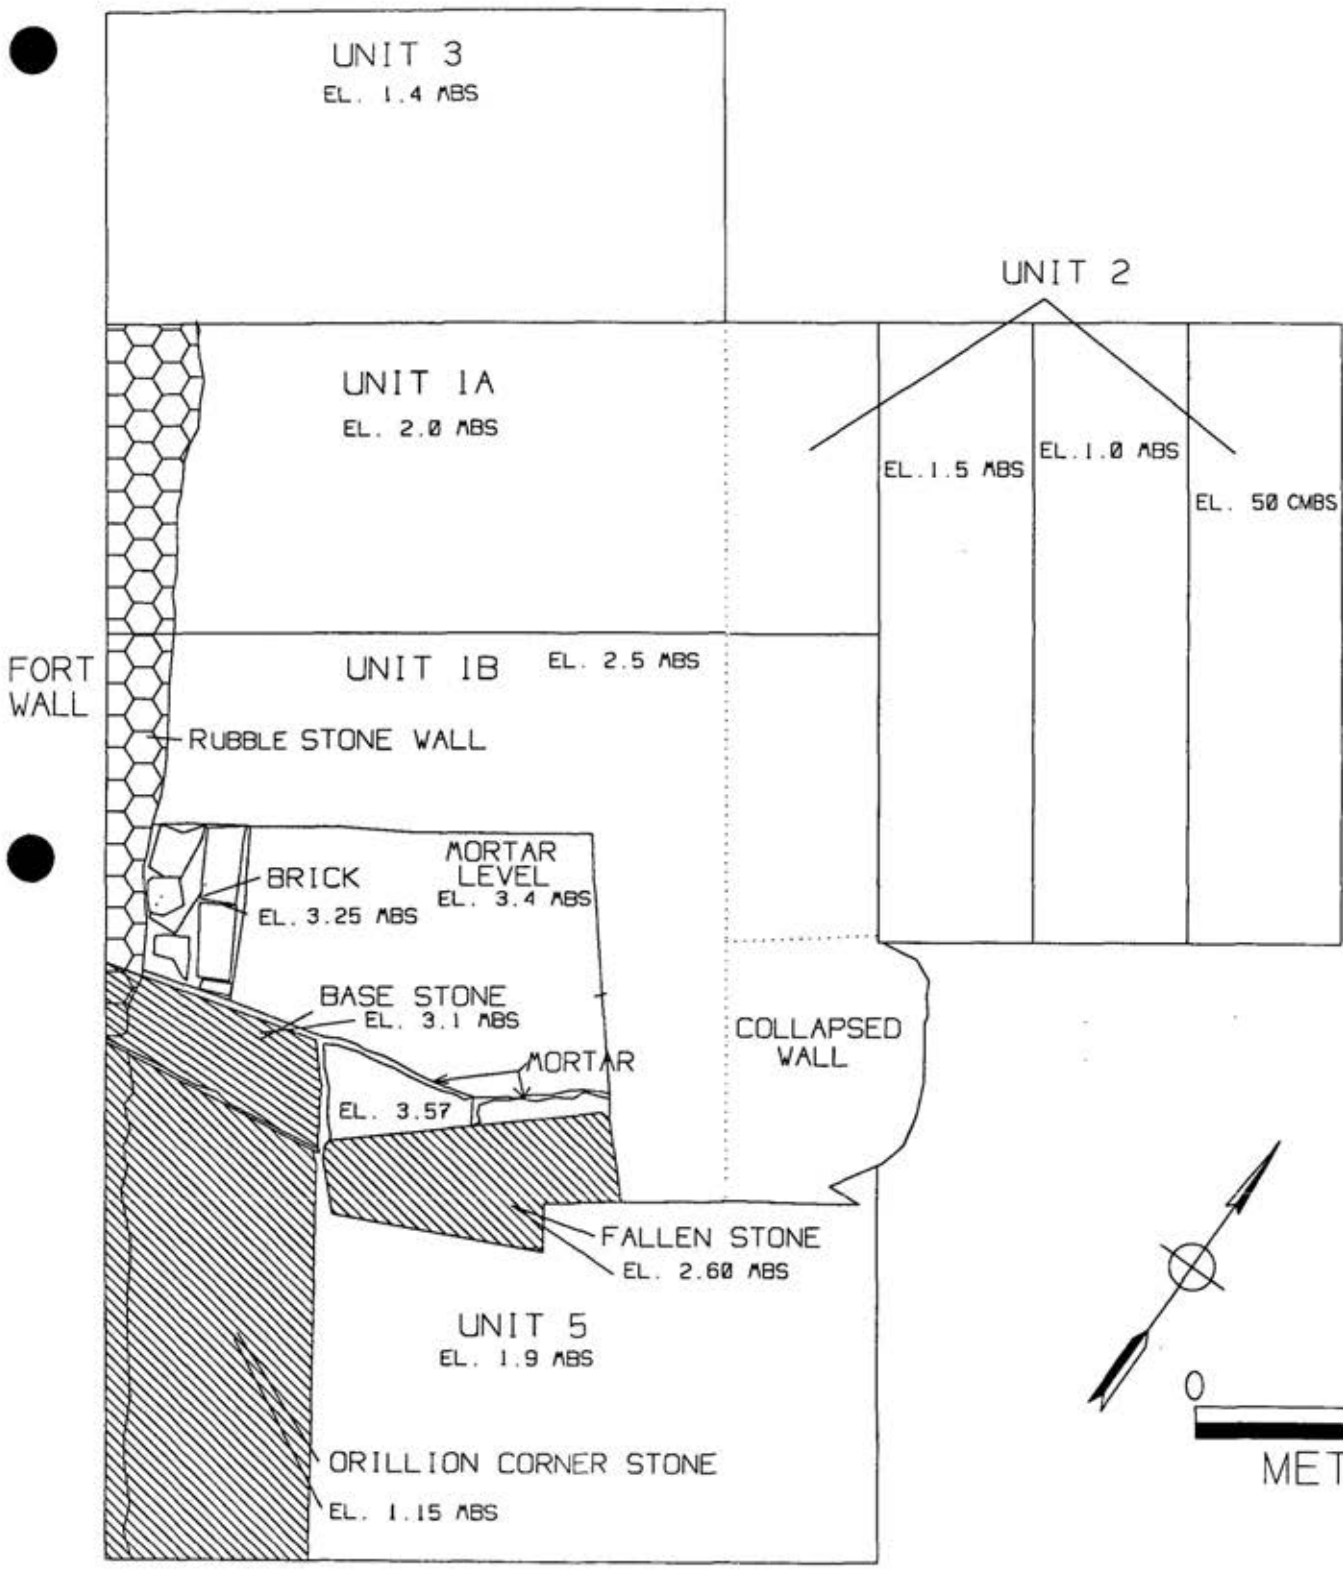
Figure 15. Plan View of Excavated Area.

Excavation reached the base of the rubble stone wall in the southeastern quarter of unit 1B at 3.25 meters below the surface (Figure 15). At the base of the wall two parallel courses of brick were located; the bricks were attached to the rubble stone wall and laid with their long axis to the wall (Figure 16). Three courses of the bricks were recorded. Whole bricks measured 28 cm long, 10 cm wide and five cm thick. A prepared level of mortar and sandstone was also found in association with the courses of brick. This mortar and sandstone level sloped away from the brick to 3.36 meters below the surface. The last 50 centimeters of soils atop this mortar floor were divided into three zones (A, B, and C) according to color and texture (Figure 16). Within zone C 11 pottery sherds identified as refilled earthenware (Smith 1962) were recovered. No date for this type of ware has been determined; however, the recovery of brick fragments identical to those used along the base of the rubble wall indicated that these redfilled sherds were deposited during the later half of the 18th century. Smith (1962) had also located this prepared floor and brick courses at the base of his excavations along the flanking battery wall. He excavated a portion of the floor and found it to be approximately 12 centimeters thick.

The stones of the vertical wall are 70 cm wide and between 40 and 45 cm thick except for a base stone which is 30 cm thick. The base stone extends out 30 cm from beneath the upper stones to the northwest providing a footing. The length of the stones was not determined as they continued beyond the width of the excavation (Figure 15).

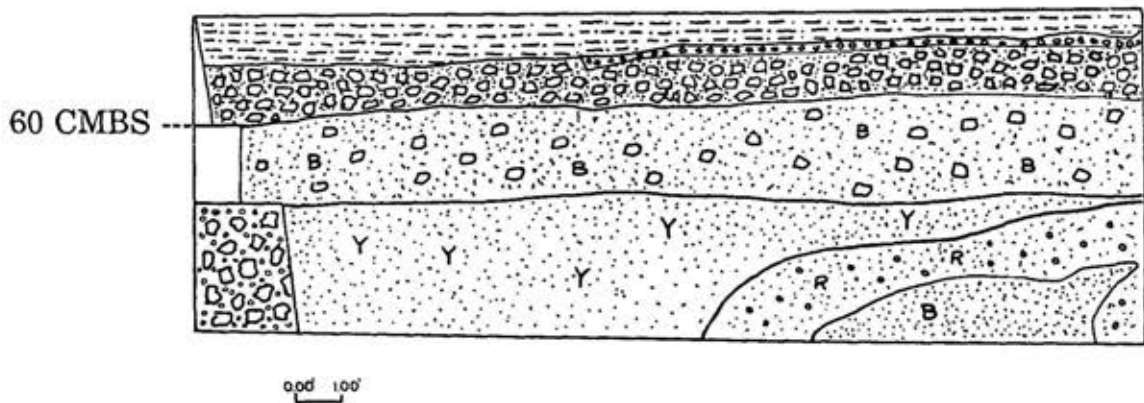
Figure 21. Northeast Profile of Trench A Located Along the Curtain Wall as Excavated in 1961 (Smith 1962).

Along the flanking battery wall, however, the ca. 1602 hornwork was used as foundation for the present battered wall. It occurred at the same depth (1.95 cms) as the rubble wall used to fill the orillon. The orillon was filled to the curtain wall as this rubble construction was located by Smith in 1960 at the juncture of the curtain wall and the flanking battery. In that the rubble wall, ca. 1773, was also used as foundation for the battered wall confirms that the walls presently in view above grade, within the moat area, were constructed in the late 18th century and constructed to a point at which the terreplein of the bastion is now 3.5 meters above the remains of the ca. 1602 level. Excavation of the soils adjacent to the rubble wall indicated that the moat was filled 2.8 meters during the ca. 1773 reconstruction and not after the reconstruction was completed as had been indicated in previous investigations. The lack of a surface finish to the face of the orillon fill indicates the likely intent of filling the moat from the onset of construction in ca. 1773. The brick courses and mortar level located at the base of the rubble wall were attached to the rubble wall and the mortar used was of the same materials as used in the rubble wall. These features, therefore, were determined to be the footing for the rubble wall and not the moat floor as had been suggested (Smith 1962). The footing course at the base of the orillon corner was assumed to be the level of the original orillon floor.
