HISTORIC STRUCTURES REPORT

ARCHITECTURAL DATA SECTION

THE SCALE HOUSE

Salem Maritime National Historic Site

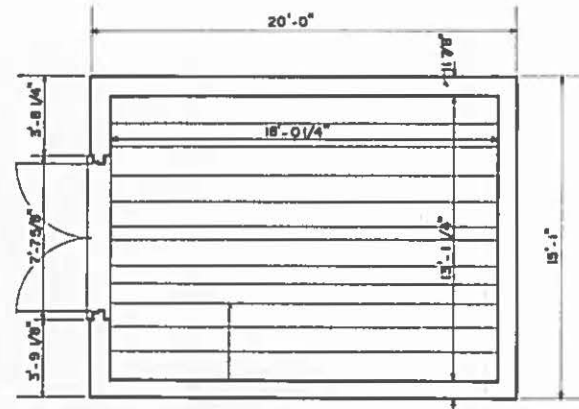
PLAN

The existing finish flooring has become oil soaked in the course of maintenance activity and must be replaced with similar pine boards of 1" (net) thickness ranging in width of 7" to 15-1/2". The sub-flooring does not need to be disturbed. The nailing pattern is to be copied and nails similar to those removed are to be used.

NOTES:
 Floor boards range in widths -
 7" - 15 1/2"
 Boards run full length of bldg.
 and are nailed to floor joists
 which are approximately 2" a.c.
 Three boards in southwest corner
 are exceptions.

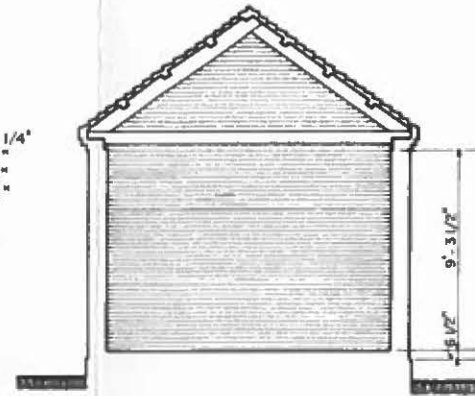
SECTION

The wooden roof structural members and sheathing are in good condition with the exception of the tie beams which should be treated to guard against further powder post beetle activity.

NOTES:
 Roof Construction
 joists bear on wood sill 8 1/4" x 8 1/4"
 joists 6" x 6"
 rafters 4 1/4" x 8"
 purlins 3" x 4"
 sheathing
 slate shingles
 lead flashing at ridge
