# Historic Housing Area Historic Structures Report

## HS-05 Quarters

Wind Cave National Park

January 27, 2016  
NPS PMIS # 158029

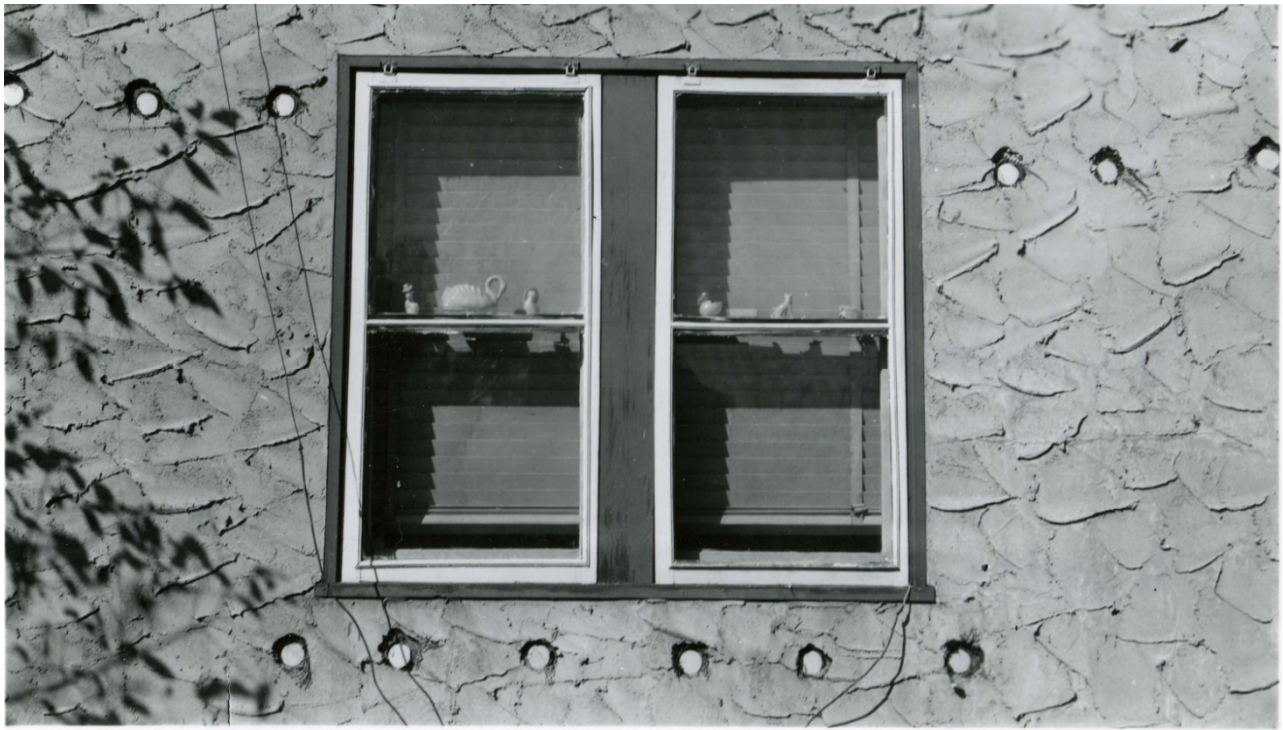
Figure 18. HS-05, ca.1952. Holes bored through stucco for insulation at Window 104. (WICA 4273)

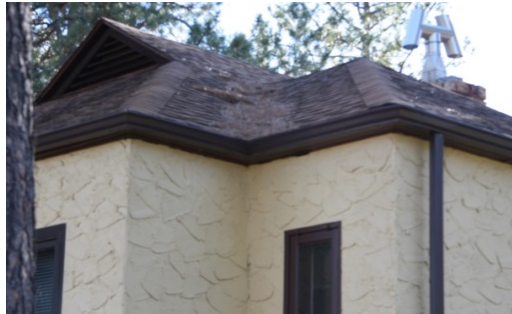
Figure R1. Valley and gutters filled with pine needles. (SRJA 2014)

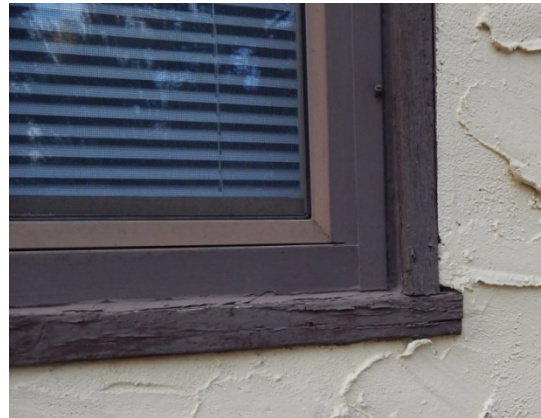
Figure W4. Detail of typical window trim deterioration where the historic trim is exposed. This shows signs of many peeling paint layers and wood rot at Window 103. (SRJA 2015)

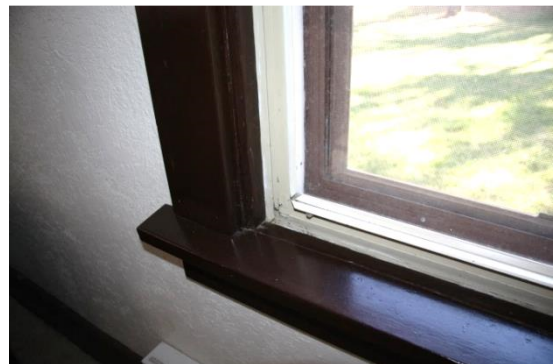
Figure W8. Detail of inappropriate aluminum interior replacement window with exterior brown storm window at Window 103. (SRJA 2014)

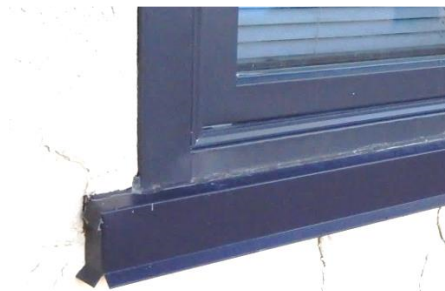
Figure W10. Detail of aluminum replacement Window 113 metal trim and sill panning. (SRJA 2015)

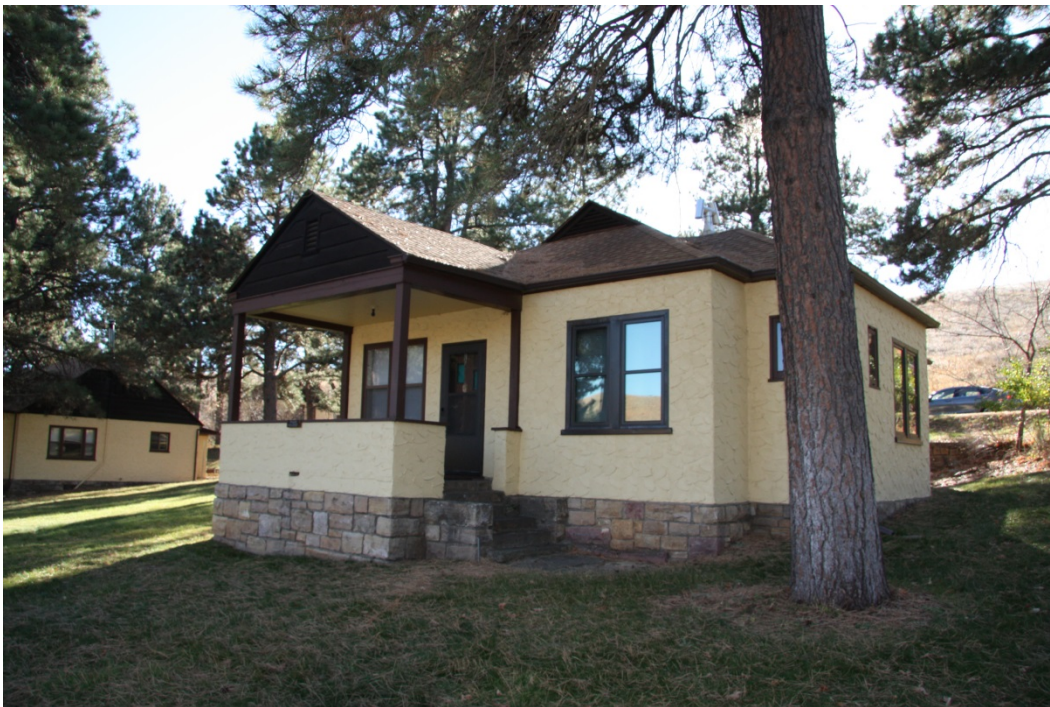
Figure X1. East Elevation. (SRJA 2014)

The front porch is missing the inside set of square wood columns at three locations (Figures X1 and X2). These were key character defining features of the front porch. The front porch light is currently an exposed bulb which originally had a globe glass cover (Figures 15 and 18). The porch ceiling is painted tongue and groove beaded board and is in good condition.

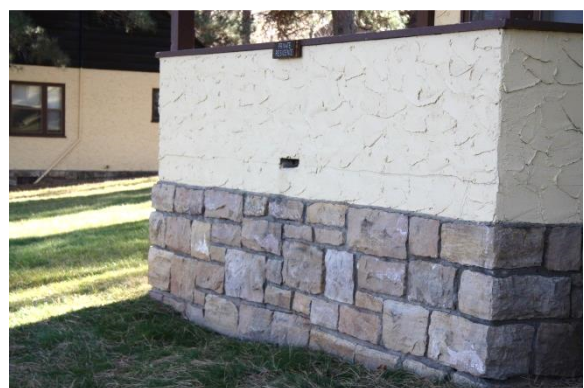
The front porch is in good overall condition, with the exception of the stucco cracking at the exterior face of the walls at the floor level. There are a few minor vertical cracks on the inside face of the porch wall, as well. The concrete floor slab is in very good overall condition, with only minor crazing. The floor is dirty and could be cleaned and have a water repellent installed. The porch walls are well below the 42-inch guardrail code requirement.

Figure X6. Porch east wall detail with cracking at floor level. (SRJA 2015)

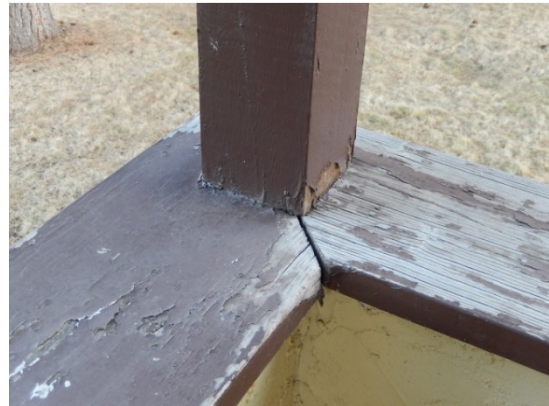
Figure X9. Porch southeast column and wall cap deterioration. (SRJA 2015)

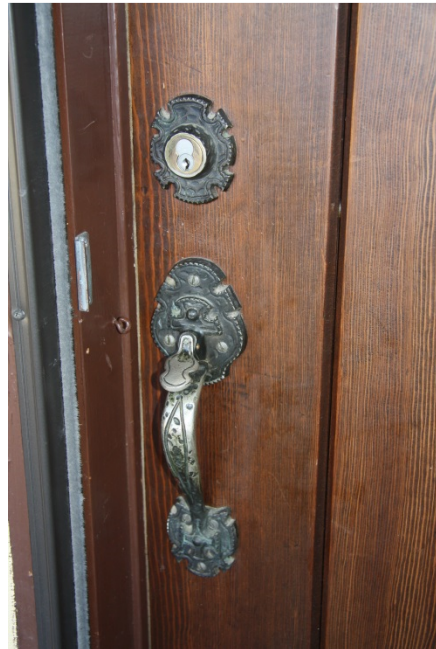
The entry Door 100/1 wood V-joint tongue and groove door with two glass lites, spaced diagonally across the door (Figures X12 and X13). This door dates to the ca. 1935 renovation. The hardware is original to the door and is manufactured by Yale and retains the original finish. The door is in very good overall condition, having been protected by the porch overhang and the storm door. The storm door is an aluminum pre-finished metal door (Figure X11). The weatherstripping at the base of the door is loose and requires either repair or replacement.

Figure X13. Door 100/1 hardware. (SRJA 2014)

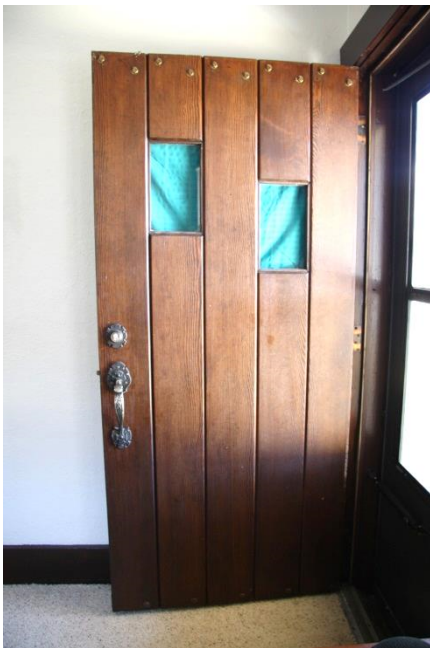
Figure X12. Door 100/1. (SRJA 2014)

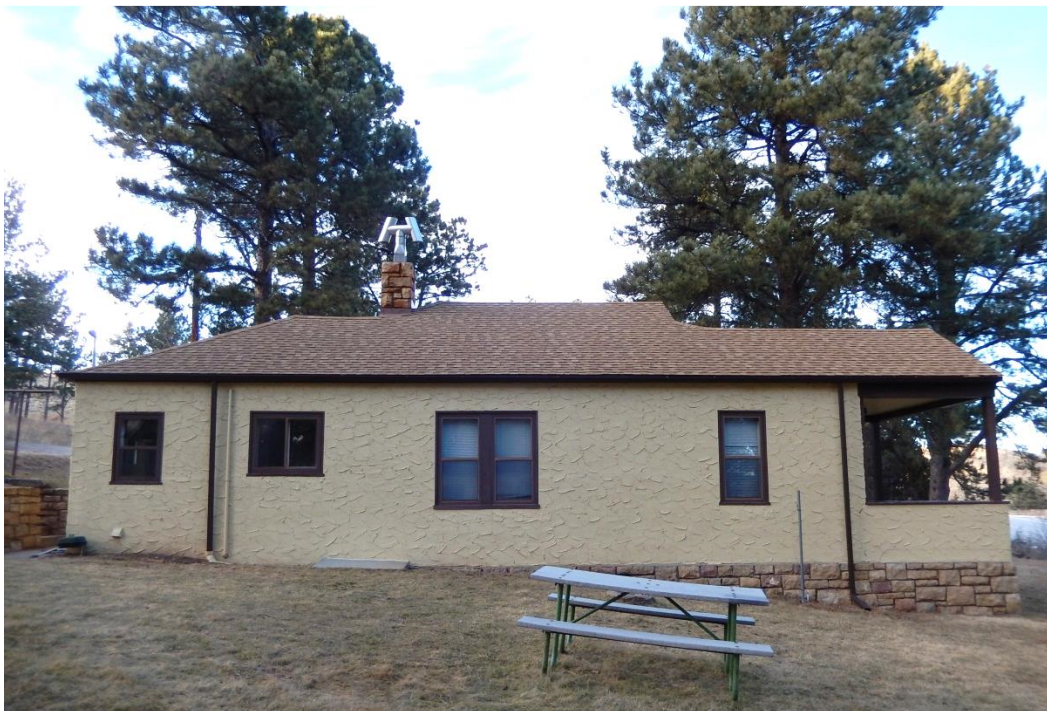
Figure X14. South Elevation. (SRJA 2014)

The South Elevation is set into the hillside with a gentle slope from the back of the property towards the front. The stone foundation is exposed at the front porch, while grade is well above the top of the stone near the back of the property. The stone foundation is in fair condition, yet will require nearly 100% repointing. The stone requires cleaning and the mortar wash across the top of the wall requires replacement. The foundation shows several campaigns of mortar types and colors.

The grade around the house has risen near the west side of the property and is now well above the top of the stone foundation walls, in full contact with the stucco wall. This condition is not acceptable for the stucco and is not the intended detail, as indicated in the original construction documents.

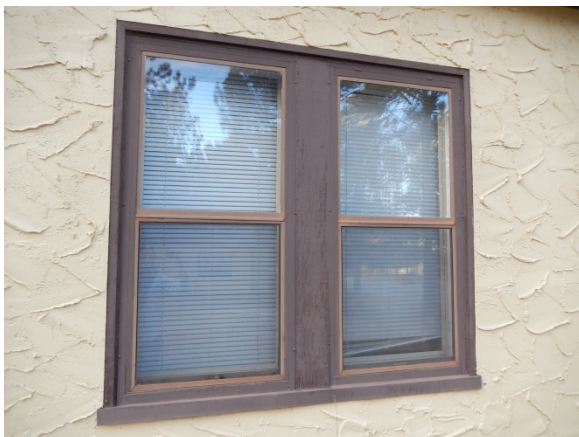
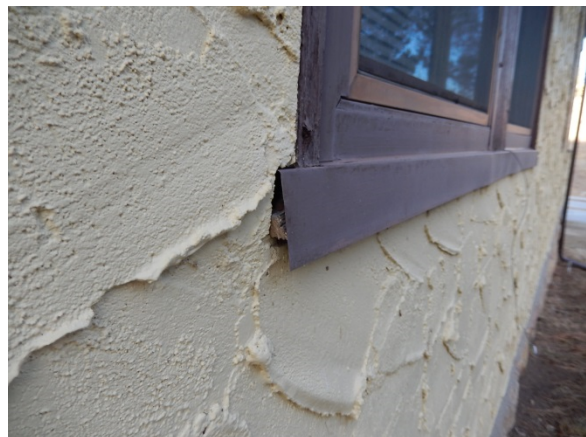
The wood window trim and sills on this elevation are in deteriorated condition, with peeling paint. Small sections of stucco are missing at the transitions between the long wood sills and the vertical window trim (Figure X17). The sill of Window 104 has been wrapped with metal panning (Figure X18). The panning is not well sealed and the wood sill is exposed, indicating it

Figure X18. South Elevation detail at Window 104. (SRJA 2015)

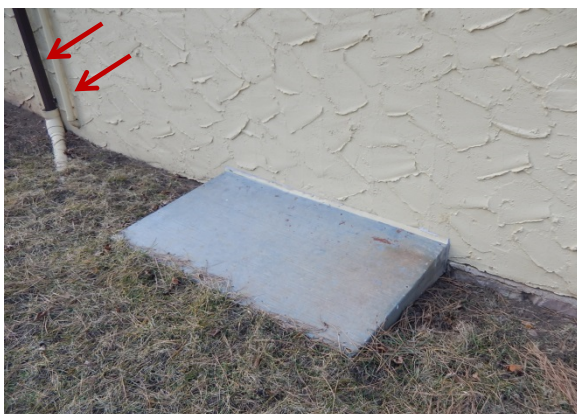
The basement Window 001 stone areaway is covered with a stainless steel fixed cap (Figure X19). The reason for this installation is unknown, but is likely to for maintenance reasons. The plumbing vent for the kitchen sink is installed on the exterior of the building west of Window 105. This is not in keeping with the historic character of the building. The hole drilled through the wall for the pipe vent is not sealed. The west downspout is directed into a boot and daylights away from the building. The east downspout drains to grade away from the building.

Figure X19. South Elevation basement Window 001. The exposed pipe on the left is the downspout. The painted pipe on the right is the exposed kitchen sink vent pipe. (SRJA 2015)

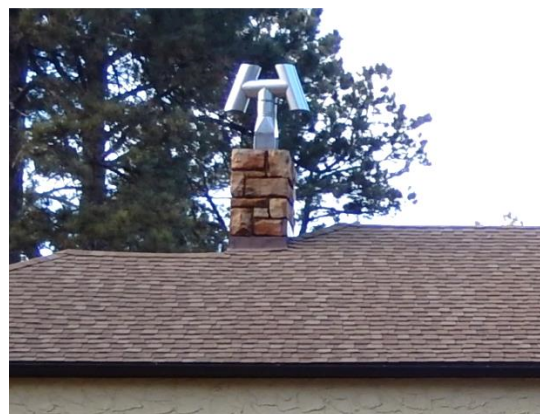
The wood trim on this elevation requires painting, especially around the windows. The stone chimney is most visible from this side of the house. There appears to be two flues in the chimney. The northernmost flue has been capped and the south flue has been topped with the stainless steel downdraft flue. The pellet stove and flue are no longer used. The chimney requires stone cleaning spot repointing, mortar wash repair and potentially a new cap, if the downdraft cap is removed.

Figure X20. South Elevation chimney detail. (SRJA 2015)

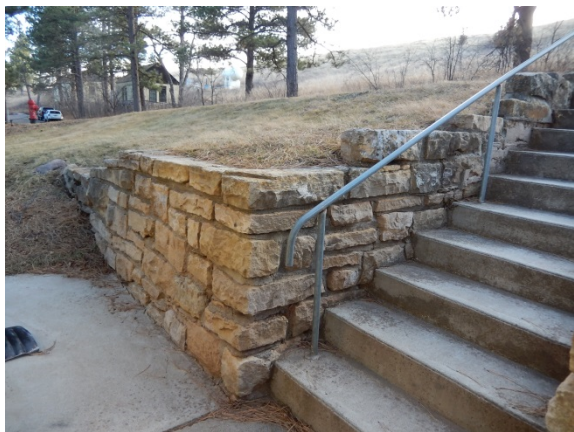
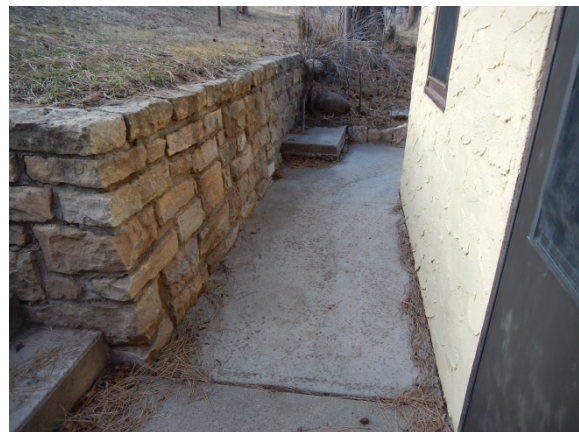
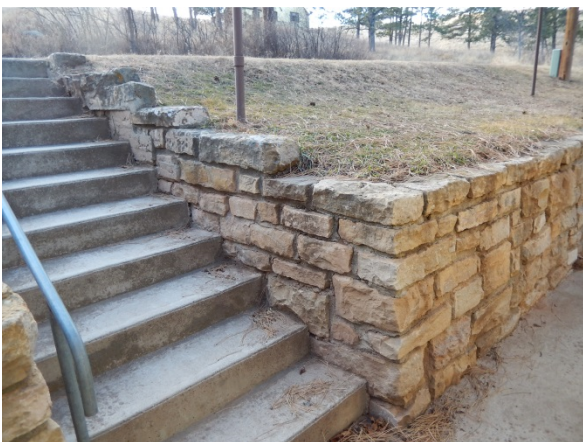
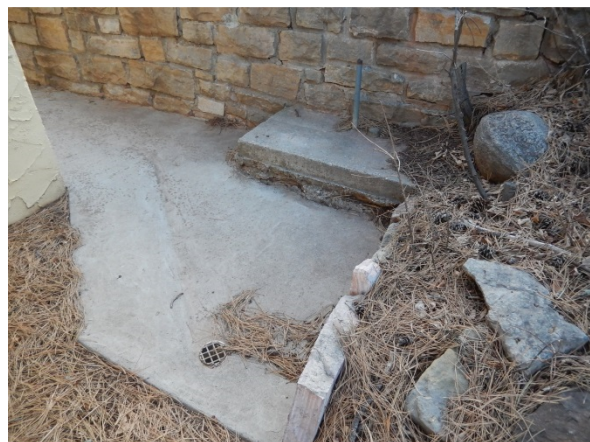
The West Elevation of the house faces the upper rear road. The road is several feet above the finish floor of the house. The house and road are separated by a stone retaining wall and in-grade concrete steps (Figures X22 – X25). The stone walls at the steps appear to be in good overall condition, requiring only spot repointing and cleaning. The concrete steps are in good condition. A concrete slab spans the area between the retaining walls and the house. This concrete slab is set well above the top of the stone foundation, in full contact with the stucco wall. There is not a soft joint between the concrete and the stucco wall. There are two drains in the concrete slab – one at the south end and another at the north end (Figures X25 and X28).

Figure X22. West Elevation. (SRJA 2015)

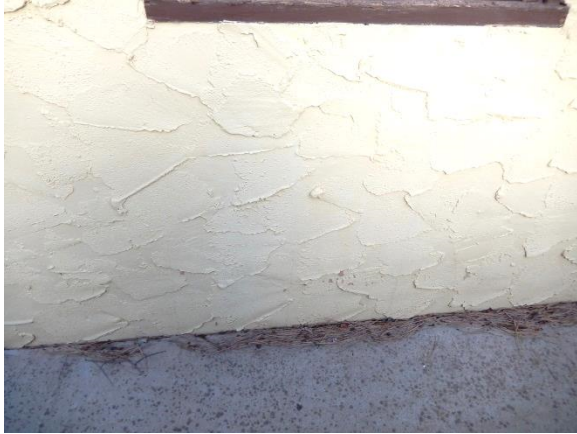
The west wall of the house is clad in stucco. The stucco has a lot of crazing near the concrete patio surface (Figure X26). This is either due to moisture in the stucco or from expansion and contraction of the concrete slab against the stucco wall. A large crack extends from the top left of Door 103/1 to the eave (Figure X27). Door 103/1 is the back door of the house and is protected by an aluminum storm door. The storm door is in good overall condition with the exposed wood frame requiring painting. The light fixture above the door is missing its glass shade. Window 107 is discussed in the Window section above. This is one of the few remaining historic wood 1/1 double-hung windows. It is currently covered by a deteriorated screened sash. The wood window sash, frame and screened sash require restoration. The electrical service enters the building at this side of the house. The lines are overhead and enter a weatherhead above the roof line. The meter is mounted on the west wall, just south of Door 103/1. The service enters the building just below grade. The concrete sidewalk had to be formed around the service entry, due to it being slightly below grade.

Figure X26. West Elevation detail at sidewalk and stucco wall. (SRJA 2015)

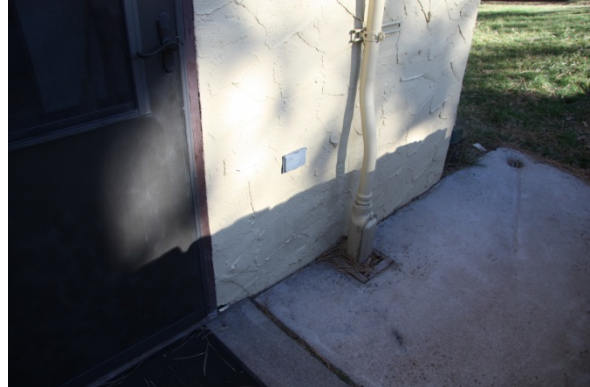
Figure X28. West Elevation detail at south side of concrete patio. (SRJA 2015)

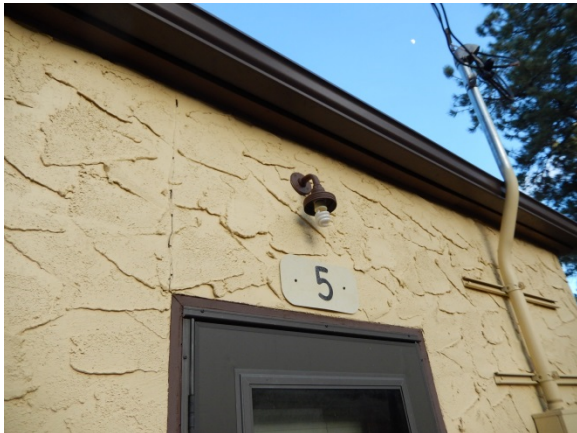
Figure X27. West Elevation detail at door. (SRJA 2015)

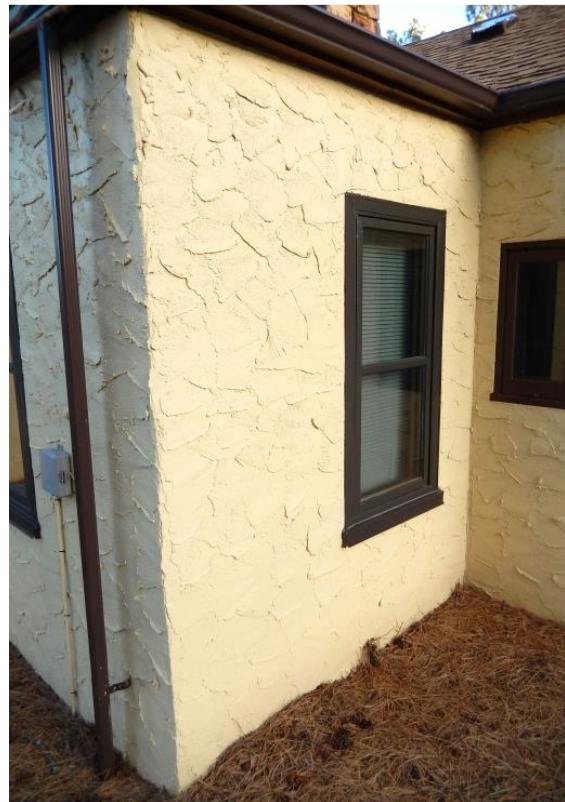
Window 109 is a west-facing window, which has been replaced with an aluminum wood clad casement egress window (Figure X29). The trim is panned on the exterior with pre-finished metal. The stucco grade in this corner of the building is well above the stone foundation and is in full contact with the stucco cladding. The stucco along the bottom of this wall exhibits crazing and paint loss due to the moisture infiltration. Window 112 is also a west-facing window, which has also been replaced with a new aluminum wood clad casement egress window. The trim is panned on the exterior with pre-finished metal. There is a spot below the window on the wall that requires painting.

Figure X29. West Elevation Window 109. (SRJA 2015)

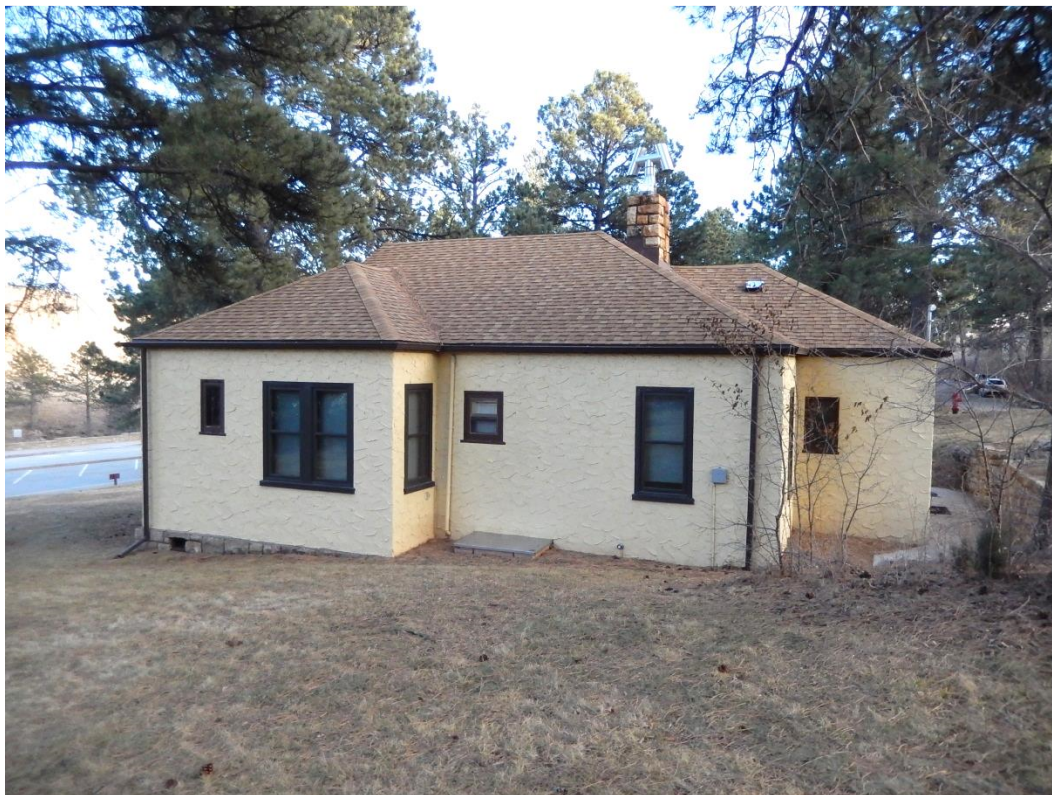
Figure X30. North Elevation. (SRJA 2015)

The North Elevation of the building is one story. The stone foundation is exposed at the east side, and is either level with or well above the top of the stone foundation about mid-way across the elevation towards the west side. The cross slope of the grade from north-south is almost more pronounced at this elevation than the east-west slope (Figure X30). The grade drains directly into the north foundation wall. There is not adequate swale to prevent water from coming into contact with the stucco walls near the west side of the house.

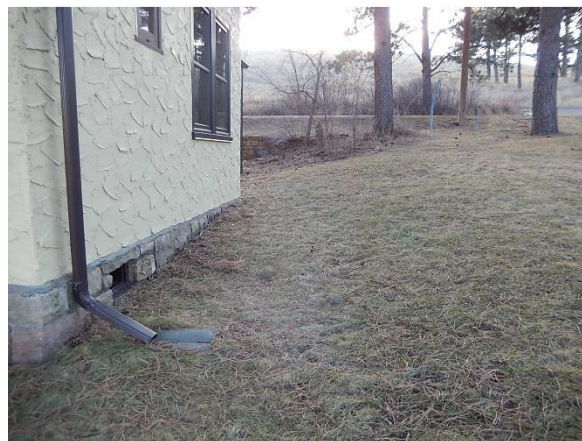
Figure X31. North Elevation of house looking west at north-south grad cross-slope towards house. (SRJA 2015)

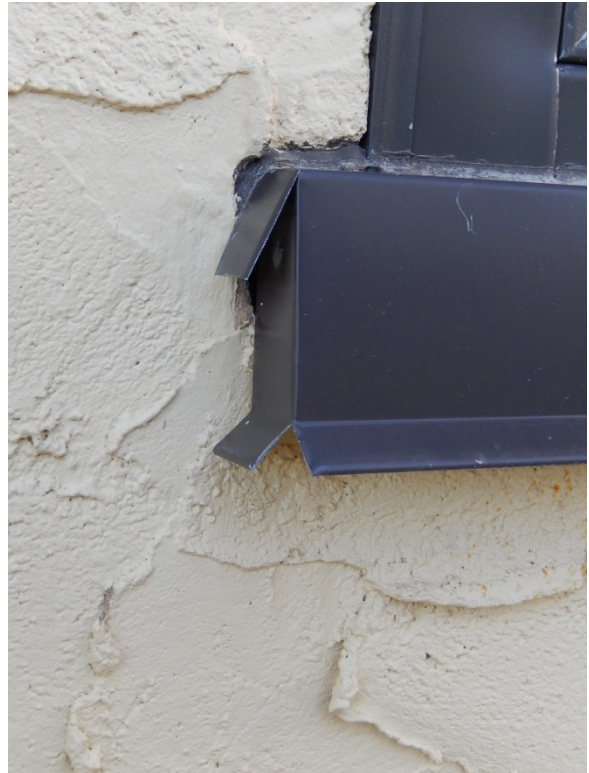
Window 108 is an original fixed wood sash and is clad with an original wood storm window (Figure X32). The wood storm window is deteriorated and requires restoration. Window 110 is an aluminum clad wood replacement casement window. The exterior wood trim and sill is clad with metal panning (Figure X33). Window 111 is an original wood double-hung window that is clad with a metal storm window. Windows 112 and 113 (Figure W9) are aluminum casement replacement windows with the exterior trim clad with metal panning, matching the detailing of Window 110. Window 114 is an original fixed wood sash with an original wood storm window (Figure W9). The wood storm window is deteriorated and requires restoration.

Figure X33. North Elevation Window 110 sill panning detail. (SRJA 2015)

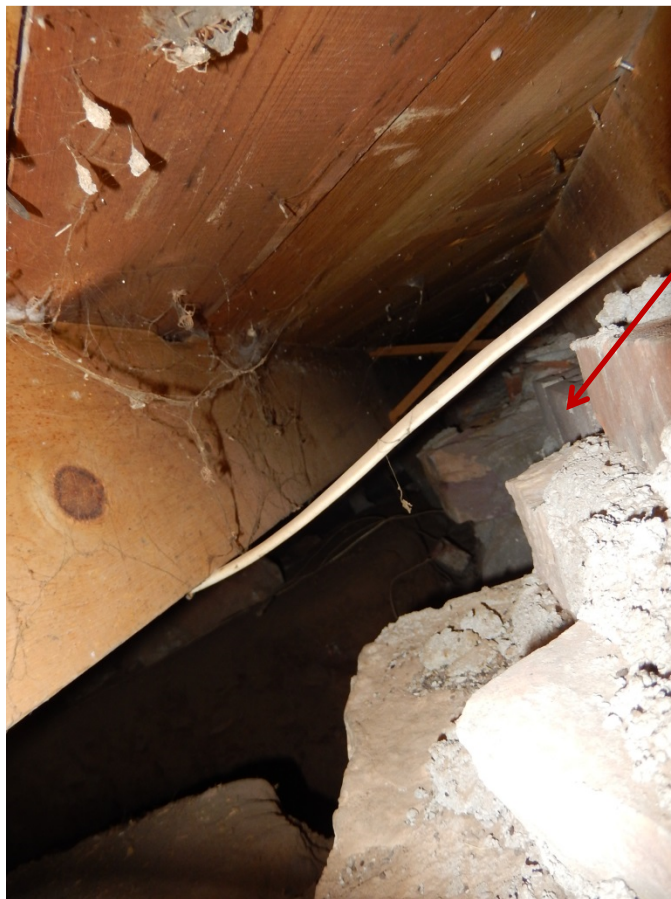
B-8). This was likely used to install the forced air HVAC system that is no longer utilized, as well as for the installation of wiring. There is no record of why this opening was infilled (Figure B-9). No other apparent access for maintenance in the crawl space was found. Crawl Space 004 only contains a single foundation vent in the north wall. There is no insulation at the first floor joists in the crawl space.

The red arrow points to old crawl space access that has been infilled and plastered over on the interior. This is just south of the existing small access hole.

Figure B-8. Crawl Space 002 Looking south along back side of foundation wall. (SRJA 2014)

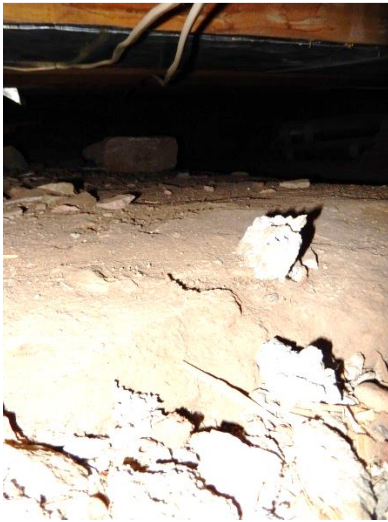
Figure B-9. Crawl Space 002 Looking east.  
(SRJA 2014)

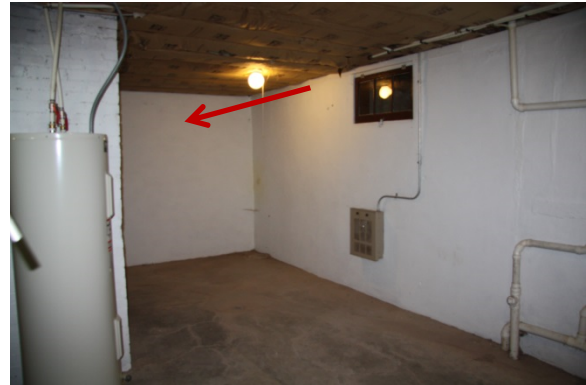
Figure B-10. Basement 001 Looking south and east. The red arrow points to where there used to be a larger crawl space access that has been infilled. (SRJA 2014)

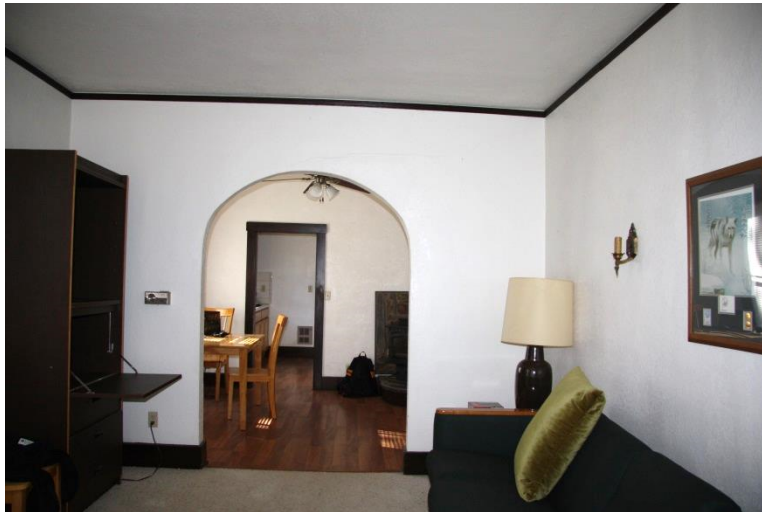
ceiling are painted plaster. There are several diagonal cracks along the ceiling that have been previously repaired. A large horizontal crack at the Opening 100/2 outlines where a larger squared opening was originally located before the arched opening was constructed (Figures 1-8 and 1-9). The floor is carpeted over an unknown wood substrate. A pair of matching decorative candle type historic wall sconces are installed on the north wall (Figures 1-5 and 1-11). Both Windows 102 and 103 have metal replacement sash that are not historically appropriate or energy efficient. Baseboard heaters are installed along the east and south walls near the windows.

Figure 1-8. Living Room 100 looking at west wall towards the Dining Room. (SRJA 2014)

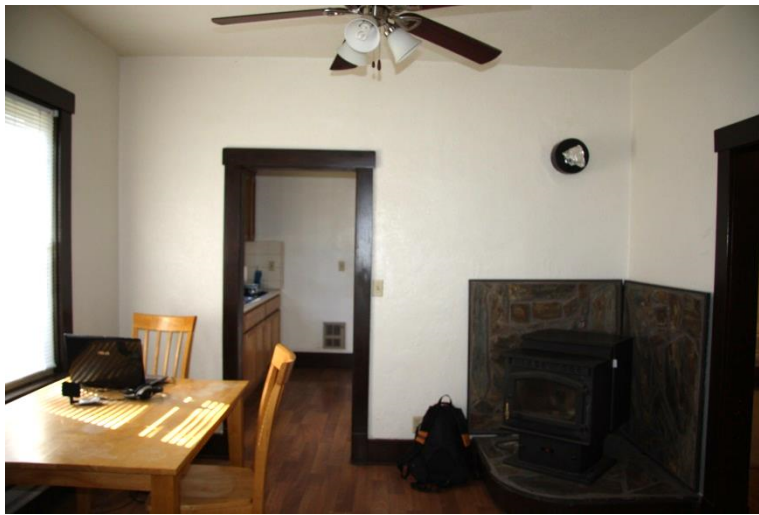
Figure 1-15. Dining Room 101 east wall. Note the flue is disconnected from the pellet stove and is covered. (SRJA 2014)

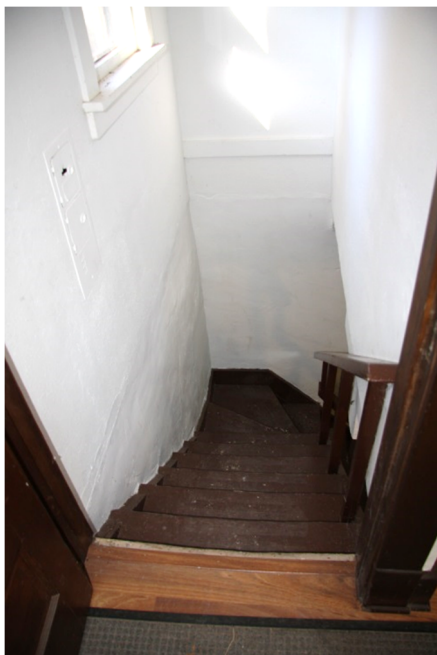
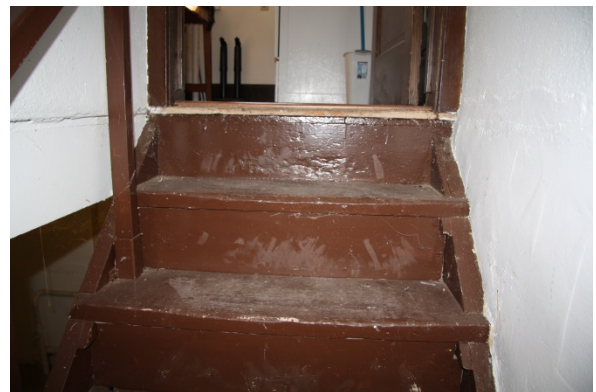
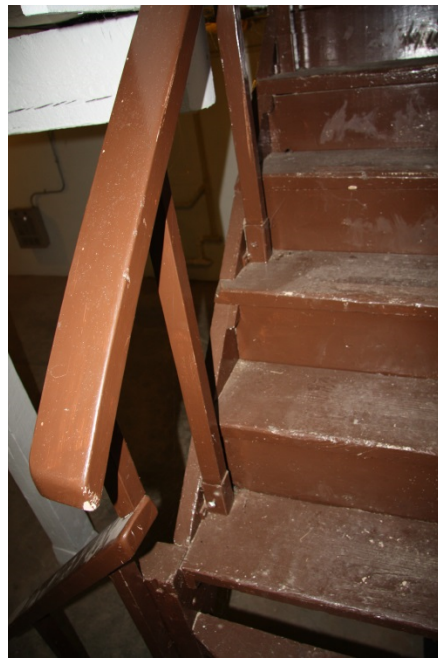
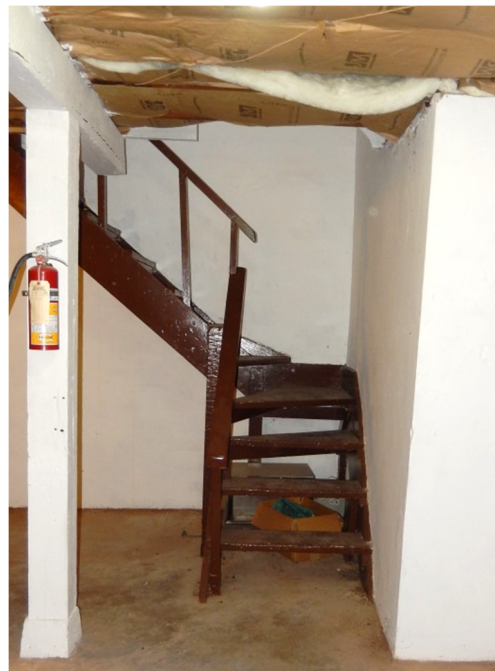
A narrow and steep winding wood staircase with wood treads leads to the basement (Figures 1-24 – 1-29). There is no landing at the door. Window 107 is located in the west wall. This is one of two original ca. 1935 wood double-hung windows remaining in the house. The window appears to be in good condition on the interior, with a lot of overpaint on the glass. The walls and ceiling are plaster. The foundation wall is also plastered.

The existing stair does not meet current residential code for rise/run, headroom at the stair turn or handrail/guardrail installation.

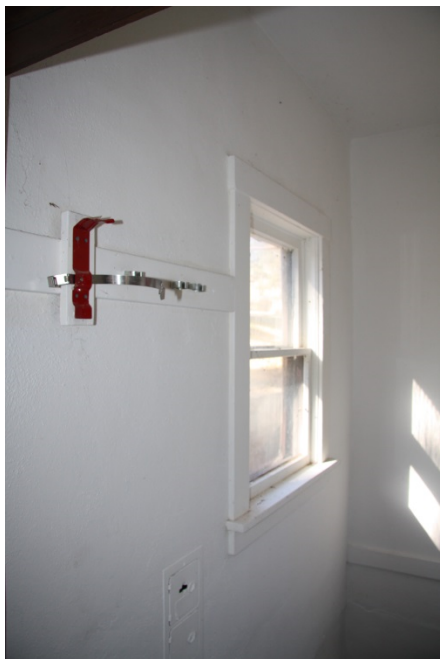
Figure 1-27. Stair 104 west wall. Note the old fuse panel that is no longer used. (SRJA 2014)

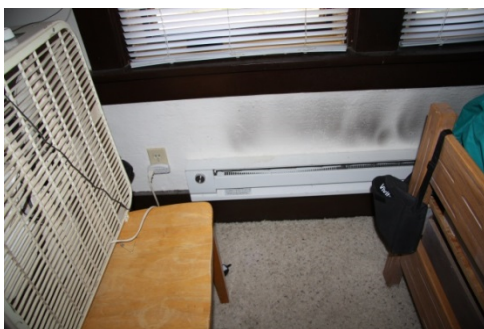
Figure 1-34. Bedroom 106 Looking east. Note the staining on the wall above the baseboard heater. (SRJA 2014)

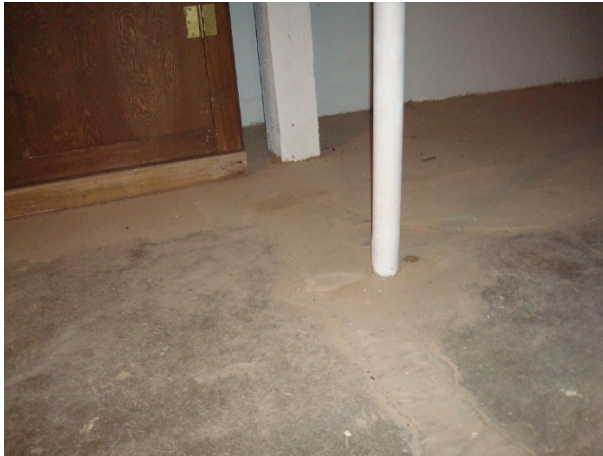
The east girder spans from a brick haunch built into the chimney eastward to a 6 x 6 (nominal) timber post. The post is located adjacent to the foundation wall at the transition from the basement to the crawl space. The timber post bears directly on the slab on grade. There is a 2-1/2-inch diameter steel post that cuts the girder span in half. The steel post is buried in the slab-on-grade (Figure S1). It is unknown if there is a footing beneath the steel post.

Figure S1. Timber post on slab-on-grade, steel post buried in concrete. (SEA 2015)

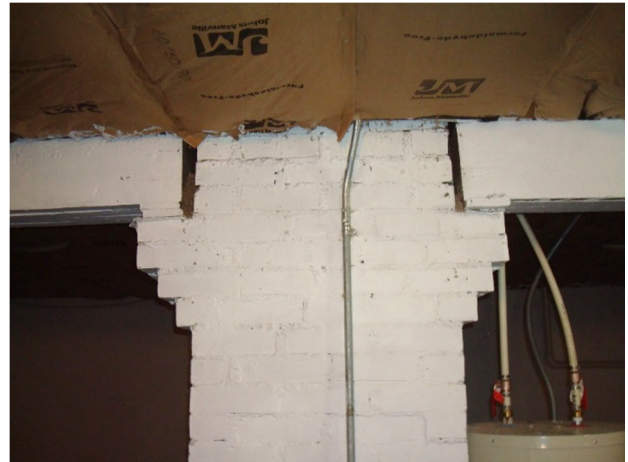
The west girder is supported on the east end by the chimney brick haunch and spans westward to a timber post (Figures S2 and S3). The timber post bears on a small, roughly 6" x 6" (actual) concrete pilaster. The girder cantilevers past the west most timber post (Figure S4). The girders and posts appear to be functioning adequately at this time.

Figure S3. Girders bearing on chimney haunch. (SEA 2015)

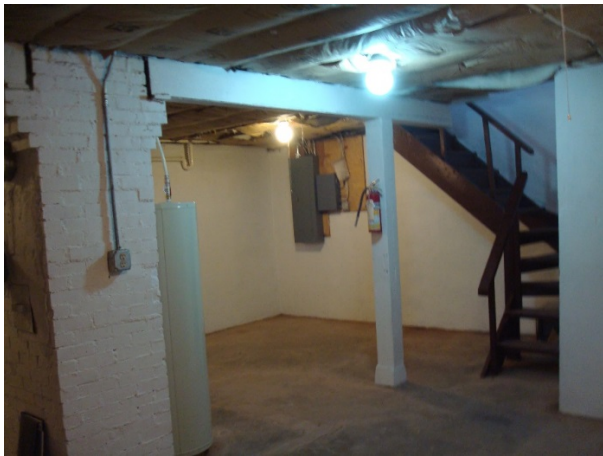
Figure S2. West girder in basement. (SEA 2015)

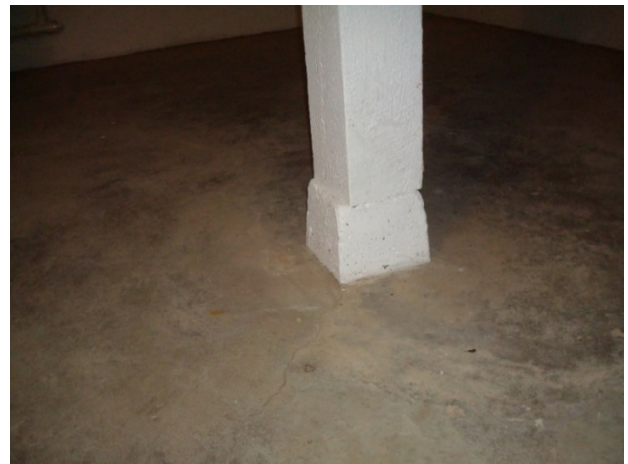
Figure S4. Post bearing on pilaster, girder cantilevers past post. (SEA 2015)

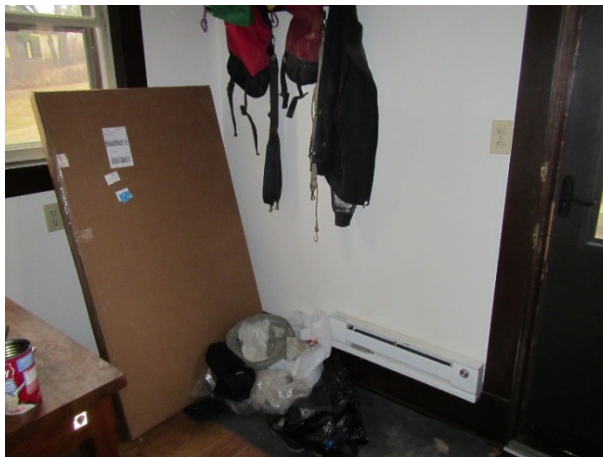
An electric baseboard heating system (Figure M01) was installed throughout the house during a remodel that took place in the 1980s. An abandoned pellet burning stove (Figure M02, Figure M03, and Figure M04) is currently in Dining Room 101. The flue routed from the pellet burner has been removed and capped at the penetration to the fireplace.

Figure M01. Example of electric baseboard heaters in Mud Room 103. (HEI 2015)

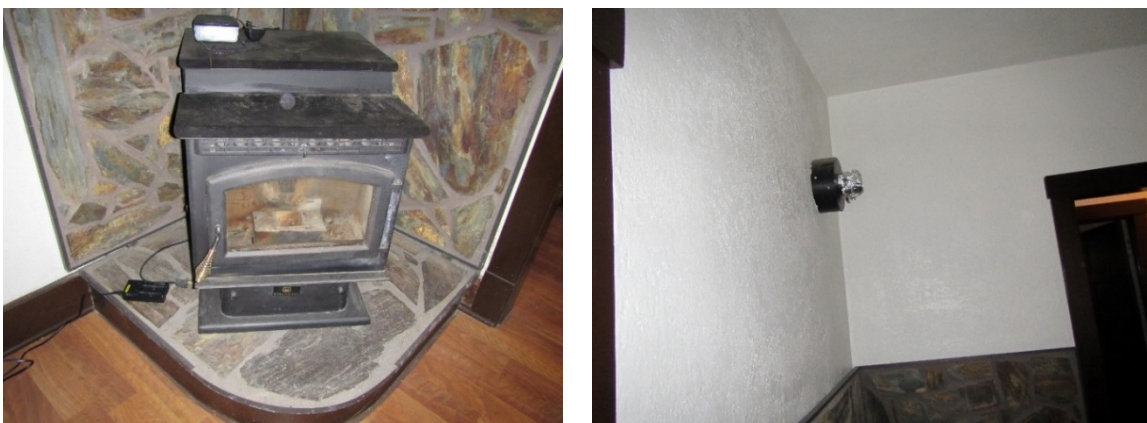
Figure M02. Dining Room 102, Pellet burner and capped flue. (HEI 2015)

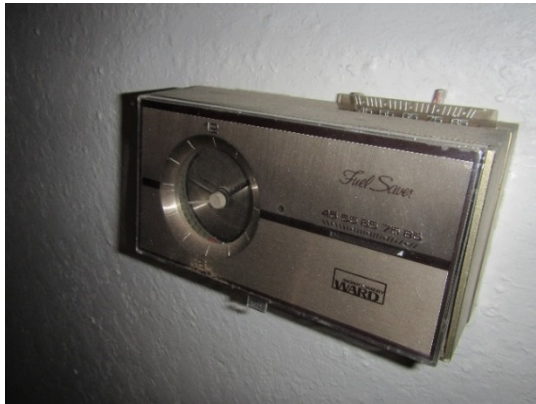
Figure M03. Pellet burner thermostat in Living Room 100. (HEI 2015)

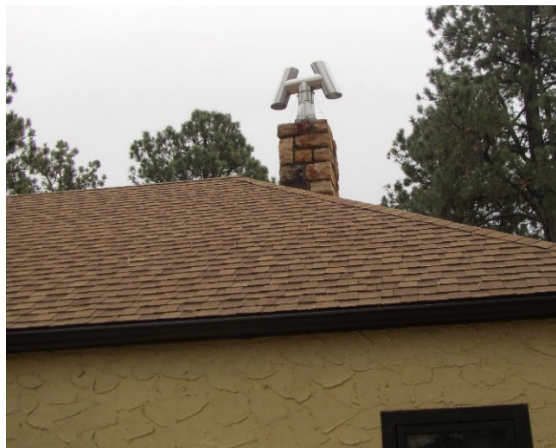
Figure M04. Pellet burner flue termination.  
(HEI 2015)

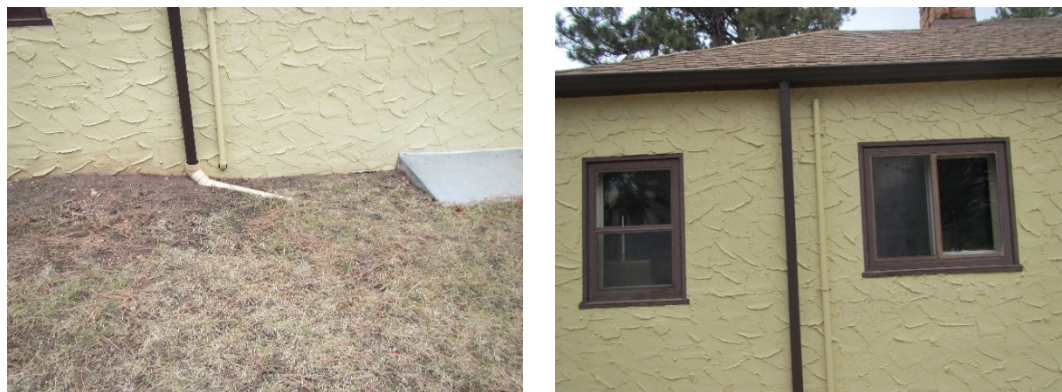
Plumbing fixtures are vented through a vent system that is routed from the basement, out the exterior wall at approximately 5-inch above grade, and then routed up vertically along the exterior wall (Figure P08). The vent pipes then terminate with insect screen a few inches below the roof soffit (Figure P08). These pipes are not insulated. The venting system does not appear to be code compliant. Refer to treatment recommendations section for additional information on vents.

Figure P08. Example of exterior vent piping. (HEI 2015)

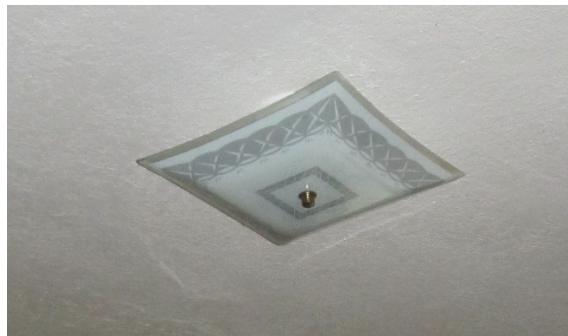
Bedrooms 106, 107, and 109 each have a single vintage square glass incandescent fixture with two screw base compact fluorescent lamps (Figure E11). The light fixture in Bedroom 109 is missing the square glass cover.

Figure E11. Light fixture located in Bedrooms 106, 107, and 109. (HEI 2015)

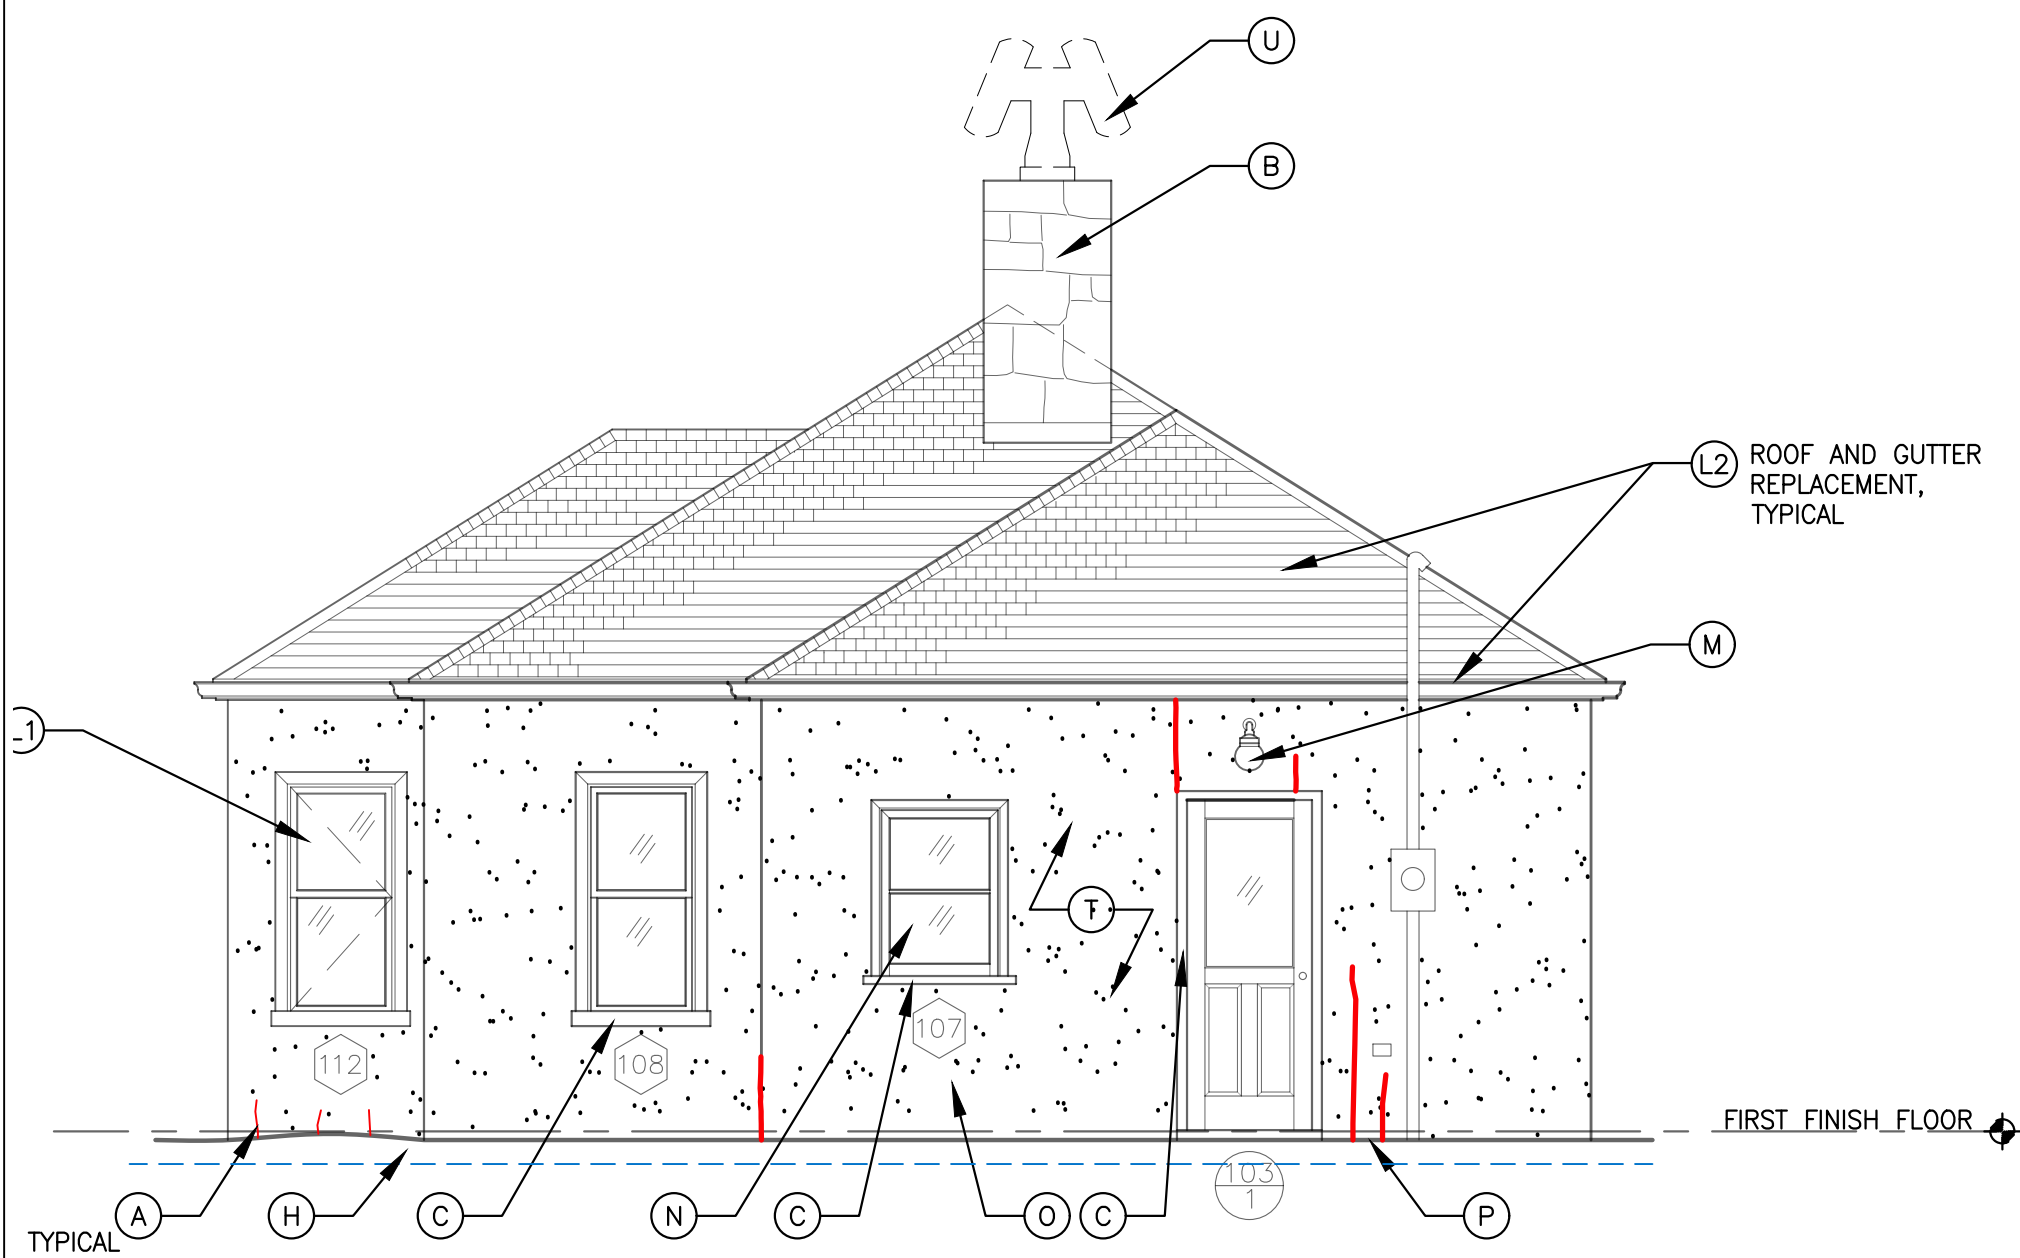
1 HS-05 IMMEDIATE AND LONG TERM TREATMENT — WEST ELEVATION  
TA4 1/4" = 1'-0"

Repair cracks and crazing in stucco. These are prevalent along the west and north elevations, with a few on the east and south elevations.

Re-grade along the west and portions of the south and north elevations to achieve a minimum of 4-inches below the top of the stone foundation walls. Install a French drain to daylight and a swale. The grade is in contact with the wood frame stucco walls and is causing advanced deterioration in these locations.
