# Historic Housing Area Historic Structures Report

## HS-05 Quarters

Wind Cave National Park

January 27, 2016  
NPS PMIS # 158029

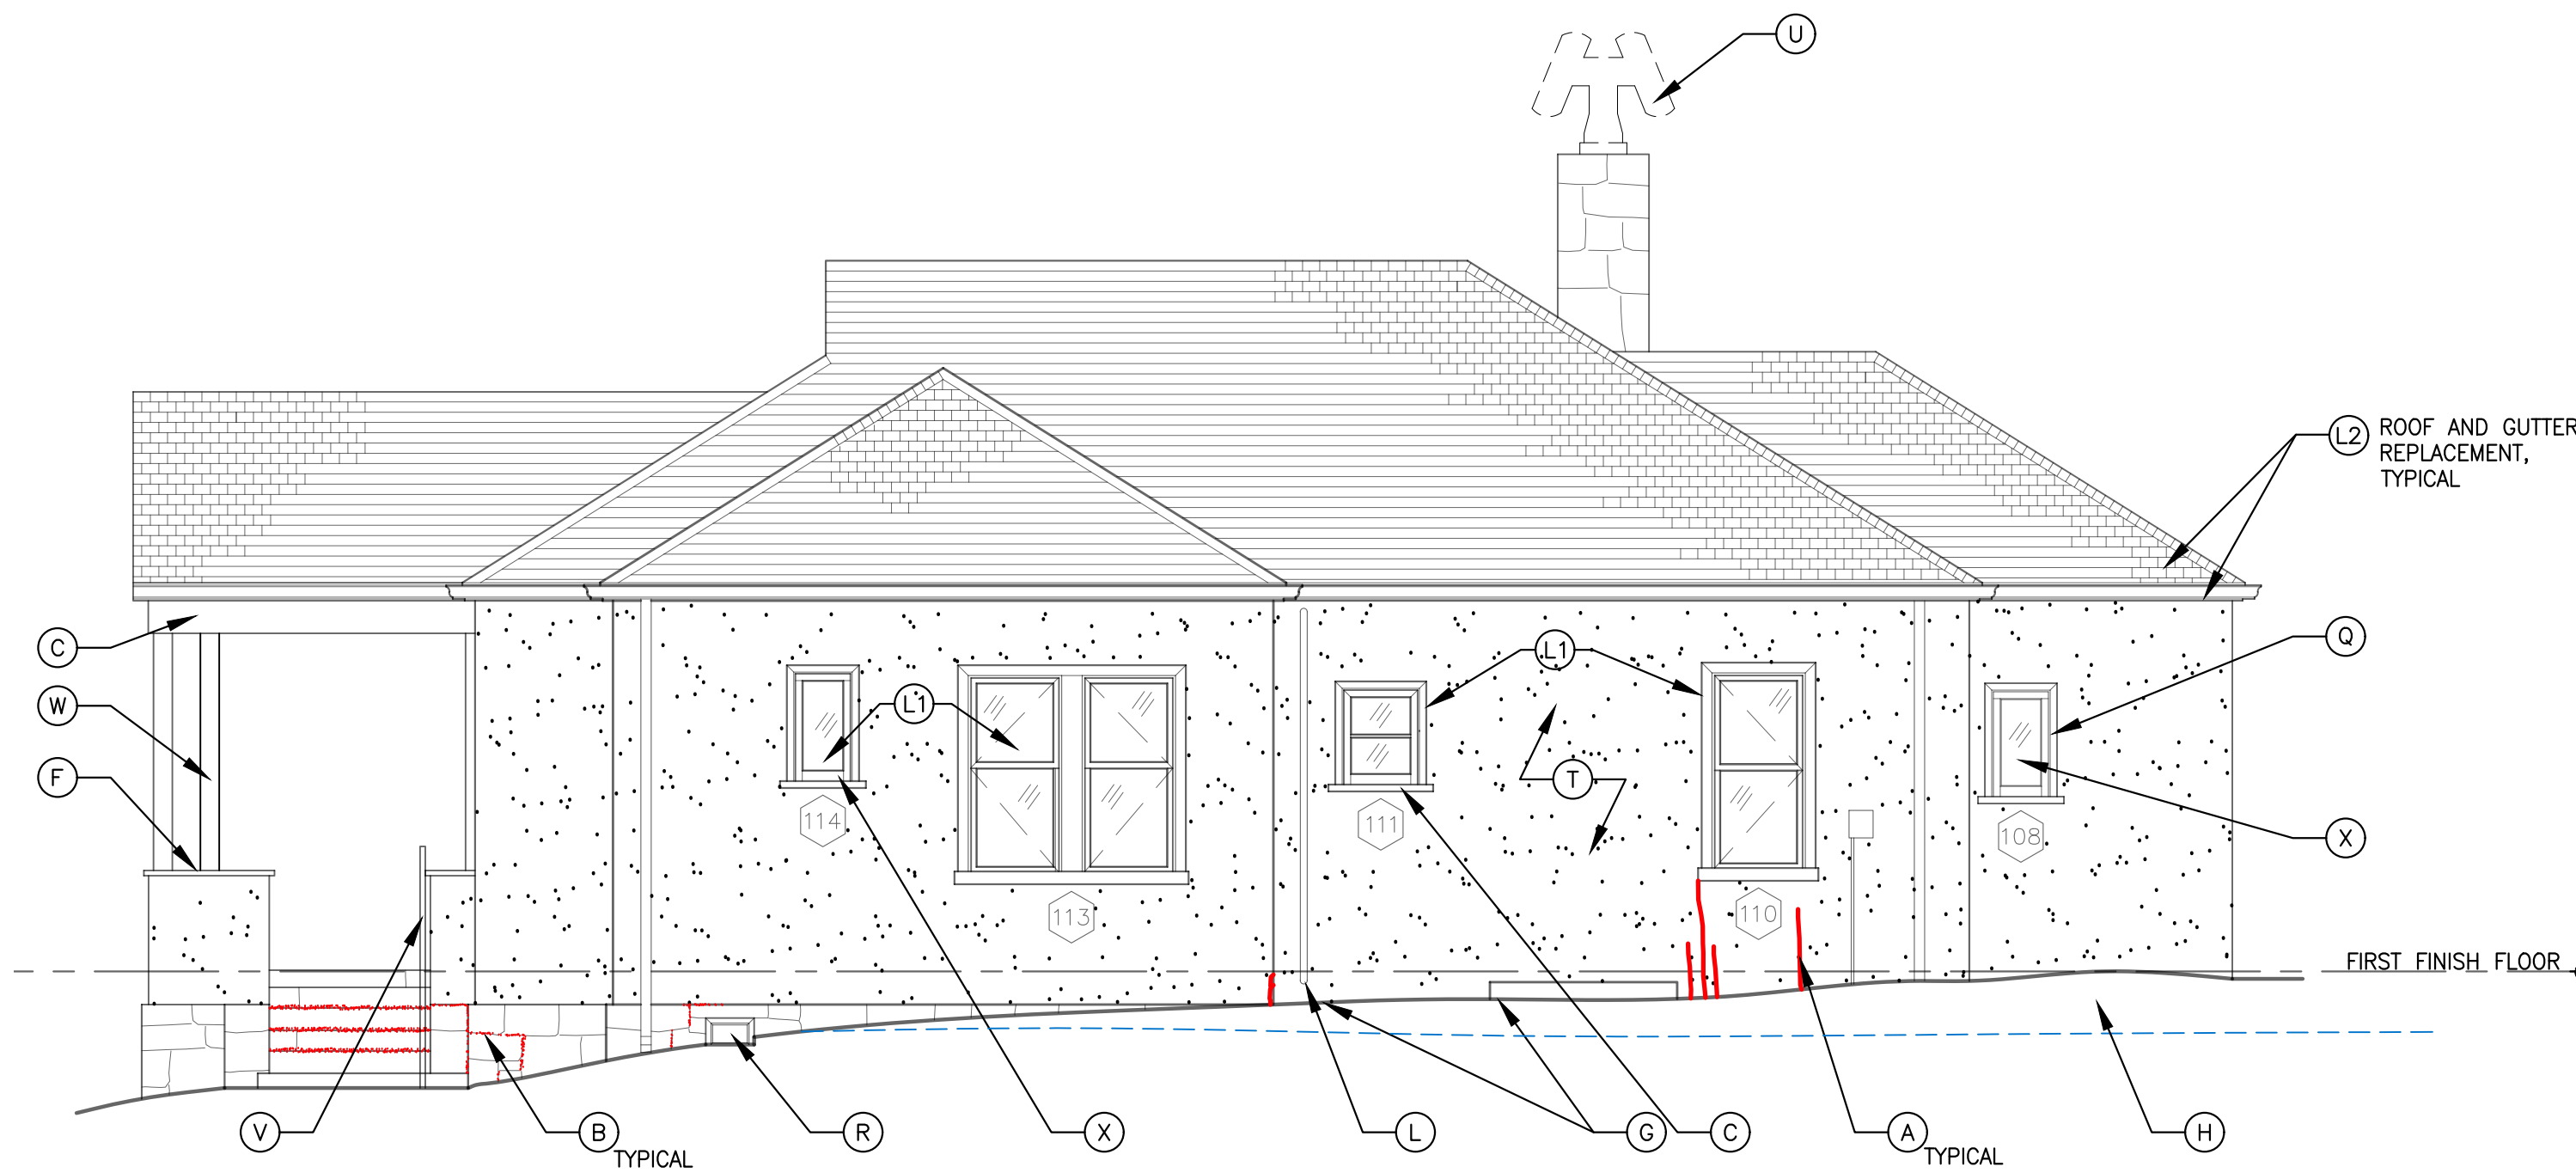
2 HS-05 IMMEDIATE AND LONG TERM TREATMENT — NORTH ELEVATION  
TA4 1/4" = 1'-0"

Cracks consistent with settlement are present on the south and north elevations. Consideration should be given to installing underpinning piers on this building. Piers could be installed under the areas at and adjacent to the cracks, however new cracks may appear as other parts of the building continue to settle.

Repair cracks and crazing in stucco. These are prevalent along the west and north elevations, with a few on the east and south elevations.
