# Historic Housing Area Historic Structures Report

## HS-07 Quarters

Wind Cave National Park

January 27, 2016  
NPS PMIS # 158029

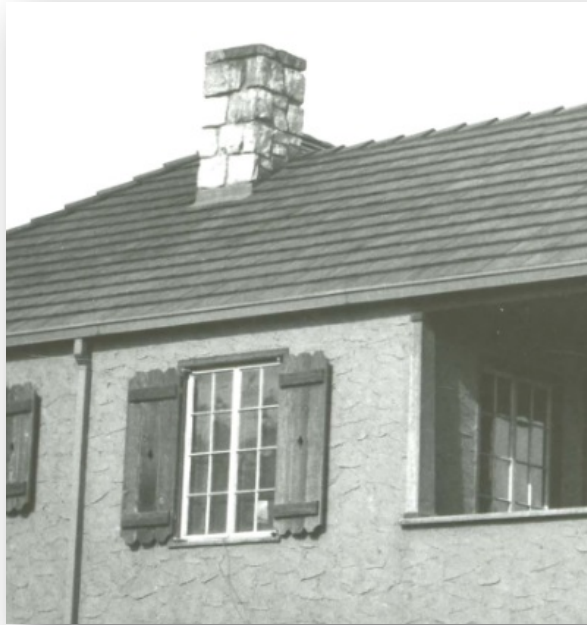
Rustic board and batten shutters with a diamond silhouette design in the center were installed on this house when it was first constructed (Figure W1). These shutters were also indicated on the original construction documents. They were installed on the windows on the south, east and north elevations, but were not installed on the west (rear) elevation. The last photograph in the file indicates they were installed at least until 1952 and were removed sometime prior to 1959. These were an important character defining feature of the exterior that lent the 'rustic' style to the building.

Figure W1. HS-07. ca.1940. Note the steel casement windows and the rustic board and batten shutters with the diamond silhouette design in the center. (WCNP Archive Number: WICA 4730.)

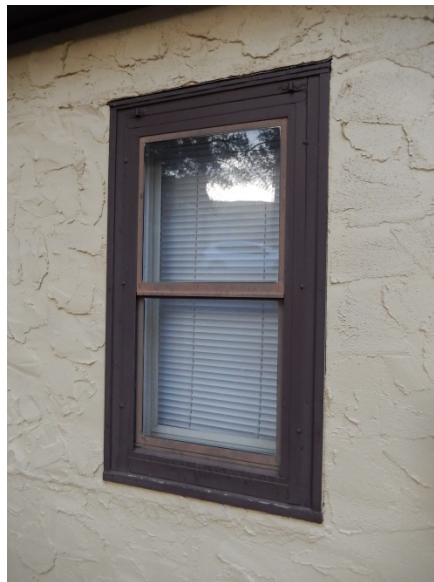
Figure W2. Window 106 on the west elevation. (SRJA 2015)

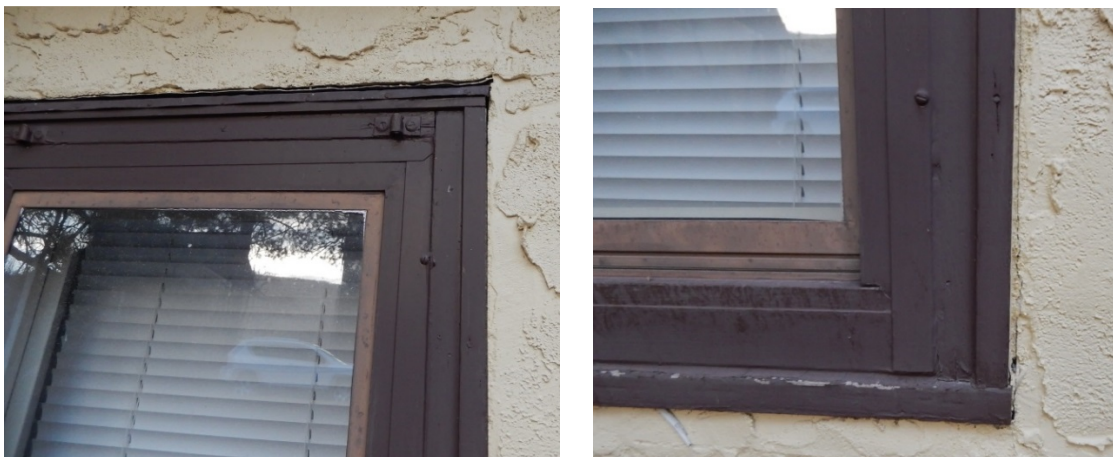
Figure W3. Window 106 on the west elevation details. (SRJA 2015)

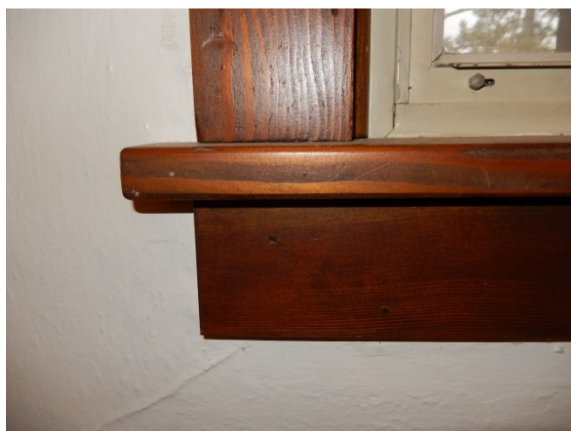
Figure W4. Window 101 interior detail of the metal interior sash against the stained pine trim. (SRJA 2015)

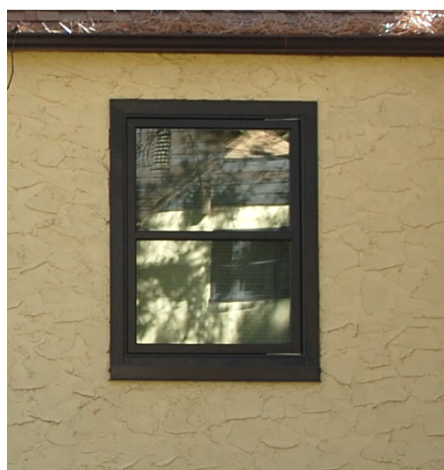
Figure W5. Window 109 on the north elevation. Aluminum replacement casement window with metal paning covering the historic trim. (SRJA 2014)

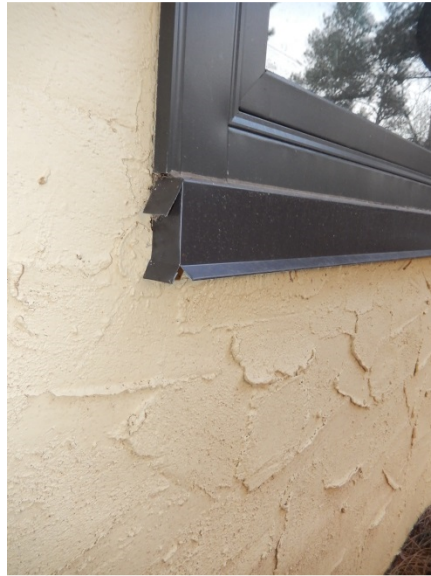
Figure W6. Window 107 on the west elevation detail. (SRJA 2015)

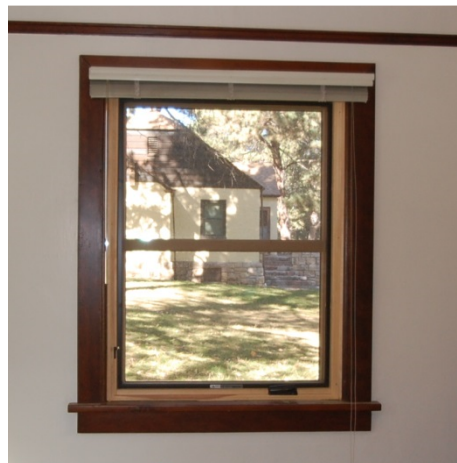
Figure W7. Window 108 replacement window that is not finished on the interior. (SRJA 2014)

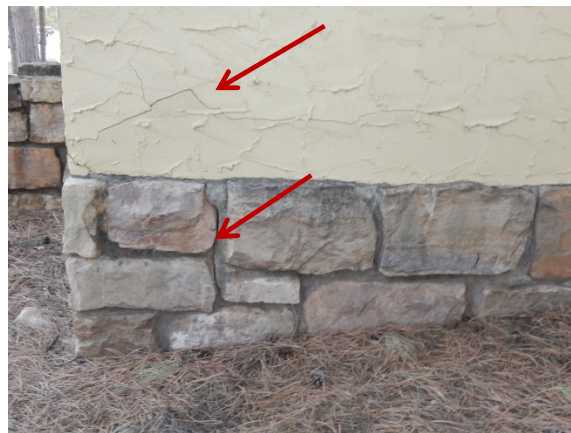
Figure X4. Porch – North Elevation foundation and stucco cracks. The top red arrow identifies a long traveling crack in the stucco. The bottom red arrow identifies a long vertical crack in the mortar joints that begins below grade and projects to the top of the foundation wall. (SRJA 2015)

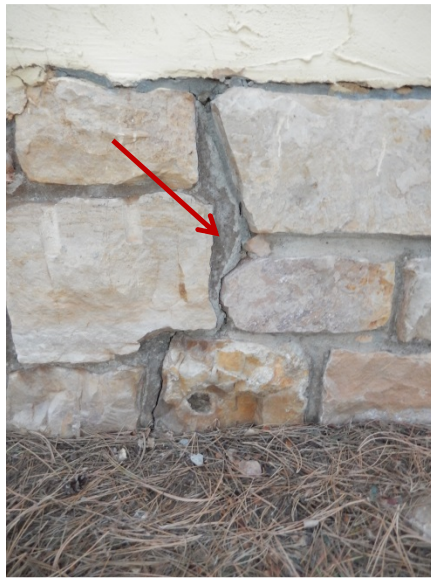
Figure X5. Porch – East Elevation foundation crack detail. The red arrow indicates a vertical crack through the mortar joints from below grade to the top of the foundation wall. (SRJA 2015)

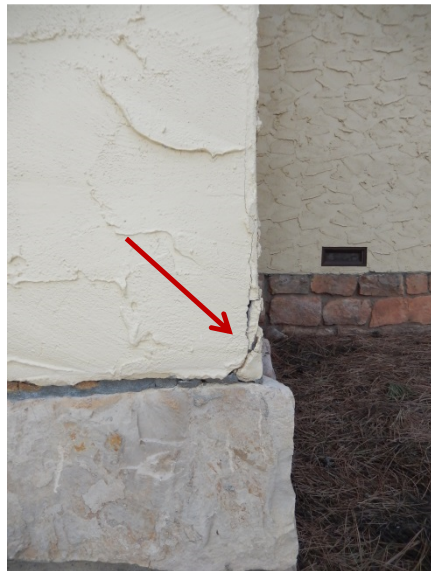
Figure X6. Porch – East Elevation stucco crack at northeast corner. The red arrow identifies a crack in the corner of the plaster that has traveled from the north side of the wall. (SRJA 2015)

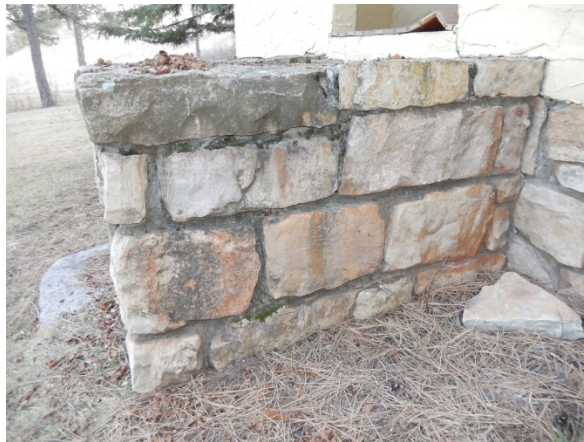
Figure X7. Porch Steps – North Elevation. (SRJA 2015)

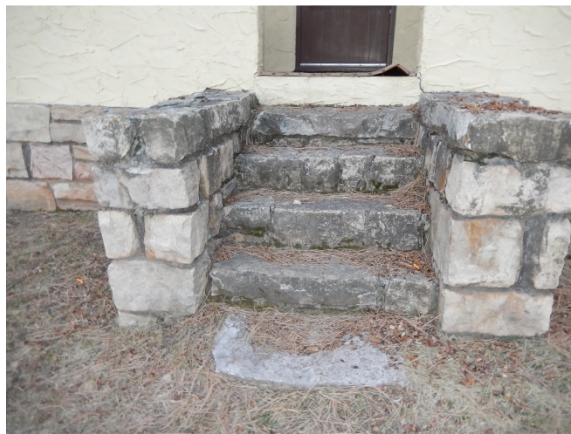
Figure X8. Porch Steps – East Elevation. (SRJA 2015)

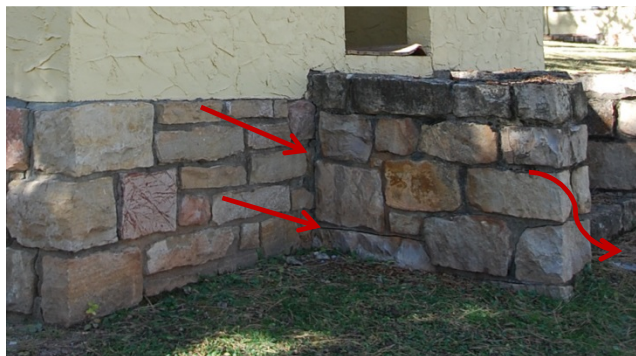
Figure X9. Porch – East Elevation and south wall of steps. The red arrows indicate open mortar joints due to wall movement. The curved arrow indicates the wall is beginning to rotate forward. (SRJA 2014)

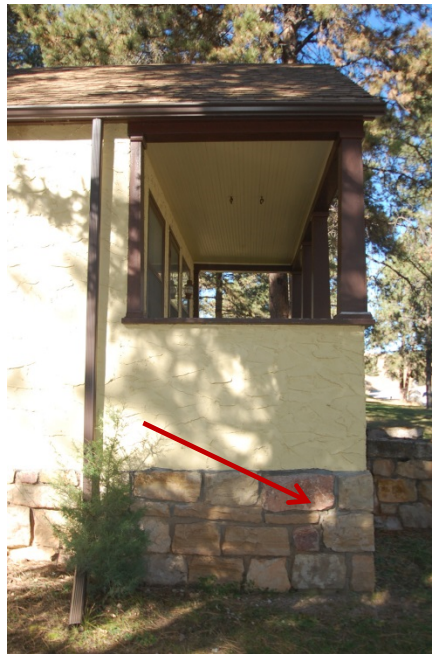
Figure X10. Porch - South Elevation. (SRJA 2014)

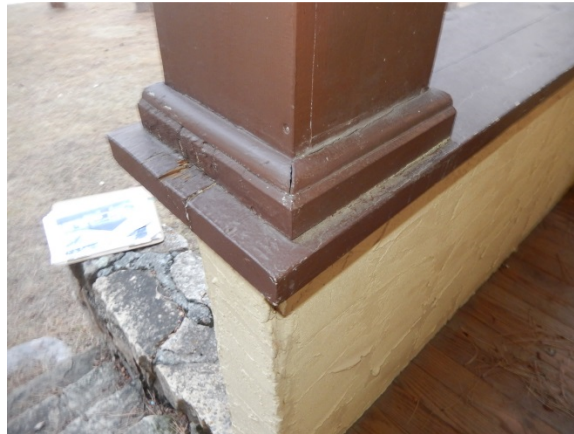
Figure X12. Porch – Center column detail with wood deterioration at bottom cap. (SRJA 2015)

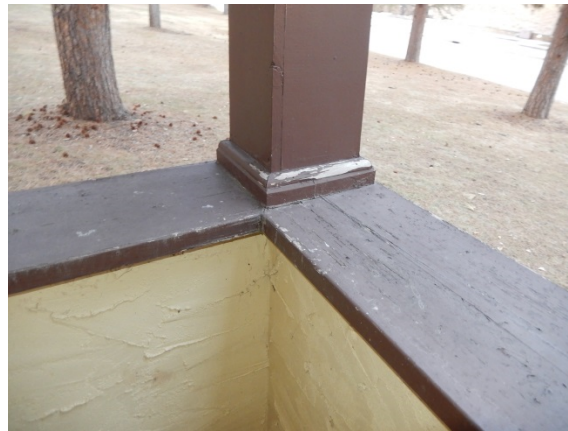
Figure X13. Porch – northeast column detail of missing paint. (SRJA 2015)

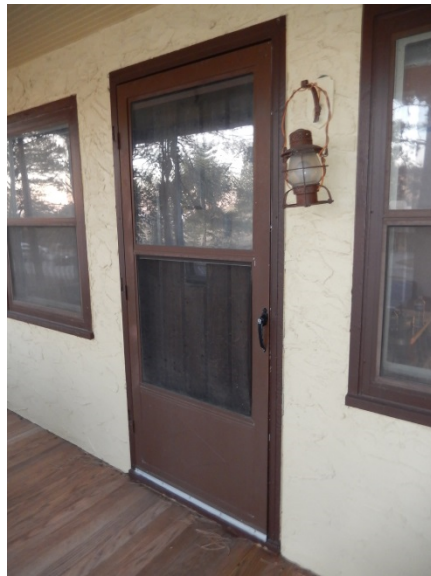
Figure X15. Front Door 100/1. (SRJA 2014)

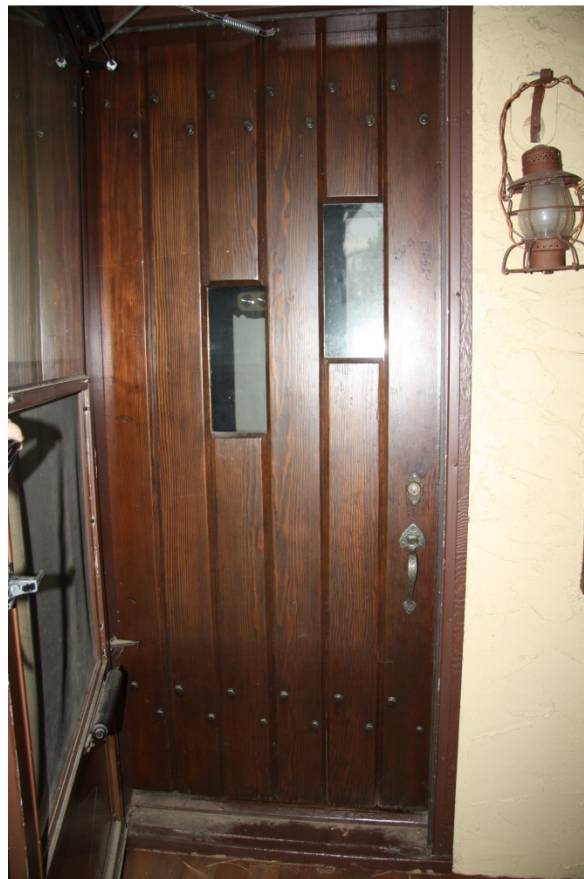
Figure X16. Front Door 100/1. (SRJA 2014)

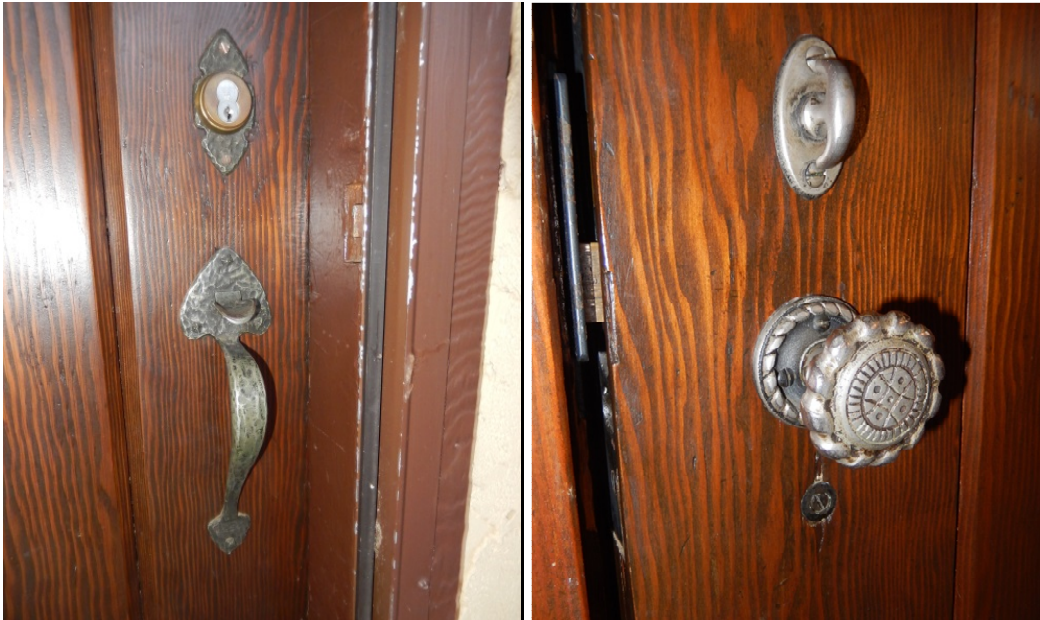
Figure X17. Front Door 100/1 hardware detail. (SRJA 2015)

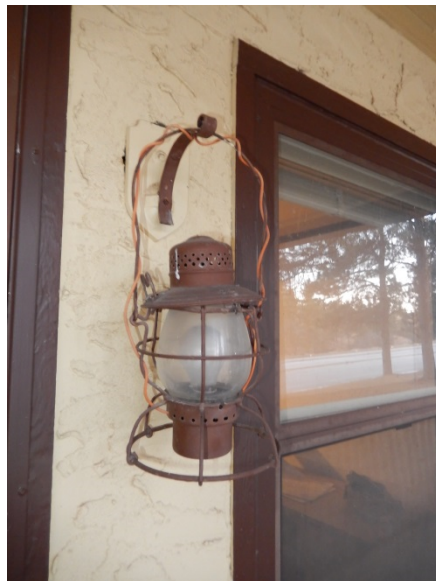
Figure X18. Porch light fixture. (SRJA 2015)

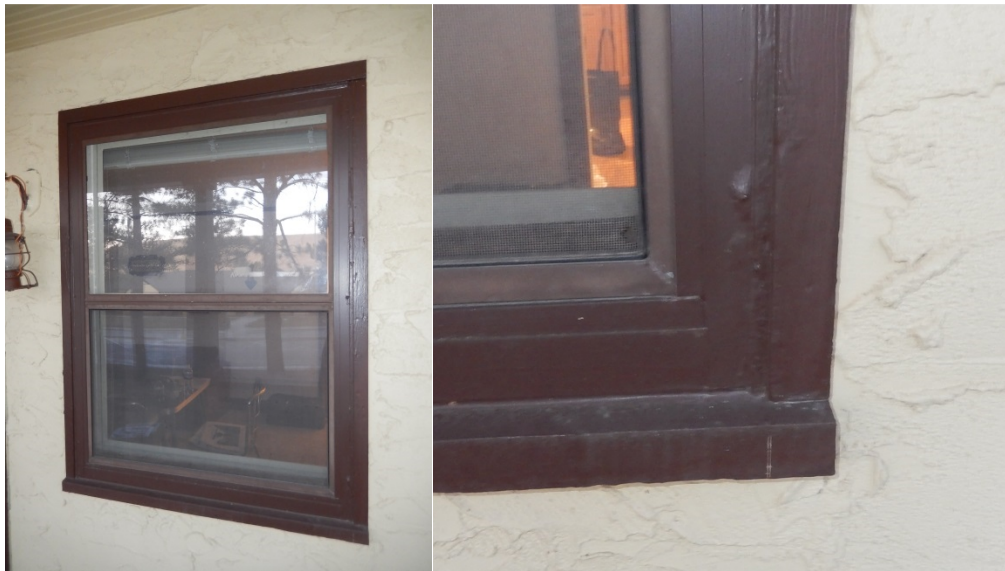
Figure X19. Window 101 details. (SRJA 2015)

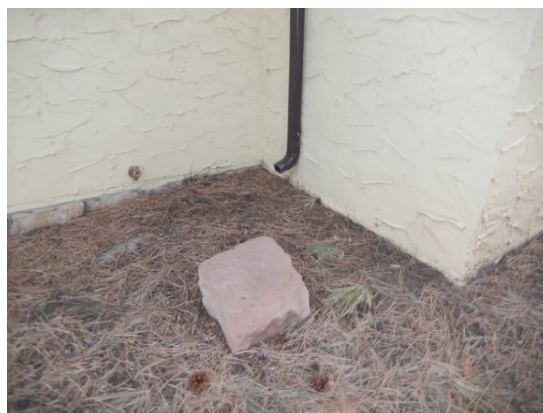
Figure X21. Northeast corner of the building. The grade is well above the top of the stone wall and the stucco is cracked and has peeling paint. The downspout extension is missing. (SRJA 2015)

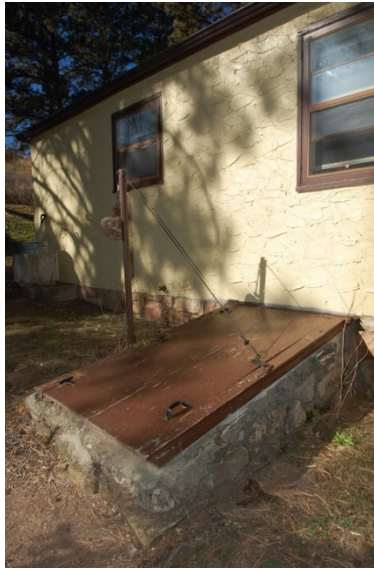
Figure X24. South Elevation bulkhead door. (SRJA 2014)

The bulkhead door was constructed ca. 1937 for access into the newly excavated basement (Figures X24 and X25). This bulkhead has stone foundation walls and poured concrete steps. The door and frame are wood and are in deteriorated condition, requiring some restoration and painting. The grade surrounding the stone bulkhead foundation is low at the southeast corner, exposing the top concrete wash.

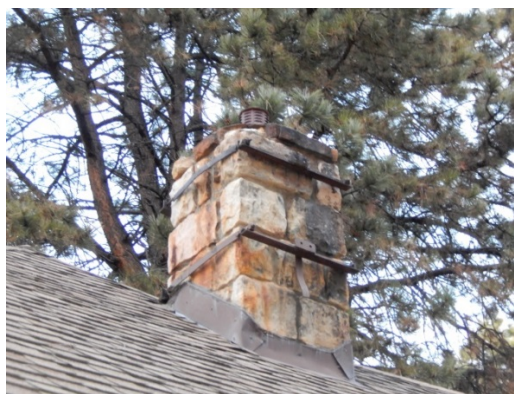
Figure X26. Chimney detail. (SRJA 2015)

The stone chimney is most apparent from this side of the house (Figure X26 and R1). This chimney has been skirted with metal strapping from a previous antennae installation. The southwest stone at the top of the chimney appears to be missing. The cap is not visible from grade. Park staff have stated that this chimney serves as the discharge vent for the radon mitigation system in the basement. This chimney will require a closer inspection to review the termination at the top to determine it is adequately sealed to prevent bird and water infiltration.

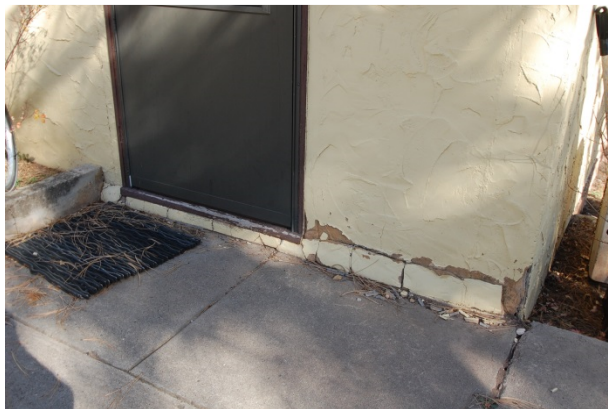
The west wall of the house is clad in stucco. A concrete slab spans the area between the steps and the house. The concrete landing lies directly against the stucco on the side of the house with no soft joint separating the materials (Figure X30). The landing is well above the top of the stone foundation wall in this location. The stucco wall adjacent to the concrete slab is severely deteriorated, exhibiting stucco loss, cracking and peeling paint. The original construction drawings for this side of the house show a minimum of 6-inches from the top of the stone foundation wall to the landing. Grade along this entire elevation has risen over time to well above the top of the foundation wall and there is no swale to carry water around the house. Therefore, the water drains down the hill and against this stucco wall. The foundation vent under Window 106 is almost completely covered by grade (Figure X31). Vertical cracks to the left and right of the front door align with the infilled screen porch area. The remainder of the west stucco wall has a significant amount of crazing and vertical cracks. This may be due to moisture in the stucco.

Figure X30. West Elevation.  
Showing concrete landing and stucco wall deterioration. (SRJA 2014)

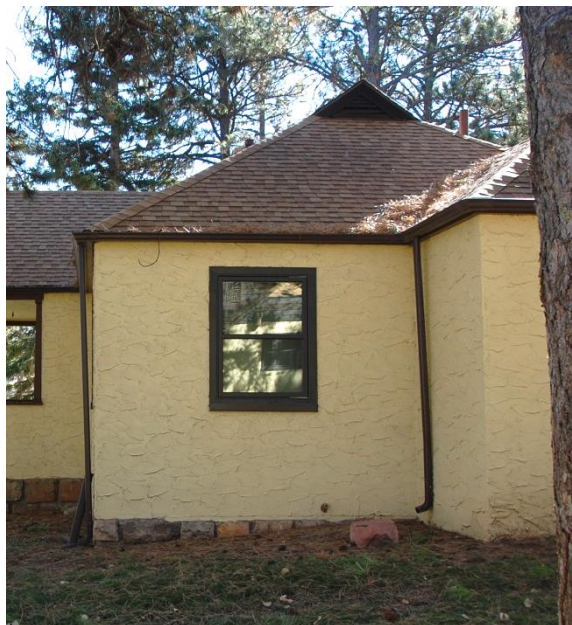
Figure X37. North Elevation – Window 109. (SRJA 2014)

The North Elevation is a single story with projecting rooms and hipped roofs (Figure X36). The stone foundation of the house is exposed at the east side of the elevation and grade rises towards the back (west side) of the house. About mid-way across the elevation, the grade rises above the top of the stone foundation. The grade is in direct contact with the stucco walls and has led to some minor stucco cracking in this area, especially in the northeast corner of the elevation (Figure X37). The west downspout is missing its extension.

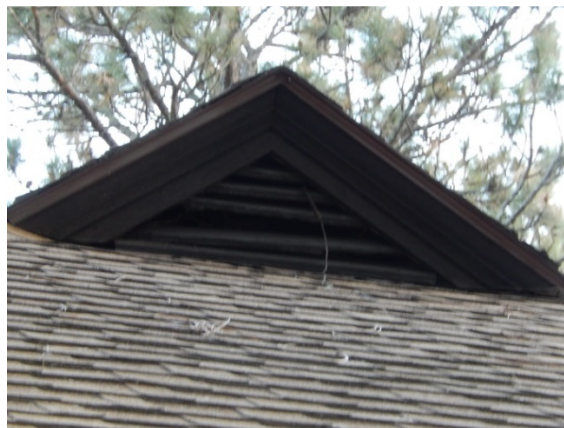
Figure X38. North Elevation – wood louver detail. (SRJA 2014)

The wood trim and horizontal wood siding in the north-facing gable appears to be in good overall condition, requiring only touch-up painting. It was not apparent if the wood louver in the gable contains a screen. This should be verified to be in place and in good condition. One of the wood louvers is loose and requires repair (Figure X38). The cause is not evident from grade.

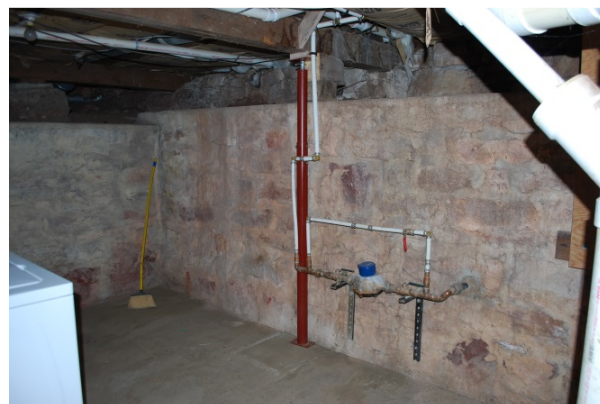
Figure B-11. Basement Room 001 Looking at west wall. (SRJA 2014)

There is some evidence of water infiltration along the west stone foundation wall (Figure B-11). This is likely due to the exterior grade being too high (above the top of the stone foundation walls) along this side of the house.

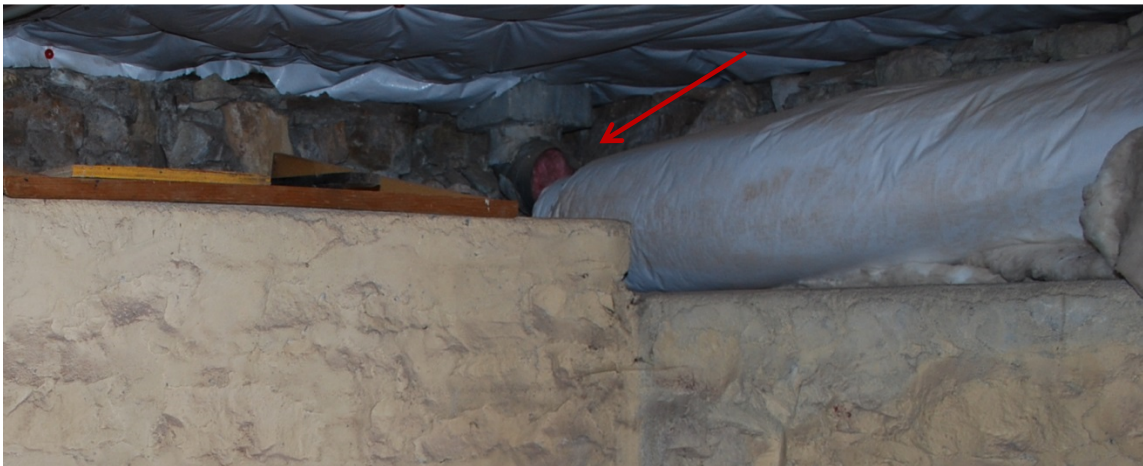
Figure B-16. Basement Room 001 Looking northeast at a sample of abandoned ductwork. (SRJA 2015)

Abandoned metal ductwork is found throughout the basement from an earlier forced air heating system (Figure B-16). A section of ductwork in the northeast corner of the basement has a fibrous material applied directly over the exterior of the ductwork. This should be tested as part of a comprehensive inspection for asbestos containing material.

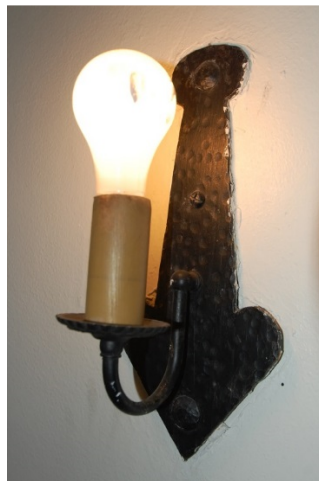
Baseboard heaters are installed along the east wall under the windows. Two historic wall sconces remain installed on the west wall (Figure 1-6). The room is lit by a ceiling fan in the center of the room.

Figure 1-6. Living Room 100 Historic wall sconce. (SRJA 2014)

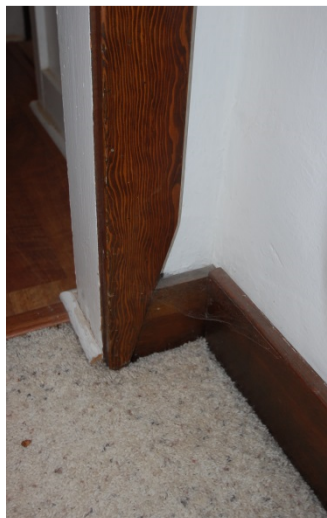
Millwork installed on the doors and windows matches other millwork throughout the house. A stained picture molding approximately 6-inches below the ceiling and a stained baseboard line the perimeter of the room. In the northwest corner of the room, the door trim is cut at an angle and the baseboard patch does not match the original baseboard (Figure 1-7). The cause for this repair is unknown. The floors are a carpeted over an unknown wood substrate. The original floors in the Living Room were specified originally to be oak plank.

Figure 1-7. Living Room 100 Detail of millwork anomaly in the northwest corner of the room. Perhaps there was once a furnace damper in this location. (SRJA 2014)

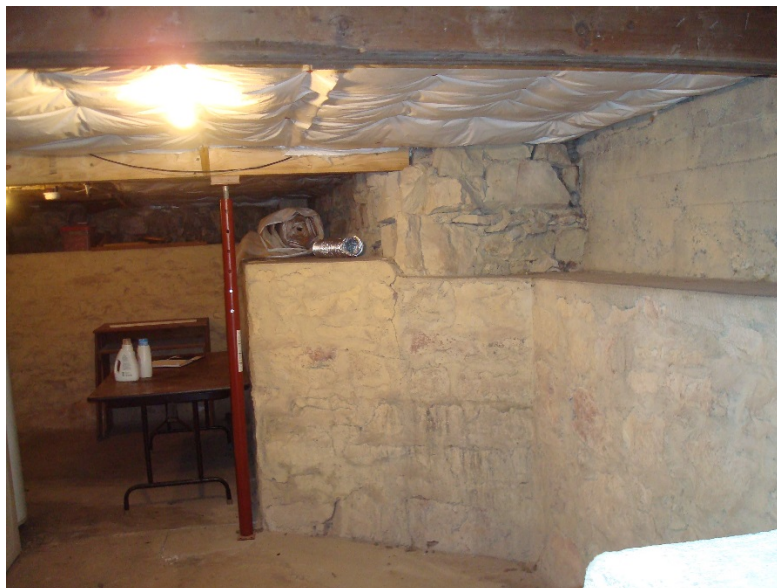
Figure S1. Stone retaining walls looking north. (SEA 2015)

The stone retaining walls do not exhibit cracking or displacement. At the corner of the stone retaining wall adjacent to the southwest crawl space, there is evidence that repairs have been made (Figure S2). The repairs that are visible consist of stainless steel bands tying the two

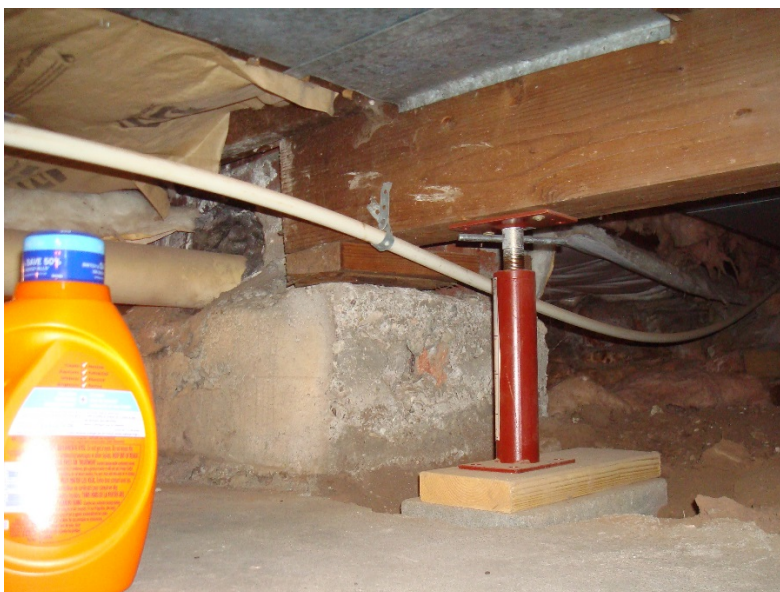
On the west side of the chimney in the crawl space area, there is a similar detail where the girder bears the chimney footing, but a short steel post has also been installed (Figure S4). The steel post bears on wood blocking that bears on a concrete block.

Figure S4. Girder support west side of chimney looking southeast. (SEA 2015)

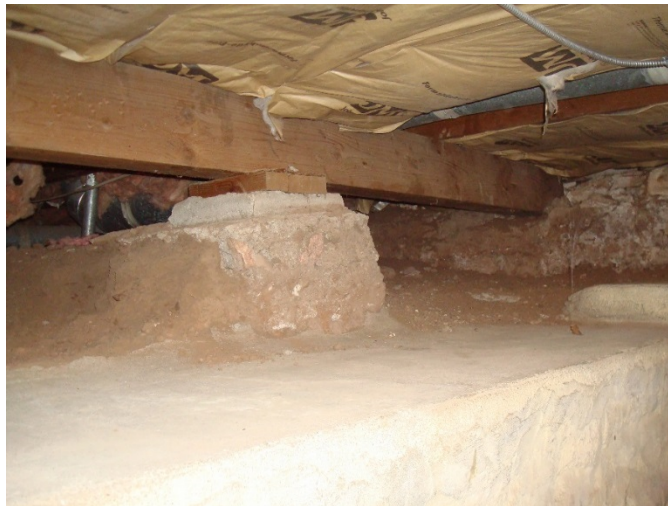
Further to the west on the same girder, what appears to be one of the original footings is present. Wood blocking sits on top of the footing and provide support to the girder (Figure 5). The wood blocking does not appear to be treated lumber.

Figure S5. Girder support on original crawl space footing. (SEA 2015)

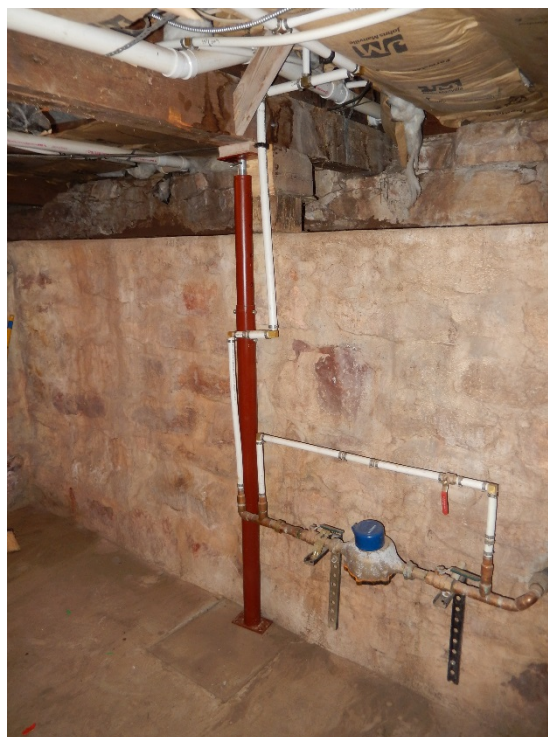
A steel post also supports the east end of the northern-most girder. This post also bears on the slab-on-grade which has a rectangle of new concrete (Figure S6). This may or may not indicate the presence of a footing under the post.

Figure S6. Girder support on steel post along east wall. Note the concrete many indicate there is a footing in this location. (SEA 2015)

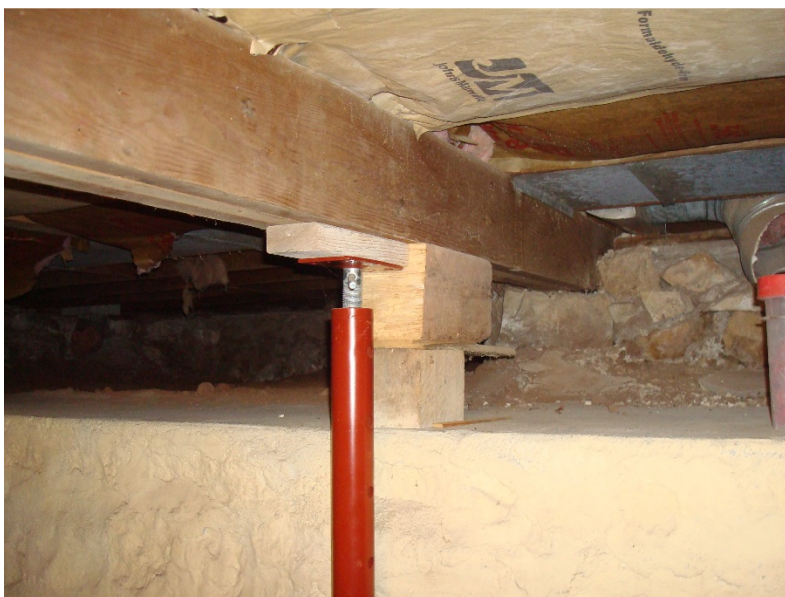
At the north end of the north-south girder the girder is supported by the exterior perimeter foundation wall, wood blocking on the stone retaining wall and a 2 ½-inch diameter steel post (Figure S8). This steel post also has a square area of newer concrete in the slab-on-grade indicating the possibility of a footing (Figure S9).

Figure S8. Support of north girder at west end looking north. (SEA 2015)

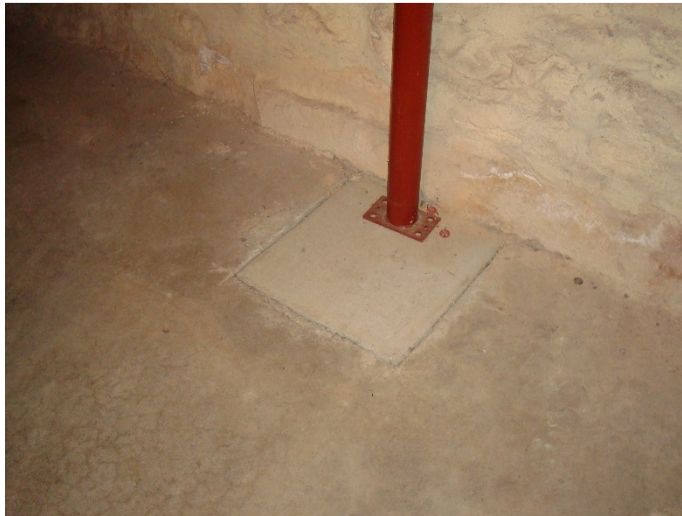
Figure S9. Newer slab-on-grade below steel post detail. (SEA 2015)

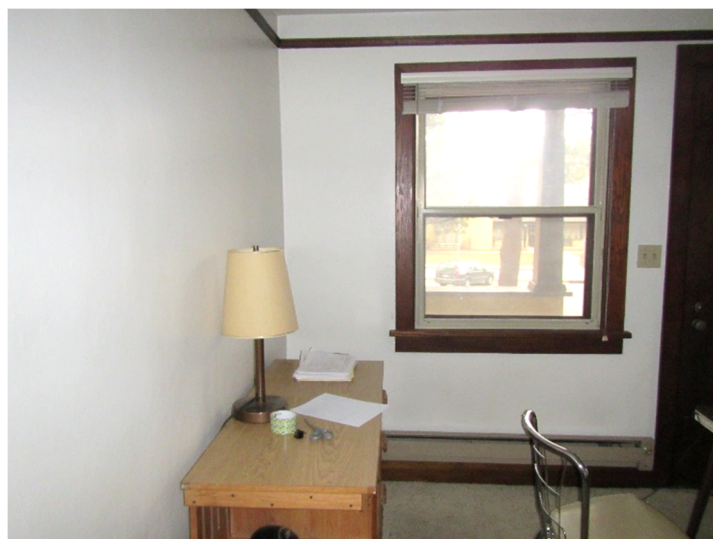
Figure M01. Example of electric baseboard heaters In Living 100. (HEI 2015)

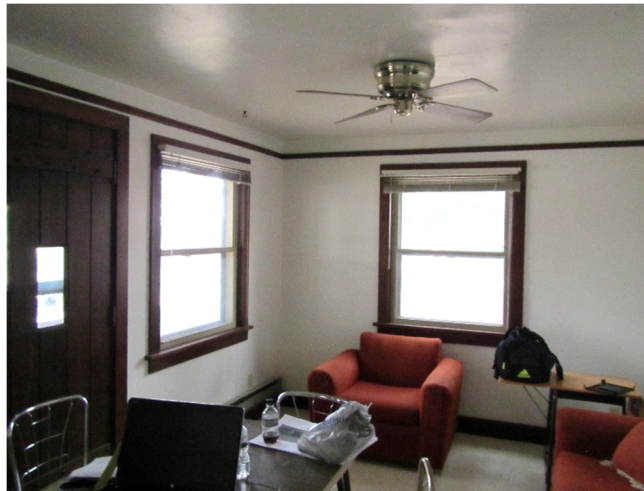
This building does not have a cooling system or a forced air system installed. Ceiling fans are installed in Living 100 and Kitchen 101 for general air circulation (Figure M02).

Figure M02. Example of ceiling fan in Living 100. (HEI 2015)

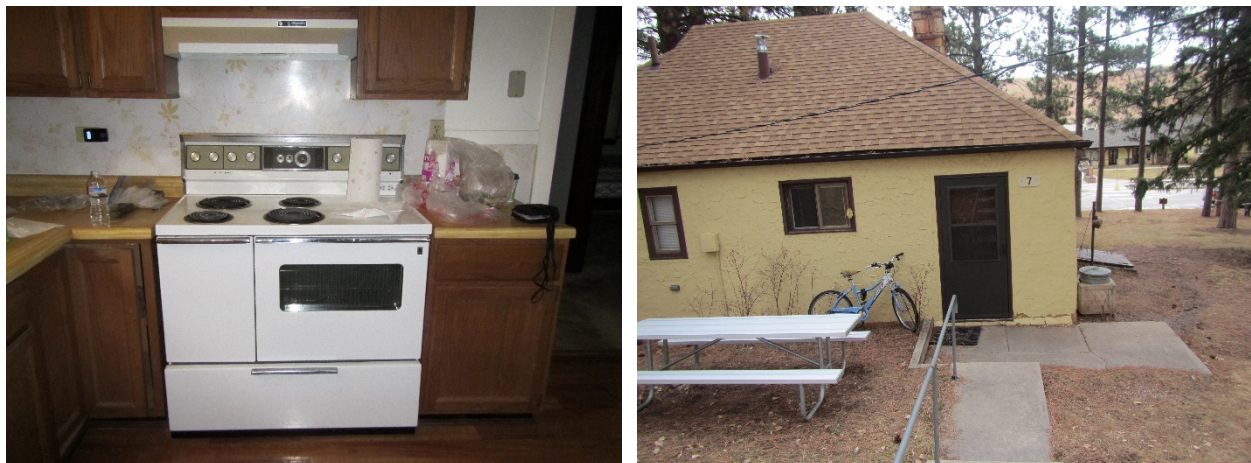
An exhaust hood is located above the stove in the Kitchen 101 and is ducted to the exterior through the roof (Figure M03).

Figure M03. Kitchen 104, Exhaust hood and termination. (HEI 2015)

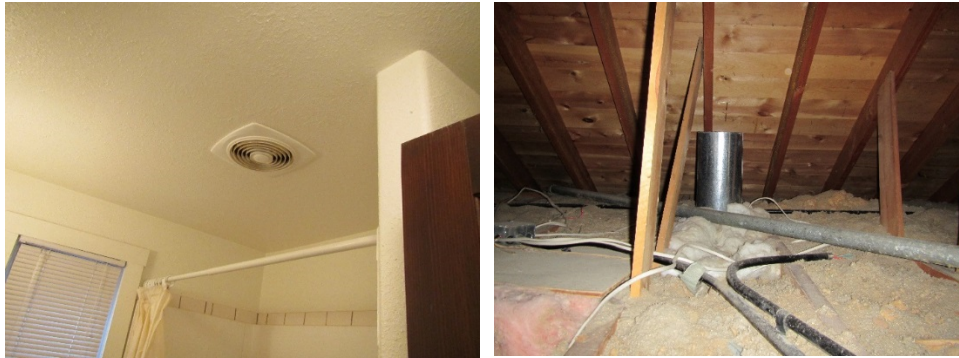
Bathroom 104 has an existing ceiling mounted exhaust fan. It is ducted up through the ceiling and discharges exhaust air into the attic space. Per International Mechanical Code section 501.3, air shall not be exhausted into an attic space. (Figure M04). Moisture can potentially build up in the attic creating deterioration and mold problems.

Figure M04. Bathroom – 104, Exhaust fan and termination. (HEI 2015)

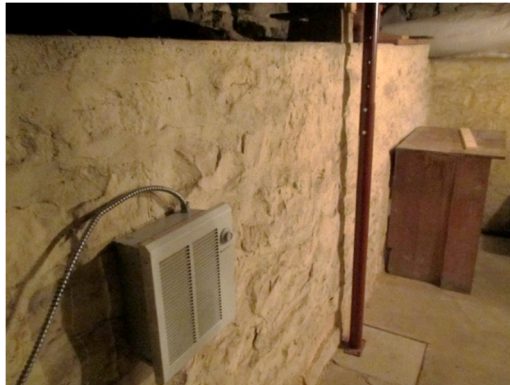
Figure M05. Electric heater in Basement 002. (HEI 2015)

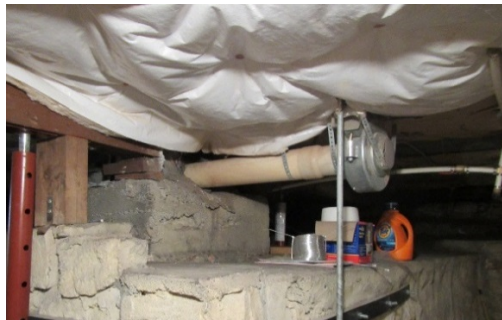
A fan for radon mitigation exhausts air from Basement 001 through a PVC pipe that is routed through the existing chimney to outside (Figure M06).

Figure M06. Radon system in Basement 005. (HEI 2015)

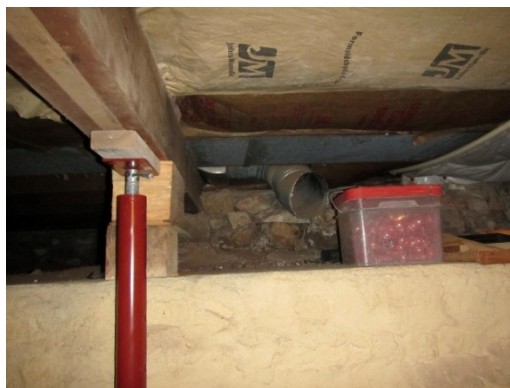
Abandoned ductwork for an old forced air system is located around the perimeter of Basement 001 in several locations (Figure M07). No construction documents have been found for this work.

Figure M07. Example of abandoned ductwork in Basement 001. (HEI 2015)

All suspect building surfaces and materials should be tested for lead based paint and asbestos containing materials prior to the initiation of any work. Testing should be done by a qualified hazardous materials consultant. Abandoned ductwork in the basement and floor tile under the first floor carpet are suspect materials. Conduct an independent radon test and inspection of existing systems. Repair, as required to meet current code.

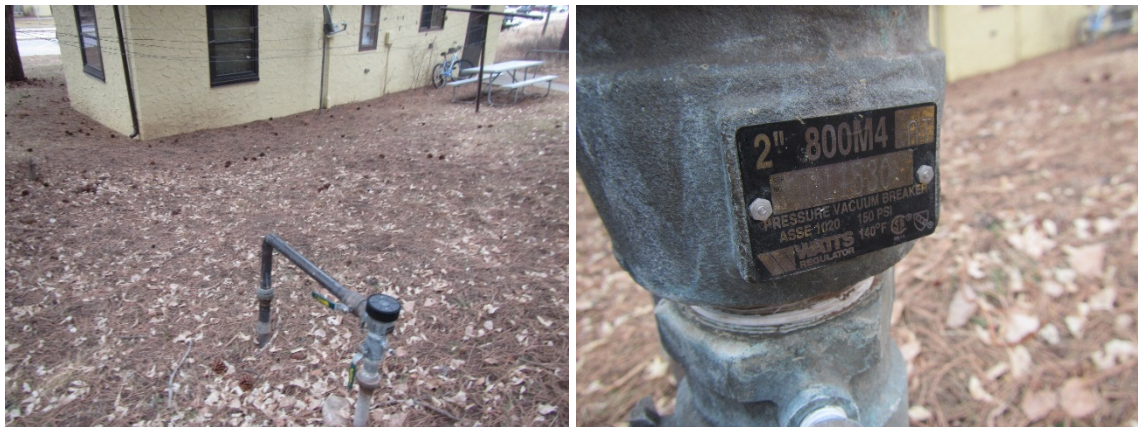
Prior to entering the building, the water main splits to serve the potable water system in the building and the irrigation system on the site. The irrigation system pipe is routed above grade, through an anti-siphon pressure vacuum breaker, routes back below grade, and then runs to concealed sprinklers (Figure P01). The irrigation system is controlled by manually operated shut off valves. The potable water system is routed below grade and enters the building in the south side of Basement 002.

Figure P01. Irrigation vacuum breaker. (HEI 2015)

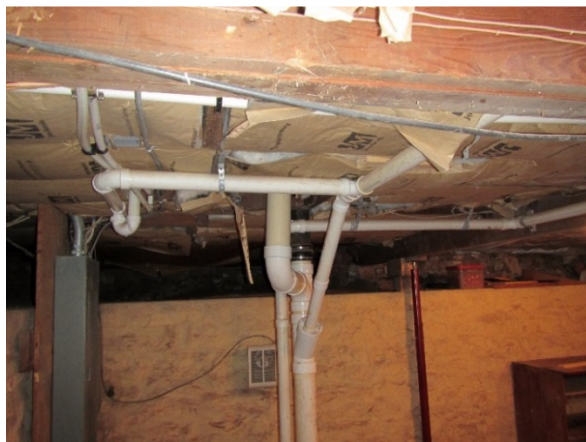
The water then exits the meter to serve the building plumbing fixtures. All domestic water piping downstream of the copper water entry is cross-linked polyethylene (PEX) with brass fittings (Figure P06). The domestic entry does not currently have a building backflow preventer installed.

The sanitary waste piping is polyvinyl chloride (PVC) drain, waste, and vent (Figure P06). The first floor plumbing fixtures and floor drains located in Basement 001 drain into a four-inch sanitary waste system that is routed below the basement floor and exits the building to the east (Figure P05). Sanitary cleanouts are located in lines prior to the line going beneath the basement floor. The 4-inch building sewer is routed to the private sewer system owned by the National Park Service. The yard cleanout cover is damaged at the exterior of the building and needs replaced.

Figure P06. Example of water and sanitary piping system in Basement 001. (HEI 2015)

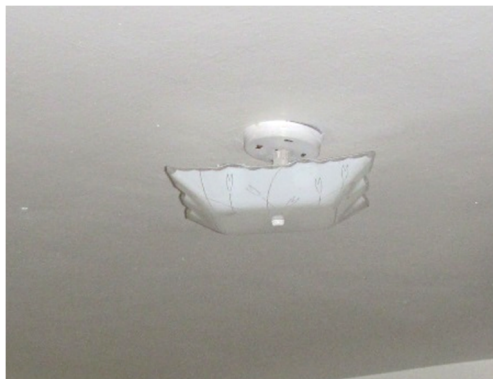
Bedrooms 106 and 107 each have a single vintage square glass incandescent fixture with two screw base compact fluorescent lamps (Figure E14). The light fixture in Bedroom 107 is missing the square glass cover. They are each controlled by a toggle switch.

Figure E14. Light fixture located in Bedrooms 106 and 107. (HEI 2015)

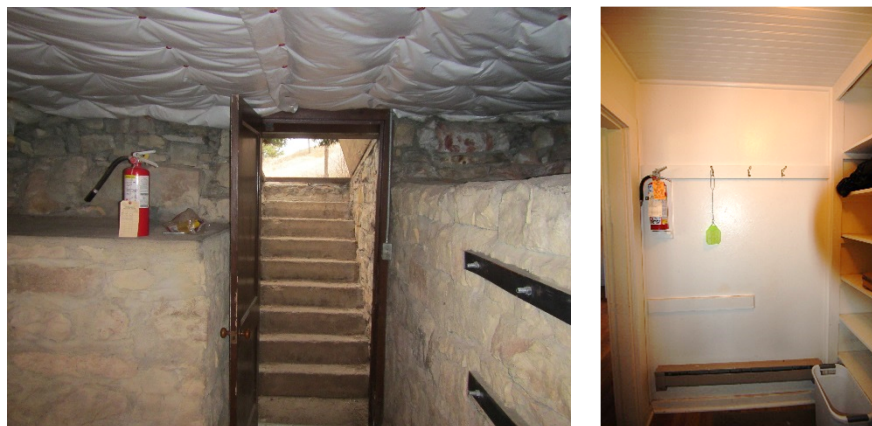
The house has two hand activated dry chemical fire extinguishers. The first is located in Basement 001 and the second is located in West Entry 103 (Figure F01).

Figure F01. Fire extinguishers. (Basement 001-Left, West Entry 103-Right)  
(HEI 2015-Left, SRJA-Right)

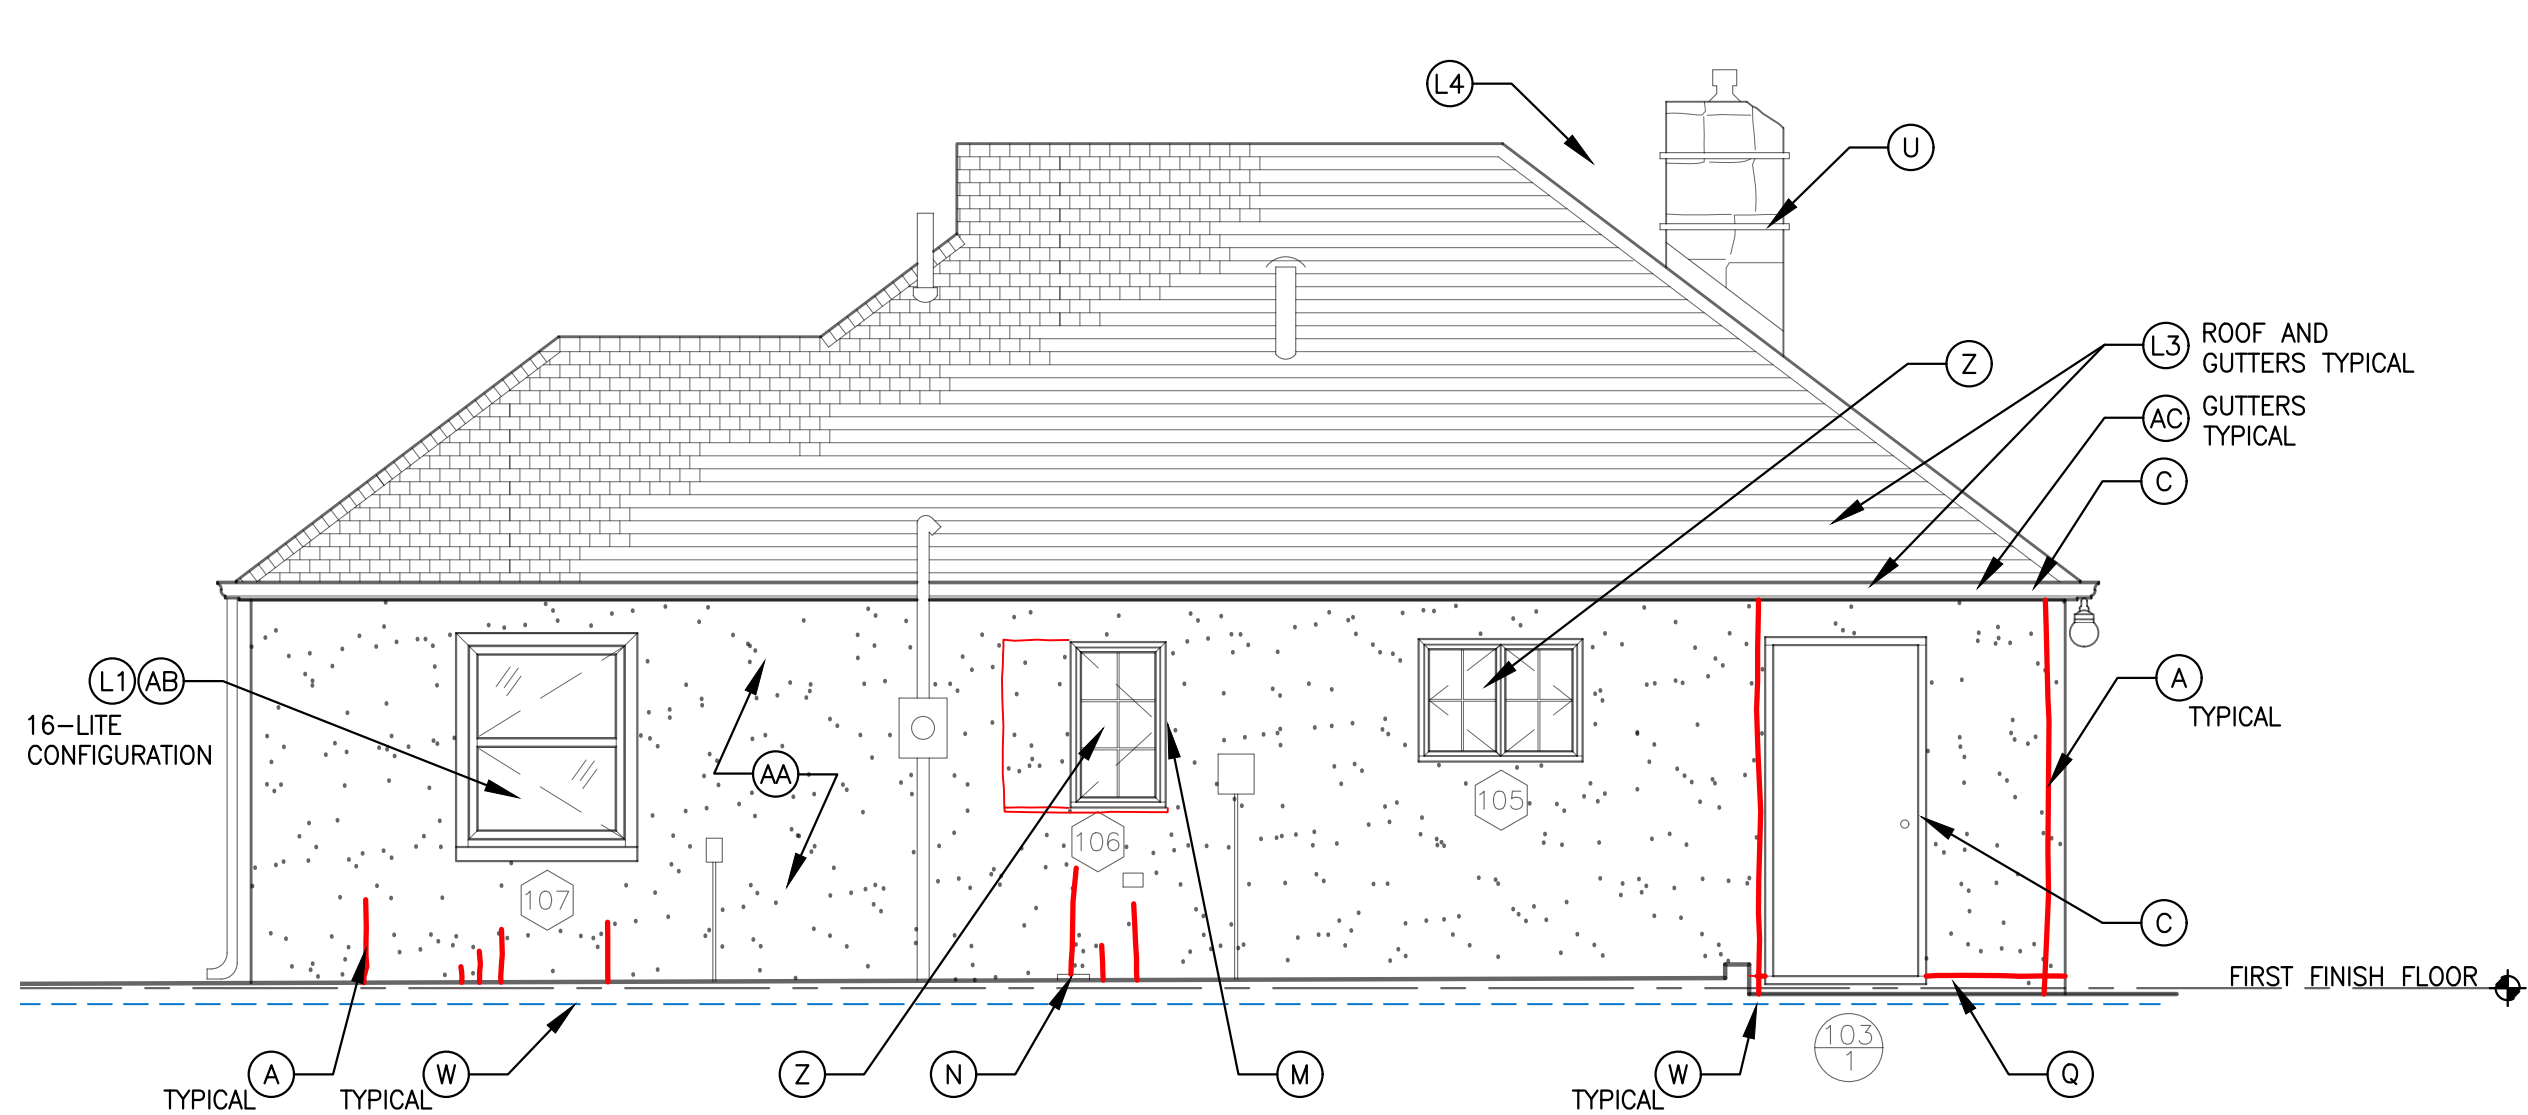
1 HS-07 IMMEDIATE AND LONG TERM TREATMENT DRAWINGS - WEST ELEVATION  
TA3 1/4" = 1'-0"

Re-grade along the west and a portion of the north elevations to achieve a minimum of 4-inches below the top of the stone foundation walls. Install a French drain to daylight and a swale. The grade is in contact with the wood frame stucco walls and is causing advanced deterioration in these locations.

7. Stucco –  
Repair cracks and crazing in stucco. These are prevalent along the west elevation, with a few on the east, south and north elevations.
8. Paint –

This work will require the demolition and reconstruction of the existing concrete landing along the west elevation to be reconstructed at a lower elevation. Install a soft joint between the new concrete and the stone/concrete foundation. Repoint the newly-exposed stone foundation, as required.

- L1. EXISTING EXTERIOR REPLACEMENT TRIM PANNING AT REPLACEMENT WINDOWS IS TOO WIDE AND DOES NOT MATCH THE HISTORIC CONDITION. THE EXISTING WINDOWS DO NOT ACCURATELY REFLECT THE HISTORIC WINDOW SASH AND LITE CONFIGURATION. INSTALL NEW REPRODUCTION EGRESS WINDOWS TO BETTER REPLICATE THE HISTORIC WINDOW CONFIGURATION.
- L2. INSTALL REPRODUCTION WOOD SHUTTERS TO MATCH THE ORIGINAL HISTORIC SHUTTERS.
- L3. WHEN THE EXISTING ROOF IS READY FOR REPLACEMENT, CONSIDER THE DECRA METAL REPLACEMENT ROOFING SYSTEM OR ONE OF THE OTHER RECOMMENDED REPLACEMENT ROOFS DISCUSSED IN THE TREATMENT RECOMMENDATIONS. REPLACE GUTTERS AND DOWNSPOUTS TO MATCH THE HISTORIC BOX GUTTERS.
- L4. INSPECT NORTH SIDE OF STONE CHIMNEY FOR CRICKET. IF ONE DOES NOT EXIST, INSTALL A NEW CRICKET DURING THE NEXT ROOF REPLACEMENT PROJECT.
