# Historic Housing Area Historic Structures Report

## HS-07 Quarters

Wind Cave National Park

January 27, 2016  
NPS PMIS # 158029

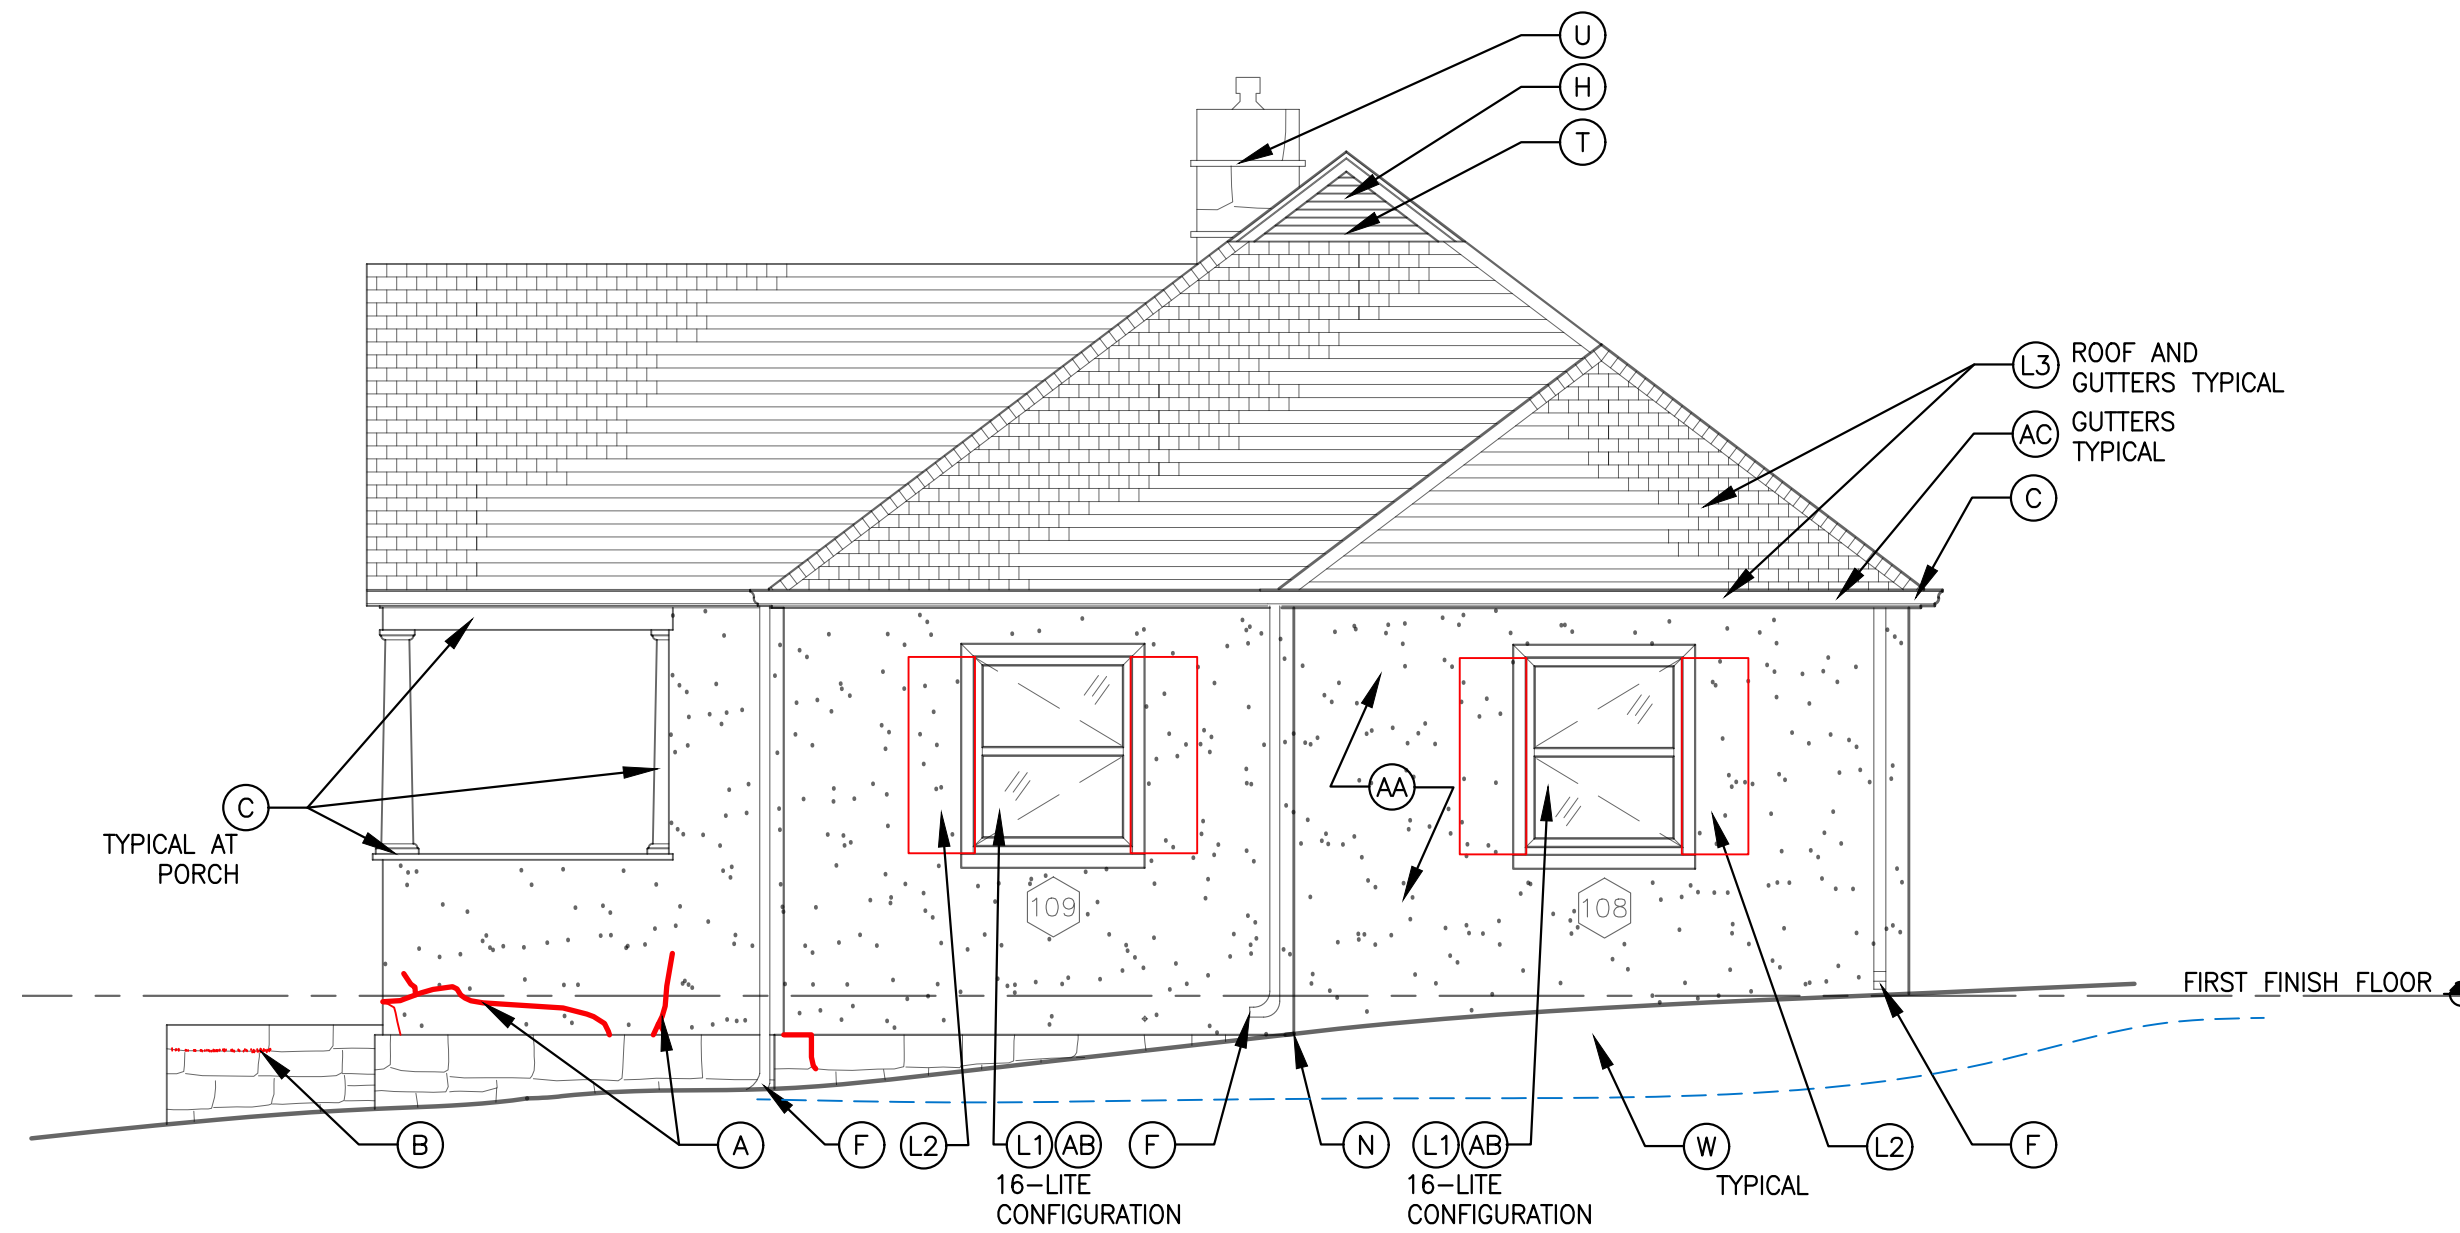
2 HS-07 IMMEDIATE AND LONG TERM TREATMENT DRAWINGS - NORTH ELEVATION  
TA3 1/4" = 1'-0"

Re-grade along the west and a portion of the north elevations to achieve a minimum of 4-inches below the top of the stone foundation walls. Install a French drain to daylight and a swale. The grade is in contact with the wood frame stucco walls and is causing advanced deterioration in these locations.

- L1. EXISTING EXTERIOR REPLACEMENT TRIM PANNING AT REPLACEMENT WINDOWS IS TOO WIDE AND DOES NOT MATCH THE HISTORIC CONDITION. THE EXISTING WINDOWS DO NOT ACCURATELY REFLECT THE HISTORIC WINDOW SASH AND LITE CONFIGURATION. INSTALL NEW REPRODUCTION EGRESS WINDOWS TO BETTER REPLICATE THE HISTORIC WINDOW CONFIGURATION.
- L2. INSTALL REPRODUCTION WOOD SHUTTERS TO MATCH THE ORIGINAL HISTORIC SHUTTERS.
- L3. WHEN THE EXISTING ROOF IS READY FOR REPLACEMENT, CONSIDER THE DECRA METAL REPLACEMENT ROOFING SYSTEM OR ONE OF THE OTHER RECOMMENDED REPLACEMENT ROOFS DISCUSSED IN THE TREATMENT RECOMMENDATIONS. REPLACE GUTTERS AND DOWNSPOUTS TO MATCH THE HISTORIC BOX GUTTERS.
- L4. INSPECT NORTH SIDE OF STONE CHIMNEY FOR CRICKET. IF ONE DOES NOT EXIST, INSTALL A NEW CRICKET DURING THE NEXT ROOF REPLACEMENT PROJECT.

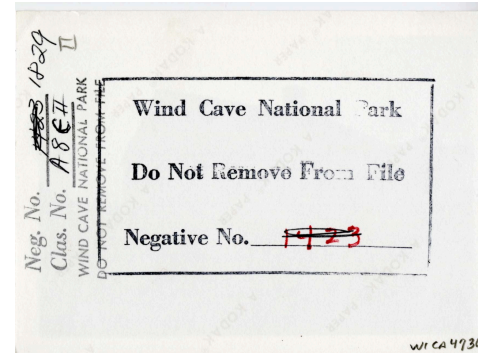
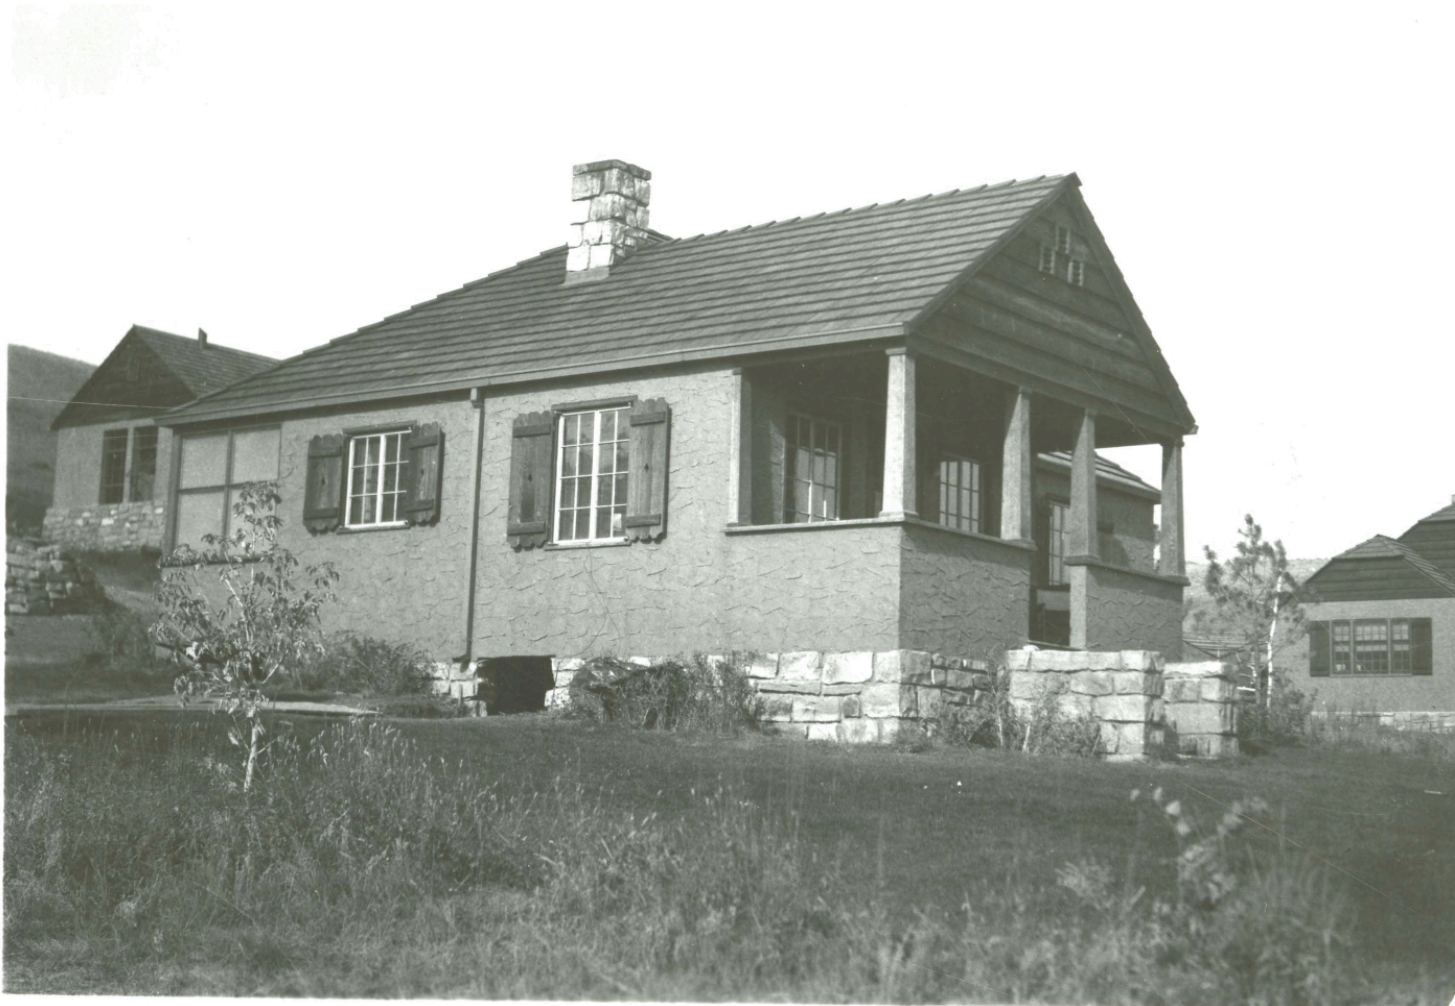
*Note screened porch on back wall. The hole in the foundation wall is a location for a new bulkhead door, which was added with a new basement in the mid 1930s.*
