# Historic Housing Area Historic Structures Report

## HS-11 Upper Garage

Wind Cave National Park

January 27, 2016  
NPS PMIS # 158029

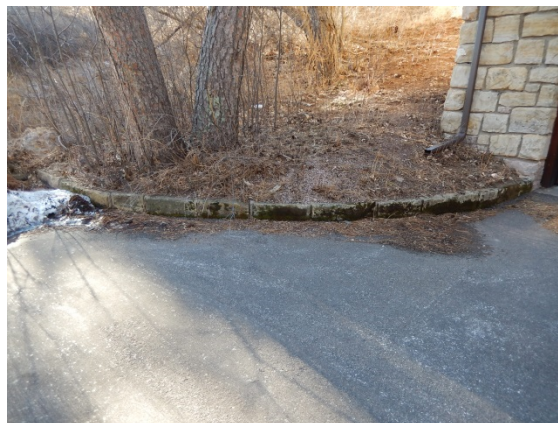
Figure X5. East Elevation detail at stone curbing. (SRJA 2015)

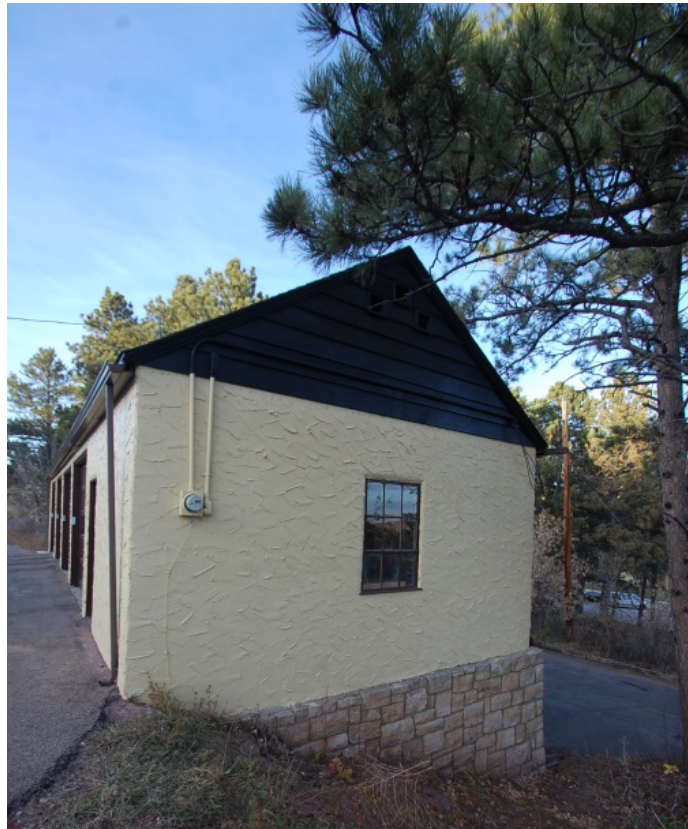
Figure X6. South Elevation. (SRJA 2014)

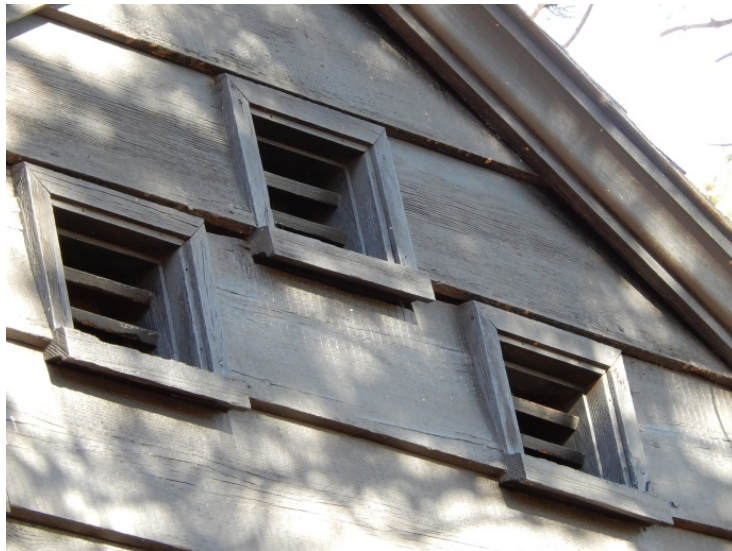
Figure X9. South Elevation detail of louvers. (SRJA 2015)

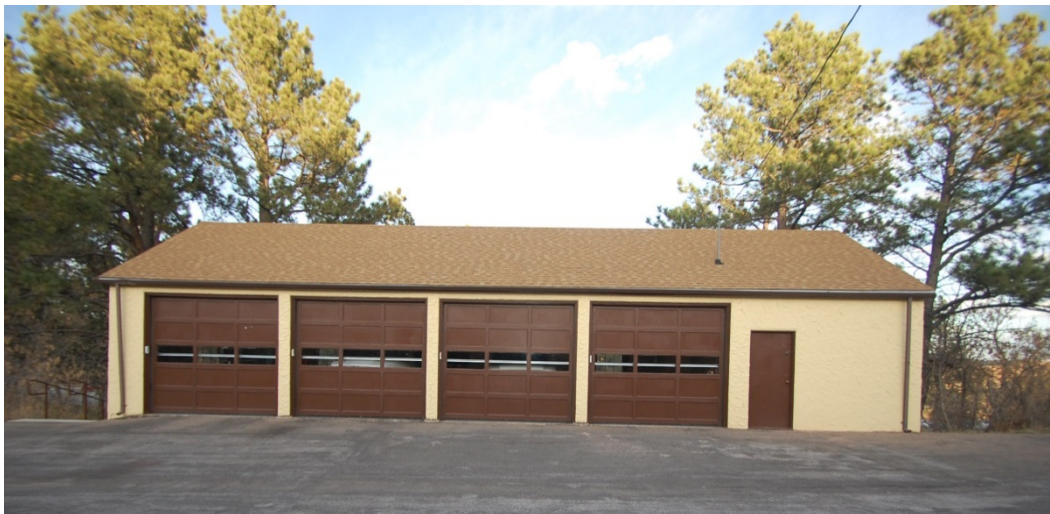
Figure X10. West Elevation. (SRJA 2014)

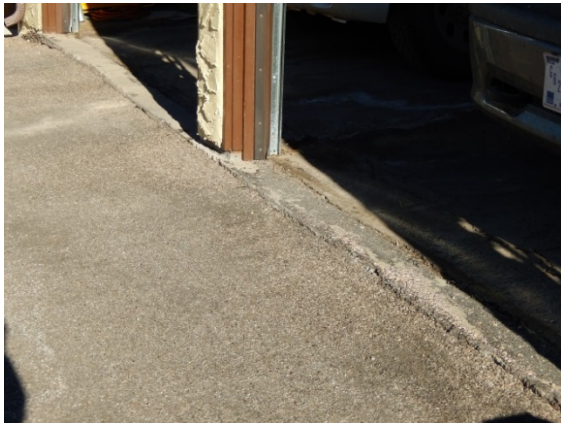
Figure X11. West Elevation detail at the garage.  
(SRJA 2015)

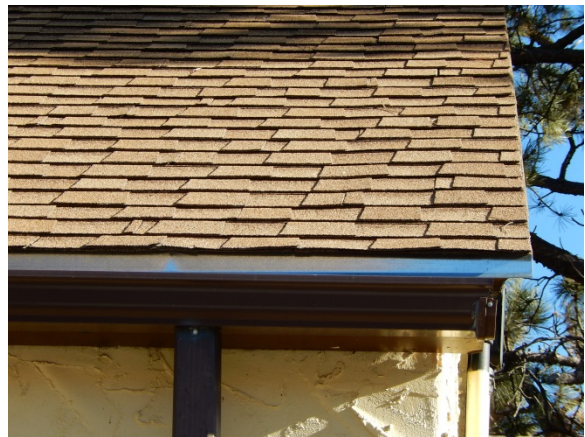
The stucco on this elevation is in fair condition. There is some crazing near the concrete on the south side of the west wall. There is no soft joint installed between the stucco cladding and the asphalt driveway (Figure X12). There is some missing stucco at base of the walls between the first and second garage bays and also at the north side of the northernmost bay (Figure X13). There is some diagonal cracking at the head of the door and near the base of the door. The southernmost downspout is crushed. Both downspouts on this side drain directly to the asphalt pavement abutting the building. The gutter on the south side is run short of the roof and therefore cannot pick up the edge of the roof drainage (Figures X15 – X16). The exposed drip edge on the west side is unfinished galvanized sheet metal.

Figure X15. West Elevation detail of south side  
of the gutter that is short of the roof.  
(SRJA 2015)

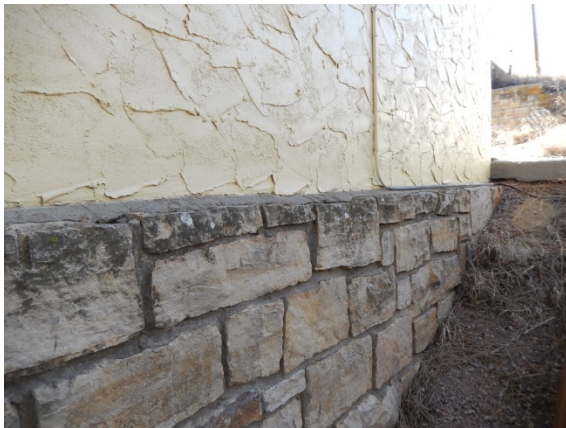
Figure X18. North Elevation foundation detail.  
(SRJA 2014)

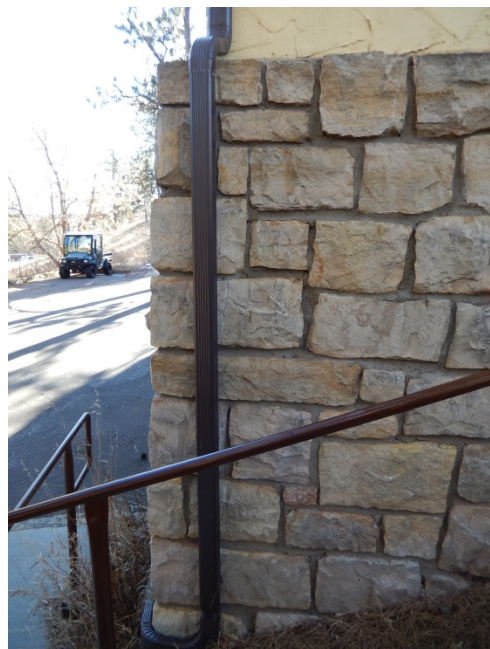
Figure X21. North Elevation detail at northeast  
corner. (SRJA 2014)

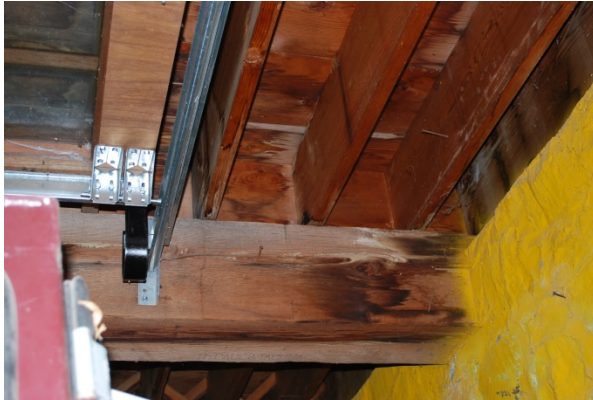
Figure 1-3. Garage 100 North end of girder pocketed into the north wall. (SRJA 2014)

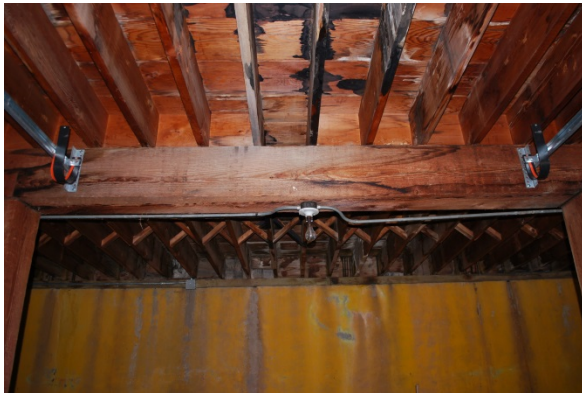
Figure 1-4. Garage 100 Looking west at second level floor framing, girder and west concrete foundation wall. (SRJA 2014)

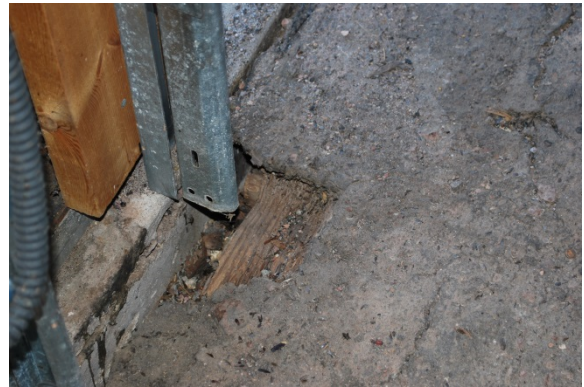
Figure 2-6. Garage 200 Detail at hole in floor near garage doors. (SRJA 2015)

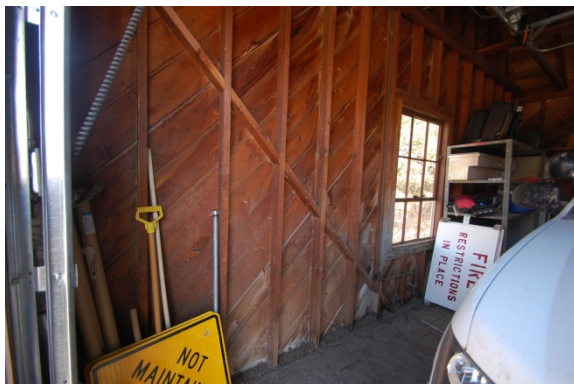
Room 200 is comprised of the north three bays of the second level of the garage (Figures 2-1 – 2-9). The exterior wall framing and roof framing are visible throughout the space. The diagonal exterior sheathing is visible through the open 2x4 wood stud walls. The roof trusses are visible. There is no building insulation in this section of the building. Signs of previous water infiltration are evident on the interior of the wall sheathing and studs (Figure 2-5 and 2-7). The wood frame

Figure 2-5. Garage 200 Looking east along north wall. (SRJA 2015)

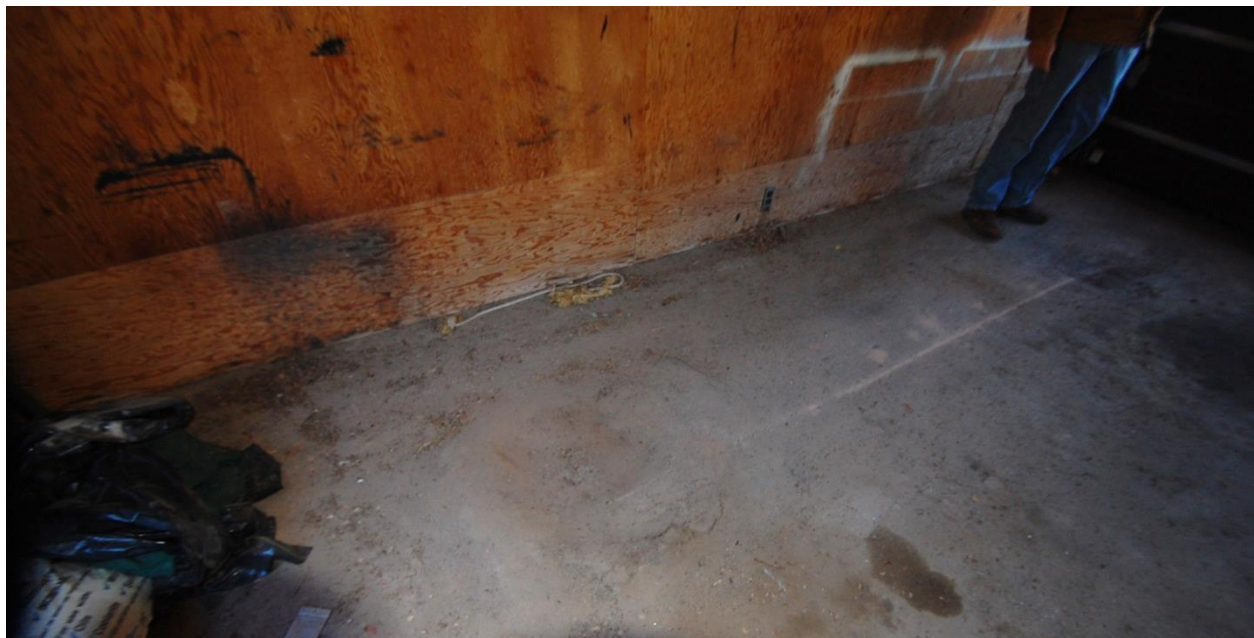
Figure 2-9. Garage 200 Looking at deep depression in the asphalt in the south garage bay. (SRJA 2015)

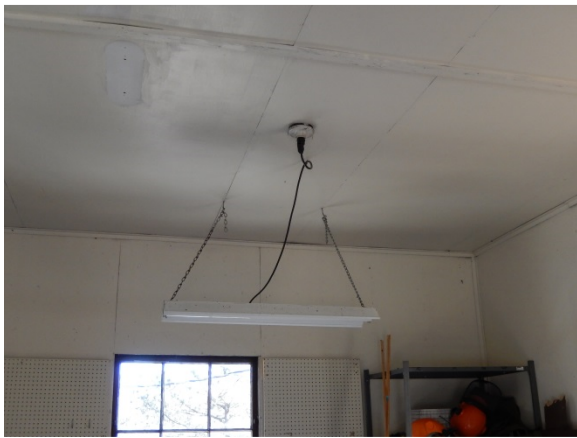
HS-13 is below grade. The electric heat and thermostat were installed in 1988. Light is provided by two hanging fluorescent fixtures that have been retrofitted to take power from two single porcelain sockets in the ceiling (Figures 2-12 and 2-15). The floor is painted over and asphaltic or granular material, and the paint is peeling (Figure 2-16). The room is naturally lit by two steel windows. An access panel is located in the northwest corner of the ceiling for access into the roof framing area above. It is not known if this room is insulated.

Figure 2-15. Room 201 Ceiling light fixture  
detail. (SRJA 2014)

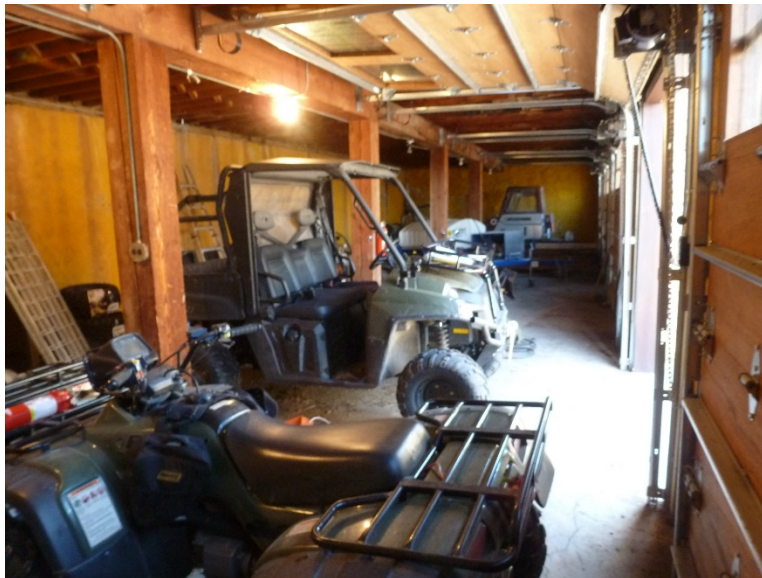
Level one is a garage level and is currently being used to park and store yard and maintenance equipment (Figure S1). The west foundation wall is constructed of cast in place concrete. The north, south and east foundation walls are constructed of unreinforced stone. The north, south and west elevations are in contact with grade. The east face has stone pilasters with timber girders over the door openings (Figure S2). The floor is a concrete slab-on-grade. Wood girder timbers span over the door openings and support the floor framing and wall framing above. The girders are spliced over the two center pilasters (Figure S3). The girders over the door openings display some splitting, but it does not appear to be affecting their performance (Figure S4). No excessive deflection was noted.

Figure S1. Lower garage level. (SEA 2015)

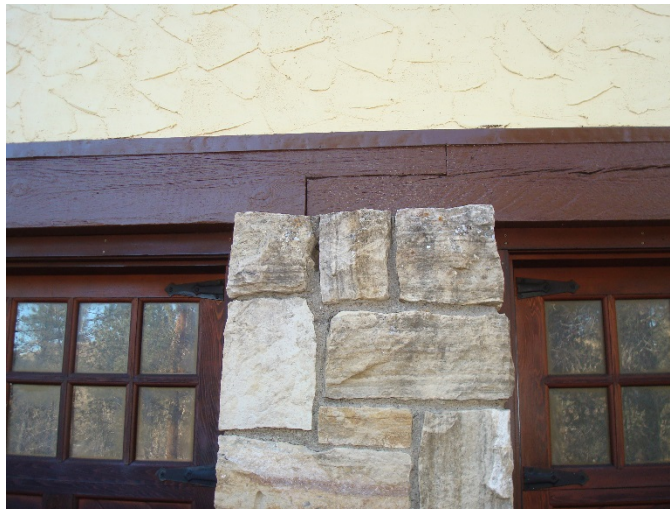
Figure S3. Girder splice over stone pilaster. (SEA 2015)

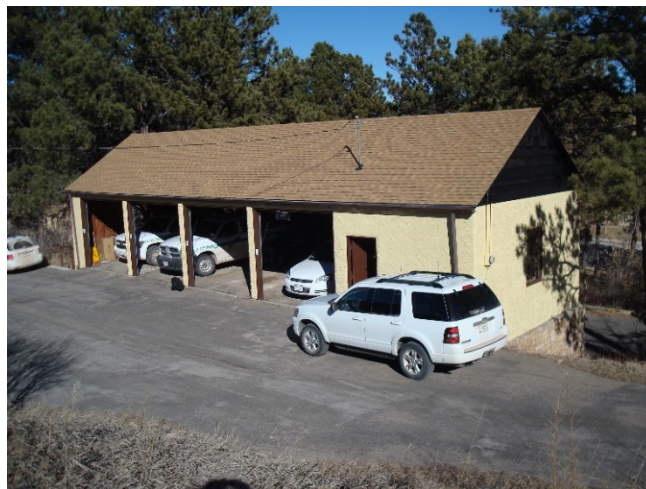
Figure S6. West Elevation. (SEA 2015)

Level Two is currently being used to park vehicles in the north four bays. Overhead garage doors are present on the west face of the structure on this level. Vehicles present at the time of observation ranged from a mid-sized car to a  $\frac{3}{4}$  ton or 1-ton pick-up truck (Figure S6).

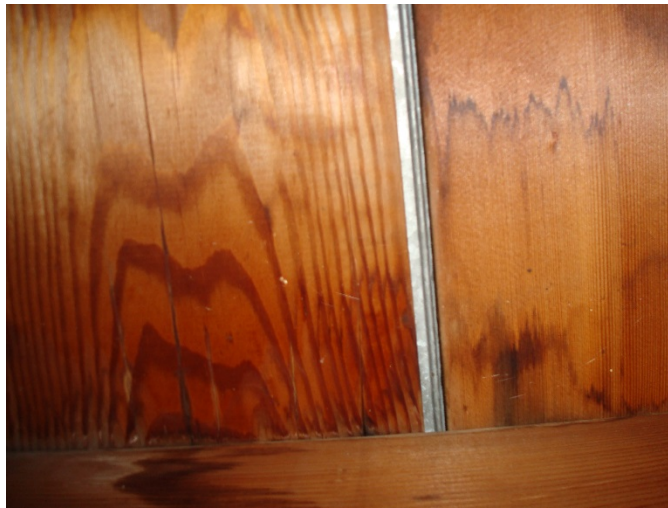
The floor framing consists of 2x12 (nominal) joists at 12-inches on center spanning from the west wall to a center 10 x 12 (nominal) timber girder, then from the girder to the east wall. Bridging is present on between the floor joists. The floor consists of 1 x wood decking with an asphalt overlay. From limited observation, it appears as if there is a metal deck material present immediately above the wood deck material (Figure S7). It is unknown if the metal deck is continuous or if is just located at the joints in the wood deck. The precise thickness of the asphalt topping is unknown, but it appears to range in thickness from one-inch or less at the west face to approximately six-inches at the east wall.

Figure S7. Metal above Level 2 wood deck. (SEA 2015)

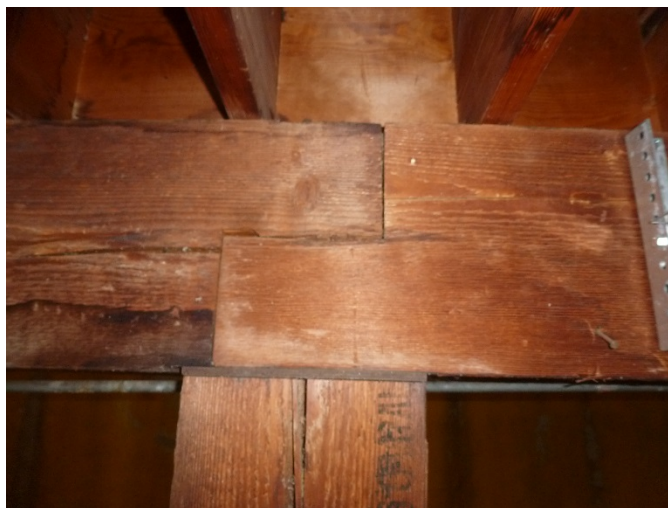
The timber girder is supported by (4) 10x10 (nominal) timber posts. The 10x12 (nominal) girder is spliced over the two interior posts. There is a steel plate on top of the post that the timber girders bear on (Figure S8).

Figure S8. Girder splice on steel plate over post. (SEA 2015)

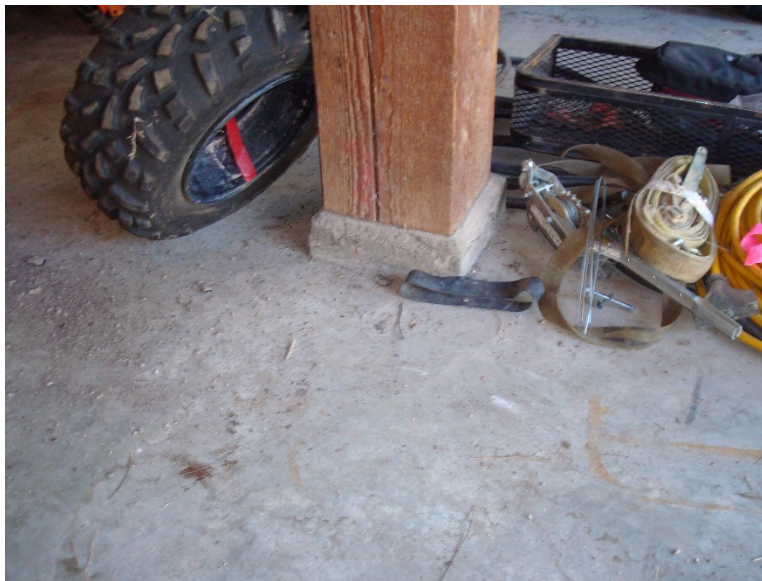
The timber posts bear on a small concrete pilaster at the slab-on-grade level (Figure S9).

Figure S9. Post bearing on pilaster. (SEA 2015)

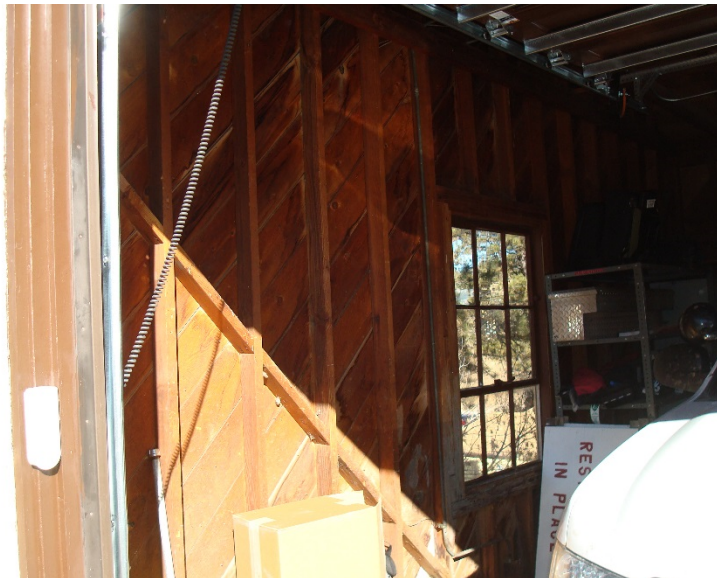
The wall framing is typical 2 x 4 (nominal) wood construction with 2x bracing for lateral loads (Figure S15). No defects were noted in the wall framing.

Figure. S15. Second Floor wall framing. (SEA 2015)

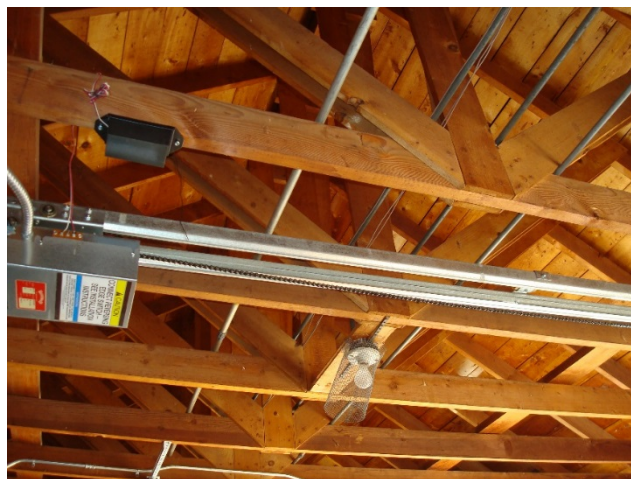
The roof framing consists of wood trusses with 2x bottom chords and rafters, and 1x diagonal members (Figure S16). No defects were observed in the roof truss framing.

Figure S16. Roof Truss framing. (SEA 2015)

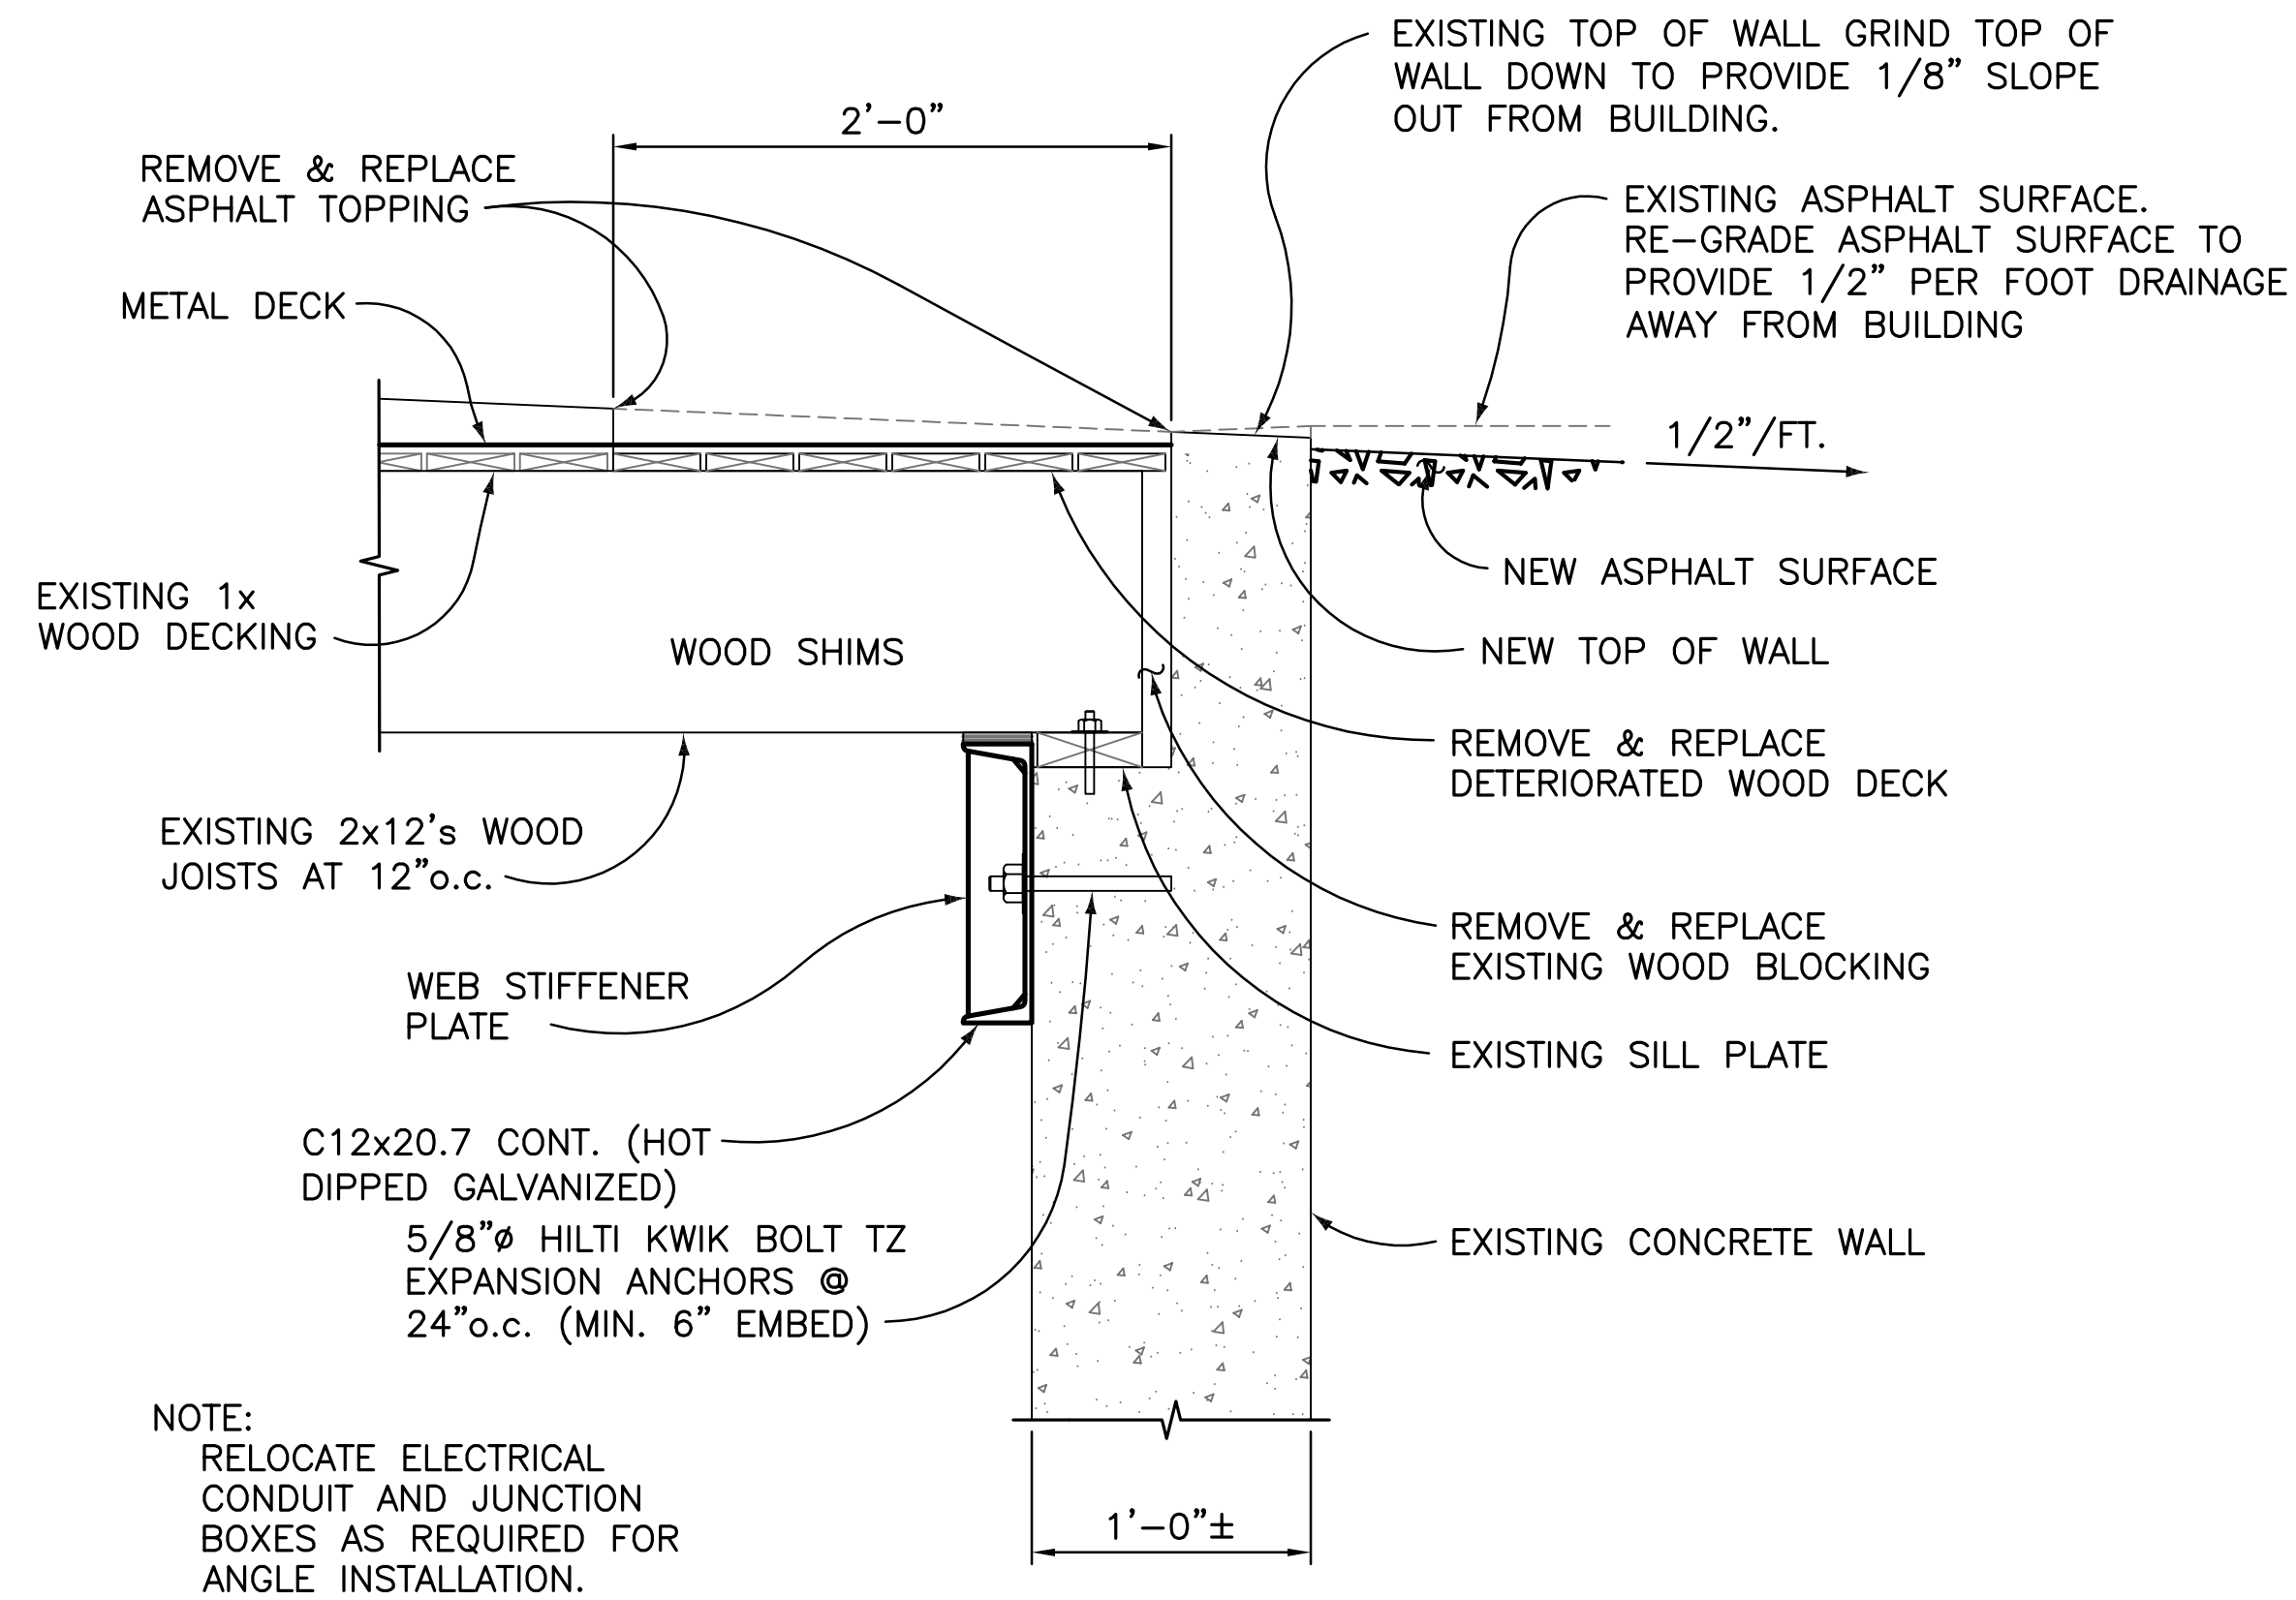
**A** **SUPPORT OF FLOOR FRAMING**

1. Do not park or store heavy equipment on the second level until shoring or permanent repairs can be made.
2. Repair wall and framing at west wall -  
The detail at the bearing condition of the second level floor joists is problematic. As constructed, the top of the concrete foundation wall on the west face slopes into the structure. The water then travels down through the wood decking, saturating the ends of the floor joists and the sill plate. This leads to deterioration of the floor framing.

Many of the floor joists are rotted at the west wall. Additional support is needed. Inspect entire length of the wood sill and replace, in kind with pressure treated wood, as required. A support angle should be installed on the foundation wall to support the floor joists. The angle will be anchored into the foundation wall with stainless steel expansion anchors. The angle should be hot dipped galvanized to minimize corrosion. See SK-1. This will require the temporary or permanent relocation of electrical junction boxes and conduit from the west wall and adjacent floor joists.

In order to minimize future deterioration from water infiltration, the top slope of the foundation wall needs to be changed. As constructed, the top of the wall slopes inward to the structure. The top of the wall should be ground down to slope the top of the wall outward by at least ½-inch. In addition, the grade of the asphalt drive to the west of the building should be lowered to provide a ½-inch lip on the outside face of the foundation wall. The asphalt drive should have a slight swale added before it comes into contact with the building. A soft joint between the asphalt drive and the building should be detailed and provided. Positive drainage should be provided away from the building of one-half-inches per foot. Detail A/TS3 shows a repair detail for supporting the west end of the floor joists.
