# VILLAGE HALL

## Women's Rights National Historical Park

**Historic Structure Report**

VILLAGE HALL  
HISTORIC STRUCTURE REPORT  
Women's Rights National Historical Park  
Seneca Falls, New York

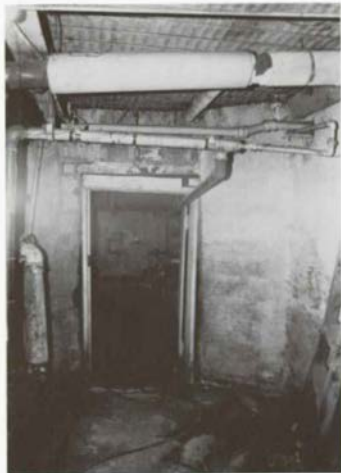
Fig. 22. Boiler Room, South Wall,  
Looking Toward Meter Room [1988].

The walls are original, and are composed of poured, rough concrete with inclusions of large aggregate (up to 2 inches in diameter). The indentations of the forms are visible on the surface. The south wall (see figure 22) is an 18-inch-thick fire wall. In the southwest corner is a concrete buttress that appears to have been added in 1927 for increased load-bearing support. (The concrete used for this buttress has a much finer aggregate size.) In the southeast corner is a brick chimney. There is storage shelving against the north wall.

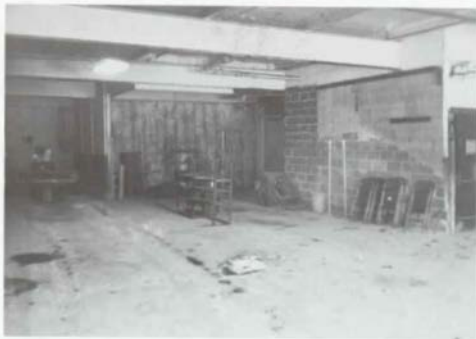
Fig. 33. Room 106 (Garage), Looking Southwest [1988].

inal, judging by the former's characteristically smooth texture. The plaster is in poor condition, being cracked throughout. At the north end of the wall, where a steam radiator is attached, the plaster has spalled extensively.

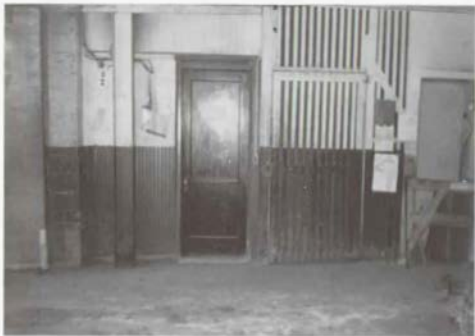
Fig. 35. Room 106 (Garage), Doorway  
to Toilet [1988].

Doorways. The architrave of the doorway leading from the garage into the toilet is not the Type-A architrave that has been dated to 1927. This suggests that the toilet was not installed at that time, but rather earlier. The door here is a solid wooden door with two recessed panels: a square panel in the lower third and a rectangular panel in the upper two-thirds.

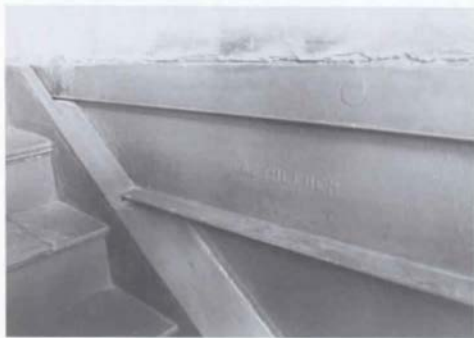
Fig. 41. Room 201 (Main Stairway) [1988].

The wainscot is painted an orange-brown color, as part of the two-tone color scheme. The corresponding portion of the east wall is also painted orange-brown, even though there is no wainscot here. The east wall does display a horizontal steel I-beam--presumably a support for the stairway (fig. 41). It is marked with the word, "BETHLEHEM," denoting the company that manufactured the building's steel framing members. The treads and risers of the stairway are wood.

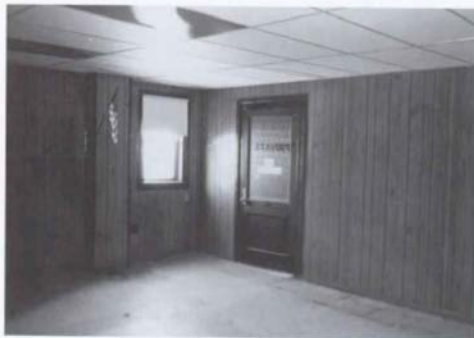
Fig. 42. Room 203 (Police Locker Room),  
Southeast Corner [1988].

This space (fig. 42) is located north of the East-West Hallway. It is known as the Police Locker Room or Mess Room. The HABS drawings simply label it as an office.

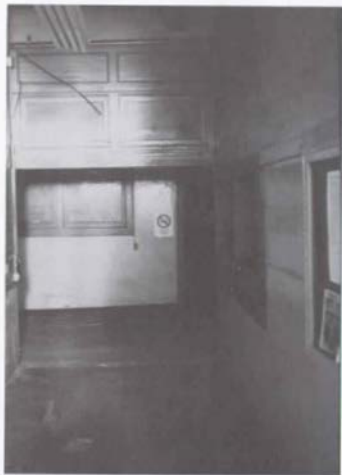
Fig. 43. Room 204 (Dispatcher Room),  
Looking North [1988].

Doorways. Three doorways are located in the Dispatcher Room. A wide doorway opening comprising the north wall of the room leads to Room 202. It has a large overhead area that contains two transom windows holding clear glass and topped by two solid wood panels (fig. 43). There is no door here.

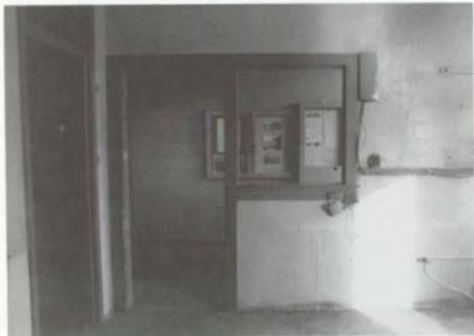
Fig. 44. Room 205 (Records Office),  
Looking East [1988].

Doorways. The doorway to Room 204 (fig. 44) is located in the south portion of the room, at the north end of the east wall. Its architrave is a 4-inch-wide board that may postdate 1927, since it has only two finish layers. The doorway is missing its door.

The east wall of the Records Office contains--south of the doorway to the Dispatcher Room--a "pass-through" opening (see fig. 44). This opening is trimmed with a plain, 4-inch-wide board identical to that used around the adjacent doorway. One window opening is located in the partition wall at the same level as the adjacent doorway's transom windows. The opening contains three fixed lights, and was undoubtedly installed to bring more natural light into the north portion of the office. Its frame and muntins are painted a dark apple-green color.

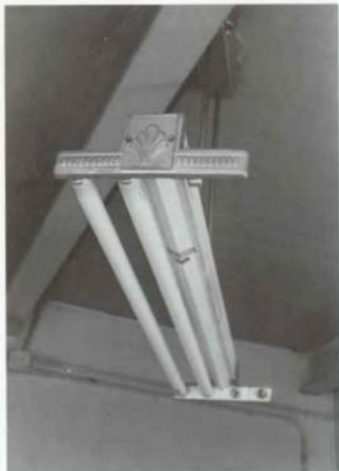
Fig. 45. Room 205 (Records Office),  
Light Fixture Type FL-C [1988].

Electrical Fixtures. Each portion of the Records Office contains an early hanging fluorescent lighting fixture with end pieces rendered in the Art-Deco style (fig. 45). This type of fixture has been labeled Type FL-C in Appendix D. There are cable wires, transmitter boxes, and an electrical receptacle on the east wall.

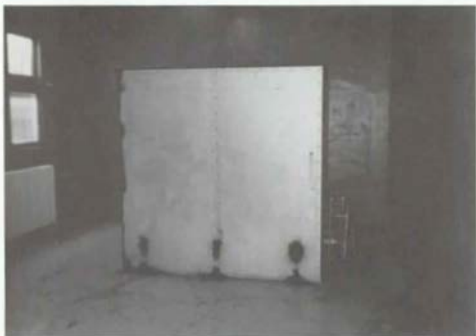
Fig. 50. Room 210 (Jail), Cell Block [1988].

The room containing the jail cells was created as part of the 1927 remodeling. A sheet-metal cell block in the north half of the room (fig. 50) held two separate cell units. The units at one time each contained a sink, a toilet, and a bed.

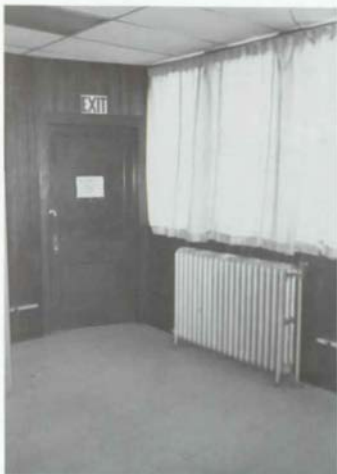
Fig. 51. Room 214 (Village Meeting Room), Northwest Corner [1988].

A second exit doorway leads into the north end of the rear stairway enclosure (fig. 51). A third doorway is located in the east end of the south wall, and leads to a closet. These two doorways share the same type of architrave profile: it simulates the Type-A molding, but is smaller (1/2-inch trim on flat board) and probably later. The door to the stairway enclosure is a solid two-panel door. The door to the closet is missing.

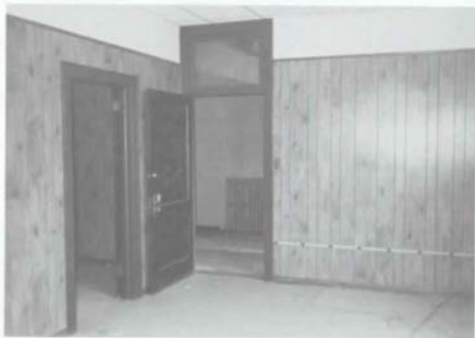
Fig. 52. Room 215 (Chief's Office), Southwest  
Corner [1988].

The Chief's Office (fig. 52) is located in the northeast corner of the second floor.

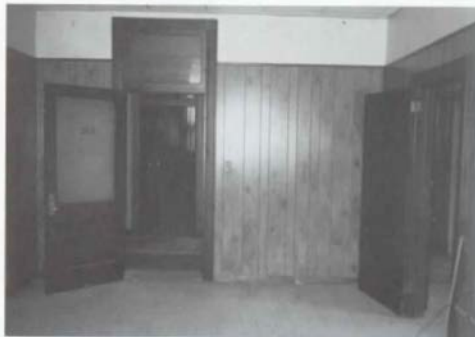
Fig. 53. Room 216 (Investigator's Office),  
West Wall [1988].

The Investigator's Office (fig. 53) is located on the east side of the building, just south of the Chief's Office.

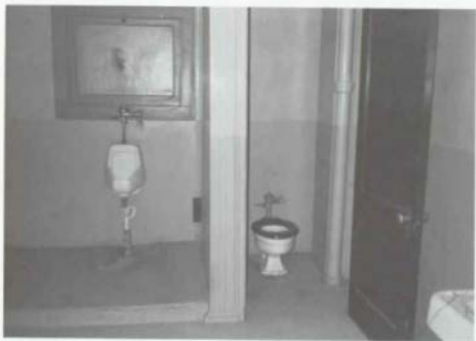
Fig. 54. Room 219 (Men's Bathroom),  
North Wall [1988].

The Men's Bathroom (fig. 54) is located against the east exterior wall of the building. It sits east of the Women's Bathroom, and is accessed by the same short corridor off the Main Hallway.

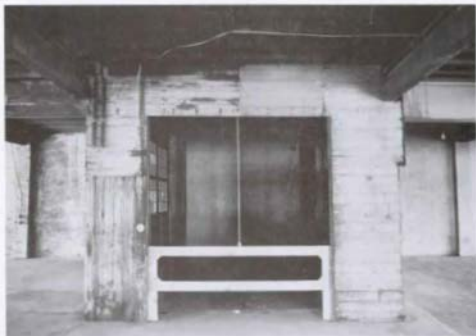
Fig. 58. Third-Floor Elevator Enclosure  
[1988].

Walls. Much of the west wall of the enclosure is taken up by the main doorway to the elevator. The rest of the wall area consists mostly of horizontal tongue-and-groove flush-board siding (fig. 58). A section of vertical boards north of the doorway reveals the presence of another doorway (see "Doorways," below). The north and south walls of the elevator enclosure each consist of narrow, vertical, beaded, ship-lapped boards above and below a wide window opening. One steel column is located toward the west end of both walls, inside the elevator enclosure. The east wall of the enclosure is the exterior brick wall of the building. The walls have one deteriorated coat of white paint.

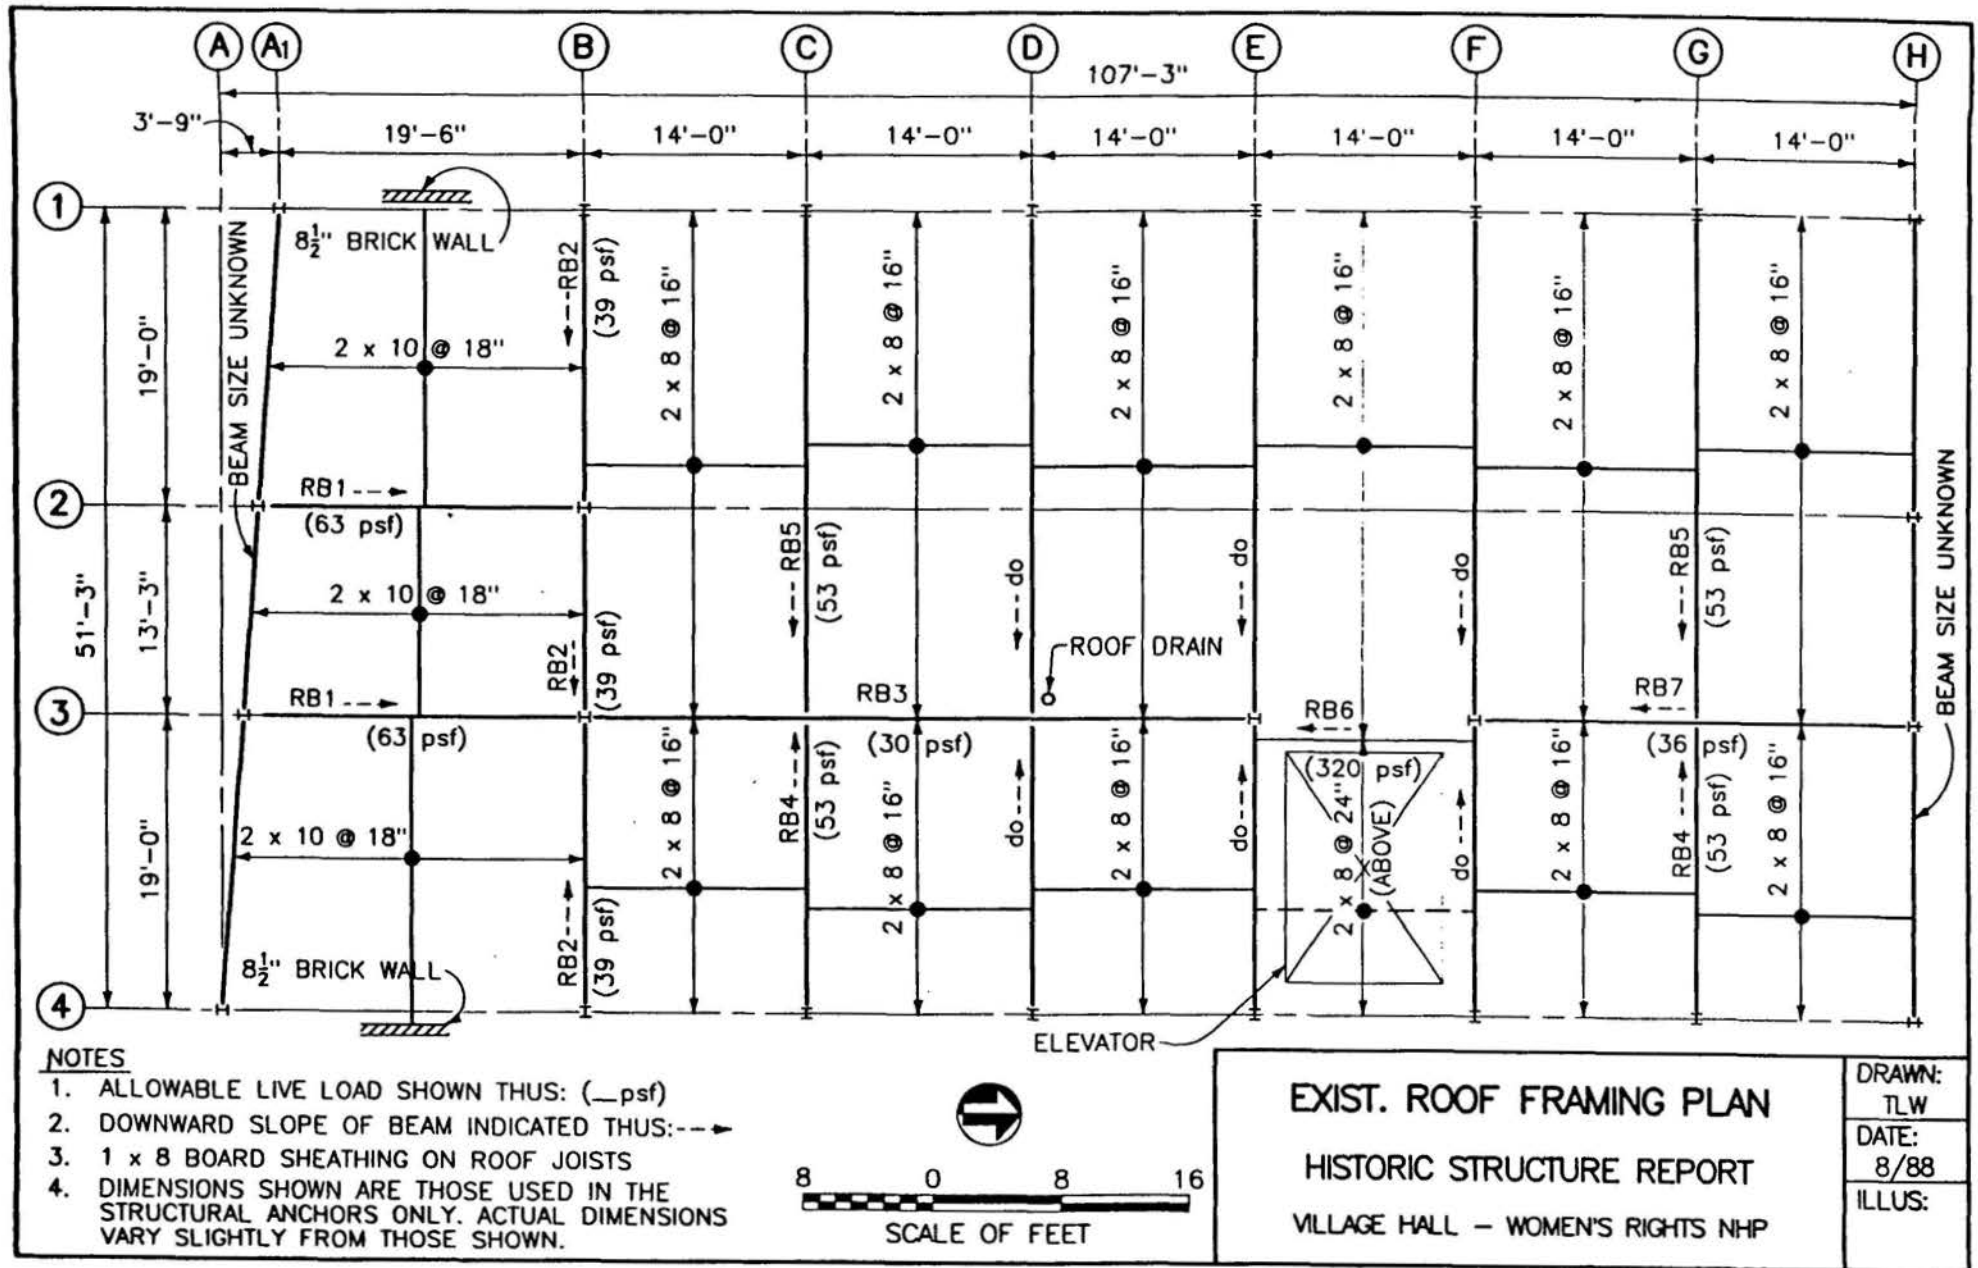
Fig. 63. Existing Roof Framing Plan [1988].

The flat roof system consists of a built-up roof on 1- by 8-inch sheathing boards supported by wood joists and steel beams. The wood joists measure 2 by 8 inches and 2 by 10 inches. The existing roof framing plan is shown in figure 63.

joists were not properly seasoned prior to installation, and in the absence of any blocking or bridging, movement occurred unrestricted. All of the steel roof beams are in good condition.

The elevator penthouse floor and walls are constructed of wood. Much of this framing is original, but the east side features newer framing. Apparently this later framing is replacement material for members that were burned during the fire at the adjacent Fisher Theatre in 1972. Both the original framing and the newer framing are in fair condition. There is no evidence of decay. Some of the framing has been modified by splicing, and these areas will require strengthening and/or reframing.

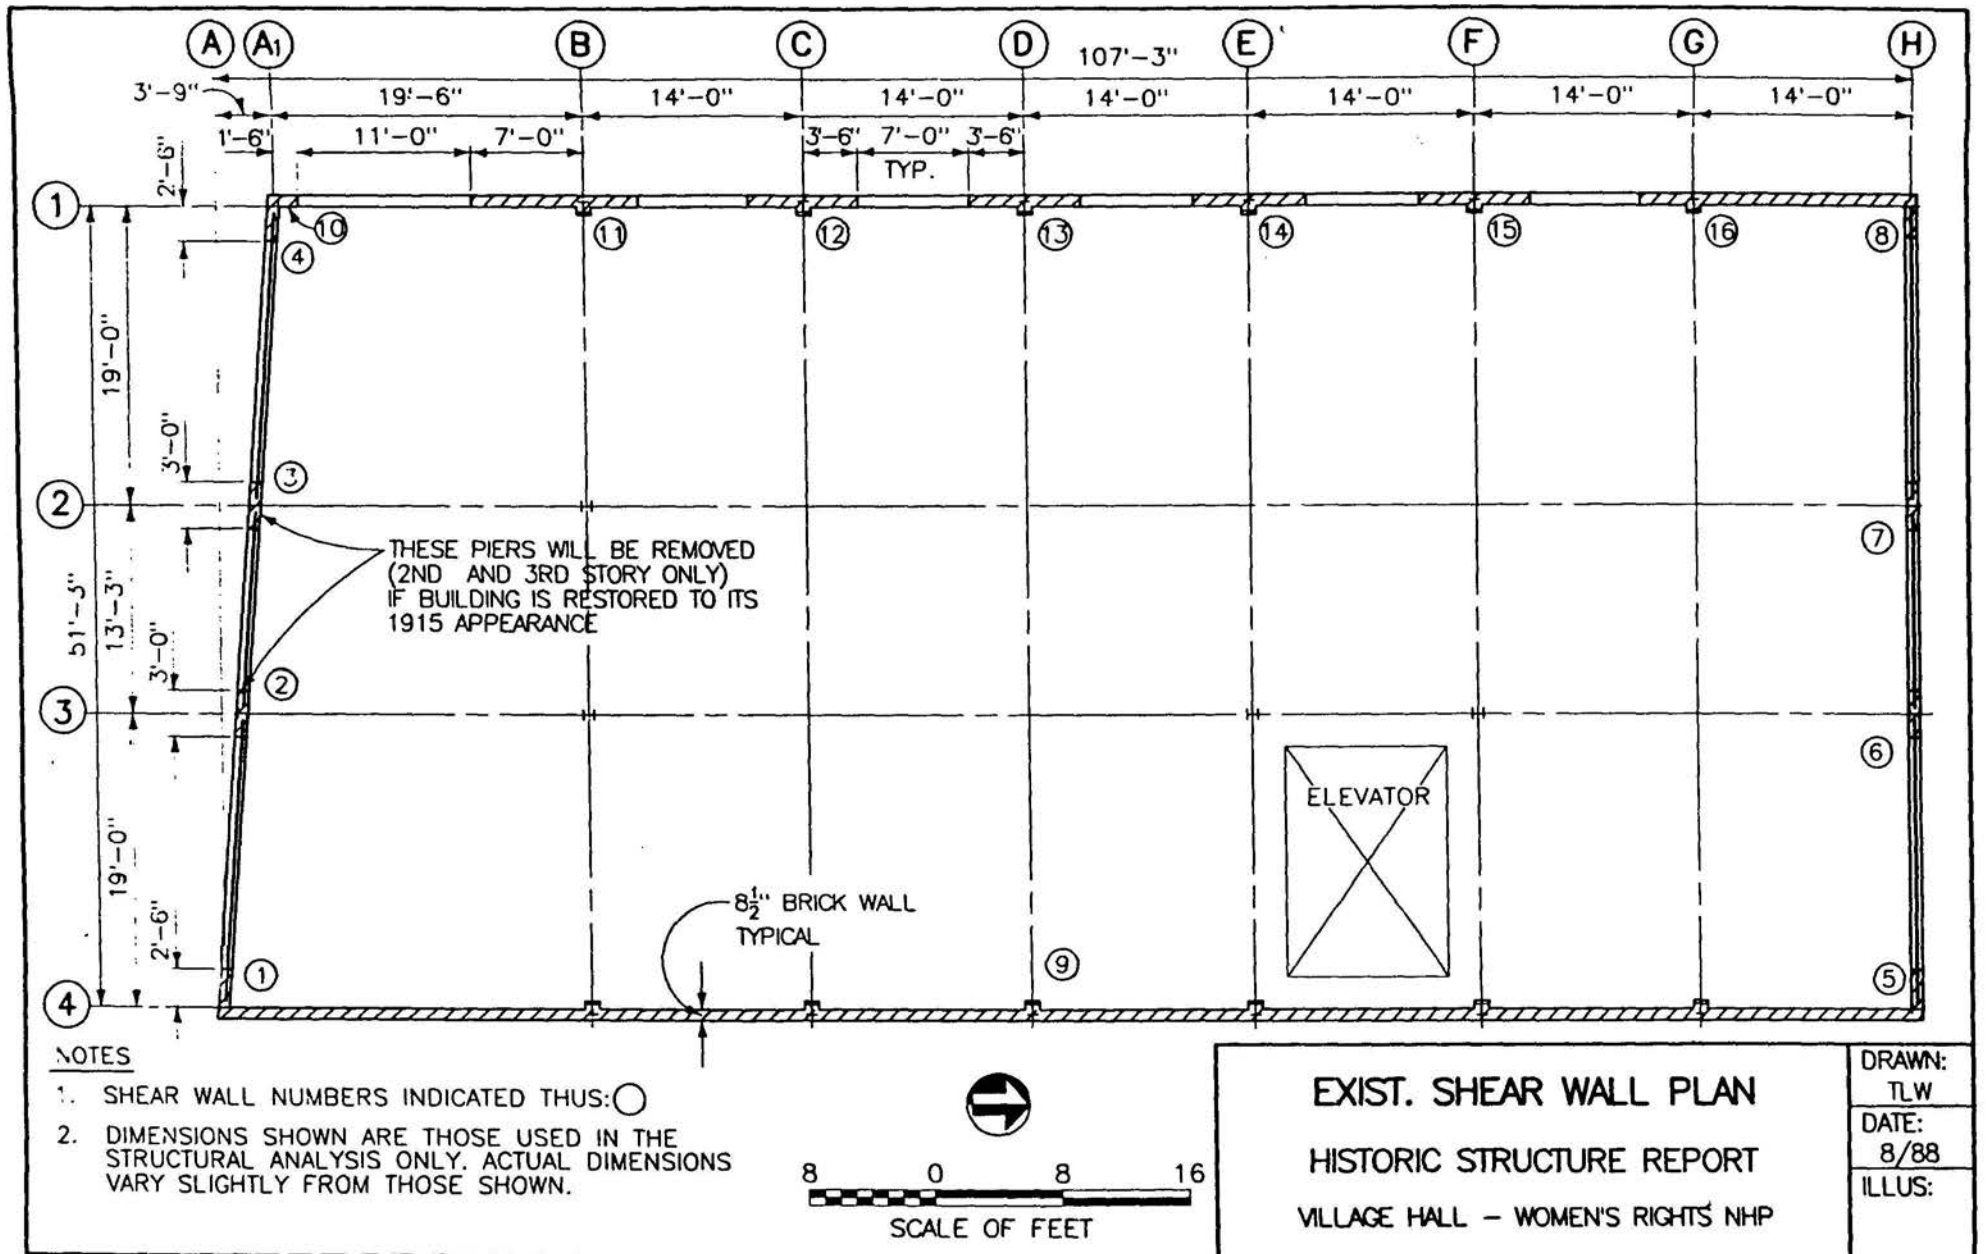
Fig. 65. Existing Shear Wall Plan [1988].

A lateral-load analysis of the structure was also performed. Due to the mass of the structure and the relatively high seismic coefficient ( $Z$ ) of 0.5, seismic loads control over wind loads. The concrete floors were assumed to act as rigid diaphragms. Diaphragm action of the roof and adequate transfer of the roof shears to the walls was also assumed for the analysis. The roof is currently board sheathing, which is not recognized as a diaphragm by the code, although numerical values do exist in some publications. The shear wall locations are shown in figure 65.

The second analysis presumed the removal of the portions of brick piers at second- and third-story levels. Results of this analysis are shown in Table 3 (fig. 67). Shear walls 1 through 8 at the first-story level are again overstressed 48%. At second-story level, shear walls 1 and 4 are overstressed 64%, and shear walls 5 through 8 are overstressed 58%.

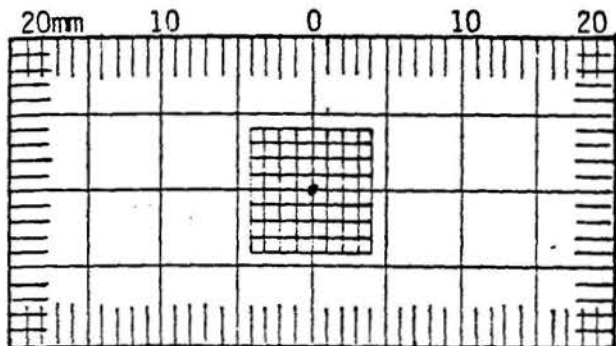
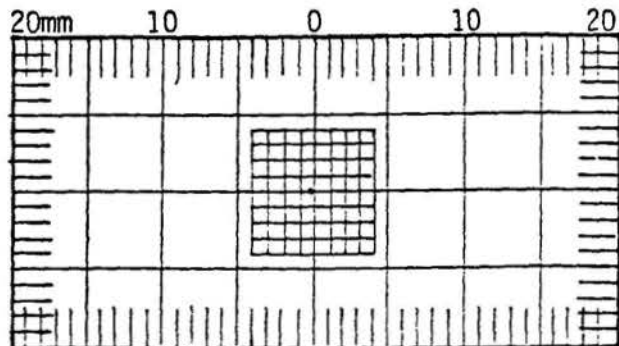
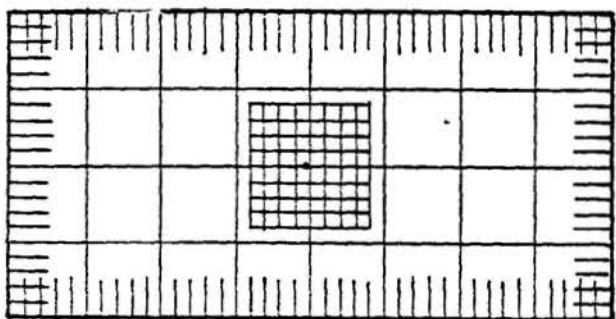
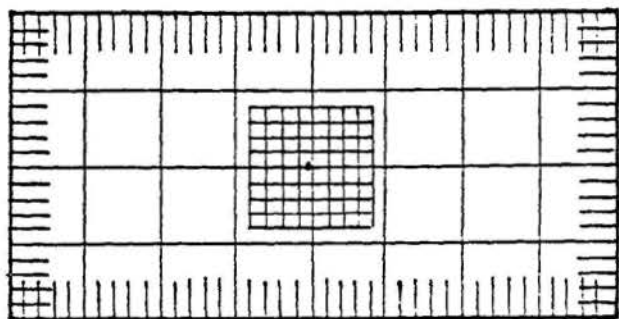
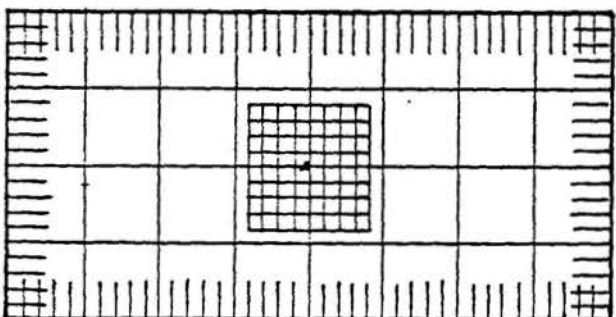
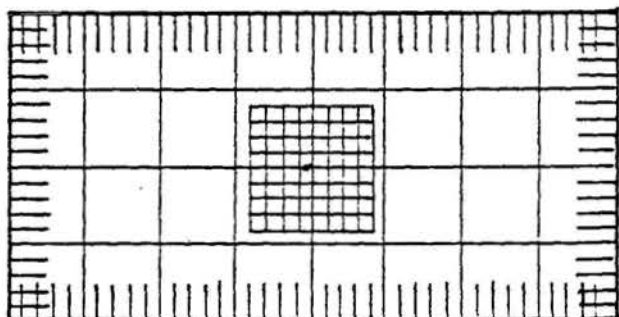
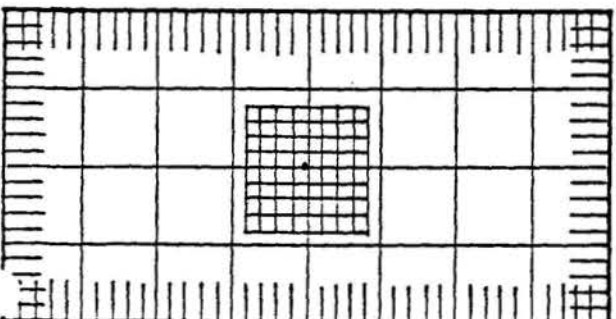
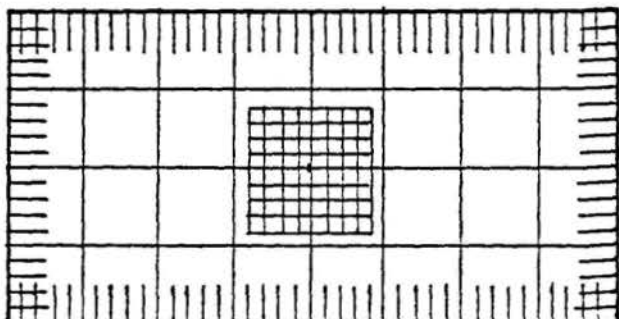
Location of Monitor Exter., N. Wall, 2nd Flr., N.E. Corner

The walls of the Village Hall were monitored for structural movement for a 10-month period between April 1988 and January 1989. Substantial cracks in the masonry had prompted concern as to what, if any, movement is occurring in these walls. As of January 26, 1989, all movement appears to be either cyclic or fluctuating with the temperature.
