SOUTHWESTERN MONUMENTS

SPECIAL REPORT

SAN JOSE DE TUMACACORI
PICTORIAL RESTORATION

BY
J. H. TOVREA

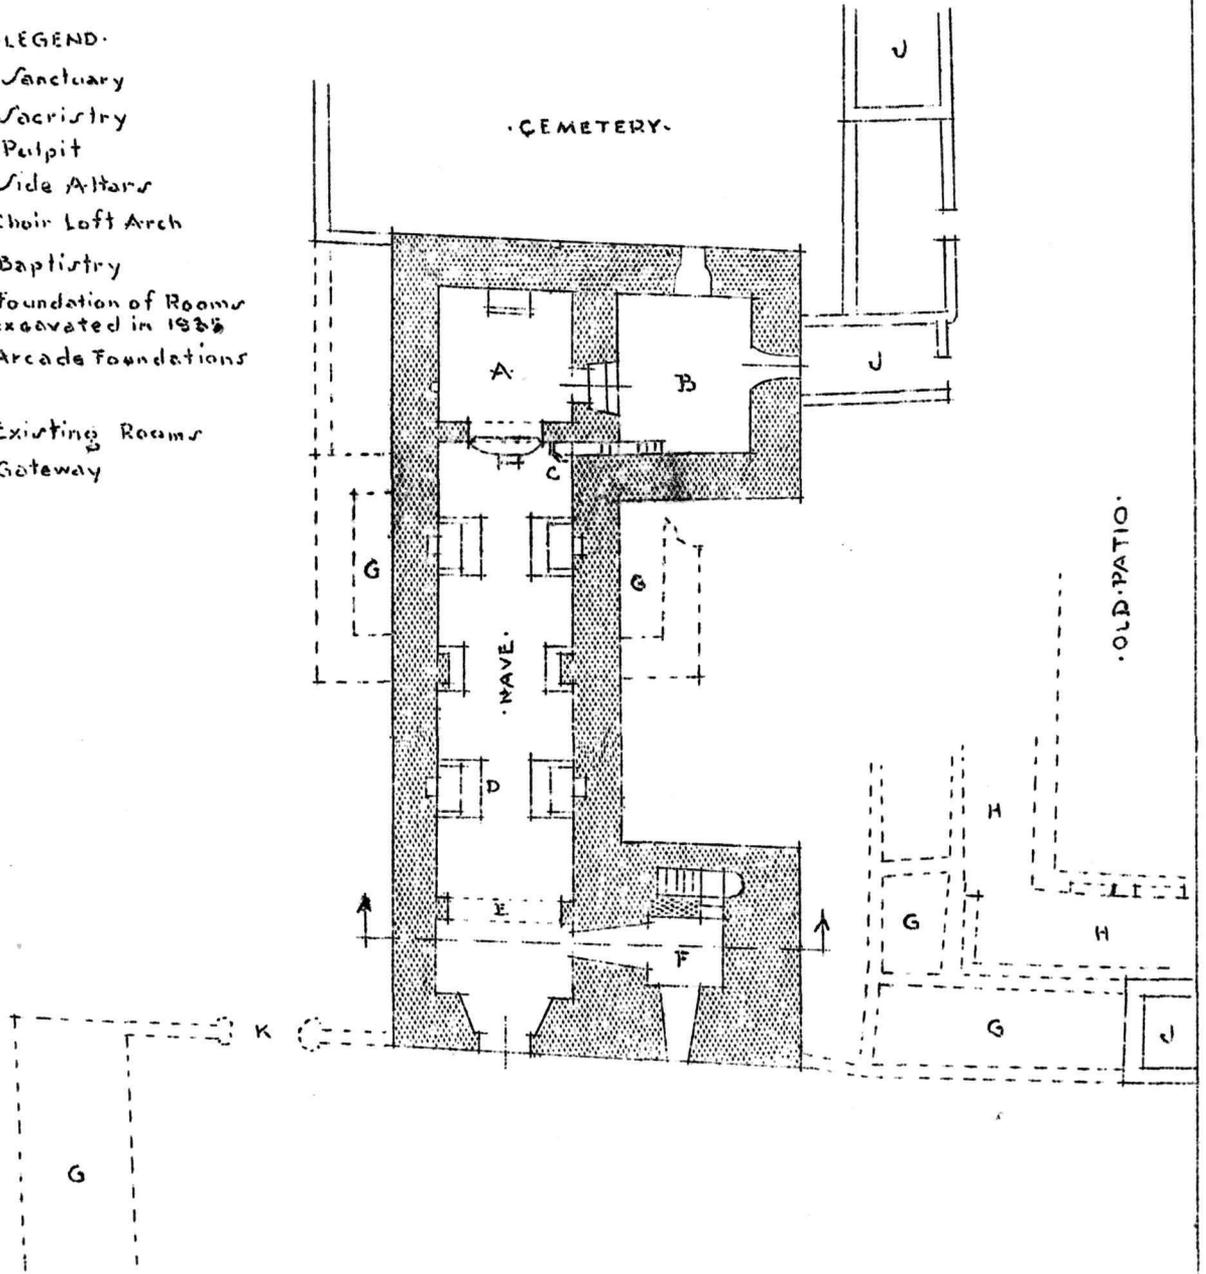
·PLATE· 4·

- A- Sanctuary
- B- Sacristy
- C- Pulpit
- D- Side Altars
- E- Choir Loft Arch
- F- Baptistry
- G- Foundation of Rooms excavated in 1936
- H- Arcade Foundations
- J- Existing Rooms
- K- Gateway

·TUMACACORI·FLOOR·PLAN·

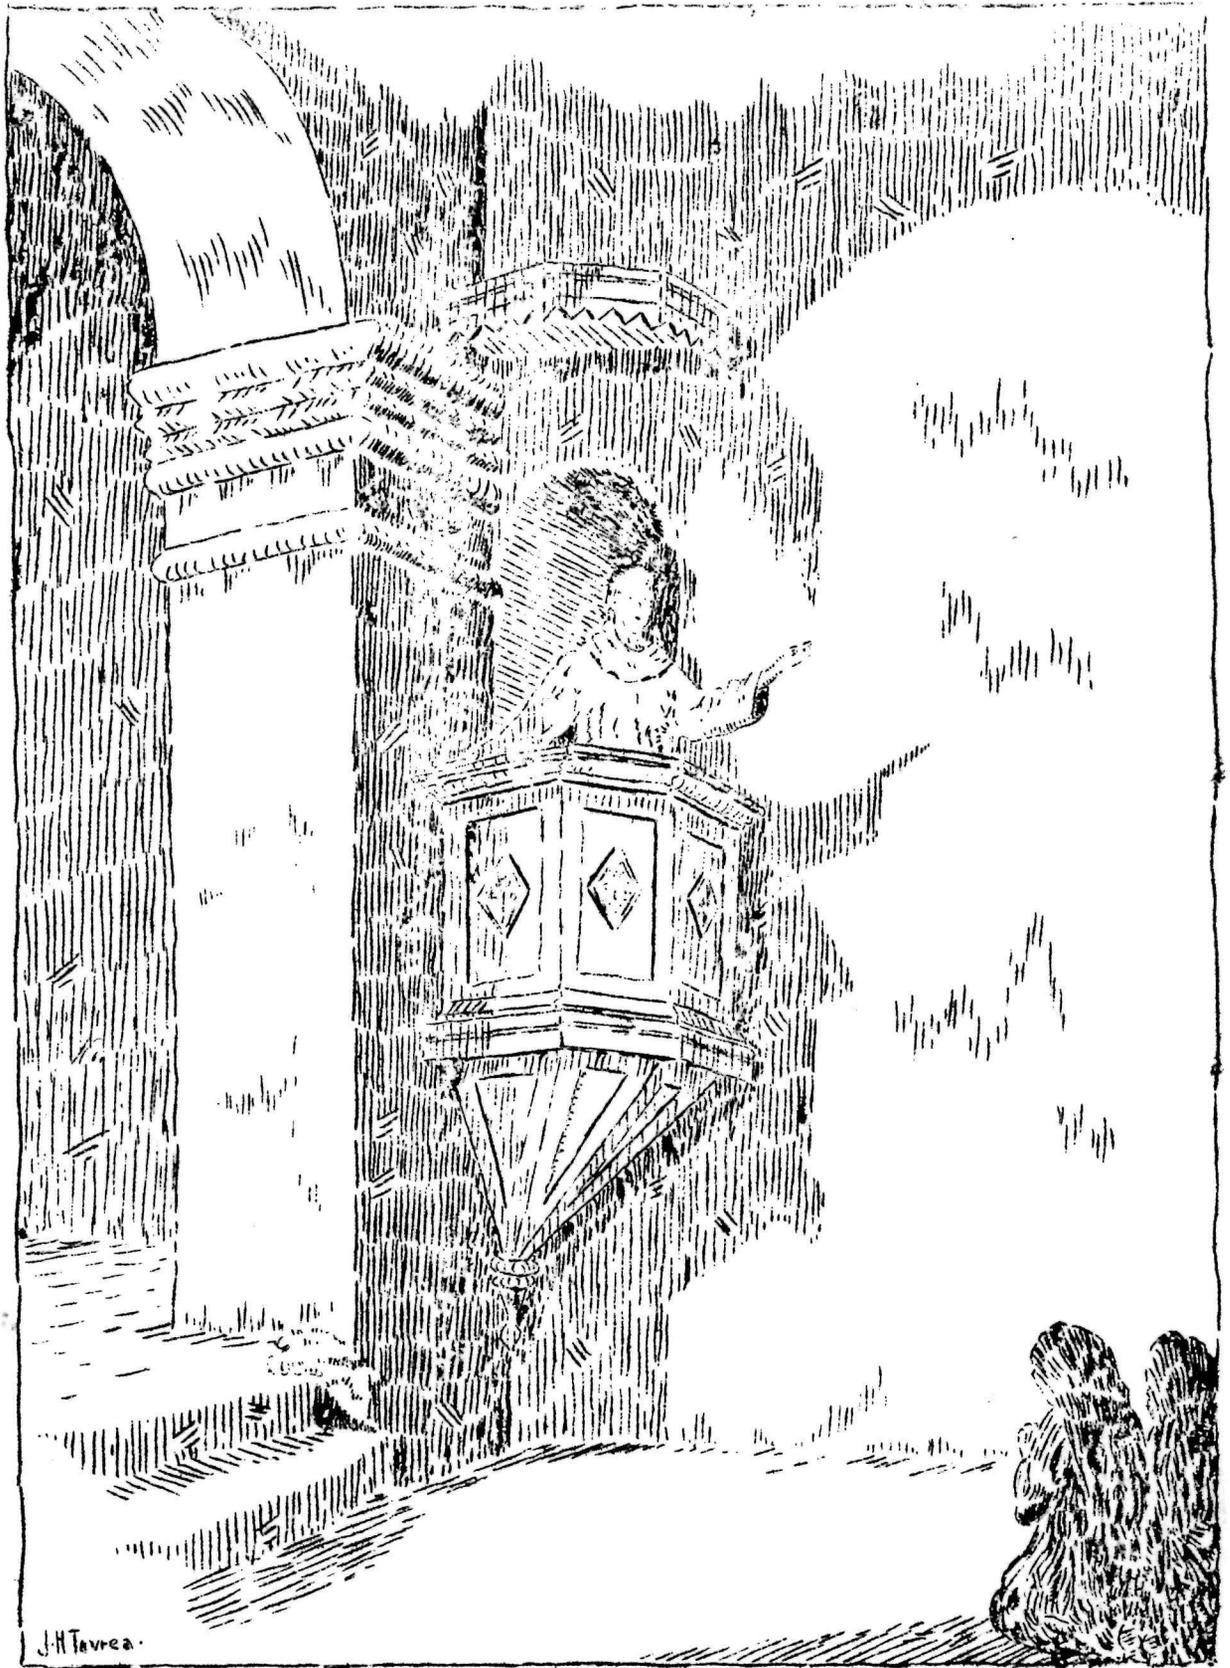
·PLATE 2 - PULPIT RESTORATION·

the corner formed by the intersection of the two main walls, was a mark which indicated the presence of an ornament which might have terminated the point of an inverted pyramidal corbel that supported the floor of the pulpit. With this scanty evidence to work from a square pulpit floor was constructed with the corbel below. This construction was then plastered over. If a pulpit of this square shape were used the speaker could not have faced his listeners in a graceful manner unless he faced directly south where he would be looking along the line of the east wall, or directly west where he would be looking at a wall seventeen feet away and not at his listeners.

It would seem that the ideal horizontal section of a pulpit for this particular situation would be a quarter round, which would permit the speaker to face any direction in the space of ninety degrees. For the purpose of ornamentation, however, this section would not be very satisfactory, as well as being a difficult one to build out of wood. All of the pulpits which we studied in the other missions were some portion of an octagon, depending upon their position. This octagon shape gave the same effect as a circle, was easier to construct, and when ornamented was more pleasing to the eye. The one at San Ignacio looked so appropriate for Tumacacori, if modified a bit, that I made a rough water color of it. Using this as a model, I have made a restoration drawing of a pulpit for Tumacacori. (Plate 2). This pulpit would meet the requirements established by the marks left on the walls by the original pulpit and would, I believe, resemble the original very closely. The construction would be of wood and the colors similar to those of San Ignacio's pulpit. If this pulpit were restored, I believe it would create a pleasing contrast to the present drab interior.

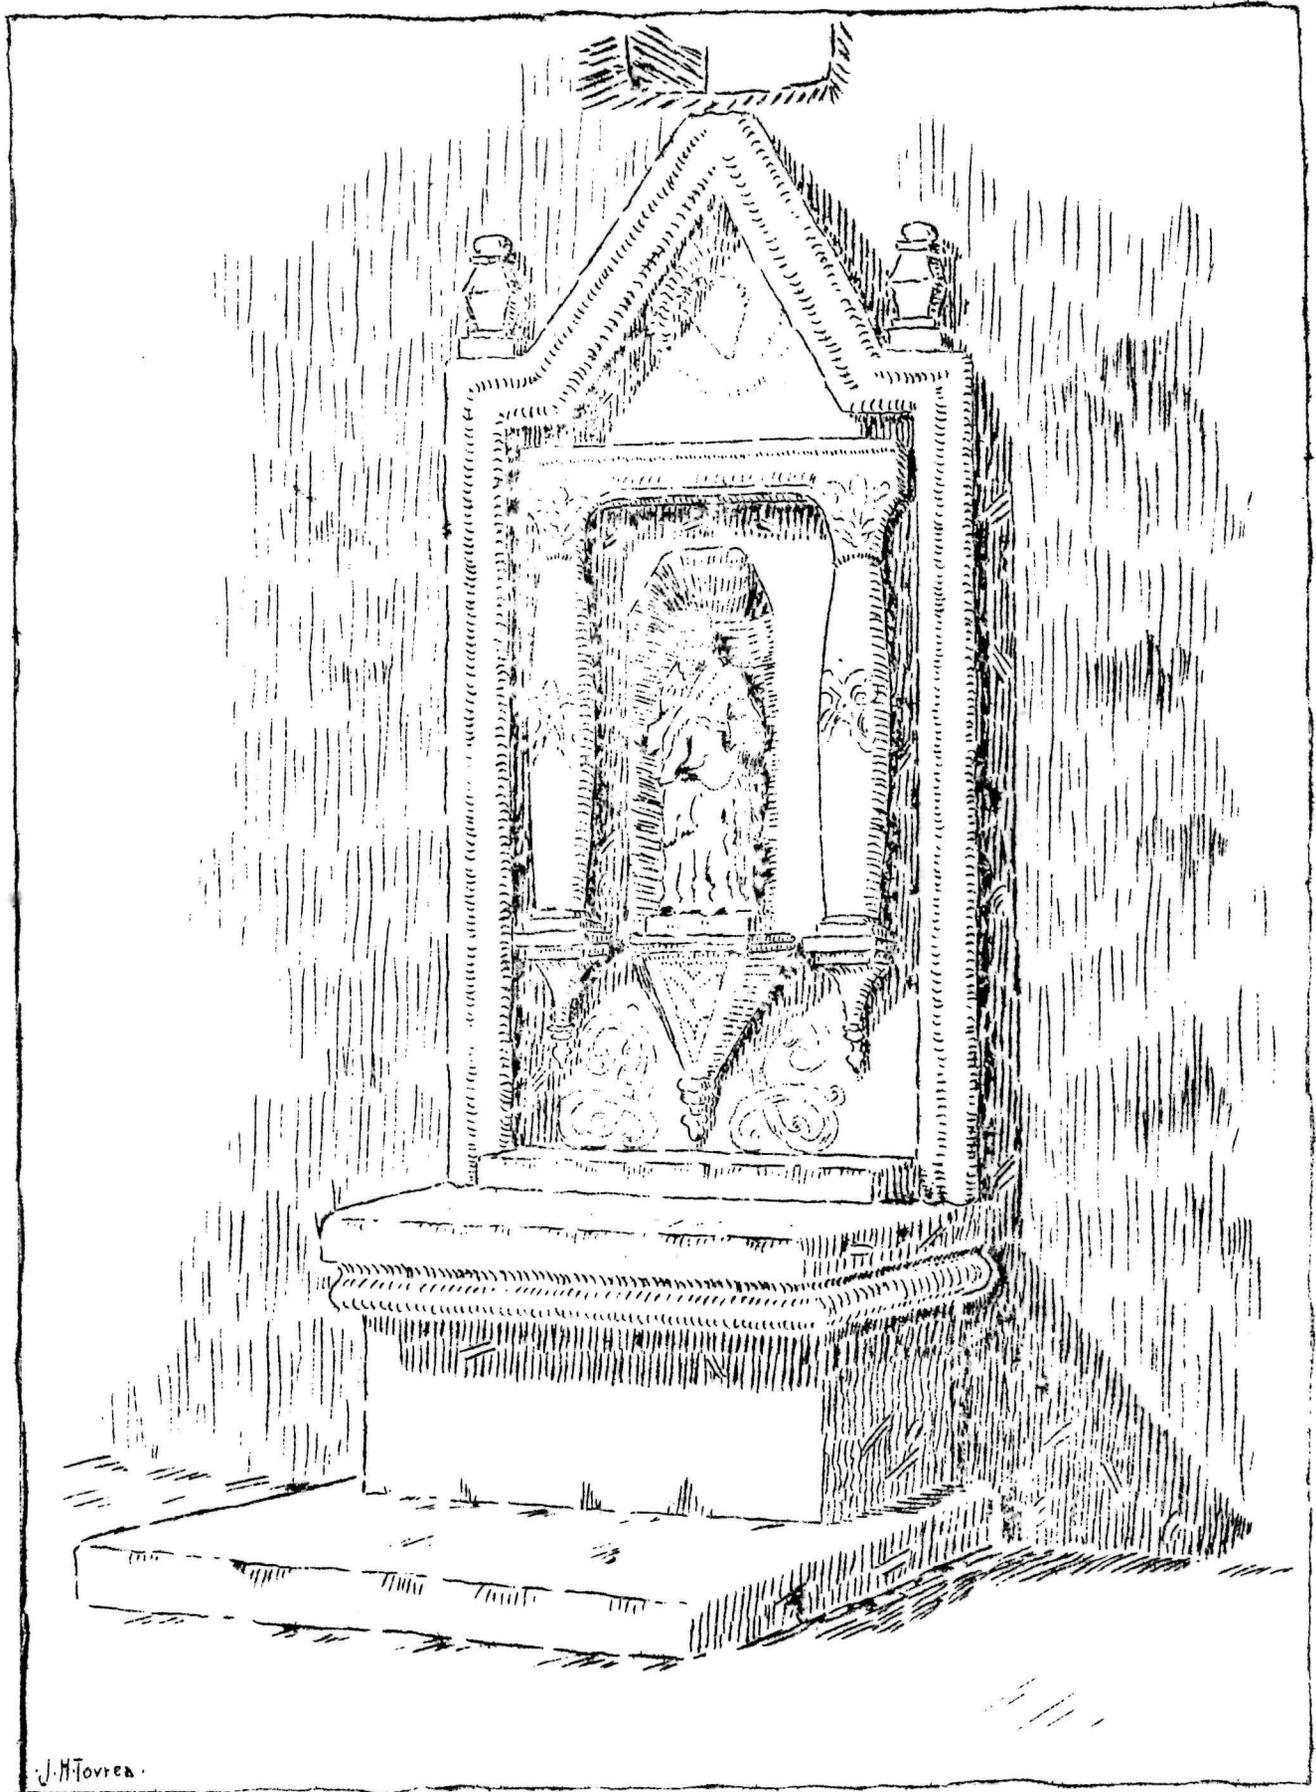
·PLATE·3·SIDE·ALTAR·RESTORED·

Tumacacori had seven altars--three on each side of the nave and the high altar in the sanctuary. One can imagine how impressive the interior of this old mission must have been when all these altars stood complete, each one enshrining the image of a saint. Could not this picture be more clearly imagined by the visitor if one of these altars were completely restored? The possibilities of such a restoration are shown by the drawing in Plate 3. This particular altar is the first side altar on the left as we enter the building. All that remains of it now is the base, and the lower portion of the altar proper. The flat top has been restored. Existing evidence to support the accuracy of this restoration drawing is in the form of marks on the plaster wall showing the outline of the gabled moulding that frames the altar background, and the small remaining fragments of one of the columns, and one end of the lintel.

The ornamental designs on the column and lintel are painted and were suggested by the designs on other altars of the chain. At least two of the old carved wood images, which are now at San Xavier, belonged

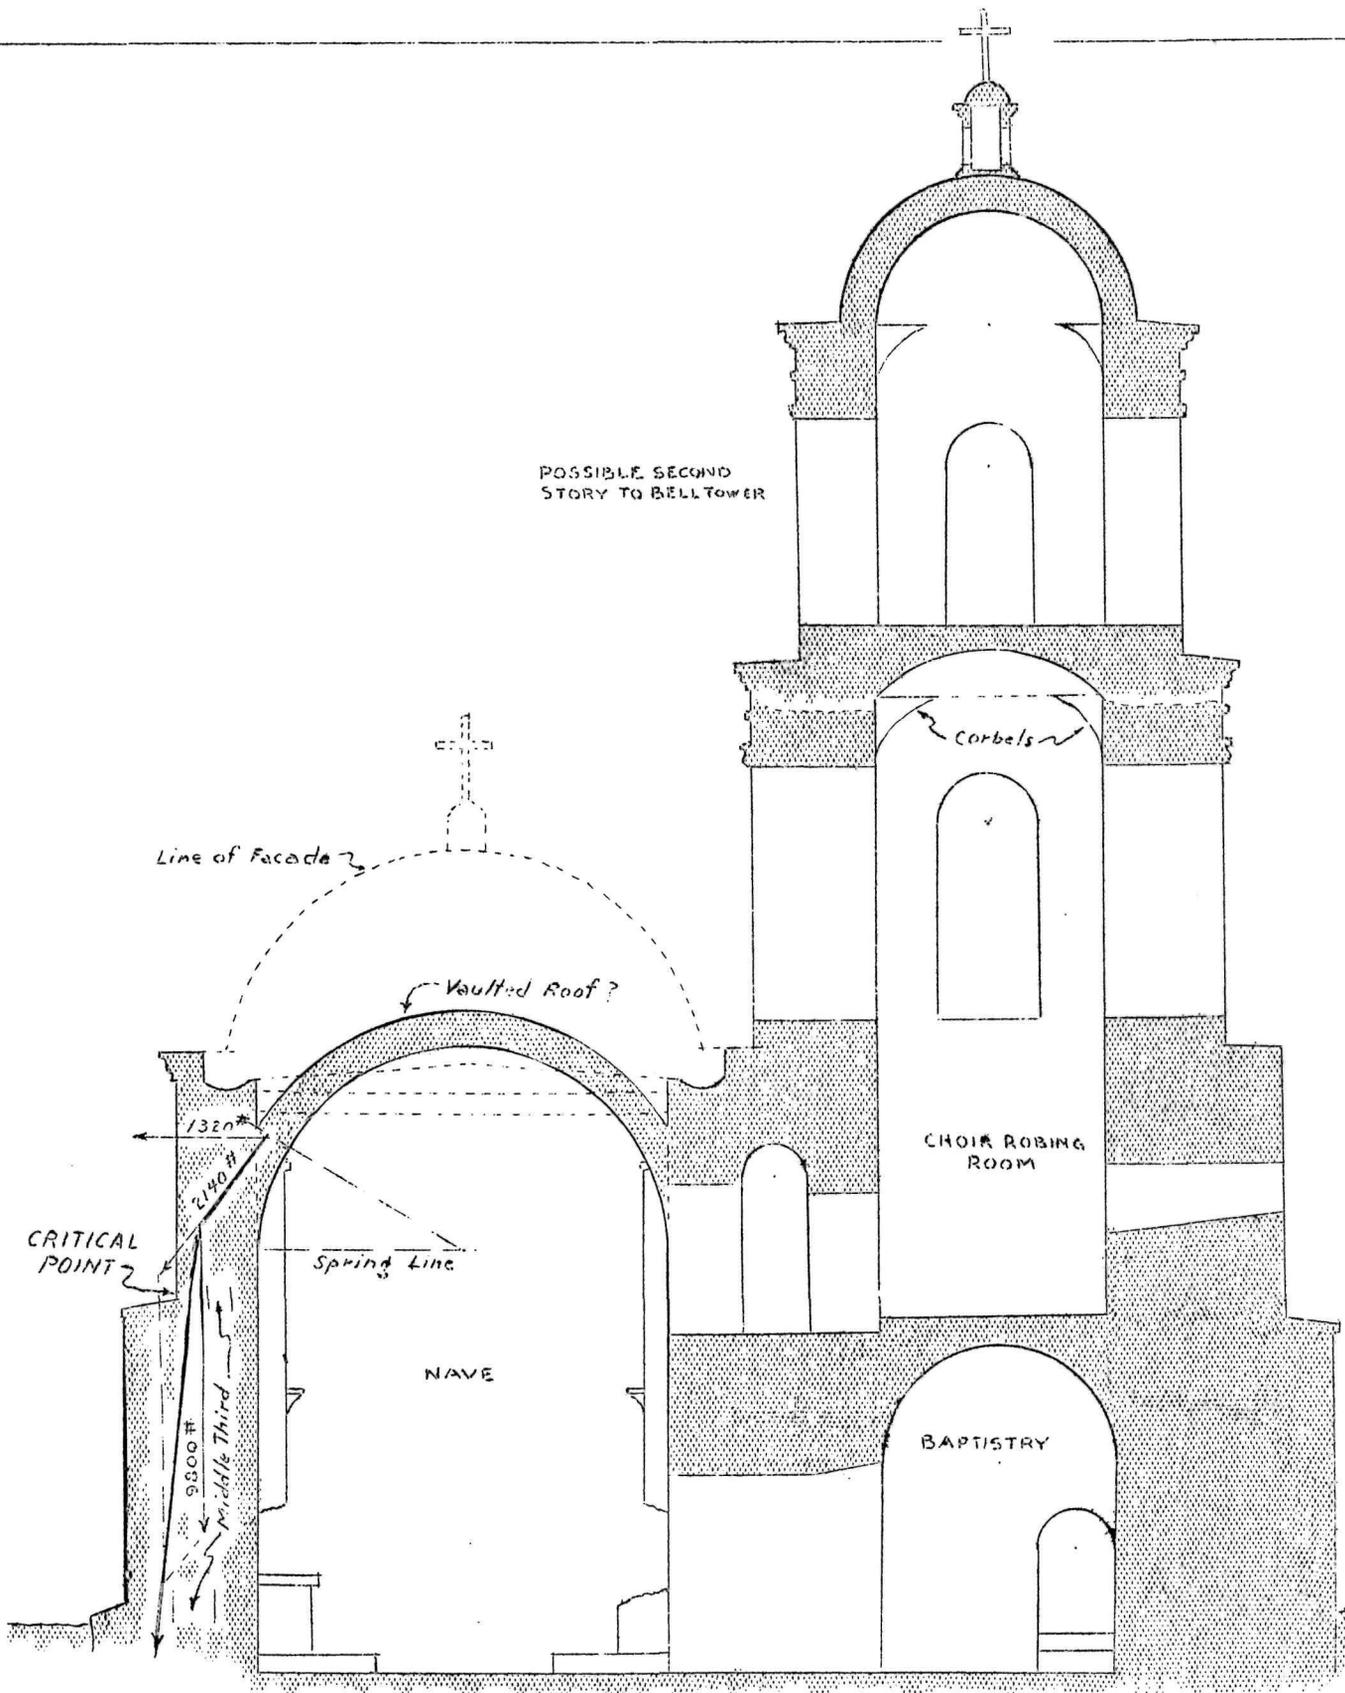
· PLATE · 5 ·
 · SECTION · THRU · MISSION ·
 1/8" scale

Referring to Plate 5, let us study the wall section. If this section were designed in the original plans of the building, a section of this shape could have been designed for only one purpose; namely, that of supporting a barrel vaulted roof. If the wall had been designed primarily to support a flat roof, the designer would surely have used a three-foot wall section all the way up. It is well to bear in mind that when the present roof was restored there was no evidence that a vaulted roof had covered the walls; but, at the same time, it might have been the intention of the designers to use the flat roof temporarily and eventually replace it with the highly favored barrel vault.* It is a well known fact that the padres were clever architects and that when they built a vaulted roof it was well designed and did not fail through structural weakness. In fact, they had a tendency to over-design; that is, to construct their walls even a bit thicker than was necessary in order to be sure that their buildings would not fail. Churches in Mexico which they built four hundred years ago (some of which would hold a half dozen of the Kino missions), are still in use today and are structurally sound.

Referring again to Plate 5, let us actually determine whether this section would support a vaulted roof. Since the width of the nave is the same as that of the sacristy, it can be assumed that the proposed vault for the nave would have the same thickness as that of the one that now exists over the sacristy. The spring line of the intrados of the arch is a point fixed by the fact that the proposed vault could not be higher than the north wall supporting the dome over the sanctuary. The stress diagram shows a resultant thrust of 2140 pounds per lineal foot, acting at an angle of 38 degrees from the face of the vertical wall. The center of gravity of the wall section can be calculated to be 2.42 feet from the vertical face of the wall and the weight of the

wall section creates a force downward of 9,800 pounds per lineal foot through the point of the center of gravity. The resultant force between the thrust of the arch and the weight of the wall section completes the line which the thrust of our proposed vault would travel. This line of pressure is the heavy line shown on the wall section. It will be noted that the wall section is divided into thirds at the base of each of the two different wall thicknesses. When a wall section is designed to carry an arch, it is so designed that the line of thrust always stays within the middle third of the wall section. If it runs outside of this middle third, the section is considered unsafe and apt to fail. It will be noted that the thrust line of our proposed arch runs considerably outside of the middle third, both at the offset point and at the base of the section--which are the two critical points. We know then that if a barrel vaulted roof were built there would be great danger of the side walls failing.* Therefore, since the padres were efficient designers and even tended to over-design, I believe we can safely say that the two-foot offset was not a part of the original plans of the building. That eliminates one theory and leaves us two; namely, that the plans were changed when the offset point was reached, or, the portion of the building above the offset was an addition to the building. I believe that the five-foot section of wall was started with the idea of using the vaulted roof--otherwise a narrower wall section would have been used. I believe that it was intended to carry this thick wall up to the point where the spring line of the arch we figured starts. When the point was reached which is now the offset point of the walls, plans were changed. 1. There could be several periods when Tumacacori was abandoned by the padres due to Indian attacks at Tumacacori and other missions farther south. 2. It is possible also that since the Indian labor was not particularly skilled and was very slow, the padres decided to use a flat roof instead of a vaulted one, and so the wall was made narrower from the offset point on up. It will be noted that on each side of the main entrance there are buttress-like columns. (Plate 4). It seems logical to assume that they were used to support the back part of the choir loft. However, if this were true, they would be superfluous construction; as the choir loft beams would receive their proper support and bearing in the front wall of the building, and a beam under them would not be necessary. I puzzled over these peculiar columns for a long time before an apparently simple answer presented itself to account for them. When the plans

Mr. Tovrea however tells me a thinner section would probably be dangerous, due to the fact that the line of pressure could more easily fall outside of the middle third in a thinner section. - Frank Pinkley

were changed and it was decided to use the flat roof which could be taken care of by a three-foot wall, the designer could easily take care of the offset on the side walls of the nave by putting it on the outside of the building where the break would make the elevation even more pleasing. But the front of the building, the main facade, would be practically ruined if the offset ran across it and divided it into two elements. So in this place he put the offset on the inside of the building where it could be nicely concealed by the choir loft floor. Any offset on the inside of the nave that could be seen would cut down the apparent height of the ceiling. There is nothing much harder to do than to make a radical change in a good set of plans and still keep them good. This is especially true when the building planned is half built. Though Tumacacori is hardly an architectural jewel, it is an interesting building with many pleasing features. The fact that the building is still quite presentable should reflect even more credit to the padre architects.

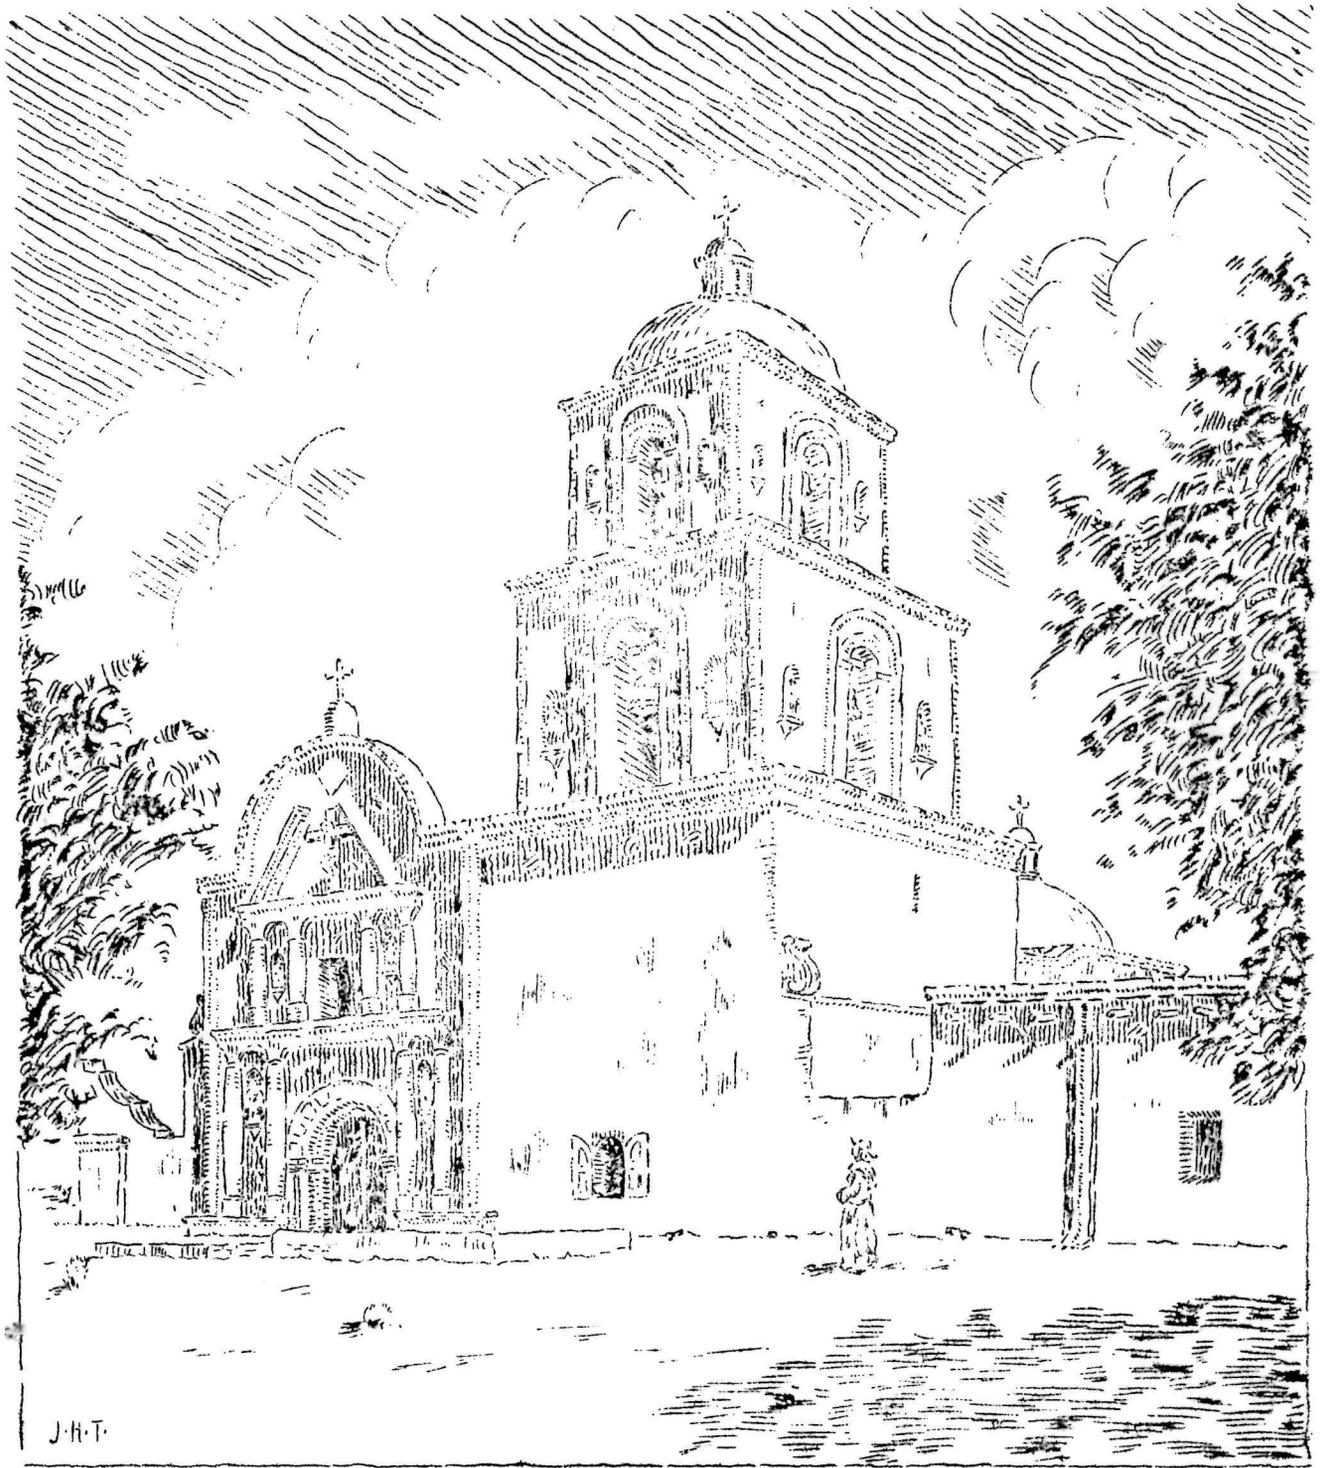
· PLATE · 6 · TUMACACORI ·
· RESTORED ·

There are three drawings in the report which will be used to illustrate the discussion. Plate 8 shows a restoration with a one-story bell tower; and Plate 6 shows a restoration with two stories.

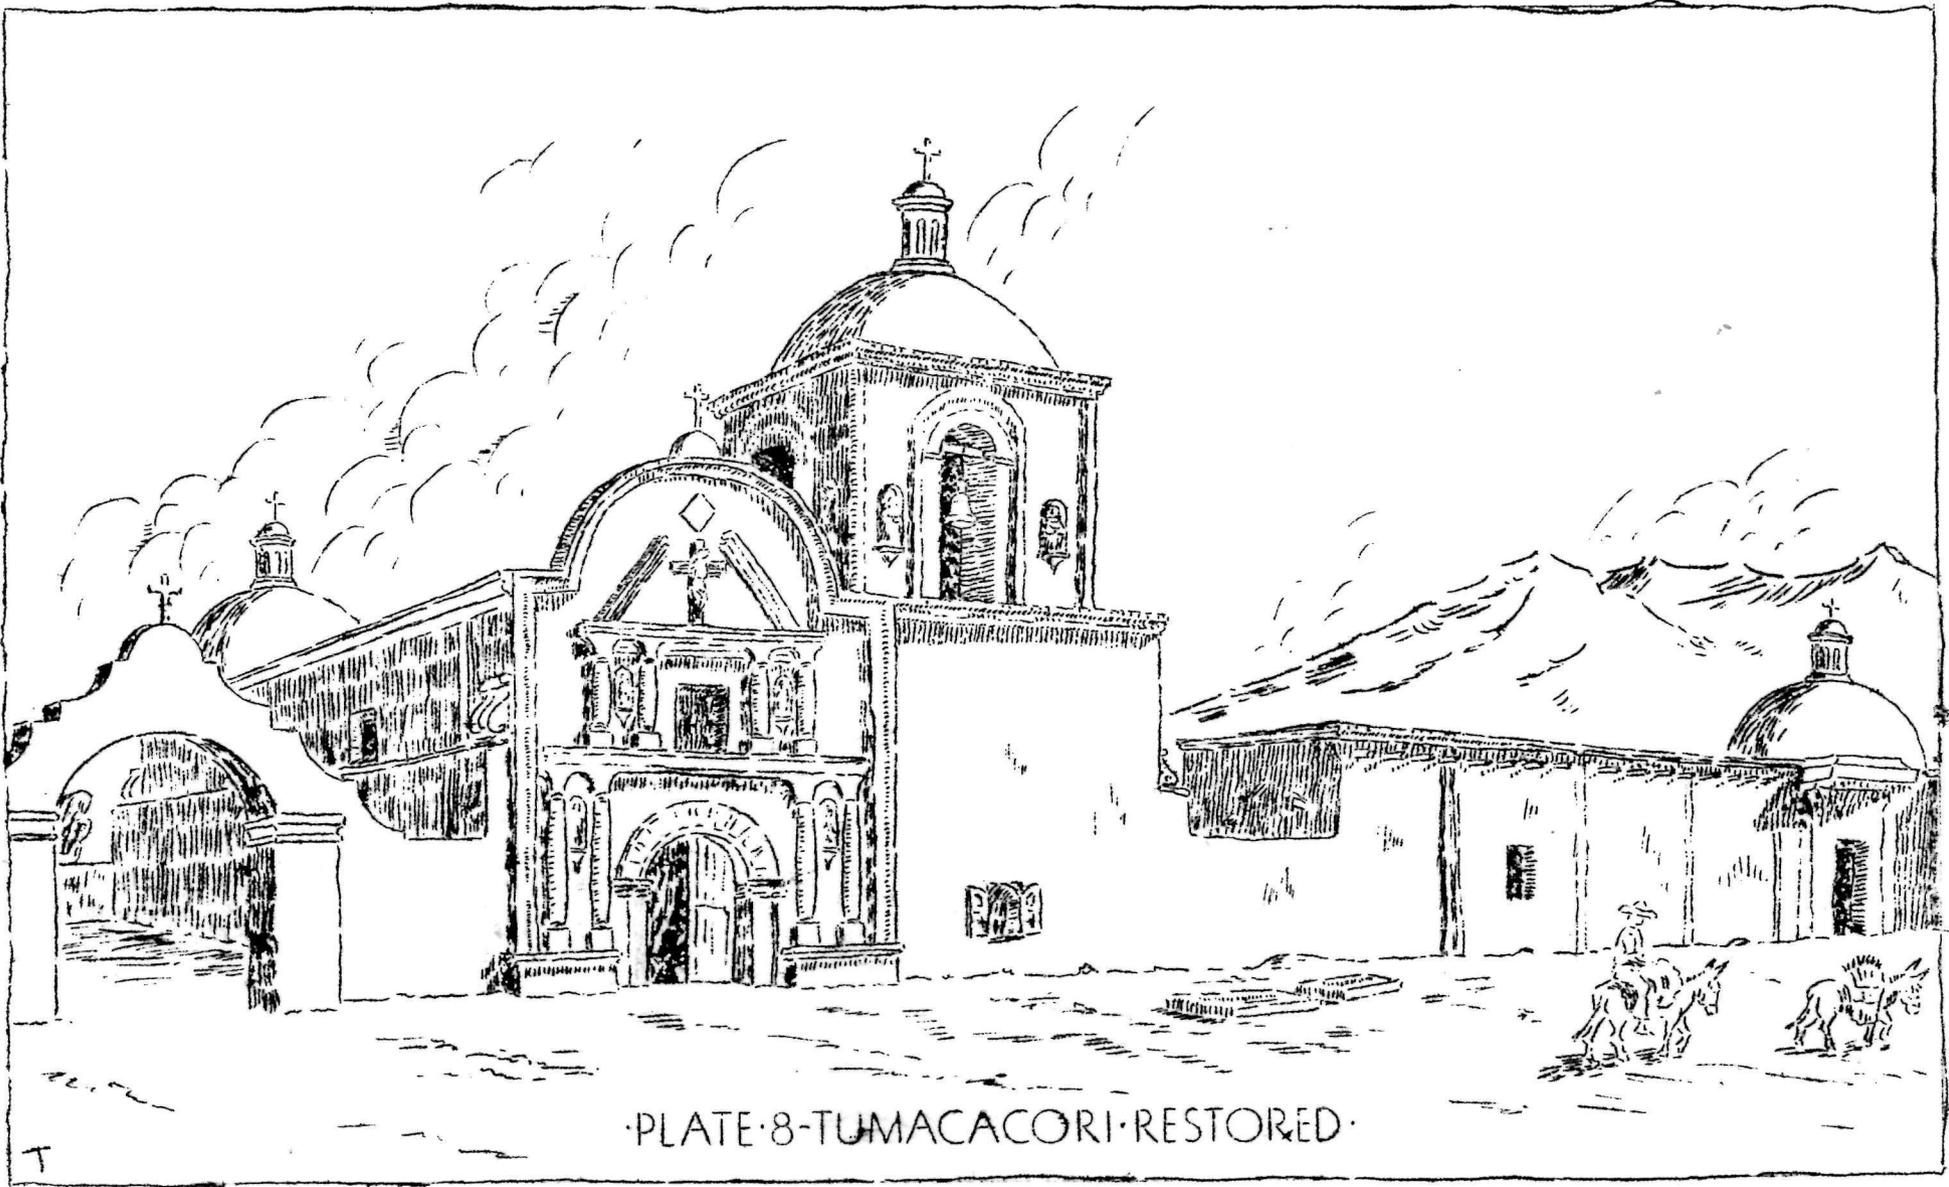
·PLATE 8-TUMACACORI-RESTORED·

Referring to the drawing (Plate 8), let us analyze the details and I will try to explain why each was restored as it is shown. In order to clearly show the details, it was necessary to make the drawing more or less a working perspective, showing each detail clearly and leaving nothing to the imagination. This did not help the artistic value of the drawing, so please consider it for its working value.

Beginning at the left of the drawing, let us analyze the large archway through the adobe wall. The Powell drawing shows just the beginning of this arch--perhaps two feet of it above the first column west of the mission. The irregular shape of the top of the fragment indicates that the upper portion of the arch was not a concentric circle. The design shown on my drawing is typical of gateways in old Mexico and California Missions, so it is safe to assume that this design is very close to the original. On the west wall of the nave at the point of offset are two scroll shaped buttresses--one at each end of the building. The Powell drawing vaguely shows these and Mr. Pinkley's memory of the marks left by the originals gave me a basis for the design. The Powell drawing clearly indicates that the four columns of the first story of the facade extended down from their present level and rested on bench-like foundations. I have shown the window above the arched doorway as being covered with bars. I doubt if this were true, as iron bars were hard to transport to this new country, and wooden shutters closing from the inside of the building would probably have served the purpose. I have shown a dome on top of the existing story of the bell tower to show what might have been planned for the unfinished tower. It is my belief, however, that a second story was planned for this tower; a discussion of which I have already given. The buildings east of the mission were rather sketchy on the Powell drawing, but a careful study and comparison with a plan of the foundations (Plate 4) excavated last year, made it possible to work out a restoration. The dome shown is a doubtful guess at what the Powell artist shows and it is too far to the east to check with the possible church foundation that was excavated.

I was able to work out graphically the probable location point of the artist when he drew his picture. This point was on a line

extending from the northwest corner of the mission in a southerly direction, just missing the gate column farthest west from the front of the mission. I plotted the line on the map of the excavated foundations which showed this gateway. I then drew an imaginary picture plane across the southwest corner of the mission; next I moved a point on the known line to a position where the proportion between the distances shown on the Powell drawing for the north and west walls of the mission were the same on the picture plane of the plan. This theoretically fixed the position of the artist and the more accurate his drawing was, the closer he was to this position. In order to check the accuracy of his drawing and thereby check the accuracy of my theoretical point, I located it on the ground at Tumacacori and found that the Santa Rita mountains shown in the background were in almost perfect position in relation to his drawing and the mission also compared well for perspective. Therefore, I assumed my point to be very close to the position of the artist. Returning to the plan of the foundations (Plate 4), I projected lines from this point to various points on the east foundation walls. This gave me distances on my plan picture plane which I could check against the Powell drawing, and in this way I had a basis for making a check comparison of the drawing against the plan of the excavated foundations.

I believe this working study gives an accurate foundation for a more artistic presentation rendering of Tumacacori restored, with the exception of the single story bell tower. A rendering of this nature would be of great interest to the visitor.

I have explained how I arrived at the various details of the restoration drawing shown in Plate 8. This drawing not only shows the missions, but also some of the other buildings and walls which existed at one time.
