Badlands National Park
South Dakota

Cedar Pass Development Concept Plan and Environmental Assessment

APPENDIX A: FLOODPLAIN STATEMENT OF FINDINGS

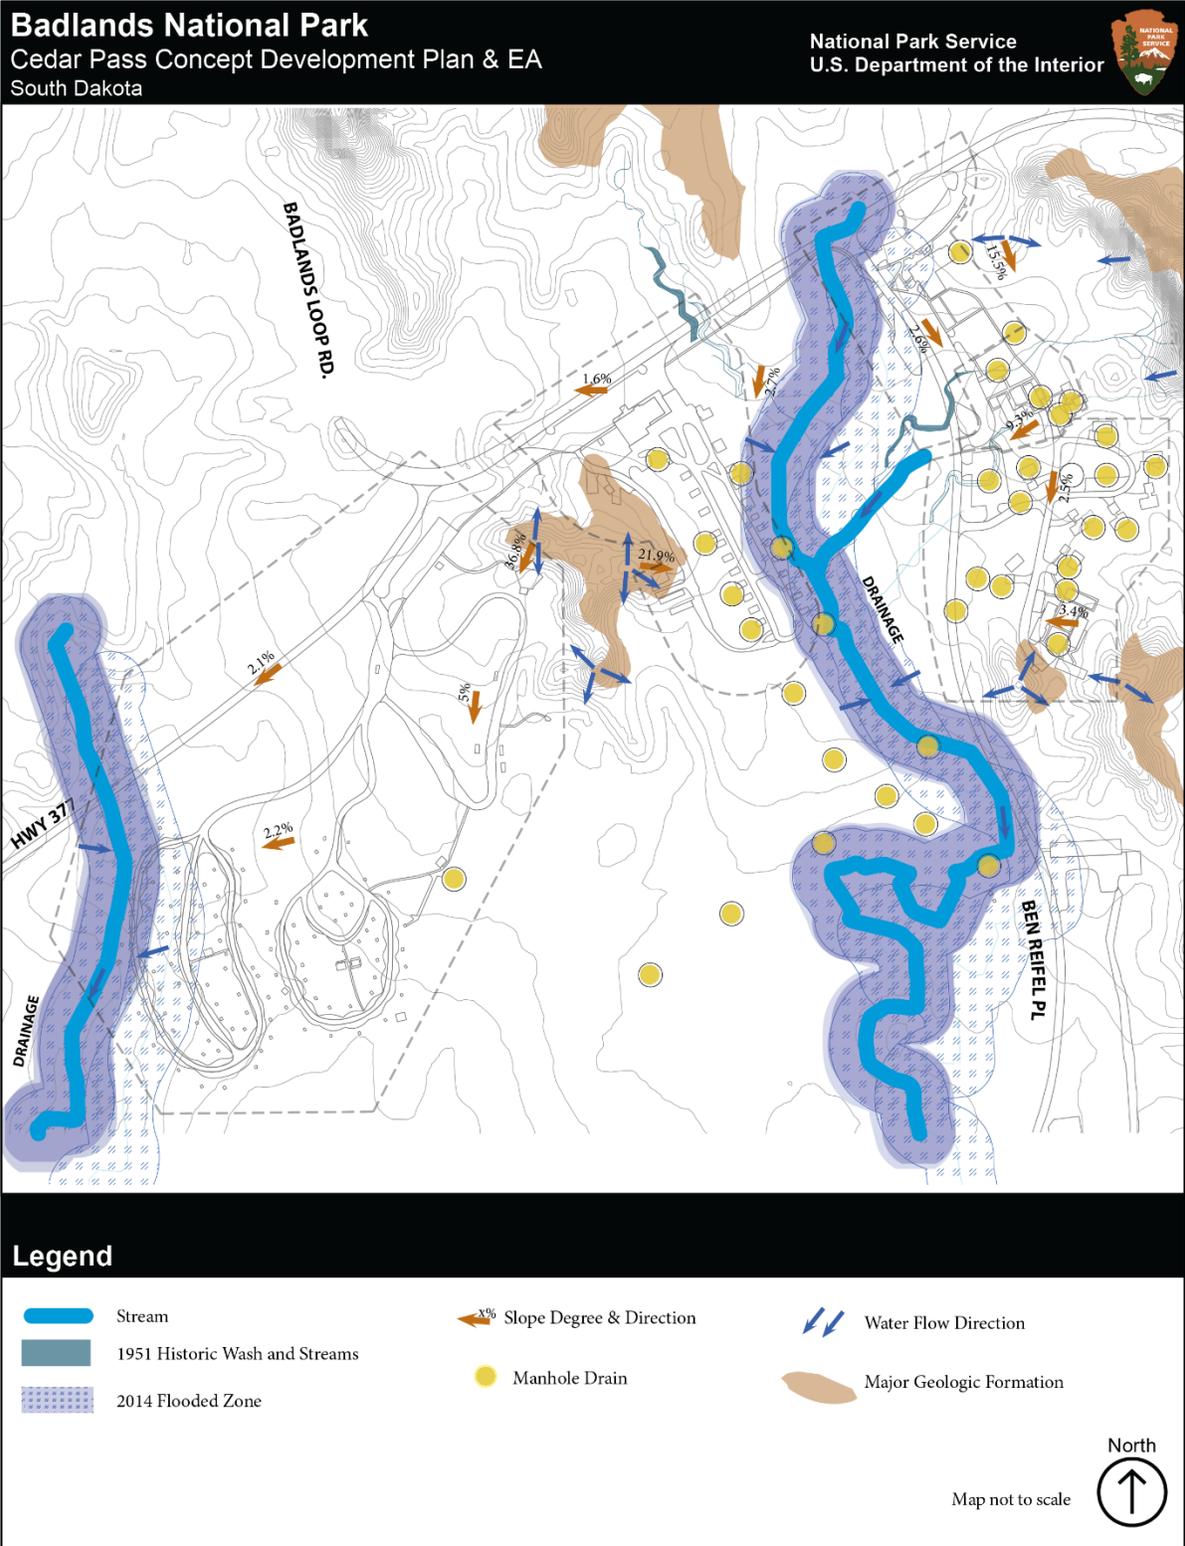
FIGURE 3: CEDAR PASS HYDROLOGIC RESOURCES

The project area is located within the 215-acre Cedar Pass area of the north unit of the park, approximately 70 miles east of Rapid City, South Dakota (figure 2). Federal Emergency Management Agency (FEMA) floodplain mapping indicates that the Cedar Pass area is located in an unmapped area of the Jackson County unincorporated areas. The Federal Emergency Management Agency has not completed a study to determine flood hazard or floodplains for the Cedar Pass area; therefore, a flood map has not been published (FEMA n.d.). However, areas surrounding the streams running through the Cedar Pass area are susceptible to flooding risk on a seasonal basis from intense precipitation events (figure 3). Two intermittent streams in the Cedar Pass area receive drainage from land north of Badlands Loop Road,
