CULTURAL LANDSCAPE REPORT FOR CHARLESTOWN NAVY YARD

BOSTON NATIONAL HISTORICAL PARK
BOSTON, MASSACHUSETTS

INTRODUCTION

SITE HISTORY

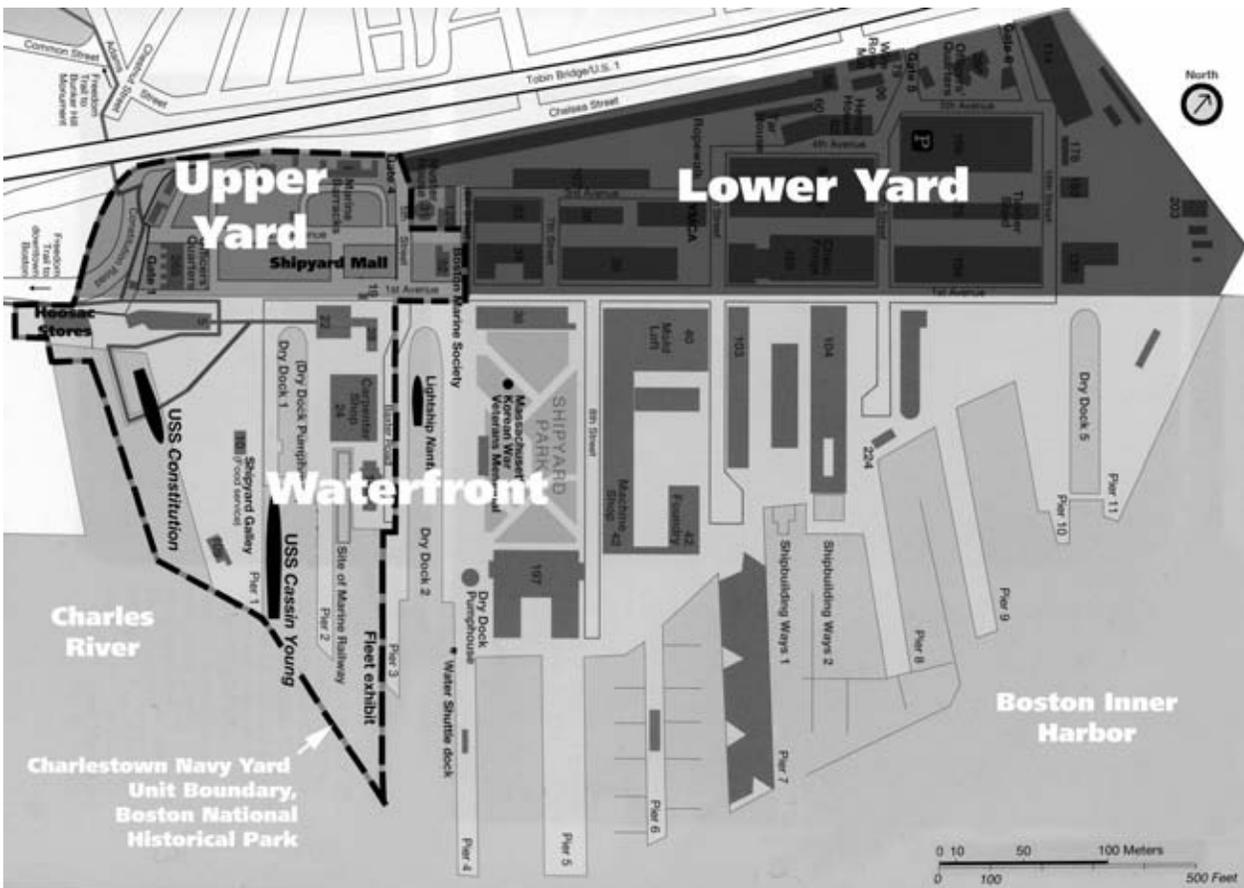
Figure 1. Charlestown Navy Yard, Boston National Historical Park, 2004, illustrating the park unit’s boundary and major precincts (NPS).

This study focuses on the land owned by the National Park Service that was part of the Charlestown Navy Yard. The study does not include the Hoosac Stores area because it is a separate National Register district of local and regional significance and was never part of the Charlestown Navy Yard (see Figure 1). The study area includes the waterfront Piers 1, 2, and 3, though only a portion of Pier 3 is in the park. The history of both Dry Docks 1 and 2 is examined, though Dry Dock 2 is outside of the park. In the upper yard, the study includes the area surrounded by the boundary wall from Gate 1 to Gate 4, and Fifth Street, as well as the block between Fifth and Sixth Street that contains the former Shell House now used by the Boston Marine Society (Building 32).

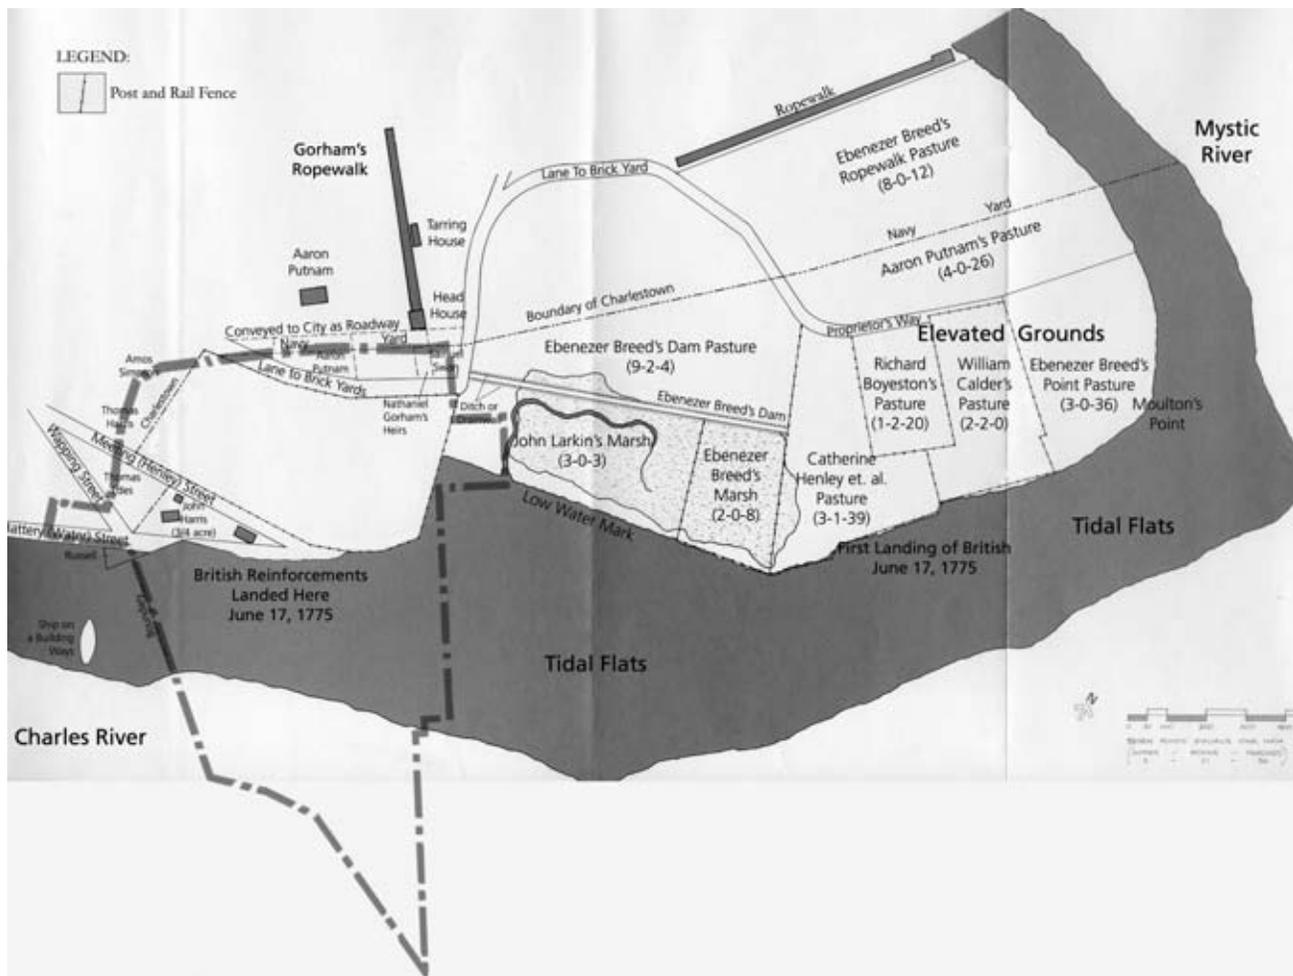
Figure 1.6: Digitally enhanced Historical Base Map showing roads, property ownership, structures, fences, and the waterline in c. 1800. Current park boundary is outlined at the left (National Park Service, Denver Service Center, in Bearss 1984; 1059).

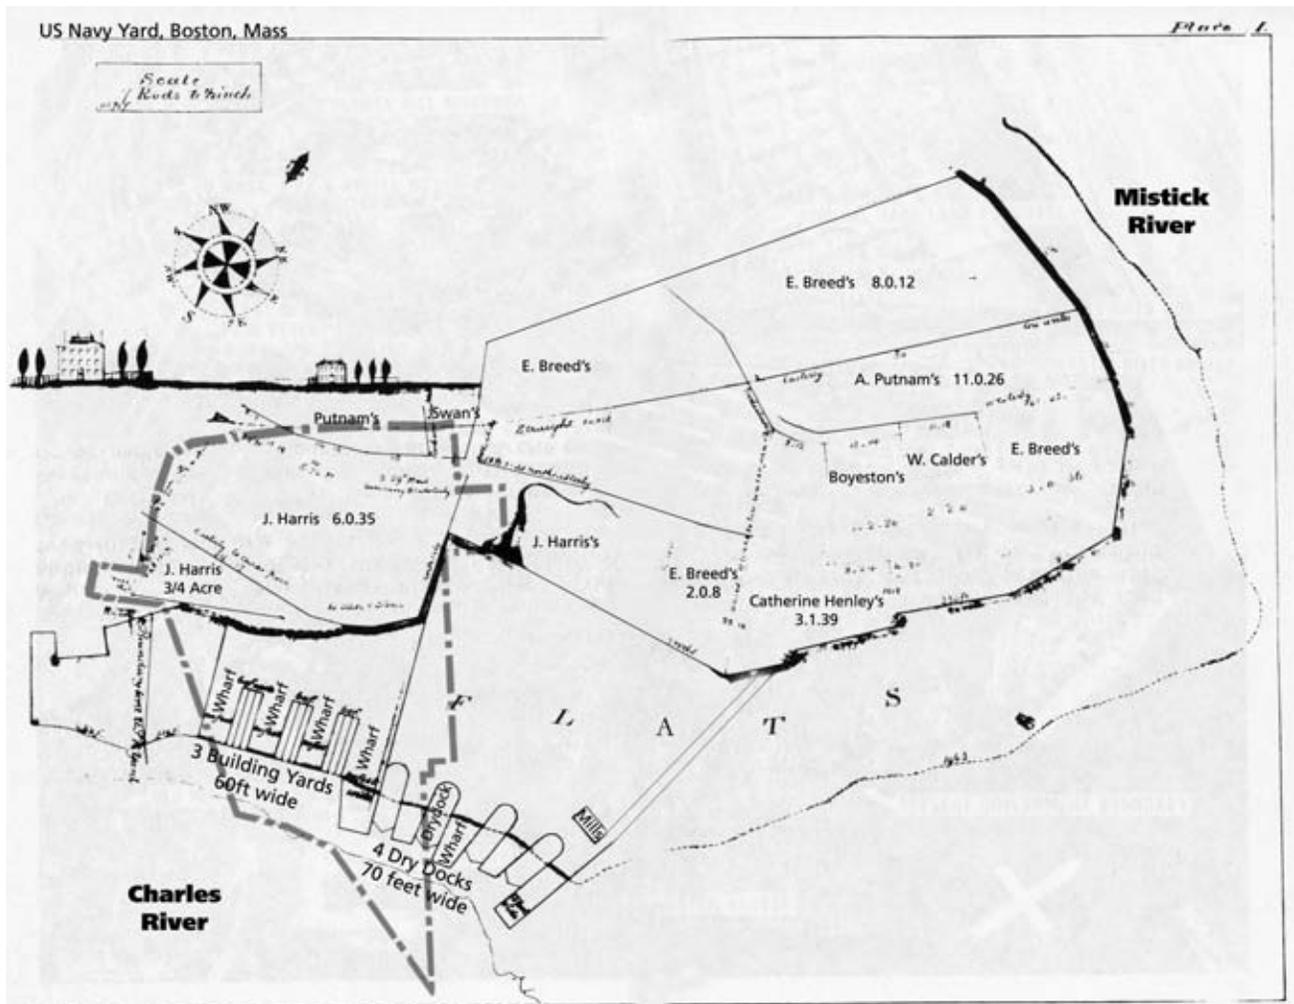
Figure 2.1: Digitally enhanced map of the yard by Peter Tufts in 1801 showing proposed building yards, dry docks, and timber wharves. Current park boundary is outlined (BOSTS-13494 from the National Archives).

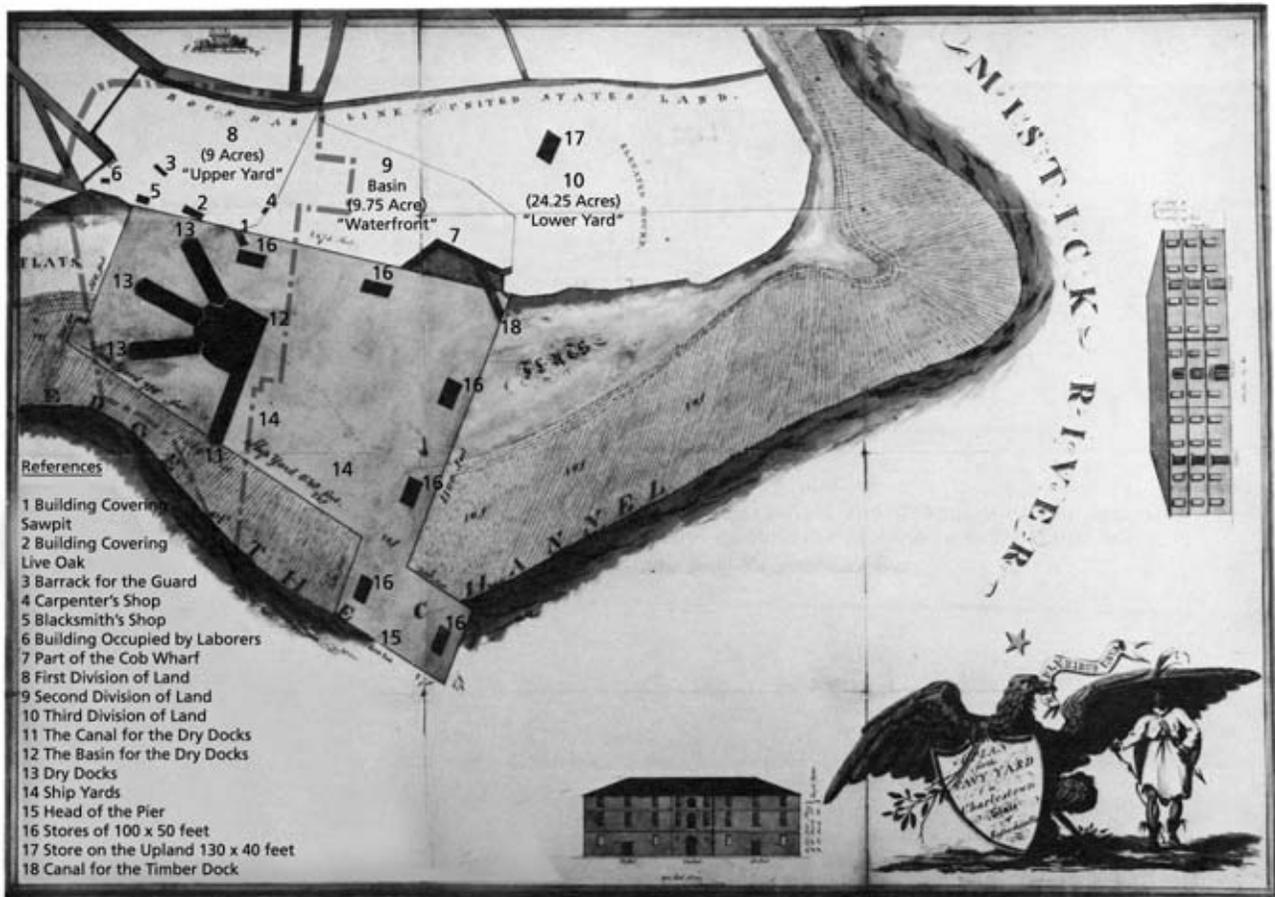
Figure 2.2: Digitally enhanced Carleton Osgood's 1802 drawing of the three tracts of the Charlestown Navy Yard. Current park boundary is outlined (From the National Archives in Bearss, 1081).

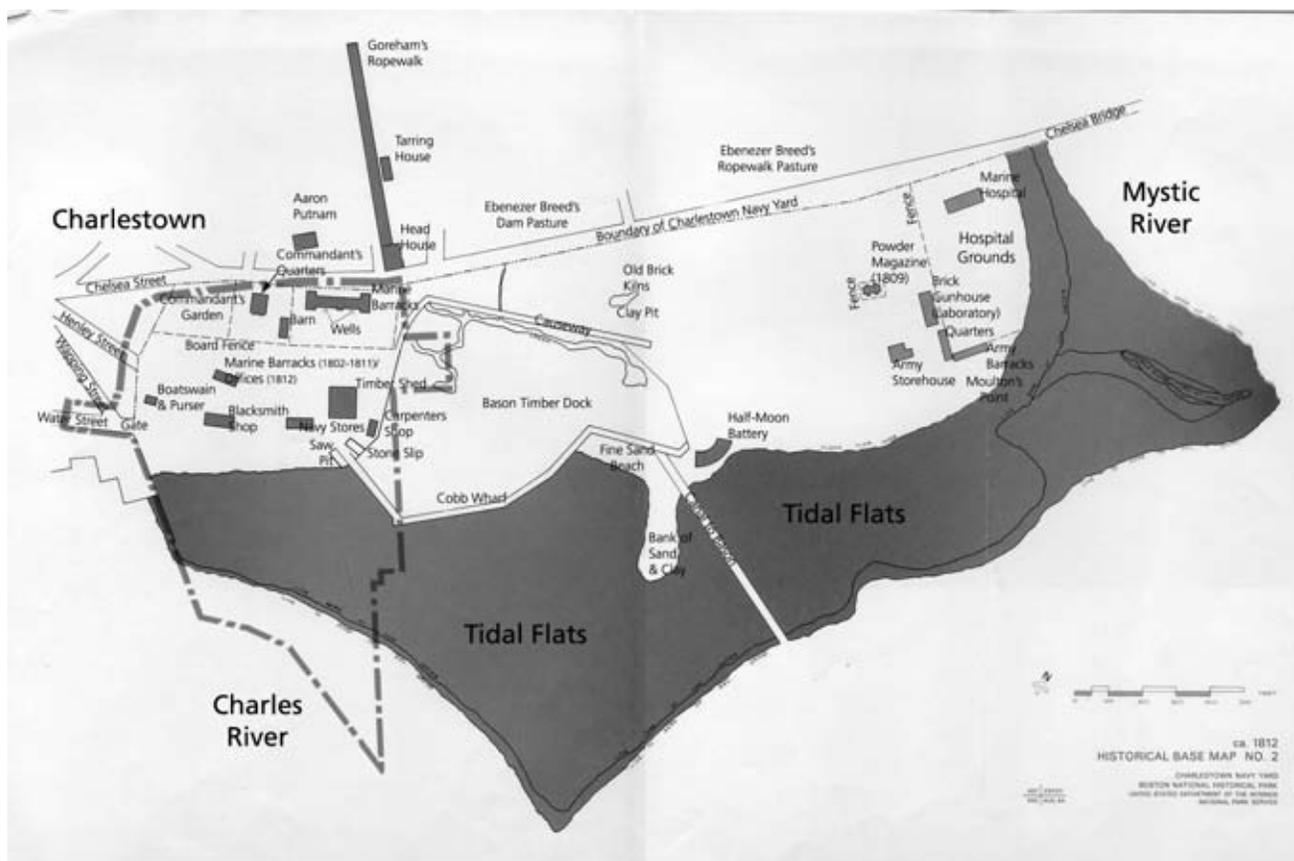
Figure 2.3: Digitally enhanced Historical Base Map of the yard in c. 1812 showing the Commandant's House, Marine Barracks, storage buildings, blacksmith shop, cobb wharf, half-moon battery (center), hospital grounds and War Department buildings (upper right). Current park boundary is outlined (NPS, DSC, 1984 in Bearss, 1063).

In June 1810 the Marine Corps selected a site for a new barracks, east of the Commandant’s House and south of the Salem Turnpike. This was the first portion of the Marine Barracks that later became “Quarters H-I-K.”¹⁴ Plans included excavation of a portion of the hill to the east of the Commandant’s House, designs for a garden southeast of the barracks, two wells, and diversion of turnpike drainage through a drain near the fence. Constructed largely by the Marines themselves, it consisted of a single-story central section containing enlisted men’s barracks and three-story wings at each end housing officers.¹⁵ Marine Corps Commandant Franklin Wharton’s correspondence also suggests that the ground fronting the barracks had been graded. During the following year, Wharton gave instructions for the laying out of a parade ground, including a provision for a “Lane or Alley between the Commanding Officer’s garden & the Stables of the Commodore for the former & latter to use.” Wharton requested a board fence, rather than post and rail, to enclose the barracks and parade ground. Upon completion of the project in early August, Nicholson complained that the Marines’ parade ground, extending 305 feet along the fronts facing the turnpike and the river, was “absolutely spoiling the Navy Yard,” but Paul Hamilton, who succeeded Smith as Secretary of the Navy, chose not to intercede (Figure 2.3).¹⁶

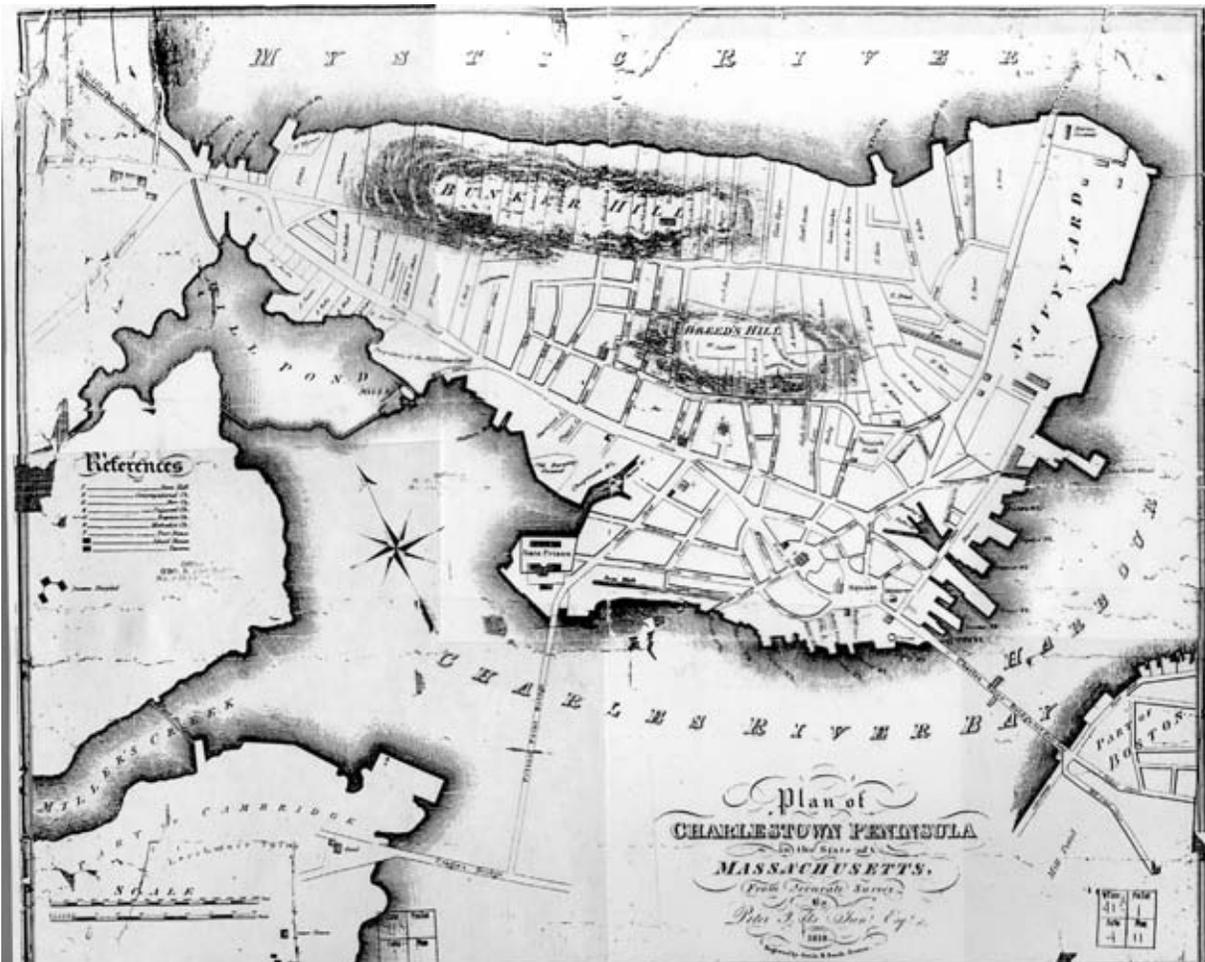
Figure 2.4: Map of Charlestown by Peter Tufts, Jr. in 1818, shows the Navy Yard and surrounding streets. A few of the yard's structures are indicated including Buildings 5, 6, 7, the Commandant's House, Marine Barracks, a timbershed, and the Blacksmith's Shop. At the lower end of the yard (upper right), the Marine Hospital and other buildings are shown (Boston NHP Archives).

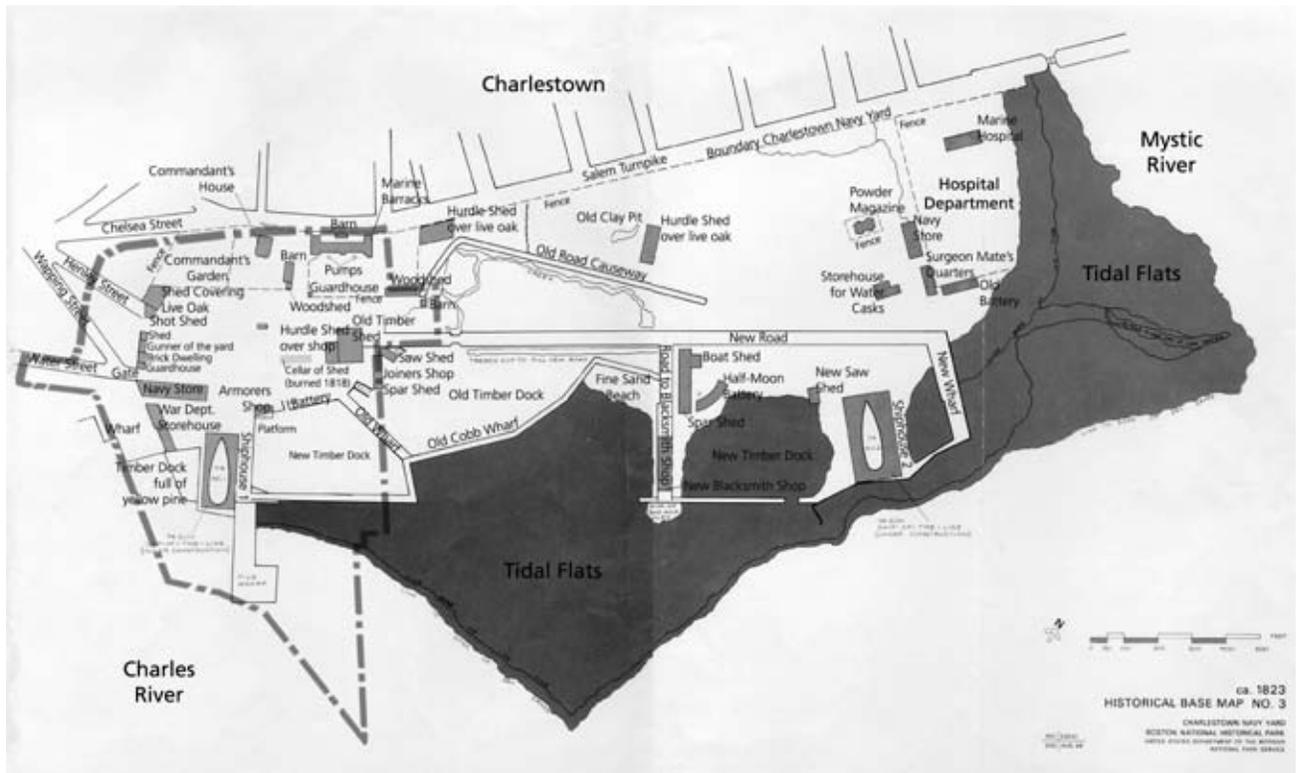
Figure 2.6: Digitally enhanced Historical Base Map of the yard c. 1823 showing the growing residential campus, the dispersed wharves and shiphouses, and relatively undeveloped central portion of the yard (NPS, DSC, 1984 in Bearss, 1065).

Two additional shiphouses, built in 1820 and 1824, provided additional building sites. Shiphouse 2 (later known as Shiphouse H or Building 68), located between a new timber dock and new wharf, housed construction of the 44-gun frigate *Cumberland*. Shiphouse 3 (later known as Shiphouse I) stood just to the east and contained the 74-gun *Virginia*. A causeway, “piled and built,” connected a waterfront smithy and Shiphouse 2 (Figures 2.5-6).²⁷

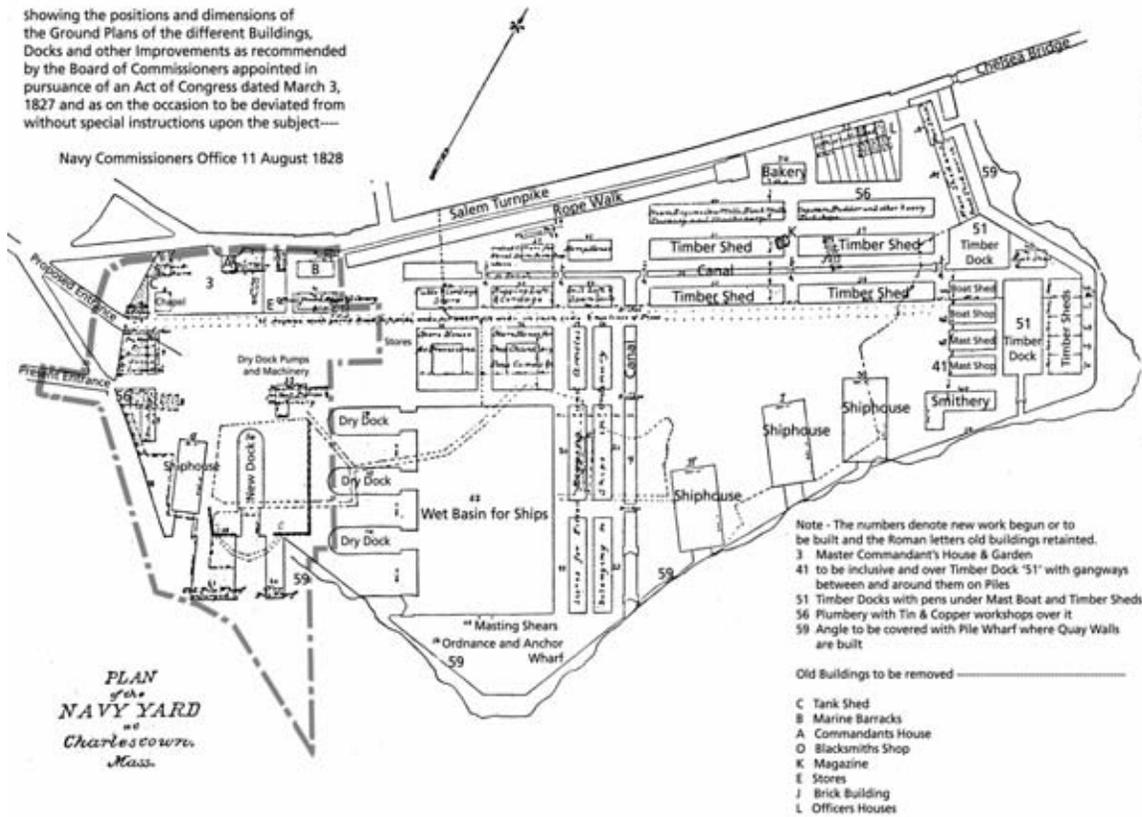
Figure 3.1: Digitally enhanced plan of the yard showing existing conditions and proposed additions, 1828. Current park boundary is outlined (from Prebble, 1875).

The 1828 master plan embraced trees as an integral element and proposed an allée along the Main Avenue across the entire yard (see Figures 3.1 and 3.2). In the upper yard, Commandant Jesse D. Elliott, 1833 to 1835, authorized several aesthetic improvements, including the setting out of trees, the beautification of Main (Second) Avenue, and the laying out of stone runners in the enlarged gun park. In 1839 a local newspaper article praised the “spacious avenue, which runs the...length of the yard, bordered with young and thriving elms.”¹⁵ Comparable to the rowhouse built at the eastern end of the yard in the 1820s, the Navy built the larger five-unit Upper Quarters (Quarters B-C-D-E-F/Building 265) in 1833. With front doors facing east, the building enclosed the western end of the yard, creating a campus quadrangle between the Commandant’s House (Quarters G), Marine Barracks (Quarters H-I-K), Navy Store (Building 5) and Dry Dock Engine House (Building 22).¹⁶ In the center of the upper yard, post-and-rail fences defined gun, shot, and anchor parks in between what would become First and Second Avenues, creating a space that was both ceremonial and functional for storage.

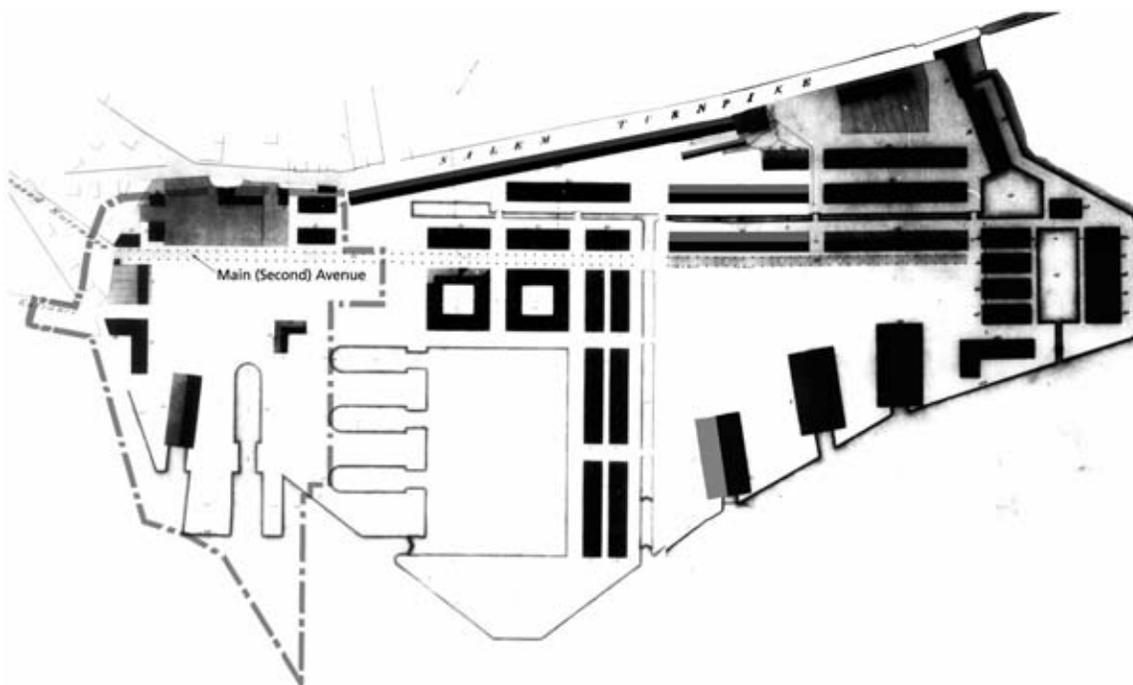
Figure 3.2: Digitally enhanced plan for the Charlestown Navy Yard prepared in 1840. The double row of dots indicates elm trees planned for Main (Second) Avenue. The original plan omitted extant structures identified for removal in the master plan and was color-coded to differentiate the structures that were built from those proposed but not yet built. Current park boundary is outlined (Boston National Historical Park).

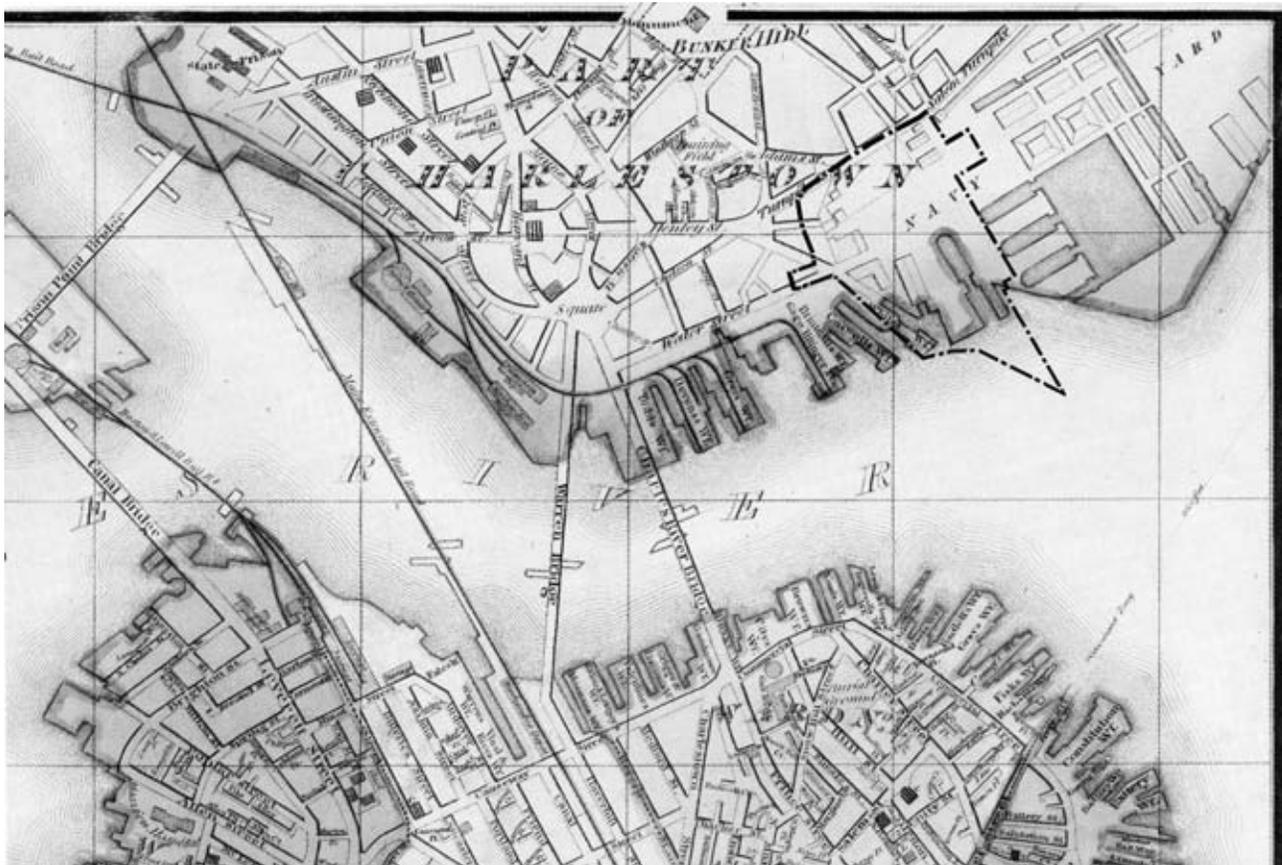
Figure 3.3: A portion of an 1846 map of Boston showing the Charlestown Branch rail lines terminating just west of the Navy Yard. The 1828 master plan was superimposed on the map (From *Mapping Boston*, 2001; 123).

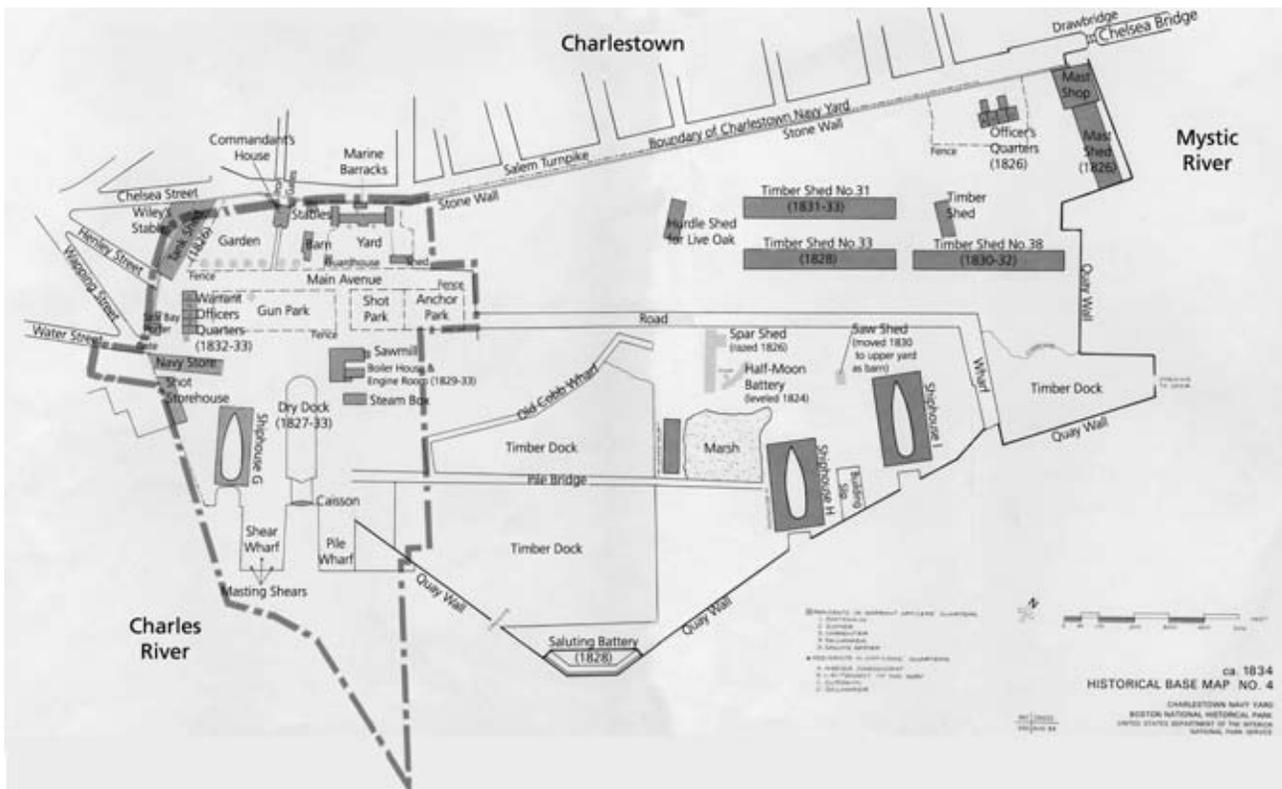
Figure 3.4: Digitally enhanced Historical Base Map of the yard c. 1834 showing the beginnings of First and Second Avenues and several new structures in the upper and lower portions of the yard. Current park boundary is outlined (NPS DSC, in Bearss, 1071).

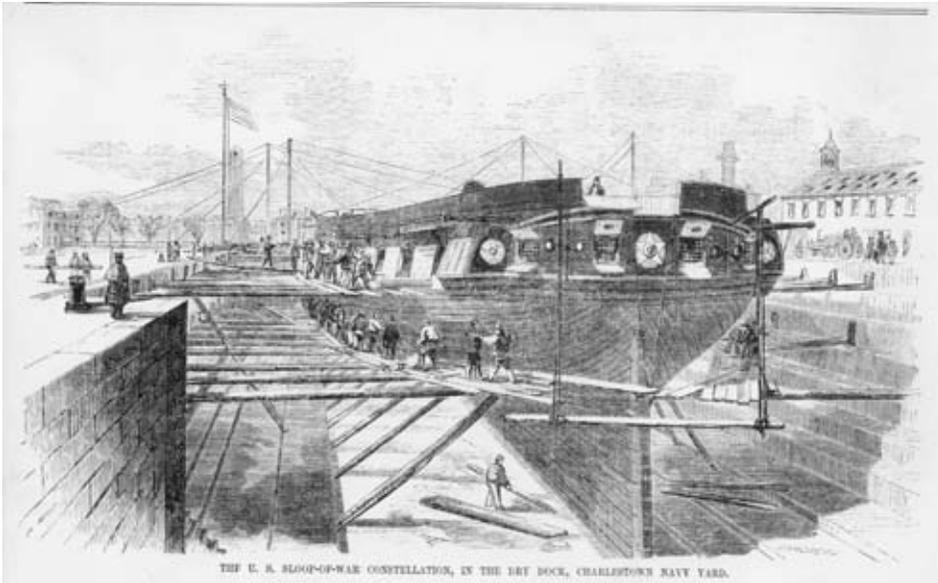
Figure 3.5: Engraving from c. 1859 of Dry Dock 1, which was completed in 1833. Staging installed in the dry dock allowed workers to work on the hull of USS *Constellation* at two levels from Gleason’s *Pictorial Drawing-Room Companion* (BOSTS 10721).

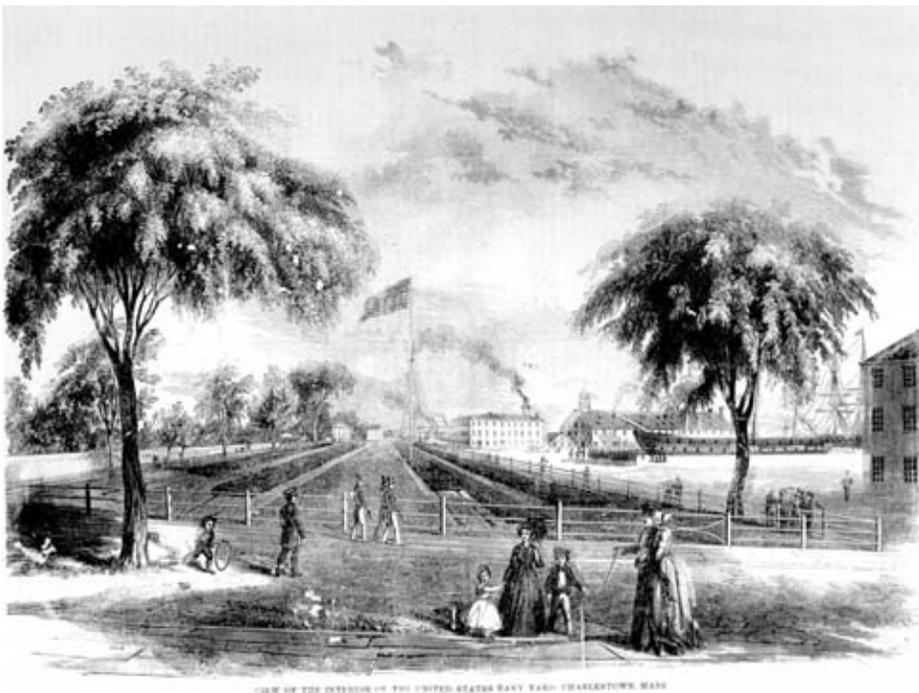
Figure 3.7: 1850s view of the yard from the exterior looking east along First Avenue and the waterfront. Visible to the north (left) is the gun park with rows of cannon set upon stone runners and Main (Second) Avenue. Elm trees line the avenues (From *Gleason's Pictorial Drawing Room Companion*, November 29, 1857, BOSTS 8635).

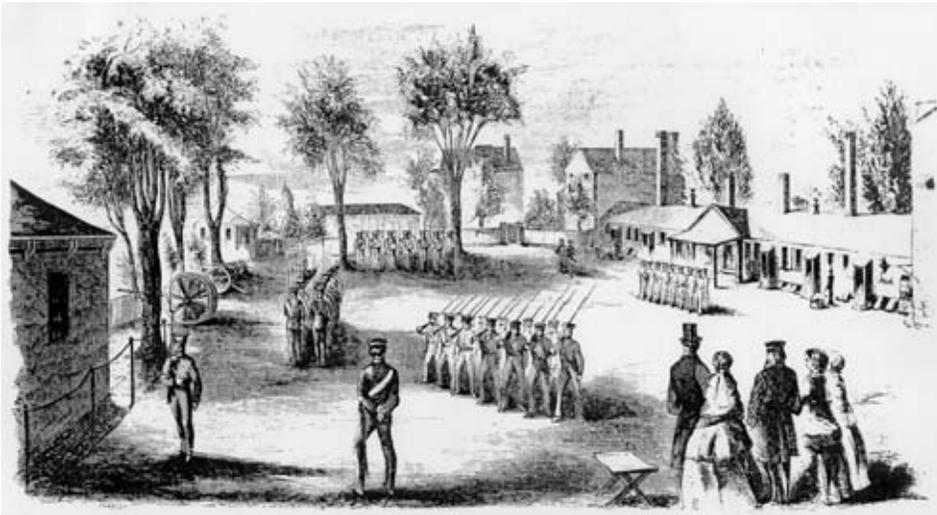
Figure 3.8: An 1856 view looking northwest across the elm-lined parade ground. Cannons and pipe-and-chain fencing line the edge of the parade ground that faced the waterfront. In the distance, a wooden-board fence separates the yard around the Commandant's House. From Gleason's *Pictorial Drawing Room Companion*.

[The barracks are] capable of accommodating a large body of Marines, although at present the establishment is reduced to comparatively few. There are but thirty Marines quartered there at present, sufficient for the duties of the well-regulated establishment. The place of the parade is the prettiest enclosure to be found anywhere, and in the shade of beautiful elms, affords a very pleasant retreat for the leg-wary sentries during the relief from duty, on the hot days of summer (Figures 3.8-9).²³

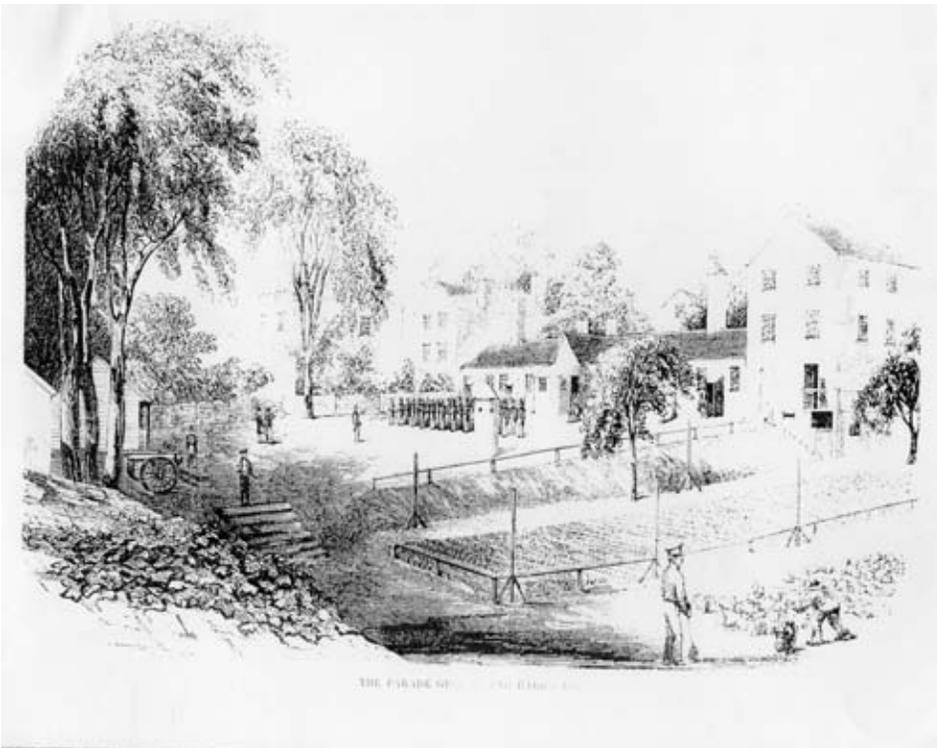
Figure 3.9: The Marine Barracks (right) consisted of a single-story central section with three-story wings in 1856. Elms shaded the parade ground which changed grade at the eastern end just before a vegetable garden to the southeast (BOSTS-9218).

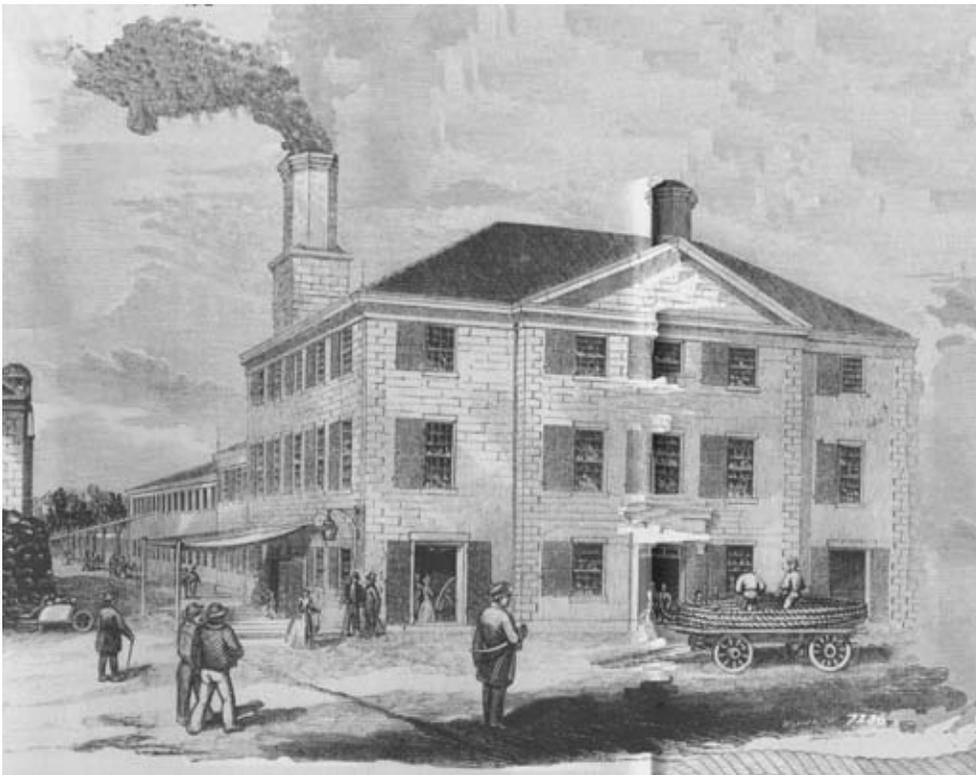
Figure 3.10: Ropewalk (Building 58) designed by Alexander Parris and completed in 1837, from Gleason's Pictorial Drawing Room Companion, 1852.

Spanning the upper and lower yards along the northern boundary wall, the granite Ropewalk (Building 58) completed in 1837 represented Charlestown Navy Yard's new manufacturing capacity. Parris designed the Navy's only ropemaking facility, a complex that included a quarter-mile rope "laying" area running the length of the building.²⁵ The Charlestown Navy Yard had been chosen as the site of a ropewalk intended to supply the needs of the entire Navy for a number of reasons: Boston was one of the leading ports trading in hemp, the raw material for rope; the area had a number of commercial ropewalks from which the necessary skilled workers could be drawn; and the area was a major center of innovation in the textile industry (Figure 3.10).²⁶ Construction of the ropewalk required regrading the eastern edge of the parade ground in front of the Marine Barracks as seen in later images.²⁷ At the east end of the Ropewalk—near a Timber Shed (Building 75) built in 1831—several buildings supplied the ropemaking facility. In association with the Ropewalk, a Hemp House (Building 62) built in 1837 contained raw materials, a Tar House (Building 60) built in 1838 provided a location to coat the rope with preservative tar. A Storehouse (Building 34) built in 1837 may have been used for rope storage. A Coal House (Building 79) added in 1852 supplied the steam-powered machinery in the Ropewalk and was enlarged six years later to become the Engine House.

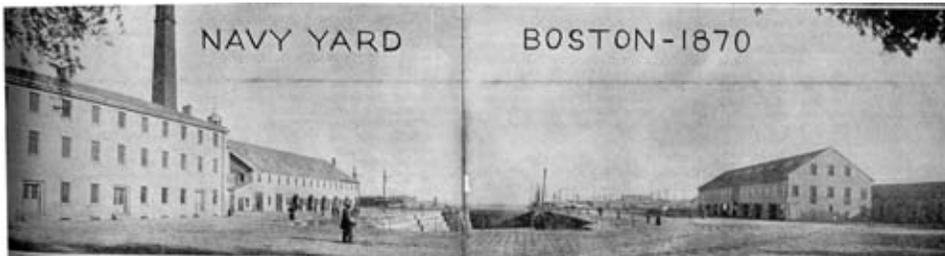
Figure 3.12: Buildings 22 and 24, Dry Dock 1, the Shears in the distance, and the Shiphouse in 1870 (from *Boston Navy Yard News*, 10 February 1945).

During the Civil War, much of the Navy's construction program reflected the immediate needs of the Union effort, but there Navy made some permanent improvements to the Charlestown Navy Yard during this period. In 1863, Congress authorized payment to the owners of White's Wharf, and the yard took possession of the 2.3-acre property at the boundary along its western shoreline. Increased production and the use of steam technology demanded certain immediate infrastructural improvements. Dry Dock 1 was extended, adding 65 feet to a floor length of 368 feet, and an overall length of 393 feet. Coal was stock piled along the waterfront in many locations since the yard still lacked an internal rail system until 1865. The new Machine Shop (Building 42) served as the hub of operations (Figure 3.12).

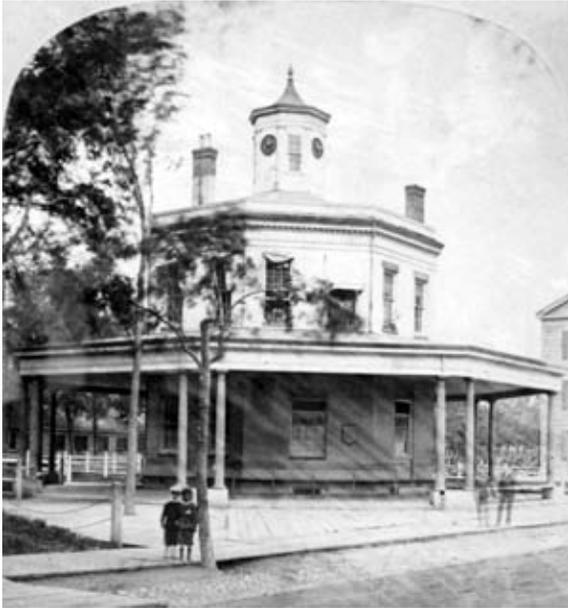
Figure 3.13: A c. 1870 view of the Muster House (Building 31) constructed between 1852 and 1854. The photograph also shows post-and-chain fence, post-and-rail fence, wooden boardwalks, and cobble-lined street drains and granite block paving. A third floor was added in 1871 (BOSTS 9315).

Joseph Billings maintained his office in the Muster House (Building 31), an unusual structure he built between 1852 and 1854. Commandant Francis Gregory requested a plan for the Muster House “similar to the one in New York.” The octagonal brick building, with a surrounding porch, served as the civilian workers’ mustering post (Figure 3.13).³⁹ More importantly, the stylistic departure evident in the Muster House paralleled a transformation in the yard’s industrial landscape during Billings’ tenure as chief architect and civil engineer. Soon after daily musters were moved to the new Muster House, yard workmen requested a new gate in the yard wall for convenience. In 1853, Gate 4 was opened along Chelsea Street and a guardhouse established at the west end of the Ropewalk (Building 58) in order to accommodate the growing stream of workers.

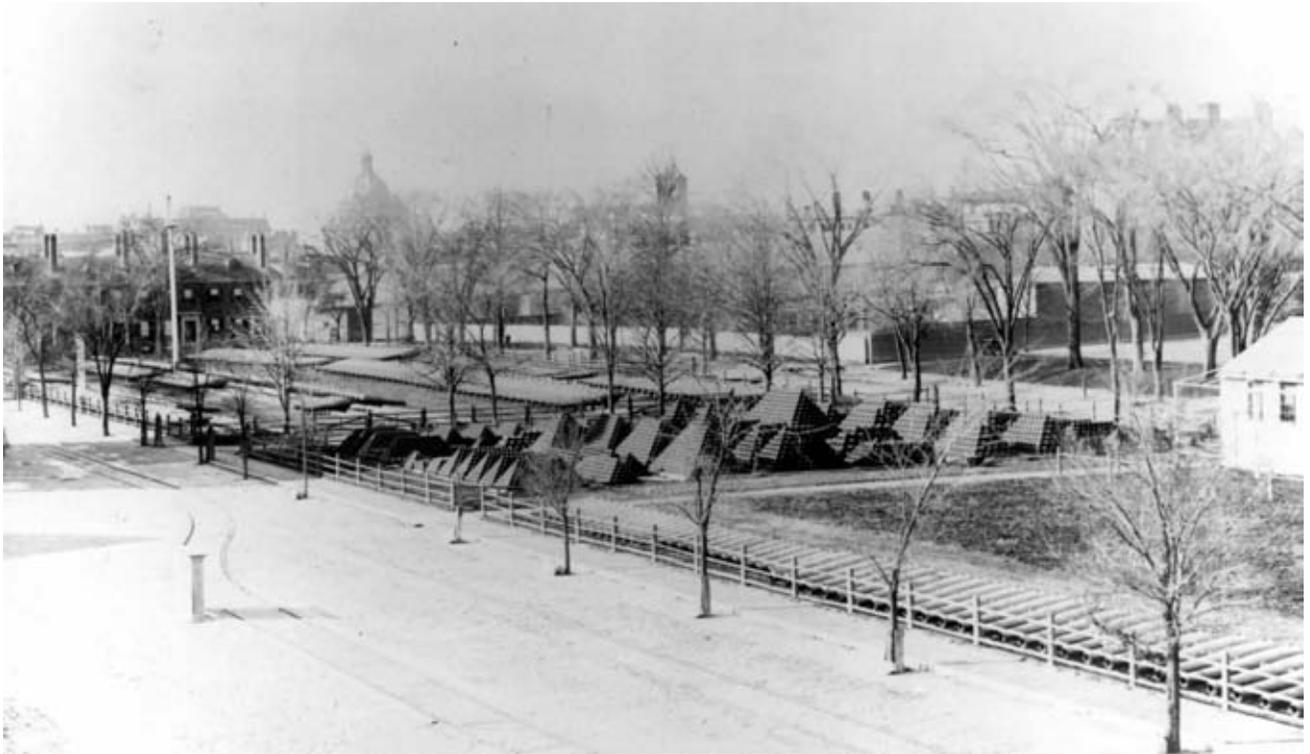
Figure 3.14: The gun and shot parks in the shipyard mall (recreation area) of the yard, 1874. Tree-lined First Avenue is in the foreground, and tree-lined (elms) Second Avenue is to the north in the background. The Officers Quarters (Building 265) is to the west (left) behind the flagpole in the park (BOSTS-nhf150).

transferred to an area south of Building 5 (Figures 3.14 through 3.19).⁴⁰ The replacement of twenty-four dead trees enhanced the yard's appearance.⁴¹

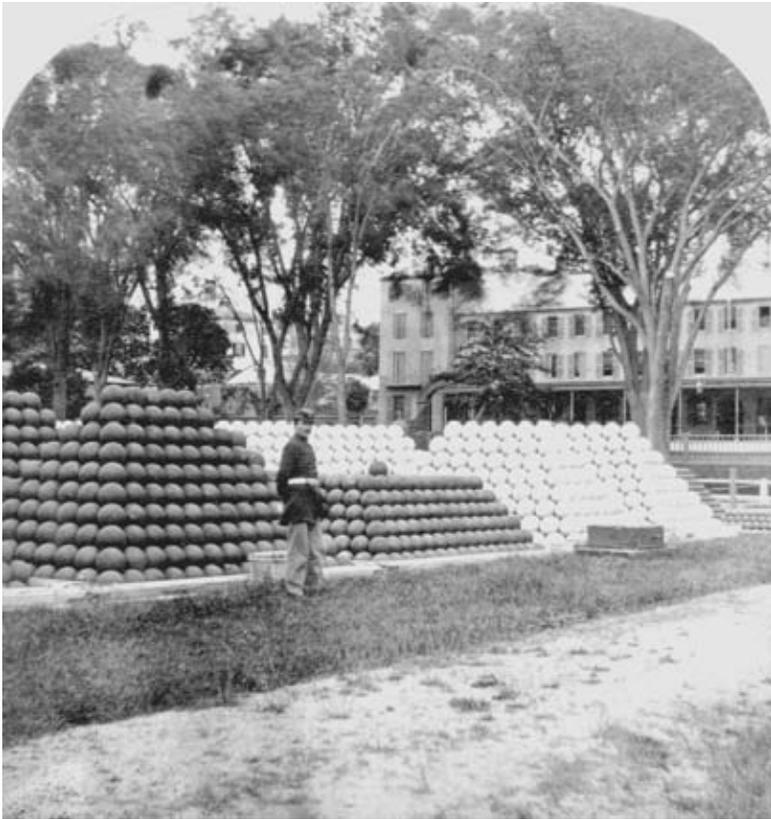
Figure 3.15: Circa 1865 view facing northwest of the shot park between First and Second Avenues with elms fronting the remainder of the parade ground and Marine Barracks. Each pyramid contains approximately 700 cannonballs. After the Civil War, the Navy stored excess armament in the gun and shot parks (BOSTS-8875).

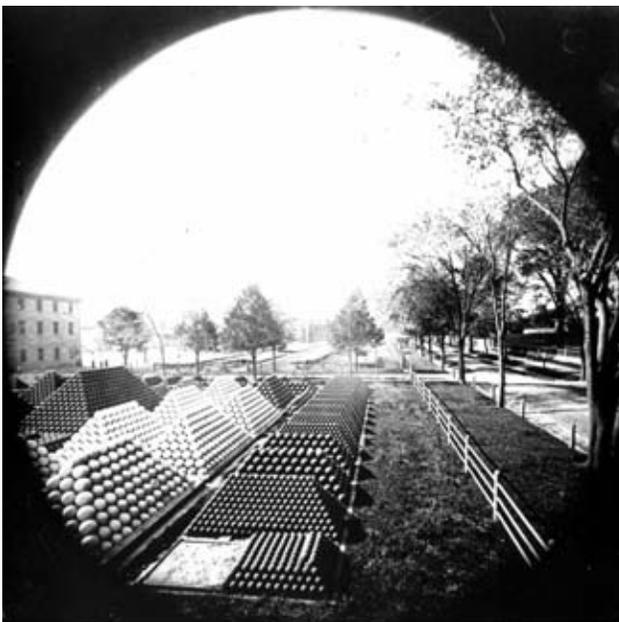
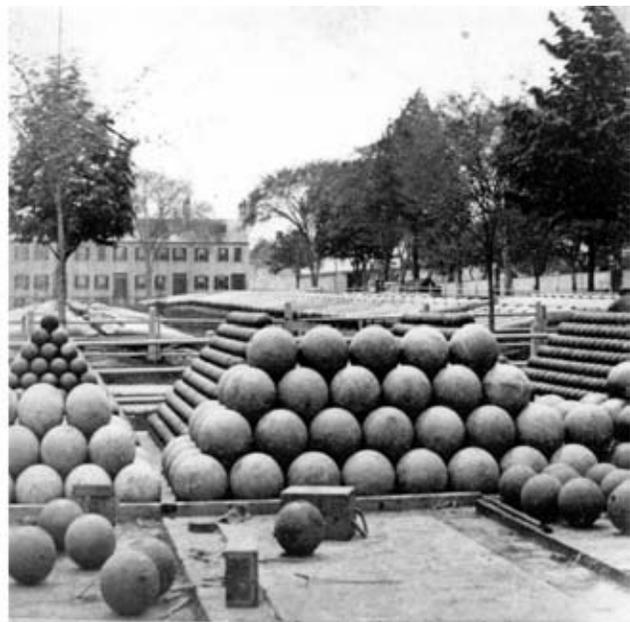
Figure 3.16: View west of shot park with Officers Quarters visible in distance, c. 1870. Note the tree-lined paths and post and rail fence (left: Hawes 269 and right: from Portsmouth Naval Shipyard Archives).

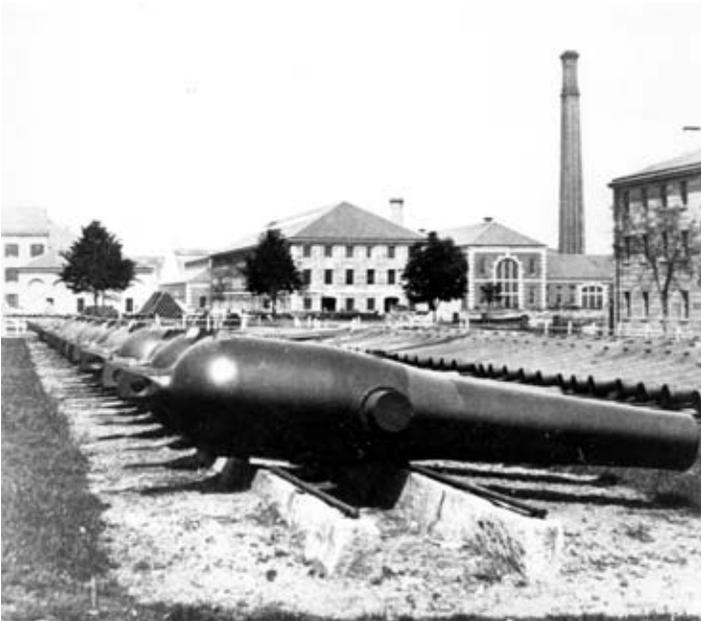
Figure 3.18: View east of the gun park with Buildings 32, 36, 42 and 22 in the distance and the 240-foot chimney of Building 42, c. 1870 (from Portsmouth Naval Shipyard Archives).

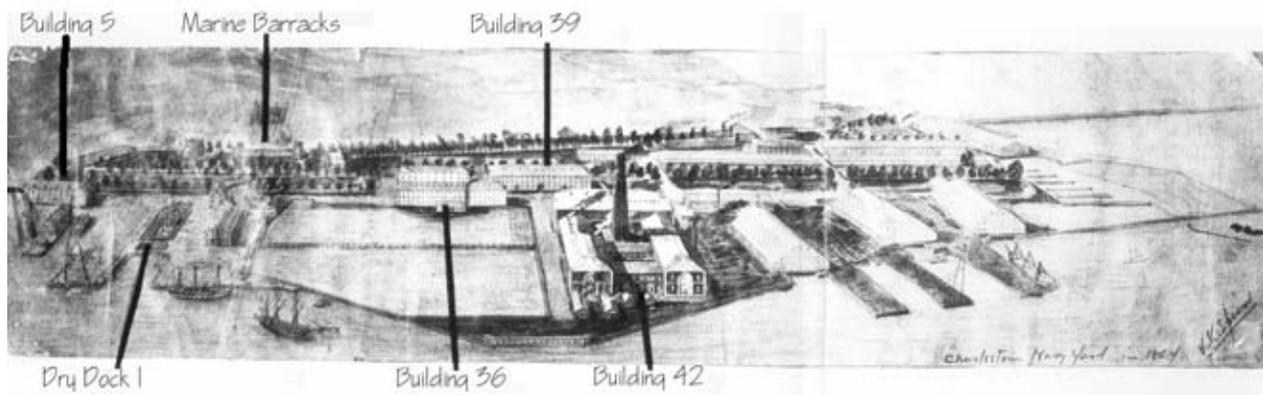
Figure 3.20: 1866 bird's eye view of the Navy Yard as interpreted by V.K. Spicer in 1904 (BOSTS 8871).

As the yard approached its seventieth year, it portrayed both an ordered and stately appearance with its paved avenues and mature elm and maple trees, and its extensive long buildings of granite and brick, capped by the Machine Shop's 240-foot tower (Figures 3.20 and 3.21). The yard embraced modern amenities including paved streets and sidewalks, a pipe-fed municipal water system, gas lighting, and a network of rail lines. Upon closer inspection, the yard likely had a more cluttered appearance, with numerous temporary buildings and large quantities of stores and materials piled along the waterfront and around manufacturing buildings. Excess armament was stored in gun and shot parks located south of the parade ground, between First and Second Avenues.⁴³ Numerous vessels lay in ordinary, either unlaunched, unfinished, uncommissioned, or out of commission.⁴⁴ Unfortunately, this neglect increased over the next decade.
