CULTURAL LANDSCAPE REPORT FOR CHARLESTOWN NAVY YARD

BOSTON NATIONAL HISTORICAL PARK
BOSTON, MASSACHUSETTS

INTRODUCTION

SITE HISTORY

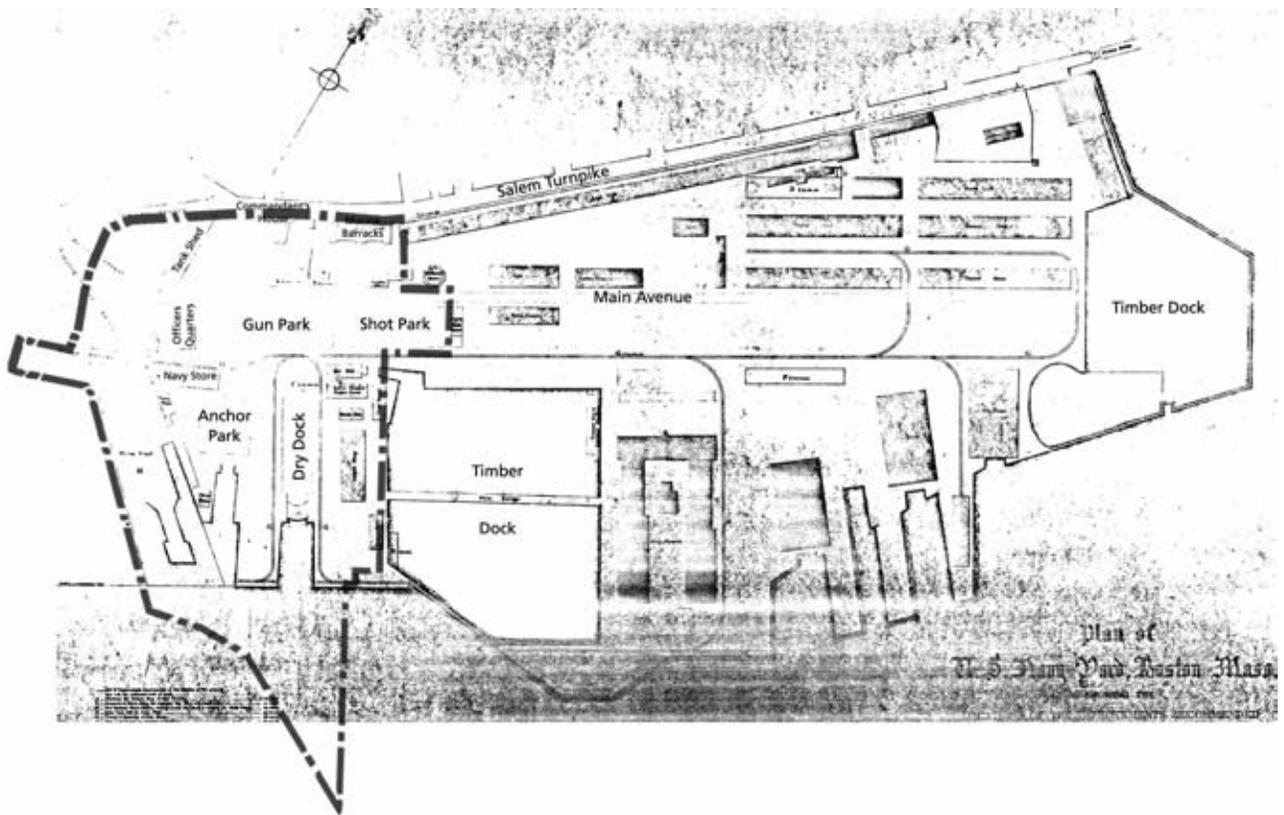
Figure 3.21: 1862 plan of the yard showing proposed rail lines, which were partially installed in 1865 (Boston NHP).

As the yard approached its seventieth year, it portrayed both an ordered and stately appearance with its paved avenues and mature elm and maple trees, and its extensive long buildings of granite and brick, capped by the Machine Shop's 240-foot tower (Figures 3.20 and 3.21). The yard embraced modern amenities including paved streets and sidewalks, a pipe-fed municipal water system, gas lighting, and a network of rail lines. Upon closer inspection, the yard likely had a more cluttered appearance, with numerous temporary buildings and large quantities of stores and materials piled along the waterfront and around manufacturing buildings. Excess armament was stored in gun and shot parks located south of the parade ground, between First and Second Avenues.⁴³ Numerous vessels lay in ordinary, either unlaunched, unfinished, uncommissioned, or out of commission.⁴⁴ Unfortunately, this neglect increased over the next decade.

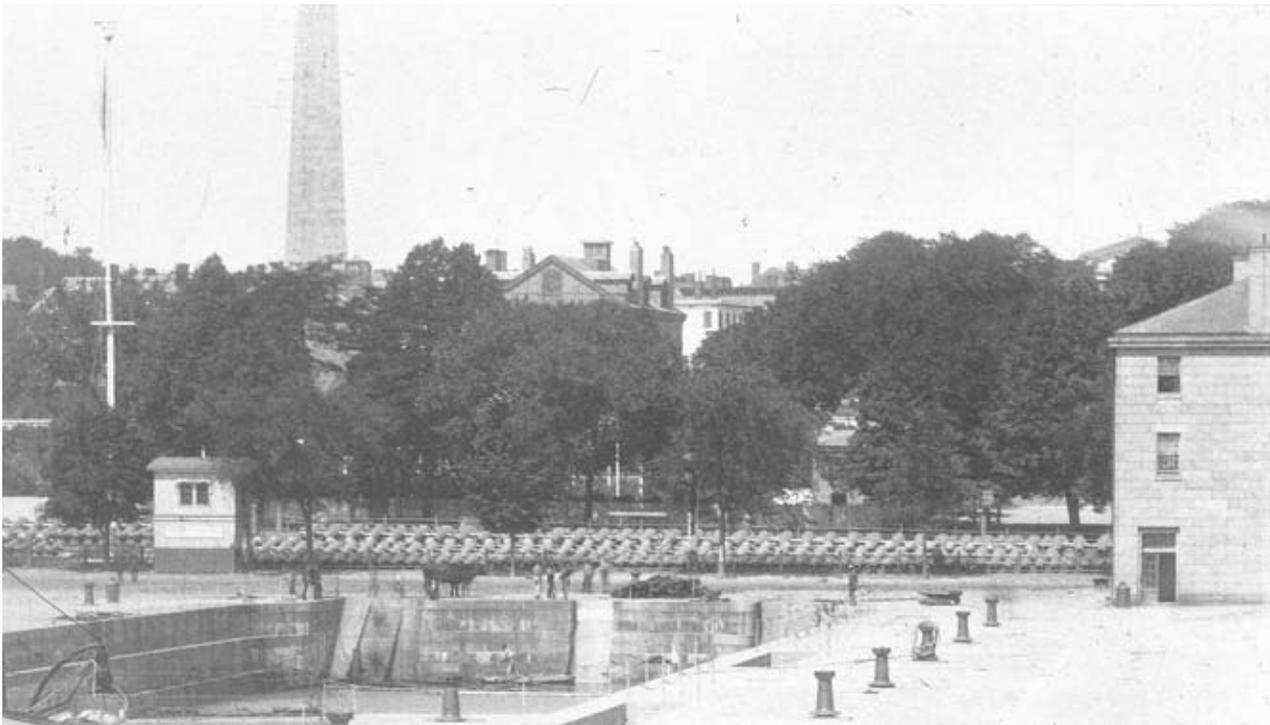
Figure 4.2: View north of the head of Dry Dock 1 in 1872 looking towards the gun park and Bunker Hill Monument. Mature trees lining First and Second Avenues obscure all but the roof of the Commandant's House. Oxen, used to haul timbers, stand by the dry dock (BOSTS-8880).

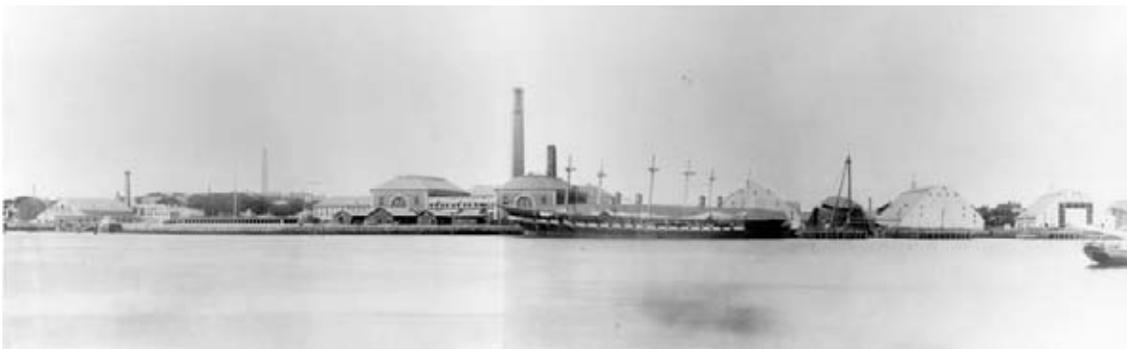
Figure 4.3: C. 1874 view north of the yard from East Boston. From west (left) to east, buildings include the Smithy with multiple chimneys (removed in 1875), the Carpenters Shop (Building 24), Dry Dock Pump House (Building 22) with a large chimney, the Tanners and Plumbers Shop (Building 28), the long arched wall of the yard's battery, with the flagpole and Magazine (Building 48), and Bunker Hill Monument behind it. In the center is the Machine Shop, Foundry and Smithery (Building 42) with its 240-foot smokestack and several temporary waterfront sheds in front of it. Three Shiphouses (Buildings 68, 71, and 73) are visible to the right and in the water, USS *Wabash*, the yard's receiving ship (BOSTS-8639).

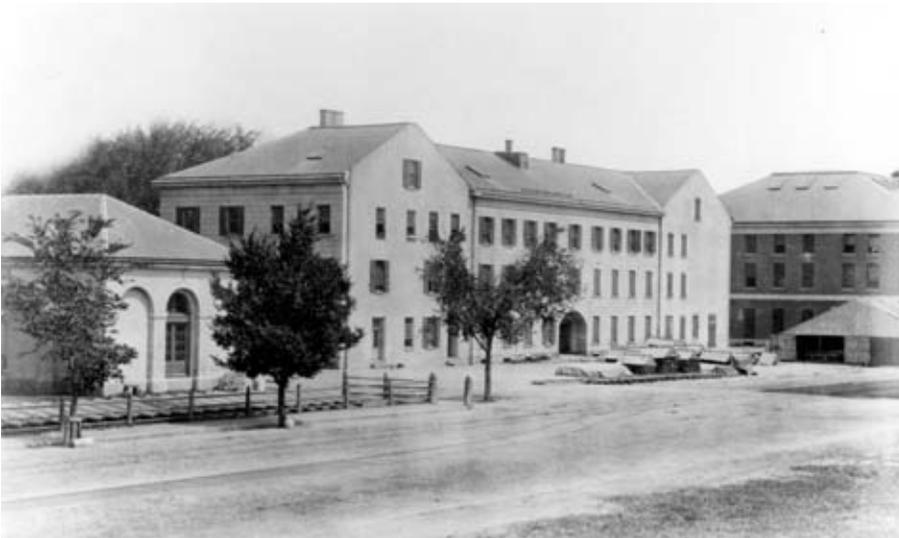
Figure 4.6: Shell House (Building 32) Storehouse (Building 34), Gun Sighting Shed (Building 35), and Ordnance Store (Building 39) at eastern end of the gun park with trees along First Avenue, 1874 (BOSTS-9339).

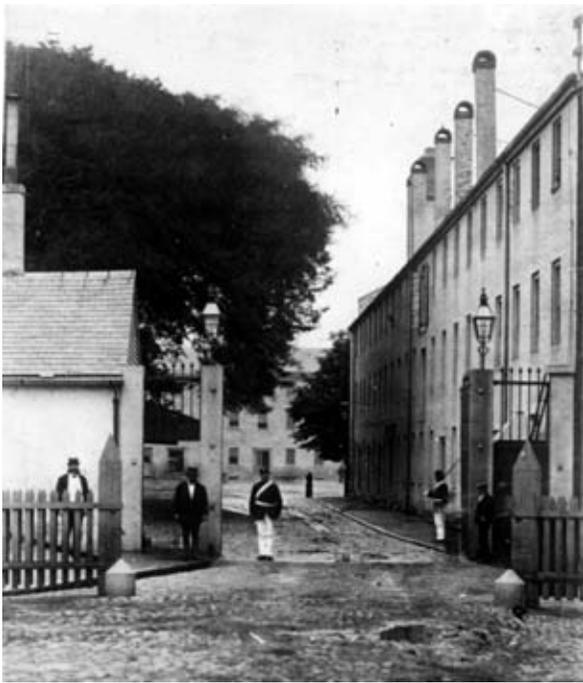
Figure 4.7: View east of Gate 1 in 1874 showing the new granite and iron gateposts with the older wooden picket fence remaining. The roads, surfaced with granite pavers, are in disrepair (BOSTS-8940).

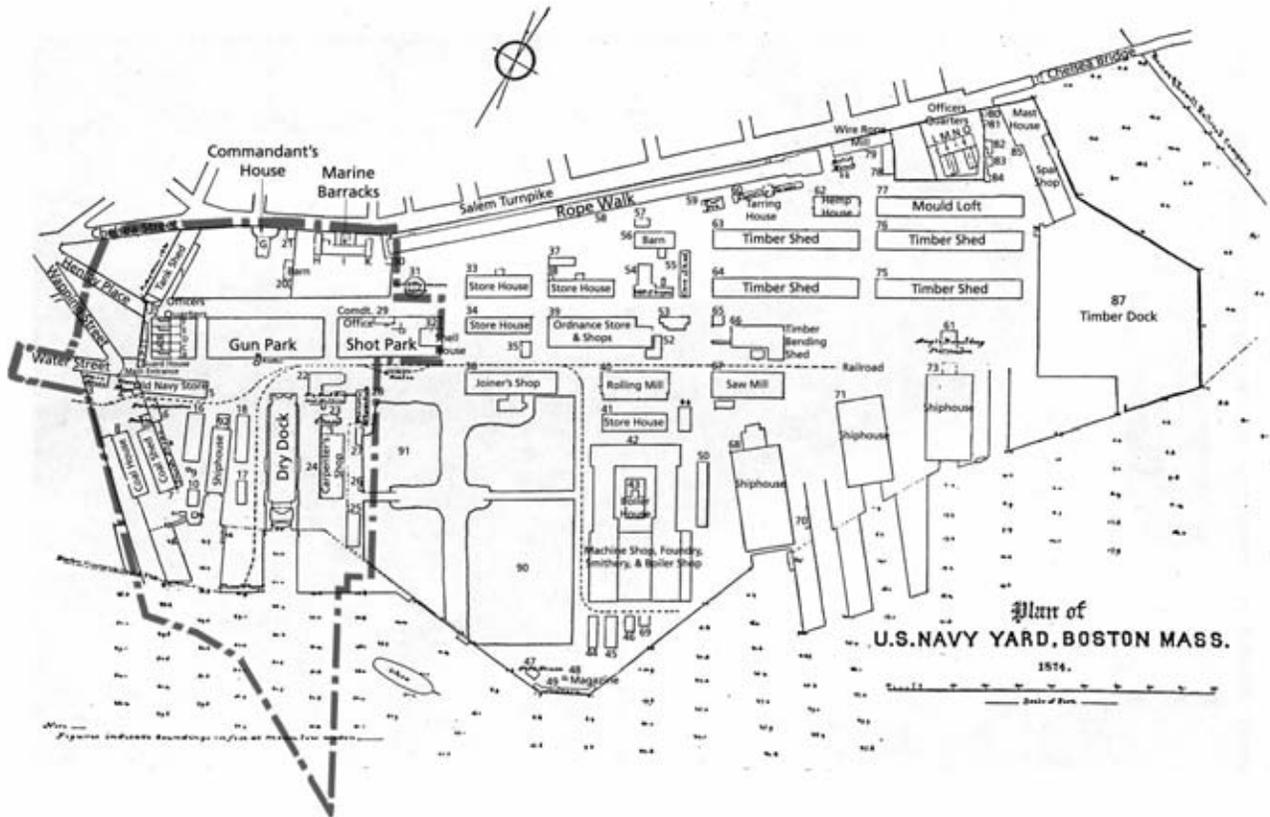
Figure 4.8: Digitally enhanced plan of the yard in 1874 showing the Shiphouse (Building 92) built in the 1870s and demolished in the 1890s between Wharves 1 and 2. Current park boundary is outlined (Prebble, 1875).

Awnings graced the former Shell House (Building 32), converted for use as the Commandant's Office, and a tennis court replaced the adjoining shot park. An alleé lined "Flirtation Walk," the boardwalk that ran along the south wall of the Ropewalk (Building 58). Two narrow strips of lawn, which supported the alleé, separated the promenade from the building and the adjoining anchor park (Figures 4.8 and 4.9).¹⁷

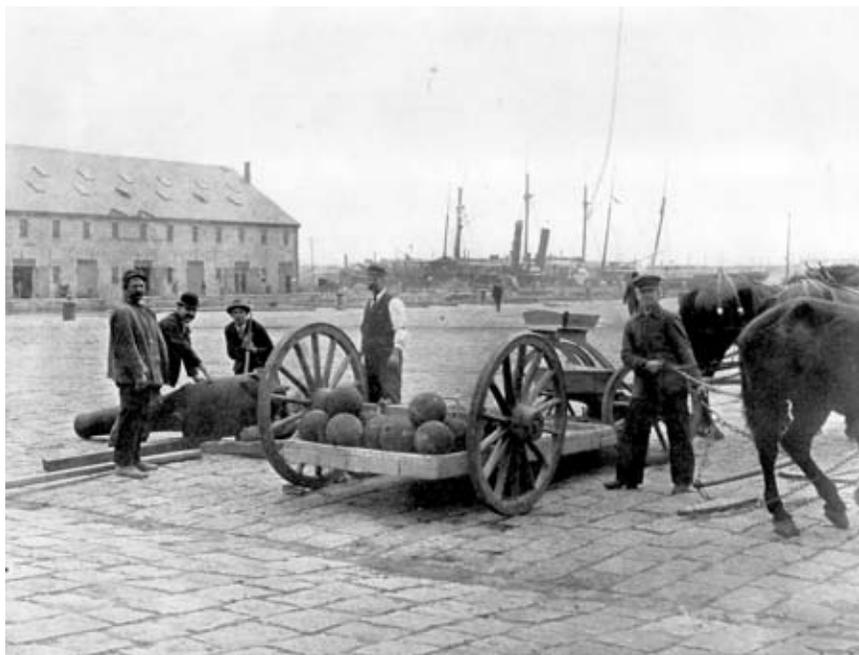
Figure 4.12: View southeast in the 1890s of a cannon ball laden cart rolling over recently installed granite block pavers. Dry Dock 1 and the Carpenter Shop (Building 24) are visible in the background (BOSTS-8788).

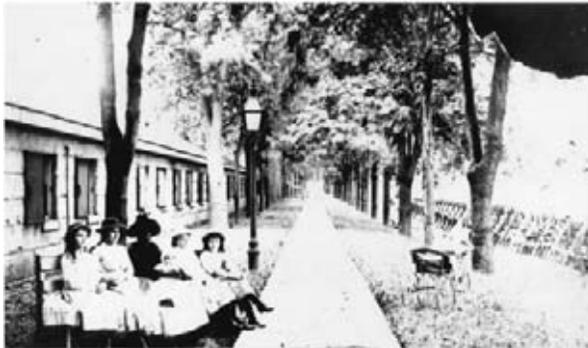
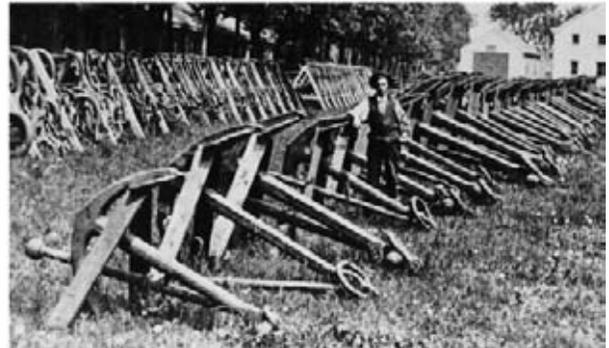
Figures 4.14 and 4.15: Left: C. 1890 view of "Flirtation Walk," a promenade lined with elm trees along the Ropewalk (Building 58) with the anchor park to the right. Right: C. 1890 view of anchors in the anchor park, manufactured in the yard, each braced with two notched boards (BOSTS-9512 and BOSTS-8872).

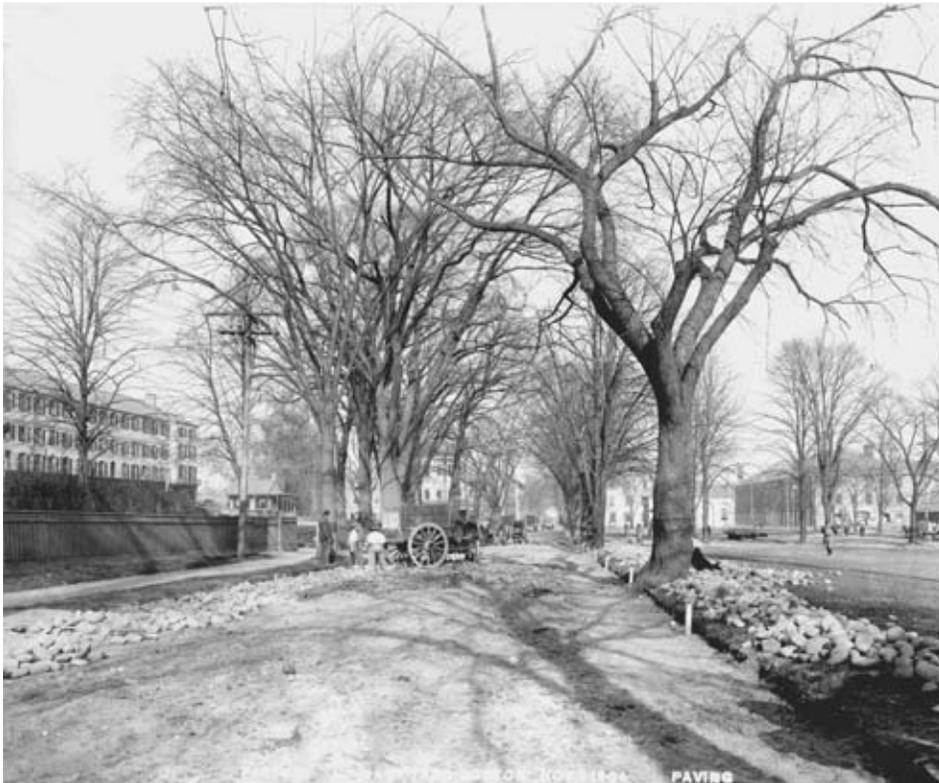
Figure 5.1: Second Avenue repaving project in 1904. Quiet woodblocks paved the street with cobblestone side gutters. Note the mature elm trees lining the road (BOSTS-8656).

Improvements to the yard’s circulation systems were necessary to meet both the increasing demands of modern naval design and the administration’s appeal for scientific management principles and maximal production (Figures 5.1 through 5.12). A more rational system of nomenclature, surface paving, and railroad tracks facilitated traffic among the sites of increasingly integrated modes of production. In 1902, the yard assigned numbers to its twenty-five thoroughfares and designated the east-west roadways as “avenues” and north-south roads as “streets.” Between 1902 and 1904, the Navy replaced the paving along Second Avenue with a wood block surface with cobblestone gutters to provide a quiet road surface near the Commandant’s House (Quarters G), reportedly so traffic noise would not interfere with the commandant’s wife’s sleep (Figure 5.1). The Navy also constructed the Conduit (Structure 280), an underground utility tunnel topped by a concrete sidewalk, along the north side of First Avenue in 1902 (Figures 5.2-7).¹⁰ As part of this construction project, the Navy widened and paved First Avenue with granite Belgian blocks and brick (the section of First Avenue from Gate 1 to Third Street was brick).¹¹ The Navy paved Sixth Street with granite cobblestones in 1905. The administration experimented with other paving materials including brick, bituminous concrete, and granite and granolithic paving throughout the yard during the years leading up to World War I. For example, brick paving was used for First Avenue and granite paving for the western edge of Pier 1.¹²

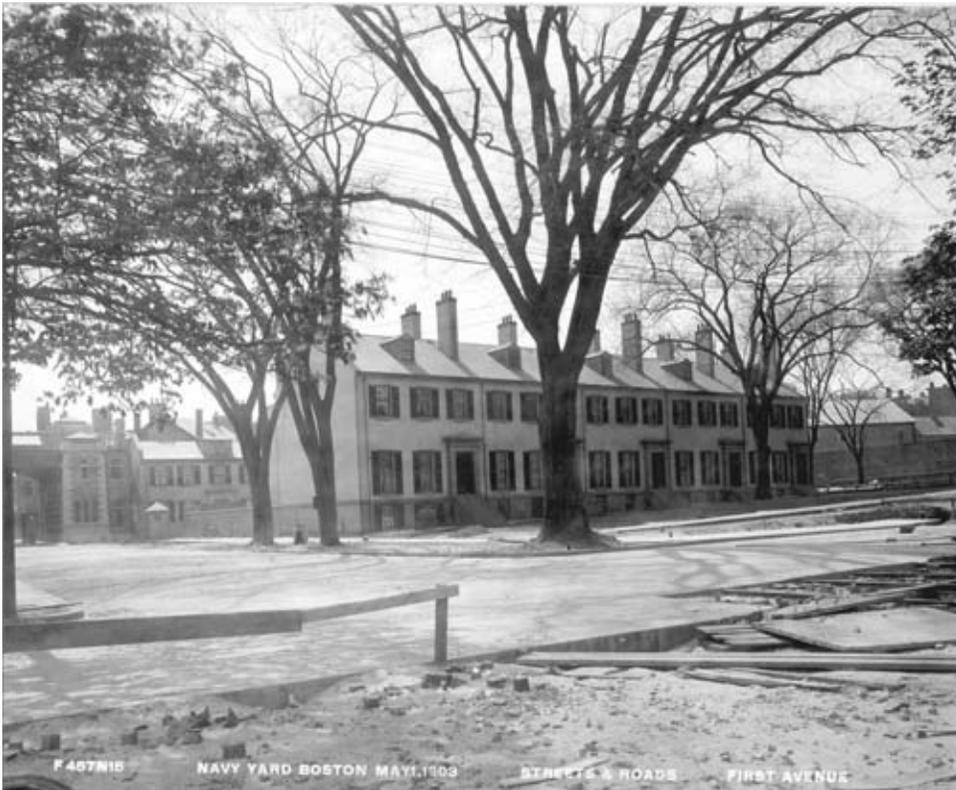
Figure 5.2: Paving of First Avenue by the Officer's Quarters (Building 265) in 1903. Note the mature elm trees and the Main Gate (Building 97) on the left (BOSTS-9168).

Figure 5.43: The Officers Quarters (Building 265) in 1921 showing a replacement tree where a large elm once stood (see center of Figure 5.2). A pin oak grows there today (BOSTS-9164).

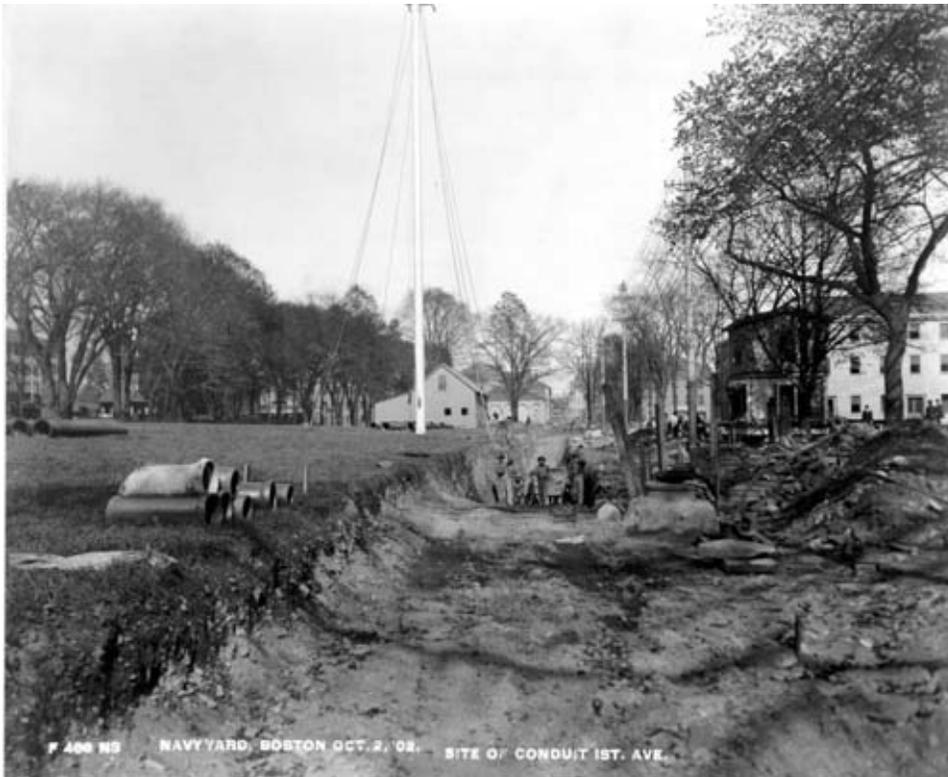
Figure 5.3: Construction of the Conduit (Structure 280) and repaving of First Avenue in 1902. Note the flagpole in the gun park (left center). Trees along the north side of First Avenue have been removed for the project (BOSTS-8654-3).

¹⁵ This first Scale House, located south of the first gun park near the present flagpole, was later replaced by the current Scale House (Building 19) in 1919. It is pictured in Figures 5.3-5. Bearss and Black, 236 and Handbook, 17.

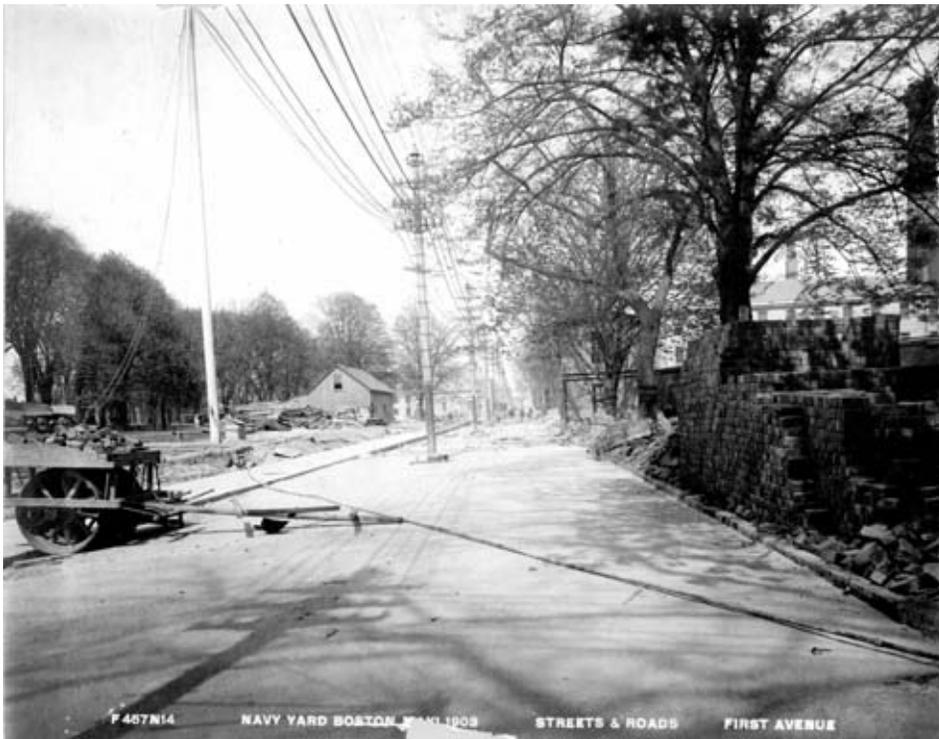
Figure 5.4: Brick paving of First Avenue in 1903 looking east. The sidewalk slabs to the left cover the newly completed Conduit (Structure 280). Note the flagpole and the gun park to the left and the mature trees to the right. Utility lines and poles marked the road (BOSTS-8654).

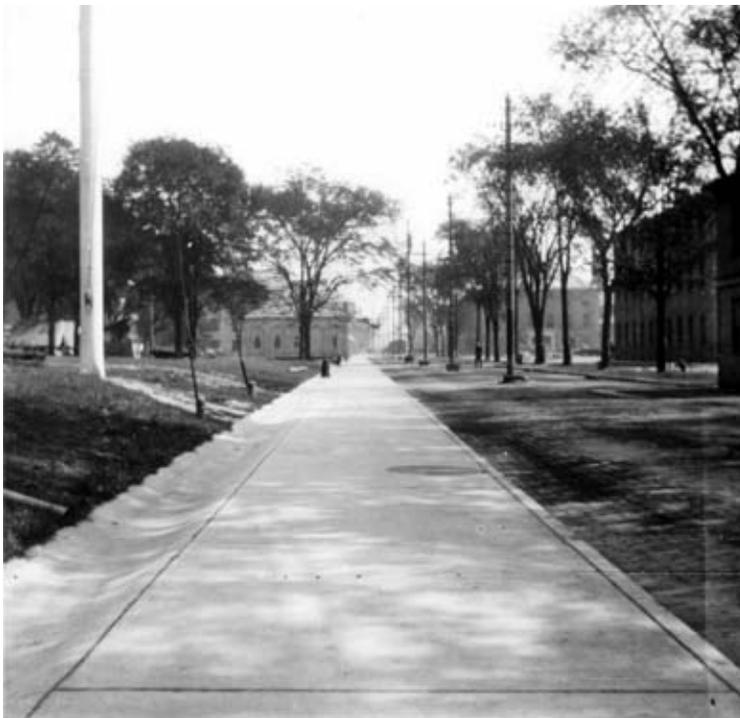
Figure 5.5: First Avenue after paving c. 1903. The concrete sidewalk covers the new Conduit (Structure 280). Note the gutter to the left and the flagpole in the former gun park. Utility poles and lines run down the middle of the avenue, and elm trees still line the south side of the street (BOSTS-8654).

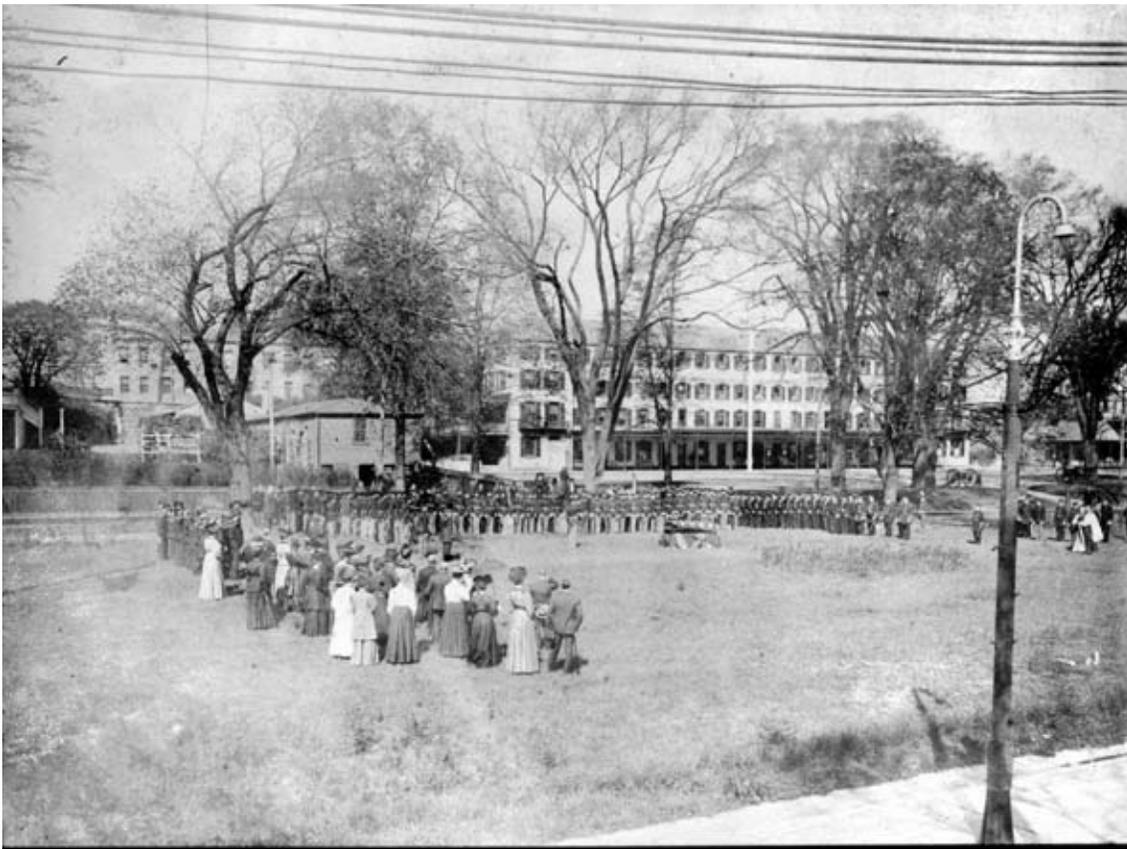
Figure 5.6: 1904 gathering in the former gun park. The newly completed sidewalk and Conduit (Structure 280) along First Avenue are visible at the bottom. The Commandant's Tool Storage Barn (Building 20) and the Marine Barracks (Quarters H-I-K) are visible in the background behind the elm trees lining Second Avenue (BOSTS-9221).

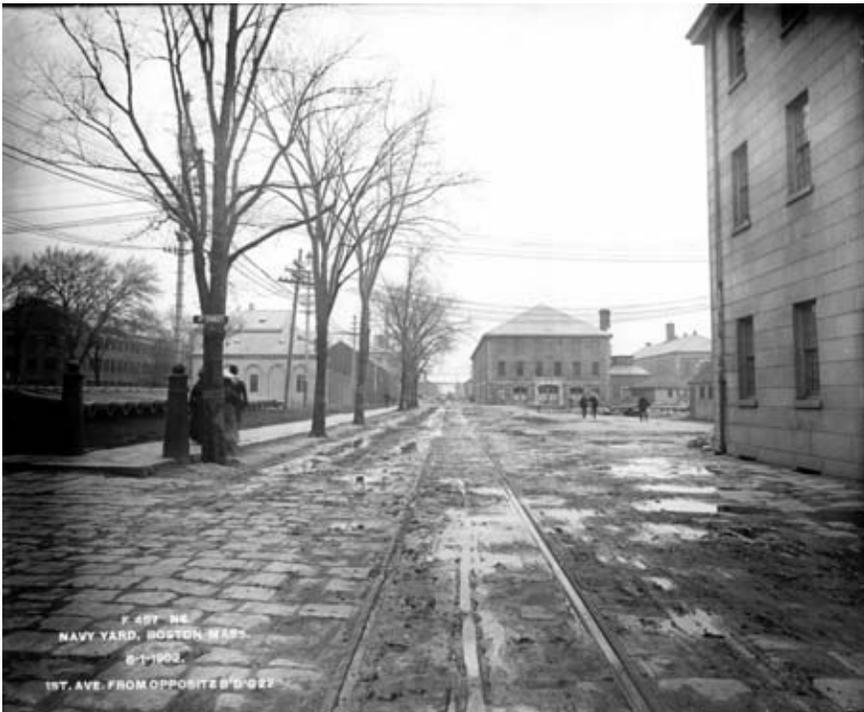
Figure 5.7: First Avenue at Fourth Street in 1902 before repaving. The gun park is to the left, and the Dry Dock Engine House (Building 22) is to the right.

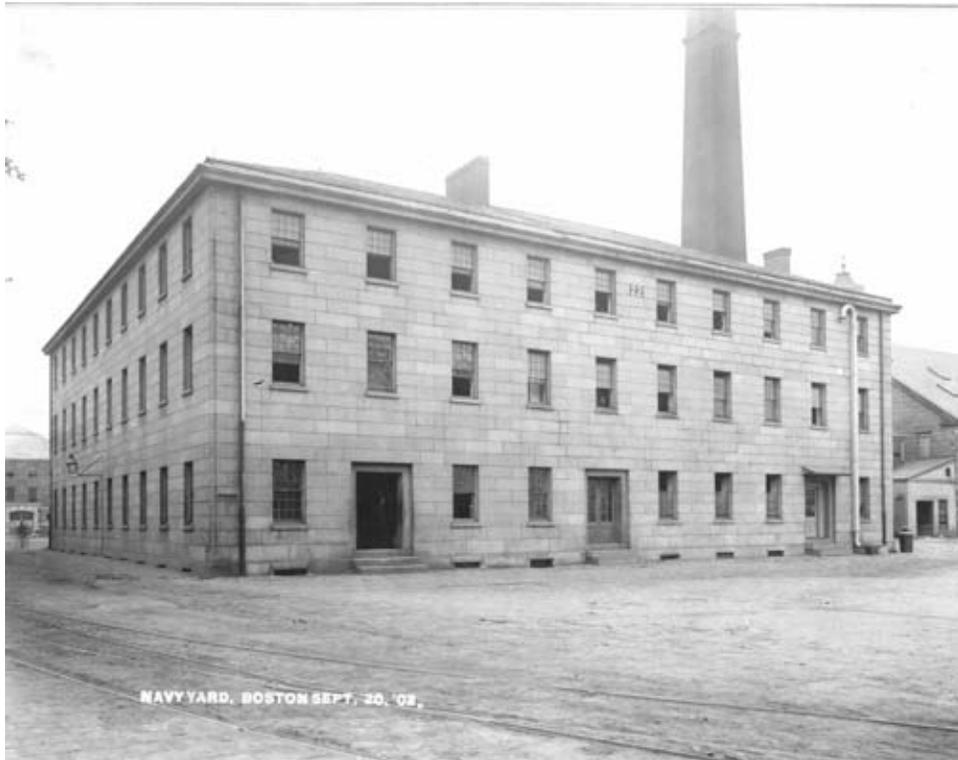
Figure 5.8: Dry Dock Engine House (Building 22) showing granite block paving and rail lines in September 1902 (BOSTS-9288).

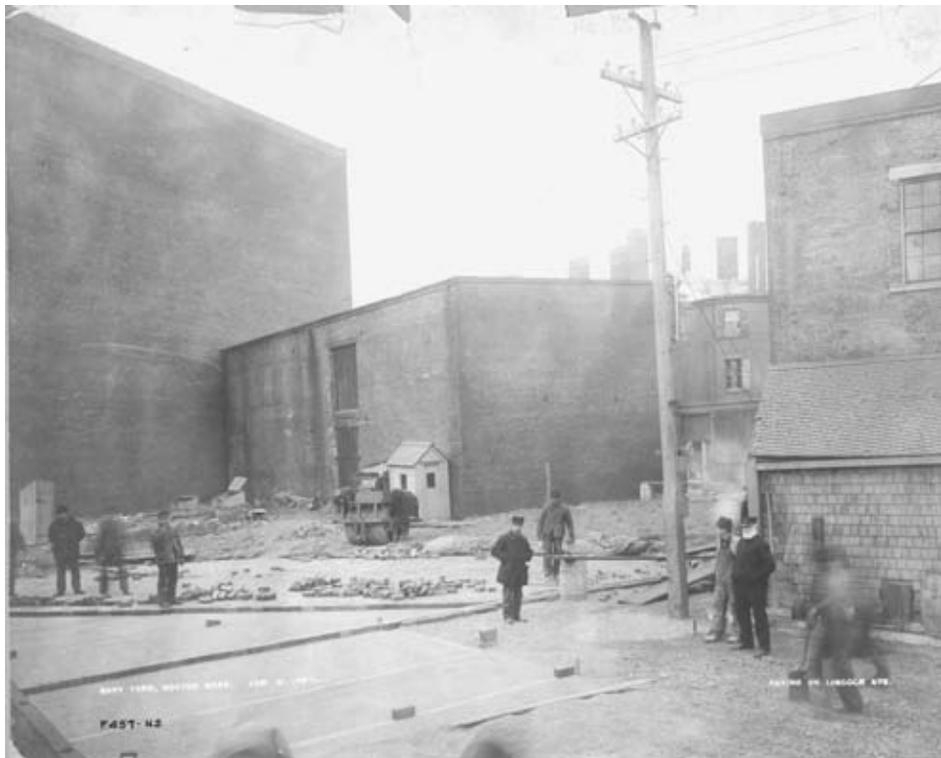
Figure 5.9: Resurfacing Lincoln Avenue and First Street between Hoosac Stores (left) and the Storehouse (Building 4) (right) in 1902 with either Belgian block or brick. An additional Storehouse (Building 3), demolished in 1906, is in the center (BOSTS-9251).

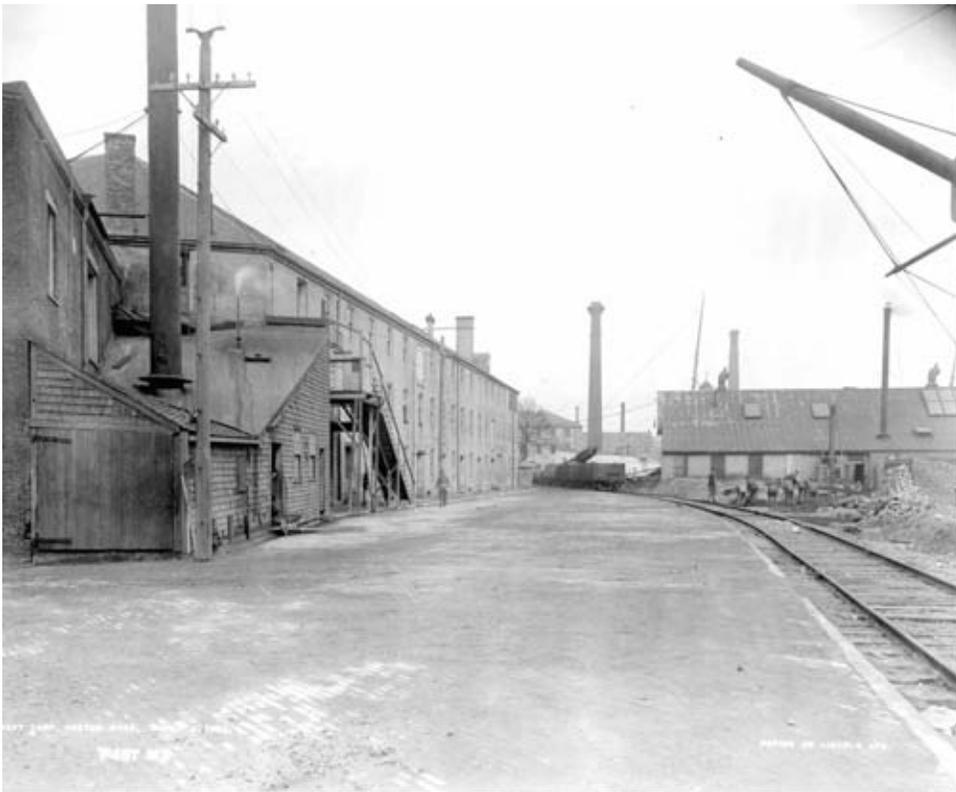
Figures 5.10: Granite Belgian block paving between the Storehouse and Navy Store (Buildings 4 and 5) on the left and the railway in 1903 looking east (BOSTS-9256).

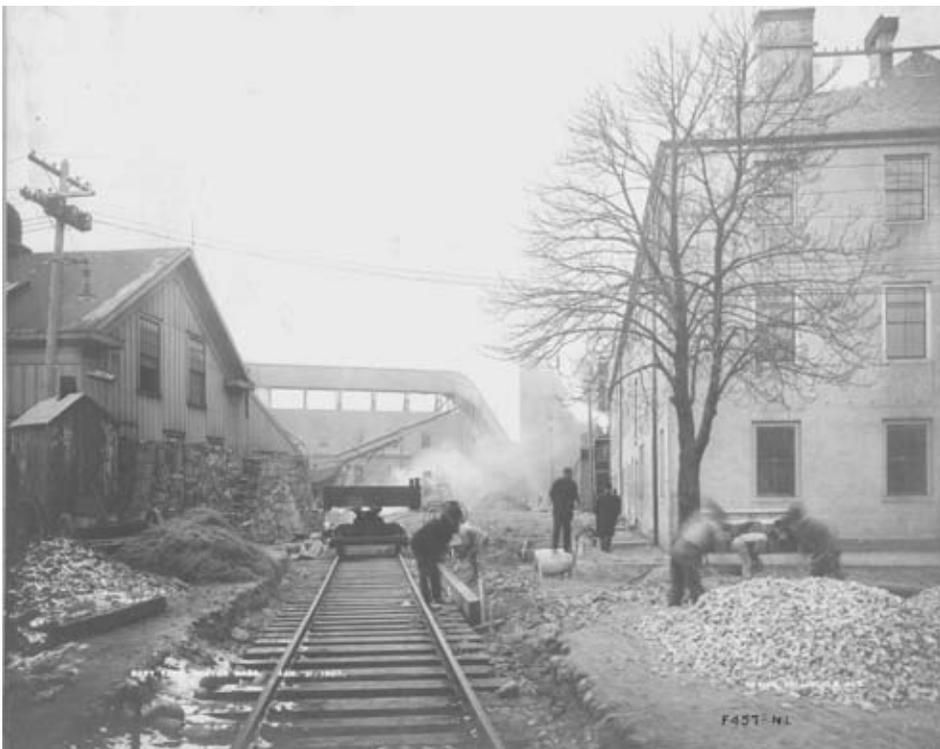
Figure 5.11: Railway construction along the south side of the Navy Store (Building 5) in 1902 looking west (BOSTS-9252).

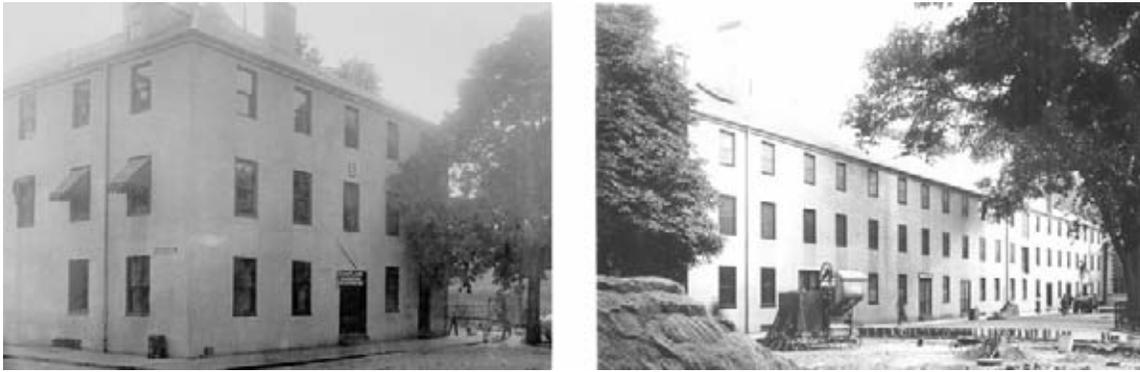
Figure 5.12: In 1918, surface improvements were made to the roads on the east and north sides of the Navy Store (Building 5) including paving around the base of the horse chestnut tree (BOSTS-9257).

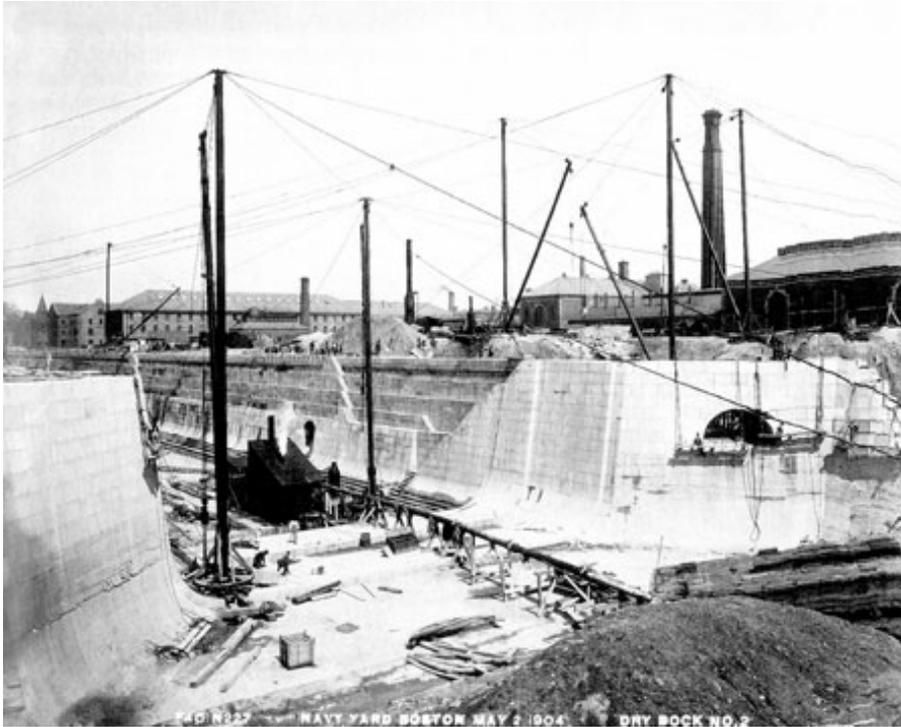
Figure 5.13: Dry Dock 2 under construction in 1904, showing the dramatic transformation of this portion of the yard (BOSTS-8808).

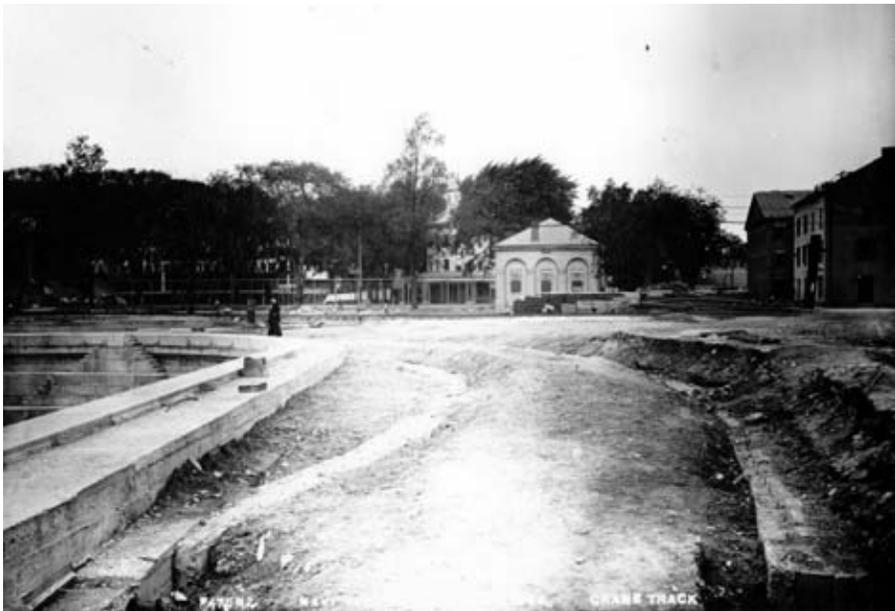
Figure 5.14: Improvements to the yard in 1904 included installing additional crane and rail tracks as seen from the northeast corner of Dry Dock 2. In the distance are the tennis courts, Muster House (Building 31), and Commandant's Office (Building 32), while trees obscure the Marine Barracks (Quarters H-I-K) (BOSTS-8656).

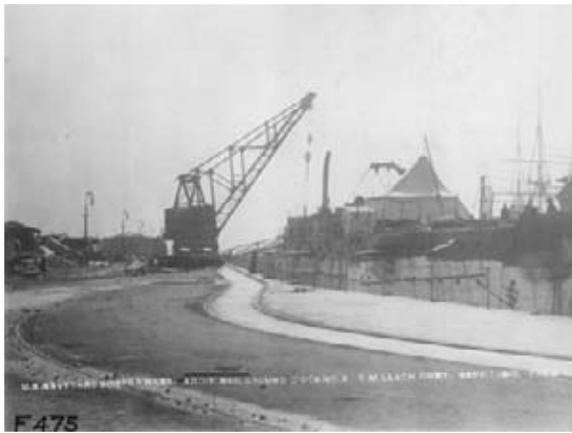
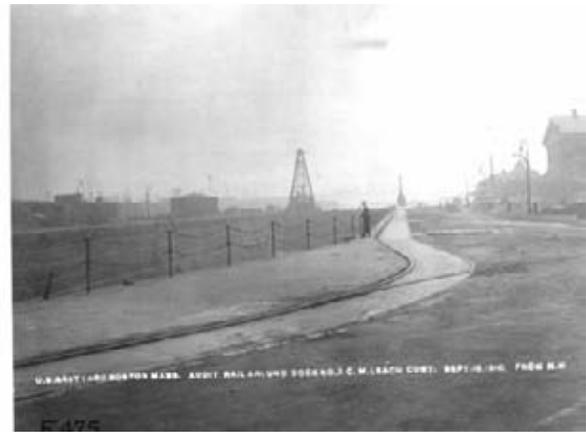
Figure 5.15: 1910 views of the forty-ton portal crane and its twenty-foot gauge tracks as well as railroad tracks around Dry Dock 2 (BOSTS-8810b).

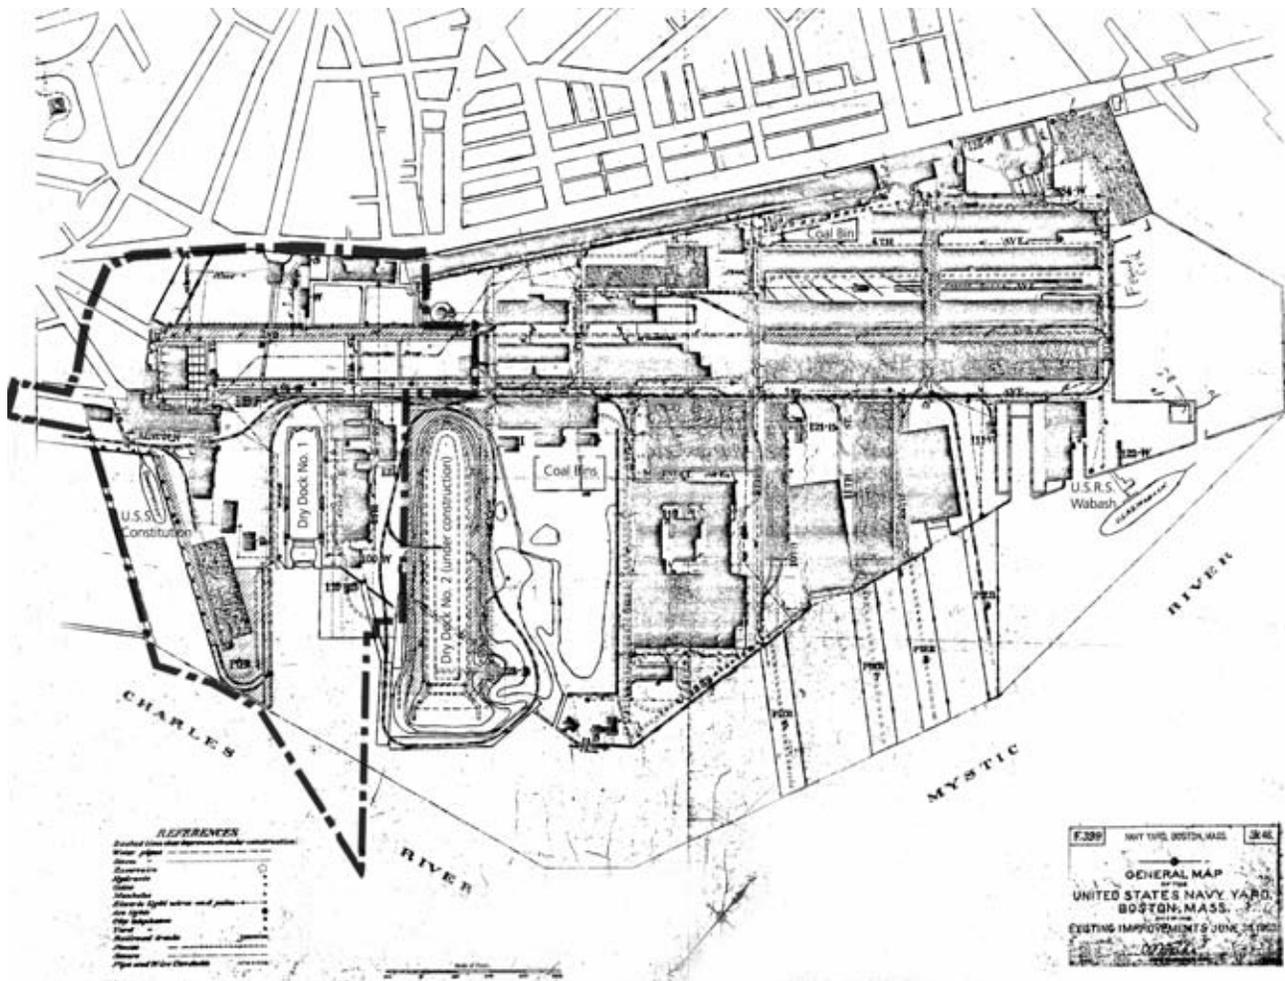
Figure 5.16: Digitally enhanced plan for the yard in 1902-03 showing the new bulkhead line with the existing piers extended, Dry Dock 2 under construction, and relocation of Buildings 10. Current park boundary is outlined (Courtesy of Boston NHP Archives).

The most dramatic alterations took place at the western end of the waterfront. Unlike the other wood decked piers, Pier 1 was designed with a solid core to support a massive new coal facility. The old coaling wharf (Whites Wharf) and the Shear Wharf were extended to form one pier. Piles were driven thirty feet into the water and concrete piers were poured and topped with concrete arches with forty-foot spans. The rear of the arches was backed with concrete curtains to contain fill. Construction of Pier 1 required removal of the western end of the yard boundary wall, the Fire Apparatus House (Building 6), the Coal Shed (Building 7), and a shipbuilding slip. Buildings retained during the work included the Storehouse, Navy Store, Foundry, (Buildings 4, 5, and 16) and the Pitch House (Building 10) which the Navy moved several feet to the east (Figure 5.17). A small Boathouse (Building 94) was also retained but shortened and later removed in 1904. The large shears at the end of the former Shear Wharf were moved to another pier but subsequently removed by 1908. Just to the west of the new Pier 1, the Navy shared a slip known as the “Fitchburg Slip” with the Fitchburg Railroad Company, who owned the abutting Hoosac Pier. As shown on the 1902-03 map of the yard, the slip held USS *Constitution* during this period.

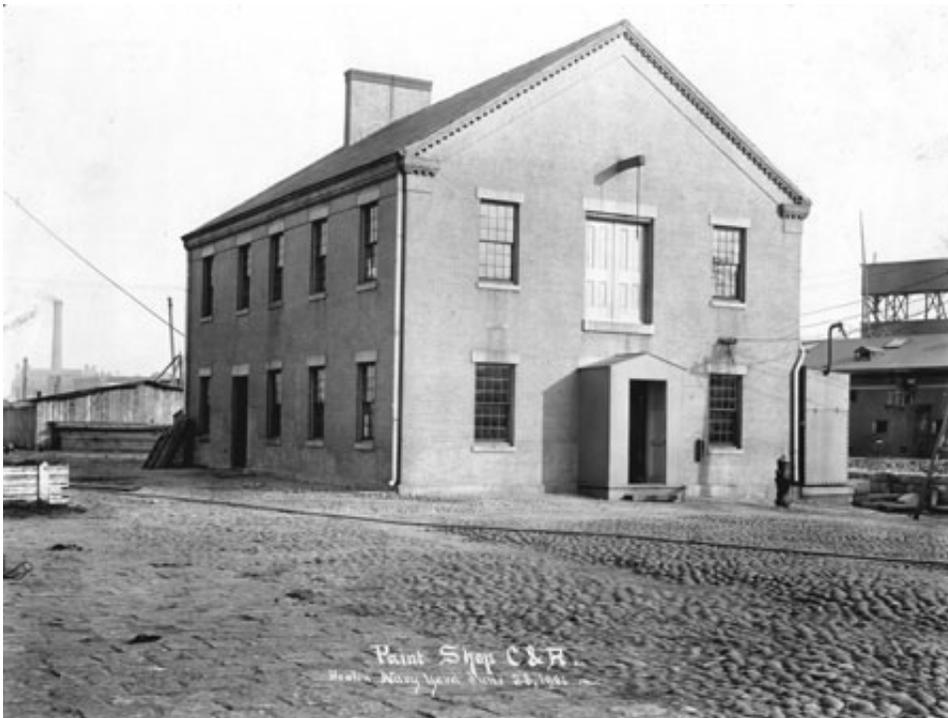
Figure 5.17: North and east sides of the relocated Pitch House (Building 10), 1901. Then used as a paint shop, with granite pavers in foreground, stone cobble paving around building, and the new Coaling Plant (Building 109) in the background (BOSTS-9270).

In 1901, the War Department laid down a new pier and bulkhead line further into the harbor that constituted a new waterfront boundary for the yard. Following its acceptance by state and municipal authorities, the Navy extended the existing piers and constructed five new piers, named 3, 4, 4-A, 5 and 6, in an area absent of piers before 1900. Two of these wharves, Nos. 3 and 4, each sixty-feet-wide, were added to either side of the entrance of the new Dry Dock 2. Increased wharfage, through new construction and extensions, necessitated the institution of a new numbering system for piers in 1900 (Figure 5.16).¹⁶ By 1914, the yard possessed nine industrial piers and one light-usage pier, Pier 10, to access the yard's receiving ship, the *Wabash*. Nine cranes operated along the piers.¹⁷ Much of the waterfront was paved with granite blocks at this time (Figures 5.17 & 21).

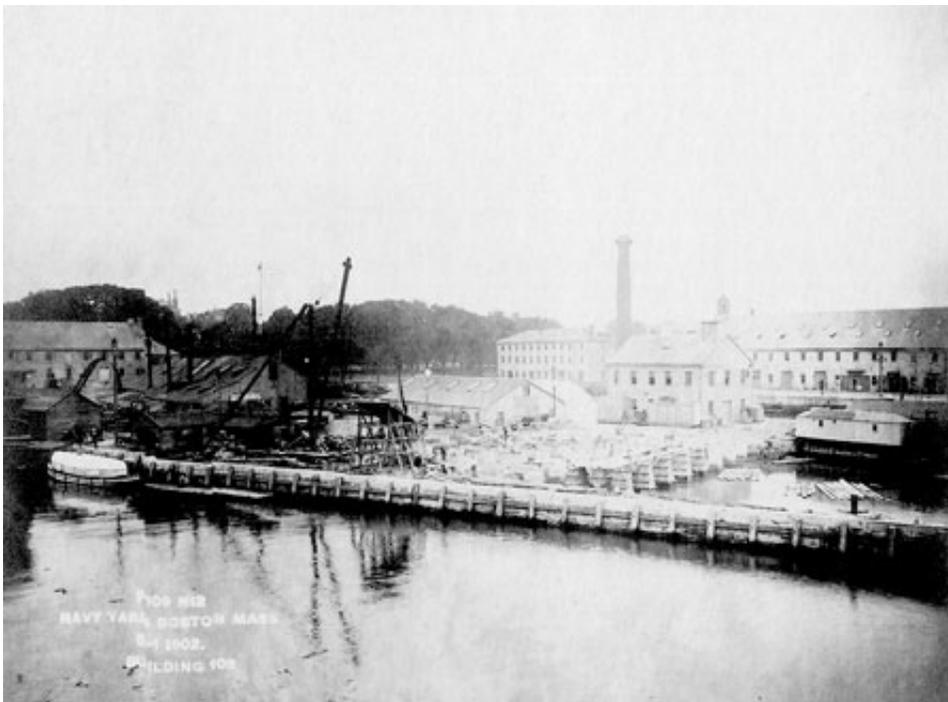
Figure 5.18: Pier 1 under construction in 1902 with the Navy Store (Building 5) to the left north of the Pitch House (Building 10) in the center right (BOSTS-9807 or 9808).

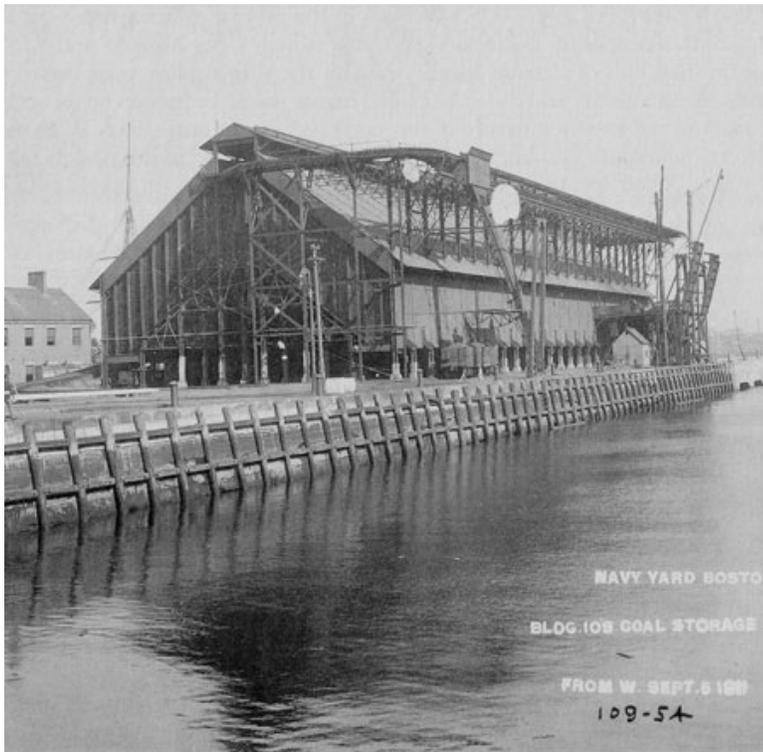
Figure 5.19: 1911 view of the enormous new Coaling Plant (Building 109) completed in 1904 on Pier 1 (BOSTS-9807,9808).

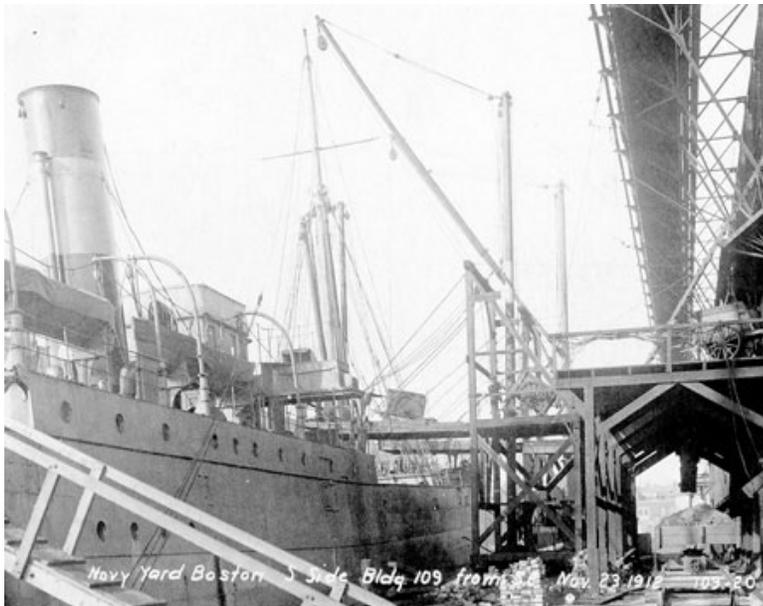
Figure 5.20: 1912 view of the Coaling Plant (Building 109) in operation with a rail line and one of the yard's thirteen dump cars for coal in the foreground (BOSTS-9807,9808).
