CULTURAL LANDSCAPE REPORT FOR CHARLESTOWN NAVY YARD

BOSTON NATIONAL HISTORICAL PARK
BOSTON, MASSACHUSETTS

INTRODUCTION

SITE HISTORY

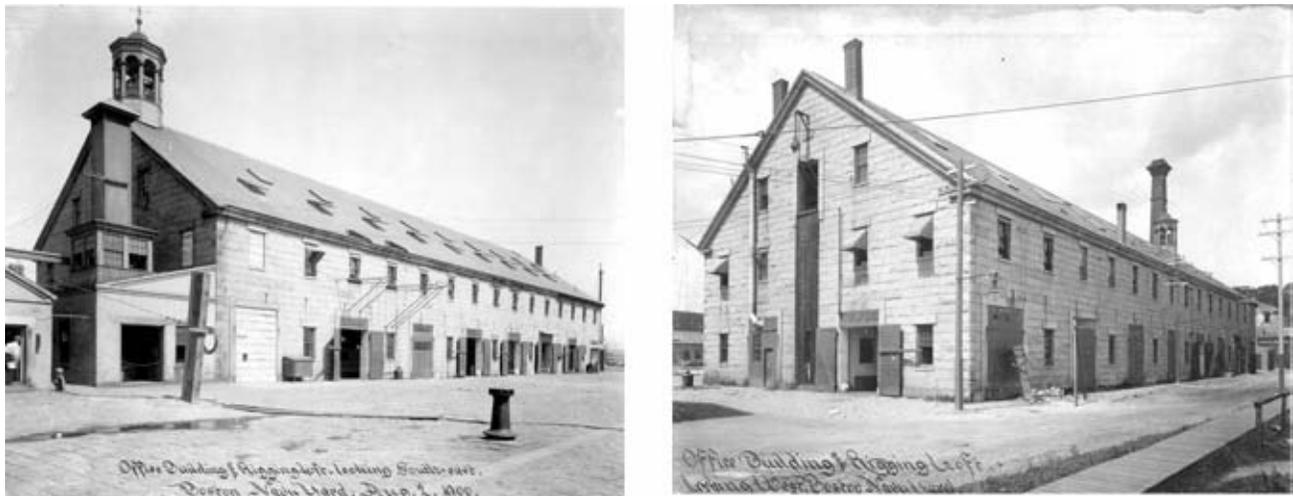
Figure 5.21: In 1900 circulation materials differed on either side of the Carpenter's Shop (Building 24). Left, granite paving against the west façade facing Dry Dock 1. Right, a wooden boardwalk paralleled the building's east façade and Dry Dock 2. The cleared area between the building and the boardwalk is Fifth Street (now covered by a WWII building addition). The soaring smokestack of the Dry Dock Engine House (Building 22) can be seen in the background (BOSTS-9298).

In 1901, the War Department laid down a new pier and bulkhead line further into the harbor that constituted a new waterfront boundary for the yard. Following its acceptance by state and municipal authorities, the Navy extended the existing piers and constructed five new piers, named 3, 4, 4-A, 5 and 6, in an area absent of piers before 1900. Two of these wharves, Nos. 3 and 4, each sixty-feet-wide, were added to either side of the entrance of the new Dry Dock 2. Increased wharfage, through new construction and extensions, necessitated the institution of a new numbering system for piers in 1900 (Figure 5.16).¹⁶ By 1914, the yard possessed nine industrial piers and one light-usage pier, Pier 10, to access the yard's receiving ship, the *Wabash*. Nine cranes operated along the piers.¹⁷ Much of the waterfront was paved with granite blocks at this time (Figures 5.17 & 21).

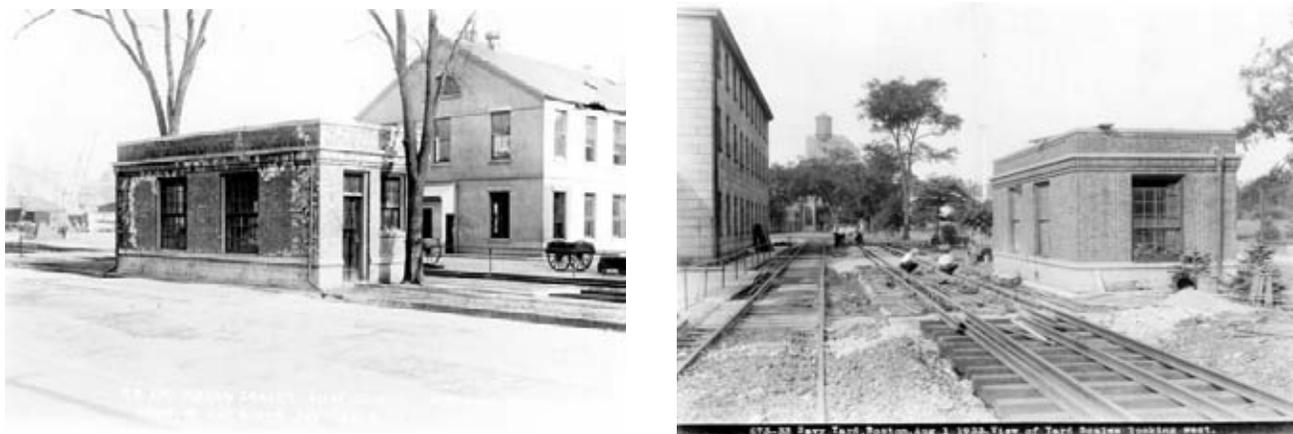
Figure 5.22: Left: The Scale House (Building 19) shortly after its relocation and construction (1918-1919), flanked by two of the yards' many elm trees. First Avenue is in the foreground and the Dry Dock Engine House (Building 22) is in the background. Right: The Scale House (Building 19) and rail scales in 1933. The Dry Dock Engine House (Building 22) is to the left and Gate 1 is in the background through the arching canopy of elm trees. Note the young spruce trees planted east of the Scale House (BOSTS-9280 and 9281-8133).

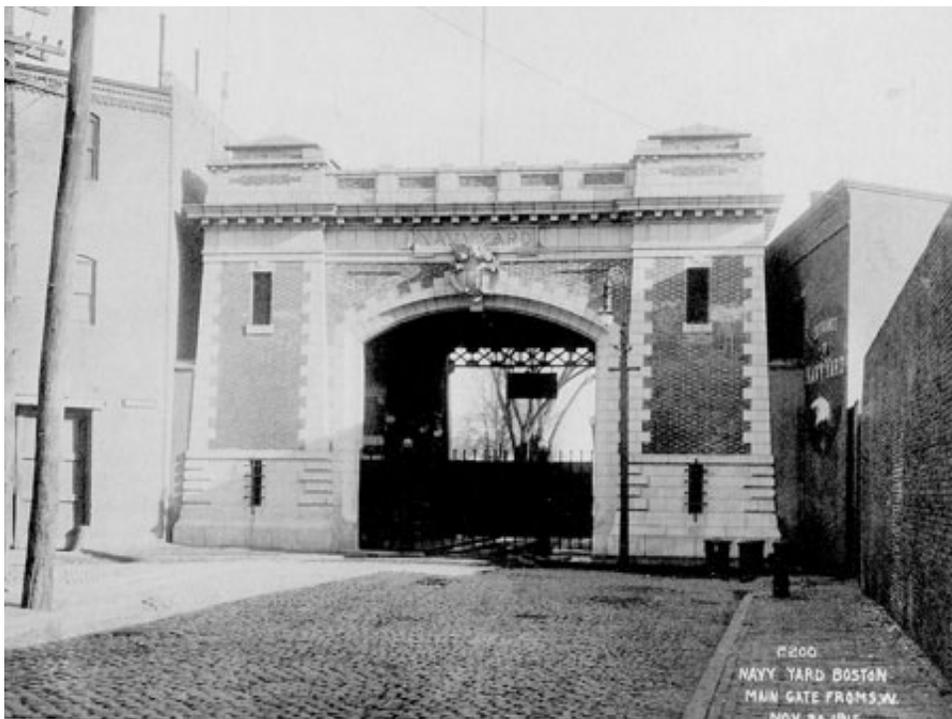
Figure 5.26: Main Gate (Building 97) on 26 November 1915. Built in 1903, it was demolished in 1958 to improve truck access (BOSTS-8943).

Of the forty new buildings added to the yard between 1899 and 1914, only two were added to the upper yard north of First Avenue and west of Sixth Street, though several others received additions. In 1903, the Navy erected an elegant new brick and stone Main Gate (Building 97) (Figure 5.26).²⁴ In 1909, the Navy demolished the small one-story structure at the east end of the Marine Barracks parade ground that had served as the USMC Officer-of-the-Day's Quarters (Building 30) and constructed a new three-story Marine Corps Administration Building (Building 136) in its place. The Navy enlarged the Marine Barracks (Building I) throughout the twentieth century (Figure 5.27).²⁵ In 1910, the Navy enlarged the Commandant's Office (Building 32), located in the former Shell House at this time (Figure 5.28).

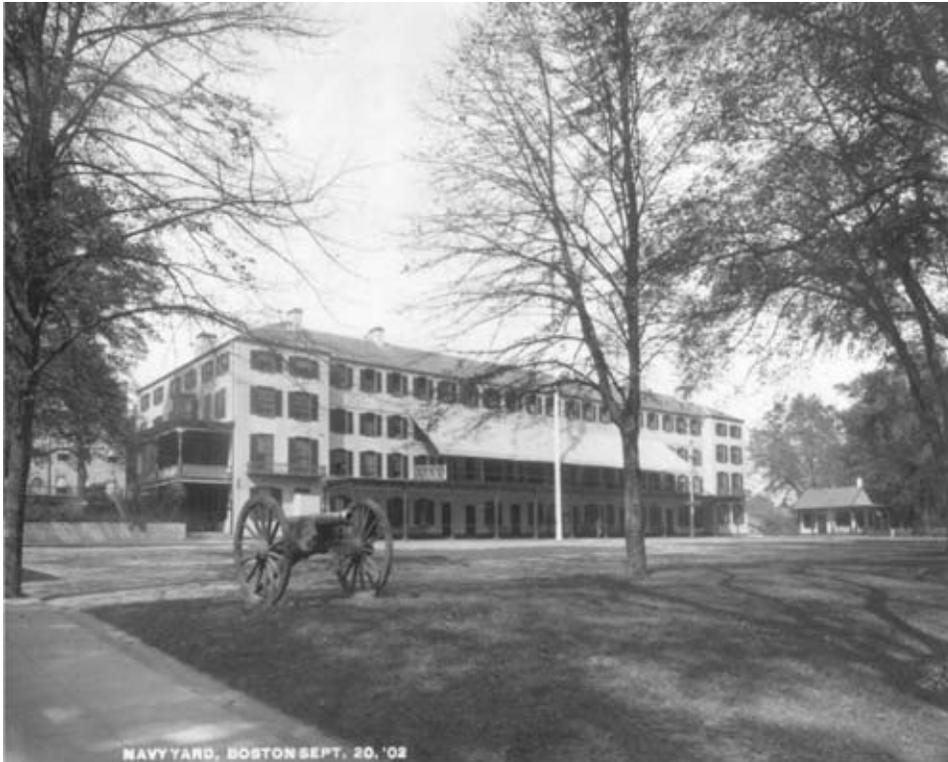
Figure 5.27: Marine Barracks (Quarters H-I-K) in 1902 with fourth floor addition to the central portion of the building (BOSTS-9220).

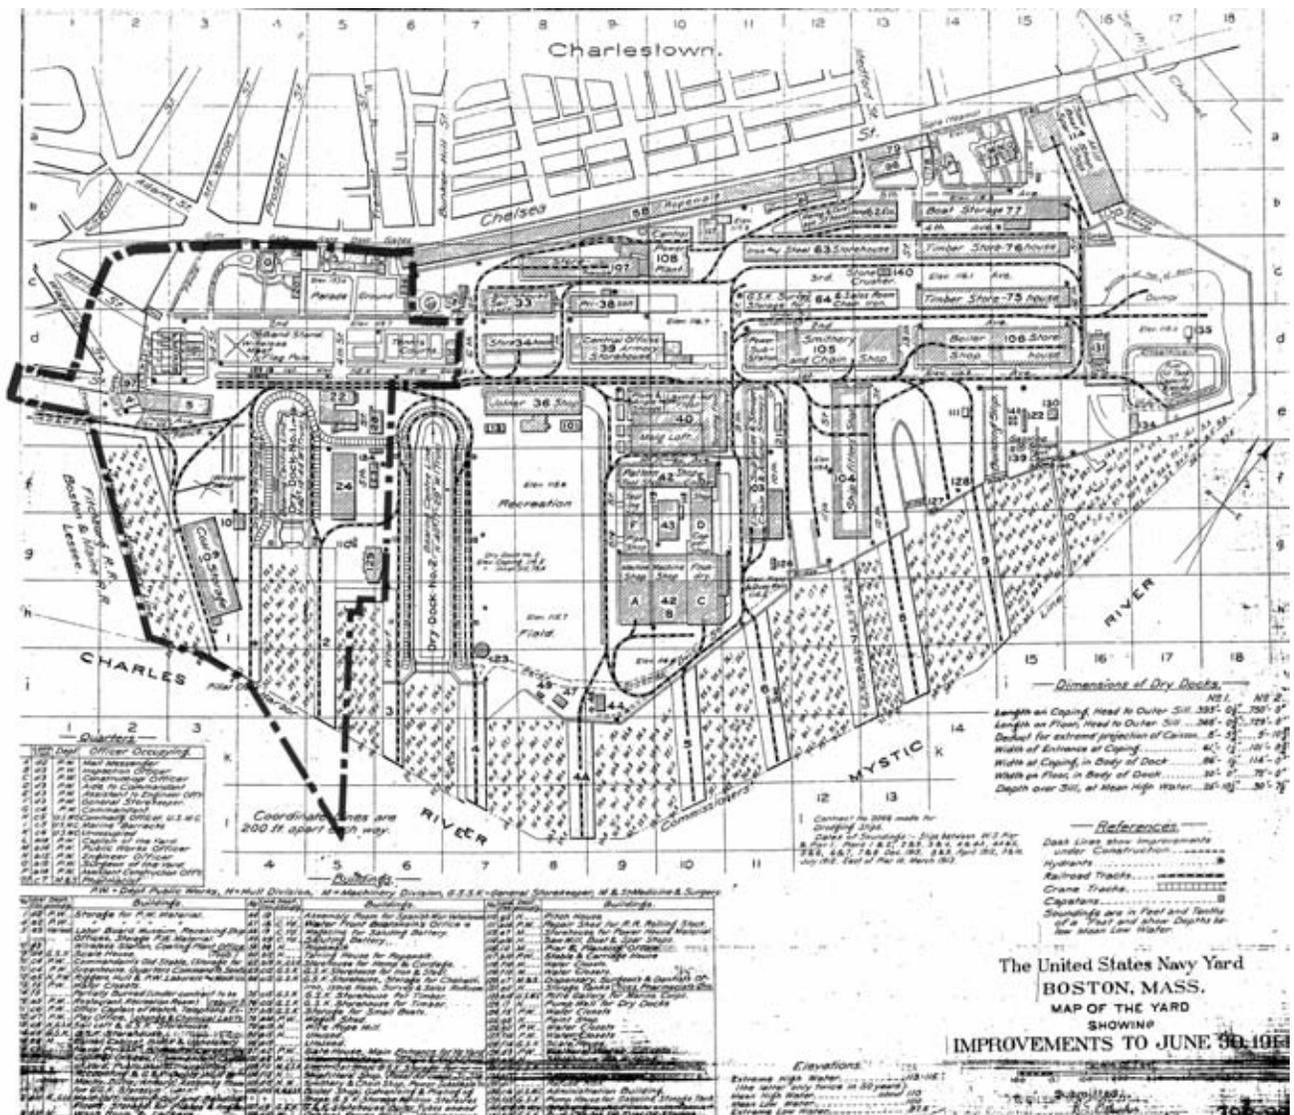
Figure 5.30: Digitally enhanced plan for the yard in 1914. Current park boundary is outlined (Courtesy of Boston NHP).

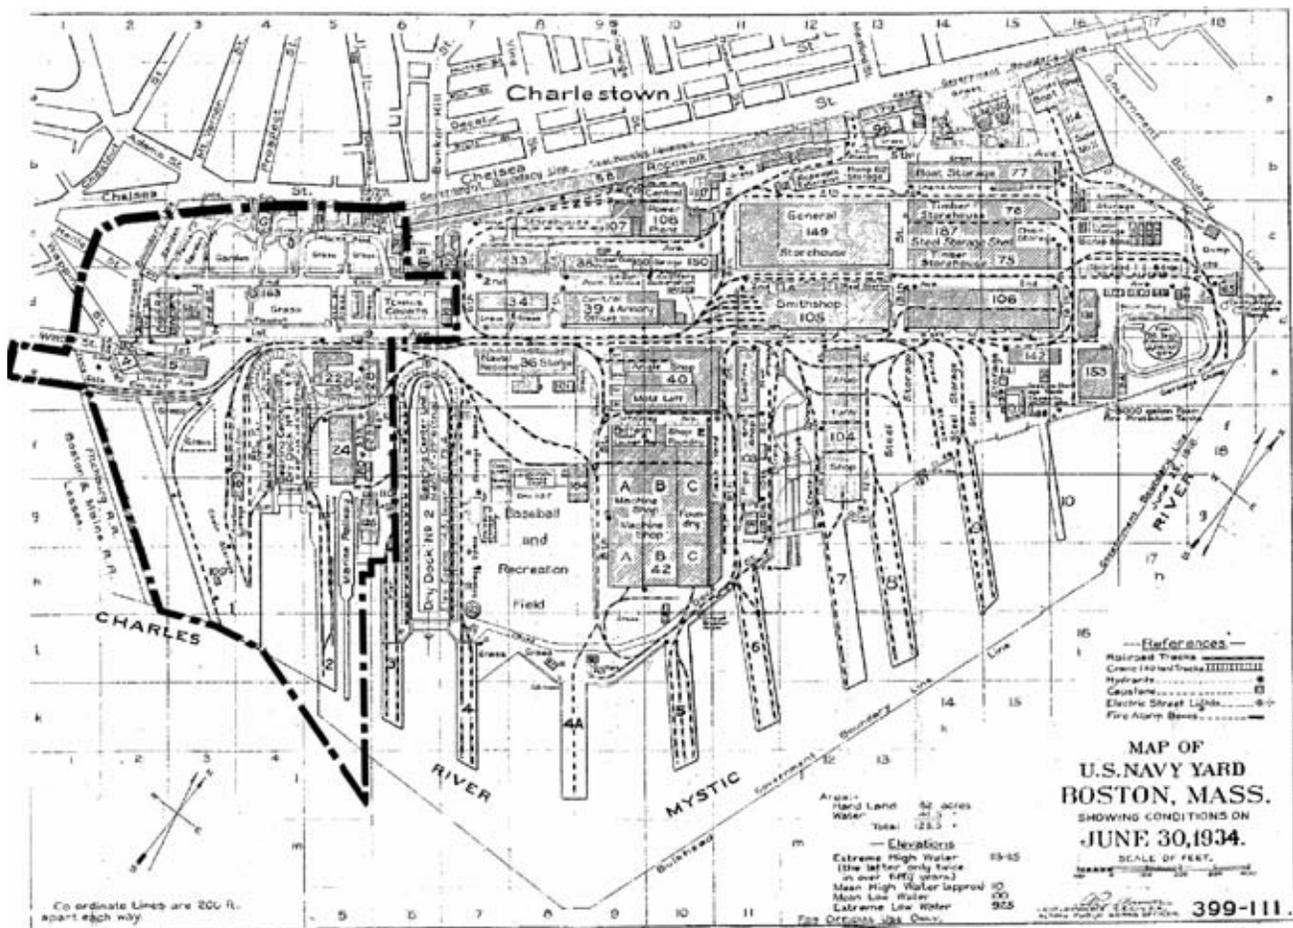
Figure 5.31: Digitally enhanced plan for the yard in 1934. Current park boundary is outlined (Courtesy Boston NHP).

By the 1920s, the Navy and its yards declined as the nation shifted its attention to private enterprise and business. The Five-Power Naval Treaty, negotiated in 1921-22, set limits on new ship construction and fleet size, including a ten-year moratorium on capital ship construction.²⁹ The decreased work, together with the diversion of much of the American fleet to the West Coast in response to tension with Japan, further reduced activities at the main yard. After the launching of the destroyer tender *Whitney* in 1924, construction work at Charlestown halted for the remainder of the decade. Repair work was largely limited to naval battleships and some passenger liners. Fiscal austerity limited both improvements to and maintenance of the yard's buildings, facilities, and grounds (Figures 5.31-32).

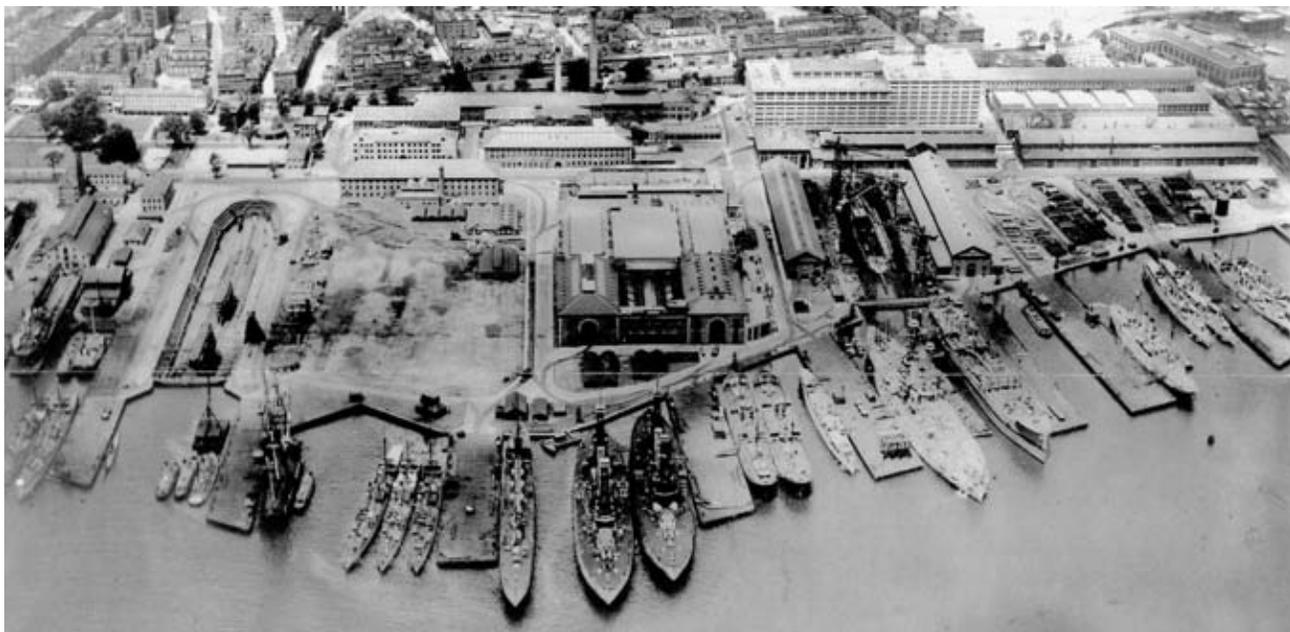
Figure 5.32: Aerial photograph of the yard c. 1921 showing 29 battleships, cruisers, destroyers, and submarines docked for maintenance and repair. USS Constitution is shown east of Dry Dock 2 at the left. Note the trees at the Commandant's House (upper left) and along Second Avenue and the former Flirtation Walk south of the Ropewalk (Building 58) (top center) (National Geographic Society Image Collection, Photograph by Hamilton Maxwell).

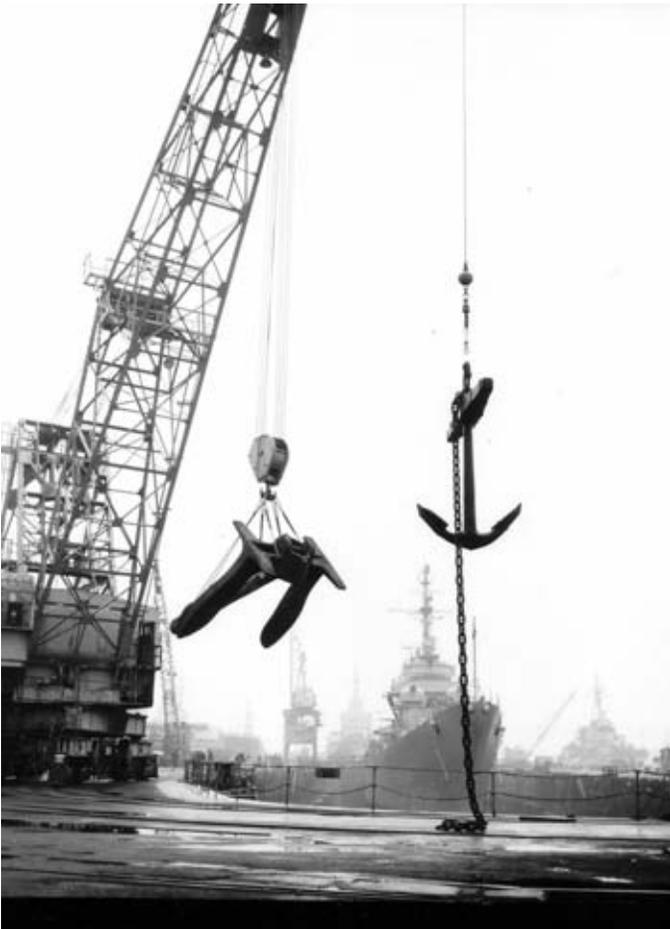
Figure 5.34: Dry Dock 2 with rail crane (BOSTS-9690).

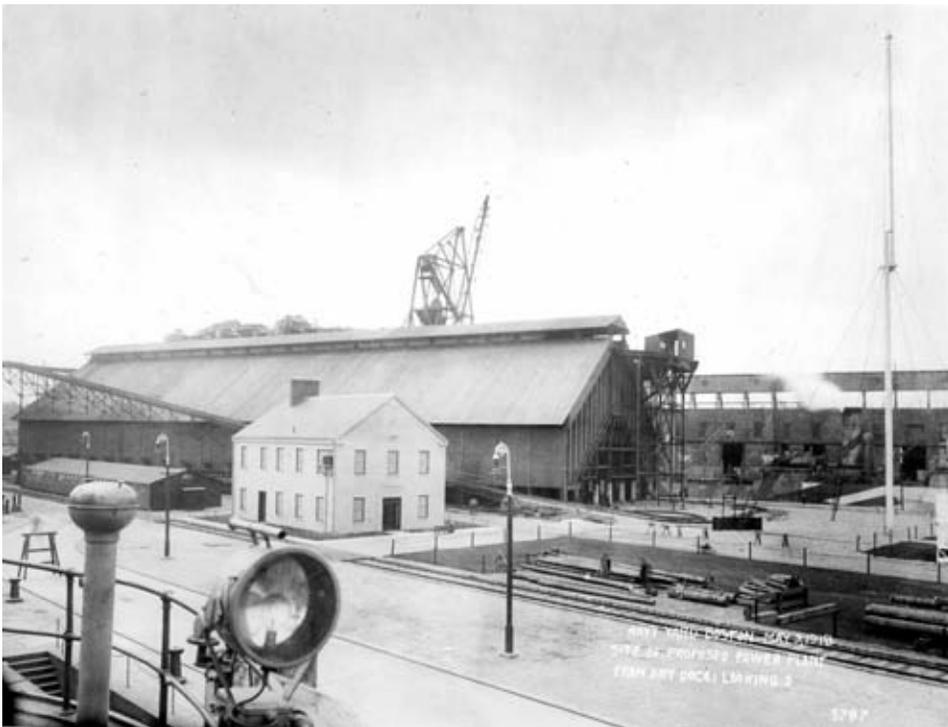
Figure 5.35: 1921 southwest view of Pier 1 with the Pitch House (Building 10) in the center and the Coal Storage & Handling Plant (Building 109) just behind. Note the Dry Dock 1 stairs in the lower left and the orderly lay down space and wireless radio mast at center right (BOSTS-9258).

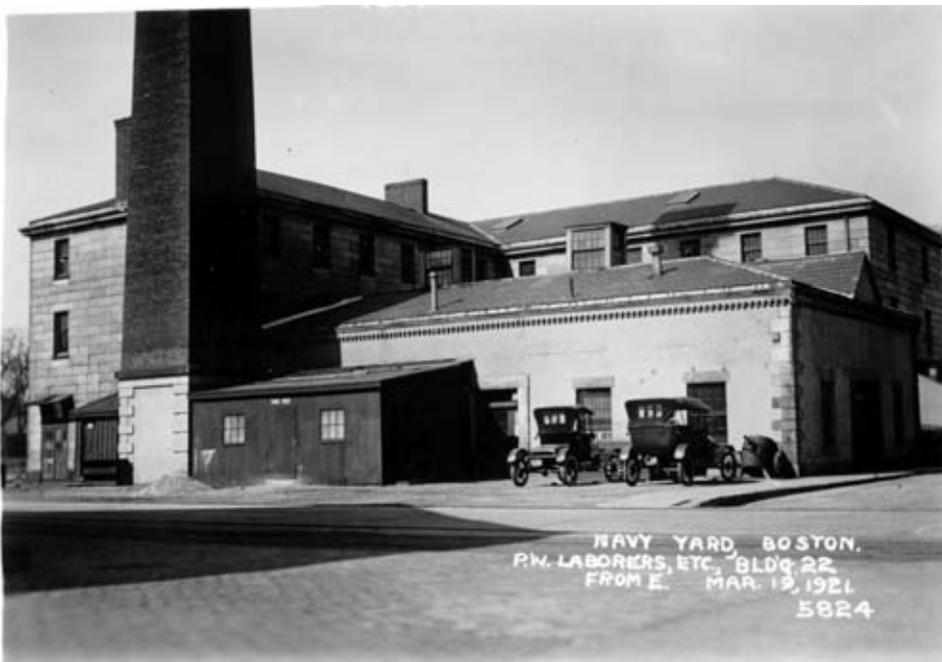
Figure 5.36: The Dry Dock Engine House (Building 22) in 1921 surrounded by granite paving (BOSTS-9285).

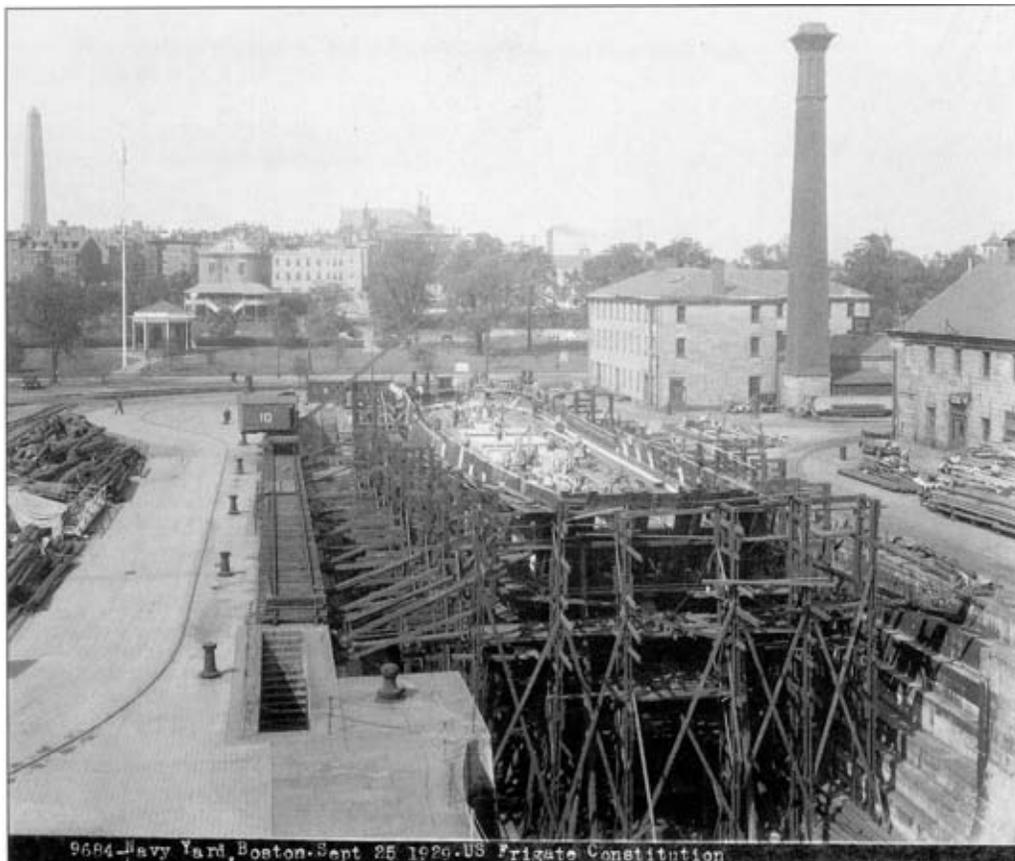
Figure 5.40: USS *Constitution* sits in Dry Dock 1 during its restoration in the late 1920s. The Bunker Hill Monument rises in the distance with the Commandant's House (Quarters G) with awnings and two grand staircases is in the background left of the dock with the Bandstand and flagpole in the shipyard mall. Many trees line the mall and the avenues. The Dry Dock Engine House (Building 22) is right (east) of the dock's head. Note the temporary crane tracks along the west side (BOSTS-10748).

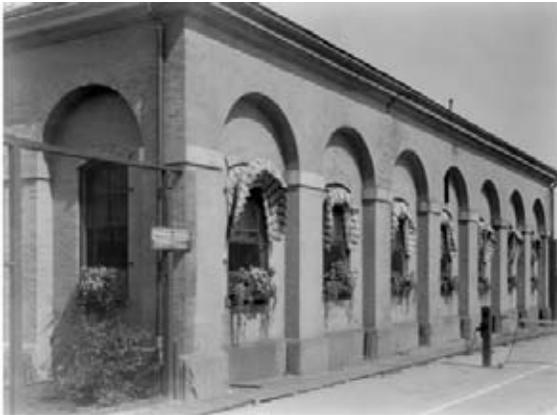
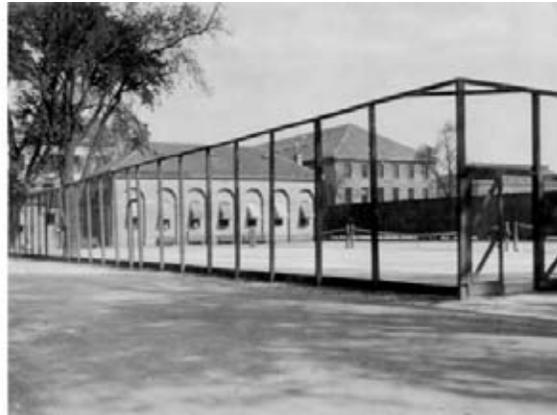
Figures 5.44: 1920s views of the Commandant's Office (Building 32, the former Shell House). The photograph on the left shows the west façade embellished with flower boxes and awnings. On the right is a longer view of the same building elevation with three adjacent tennis courts (BOSTS-9324).

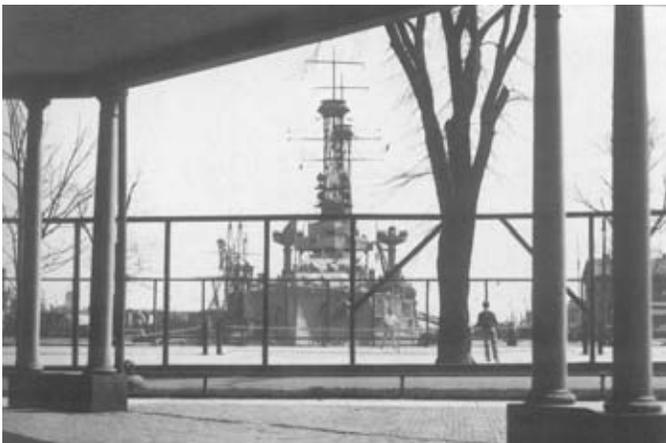
Figure 5.45: Muster House (Building 31) porch in the 1920s, brick paving, tennis court and view of a ship in Dry Dock 2 (BOSTS-14516).

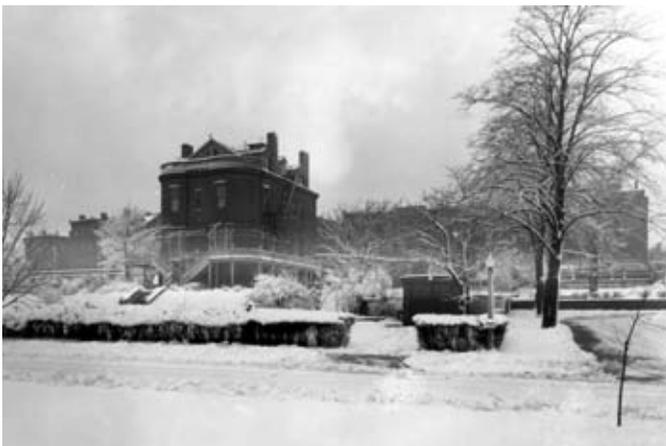
Figure 5.46: The Commandant's House (Quarters G) in c. 1930. The arbor, guardhouse, and wooden fence along Second Avenue are gone, and a privet hedge defines the property. An electric light post is visible southeast of the Garage (Building 245) that replaced the Tool Storage Barn (Building 20) (BOSTS-9183).

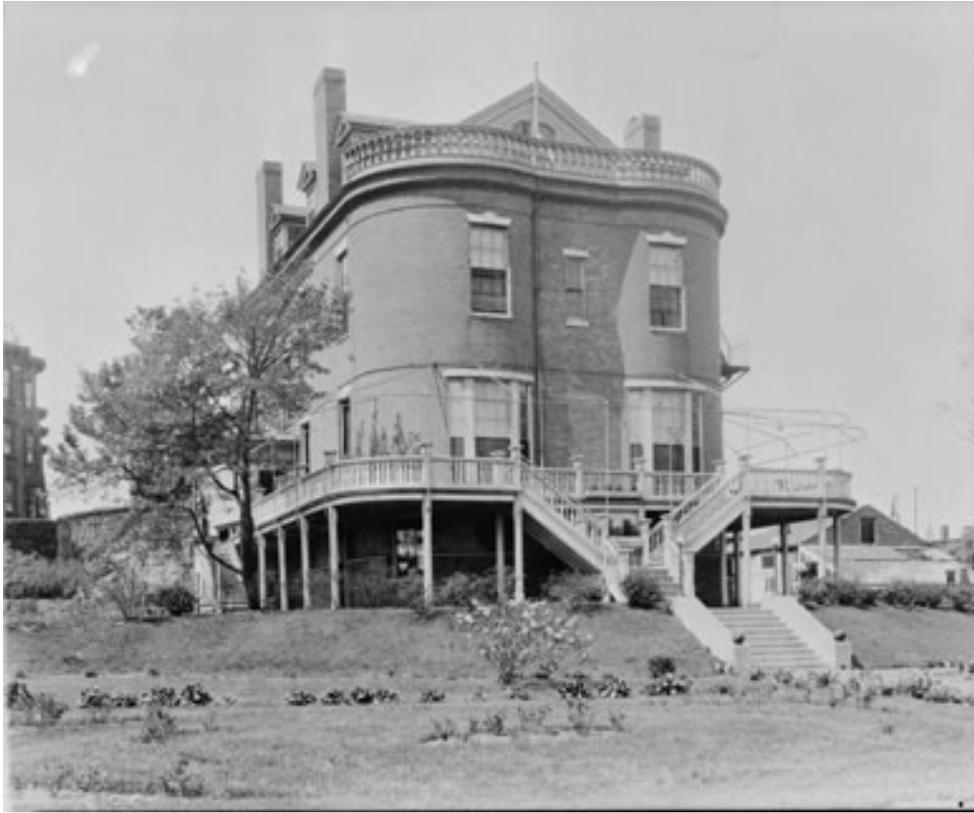
Figure 5.47: The south facade of the Commandant's House (Quarters G) as it appeared in 1934, just before WPA work enclosed the main floor porch (HABS photo (MA-2-10), LC HABS, MASS,13-CHAR,2-2).

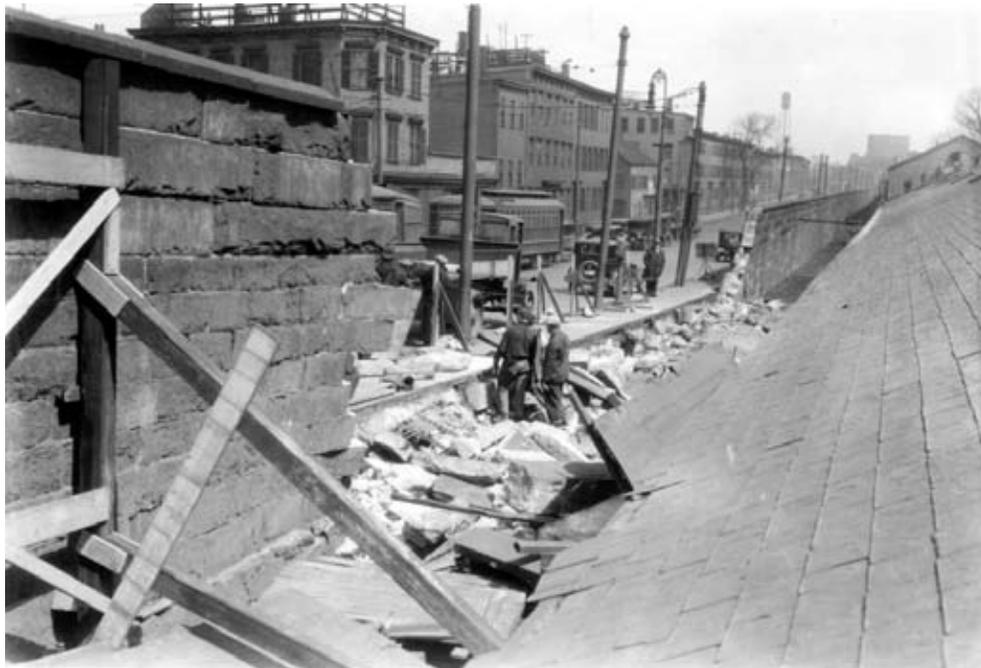
Figure 5.48: Removal of the rubble-filled granite boundary wall between the Ropewalk (Building 58) and Chelsea Street in 1929 (BOSTS-8951).

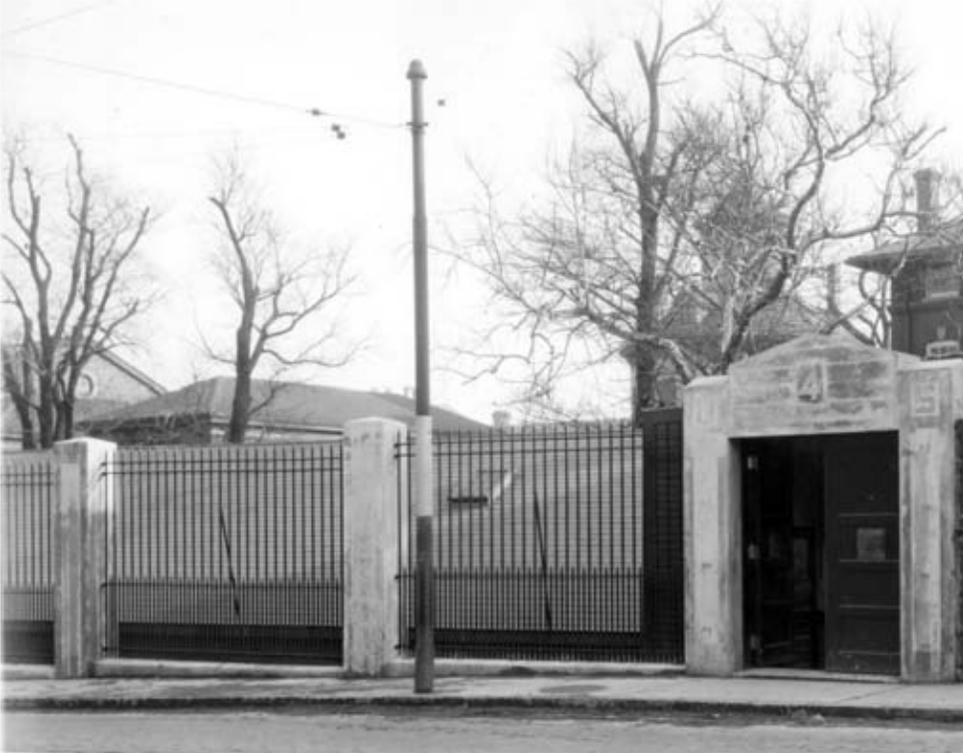
Figure 5.49: Gate 4 after the Navy replaced the granite boundary wall along the Ropewalk (Building 58) with concrete posts and wrought iron fence in 1929 (BOSTS-8951).

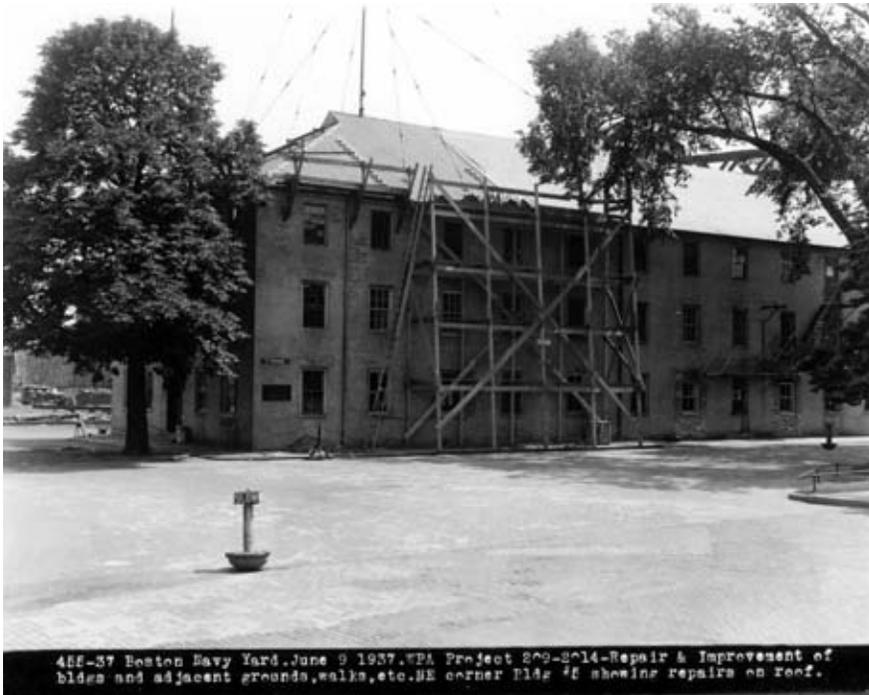
Figure 6.1: WPA repairs and improvements to the north façade of the Navy Store (Building 5) in 1937. First Avenue and Third Street are paved with brick, and a mature horse chestnut tree stands northeast of the building.

WPA projects in the waterfront area included the complete interior reconstruction of the Navy Store (Building 5), reconditioning of the Storehouse (Building 4), remodeling of the Dry Dock Engine House (Building 22), which housed tinsmiths and shipwrights, and extensive paving (Figures 6.1-2). At the head of Pier 1, south of the Navy Store (Building 5) and near the former lawn area, WPA labor constructed the "Navy Exchange Service Station" (Building 194) in the vicinity of the former lawn area (Figures 6.2-3). The gas station was later expanded to include a service bay and served the yard's needs until its removal in the 1970s. To assist in the management of increased water traffic, the Pier 1 Substation (Building 109), the last remnant of the old Coal Storage & Handling Plant, was enlarged in 1942 and again two years later to provide office space for the yard's harbor master.

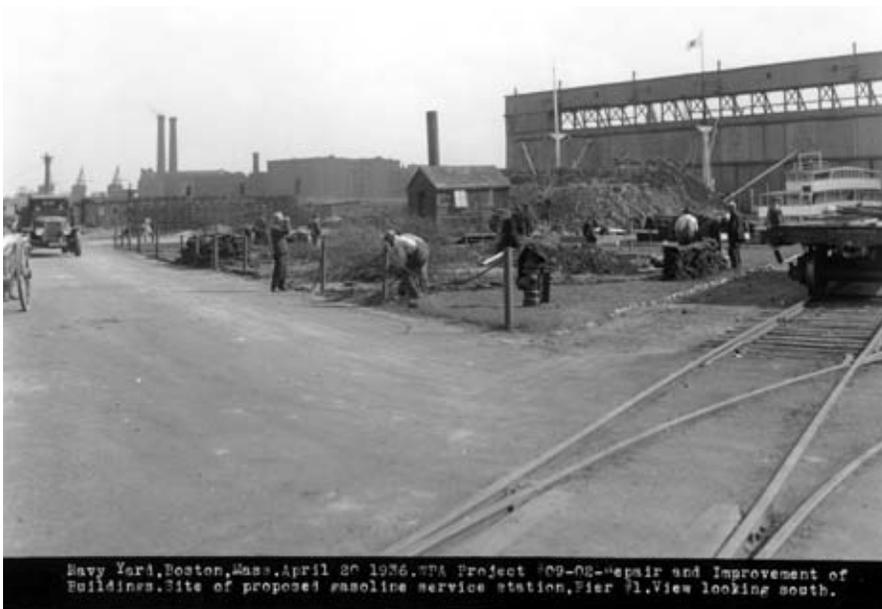
Figure 6.2: Area paved by WPA and crews Navy Exchange Service Station (Building 194) in 1936 (BOSTS-15755).

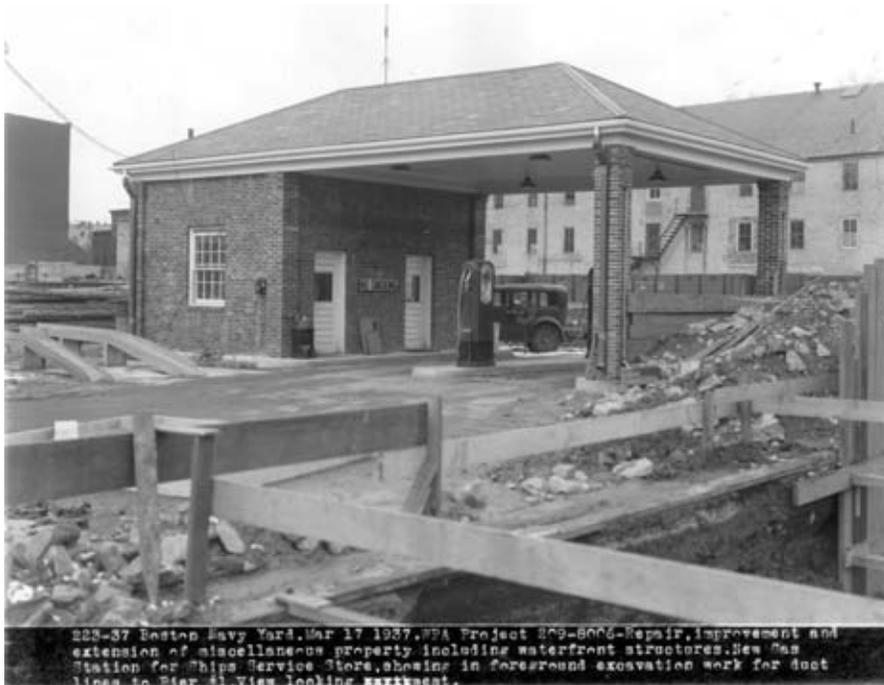
Figure 6.3: The new Navy Exchange Service Station (Building 194) on Pier 1 in 1937 (BOSTS-15755).

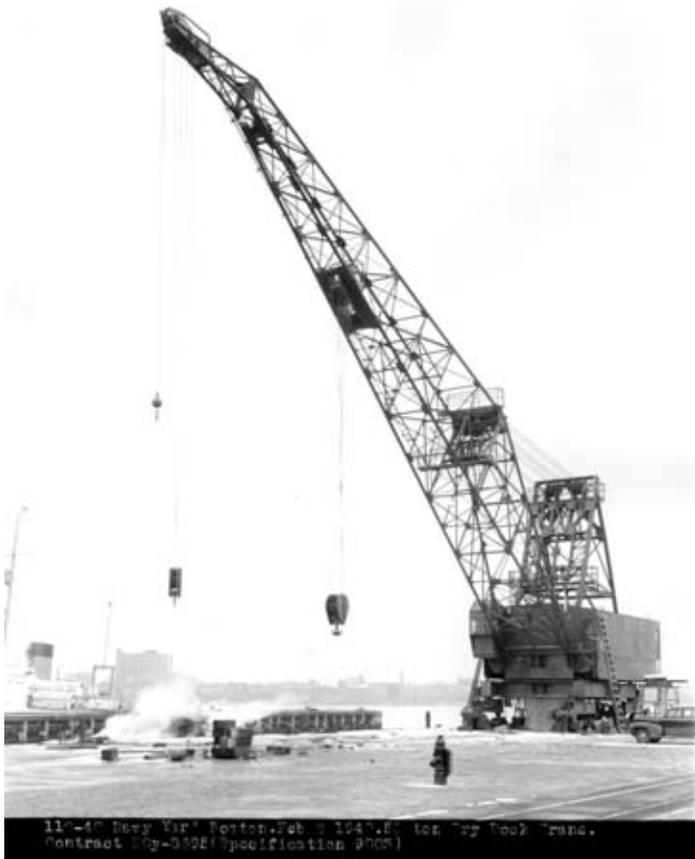
Figure 6.4: A portal crane in 1940 (BOSTS-15673).

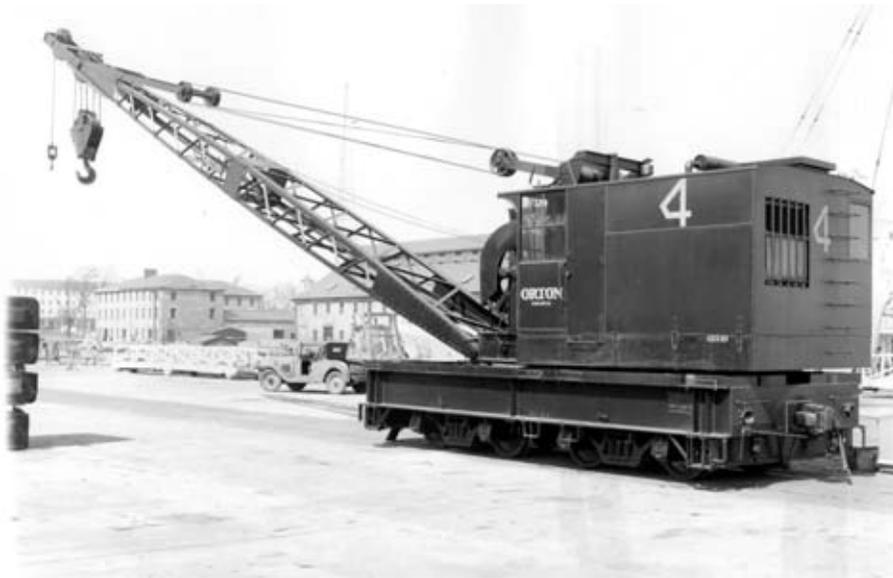
Figure 6.5: A locomotive crane in 1940 (BOSTS-15673).

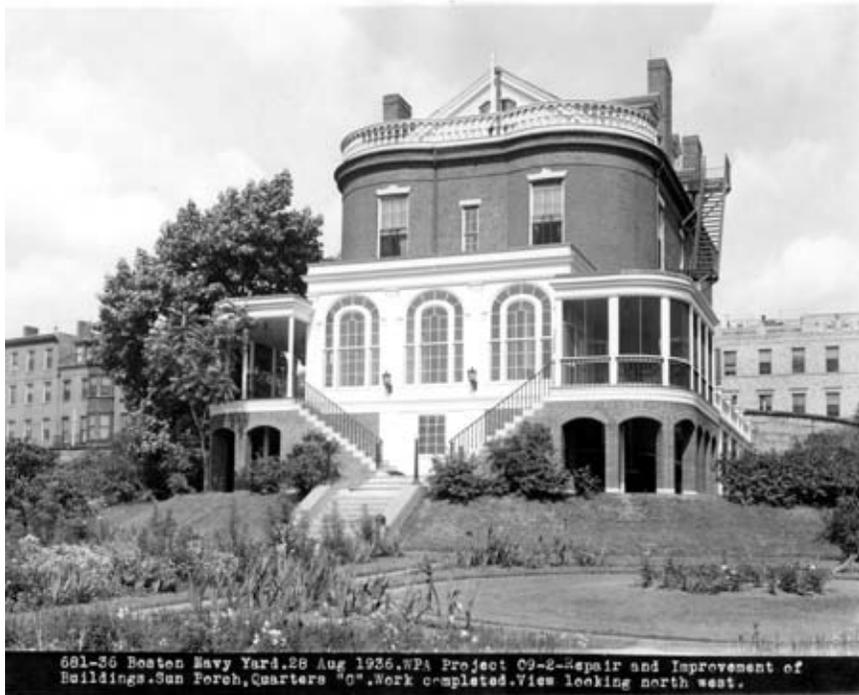
Figure 6.6: The Commandant's House (Quarters G) in 1936 during construction of the new sun porch. Note the garden beds along the walkway (BOSTS-9185).

WPA projects in the upper yard included replacement of the rear porches of the Officers Quarters (Building 246) and the construction of a new sun porch on the south façade of the Commandant's House (Quarters G) along with an addition containing a new brick kitchen and butler's pantry (Figures 6.6-8). 1930's photographs show the south grounds with carefully maintained flower beds on both the lawn and along the central path. Some traces of the Victorian shrub and tree remain, but the plantings were less dense by this time.

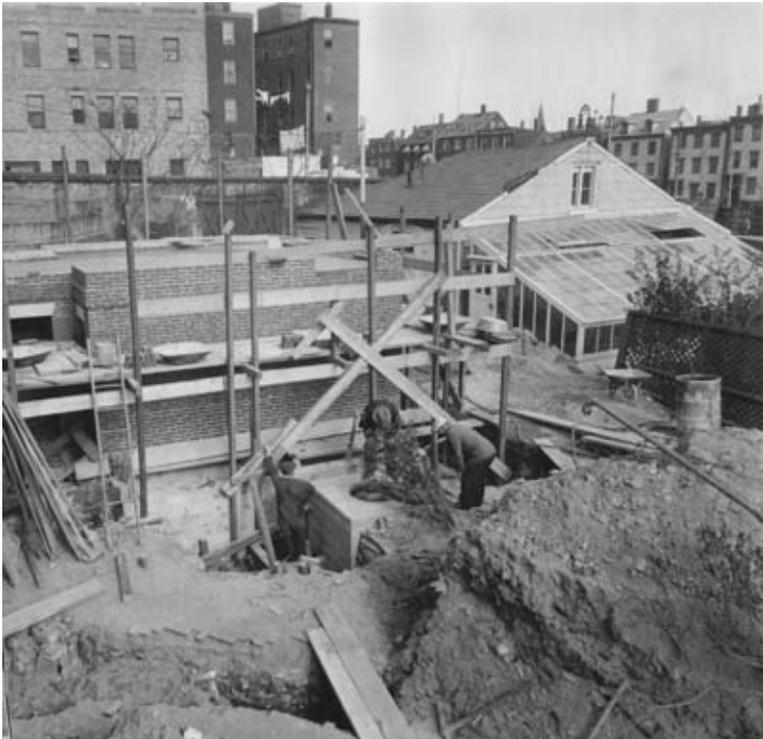
Figure 6.7: WPA crews constructing the kitchen and butler's pantry on the east side of the Commandant's House (Quarters G) in 1938. The Stable (Building 21) and attached greenhouse are in the background (BOSTS-9185).

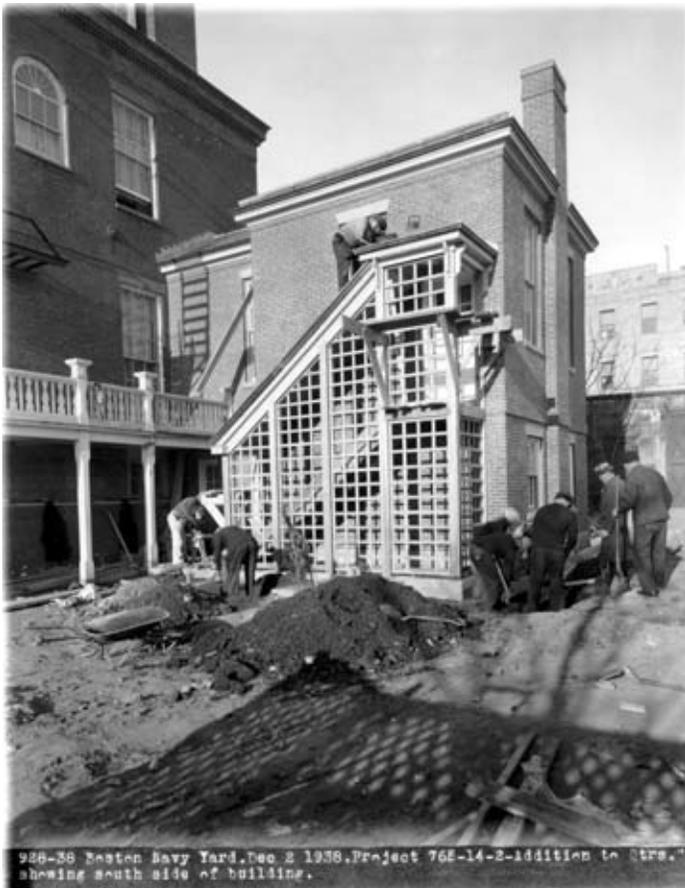
Figure 6.8: The Commandant's House (Quarters G) new kitchen and butler's pantry east wing in 1938 (BOSTS-9185).

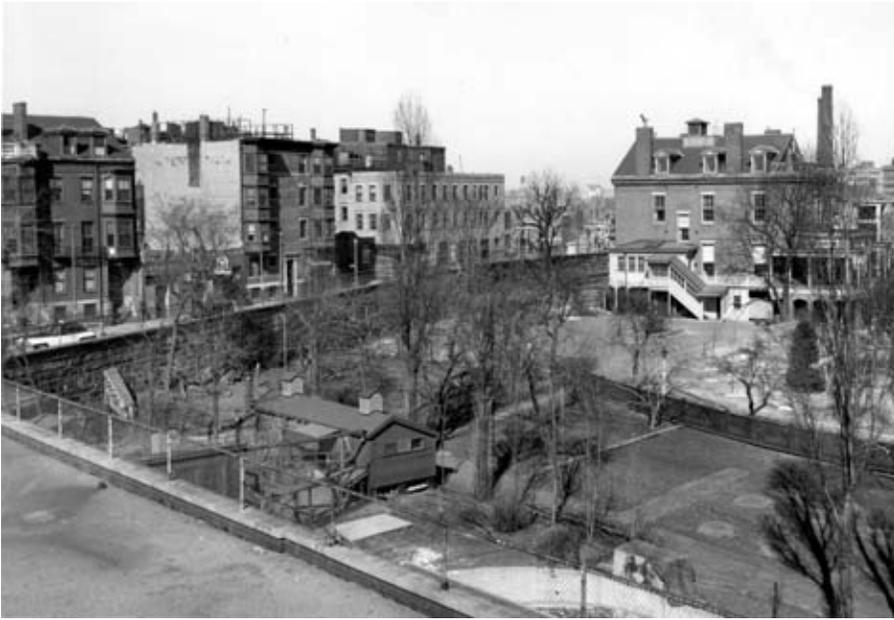
Figure 6.9: The Commandant's House (Quarters G) west yard and boundary wall in 1942 (BOSTS-9187).

side entrance on the basement level gained prominence with access to the west driveway from Second Avenue (Figures 6.9 and 6.10). During World War II, a large water tank was buried beneath the Commandant's House front lawn southwest of the house, and another water tank was installed beneath the Marine Barracks (Building I) Parade Ground. The Commandant's House served as the home for the yard's commandant and family until 1945, when the functions of yard commandant and commandant of the First Naval District were separated. For the next thirty years the district commandant occupied the house. The shipyard's commandant was relocated to Quarters P in the eastern end of the yard.⁹

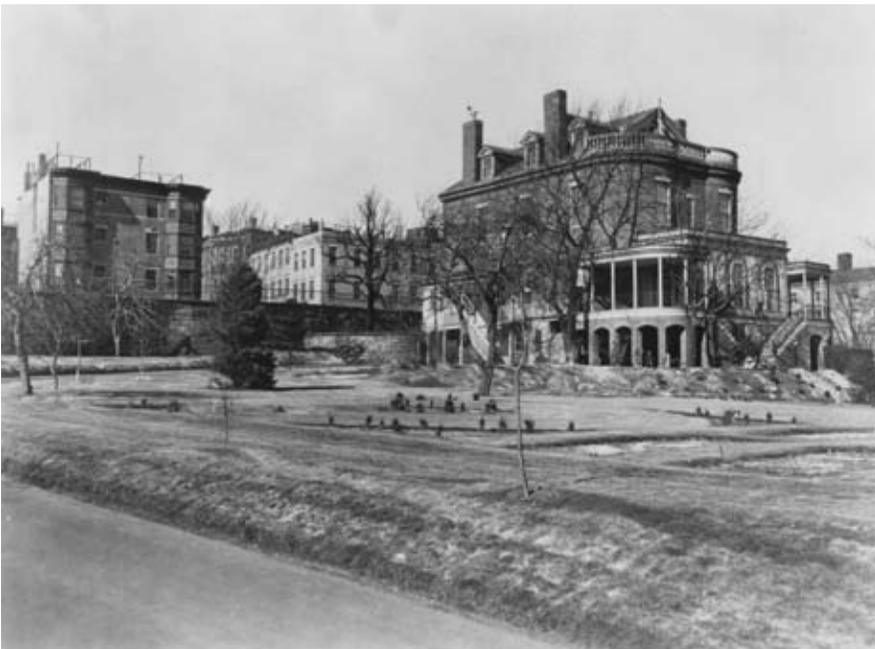
Figure 6.10: The Commandant's House (Quarters G) west yard and boundary wall in 1942 (BOSTS-9187).

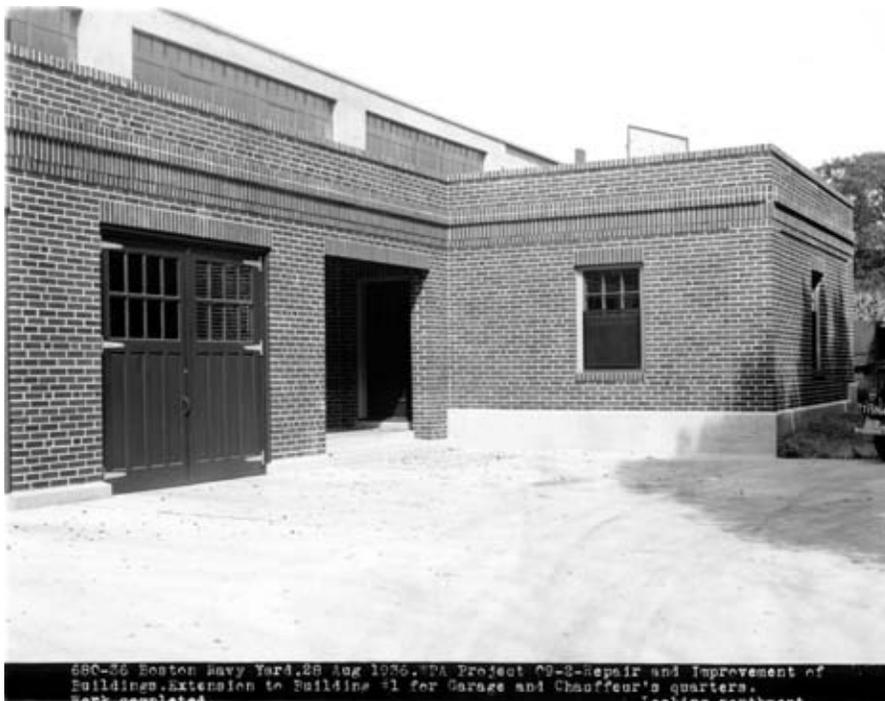
Figure 6.11: The completed Garage and Chauffeur's Quarters (Building 1) in 1936 (BOSTS-9250).

To the west of the Commandant's House, the WPA built the Garage and Chauffeur's Quarters in 1936 (Figure 6.11) with the Quarters B-F Garages (Building 269) to the north. These new structures along with the new drive to the Commandant's House reduced the green space associated with this corner of the yard. In 1941, with the opening of Gate 2, a gatehouse was added to Garage and Chauffeur's Quarters which then became Building I with the razing of the existing Building I. WPA workers added fireproof stair towers and open porches to the Marine Barracks (Building I). The WPA crews also enlarged the south end of the Marine Corps Administration Building (Building 136), which was later demolished in the 1970s (Figure 6.12). Similarly the WPA improved the tennis courts in front of the Marine Barracks but their work was subsequently obliterated in 1940 with the construction of a three-story, wood-frame Temporary Storage Structure (Building 198) (Figure 6.13-15). This building also housed Women Accepted for Volunteer Emergency Service (WAVES) during the war. The Navy constructed three new tennis courts in 1946 in the area south of the Commandant's House (Quarters G) between First and Second Avenues and Third and Fourth Streets.

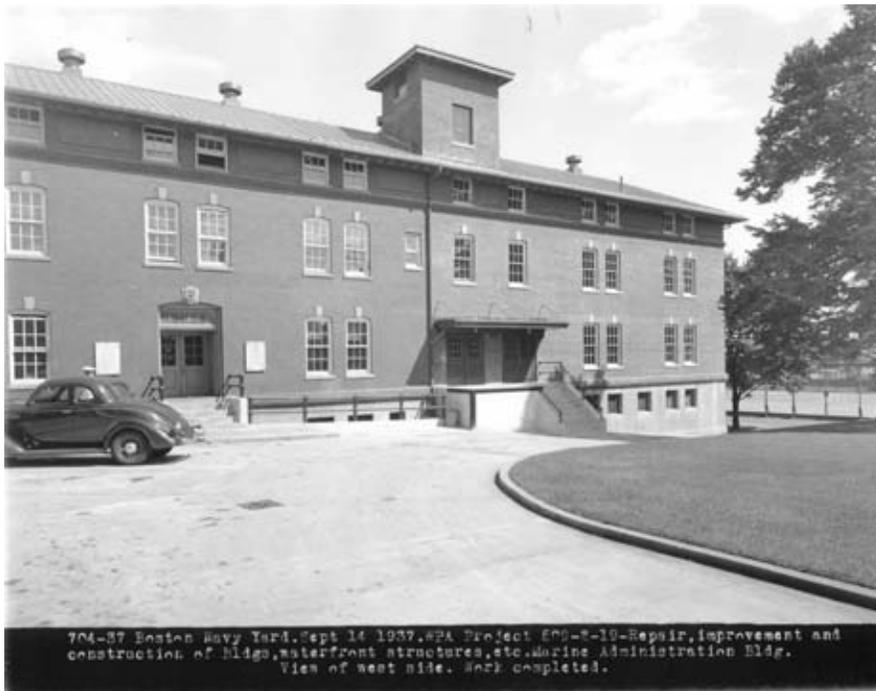
Figure 6.12: The Marine Corps Administration Building (Building 136) in 1937 after being enlarged to the south by the WPA (BOSTS-9883).

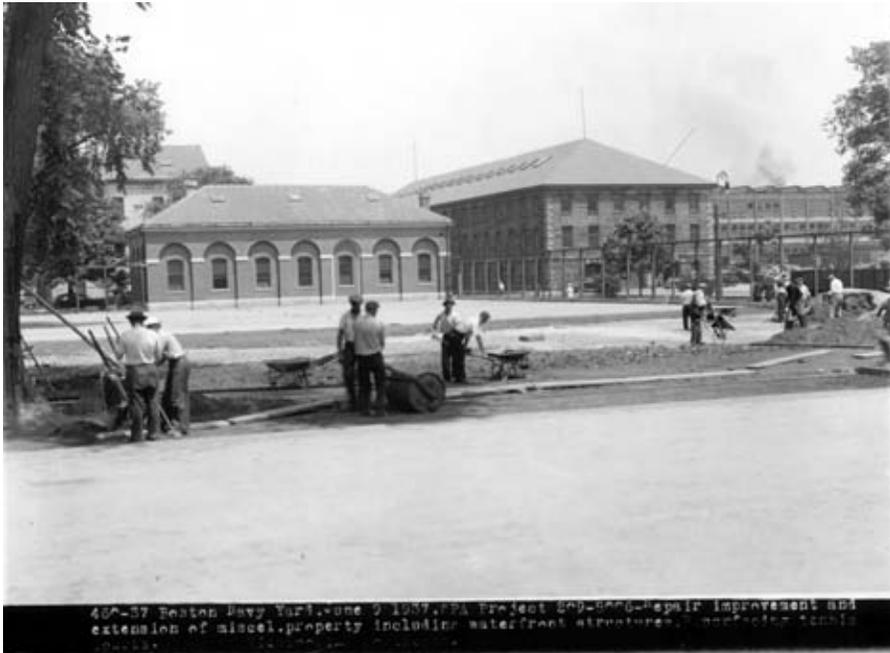
Figure 6.13: WPA crews improving the tennis courts in 1937 (Future site of the Temporary Storage Building (Building 198)) (BOSTS-1660).
