CULTURAL LANDSCAPE REPORT FOR CHARLESTOWN NAVY YARD

BOSTON NATIONAL HISTORICAL PARK
BOSTON, MASSACHUSETTS

INTRODUCTION

SITE HISTORY

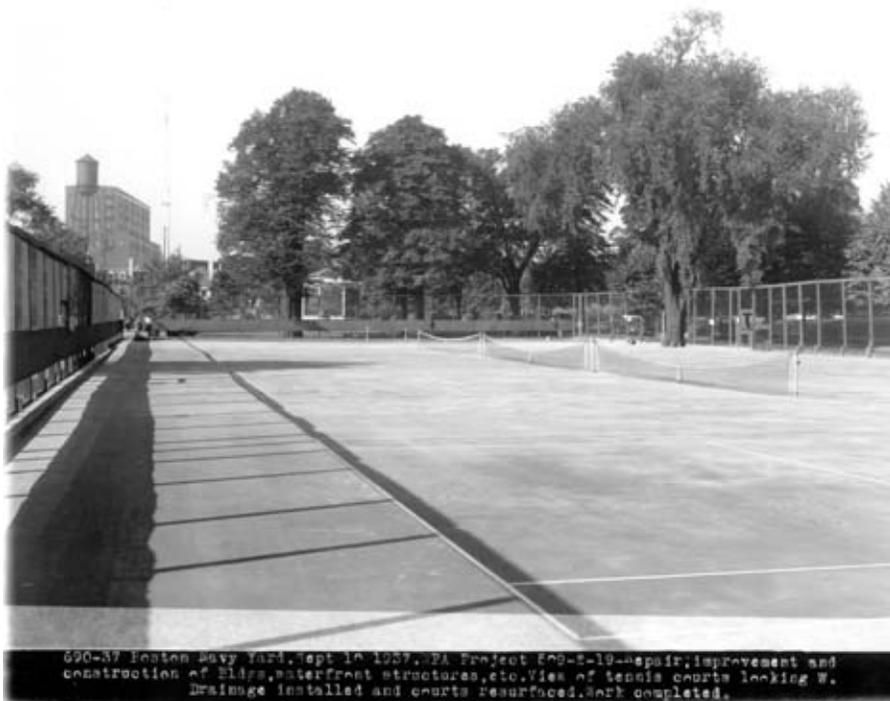
Figure 6.14: Tennis courts improved by WPA in 1937 (BOSTS-15660).

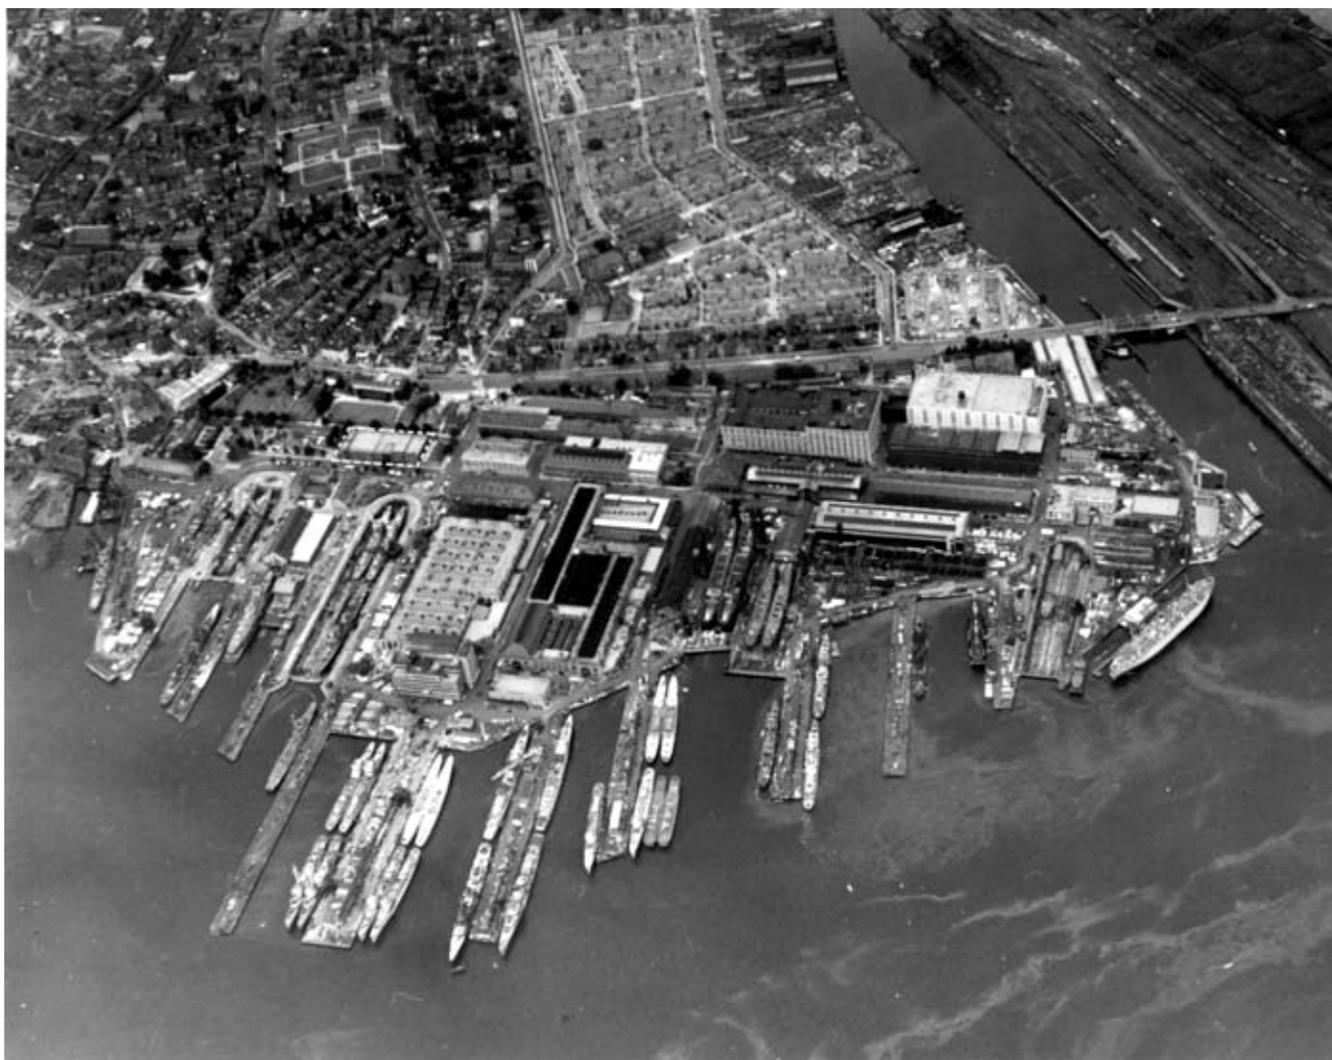
Figure 6.15: Aerial photograph of the yard in 1945 showing the impact of the Temporary Storage Building (Building 198) (highlighted with a dashed line) on the upper yard. Note trees along First and Second Avenues in the upper yard and along the former Flirtation Walk south of the Ropewalk (Building 58) (BOSTS-8615).

Central Power Plant, and the Dispensary (Buildings 31, 108, and 120) eliminated Flirtation Walk, the tree-lined boardwalk that led from Gate 4 to the lower officers' quarters. Some of Flirtation Walk's trees persisted into the 1950s though (Figure 6.15). As temporary structures and building extensions intruded upon secondary streets and avenues, the main unit seemed to have reached its maximal capacity. Crowding at the main yard, together with its limited anchorage, led to an aggressive program of external plant expansion, particularly at the South Boston Annex. Structural improvements at South Boston Annex included construction of twenty-five new buildings and expansion of docking capacity to service large warships. Additional quarters for crews of destroyers of the North Atlantic patrol supplemented those at Frazier Barracks in the main yard. In addition, the Navy retook possession of Lockwood's Basin facilities (leased in 1934 to the Bureau of Marine Fisheries of the Commonwealth of Massachusetts) and developed the U.S. Naval Fuel Annex in the Orient Heights section of East Boston.¹¹

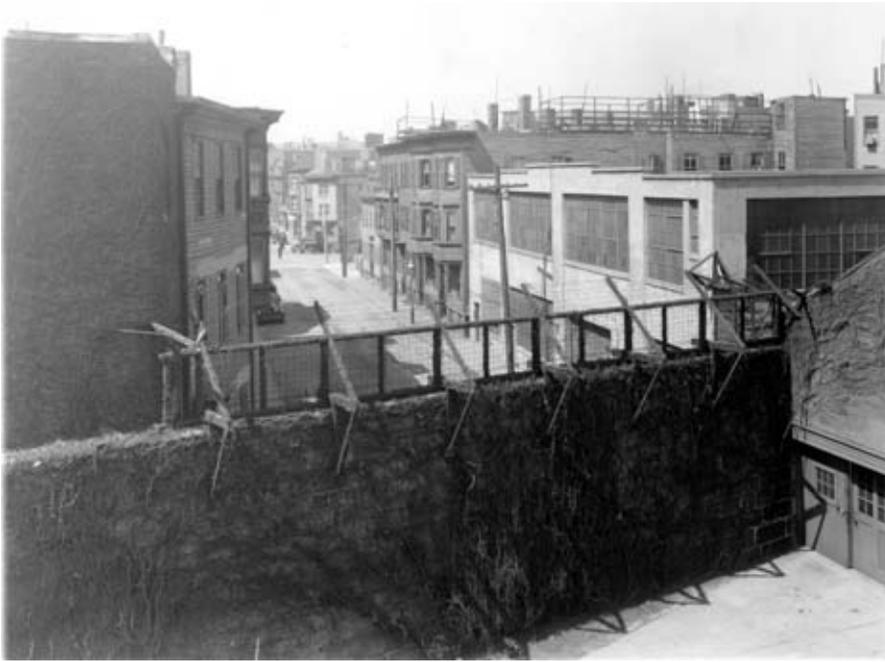
Figure 6.16: Looking west down Henley Street in 1937, showing the Transportation Office (Building 204) outside the wall and the original Building 1 inside the wall, lower right. This section of wall was removed to create Gate 2, and the original Building 1 was replaced by a gatehouse addition to the WPA Garage and Chauffeur's Quarters (new Building 1). Riordan Stables on the left was demolished during World War II (BOSTS-9155).

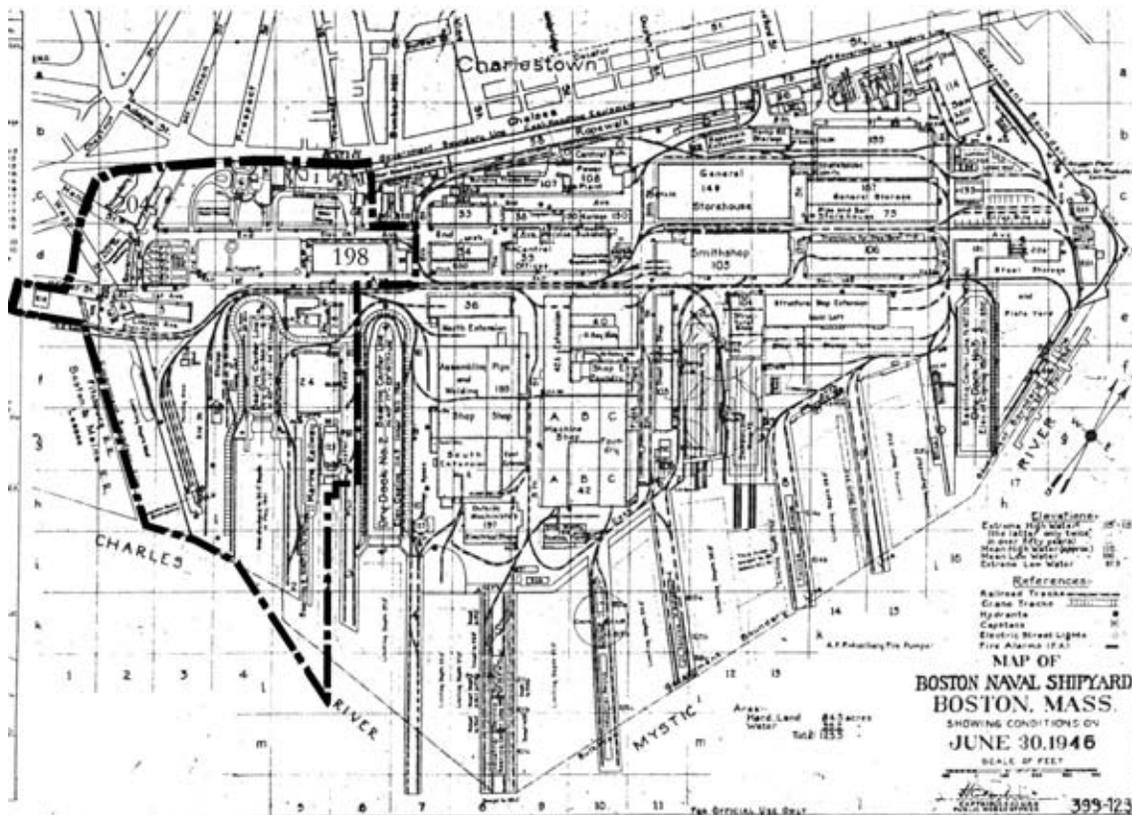
Figure 6.17: Plan of the yard in 1946 showing the extended bulkhead line, and the congested post-war yard, including the Temporary Storage Building (Building 198) and the Transportation Office (Building 204) in the upper yard and Navy Exchange Service (Building 194) on Pier 1. The current park boundary is outlined (Boston National Historical Park).

Following the war's end, the Boston Navy Yard's multi-site facility was designated the Boston Naval Shipyard beginning in November 1945 and remained busy converting troop transports, deactivating ships, and completing ship construction (Figures 6.17-18). The demobilization of the fleet included mothballing several vessels, as well as completion of construction, repairs, and outfitting, and preparation of some vessels for scrapping. Demobilization and the paring of the civilian labor force dictated removal of surplus equipment, material, and supplies, including excess cranes, trucks and passenger cars and stockpiled shipbuilding materials in the immediate post-war years. In addition, the yard became responsible for maintenance and security of local deactivated facilities, including Hingham's Bethlehem shipyard, renamed the U.S. Naval Storehouse in Hingham.¹²

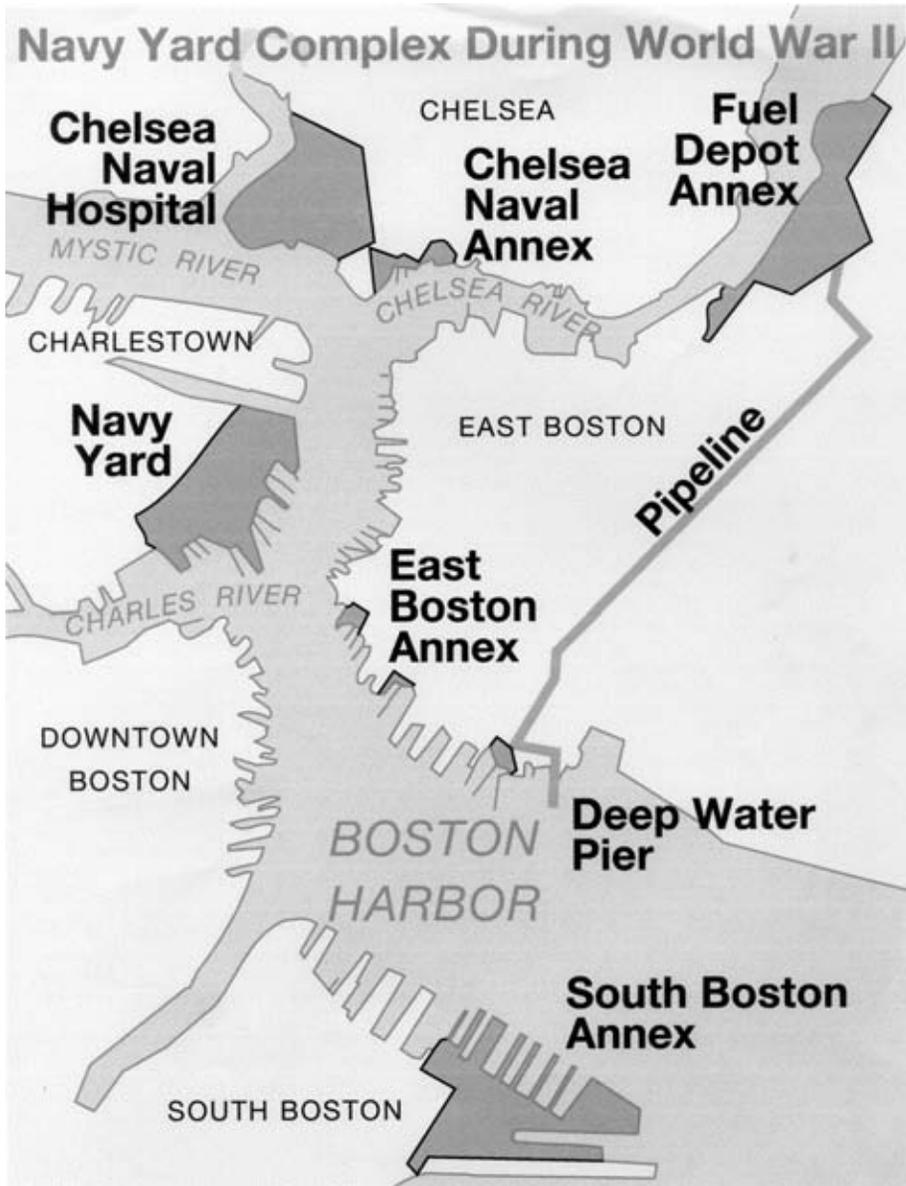
Figure 6.18: Plan of the multi-site Boston Naval Shipyard during World War II (Boston National Historical Park).

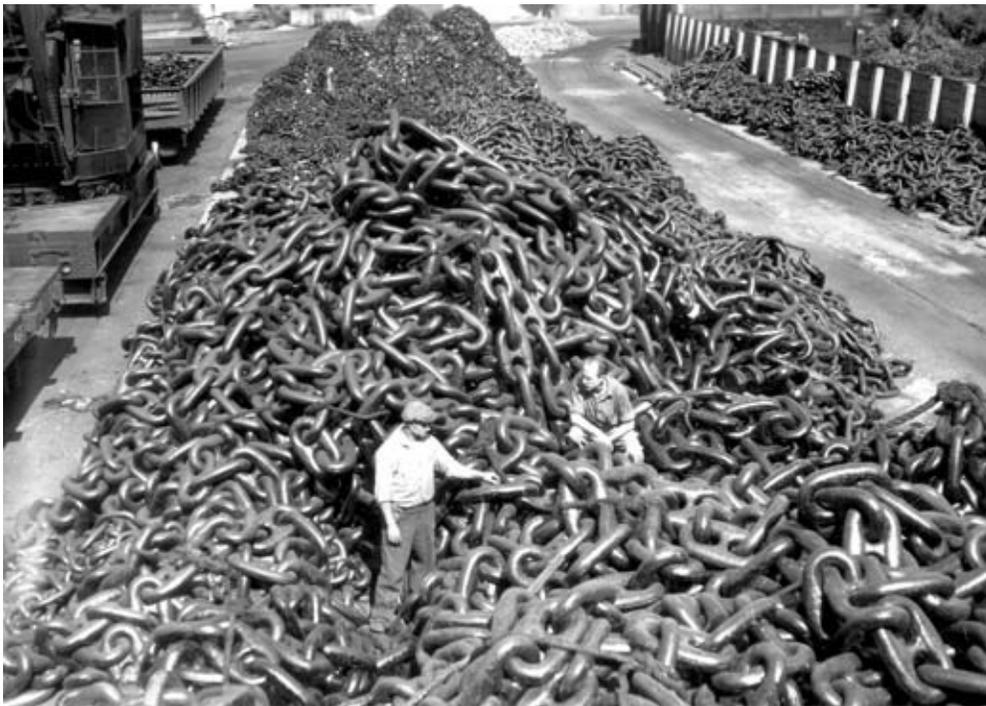
Figure 7.1: Yard-manufactured die-lock chain stored in piles, 1943 (BOSTS-9669).

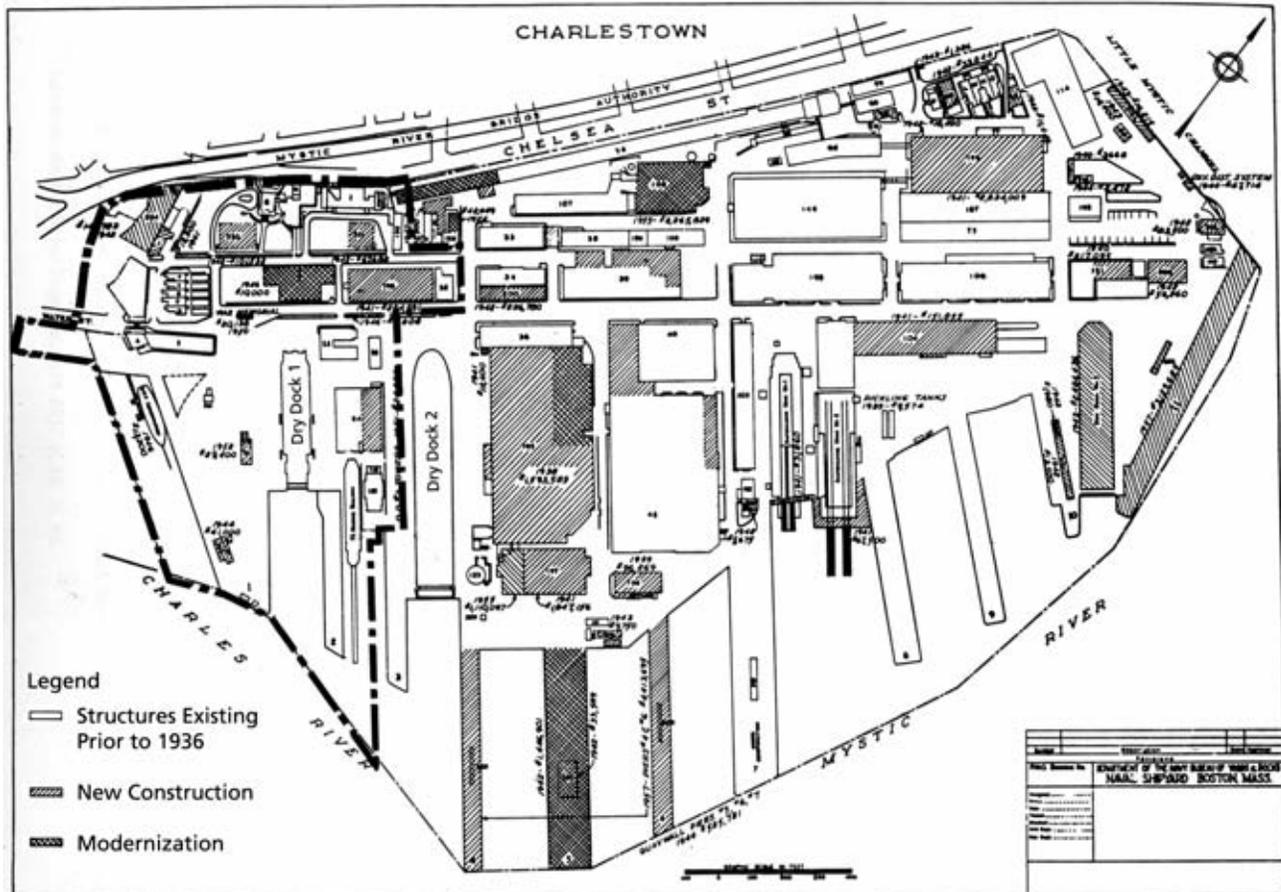
Figure 7.2: A shortage of space and funding favored the modernization and enlargement of existing structures, rather than construction of new facilities as recorded in 1957. Current park boundary is outlined (Boston National Historical Park).

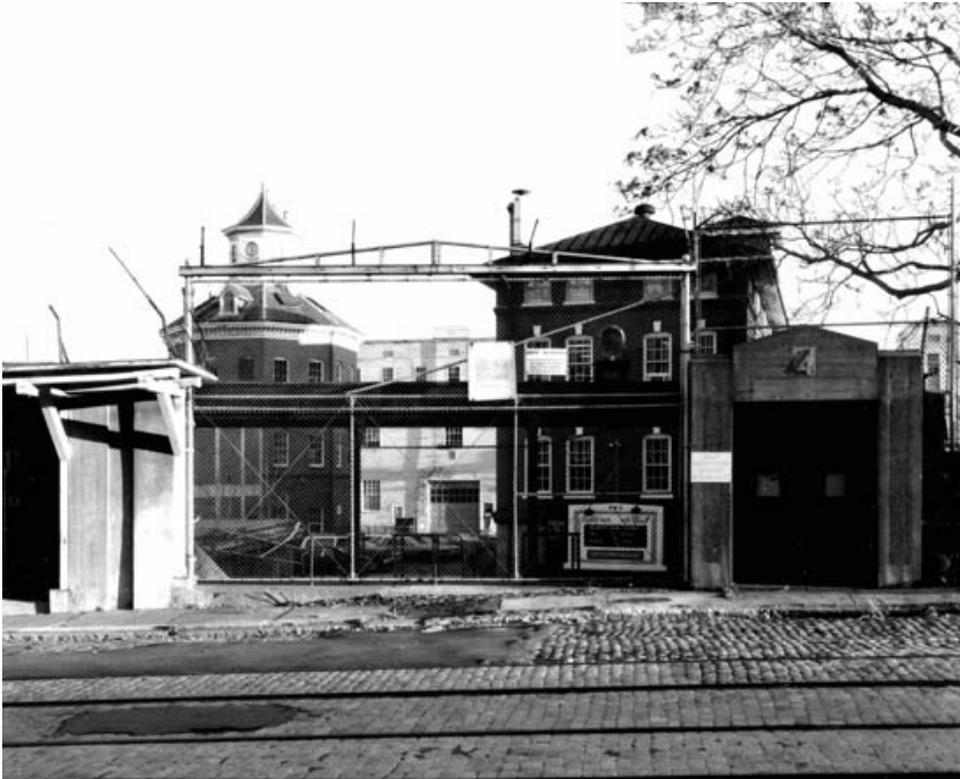
Figure 7.3: The pedestrian Gate 4 looking into the yard from Chelsea Street in 1977. The Muster House (Building 31) is to the left, the Temporary Storehouse (Building 198) is in the center, and the Marine Corps Administration Building (Building 136) is to the right (HAER photo).

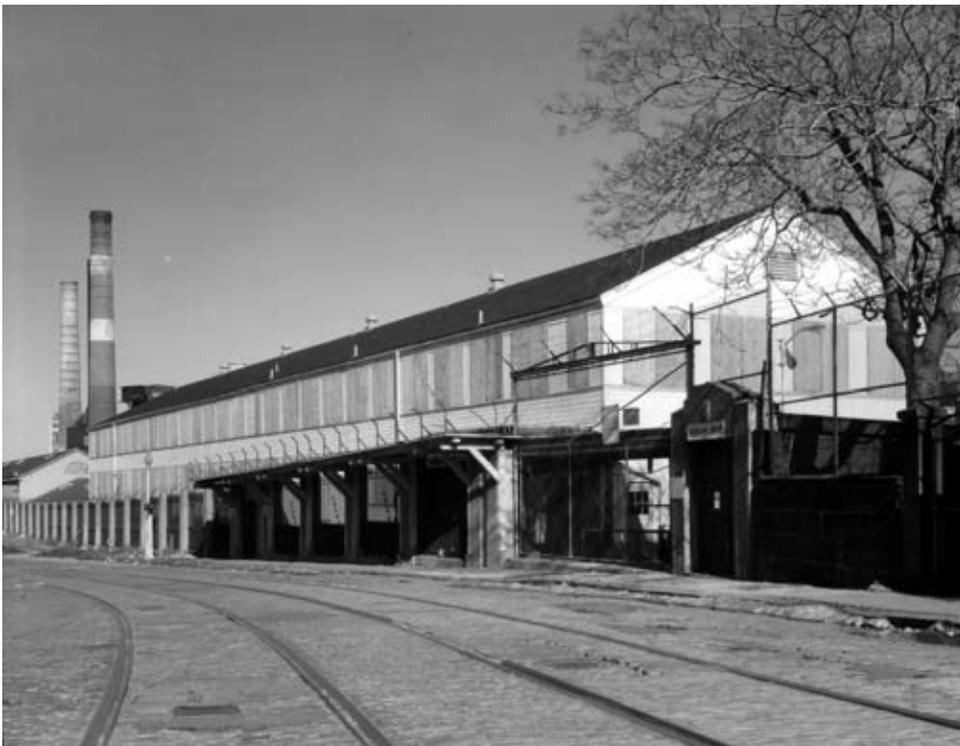
Figure 7.4: The Chelsea Street trolley tracks, the Ropewalk (Building 58) wooden second-story addition, and pedestrian Gate 4 in 1977 (HAER photo).

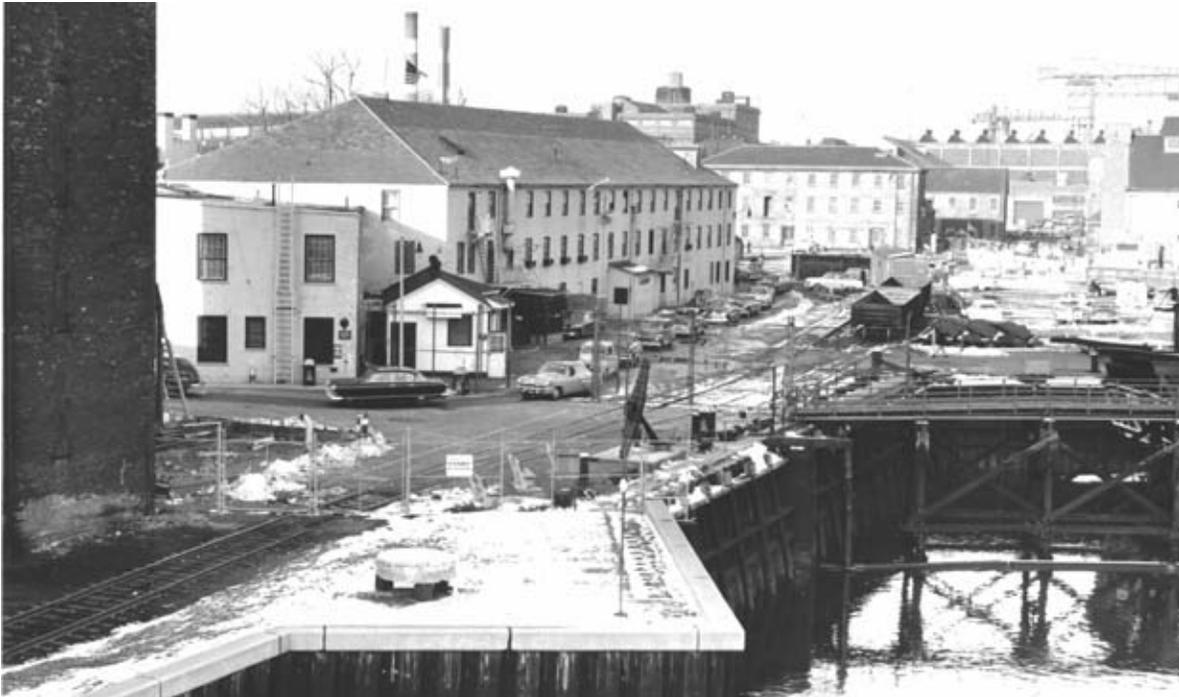
Figure 7.5: The west and south facades of the Storehouse (Building 4) and the Navy Store (Building 5) in 1955. Pier 1 is to the right. The Police Booth, used to screen cars, sits in the corner of the two buildings. Vehicles on Lincoln Avenue are leaving the yard by the “out” gate between the Storehouse (Building 4) and the Hoosac Stores (BOSTS-15714).

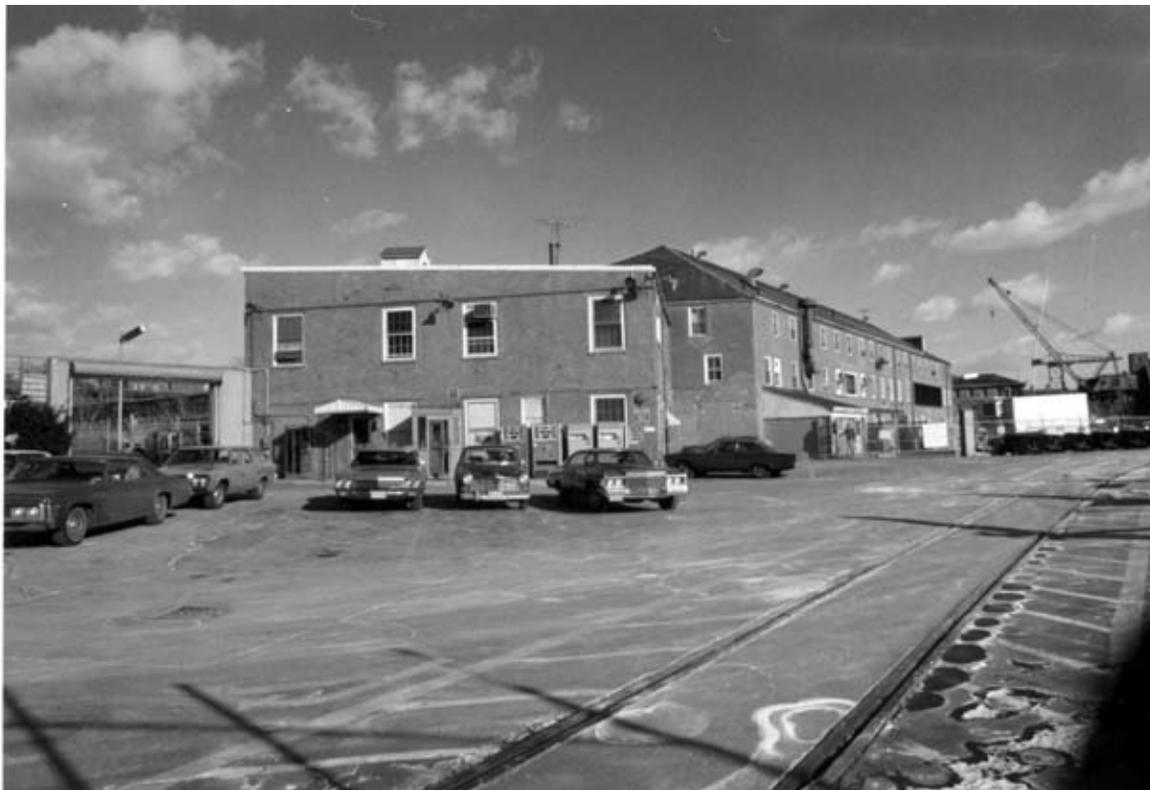
Figure 7.6: The west and south facades of the Storehouse (Building 4) and the Navy Store (Building 5) in 1974. The Police Booth adjacent to the Storehouse (Building 4) and the chain link fence and gate that ran between Building 4 and the northeast corner of Pier 1 are gone. The “in” gate is visible to the left of Building 4 (BOSTS-8869).

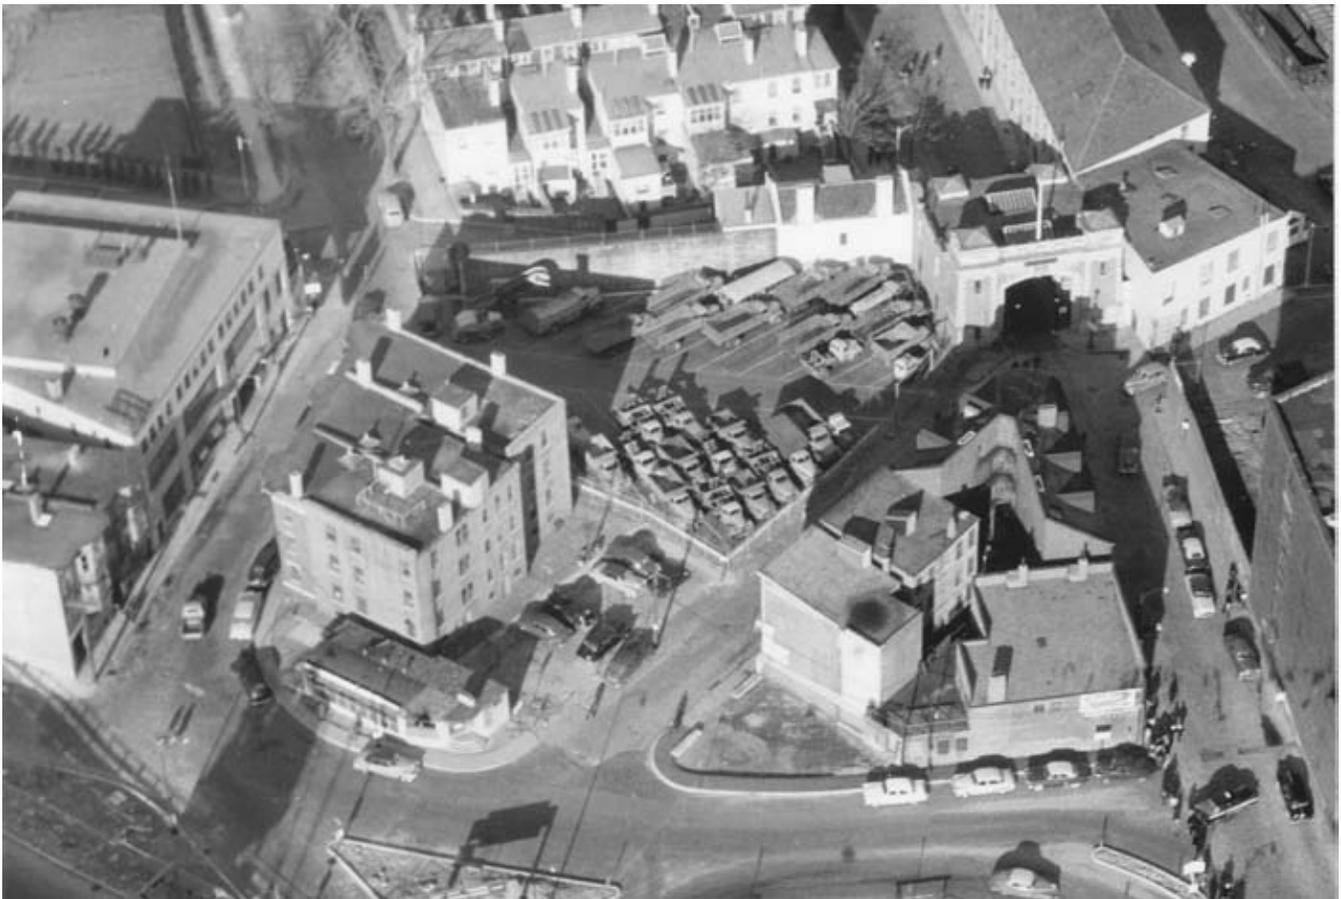
Figure 7.7: An October 1954 aerial view of a parking lot outside the Yard's western wall, between Gates 1 and 2. The Officers Quarters (Building 265) are seen at the top of the image, and Gate 1 (Building 97) is in the upper left attached to the Storehouse (Building 4) (BOSTS-8665).

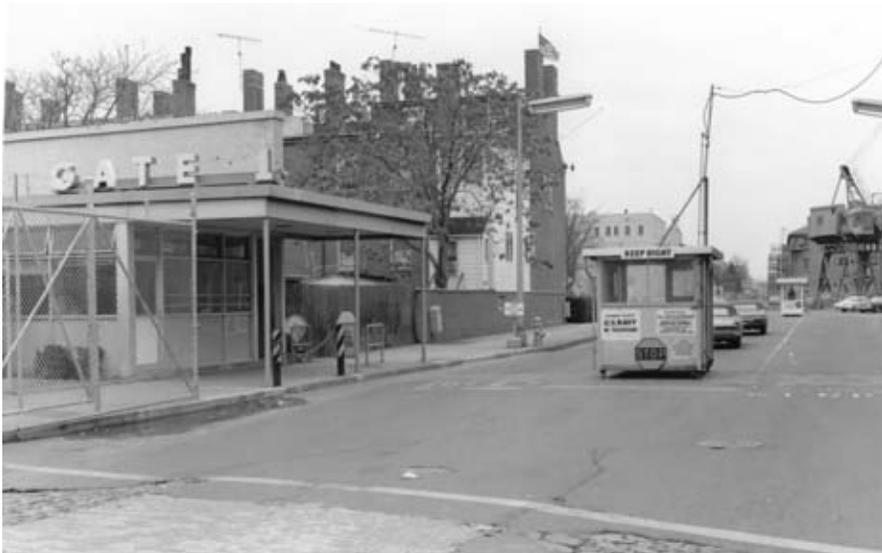
Figure 7.8: Gate 1 Gatehouse (Building 267) constructed in 1959 (BOSTS-8949das163a).

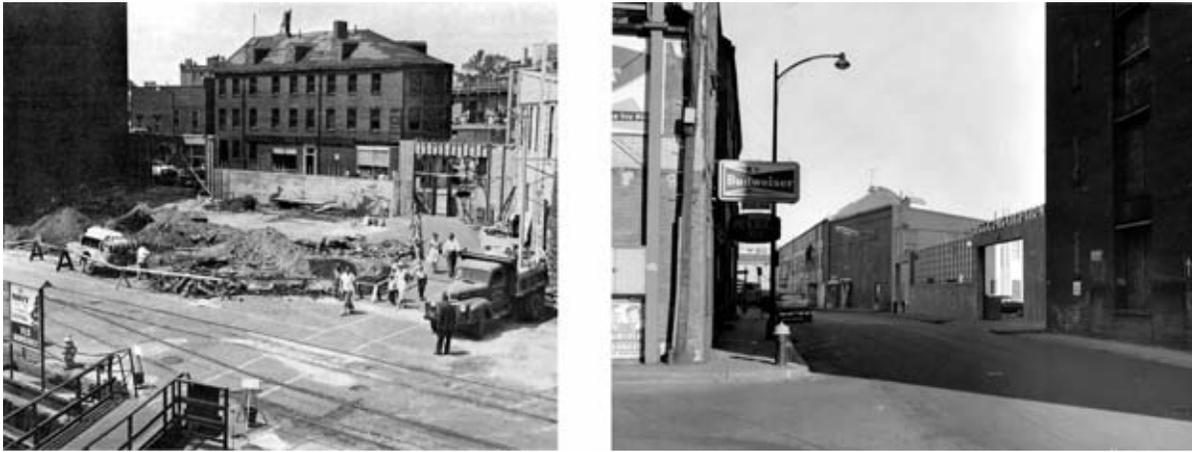
Figure 7.9: USS *Constitution* parking area south of Gate 1. Left: 1955 view of the construction looking northwest as seen from Pier 1. Right: 1959 view from First Avenue looking southeast. The Storehouse (Building 4) is left of the gate, and the Hoosac Stores are to the right (Boston Naval Shipyard News and BOSTS-15655).

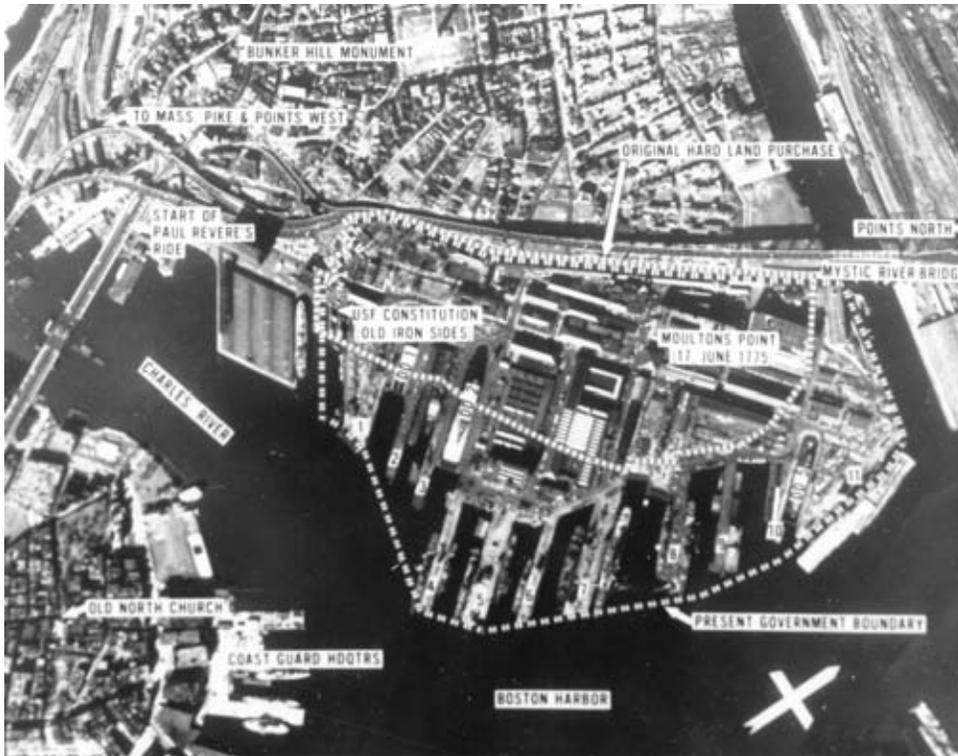
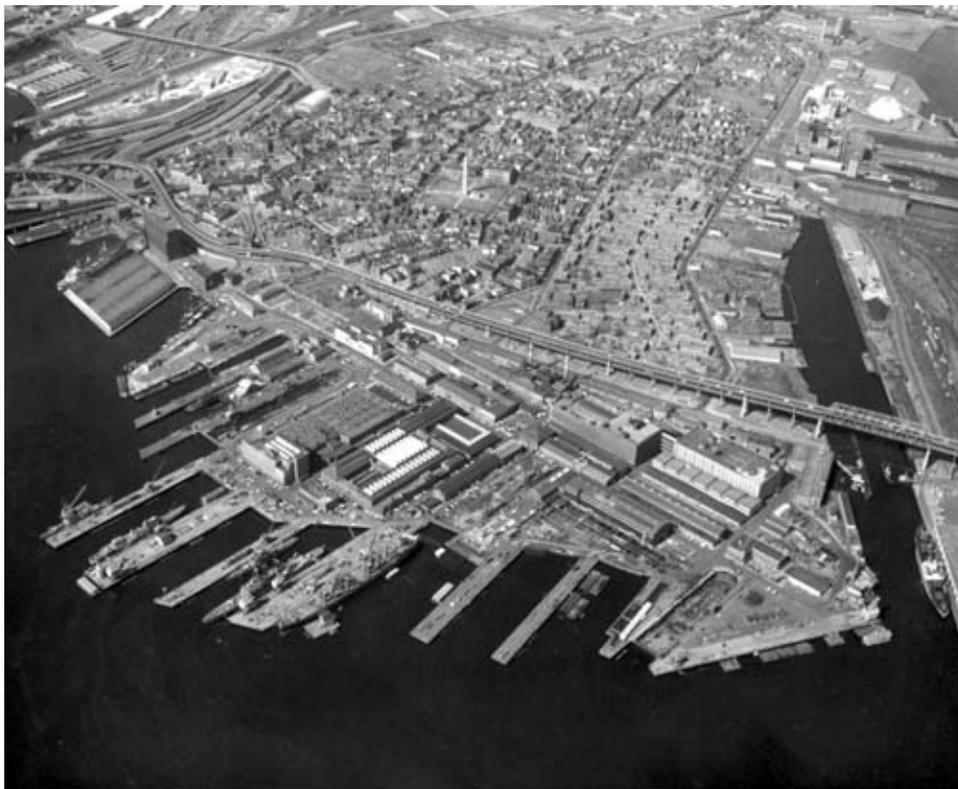
Figure 7.10: Aerial photographs in 1966 showing Mystic River Bridge along the northern boundary of the yard (Boston NHP).

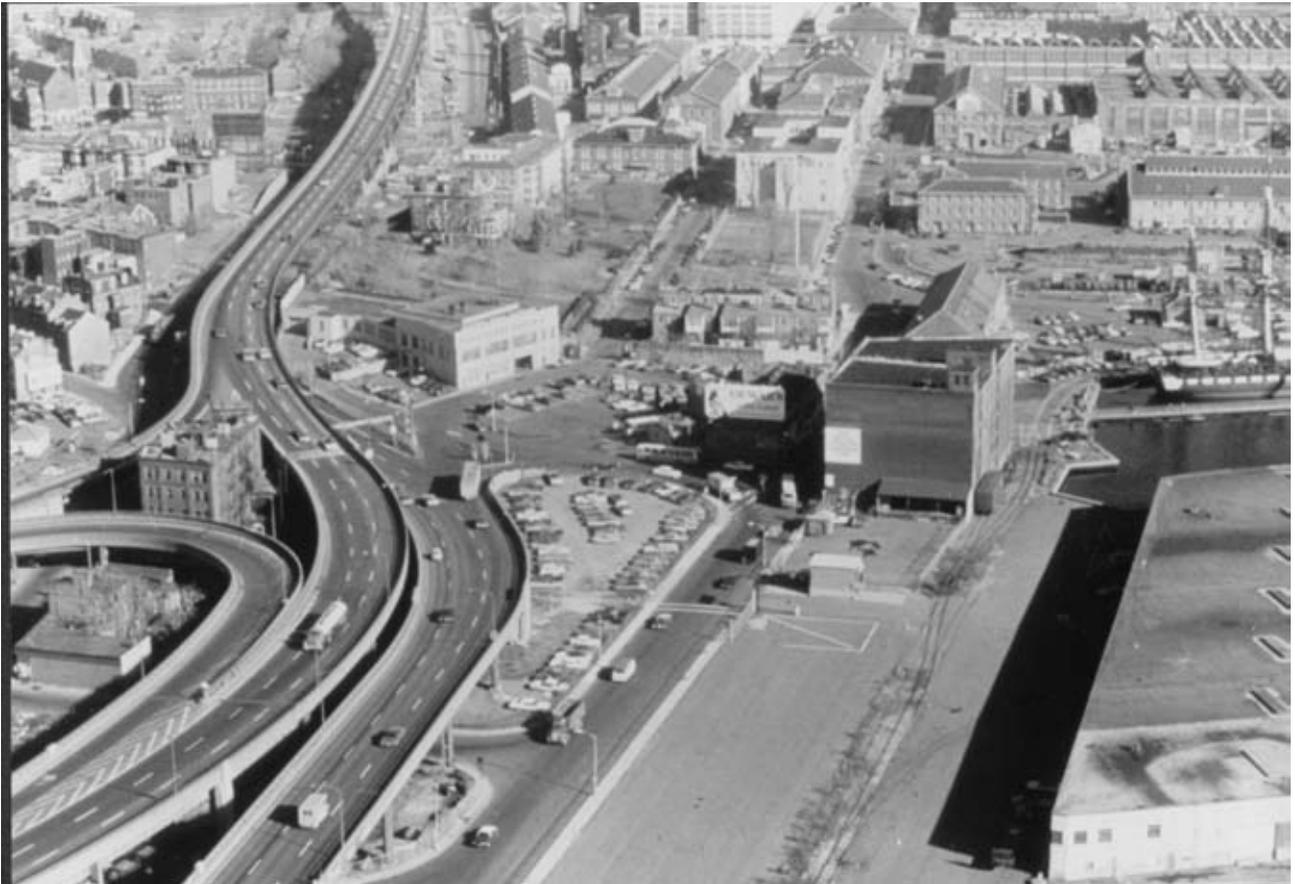
Figure 7.11: By 1974, the parking area had increased with the demolition of several buildings outside the yard. The Mystic River Bridge and Central Artery connector is on the left, and the Hoosac Stores building is on the right. The northern boundary wall remains in its original configuration, and the white, cube-shaped Transportation Garage (Building 204) still stands west of the Commandant's House (Quarters G) (BOSTS-8874, 8674).

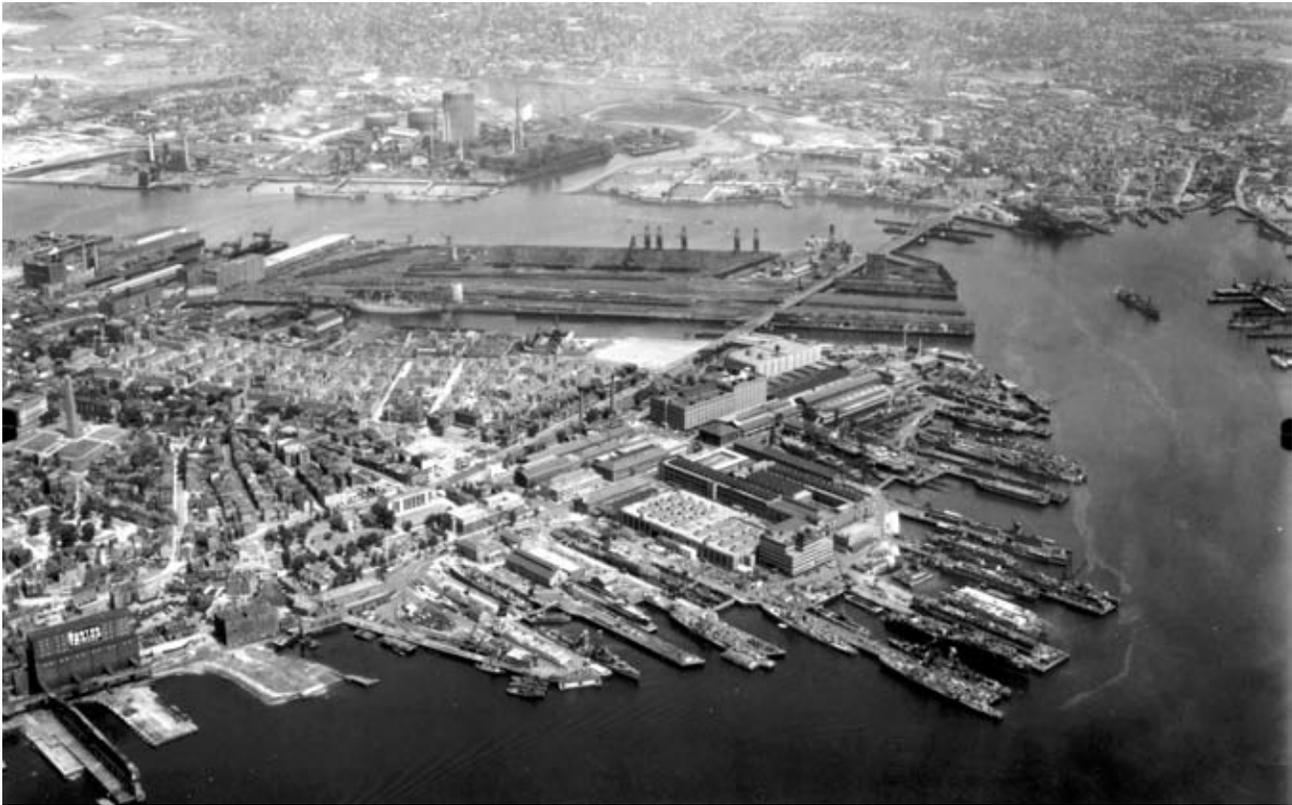
Figure 7.12. The densely congested yard, hemmed in by the Mystic and Charles Rivers on three sides and Charlestown on the fourth side as seen in July 1945. The only trees are located in the upper yard mainly at the Commandant's House (Quarters and along First and Second Avenues by the Shipyard Mall (recreation area). Some trees remain along the former Flirtation Walk south of the Ropewalk (Building 58) (BOSTS-8615-1073).

In 1951, Shipyard Commander Pleasant D. Gold Jr. described the site as a “densely congested area of buildings and facilities, hemmed in by the Mystic and Charles Rivers on three sides and the overhead Mystic River Expressway on the fourth side” (Figure 7.12).²⁸ The Muster House (Building 31), having been stripped of its porch c. 1930, looked even more stark by the close of the 1950s after hurricanes had destroyed many of the remaining trees along Second Avenue in the upper and lower yards. Now virtually no vegetation surrounded this building or its neighbors, the Marine Administration Building, the Temporary Storehouse, and the Shell House (Buildings 136, 198, and 32). At this time, yard employees parked their cars on angle against each of the buildings further adding to the cramped conditions.

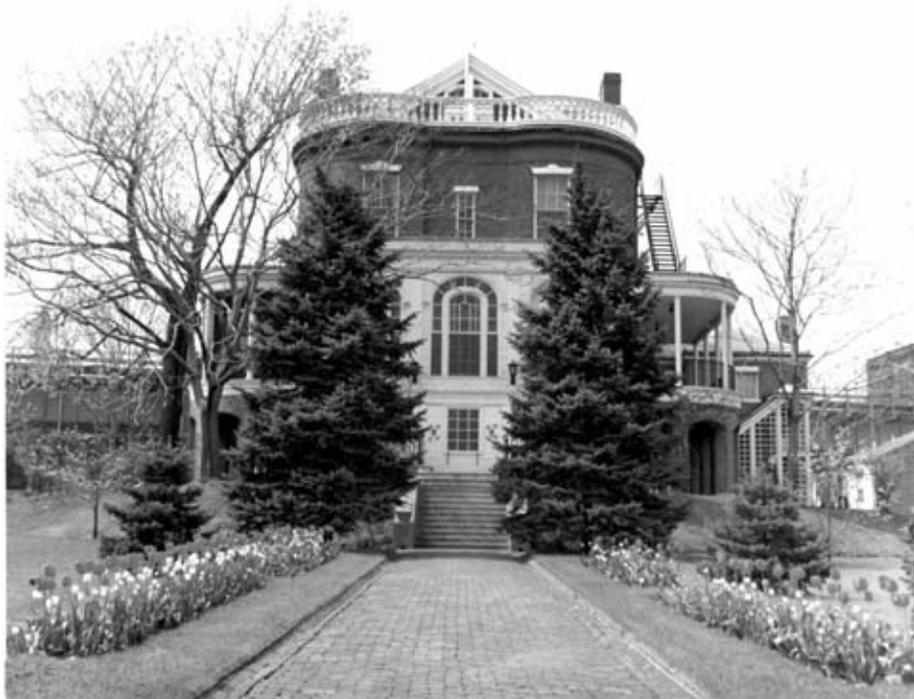
Figure 7.13: Commandant's House, c. 1966. Note the large spruce trees (BOSTS-9192).

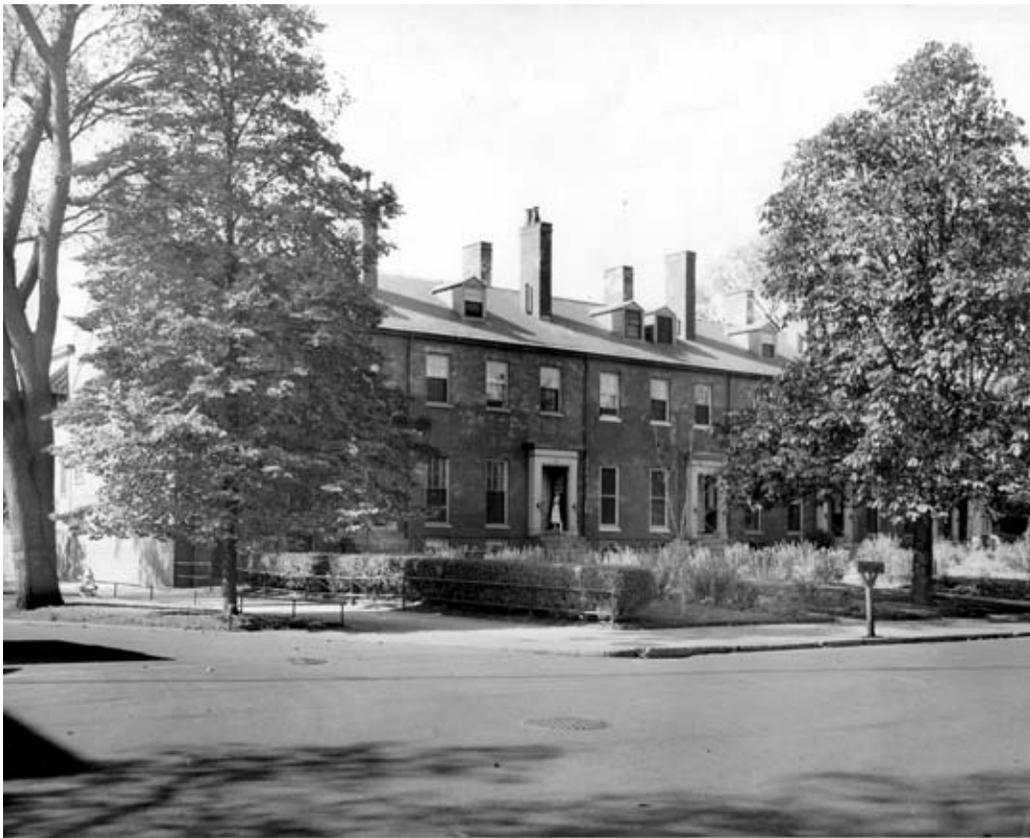
Figure 7.14: Officers Quarters (Building 265) in 1948. Hedges line the front walkways and a horse chestnut tree grows along Third Street. A large elm tree grows south of the building along First Avenue (BOSTS-9167).

Vegetation also highlighted the grounds of the Officers Quarters (Building 265) and the Marine Barracks (Building I) (Figure 7.14). In 1964, the 1.35-acre parcel encompassing the Marine Barracks (Building I), the parade ground, and

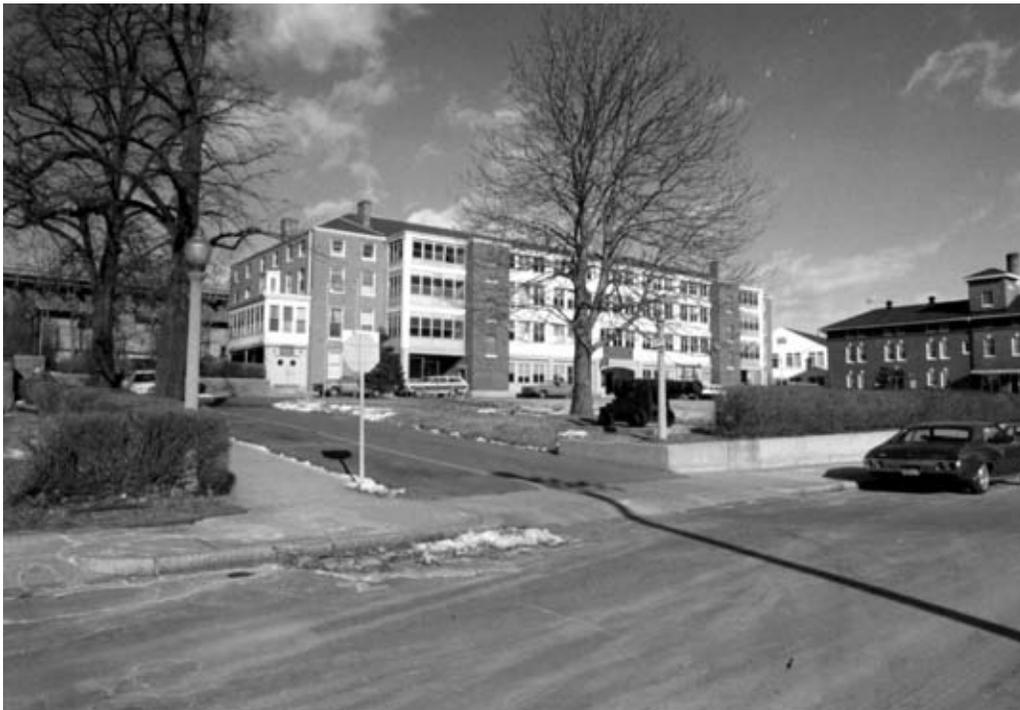
Figure 7.15: Marine Barracks (Building I), driveway, and Parade Ground, 1974. Note the privet hedges and the linden trees to the left (BOSTS-9228).

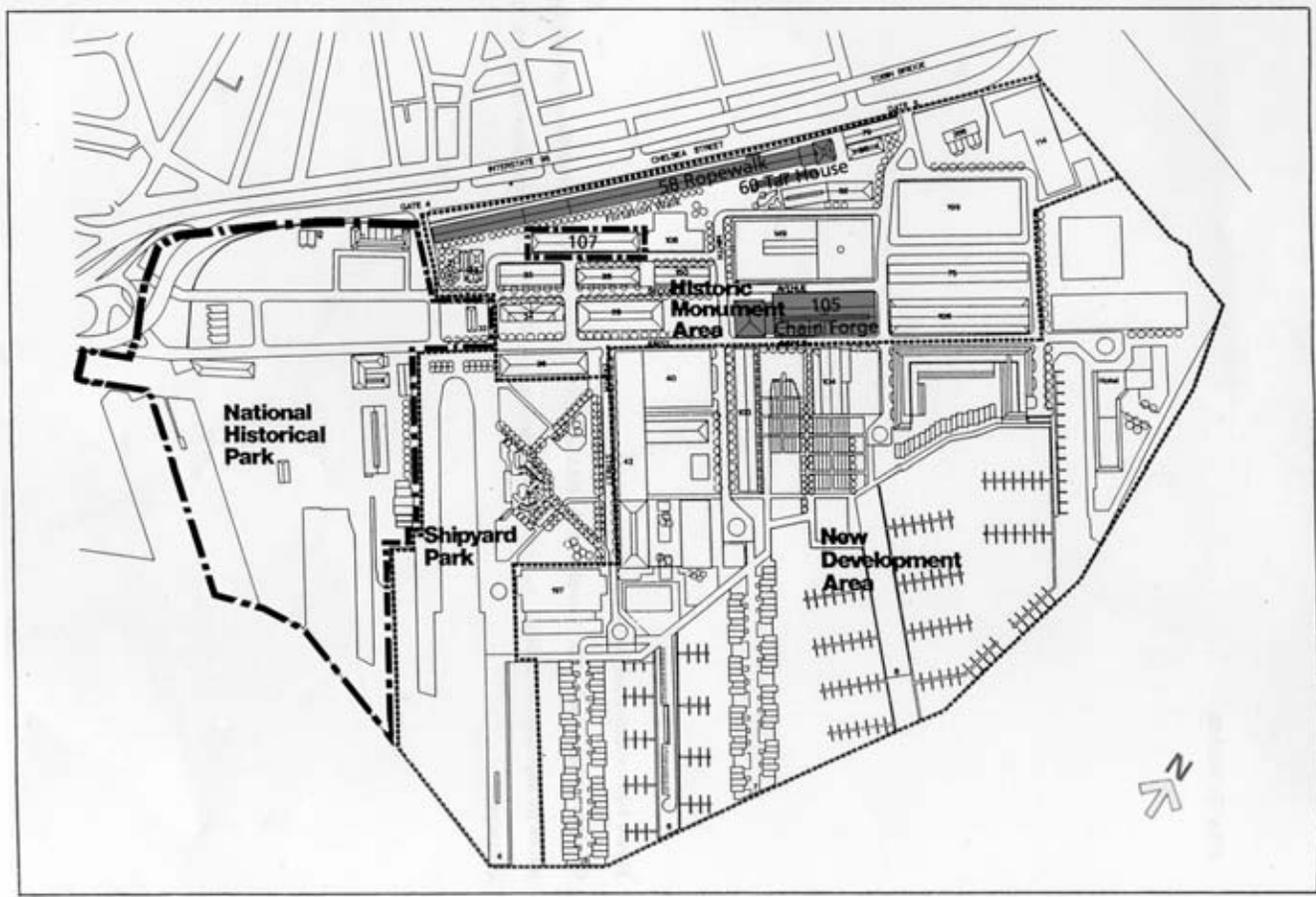
Figure 8.1: Charlestown Navy Yard plan showing National Park Service property (dashed lines) and Boston Redevelopment Authority property (dotted lines). The three noncontiguous properties that are included in the park's legislative boundary are highlighted in gray and include the Ropewalk (Building 58), the Tar House (Building 60), and the Chain Forge (Building 105) (General Development Plan, 1980).

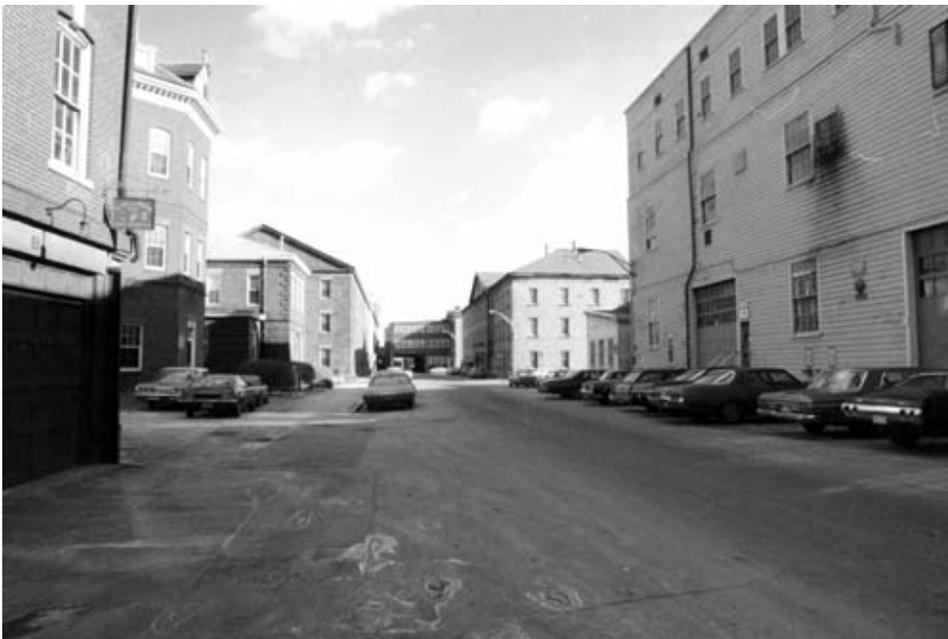
Figure 8.2: View looking east on Second Avenue in 1974 (BOSTS-8671).

while inadvertently providing a snapshot of the conditions at the yard. In general, few changes had been made since the yard's closure. Photographs show that the streets were completely paved to the facades of buildings, with few sidewalks and almost no curbing (Figures 8.2-8.7). Railroad and crane tracks were extant, as were numerous chain link fences.

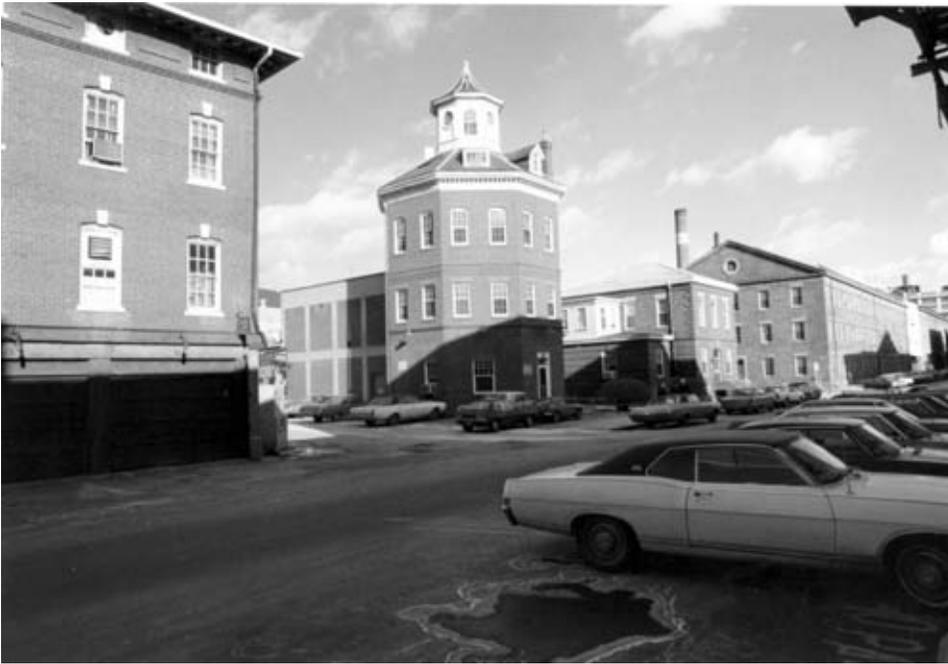
Figure 8.3: View of the Muster House (Building 31) without its porch at the intersection of Second Avenue and Fifth Street. The World War II addition (behind) and the Marine Corps Administration Building (Building 136) would soon be razed (BOSTS-8671).
