CULTURAL LANDSCAPE REPORT FOR CHARLESTOWN NAVY YARD

BOSTON NATIONAL HISTORICAL PARK
BOSTON, MASSACHUSETTS

INTRODUCTION

SITE HISTORY

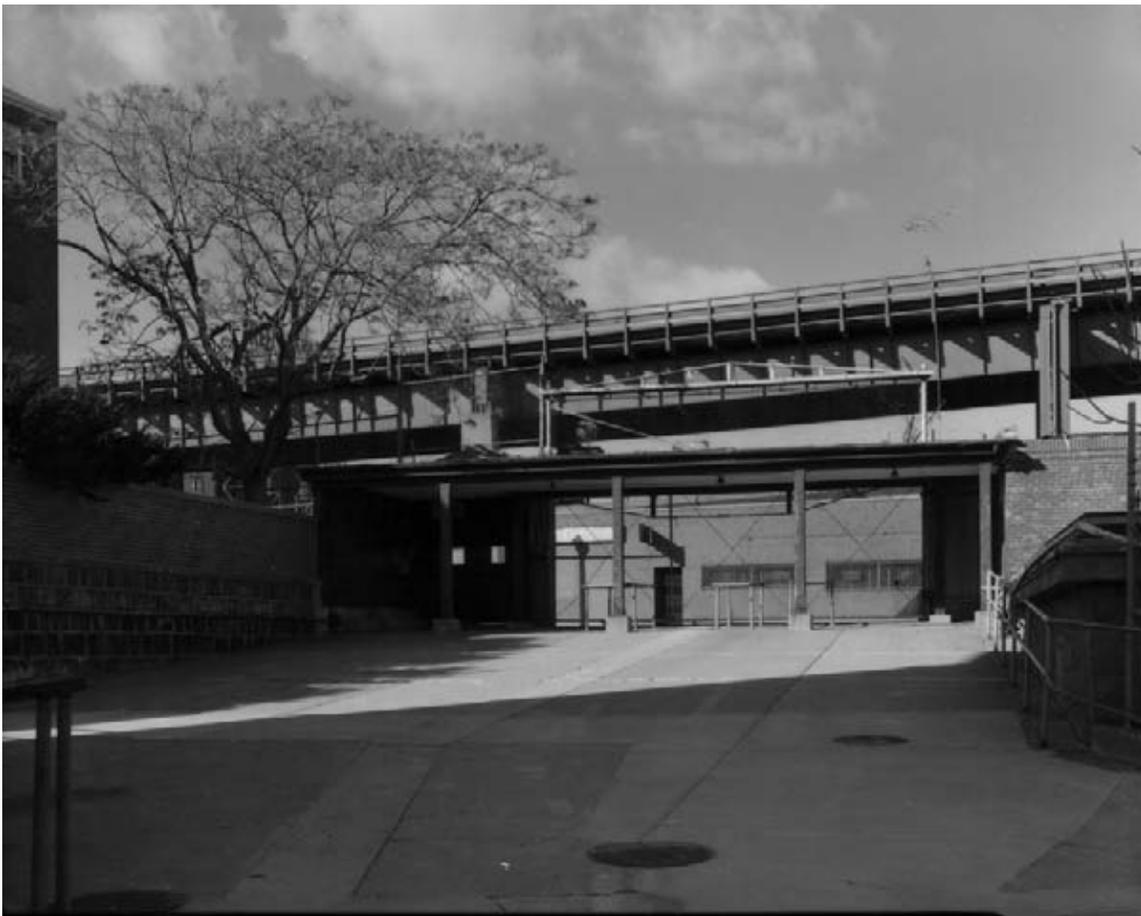
Figure 8.6: The pedestrian Gate 4 in 1977 before Fifth Street was extended to Chelsea Street. Note the concrete gate structure to the left (west) side (with the 2 square windows) before it was moved to the right (east) side (HAER MA-90-113).

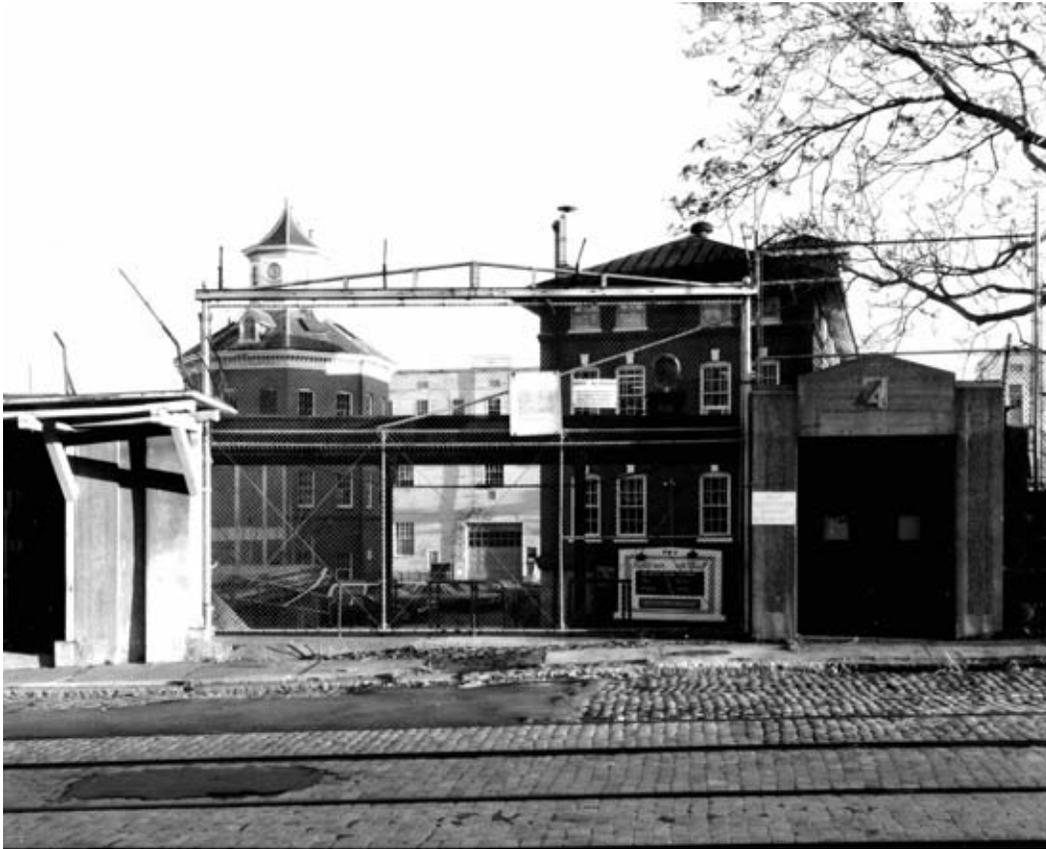
Figure 8.7: The pedestrian Gate 4 in 1977 before Fifth Street was extended and the concrete gate to the right (west) was relocated to the left (east) (HAER MA-90-114).

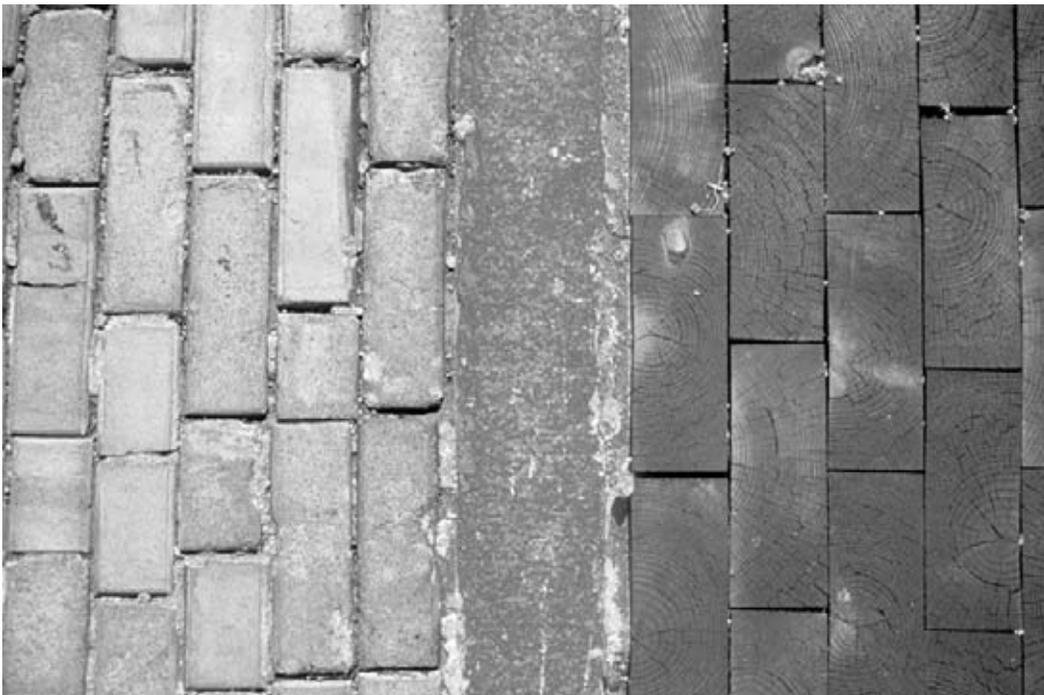
Figure 8.10: Fourth Street paving with yellow bricks on the southern half of the street separated from the wood blocks on the northern half of the street by a strip of granite (OCLP, 2002)

A repaving project in 1999 and 2000 included all of the public streets within the park. In making changes to improve accessibility for visitors, the NPS utilized the results of the 1995 Charlestown Navy Yard Historic Pavement Study. The study showed that historically a number of materials had been used to pave the yard and that most of these were lifted or subsequently covered with concrete and asphalt.¹⁰ The preferred alternative in the plan involved treatment of the Freedom Trail (brick), First Avenue (brick) beginning at Gate 1, 3rd Street (mainly yellow brick), 4th Street (brick and wood block), and Pier 1 edging (granite) (Figure 8.10). The preferred alternative for First Avenue and Pier 1 was abandoned in favor of asphalt for cost reasons. However, when much of Pier 1's historic granite paving (including strips of granite block paving in the center of the pier and along the west side) was discovered to be largely intact, it was retained uncovered. Remaining areas to be addressed with the study included the treatment or removal of some of the railroad tracks on Pier 1, which were considered a hazard to pedestrians. Rubber crossing pads were to be laid on the tip of exposed crane rails to avoid tripping. Also on Pier 1, traffic and parking were reconfigured away from USS *Constitution*. The plan also called for resurfacing of the concrete deck and stabilization of the end.¹¹ By 2002, Fourth Street's wood blocks, dimensioned like standard brick pavers and laid in a running bond pattern, had failed. The impervious concrete layer under the wood collected rainwater causing the blocks to float out of place.¹² Historically the wood block paving in the upper yard was laid atop a pervious base. The park repaved this section of Fourth Street with asphalt.

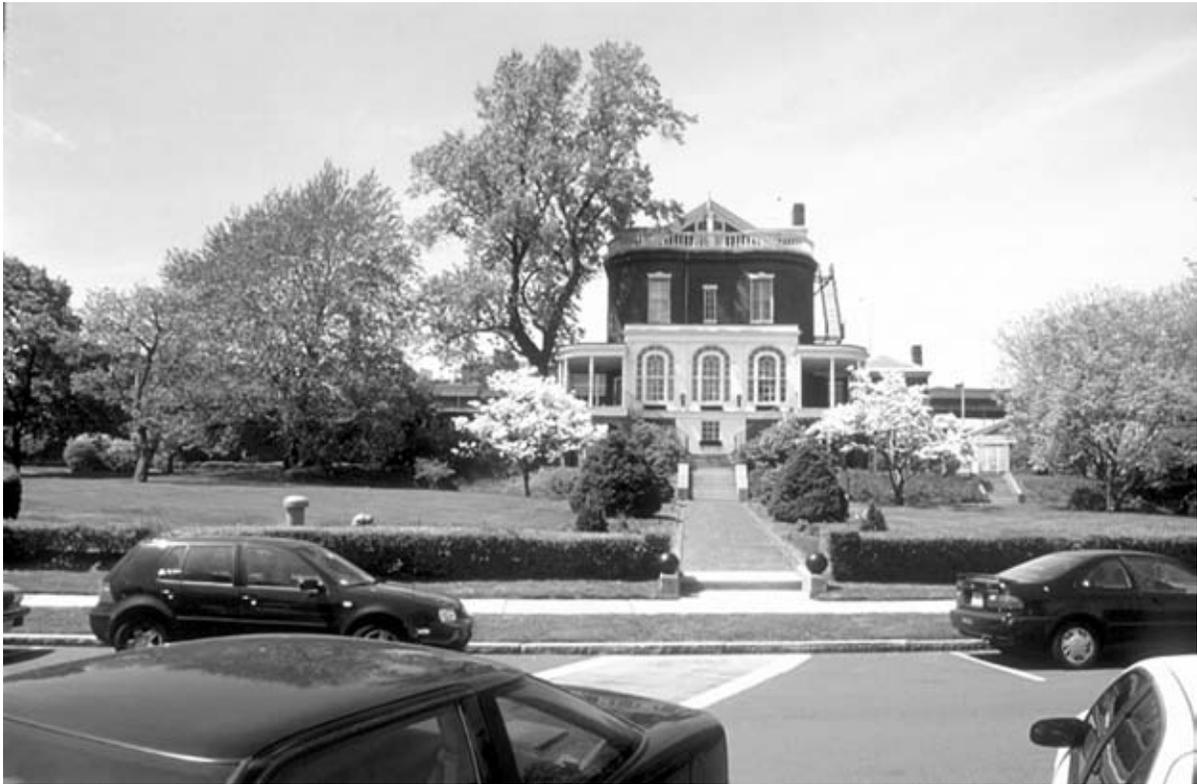
Figure 9.1: The south elevation of the Commandant's House (Quarters G) and landscape terracing (OCLP, 2002).

The topography of the yard is nearly level with a rise in the land near the Commandant's House (Quarters G) and the Marine Barracks (Building I). The Commandant's House sits on the highest point of the yard, and the surrounding grounds are formally terraced with earthen banks (Figure 9.1). The semicircular section of wall north of the house retains fill making the former entrance area even with Chelsea Street (Figure 9.2). In front of the Marine Barracks (Building I), the level Parade Ground is maintained with a retaining wall along Second Avenue and part of the drive. Beyond the boundary wall of the yard, the land ascends more steeply to Breed's Hill.

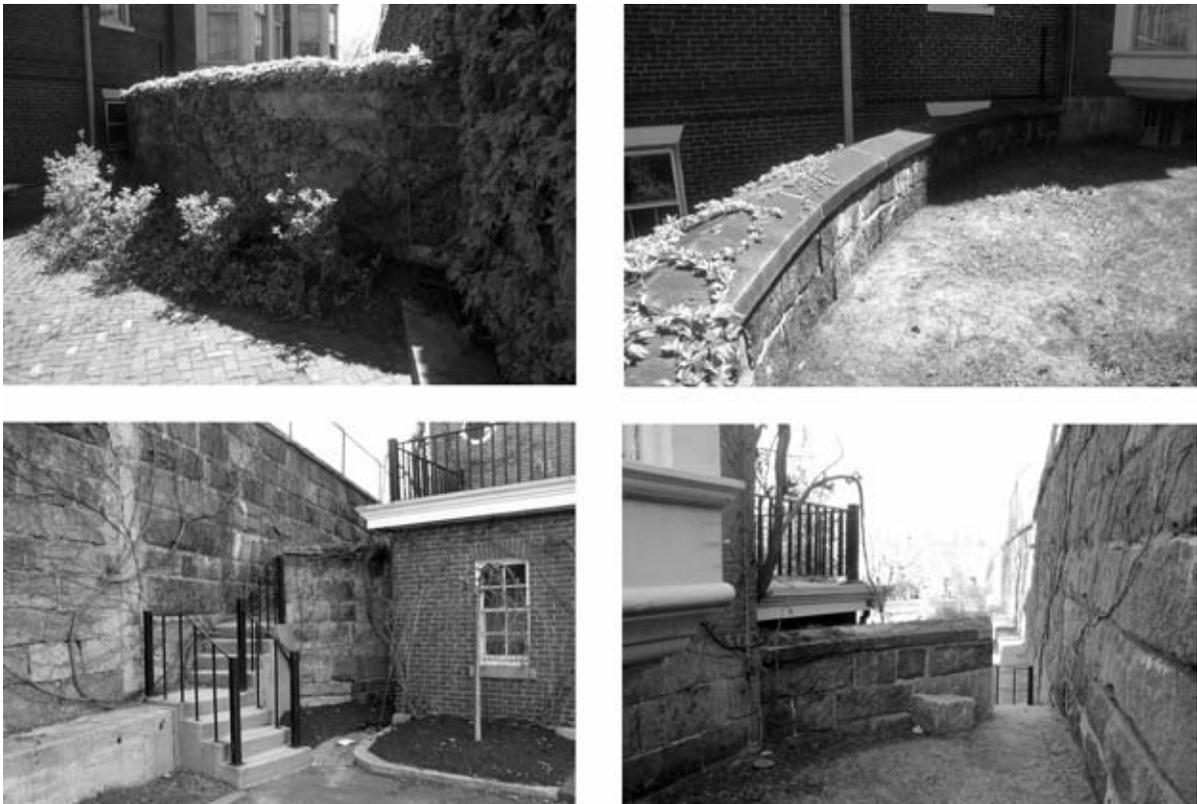
Figure 9.2: The change in grade between the inside (left images) and outside (right images) of the eastern (top images) and western (bottom images) portions of the old boundary wall where it curves toward the former front (north) door of the Commandant's House (Quarters G) forming a semicircle. A staircase negotiates the western portion, bottom left (OCLP, 2002 and 2005).

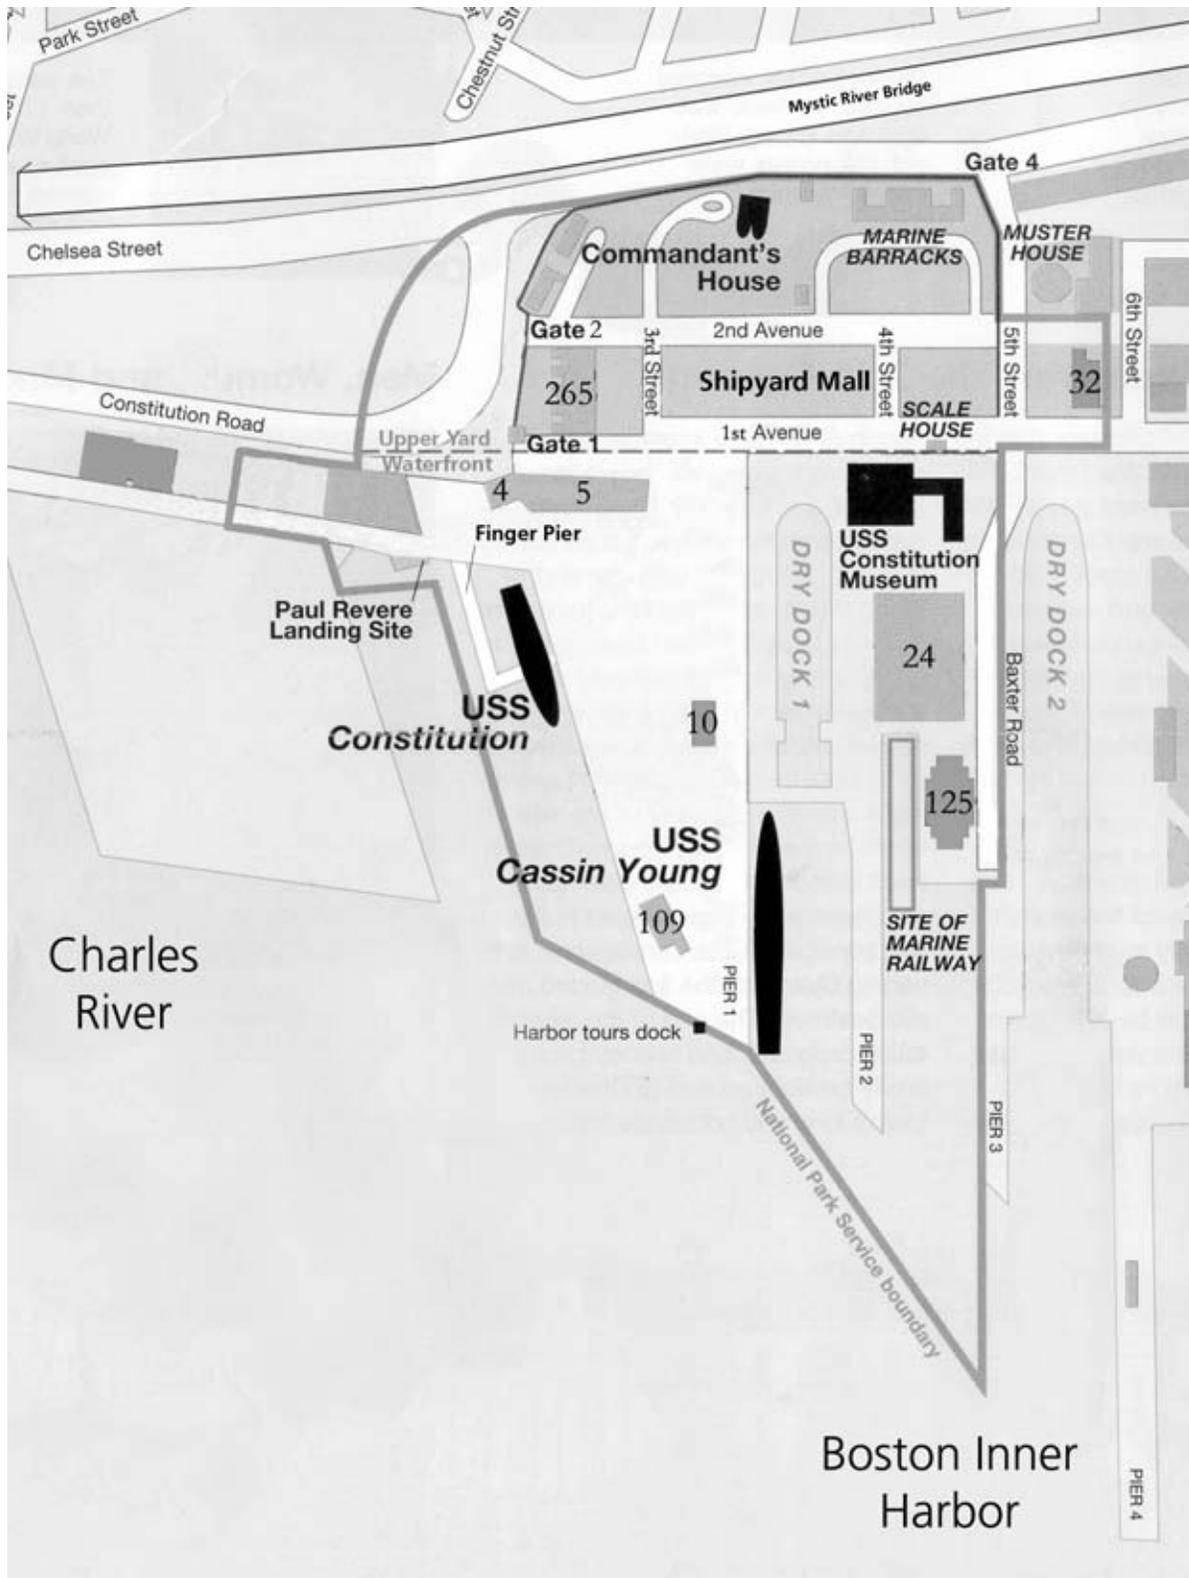
Figure 9.3: Spatial organization of the park portion of the Charlestown Navy Yard, 2004 (NPS Unigrid).

The National Park Service-owned portion of the Charlestown Navy Yard is organized by a grid of streets, with avenues running east to west and streets north to south (Figure 9.3). The waterfront is located south of First Avenue and includes the piers and dry docks, and the upper yard is located north of the avenue and includes residential and ceremonial areas. Large residential buildings surround the open gardens, Shipyard Mall, and Parade Ground of the upper yard to the east and north. The openness of the upper yard projects across First Avenue onto the waterfront like fingers where industrial buildings and features line the piers.

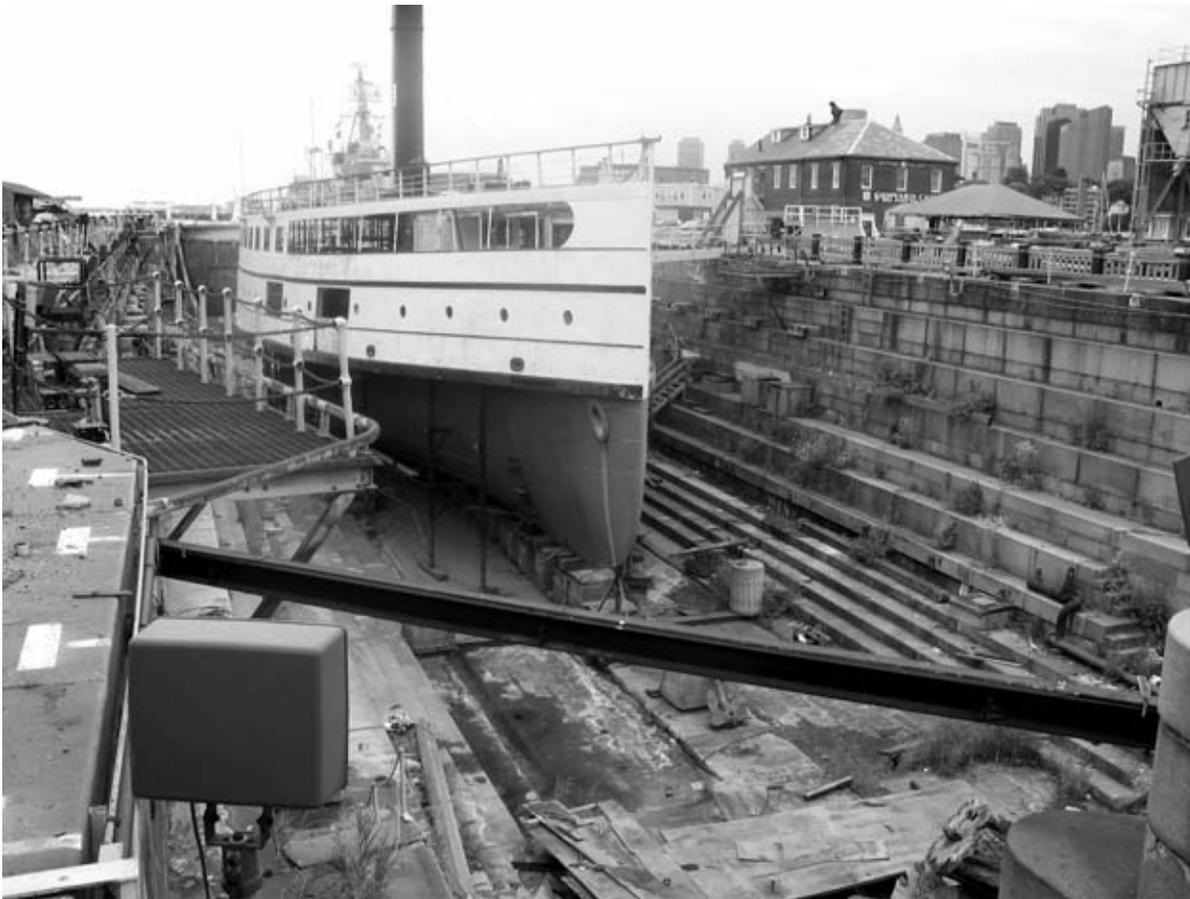
Figure 9.8: Dry Dock 1 and the SS *Nobska* looking south with Pier 1 and the Boston skyline to the right. The ship rests on keel blocks and is stabilized by the vertical shoring (OCLP, 2003).

Several boats, dinghies, and tenders lie in and around Dry Dock 1. Most notable is the SS *Nobska*, a 1925 steamer that has been in the dock for repair since 1996. Funding from its owner the New England Steamship Foundation (NESF) has dwindled and repairs to the ship no longer continue. In 2004, the park and U.S. Navy ordered that the steamer be removed from the dry dock or scrapped. Rail and crane tracks are set within the bituminous paving. A steel caisson holds back harbor water on the south (Figure 9:26).

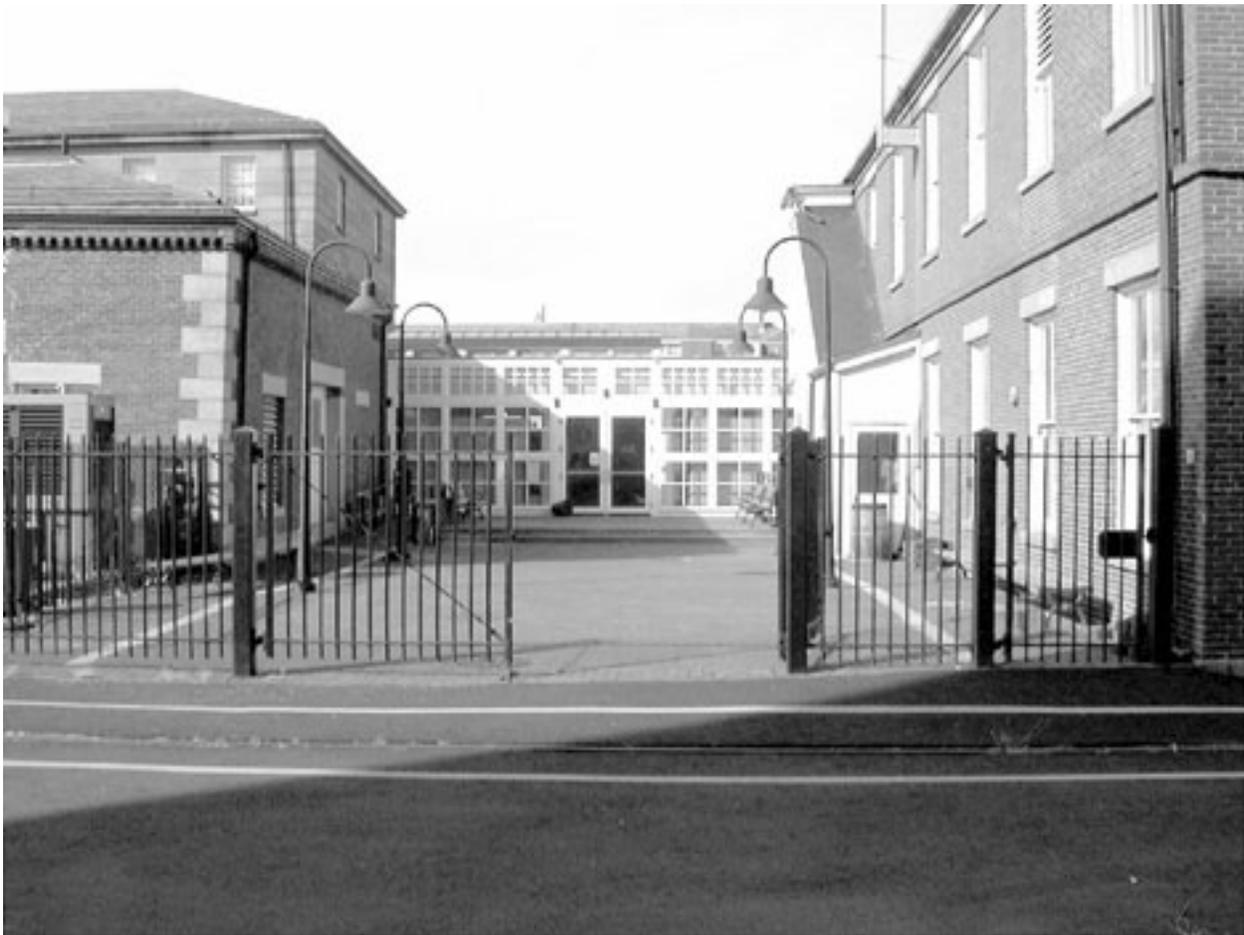
Figure 9.9: The south elevation of the USS Constitution Museum (Building 22) (right) with the courtyard and connector connecting it with Building 28. Note the crook-neck lamps typical of historic ones manufactured at the yard (OCLP, 2002).

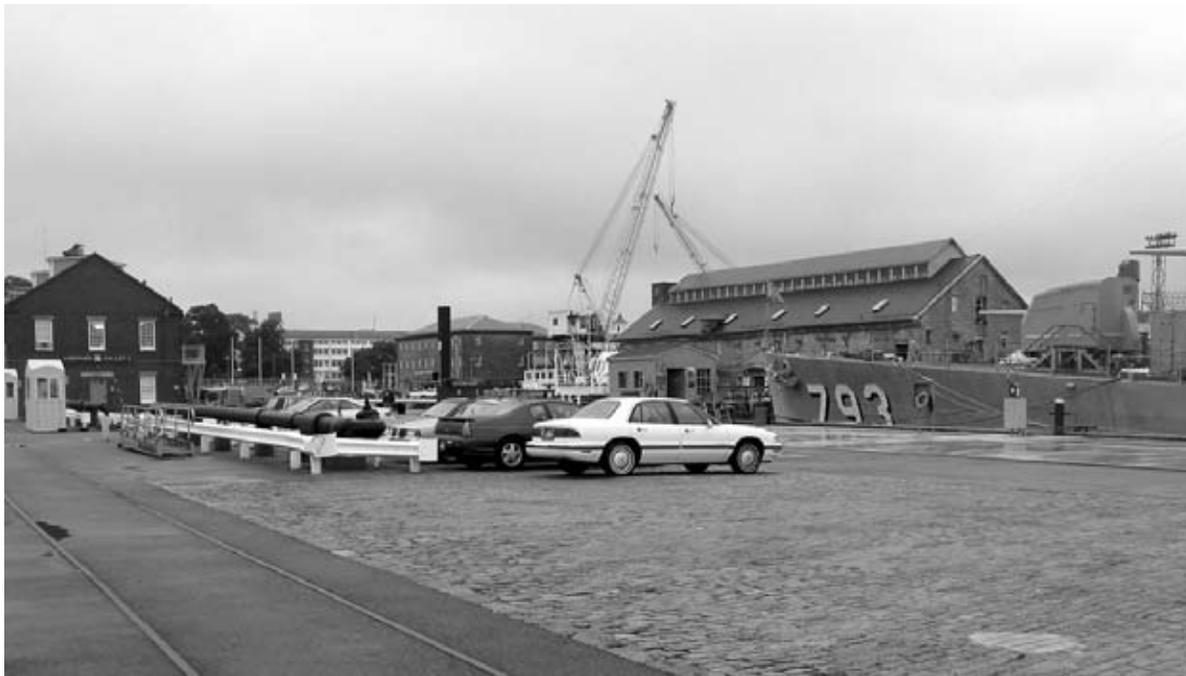
Figure 9.11: Parking on Pier 1. Note the rails, historic granite paving, elevated steam pipes, and USS *Cassin Young* (OCLP, 2003).

Lincoln Avenue runs along the northern edge of Pier 1 from the railroad gate to Third Street. Third Street runs from Second Avenue to the end of the pier. Much of Pier 1 is used for parking (Figure 9.11). Traffic lanes are not well demarcated and there are no designated walkways for pedestrians. Railroad tracks run through the pavement with flangeways filled to reduce tripping hazards. The variety of paving material reflects different periods of the Navy's use of the pier. Asphalt has predominated since the 1950s. Historic granite block paving has been exposed along the western edge by USS *Constitution* and in the center of the pier along with areas of brick paving. West of USS *Constitution*, a fence blocks pedestrian access to the Finger Pier. The eastern side of the pier, along Dry Dock 1, has taken on the form of a storage yard and is difficult to maneuver (Figure 9.12). The southern tip of the pier is bordered by a concrete deck supported by stone piers. There is no sidewalk on the south side of First Avenue between the proposed Visitor Center (Building 5, the former Navy Store) and the USS Constitution Museum (Building 22, the former Dry Dock Engine House).

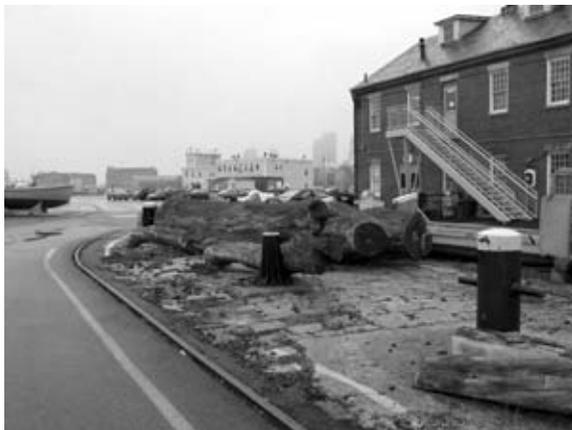
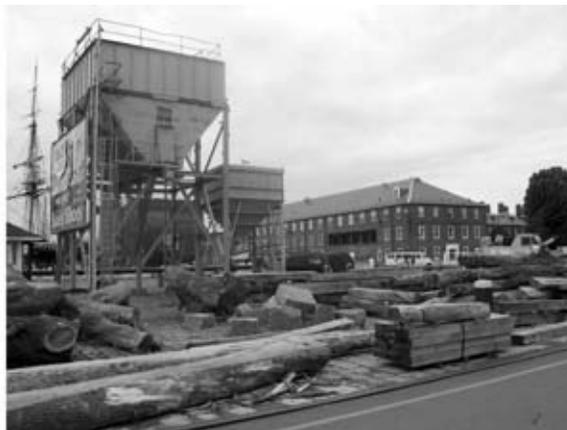
Figure 9.12: Pier 1 looking southwest showing rails, historic granite paving, supply piles, bollards, and Building 10 (left) and northwest showing rails, historic granite paving, supply piles, USS *Constituiton*, Grit Hoppers, and Building 5 (right). (OCLP, 2003).

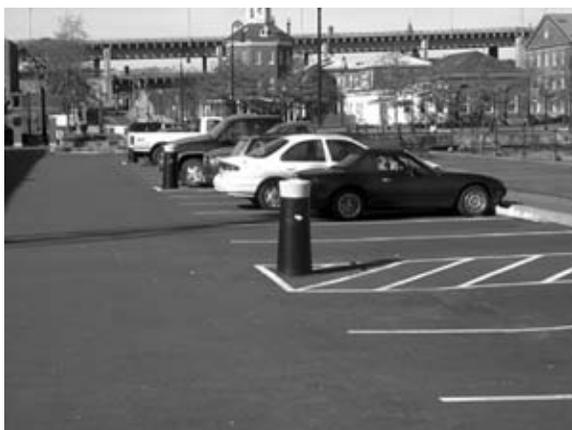
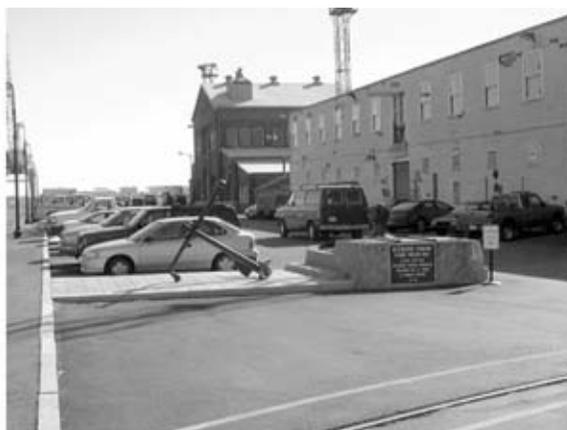
Figures 9.13: View north between Buildings 24 and 110 with Baxter Road left of the parked cars (left). Granite curbing separates the parking area from pedestrian traffic. View south from the same location (right). A large capstan rests atop a concrete base next to the anchor (OCLP, 2002).

Baxter Road travels east of the museum along the western side of Dry Dock 2, passing through two restricted parking areas and ending at Pier 3 (Figure 9.13). There is perpendicular parking along much of this road. East/west circulation south of the USS Constitution Museum is controlled by fences located between the buildings (see Figure 9.14). The area south of the museum is paved with bituminous material and off-limits to visitors for safety reasons. Some historic granite pavers are exposed northwest of and along the edge of Building 24. Steel plates cover a sink hole at the bulkhead near the capstan house. Pier 2 consists of wood decking on wood pilings and is in poor condition with only pilings remaining at its southern tip. Most of Pier 3 is paved with bituminous material, and a chain link fence blocks access to severely deteriorated southern half of Pier 3 (Figure 9.15). Failure of the bulkhead has contributed to its poor condition.

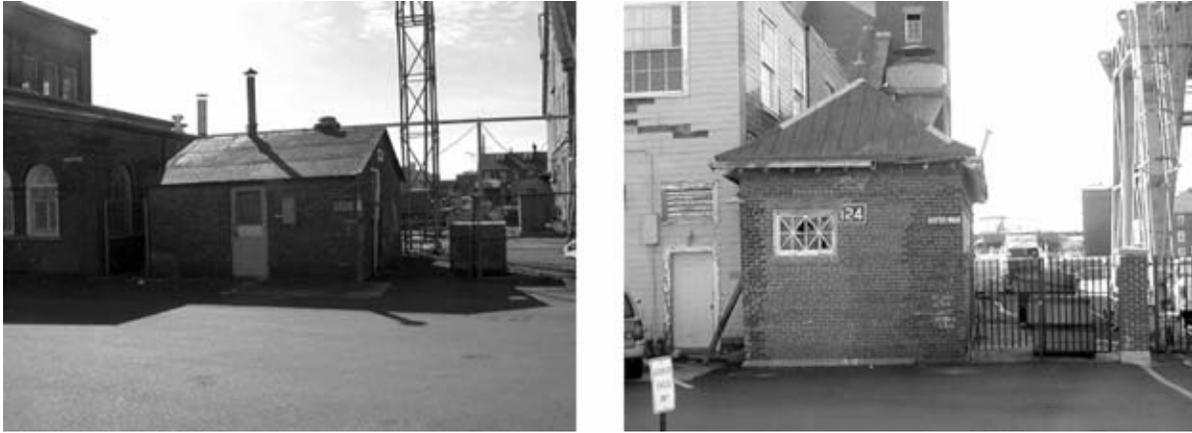
Figure 9.14: A high chain link fence runs between Buildings 110 and 24 (left), while an iron fence with brick posts runs from Building 124 to 28 (right). The bottom part of a floodlight tower is seen in the image on the left. A crane is visible on the right (OCLP, 2002).

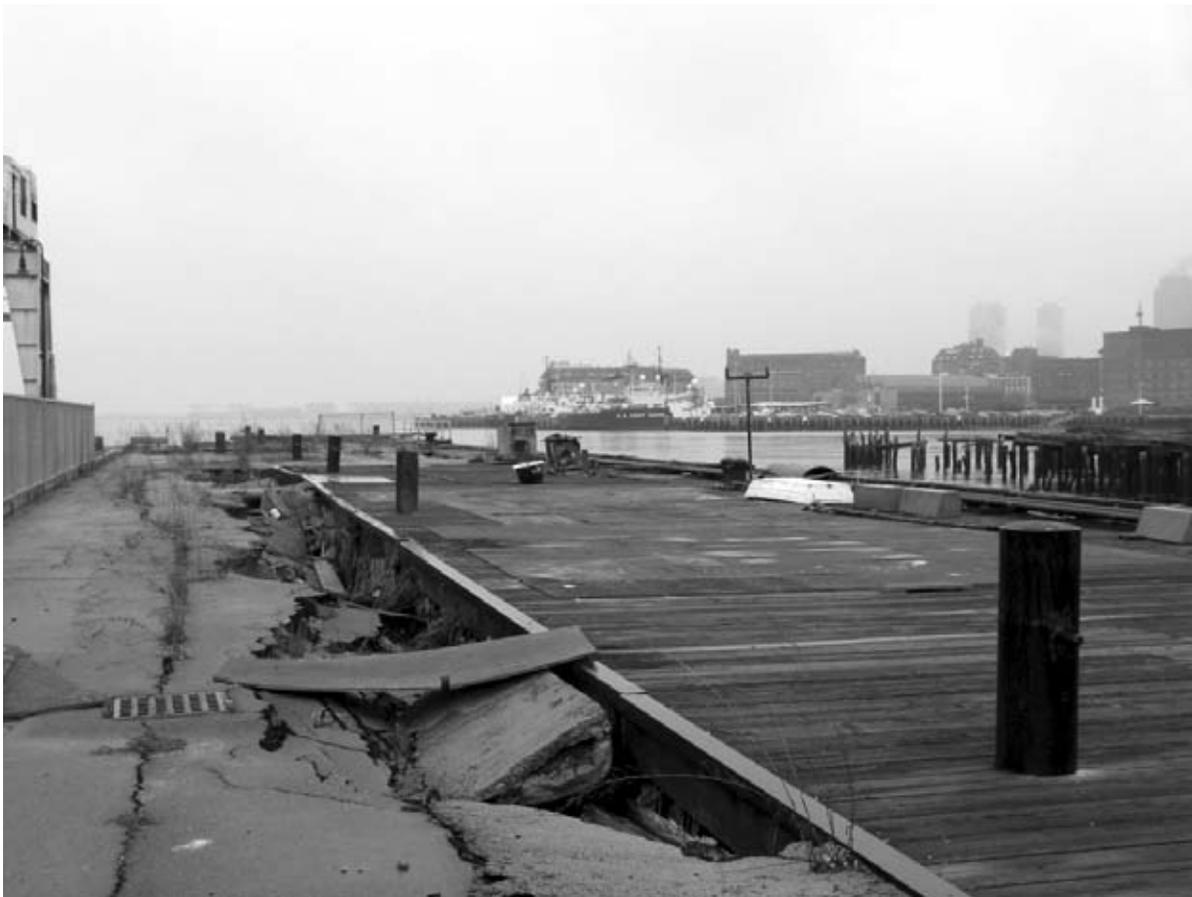
Figure 9.15: This image of Pier 3 shows its deteriorated condition. Pilings are all that remain of the end of Pier 2 (right) (OCLP, 2003).

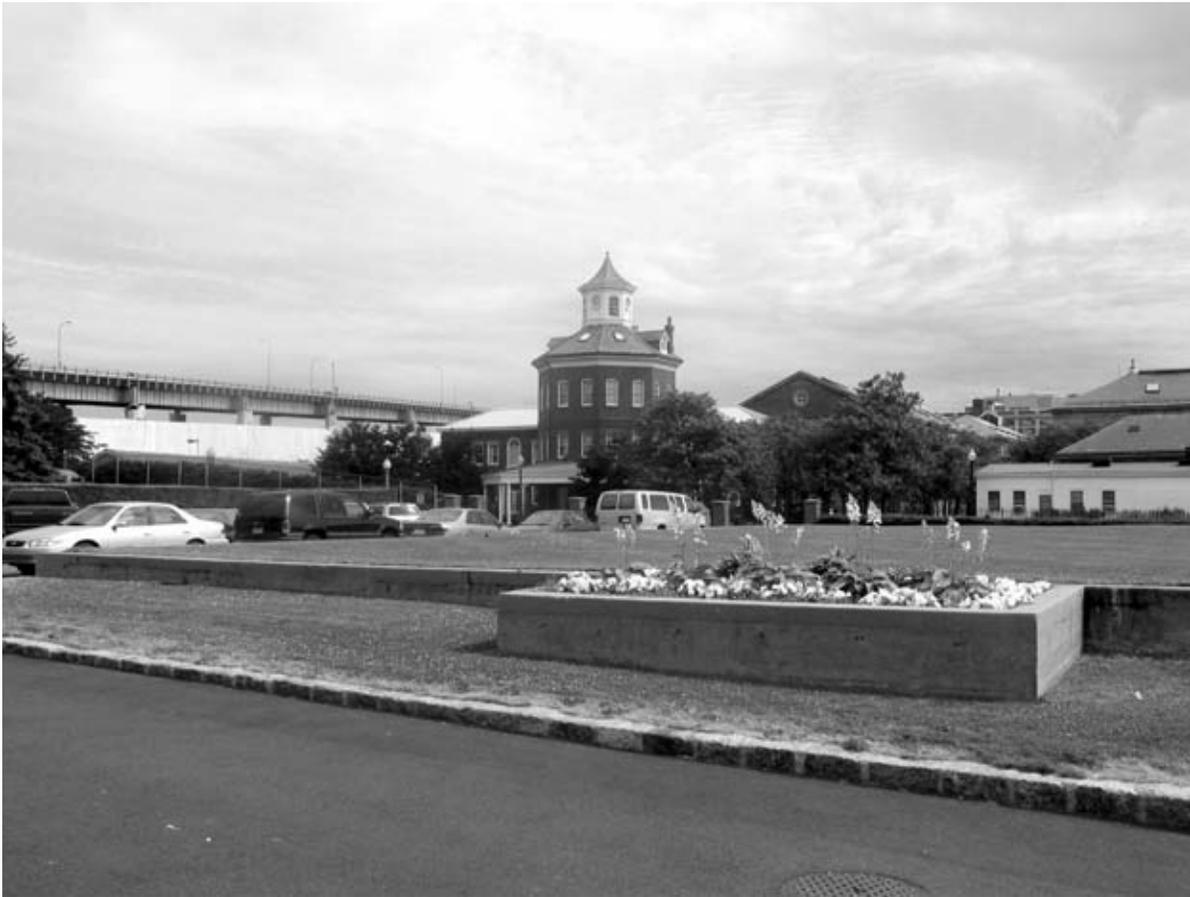
Figures 9.16: Fourth Street looking northeast. The former Building 198 foundation acts as a retaining wall for part of the Shipyard Mall. The Muster House and Mystic River (Tobin) Bridge are in the background (OCLP, 2003).

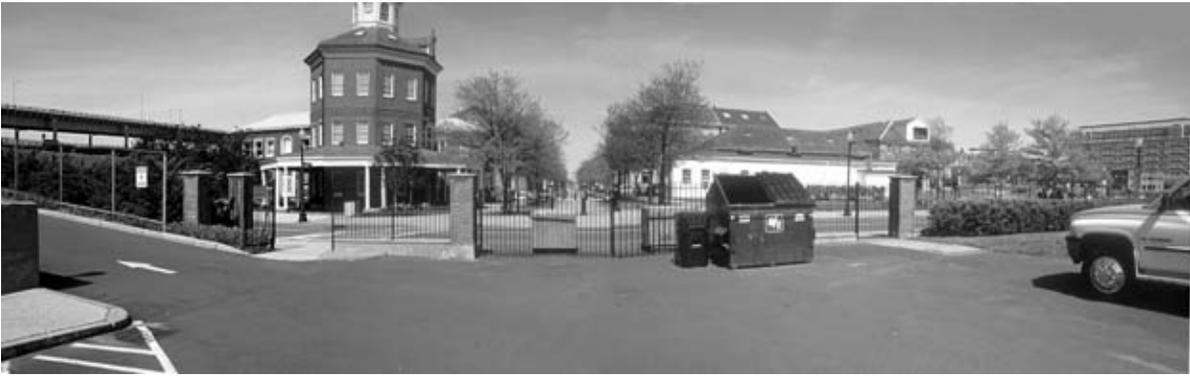
Figure 9.18: The pedestrian entrance at Second Avenue looking east toward the BRA portion of the yard. An iron gate, keel blocks and a dumpster prevent vehicular use (OCLP, 2002).

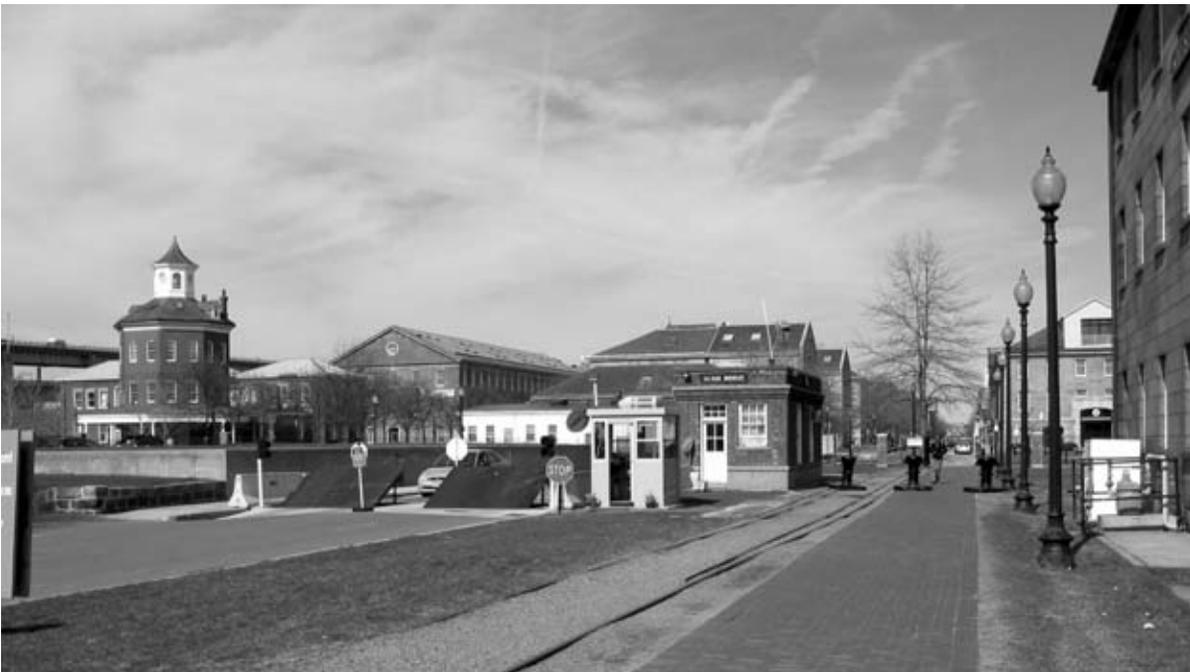
Figure 9.19: View east of the park's main vehicular entrance on First Avenue near the intersection with Fifth Street. From left to right: the pop-up barriers, the new Guard Booth, the Scale House (Building 19), and the moveable steel bollards along the brick pedestrian walkway. The Muster House (Building 31) is at the far left and the USS Constitution Museum (Building 22) is to the far right (OCLP, 2005).

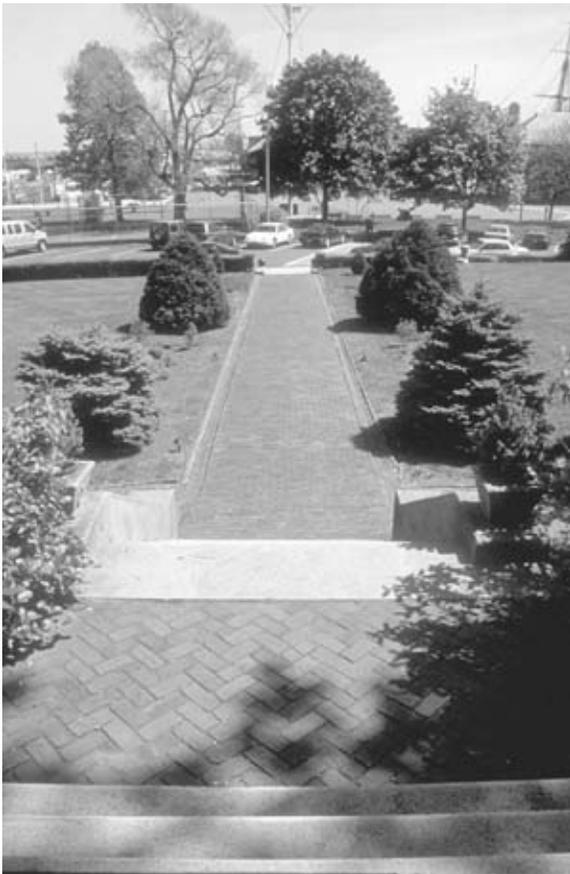
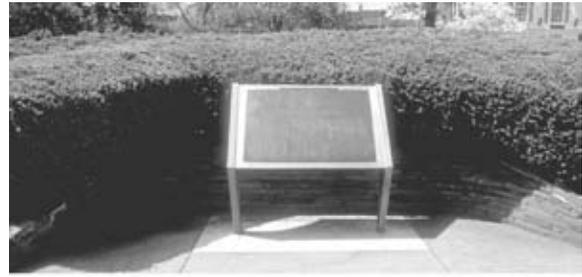
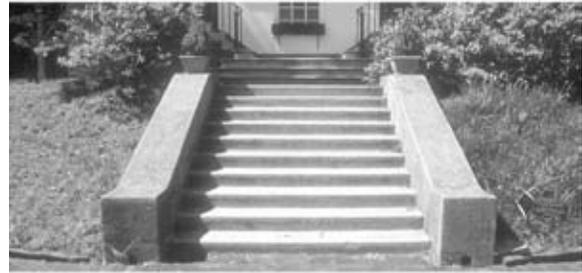
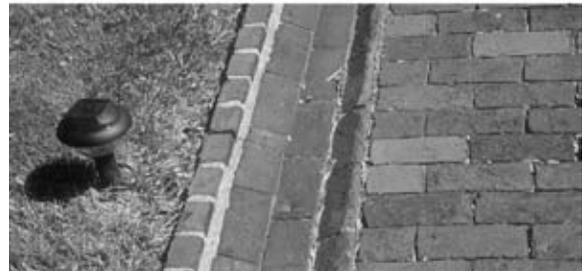
Figures 9.20: The brick walkway between the Commandant's House (Quarters G) steps and Second Avenue is flanked by two garden beds separated by evergreen trees (left). A yew hedge (top, right) runs the full width of the property along Second Avenue, bowing in near a memorial plaque. Weep holes in the foot of the stair cheekwall (center, right) conduct runoff from the upper landings into the gutters (bottom, right) lining either side of the walkway (OCLP, 2002).

A privet hedge runs the full width of the Commandant's House (Quarters G) property along Second Avenue, with a curved section of yew hedge above the Yard Commandants Plaque (Structure 270). The brick walkway between the building steps and Second Avenue is flanked by four rectangular beds, two on each side of the walkway, containing herbaceous plant material and separated by compact blue spruce. A flowering dogwood is planted on each side of the main walkway at the base of the house terrace providing a visual anchor (Figure 9.47). Ornamental trees and shrubs serve as foundation plantings at the top of the slope. A privet hedge borders the lawn east of the Commandant's House. The lawn on the west side extends west to the drive and north to the stone boundary wall. The only vegetation on the north side of the Commandant's House is a foundation planting of azalea. Weeping hemlock flank the drive entrance and an American holly grows in the center of the turn-around (Figure 9.48). A hedge of arborvitae along the western edge of the property effectively screens the Officers Quarters Five Bay Garages (Structure 269) and the Garage and Chauffeur's Quarters (Building 1), now the park's grounds maintenance shop (Figure 9.49).

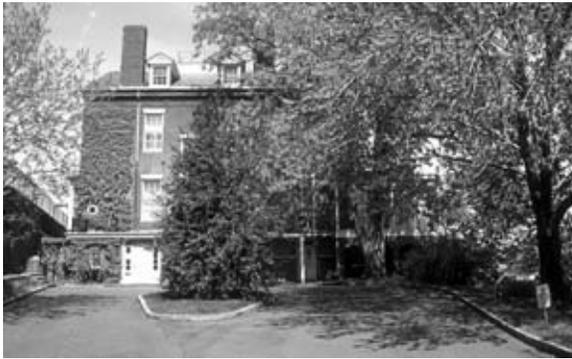
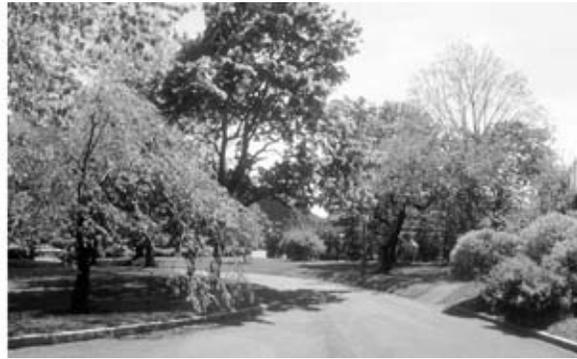
Figure 9.22: The turnaround at the head of the driveway circles an American holly (left). Boston Ivy covers the wall and a portion of the house. The main porch and its open passage beneath are seen beyond the trees. Large trees and ornamental plantings line the driveway as it curves from the house to Second Avenue (right) (OCLP, 2002).

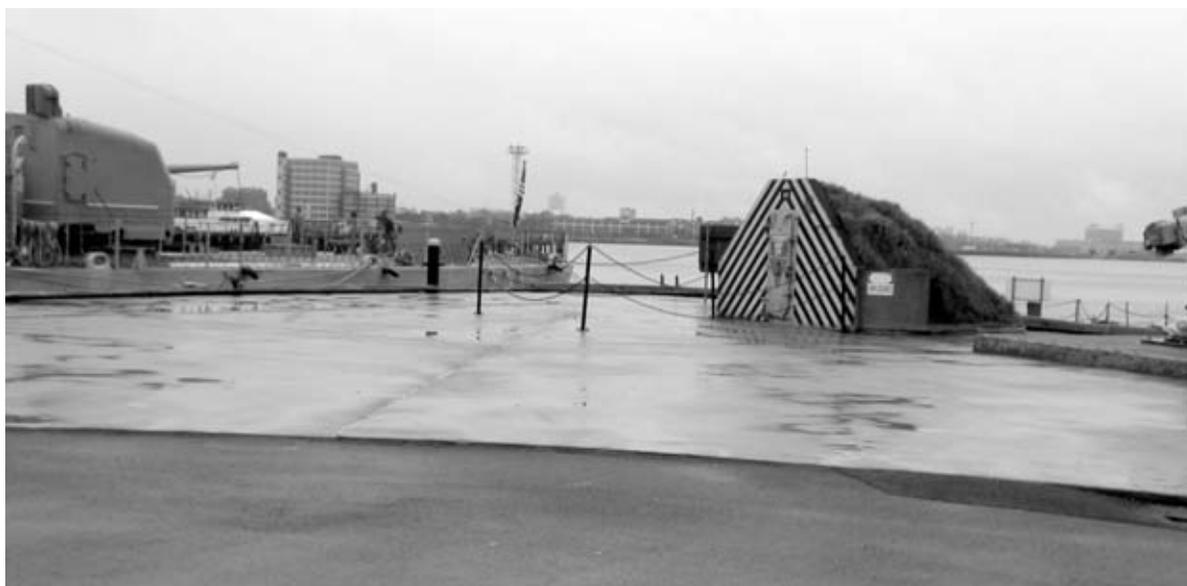
Figure 9.25: Explosives Bunker (Building 272) at the end of Pier 1. USS Cassin Young is to the left (OCLP, 2003).

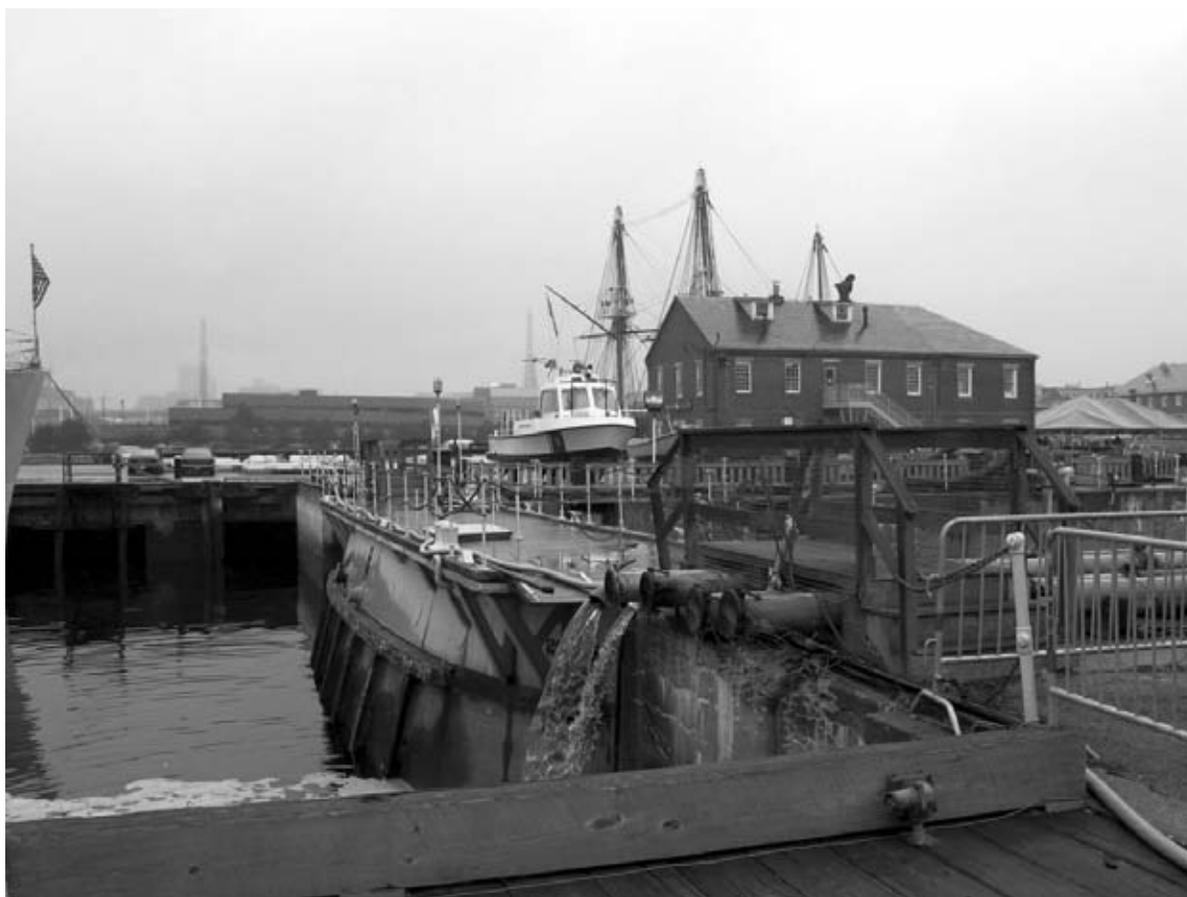
Figure 9.26: Dry Dock 1 caisson with the Leonard P. Zakim Bunker Hill Bridge and USS Constitution in the background (OCLP, 2003).

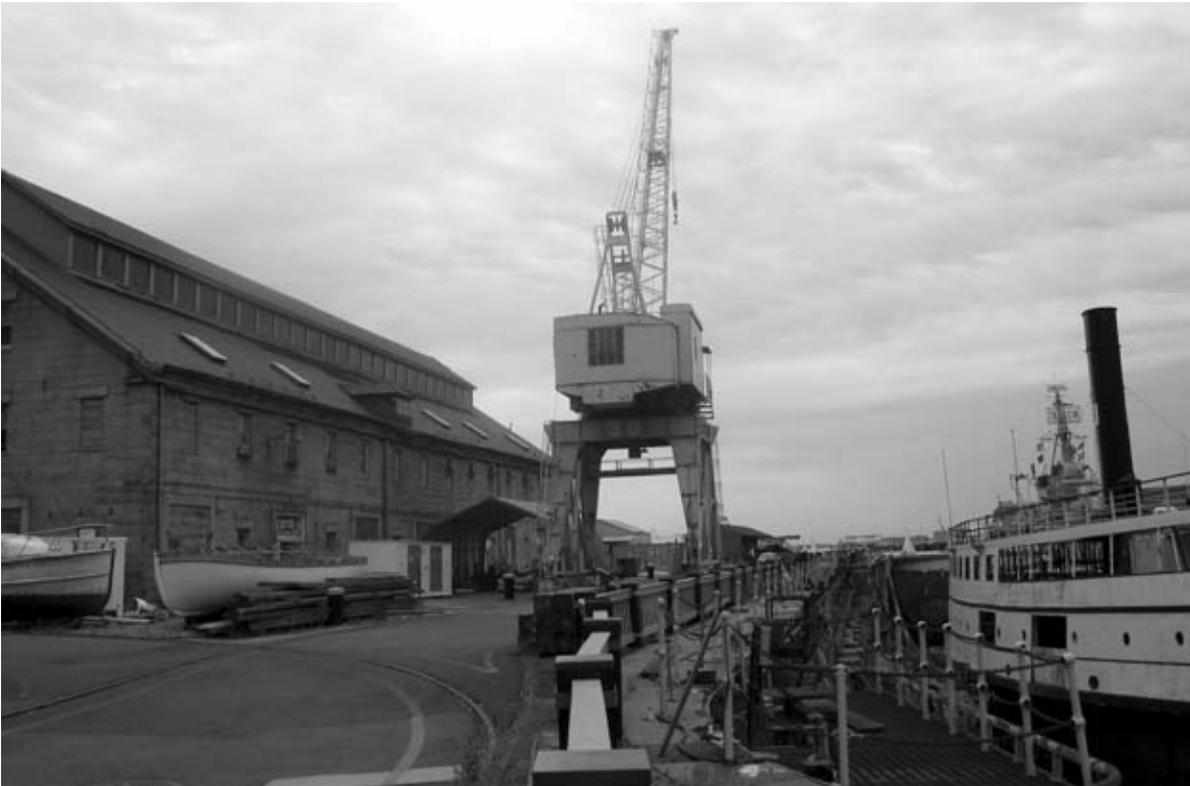
Figure 9.27: Pier 3 with Building 24, the Navy's *USS Constitution* maintenance shop, on the left. Crane # 30 is in the center, and Dry Dock 1 is to the right. A temporary shed between the building and crane provides additional workspace for the facility (OCLP, 2003).

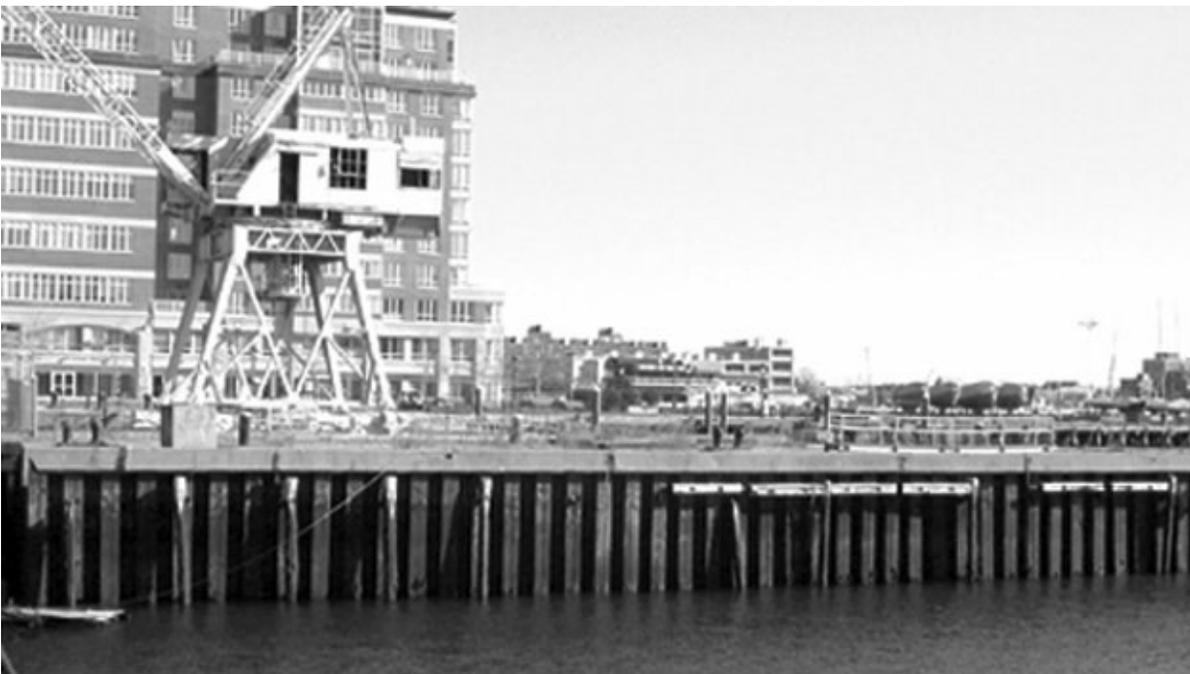
Figure 9.28: Pier 3 from Pier 2 with one of the cranes. Part of the pier is closed due to severe deterioration. The large building in the background is Flagship Wharf condominiums, part of the parcel administered by the Boston Redevelopment Authority (OCLP, 2002).
