CULTURAL LANDSCAPE REPORT FOR CHARLESTOWN NAVY YARD

BOSTON NATIONAL HISTORICAL PARK
BOSTON, MASSACHUSETTS

INTRODUCTION

SITE HISTORY

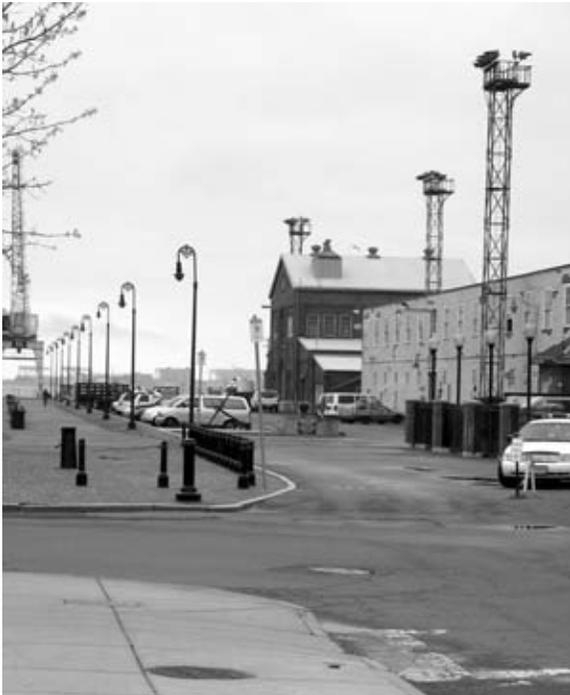
Figure 9.29: Pier 3's floodlight towers (right) are typical of those installed throughout the yard in the 1960s. Dry Dock 2 and a crane are on the left, Baxter Road is in the center, and Buildings 125 and 24 are on the right (OCLP, 2002).

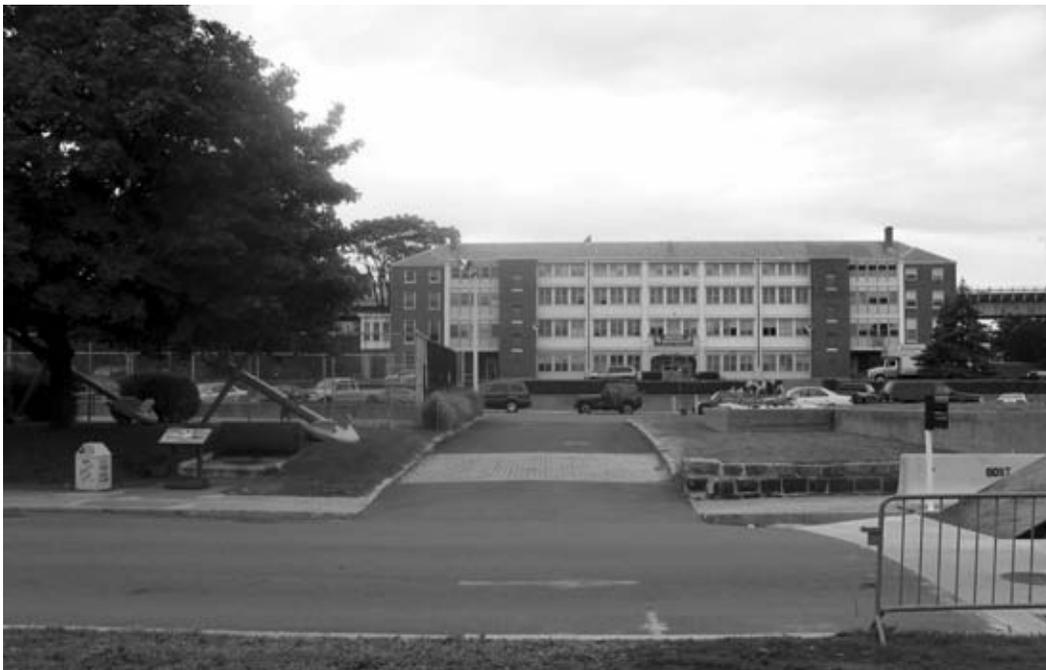
Figure 9.32: A level playing field is supported by a retaining wall along First Avenue (right). A smaller terrace bordered with granite blocks provides an interval between the playing field and Fourth Street. The retaining walls are foundation remnants of the World War II Temporary Storage Building (Building 198). A small corner parklet with a wayside, bench, and anchors is located across Fourth Street south of the tennis courts (left). The Marine Barracks (Building I) and the Mystic River (Tobin) Bridge are visible in the background (OCLP, 2003).

Within the Shipyard Mall, a level playing field is supported by a concrete retaining wall along First Avenue between Fourth and Fifth Streets (Figure 9.32). A smaller terrace bordered with granite blocks provides an interval between the playing field and Fourth Street. These retaining walls are the foundation remnants of the Temporary Storage Building (Building 198). The middle section of the Shipyard Mall, between Third and Fourth Streets contains the Playing Courts (Structure 236) introduced in 1946 and enclosed by a chain link fence (Figure 9.33). The Reviewing Stand (Structure 260) is a small concrete platform enclosed by pipe-and-chain on its east and west sides, is located in the western end of the area along First Street (Figure 9.34). The War Memorial (Structure 279) is a freestanding stone monument located directly in front of the Reviewing Stand.

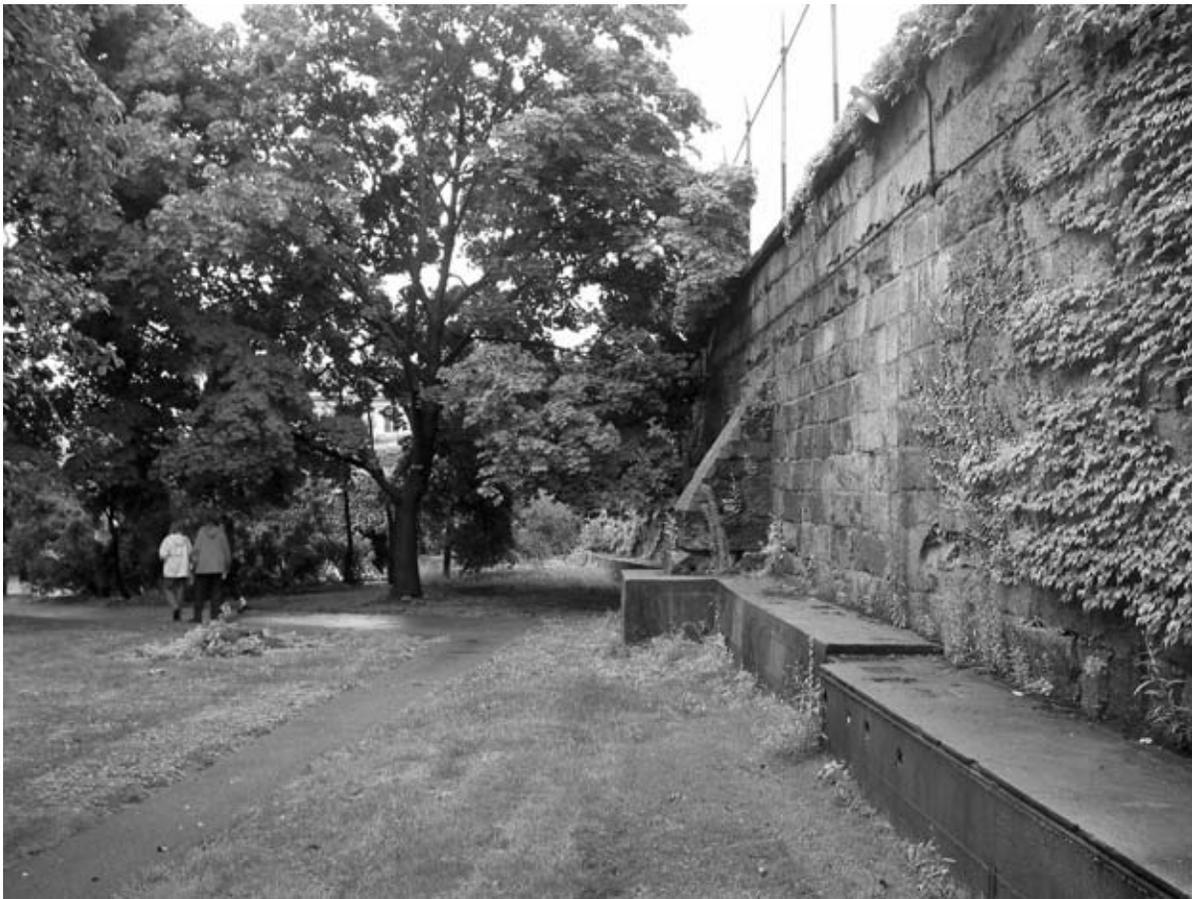
Figure 9.35: The yard's granite block boundary wall northwest of the Commandant's House (Quarters G). The concrete footings were poured during the relocation of the wall in 1981-82 (OCLP, 2003).

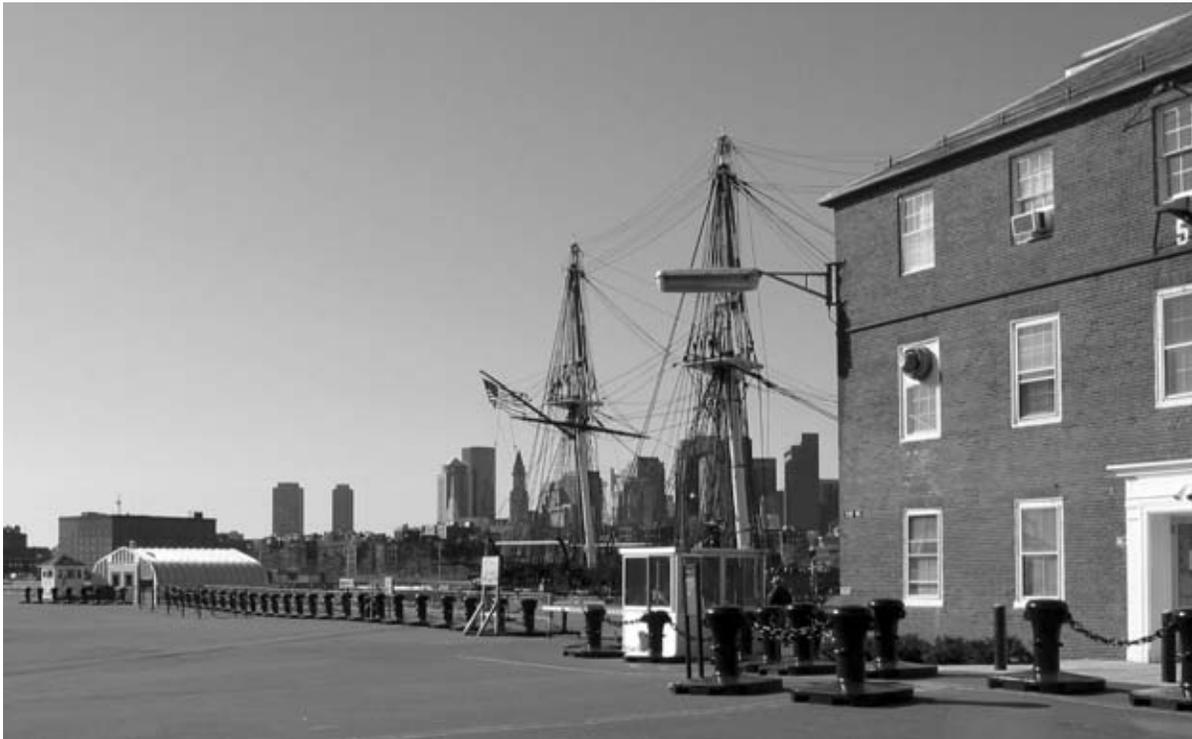
Figure 9.36: Security and safety features protect USS *Constitution* and guide visitors including moveable steel bollards with chain, bicycle fencing, and Visitor Screening (Structure 287) (left) and Guard Booth (Structure 286) (right foreground) (OCLP, 2005).

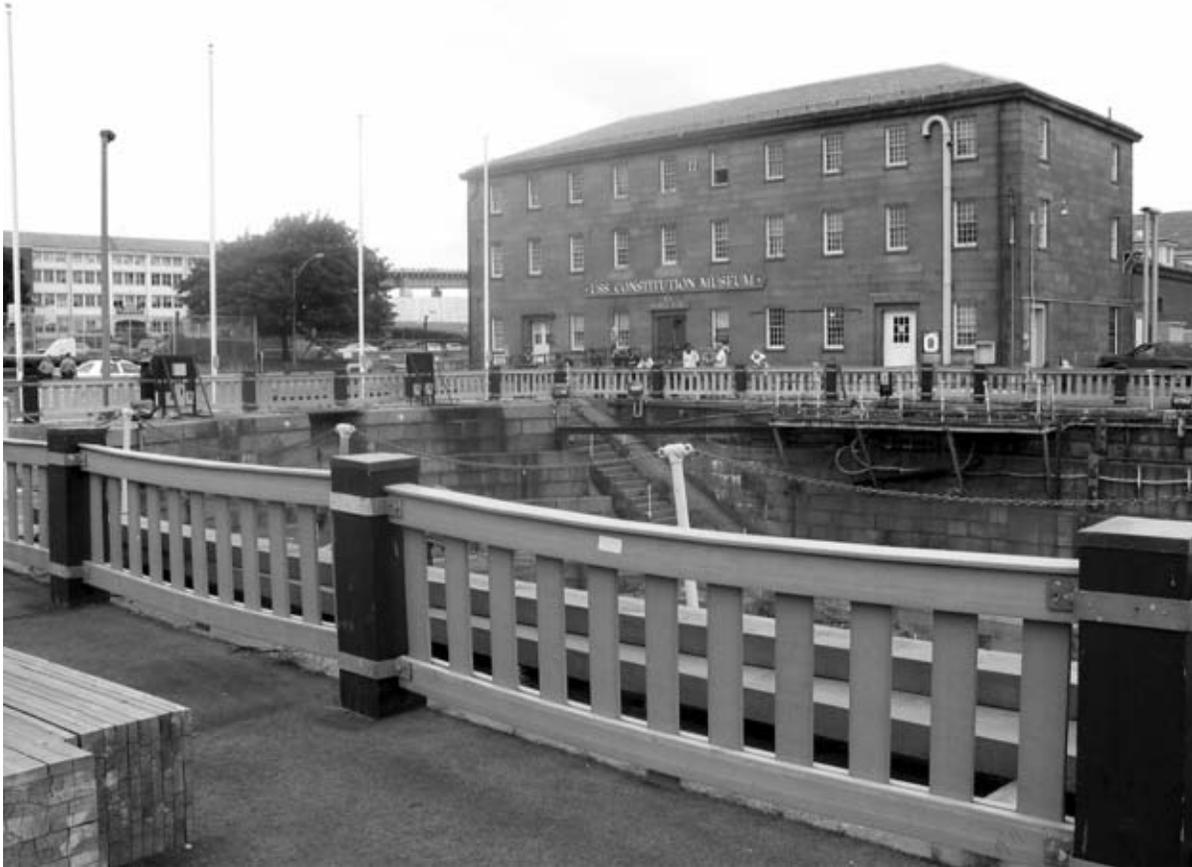
Figures 9.39: Synthetic material is used to create a post-and-pale fence around Dry Dock 1. The pipe-and-chain railing that also surrounds the dock is just inside this fence (OCLP, 2002).

Dry Dock 1 is surrounded by a recently built post-and-pale fence. The posts are wooden and the rails and palings are grey recycled plastic timbers (Figure 9.39). The original pipe-and-chain railing, painted yellow and set in the granite coping, is located just inside this new barrier. The Portable Steel Shed (Building M-37) and the frame of the Navy M&R work tent are currently stored at the bottom of the dock. There are five flagpoles and two outdated waysides that describe the restoration of the SS *Nobska* at the head of the dock (Figure 9.40). A historic concrete light pole stands among the flagpoles. An exhibit of old masts is displayed horizontally and parallel to First Avenue. The accompanying wayside is poorly located, often going unnoticed (Figure 9.41).

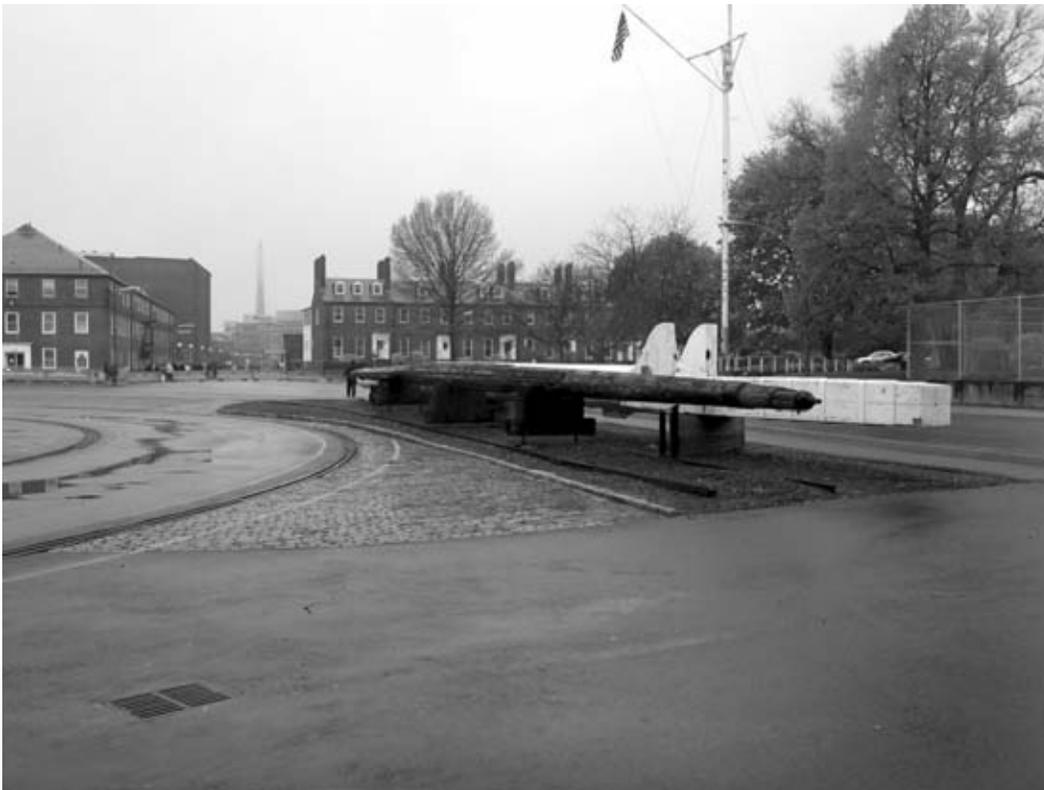
Figure 9.41: An installation of masts is displayed south of First Avenue north of Dry Dock 1 and Pier 1. The accompanying wayside is poorly located between masts, is difficult to read, and often unnoticed. The masts are surrounded by historic brick paving and rails. The Navy Stores (Building 5), the Leonard P. Zakim Bunker Hill Bridge, the Officers Quarters (Building 265), the Reviewing Stand (Structure 260)/War Memorial (Structure 279), and the Playing Courts (Structure 236) are in the background (OCLP, 2003).

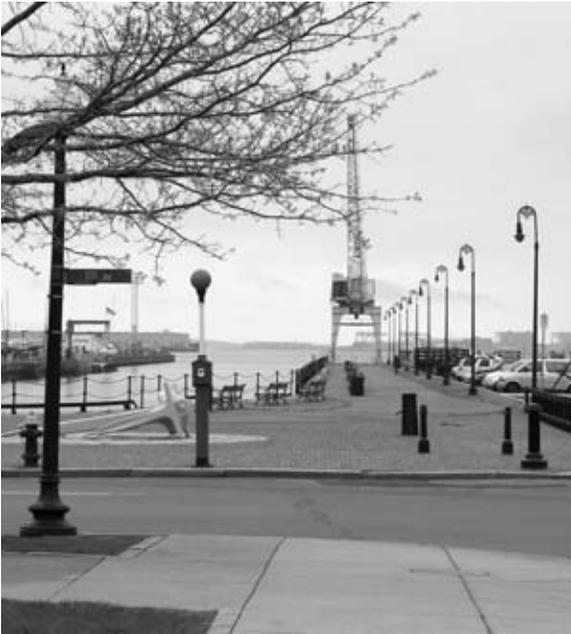
Figure 9.43: The northwest corner of Dry Dock 2 showing First Avenue, the pipe-and chain fence, one of the two anchors resting on granite blocks set within brick paving, and typical bench and trash receptacles. Crane tracks lead to the crane at the southern end of the dock. To the right, crook neck lamps and bollards line the dock along Baxter Road (OCLP, 2003).

Metal bollards line the edge of First Avenue at the northern end of Dry Dock 2, and two large granite circles are set into the paving, each displaying a large anchor (Figure 9.43). A pipe-and-chain railing, set in the granite coping, lines the dock. A row of black crookneck lampposts borders the outside of the rail. Benches are symmetrically placed on both sides of the dock in groups of four. They are constructed of metal ends connected by wooden slats. A trash receptacle is included in each grouping.

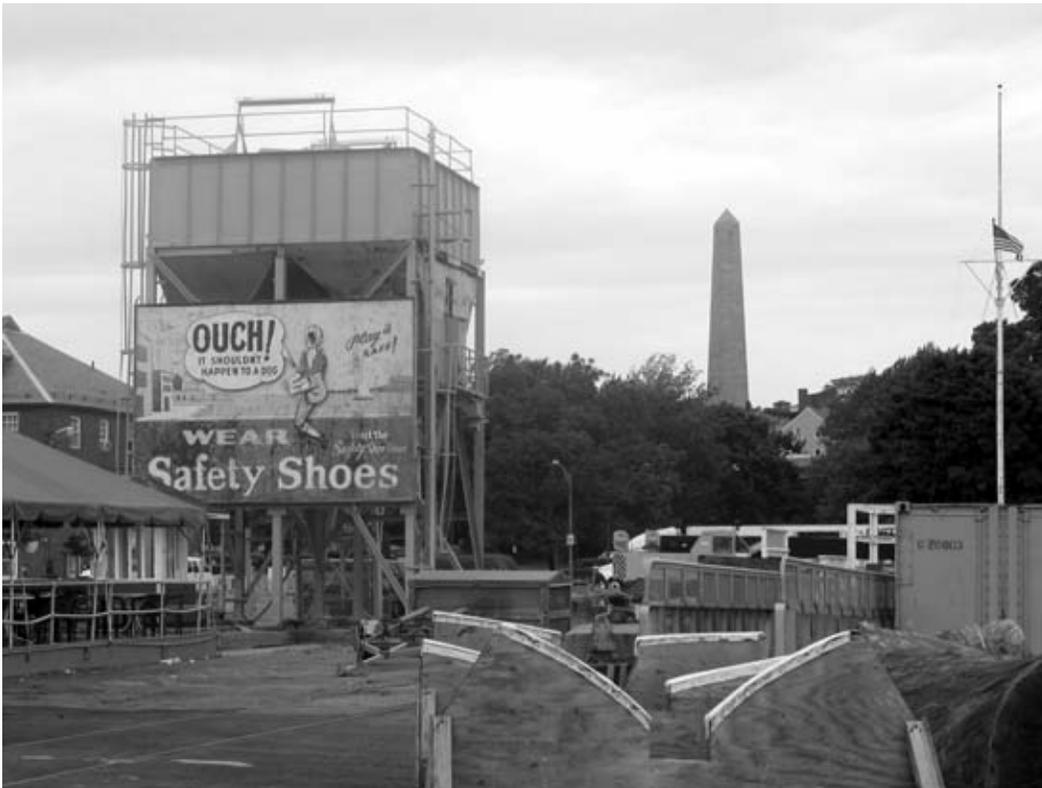
Figure 9.50: The Bunker Hill Monument is visible from many parts of the yard especially the waterfront. Here a historic cautionary safety sign is mounted on a grit hopper with Bunker Hill in the background of the laydown (storage) space west of Dry Dock 1. The edge of the Outside Seating Area (Structure 284) is to the left (OCLP, 2003).

visitors progress east along First Avenue, they can see the Bunker Hill Monument, the Leonard P. Zakim Bunker Hill Bridge, and USS *Constitution*. Pier 1, Dry Dock 1, and Pier 2 provide better views of these landmarks in addition to views of Boston Harbor and downtown Boston (Figure 9.50). The yard buildings owned by the Boston Redevelopment Authority are visible to the east from the park. The view from the Scale House gate into the NPS portion of the yard, down First Avenue, includes the Navy Store (Building 5) and a distant view of Gate 1. The Mystic River (Tobin) Bridge dominates many northern views from the yard's waterfront and upper yard areas (Figure 9.51).

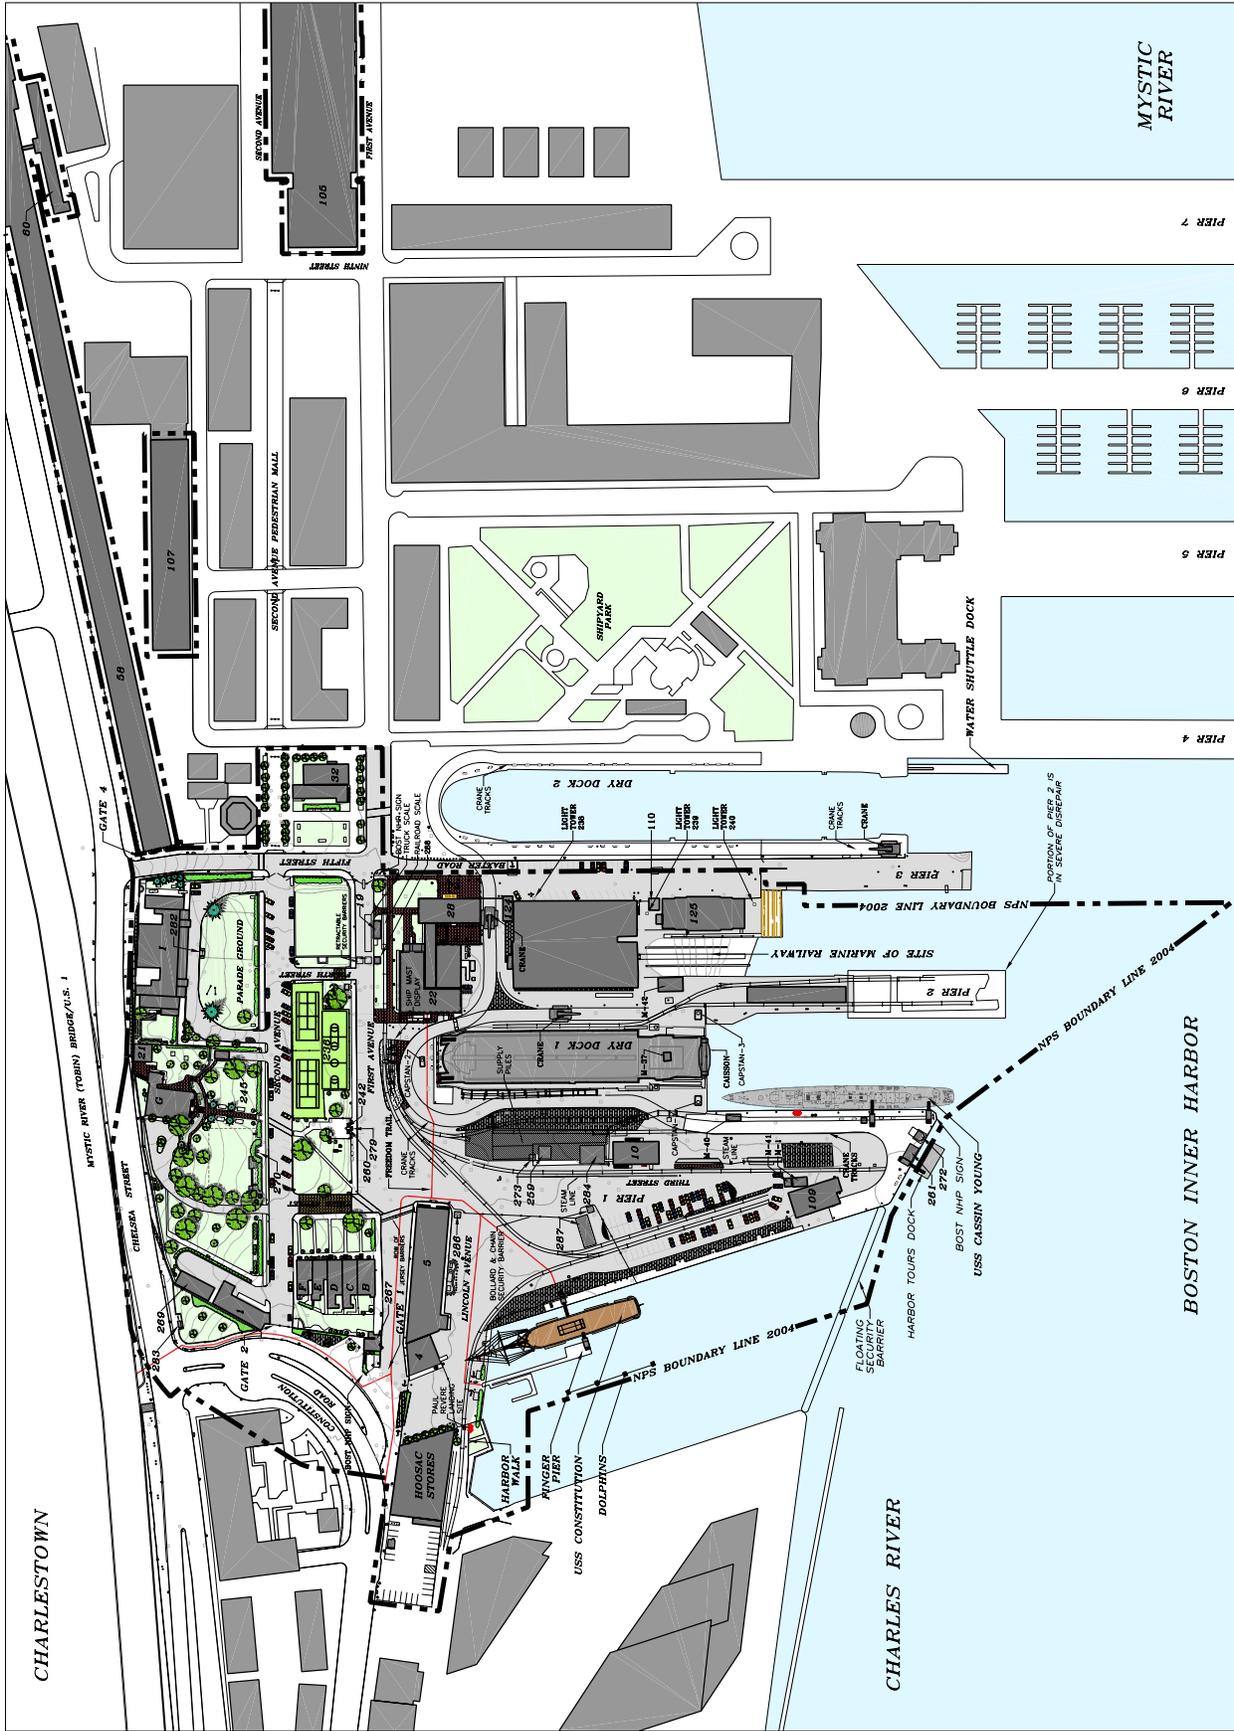
Figure 9.53

Existing Conditions 2004 Vegetation Plan

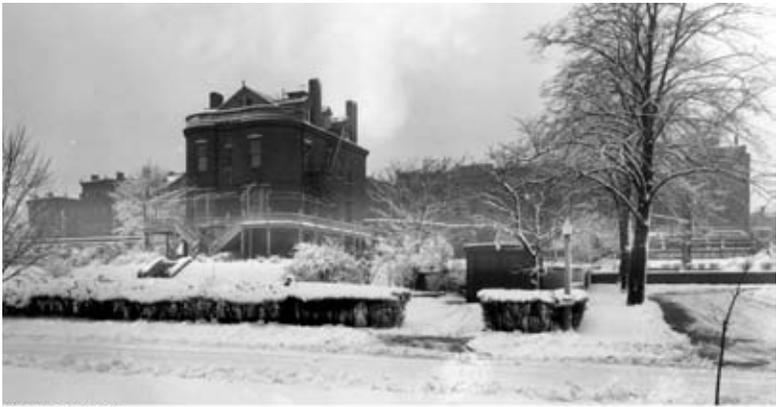
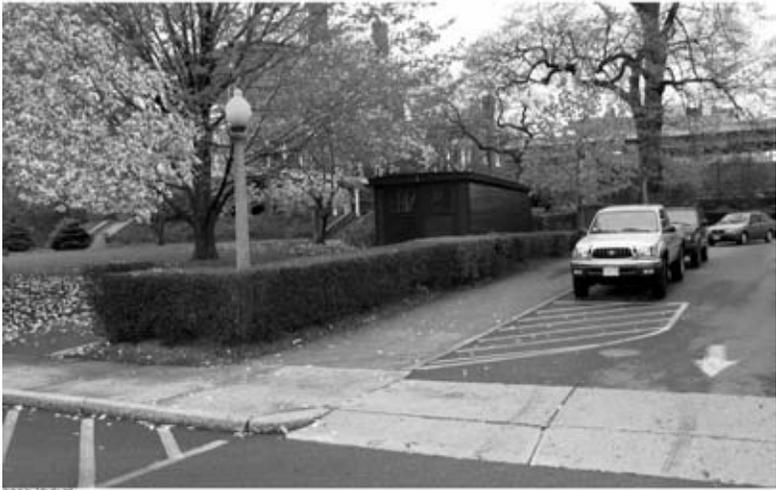
Figure 10.1: The southeast corner of the Commandant's House grounds during the 1930s (top) and currently (bottom). This landscape, virtually unchanged for the past seventy years, and other landscapes of the upper yard possess integrity with respect to the nineteenth-century appearance of the yard.

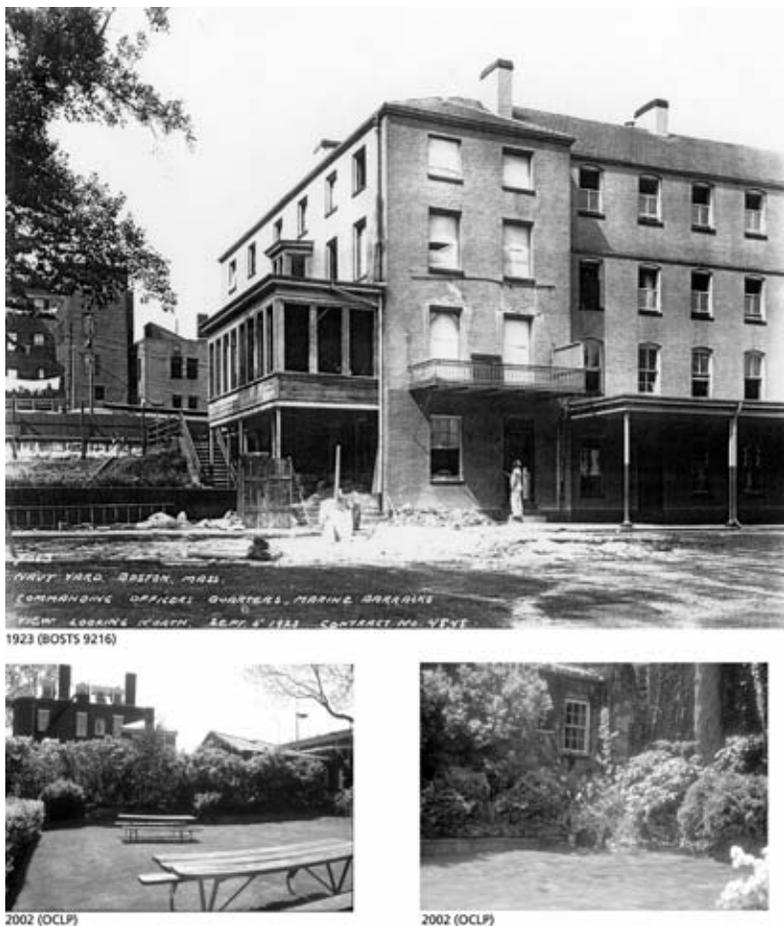
Figure 10.2: The Marine Barracks terraces. West side terrace and Parade Ground in 1923 (top) and west side terrace garden in 2002 (bottom).

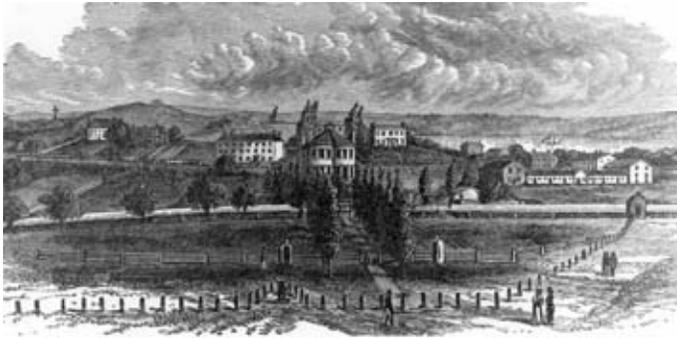
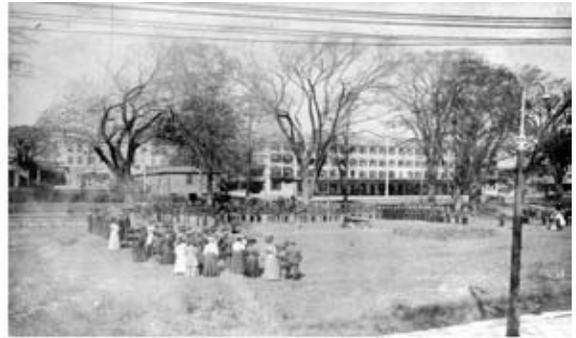
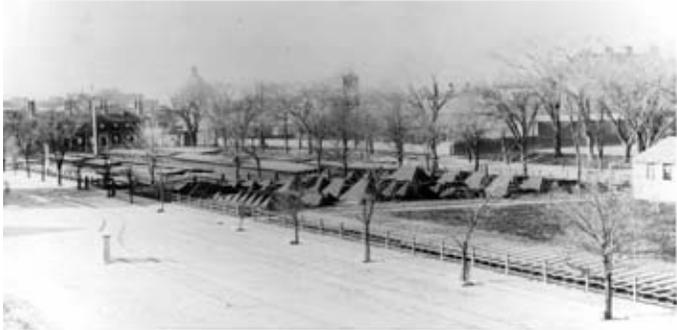
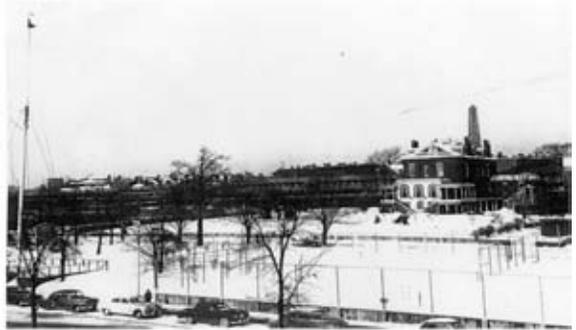
Figure 10.3: The Shipyard Mall's open space at the core of the Charlestown Navy Yard serving as a military park, ceremonial space, and recreation yard.

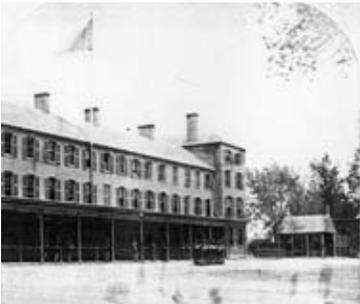
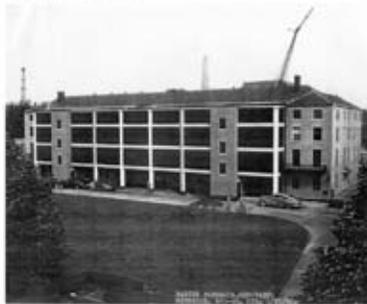
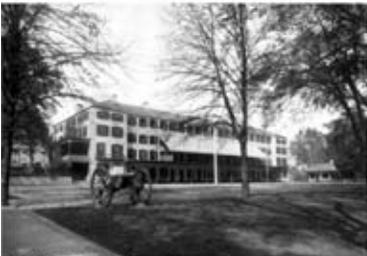
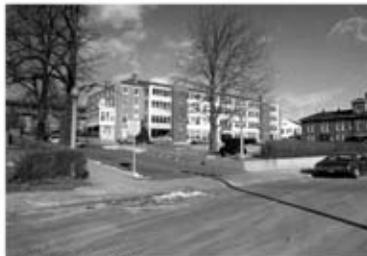
Figure 10.4: The open and flat Marine Barracks Parade Ground used for drilling exercises has changed little over time, while the building has changed greatly.

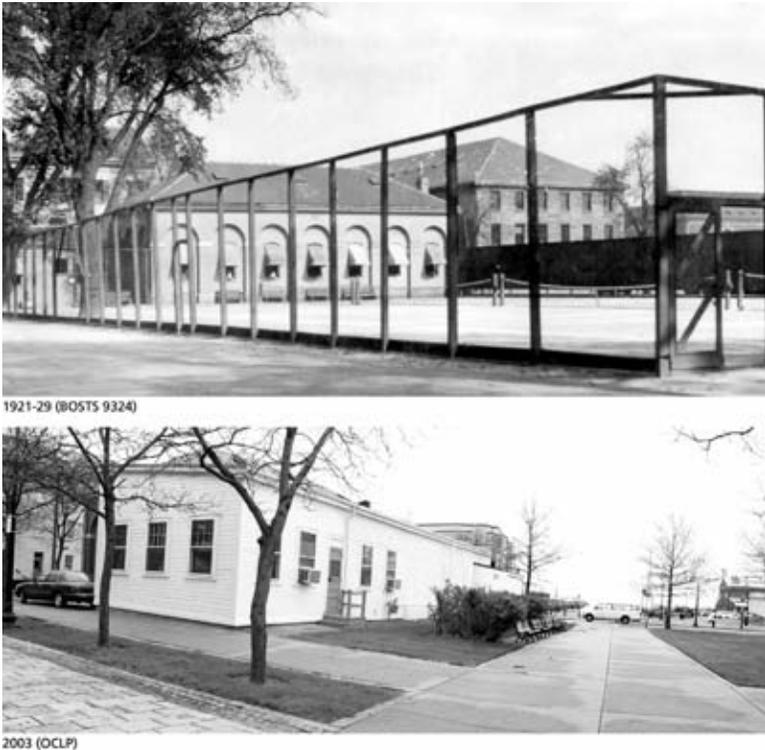
Figure 10.5: The tennis courts west of the Shell House (Building 32) in 1921-29 (top) with the building's addition and plaza in the same space today (bottom). This was the location of the World War II era Temporary Storehouse (Building 198) demolished by the park in 1979.

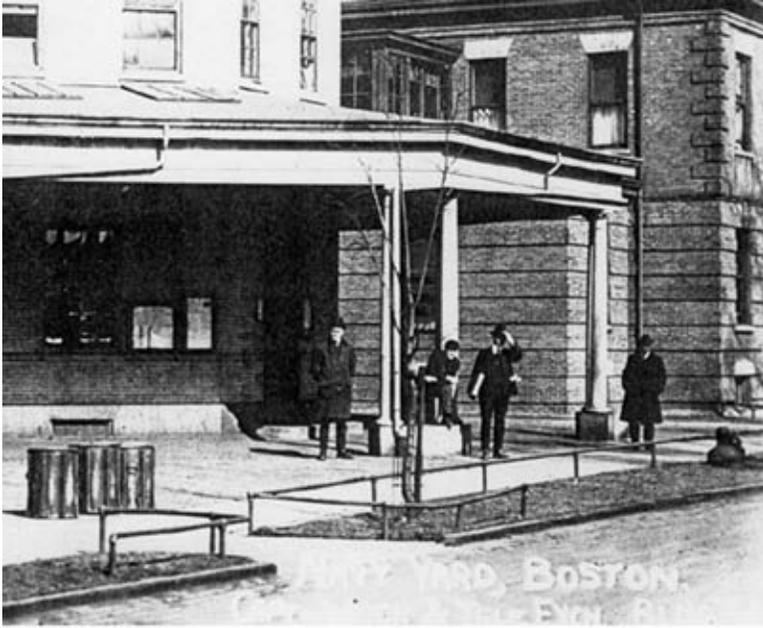
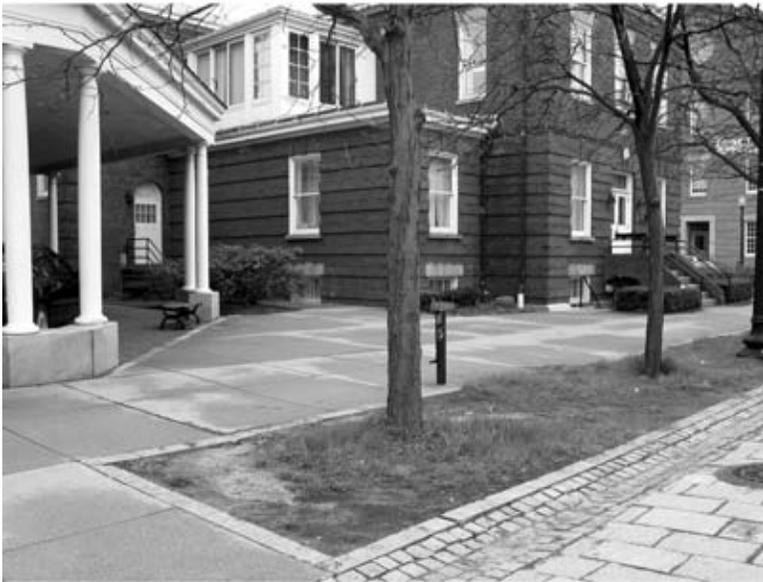
Figure 10.6: Low pipe-fencing protected the turf in front of the Mustert House (Building 31) during the 1920s (top), but no fence exists today and the turf is showing wear.

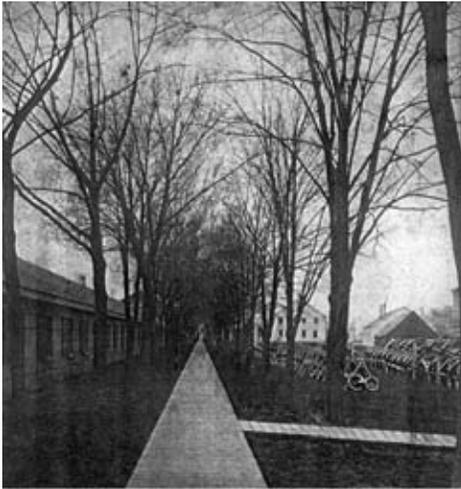
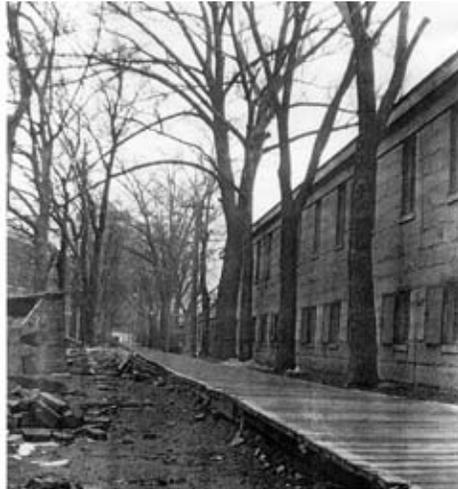
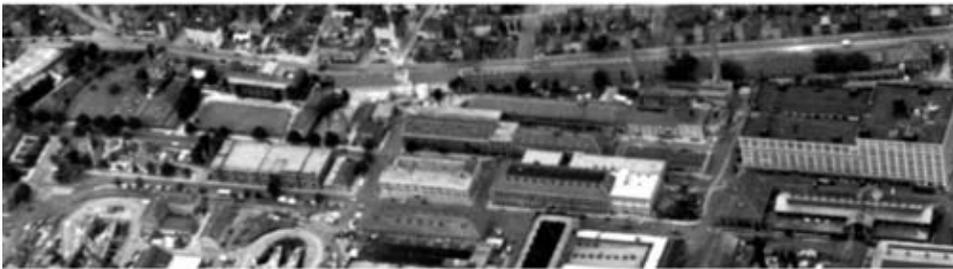
Figure 10.7: The elm trees lining Flirtation Walk (top) are still visible in the 1945 aerial photograph (bottom). Many street trees still shaded First and Second Avenues in 1945 too.

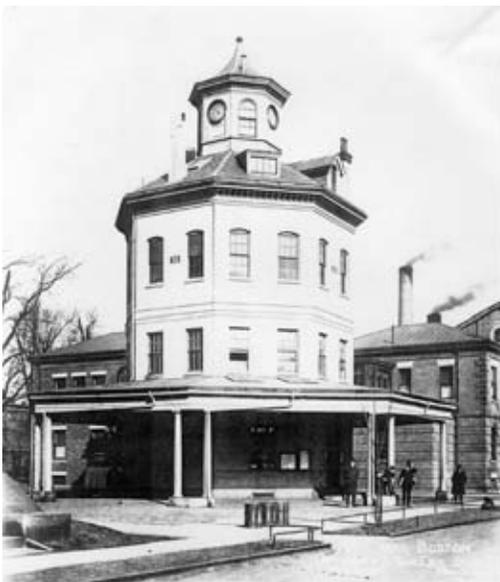
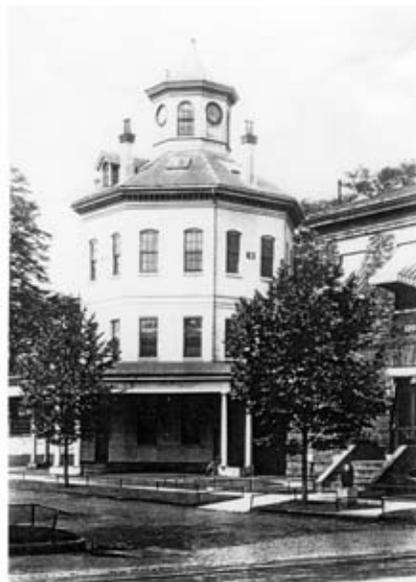
Figure 10.8: Young street trees growing along Second Avenue during the 1920s.

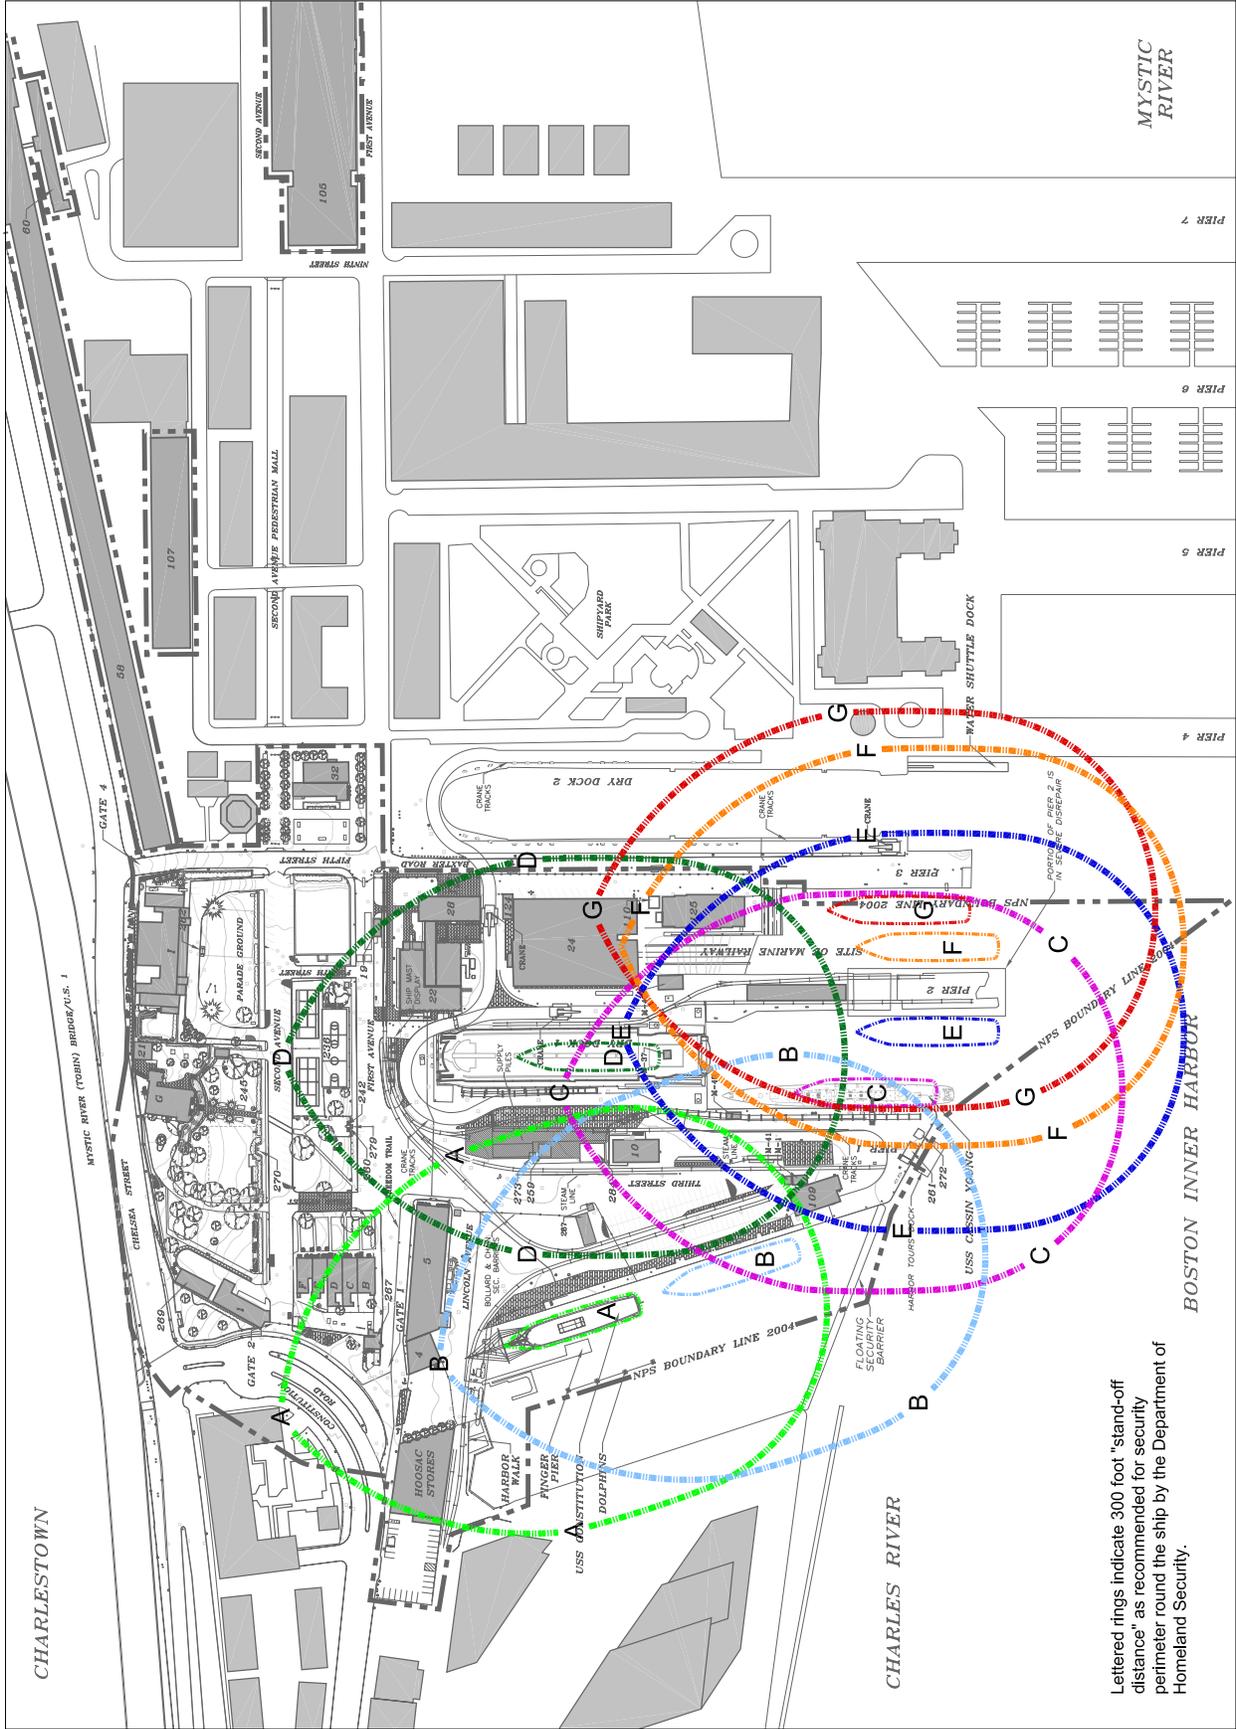
Lettered rings indicate 300 foot "stand-off distance" as recommended for security perimeter round the ship by the Department of Homeland Security.

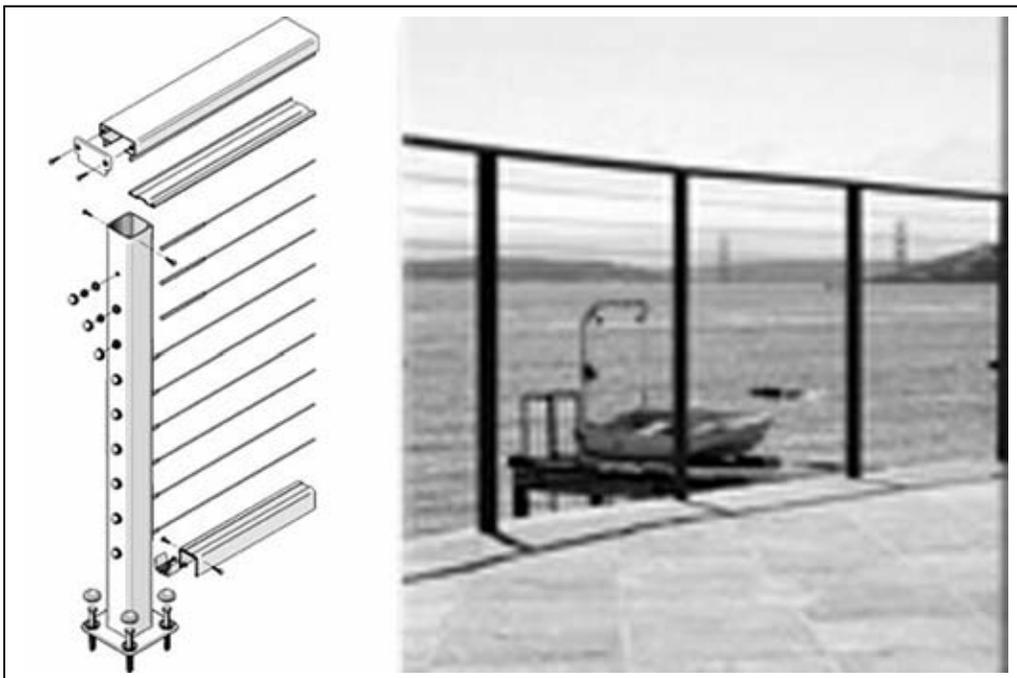
Examples of tension cable fencing. Left: schematic drawing; Right: unobstructed views of a harbor through a fence (Feeney Gateway, http://www.cablerail.com/index_2.html).

The assemblies are laced horizontally through holes drilled in the intermediate posts of the railing frame and then tensioned at opposite end posts with turnbuckles. To ensure proper tensioning, straight runs of cable should include a tension adjustment fitting about every fifty feet, and runs with bends or corners should have a tension adjustment fitting about every forty feet or after every second corner bend.

Building codes vary by city and county, so before starting the project consult the local building department for requirements on using and installing cable railings. Local codes often guide support spacing, cable spacing, and tension. Cable is movable and code often specifies that a 4" (some have 5 or 6") sphere can not pass through any spot on the railing.

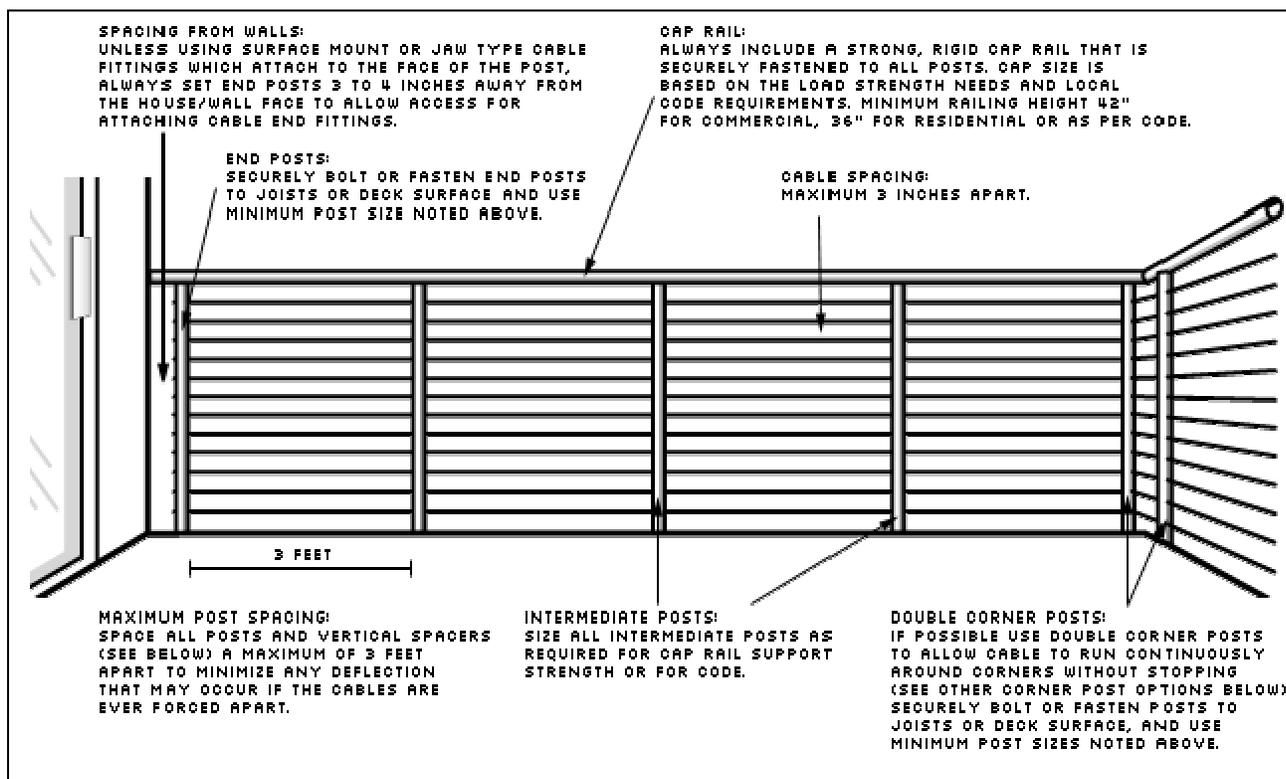
Example of a tension cable fence with double corner posts and no foot rail (Feeney Gateway, http://www.cablerail.com/index_2.html).

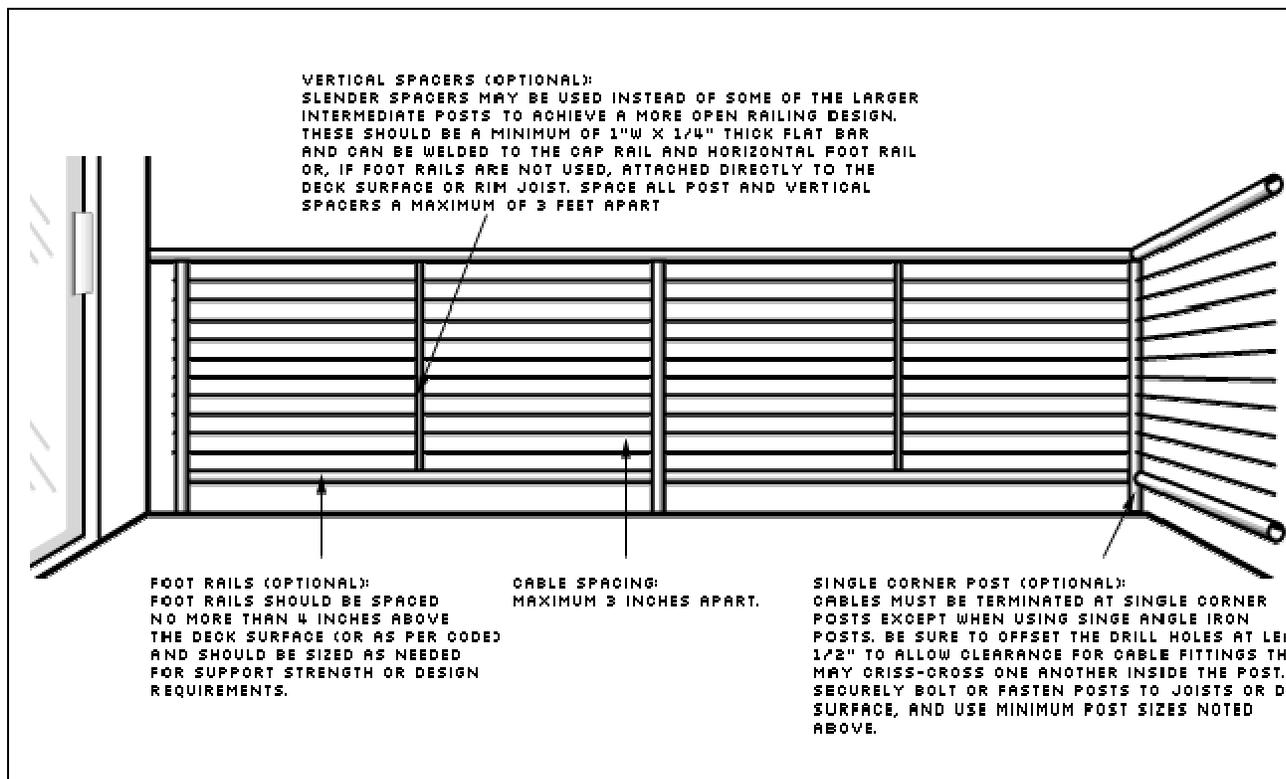
Example of a tension cable fence with a single corner post and a foot rail (Feeney Gateway, http://www.cablerail.com/index_2.html).
