# Cape Hatteras Light Station Cultural Landscape Report

**Cape Hatteras Light Station,  
Cape Hatteras National Seashore**

**Cultural Landscape Report**

Prepared by Susan Hart Vincent  
Historic Land Design  
Charlotte, North Carolina

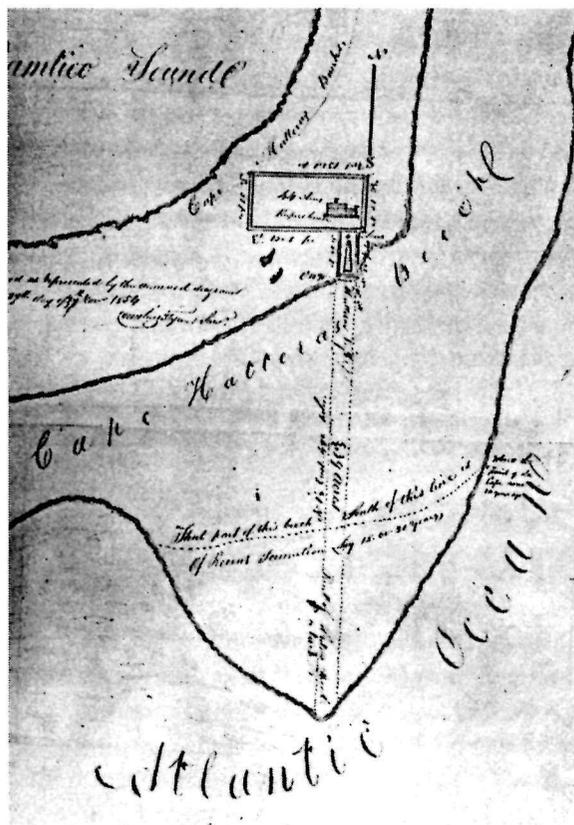
FIGURE 2. Cape Hatteras Light Station Survey of November 29, 1854, showing the 4-acre original tract and the 1828 40-acre tract, as found in Holland, 1968.

The 1854 survey in figure 2 illustrates the quarters north of the lighthouse and within the forty-acre tract purchased in 1828. Although not shown in the survey, a smokehouse may have been built along with other necessary outbuildings.<sup>12</sup>

The survey showed the boundaries of the reservation enclosing a square area of approximately 40 acres. How the property holdings changed from forty-four acres to forty acres is not known. Bamber's boundaries are incongruous with the 1854 map in figure 2.

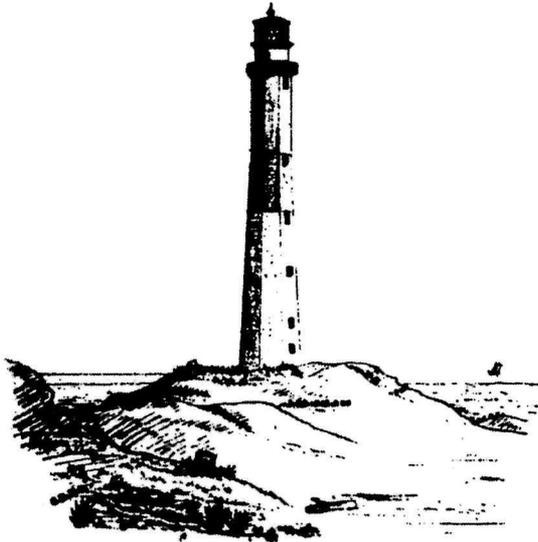
Illustration No. 1  
 OLD TOWER, CAPE HATTERAS N.C., OCT. 24 '70  
 View from the West

*Height of sand hill above the general level of the beach to feet  
 From base to top of addition - 70 feet*

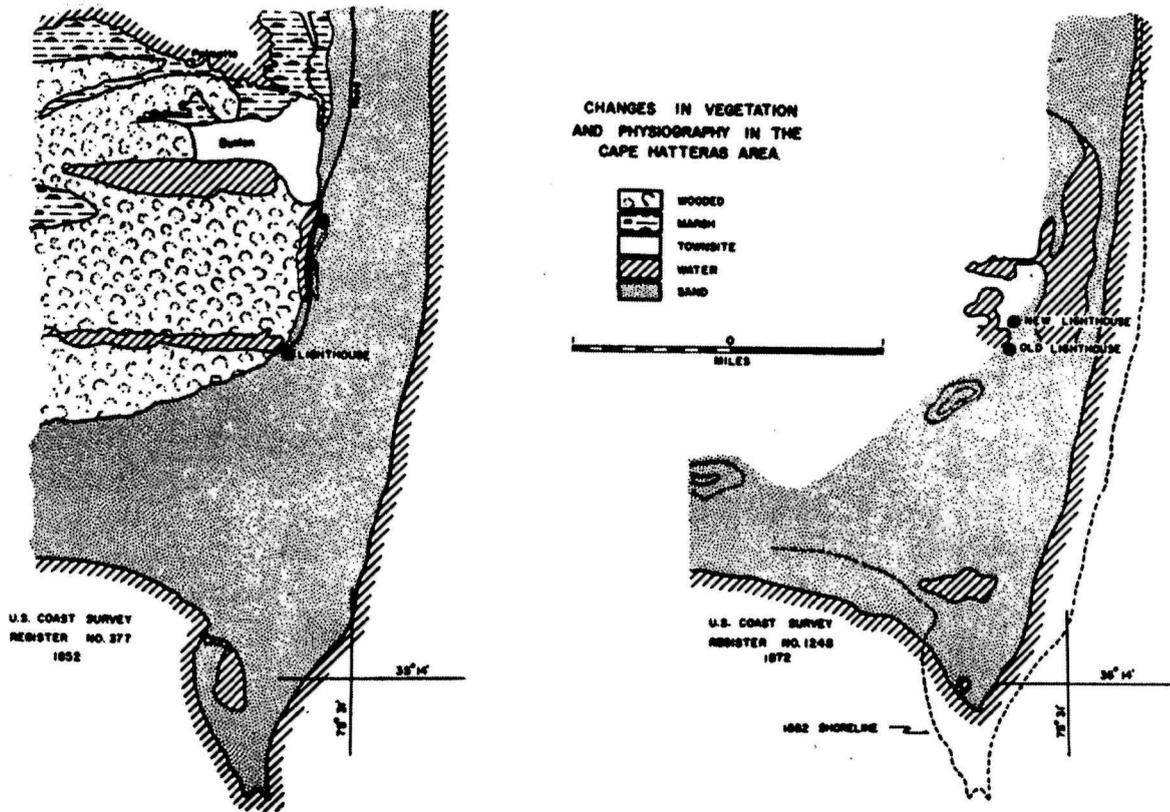
FIGURE 4. Physiographic changes in the Cape Hatteras area, 1852 - 1872.

of the light station. Another north-south pond ran parallel to the lighthouse road approximately one-half mile to the north. This pond may have been associated with Cape Creek, the eastern boundary of the station property (formerly Farrow's) that drained north to the Pamlico Sound. By 1872, the north-south pond had moved east and enlarged, leaving a thin piece of land between it and the ocean. The linear east-west pond also appears to have enlarged (fig. 4).

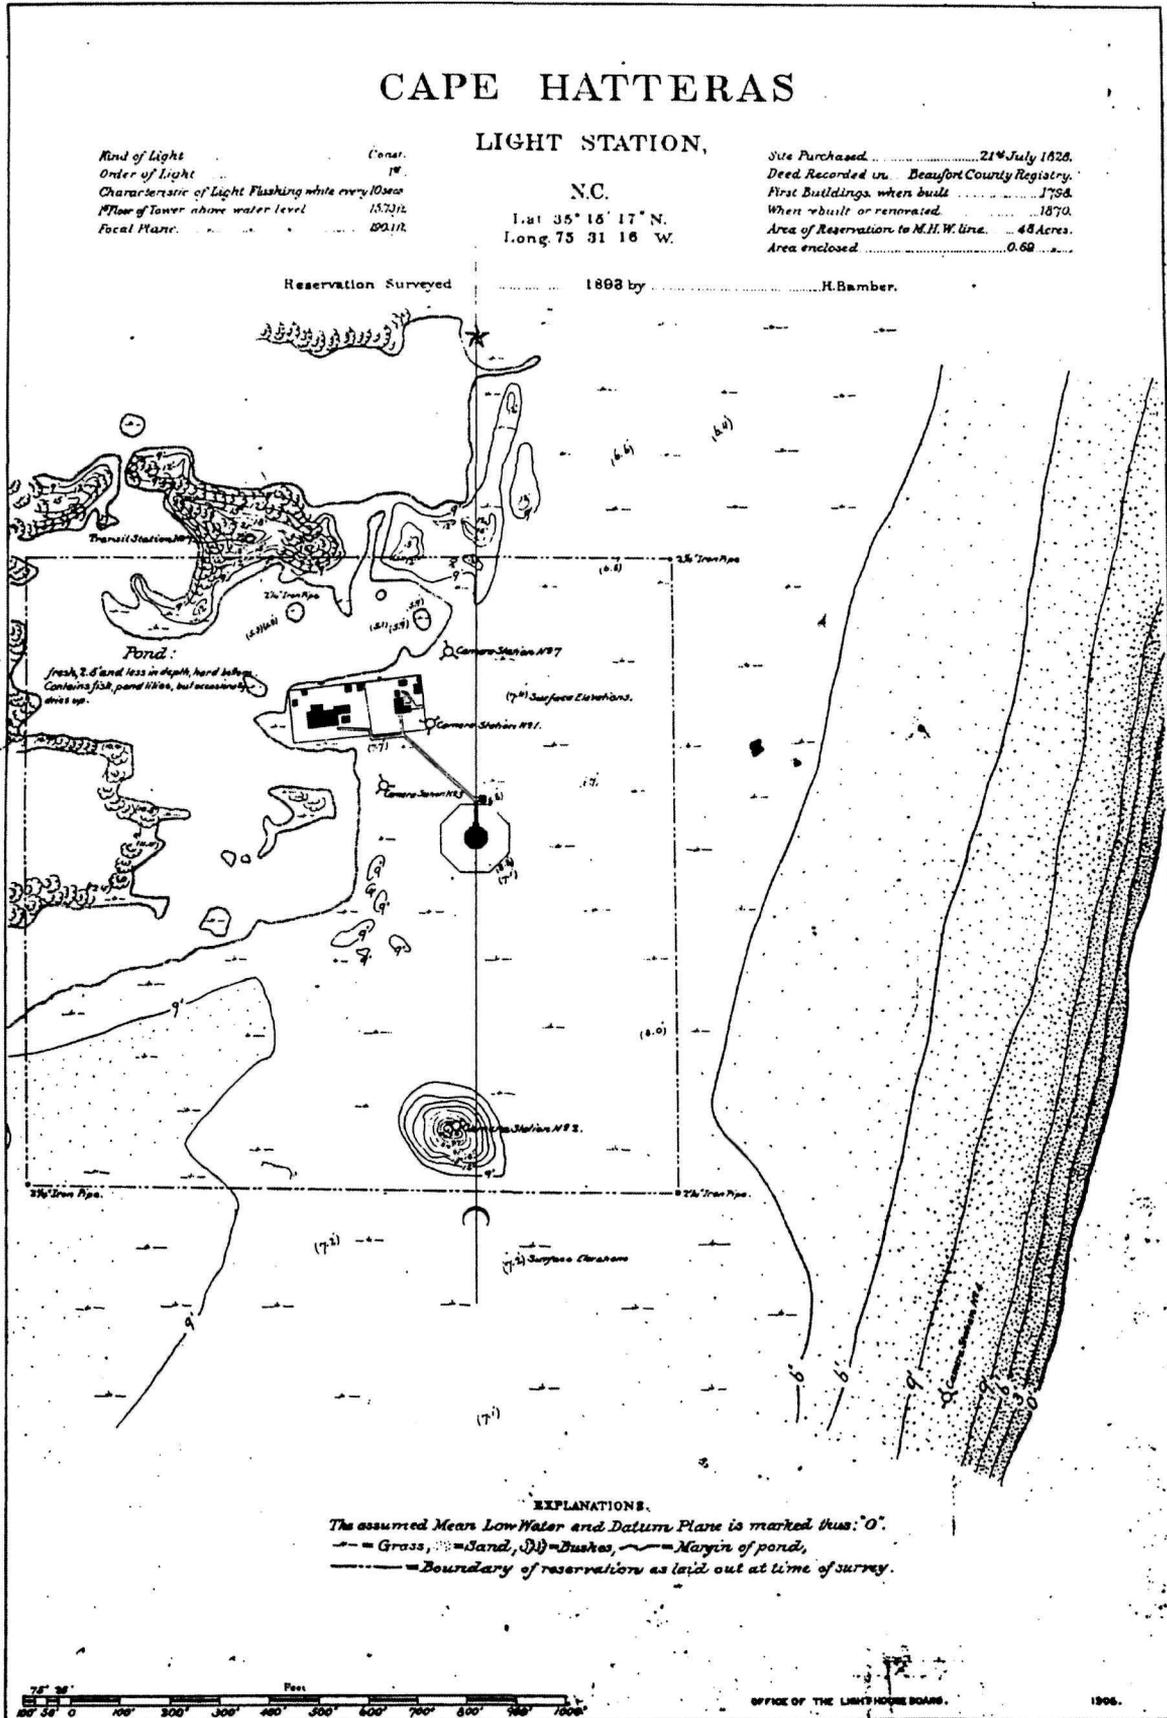
FIGURE 5. H. Bamber's 1893 Survey of Station Boundaries and Shore Line.

The 1870 light station was surveyed in 1893 by H. Bamber for the Office of the Lighthouse Board (fig. 5).

Despite the optimism of this report, the shoreline erosion near the lighthouse was increasing. The 1893 Bamber survey (fig. 5) indicated the water had moved to within approximately 1,300 feet of the new tower. In addition, photographs of the same period show a flat, open sandy beach south and southwest of the tower. In 1919, a low sand ridge, remnant of an old dune line, ran parallel with the shore about 500 feet east of the light. Soon after, the ocean overcame the dunes and washed to within 300 feet of the lighthouse.

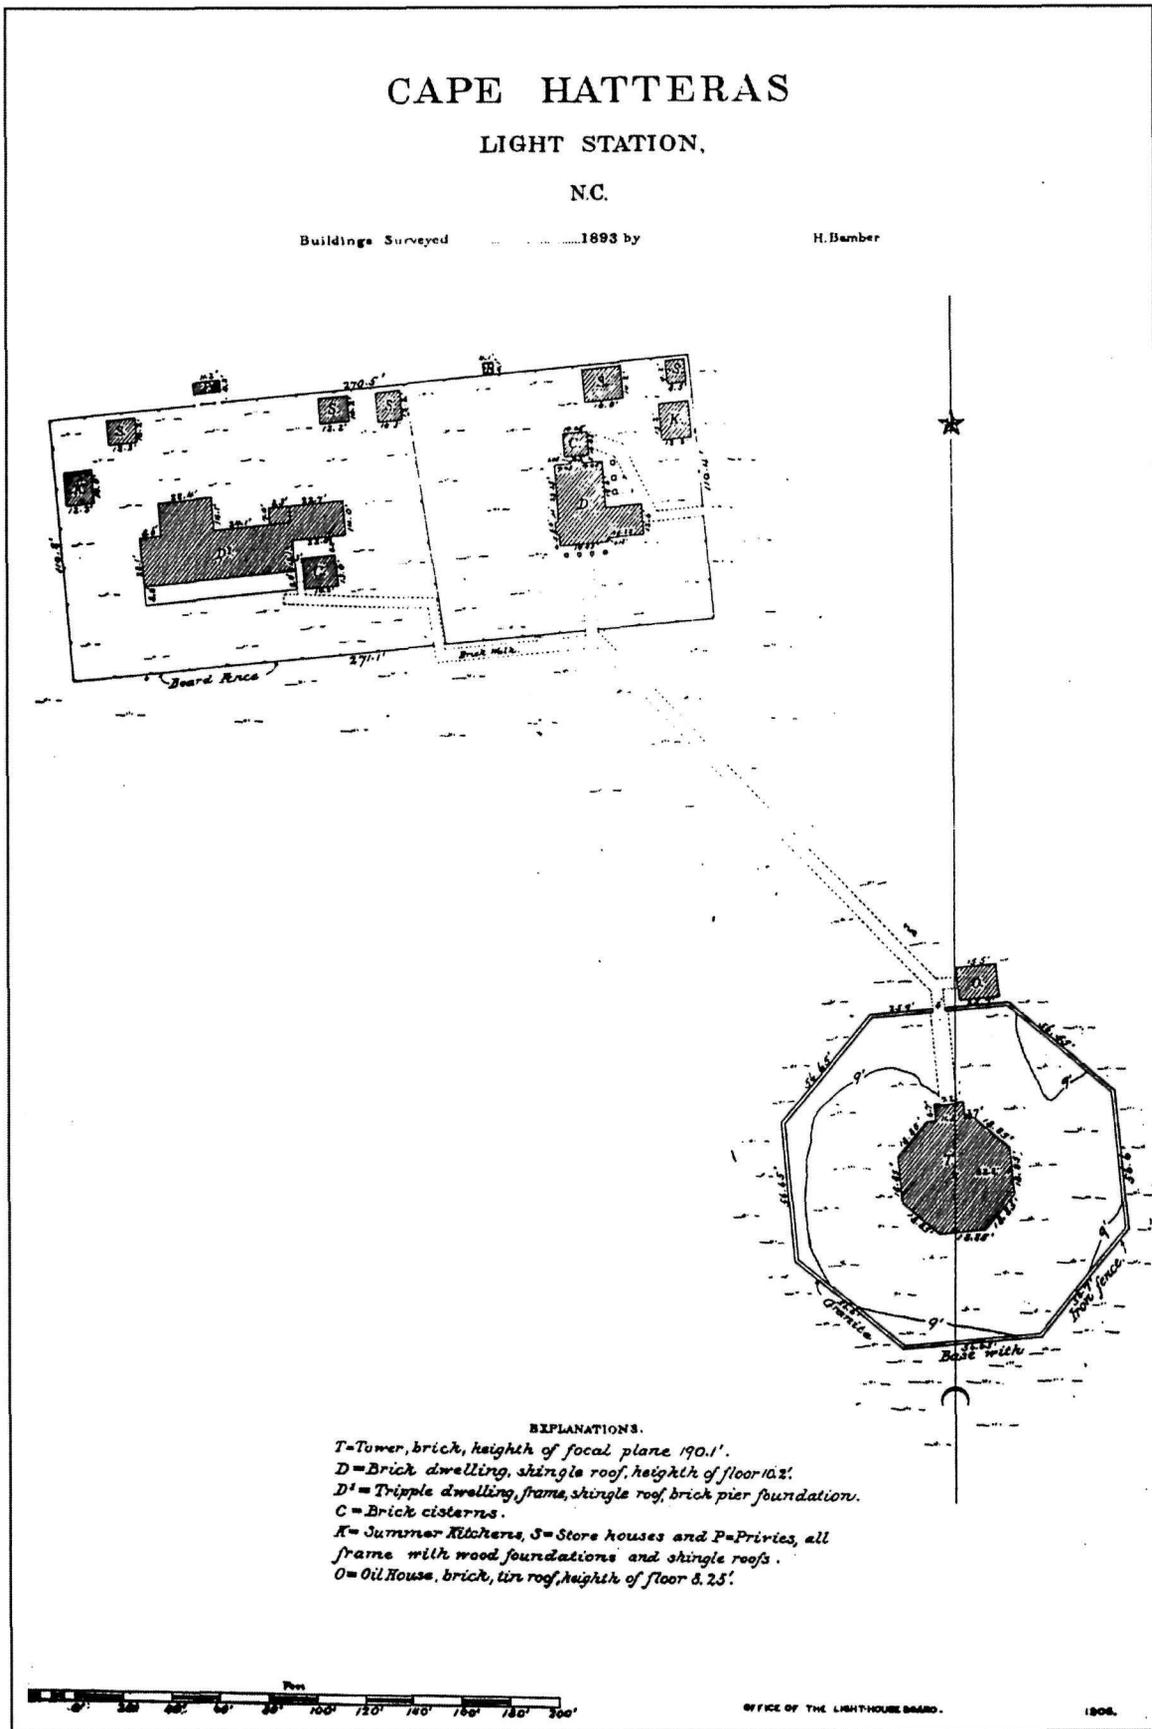
FIGURE 6. H. Bamber's 1893 Survey of Cape Hatteras Light Station, NC.

summer kitchen, three storage structures, a cistern, and double privy (fig. 6). All structures were painted white.

The principal keeper's wooden picket fence, constructed in 1870, was replaced in 1888. Although historical sources cite 400 feet of new fence being built, it appears that approximately 900 feet were needed to construct the white board fence that surrounded both dwellings in 1893 photographs.<sup>20</sup> The fence was approximately 110 by 270 feet, with a 110-foot segment dividing the two properties (fig. 6).

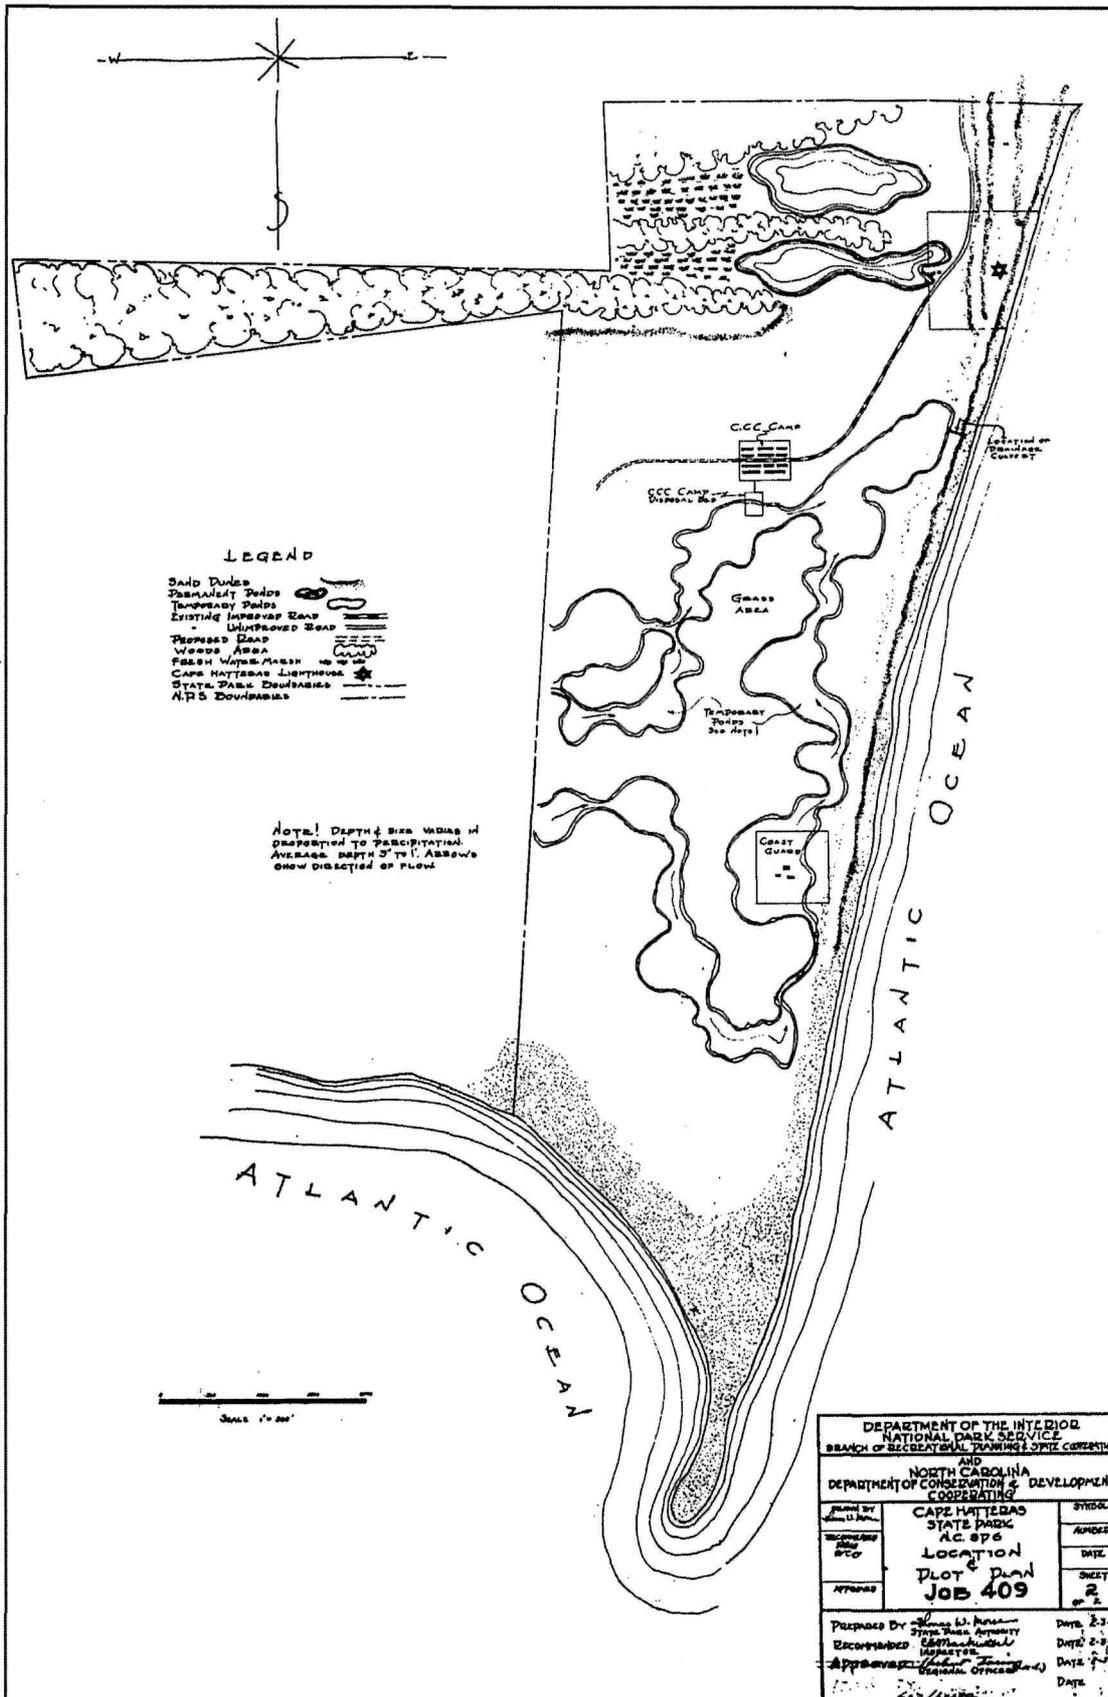
FIGURE 8. Cape Hatteras State Park, N.C. SP-6, 1937 Location and Plot Plan.

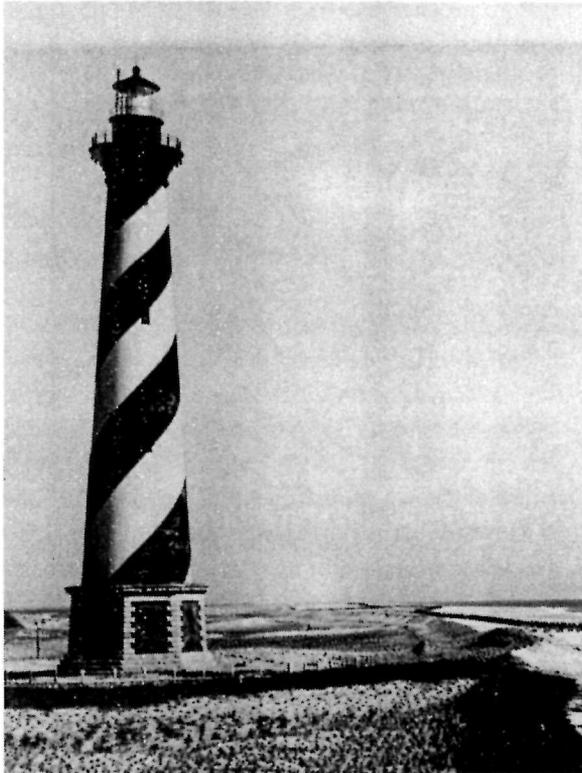
FIGURE 9. North view of Lighthouse and CCC brush fences and grass plantings. Lighthouse revetments can be seen along the beach, ca. 1935.

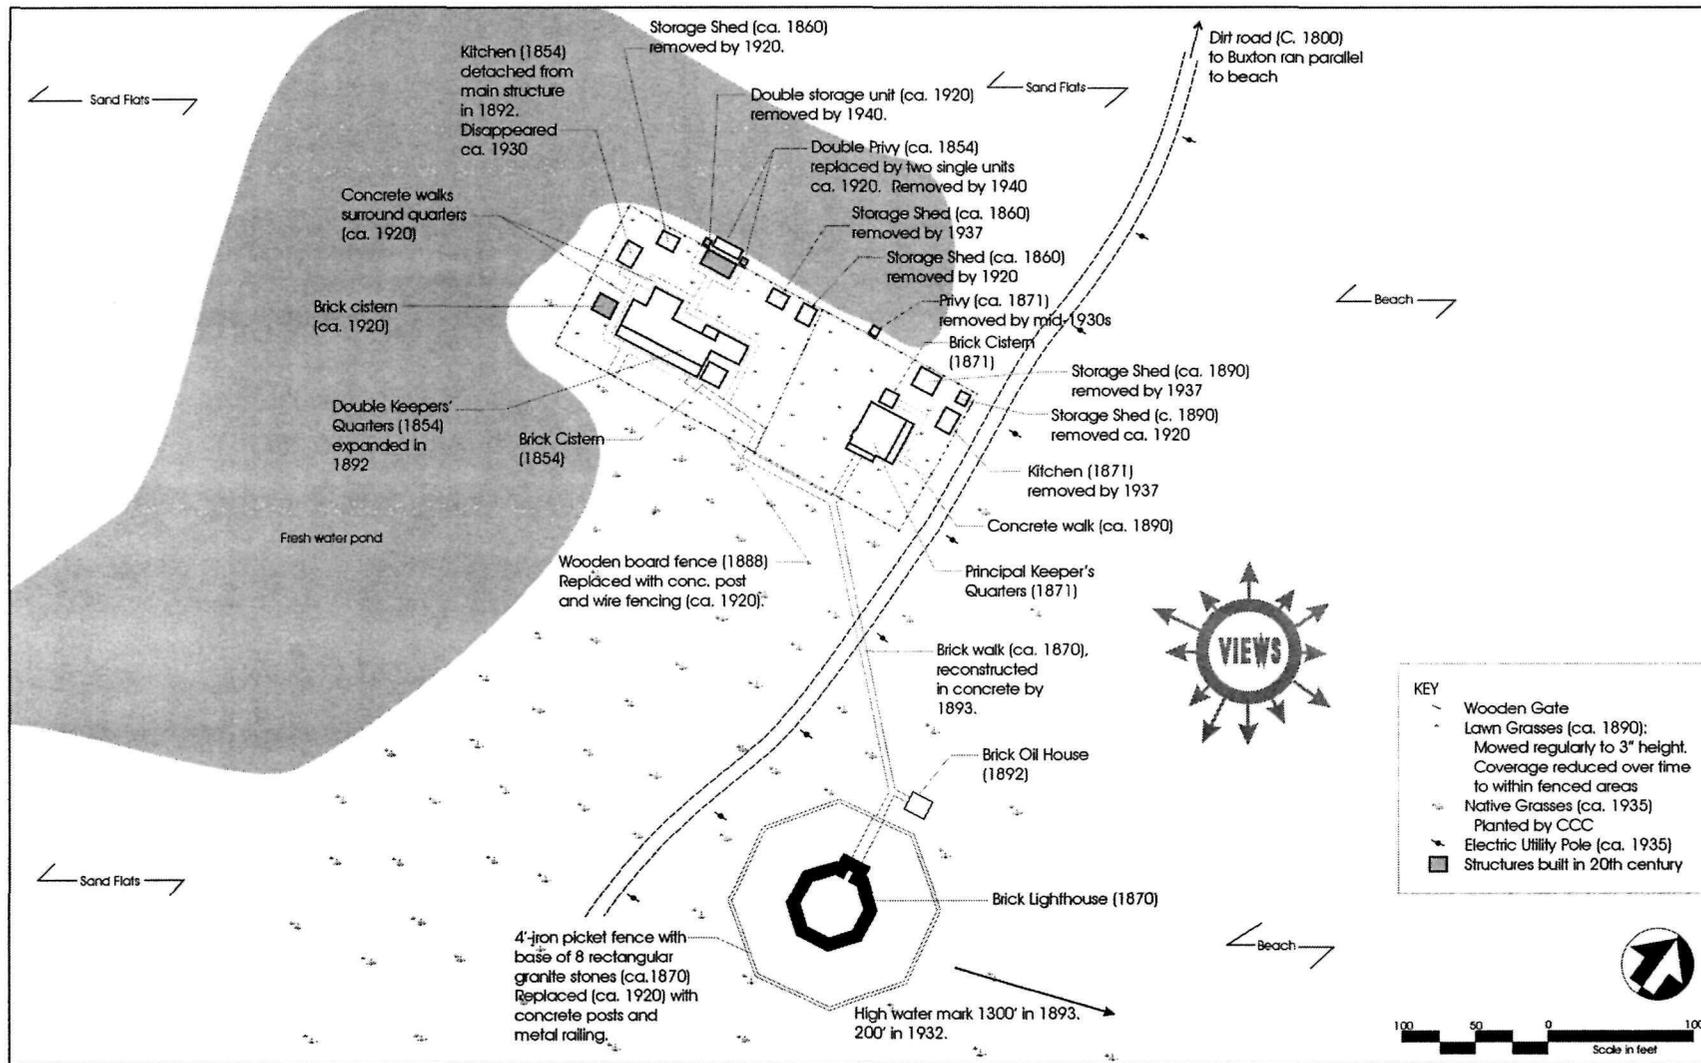
FIGURE 11. Cape Hatteras Light Station Historic Period (1870-1936).

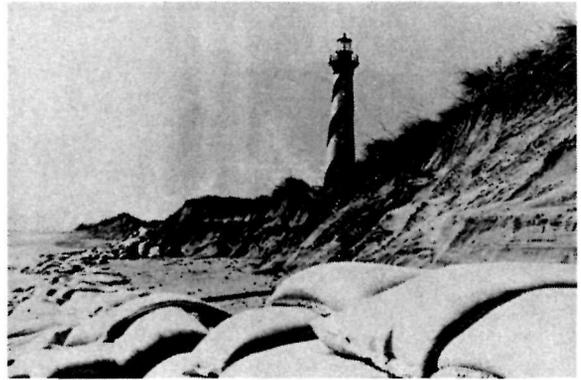
FIGURE 12. Sandbagging efforts in 1968 to protect the lighthouse.

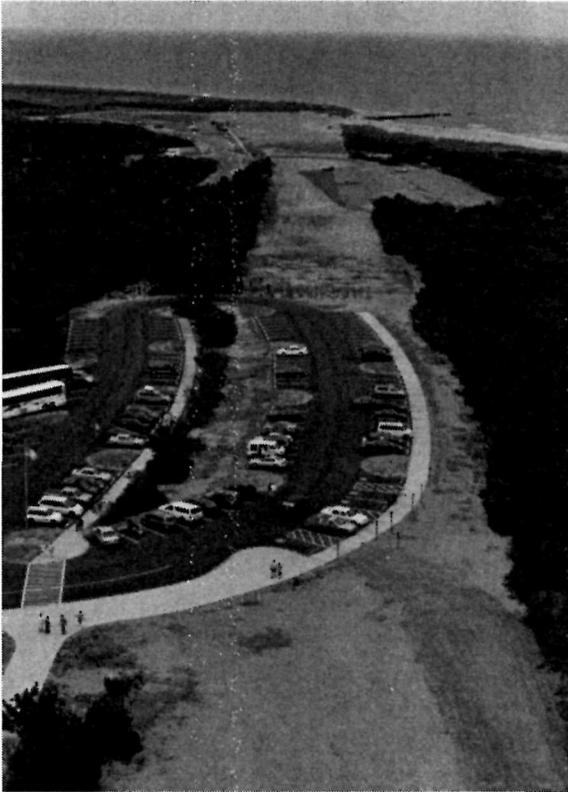
FIGURE 14. Northeast view of move corridor and old lighthouse site, May 2001.

Once all the structures were relocated, ICC removed the tracks and any debris that resulted as a byproduct of the move. The move corridor was back-filled and re-graded to resemble pre-move elevations (fig. 14).

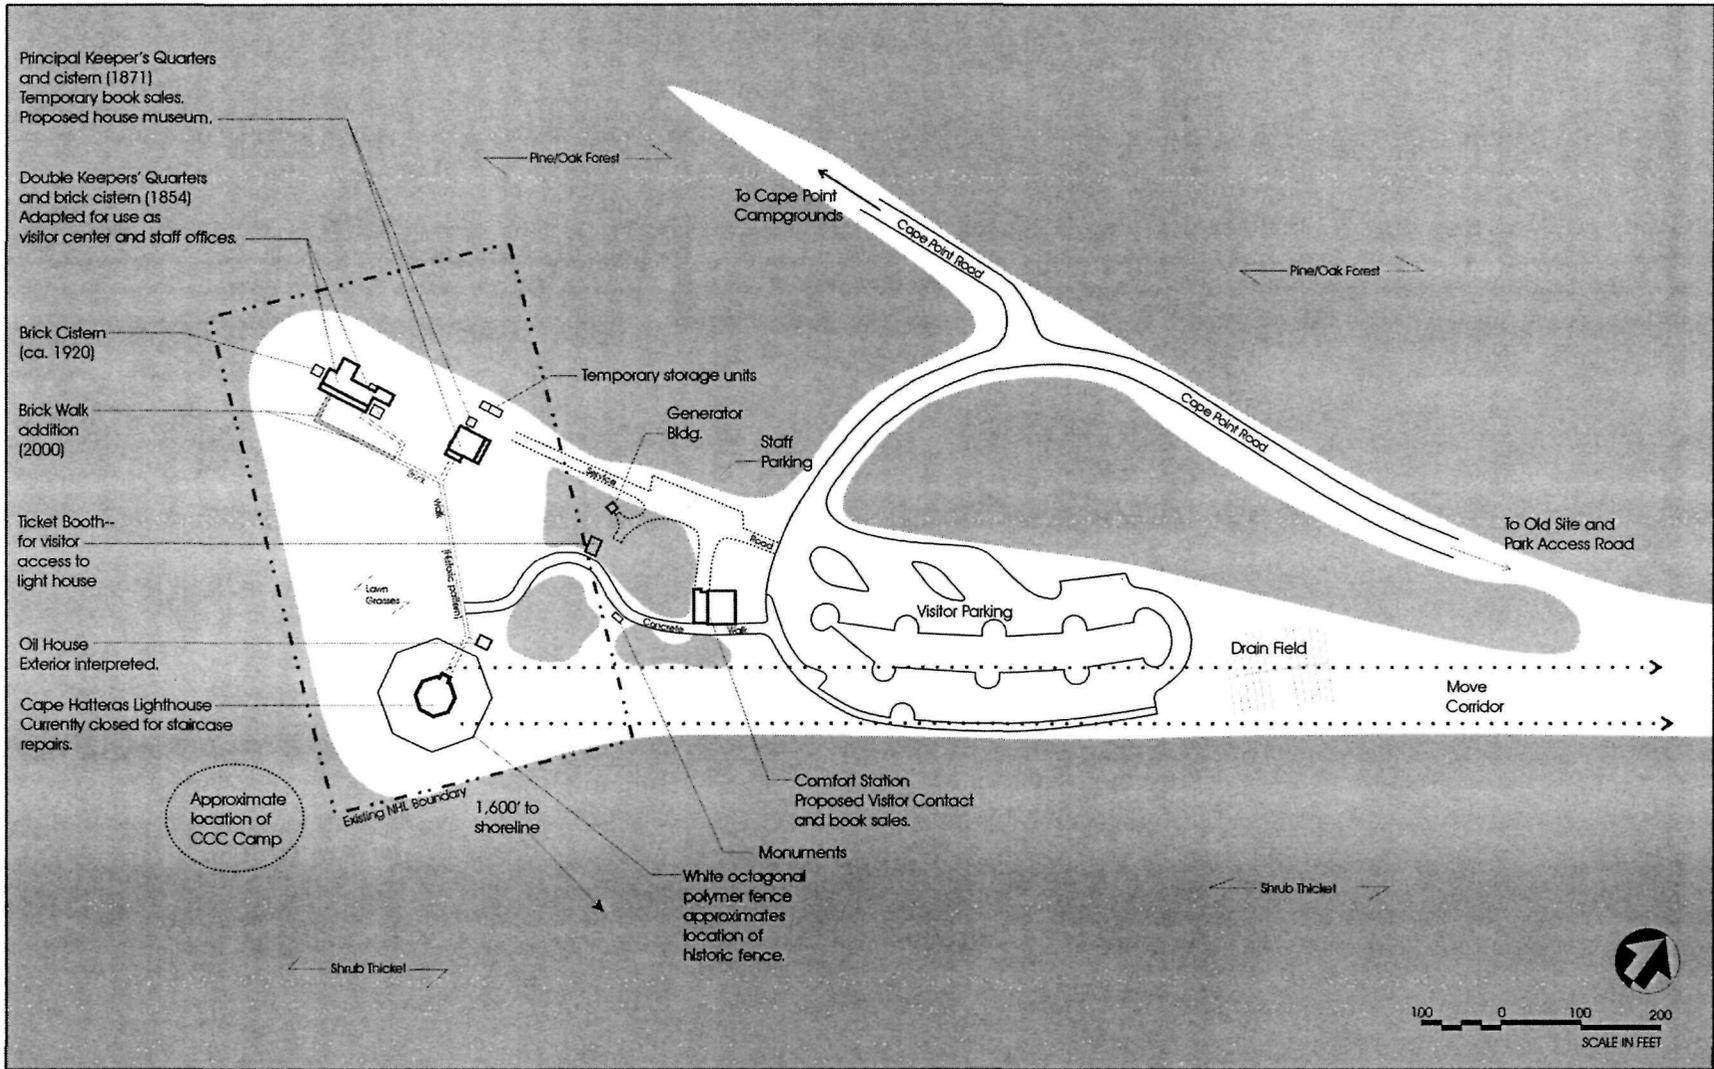
FIGURE 15. Existing Conditions Plan.

Existing conditions reflect the ongoing development of the site (fig. 15). Three phases of development were planned, of which two have been realized. Phase one involved the preparation and relocation of the light station complex to its new site. Phase two, completed in 2001, provided for site visitation and included the construction of a light station access road, a visitors parking area, a comfort station, a temporary ticket booth, and walkways. Clearing away trees in the historic zone and planting lawn grasses was also completed in this phase.

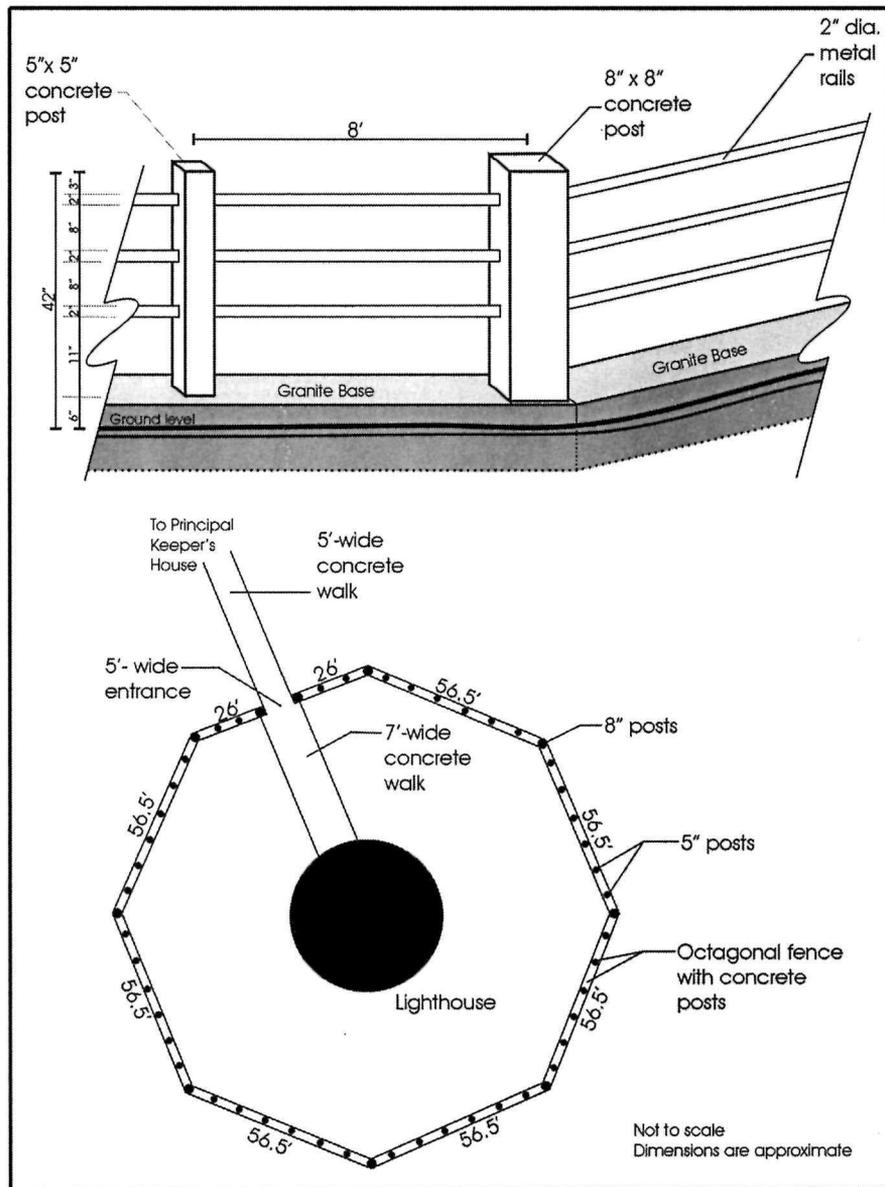
FIGURE 17. Lighthouse Fence Details.

- Maintain the exterior of extant keepers' quarters and cisterns white, which is consistent with the end of the historic period.
- Restore the historic concrete post and metal rail fence that surrounded the lighthouse at the end of the historic period. Use the original granite stones that supported an octagonal fence there throughout the historic period (fig. 17).
- Restore the historic concrete post and wire fence that surrounded the principal and double keepers' quarters at the end of the historic period. This is consistent with the period of significance in that a rectangular fence surrounded the quarters from 1888 to ca. 1950. Nine hundred yards of four-foot-tall welded wire fencing, with 8-inch-by-12-inch rectangles, can be specially made for approximately \$500 (fig. 18).<sup>2</sup>

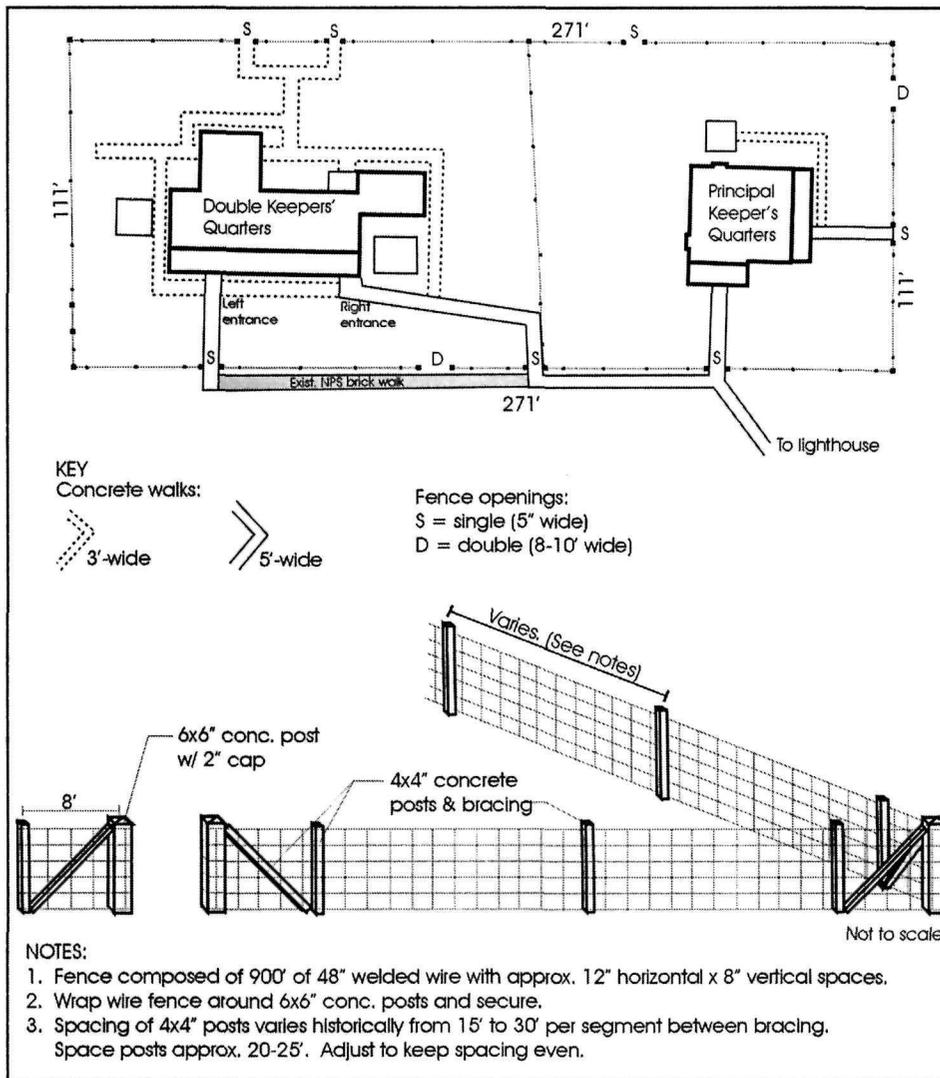
FIGURE 18. Keepers' Quarters Fence and Walk Details.

- Restore a five-foot-wide concrete walk from the east door of the principal keeper's house to the proposed fence. This walk is a visual contribution to circulation patterns and not to be used as a visitors entrance. Therefore, elevation changes to meet ADA requirements are not necessary (fig 18).

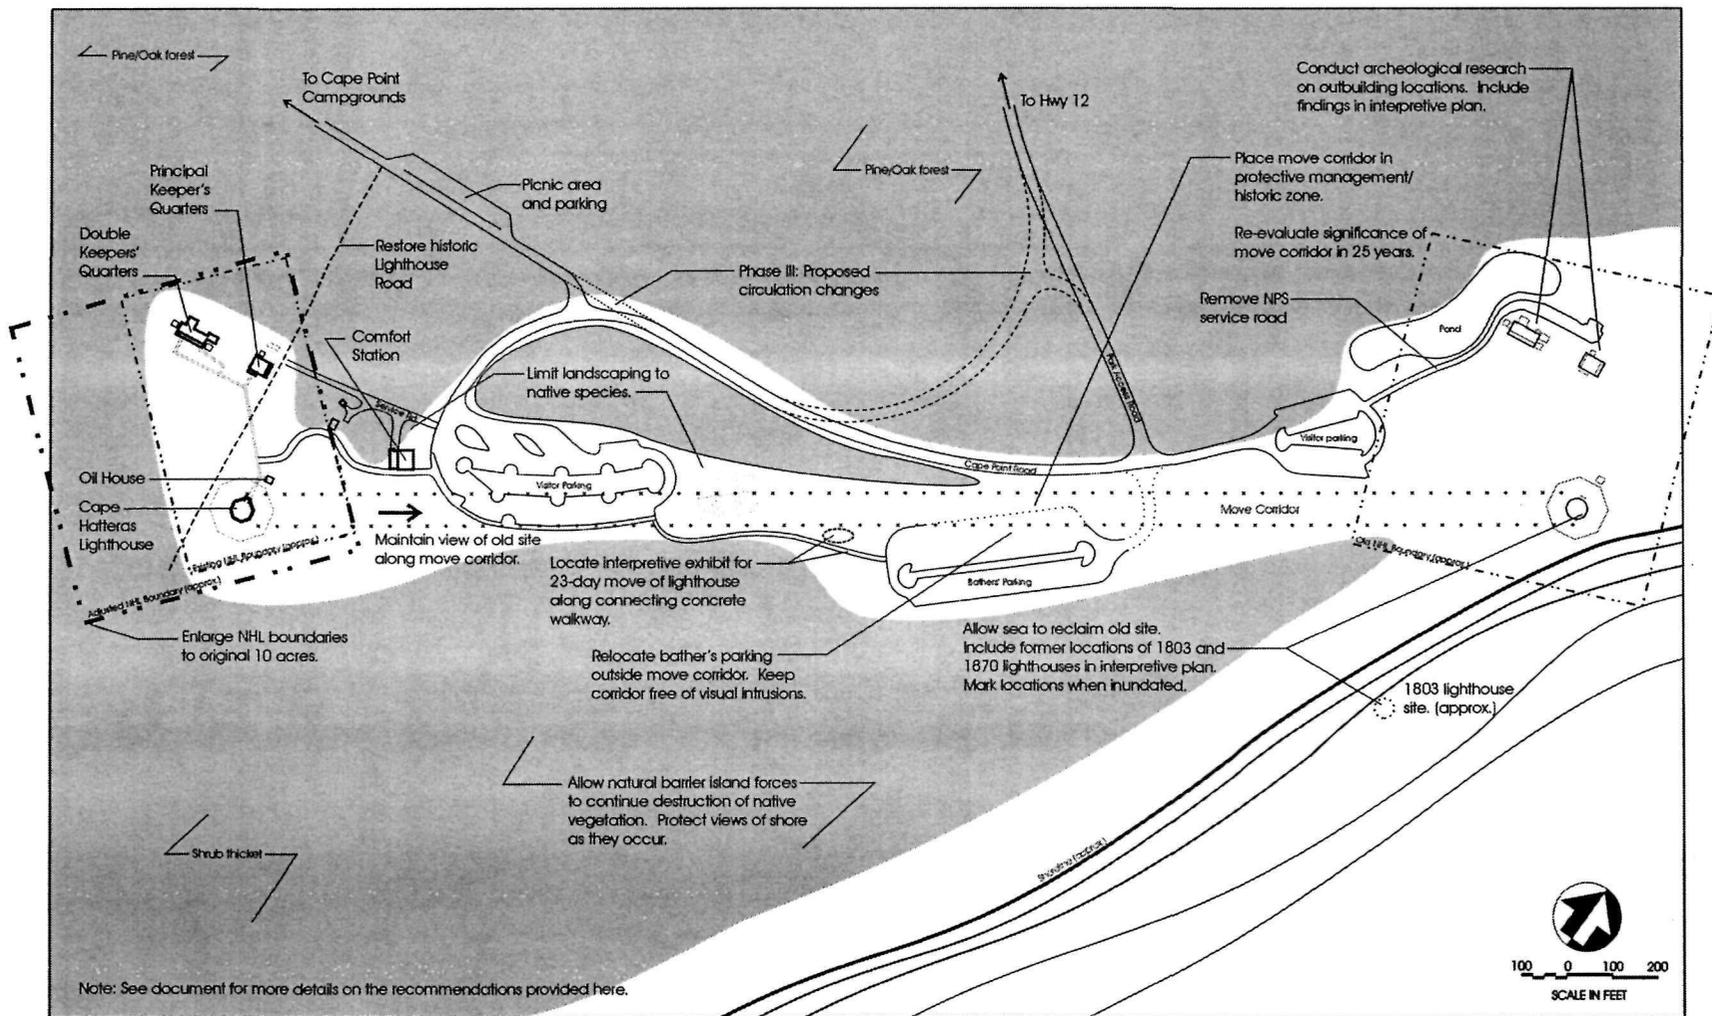
FIGURE 19. General Treatment Recommendations.

Phase three will finalize vehicular circulation patterns near the two lighthouse sites. (These are illustrated in Figure 17, General Treatment Recommendations, in the following chapter.) The three-way stop at the junction of the Park Access Road and Cape Point Road will be eliminated and a shortcut will pull the road further to the west. Access to the bathers parking and the old lighthouse site will require a turn off of Cape Point Road.

The following discussion of treatment recommendations focuses on a preservation/rehabilitation strategy for the resources at the old and new Cape Hatteras Light Station sites that contribute to the historic period of significance. General recommendations applicable to the historic site precede more specific recommendations for individual features. This section provides treatment for historic as well as non-historic features. Recommendations are illustrated on treatment plans at the end of this chapter (figs. 19 & 20).

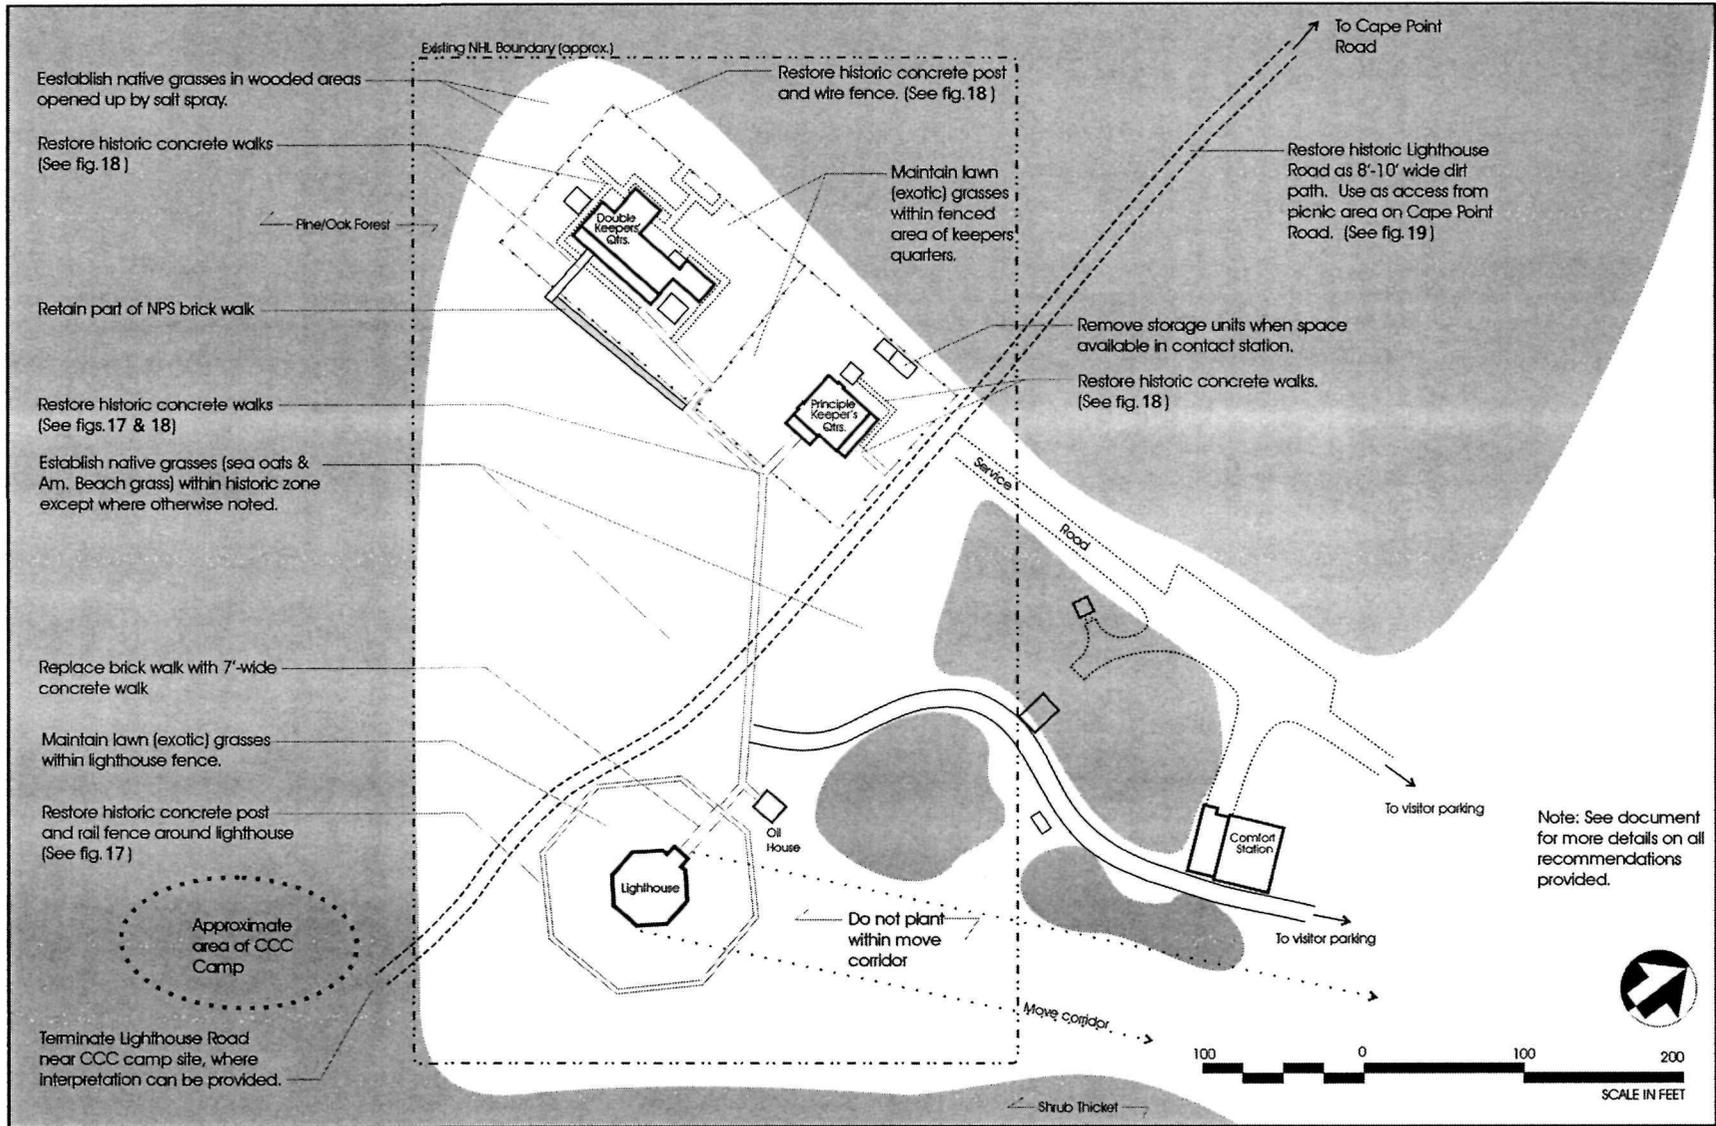
FIGURE 20. Lighthouse Complex Treatment Recommendations.
