Ocracoke Light Station Rehabilitation Project Environmental Assessment

US DEPARTMENT OF THE INTERIOR, NATIONAL PARK SERVICE
Cape Hatteras National Seashore Recreation Area
Ocracoke Light Station Rehabilitation Project Environmental
Assessment

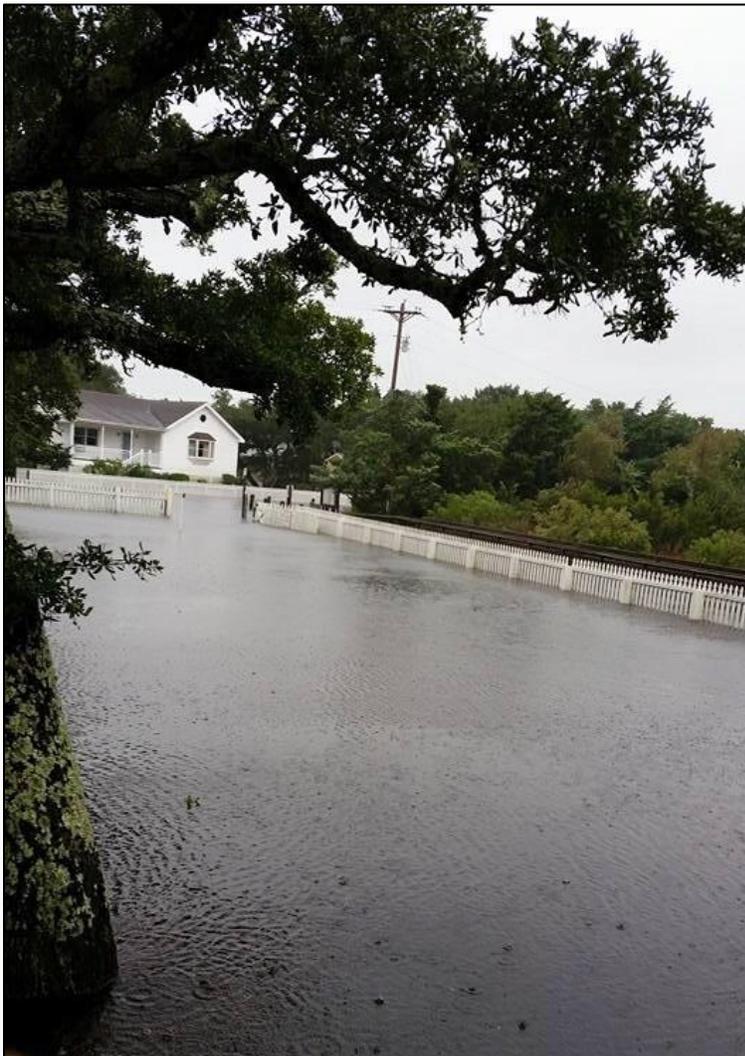
Future impacts associated with climate change and sea level rise should be considered when making decisions on the long-term management of the Ocracoke Light Station. Between 2017 and 2019, Hurricanes Matthew, Florence, and Dorian damaged the buildings and structures at the Ocracoke Light Station. Most recently, the site was severely flooded from Hurricane Dorian in 2019, as shown in the photograph to the left.

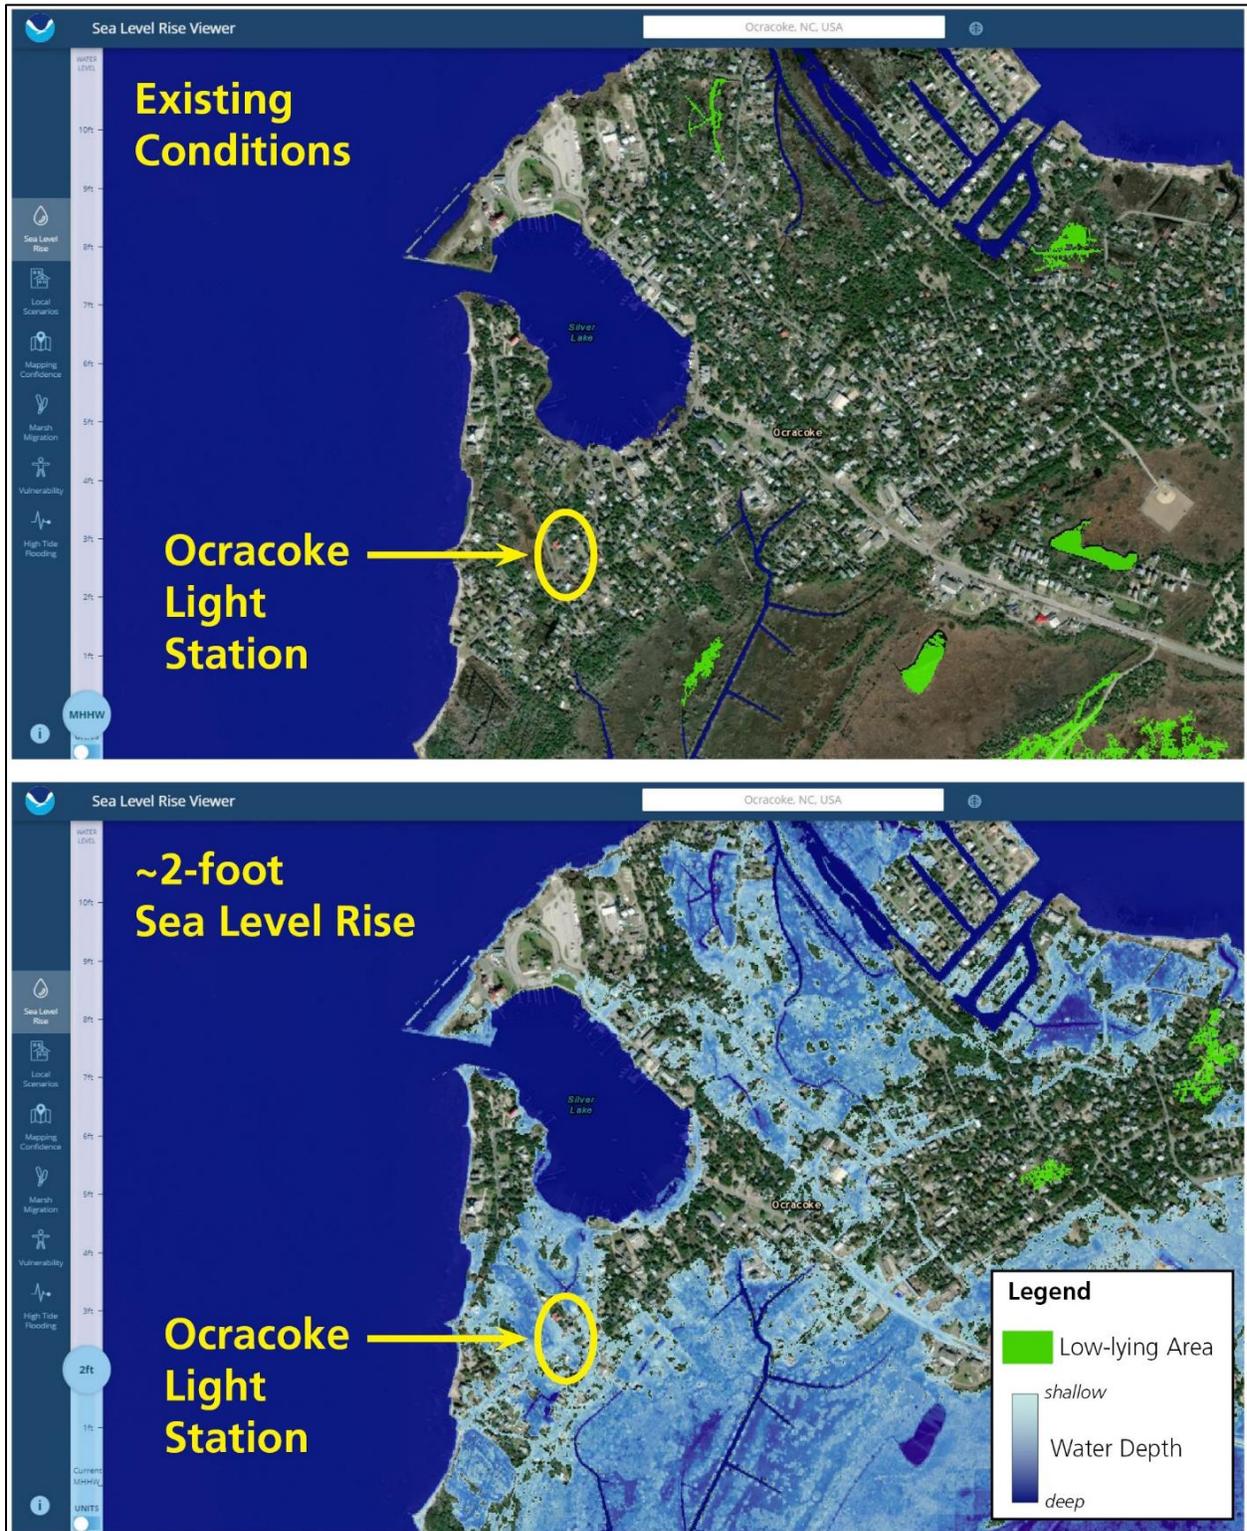
Figure 3. Current Conditions and Projected Sea Level Rise at Ocracoke Light Station

Source: National Oceanographic and Atmospheric Administration Sea Level Rise Viewer (NOAA 2021)

The Seashore is vulnerable to multiple coastal hazards including coastal erosion, storm surge, and sea level rise. Ocracoke Light Station is not located on the oceanfront or immediately adjacent to Pamlico Sound, so erosion of coastline has not directly affected the site; however, the site is at low elevation and frequently inundated with rainwater and surge associated with storms and tidal flooding during exceptionally high tides. Climate change and resulting sea level rise are likely to increase the frequency and magnitude of flooding events in the future. Vulnerability to flooding at the low-elevation Ocracoke Light Station landscape is projected to increase with local estimates of 2 to 3 feet of sea level rise over the next 50 years (Sweet et al. 2022). As the sea level rises, the site's vulnerability to coastal storms and the associated surges also increases, putting the historic structures at an elevated level of risk during severe weather events (Allen 2017). Figure 3 shows the current mean higher high water at Ocracoke Light Station and the same area with a sea level rise of 2 feet.

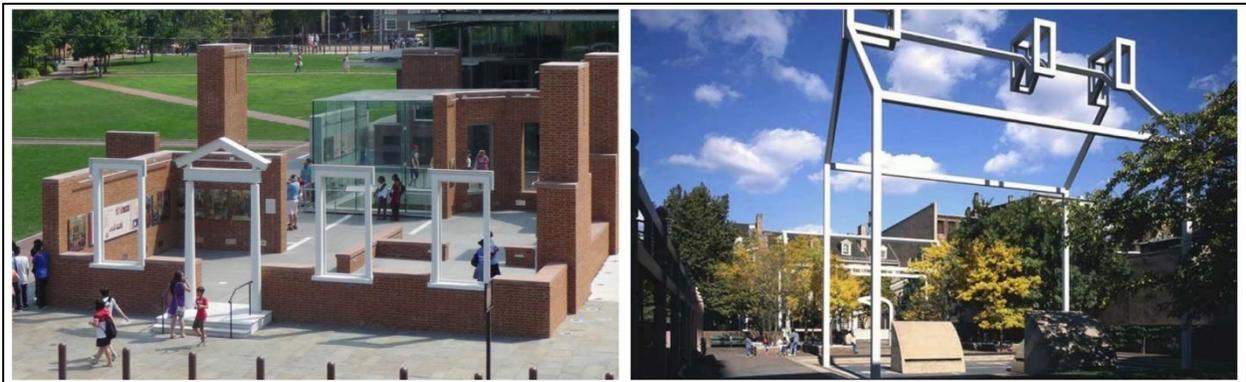
Alternative C would rehabilitate the Ocracoke Lighthouse in place and repair storm damage to the Carpenter’s Shop, Store House, Oil House, Generator House, and Privy, as discussed in the “Common to All Action Alternatives” and “Alternative A: No-action Alternative” sections, respectively. Alternative C would also demolish and replace the Double Keepers’ Quarters with a ghost structure (figure 6). This alternative is proposed because the long-term preservation of the Double Keepers’ Quarters may become challenging in the future. Before removing the structure, the National Park Service would document it in accordance with the *Secretary of the Interior’s Standards for Architectural and Engineering Documentation* for the Historic American Landscapes Survey and the Historic American Buildings Survey. Once removed, the site would be leveled by the placement of suitable imported fill material. The ghost structure of the Double Keepers’ Quarters would most likely be a pavilion with a closed roofline mirroring the existing building. Interpretive materials would be installed, allowing for an educational history of the site, the maritime environment, sea level rise and climate change, and their impact on the Ocracoke Light Station and adjacent village. The photographs below present examples of ghost structures at Independence National Historical Park. The President’s House Site (left) contains the foundations of a house that Presidents Washington and Adams lived and worked in, and Franklin Court (right) contains a steel ghost structure outlining the spot where Benjamin Franklin’s house previously stood.
