National Park Service
Cultural Landscapes Inventory
2020

Castillo de San Marcos and Fort Matanzas National Monuments
Saint Augustine, Florida

**Existing Conditions:
 Park Headquarters and
 Maintenance Facility, City Gate**
 Castillo de San Marcos National Monument
 November 2019

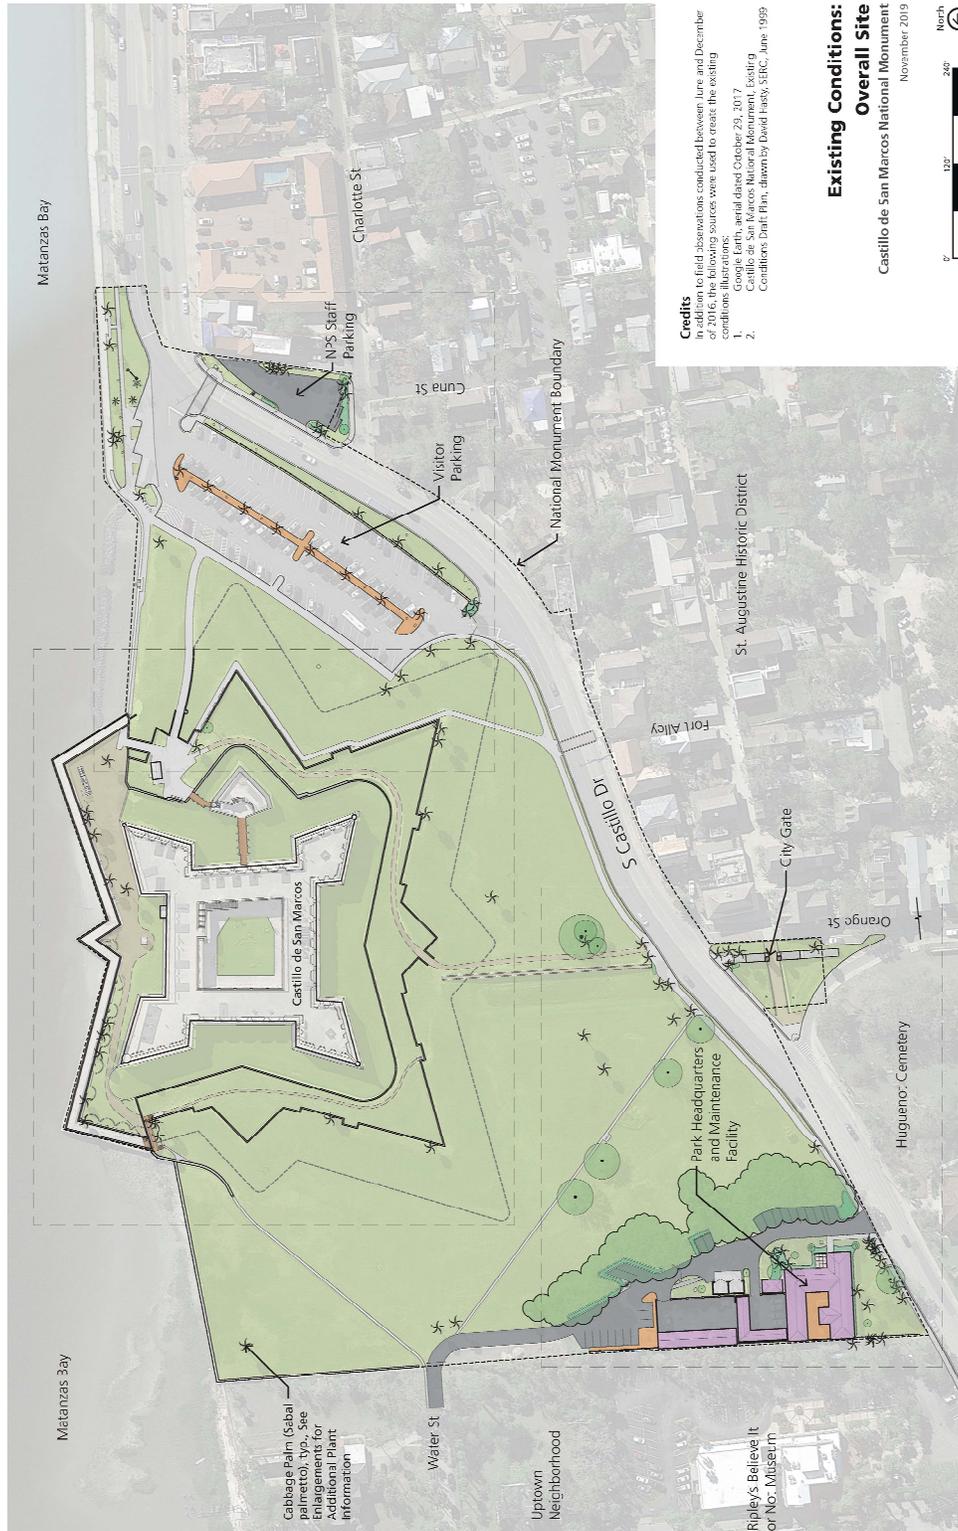
Castillo de San Marcos National Monument, December 2019.

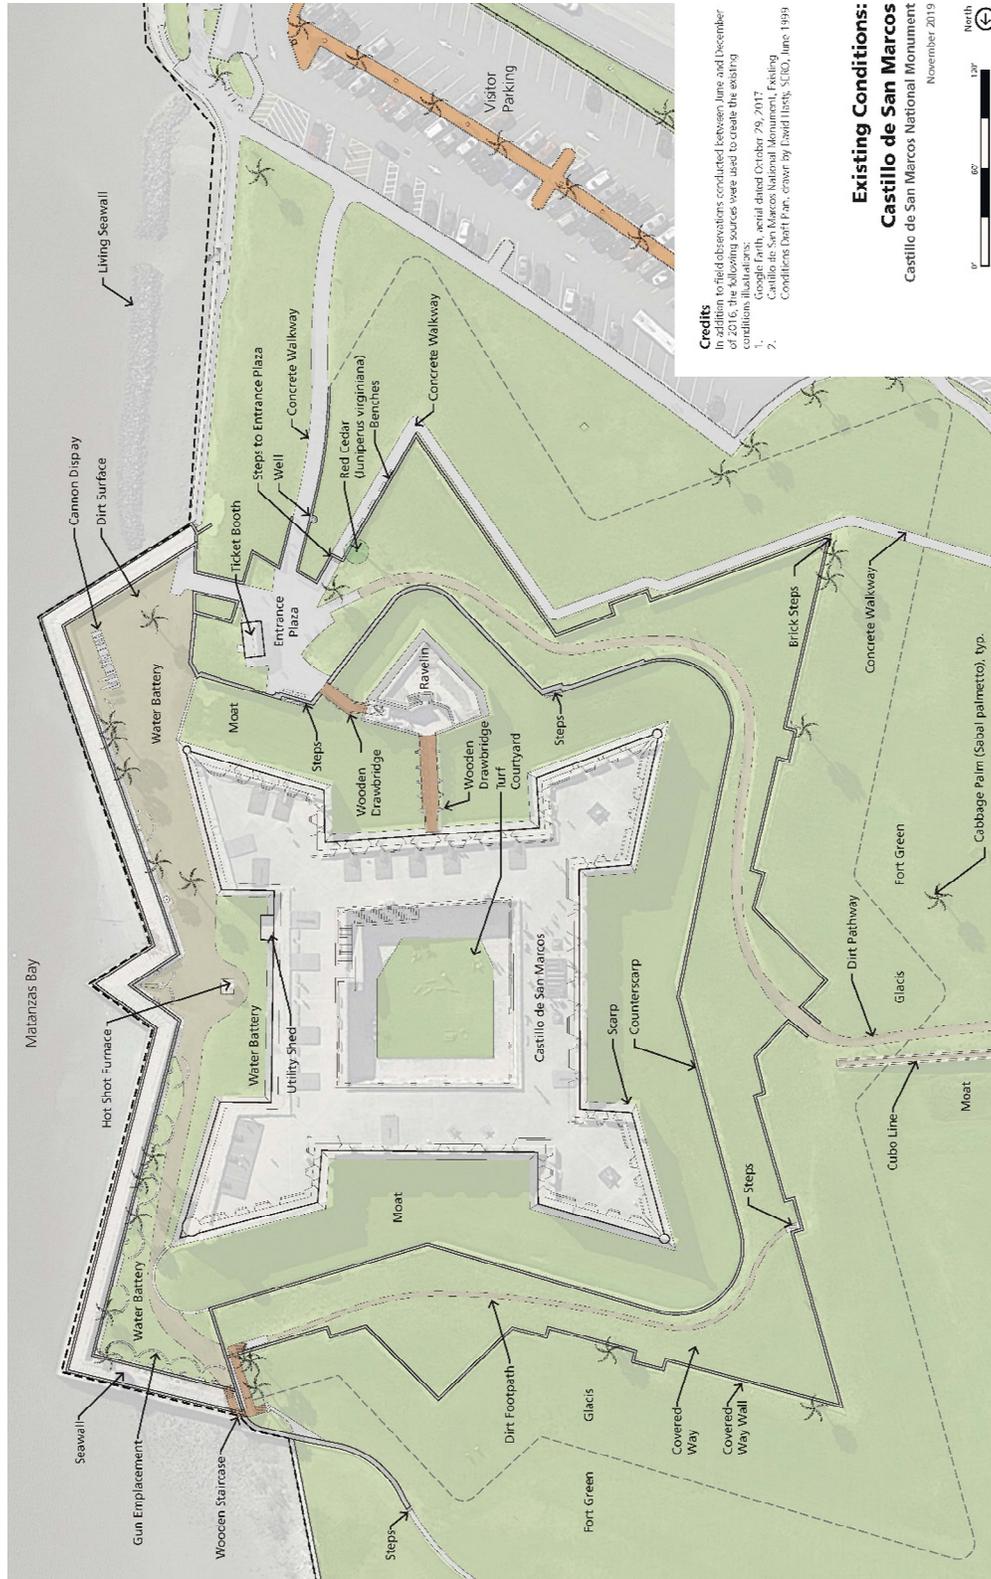
Detail of Castillo de San Marcos National Monument, December 2019.

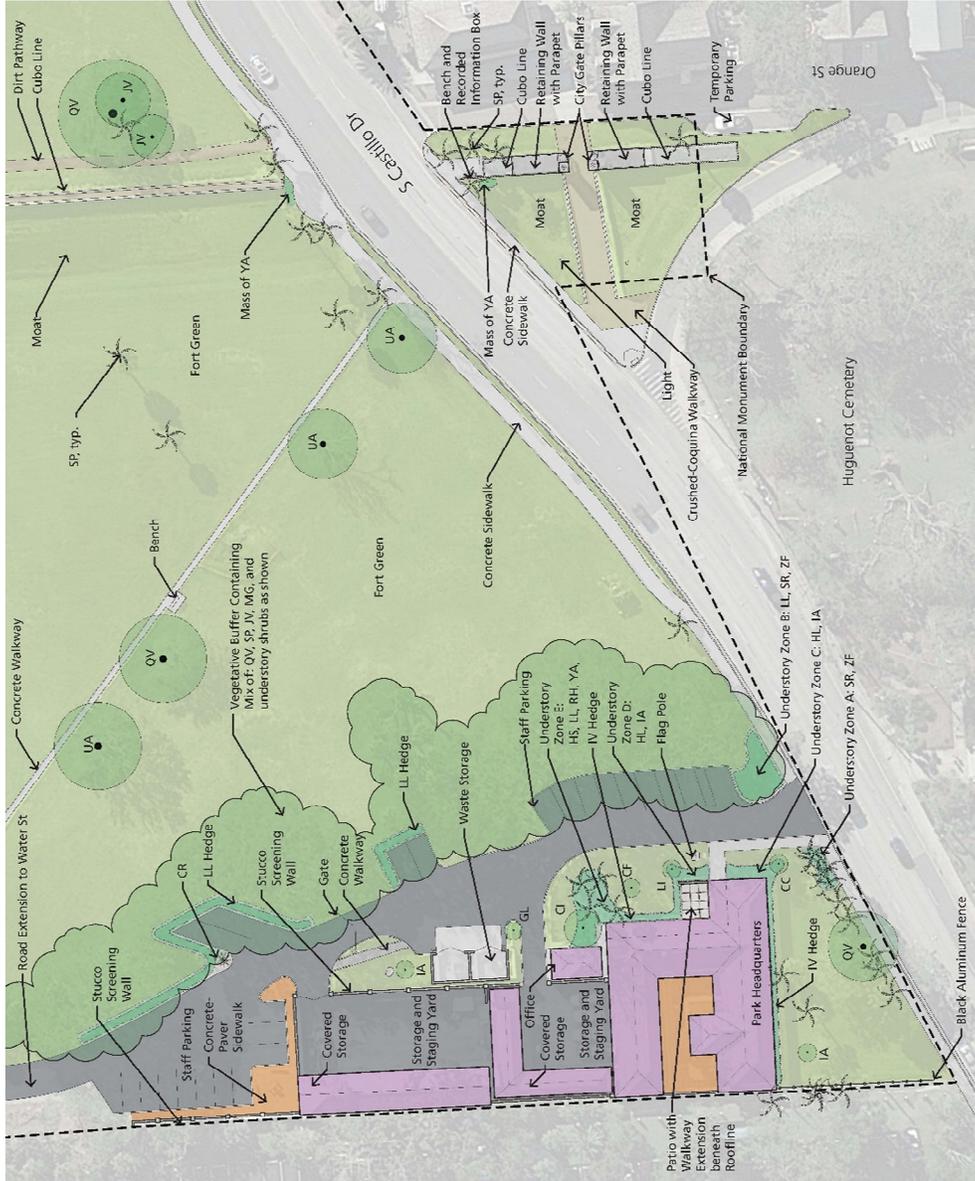
Detail of Park Headquarters and City Gate Castillo de San Marcos National Monument, December 2019.

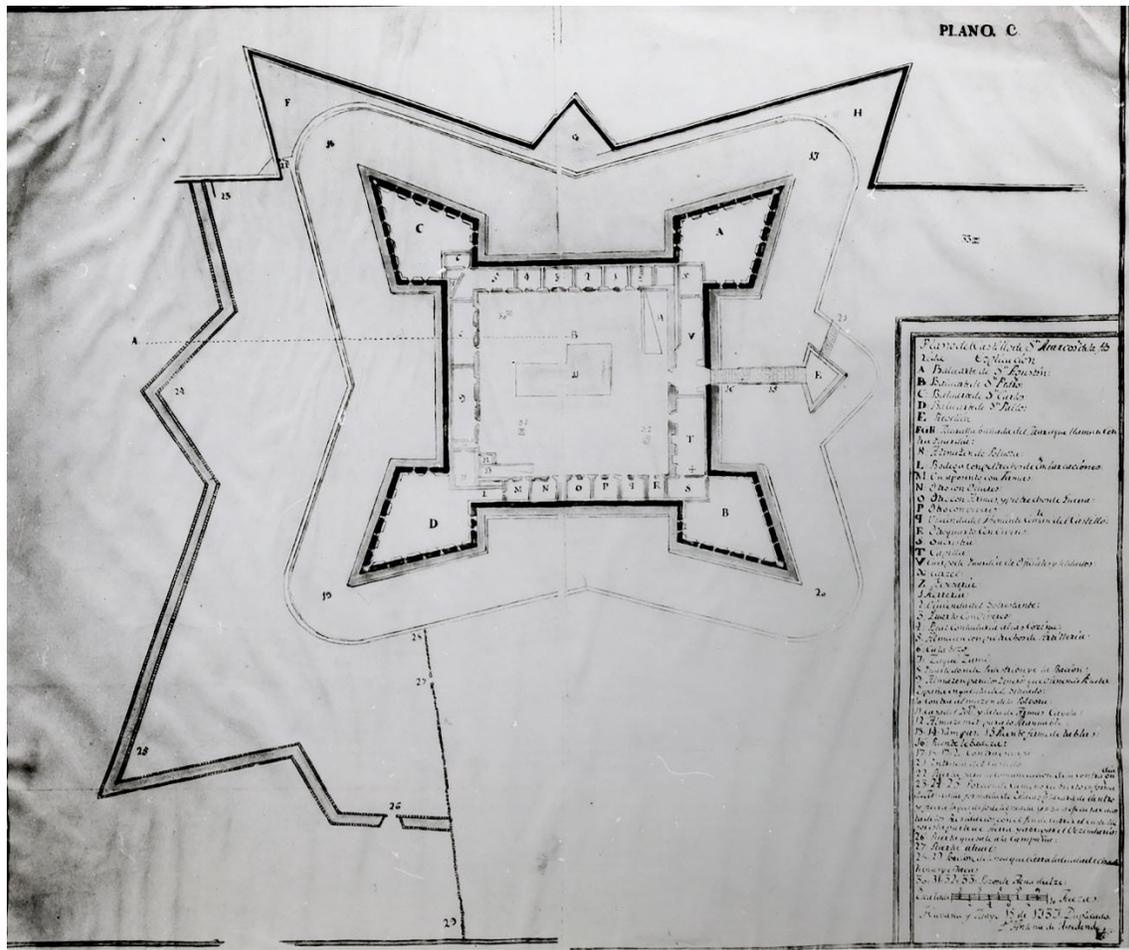
1737 Arrendondo Map of Castillo de San Marcos (CASA no. A400)

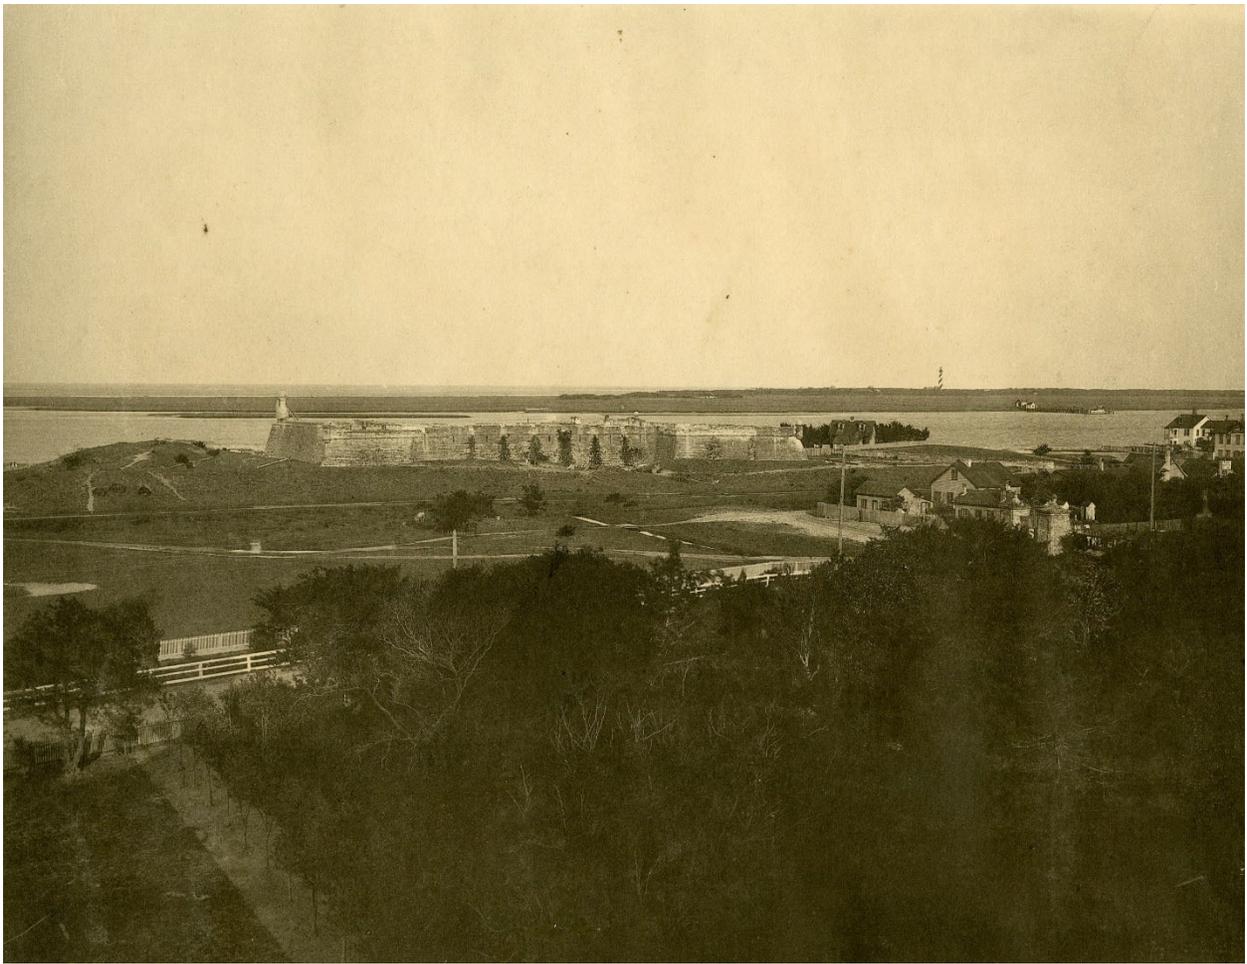
View of Castillo de San Marcos circa 1890 (CASA no. A19); baseball diamond is visible on the left side of photo.

This CLI also recommends expanding the statement of significance of the site to include recreation under Criteria A. The fort's green was the site of an early exhibition baseball game in 1886, which included members of the Cuban Giants, considered the first African American professional sports team. The fort's green was also the location of the first golf course constructed in Florida. In 1895, a group of winter residents in St. Augustine installed a course on the fort's grounds. The course remained in operation until 1925.

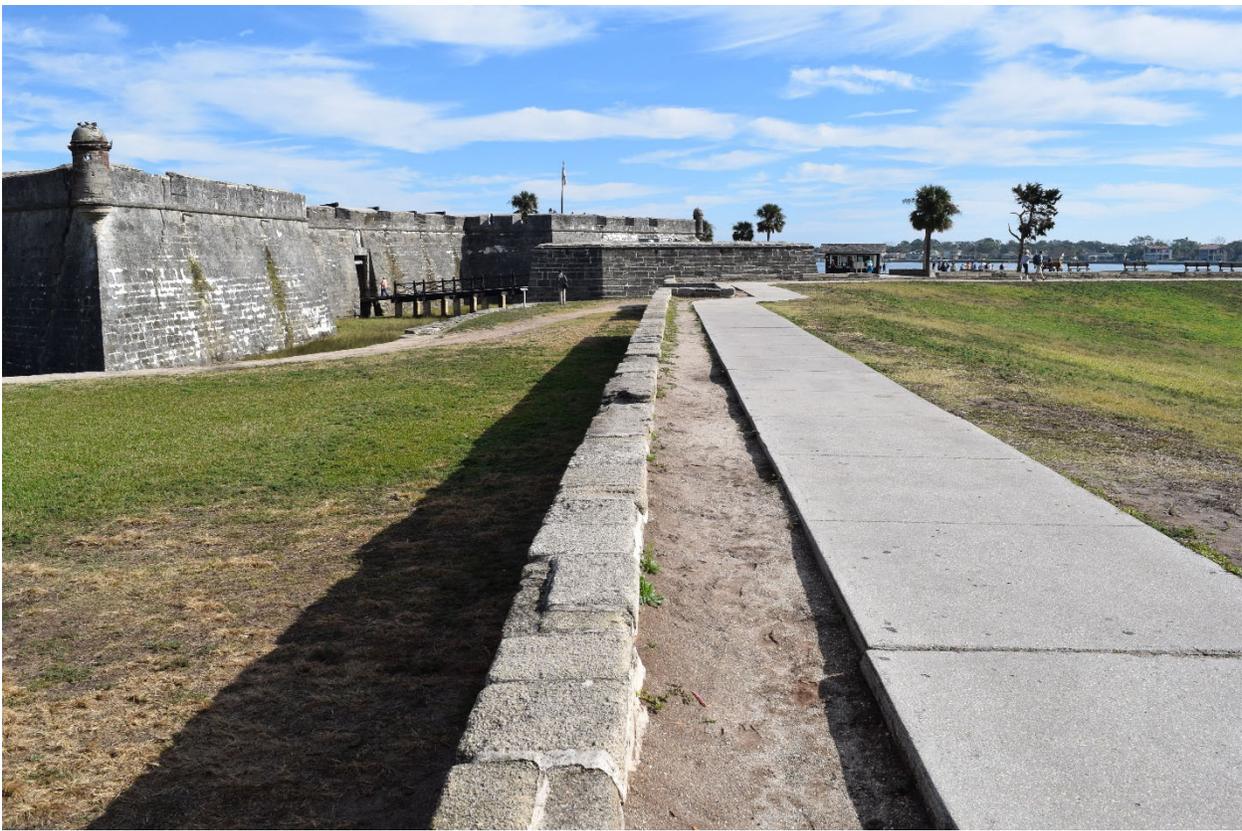
Concrete walkway along top of covered way wall; View looking east towards Castillo de San Marcos and entrance area. Photo taken by the author, October 2018.

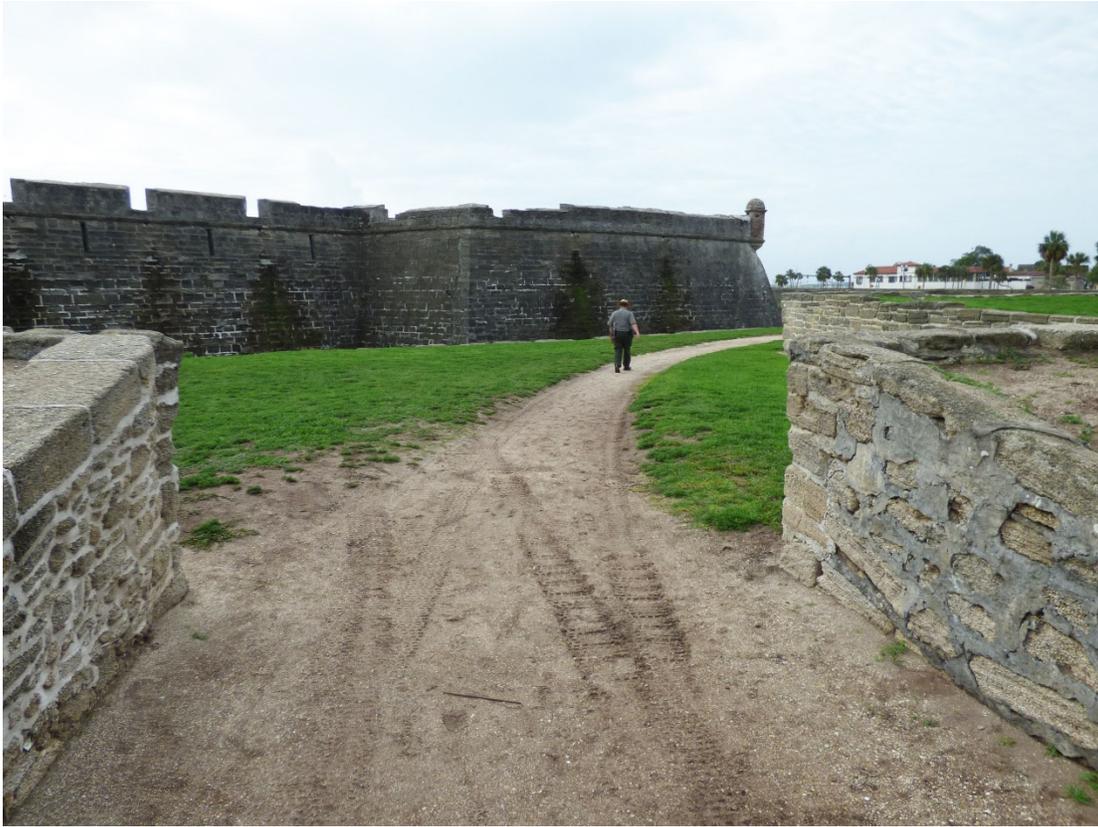
Dirt path in covered way and passage through covered way wall; View looking east towards Castillo de San Marcos.
Photo taken by the author, October 2018.

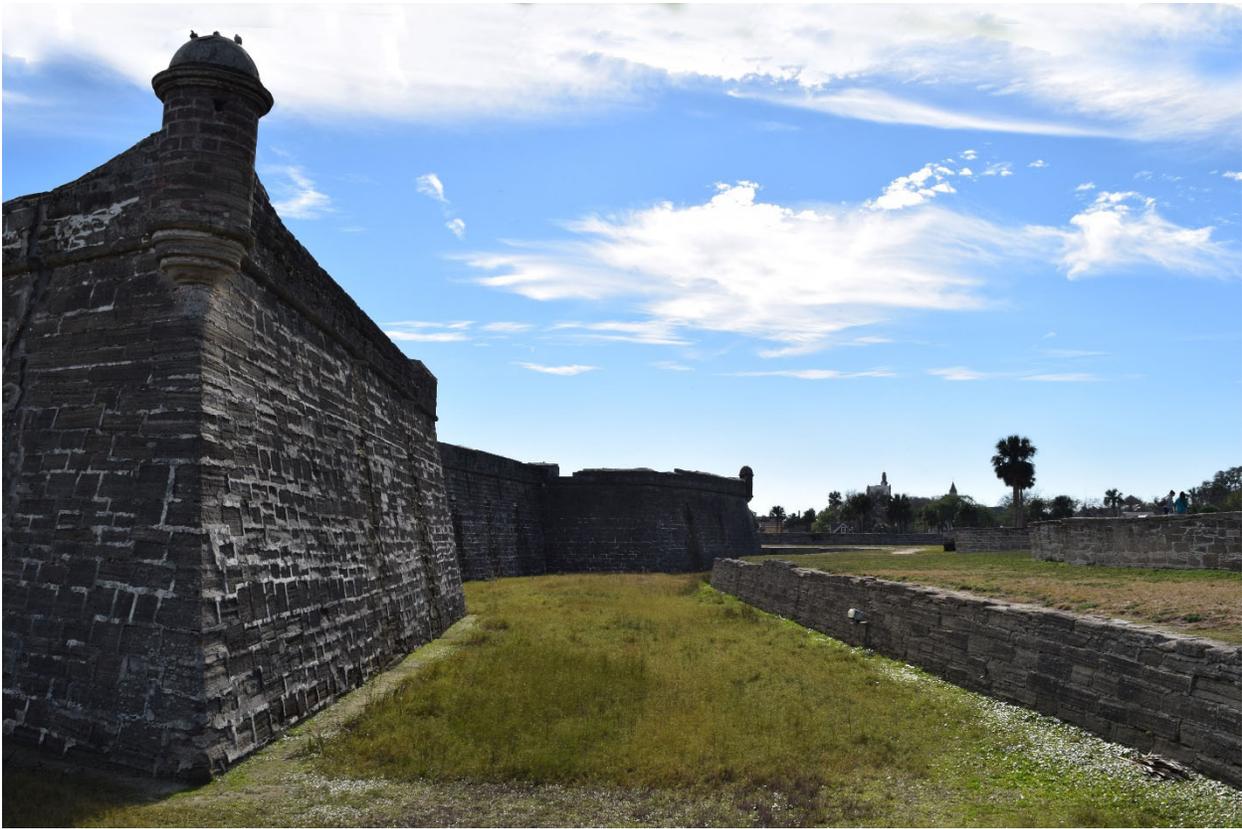
Moat and covered way. View looking west. Photo taken by the author, October 2018.

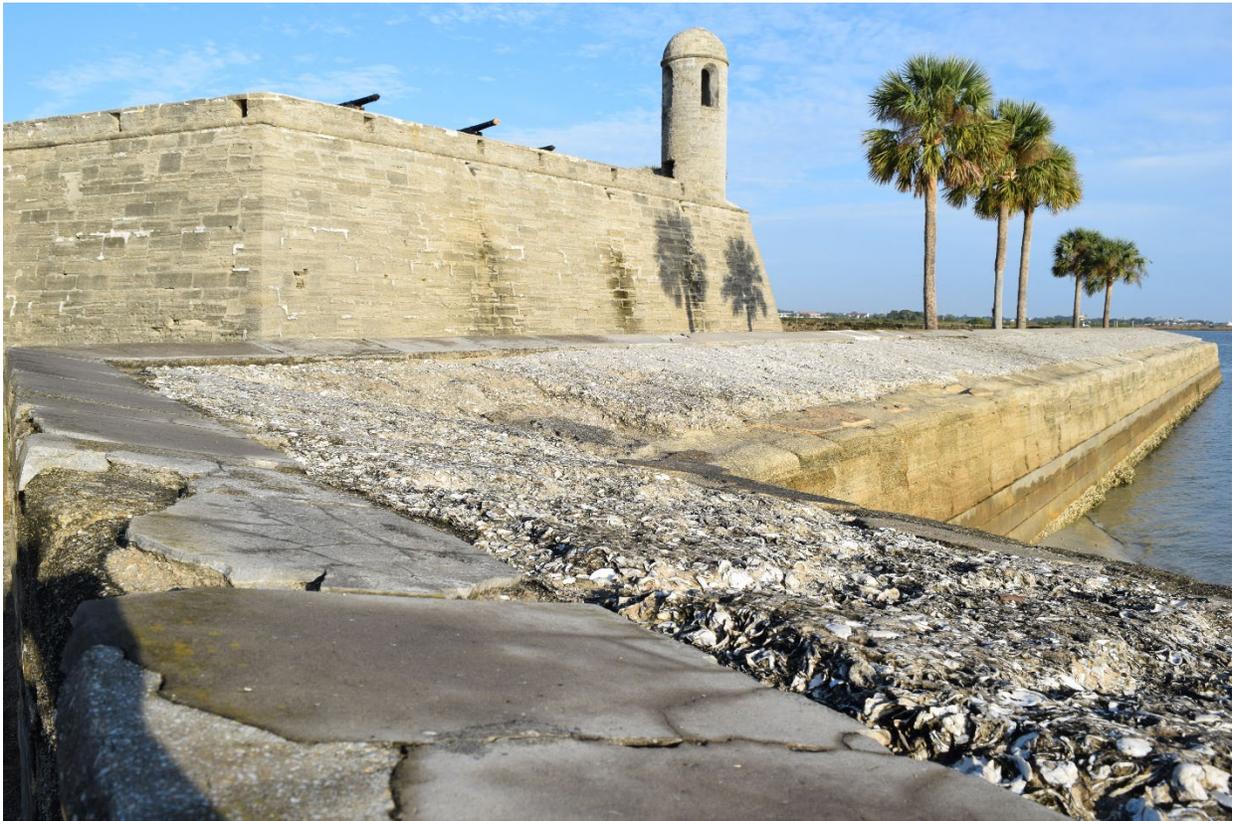
View of Castillo with water batter seawall in foreground. View looking north. Photo taken by the author, October 2018.

The U.S. Army constructed the seawall, water battery, and the hot shot furnace between 1833 and 1844. They reconstructed the seawall after residents of St. Augustine raised concerns about the deteriorated condition of the existing seawall and the potential threats of flooding. While the U.S. Army initially did not consider the fort as a strategic resource, after the outbreak of the

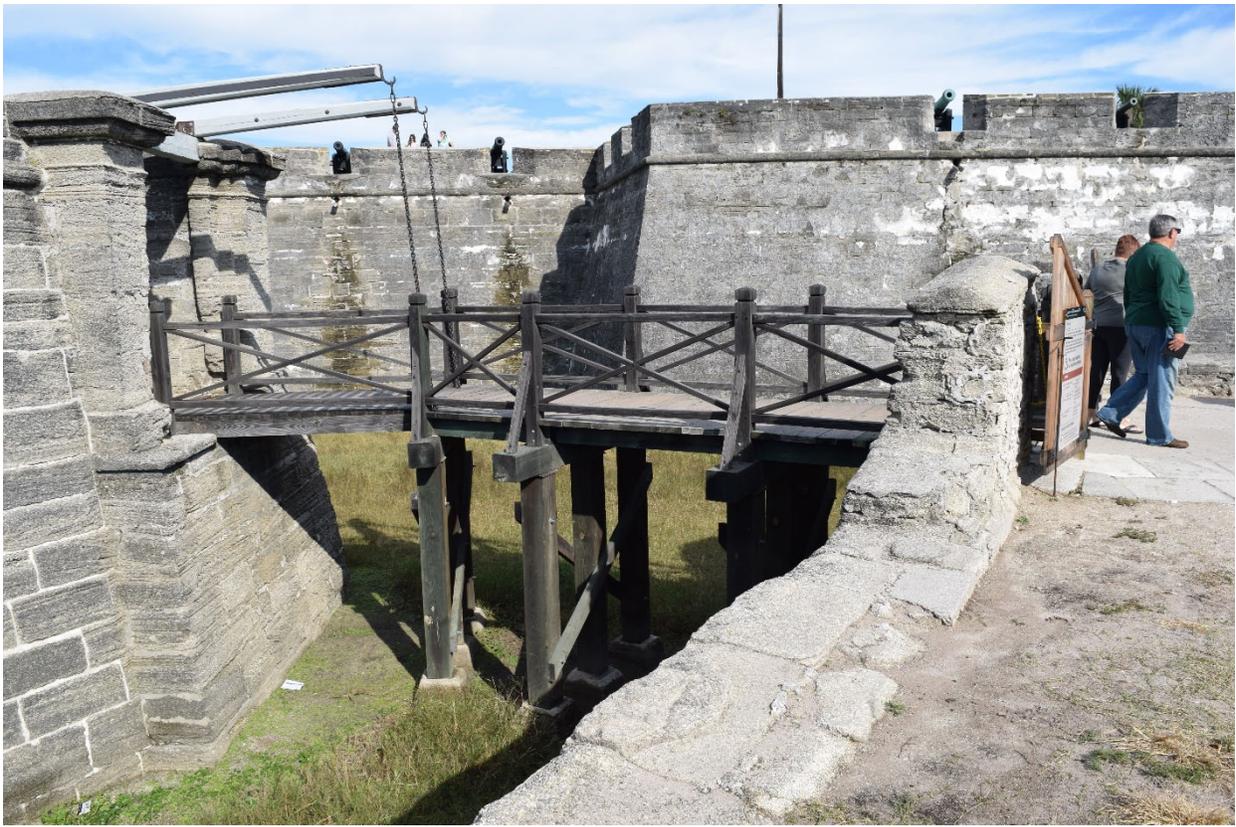
View of ravelin, bridge, moat, and Castillo de San Marcos. View looking north. Photo taken by the author, October 2018.

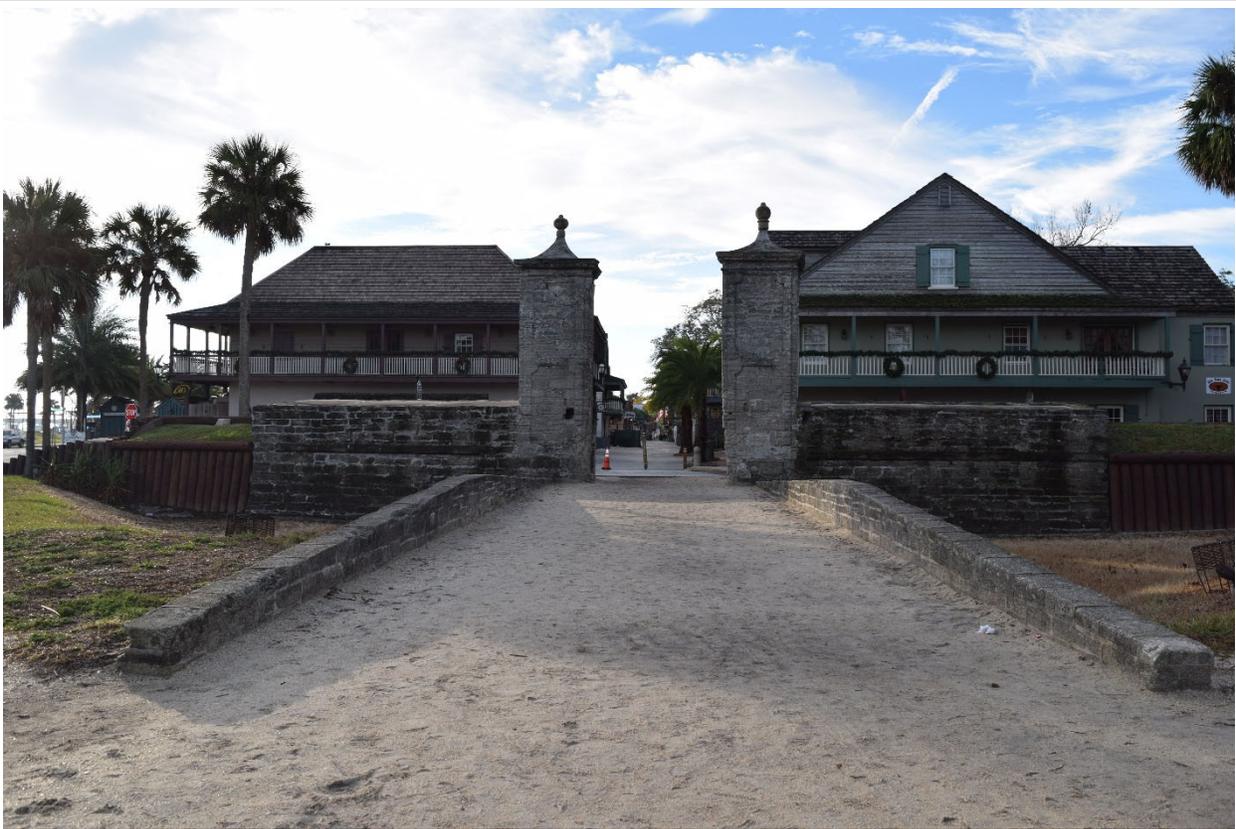
View of City Gate. View looking south. Photo taken by the author, October 2018.

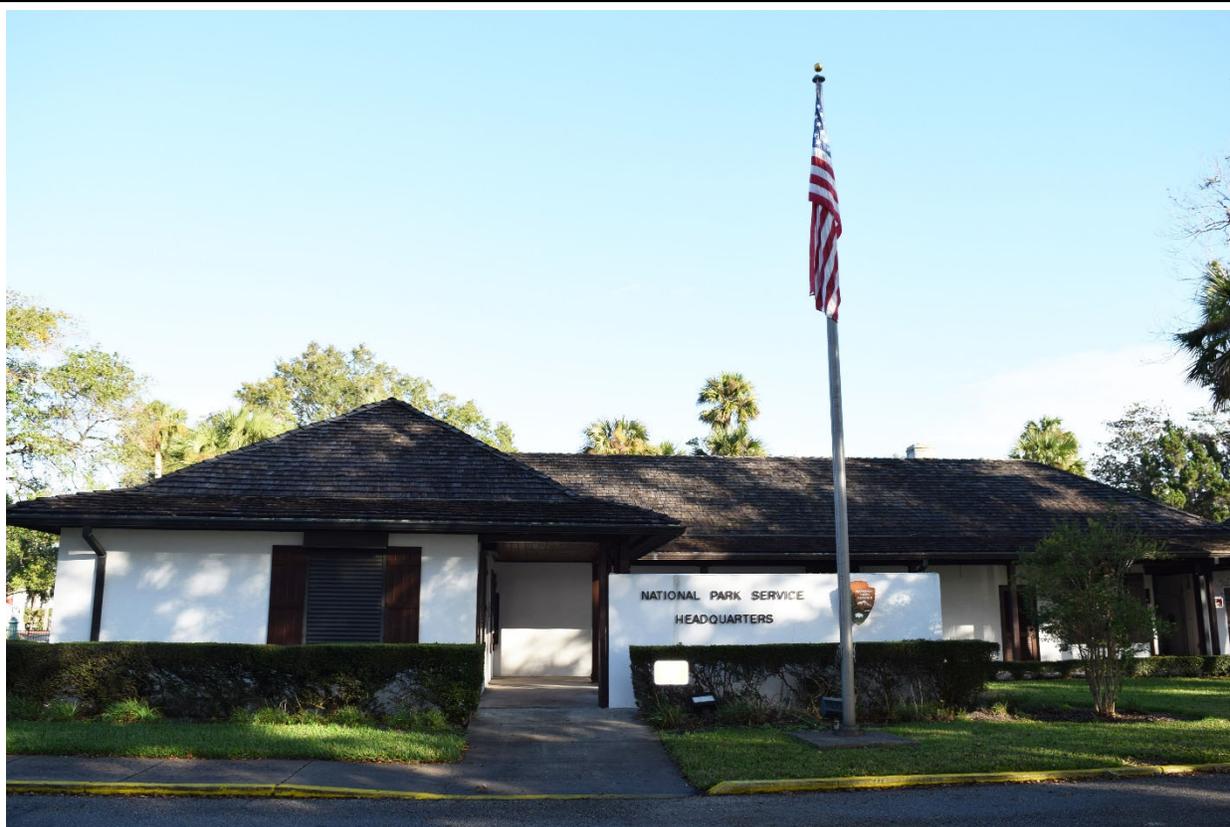
View of Castillo de San Marcos headquarters building. View looking north. Photo taken by the author, October 2018.

Additionally, this CLI recommends examining the eligibility of Mission 66 resources at Castillo de San Marcos. In addition to constructing an administration building (currently called Park Headquarters and Maintenance Facility), the NPS also reconstructed historic features, including the Cubo Line and City Gate moat, which are contributing features to the National Register-listed district.

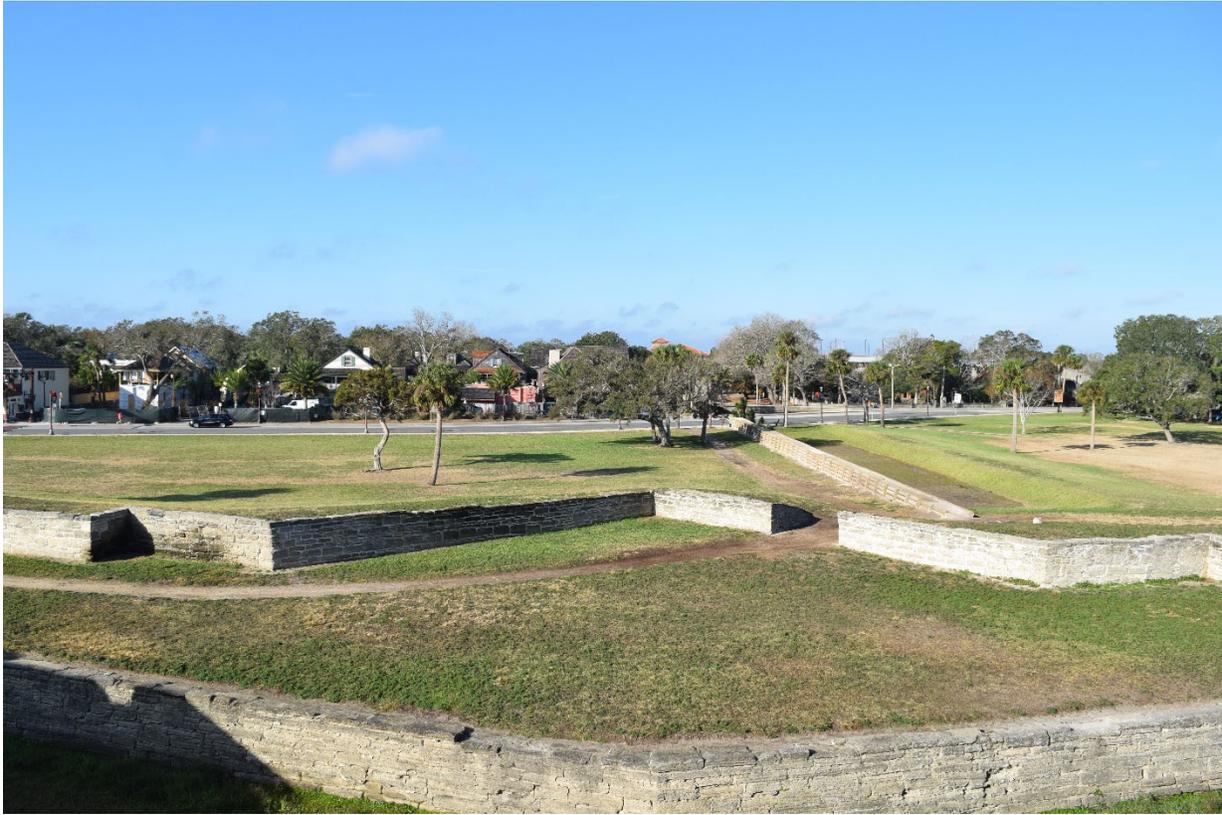
View from Castillo de San Marcos towards St. Augustine; City Gate in background and Cubo Line in foreground.
Photo taken by the author, October 2018.

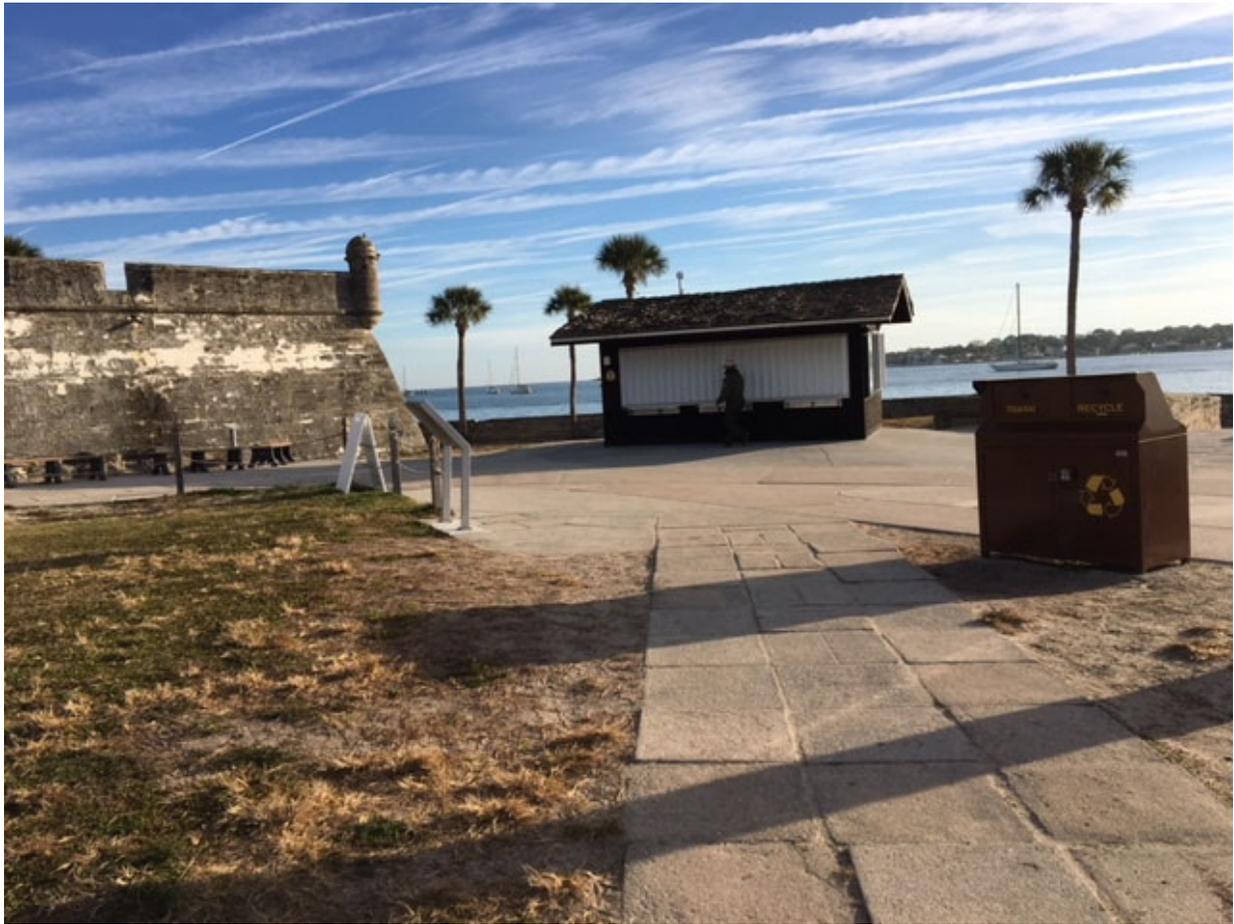
View looking north towards ticket booth. Small-scale features include waste receptacle, portable benches, interpretive signage and bollards. Photo taken by the author, October 2018.
