Preservation Guide for Stone Masonry and Dry-Laid Resources

ABBY GLANVILLE

GREG HARTELL INTERN FOR HISTORIC PRESERVATION

SUMMER 2008

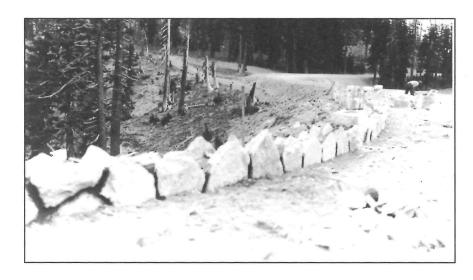
Historic photograph of the construction of a stone masonry guard wall near Pumice Point, 1934 (Photo: National Park Service)
