THE HOUSE AT GLENMONT

HOME OF THOMAS EDISON

Historic Structure Report

**THE HOUSE AT GLENMONT
HISTORIC STRUCTURE REPORT**

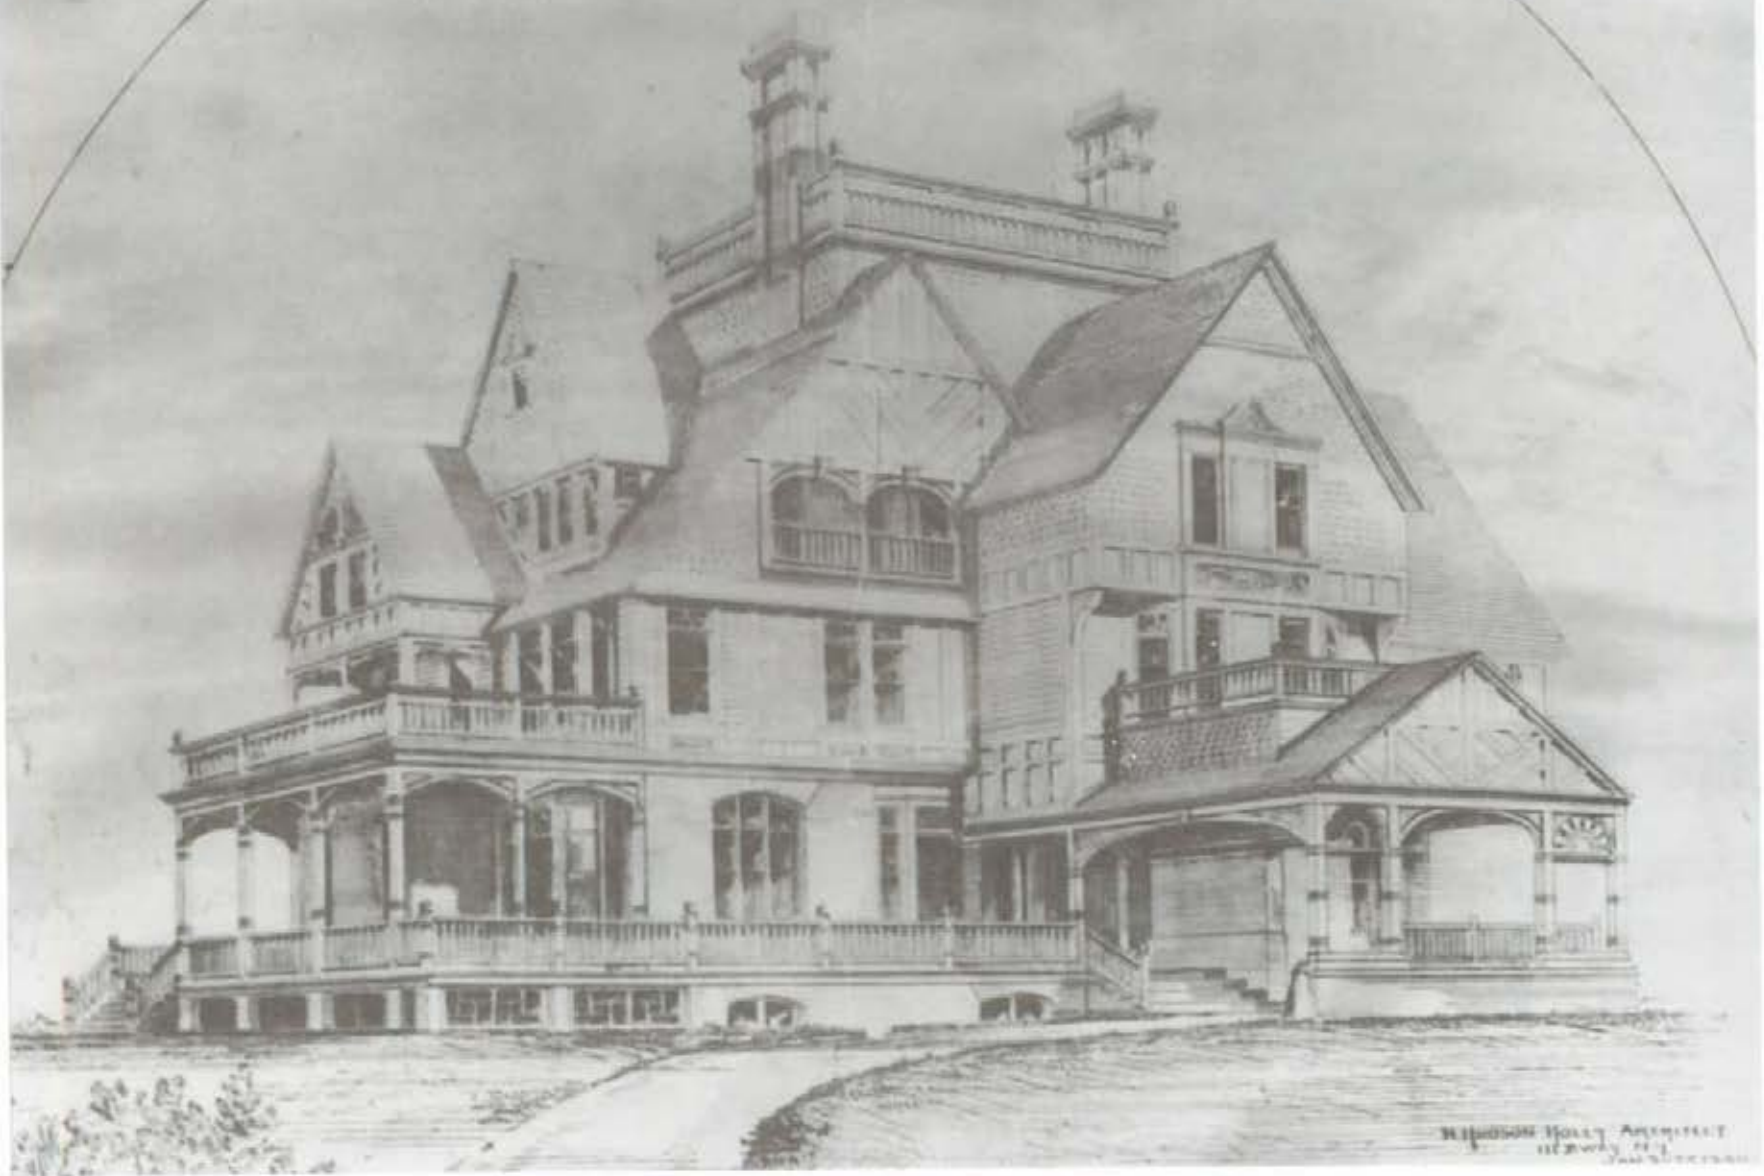
Figure 1. Early sketch of the Pedder house, January 30, 1880.

Despite this recommendation, Holly illustrated the chimneys in an early sketch of the house as being fairly plain in design (fig. 1).⁹⁹ The chimneys as actually constructed, however, were more in keeping with the style espoused in *Modern Dwellings*. The house was built with six chimneys of similar design. The tops of the chimneys were corbeled outward, and the two long sides of each stack were embellished with raised brickwork to look like pilasters. Each stack was capped with bluestone, and the top of every flue was fitted with a terra cotta pot.

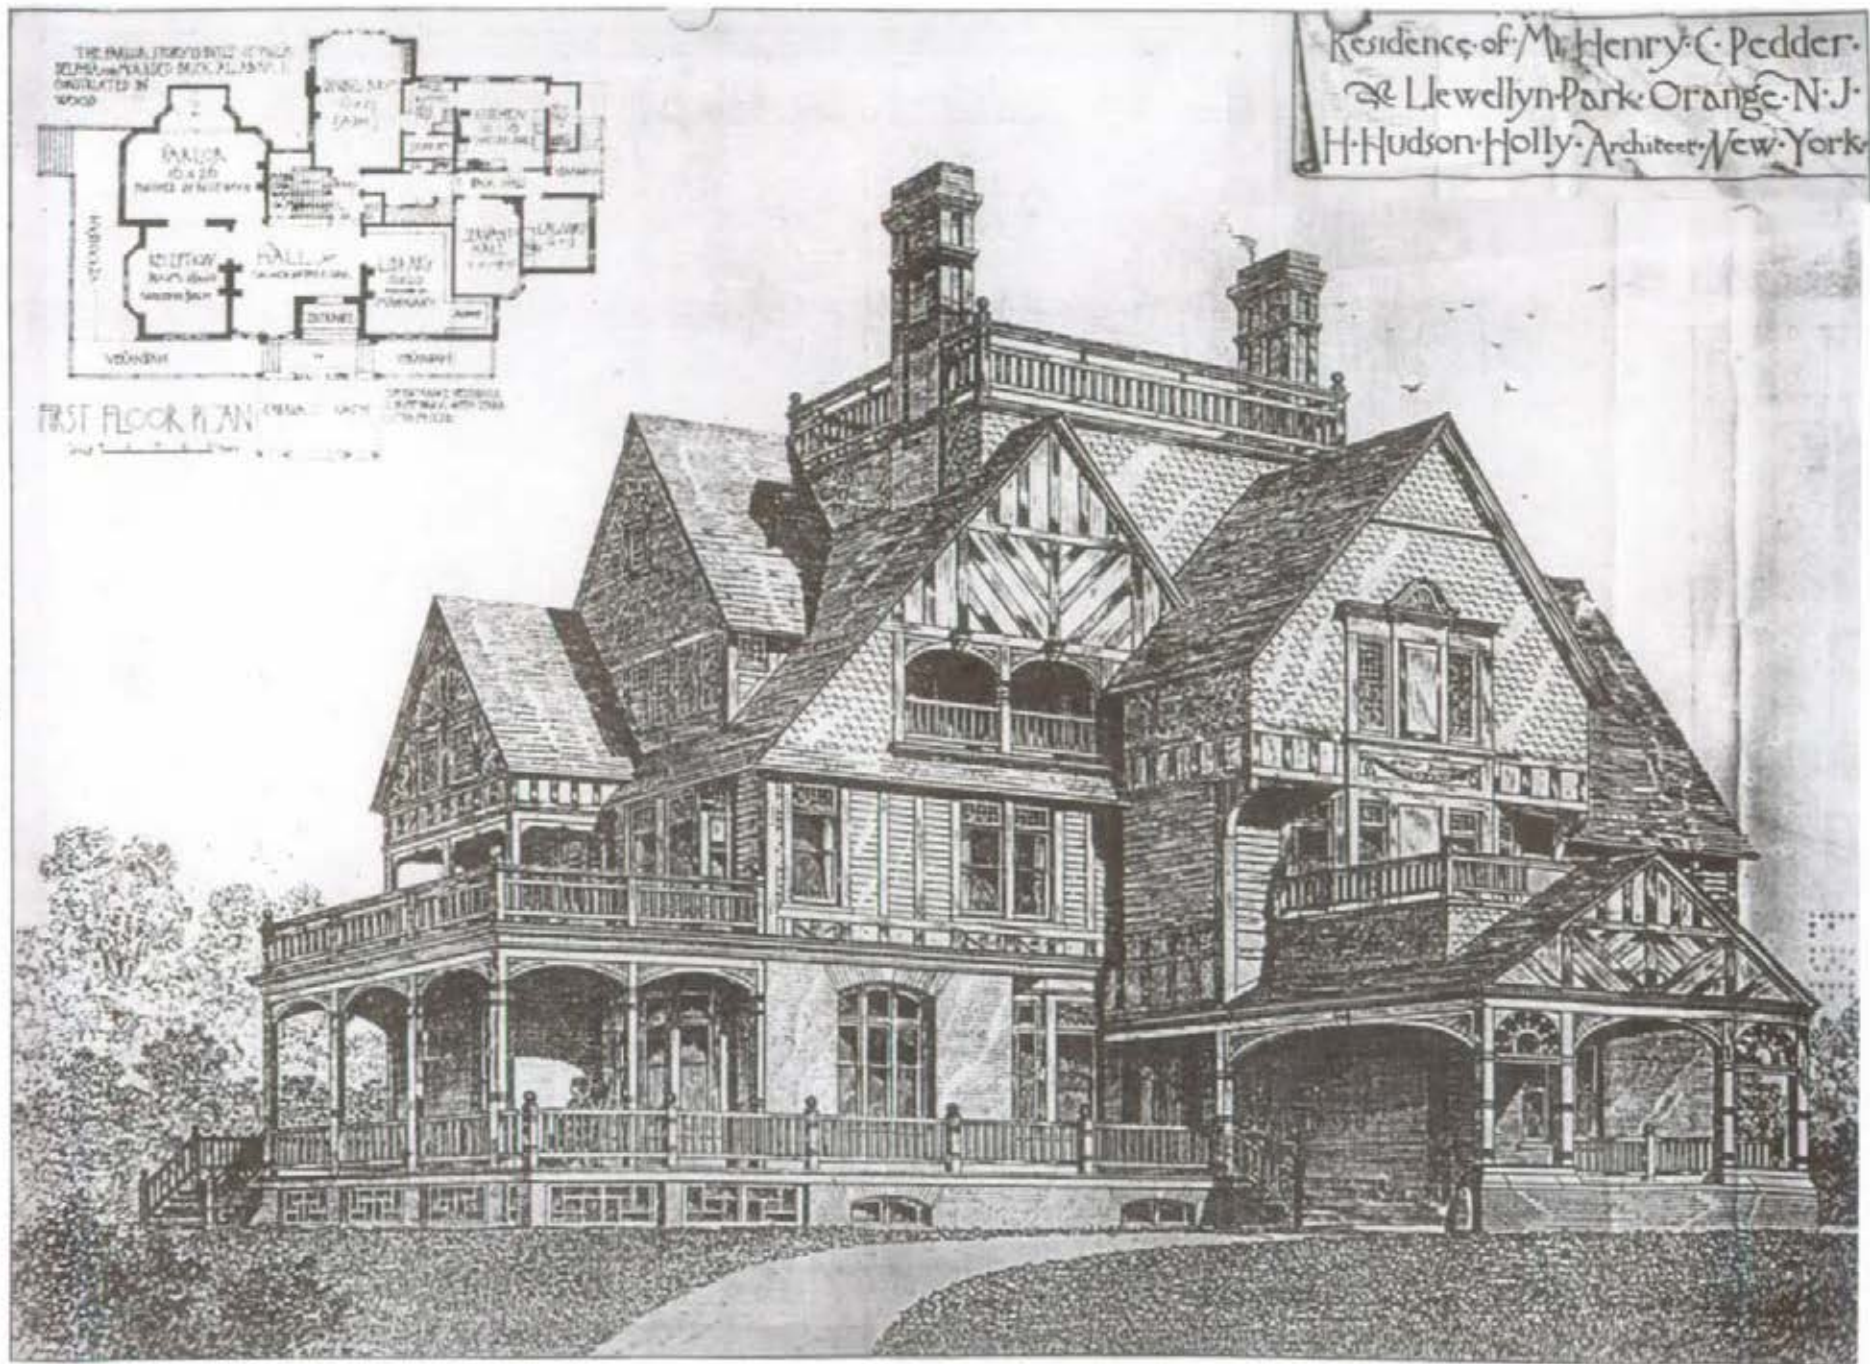
Figure 2. Exterior elevation drawing and first-floor plan, Aug. 27, 1881.

A smaller balustraded roof deck was here originally, atop the original south verandah (fig. 2). It was replaced by a larger balustraded roof deck above the Conservatory when the latter was built circa 1882 (fig. 4). Another roof deck was created just west of this deck when the Drawing Room was enlarged southward circa 1883-84. The new roof deck was incorporated into the existing Conservatory roof deck (fig. 5) to form the present-day south roof deck.

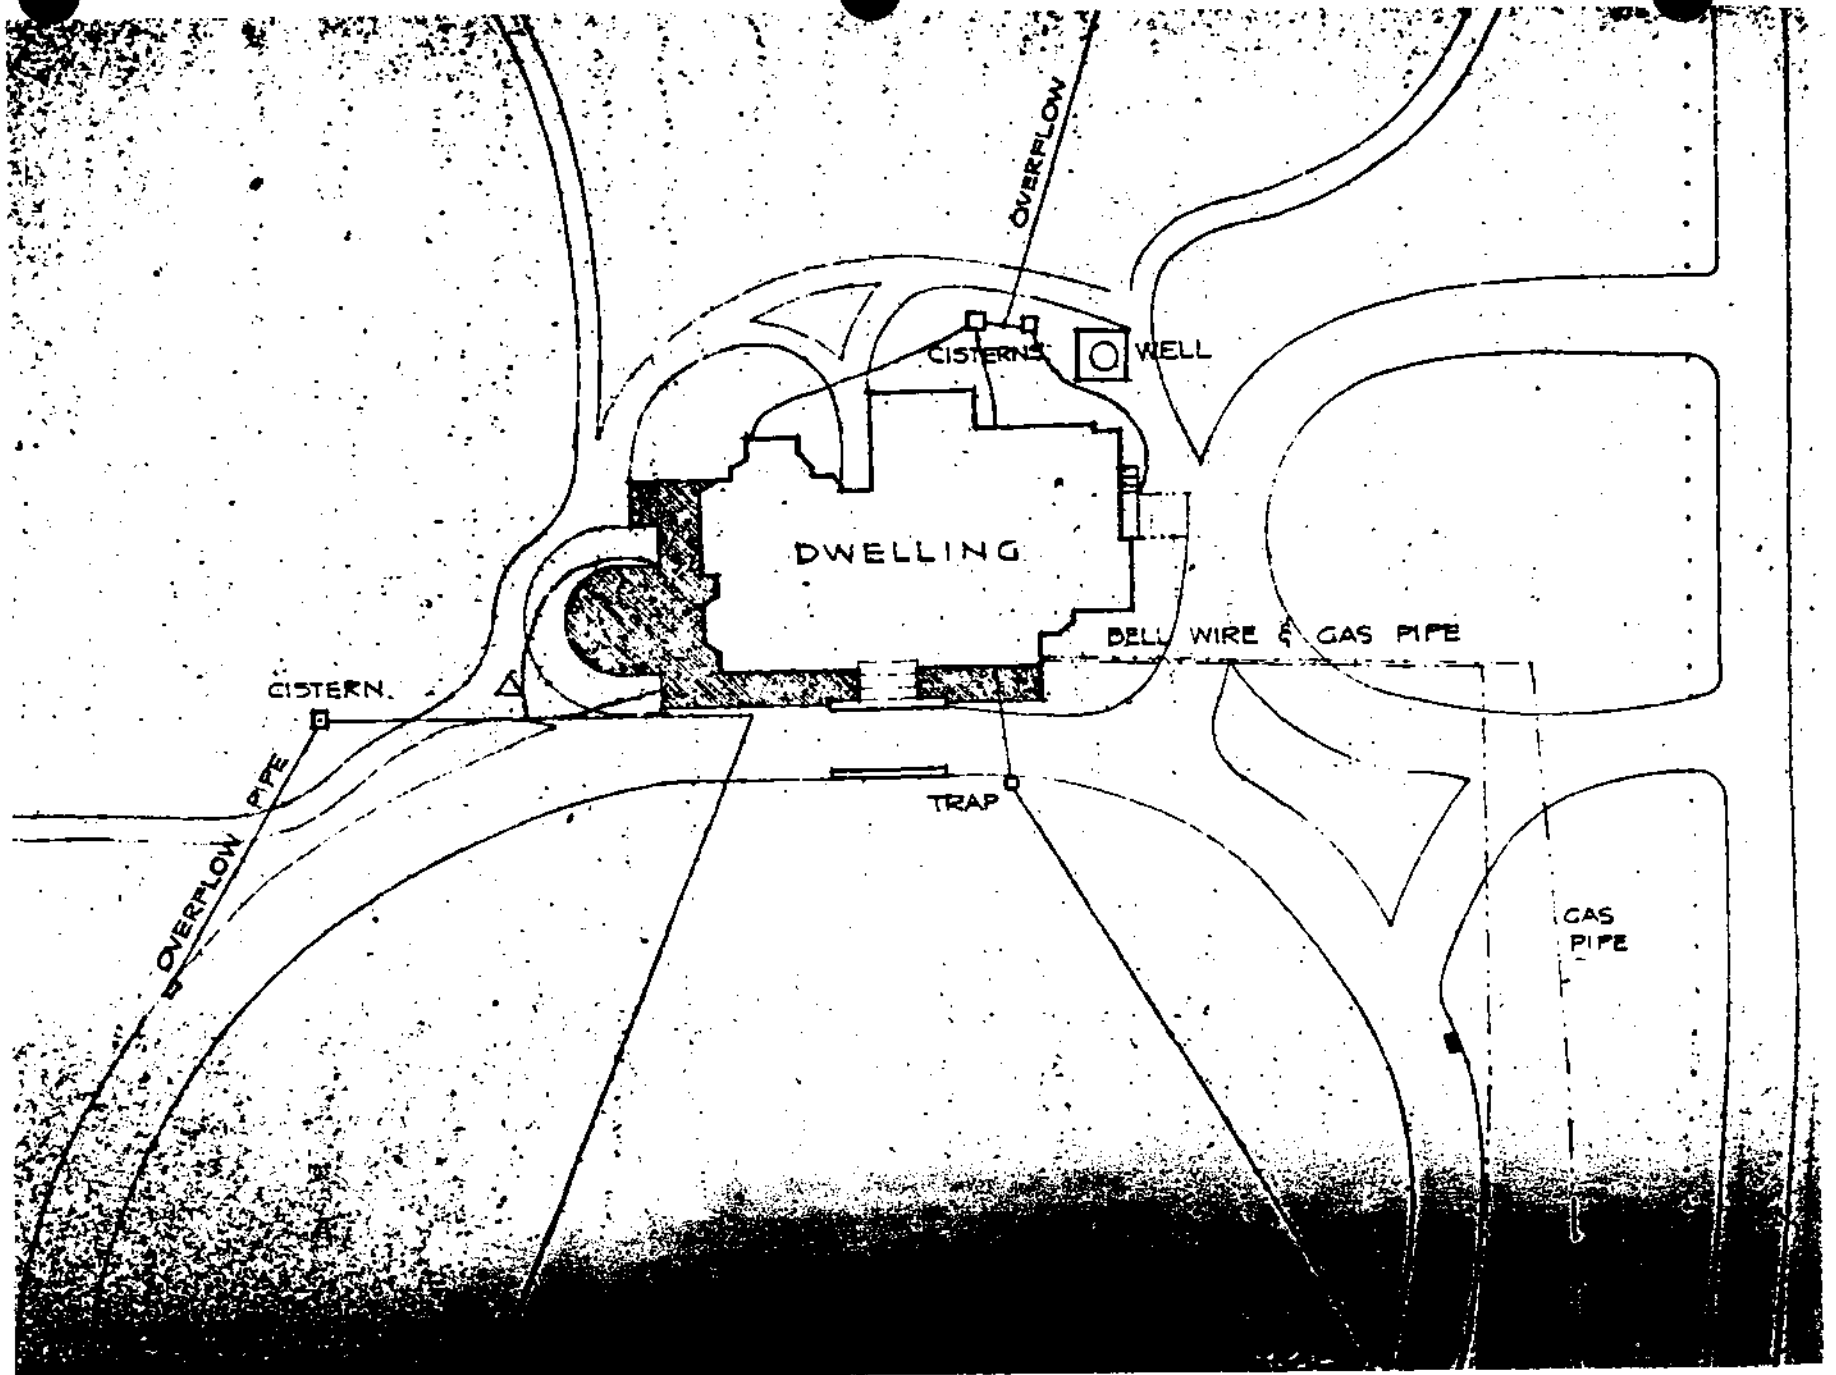
Figure 3. Detail of "Map of Residence and Grounds Belonging to H.C. Pedder Esq.," by Mead & Taylor, Engineers, 1882.

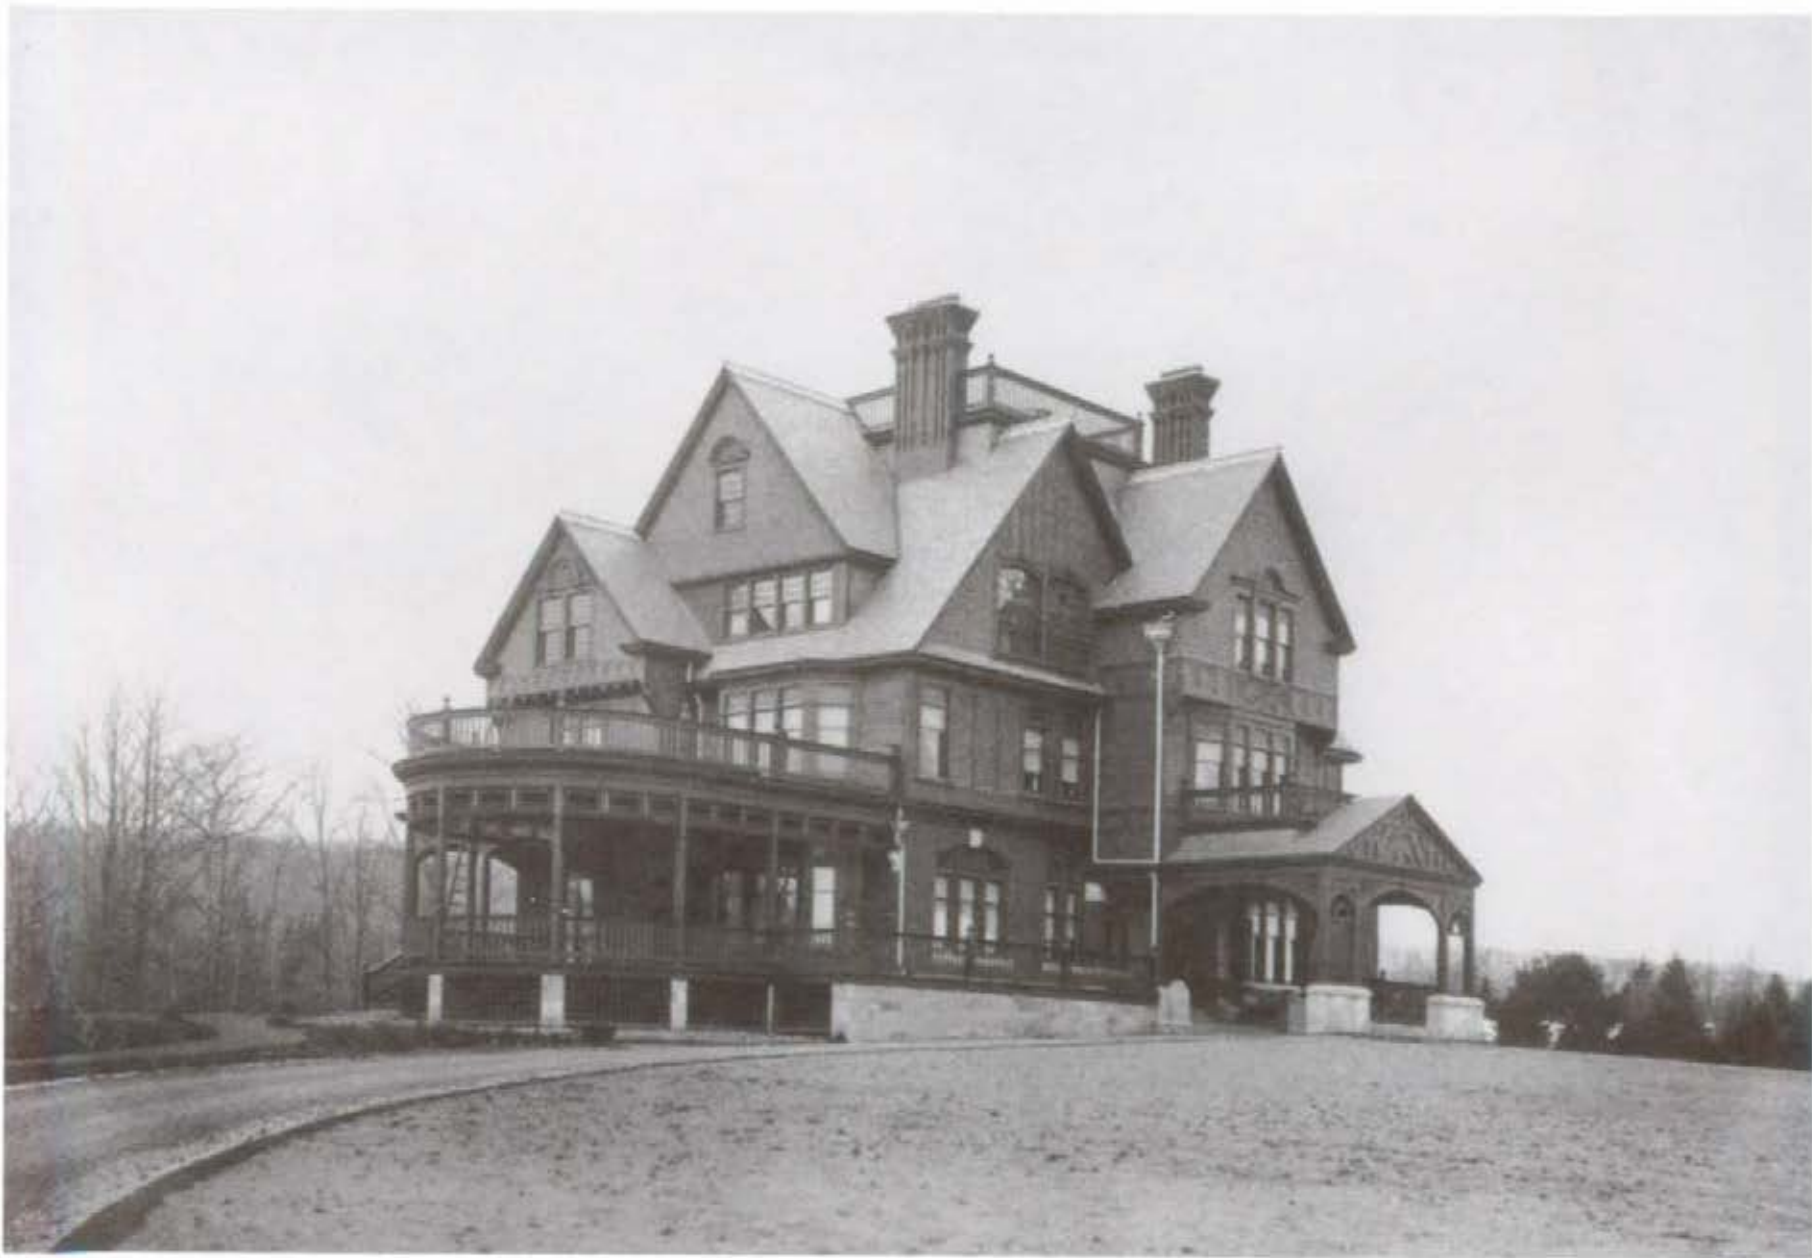
Figure 4. Earliest-known photograph of the Pedder house, circa 1882-83.

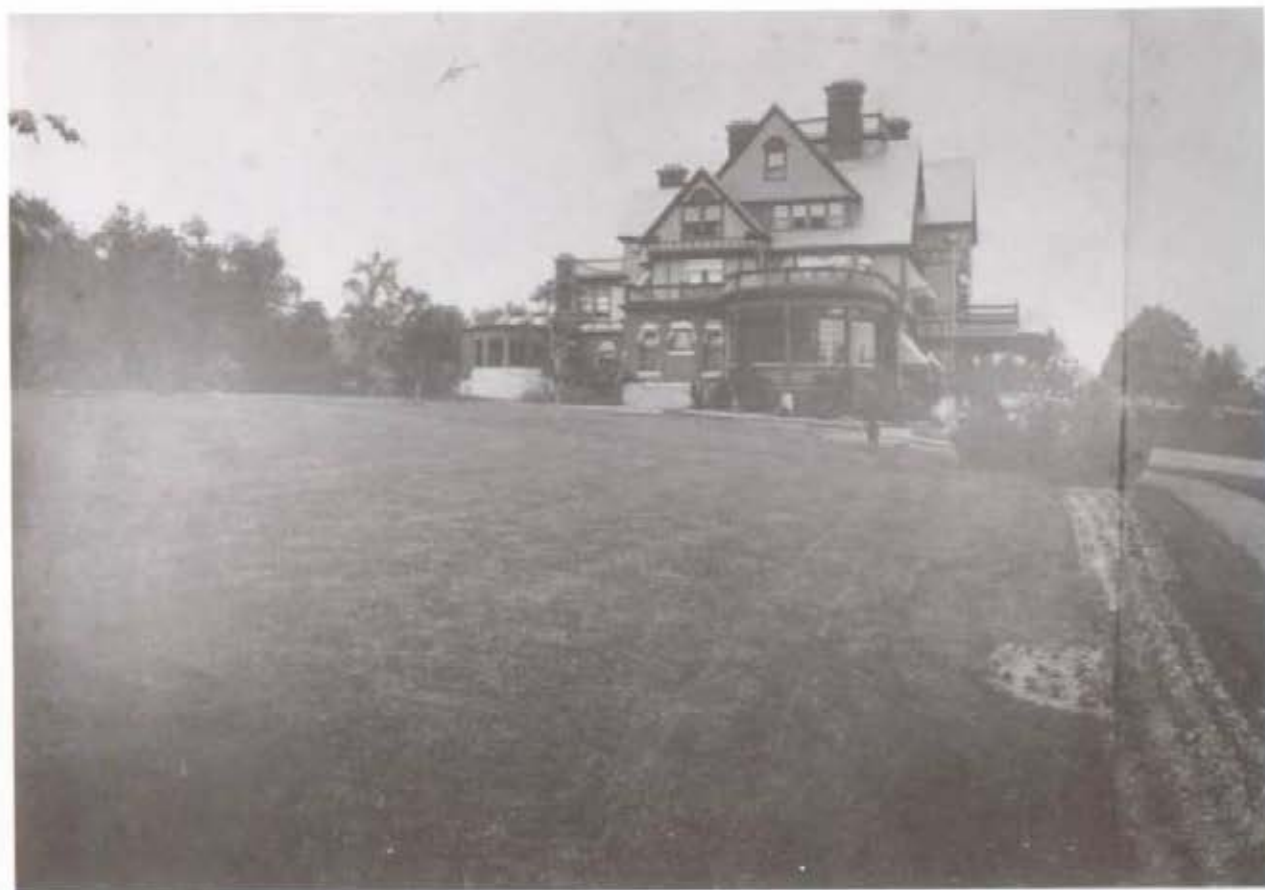
Figure 5. South elevation, circa 1884-90. Note the "billiard room" addition on the back (left) side.

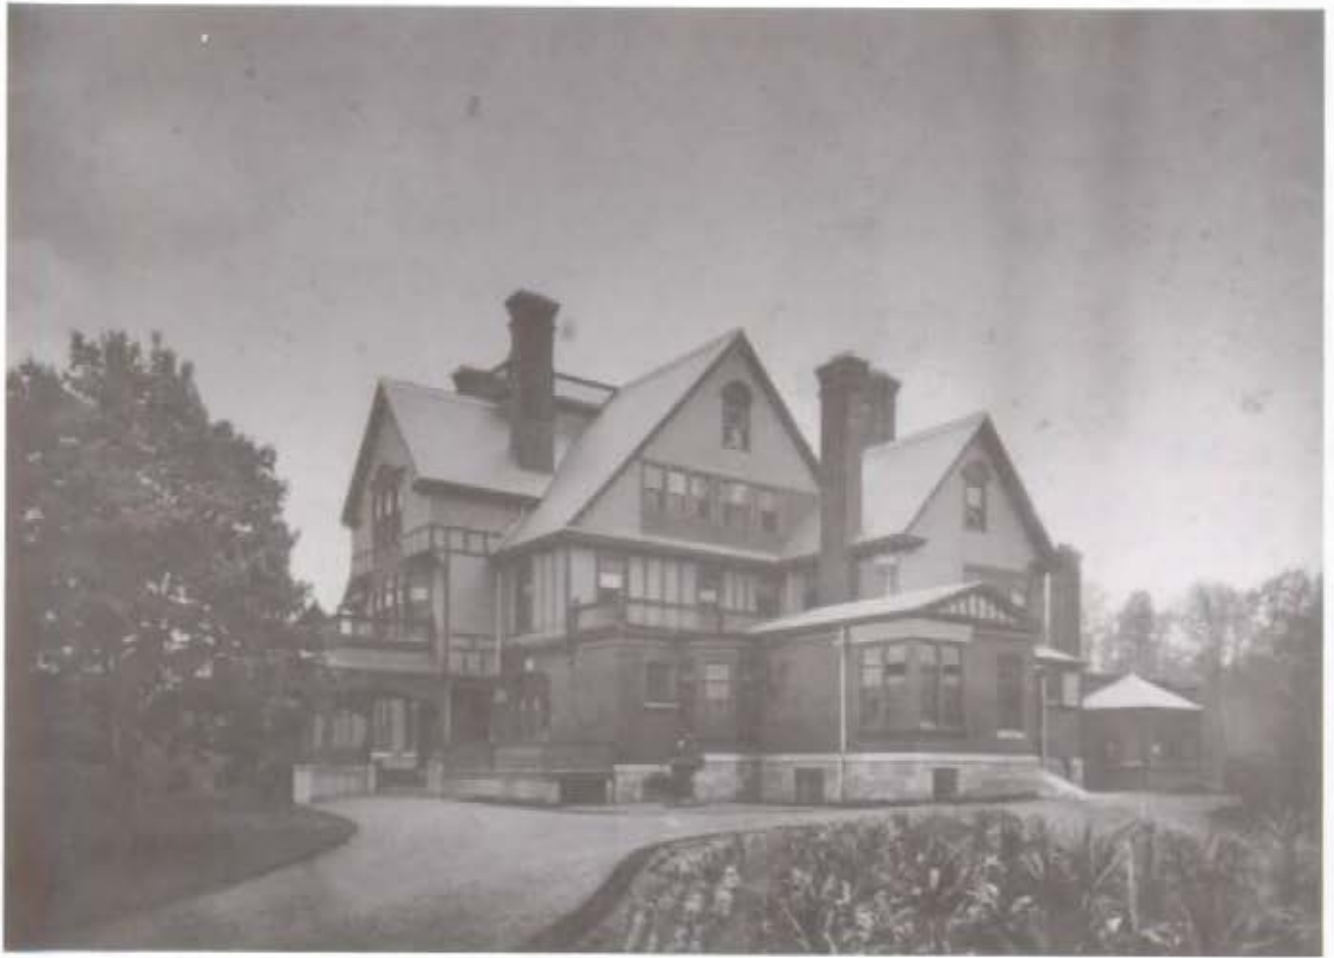
Figure 6. Northeast elevation, circa 1884-90.

The second-story roof deck off Mr. Theodore's Room (Room 206) was built in 1880-81. It functions as the roofs for the north alcove of the Library (Room 104) and the Service Dining Room (Room 105). The porch is documented by early photographs taken in the 1890's (figs. 6 and 10) as having had a wood balustrade with three posts.

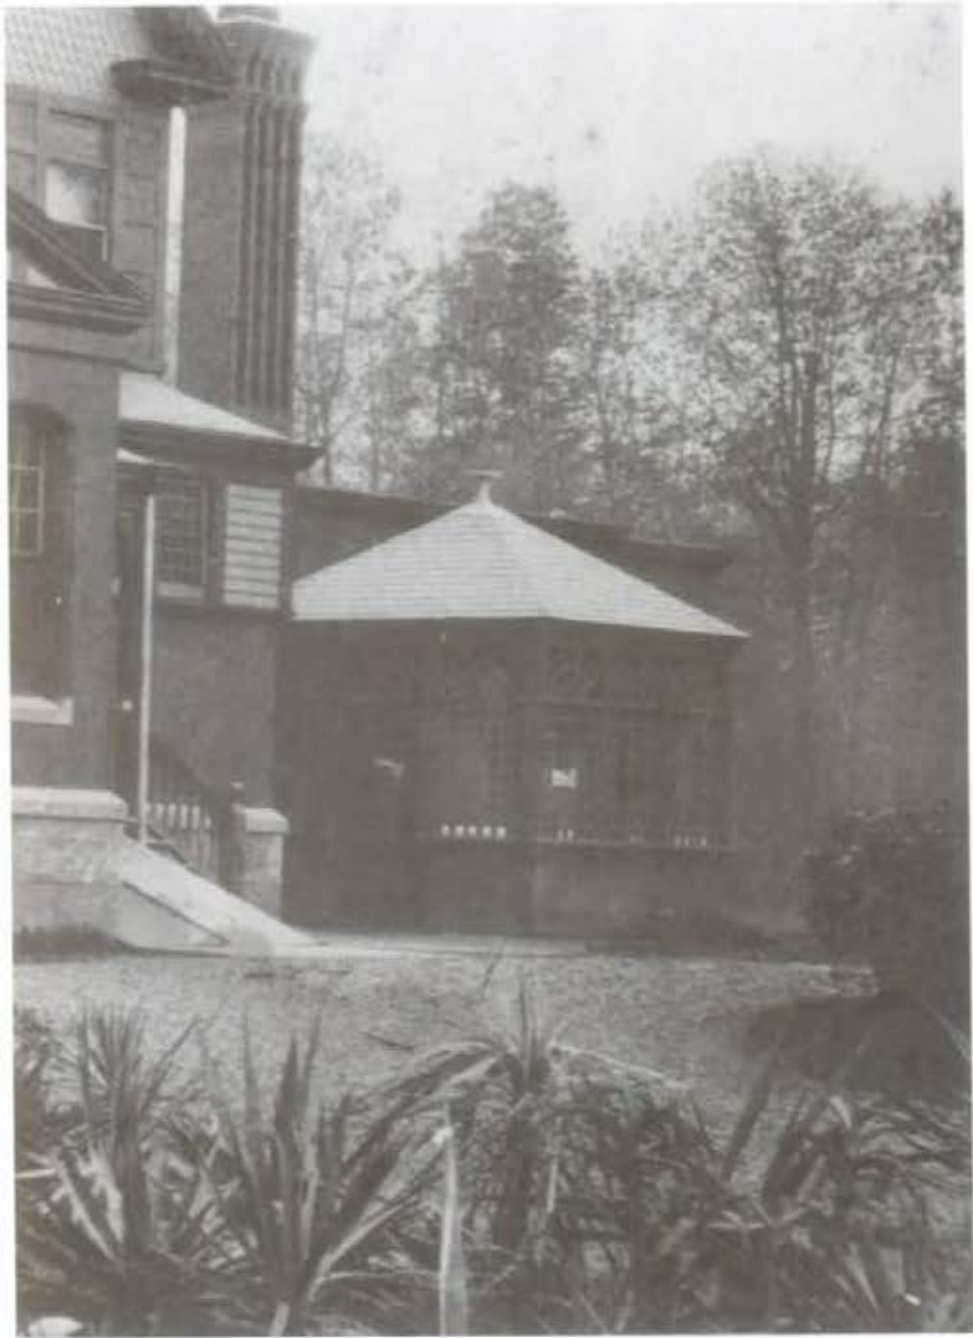
Figure 7. Detail of Figure 6, showing the "well house."

¹²⁰ It is believed that one of these buildings may have been the original well house that had been located on the north side of the house. The well house was moved in 1899, according to a bill from carpenter Adolph Vogel dated Dec. 15, 1899. Both buildings were wired for electricity by 1920, according to a memorandum dated Mar. 10, 1920, from the Edison Insurance Service Department.

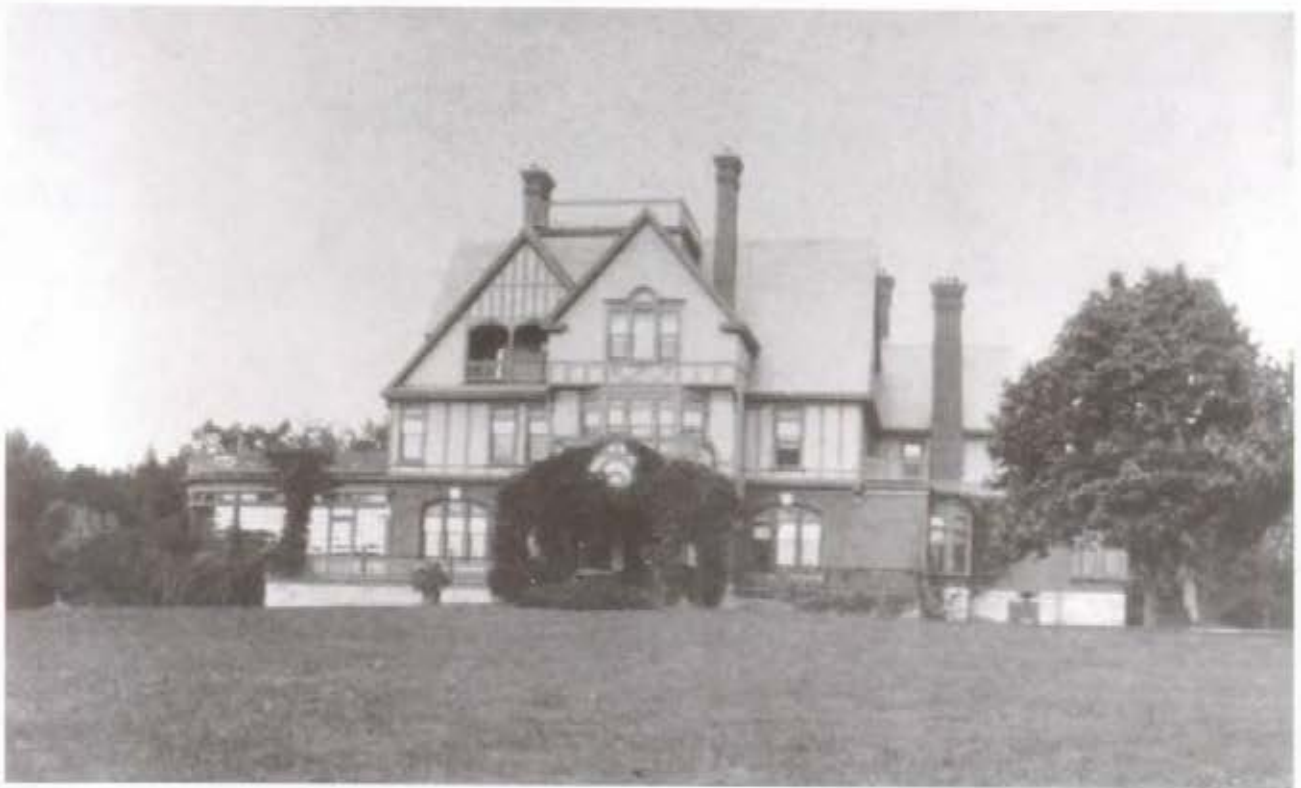
Figure 11. East elevation, circa 1891-97.

11.	Photograph of the east elevation, circa 1891-97. The date 1891 is based on the presence of the hinged skylight covers at the Den that were installed in June of that year (see figure 12); the date 1897 is based on the dark trim color that was lightened by 1897. Edison NHS catalog #12.420/16, no negative	50

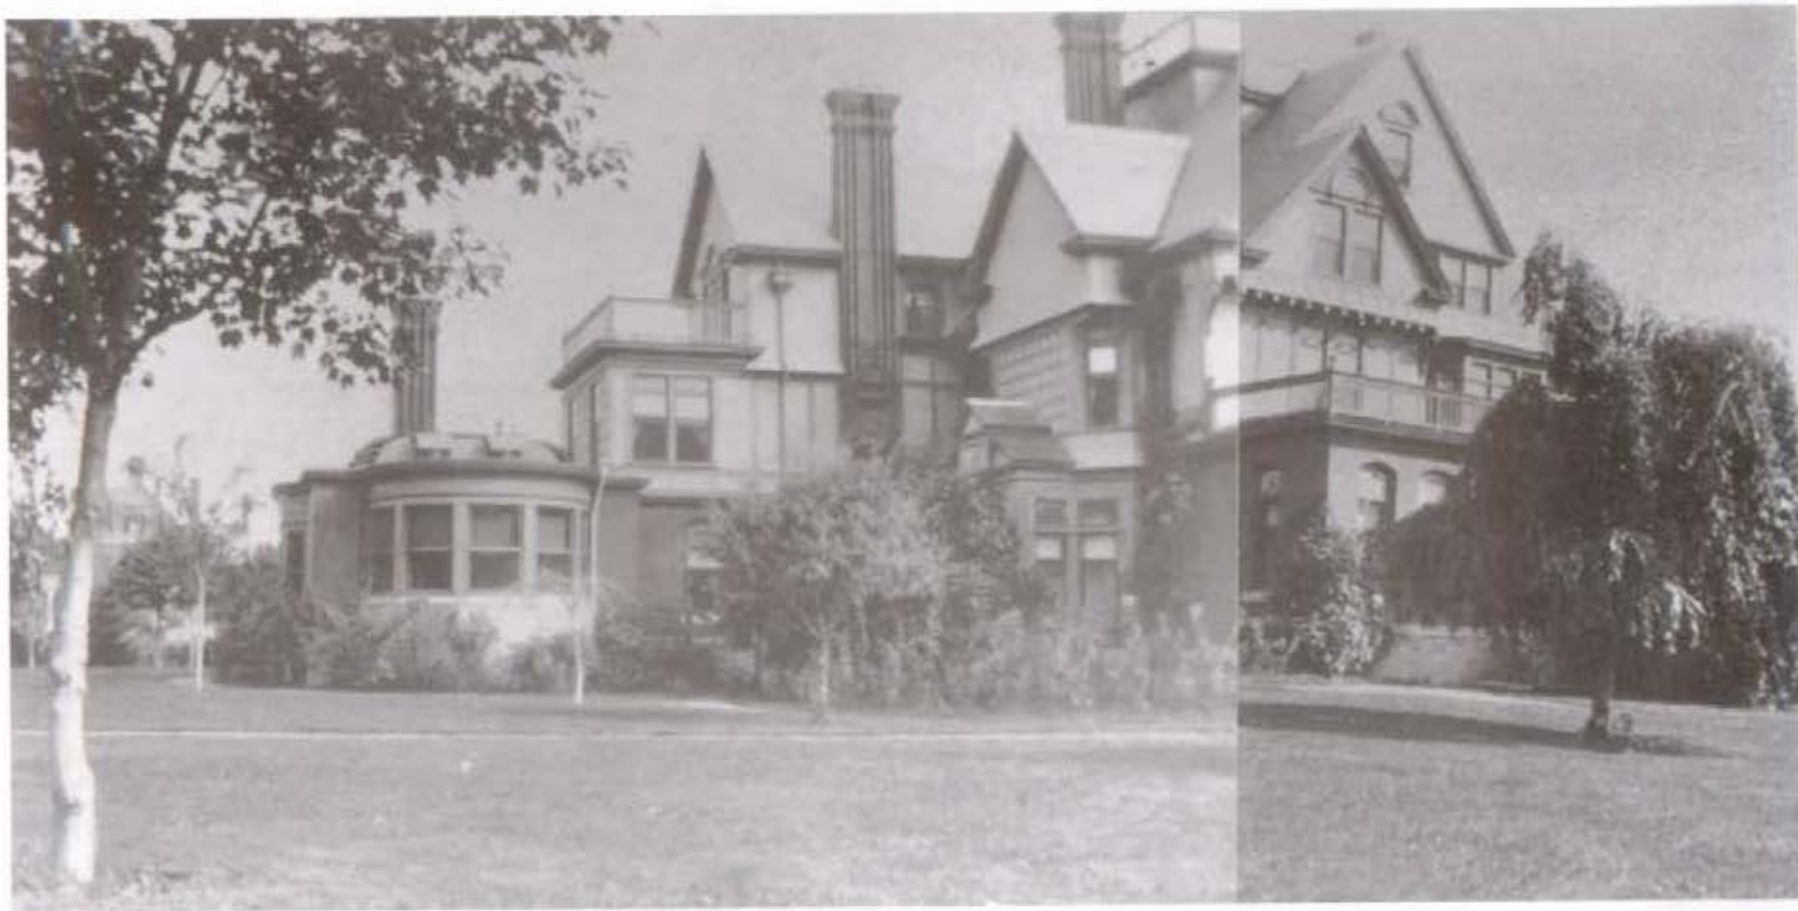
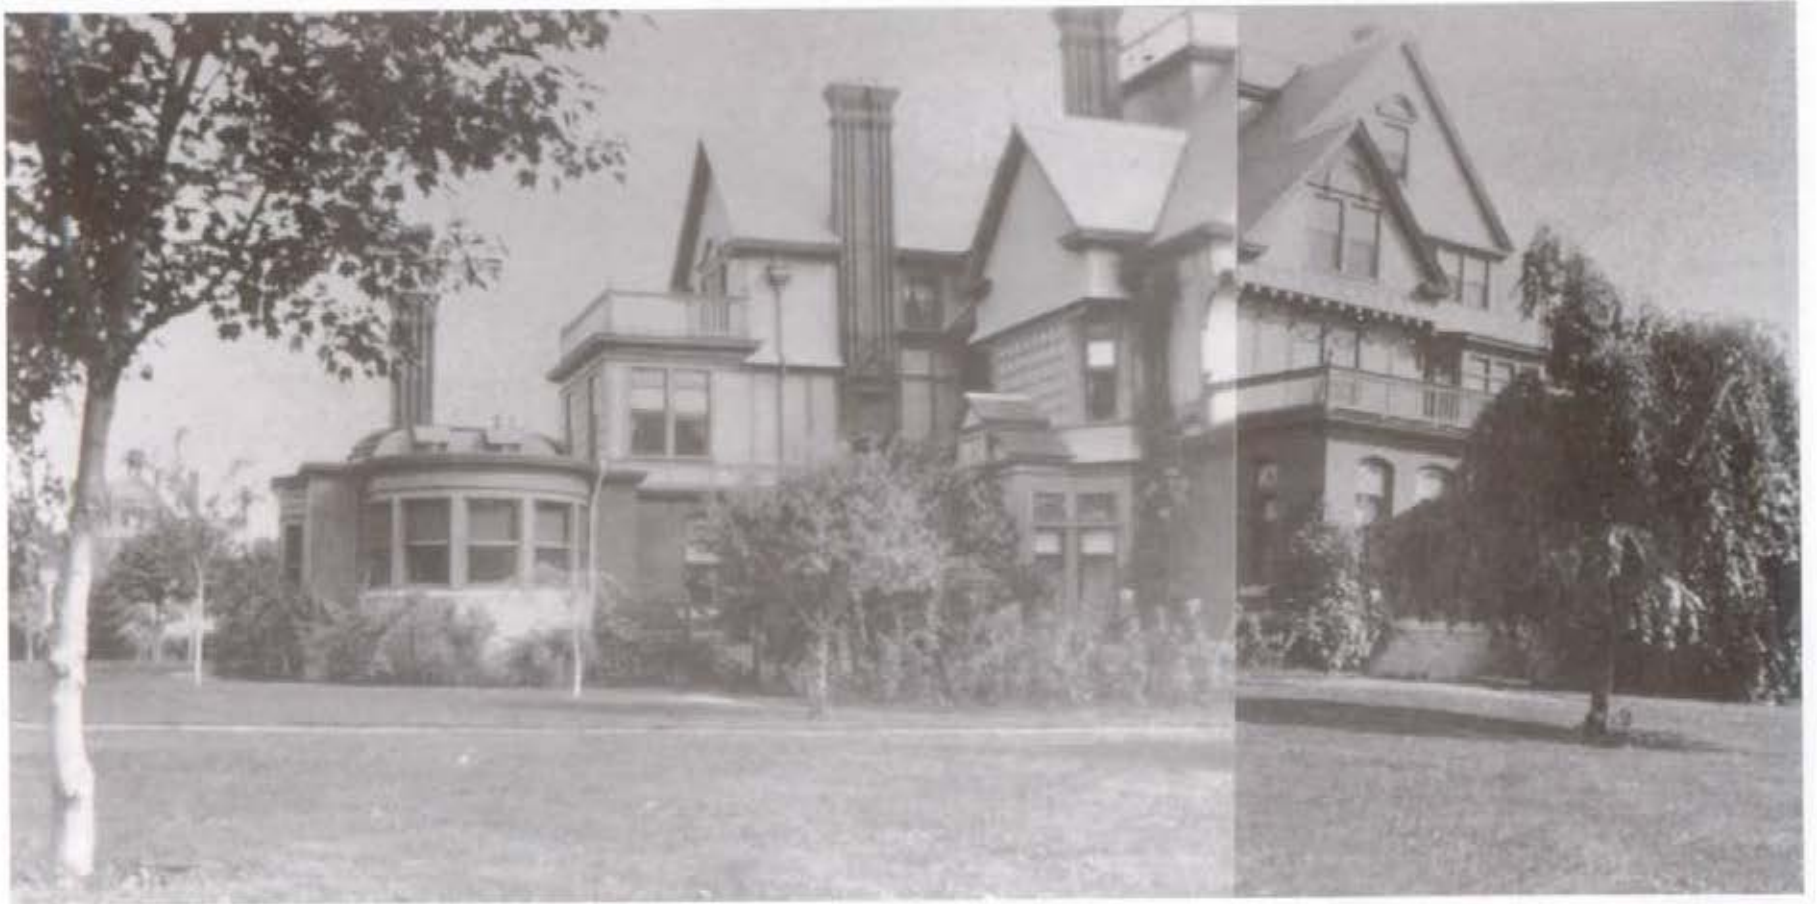
Figure 12. Southwest elevation, circa 1891-97.

12.	Two photographs joined together to show the entire southwest elevation. Both views were taken at the same time as figure 11, circa 1891-97. Edison NHS catalog #12.420/29 (left side)	51

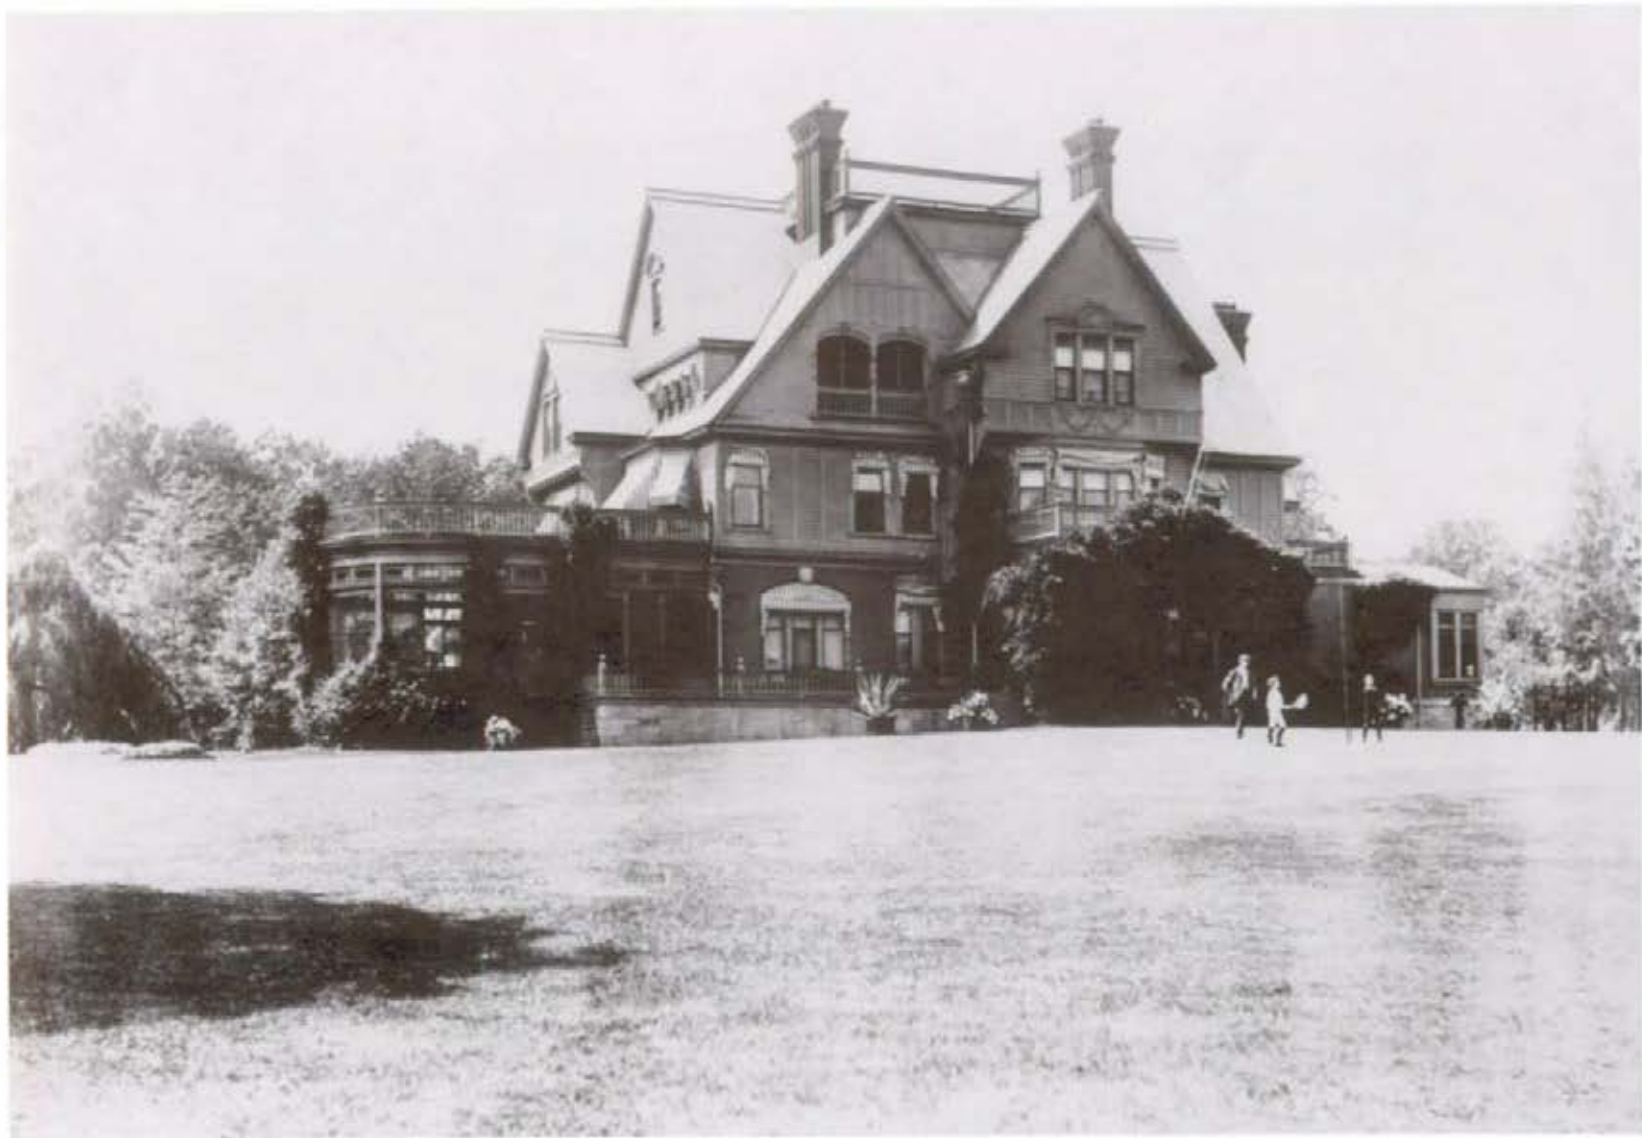
Figure 14. East elevation, circa 1897-1902.

that some of this work included making screens for the Conservatory, but this is not clearly stated. That the Conservatory may have been outfitted with screens about this time is suggested by an early photograph of the house taken sometime before 1903 that shows the screens in place (fig. 14). The Conservatory screens were divided into panels, with the large curved screens having six panels each, and the smaller flat screens having four panels each. These screens were removed during the cold months, when storm sashes were installed.

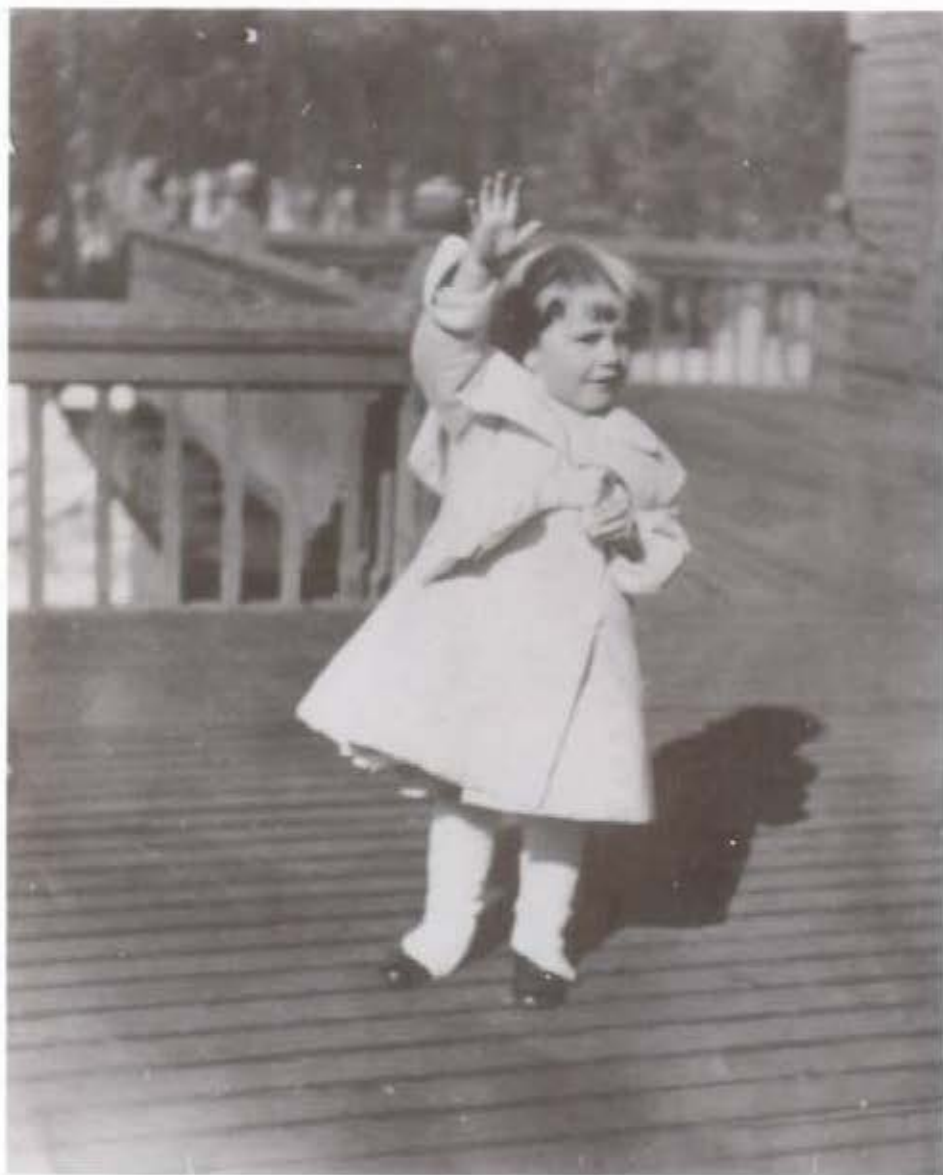
Figure 15. Theodore Edison on the south roof deck, above the Conservatory, circa 1902.

The second-story south roof deck was the one used most frequently by the Edison family. A large awning was installed over the Conservatory portion in May 1890.¹⁹ The flooring material was wood boards that were widely spaced for drainage, according to a photograph dated circa 1902 (fig. 15).²⁰ The Drawing Room portion of the deck, and part of the Conservatory portion, were screened in 1907 and enclosed with glass in 1935. For more information on the enclosed sun porch, see the discussion of Room 202.

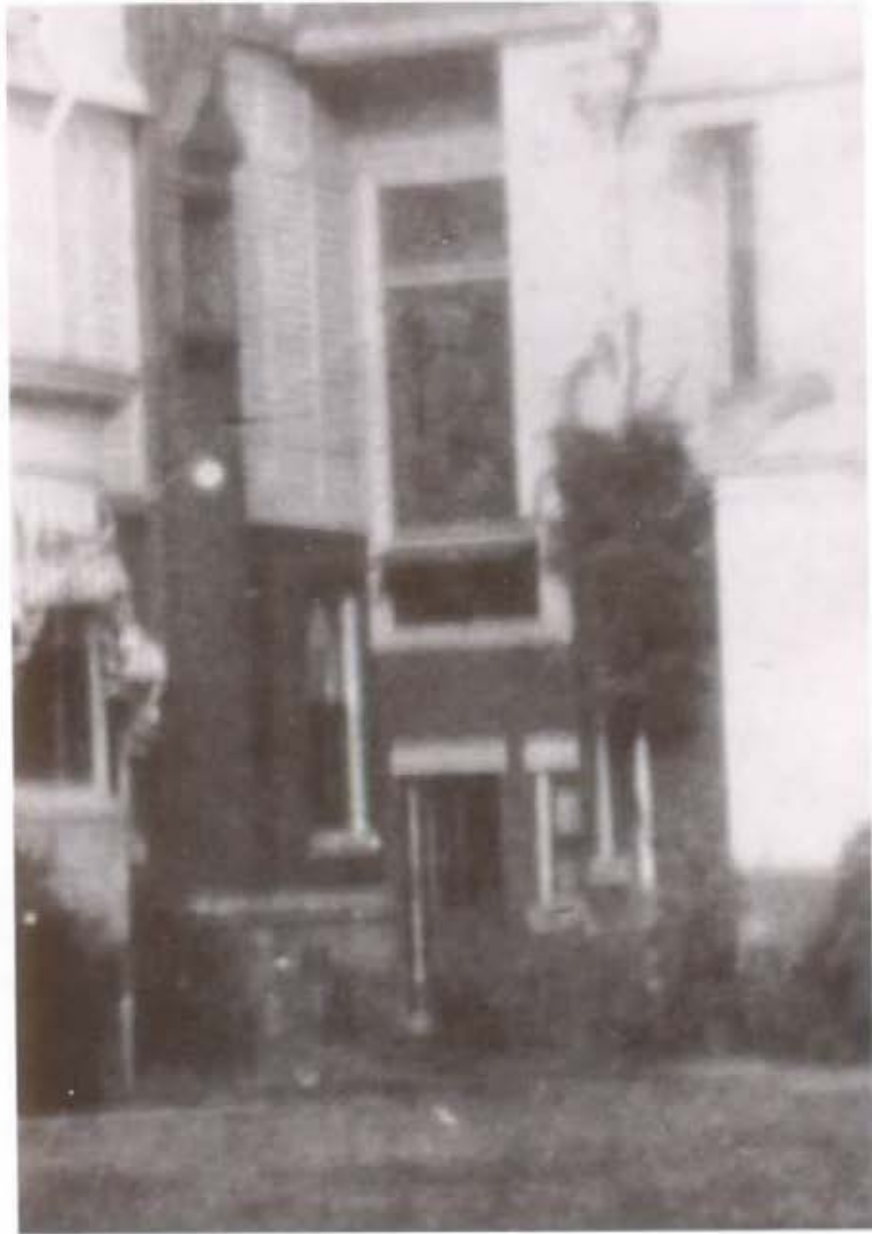
Figure 20. Detail of Figure 19, showing the original back doorway.
