THE HOUSE AT GLENMONT

HOME OF THOMAS EDISON

Historic Structure Report

**THE HOUSE AT GLENMONT
HISTORIC STRUCTURE REPORT**

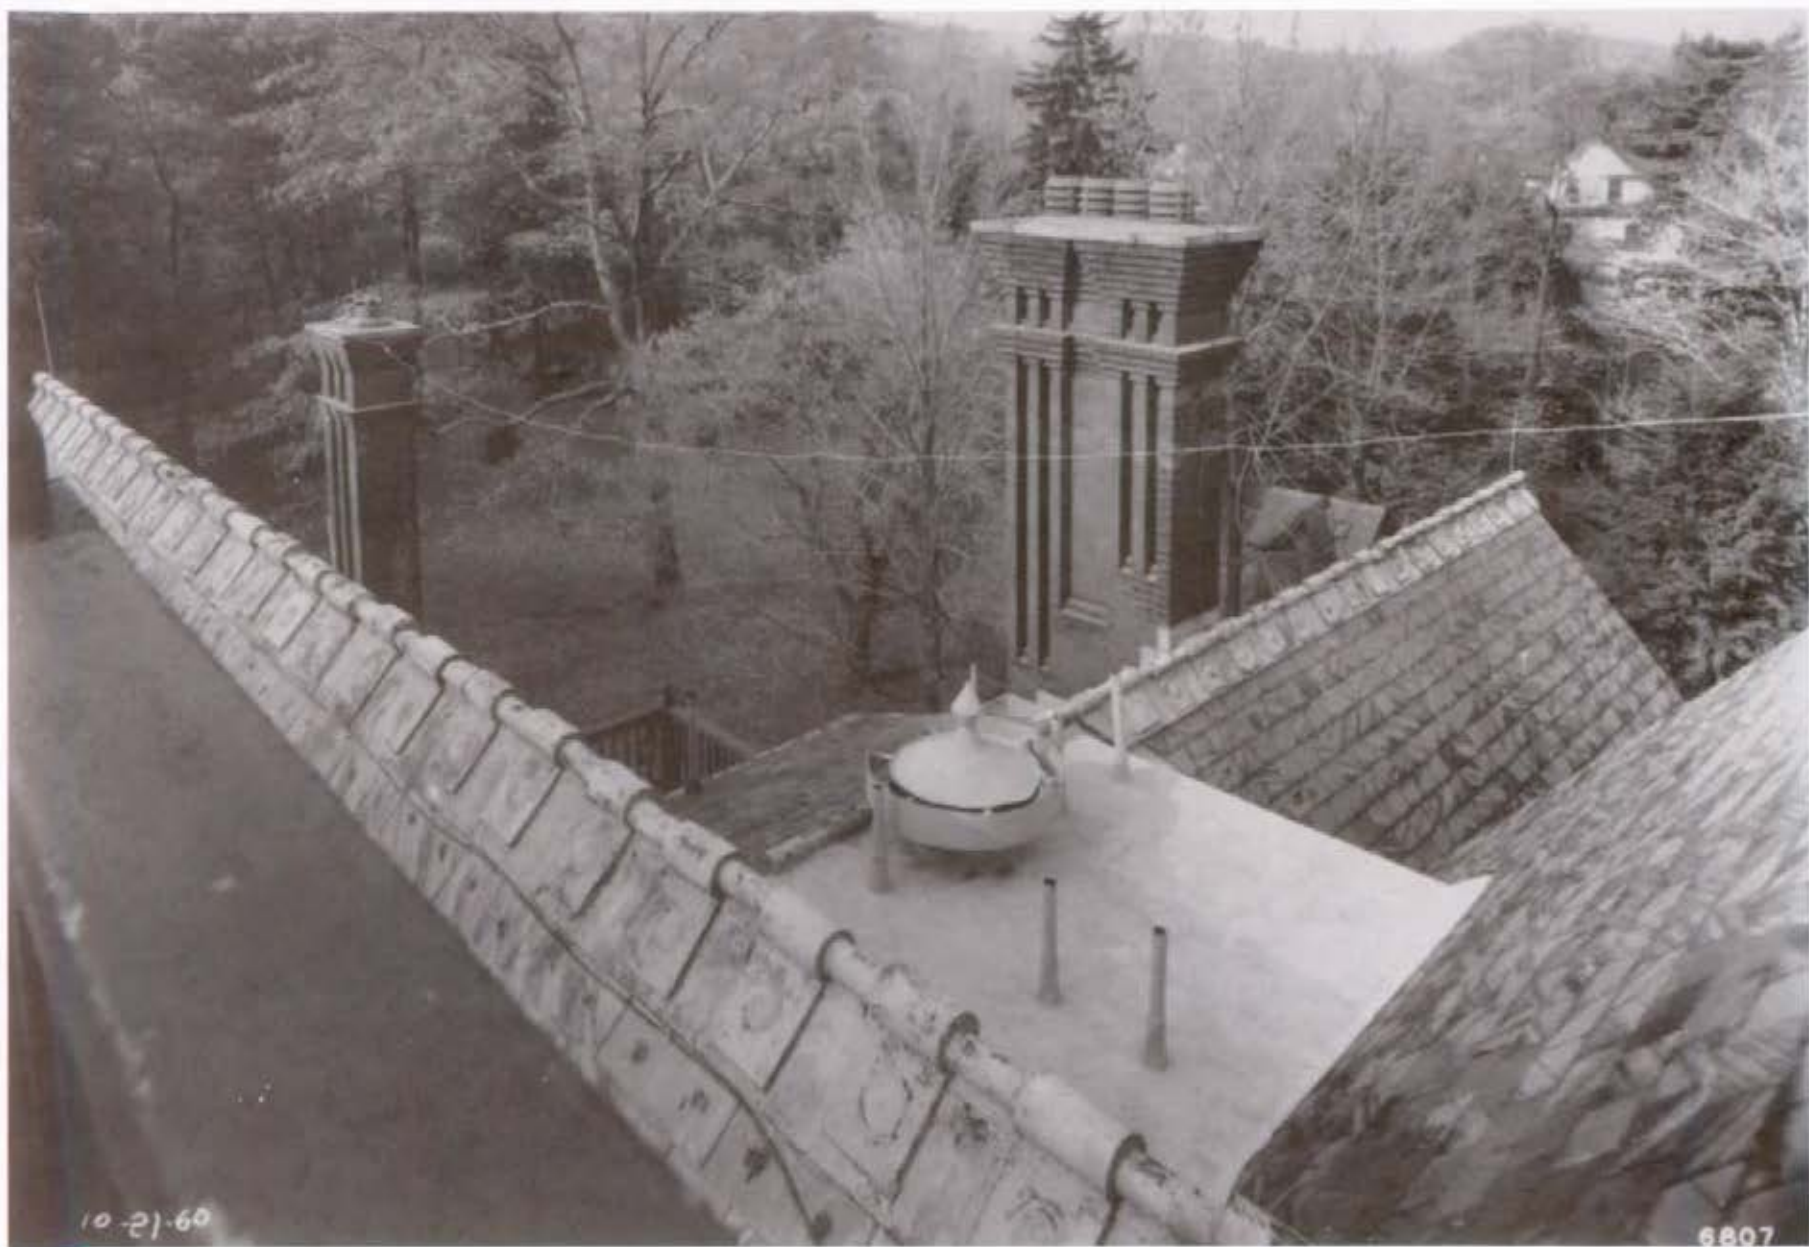
Figure 34. View of the roof, looking northwest, 1960.

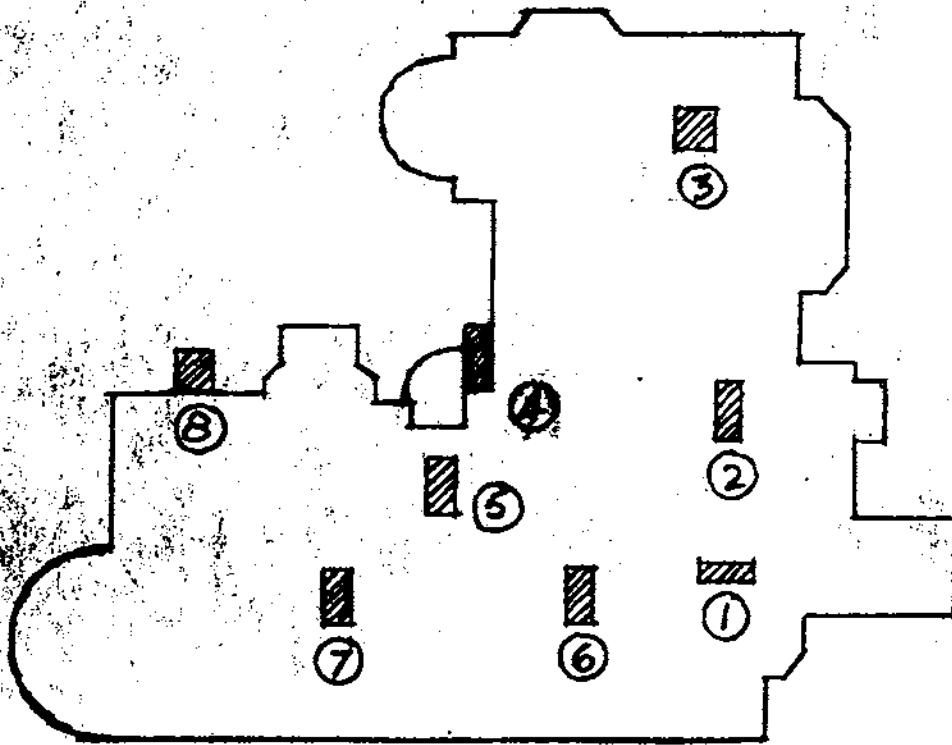
(FRONT OF BUILDING)

ROUGH PLAN OF GLENMONT CHIMNEYS

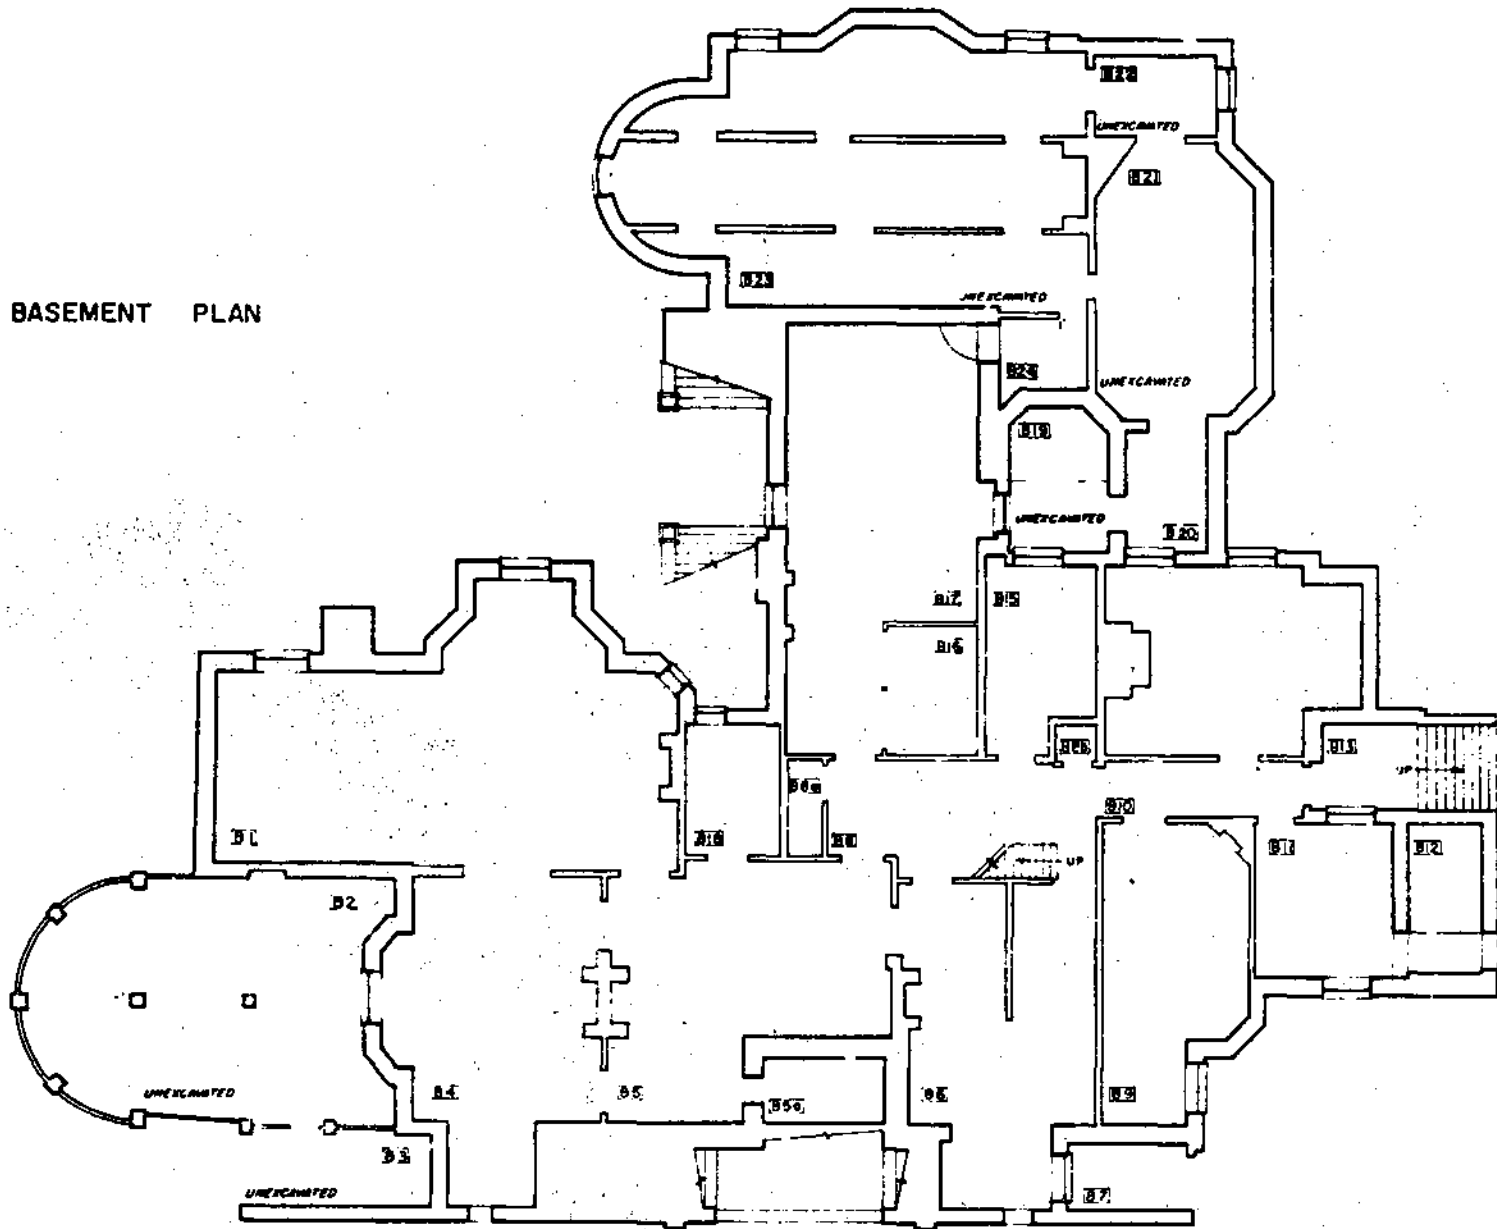
BASEMENT PLAN

Figure 36. Cellar floor plan, 1963.

The section that follows is a general description of the cellar features. Each individual cellar room and unexcavated area is referred to by a number from B1 to B23. These numbers were assigned by the Historic American Buildings Survey (HABS) in the summer of 1962. The numbers are keyed to the floor plan of the cellar in figure 36. The numbers for both the cellar rooms and the unexcavated areas are listed below. The names for the cellar room are taken from the residence appraisal of January 1931:

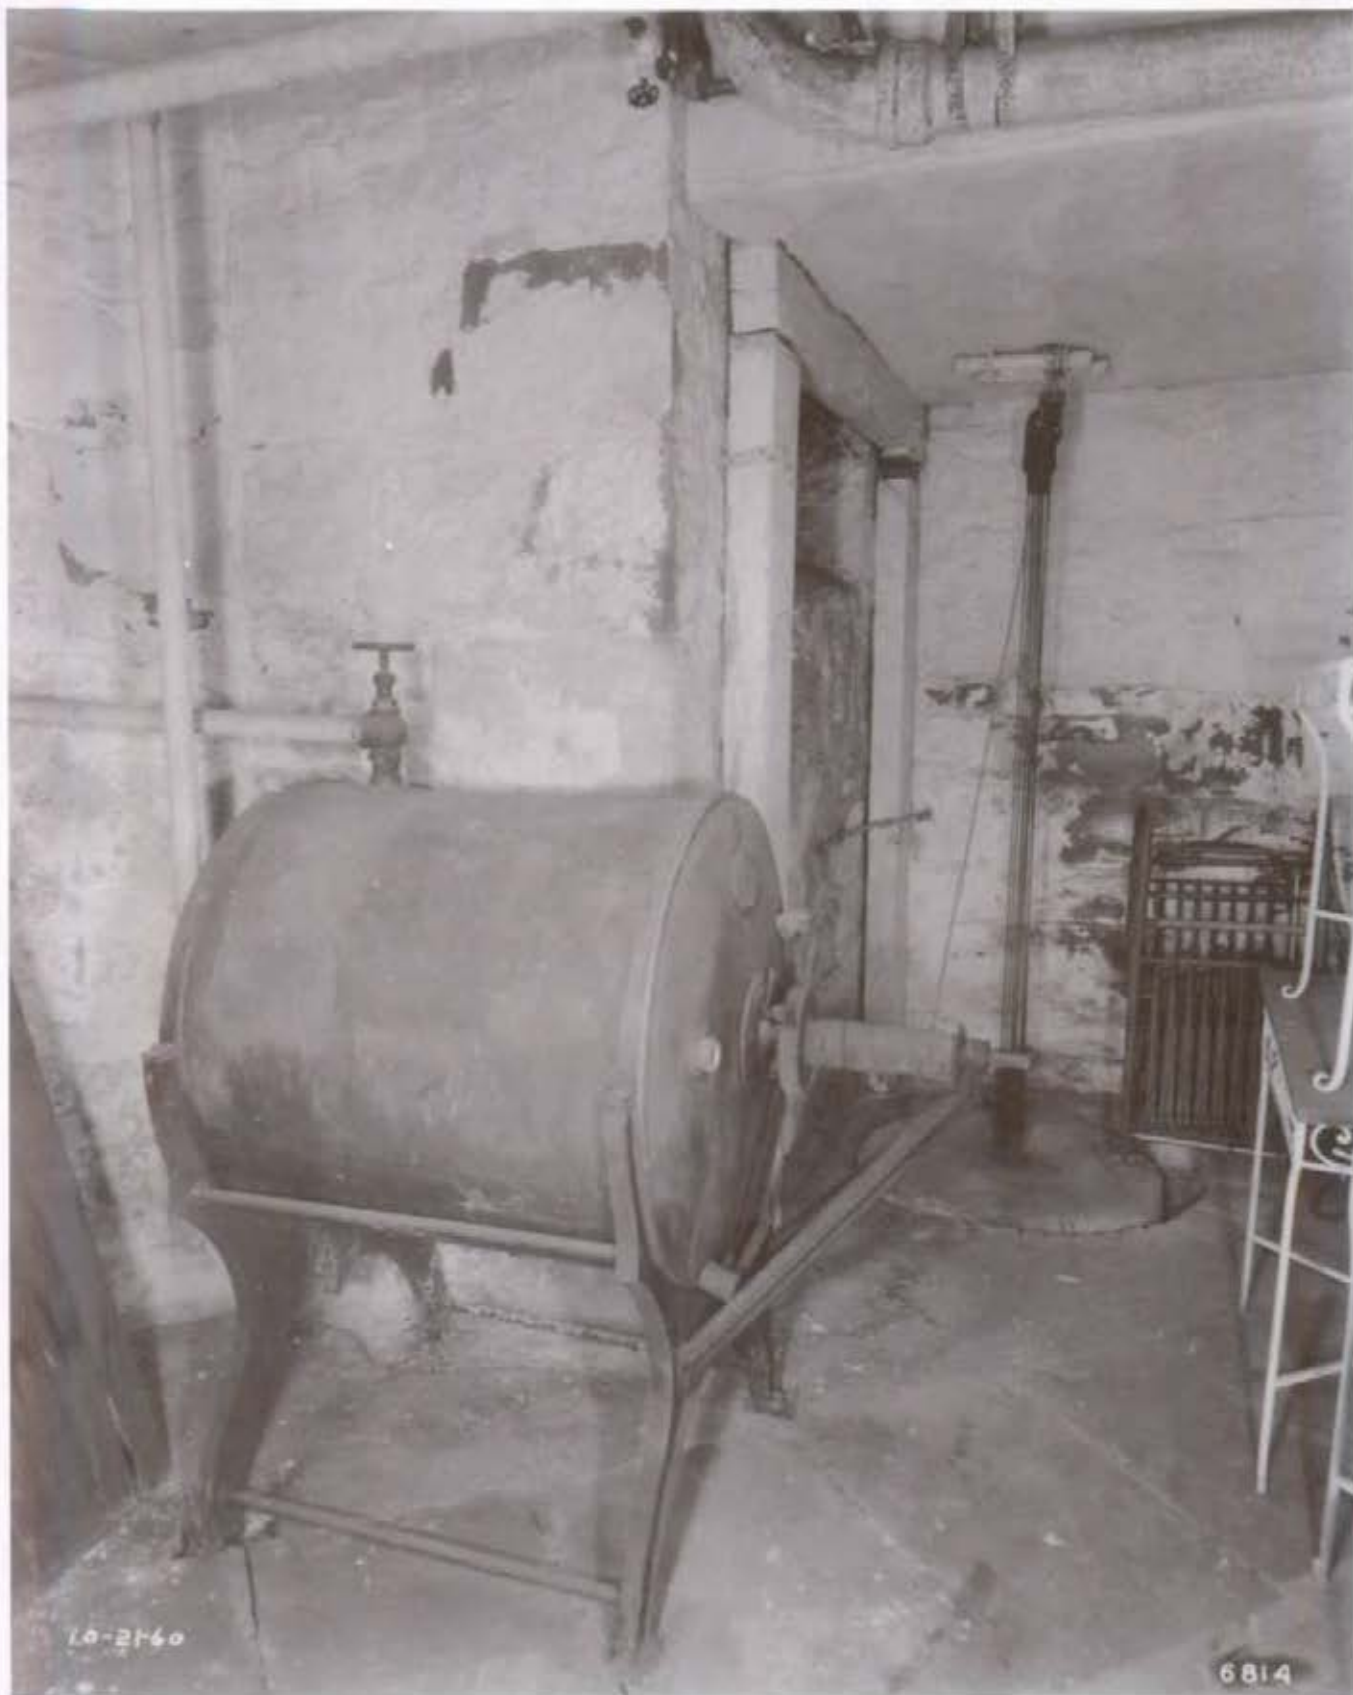
Figure 37. Room B9, northeast corner, showing the obsolete Springfield Gas Machine, 1960.

The Edison family used the gas-making equipment, including the "gas machine," until sometime before 1921. It was noted as being "obsolete" by the time of the residence appraisals of 1921, 1924, and 1931. The 1931 appraisal described the equipment in the cellar as follows:

1 Springfield gas machine, #1822, receiver 32" x 32" diameter, Gilbert and
Barker Mfg. Co. (obsolete).

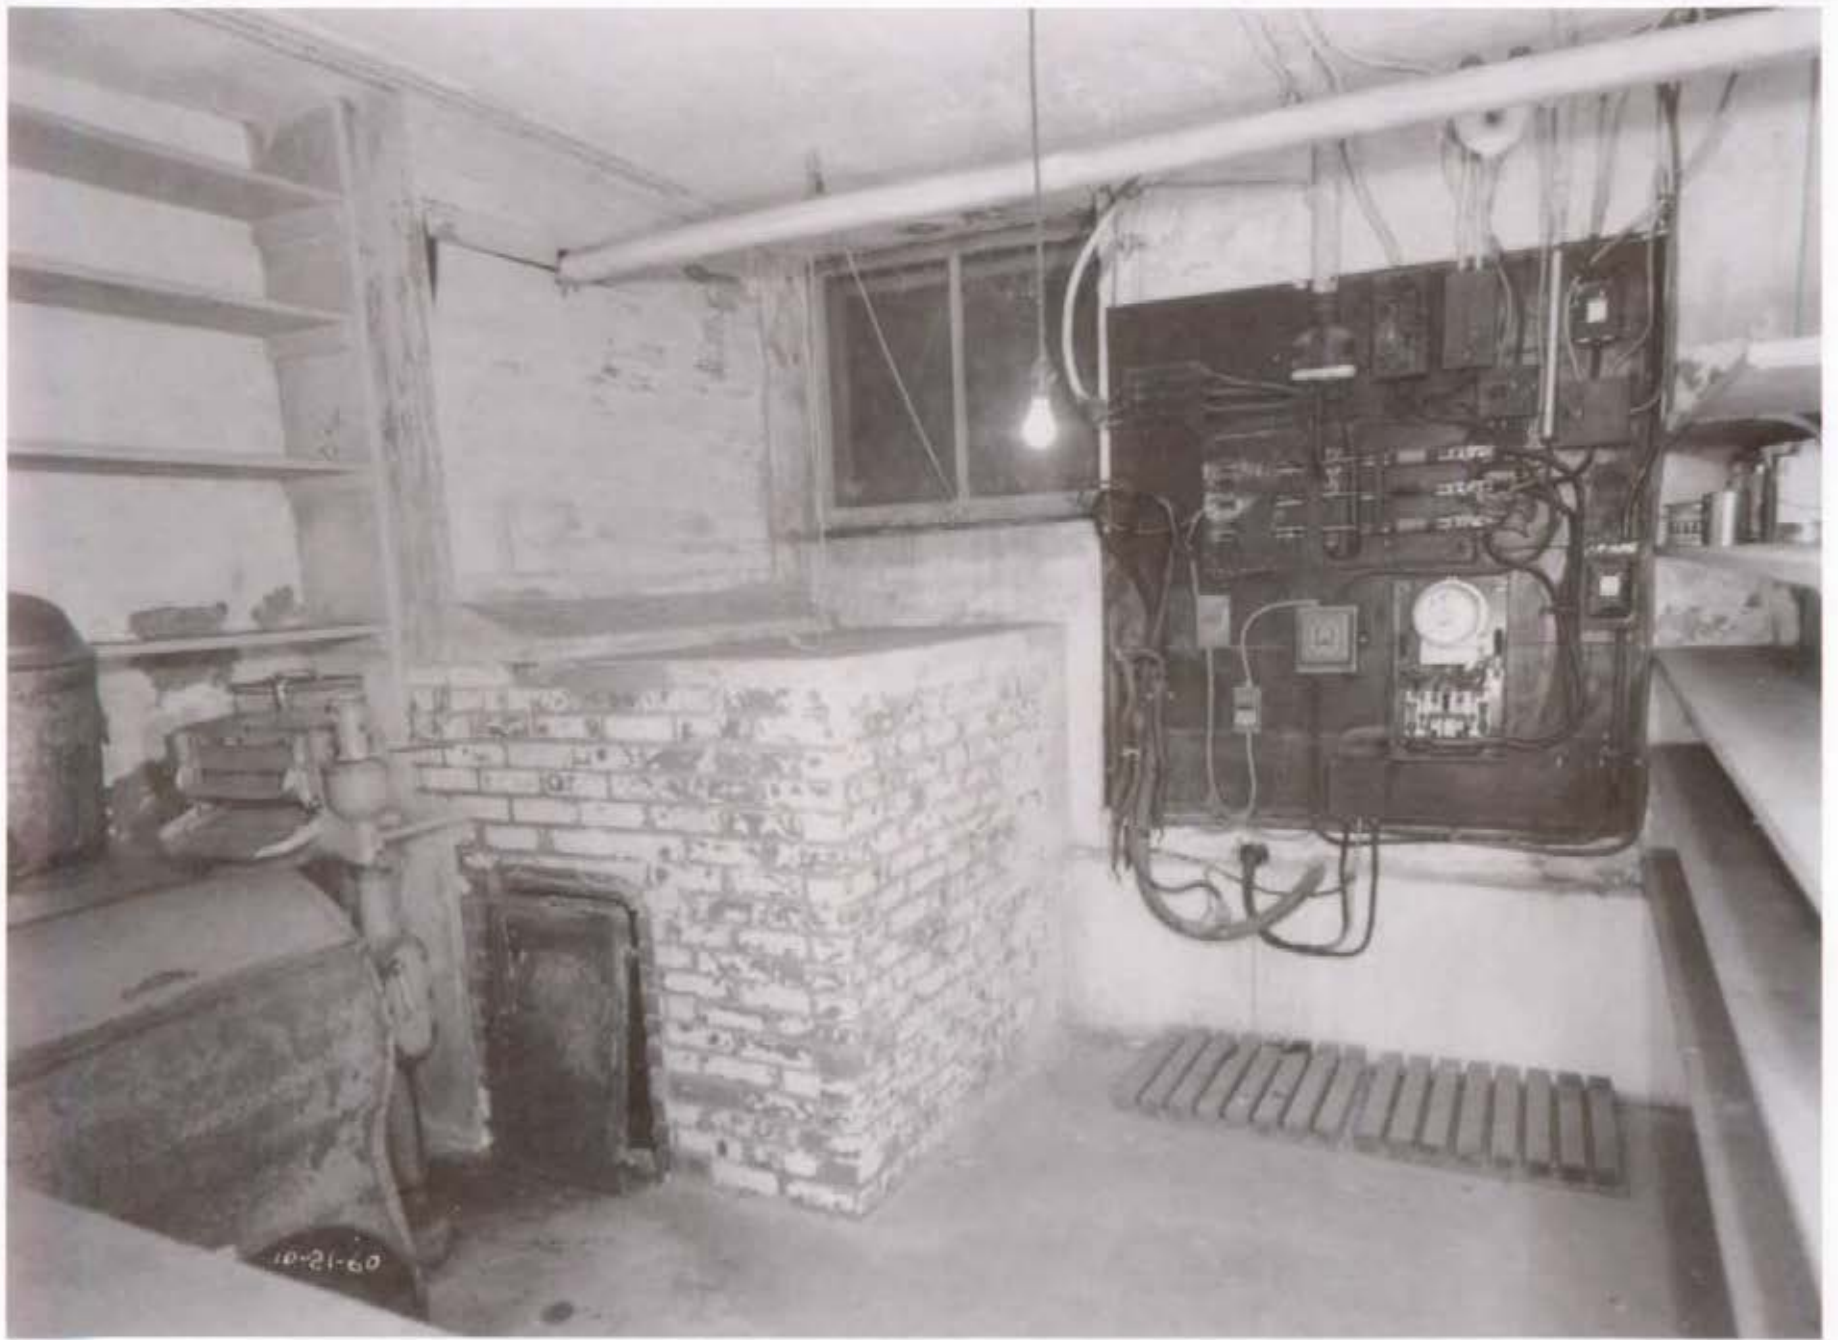
Figure 38. Store Room #2 (Room B11), northeast corner, showing the fresh-air plenum for the original heating system (left), and the electrical panel for incoming service (right), 1960.

Two new electrical distribution panels replaced the old entrance panel in 1968. The two new panels are mounted to the south wall. Both are housed in metal boxes. One of the boxes is labeled "Panelboard A." Circuit breakers within the box are identified as being for the lights, receptacles, and other electrical fixtures that are outside, in the cellar, and in the first story. The second electrical panel box is unlabeled.

The floor channel is missing today from Room B11, having been filled in and covered with concrete at an unknown date. This had occurred by October 1960, based on a photograph of the room that shows the floor as it appears today. The floor channel appears to have run in a north-south direction, from the brick plenum to the south interior wall. The place where the channel intersected the south wall can be determined from the locations of the surviving floor channels in adjacent Room B9, with which it connected.

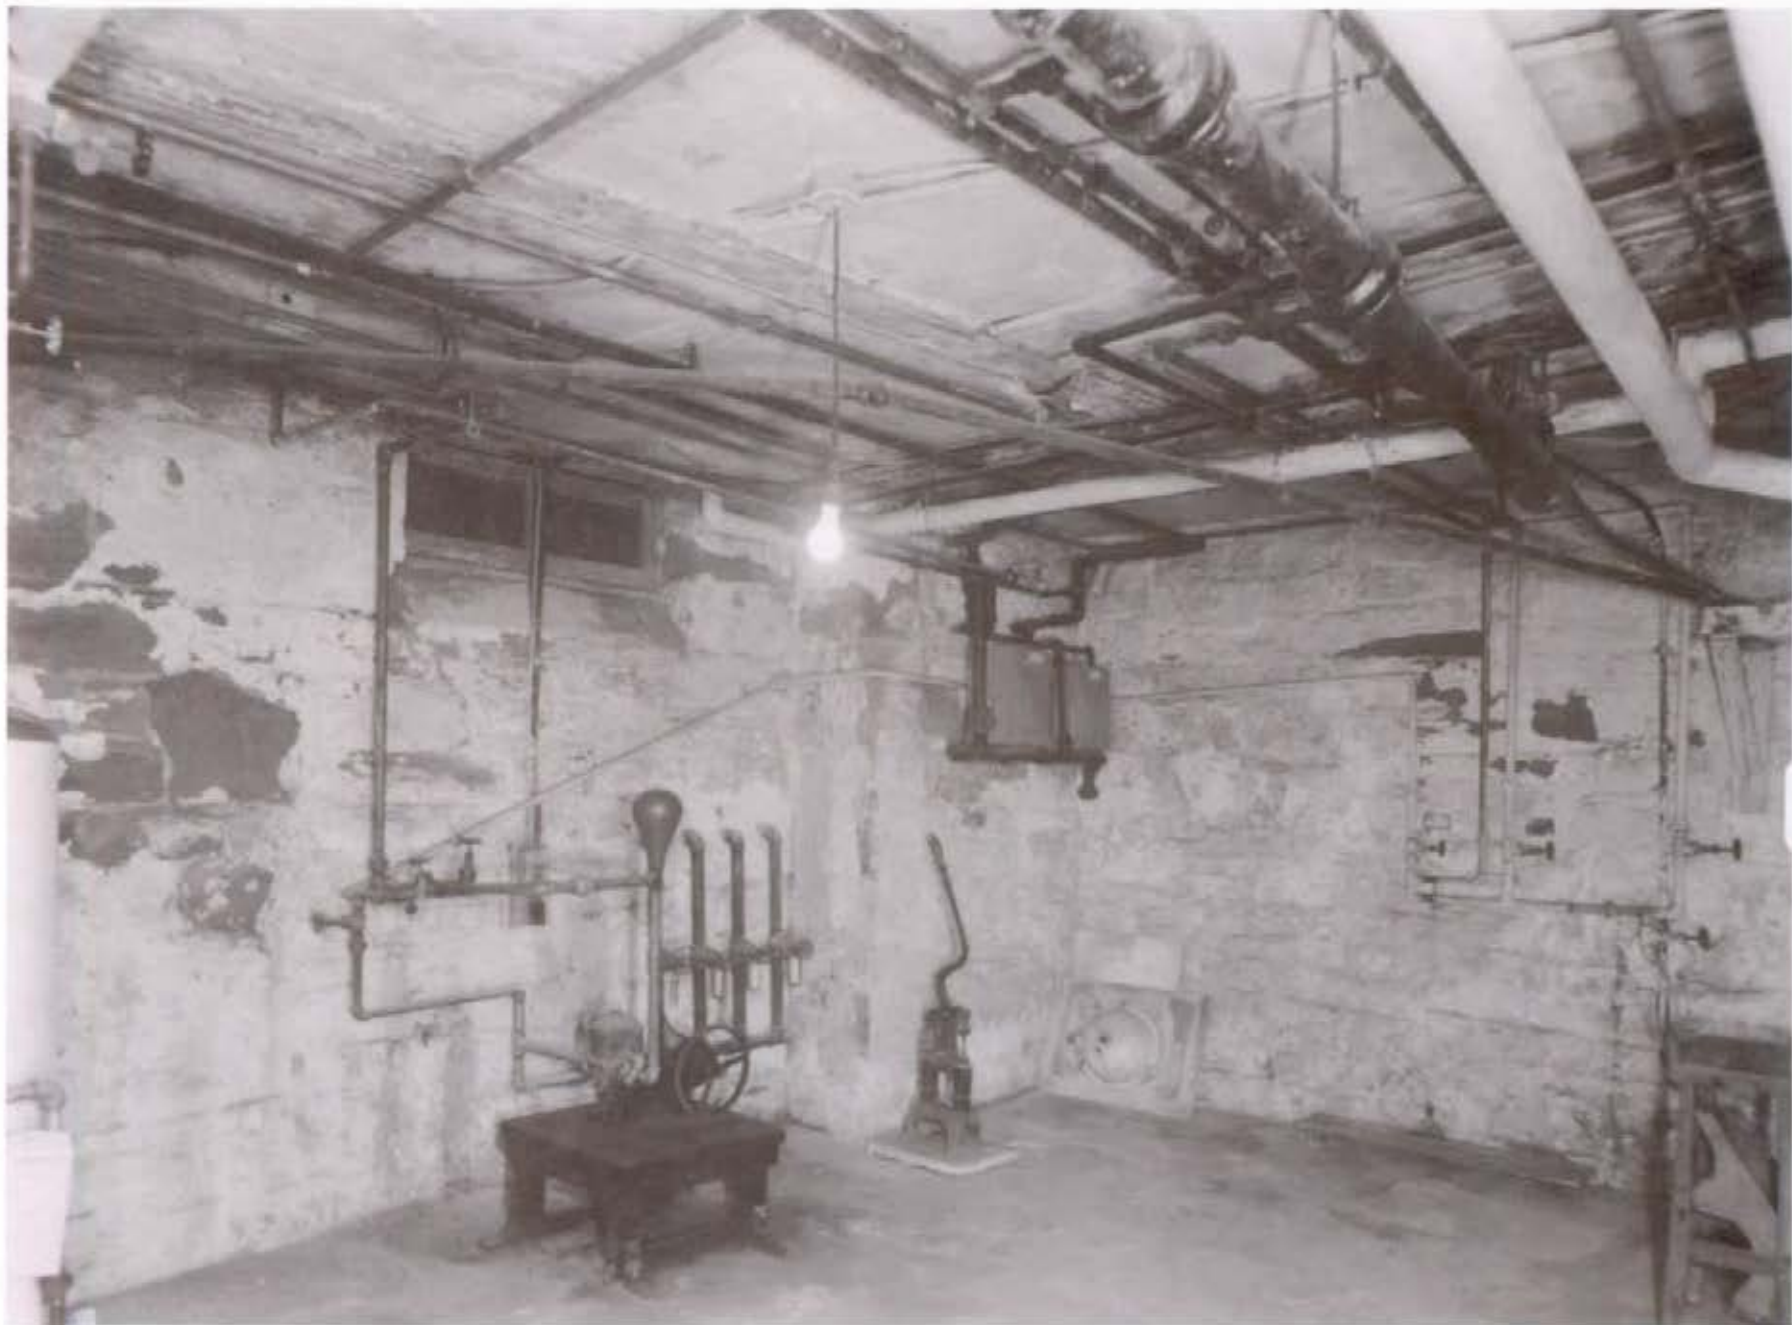
Figure 39. Pump Room (Room B14), northwest tower, showing the cistern valves and water pumps, 1960.

Plumbing fixtures include the entrance pipes from the rainwater cisterns, a pump, and various shut-off valves. Two hot-water heaters formerly in the room—one present in 1921, the other there in 1931—are missing today.

The pump in the room today has written on it "Seneca Falls, N.Y. 35-B-1." It is not known for certain if this is the same pump that was in the room during Thomas Edison's lifetime, or if it was installed at a later date. The motor that powered the pump is missing. It most likely became obsolete in 1950, when the electrical service in the house was changed from direct current to alternating current. Public water was probably used exclusively after 1950.

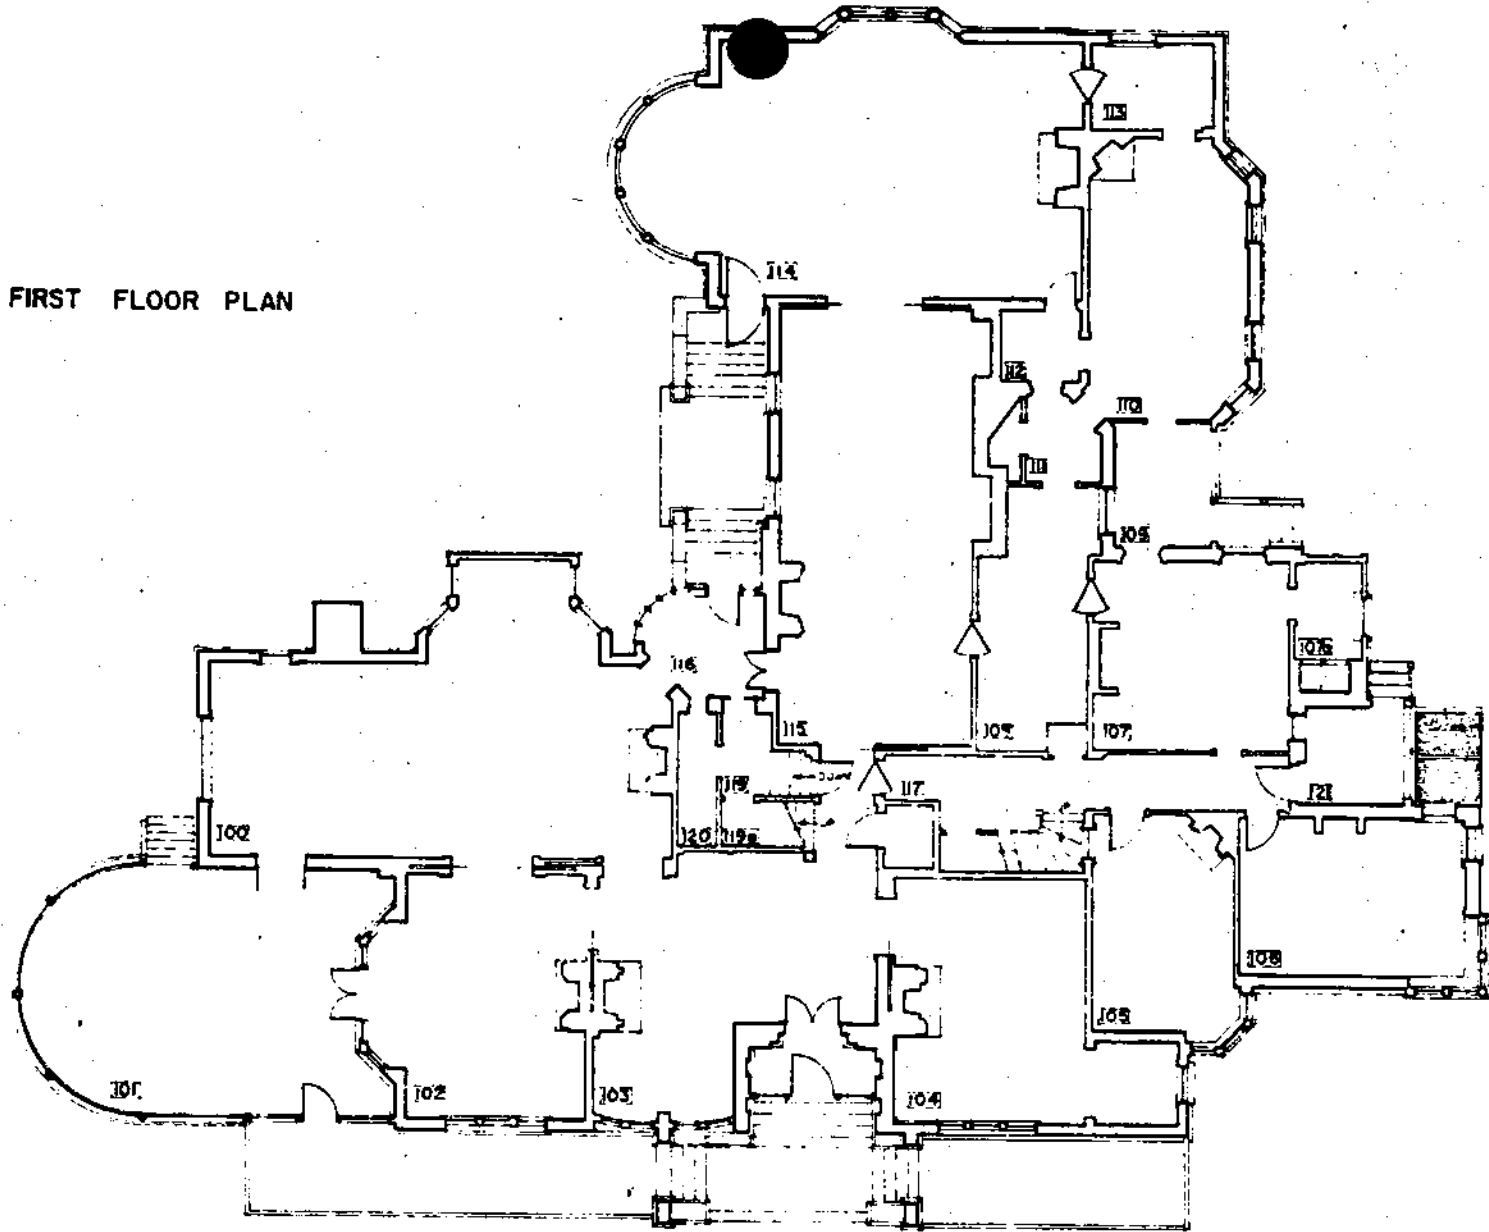
FIRST FLOOR PLAN

REDRAWN FROM NPS DRAWING-N4S ED 3011 SHEET 3
DRAWN BY JOHN G. SAITE, 1963

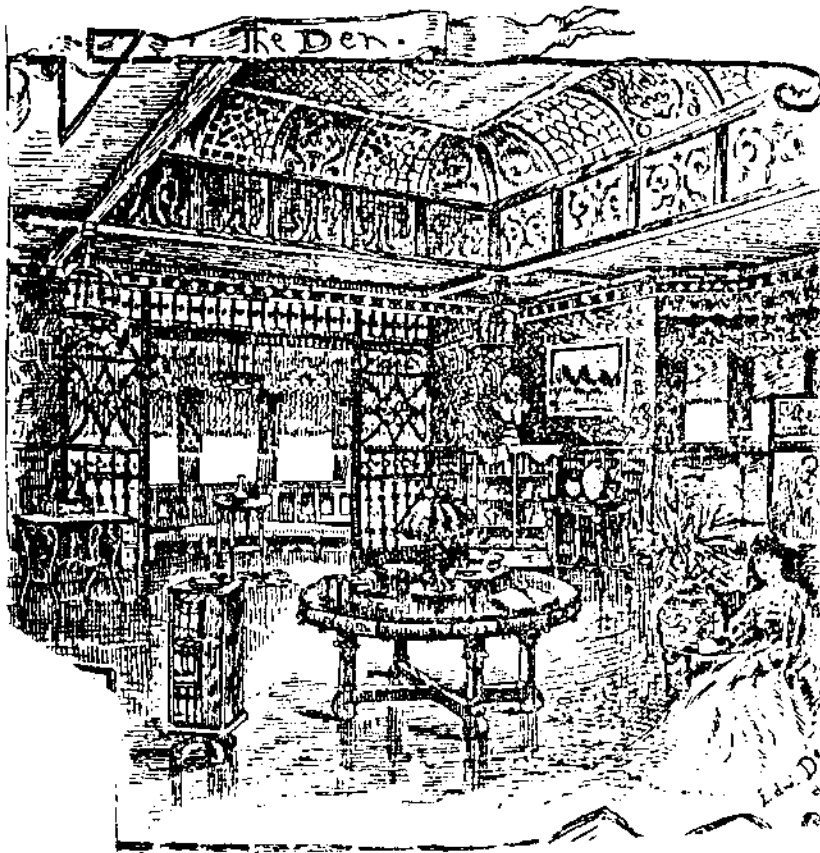
Figure 89. Sketch of the Den (Room 114), looking southwest, 1891.

Alterations were made to the woodwork when the room was remodeled in 1935. The most significant change was the removal of the original wood screen from the south-wall bay. The estimate for the work by Mrs. Renner dated July 1, 1935, described "removing existing grill partition and patching." The appearance of this screen is well-documented by several early views of the room (figs. 89 and 91-92).

The earliest visual documentation of the light fixtures is a sketch of the Den that accompanied the 1891 article (fig. 89). The earliest photograph, published in 1892, shows the two light fixtures at the north end of the room (fig. 90).²⁰⁹

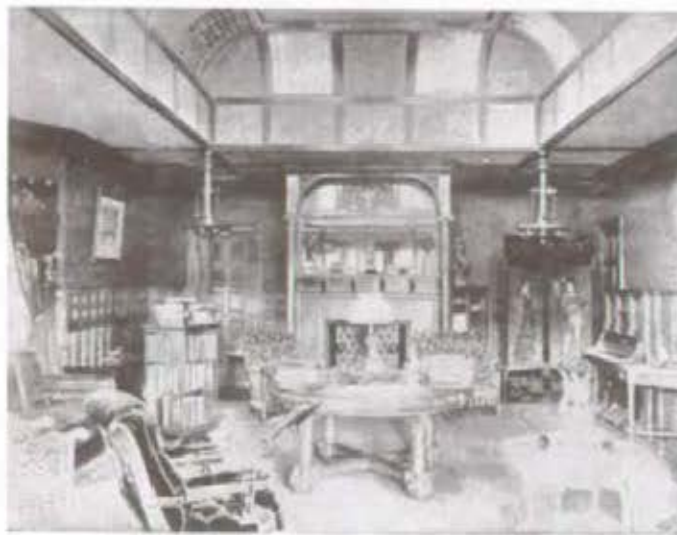
Figure 90. Den (Room 114), looking north, circa 1890.

Also altered in 1935 was the wood fireplace mantel at the north end of the room. The original appearance of the mantel is seen in a photograph published in 1892 (fig. 90). The estimate of July 1, 1935, described "removing present over-mantel and pilasters [sic: columns], re-setting pilasters [sic] under present mantel shelf."

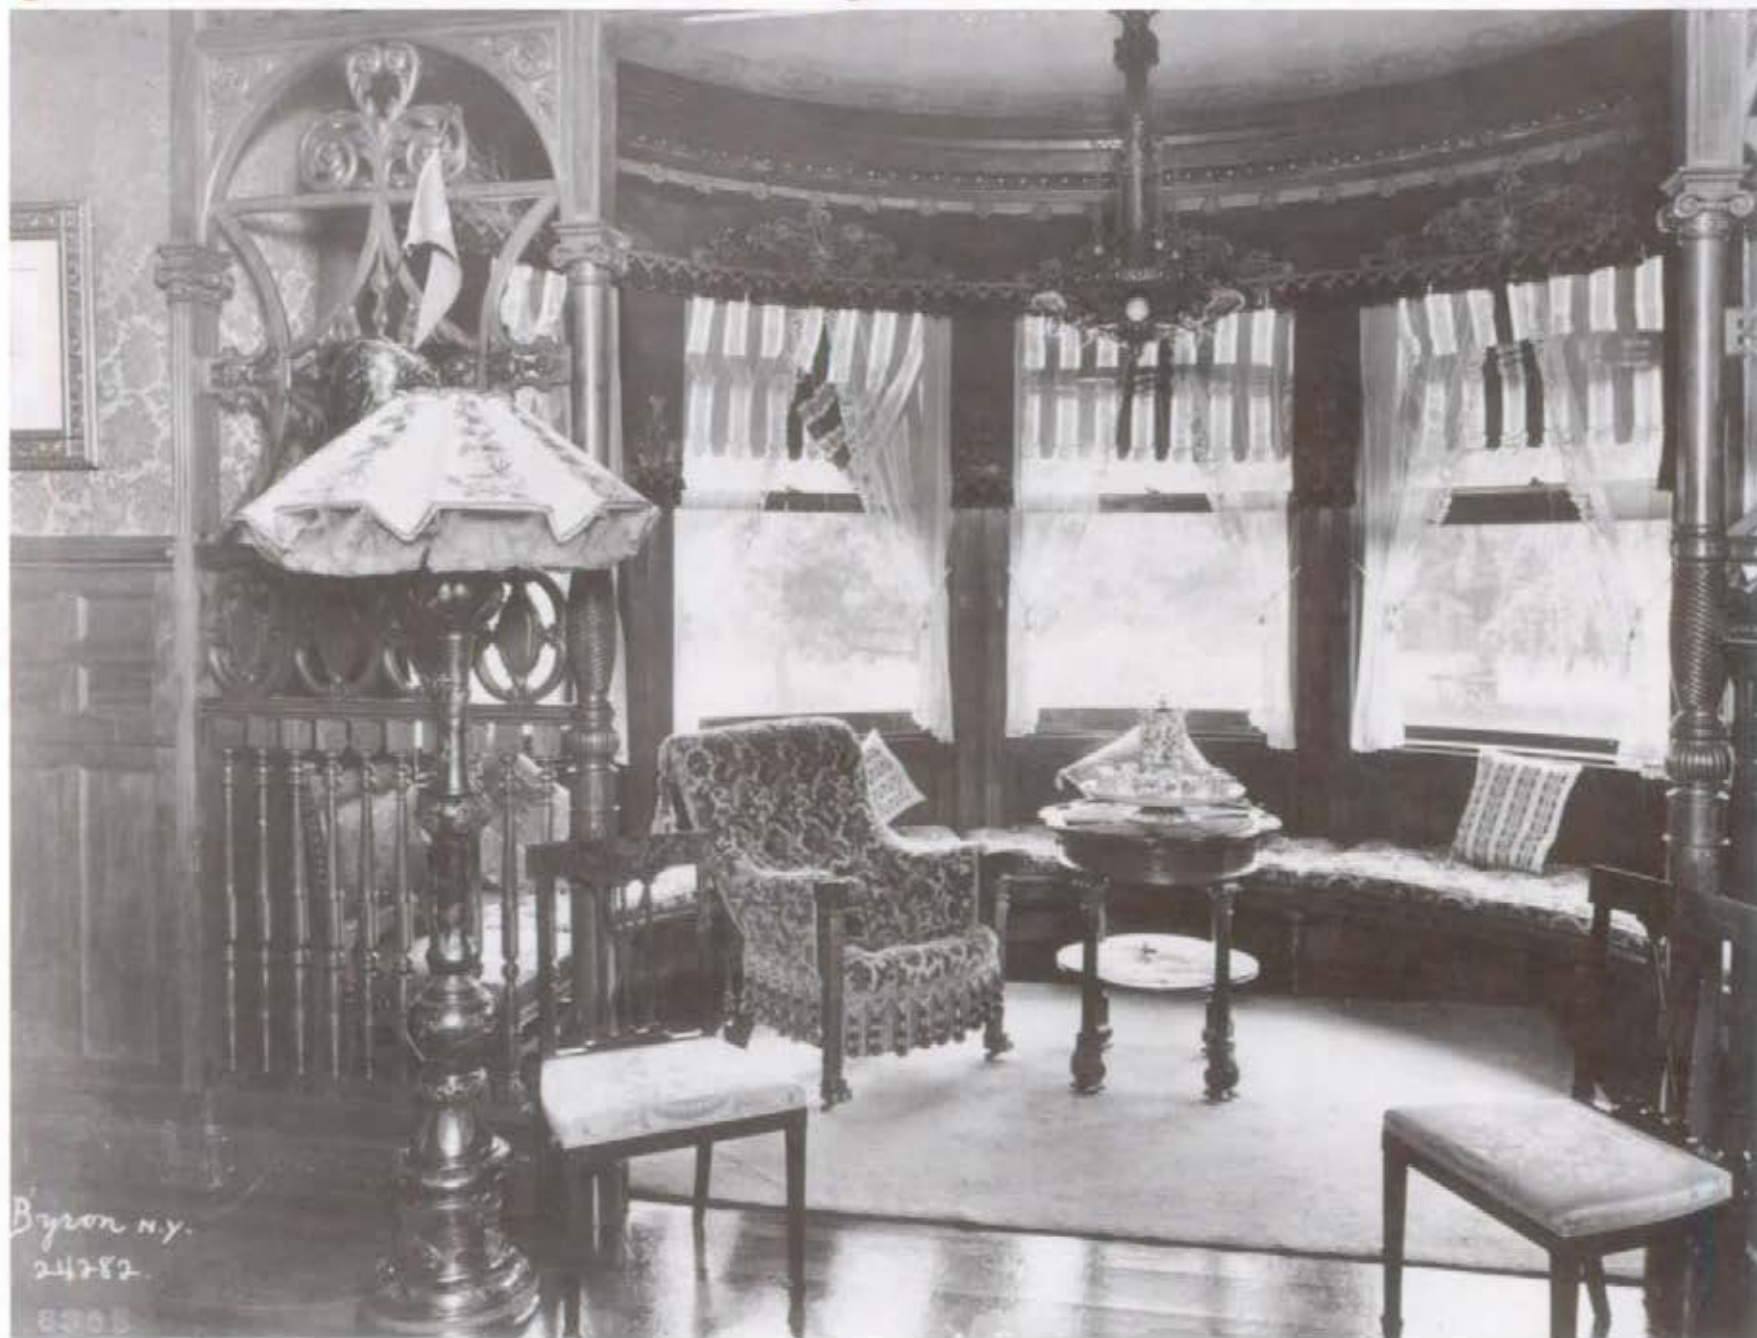
Figure 91. Den (Room 114), south bay window, 1907.

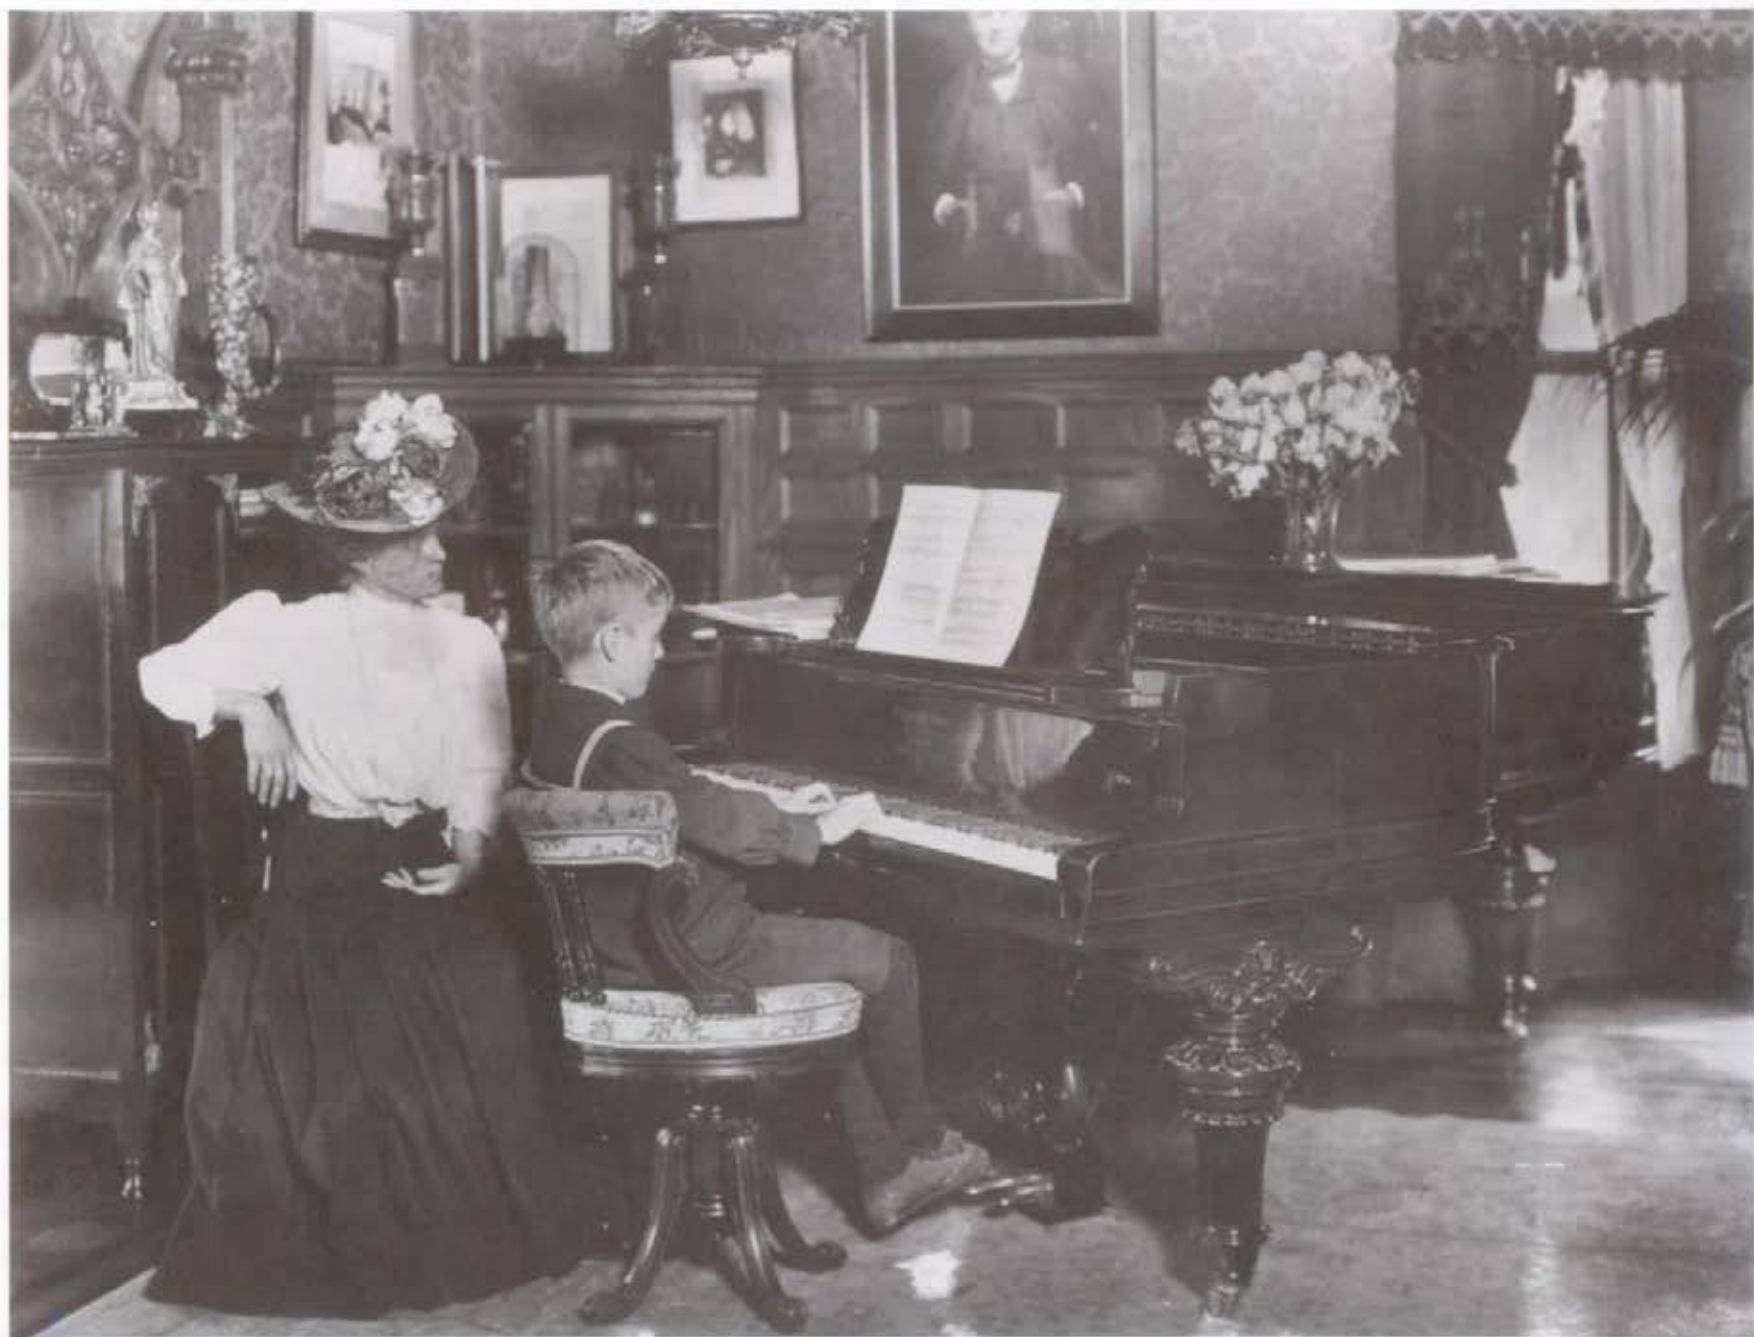
Figure 92. Den (Room [redacted]), southwest corner, 1907.

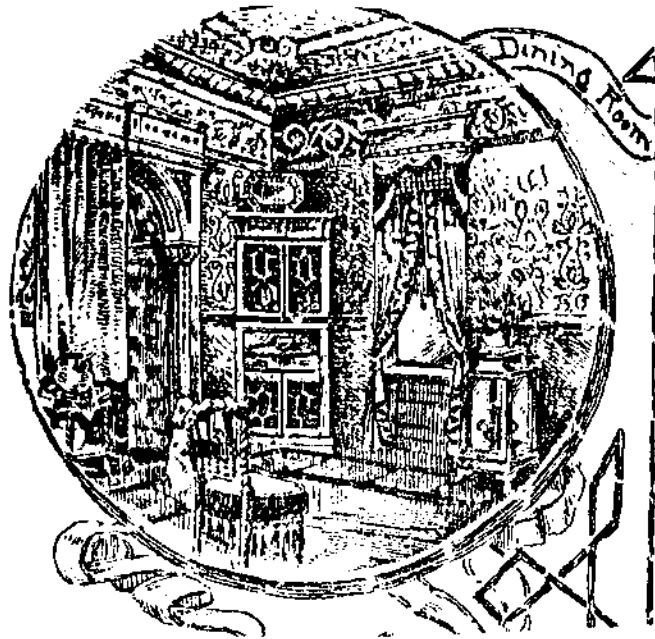
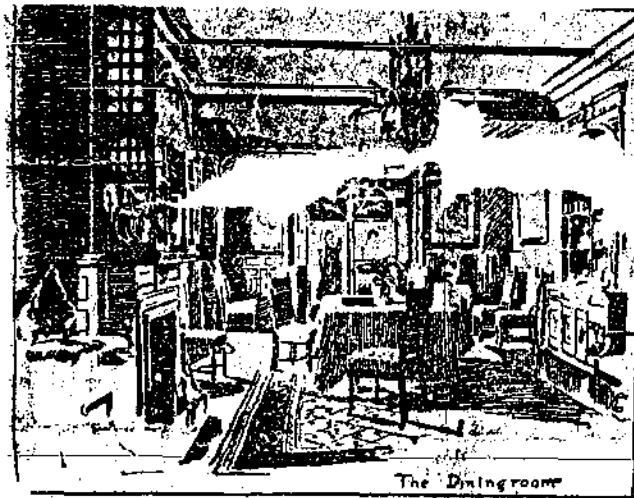
Figure 102. Two early sketches of the Dining Room: one showing the southeast corner (top, 1891); the other being a view looking west (bottom, 1894).

The article was accompanied by the earliest-known view of the room—a sketch showing the southeast corner (fig. 102).

This article was illustrated with a sketch, which was a view looking toward the west (fig. 102).

Some documentation exists on the original appearance of the fireplace as it was built in 1880-81. An inventory taken of the house in 1886 listed the Dining Room as having a "Brass and polished steel grate and fender [and] Mahogany mantel piece, with shelves and mirror." The mantel was also described in an article dated 1891 as being of "mahogany" and "reaching to the ceiling." The only known illustration of this mantel is in a sketch of the room published in 1894 (fig. 102). This shows an elaborate overmantel, with an arch on the front and open grilles on the sides.

The original chandelier is believed to have been replaced by two new chandeliers when the house was electrified in 1887. These were described by the inventory of 1891 as "2 electroliers." More detailed was an article published in 1894 that said, "There are two superb chandeliers, fitted like the others through the house with electricity." A sketch illustrating the article shows one of the two fixtures as being large and elaborate, featuring a wide spray of arms (fig. 102). No photographs of the electroliers are known.
