THE HOUSE AT GLENMONT

HOME OF THOMAS EDISON

Historic Structure Report

**THE HOUSE AT GLENMONT
HISTORIC STRUCTURE REPORT**

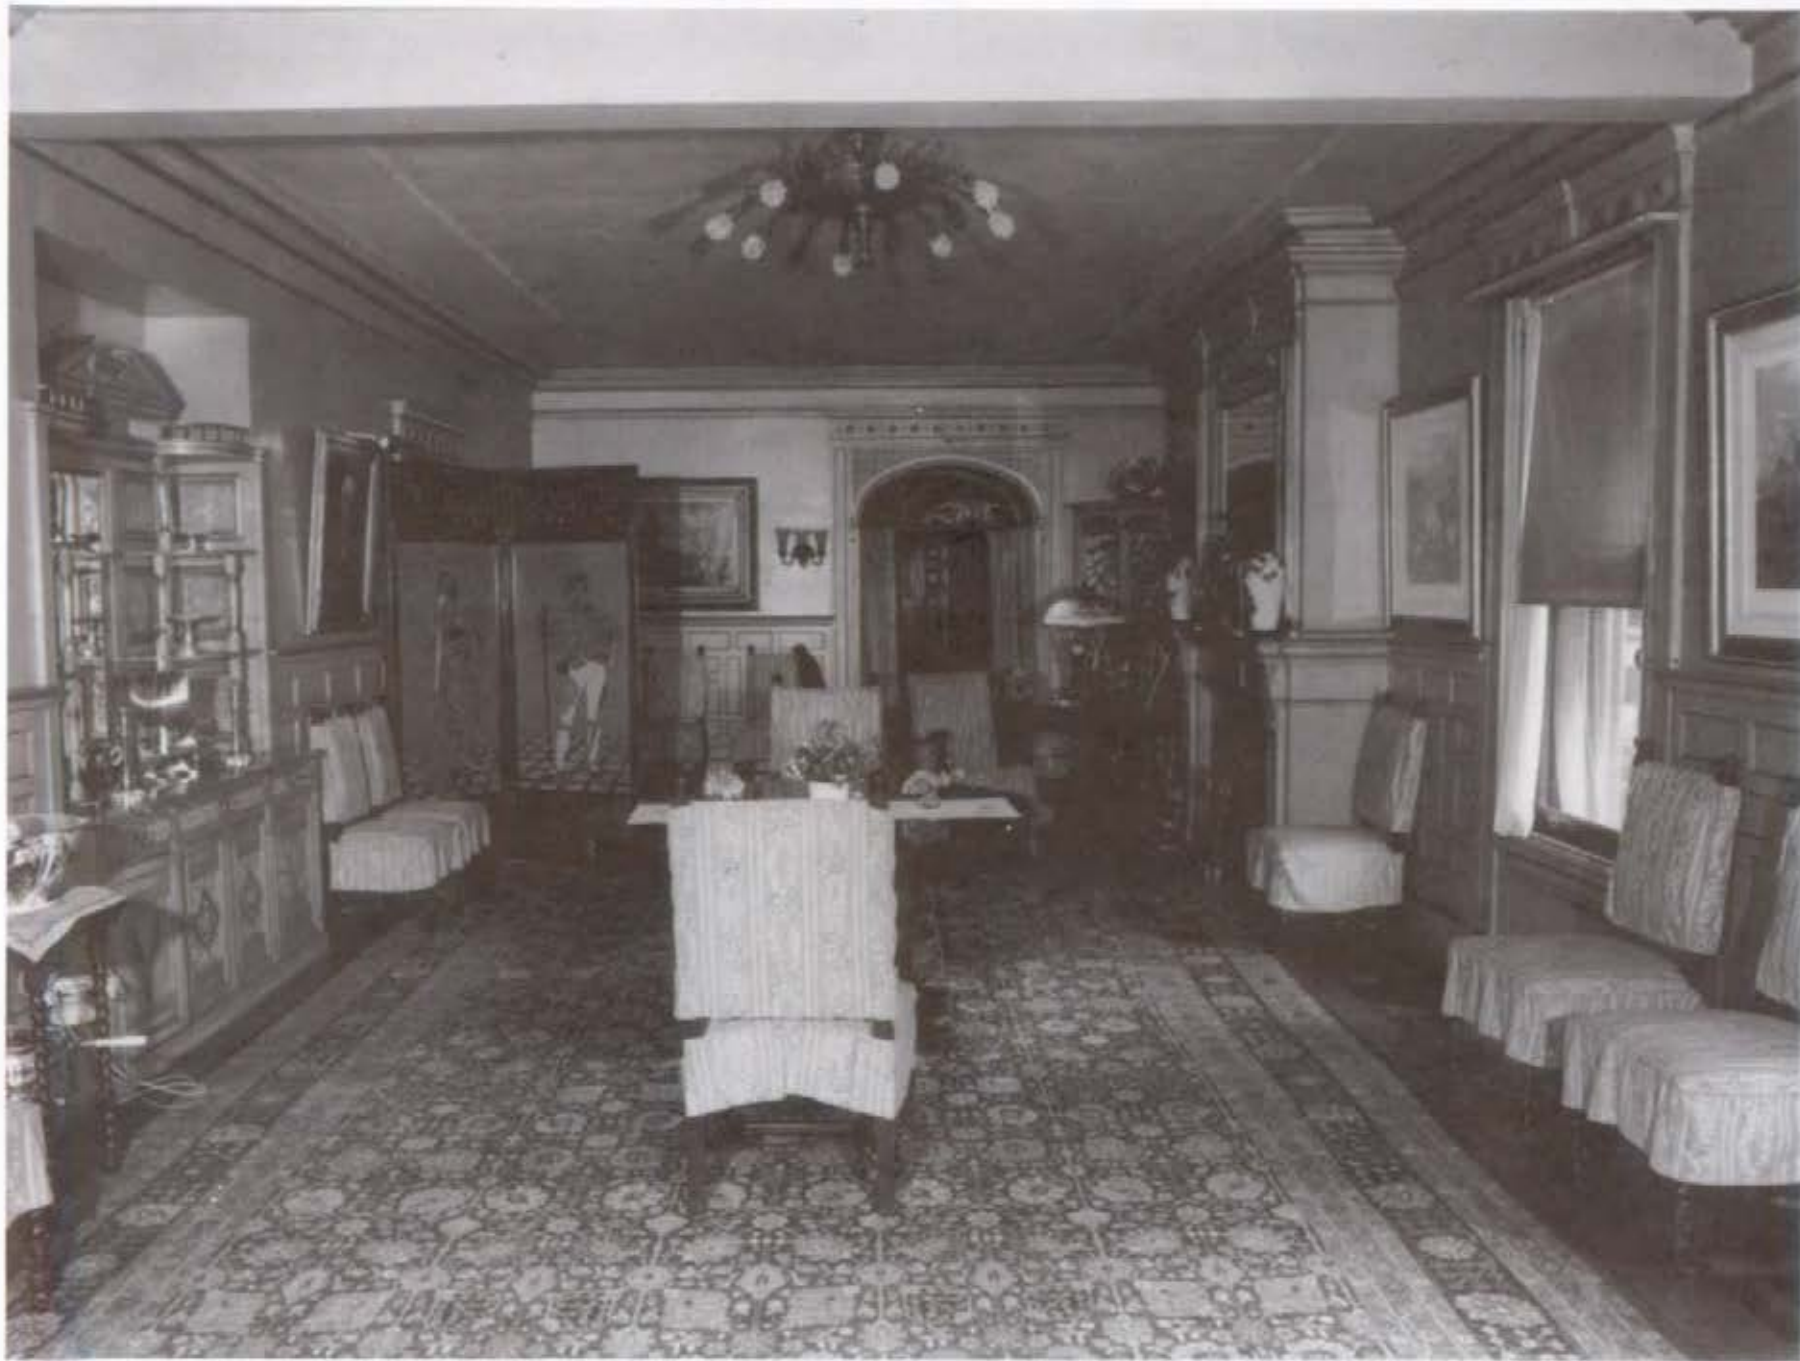
Figure 107. Dining Room (Room 115), looking east, 1947.

The earliest photograph to show the telephone is dated 1947 (fig. 107). The telephone is at the north wall, stored on a small corner shelf on the left (west) side of the built-in sideboard. The telephone cord appears to have been installed in the floor. Telephone instruments were not recorded by the residence or furnishings appraisals, most likely because they were not owned by the Edisons.

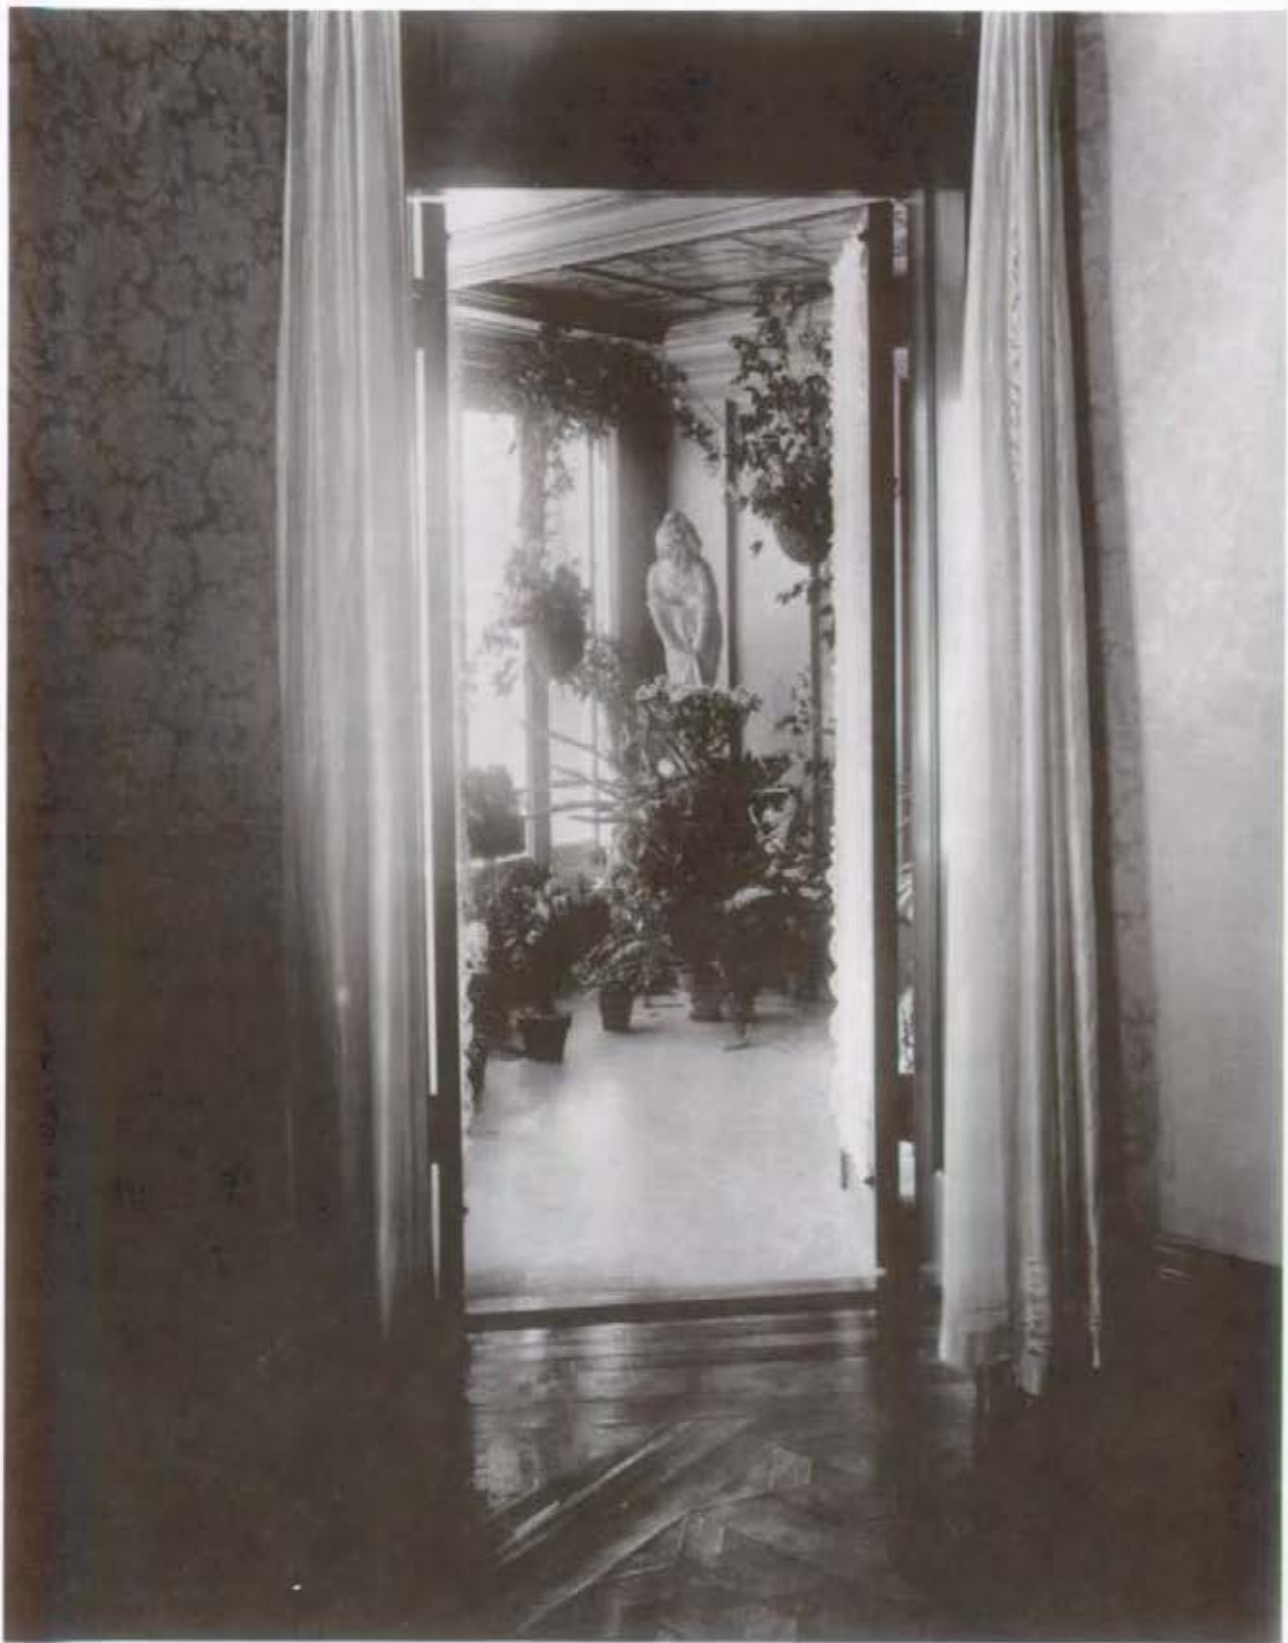
Figure 113. Fern Room (Room 116), looking northwest through the Drawing Room doorway, 1916.

looking southwest; it shows potted plants on the shelf, hanging plants, and palms. The other photograph is dated 1916 (fig. 113); it is a view looking towards the northwest, through the Drawing Room doorway. The room today is unchanged from its appearance in 1916.

The 1916 photograph of the room (fig. 113) is the only historical view of the floor. The floor was described by the residence appraisals of 1921, 1924, and 1931 as being "77 Sq. ft. colored ceramic [sic] floor tiling."

A photograph of the room dated 1916 shows the northwest corner of the room, including the board-and-batten north wall and the glazed west wall (fig. 113). The residence appraisal of 1931 recorded the room's wall features as including "90 Sq. ft. pine wall paneling" and "47 Lineal ft. 6" x 6" pine cornice."

The exterior doorway (D-108) is in the 1909-10 west wall. The doorway has a single door glazed with two long panes of glass, which is in keeping with the design of the adjacent windows. A partial view of the north doorway is shown by the 1916 interior photograph (fig. 113).

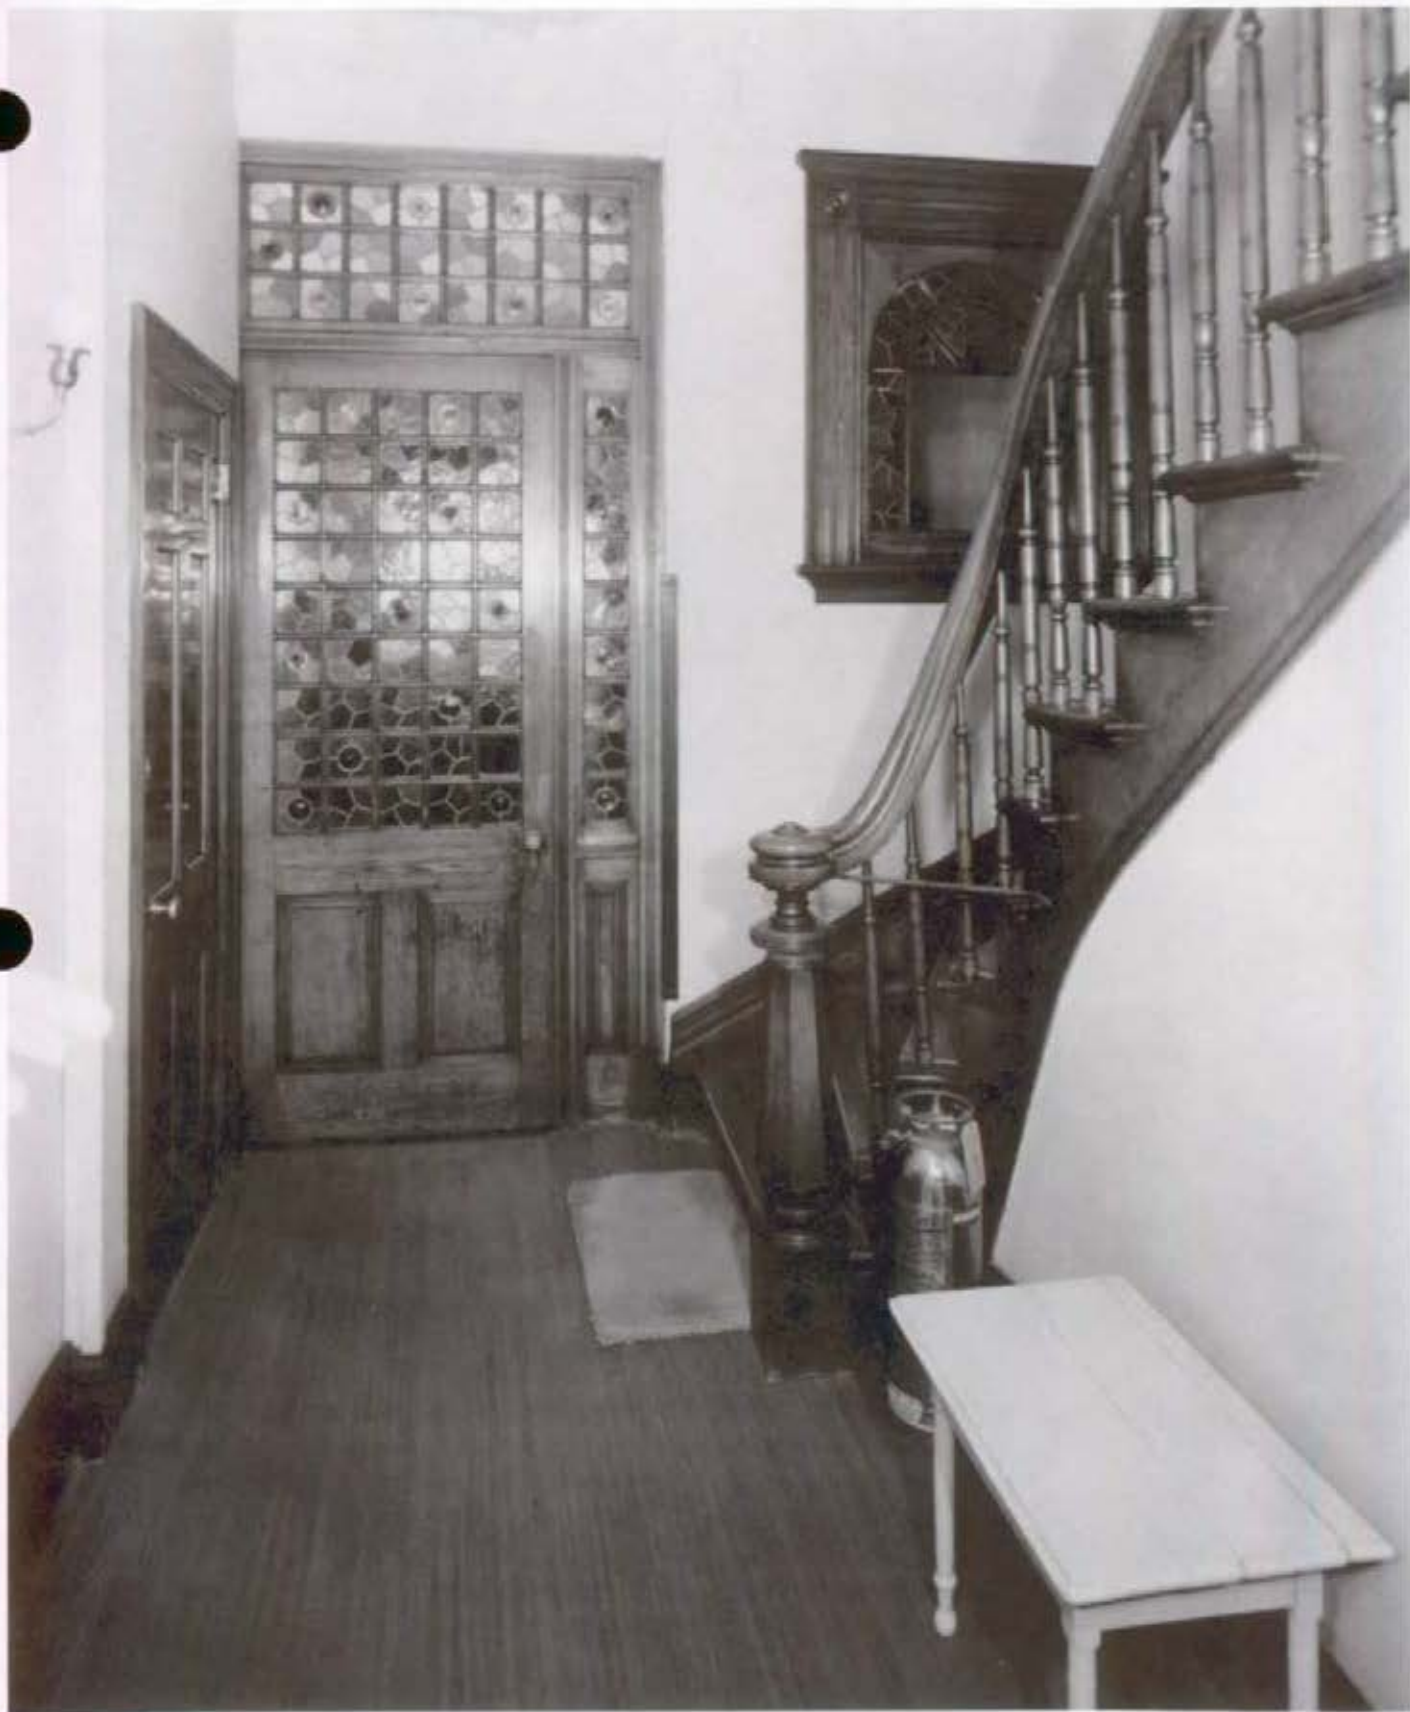
Figure 114. South part of Service Hall (Room 117), looking north, 1960.

of the hall dated October 21, 1960 (fig. 114). It shows a six-panel door hinged on its north side to swing outward. This door was removed, and the doorway was closed and covered with matched boarding, by the National Park Service in 1968.

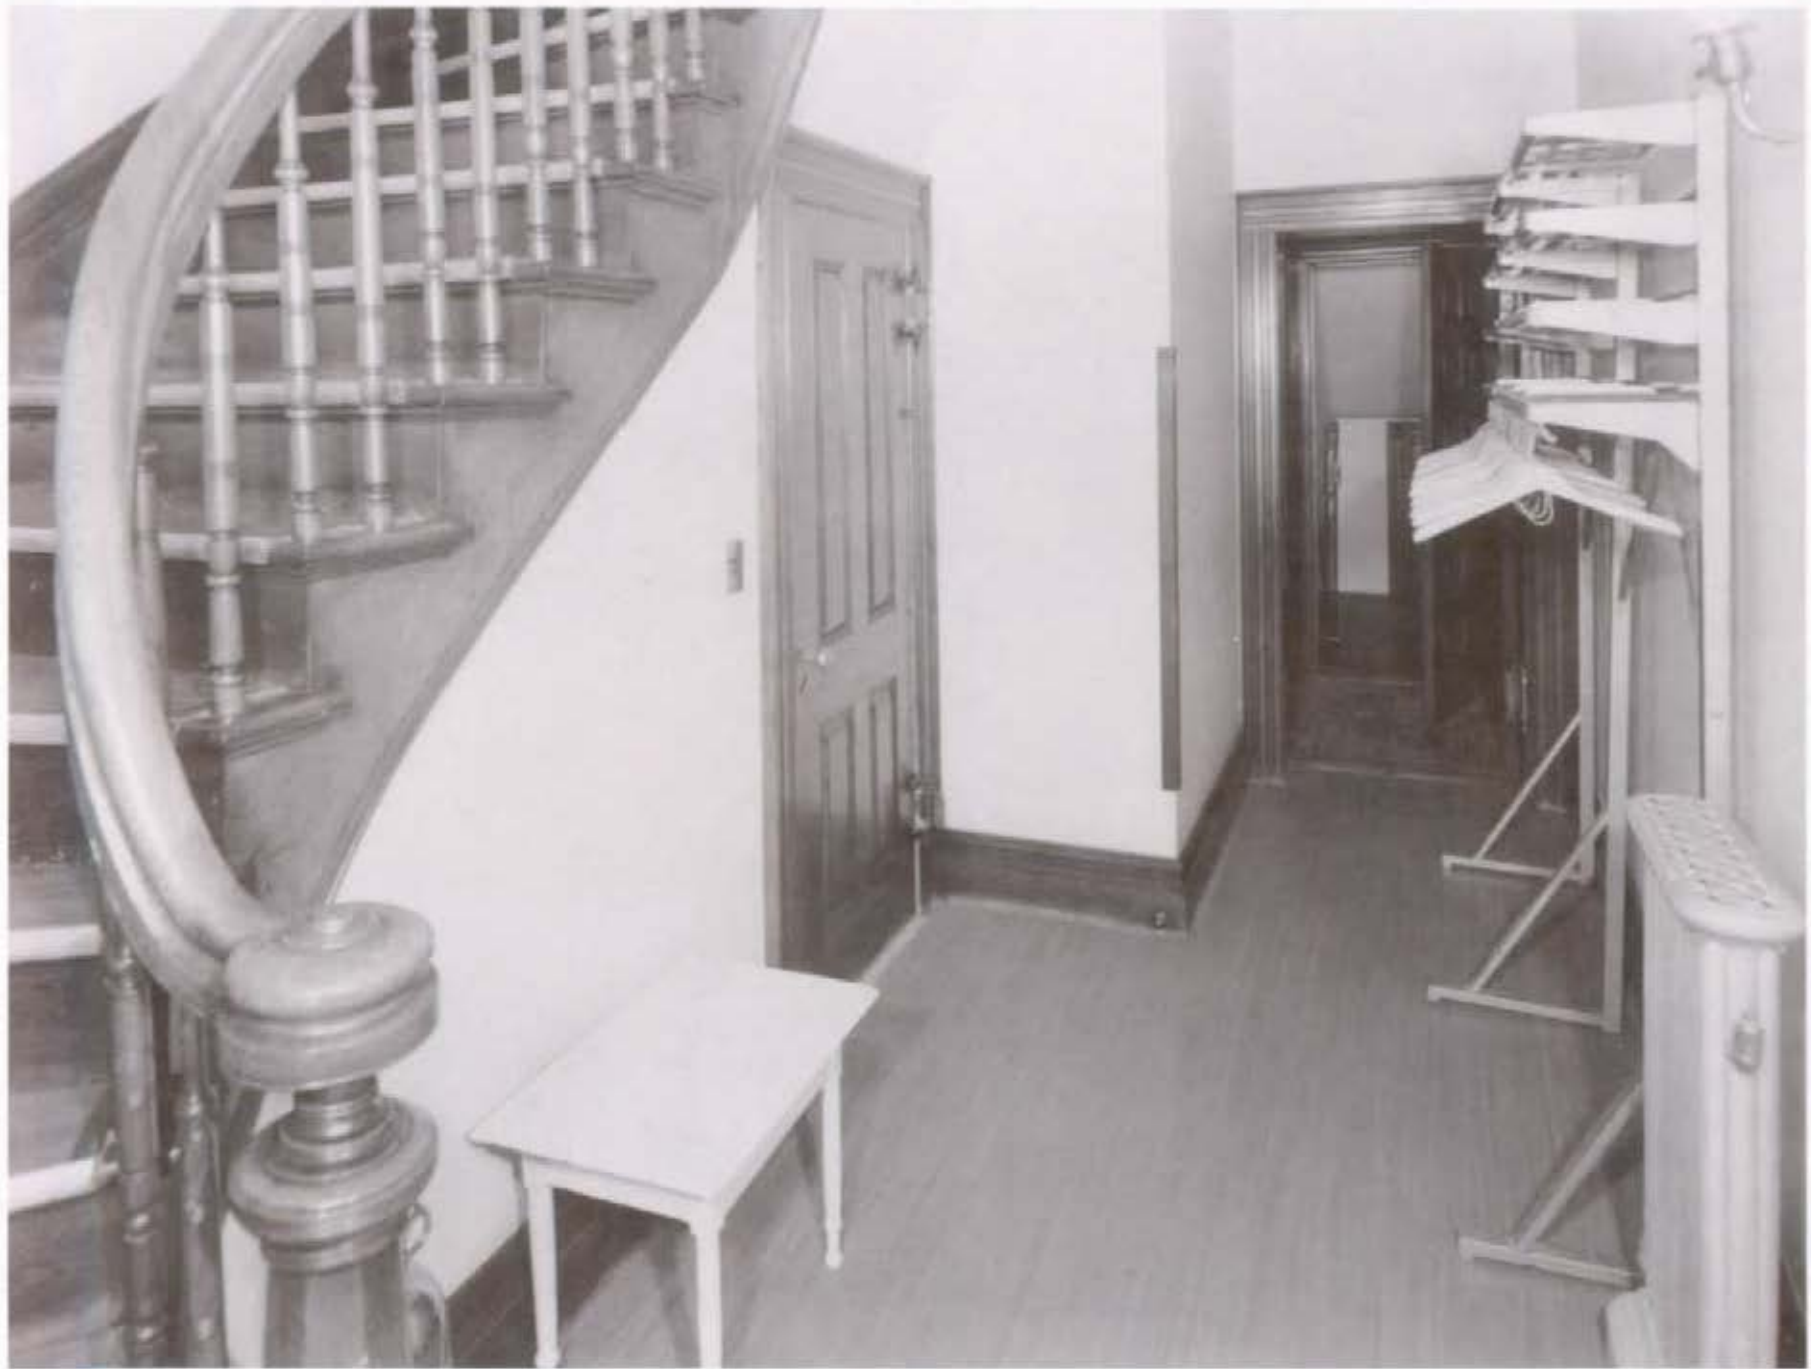
Figure 115. South part of Service Hall (Room 117), looking south, 1960.

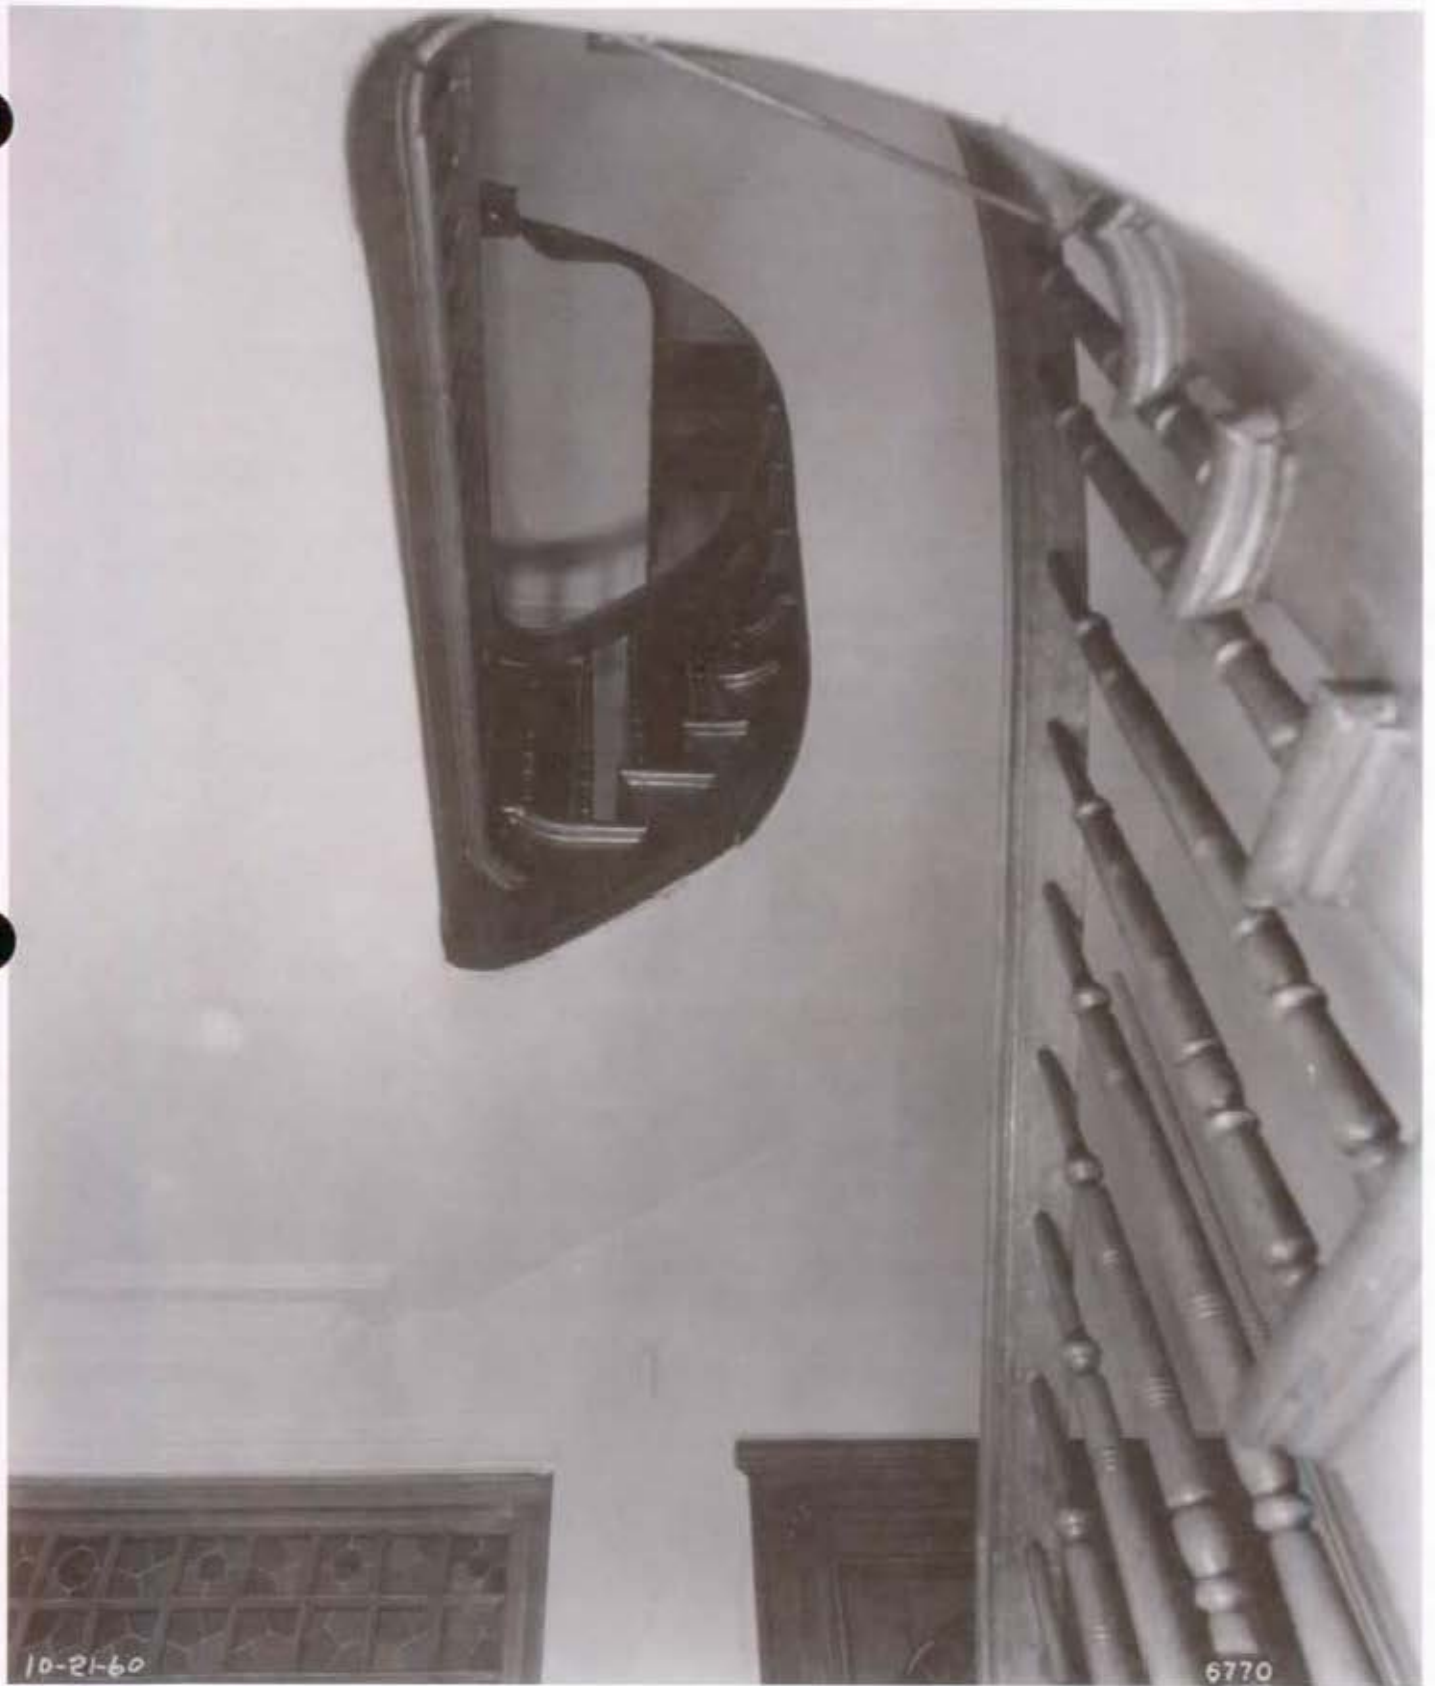
Figure 116. South part of Service Hall (Room 117), looking up at the Service Stairway, 1960.
