**ARCHEOLOGICAL EXCAVATIONS IN THE WATER BATTERIES
AT FORT DONELSON NATIONAL MILITARY PARK, TENNESSEE**

Lee H. Hanson, Jr.

December 1968

National Park Service

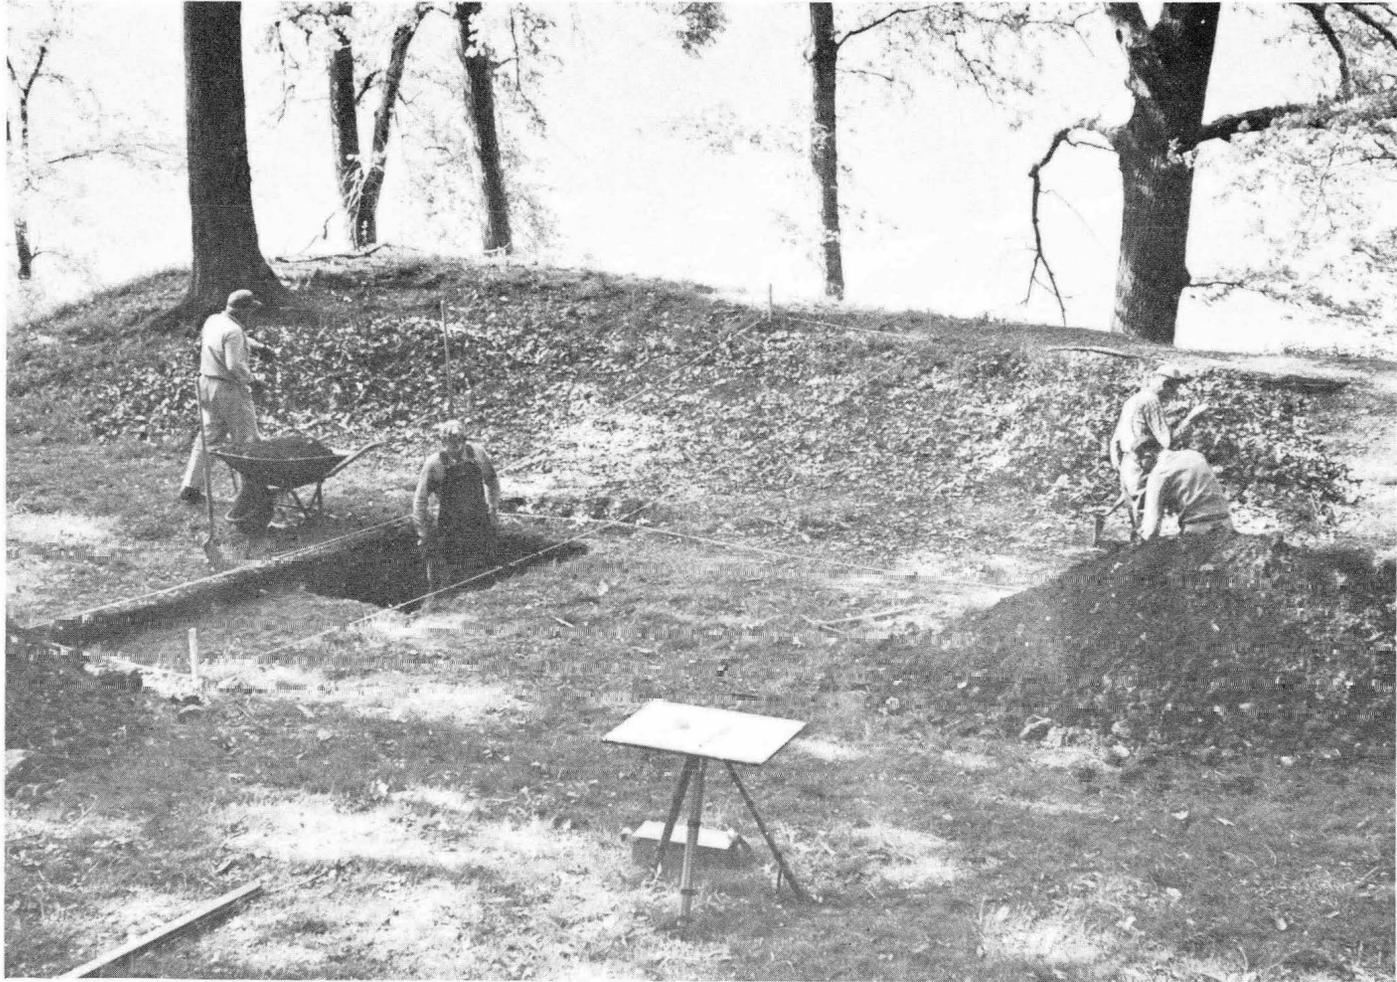
Figure 1.--Excavations in the Upper Water Battery.

Archeological excavations were conducted from April 29 to May 29, 1968, with a local crew of laborers (fig. 1). Superintendent E. J. Pratt, Administrative Officer Carlon Sills, Park Guide Don Adams, and Maintenance man J. T. Jackson assisted the investigation in numerous ways through administrative support, equipment, and enthusiastic interest.

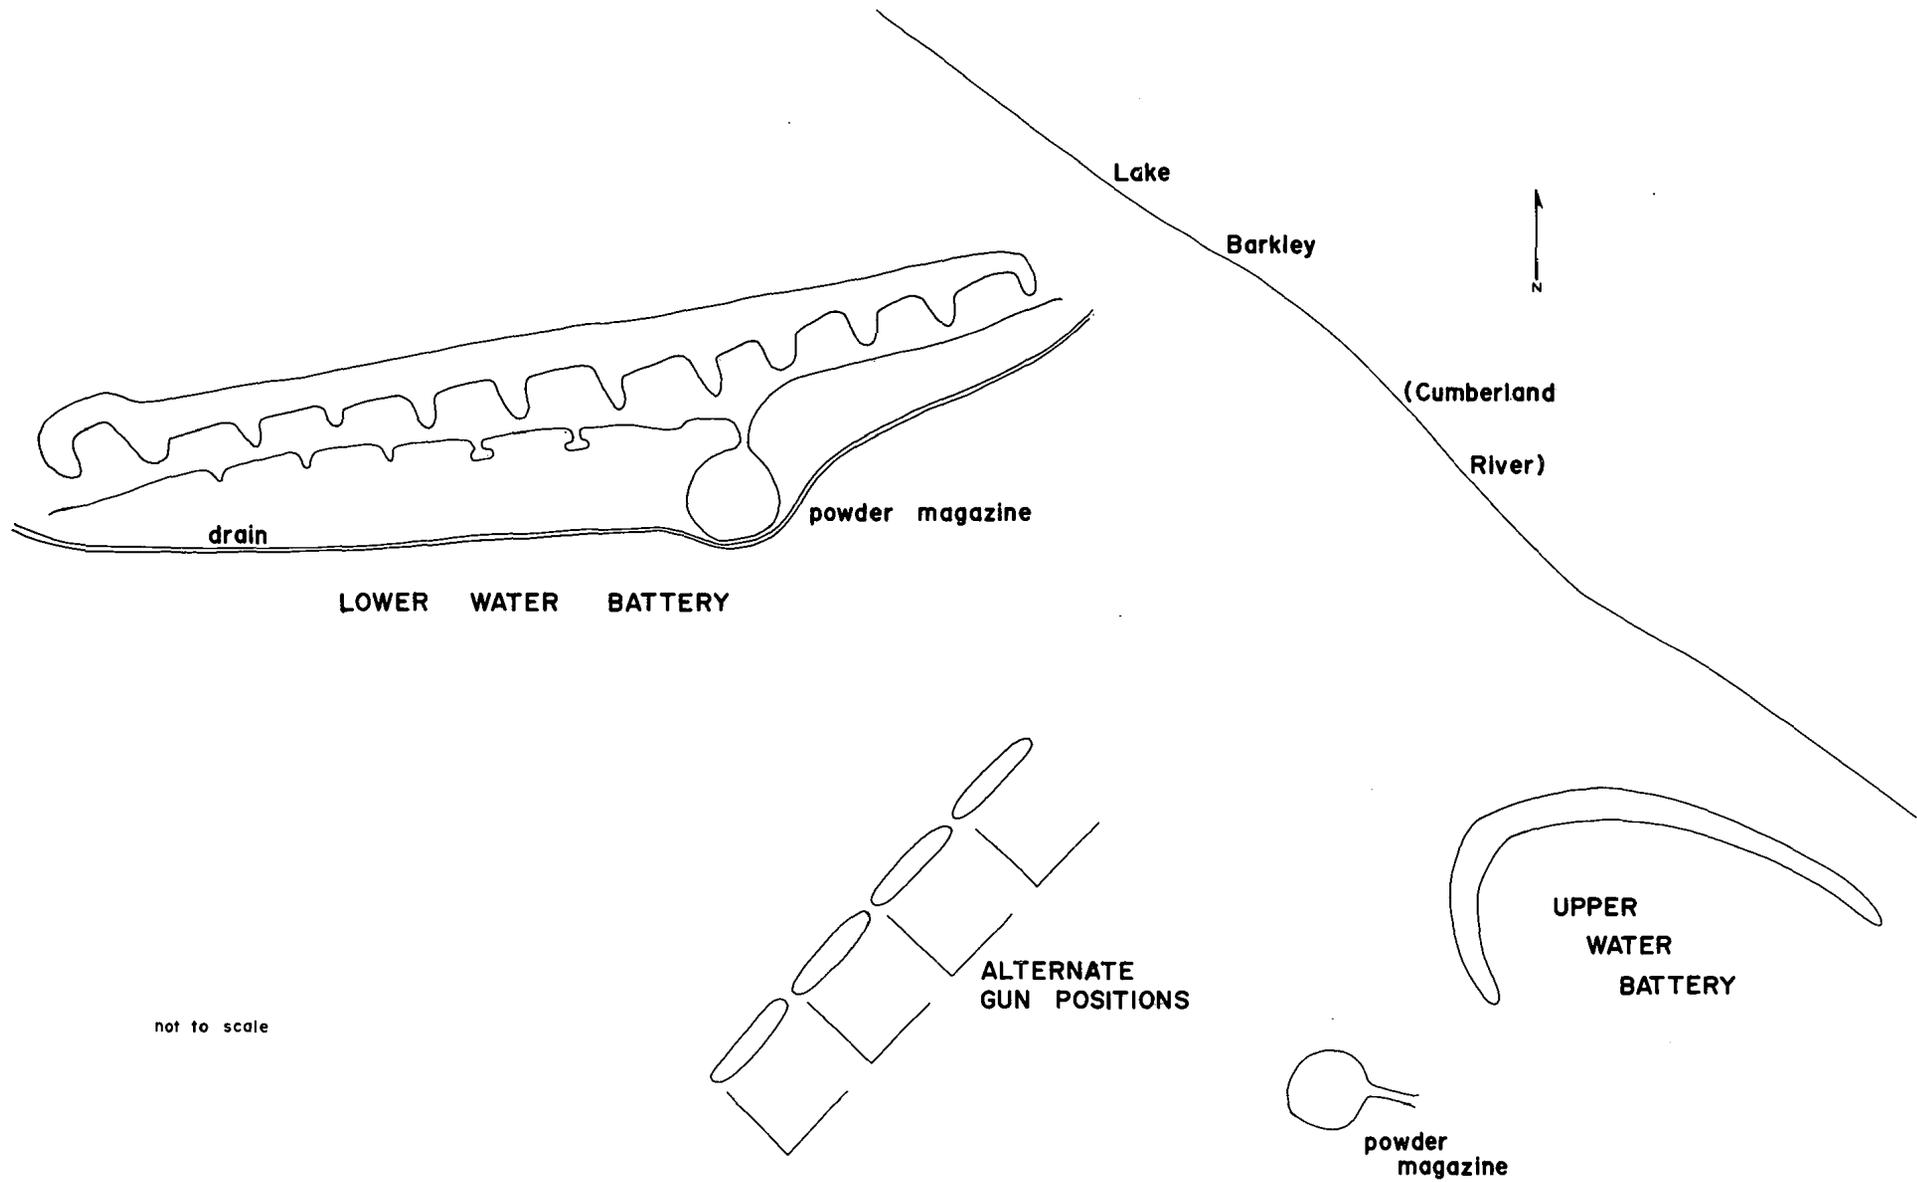
not to scale

Figure 2.--Diagrammatic Sketch of the Water Batteries.

Eleven gun positions were carved out of the end of a low ridge extending from the Fort proper to the juncture of Hickman Creek and the Cumberland River. These have been numbered 1 through 11, from right to left (fig. 2). Dirt was removed from the hillside and piled up to form a straight parapet and twelve traverses to protect the guns (fig. 3). A communications trench ran along the rear of the battery to connect the gun positions and provide access to a powder magazine behind Gun Position 5. Because of the configuration of the ridge, Gun Positions 1 to 5

The parapet around the guns was semicircular (fig. 2). Bearss (1968:47) gives its length as 50 yards, but 70 yards would be more nearly correct if the parapet were measured around the center. Parapet dimensions are the same as for the Lower Water Battery. Bearss (1968:47) states that the interior slope "was revetted with sapwood facines." On the other hand, Lovie's sketch (1862) shows the revetment to be planking held up by

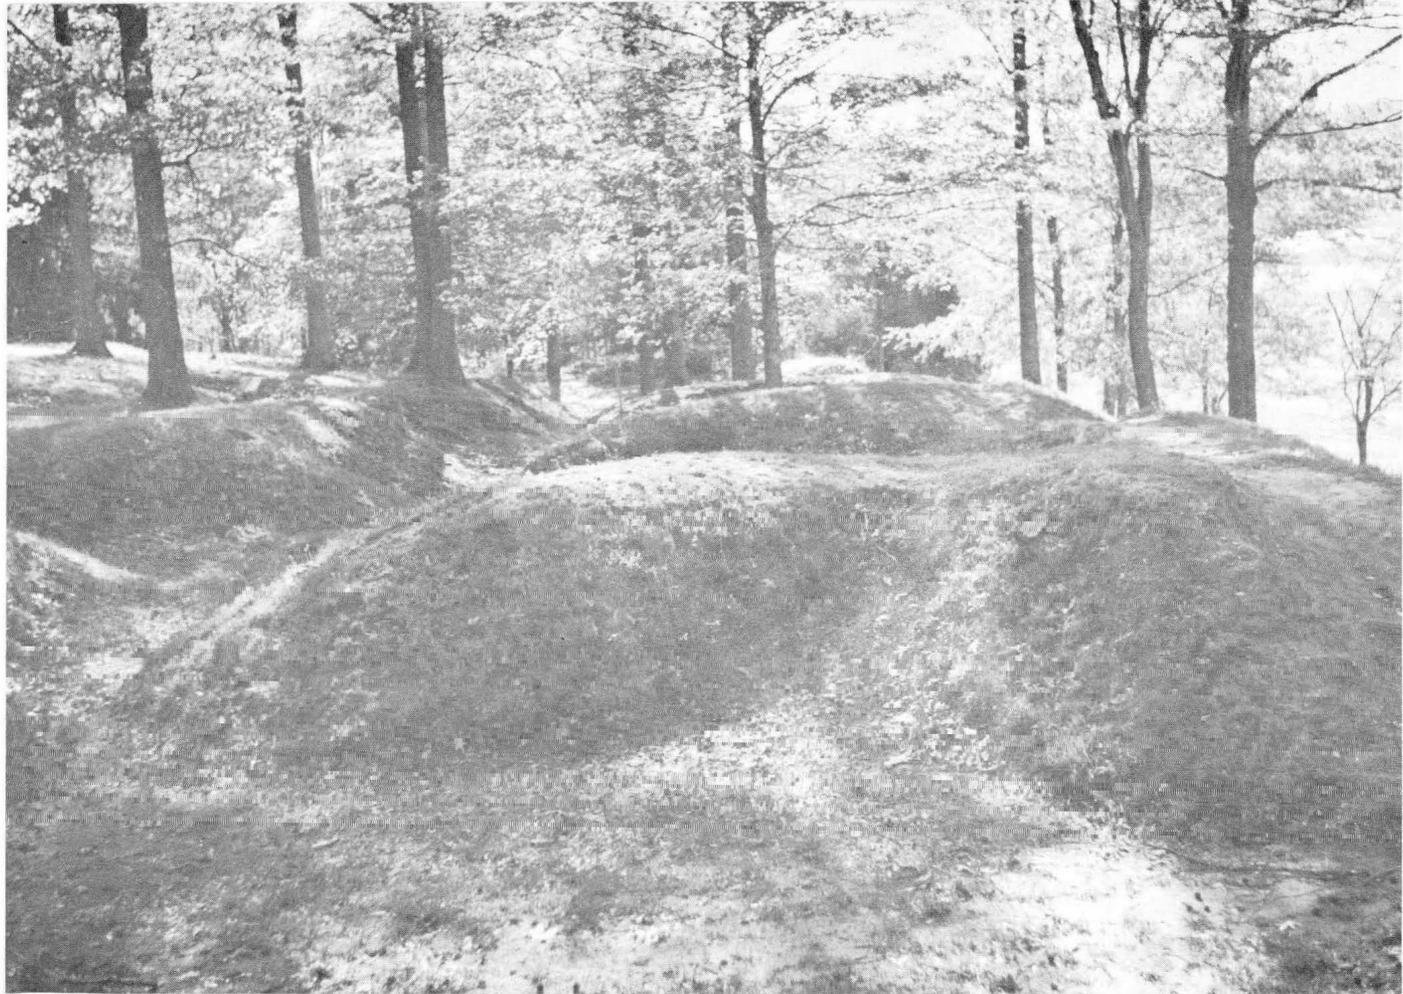
Figure 3.--View along the Lower Water Battery, looking South.

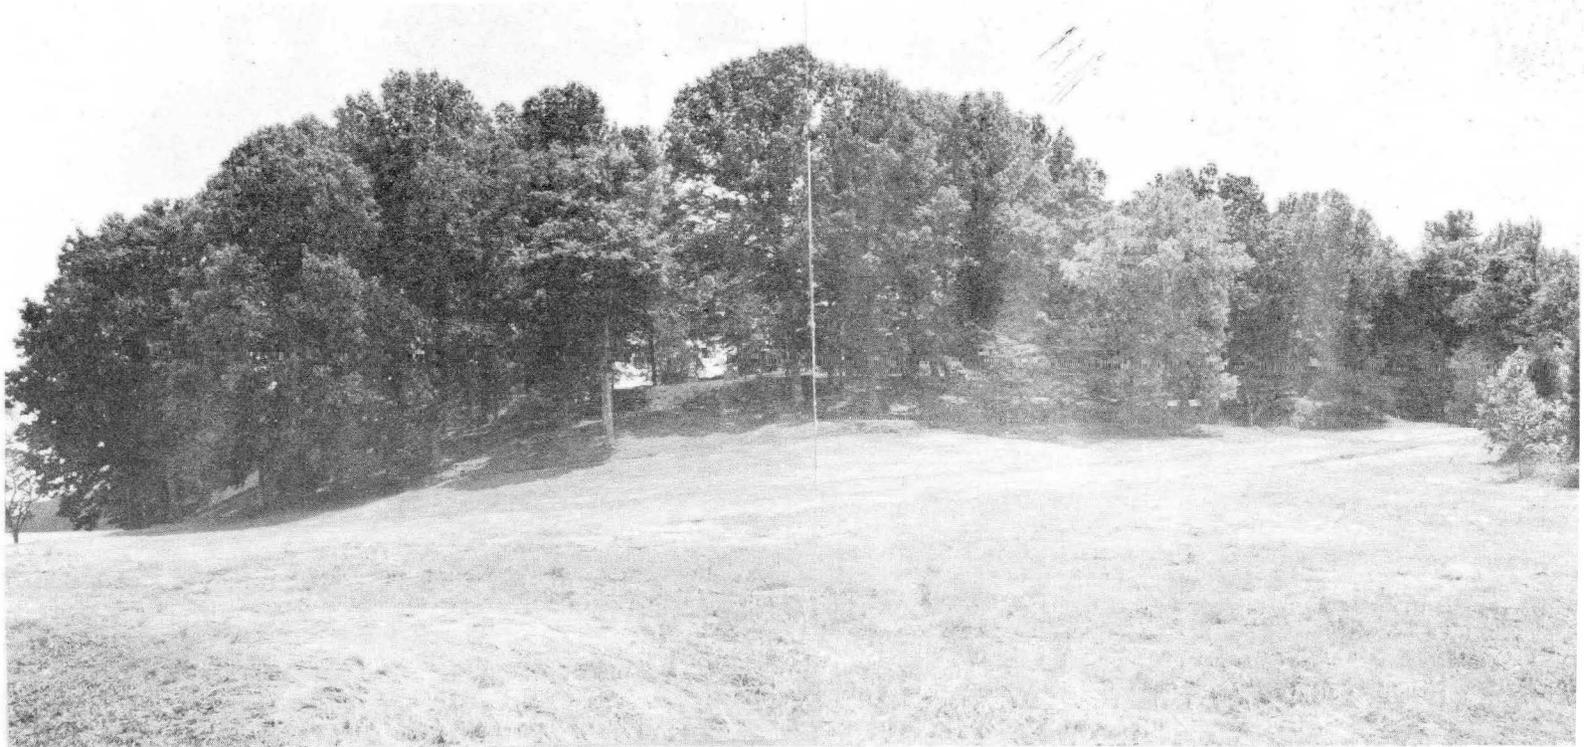
Figure 4.--View from in front of the Lower Water Battery.

The Lower Water Battery lies in open woods which extend forward of the position about 50 feet (fig. 4). Beyond this is a grassy slope leading down to the waters of Lake Barkley. To the left is moderately heavy woods, and to the right is the lake. In the rear, the ground is a grassy field sloping up to Fort Donelson on the summit, broken only by a small clump of trees around the alternate gun positions and the parking area.

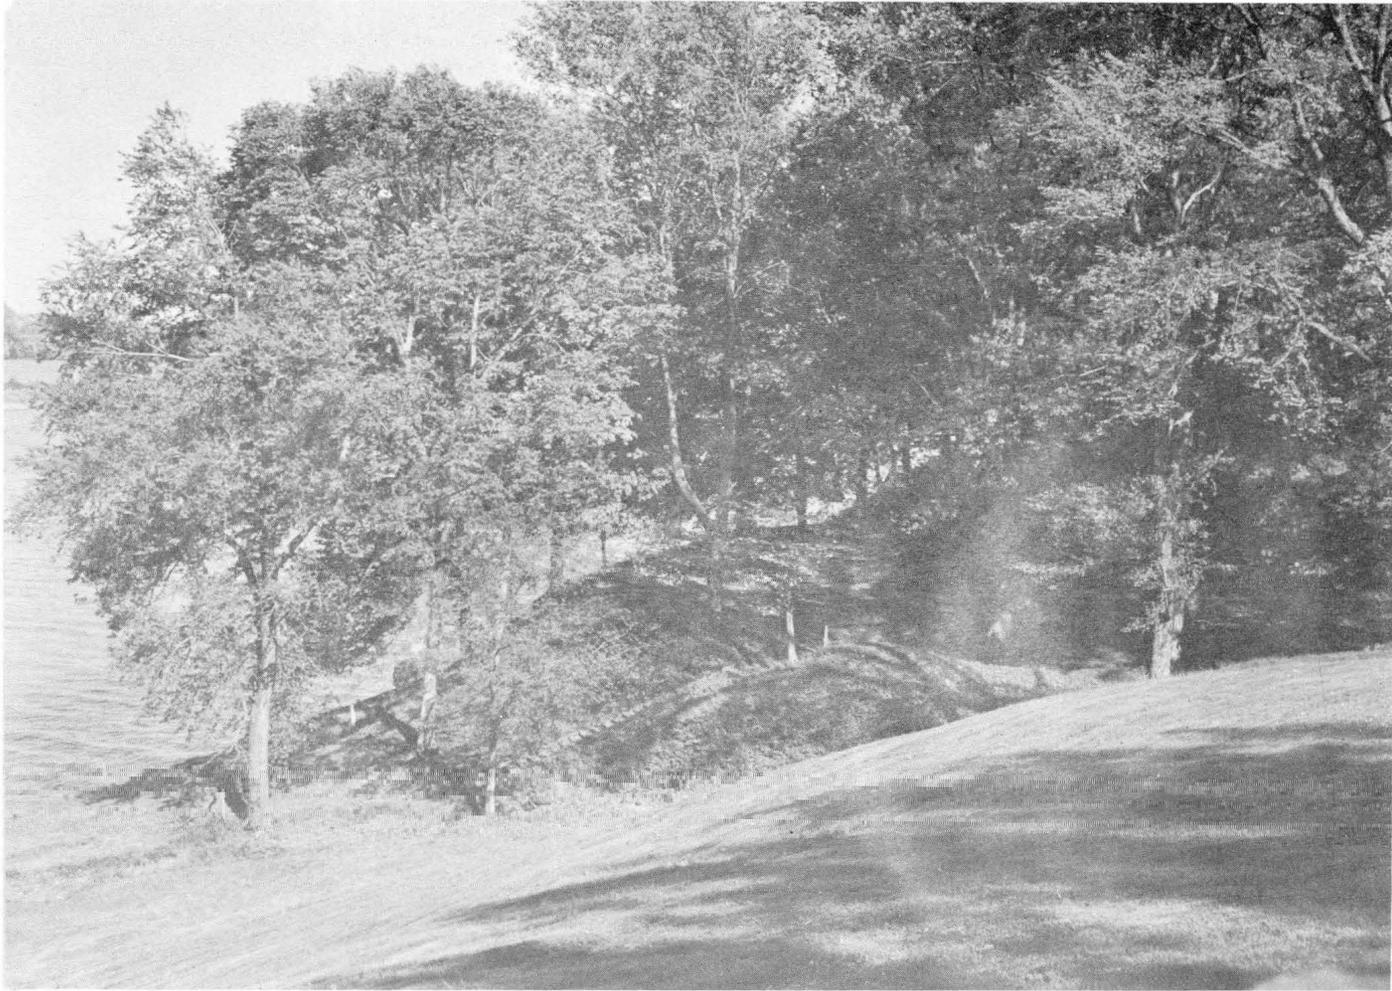
Figure 5.--View from the left of the Upper Water Battery.

The Upper Water Battery has the appearance of a forest glen (fig. 5). Large trees, 75 to 100 years old, tower over the battery and shade it. The hill behind the battery is steep and covered with brush and trees and there is a carpet of leaves on the ground. To the left is a wooded hillside and a powder magazine; in front is the parking area wall, a grassy slope, and the lake; and to the right lies the lake.

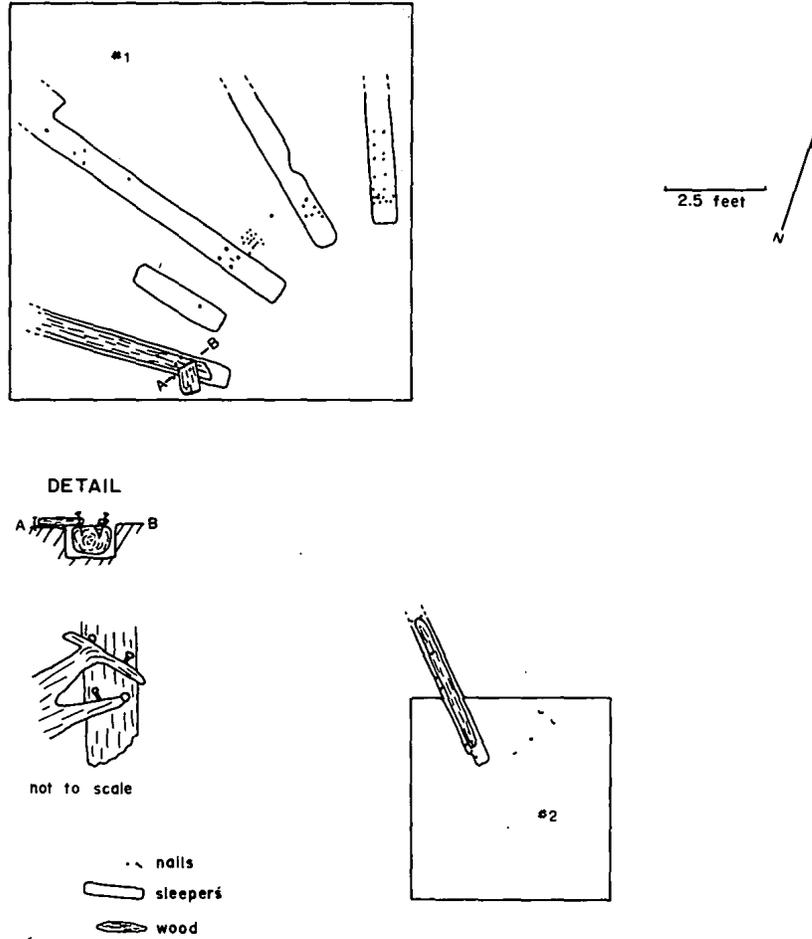
Figure 6.--Ground plan of excavations in Gun Position 1.

Gun Position 1 (fig. 6)

A 10-foot square and a 5-foot square were opened in this position. The left traverse has eroded into the position, making the surface considerably higher on the left and, more importantly, sealing off the floor with a thick layer of red clay and rocks.

Portions of seven sleepers were defined in the clay hardpan floor at a depth of 28 inches from the surface. Two of these

sleepers still contained well preserved timbers and all but one had a large number of nails driven into them. One of the timbers still had a part of a 6-inch-wide traverse plank over it, held in place by four large iron spikes. Concentrations of other spikes and nails suggested the location of other traverse planks.

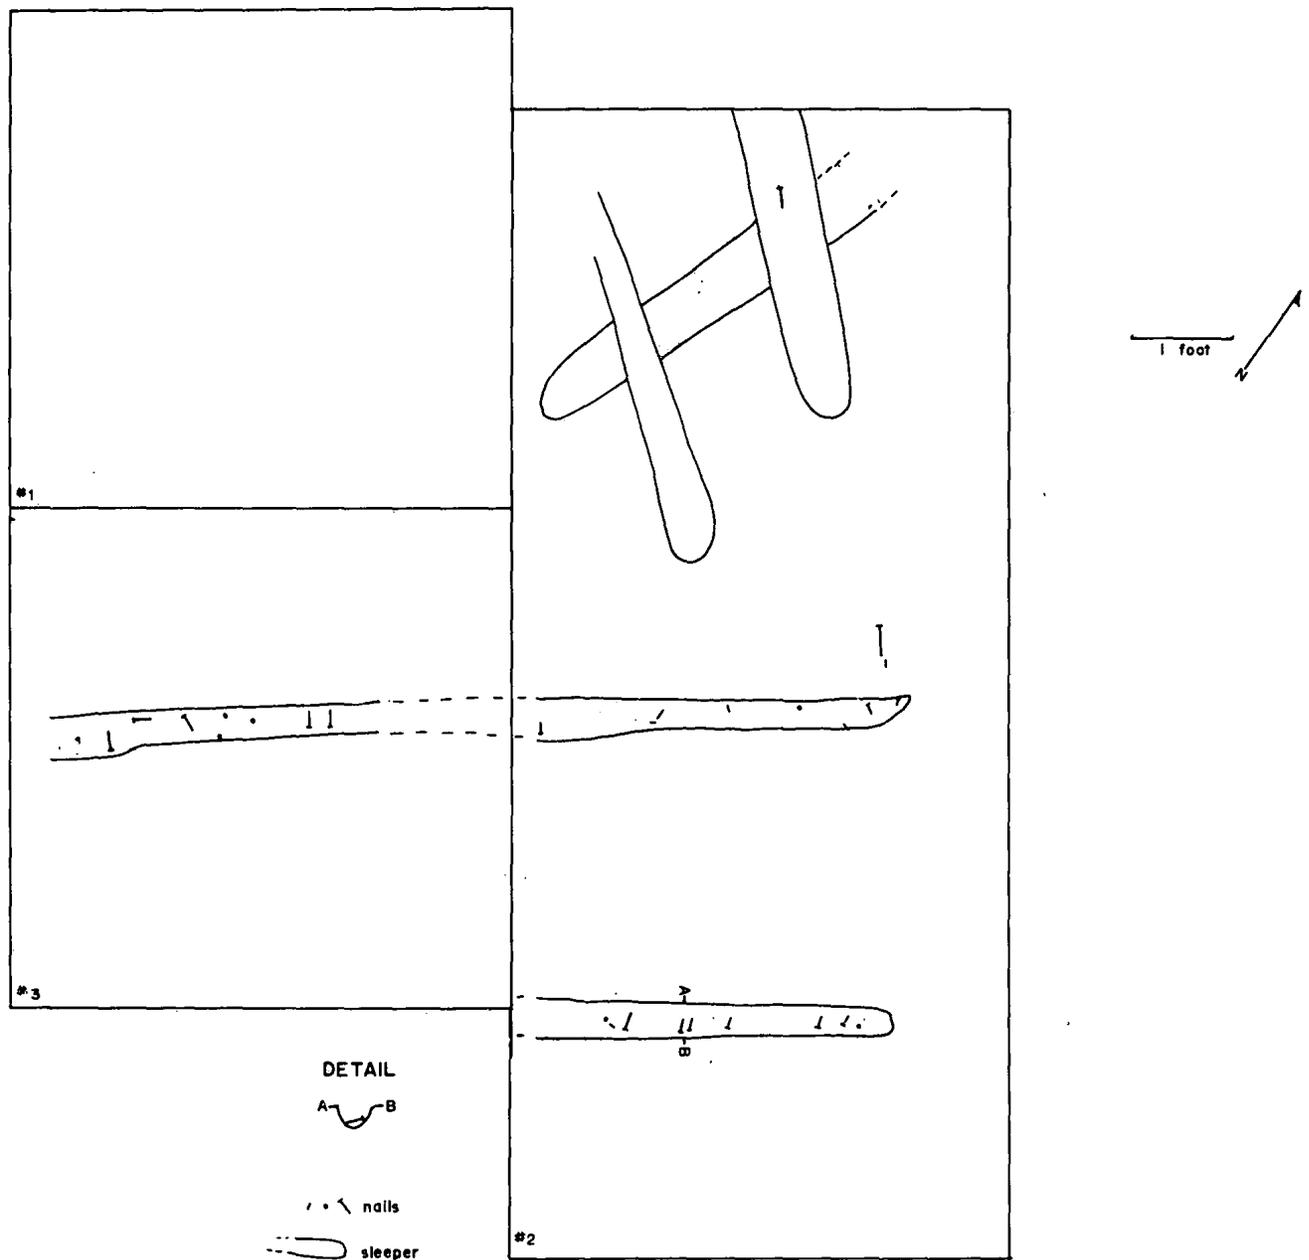
Figure 7.--Ground plan of excavations in Gun Position 2.

Gun Position 2 (fig. 7)

The first 5-by-5-foot square in this position did not uncover anything. A second was opened next to it and expanded until it

measured 5 by 11.5 feet. A third 5-foot square completed the excavations in this position. The floor was defined at a depth of 21 inches below the surface and was abnormal in that it consisted mostly of fill earth except near the back of the position. Apparently this position was too far forward on the hill for the Confederates to dig it into the hardpan like the others, and they had to dump considerable fill on the hillside to level the position. The remains found are also unique, consisting of five logs laid as sleepers to which planks were apparently attached. Two were laid across the back of the position and two were laid in front at an acute angle with the fifth log underneath. The latter three logs were difficult to trace due to the nature of the soil. A suggestion of a pit was found near the right traverse but may have been a load of darker earth. This is the only position having an actual gun platform. It was probably necessary to distribute the weight of the gun as much as possible to keep it from sinking into the fill. The gun was probably mounted on a front pintle. Another indication of a platform is the lack of debris on the floor of this position except for nails in the sleepers.

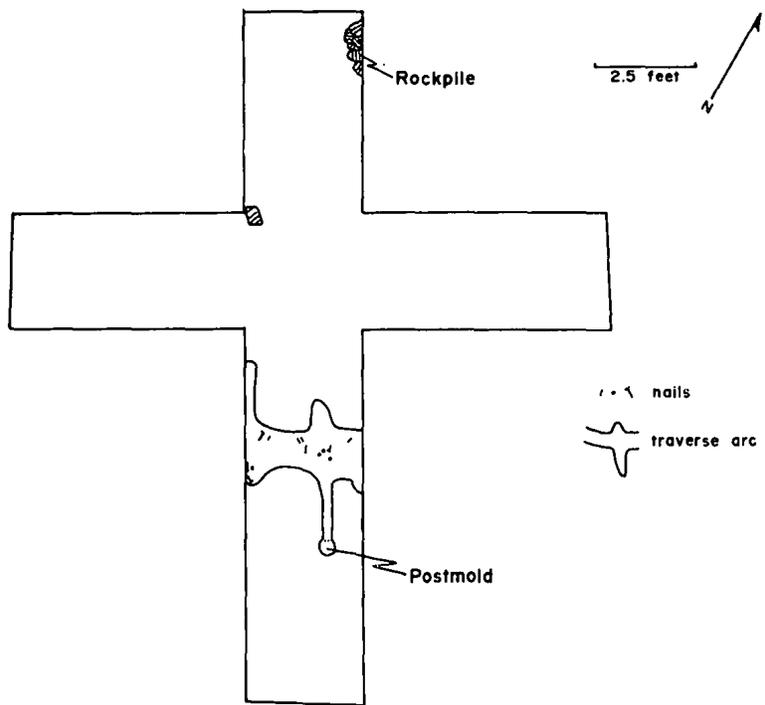
Figure 8.--Ground plan of excavations in Gun Position 3.

Gun Position 3 (fig. 8)

Two 3-foot-wide trenches were cut in at right angles through the center of the position. The original floor was found 13 inches below the present surface and is composed of red clay hardpan. Approximately 12 feet behind the parapet lay a soft dark area which proved to be a portion of a traverse arc with two sleepers. One sleeper was apparently braced against a post to the rear of the traverse arc. No front pintle was found, but the area where it should have been had a large number of rocks which might have been placed as a base for one. This was definitely the remains of a front-pintle traverse arc.

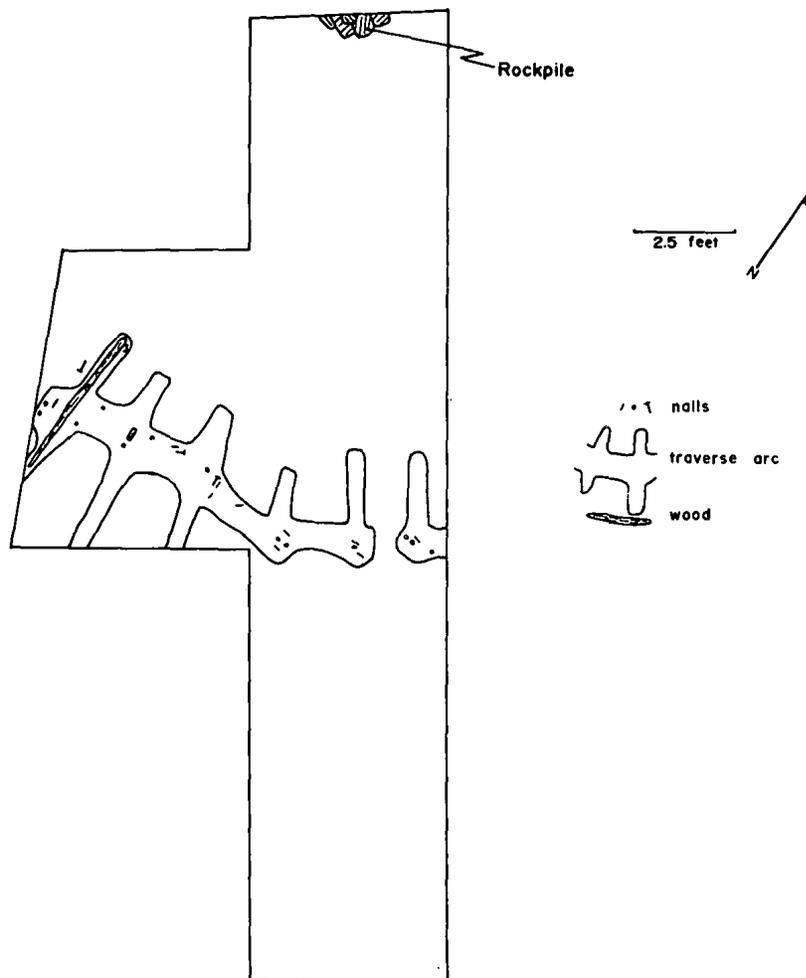
Figure 9.--Ground plan of excavations in Gun Position 4.

Gun Position 4 (fig. 9)

A 5-foot-wide trench was run lengthwise through the center of the position and later expanded to the left traverse near the center of the position. The floor was a red clay hardpan at a depth of 22 inches.

A traverse arc was uncovered about 13 feet behind the parapet. Its left end ran almost to the traverse. The right half was not excavated. Six sleepers were found, numbers 5 and 6 containing timber remains. The traverse planks were not well defined but could be discerned.

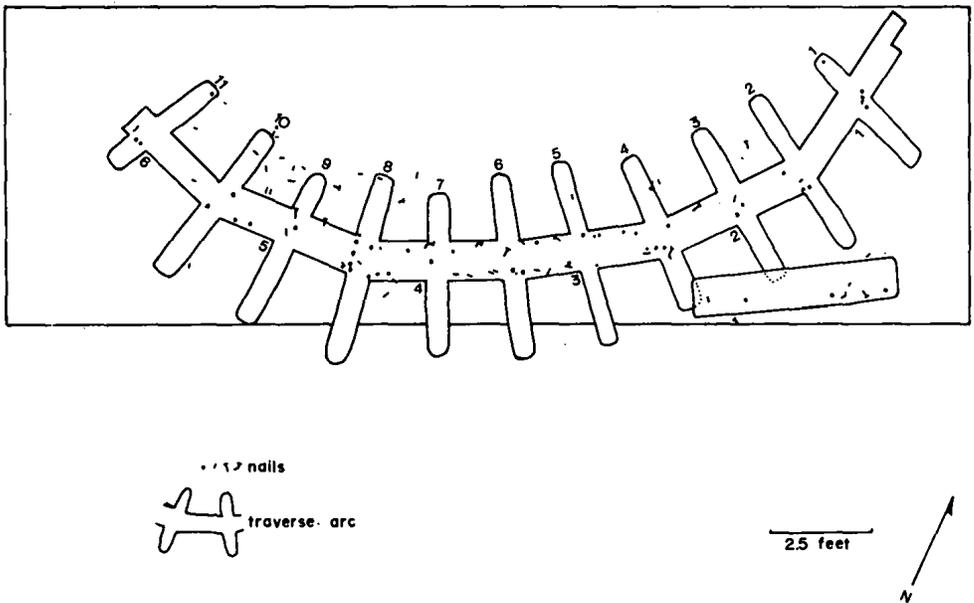
Figure 10.--Ground plan of excavations in Gun Position 7.

Gun Position 7 (figs. 10 and 11)

An 8-foot-wide trench was dug across this position. Like Gun Position 6, it was inundated for about 9 days. Fortunately, there were still about 6 inches of fill over the floor and damage was slight. The floor was 39 inches below the surface. This was the best preserved of all the traverse arcs excavated and it was possible to work out the entire pattern along with dimensions of each sleeper and traverse plank. Measurements (in inches) of the 11 sleepers and 6 planks, numbered from left to right, are as follows.

Sleepers				Planks			
No.	L.	W.	Th.	No.	L.	W.	Th.
1.	40	5	5	1.	54	9	2
2.	56	6	5	2.	45	12	2
3.	53	6	5	3.	45	12	2
4.	56	6	5	4.	45	12	2
5.	56	6	5	5.	45	12	2
6.	55	6	5	6.	39	9	2
7.	51	6	5				
8.	58	6	5				
9.	49	6	5				
10.	54	6	5				
11.	38	6	5

In addition, there was a plank behind the right side of the traverse arc. Measuring 60 inches long, 12 inches wide and 2 inches thick,

the plank's function is unknown. It should be noted that planks cross odd-numbered sleepers and meet other planks on even-numbered sleepers. The plank between sleepers 6 and 8 was still visible, but poorly preserved. Measurements on sleepers were taken from gray clay outlines found in the bottom of the sleeper trenches. These trenches averaged 1 inch wider and 2 or 3 inches longer than the sleepers they contained. Thickness was measured from the floor of the trenches to the bottom of the traverse planks. The sleepers were square cut timbers. Traverse plank width was defined by the gray clay outlined in the red hardpan; thickness was measured from the heads of vertical nails driven through the planks into the hardpan; and plank length was measured from center to center of the even-numbered sleepers except in the case of end planks which were defined in the hardpan. The radius of the arc is 11.5 feet.

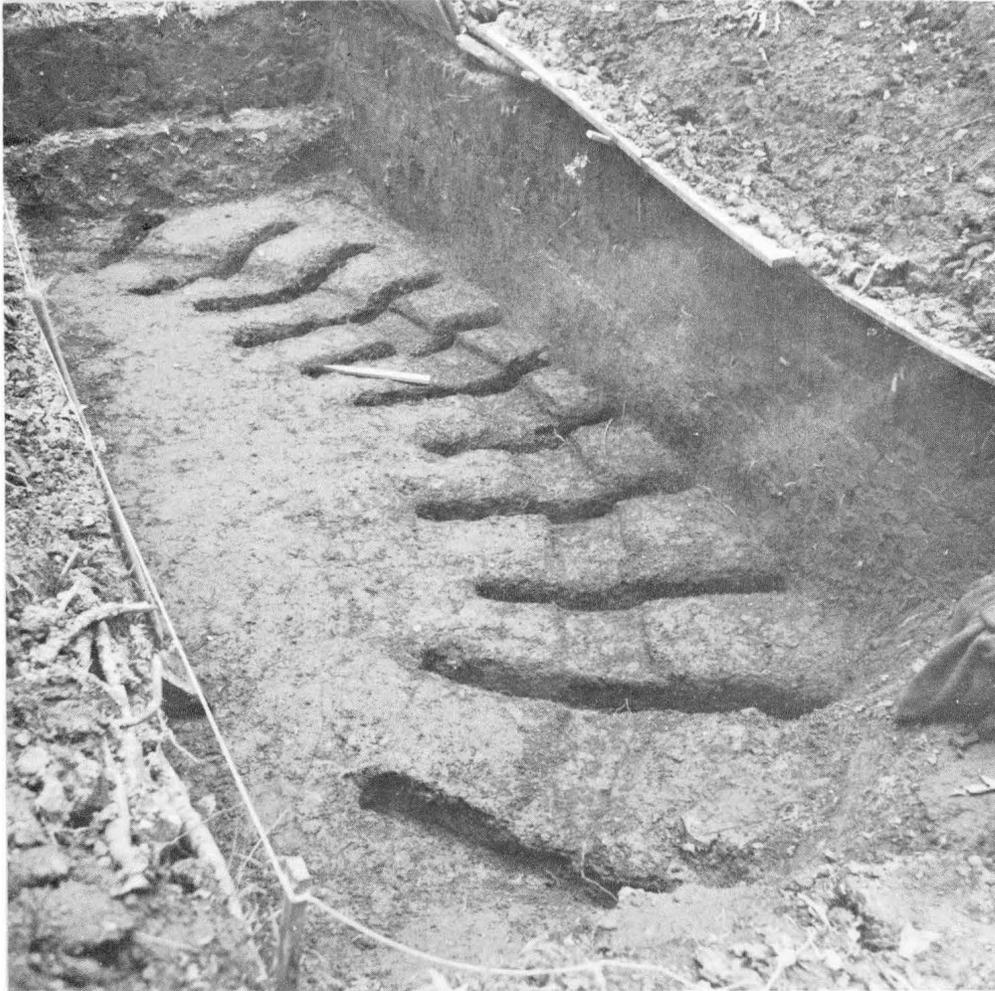
Figure 11.--View of the traverse arc in Gun Position 7.

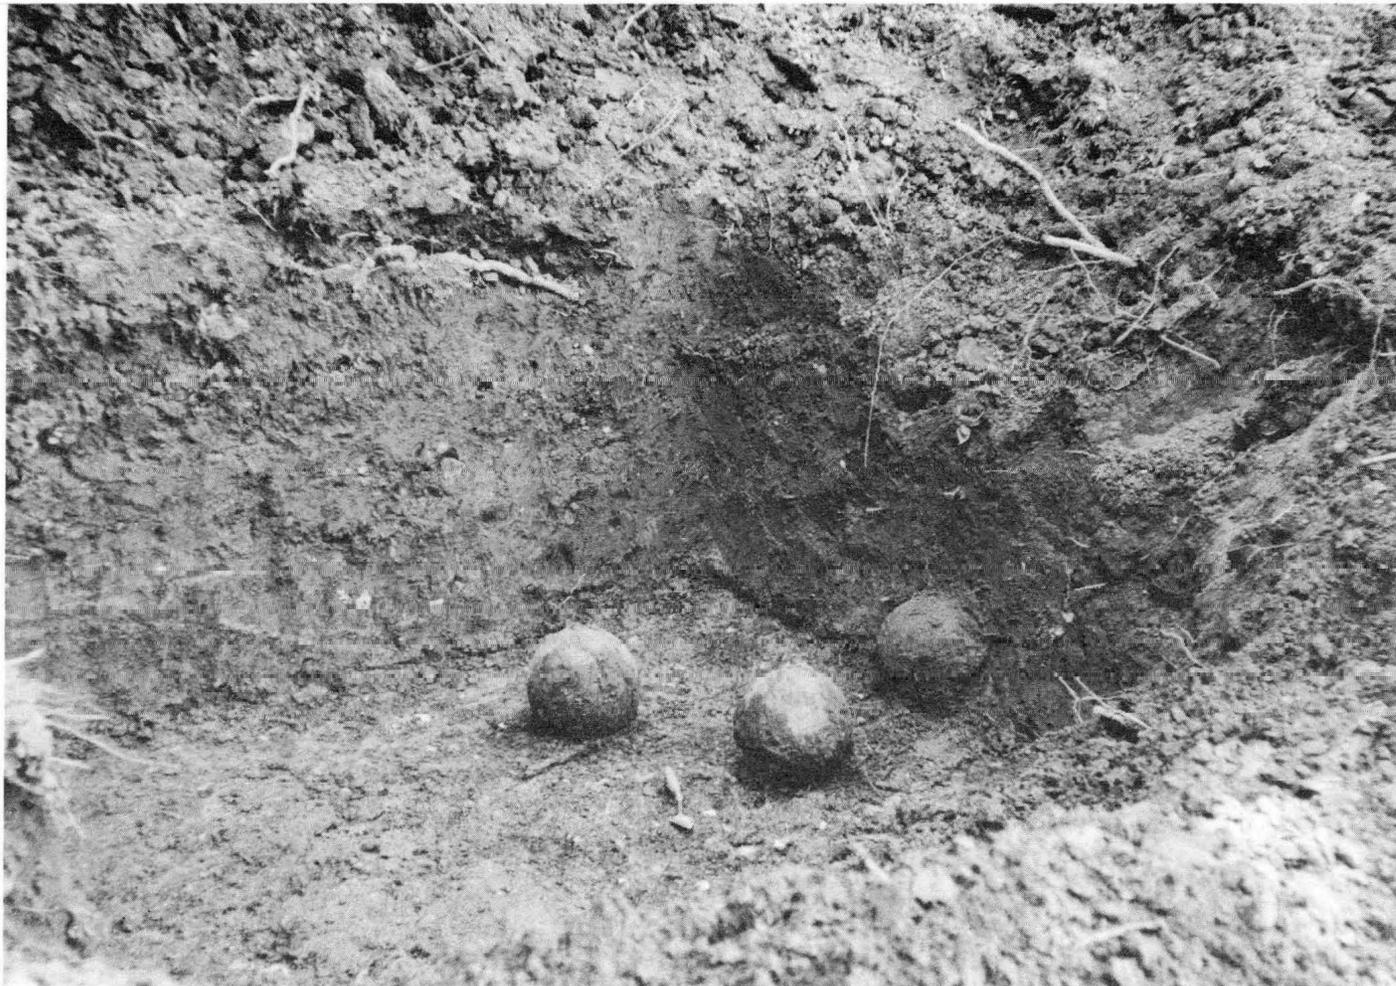
Figure 12.--Three 10-inch Cannonballs found in Gun Position 10.

Gun Position 10 (fig. 12)

The floor of this position should be 41 inches below the present surface. Some dirt will have to be added to the parapet to fill in ditches cut through it, but its height will not have to be increased except with sandbags. No gun platform was found in the position and the presence of the three 10-inch cannonballs indicates that it was used for ammunition storage for Gun Position 11.

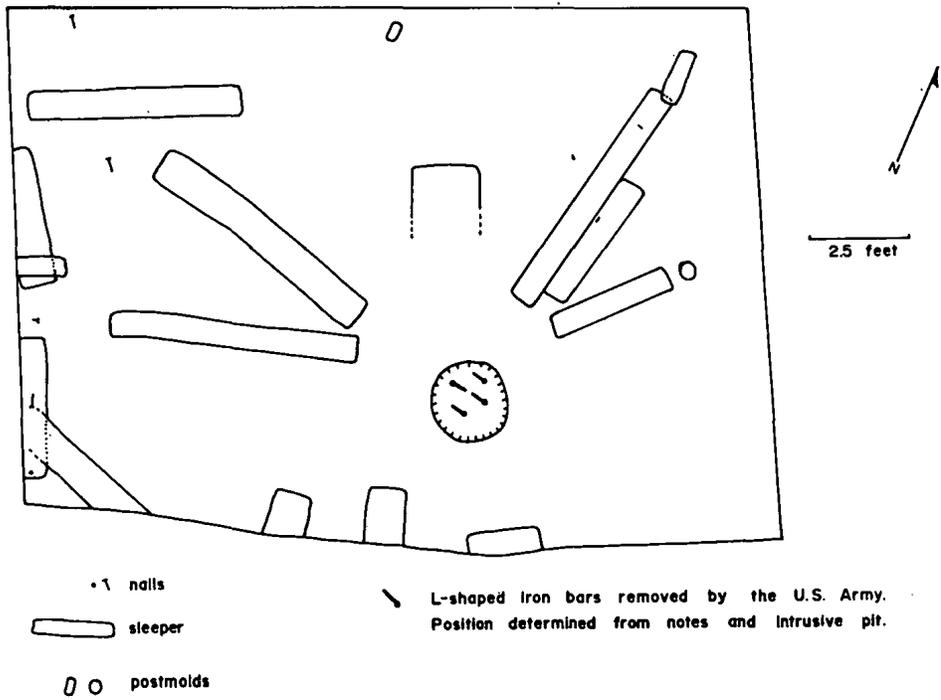
Figure 13.--Ground plan of excavations in Gun Position 11.

Gun Position 11 (figs. 13 and 14)

Before excavating this position we cleaned out the intrusive pit in the center. Nothing was found. Evidently the soldiers had dug down to hardpan and removed all traces of the iron bars or the wood they reported seeing. A pit, 18 by 13 feet, was opened to a depth of 31 inches by the backhoe, which also removed a cedar tree growing in the position. A substantial platform with large timbers was expected, but there was none. Planks about 2 inches thick were used as sleepers. These were erratically spaced around a center

point, where the Army removed four L-shaped iron bars set vertically. Iron nails were practically nonexistent, and most of the few found were not associated with the traverse arc. No traverse planks were found. All of this, even if there was an iron traverse rail, indicates a flimsy, hastily constructed traverse arc and may explain why the Confederates had so much trouble with the gun (Bearss 1968: 21-22). One sleeper deserves special mention. It was located in the front part of the arc and appeared to be set at an angle. It may have been driven under the rail to counteract the depression that developed during the battle (Bearss 1968:21); or, more probably, it may have tilted and thus created the depression. Several plank molds and a log mold were found outside the traverse arc, particularly along the left traverse. These may have been associated with the revetting of the traverse. Two post molds may have functioned in similar fashion and suggest that this position was revetted with planks held in place by posts.

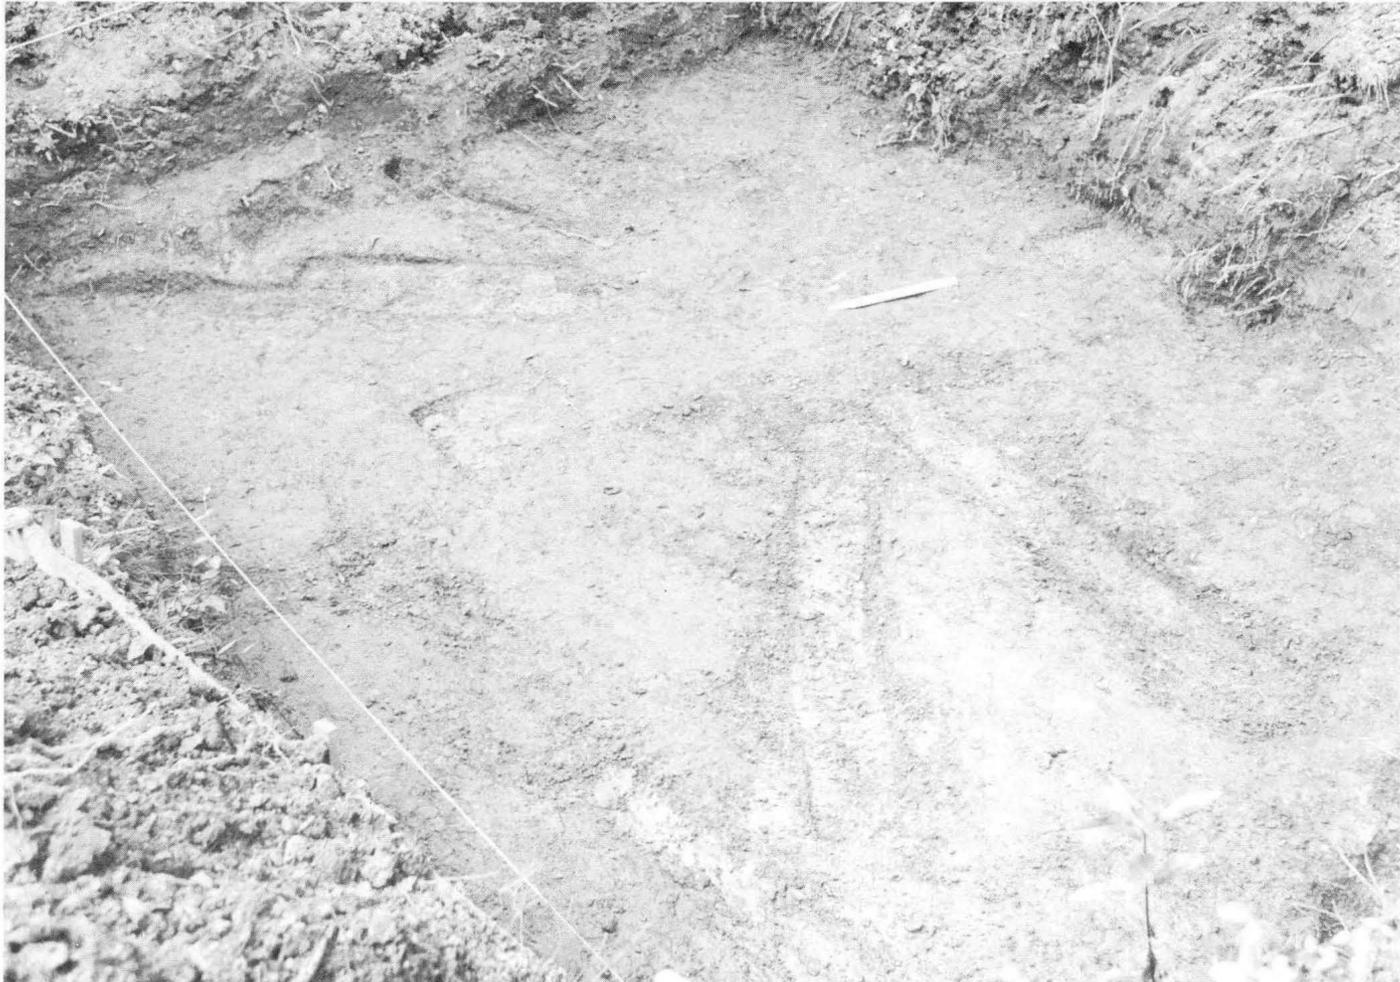
Figure 14.--View of the sleeper molds in Gun Position 11.

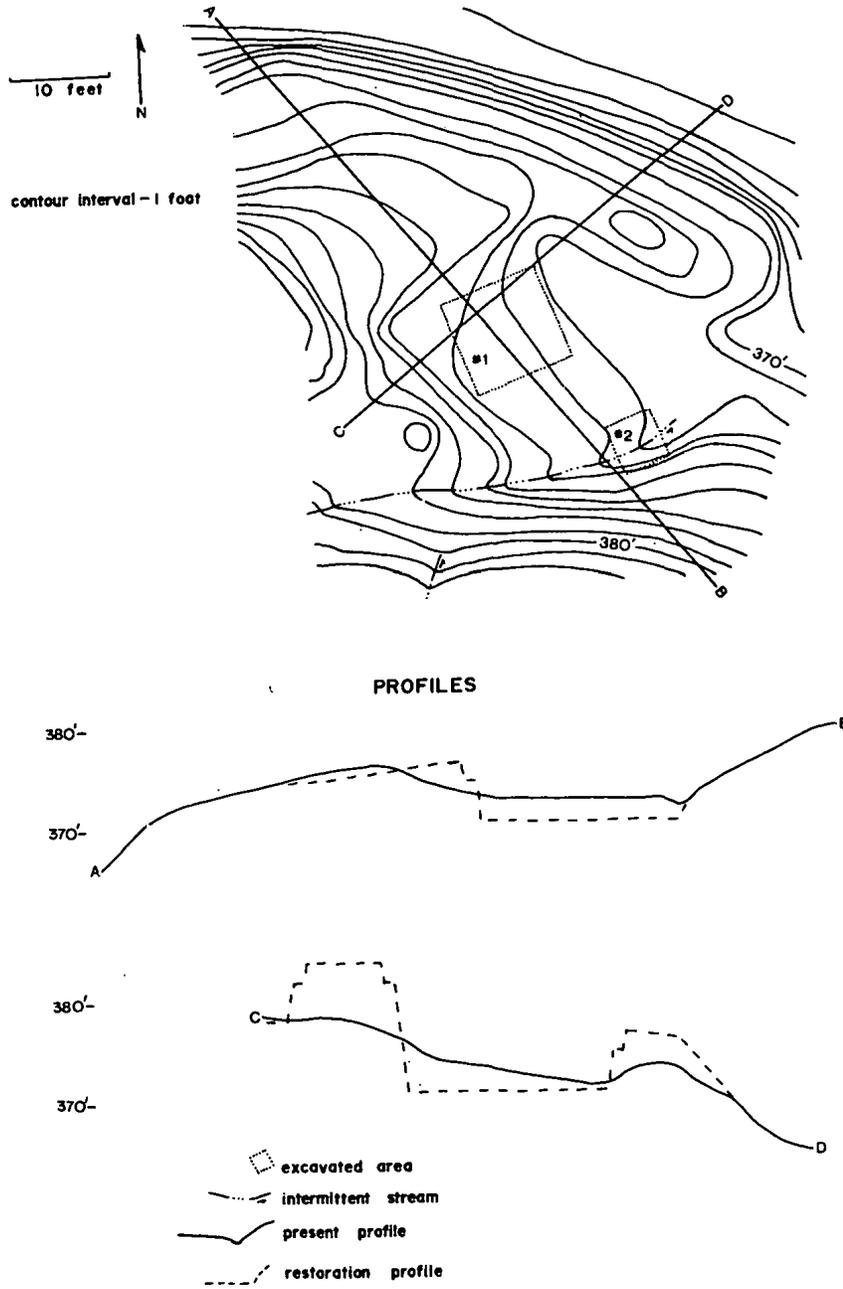
Figure 15.--Profiles of Gun Position 1.

Gun Position 1 (Fig. 15)

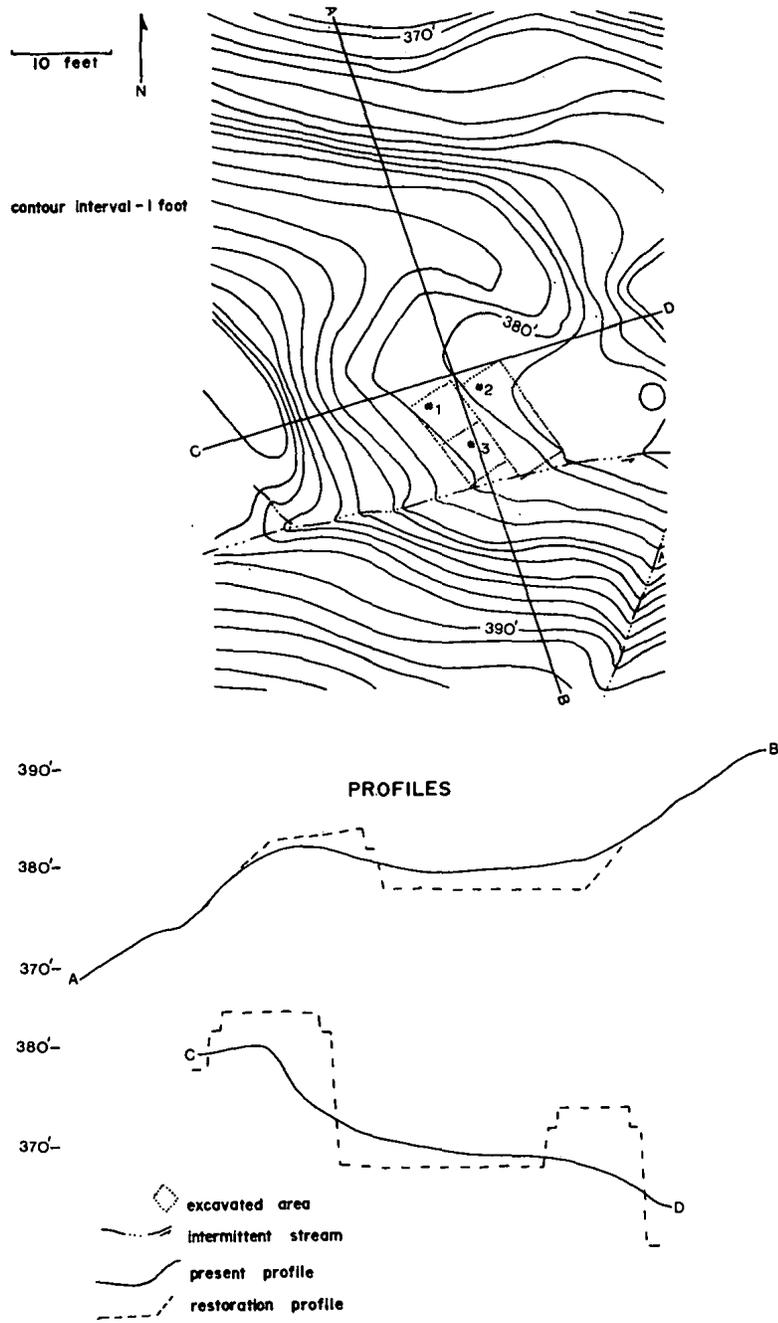
Figure 16.--Profiles of Gun Position 2.

Gun Position 2 (fig. 16)

The floor level of this position needs to be lowered 28 inches below the present surface. Two feet of fill and sandbags

need to be added to the right traverse. The parapet needs only sandbags and revetment.

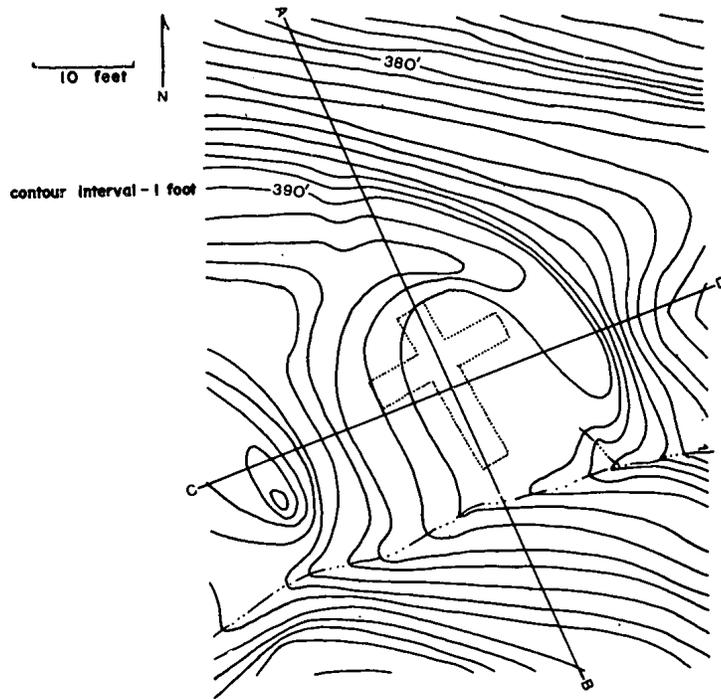
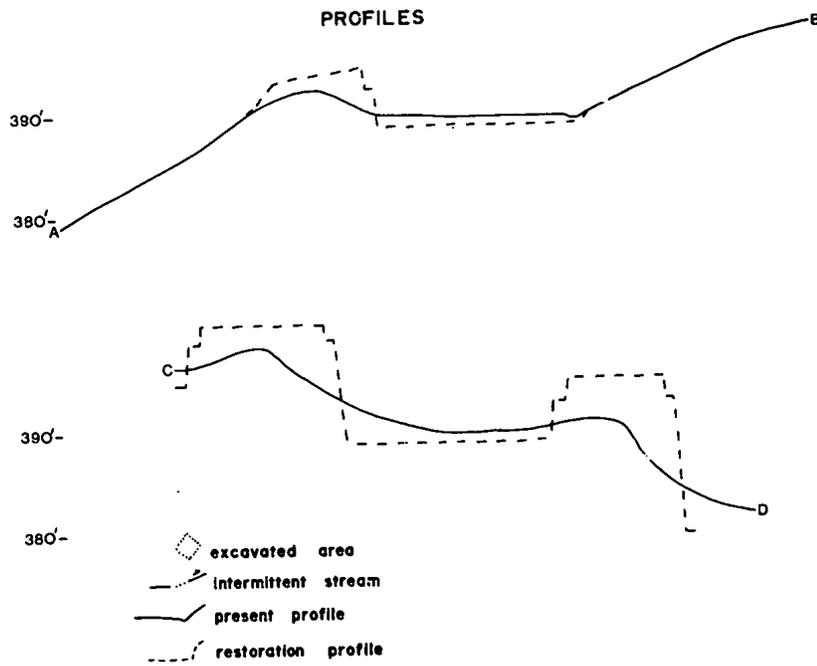
Figure 17.--Profiles of Gun Position 3.

Gun Position 3 (fig. 17)
