**ARCHEOLOGICAL EXCAVATIONS IN THE WATER BATTERIES
AT FORT DONELSON NATIONAL MILITARY PARK, TENNESSEE**

Lee H. Hanson, Jr.

December 1968

National Park Service

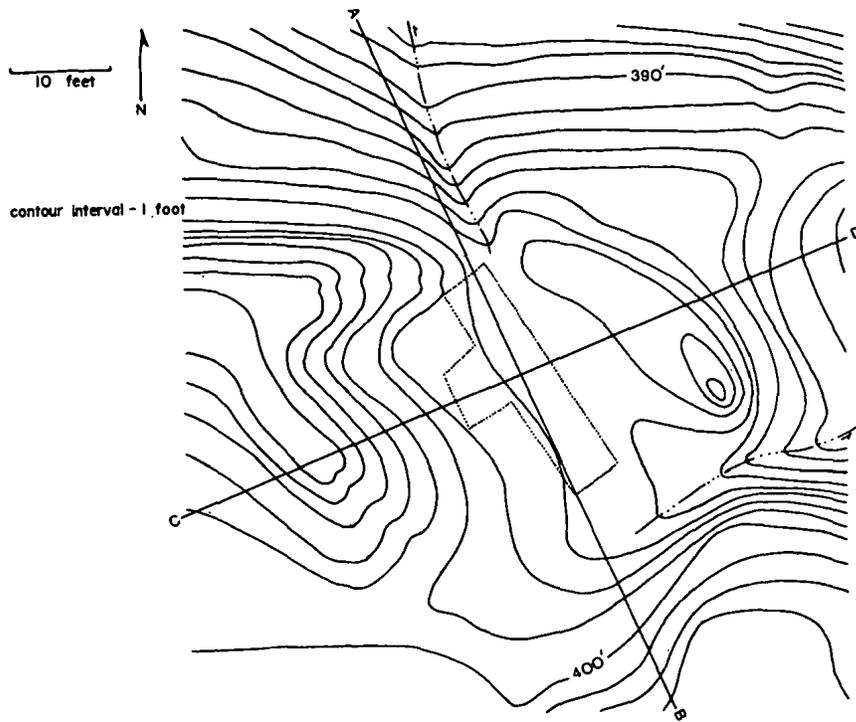
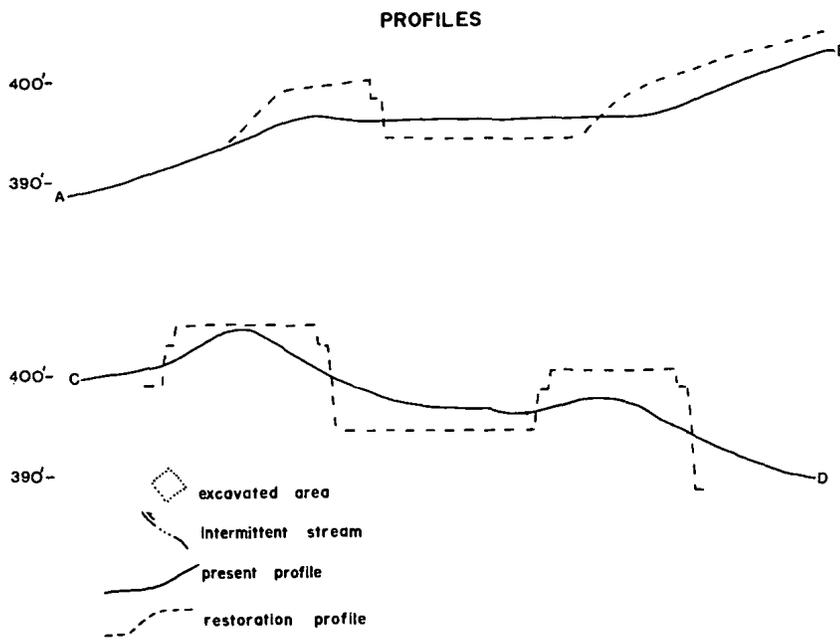
Figure 18.--Profiles of Gun Position 4.

Gun Position 4 (fig. 18)

The floor should be lowered 22 inches and the right traverse raised 1 foot. The center of the parapet has washed out and will have to be raised 3 feet.

A traverse arc mounted on sleepers should be placed 13 feet behind the parapet, with the front pintle mounted 1.5 feet back of the parapet.

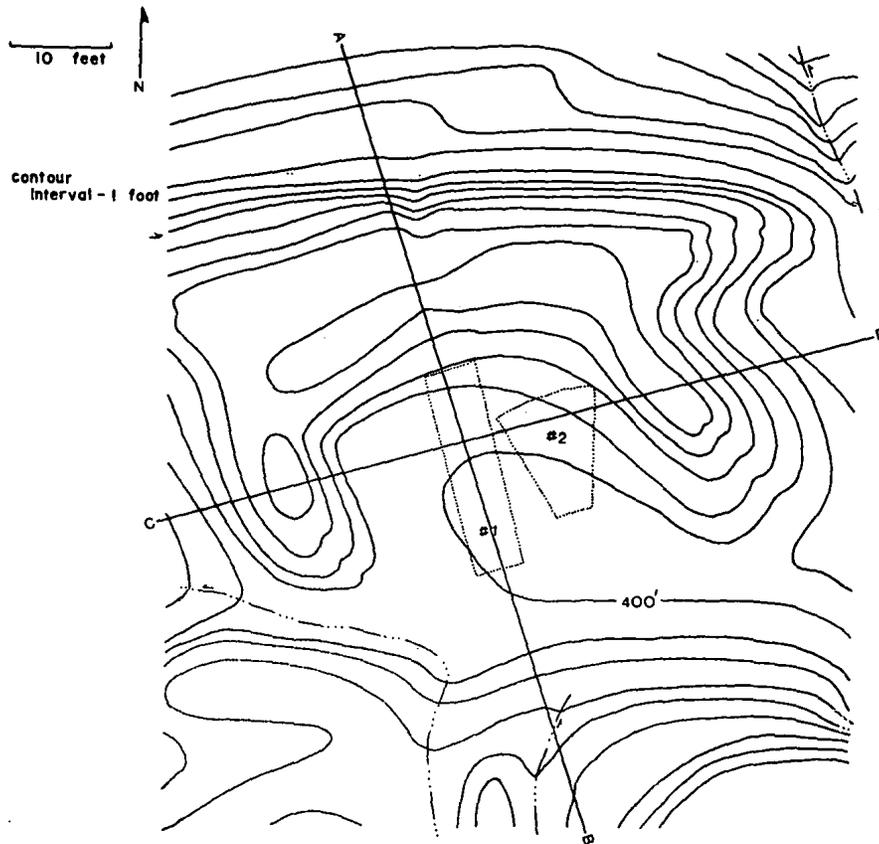
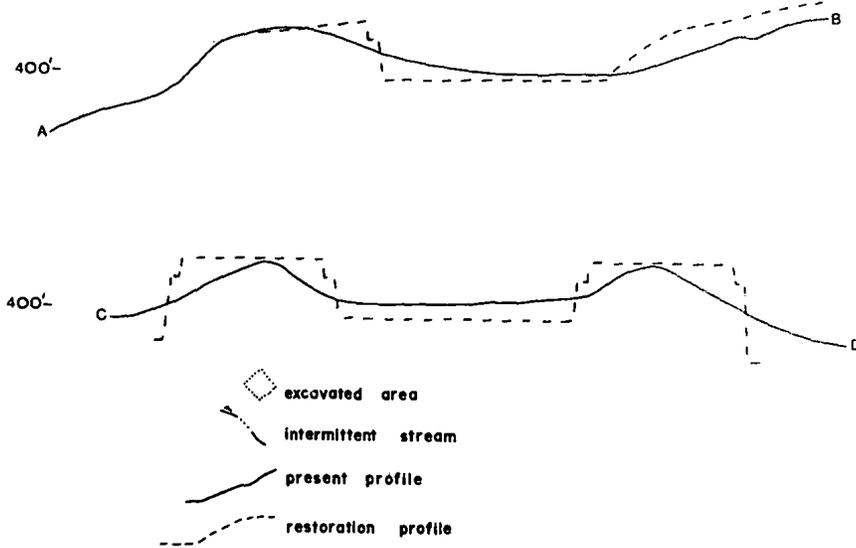
Figure 19.--Profiles of Gun Position 5.

Gun Position 5 (fig. 19)

No gun platform was found in this position, and its presence and form are conjectural. The author feels that there was one and that it was the same as those in Gun Positions 3 to 8; that is, a front-pintle mount with a wooden traverse rail. The traverse rails in Gun Positions 6 to 8 were 16 feet behind the parapet, while those in Positions 3 and 4 were closer. Since the guns were mounted in batteries of four, the traverse rail in Gun Position 5 was probably the same distance back as those in Positions 6 to 8; 16 feet.

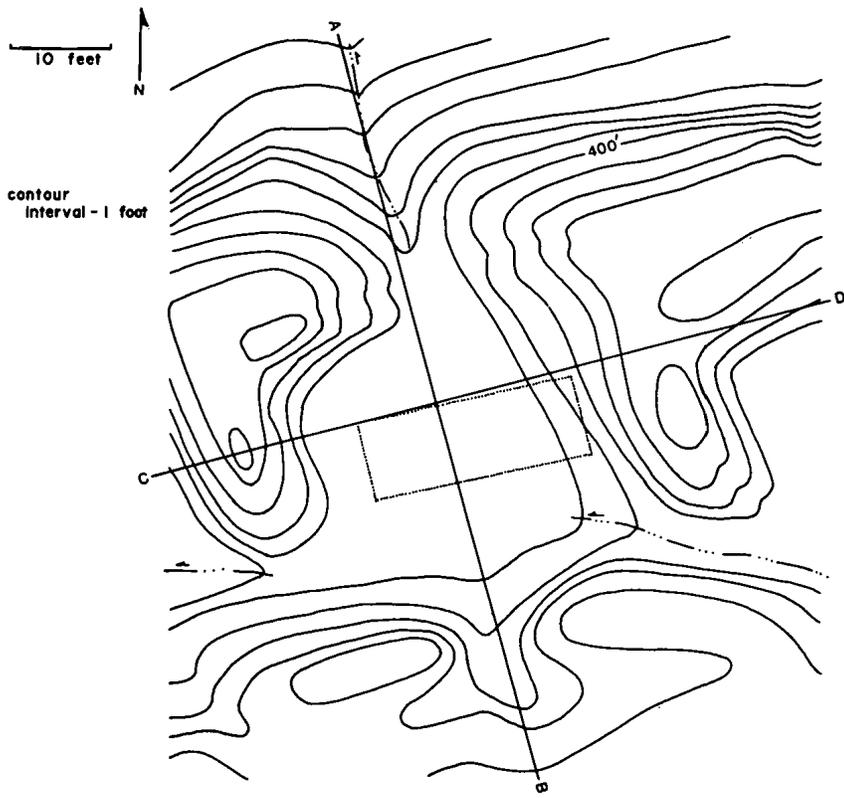
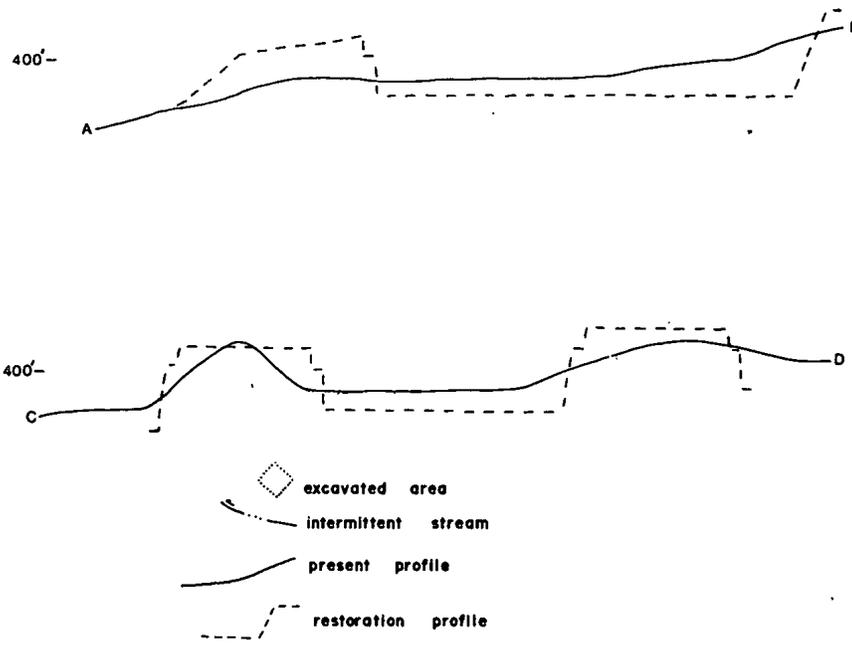
Figure 20.--Profiles of Gun Position 6.

Gun Position 6 (fig. 20)

Floor level should be 21 inches below the present surface. One foot will have to be taken off the left traverse and the center of the parapet will need to be built up 3 feet where it has washed out.

The traverse arc, about 16 feet behind the parapet, was probably a wooden rail laid on an arc of sleepers.

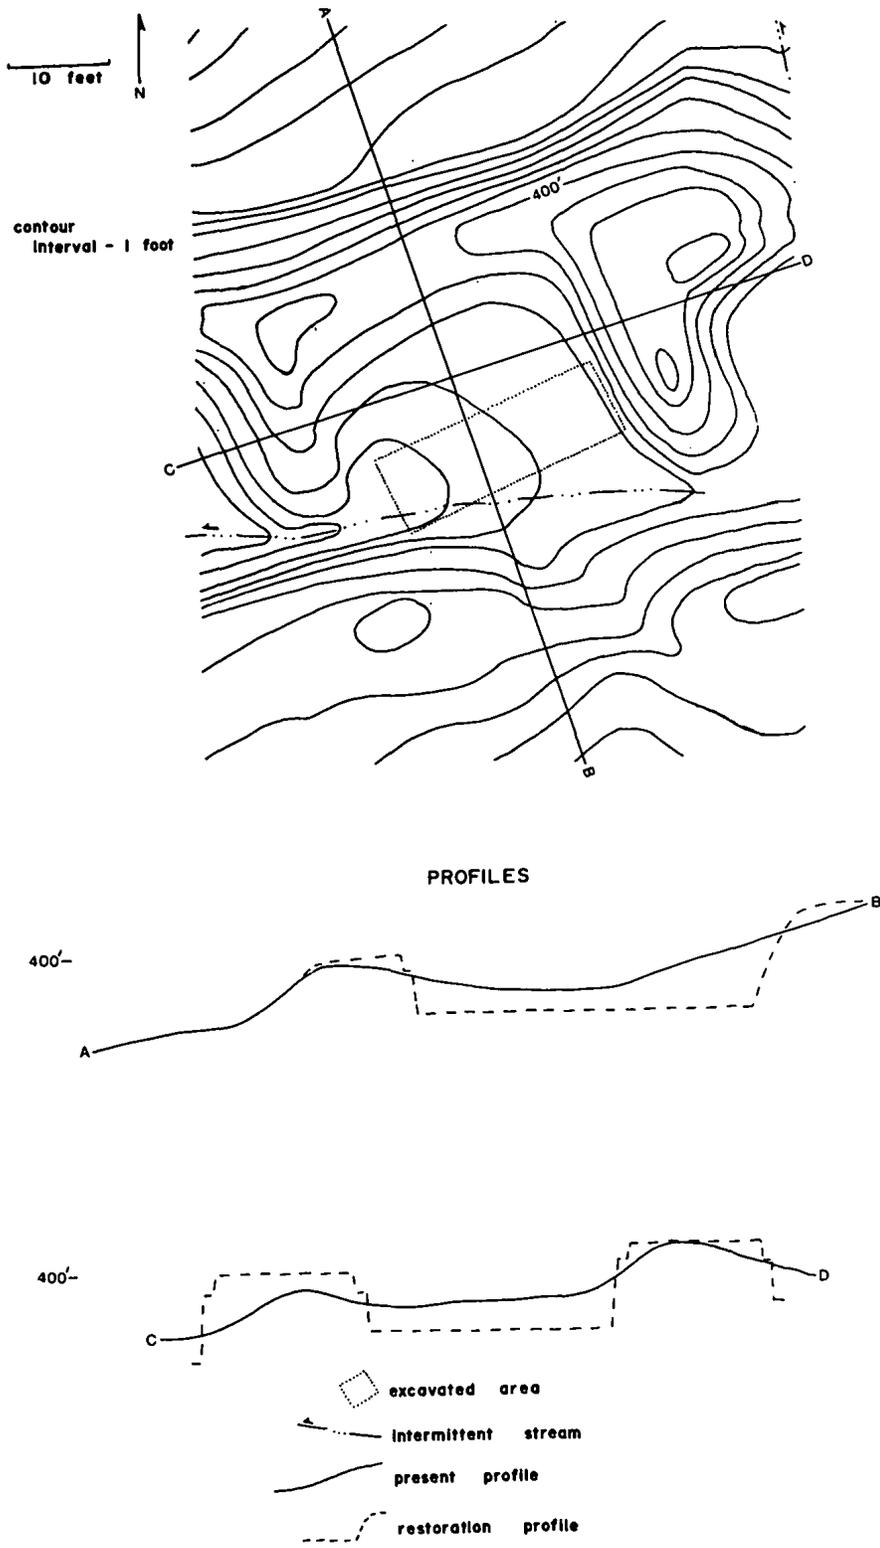
Figure 21.--Profiles of Gun Position 7.

Gun Position 7 (fig. 21)

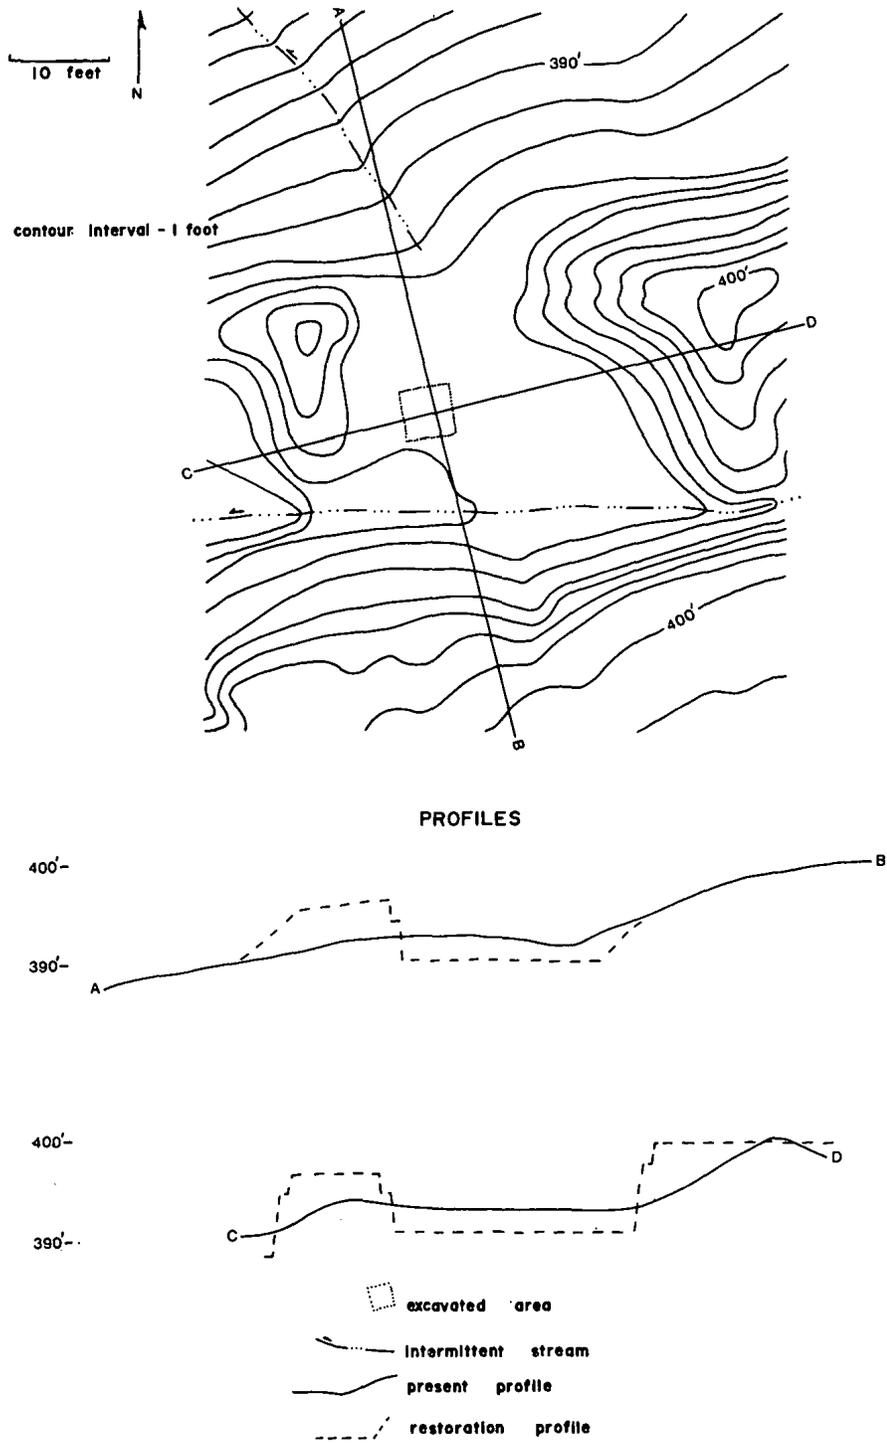
Figure 22. Profiles of Gun Position 8.

Gun Position 8 (fig. 22)

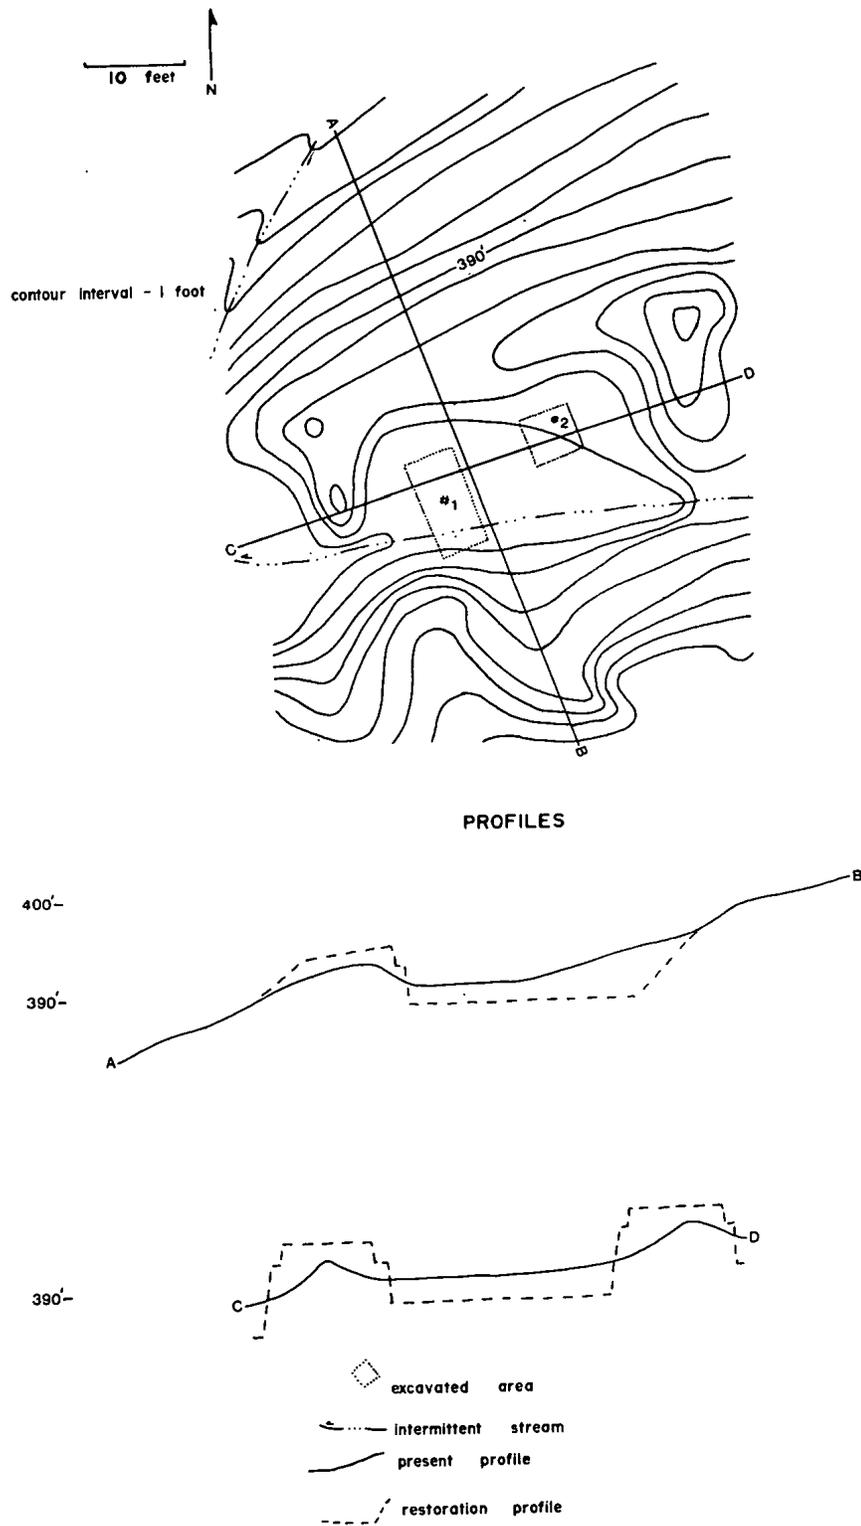
Figure 23.--Profiles of Gun Position 9.

Gun Position 9 (fig. 23)

Removal of 23 inches of fill will be about all that is necessary to restore this position, except for sandbagging. No evidence of a platform was found in it and the author doubts that one was present.

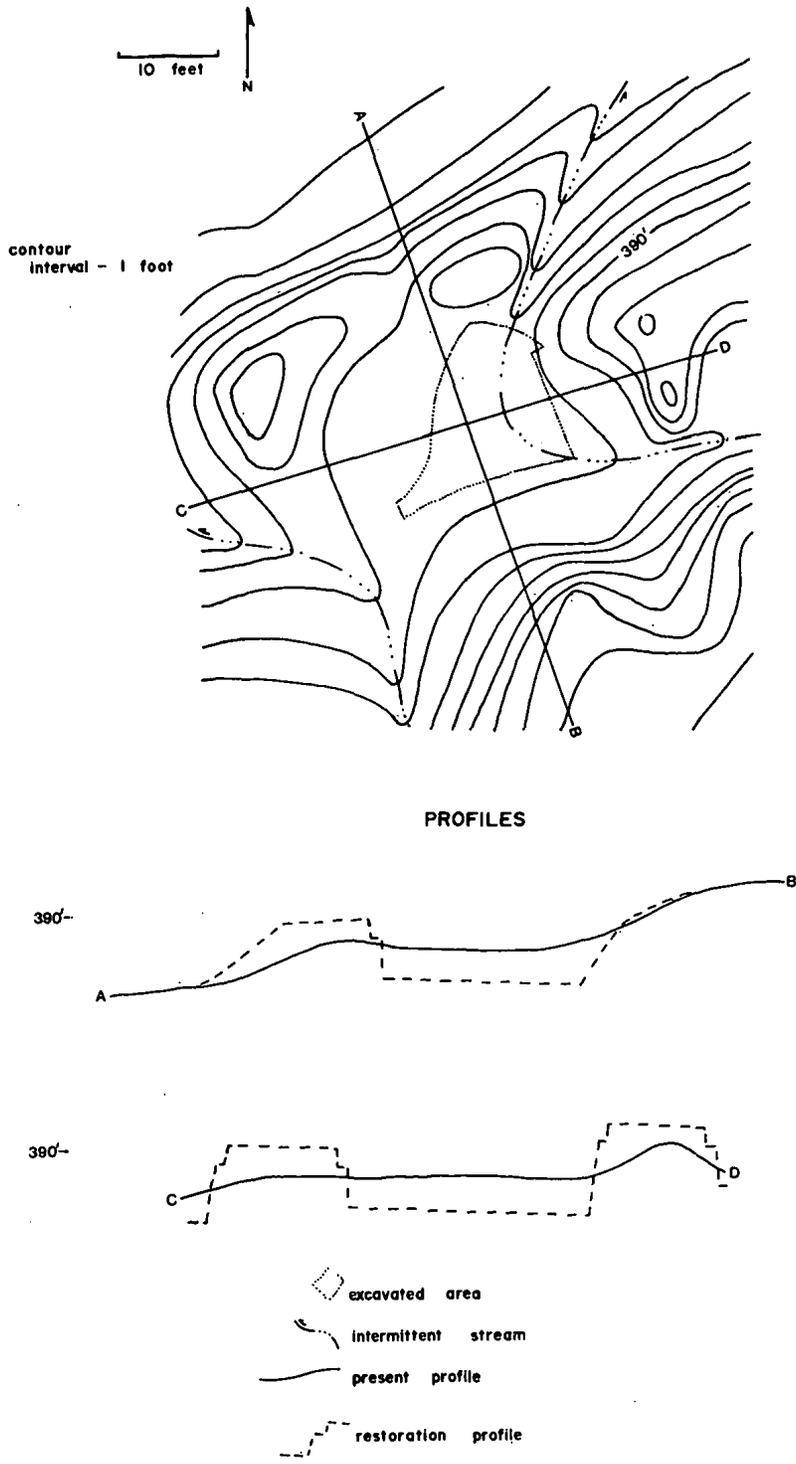
Figure 24.--Profiles of Gun Position 10.

Gun Position 10 (fig. 24)

The floor of this position should be 41 inches below the present surface. Some dirt will have to be added to the parapet to fill in ditches cut through it, but its height will not have to be increased except with sandbags. No gun platform was found in the position and the presence of the three 10-inch cannonballs indicates that it was used for ammunition storage for Gun Position 11.

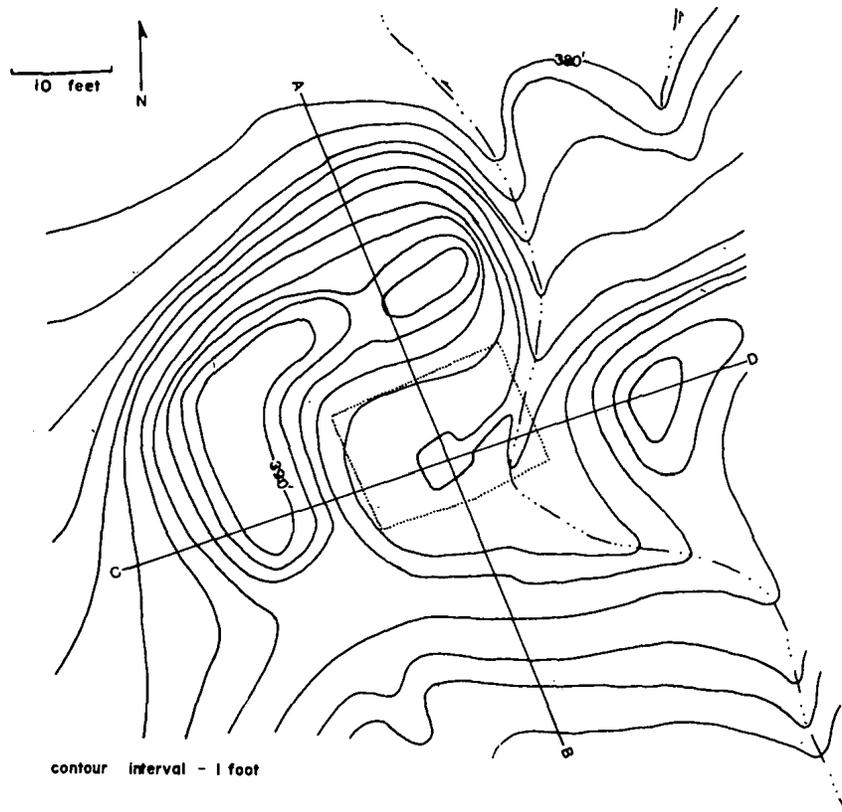
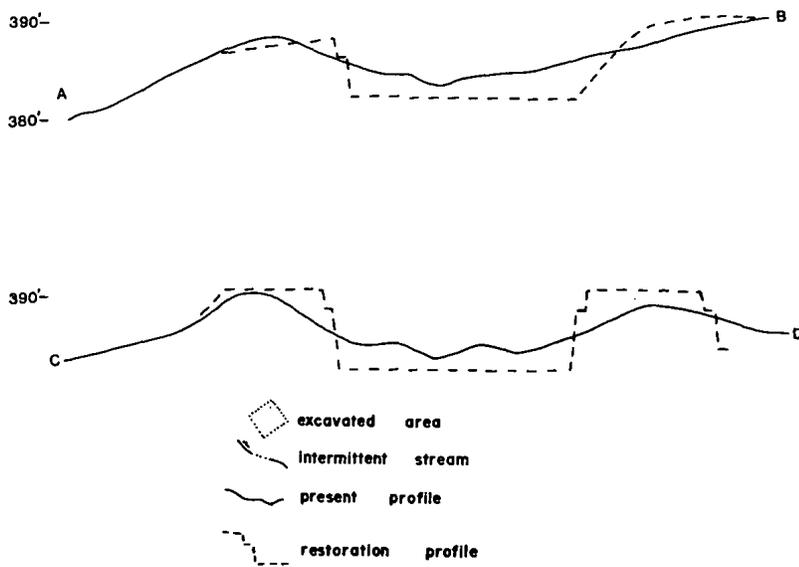
Figure 25.--Profiles of Gun Position 11.

Gun Position 11 (fig. 25)

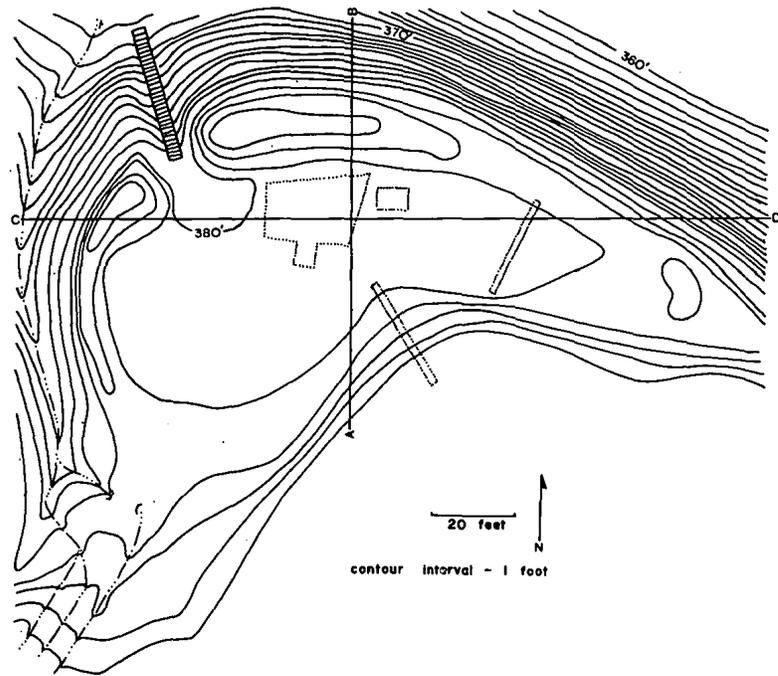
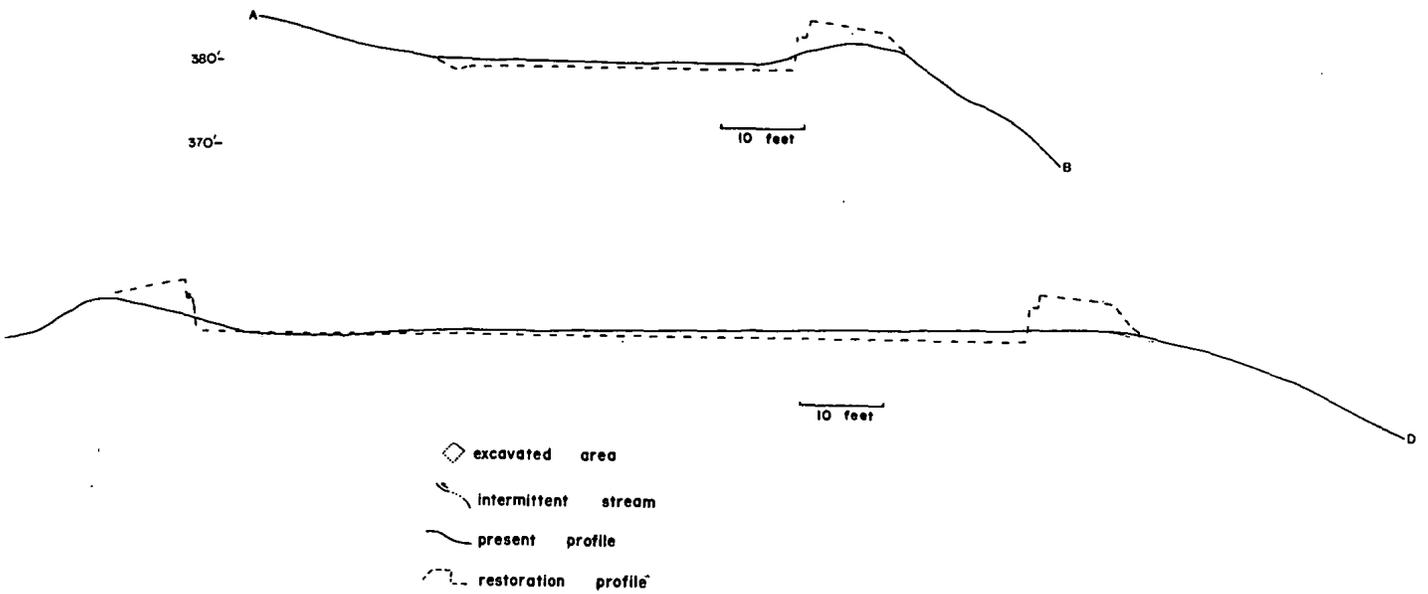
Figure 26.--Profiles of the Upper Water Battery.

Upper Water Battery (fig. 26)

Although the archeological investigation of this area produced no new information, there is enough historical documentation to make a reasonably accurate restoration of this battery. The

area between the parapet and the hillside behind it should be level and at the elevation of the present surface. The parapet should be 16.7 feet wide at the base in the center, narrowing to 12 feet wide on the flanks. It should be 9 feet wide on top in the center and 8 feet wide on top at the flanks. It should be flat on top, with an exterior slope of 8° , and rise 4 feet above the interior level.

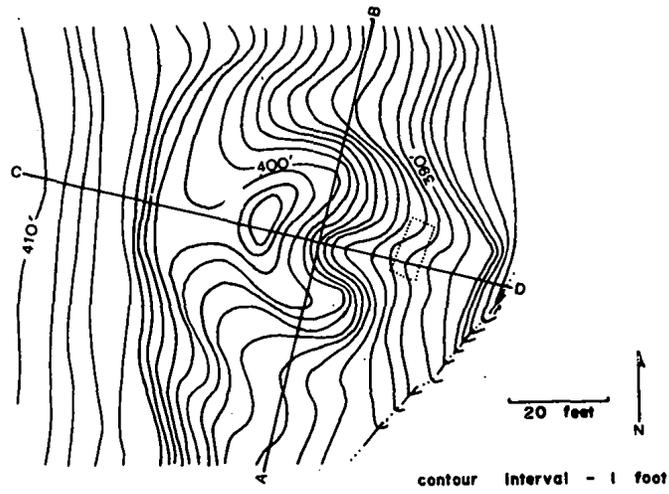
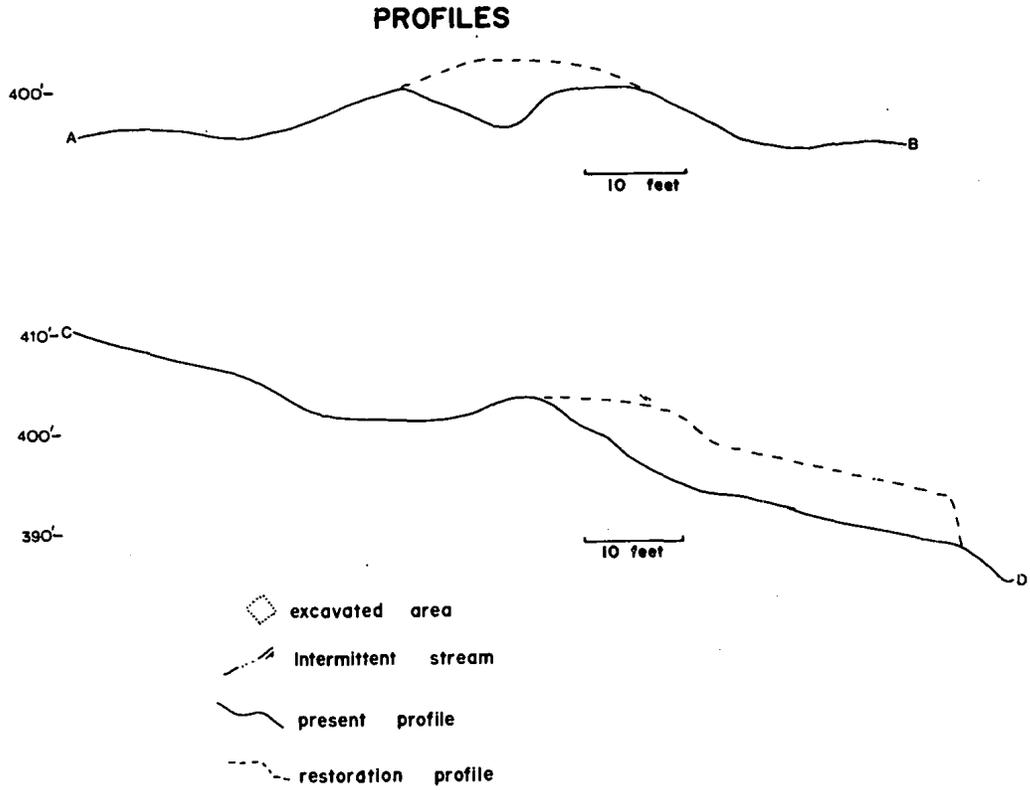
Figure 27.--Profiles of the Upper Powder Magazine.

Upper Powder Magazine (fig. 27)

The author cannot see any reason why the Upper Powder Magazine should be restored to its original state. There is already one restored magazine and, while the upper one is probably not identical, it would not add much to the story. Instead, we recommend placing a false door in the hillside and filling in the depression

along the tunnel and the center of the magazine to approximate its original contours. If a decision is made to restore it, further excavation will have to be undertaken since time did not permit study of it under this project.

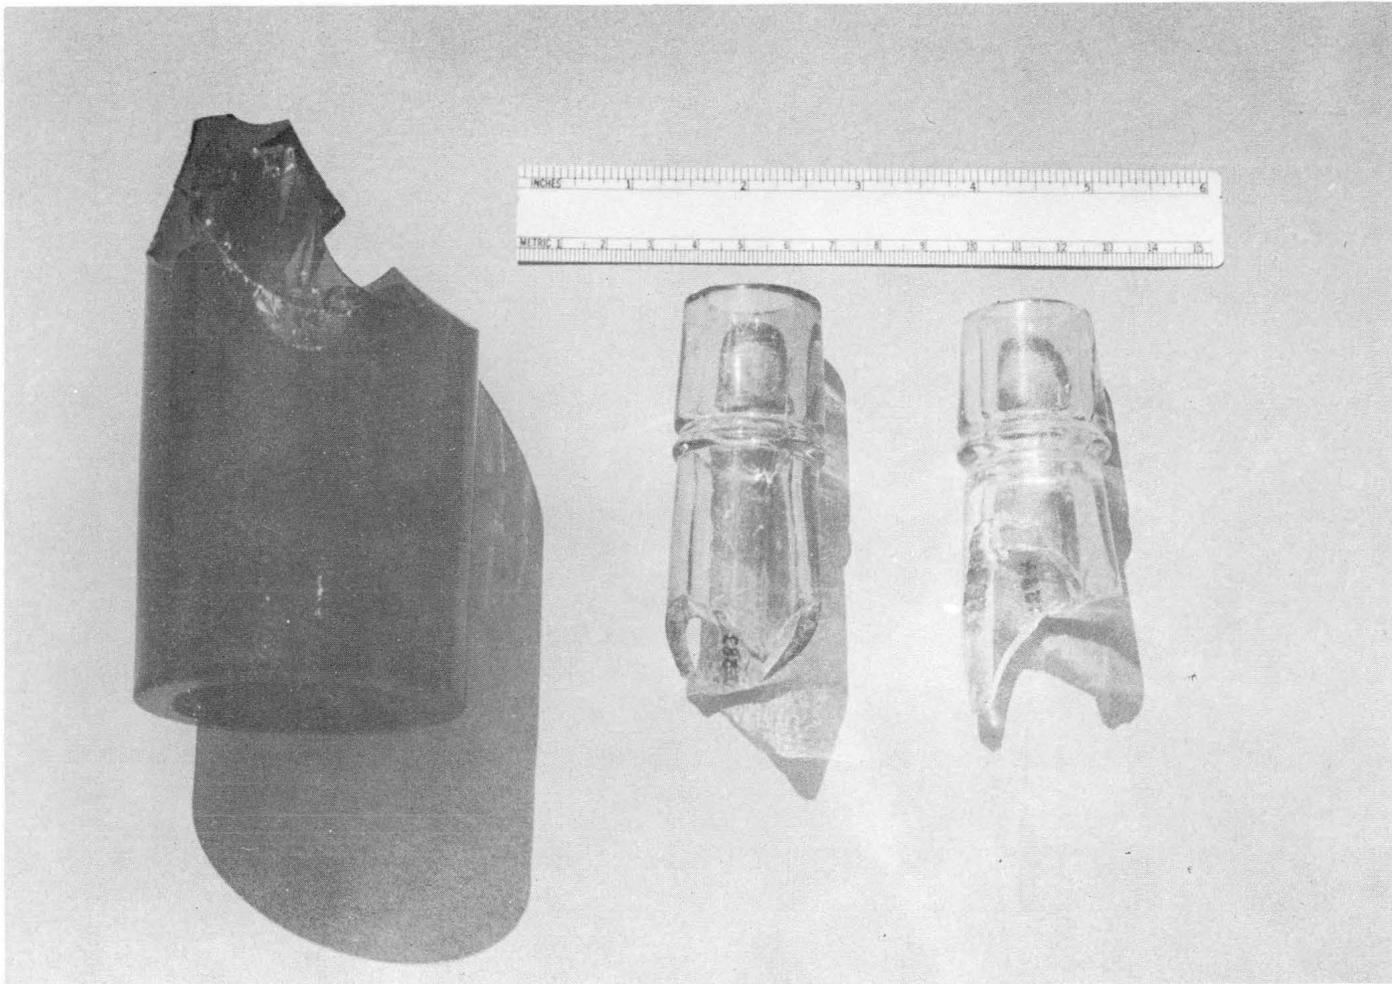
Figure 28.--Glass bottle fragments. L. to R.: Dark amber bottle blown in a mold with a kickup and 2 clear bottle necks.

1 dark amber glass bottle hand-blown in a mold
(neck missing).

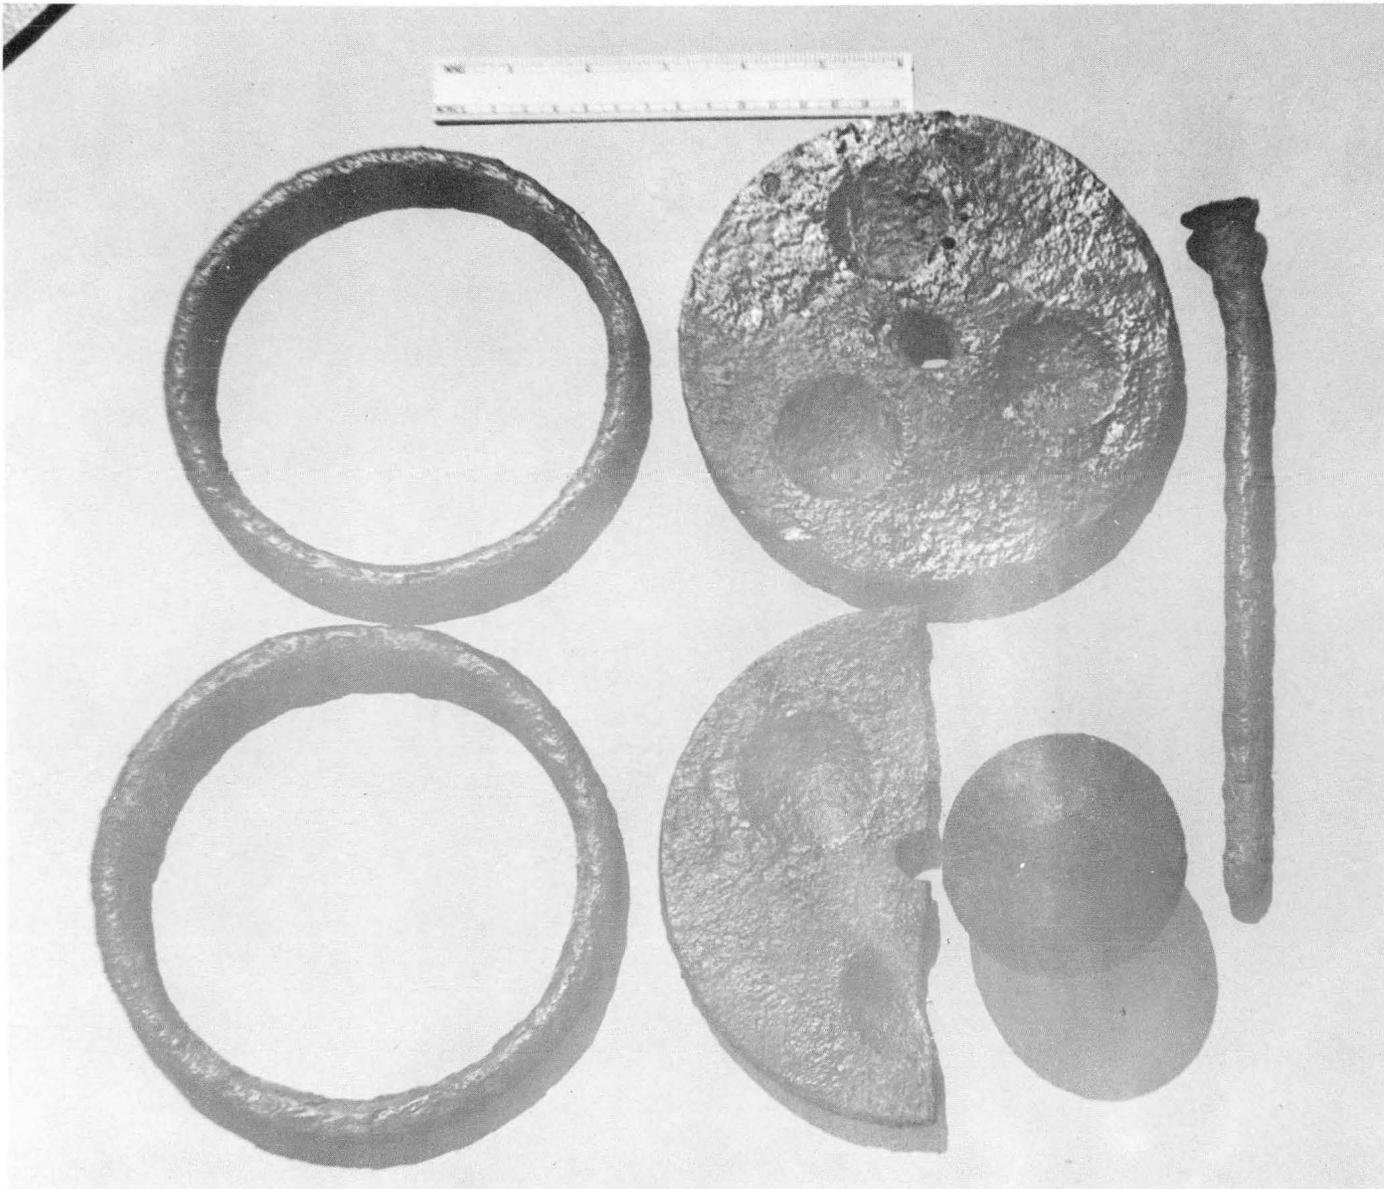
Figure 29.--Parts from stands of grape shot. L. to R.: 2 center rings, 2 end plates, 1 grape shot, and 1 center pin.

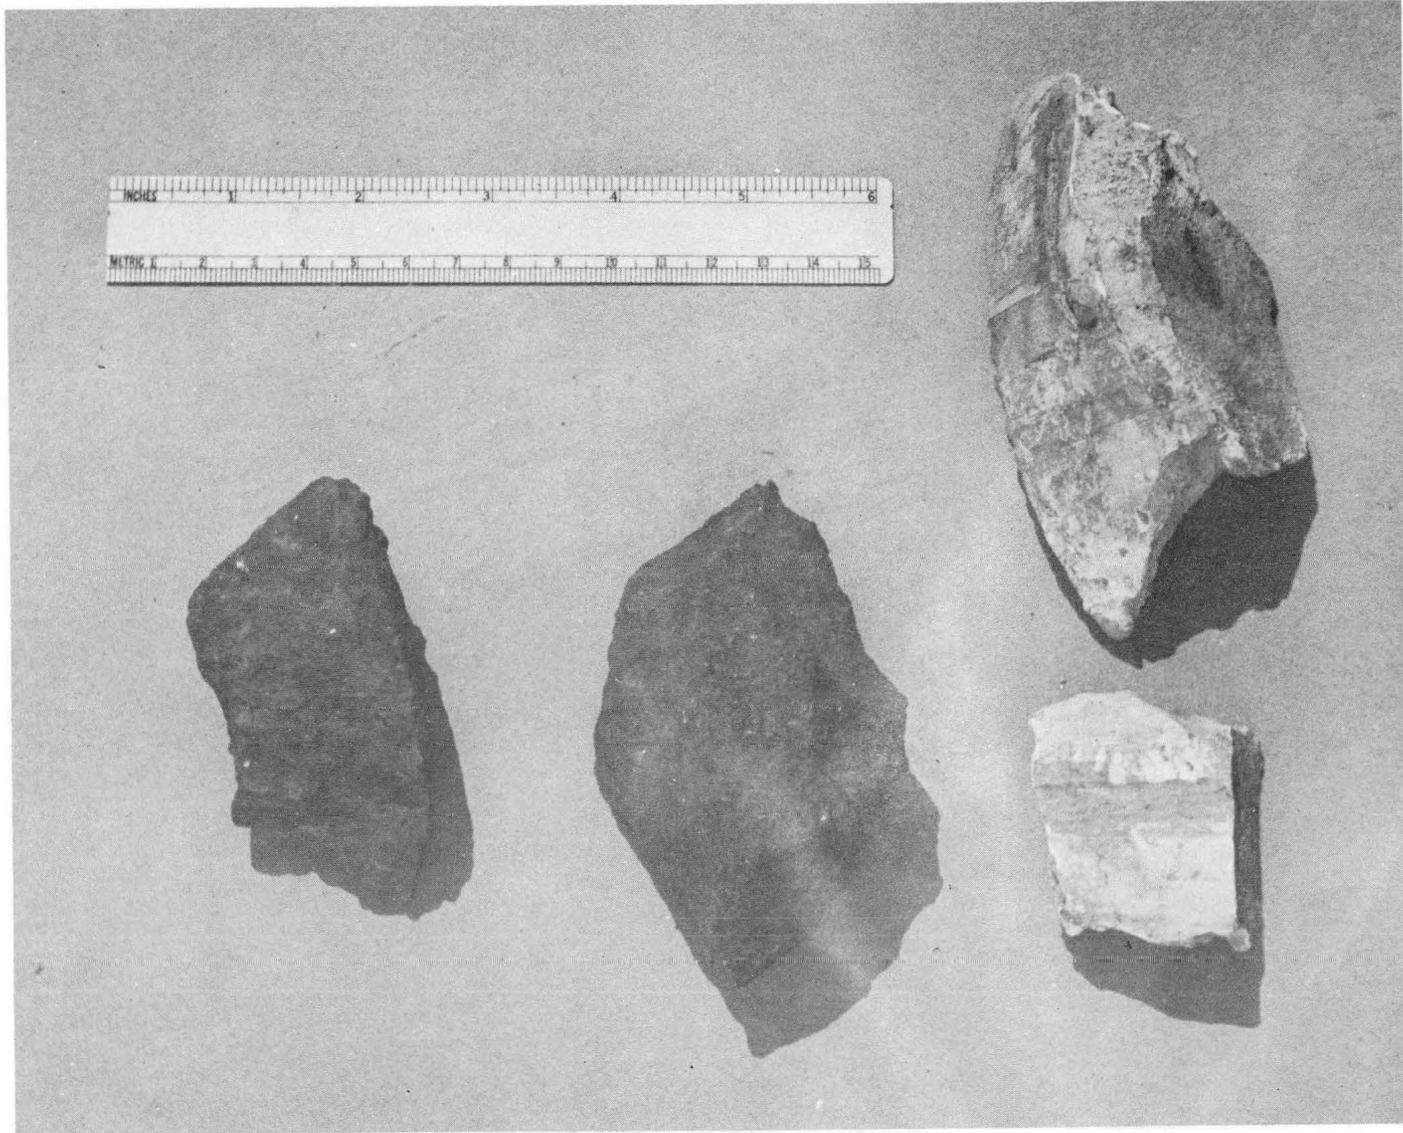
Figure 30.--Shell fragments. L. to R.: 2 iron shell fragments and 2 lead expansion ring fragments.

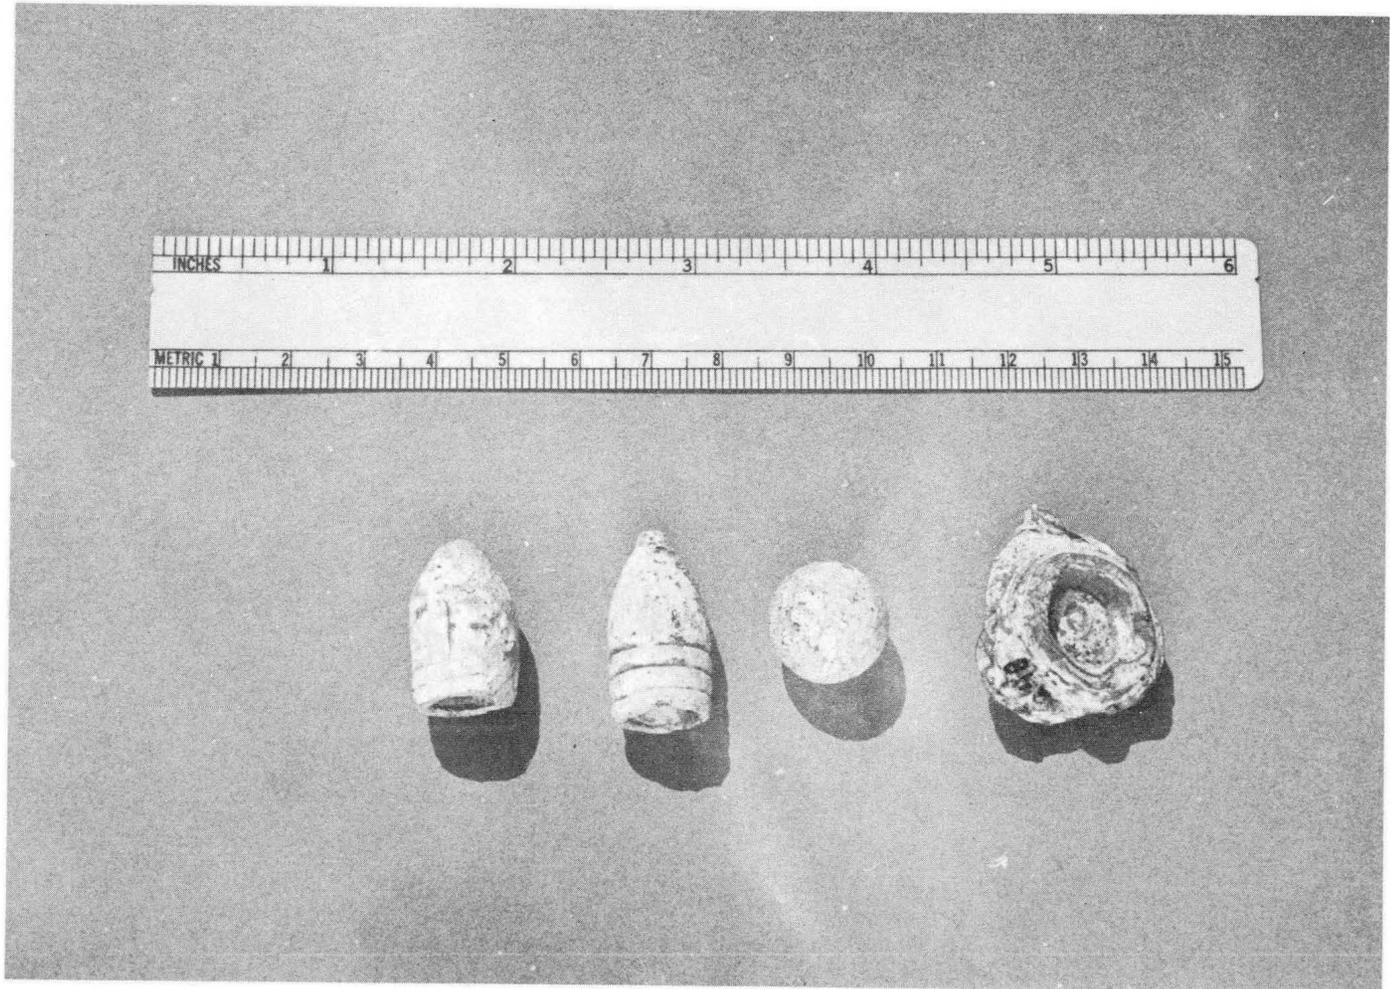
Figure 31.--Musket balls. L. to R.: 2 .58 cal. minie balls, 1 .58 cal. musket ball, and 1 flattened .69 cal minie ball.

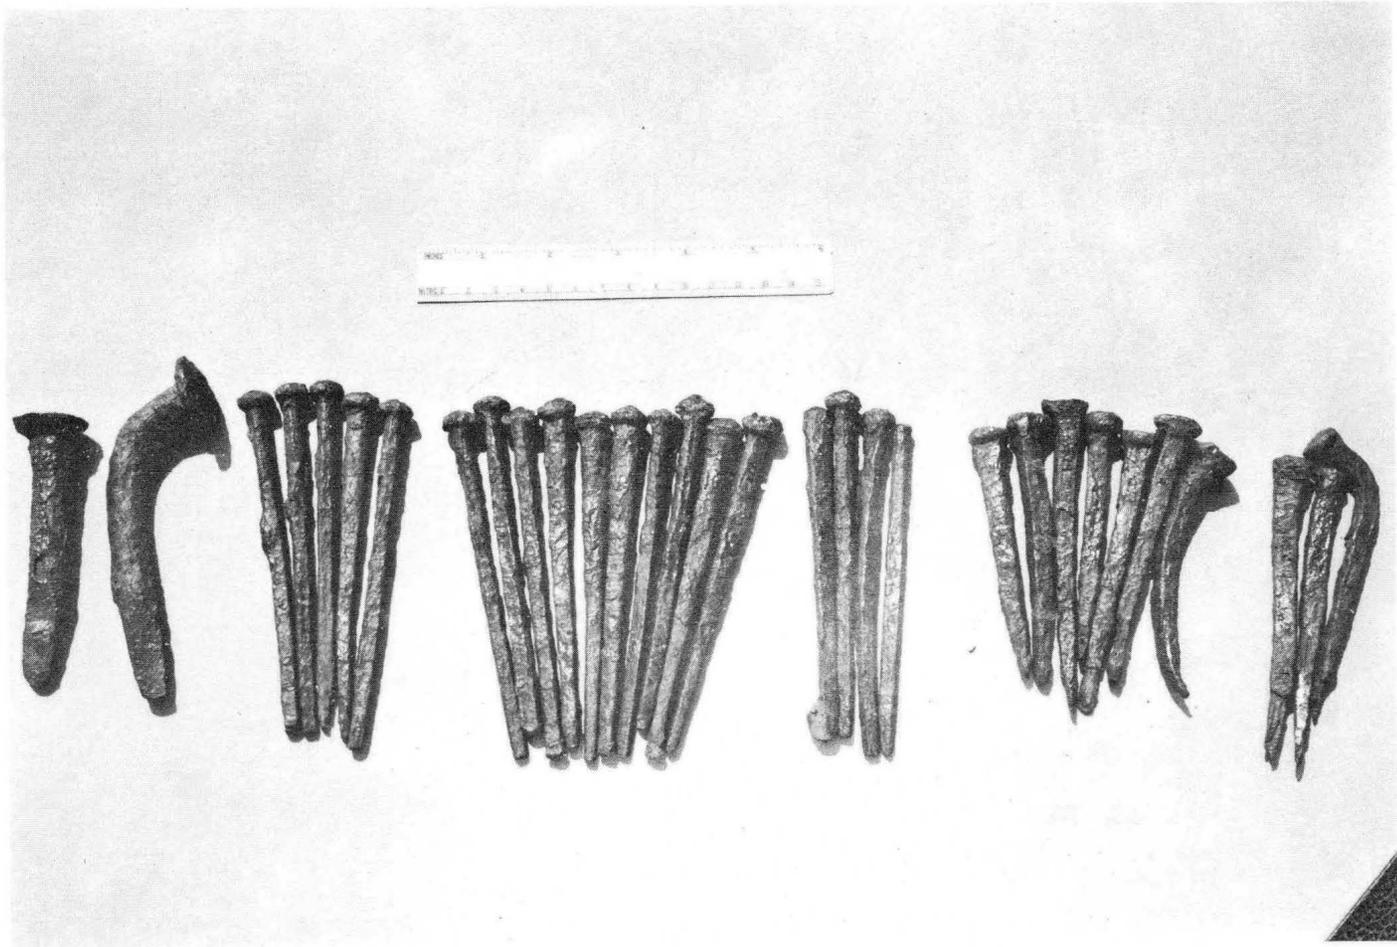
Figure 32.--Wrought iron spikes from traverse rails.

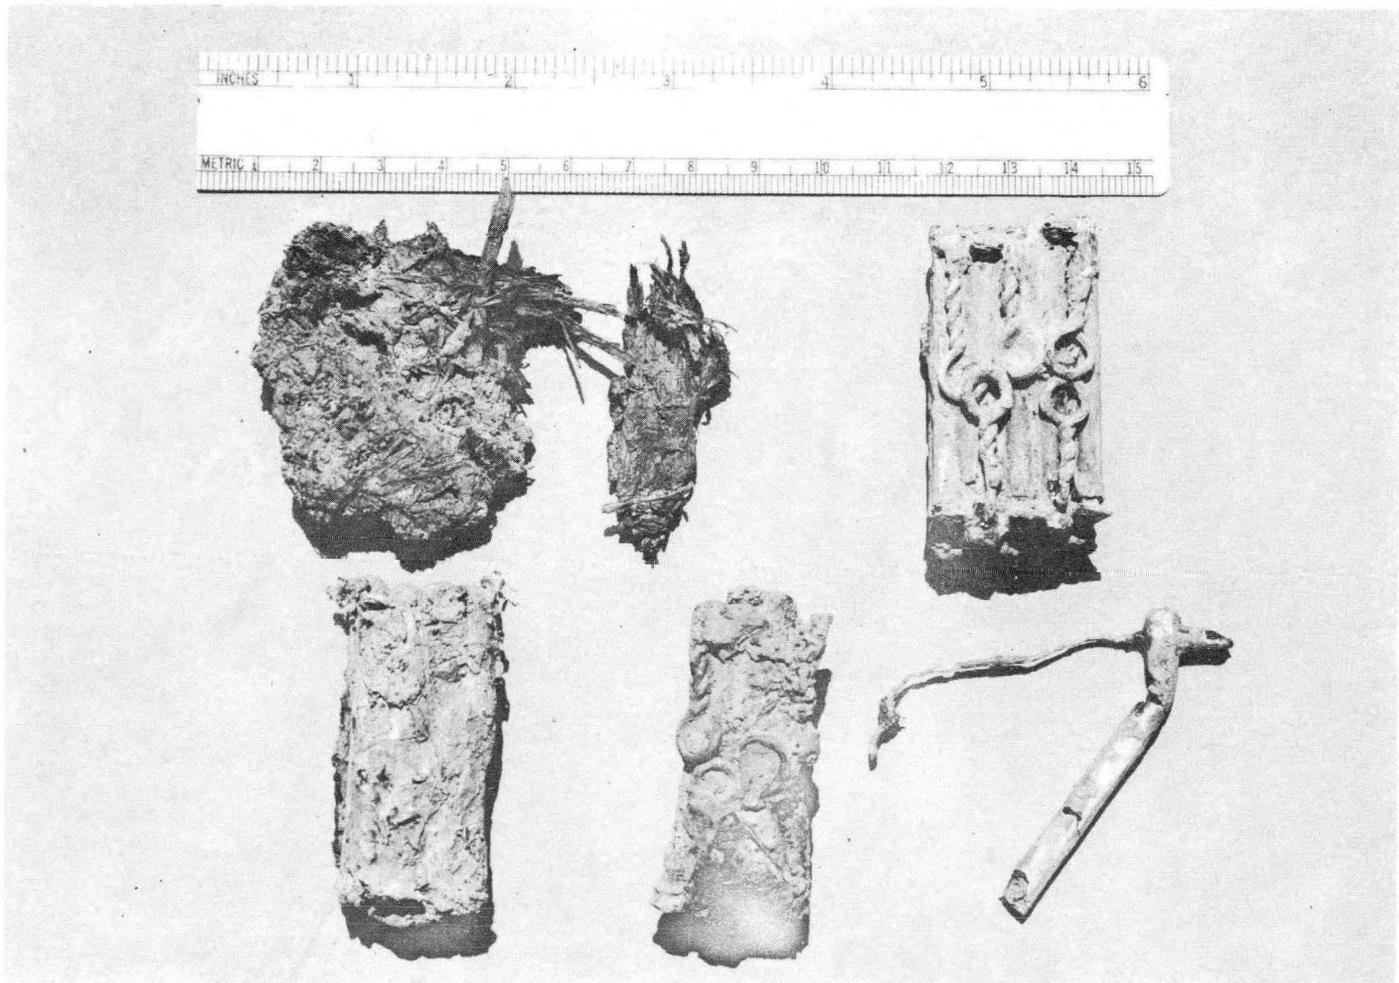
Figure 33.--Brass friction primers for cannon. Top left: straw found packed around primers; bottom left: primers wrapped in newspaper; top right: cleaned package of primers; bottom right: primer which malfunctioned when the pull ring straightened out instead of pulling out.
