HISTORIC STRUCTURE REPORT
ARCHITECTURAL DATA SECTION

CHIEF FACTOR'S HOUSE
KITCHEN
WASH HOUSE
FLAGPOLE
BELL POLE

L FORT VANCOUVER NATIONAL HISTORIC SITE
VANCOUVER, WASHINGTON

1974

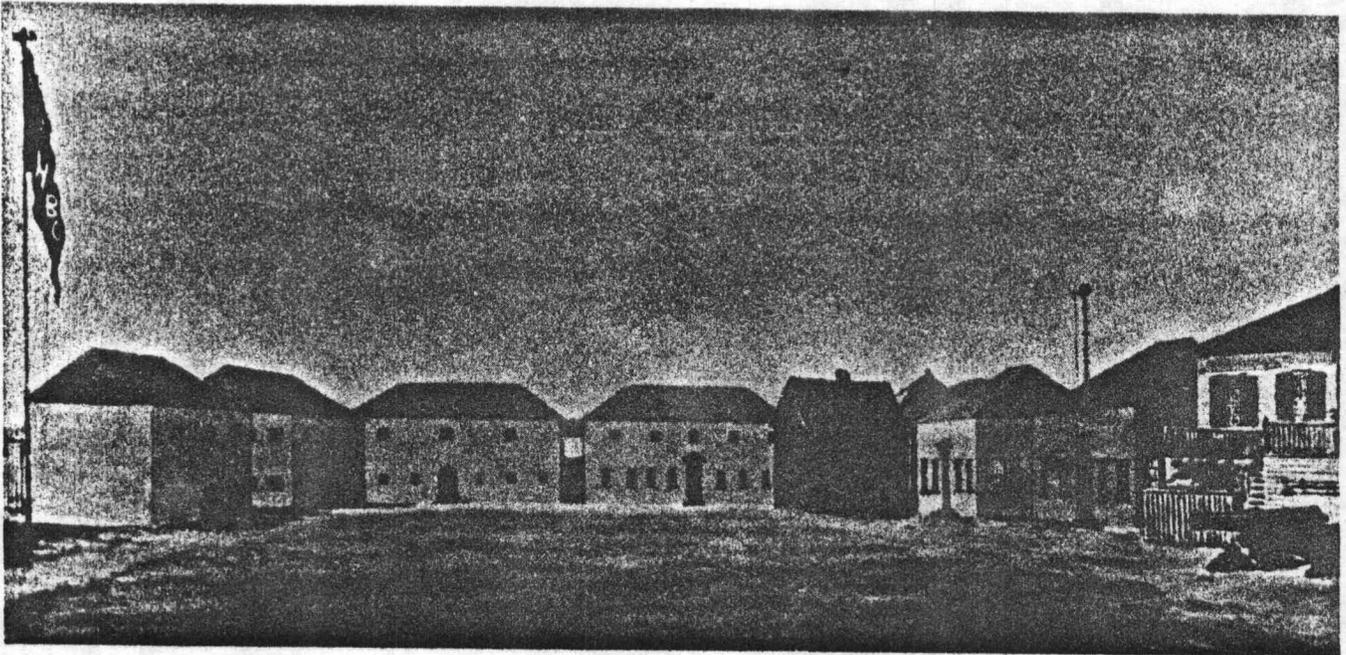
PLATE 5 —Fort Vancouver from the North, July 2, 1851, Drawn by George Gibbs.
From collection of photographs entitled "Drawings by George Gibbs in the Far North-
west, 1849-1851," in the American Bureau of Ethnology, Smithsonian Institution.

Gibbs, 1851, Plate 5 both show the roof of the Kitchen over the top of the palisade. Each sketch indicates a building smaller than, and with a ridge line a little above the eaves line of the Chief Factor's house, which is approximately 20 ft. above ground. This would indicate that the kitchen was the usual 1-1/2 story structure with floor beams three or four feet below the eaves girt and with head room below collar beams in the loft.

The appearance of the Kitchen during the historic period is largely conjectural, except that contemporary sketches, Plates 4 and 5 indicate that the structure had gable ends and was roofed with boards laid full length with the slope of the roof. The structure, as almost universal with Hudson's Bay Company establishments, most probably was post-on-sill with log infill. (7)

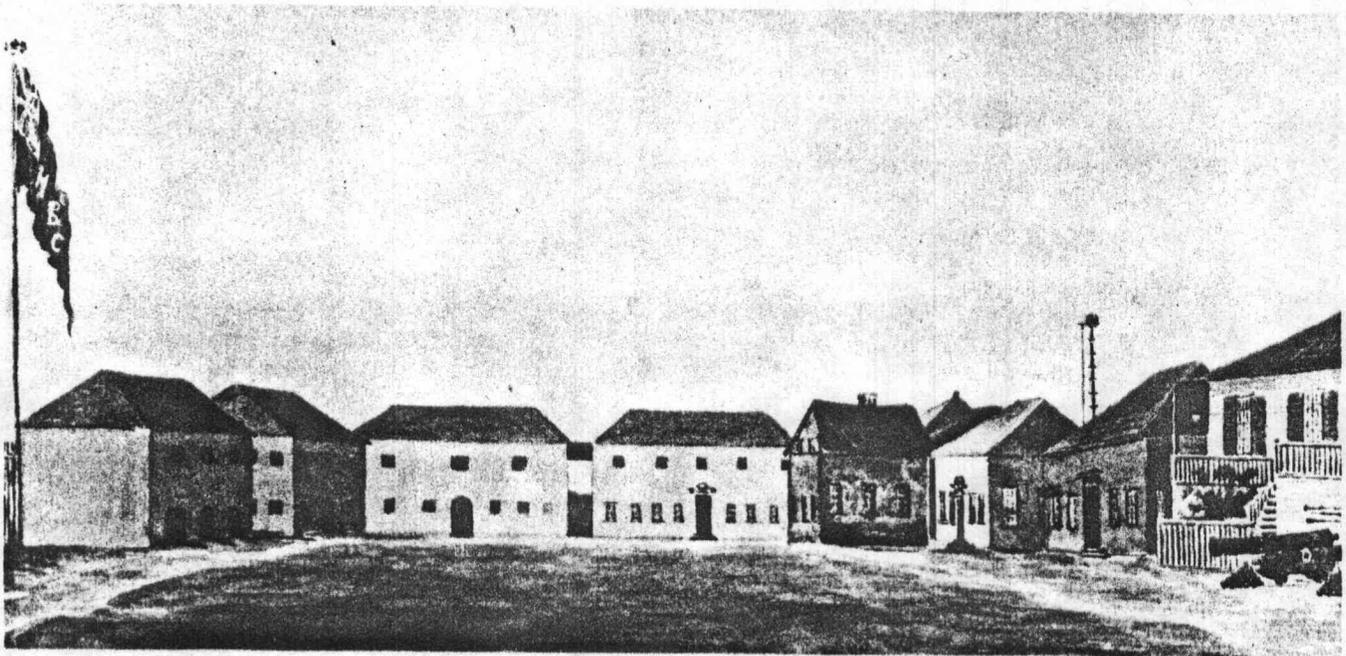
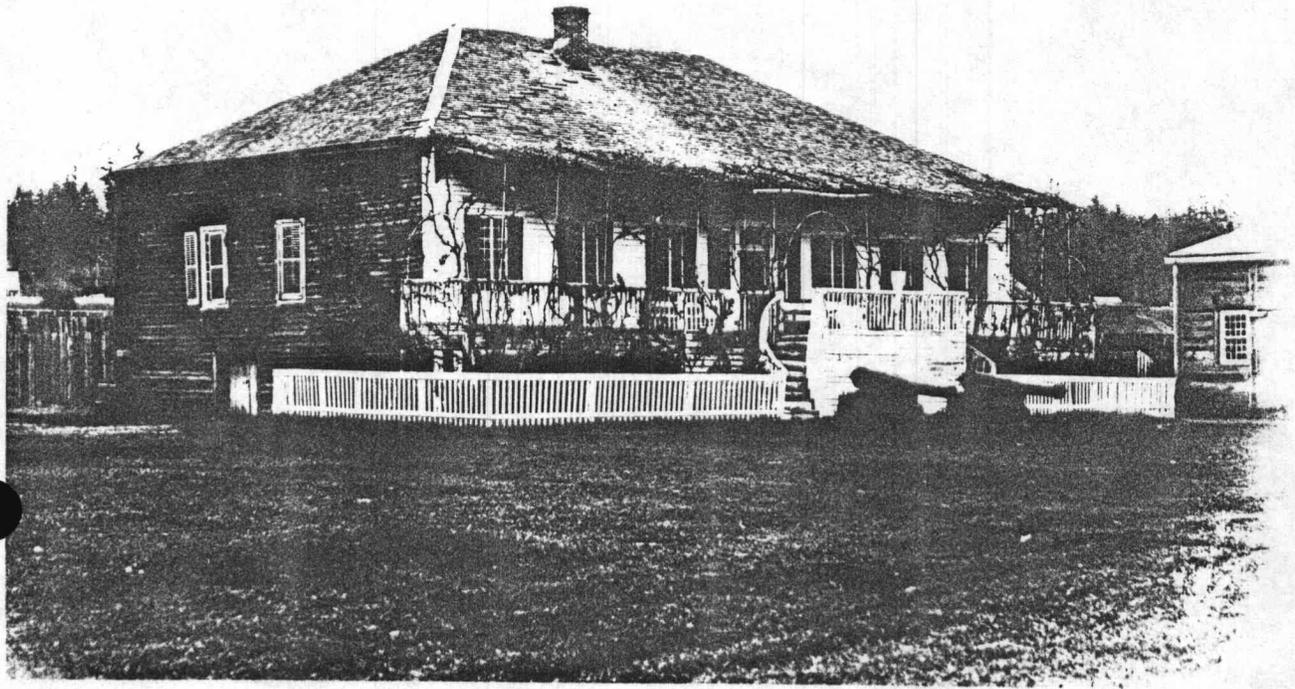
PLATE 6

a. Colored photograph made in 1928 from the original watercolor sketch.

b. Water color copy made in 1928 from the original water color sketch made by Lt. T. P. Coode, c. 1846-47.

Fort Vancouver, Washington

c. 1846, Plate 6, indicates an overhang of about 3 feet and does not show any brackets or iron supports for the roof, whereas the 1860 photograph shows the roof extended over the width of the porch and braced by brackets and, questionably, supported by the iron bars. Historically the porch was reconstructed in 1845 or 1846--only 7 or 8 years after completion of the building. Rather than poor construction, it would seem more probable that the porch deteriorated from exposure to the dampish climate along the Columbia and water running off directly onto the porch. The questionable support from the iron bars and brackets will create serious structural problems in the reconstruction of this feature.

The bell pole is most clearly depicted in the Coode watercolor sketch, Plate 6. It shows the pole with spaced cleats to facilitate climbing the spar. On top of the spar is a bell with a cantilevered arm and a line for activating the bell. The Coode sketch also indicates a wheel to activate the bell, but reliance apparently was placed on the lever arm for this purpose.

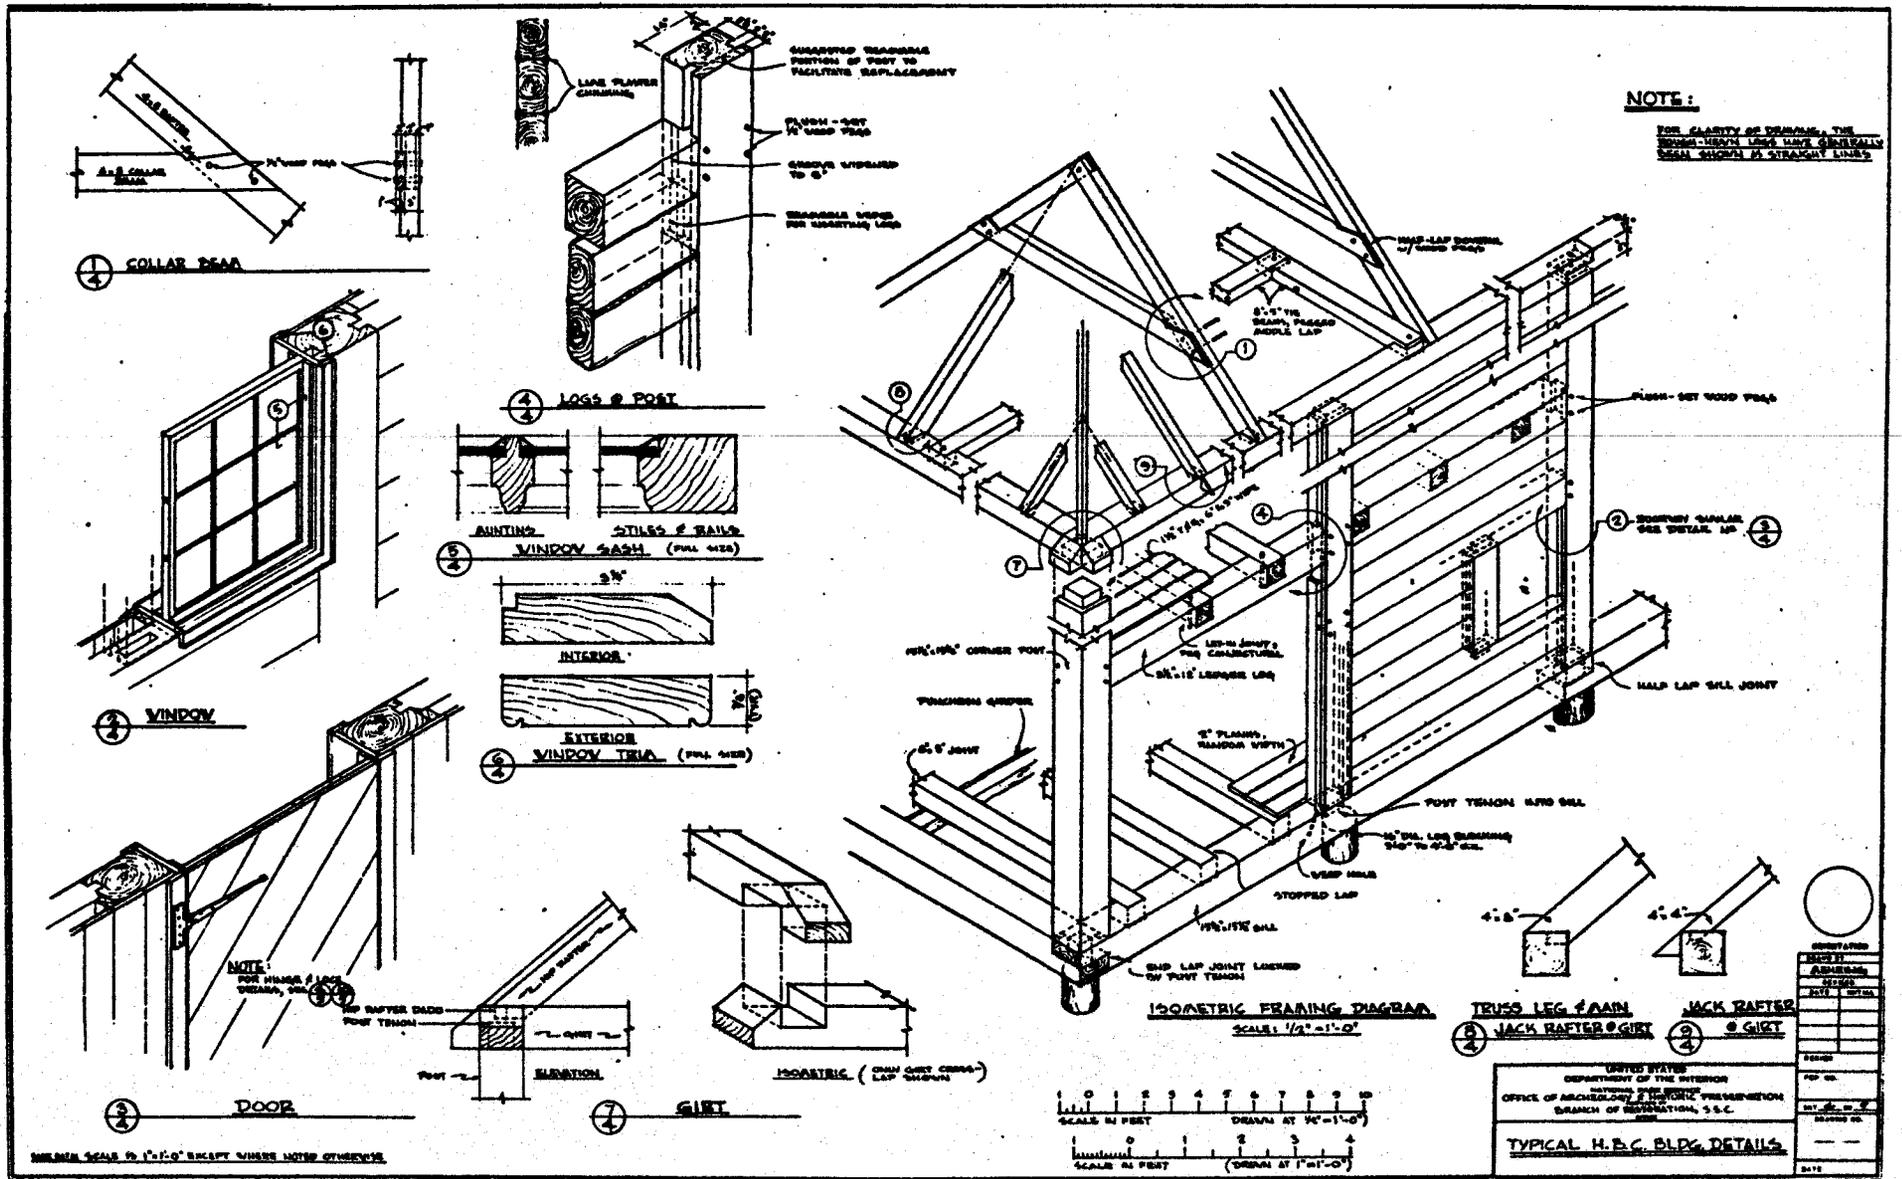
NOTE:
 FOR CLARITY OF DRAWING, THE JOINTS BETWEEN LINES HAVE GENERALLY BEEN SHOWN AS STRAIGHT LINES.

① COLLAR BEAM
