HISTORIC GROUNDS REPORT 001279

PORTIONS OF SHENANDOAH AND POTOMAC STREETS
AND THE ARSENAL SQUARE

Harpers Ferry National Historical Park

May 1965

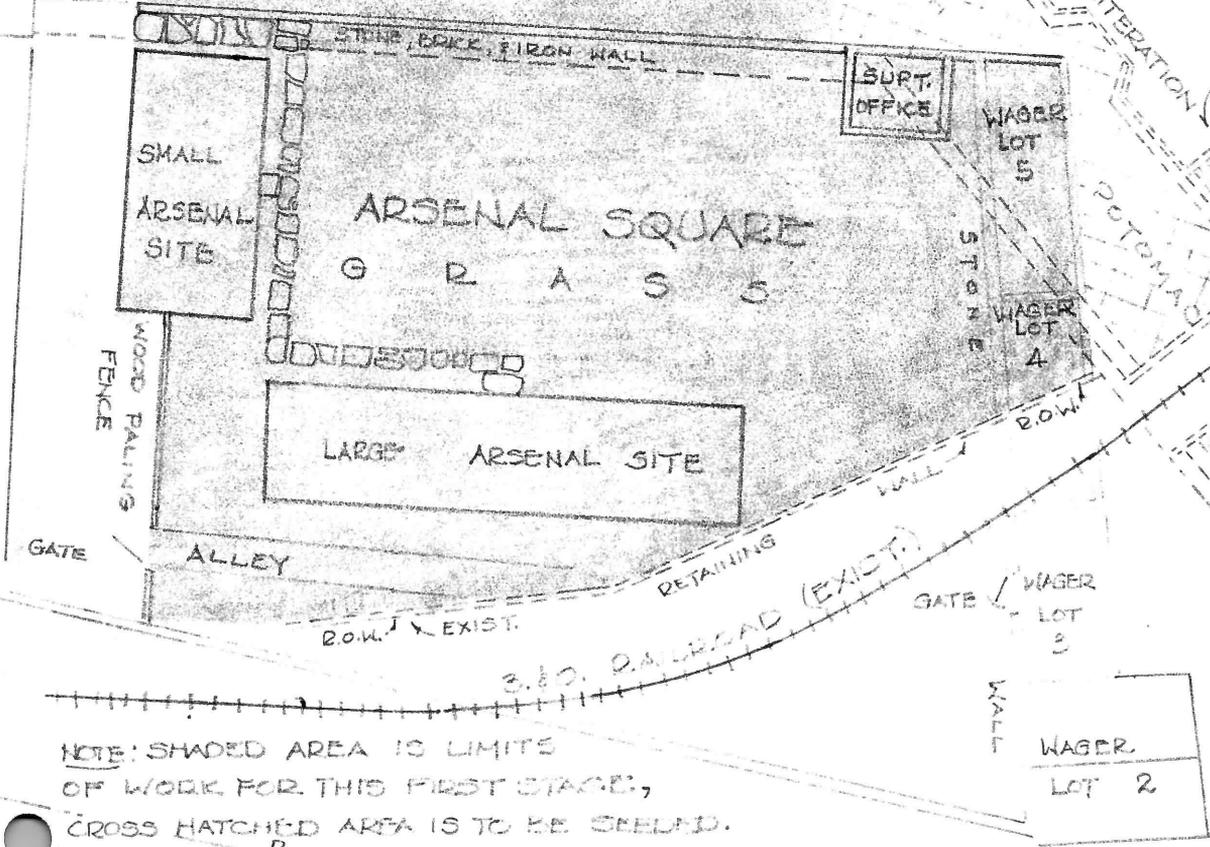
GROUND'S RESTORATION - FIRST STAGE

NOTE: SHADED AREA IS LIMITS OF WORK FOR THIS FIRST STAGE;
 CROSS HATCHED AREA IS TO BE SHELDED.
 R.O.W.

On the following page an unnumbered vicinity map indicates the limit of work that can be included at this time. The reader should also consult the Historical Base Map - 1859 (NM-HF 3021) and Plan of Existing Conditions, February 1958 (NM-HF 3016).

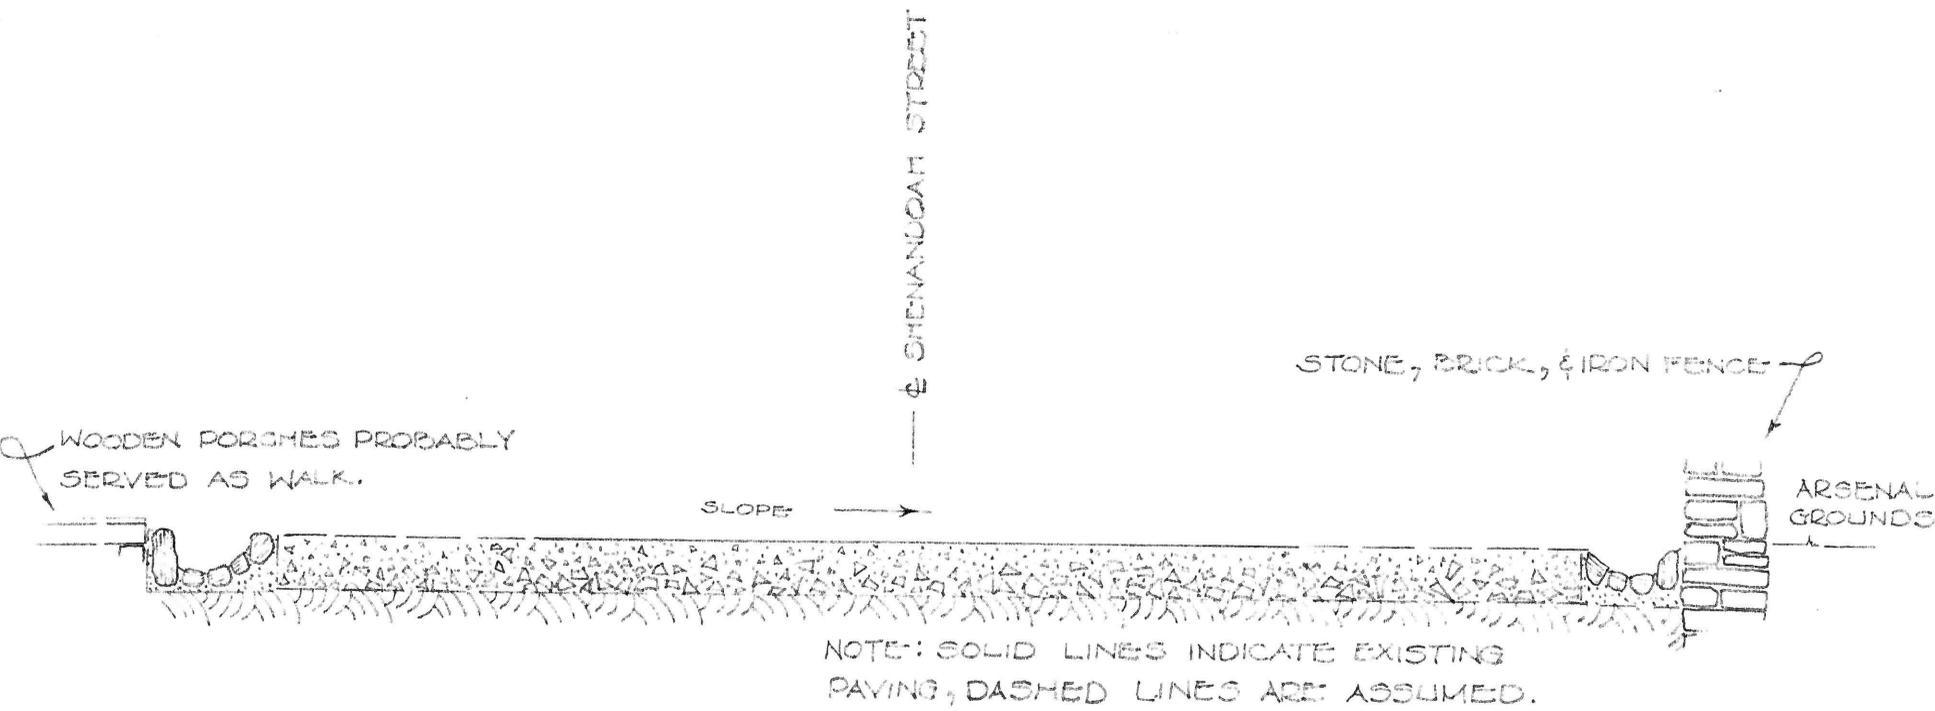
TYPICAL MACADAM PAVING ON
SHENANDOAH STREET

SCALE: 1" = 5'-0"

Shenandoah Street - Shenandoah Street should be restored as a waterbound macadam street at grades that were determined by archeological digs. The stone gutter on the east side (Arsenal Grounds) of Shenandoah Street should be restored as they probably appeared in the 1859-1865 period, although there is no concrete evidence to substantiate this at the present time. The wall and stone gutter on the west side of Shenandoah Street should not be done at this time due to the necessary future investigation to Building Nos. 9, 10, 11, and 12.

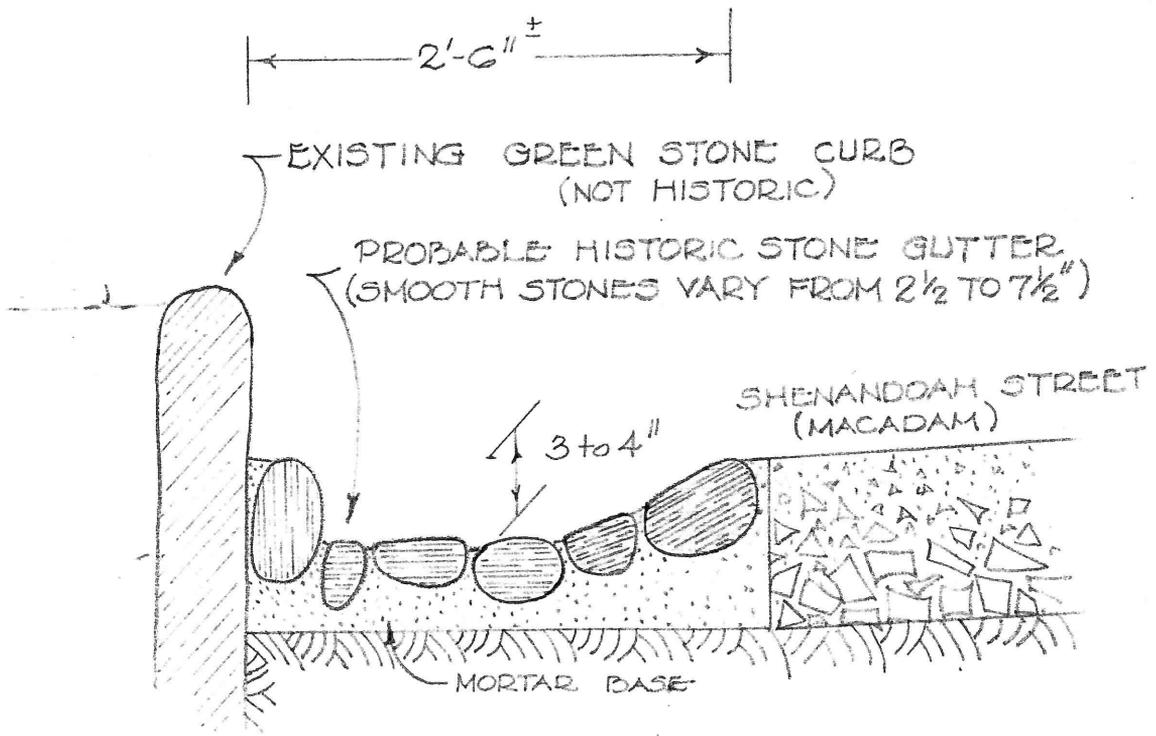
EXISTING TYPICAL STONE GUTTER SECTION

SCALE: 1" = 1'-0"

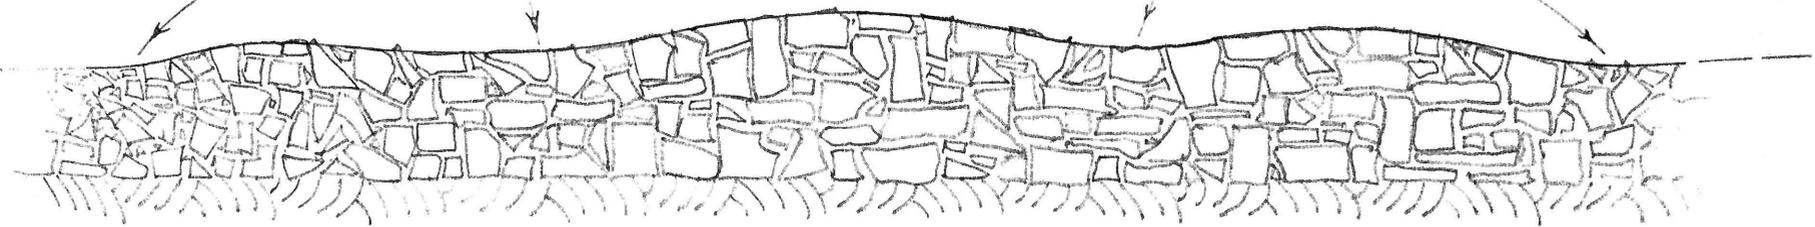
TYPICAL SECTION - POTOMAC STREET

WAGON WHEEL IMPRESSIONS

COMPRESSED STONES OF VARIOUS SIZES, VERY HARD AND STABLE ROADBED. PROBABLY 95% STONES, VERY LITTLE FINES OR SOIL. WIDTH OF STREET VARIES AS DOES THE THICKNESS OF PAVING.

Potomac Street - North Potomac Street should be restored to the original grade as was determined by archeological excavation. Due to the hardness and compactness of the historic roadbed, little if any repair is needed, except to remove minor silt that now covers

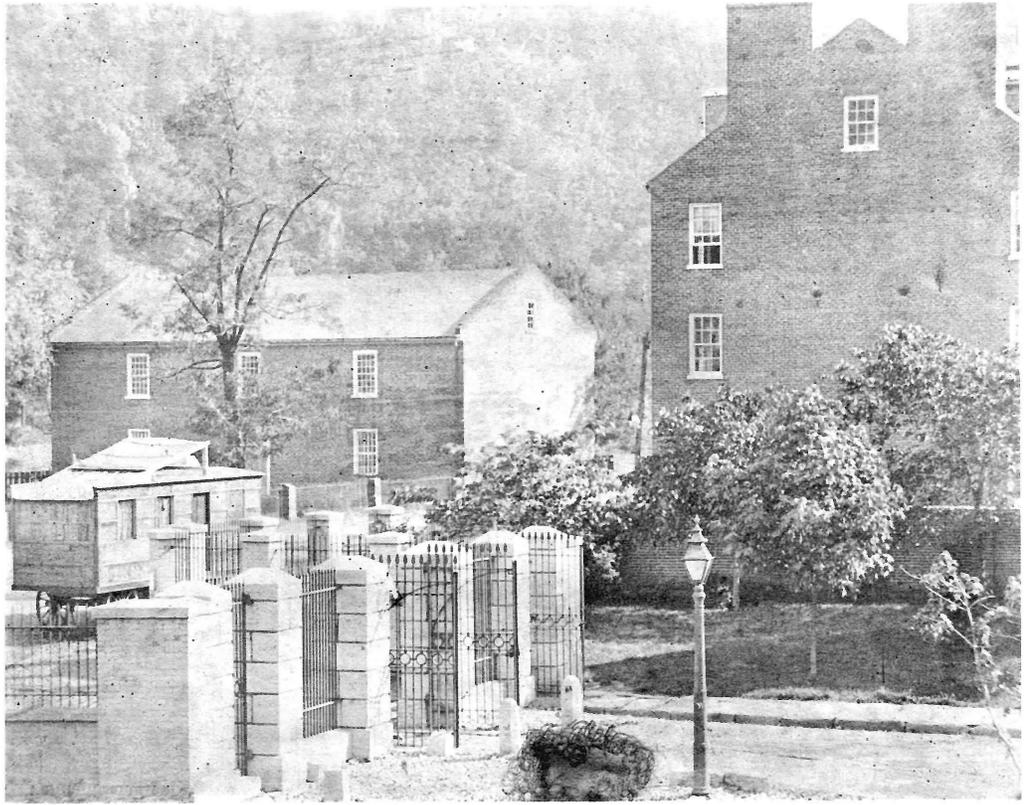
ILLUSTRATION NO. 1

Across Shenandoah Street and just to the left of Building No. 9 stands the small arsenal. Note the three windows in the second story on the east side, and also two windows and a door on the first floor (door partially hidden by the tree). A stone, brick, and iron fence encloses the street front of the Arsenal Square, and to the left of the small arsenal is to be seen a portion of the wood paling fence that enclosed the yard on the west side. The lamp post is the basis for the design shown on Illustration No. 4.

An example appears on Illustration No. 1.

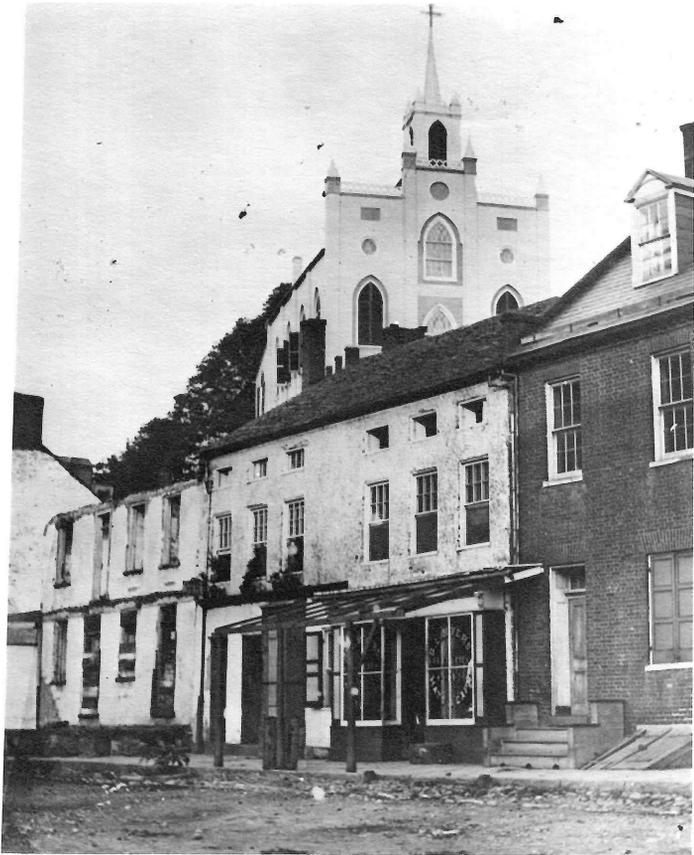
ILLUSTRATION NO. 2

The photograph shows the north side of Shenandoah Street where there appears to be a good sidewalk and possibly a curb. The street itself appears to be dirt. Lamps, hitching posts, and utility pole lines are completely missing in this picture.

This photograph confirms Illustration No. 2 that there were no utility pole lines along the street.

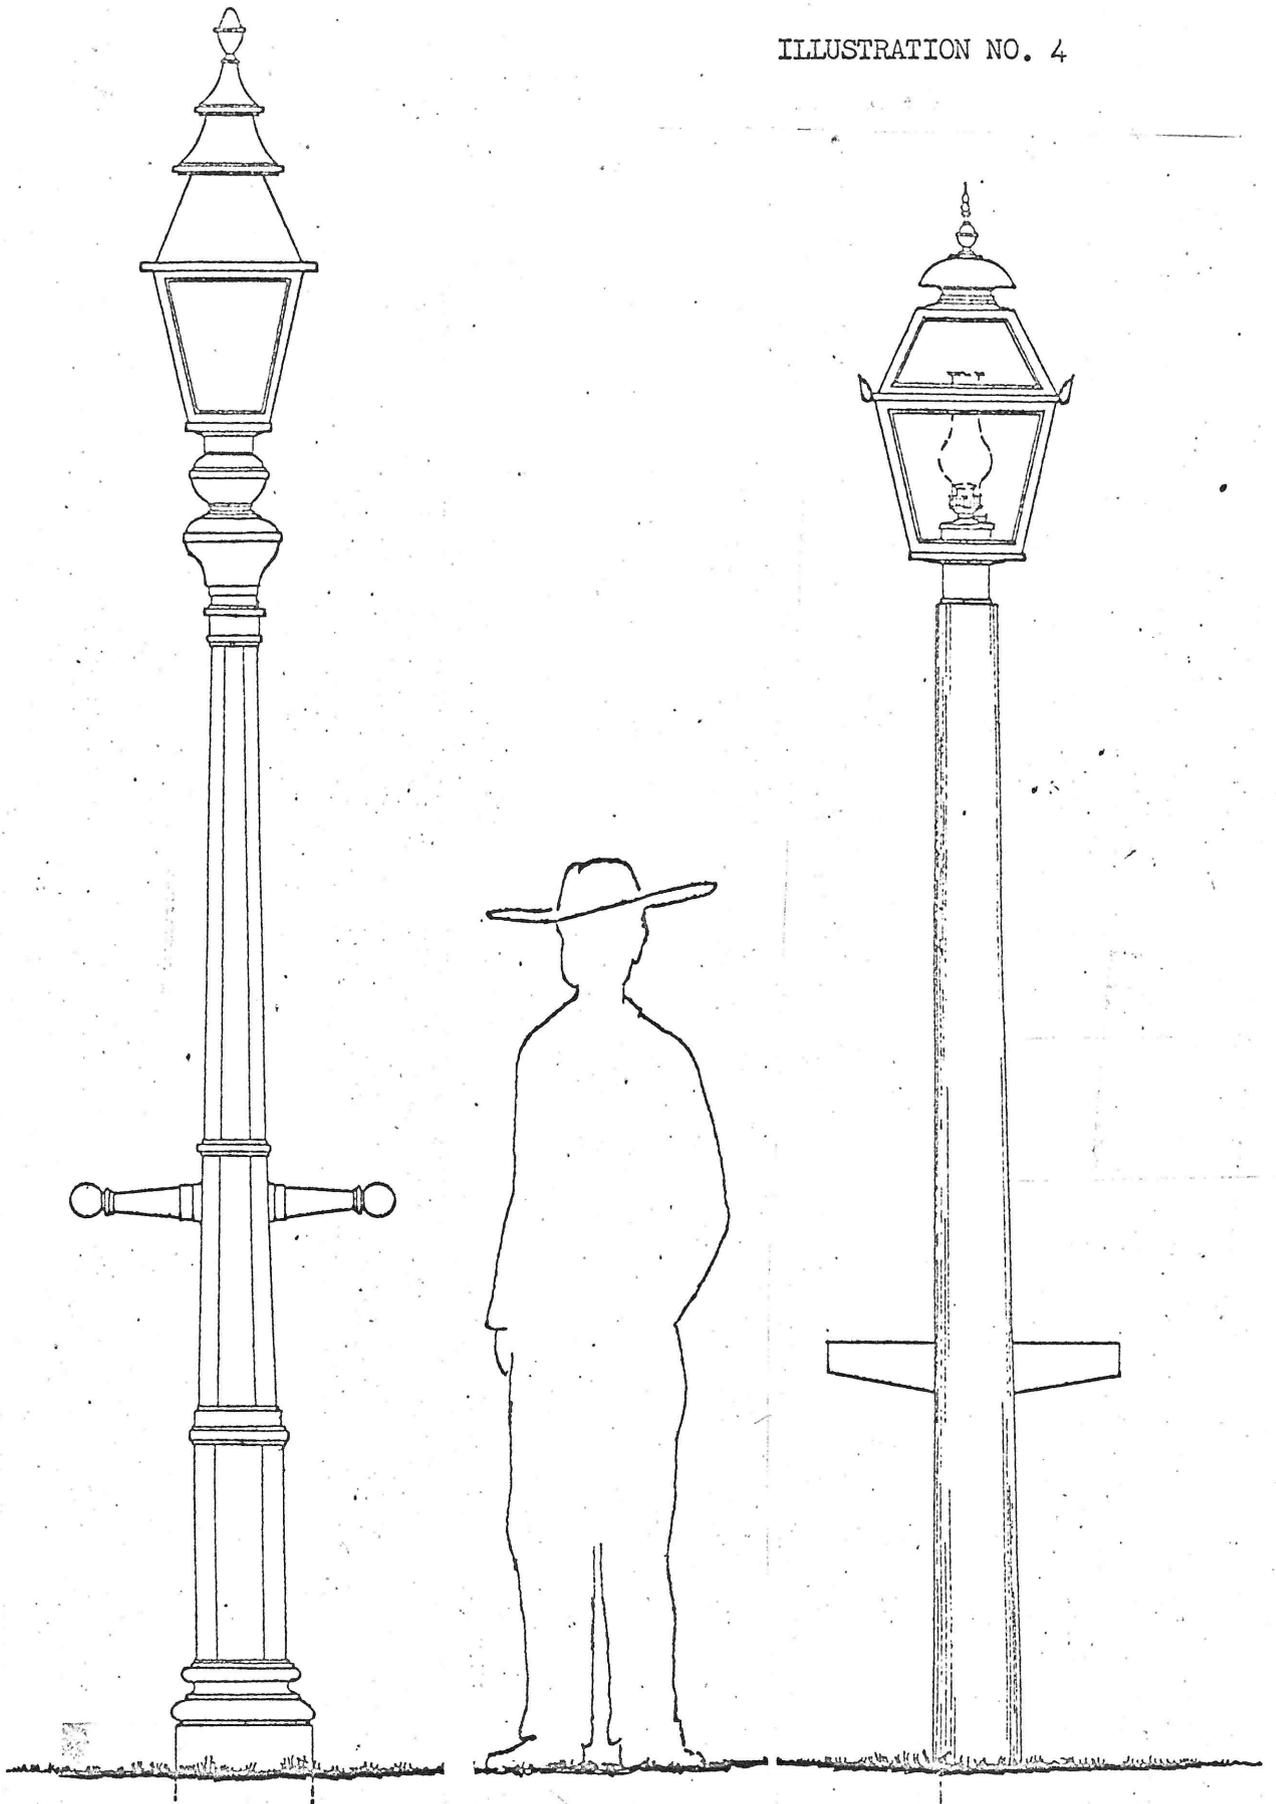
ILLUSTRATION NO. 4

The proportions and details of these Lamp Posts were determined by photographs and are purely conjectural.

IRON LAMP POST

WOOD LAMP POST
