Landscape Management Plan Bathhouse Row

landscape management plan
bathhouse row

BATHHOUSE ROW
HOT SPRINGS NATIONAL PARK • ARKANSAS

UNITED STATES DEPARTMENT OF THE INTERIOR / NATIONAL PARK SERVICE

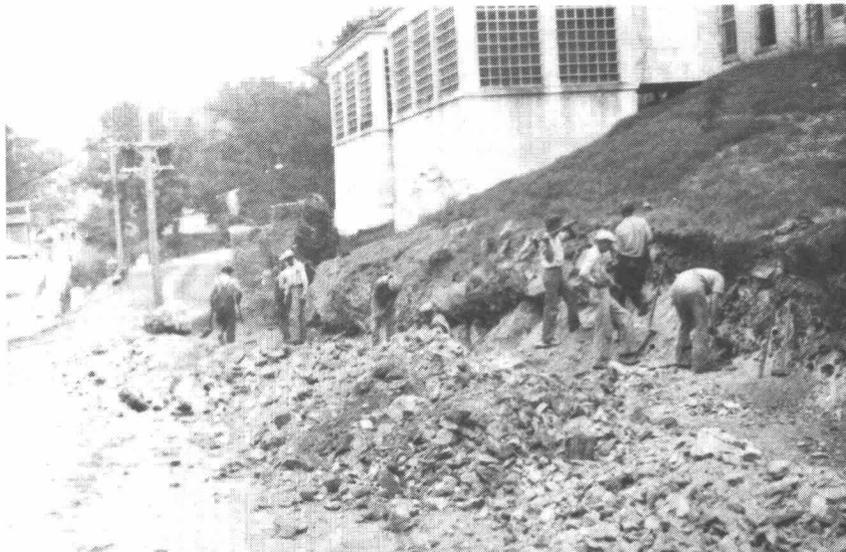
Figure 6. Grand Promenade cut near Army and Navy Hospital, early 1930s
(Source: Hot Springs National Park)

Construction of the Grand Promenade was begun in the early 1930s, but despite repeated requests from the superintendent, funding for the promenade was omitted from the 1935 and 1936 programs. Although the alignment grading was virtually completed, the project was stopped. The Grand Promenade project had been hindered throughout the 1930s by numerous design changes and delays occasioned by a variety of engineering problems. It is also likely that the reorganization of the Park Service, the popular view of national parks as "natural" entities, and escalating costs heavily influenced the director's decision to abort the project at this point.

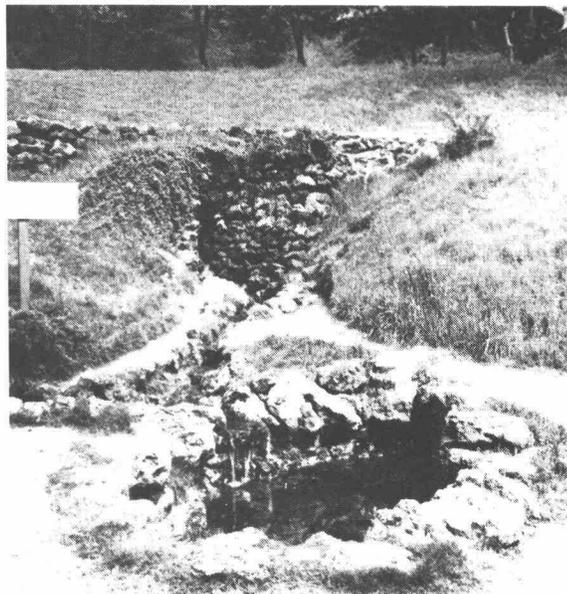
Figure 7. Display spring behind the Maurice Bathhouse, date unknown
(Source: Hot Springs National Park)

Early in the period it was proposed that a well, previously drilled in the area between the Fordyce and Quapaw bathhouses, be used to supply water for an elaborate glass and iron fountain so visitors could see a "natural" spring in action. After several months of debate and many different proposals, the idea of a formal fountain was dropped and designs were completed for a display pool between the Maurice and Fordyce bathhouses. Two seeps were led together to run over small cascades of tufa masonry into a small pool and from there into the Hot Springs Creek arch.

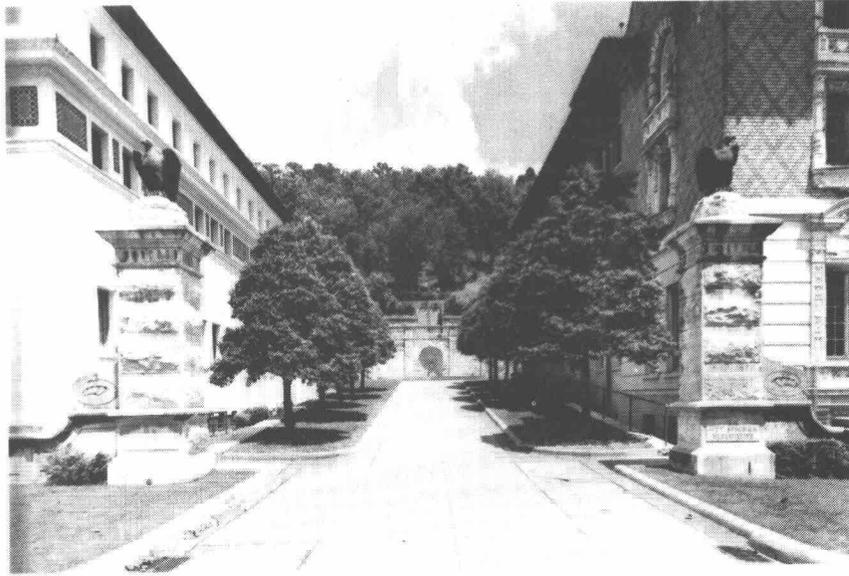
Figure 8. Historic main entrance, 1984
(Source: Historic American Buildings Survey)

In 1951 an elevated area of ground once used as a band platform was removed from the Arlington Lawn, and the area was graded, seeded, and sodded. The nearby stone steps and retaining wall were renovated, and vegetation was cut to allow better visibility. In 1958 the main entrance was further altered by removal of the concrete oval quadrants, the base of the old exedras. These were replaced with low plantings and ground cover. The drive was reworked to change it to a pedestrian walkway and prevent use by vehicles.

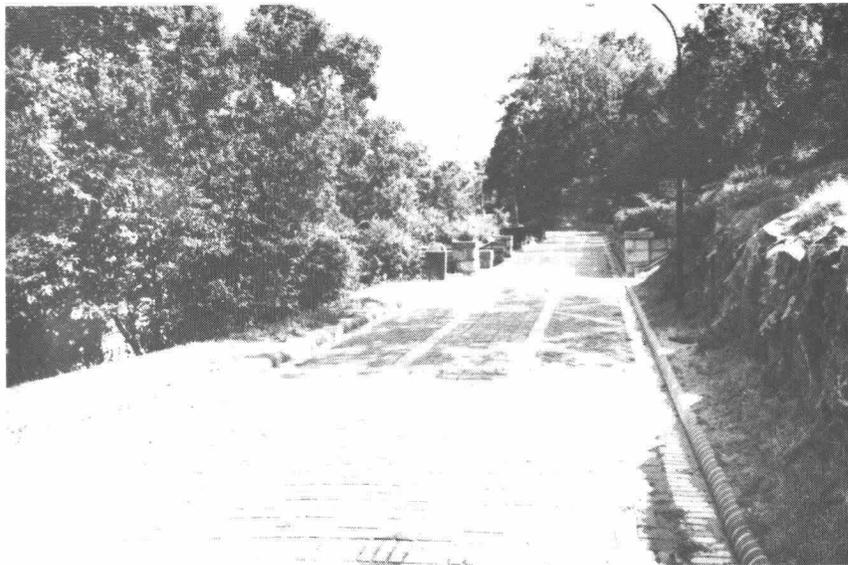
Figure 9. Grand Promenade, looking north, 1984
(Source: Historic American Buildings Survey)

During the 1950s, the promenade proposals were revived, additional changes were made in the plans, and the project was finally completed in 1959. For the most part, a simplified version of the 1930s and 1940s plans and alignments was used. The elaborate cascade was omitted, the walkway width was reduced, the terrace just north of the Fordyce was graded back, and the new promenade structures were integrated into the Stevens Balustrade and the main entranceway. The superintendent's residence was razed, and the area was graded prior to the final work on the north end of the promenade. A modest, naturalistic cascade of hot water was added near the north end of the promenade late in the period, long after promenade completion. Although various proposals were made to improve the rear view of the bathhouses as seen from the new Grand Promenade, these plans were never implemented. Instead, over the years the vegetation along the promenade was allowed to grow, closing off the view in all but a few areas.

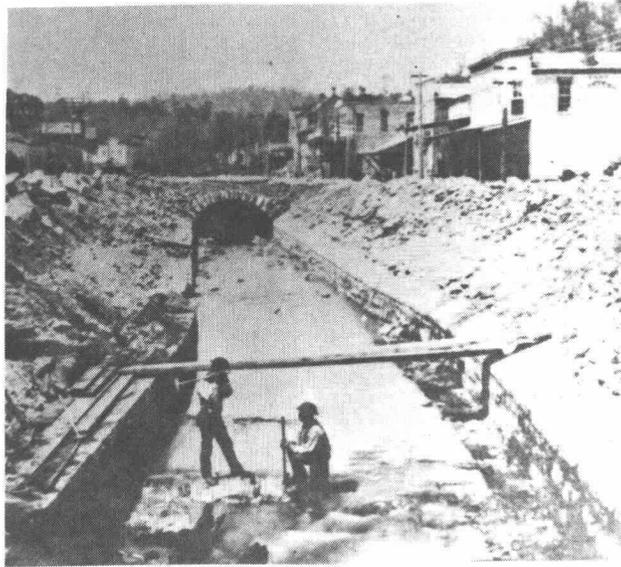
Figure 10. Construction of the Hot Springs Creek arch, 1883-84
(Source: Garland County Historical Society; cited by Brown 1982, p. 36)

first, dating from around 1877 to 1884, occurred when the Hot Springs Commission laid out the town and defined areas where development should occur. Shortly thereafter, Hot Springs Creek was arched over and the narrow, circumscribed valley floor was leveled, creating a unified linear landscape space in front of and including the row of Victorian style bathhouses.

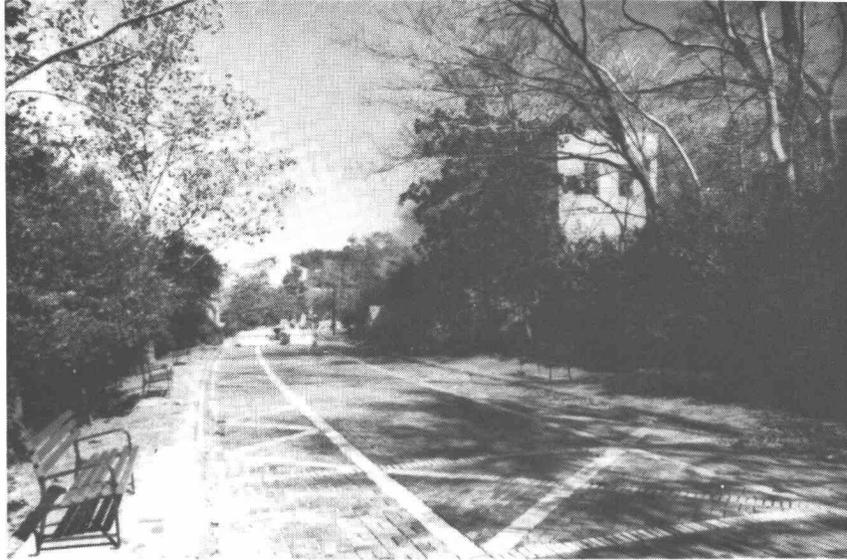
Figure 12. Grand Promenade, looking north, 1984
(Source: Hot Springs National Park)

The third and final phase of development that significantly defined landscape spaces began during the 1930s. Design and construction was confined to the upper terrace and involved creation of a brick-paved Grand Promenade with sitting areas, fountains, vista points, and three major architectural entrances.

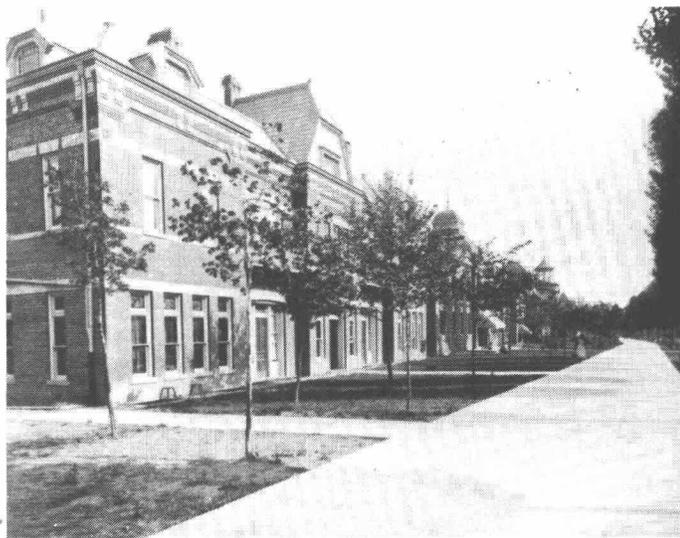
Figure 13. Bathhouse Row, ca. 1894-95 (note double row of trees along inside of promenade) (Source: Mitchell, Scenes in Arkansas, 1896)

Turn-of-the-century gardens were highly structured architectural spaces. One of the strengths of this period, the long axial element that tied garden spaces together, was borrowed from the French style. Stevens formalized the Magnolia Promenade in this style as a tree-lined pedestrian axis along the entire length of Bathhouse Row.

To reestablish the visual image and connection with Bathhouse Row that existed in the early 1900s, and to make the main entrance more inviting for evening use, the existing light standards should be replaced with contemporary five-globe lights (see fig. 13 for style and Plan E for locations). Reestablishing water service to the shell fountain will also enhance the balustrade, and no additional directional signs should be introduced in this area.

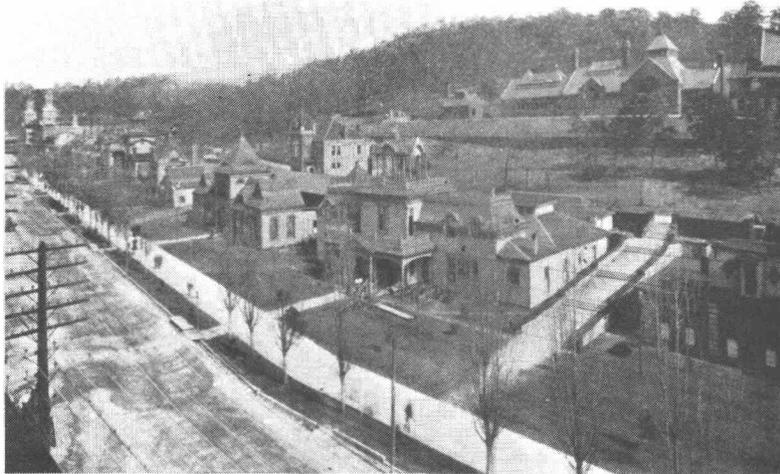
Figure 14. Bathhouse Row, with the south park beyond, ca. 1896 (the south park is pictured directly behind bathhouses and stone stairs) (Source: *Cutter's Guide*, 1896)

The south park, later known as Reserve Park, extended from the Government Free Bathhouse south to Reserve Avenue. Bordered by the bathhouse supply road and the Army and Navy Hospital grounds, this park was accessed by stone stairs and landings that extended up the hillside between the Ozark and Rammelsburg bathhouses. Here the "natural plantings" – chiefly shrubbery and lawns – provided an open green expanse in contrast to the large Army and Navy Hospital structures above.

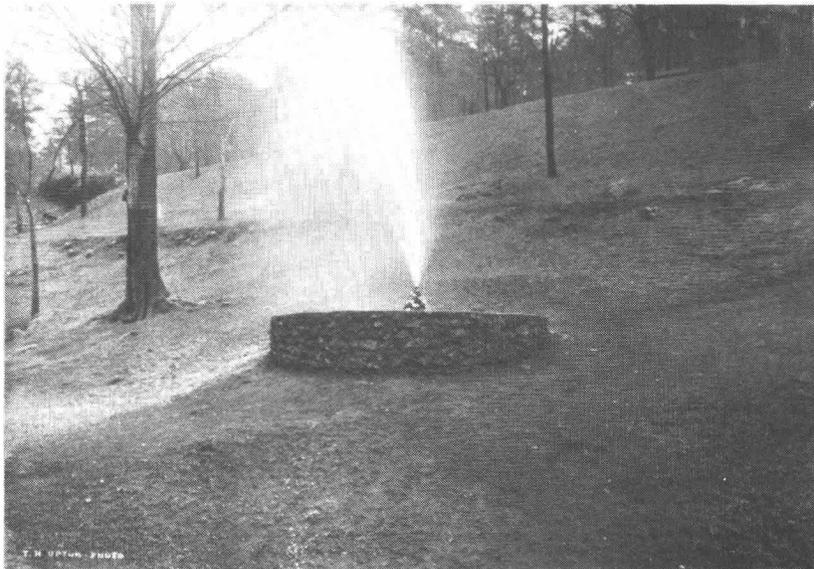
Just to the north of the foreground park was the tufa park, which continued around the mountainside to a point adjacent to and behind the Arlington Hotel. In this park the natural features of the tufa were left exposed, and plantings of vines and shrubbery were kept to a minimum. Although the clusters of wooden cooling tanks were still visible behind the various bathhouses, the unsightly system of aboveground wooden troughs and piping had been removed, the springs had been arched over with white rustic stone, and grass had been planted to complete the improvement of this area.

Figure 16a. Tufa fountain located in the tufa park, ca. 1913-1914 (Source: Hot Springs National Park)

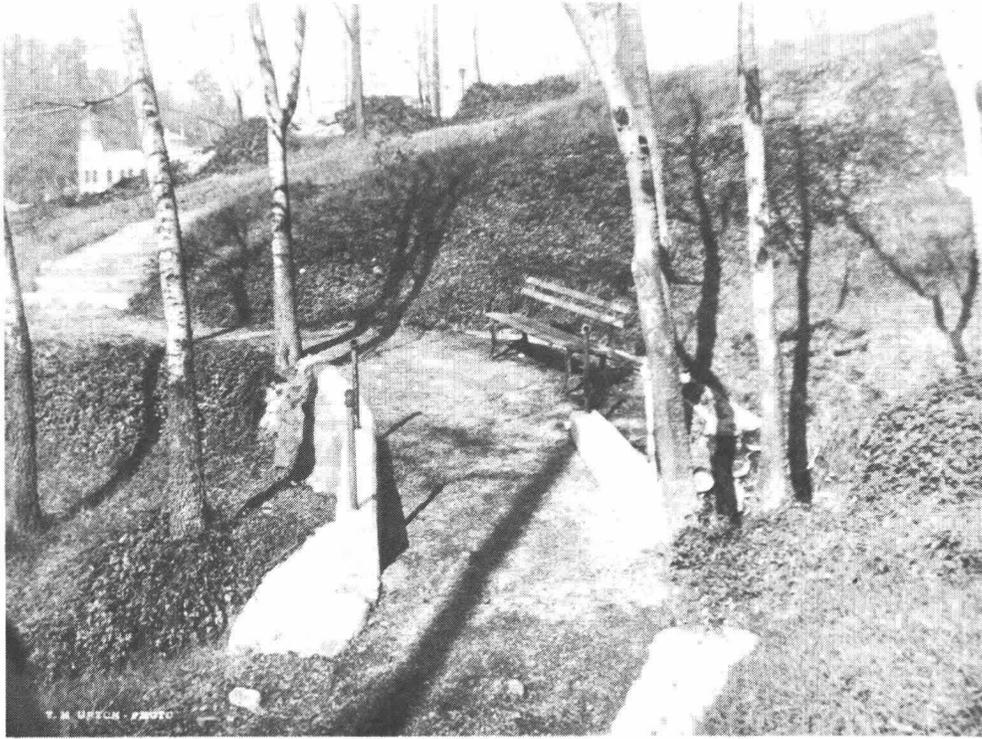
Figure 16b. Trail through tufa park, ca. 1913-1914 (Source: Hot Springs National Park)

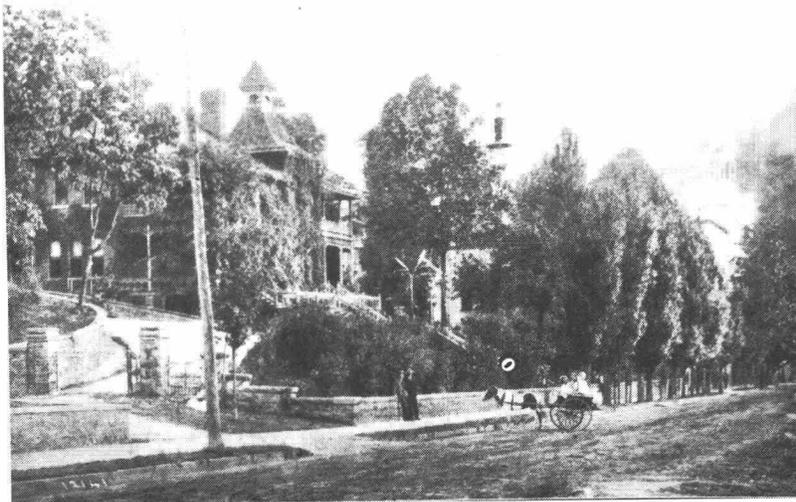
The wooded park abutted Fountain Street and the tufa park. The superintendent's office and residence were set in this park – a typically Victorian lawn and garden with vine-covered walls, exotic plants, flowering shrubs, and beds of annuals. This confined area was in turn surrounded by a natural wooded area, broken only by footpaths leading to the main road.

Figure 17. Superintendent's residence, Fountain Street, ca. 1906 (Source: Hot Springs National Park)

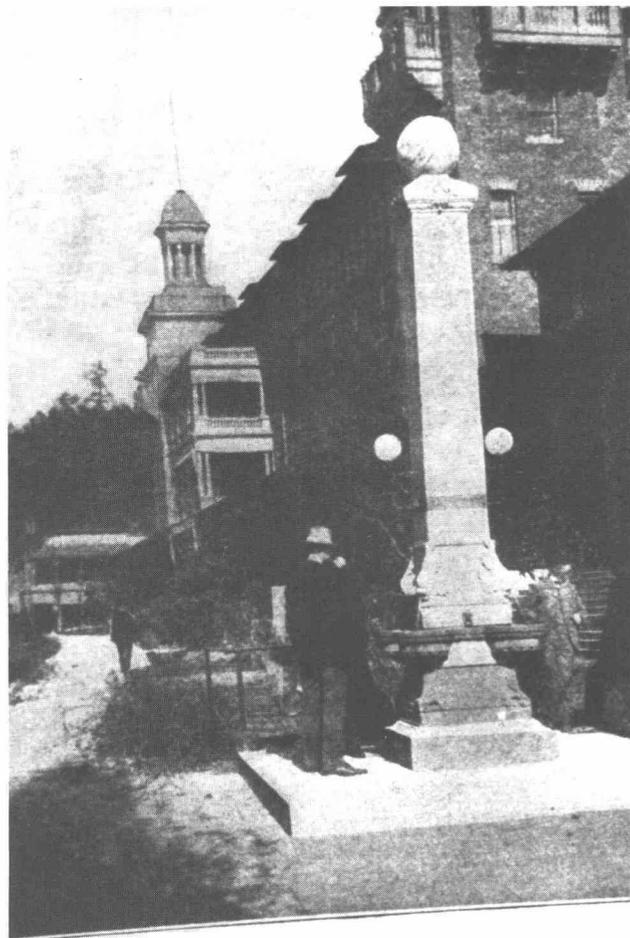
The reservation fountains were not only an ornamental part of the Victorian and post-1880s landscape but also provided hot drinking water (previously unavailable outside the bathhouses and hotels) for reservation visitors. Fountain designs were less ornate than during the Victorian period, mostly sculptured from stone and not cast iron. During the 1890s, "display" springs were formalized and structured. Several springs – among them Dripping Spring, Hale Spring, and Stevens Spring – were arched over with white limestone facades and used to provide hot water for drinking. Attractive stone and wood pavilions, since removed, sheltered Alum Spring along the promenade and Cold Spring at the Fountain Street entrance. Most of the remaining springs were covered over and diverted to bathhouse use.

Figure 19. Hoke Smith fountain, date unknown (Source: Hot Springs National Park)

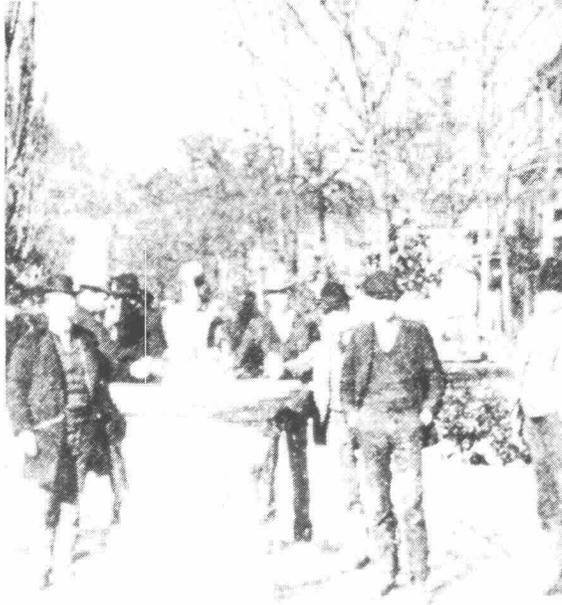
Figure 20. Noble fountain, late 1890s (Source: Hot Springs National Park)

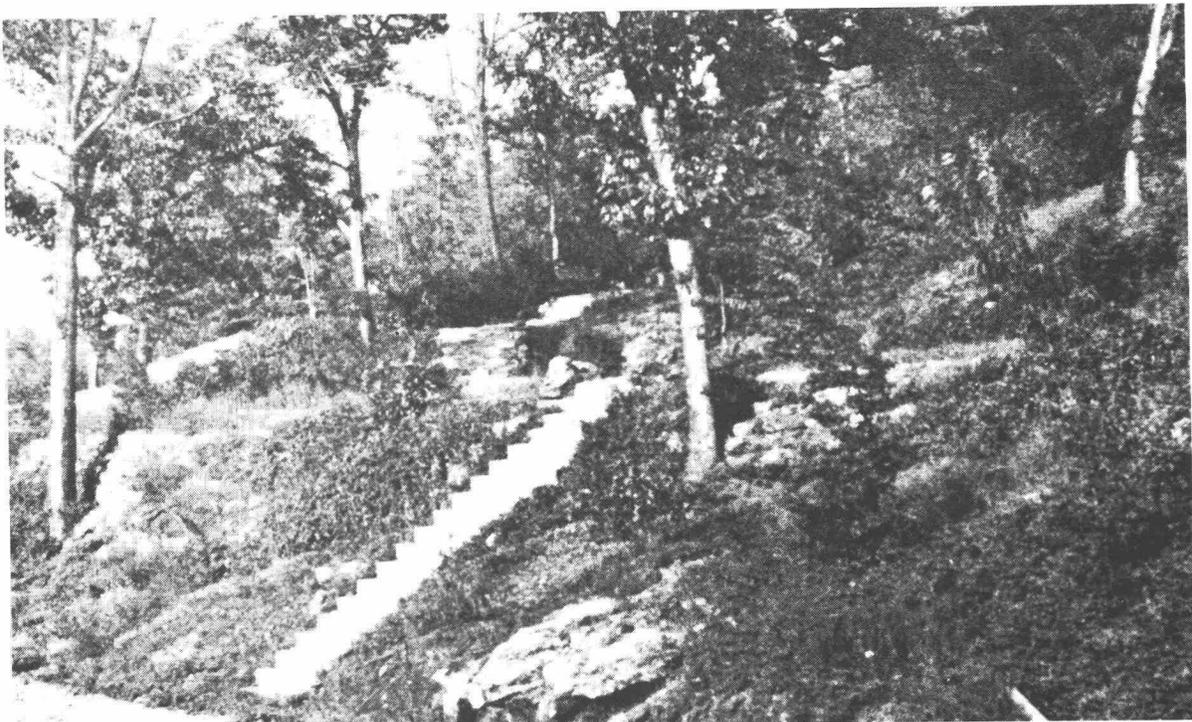
The transition from the formally defined landscape spaces to the sodded mountainside above the upper terrace was accomplished by treating the landscape in the English gardening style typical of American landscapes prior to the 1890s. Both the informal layout of trees and the predominance of plant materials in this style provided the required effect. In addition to the careful definition of landscape spaces, Stevens' planting plans used a combination of exotics, subtropical plant materials, vines, raised-massed floral plantings, and native trees such as American holly, walnut, and black gum to complete this design. Stevens recommended judicious thinning of existing trees to restore natural woodland effects and open up vistas of Hot Springs Mountain.

Figure 23. Upper terrace on Hot Springs Mountain, looking northeast at informal plantings, 1898 (Source: *Report of the Superintendent*, NPS 1878-1921)

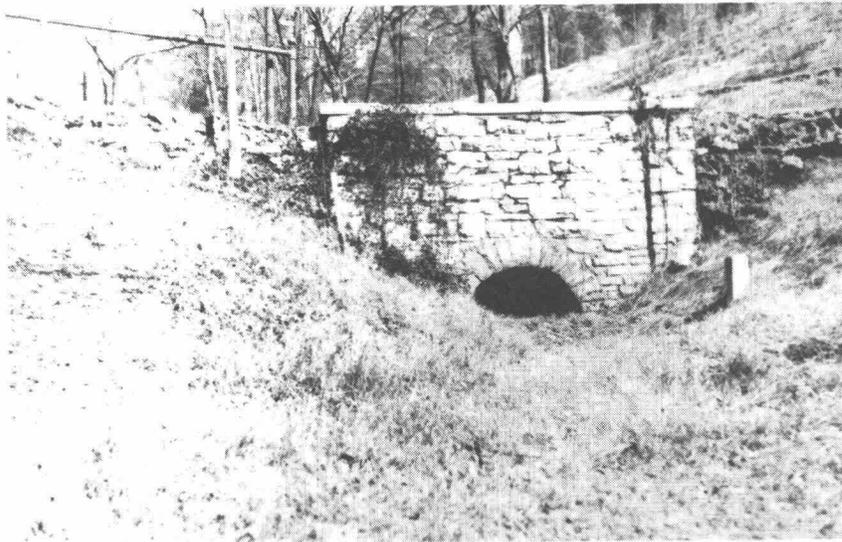
By 1900, 3-½ miles of roads had been built on Hot Springs Mountain, the largest of the three landscape spaces. Stevens designed these mountain roads and trails to be both scenic and easily maintained and to follow the natural topography of the mountainside. Attractive stone bridges and retaining walls were also built on the mountainside during the 1890s project.

Figure 24. Stone culvert on Hot Springs Mountain, date unknown
(Source: Hot Springs National Park)

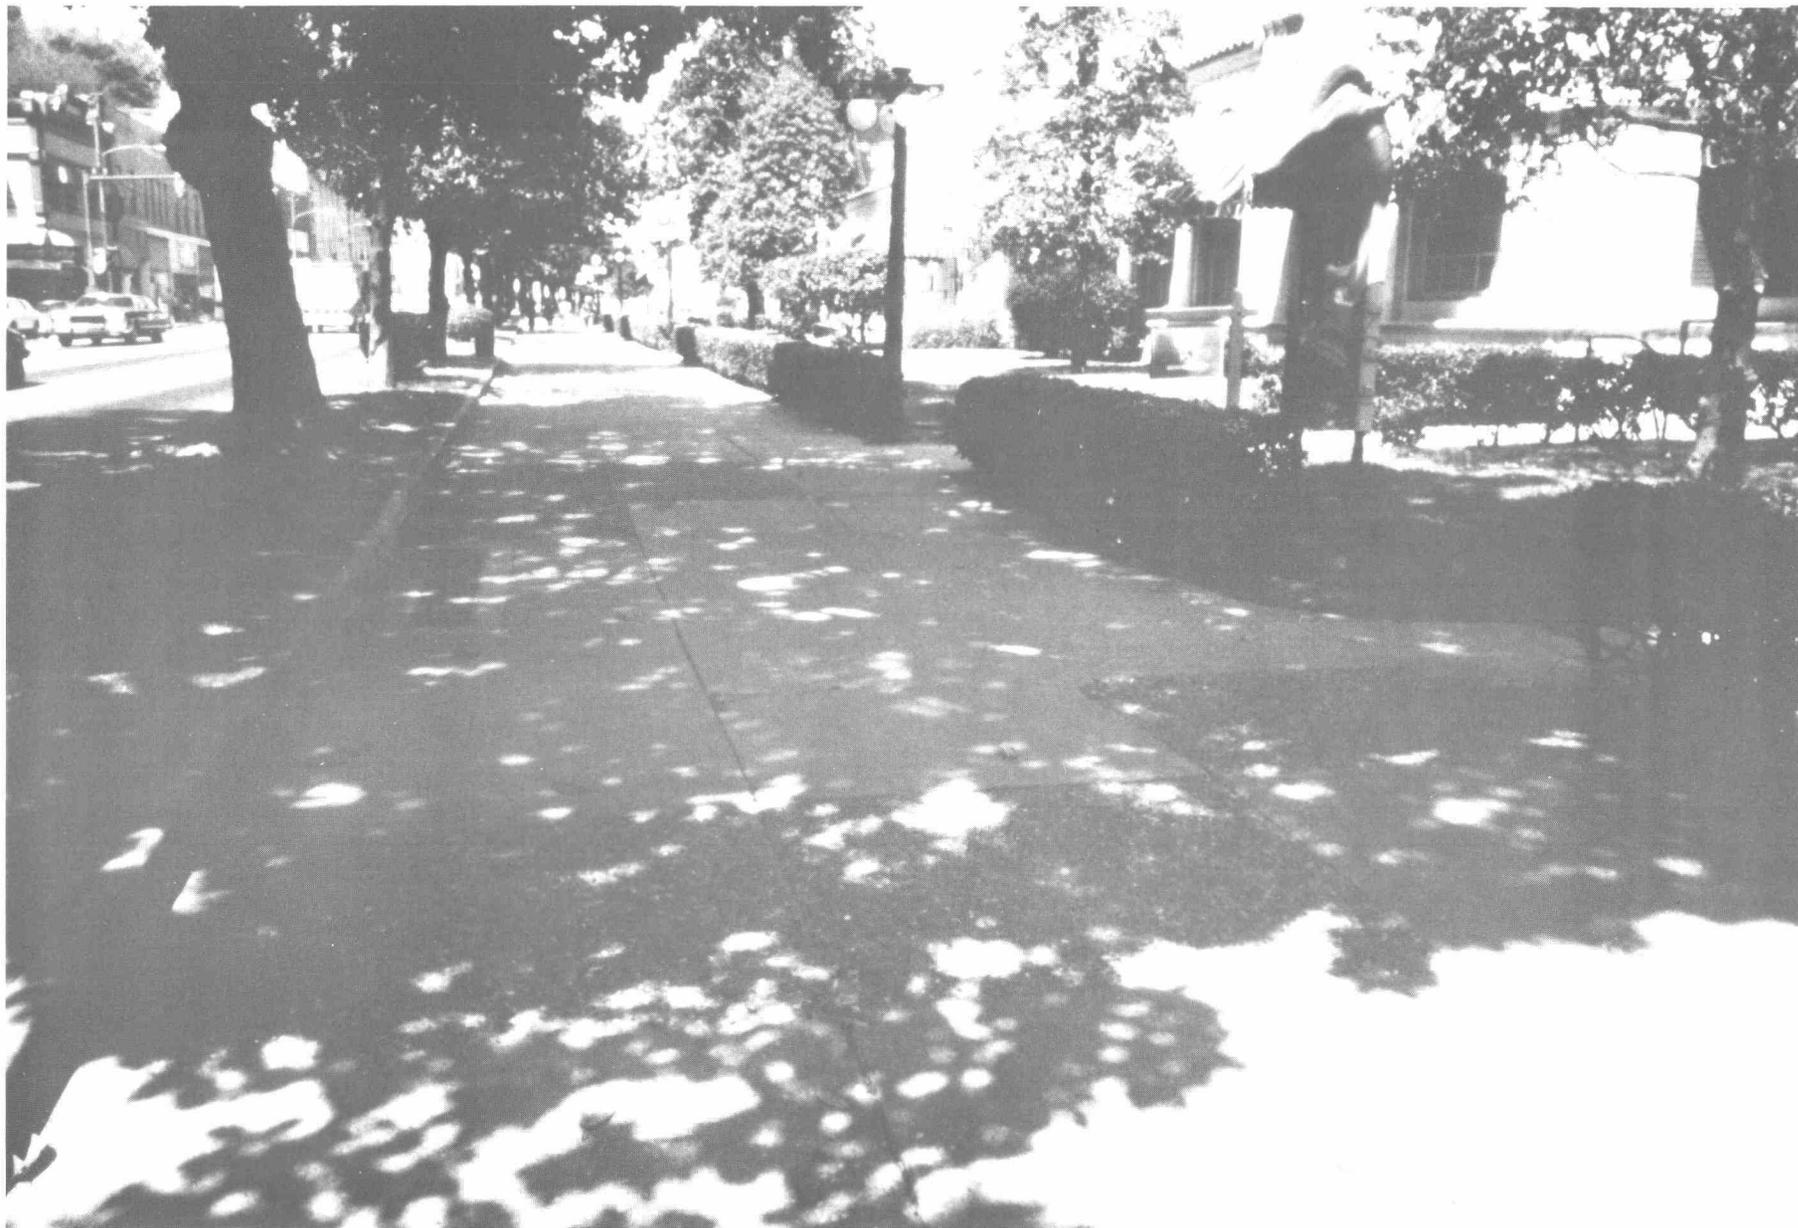
Figure 27. Bathhouse lawns and Magnolia Row, 1980s

Lawn Park Unit – Magnolia Row and Bathhouse Lawns (Fig. 27) and Maurice Display Springs. Today, as people use the Magnolia Row walkway to take a stroll or access specific buildings along the row or another part of town, they experience a formal landscape with regularly spaced pruned plantings, flat groundplane and rectilinear walkways, and a strong sense of direction and focus. The building facades and magnolia trees dominate the scene. The sight, smell, and noise of vehicles on Central Avenue remind them of the urban setting.

The row of magnolia trees has been a consistent landscape element since it replaced the row of Lombardy poplars in the 1890s. Since it was installed in 1914, the hedge in front of the bathhouses on the edge of the bathhouse lawn has also been a consistent element, although some modifications have been made over the years, such as the development of a double row of hedges along either side of the magnolia planting strip during the 1930s. Deciduous flowering shrubs along the building foundations have been an important landscape element since the 1930s – unpruned and full in the 1930s, but pruned and more formal today. Display flower beds were present in some locations within the lawns at the turn of the century, but there is no evidence of them during later periods.

The basic spatial organization of the area between the bathhouses and Central Avenue has also remained constant. The building facades, the form and spacing of the magnolias and of the hedges, and the presence of foundation plantings are all consistent elements. Magnolia Row has class I historical integrity (the highest level of integrity as defined in *Technical Report #1* [NPS 1985a], see appendix A). The bathhouse lawn area is in class II due to changes in the historic planting, such as the introduction of holly trees in the lawns. Both areas are included in management class I, indicating their sensitivity to alteration.

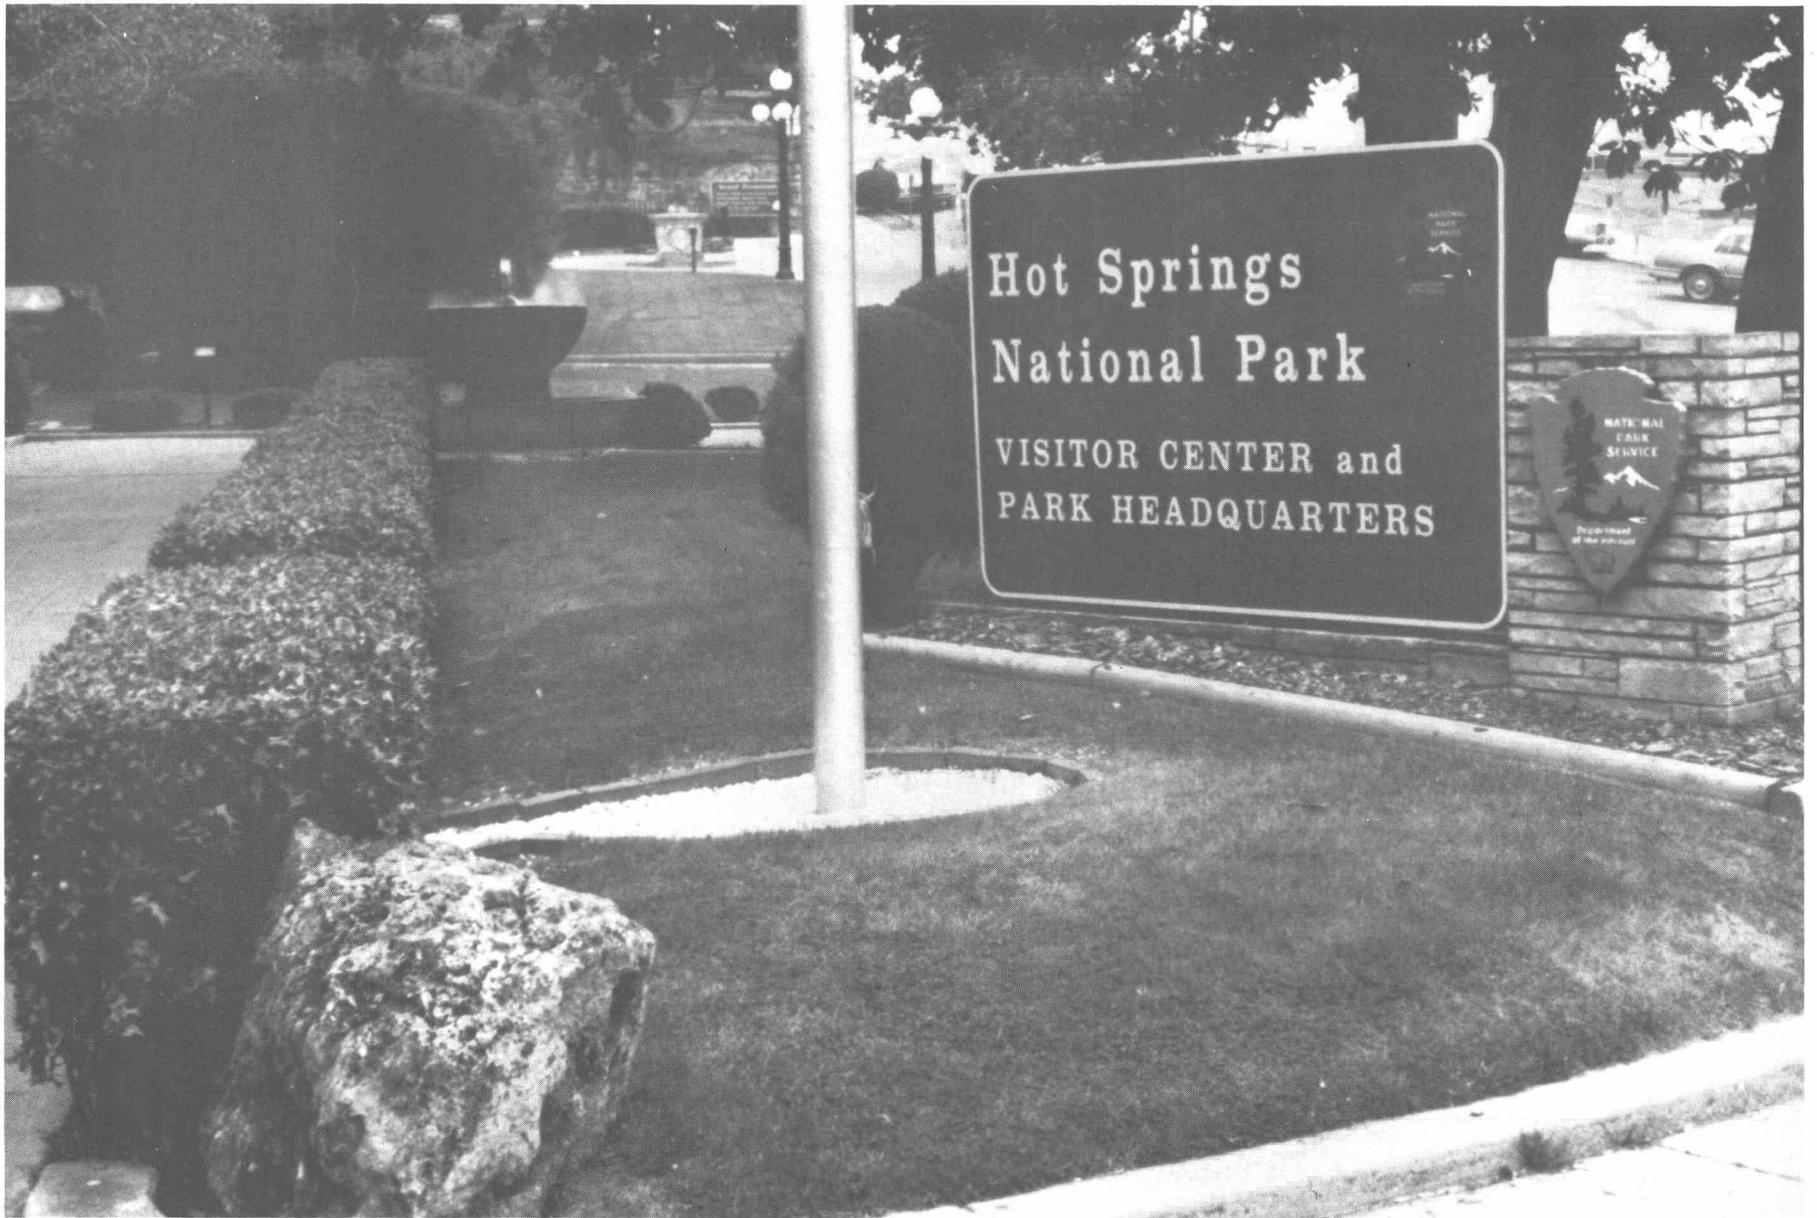
Figure 28. Administration building area, 1980s

Within this subunit, the administration building lawn area shares many characteristics with the bathhouse lawn/Magnolia Row area while also providing a distinct space for social interaction and communicating the Park Service presence on a busy street corner (fig. 28). Although the layout is formal, with the same formal elements of magnolias, hedges, lawn and foundation planting present, some informal planting, such as the ground cover on the

south edge of the lawn, is incorporated. The area is more open; the lack of magnolias on the outside of the walk and the lack of hedges on the outside of the lawns allow for views in and out of the space. Park visitors gather in the fountain plaza in front of the building entrance and can look out into the street a few feet below. Right on the corner, the U.S. flag and park entrance sign identifies it as a public space.

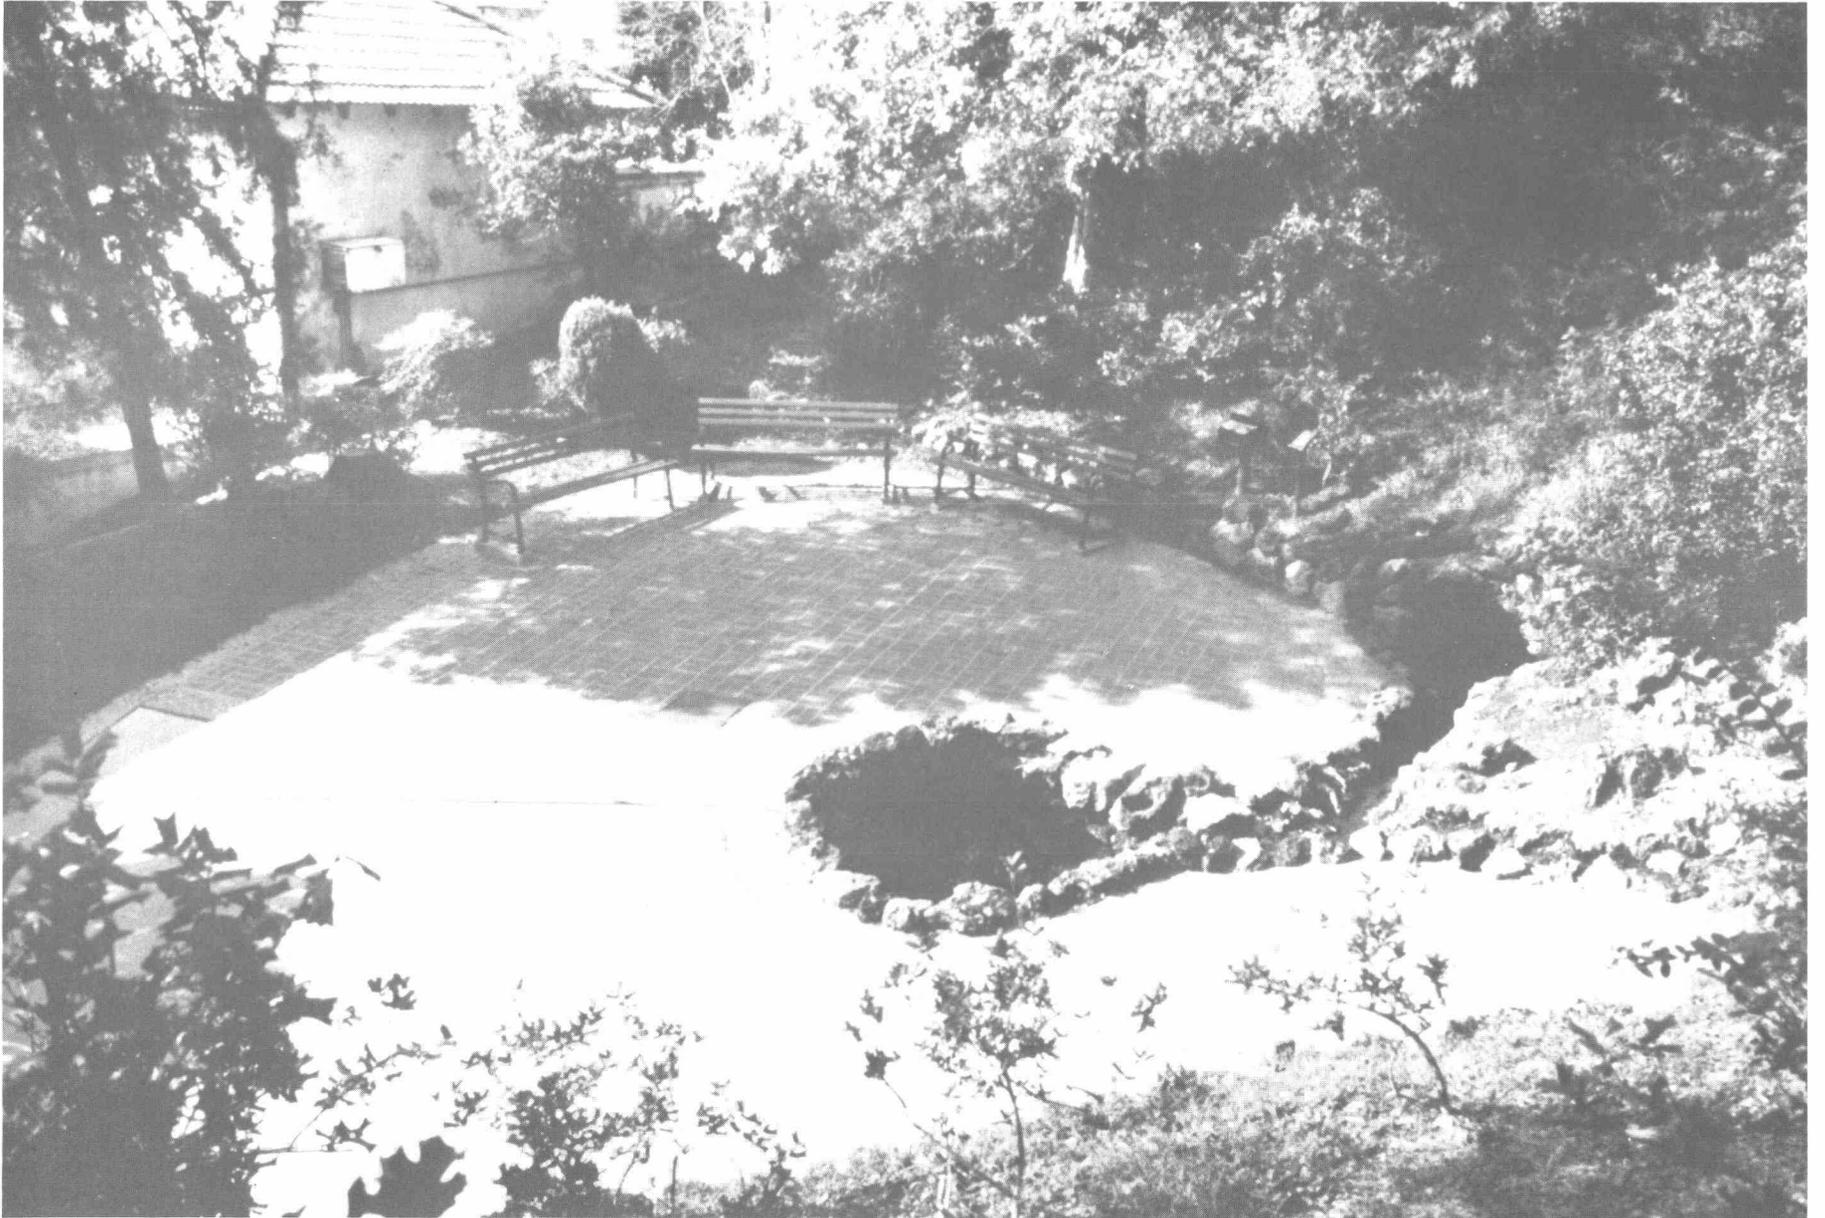
Figure 30. Display Springs, 1980s

Just to the north of the balustrade is the Display Springs area, where visitors experience spring water in a seminatural setting that is in a relatively quiet, shady area out of the main circulation flow (fig. 30). In the cooler months, the hot water vapors are visible and add to the sense of naturalness. Vegetation is dense on the north slope and thins out to the east and south, allowing views up to the promenade and Stevens' Balustrade.

The grass groundplane has been replaced over the years, first with asphalt and then with brick and concrete paving. Trees and shrubs have grown up on the once open slopes, and seating and lighting have added structure. The naturalistic spring treatment, with free-flowing water and pools and its function as a relatively cool, quiet place to sit, has remained consistent. Since the removal of a paved path that led through the space between the main entrance and the Maurice, the area has provided seating that is separated from the circulation flow. The gradual transition from more to less naturalistic design and the juxtaposition of the natural and artificial elements (the tufa and the paving and site development) are also consistent. This area is rated high in historical integrity (class I) and is also included in the most sensitive management class (class I).

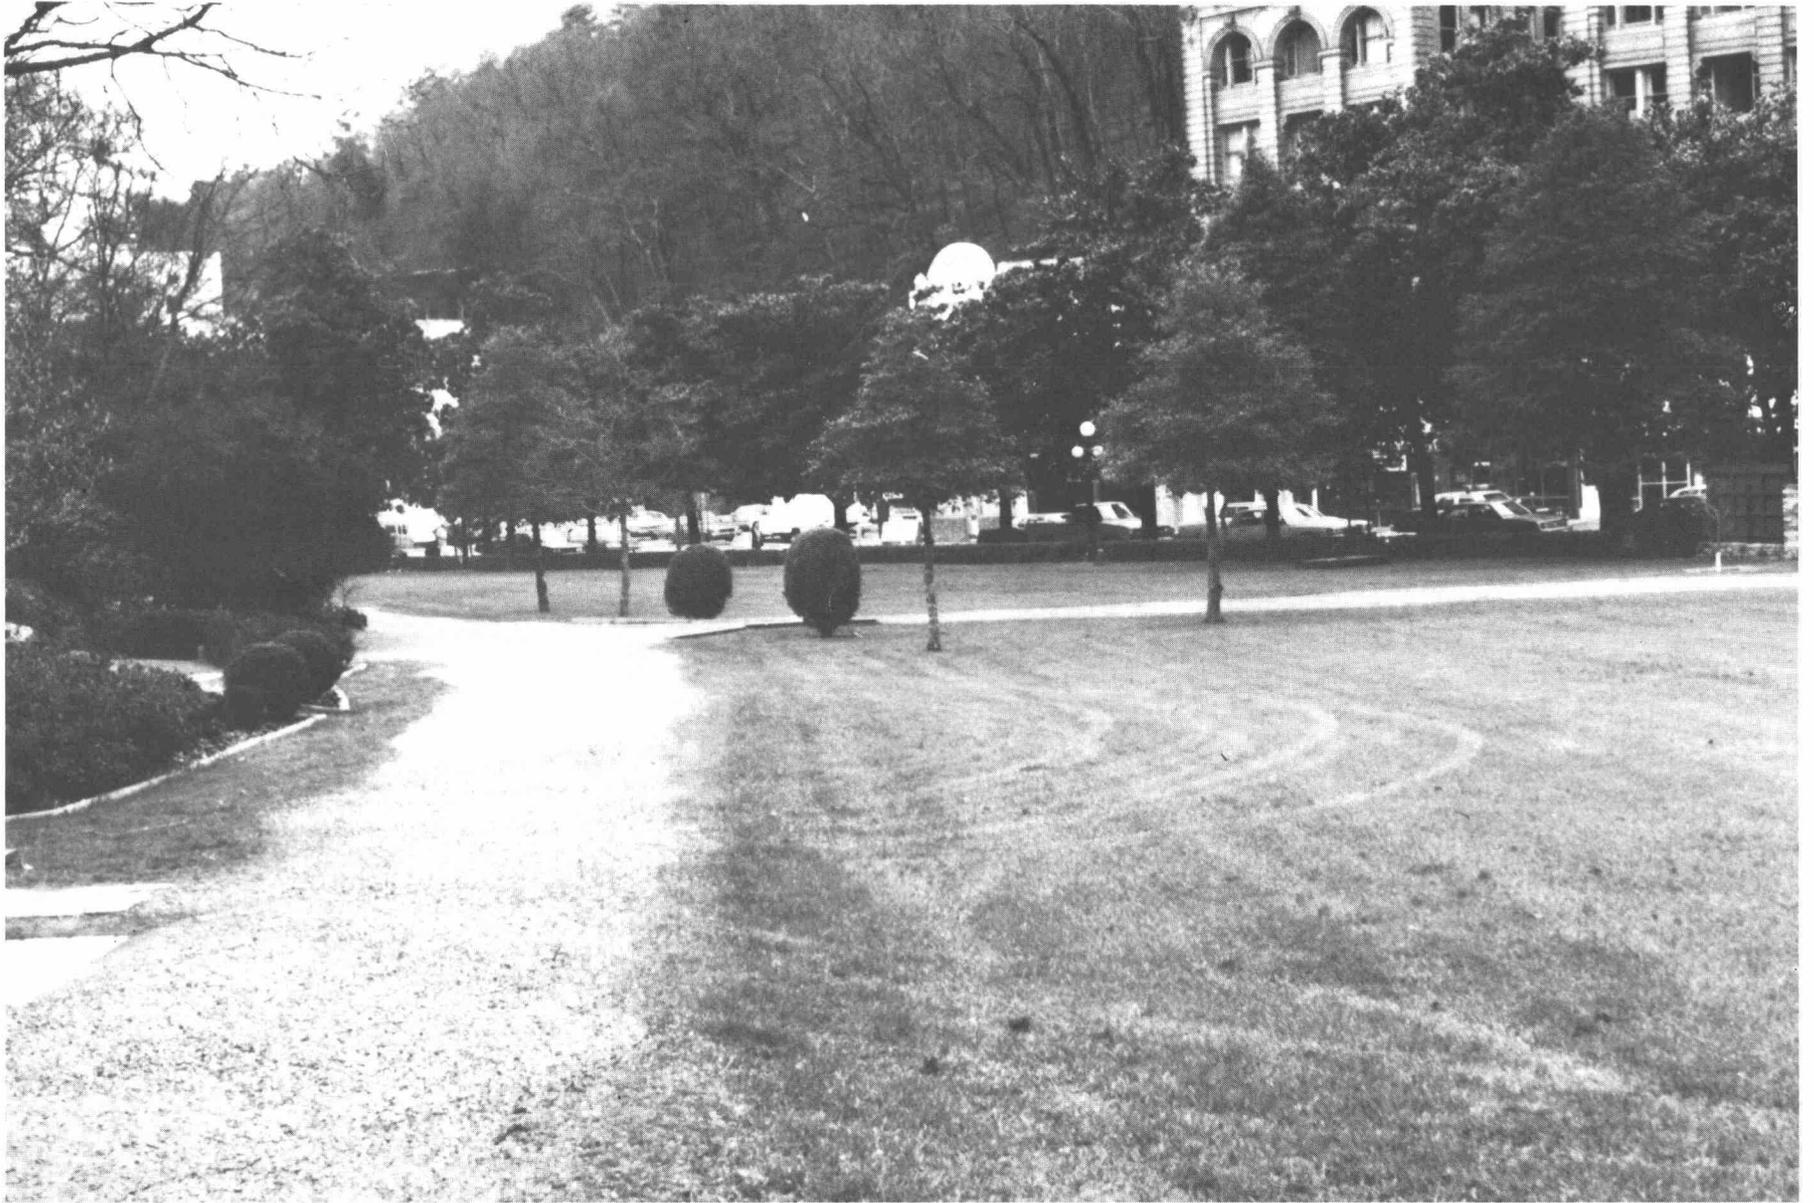
Figure 31. Arlington Lawn, 1980s

Lawn Park Unit – Arlington Lawn. After the Arlington Hotel burned and was rebuilt on the other side of Fountain Street, the Arlington Lawn area (fig. 31) was acquired for park and landscape purposes in a land exchange. A system of 6-foot-wide white gravel paths was established by the hotel by 1925, and the bronze plaque was installed in de Soto rock in 1932. In the following decades, elements on the perimeter of the lawn were added or changed while the open lawn remained virtually unchanged. The heat exchanger and cooling system structures were installed in the late 1940s and early 1950s, fenced, and partially screened with vegetation in the early 1960s. The original Hoke Smith fountain was replaced with the existing, smaller feature in 1943. A flagstone path was developed around de Soto rock, and the existing hot water cascade area was established in 1983. The existing earth stage was established in the 1970s. As a result of gravel encroachment on the lawns and service vehicle use, the gravel paths gradually widened. The row of regularly spaced deciduous trees and shrubs on the east side of the Magnolia Row walkway, present in the 1930s, has gradually been reduced to a row of more widely and intermittently spaced trees and shrubs with only a few trees present.

The basic function and nature of the space has remained constant. The lawn provides an open, informal space for events and gatherings – a landscape that contrasts with the streetscape hard edges and more constricted linear spaces of Bathhouse Row. The lawn serves as a forum or a commons – as the city's front yard. As such, the maintenance of the open lawn areas is critical. Also important for the preservation of the historic scene and spirit of the place are: the basic layout and appearance of the walks, including the tufa trail up to the promenade; the hedge, magnolias, and lights on the west; the feature/activity node where the existing cascade, earth stage, and de Soto rock are located; the presence of a hot water cascade; the seating areas with historic-appearing benches; and naturalistic planting on the slopes and rock walls.

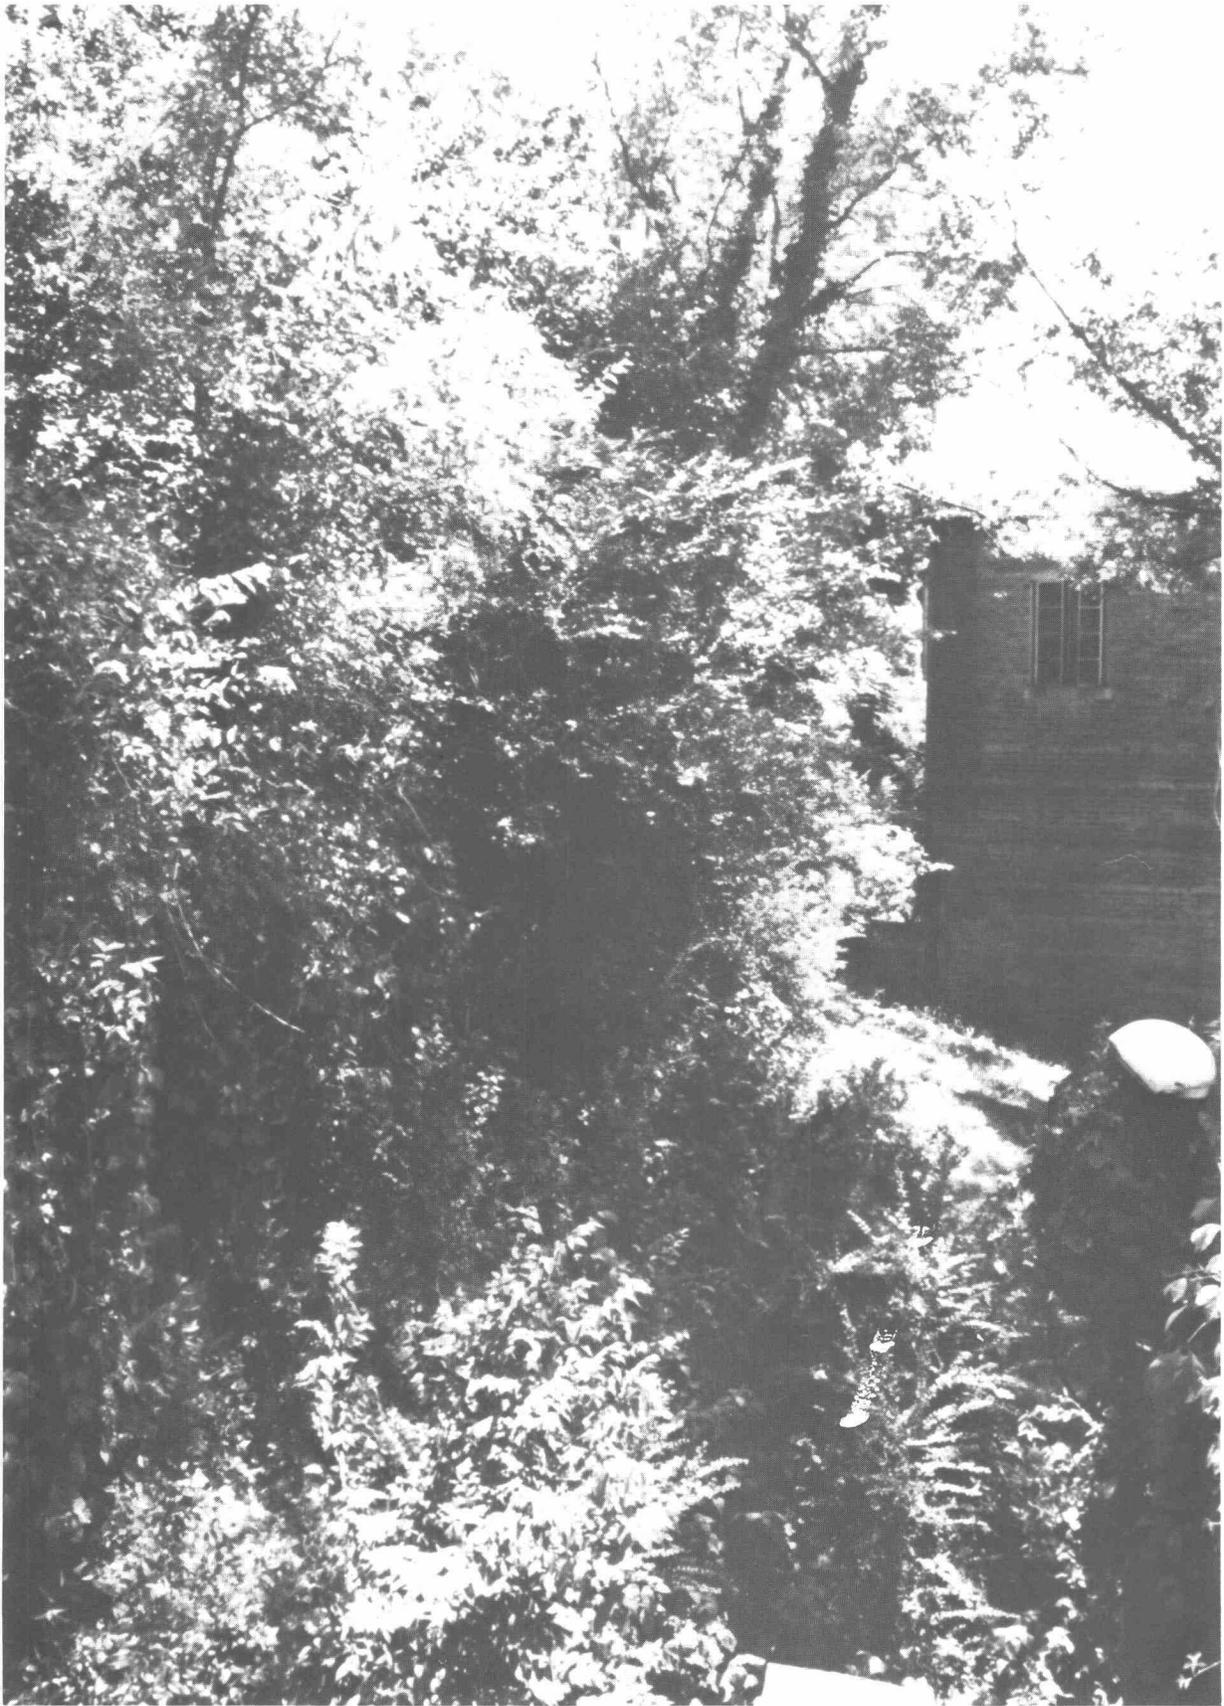
Figure 32. Transition area, 1980s

The slopes and vegetation of the transition areas function as visual and spatial buffers between Bathhouse Row and the promenade (fig. 32). The only part experienced from within by visitors is a section along the tufa trail, the foot trail connecting the Arlington Lawn with the promenade. Maintenance structures and remnants of walls and foundations can be found in the transition areas behind some of the bathhouses. The basic spatial configuration of these areas has remained the same since they were established because of cuts necessary for construction of the original Arlington Lawn and the larger bathhouses and cuts and fills necessary for the construction of the promenade. Over the years, the slopes have gradually filled in with trees, shrubs, and ground cover. Even though the transition areas are in management classes II and III, indicating that change to the landscape is not as critical here as in other sections of Bathhouse Row, the basic configuration of the slopes and the presence of the existing vegetation, the cut-stone retaining walls, and the remnants of previous structures are important to maintaining the function and historic integrity of these areas.
