Landscape Management Plan Bathhouse Row

landscape management plan
bathhouse row

BATHHOUSE ROW
HOT SPRINGS NATIONAL PARK • ARKANSAS

UNITED STATES DEPARTMENT OF THE INTERIOR / NATIONAL PARK SERVICE

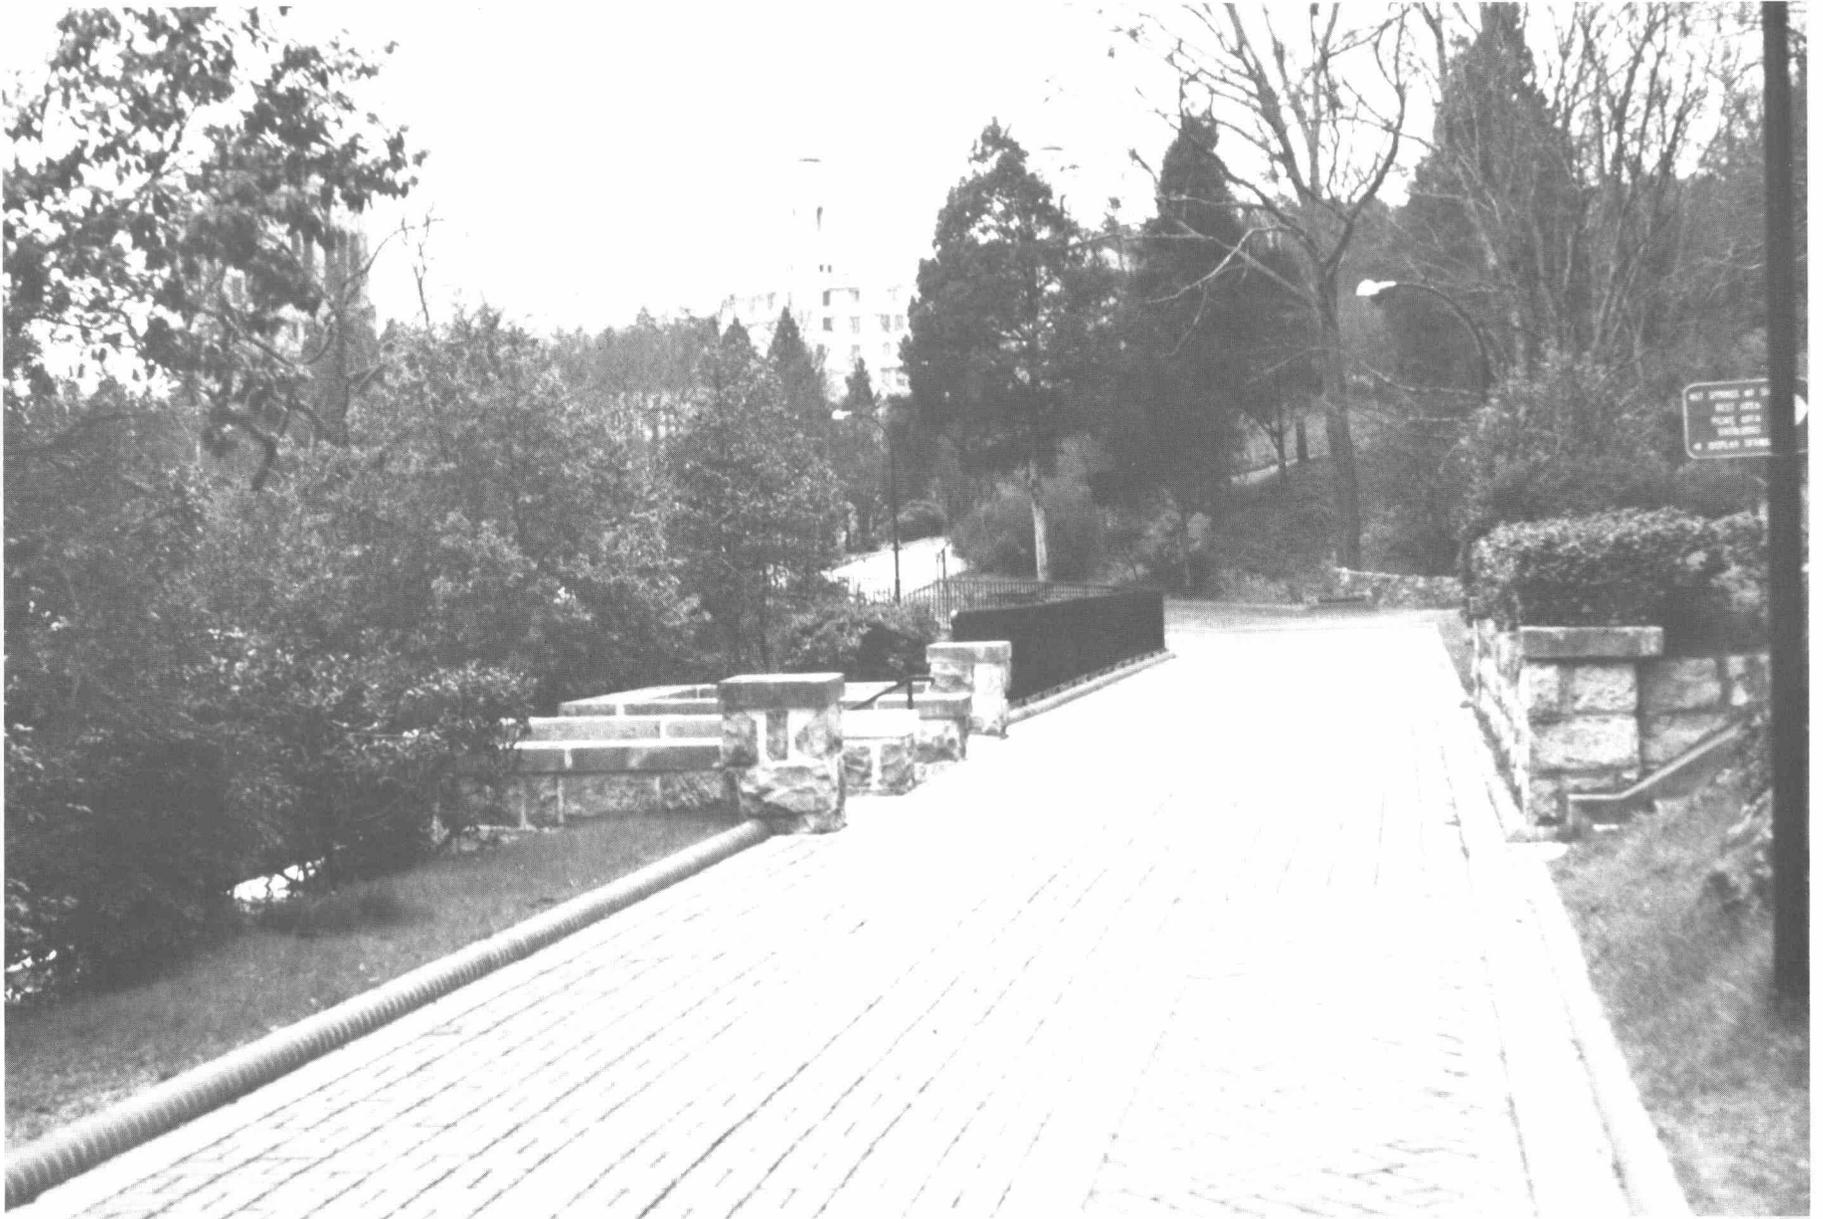
Figure 33. Grand Promenade, 1980s

Foreground Park Unit – Grand Promenade. The promenade provides visitors with a pleasant, mountainside environment away from traffic where they can stroll, jog, socialize, sit and watch, and generally enjoy the outdoors (fig. 33). The mix of enclosed tree-lined spaces and spaces opening out to adjacent lawn areas, of near and distant views, and of paving patterns and water features combine to provide a walk with visual interest and spatial variety. Small interpretive signs identify plant specimens and various natural resource features along the way. The promenade was developed for the enjoyment of convalescents, and wheelchair access was planned for and incorporated from the earliest stages. Resulting from an assumption of that era (1930s-1950s) that wheelchair users have attendants, ramps were developed that do not meet today's accessibility standards. Existing access ramps have slopes from 7-9 percent with no landings. Although the basic spatial structure and planting on the promenade have remained constant, changes have been made to individual site features. The brick paving has been reset (with an underlying concrete base added), the once-open Ral Spring has been covered over, and the original fountain at the north end has been replaced with a more contemporary feature.

Elements critical to preserving the historical integrity of the promenade include: the layout and paving pattern of the walk and entrances; the seating and overlook areas; the presence of water features at each end and along the length of the walk; naturalistic planting with visual variety (some areas are open with views, including the area above the main entrance, and some areas are enclosed with tree canopy overhead); handicap access; social interaction nodes (e.g., checkerboards near the Reserve Street entrance and main entrance terraces); and the pattern of existing vegetation.

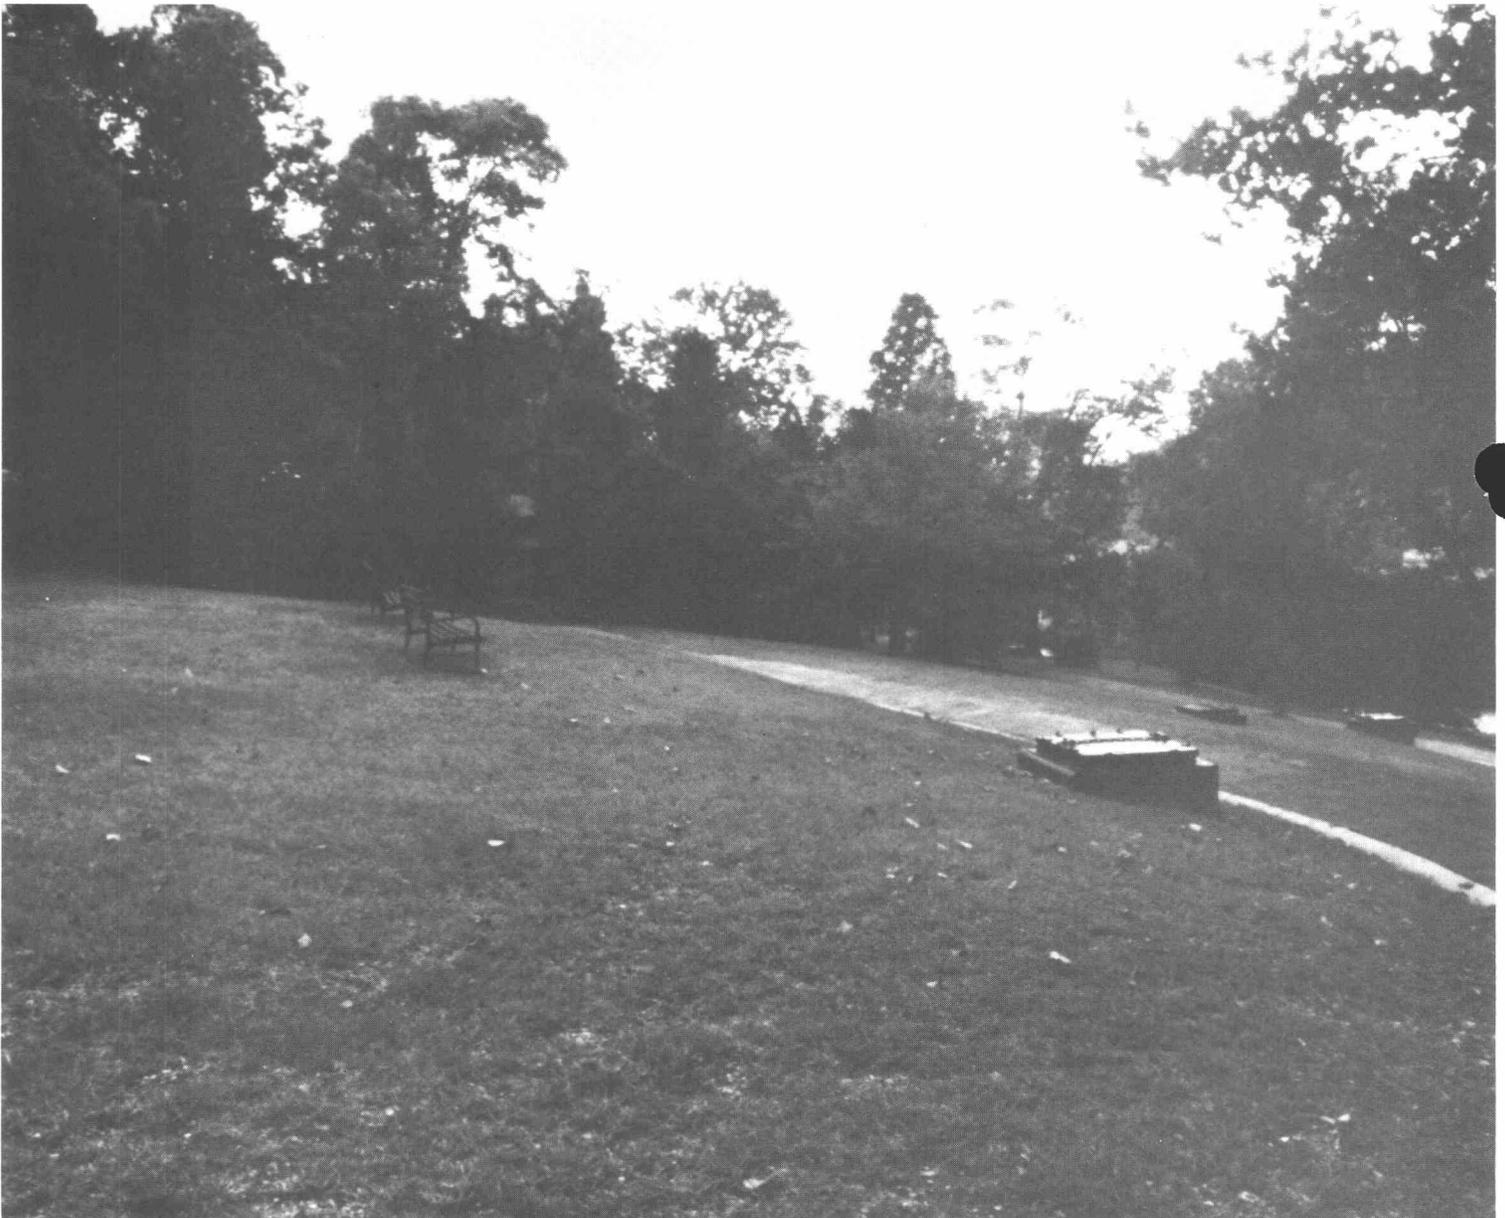
Figure 34. Open lawn bay, 1980s

Foreground Park Unit – Open Lawn Bays and Open Woods. The open lawn bays and open woods areas east and west of the promenade work together to provide a transition between the designed landscape of Bathhouse Row and the promenade and the more natural Hot Springs Mountain (figs. 34 and 35). The existing pattern of vegetation that provides contrast between open and enclosed areas, the spatial configuration and presence of benches in the open lawn areas, and the trail system that provides a variety of difficulty levels are all historically consistent elements important to the landscape's historic integrity.

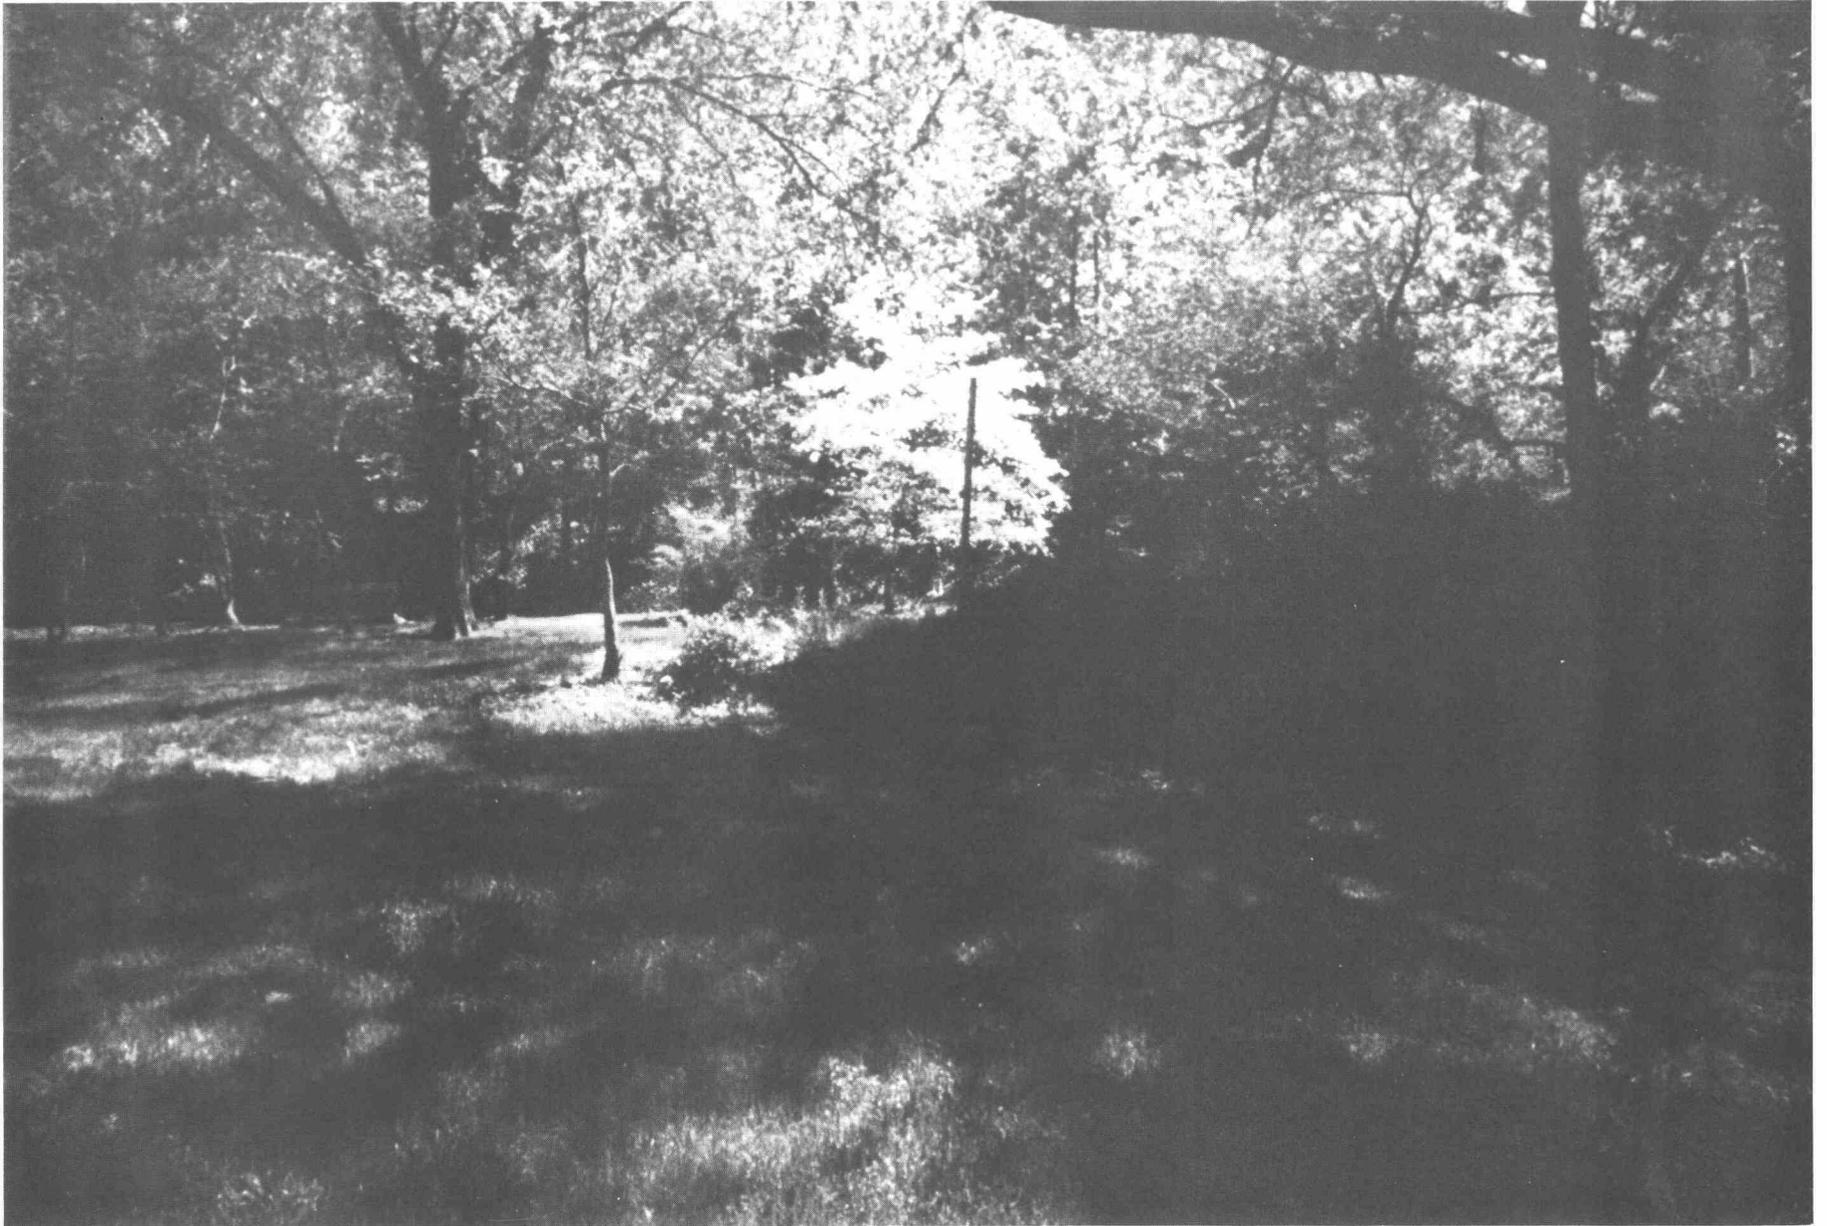
Figure 35. Open woods, 1980s

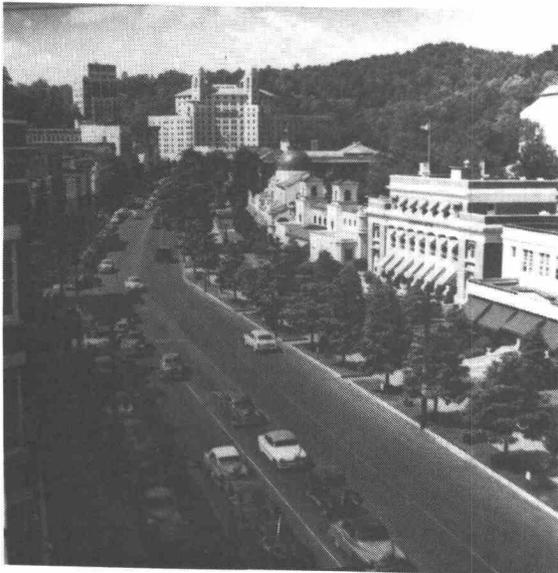
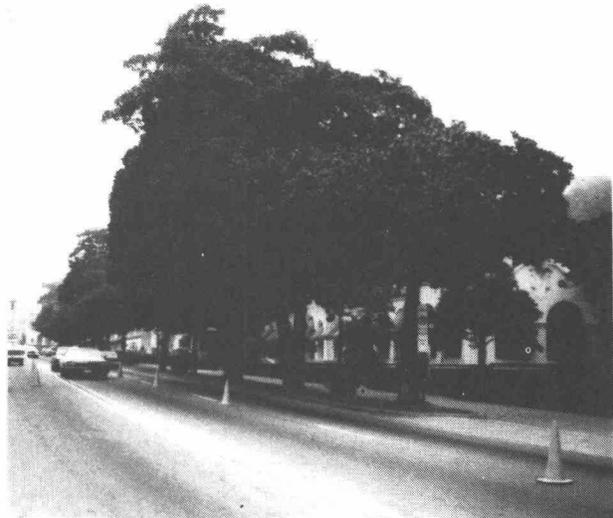
Figures 60 & 61. Bathhouse Row, view north, 1950s; Bathhouse Row, view north, 1988 (note screen of magnolias)

Vegetation. As documented by historic photographs and vegetation plans from the 1890s and 1930s, the vegetation on the bathhouse lawns was sparse, allowing unobstructed views from the sidewalk to the bathhouses. Foundation plantings were limited to give a clean and harmonious appearance to both the buildings and lawns. Also, the form of the plant material, particularly the poplars, allowed views through to the facades. Today this vegetation, particularly the foundation plantings, has matured, and additional material has been added to the lawns. The lawn edges are now clearly defined by low holly hedges, although the lawns themselves are more cluttered by the matured vegetation. Magnolia Row, with trees at an average height of 25-30 feet, provides a visual screen to the bathhouses from Central Avenue; lower branches have been pruned to allow for some sight lines and traffic clearances.

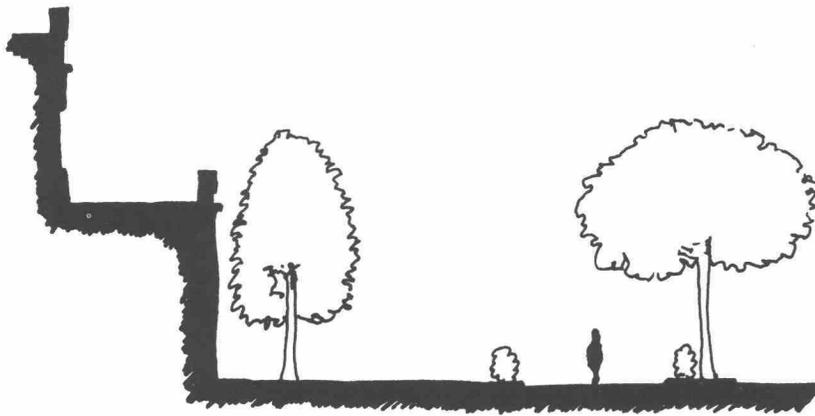
Figure 62. Section sketches at Lamar Bathhouse

Section sketch, 1930s

Section sketch, 1980s

Section sketch, future

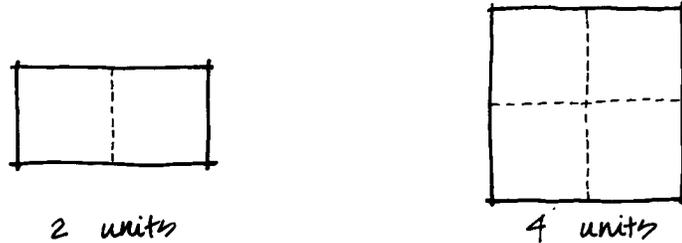
Figure 87. Sign dimensions

General Sign Format – The NPS arrowhead and a distinctive format and framing should be used on all park signs to unify the system and present a consistent image. (Format refers to the layout of the elements that make up the sign.) Sign dimensions should be determined using a basic size unit. For example, a small directional sign uses two units and a larger interpretive sign uses four.

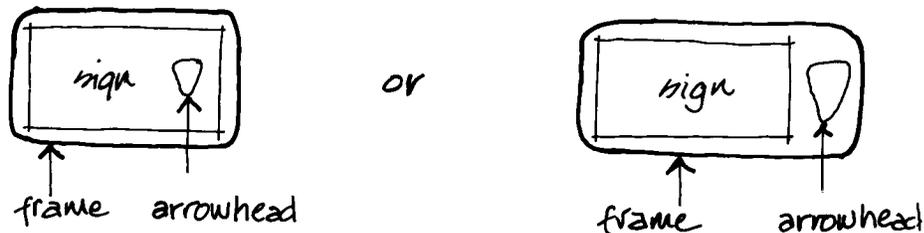
Figure 88. Arrowhead placement

The NPS arrowhead will provide a simple, clear visual image that visitors will be able to recognize at a glance and associate immediately with the park. The arrowhead should be appropriately scaled to each sign. Arrowheads could be incorporated into the signs or into the sign frames, with consistent placement throughout the system.

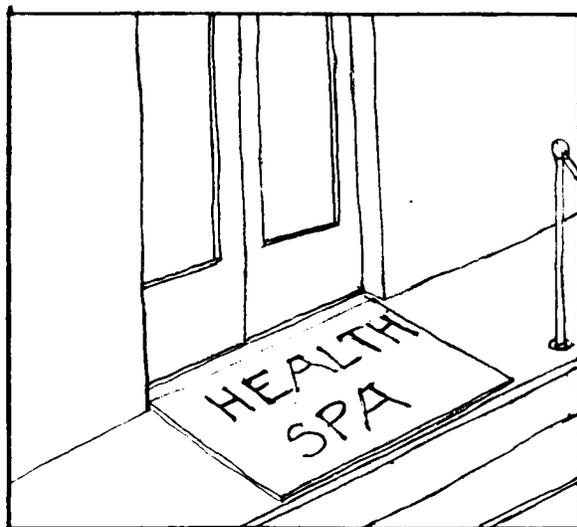
Figure 94. Design guidelines for new lessee signage

FLAG - PROPOSED, U.S. OR LESSEE'S

FLAG, ABOVE MAIN ENTRY ONLY

AWNING SIGN AT ENTRY

AWNING ABOVE ENTRY

ENTRY MAT AT DOOR

ENTRY MAT ON SIDEWALK AT ENTRY
