National Park Service
Cultural Landscapes Inventory
2004

Mineral Headquarters Historic District
Lassen Volcanic National Park

Level II
Cultural Landscape Inventory
Lassen Volcanic National Park

**MINERAL HEADQUARTERS HISTORIC DISTRICT
LASSEN VOLCANIC NATIONAL PARK**

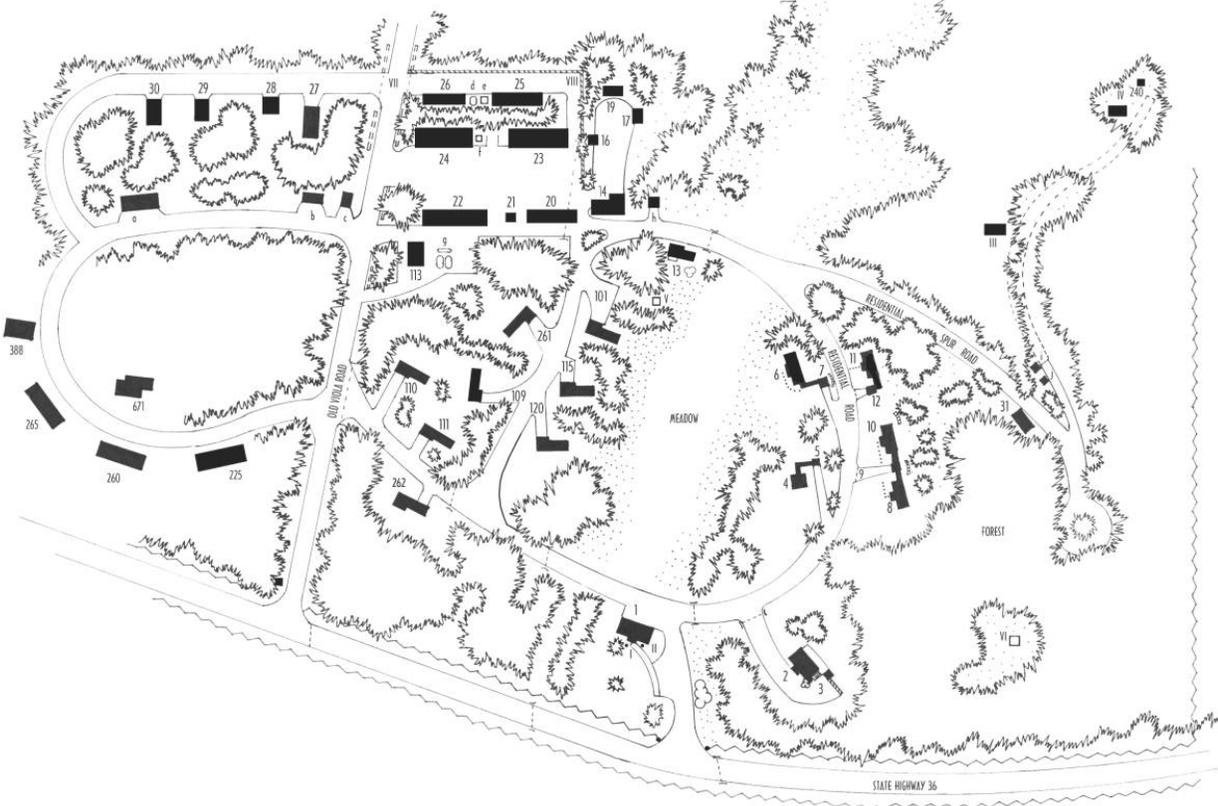
Site Plan

Mineral Headquarters area site map. See following page for map legend. See Supplemental Information #5 for a larger format site map.

- 1) Administration Building
- 2) Science Center
- 3) Garage
- 4) Residence
- 5) Garage
- 6) Residence
- 7) Garage
- 8) Residence
- 9) Garage
- 10) Residence
- 11) Residence
- 12) Garage
- 13) Residence
- 14) Dormitory (apartment)
- 16) Seasonal Ranger Residence
- 17) Seasonal Ranger Residence
- 19) Wash House
- 20) Protection Division Storage
- 21) Service Station
- 22) Warehouse and Maintenance Office
- 23) Machine Shop
- 24) Equipment and Storage Shed
- 25) Garage and Storage Building
- 26) Roads and Trails Building
- 27) Carpenter Shop
- 28) Electric Shop
- 29) Generator Plant
- 30) Fire Equipment Storage
- 31) Seismograph Building

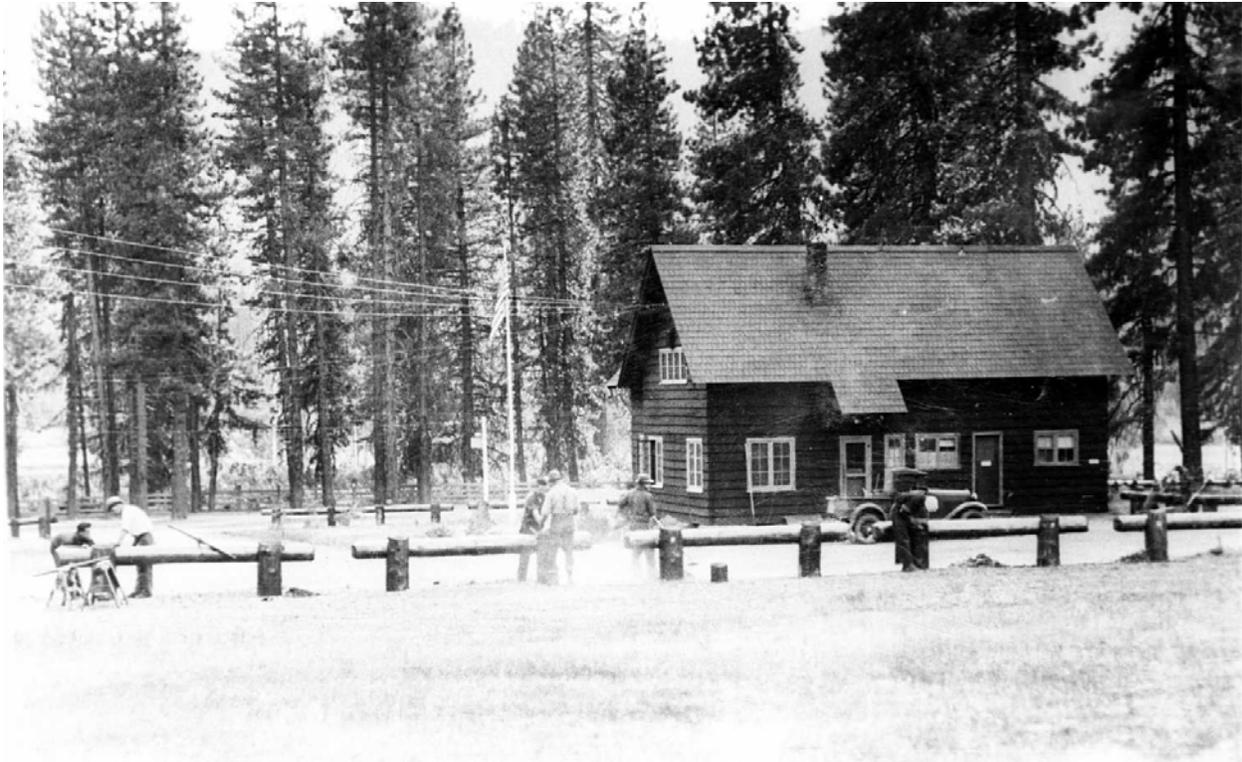
History #1: Administration building, parking lot, and barrier fence. Looking south, 1933. (LAVO-N-32-4)

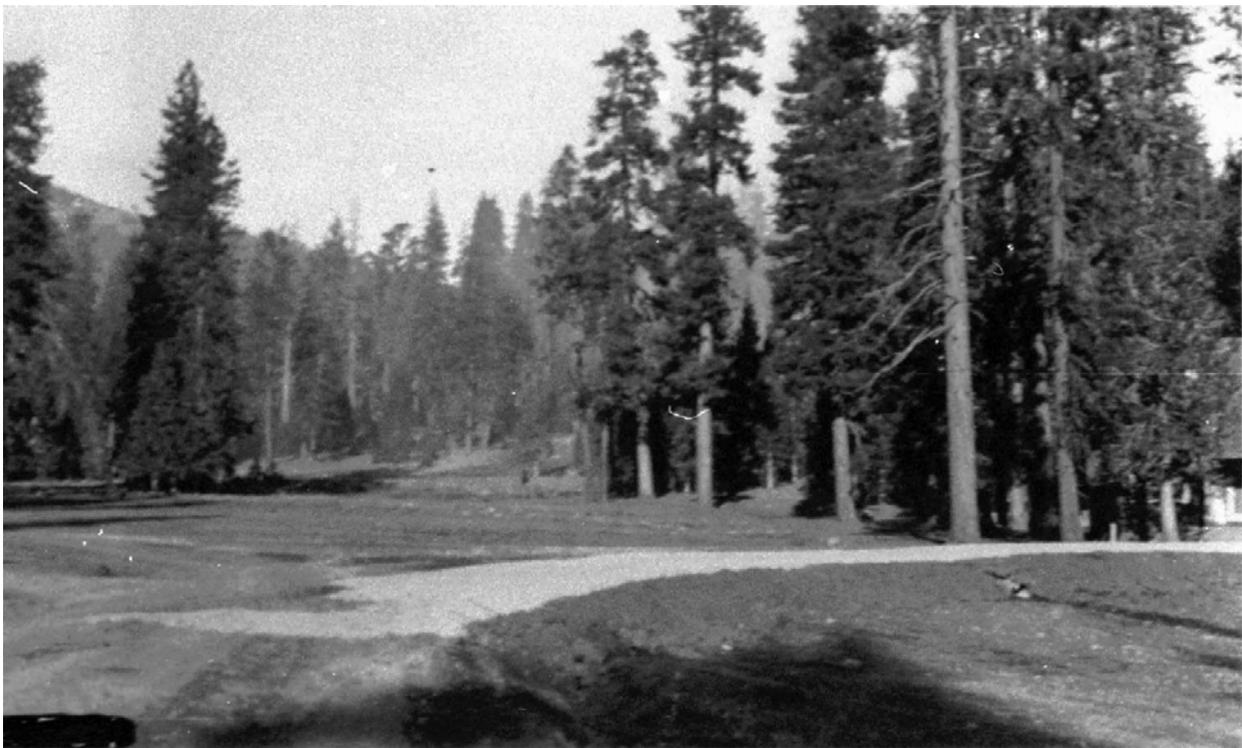
History #2: Newly constructed residential road, with meadow in background. Note fill and culvert required to maintain steady grade. Original superintendent's residence is partly visible on the right. Looking north, 1932. (LAVO-N-26-21)

The first superintendent’s residence was constructed in 1929. This building was sited to the rear and to the east of the administration building, on the east side of the meadow. The residence was designed in the same rustic style as the administration building and featured a steeply gabled roof and wood lap siding stained dark brown. The original superintendent’s residence (which was destroyed by a gas explosion in 1937) is visible in the background of a 1932 photo of the administration building (see photo: History #2).

The course the seasonal stream followed through the meadow was manipulated to allow for road construction. During construction of the residential road, culverts were built to channel the stream under the road. A ditch on the uphill side of the road was dug to divert the water to the culvert. Where the creek found its outlet south of the road, it fingered out and followed a meandering course down slope, creating seasonal riparian areas along its banks. Thus the landscape designers found a means to construct a road through the site without permanently altering the meadow and wetlands, an important landscape characteristic which supports a profusion of grasses, native sedges, and wildflowers.

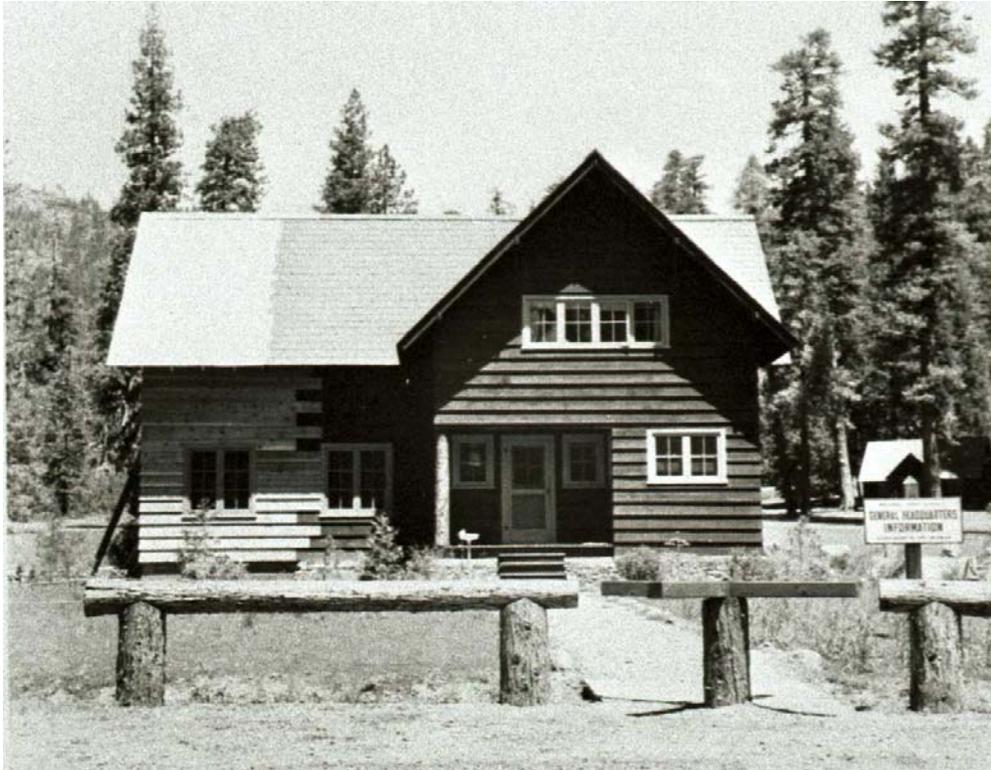
History #3: Administration building showing addition of west wing, post and pole fence, turnstyle and walkway to parking area. Note original superintendent's residence to the rear. Looking north, 1932. (LAVO-N-26-15)

Following the first expansion to the administration building in 1932, foundation plantings, including shrubs and small evergreen trees were planted, as well as a small lawn area in front of the building, which was bisected by a gravel walk from the parking area. A post and pole log fence and turnstile was constructed, which defined the edge of the parking area in front of the building (see photo: History #3).

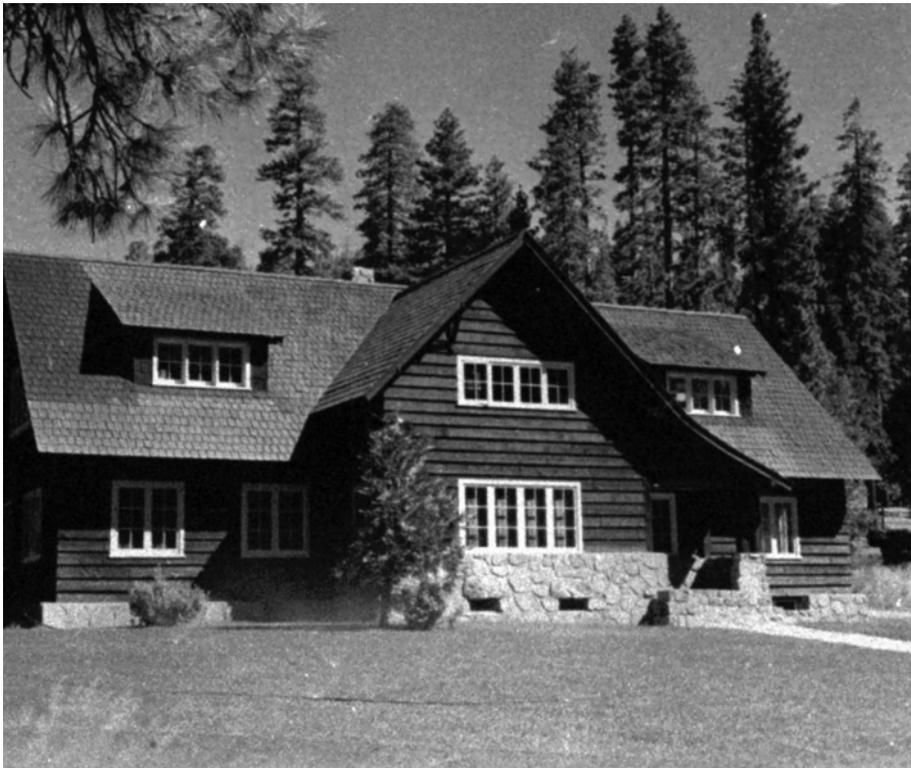
History #4: Administration building, showing foundation plantings and front lawn, looking north, 1941. (LAVO-N-26-14)

in a stone base and a stone water fountain were installed on the front lawn. A central stone chimney was built of local stone, to match the rock veneer of the foundation. Its frontage on State Highway 36 made it the most visible of the buildings in the headquarters area. The building's details, including the front porch with an overhanging roof, and rockwork on the foundations and chimney conferred a sense of permanence and dignity to the structure (see photo, History #4).

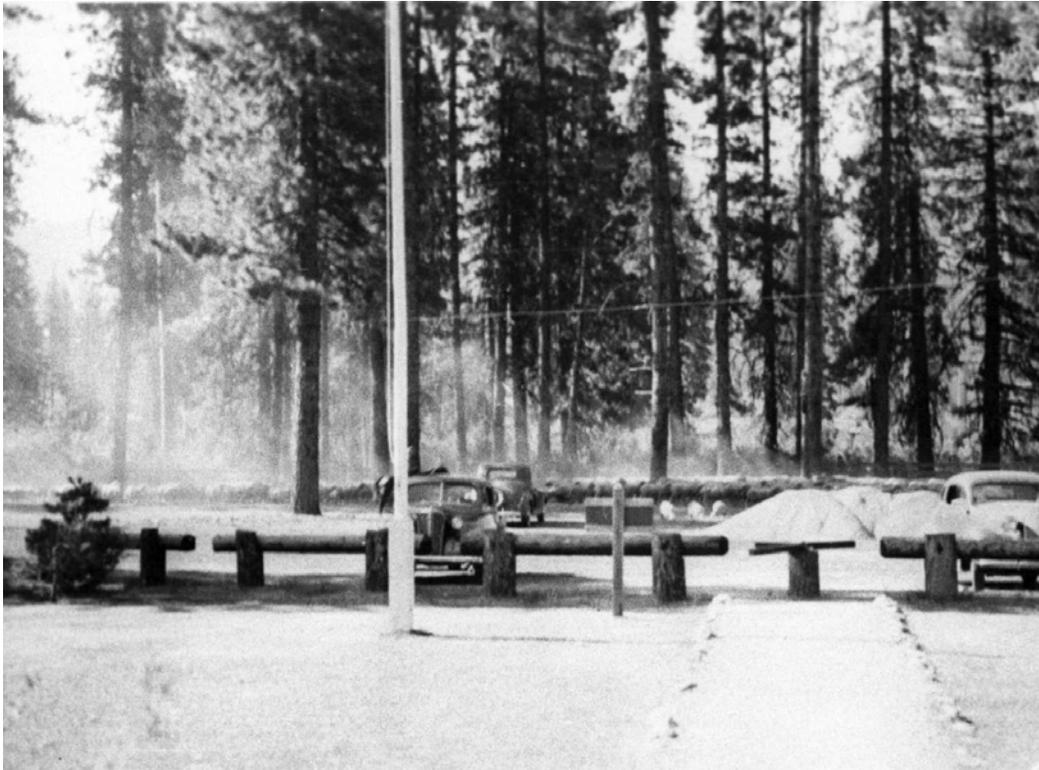
History #5: Paving the administration building parking lot, showing barrier fence, walkway, flagpole and State Highway 36 in the background. Looking south, 1937. (LAVO-N-32-19)

natural resource protection, including various forest-improvement projects such as insect control, and blister rust control, were important components of the ECW, construction of recreation structures, residences, road and trail building, campground construction and landscaping projects were also accomplished through the efforts of the CCC (Paige: 18). CCC projects, including masonry and carpentry work, usually involved a high level of manual labor and skilled craftsmanship. Highly skilled stonemasons and carpenters supervised the less experienced CCC laborers in carrying out their work. The use of hand tools and the general lack of mechanization involved in CCC construction projects accomplished two goals: it allowed the maximum number of young men to be employed on a particular job and also resulted in the construction of structures characterized by a rustic style, yet exhibiting high quality craftsmanship. Many projects at the Mineral headquarters, including the construction of buildings, retaining walls, drainage ditches, stone walkways, fences, and signs were accomplished through the use of CCC labor (see photo, History #5).

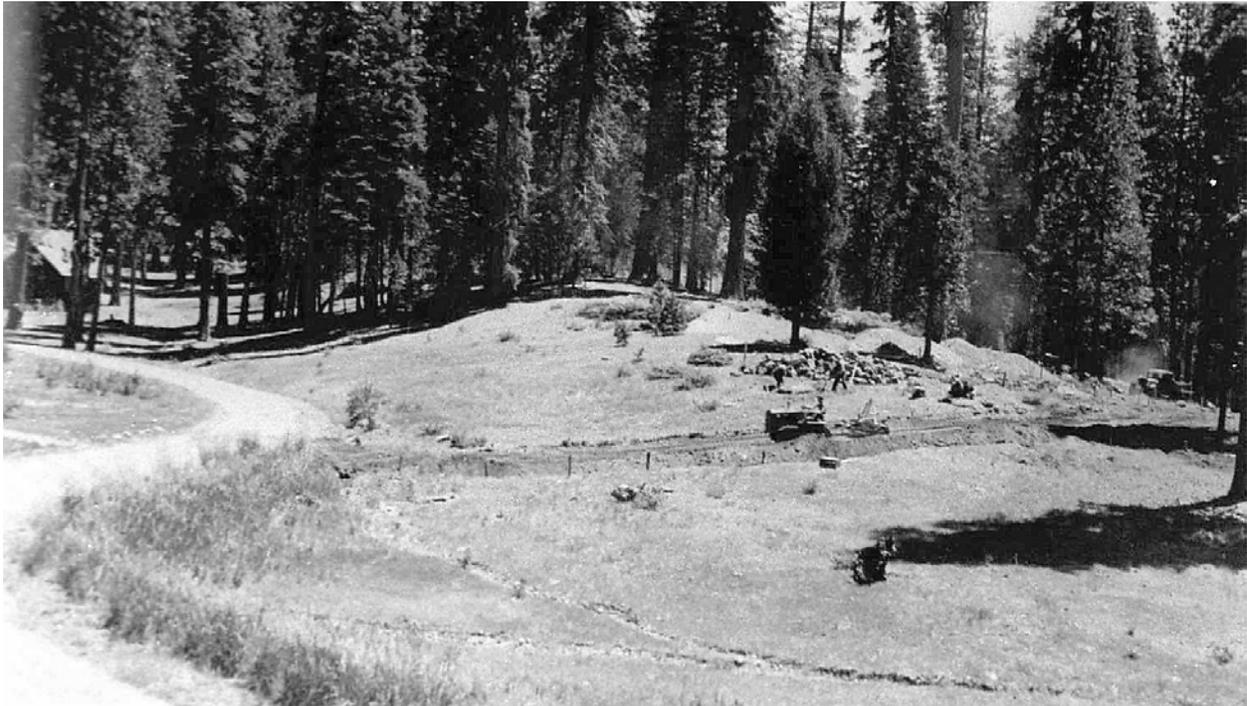
Topography #1: Driveway to Building 2 under construction. Note alignment of main residential road. Building 8 is visible to the left. Looking northeast, 1937. (LAVO-N-27-22)

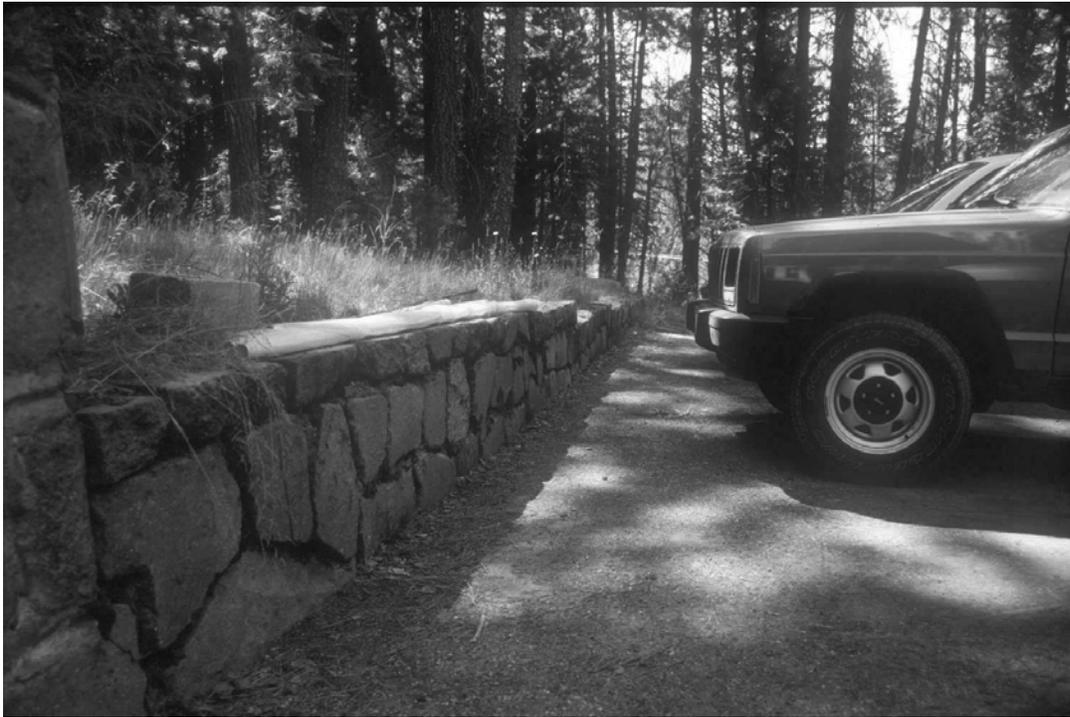
Topography #2: Stone retaining wall holding up cut along northern border of parking area, Building 2. Looking east, 2001. (LAVO-S-33-8)

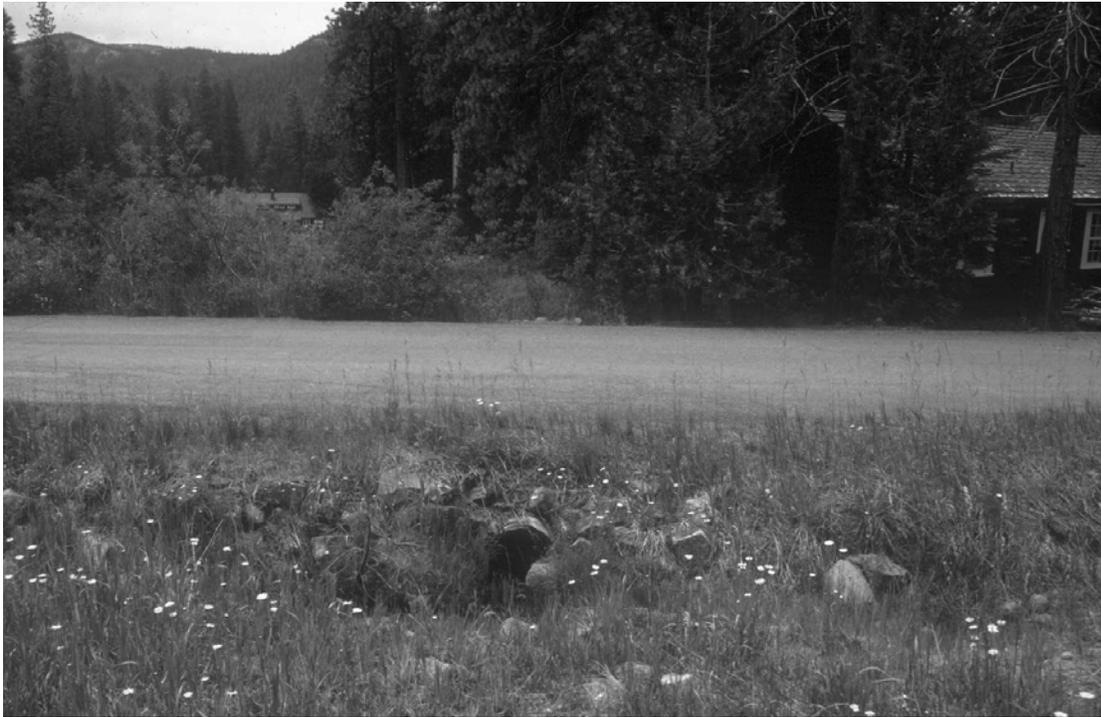
Topography #4: Drainage ditch and culvert at upper end of residential road. View looking south, 2001. (LAVO-S-33-31)

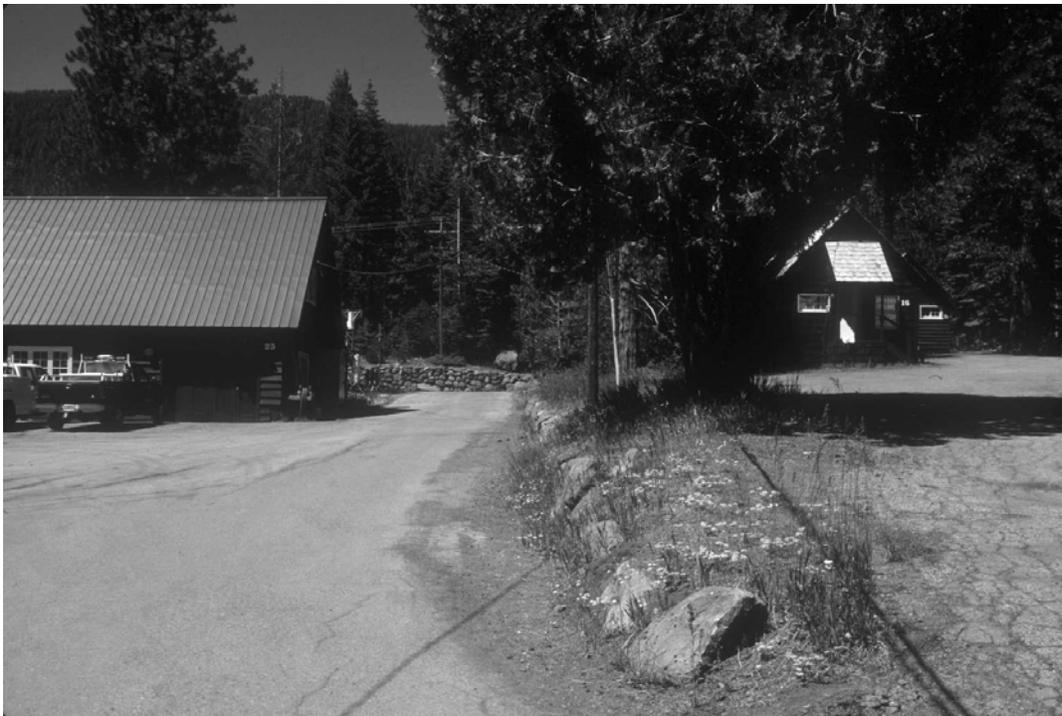
Topography #5: View toward junction of maintenance area east retaining walls, looking north, 2001. (LAVO-S-35-4)

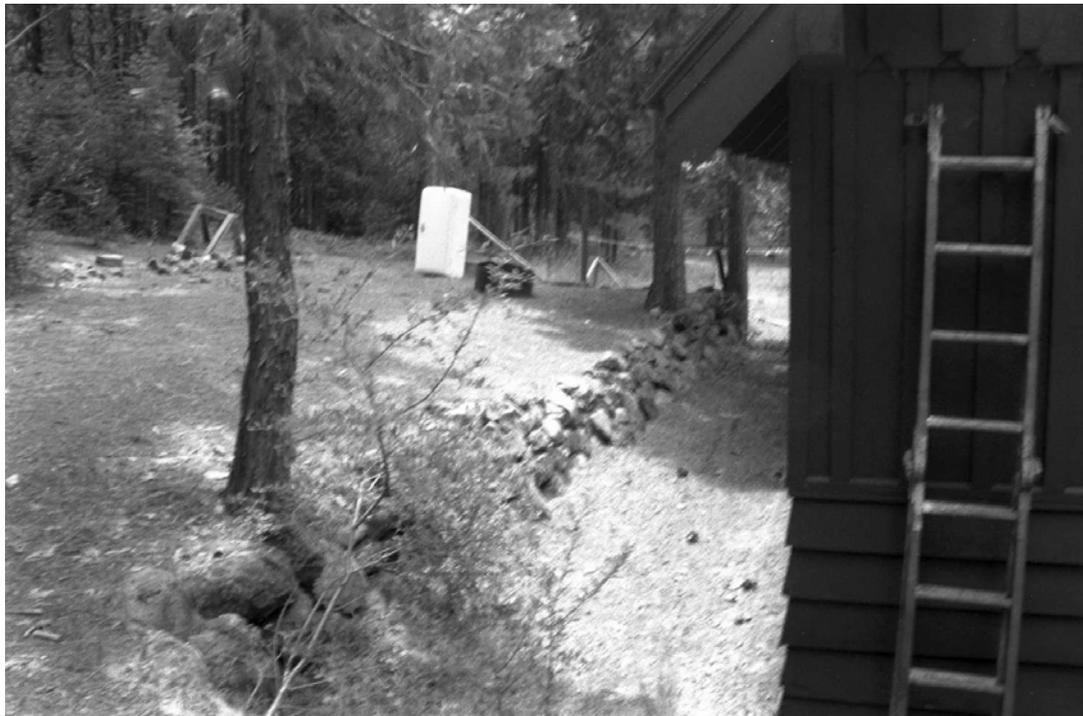
Topography #6: Dry laid stone retaining wall was constructed to shore up cut behind Building 10. View looking east, 2001. (LAVO-N-28-6)

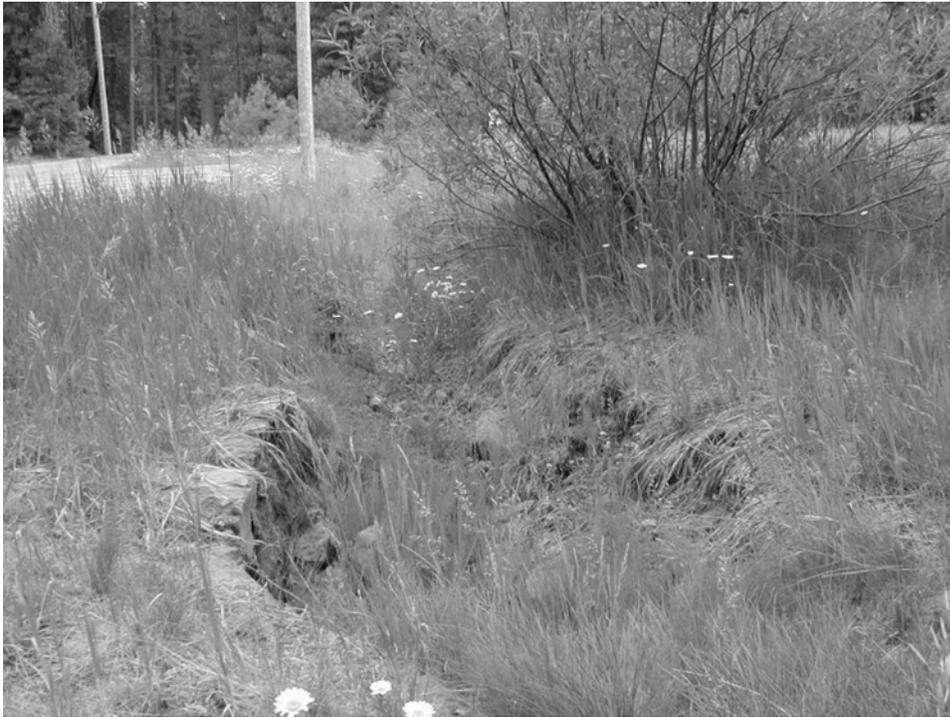
Vegetation #4: Drainage ditch along parking lot behind Administration Building, looking west, 2001. (LAVO-DSCN-3677)

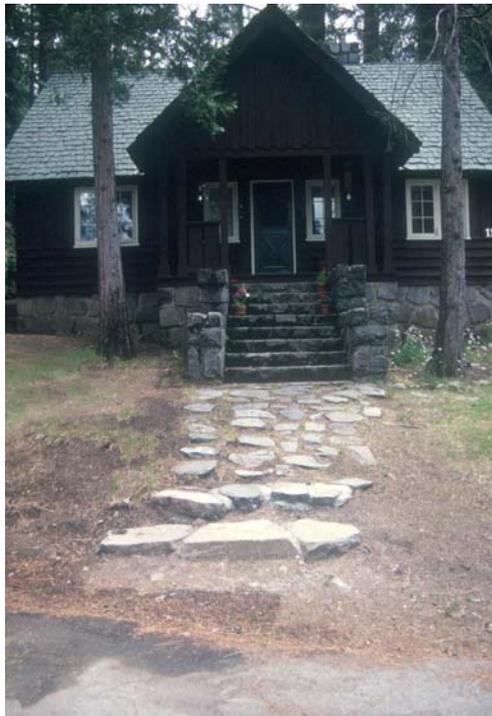
Circulation #8: Stone walkway leading to residential road from Building 11, looking northeast, 2001. (LAVO-S-33-15)

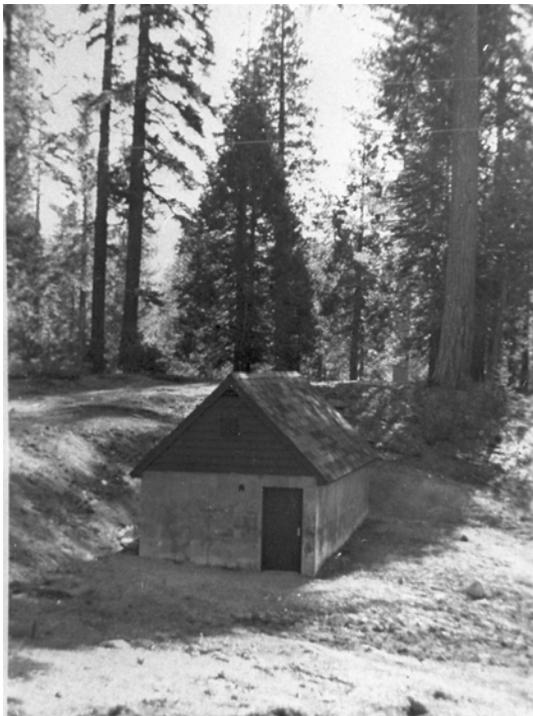
Buildings and Structures #4: Seismograph building (#31) in 1946. Note its position below the residential spur road. (LAVO-N-26-5)

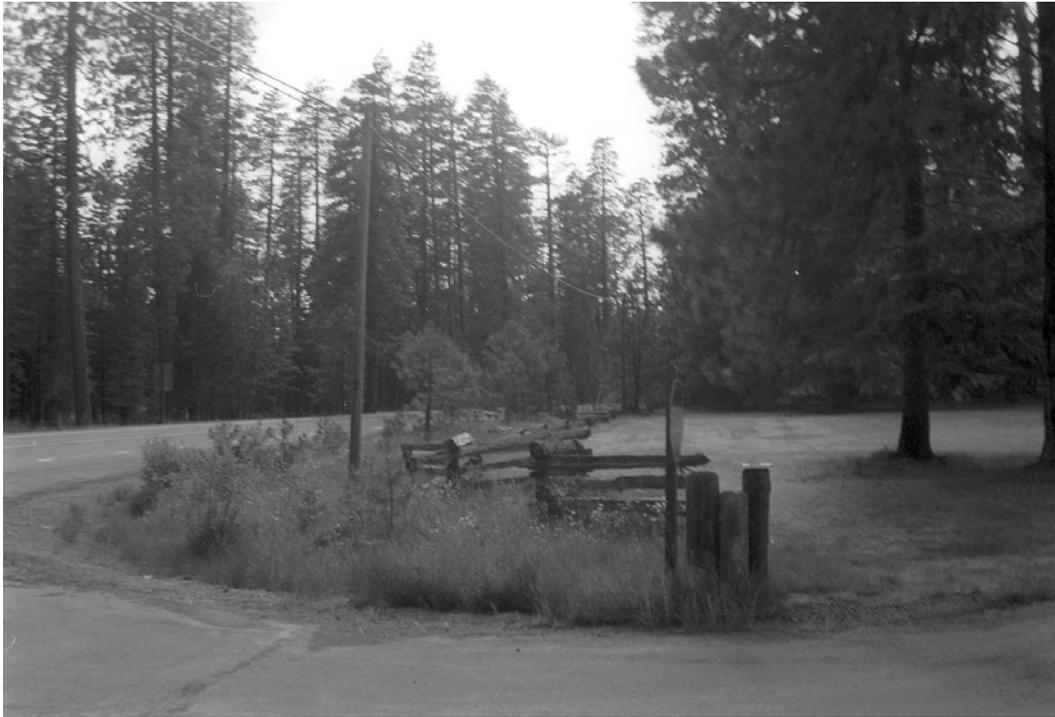
Buildings and Structures #5: Heavy log posts remain from original post-and-pole fence constructed by the CCC, later replaced by split rail in 1934. Looking west, 2001. (LAVO-N-27-8)

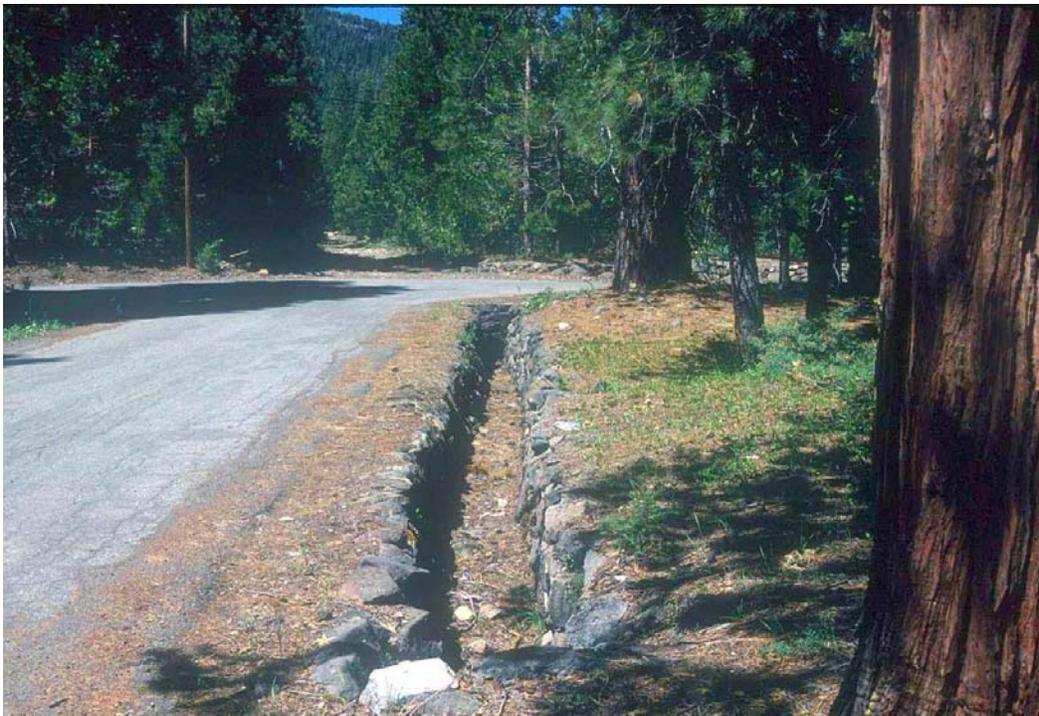
Buildings and Structures #6: Stone-lined drainage ditch along Old Viola Road, looking north, 2001. (LAVO-N-30-16)

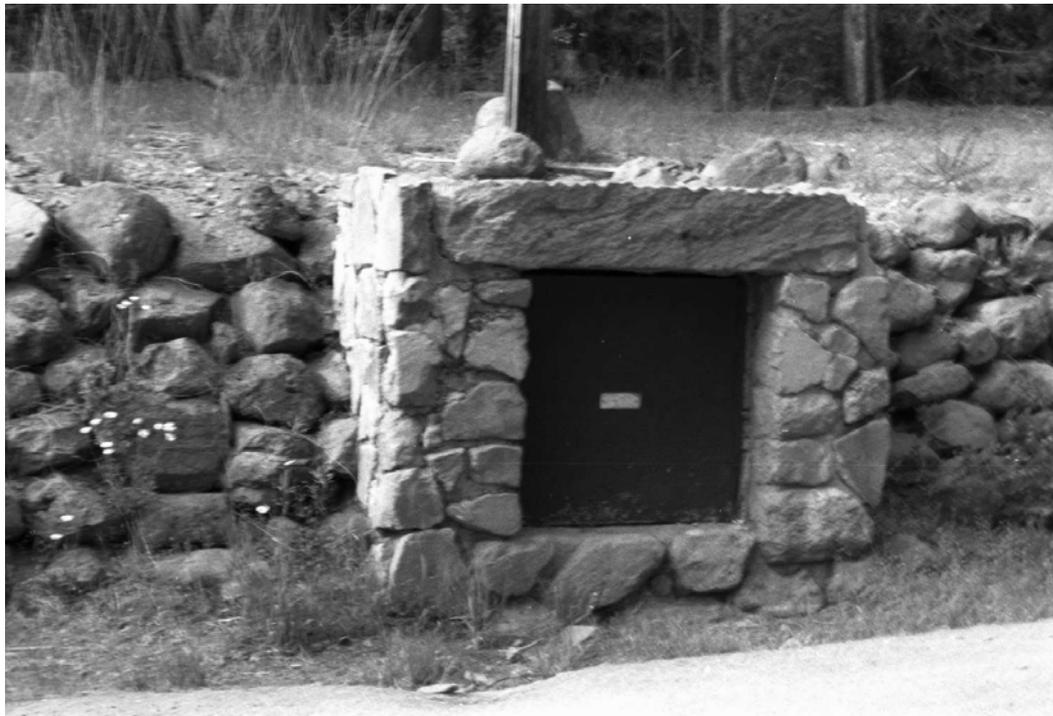
Buildings and Structures #7: Stone retaining wall and built-in fire cache, looking north, 2001. (LAVO-N-27-14)

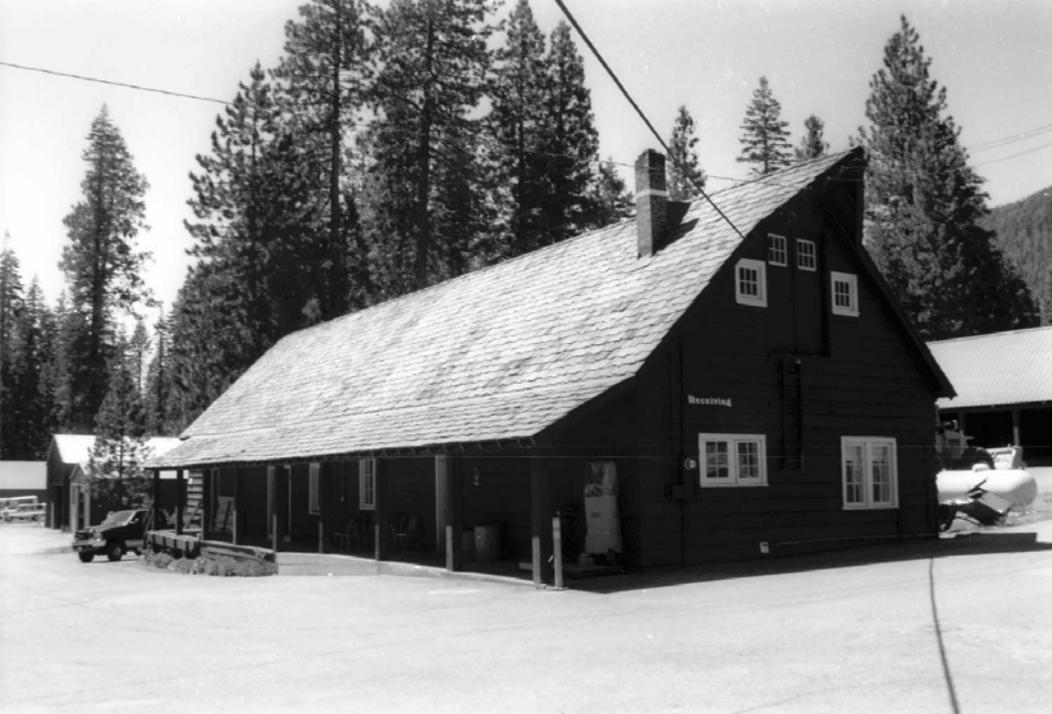
Cluster Arrangement #1: View of maintenance area. Note axial arrangement of buildings and large paved areas to facilitate maintenance activities. Looking west, 2001.

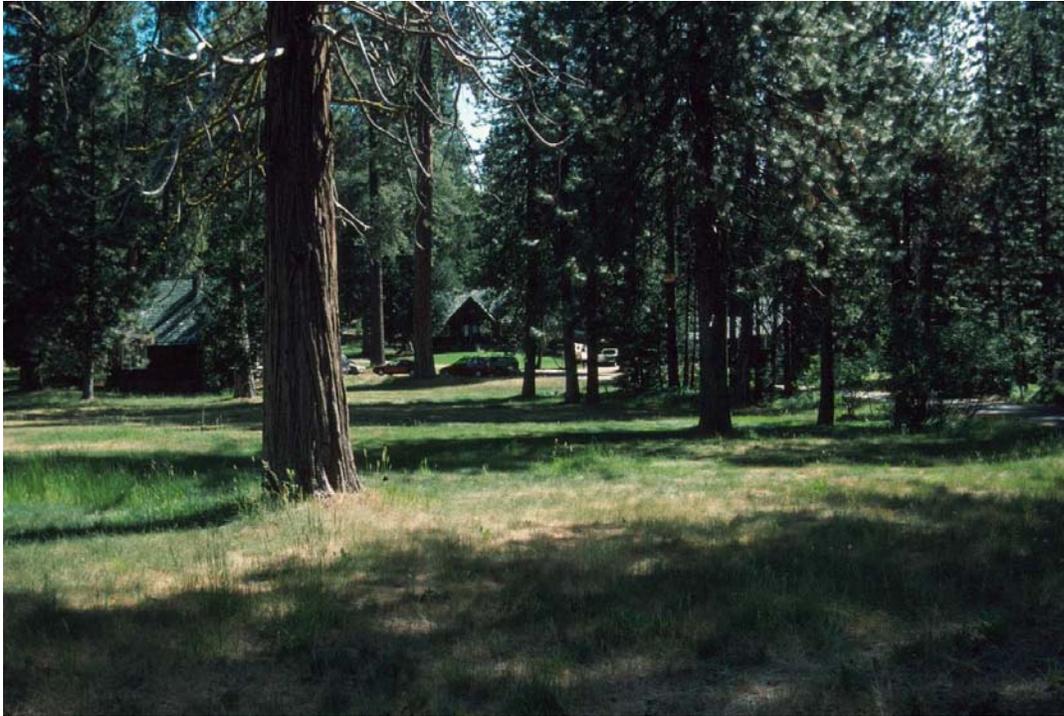
Views and Vistas #1: View across eastern edge of meadow toward residences, looking northeast, 2001. (LAVO-N-0025-2)

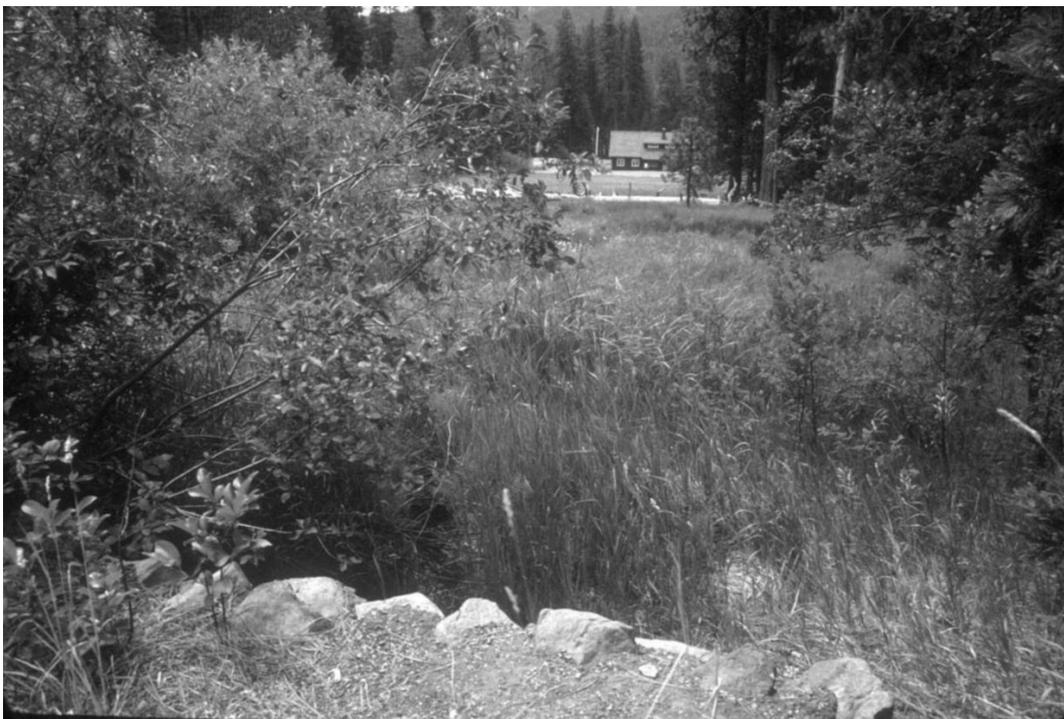
View toward administration building from residential road. Culvert headwall visible in foreground. Looking south, 2001. (LAVO-S-33-30)

The residential road offers perspectives on the landscape that capture the site's scenic, rustic architectural charm, particularly as the road arcs to the northwest before it crosses the upper meadow and from the parking area to the rear of the administration building (see photo, Views and Vistas #2). Where the road crosses the upper meadow, an expansive view toward the rear of the administration building is available to the south. This distant view extends across the meadow to the administration building, its front lawn and split rail fence, and continues to the highway and forest beyond. To the north, a long view of the upper meadow is obtained from the residential road (see photo, Views and Vistas #3).

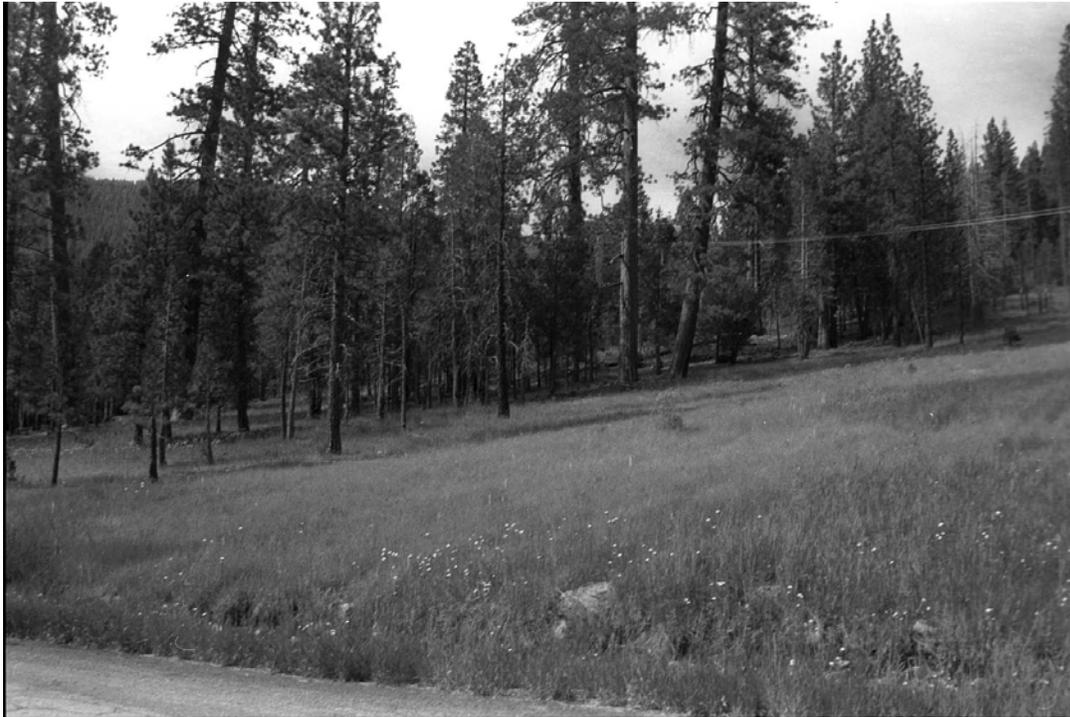
Views and Vistas #3: View toward upper meadow from residential road, looking northwest, 2001. (LAVO-N-27-6)

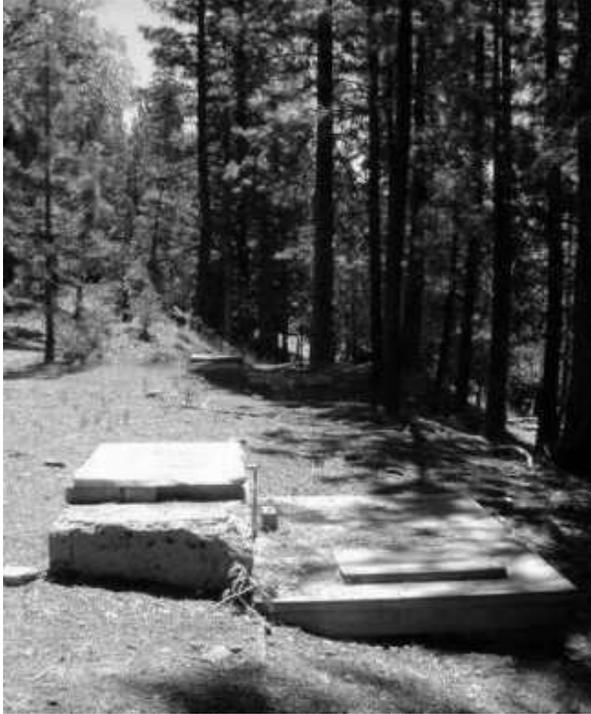
Constructed Water Features #1: Concrete structures associated with 100,000-gallon reservoir, constructed in 1938 in northeast corner of property, looking east, 2001. (LAVO-DSCN-3657)

The reservoir is composed of two 50,000-gallon reinforced concrete storage tanks. A distribution system, using separate lines for fire suppression and domestic drinking water, was constructed and laid in trenches throughout the headquarters area. This system continues to provide a year-round supply of water and contains approximately fifty connections, twenty-one of which service the residential area.

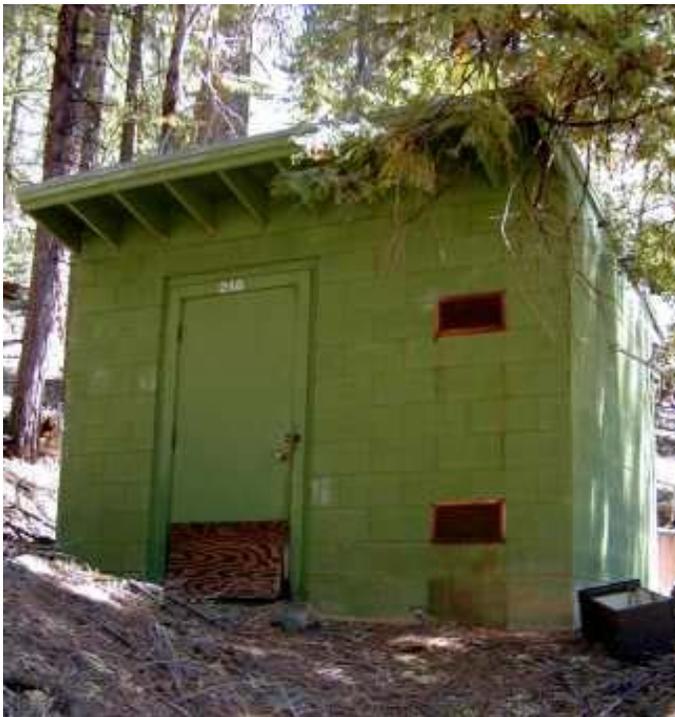
Constructed Water Features #2: Concrete block pump house at 1938 reservoir, 2001. (LAVO-DSCN-3661)
