**Archeological Investigation at the Hovagimian Barn
Stow-Hardy House
Minute Man National Historical Park
Concord, Massachusetts**

Prepared by James M. Harmon

December 2010

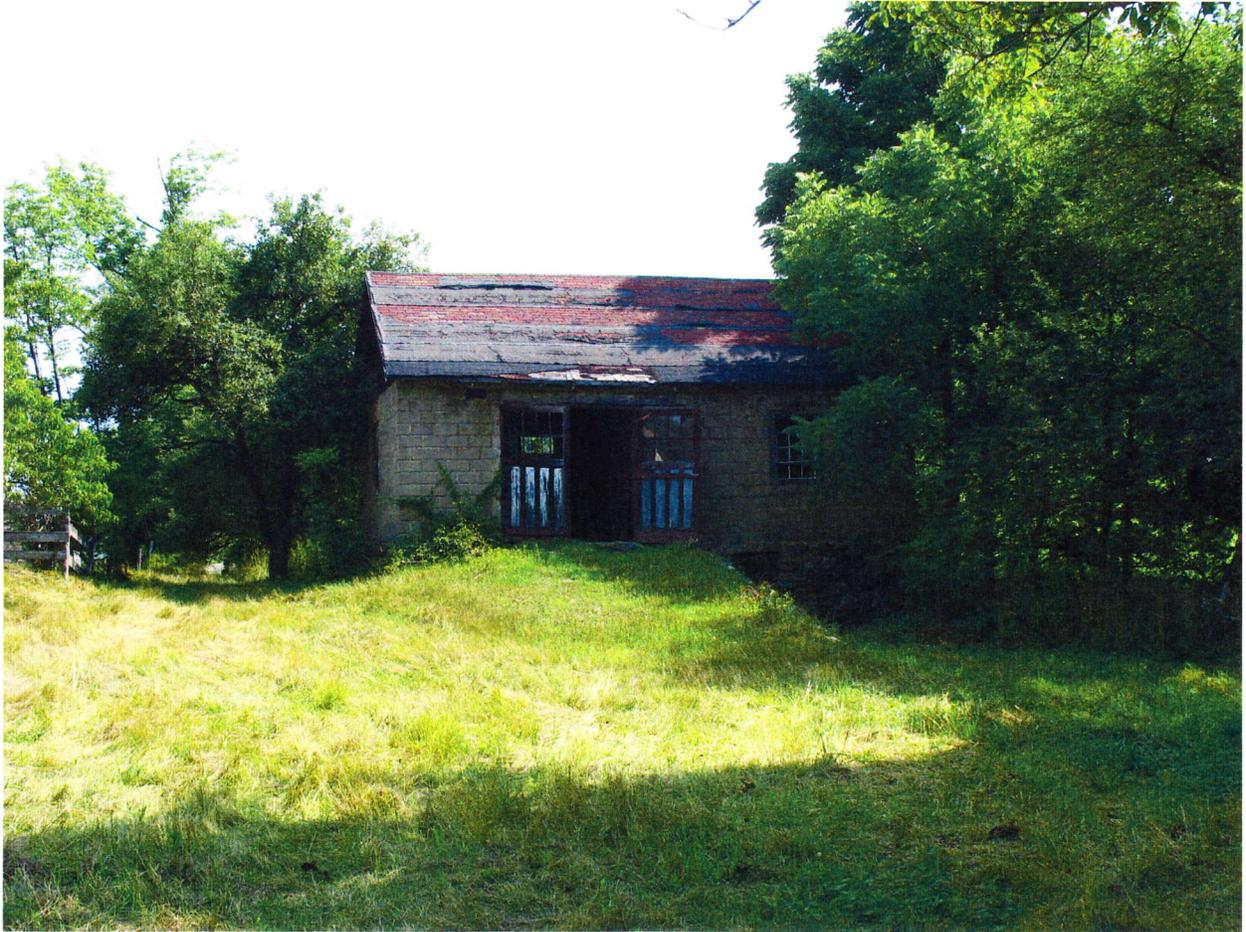
Photo 1: Hovagimian Barn Exterior Conditions at Time of Field Investigation (May 2010). Facing North.

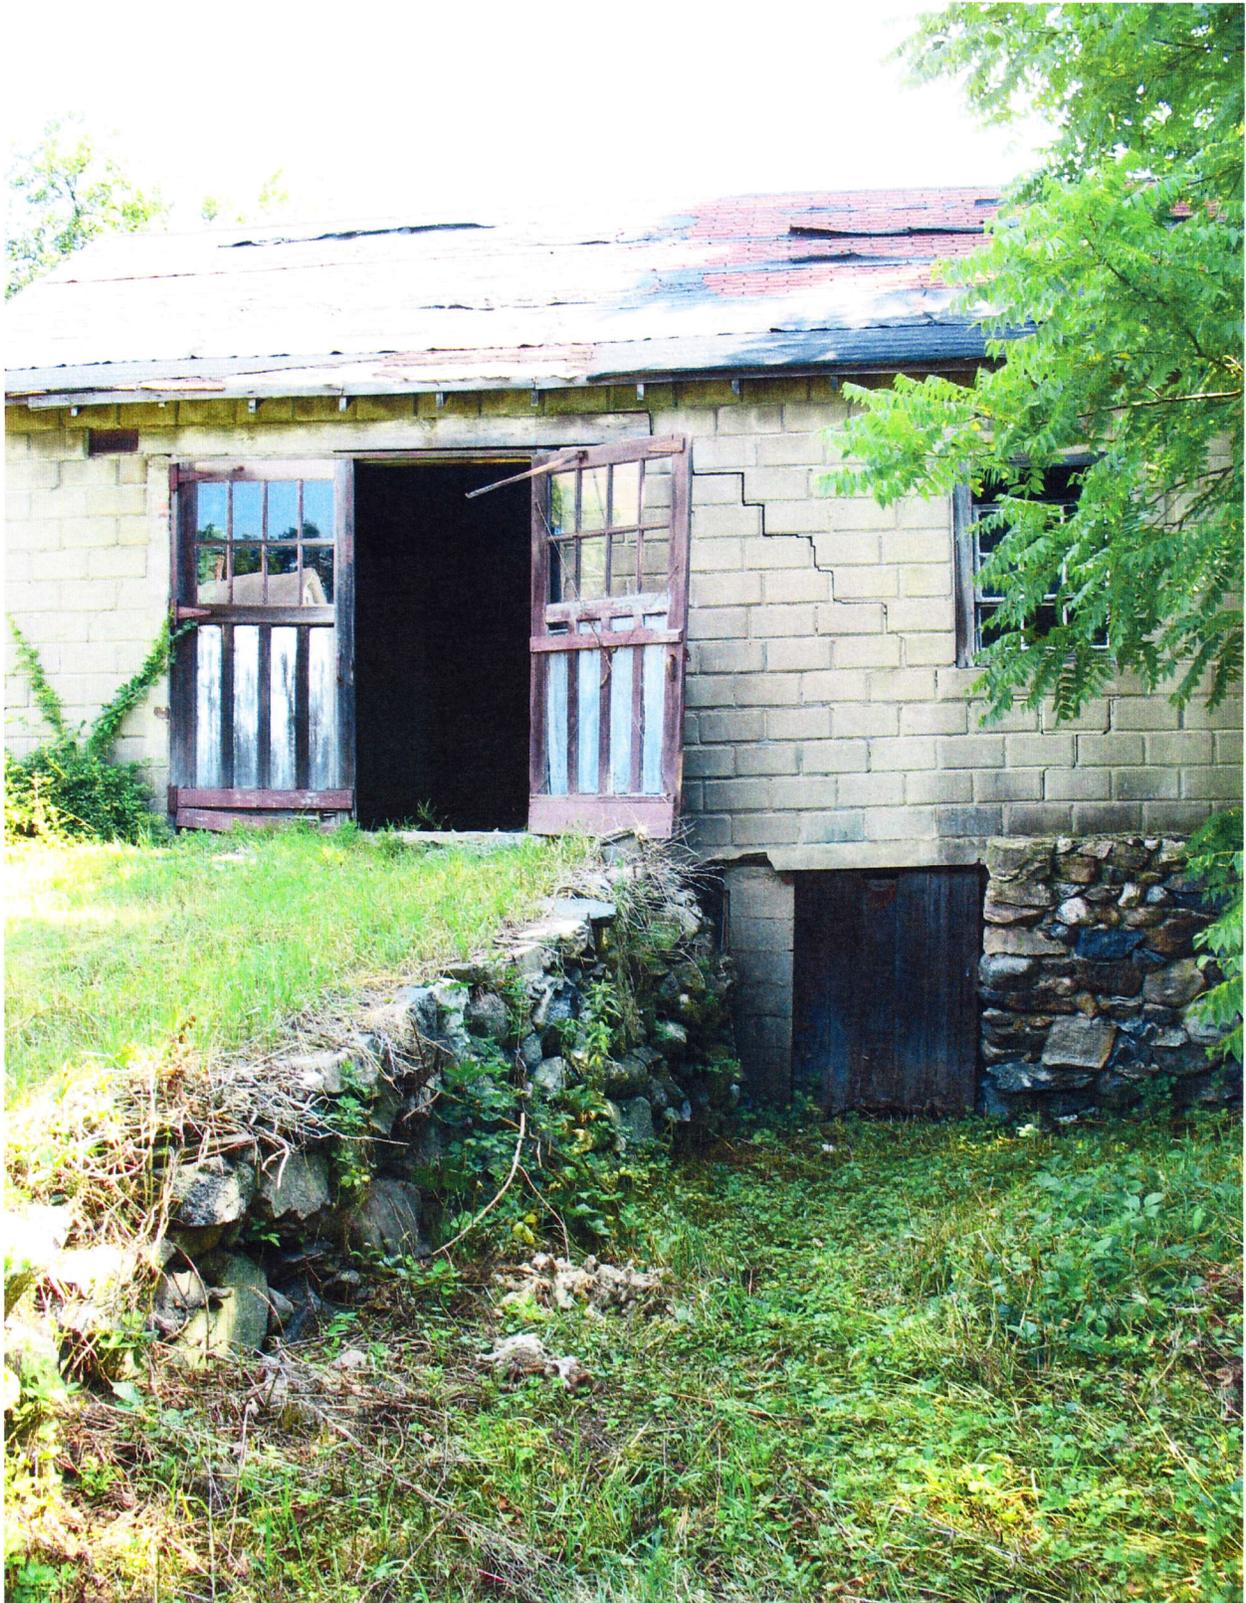
Photo 2: Hovagimian Barn Exterior Conditions Showing Entrance to Lower Level (May 2010). Facing Northwest.

The barn is thirty-three by twenty-two foot structure constructed primarily of concrete blocks, with an upper wooden floor and a lower or cellar level floored with a mixture of soil and slag or coal fragment gravel (Photo 2 and 3). The principal entrance to the building is an earthen ramp that provides access to the upper wooden-floored area. This main story was originally divided into two rooms, while the cellar level was one larger room. The archeological work described here took place within the lower level.

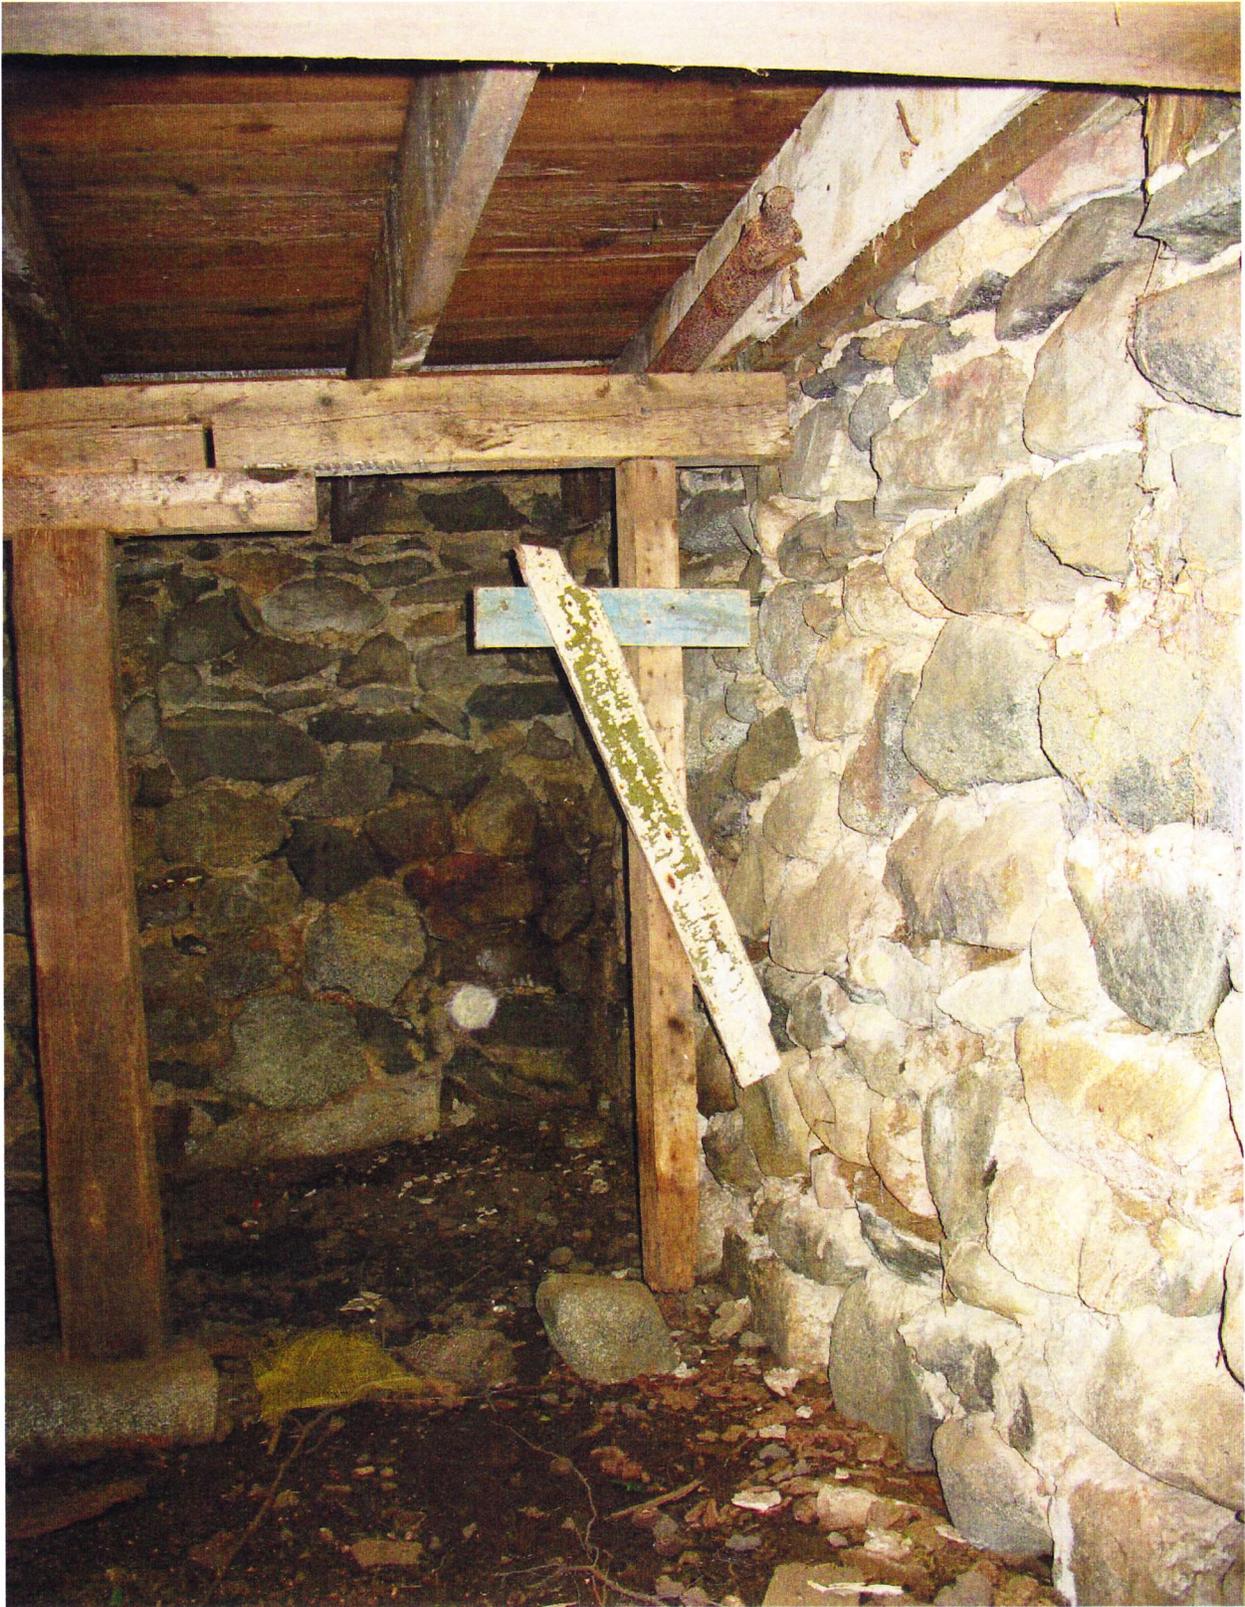
Photo 3: Interior Conditions At Hovagimian Barn. (May 2010)

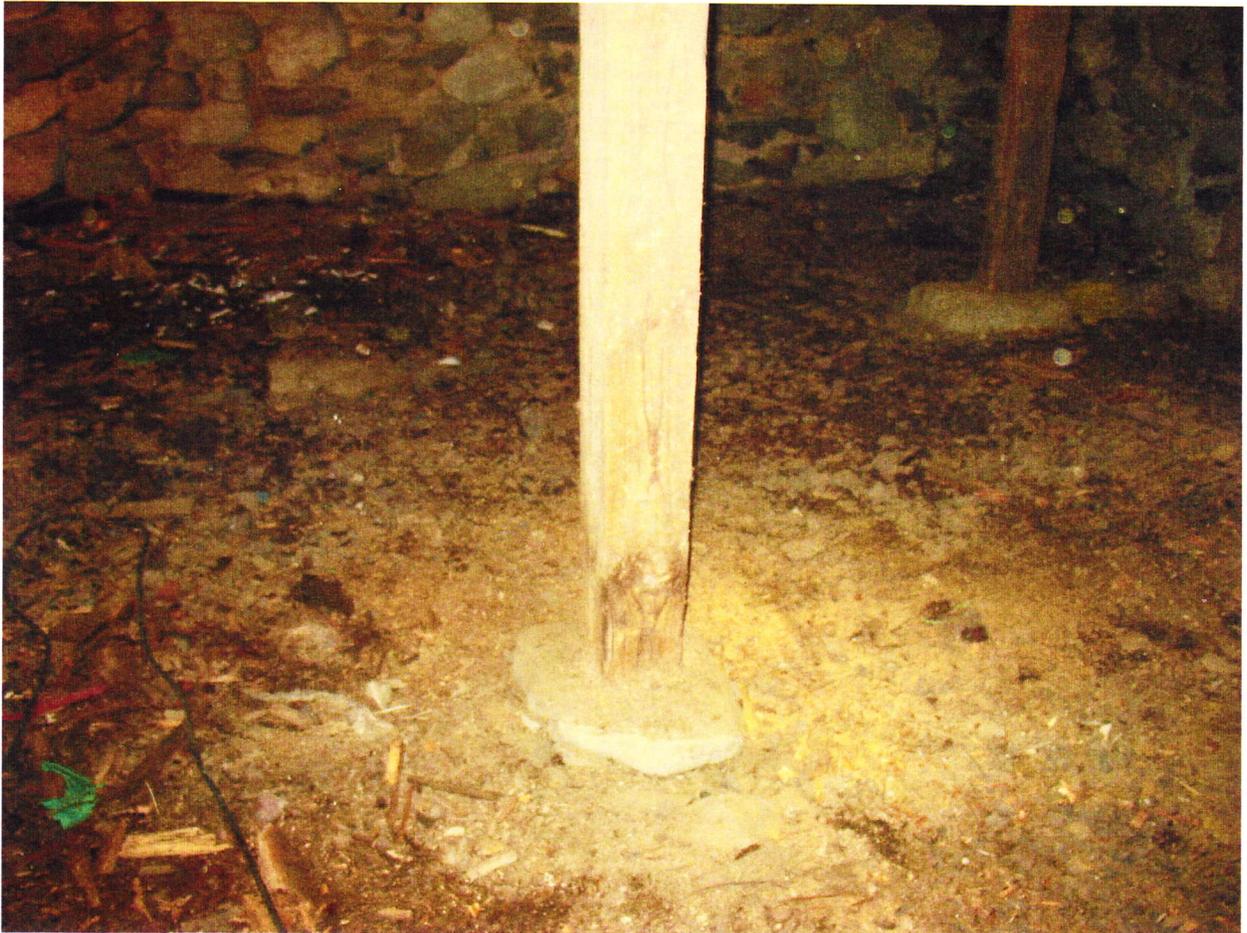
Photo 4: Typical Vertical Support within Barn Interior. Note Flat Stone Foundation and Rot at Base of Post. Facing Northeast.

first floor, and had softened and rotted due to moisture in the barn structure. The stones that were supporting them were partially buried in the soil of the barn floor, and contact between the soil and the base of the posts had caused further decay (Photo 4).

As described above, each of the three excavation units were placed in areas that were also the location of the original vertical wooden beams that had supported the upper floor of the barn. Each was also found to contain a feature consisting of a large, relatively flat, granitic foundation stone (see Photo 4 above; and Photo 6). These were pedestaled during excavation, and each was also found to have a number of smaller granite cobbles around it, placed to stabilize and allow the larger stones to more fully support the vertical beams.

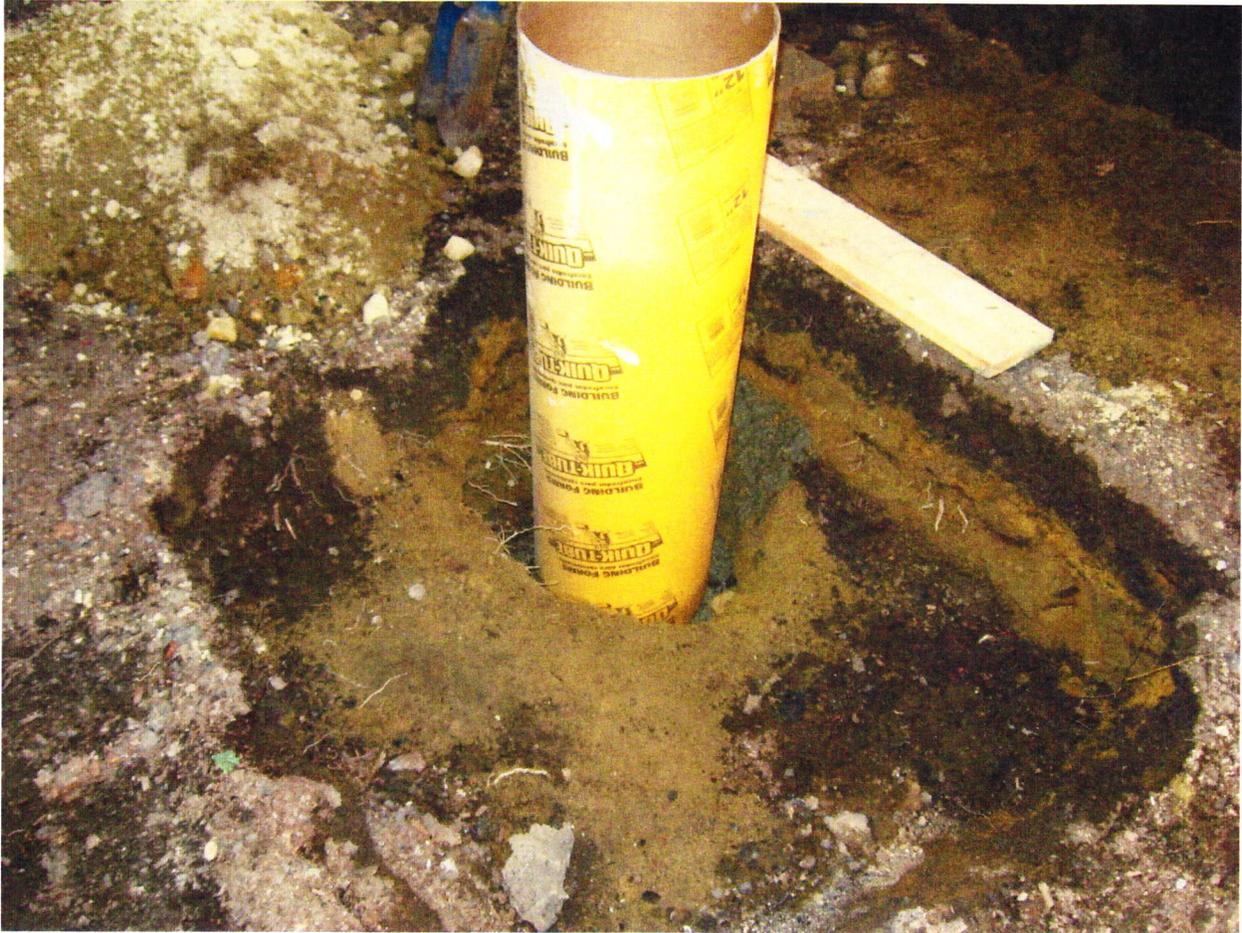
Photo 5: Sono-Tube Installation in Excavation Unit 3.

A decision was made to replace the flat stone foundations at each of the three vertical posts with concrete poured into sono-tube forms. The forms were to be buried three feet below the current floor grade, with an additional twelve inches of concrete protruding above grade. The sono-tubes to be used were twelve inches in diameter (Photo 5). Each vertical post would then be replaced, with the base above the damp interior floor. This work comprised the total extent of soil disturbance for the project.

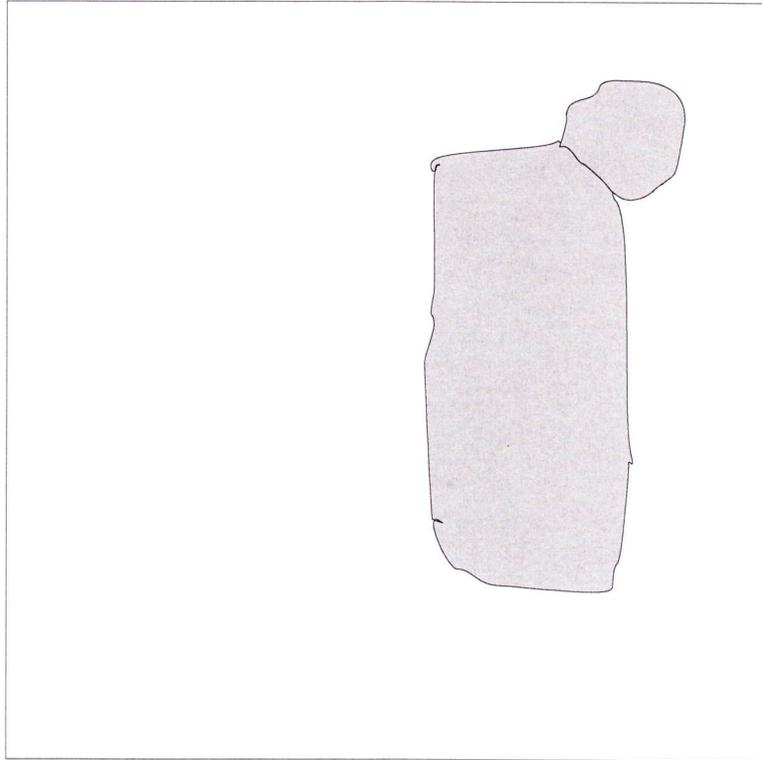
Figure 3: Surface, Excavation Unit 3.
Initial Exposure of Foundation Stones

Gray Areas represent foundation stones visible at the surface of the Hovagimian Barn floor. Surrounding soil matrix consists of very dark gray (10YR3/1) silty sand mixed with approximately 50% coal and slag fragments.

One by one meter square excavation unit, grid squares are twenty-five by twenty-five centimeters. North at top.

Figure 3 and Photo 6 represent a typical view of one of the features at the ground surface within Unit 3. As indicated, only one large stone measuring approximately fifty by twenty centimeters is visible at that level.

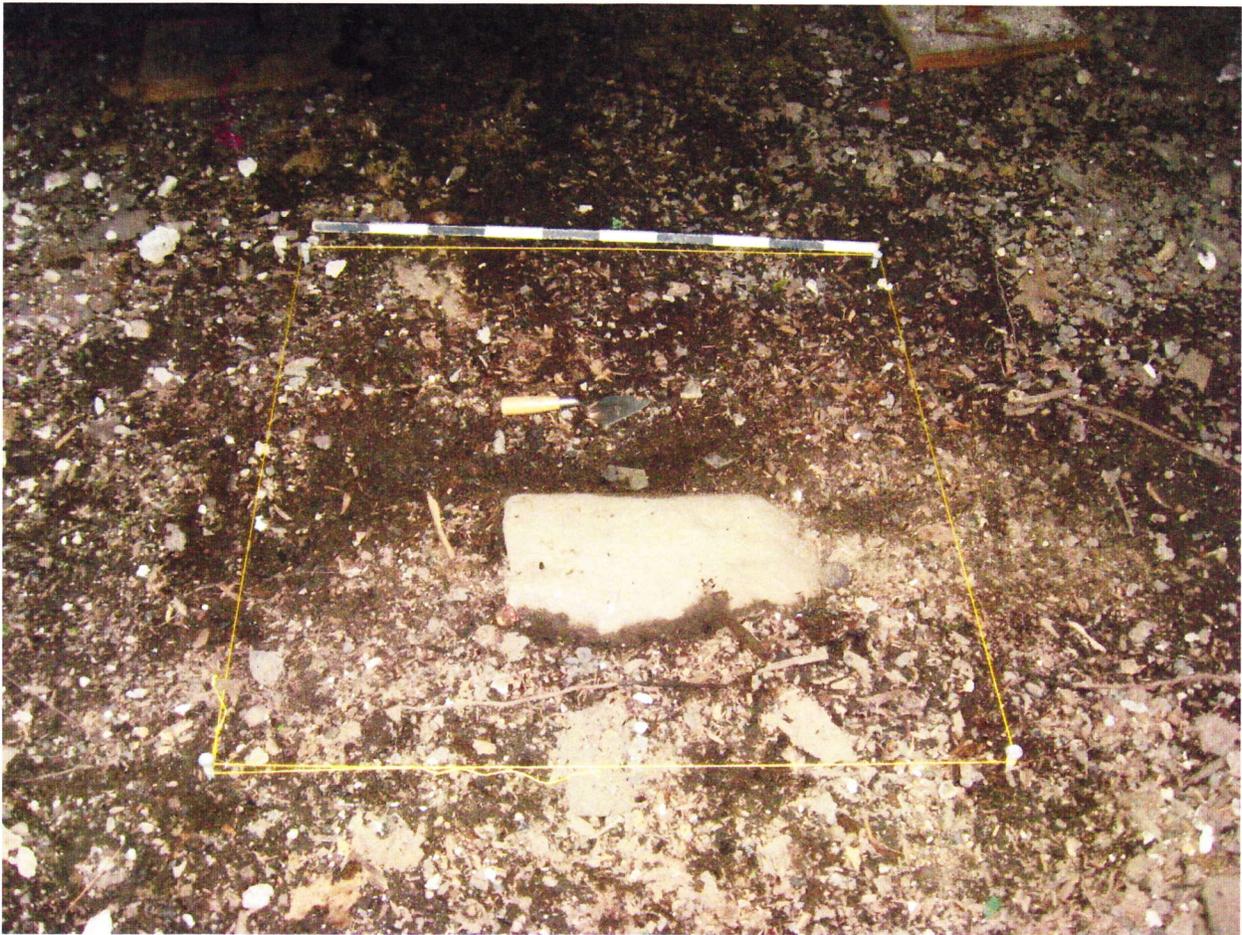
Photo 6: Surface of Excavation Unit 3 . Note Exposure of Flat Foundation Stone at Surface. Facing West.

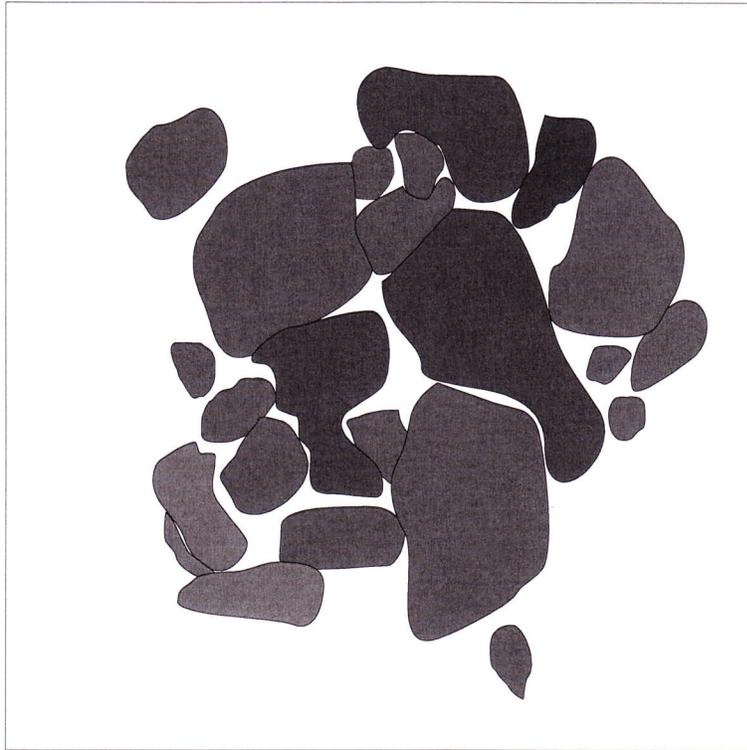
Figure 4: Excavation Unit 2, Base of Level 1

Figure depicts cobbles and small granitic stones exposed following removal of larger stone at surface of feature. Cobbles exposed here range in depth between 15 and 28 centimeters below the ground surface of the barn. Darker gray stones are lower in profile than lighter in this figure. Soil matrix within interstices is very dark gray sandy silt with coal/slag gravel and high artifact content (Stratum 1).

One by one meter square, north at top.

Figure 4 and Photo 7 depict a typical lower level of the features, this time from Unit 2. This exposure is at 12 centimeters in depth, and of note is the internal fill around and between the smaller cobbles. In addition to slag and coal, this fill contained glass, two bone fragments, an unidentifiable nail fragment, and a single undecorated whiteware rim sherd. The internal fill artifacts were indistinguishable from those in Stratum 1 in the larger surrounding unit, as was the soil color and texture.

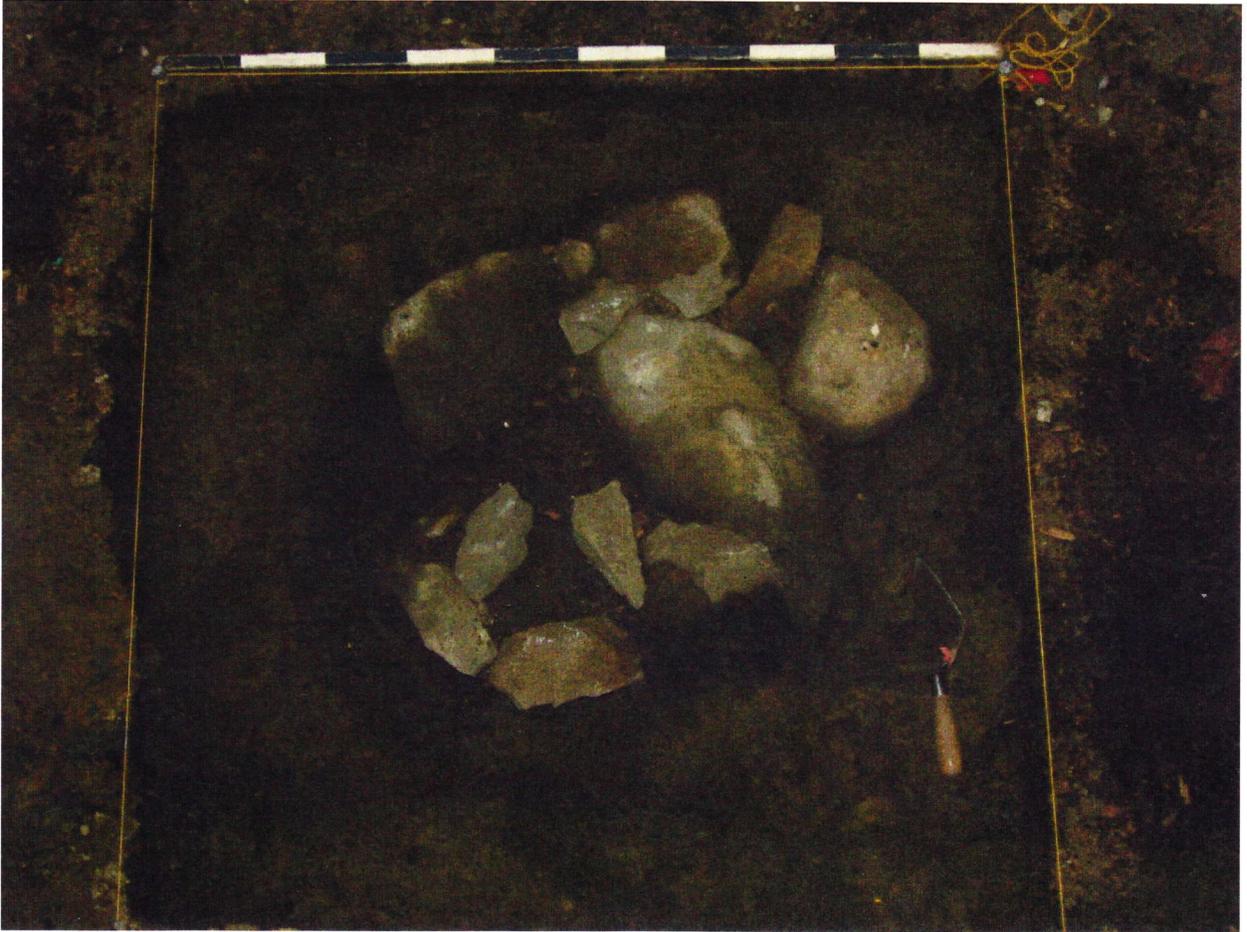
Photo 7: Foundation Stone Feature in Excavation Unit 2 Following Removal of Upper Soils. Facing North.

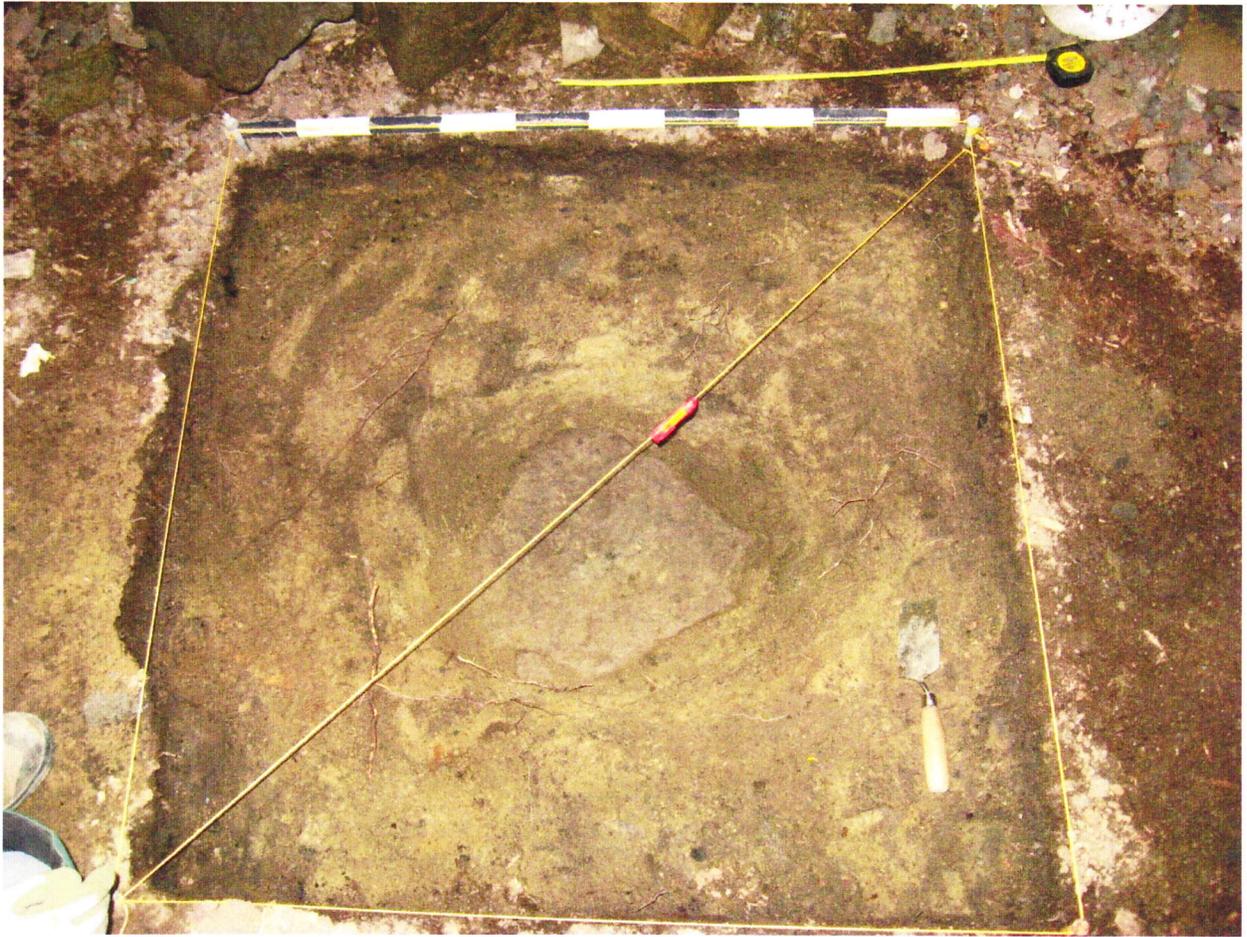
Photo 8: Base of Foundation Stone Feature in Excavation Unit 2 Following Removal of Stratum 1 Soils. Facing North.

Finally, Photo 8 represents the feature in Unit 2 following removal of the overlying small cobbles. At this depth (15 centimeters below ground surface) the subsoil stratum is has become visible across much of the unit, and there is just one granitic cobble remaining. Of note here is the fact that the final cobble is embedded within the subsoil, rather than within the Stratum 1 soils that surrounded and comprised the internal fill of the feature.

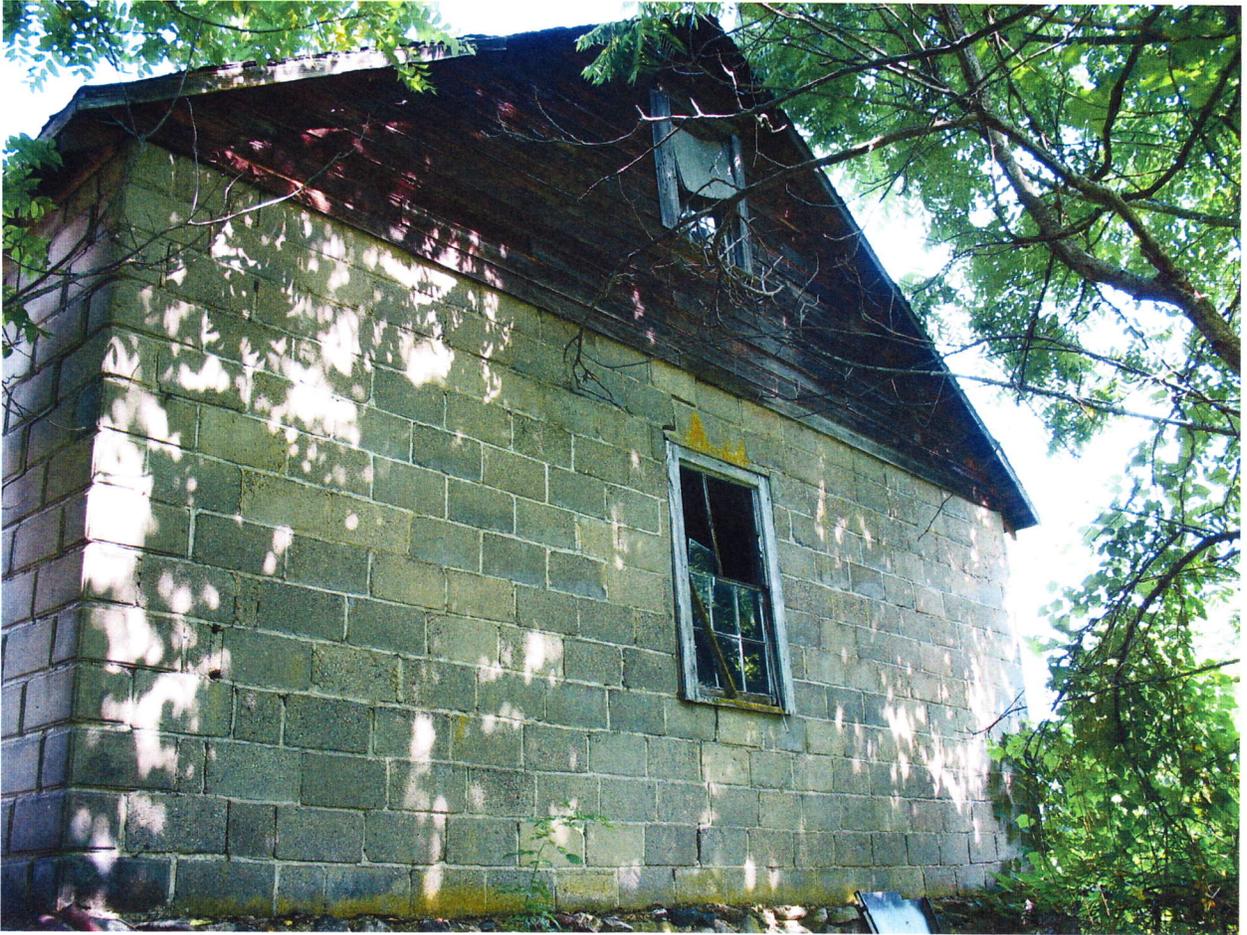
Photo 9: Remnants of Six over Six Windows, West Elevation of Hovagimian Barn

Glass, more specifically flat glass, comprised over 77% (n=406) of the total artifact assemblage. Of this, almost 47% was window glass (n=250). The source of much of this glass may have been the original windows of the barn, most of which were broken out at the time of this investigation (Photo 10). Another 9% (n=48) of the total assemblage was an embossed, colorless, flat glass that appeared to either be a shower or bathroom door panel.
