# THE HISTORY AND ARCHITECTURE OF THE POINT REYES LIGHT STATION

Historic Structures Report  
Point Reyes National Seashore

NATIONAL PARK SERVICE  
1990

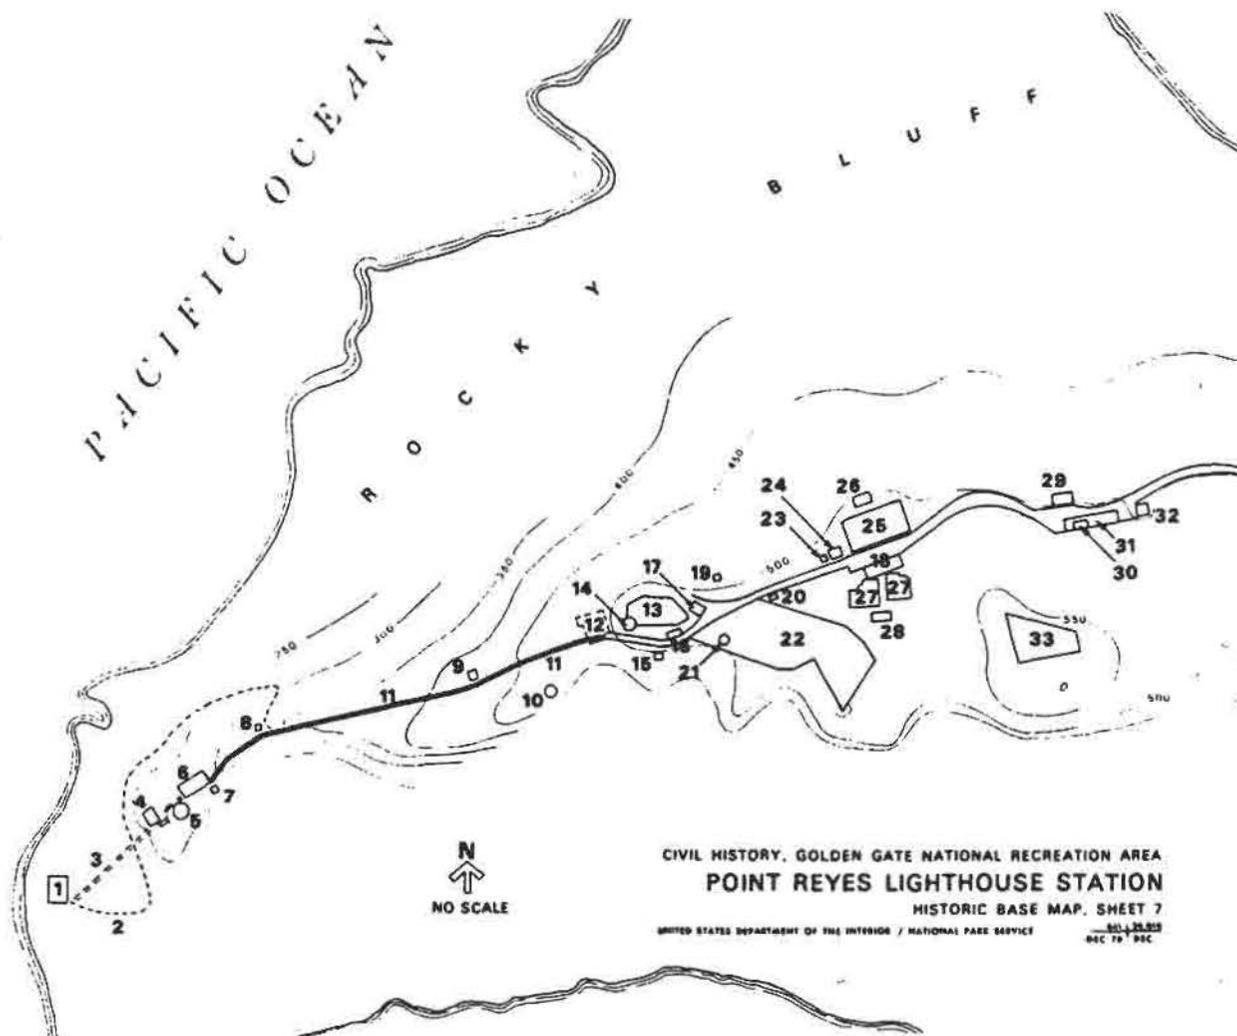
C. HISTORIC BASE MAP from Toogood

| <ol style="list-style-type: none"> <li>1. Fog signal (site, 1871-1934)</li> <li>2. Trail/stairs to fog signal</li> <li>3. Route of coal chute</li> <li>4. Modern light station/site of fog signal 1934-1974</li> <li>5. Lighthouse, 1870</li> <li>6. Equipment building, 1928</li> <li>7. Transformer building (old oil house), 1910</li> <li>8. Fuel tank (site)</li> <li>9. Gasoline storage building (site)</li> <li>10. Wooden 42,000 gal. water tank (site)</li> <li>11. Stairway, 1959 (site of original wooden stairs)</li> <li>12. Weather Bureau/keepers dwelling, 1902-c.1960 (site)</li> <li>13. Rainshed, site of storm warning pole &amp; flag pole</li> <li>14. Cistern, 1898</li> <li>15. Washhouse (site)</li> <li>16. Single garage, fuel shed (site)</li> </ol> | <ol style="list-style-type: none"> <li>17. Visitor center (ex-garage)</li> <li>18. Planked terrace (site)</li> <li>19. Pump house, 1934</li> <li>20. Fuel and paint storage building, c. 1900</li> <li>21. Cistern, 1871</li> <li>22. Rainshed, 1871-1900</li> <li>23. Paint shop (site)</li> <li>24. Coal house (site)</li> <li>25. Double keepers quarters, 1870-1960 (site), apartments, 1960</li> <li>26. Outhouses, sheds, laundry &amp; store buildings (sites)</li> <li>27. Keepers cottages, 1885-1960 (site)</li> <li>28. Fuel and store building (site)</li> <li>29. Barn, 3-car garage (site)</li> <li>30. Modern pumphouse, site of gas storage building</li> <li>31. Stable, barn (site)</li> <li>32. One-car garage, 1933 (site)</li> <li>33. Upper rainshed, 6,000 square feet, 1900 (site)</li> </ol> |

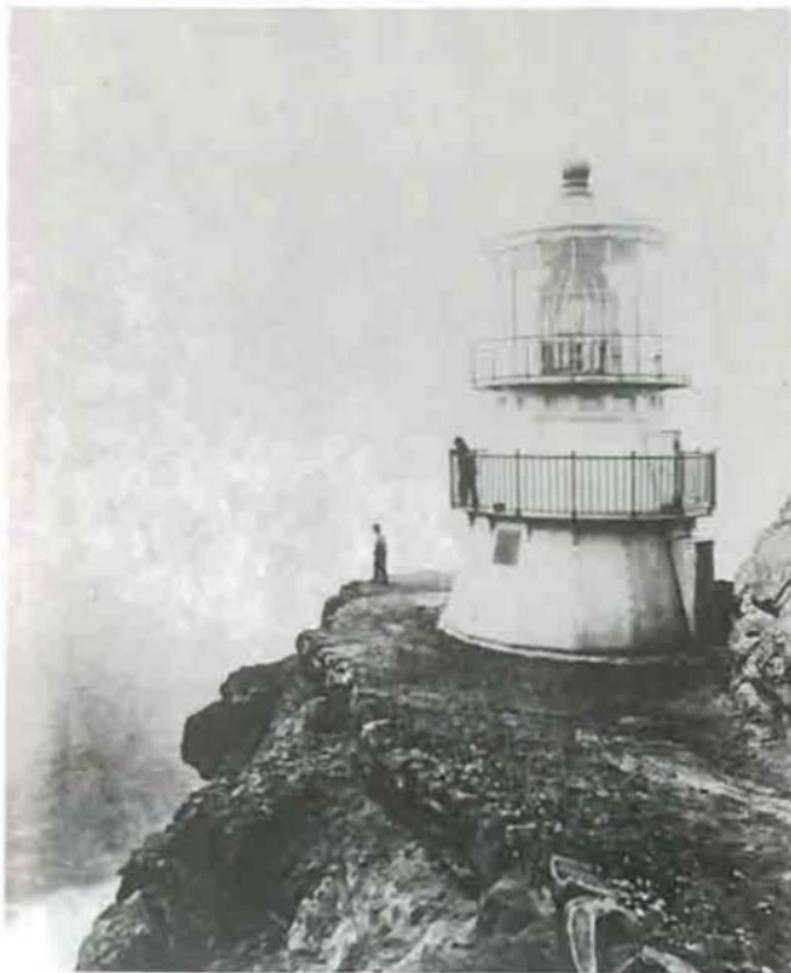
Figure 3 - Point Reyes lighthouse when new, probably taken in late 1870 or early 1871. Note the light color of lantern. Eadward Muybridge photograph, Records of the United States Coast Guard, National Archives.

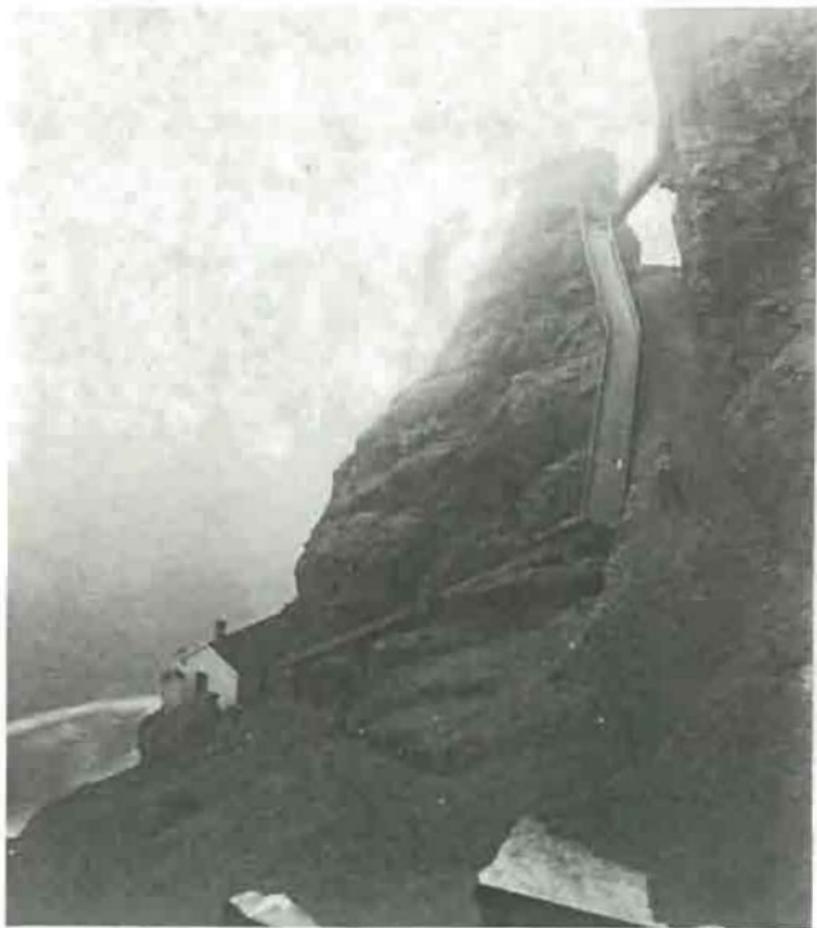
Figure 4 - Newly built coal chute and fog signal, ca. 1871.  
Eadweard Muybridge photograph courtesy of Bancroft Library.

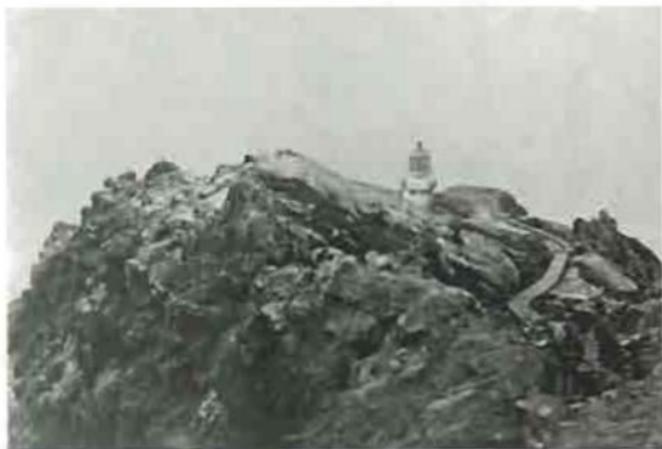
Figure 7 - View down stairs under construction, probably late 1870. Note that future site of equipment building has been graded. Eadweard Muybridge photograph, United States Coast Guard.

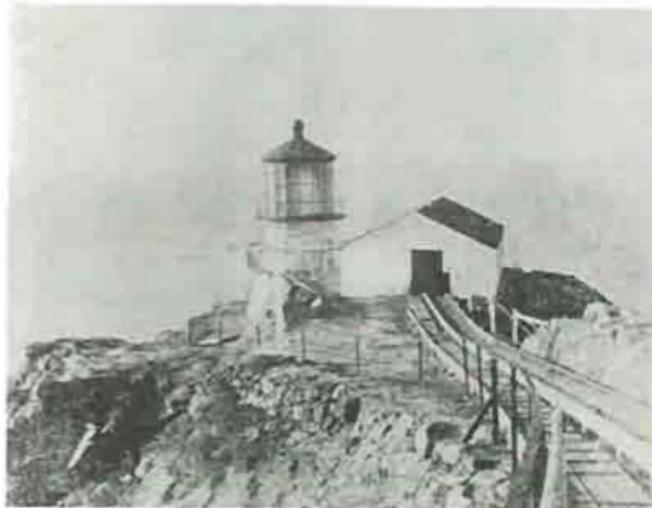
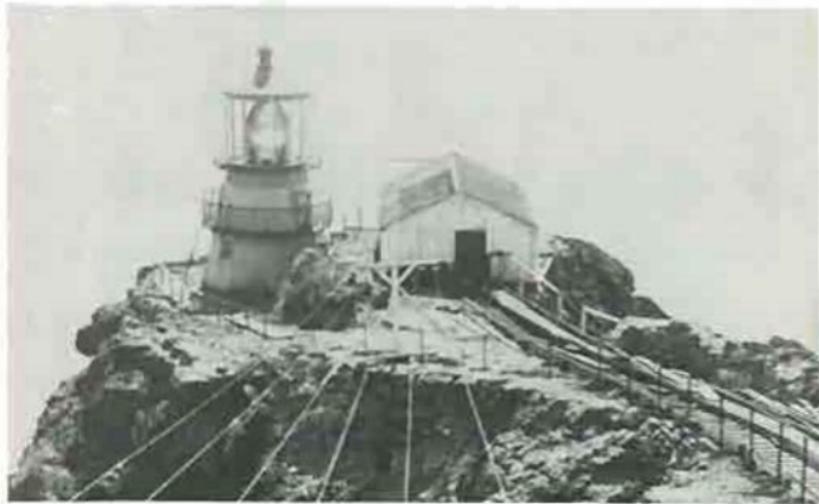
Figures 8 and 9 - Two views of the lighthouse and coal shed, before 1886. National Park Service.

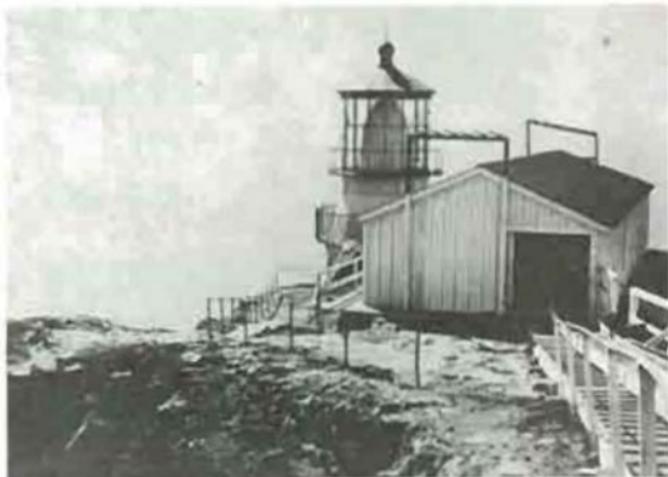
Figure 10 - Lighthouse and second coal storage building, ca. 1900. Jack Mason Museum.

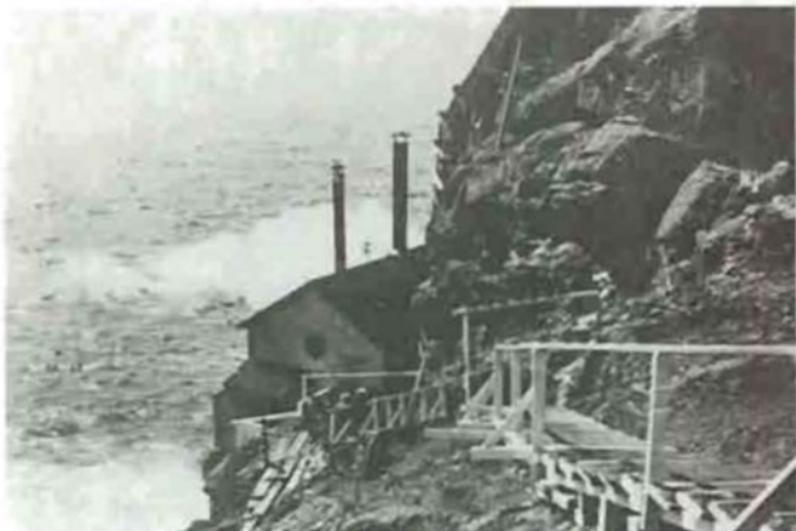
Figure 11 - Fog signal building, ca. 1900. Jack Mason Museum.

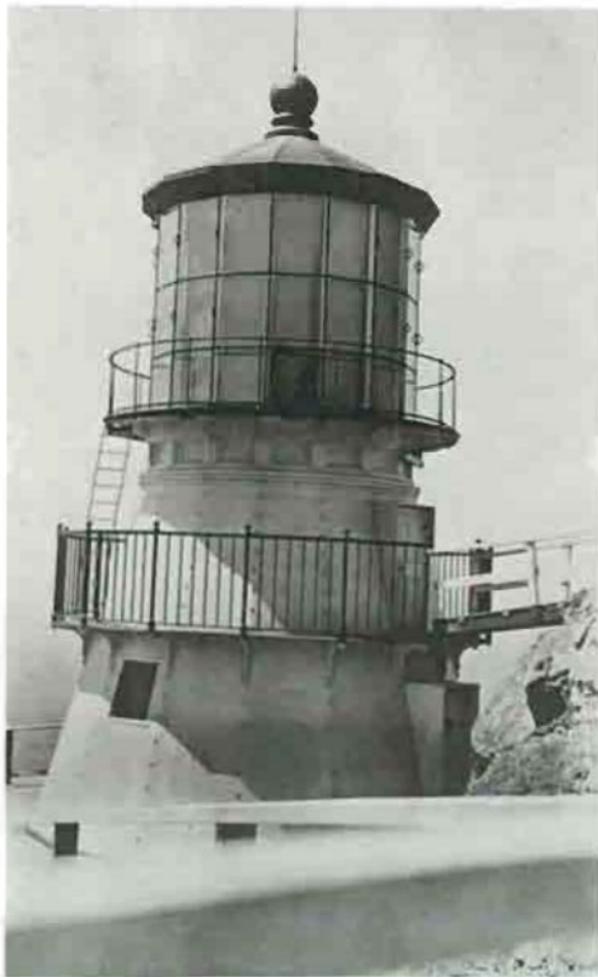
Figure 12 - Lighthouse ca. 1910. Note concrete sidewalk around tower. Jack Mason Museum.

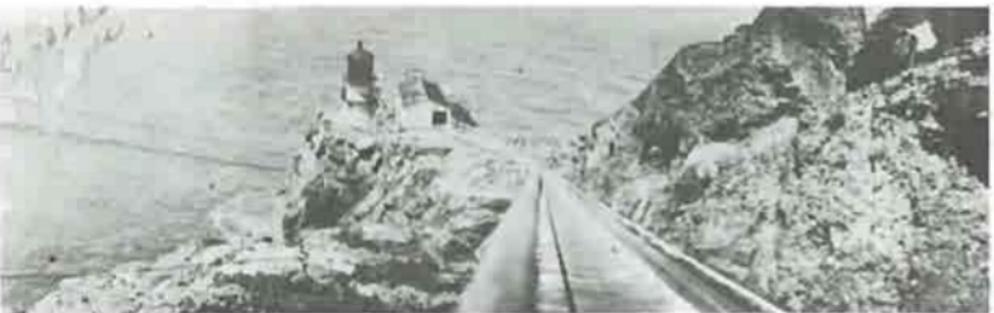
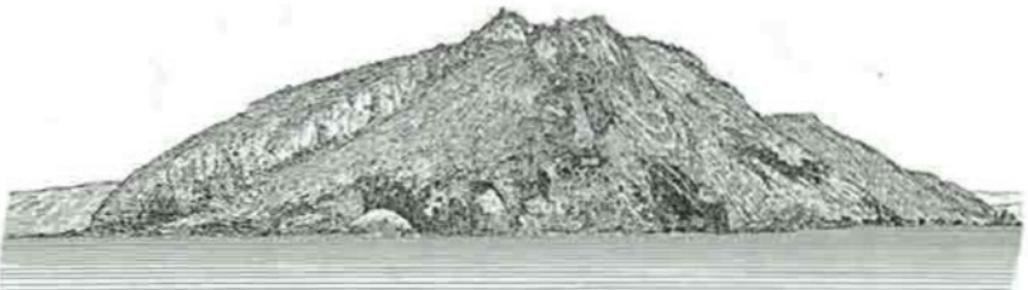
Foghorn.  
Water tank, Light-house,  
Point Reyes Light-house and Foghorn, E. 1/2 N., 1 mile.

Figures 13 and 14 - Lighthouse complex from stairs, before 1910 (left), Jack Mason Museum.  
Drawing of Point Reyes from sea (right), from 1889 Coast Pilot.

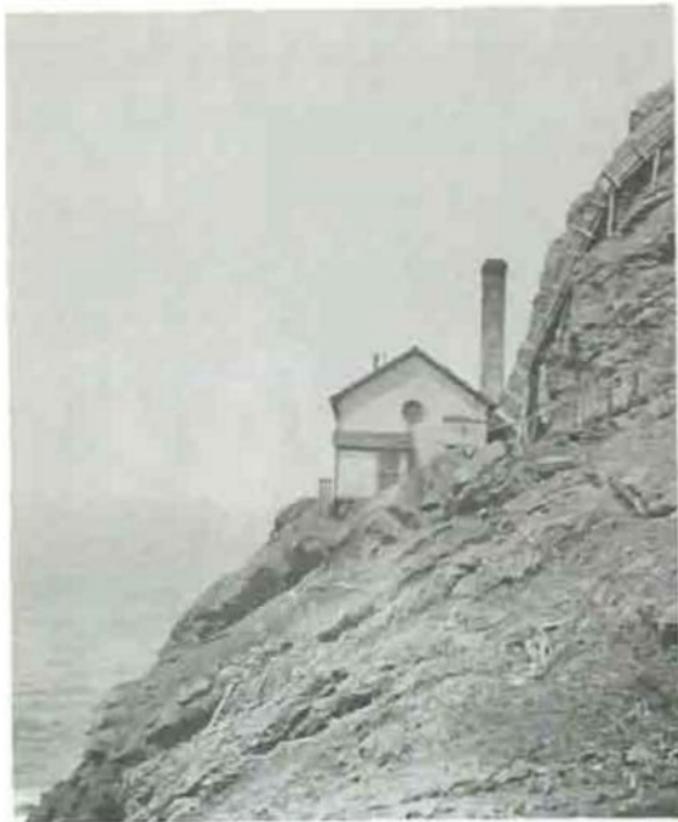
Figure 15 - Fog Signal building ca. 1915, National Park Service.

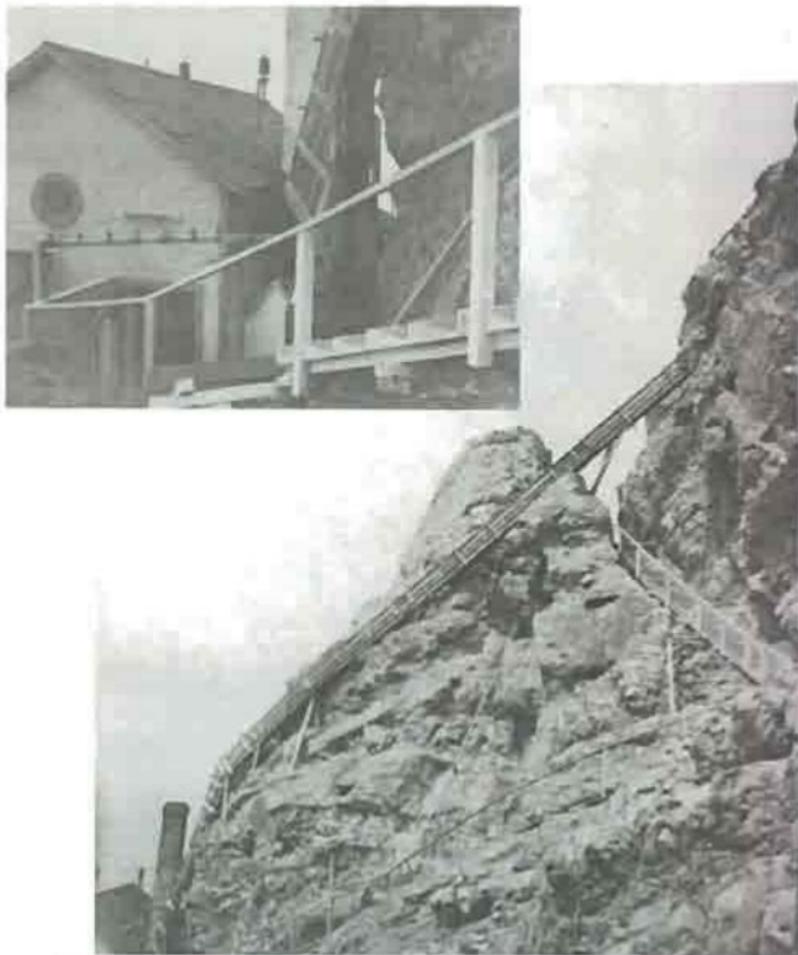
Figure 16 - Stairs and chuto, fog signal, ca. 1915; detail of fog signal building ca. 1915 (inset).  
National Park Service.

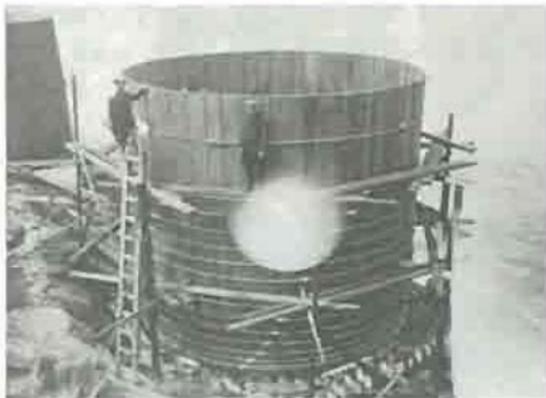
Figure 17 - Construction of new water tank near top of stairs, ca. 1915. National Park Service.

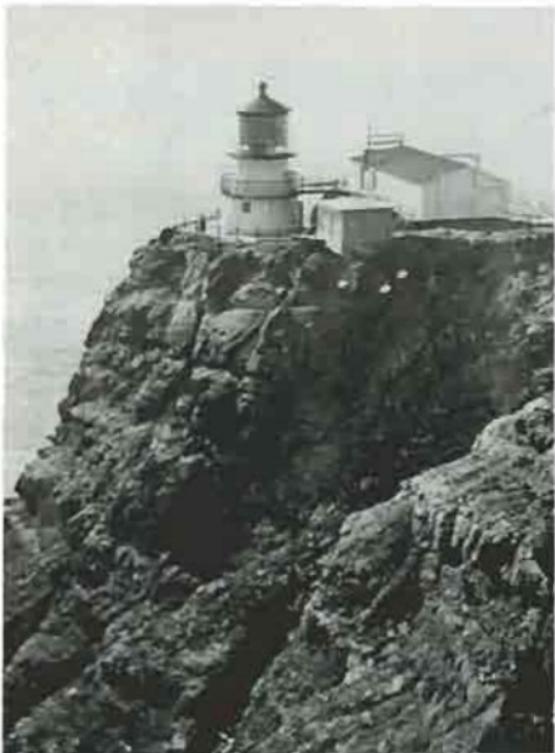
Figure 20 - Lighthouse, oil storage building, coal shed, 1927. Within a year the shed will be replaced by the equipment building. National Park Service, courtesy of Fred V. Kreth.

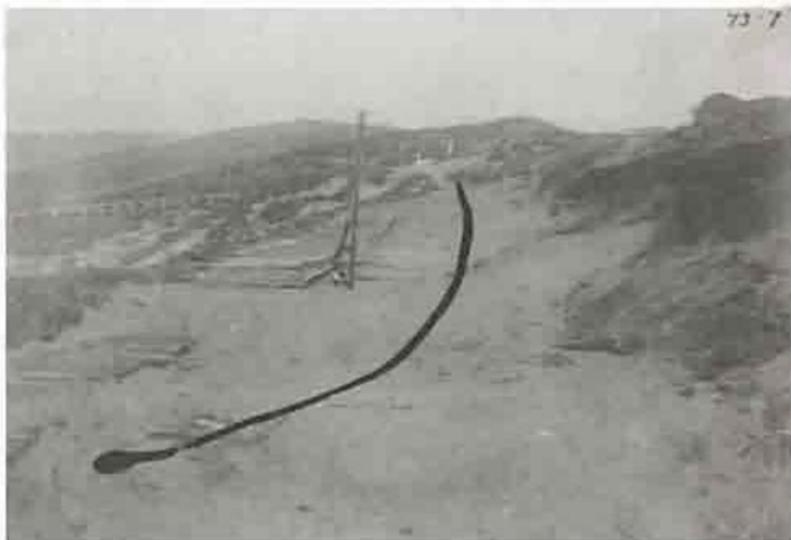
Figure 21 - Road in eastern part of reservation before repairs, 1921; line marks proposed bypass of plank road on left. National Park Service.

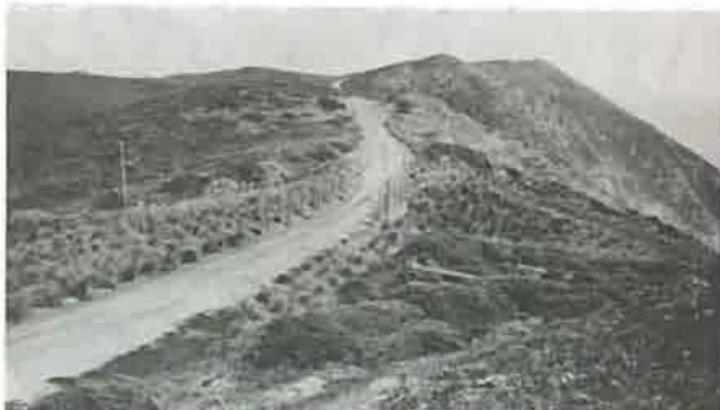
Figure 22 - Road after repairs, 1934. Notice vegetation planted to stabilize dune. National Park Service.

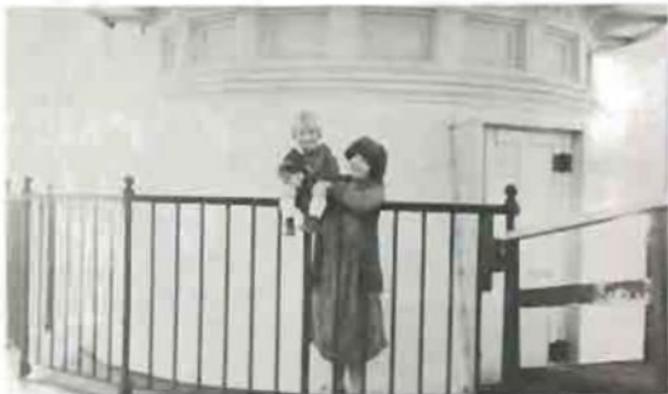
Figure 29 - Lighthouse balcony showing original door to first gallery, taken about 1922. Smith family album, Jack Mason Museum.

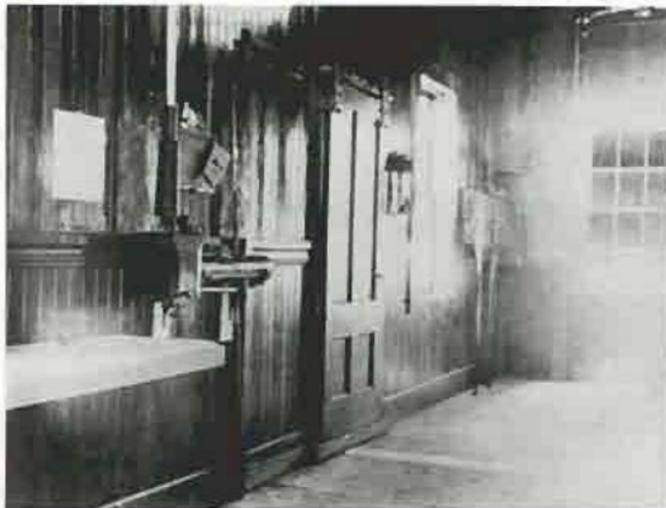
Figure 31 - Interior of fog signal building, 1915. Note similar appearance to later equipment building interior. National Park Service.

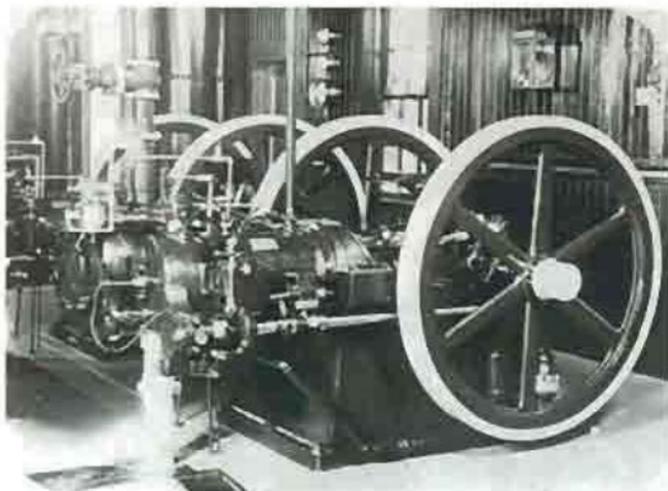
Figure 32- Doak gasoline engines, fog signal building, 1927. National Park Service.

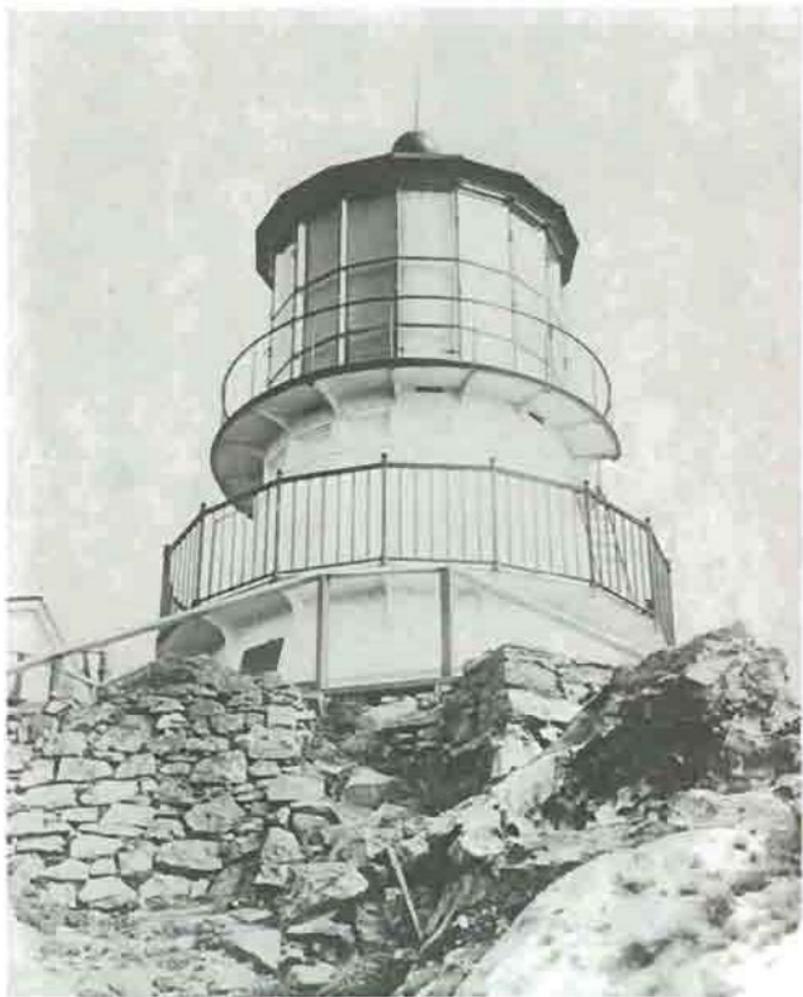
Figure 33 - Lighthouse tower from cliff below, 1927. National Park Service.

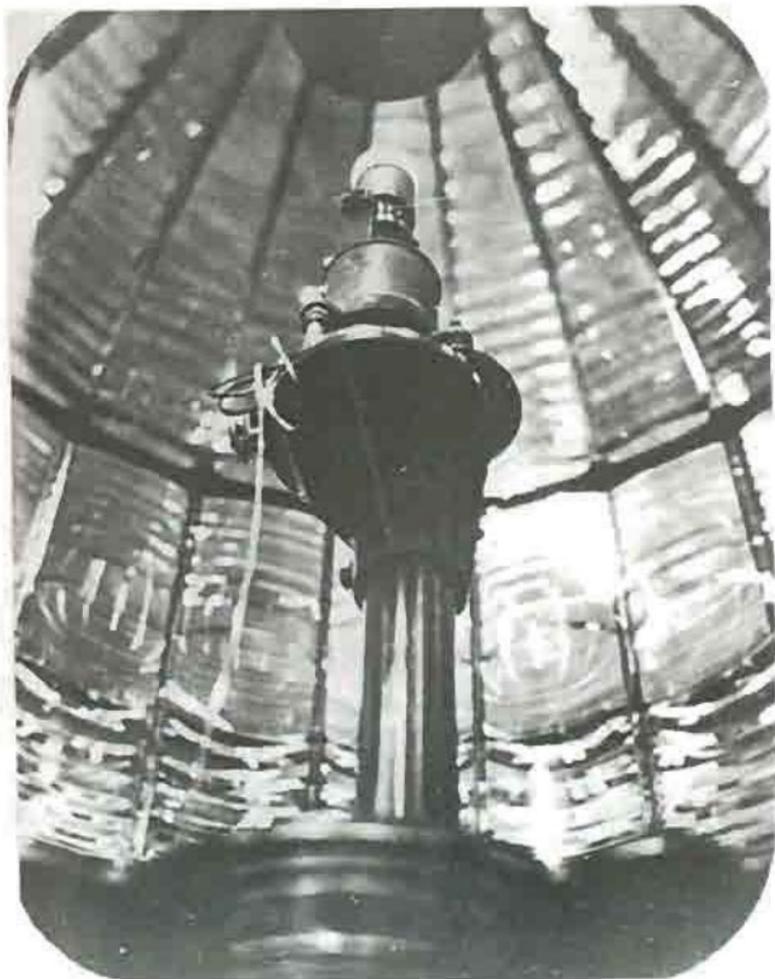
Figure 34 - Illuminating apparatus, 1927. National Park Service.

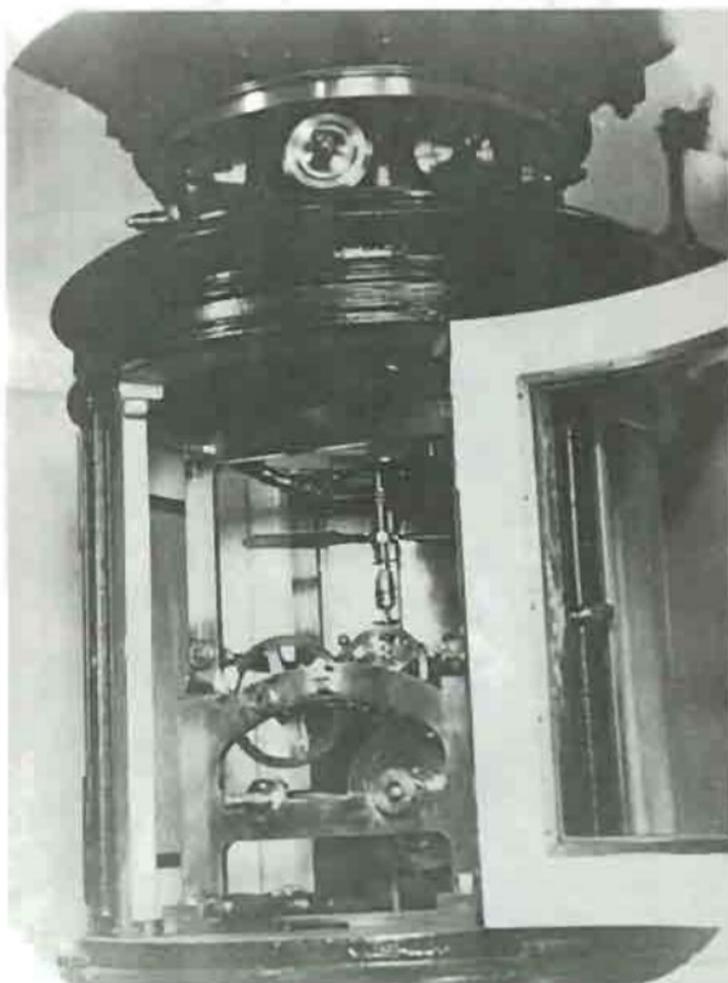
Figure 35 - Clockwork apparatus and lens pedestal, 1927. National Park Service.

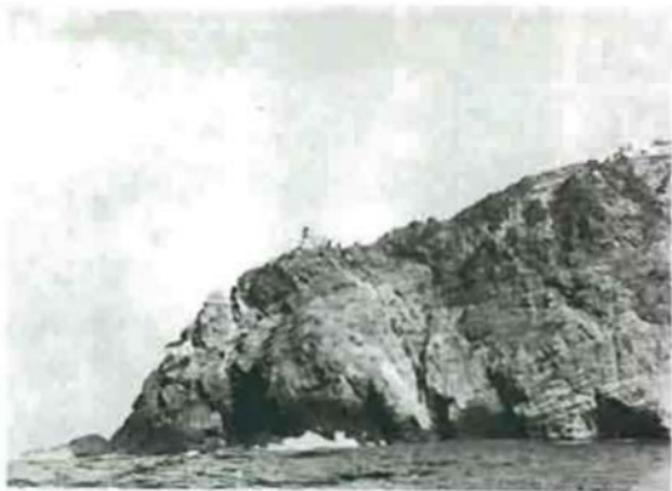
Figure 38 - Point Reyes Lighthouse from sea, looking north; newly built equipment building behind tower, February 1929. National Park Service.

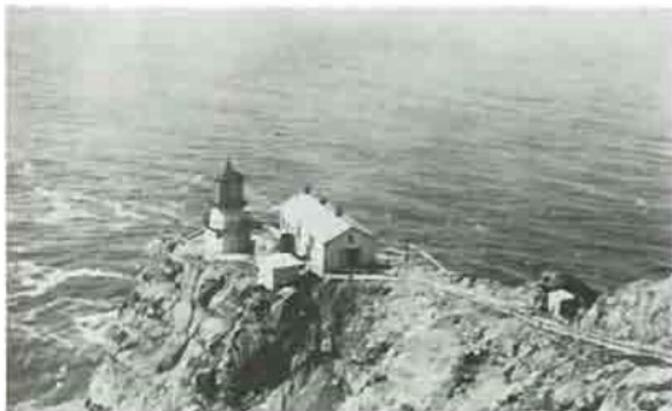
Figure 39 - Lighthouse complex with new fog signal equipment building, January 1, 1929. Photo marked by photographer, "New fog signal building at Pt. Reyes showing circulating water tank [next to building] and distillate sump tank [on right]. National Park Service, courtesy of Fred V. Kruth.

The fog signal equipment building, built in 1928 and put into operation in February 1929, is a 20' x 46' wood frame one-story building on a concrete slab foundation. Its purpose was to house the machinery necessary to power the fog signal, first located about 100' feet below on the cliff and after 1934 in a building adjacent to the lighthouse tower. It has also been called the power house, or the machinery building. It is composed of four rooms: a large machinery room with natural wood paneling, which contains a generator, two electric motors and compressors, a compressed air storage tank, work bench, sink, and related hardware, gauges and electrical utility boxes; a watch room with desk; a storage room, more recently called the TV room, with cabinets; and a lavatory, now used for storage. The building has a door on the west side and a set of rolling doors on the east side at the foot of the stairway which leads up to the visitor center and dwellings. The building is painted white with green trim and has a red composition tile roof.

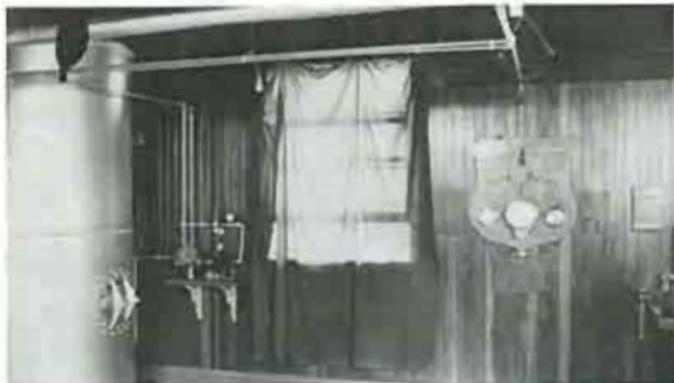
Figure 40 - Interior of fog signal equipment building in 1935, showing compressed air holding tank on left and gauge board on wall, both still extant. National Park Service.

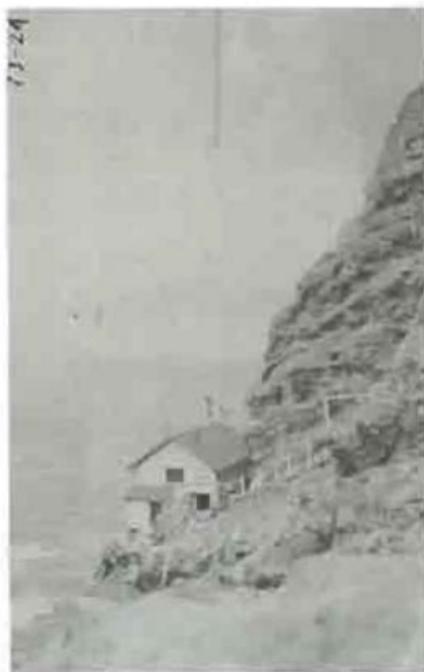
Figure 41 - Fog signal building ca. 1915-1925, before signals were moved up to the lighthouse complex.  
National Park Service.

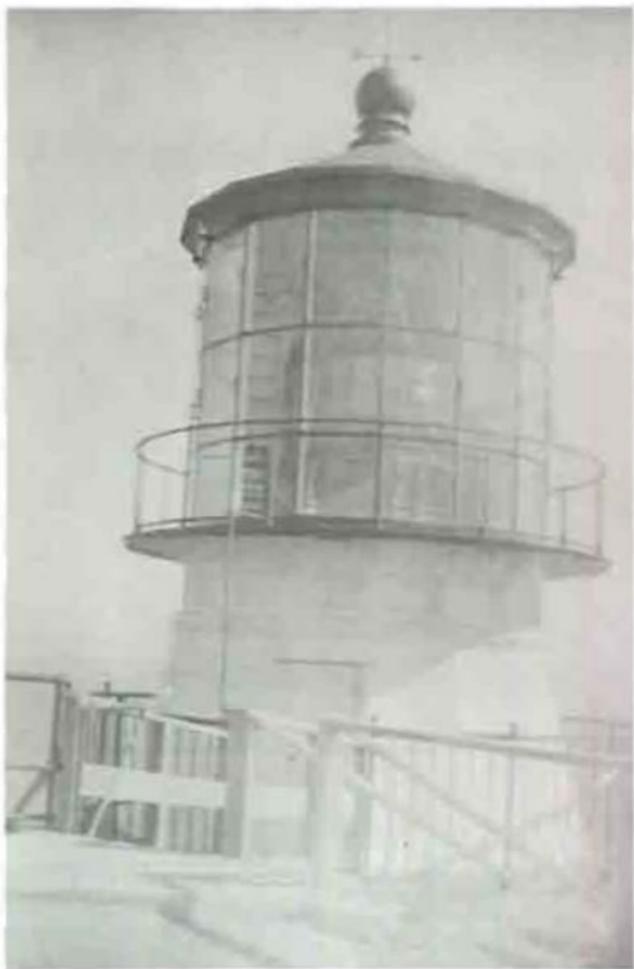
Figure 44 - Lighthouse tower, 1935. Note weathervane above the ventilator hall. National Park Service.

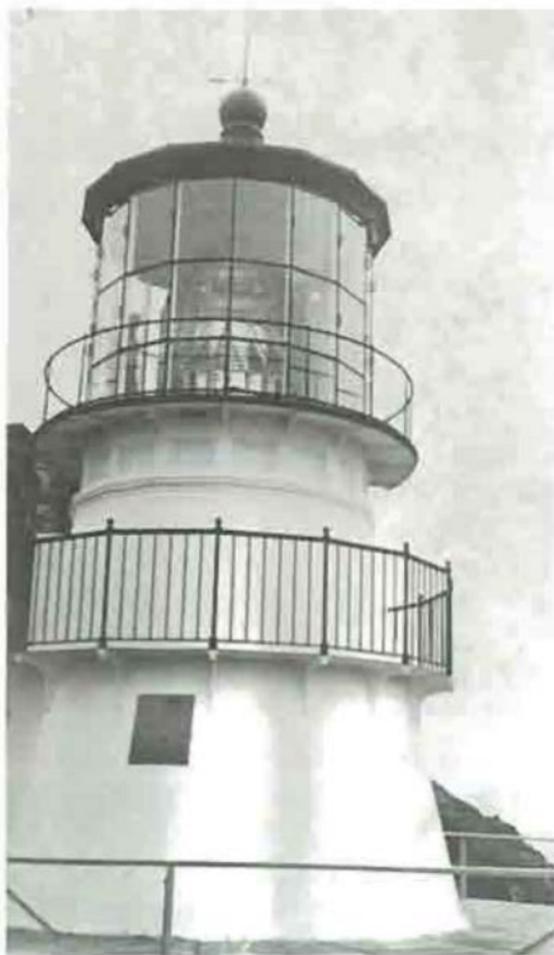
Figure 45 - Lighthouse tower, April 1941. Note weathervane. U.S. Coast Guard.

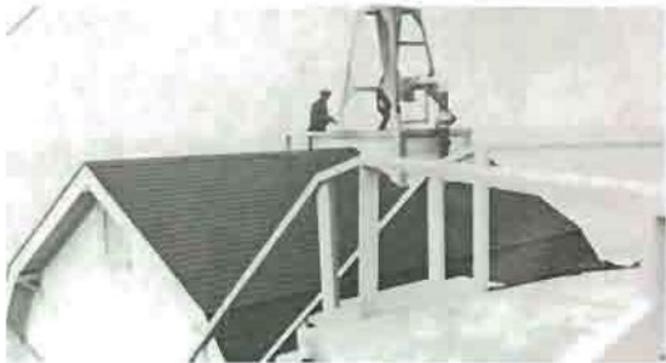
Figure 47 - Fog signal building, April 1941. Man is standing at base of diaphones. U.S. Coast Guard.

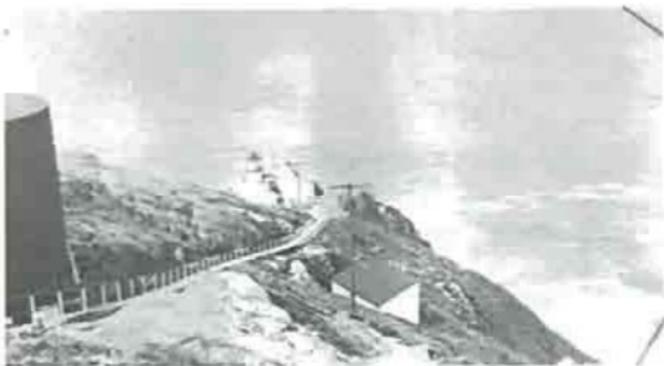
Figure 49 - Looking down lighthouse stairs, April 1941. Overflow water storage tank on left, gasoline storage shed in center foreground. U.S. Coast Guard.

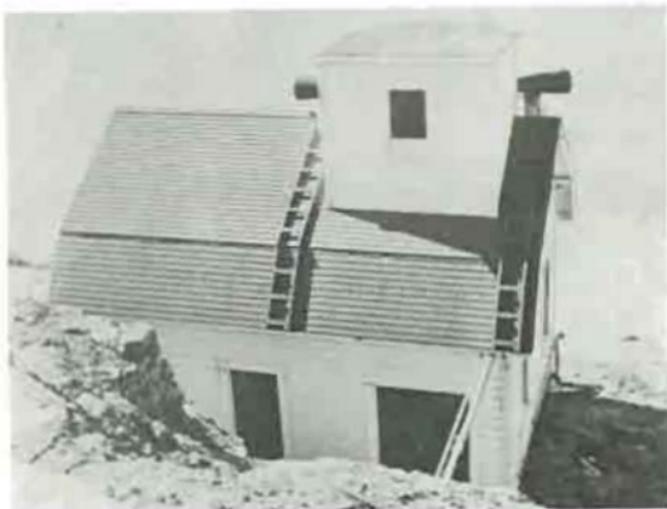
Figure 63 - Fog signal building with F2T horns, ca. 1950. U.S. Coast Guard.

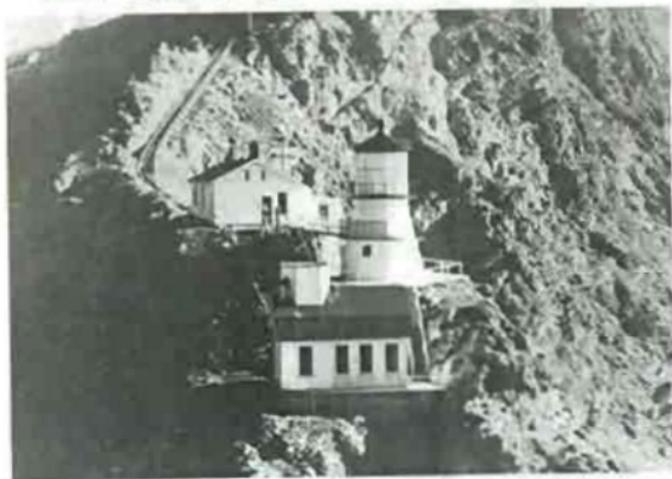
Figure 64 - Lighthouse complex, ca. 1950, shows F2T horns on fog signal building, light tower, equipment building, transformer house. National Park Service.

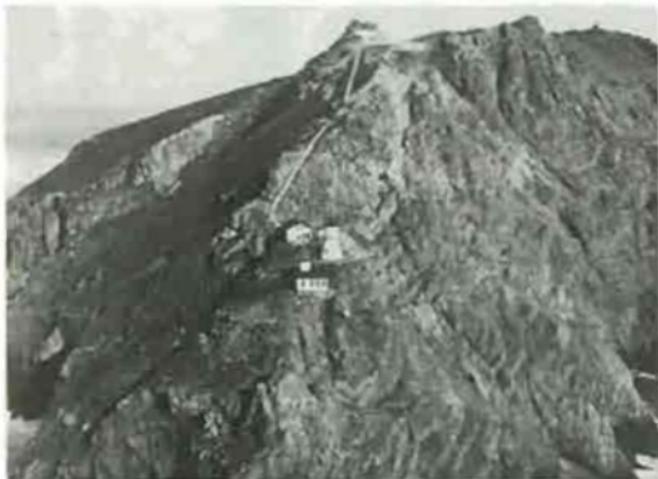
Figure 67 - Aerial view of lighthouse complex, ca. 1960. Stairs have been replaced, keepers dwelling at top of stairs has been removed. National Park Service.

The long flight of stairs to the lighthouse from the dwellings on the bluff above was originally made of thick planks of wood. It was replaced in 1959 by this sturdy, reinforced concrete stairway which measures four feet wide by 600'. There are 304 steps and two ramp sections, the equivalent height of a ten-story building. The steps are flanked by parallel ramps which accommodate a cart, operated by an electric winch at the top of the stairs. Aluminum railings with light fixtures at intervals were installed on both sides of the stairway. Three small rest areas were built by the National Park Service about halfway up the stairs in 1977.

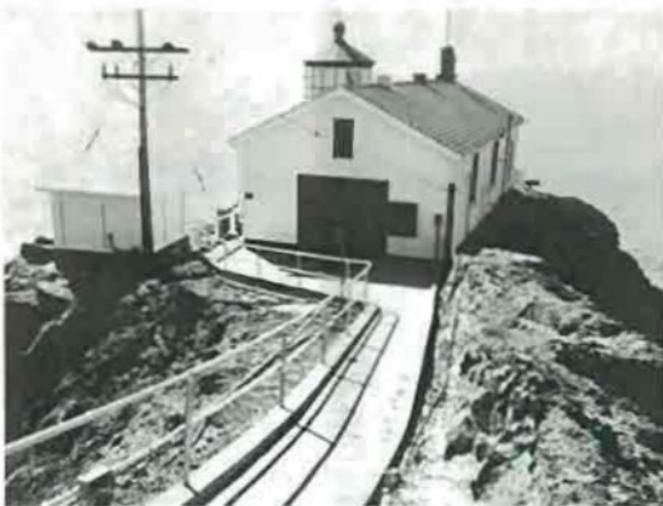
Figure 68 - Equipment building and new ramp from stairway, ca. 1960. National Park Service.

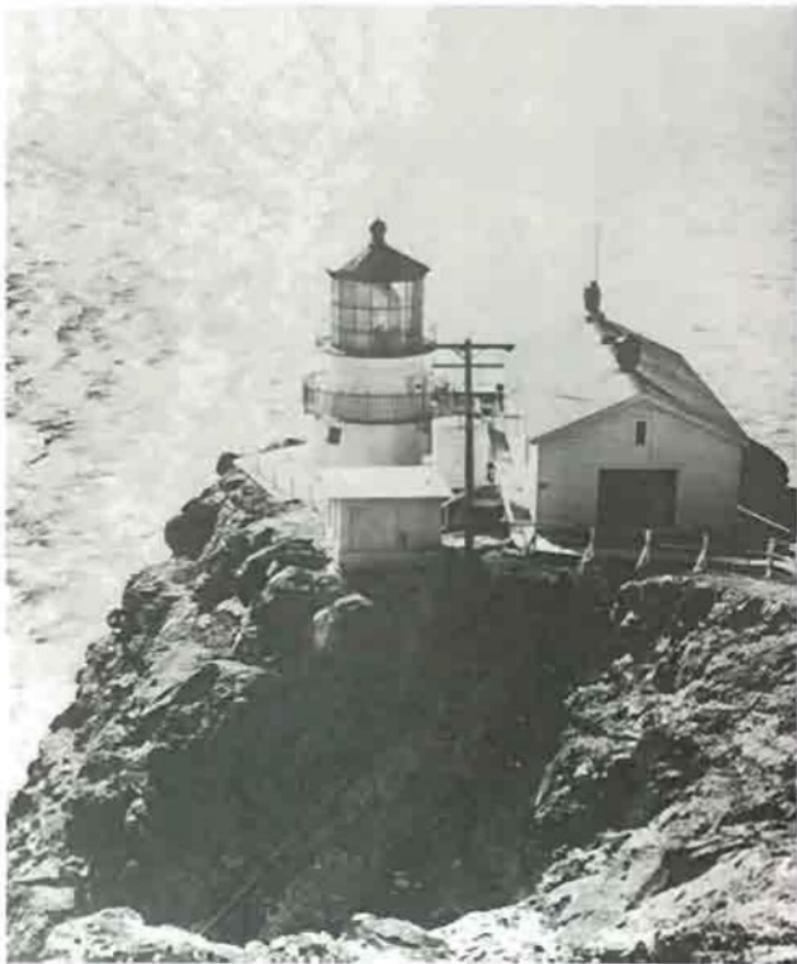
Figure 69 - Lighthouse complex, 1900s. Note lantern astragals are still painted dark.  
National Park Service.

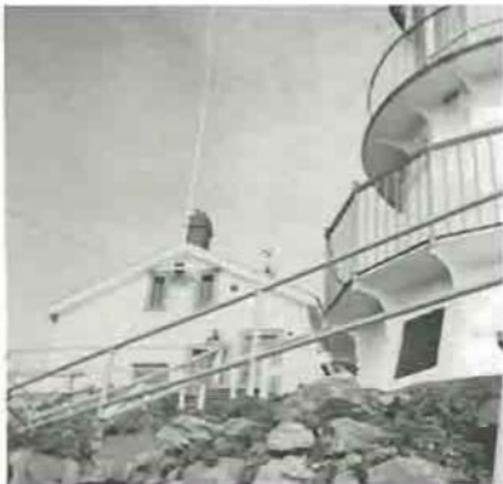
Figure 72- Equipment building and lighthouse tower from fog signal building, February 1971; note the whip antenna on the equipment building. National Park Service photo by Thomas Mulhern.

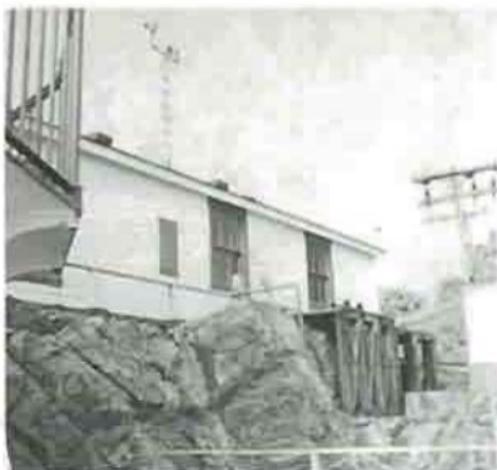
Figure 73 - South elevation of equipment building, February 1971; supports for water tanks have since been removed. National Park Service photo by Thomas Mulhern.

The equipment building has been slightly altered: the smaller door was moved from the south side to the west some time between 1935 and 1945; a door was added between the watch room and the storage room after 1951; a single swinging door was added into one of the sliding doors on the east side after 1951; the ventilators on the roof were altered over the years and have since been removed; and the machinery has been changed and updated over the years (the current equipment dates from 1962 and is no longer operable). The building is in good condition.

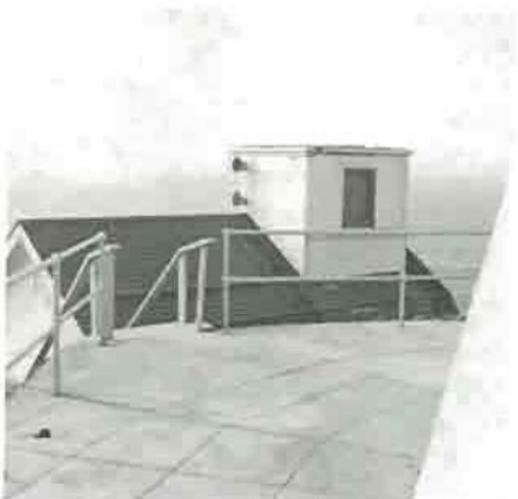
Figure 74 - Fog signal building showing previous location of super typhon fog horns, February 1971. National Park Service photo by Thomas Mulhern.

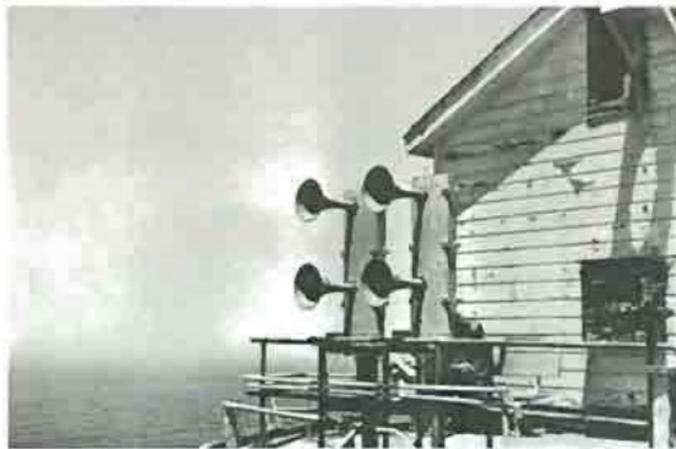
Figure 75 - Super typhon fog horns temporarily mounted outside of equipment building, 1975. Note poor condition of building during its last year of use. National Park Service.

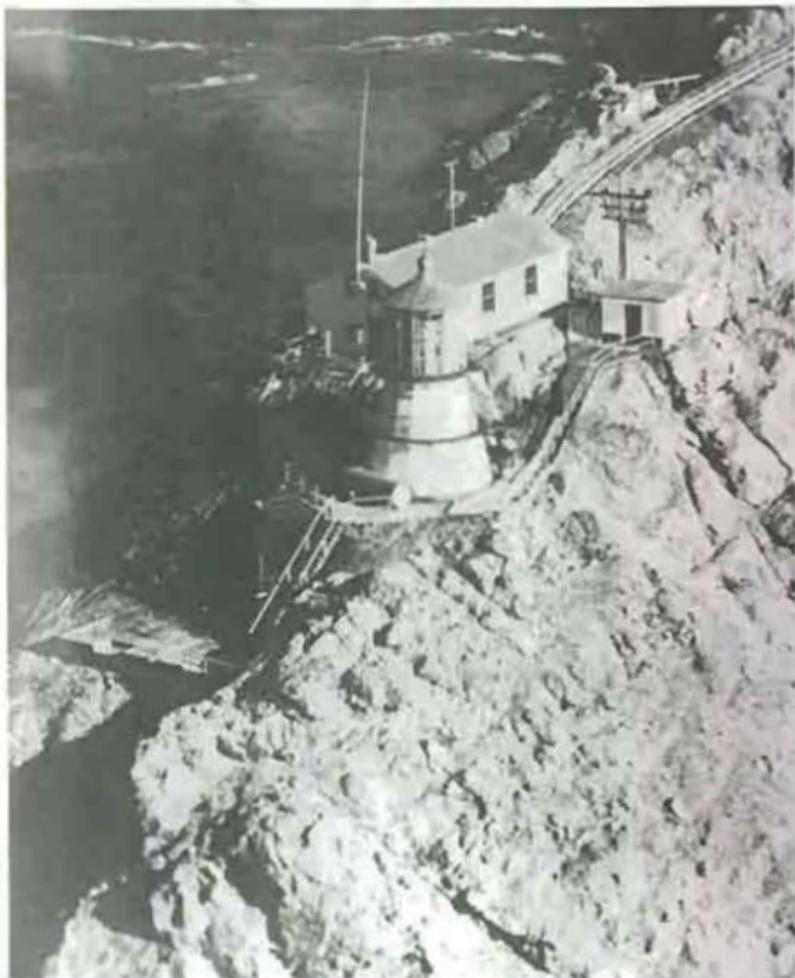
Figure 76 - Aerial view of lighthouse, 1975. Ramp is being constructed for access to fog signal site, where the new automated aids building will be constructed. National Park Service.

The lighthouse complex was abandoned in 1975 when an automated light was placed below the light tower. Now under National Park Service management, the lighthouse has undergone restoration and is in good condition. The lighthouse is fully operable and used for park interpretation programs.

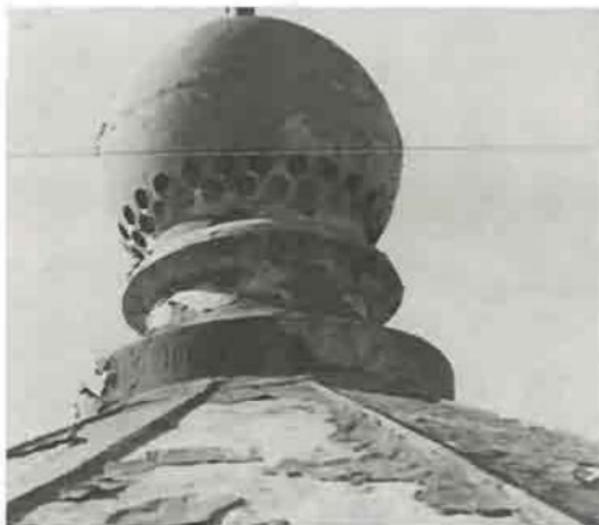
Figure 77 - Detail of lighthouse ventilator hall and roof prior to stabilization, November 29, 1979. National Park Service photo by Robert M. Cox.

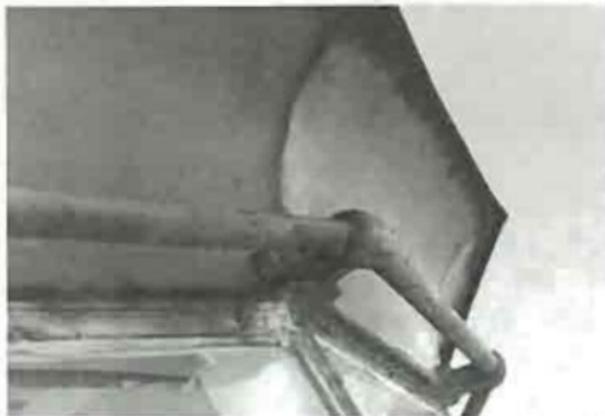
Figure 78 - Detail of lantern cornice and ladder rail prior to stabilization, November 29, 1979. National Park Service photo by Robert M. Cox.

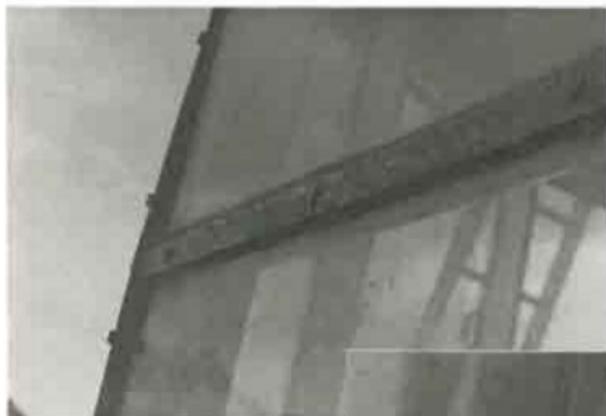
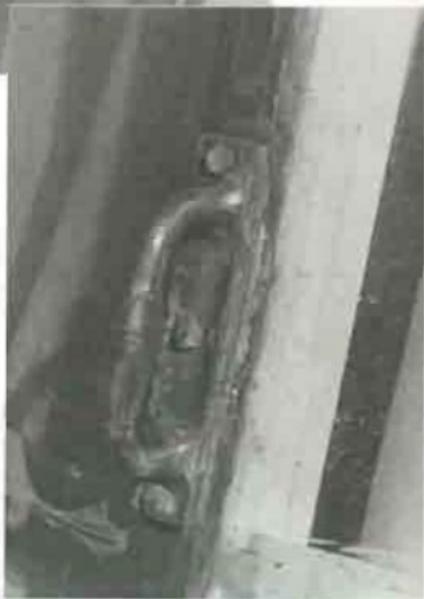
Figures 79 and 80 - Details of bronze astragal hand grip and transom cleat after white paint has been stripped off. There is visible evidence of what appears to be red lead on these pieces despite cleaning. November 29, 1979. National Park Service photos by Robert M. Cox.

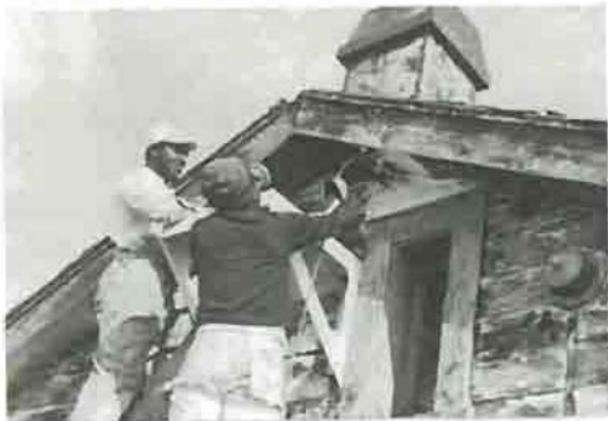
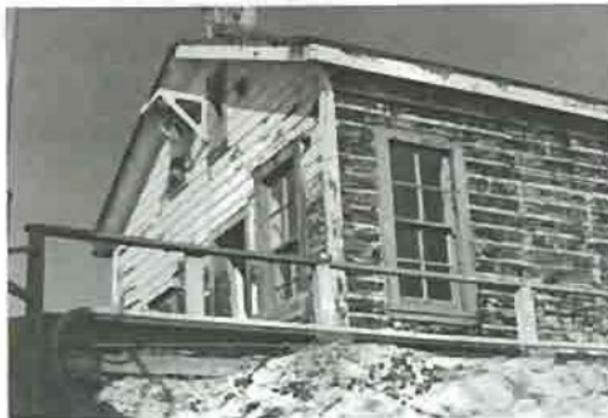
Figures 81 and 82 - Equipment building in the process of having the paint removed, November 29, 1979.  
National Park Service photos by Robert M. Cox.
