# THE HISTORY AND ARCHITECTURE OF THE POINT REYES LIGHT STATION

Historic Structures Report  
Point Reyes National Seashore

NATIONAL PARK SERVICE  
1990

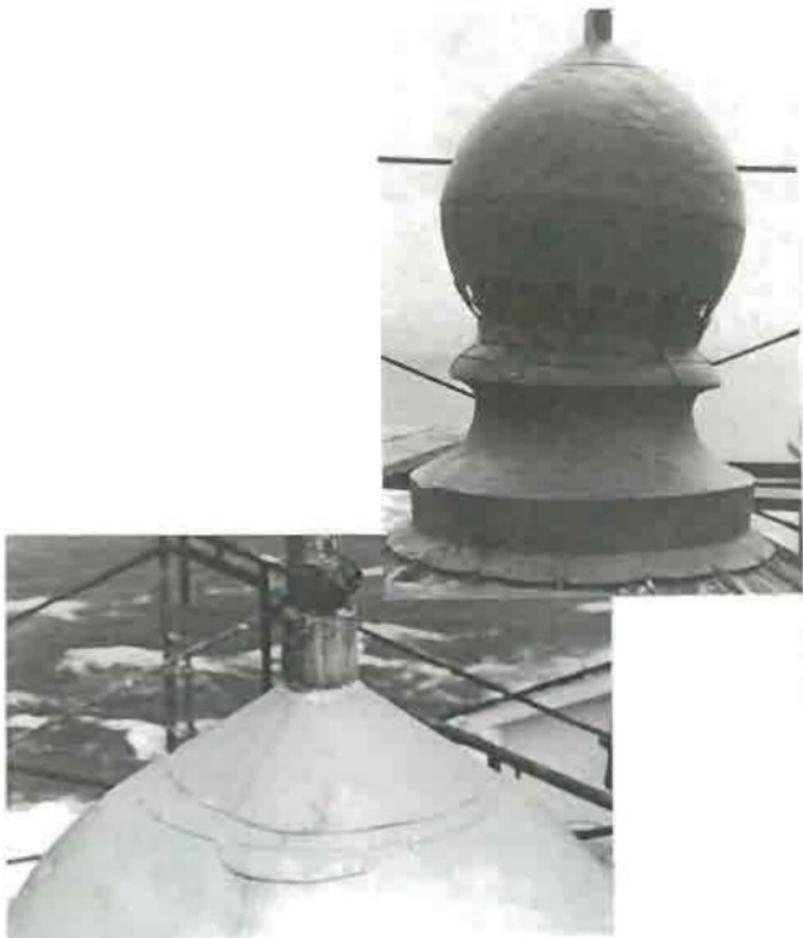
Figures 83 and 84 · Lighthouse vent ball after stabilization, April 24, 1980. Note rusted mounting bracket for weathervane base. National Park Service photos by Robert M. Cox.

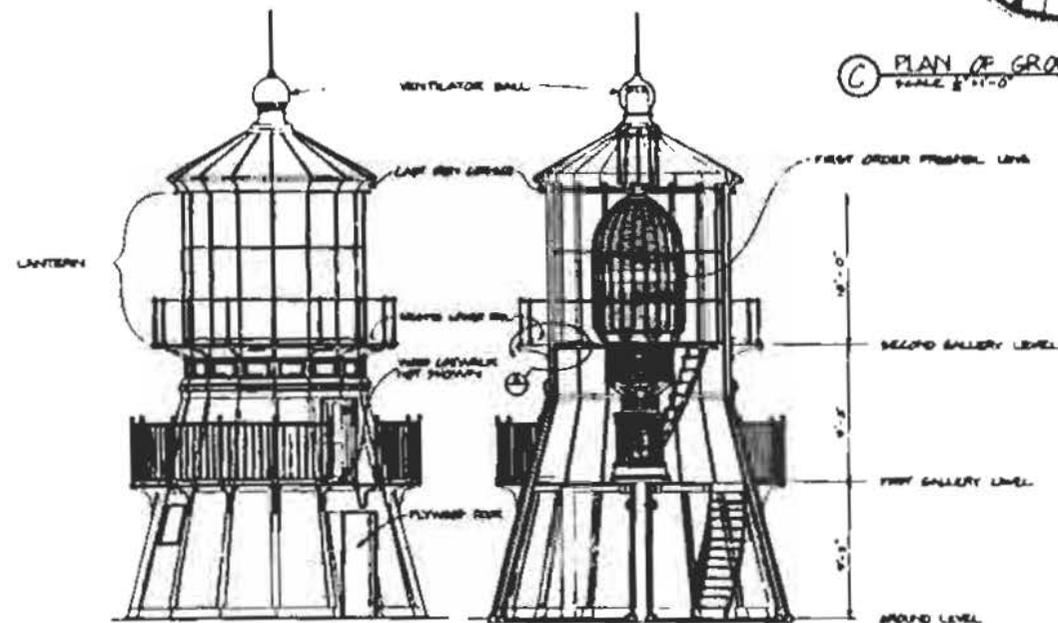
(A) EAST ELEVATION  
SCALE 1/4" = 1'-0"

(B) SECTION  
SCALE 1/4" = 1'-0"

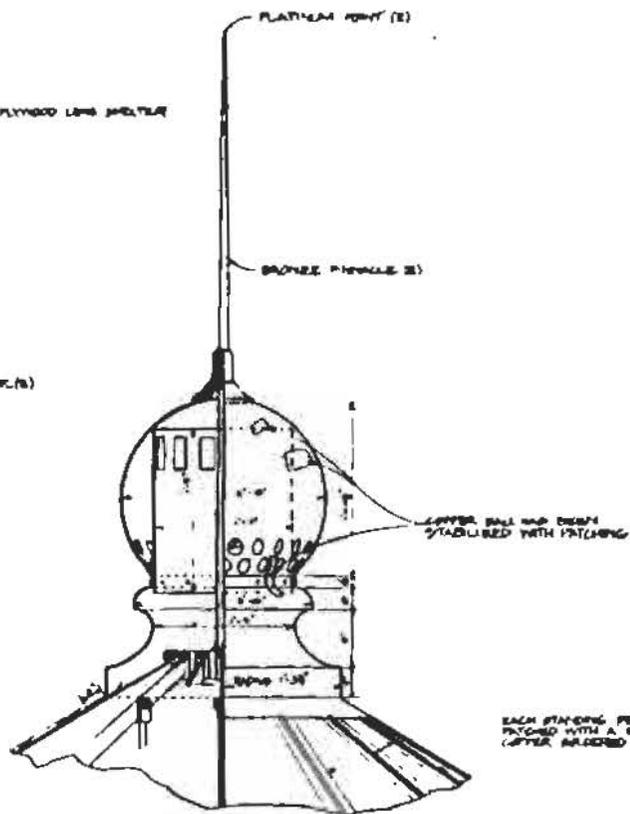
(B) SECTIONAL ELEVATION OF VENTILATOR (1)  
SCALE 1/4" = 1'-0"

EACH STANDING PEAK HAS BEEN PATCHED WITH A STRIP OF COPPER BARRIED IN PLACE.

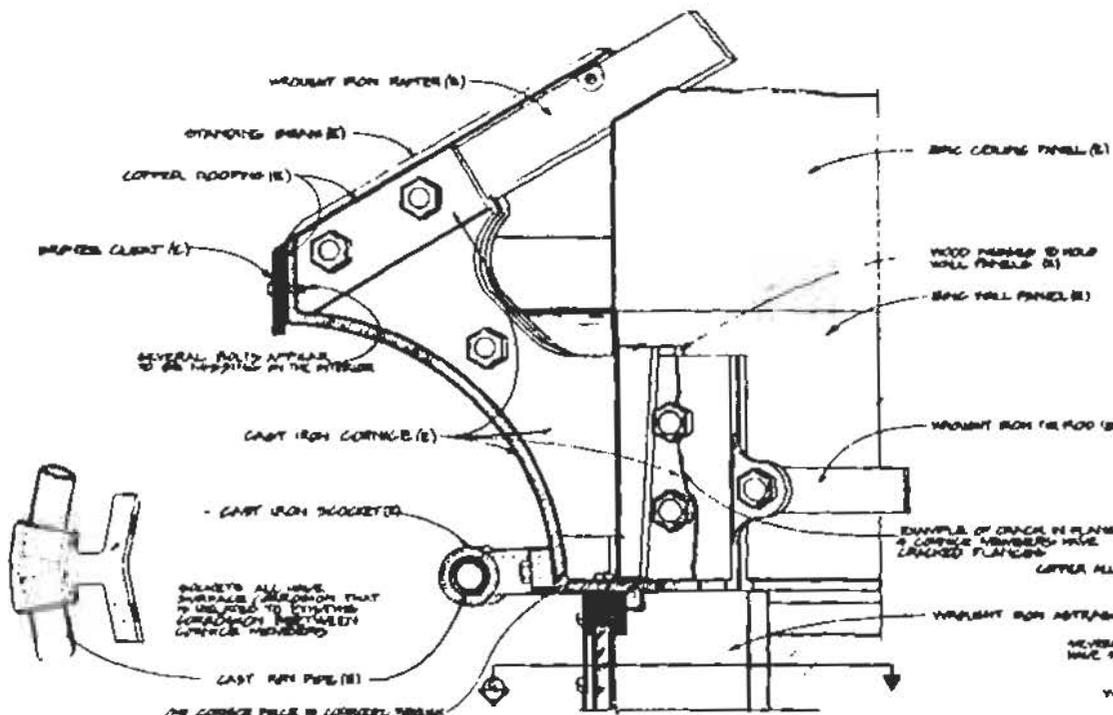
A SOCKET DETAIL  
 SCALE 3/4"=1"

B CORNICE SECTION  
 SCALE 3/4"=1"

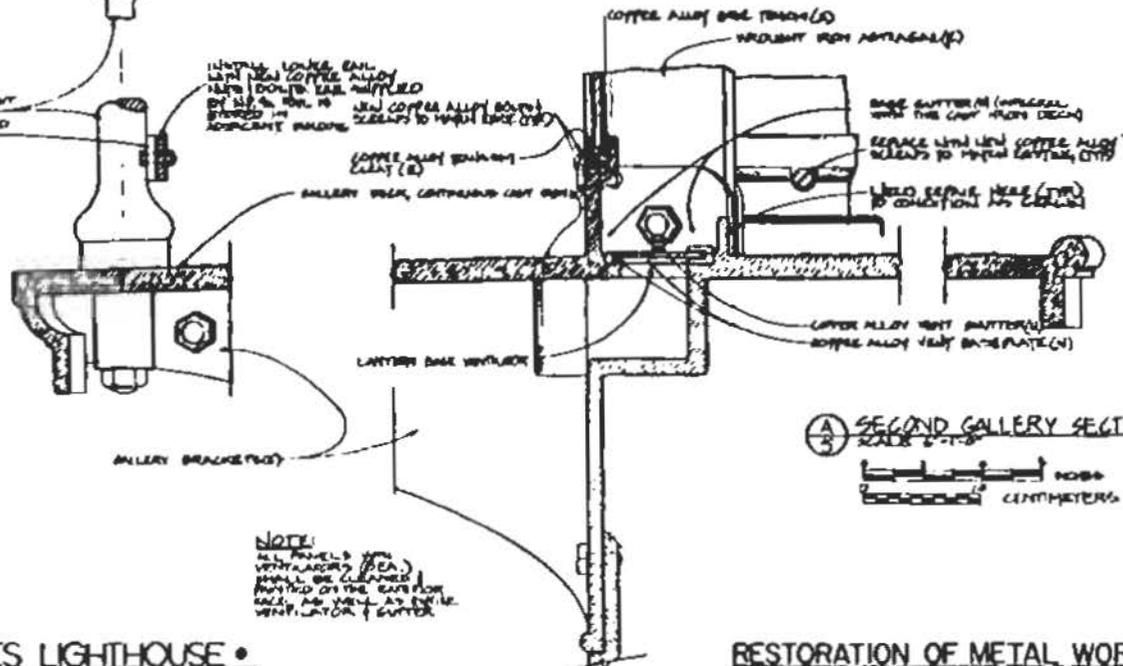
(A) SECOND GALLERY SECTION  
SCALE 2"-1'-0"

REPLACE EXISTING SCREW NUTS WITH COPPER ALLOY CAP NUTS AND WASHERS (A)

INSTALL LOCKWASHERS WITH NEW COPPER ALLOY NUTS. DO NOT USE NUTS BY THE ORIGINAL MANUFACTURER'S BRAND. USE COPPER ALLOY NUTS TO MATCH EXISTING (A)

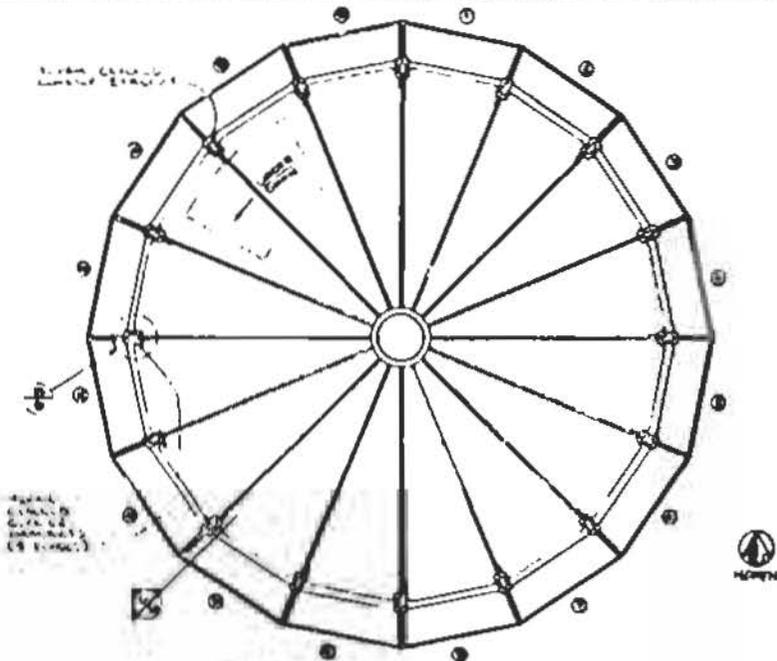
(A) SPOICE FRAME PLAN

NOTE: HAVE REQUIRED INDICATIONS LEADING TO DIMENSIONS USED THROUGHOUT DRAWING WHERE THEY DO NOT APPEAR ON THE PLAN.

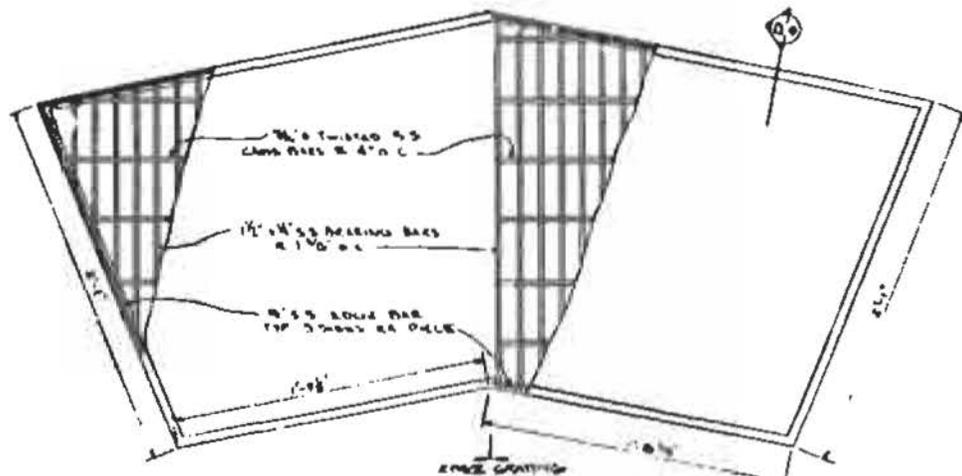
(E) FIRST GALLERY LEVEL HATCH GRATE (N)

NOTE: GRATE MUST BE BRIDGED AT POINT OF CROSSING

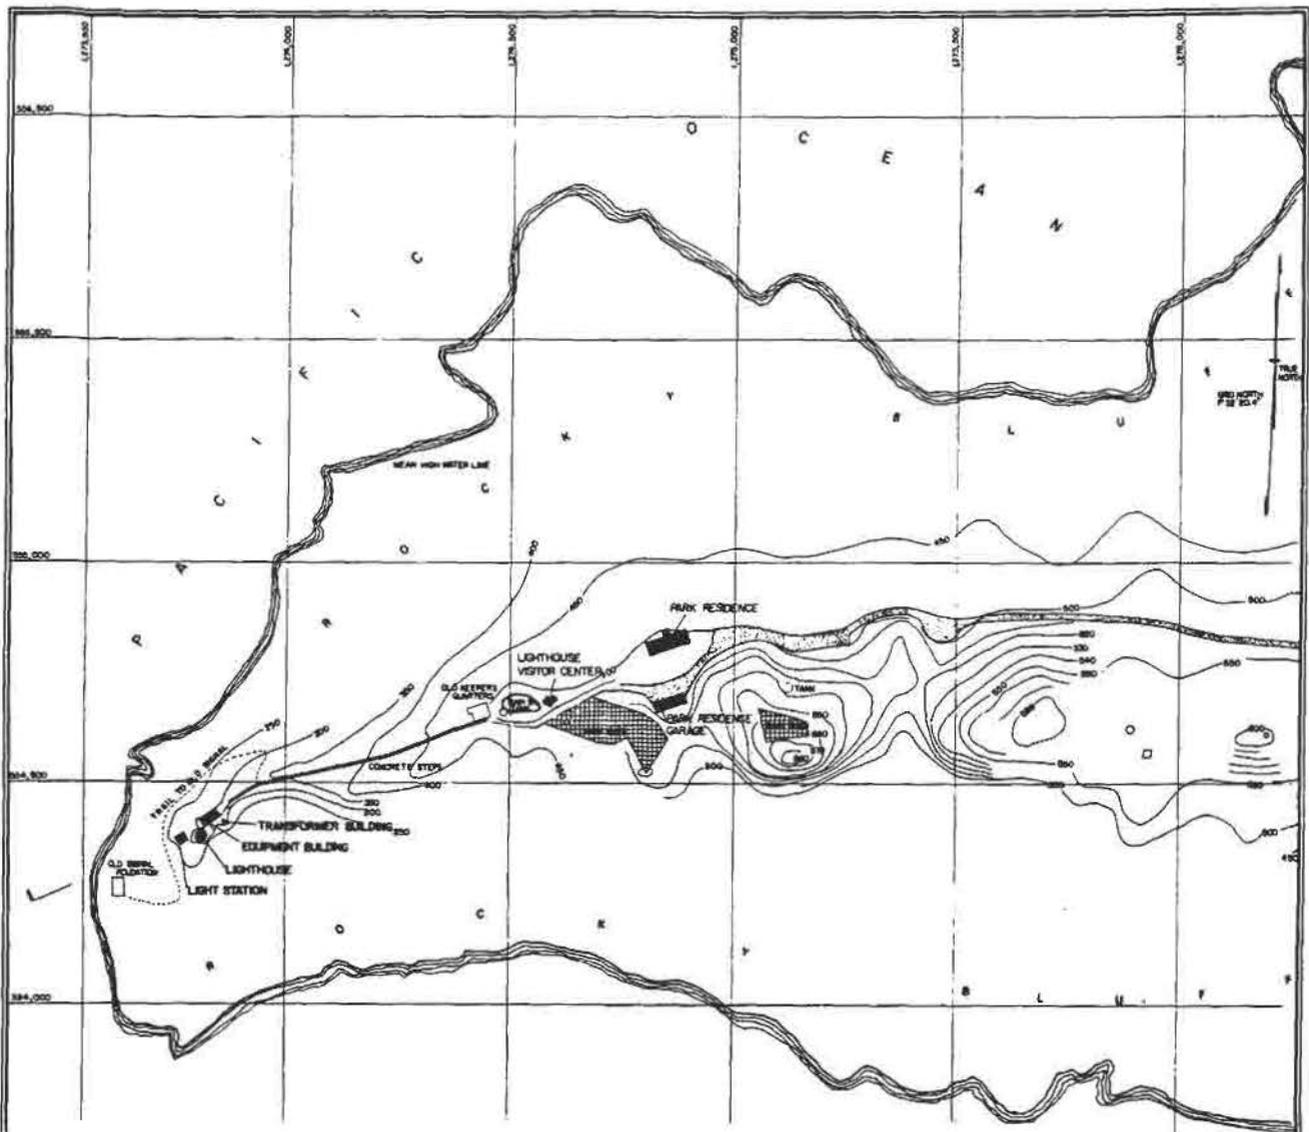
**COMPREHENSIVE SITE PLAN**  
SCALE 3/4" = 100'-0"

LIGHTHOUSE GEOGRAPHIC POSITION	
LATITUDE	LONGITUDE
37° 29' 44.650"	122° 01' 8.367"

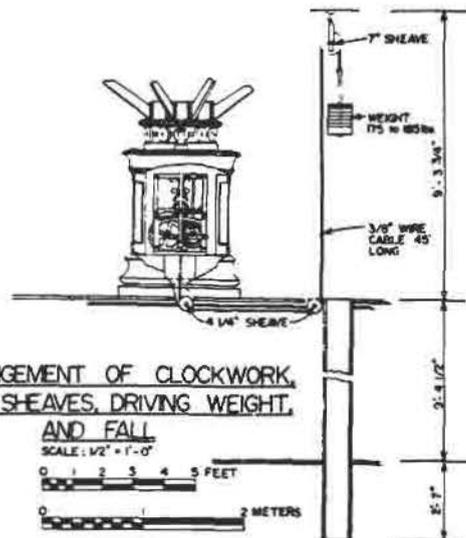
ARRANGEMENT OF CLOCKWORK, CORD, SHEAVES, DRIVING WEIGHT, AND FALL  
SCALE: 1/2" = 1'-0"

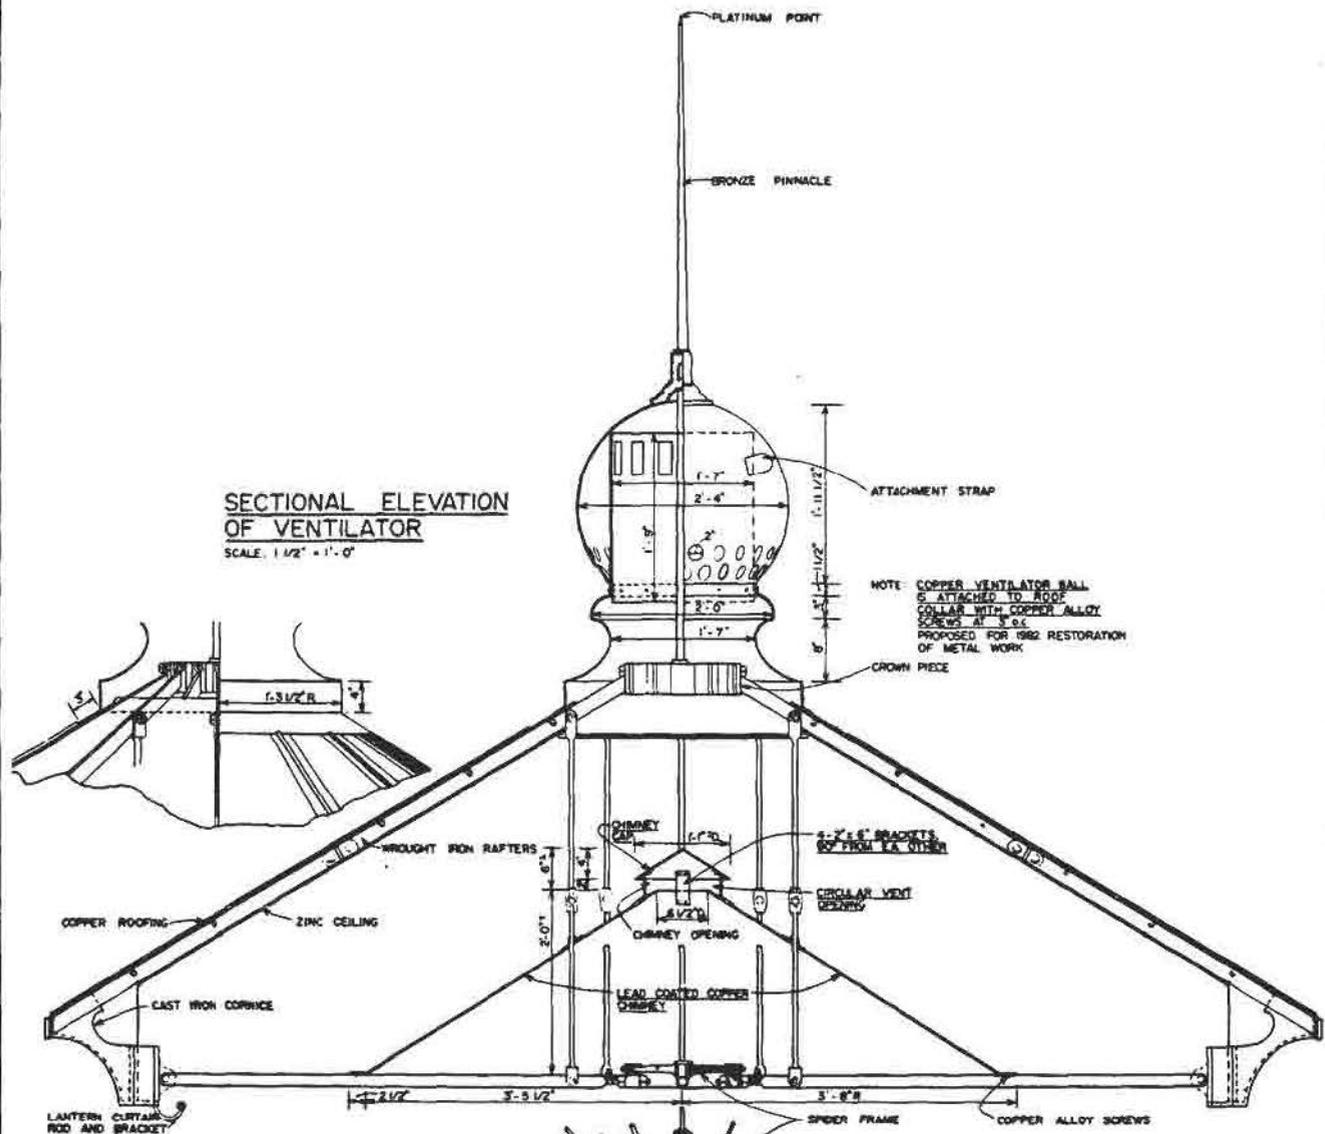
**SECTION OF ROOF**  
SCALE: 1/2" = 1'-0"

NOTE: COPPER VENTILATOR BALL IS ATTACHED TO ROOF COLLAR WITH COPPER ALLOY SCREWS AT 3 O.C. PROPOSED FOR 1982 RESTORATION OF METAL WORK

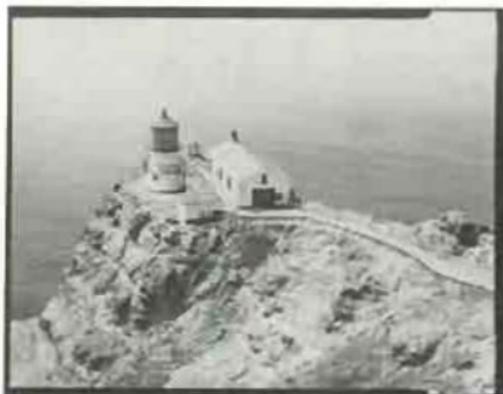
1. Lighthouse complex: lighthouse, transformer building (foreground), Coast Guard light station (rear), equipment building, stairs.

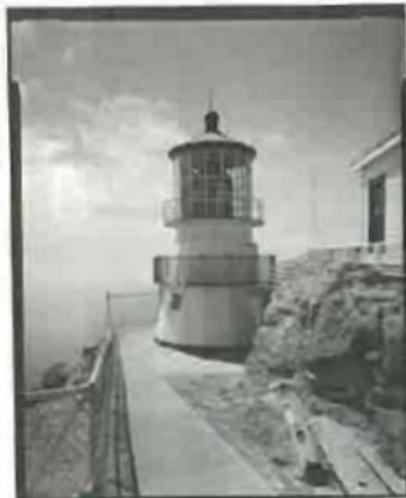
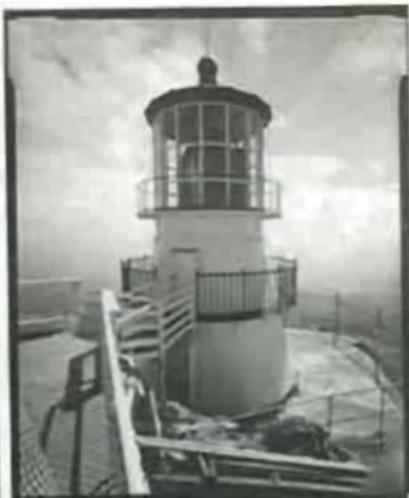
2 and 3. Lighthouse, east elevation (left), north elevation (right).

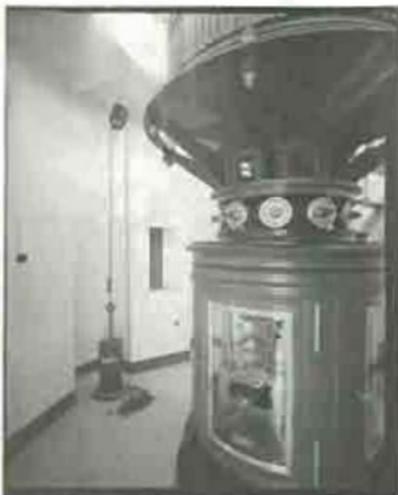
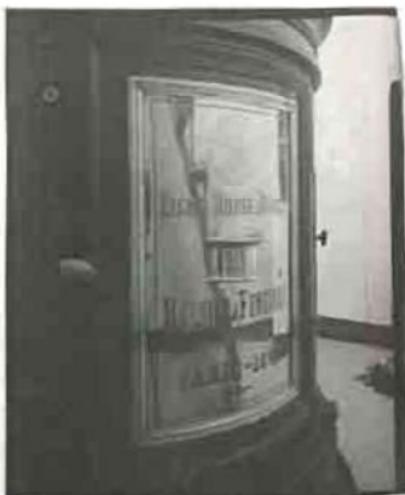
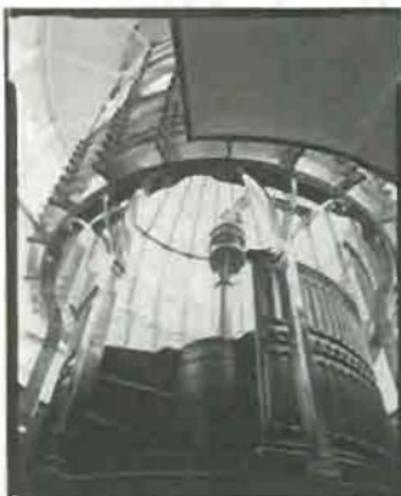
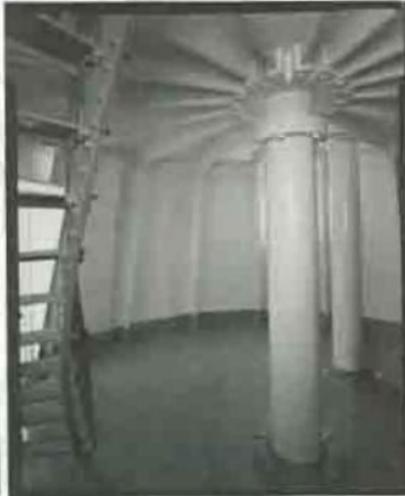
4, 5, 6, 7. Lighthouse interiors (clockwise from upper left): pedestal and weight system, builder's plaque, watch room or ground level, lens and light source.

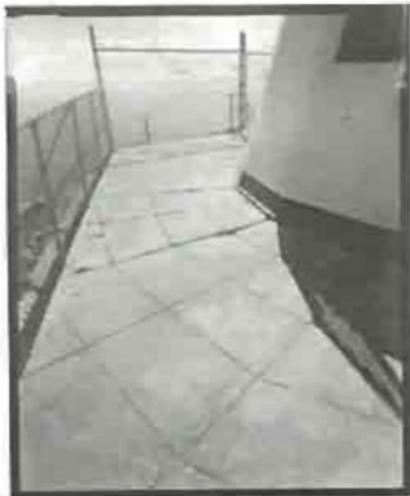
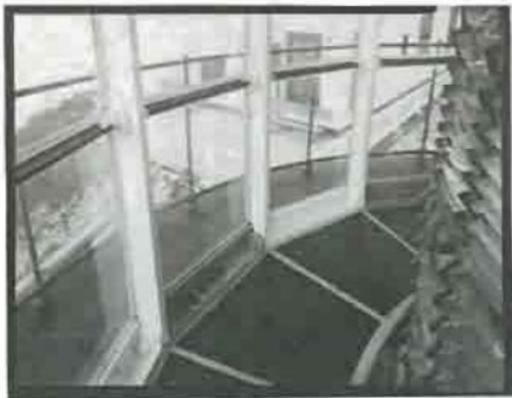
8, 9. Lighthouse details: concrete pattern (top), lantern interior (bottom).

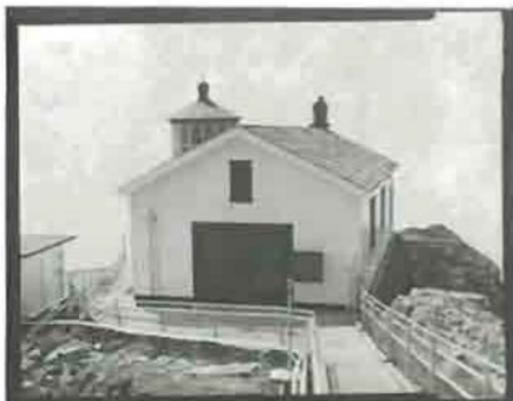
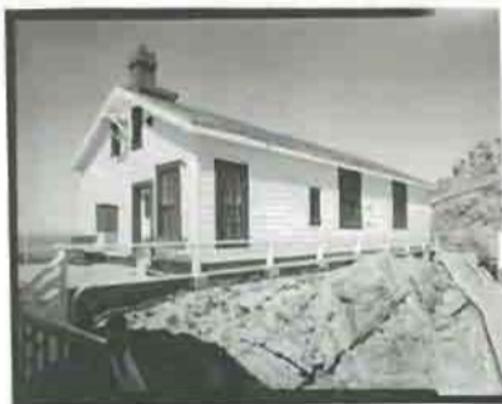
10, 11. Exteriors, equipment building: east elevation (top), south and west elevations (bottom).

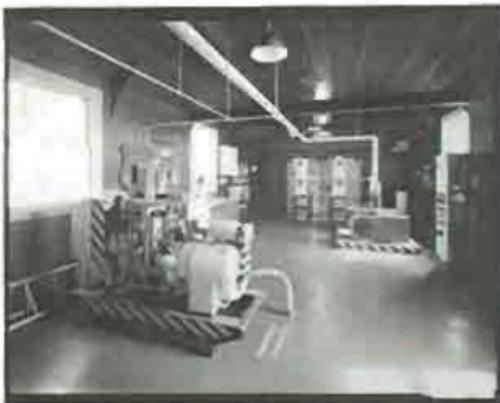
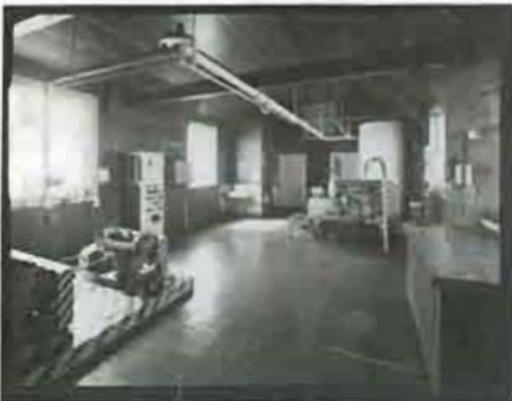
12, 13. Interiors, equipment building: view to east wall (top), view to west wall (bottom).

**Doors:** It is recommended that the large rolling doors and their hardware on the east wall be rehabilitated. Paint and fabric samples should be taken as previously described. This would require restoration of the door which has a hinged leaf, requiring removal and discarding of this later intrusion. The original door to the south would be used as a comparative guide for matching the historic appearance of the new door.

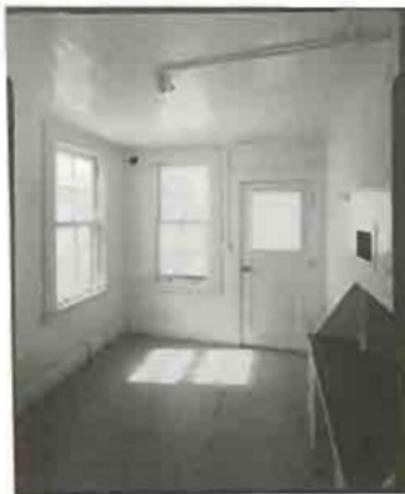
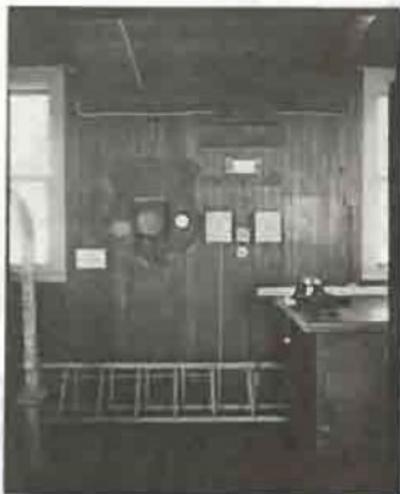
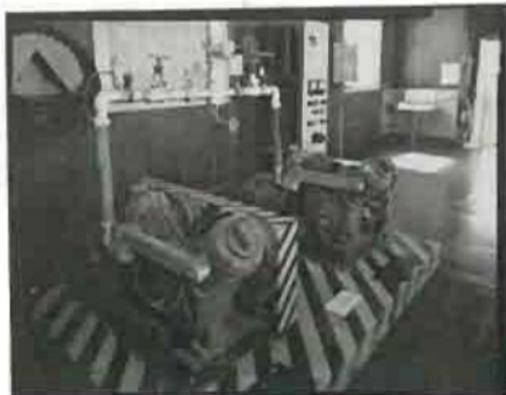
14, 15, 16. Interiors, equipment building: watch room (upper left), gauge board and work bench on north wall (upper right), compressors, (bottom).

**Diesel Engine and Electrical Motors:** It is recommended that a comprehensive paint analysis be initiated on all painted metal components of the diesel engine and the various electrical motors, generators, compressors, etc. that make up the mechanical systems for the historic fog signal. This should be done with the same procedures as previously outlined. These paint coatings are sacrificial in nature, providing a layer of protection which helps to protect these historic features from deterioration and rust, as well as maintaining an accurate visual historic character.

**Gauge Board:** It is recommended that the historic gauge board, located on the north wall, be restored to its original appearance (which is accurately documented in a 1935 historic photograph). This would require removal of the two existing instruments, refinishing of the wood plaque, with repair and replacement of the pressure gauges. The missing gauge to the west should be replaced with one that matches the missing one as closely as possible in appearance.

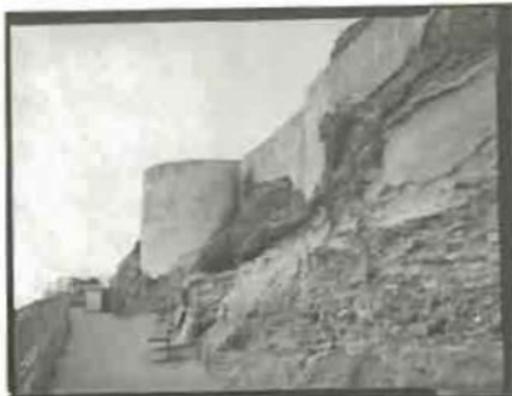
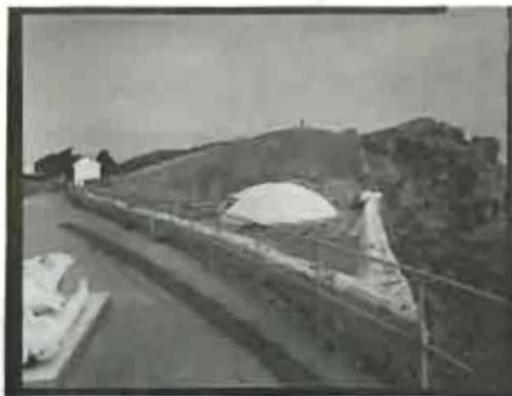
19, 20. Cisterns: west cistern (top), large original cistern (bottom).

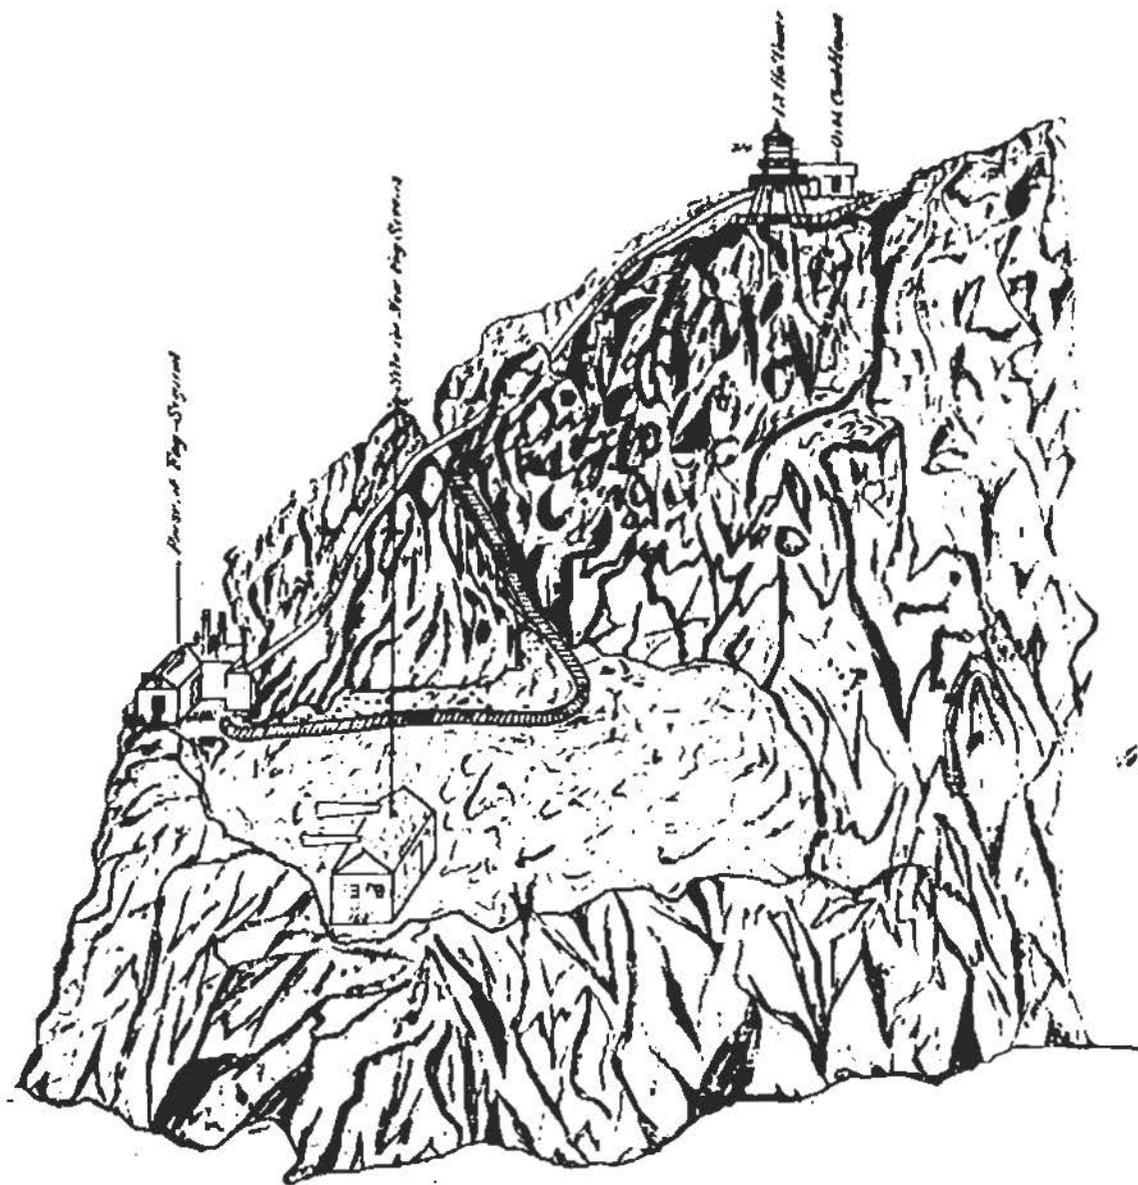
*Sketch of Point Reyes Light Station  
 from the report, dated Nov 30, 1850.  
 Elevation given in sketch.*

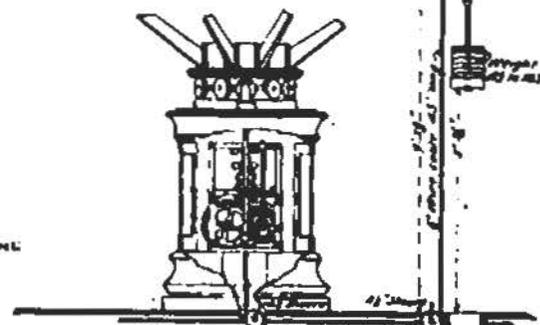
Arrangement of Clockwork, Cord, Sheaves, Driving Weight and Fall Fig. 5

Max. Characteristic of  
Light, flashing white  
every 2 seconds  
1 1/2 sec makes one re-  
volution in 2 minutes  
Total fall 11'-3"  
Time of fall 2 1/2 sec

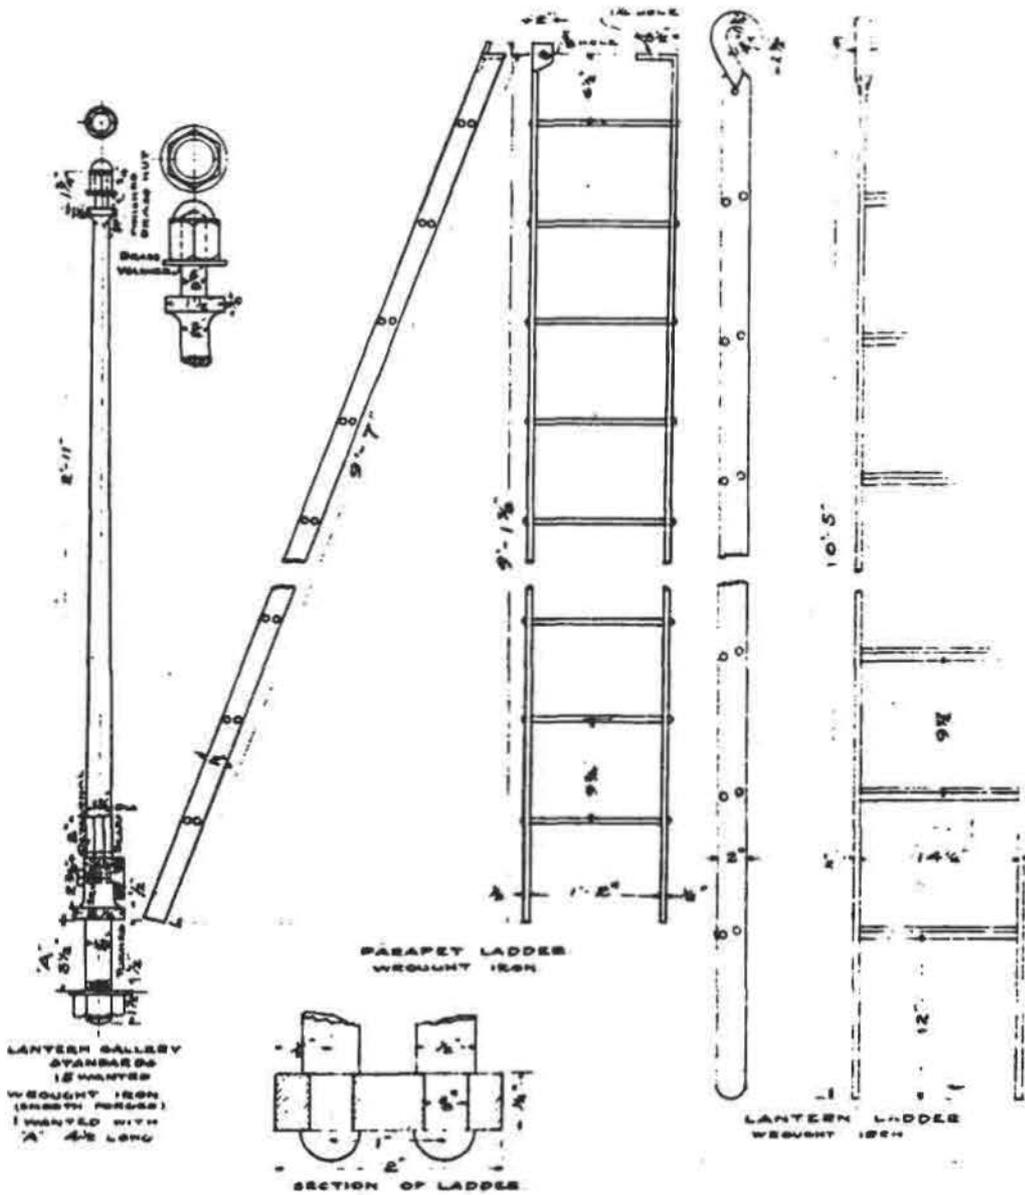
OFFICE OF THE LIGHTHOUSE INSPECTOR EIGHTEENTH DISTRICT, SAN FRANCISCO, CAL.	
FIRST ORDER LANTERN PARTS. POINT REYES LIGHTSTATION, CAL. NO 354E.	
APPROVED APR 6, 1914.	
<i>A. L. Johnson</i> SUPERINTENDENT	<i>H. W. Rhodes</i> INSPECTOR
DRAWN BY TRACED BY CHECKED BY	SHEET NO 1 OF 1 POINT REYES, CAL.

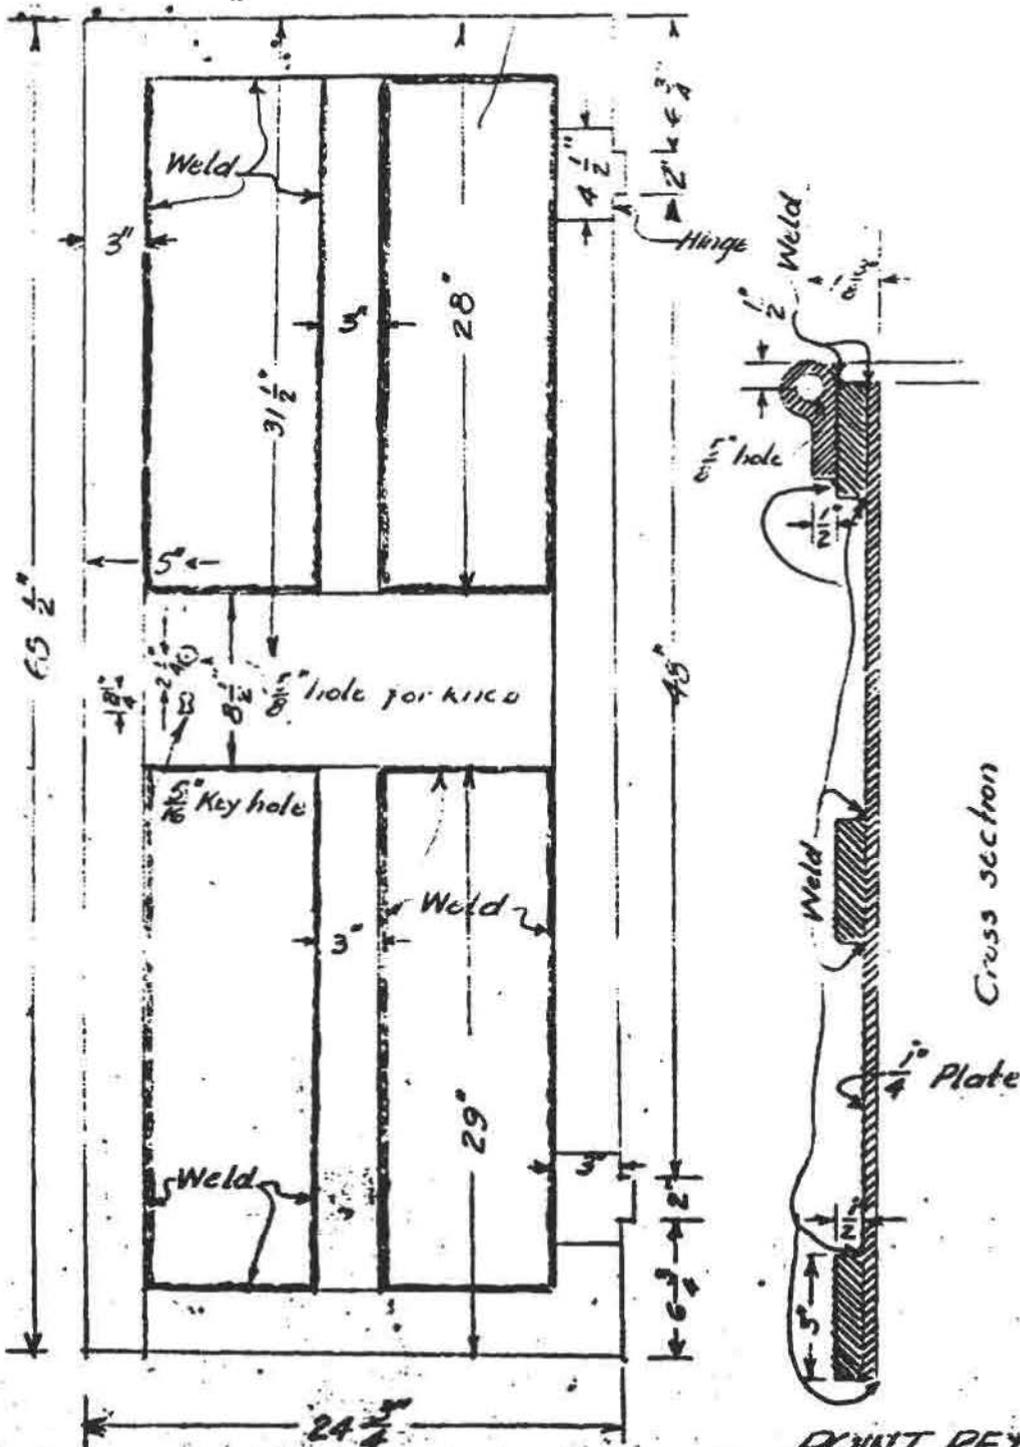
POINT REYES LIGHT STA  
TOWER DOOR

All welding to be continuous

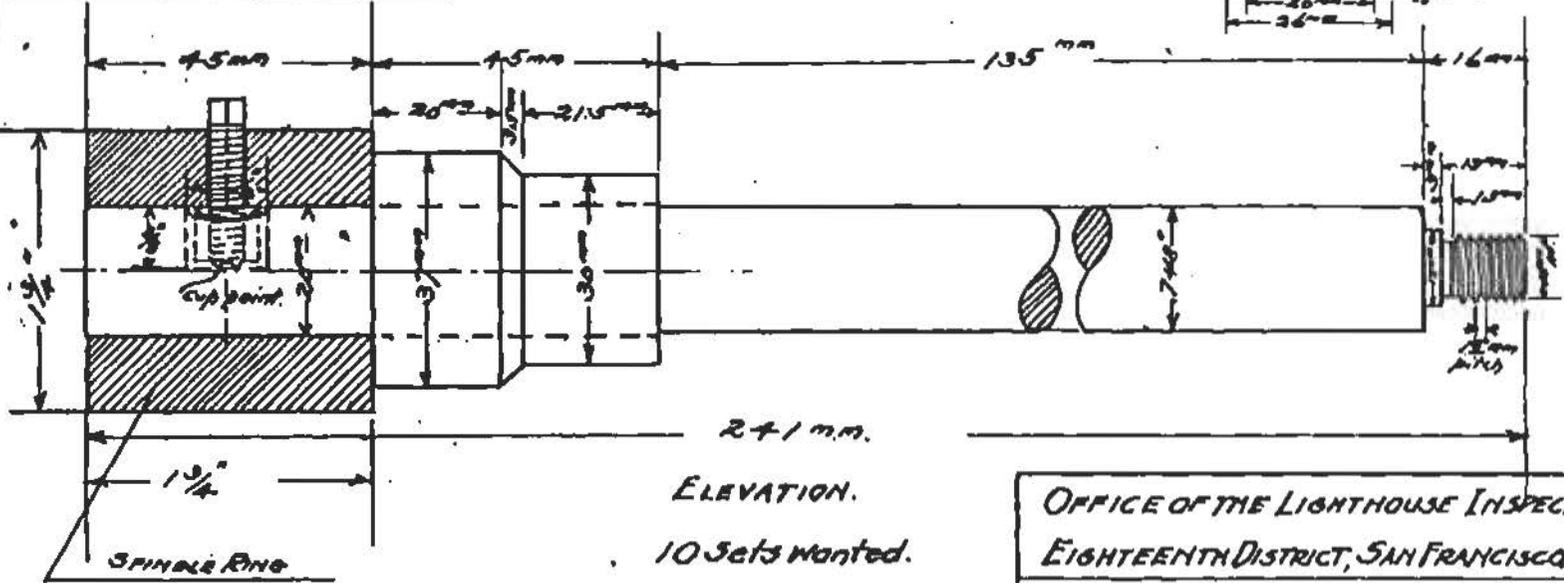
OFFICE OF THE LIGHTHOUSE INSPECTOR  
 EIGHTEENTH DISTRICT, SAN FRANCISCO CAL.  
 CHARIOT WHEEL SPINDLES.  
 POINT REYES LIGHTSTATION, CAL.  
 SCALE: - FULL SIZE APPROVED 4/8/17  
 G. J. Oster. H. W. V. Rhodes.  
 SUPERINTENDENT INSPECTOR  
 DRAWN R.P.P.  
 TRACED J.R.J. NO 1106  
 CHECKED R.P.P. Pt Reyes B.B.

The only damage to this apparatus is the bending of the upper and lower guide-roller spindles; also the displacement, inside of the lens, of the lamp stand, together with the steps and balustrade, (all being riveted together making practically one solid piece) which was doweled to the pedestal with dowels 7/8" long and about 7" apart.

By referring to exhibit A it will be seen that on account of the guide projecting through the ring, the spindle nuts are inaccessible and cannot be touched with an ordinary wrench, and it is recommended a socket wrench be made of "double X" gas pipe, about three feet long, to insure against injury to the lens, in removing the old spindles and replacing the new ones. There are six spindles in each set, one of each set being sent for a sample, to have the new ones made from. The spindle having a nut on one end and a hole for a spring cotter at the other, belongs to the upper set. Of this set only the spindles are to be renewed.

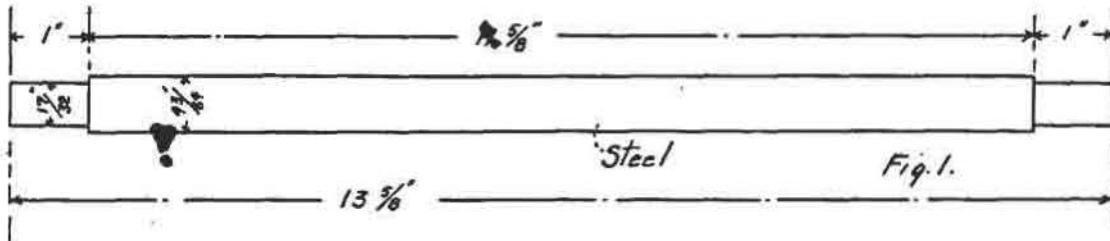
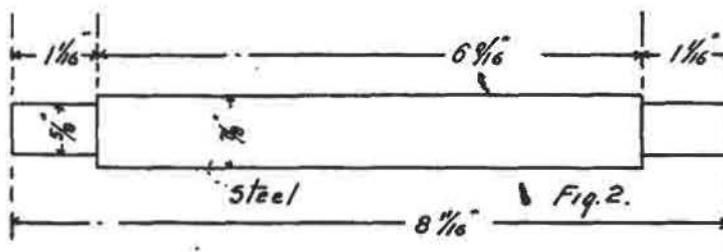
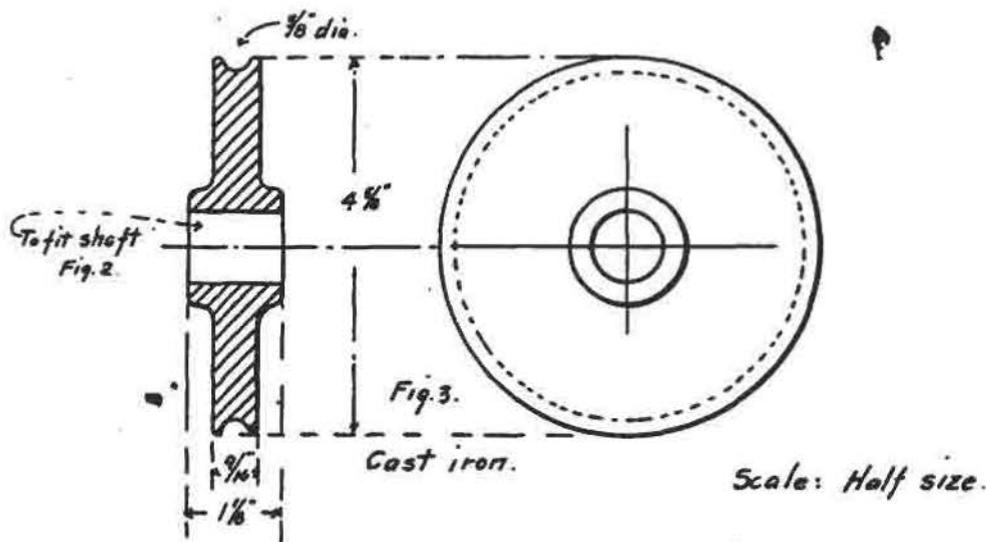
Sheave and shafts for weight cord of lens apparatus.

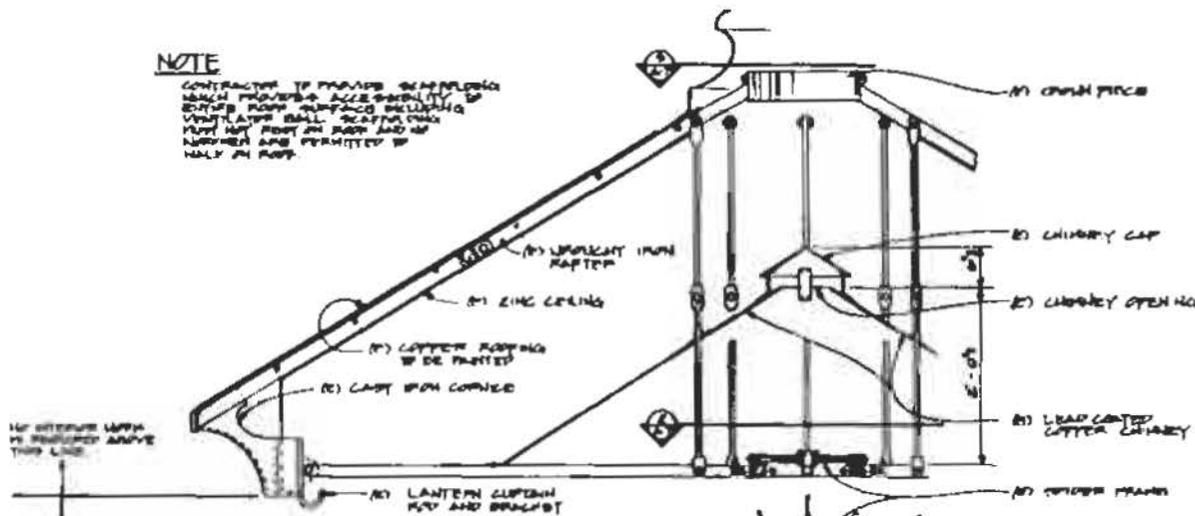
1. ROOF AND CORNICE SECTION  
 SCALE: 1/4" = 1'-0"

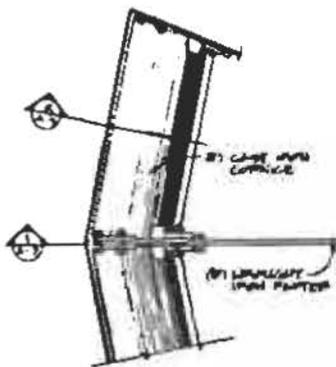
3. PARTIAL ROOF FRAMING PLAN (ROOFING REMOVED)  
 SCALE: 1/4" = 1'-0"

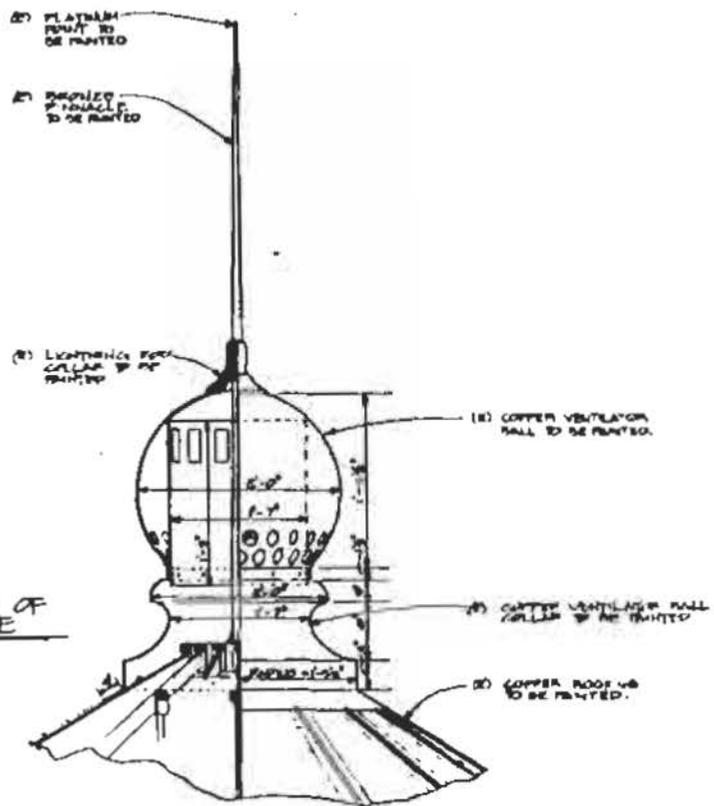
4. SECTIONAL ELEVATION OF VENTILATOR  
 SCALE: 1/4" = 1'-0"  
 0 1 2 3 4 FEET

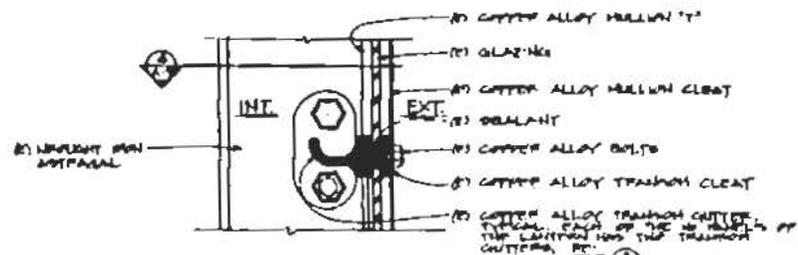
3 TYPICAL TRANSOM GUTTER SECTION  
SCALE: 1/4" = 1'-0" (HALF-SHEET)

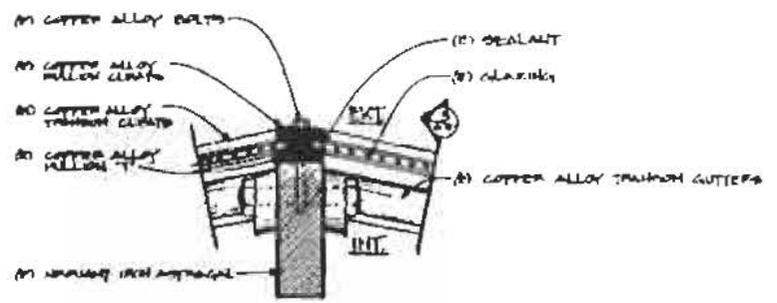
4 ASTRAGAL, MULLION & CLEAT SECTION  
SCALE: 1/4" = 1'-0" (HALF-SHEET)

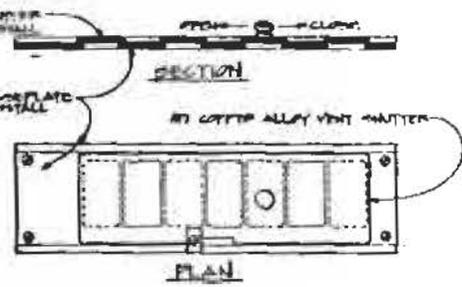
5 VENTILATOR SHUTTER DETAILS  
SCALE: 1/4" = 1'-0"

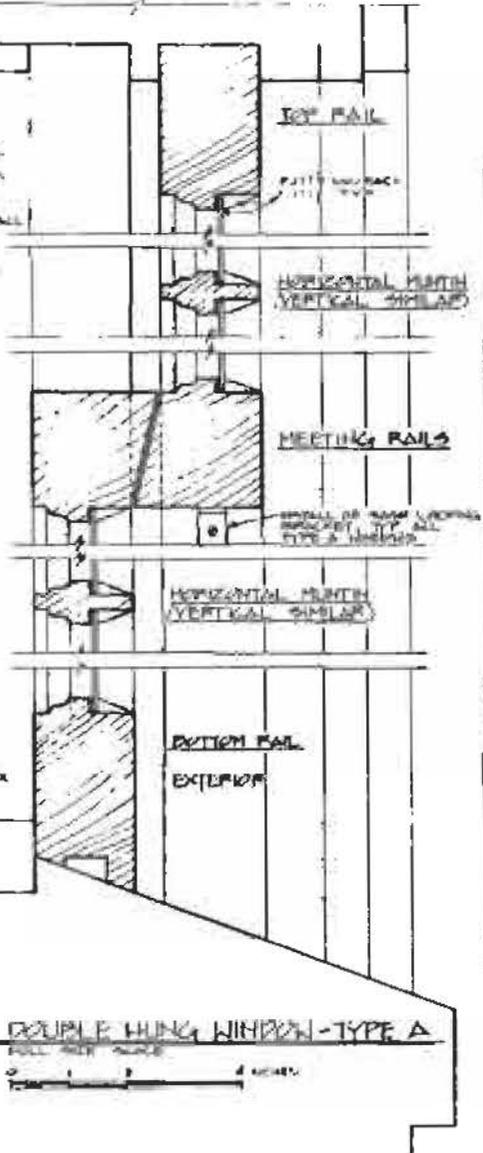
② DOUBLE HUNG WINDOW - TYPE A  
FULL SASH  
SCALE: 1" = 4'-0"

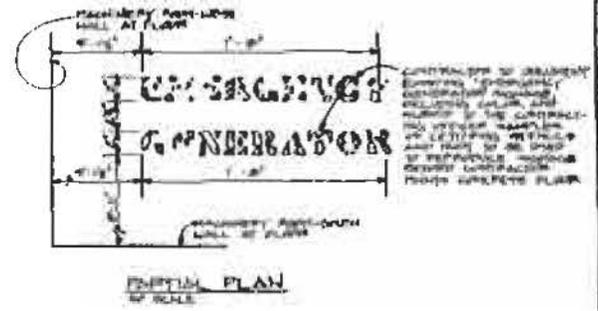
2 SIGNAGE DETAILS

EXISTING LETTER TYPE  
FULL SIZE SCALE  
0 1 2 3 4 FEET

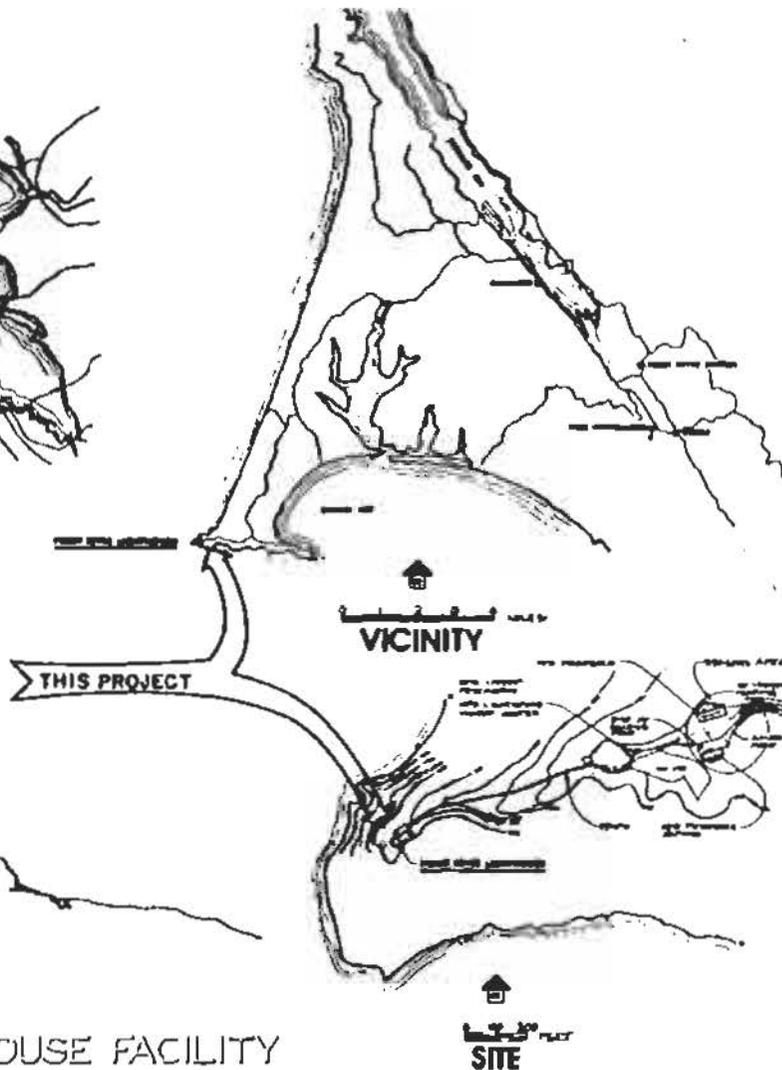
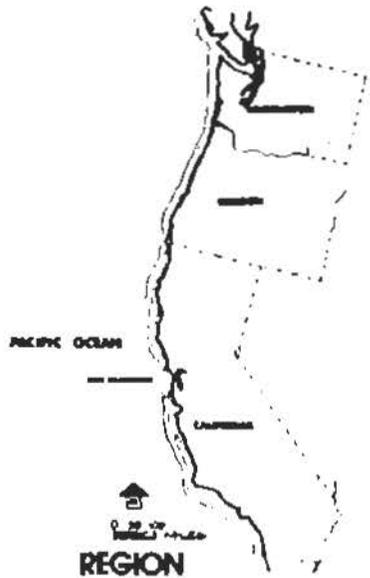
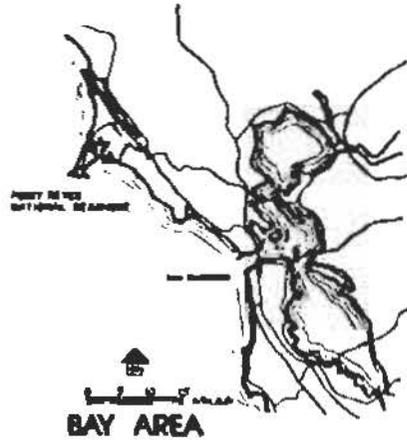
# PRESERVATION OF POINT REYES LIGHTHOUSE FACILITY

BASIC DATA, EXISTING CONDITIONS DOCUMENTED BY LEAH KENZEL ON-SITE IN FEBRUARY '86 AND MARCH '86. BRAY USA DRAWINGS PREPARED BY HENRY LEO HAVE BEEN USED AS BASE DRAWINGS.
