7 PRESERVATION BRIEFS

The Preservation of Historic Glazed Architectural Terra-Cotta

de Teel Patterson Tiller

U.S. Department of the Interior National Park Service
Preservation Assistance Division Technical Preservation Services

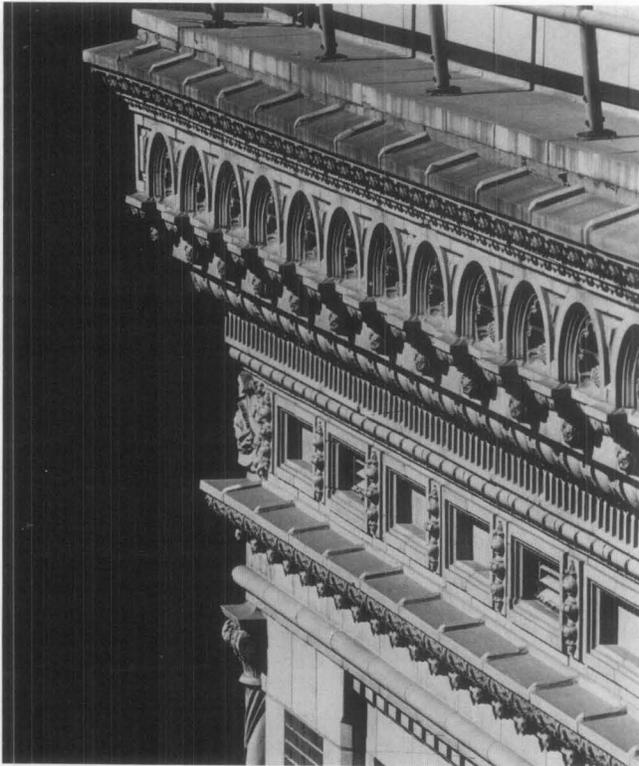
Figure 1. Terra-Cotta Detailing. Adaptable to every nuance of color, texture, and modeling, glazed architectural terra-cotta was ideally suited to satisfy the tastes of an eclectic age. Its popularity was, however, short lived; it endured only 30 or 40 years after its introduction as a building material late in the 19th century. (Larry Payne, Houston, Texas)

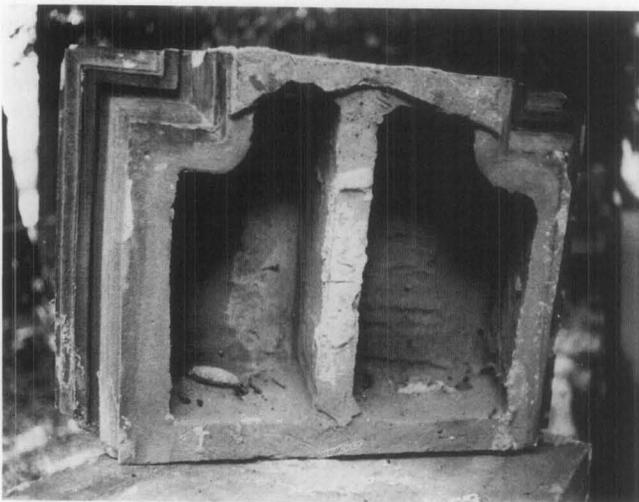
Figure 2. Webbing. Webbing, or the hollow internal compartment construction of glazed architectural terra-cotta blocks, made them inexpensive to produce, easy to handle and light in construction; these were significant factors in the popularity of the material in the first decades of this century.

Terra-cotta was usually hollow cast in blocks which were open to the back, like boxes, with internal compartment-like stiffeners called webbing (Fig. 2). Webbing substantially strengthened the load-bearing capacity of the hollow terra-cotta block without greatly increasing its weight.

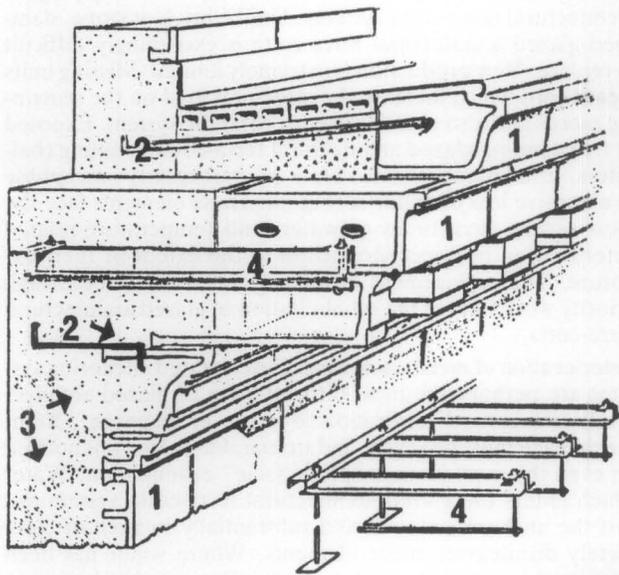
Figure 4. Typical Construction Detail of Glazed Architectural Terra-Cotta Ornament. Construction detailing was often complex. The terra-cotta units (1) which were laid in mortar were fitted with holes or slots to receive the metal anchors (2) (often called "Z" straps or "light iron") which were often fitted directly to the building frame. Masonry backfill (3) (either brick or poured cement) was laid between the terra-cotta units, with the building frame encasing the metal anchor. Overhanging or protruding elements were further secured by metal dowels or outriggers (4). (Detail, *Architectural Terra Cotta*, Charles E. White, Jr., 1920)

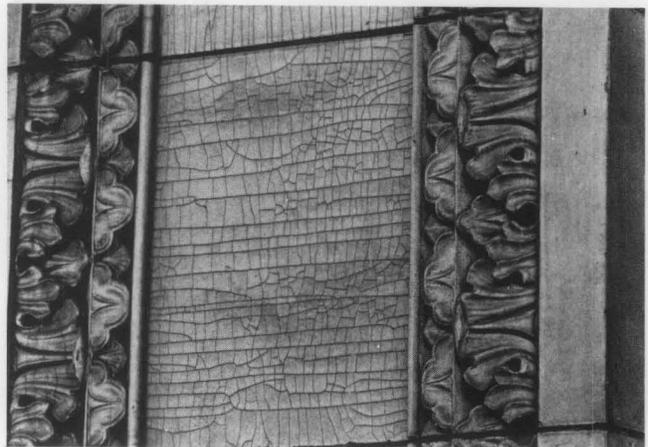
Figure 5. Crazing. Water and air-borne moisture entering the glazed architectural terra-cotta causes expansion of the porous clay body which increases its volume. This, in turn, is sufficient to upset the "fit" of the glaze and to make it shatter, commonly called crazing.

Crazing, or the formation of small random cracks in the glaze, is a common form of water-related deterioration in glazed architectural terra-cotta. When the new terra-cotta unit first comes from the kiln after firing, it has shrunken (dried) to its smallest possible size. With the passage of time, however, it expands as it absorbs moisture from the air, a process which may continue for many years. The glaze then goes into tension because it has a lesser capacity for expansion than the porous tile body; it no longer "fits" the expanding unit onto which it was originally fired. If the strength of the glaze is exceeded, it will crack (craze) (Fig. 5). Crazing is a process not unlike the random hairline cracking on the surface of an old oil painting. Both may occur as a normal process in the aging of the material. Unless the cracks visibly extend into the porous tile body beneath the glaze, crazing should not be regarded as highly serious material failure. It does, however, tend to increase the water absorption capability of the glazed architectural terra-cotta unit.

Waterproofing: The covering of crazed glazing (see Fig. 5) with waterproof coatings is the subject of an on-going controversy today. The question involves whether or not the micro-cracks conduct substantial amounts of water into the porous tile body. Tests indicate that the glaze on new unexposed terra-cotta is itself not completely waterproof. Some testing also indicates that most crazing on historic glazed terra-cotta does not substantially increase the flow of moisture into the porous tile body when compared to new material. Excessive and serious crazing is, however, an exception and the coating of those areas on a limited scale may be wholly appropriate.

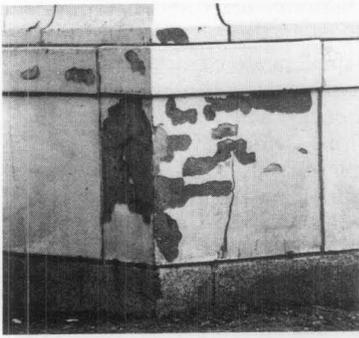
Figure 6. Glaze Spalling. Blistering of the glaze, like crazing, is the result of the increase in water in the porous clay body and the subsequent destruction of the glaze as a result of water migration and pressure. Glaze spalling may also be caused by deterioration of metal anchors behind the terra-cotta unit.

Glaze spalling may appear as small coin-size blisters where the glaze has ruptured and exposed the porous tile body beneath (Fig. 6). This may occur as several spots on the surface or, in more advanced cases of deterioration, it may result in the wholesale disappearance of the glaze. Spalling of the glaze may also be symptomatic of deterioration (rusting) of the internal metal anchoring system which holds the terra-cotta units together and to the larger building structure. The increase in volume of the metal created by rusting creates increased internal pressures in the terra-cotta unit which, in

textural terra-cotta. It is important to coat or seal these blistered areas (see Fig. 6) and to prevent further entry of water into the system by this route. All loose or friable material should be removed. This may be done easily by hand; chisels or similar small tools are most effective. The exposed material is then painted over. At this time, no permanently effective reglazing materials are available. However, there are several acrylic-based proprietary products and masonry paints which can be used effectively to protect these exposed areas, thus preventing the entry of water. These materials are effective for 5 to 7 years and can be reapplied. They also can be tinted to approximate closely the original glaze color.

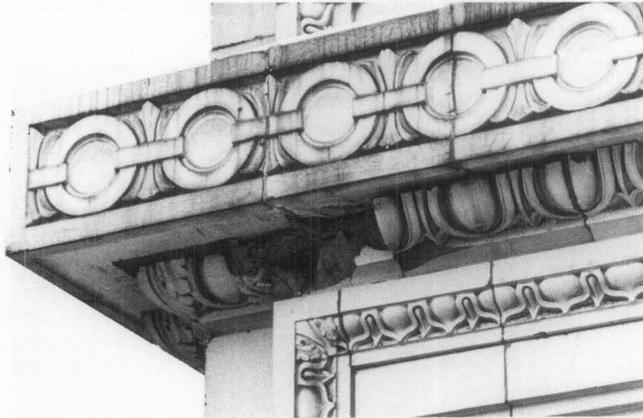
Figure 7. Material Spalling. Excessive expansion of the porous tile body caused by water and freezing temperatures produces major material spalling, a situation often difficult to repair.

Material spalling is a particularly severe situation. Not only is the visual integrity of the detailing impaired, but a large area of the porous underbody, webbing and metal anchoring is exposed to the destructive effects of further water entry and deterioration (Fig. 7). Both glaze and material spalling must be dealt with as soon as possible.

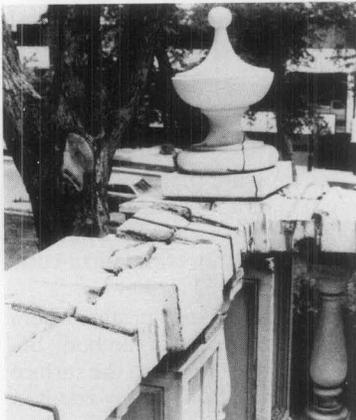
Figure 8. Deterioration of Exposed Detailing. Exposed or freestanding terra-cotta detailing (parapets, urns, balusters, etc.) have traditionally been subject to the most severe vicissitudes of deterioration as a result of freezing temperatures and water. (Colorado State Historic Preservation Office)

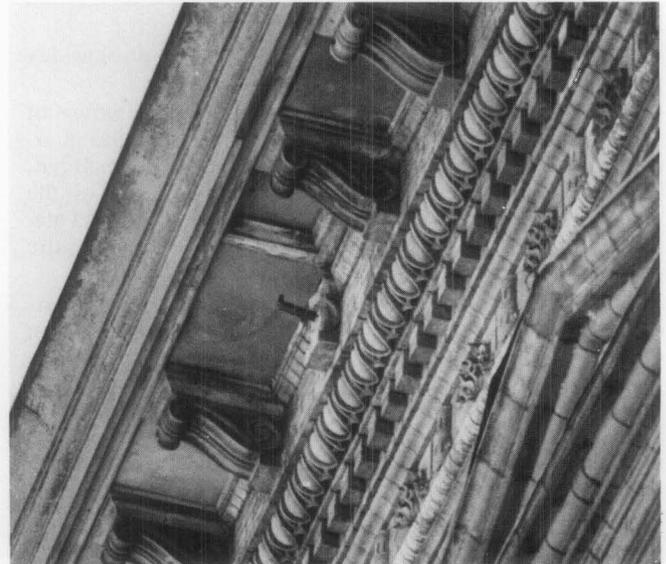
Figure 9. Deterioration of Metal Anchoring and Masonry Backfill. Trapped water may deteriorate masonry backfill or rust metal anchoring causing overhanging architectural elements to loosen and drop from the building. This is particularly true when unmaintained roof drainage systems fail and soak the masonry system. Note the exposed metal anchoring.

Deterioration of metal anchoring: Deteriorated anchoring systems are perhaps the most difficult form of glazed architectural terra-cotta deterioration to locate or diagnose. Often, the damage must be severe and irreparable before it is noticed on even the most intense "prima facie" examination. Water which enters the glazed architectural terra-cotta system can rust the anchoring system and substantially weaken or completely disintegrate those elements. Where water has been permitted to enter the system, some deterioration has more than likely taken place. Partial deterioration results in staining and material spalling. Total deterioration and the lack of any anchoring system may result in the loosening of the units themselves, threatening the architectural or structural integrity of the building. Recently, falling glazed architectural terra-cotta units have become a serious safety concern to many building owners and municipal governments (Fig. 9). Early detection of failing anchoring systems is exceedingly difficult.

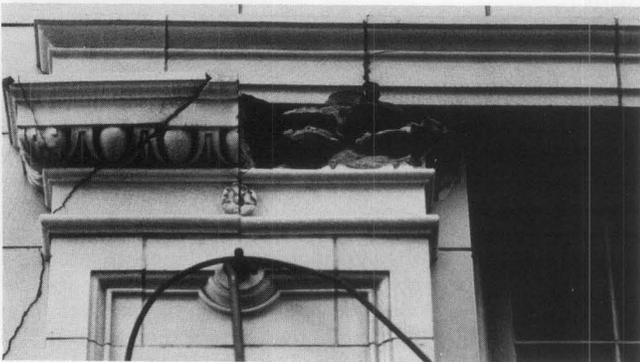
Figure 10. Structural Cracking. Structural cracking, whether static (*nonmoving*) or dynamic (*moving or active*), should be caulked to prevent water entry into the glazed architectural terra-cotta system. Note the exposed webbing.

Stress-related deterioration: Stress-related deterioration of glazed architectural terra-cotta frequently occurs in high rise buildings. The evolution of stress relieving details (flexible joints, shelf angles, etc.) occurred late in the development of American building construction. Consequently, most early continuously clad High Rise buildings (c.1900–1920s) had little or no provisions for normal material and building movement in their original design. The development of large stress-related cracks or wholesale material deterioration is often caused by unaccommodated building-frame shortening under load, thermal expansion and contraction of the façade and moisture expansion of the glazed architectural terra-cotta units themselves (Fig. 10). Cracks running through many units or stories or large areas of material deterioration often indicate stress-related problems. This sort of deterioration, in turn, permits significant water entry into the terra-cotta system.

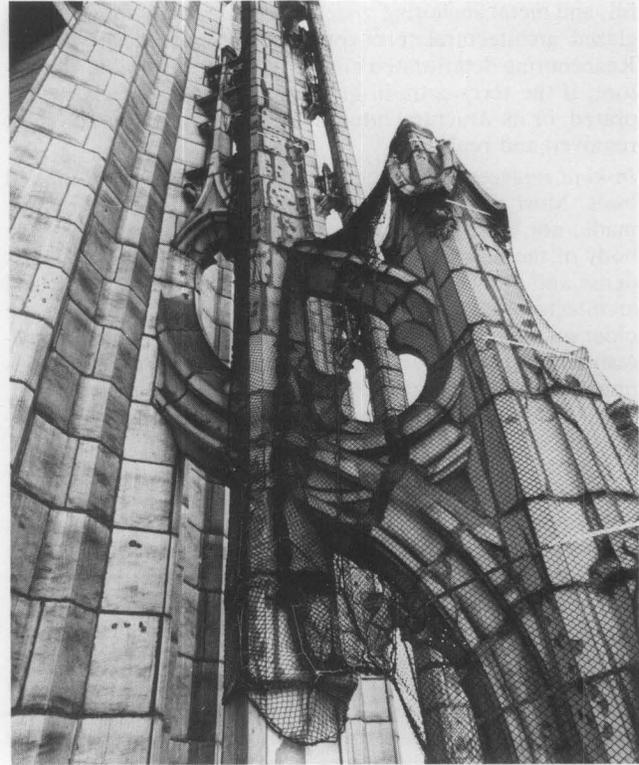
Figure 11. Temporary Stabilization Measures. Falling glazed architectural terra-cotta detailing has become a source of concern, particularly in dense urban areas and locations of high seismic activity. Nylon netting and metal strapping, while not seen as permanent preservation measures, do offer a temporary alternative to the removal of these elements.

Temporary stabilization: Stabilization measures are necessary when deterioration is so severe as to create a situation where pieces of glazed architectural terra-cotta may fall from the building. This is a particular concern with greatly exposed detailing: cornices, balconies, balustrades, urns, columns, buttresses, etc. Restoration work on these pieces is expensive and often must be carried on over a period of time. Unstable terra-cotta pieces are often removed or destroyed in lieu of such measures. This is particularly true in areas of heavy traffic-related vibrations or in earthquake zones. There are, however, less severe measures which may be employed on a temporary basis. Substantial success has been achieved in securing unstable glazed architectural terra-cotta pieces with metal strapping and nylon net (Fig. 11). While these measures should not be seen as permanent preservation solutions, they do offer temporary alternatives to the wanton destruction of significant glazed architectural terra-cotta detailing in the name of public safety and local code compliance.
