## Interpreting The Secretary of the Interior's Standards for Rehabilitation

**Subject:** Completing Never-Built Portions of a Historic Building

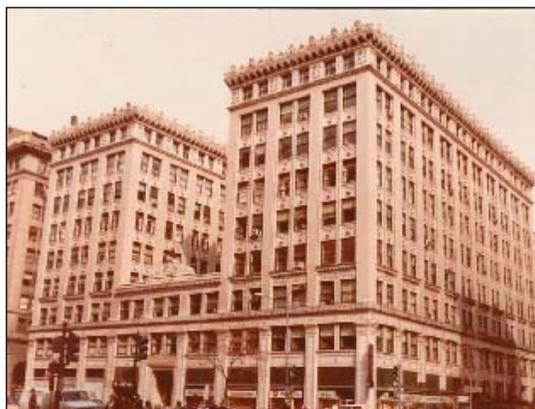
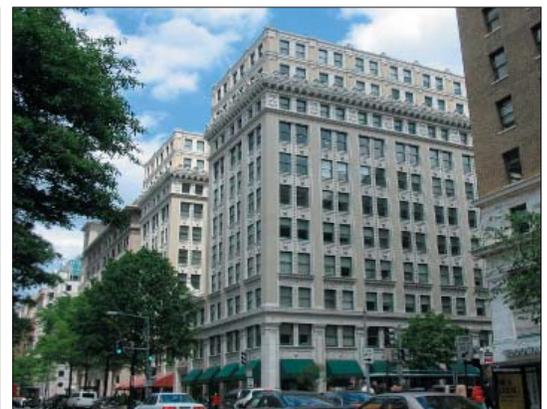
*Above is an elevation of the original design concept; the shaded areas indicate the two stories which were never built. To the right is the building as originally constructed, and to the far right, the building after the two-story addition was built.*

Extensive research into the history of the building clearly showed that the architect's original design envisioned an eleven-story building rather than the nine-story structure that was eventually built. This was documented in the historic structural drawings, original promotional material, and in the structural support for the future addition found on the roof. Such documentation, however interesting, was of little relevance since the historic character of the building was defined by what had actually been constructed, that is, a nine-story structure with a very distinctive cornice. Accordingly, constructing the proposed two-story rooftop addition, even though it followed the never-built design, was not a compatible treatment because it changed the height and proportions of the building, diminished the prominence of the cornice and, thus, negatively impacted the building's historic character. The project did not meet the Standards.

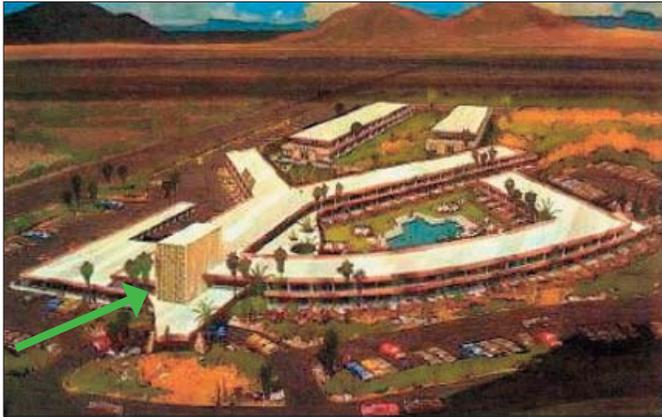
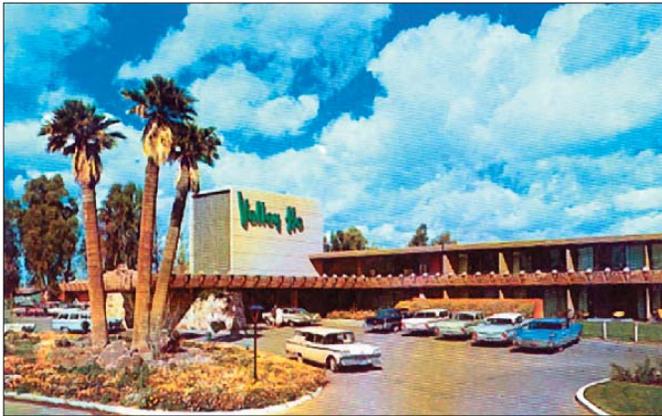
The image at the top is an architectural rendering of the original design for the hotel from 1957, which includes a tower element. Below this image is a postcard showing the main entrance to the complex as completed in the 1950's. As can be evidenced in these illustrations, the proportions of the three-story tower pylon highlighted by the long horizontal lines of the surrounding construction are part of the complex's distinctive visual character. The third image from the top shows the tower and porte-cochere before rehabilitation. While the tower's original architectural finish concrete has been covered with stucco and the original sign has been removed and replaced, its primary form remains as it was originally constructed.

**Application 2 (Incompatible treatment):** Another rehabilitation project which included a proposal to add a never-built feature on to a historic building involves a much different type of resource in terms of setting and appearance. In this case, the historic resource is a well-preserved resort hotel constructed in 1956, which embodies all the modern conveniences catering to the automobile-oriented leisure traveler of that era. Among the character-defining features of the hotel are the sprawling two-story guest wings informally arranged around a landscaped pool area. A cantilevered porte-cochere and a three-story rectangular block fitted with an illuminated sign established the presence of the hotel from afar.

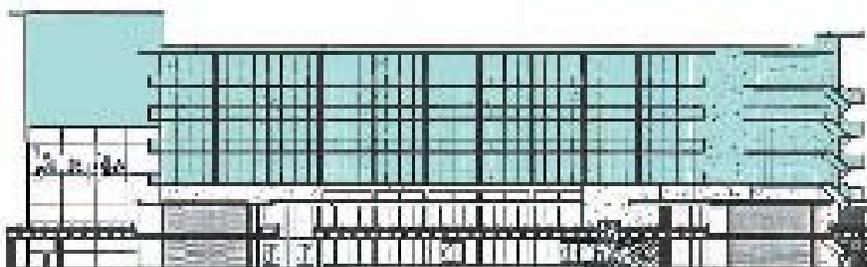
The shaded portions of this elevation drawing show the new tower addition as proposed. Even though the design for the new addition may have been planned when the building was originally conceived, the height and massing of the new construction would have substantially altered the character of the historic resort hotel.

A significant component of the rehabilitation was the proposal to construct a tower addition that was included in the original plans for the complex but was never built. The rehabilitation proposal called for constructing a four-story tower above the existing two-story portion, thereby completing the architect's original design concept (see below). As in the previous example, the completion of the un-built portion of the original design would have significantly changed the appearance of what was actually built and had acquired historic significance. If completed, the proposed four-story tower addition would have inserted a strong vertical element in this hotel complex that had essentially always been defined by its horizontality. Therefore, the construction of the tower would have substantially altered the historic character of the hotel and, thus, the proposed project did not meet the Standards. As an alternative approach, it was suggested that the new construction be added at another location on the site.
