## **Technical Preservation Services**

## ITS Number 36

## The Secretary of the Interior's Standards for Rehabilitation

**Subject:** Rooftop Additions

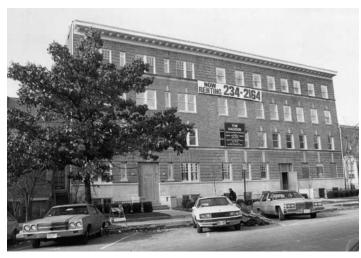
This early twentieth century apartment building was actually constructed as two buildings of harmonious but slightly different design.

Application 2 (Compatible treatment): A rooftop addition was proposed for a four-story apartment building that was being rehabilitated for continued residential use. The building was constructed in 1914 in a simply articulated, Classical Revival style with a slightly-raised limestone base, a brick facade, beltcourses, and some decoratively-carved keystones on the first floor. It is capped by a simple but prominent dentilled cornice. This building is one of several large apartment buildings located in a primarily small scale, single-family residential neighborhood. It is surrounded on both sides and across the street by two to two-and-one-half story rowhouses, and therefore is highly visible within the district. For this reason alone, it might appear that the addition of any more height to this building would not meet the Standards.

However, a new floor was added that is only minimally visible on the non-significant side elevations and is imperceptible from directly across the street. Setting the new floor into the flat roof plane lowered the profile of the addition to the height of a half story. The slanted front edge further minimized the appearance of the addition and concealed integral skylights. The mass blended with the solid, unadorned side walls of the historic building. This rooftop addition does not impact the historic character of the building and is in conformance with the Standards.

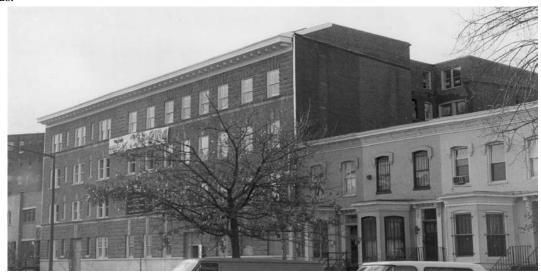
New rooftop addition and stairtower visible on the secondary north elevation, meets the Standards, and is compatible with the historic building.
