## **Technical Preservation Services**

## ITS Number 43

## Interpreting The Secretary of the Interior's Standards for Rehabilitation

Subject: Converting Fire Escapes into Balconies in Mill Complexes

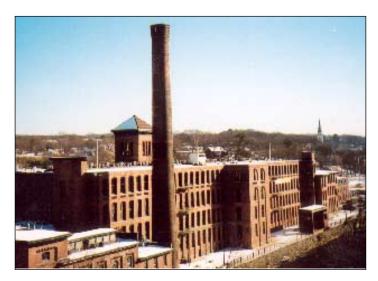
Many historic mill buildings that are being converted for residential use retain their historic fire escapes.

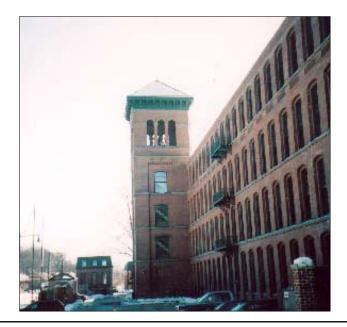
Far left: Mill building with fire escape after rehabilitation. Left: Section detail of new balconies converted from historic fire escapes.

**Application 1** (*Compatible treatment*): A large, 1868 brick mill complex was recently converted to housing with 207 market-rate and 42 low- to moderate-income units using federal historic preservation tax credits. There were two sets of historic fire escapes on both the east and west elevations of the four-story main complex. As part of the rehabilitation, the fire escape landings and railings were retained and converted into balconies after they were sandblasted, primed and painted. The fire escape stairs were removed for safety and security reasons. This treatment meets the Standards.
