Interpreting The Secretary of the Interior's Standards for Rehabilitation

Subject: Designing Compatible Replacement Storefronts

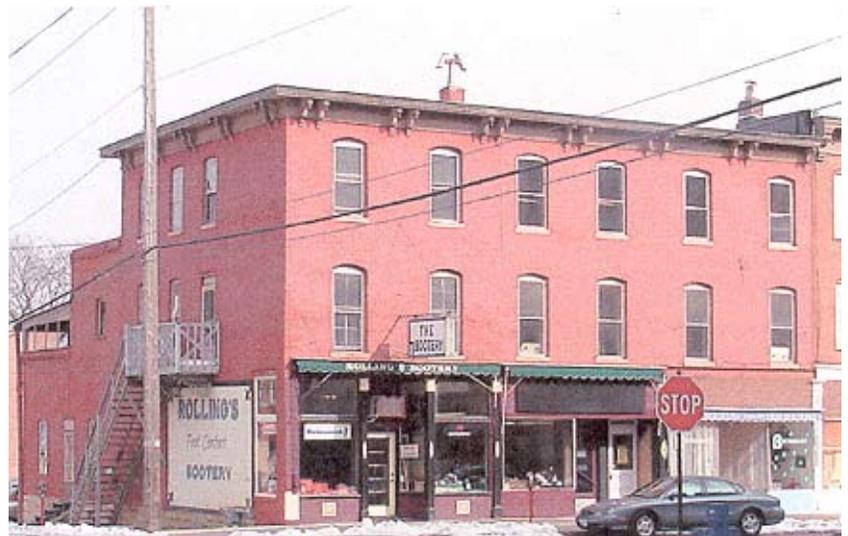
The three buildings prior to rehabilitation.

Application 1 (Compatible treatment): These three buildings constructed in 1868 are part of a three-story commercial block. The storefronts had been remodeled prior to rehabilitation, each somewhat differently, although the original cast iron pilasters that separated the storefronts remained and all the entrance doors were in their original locations.

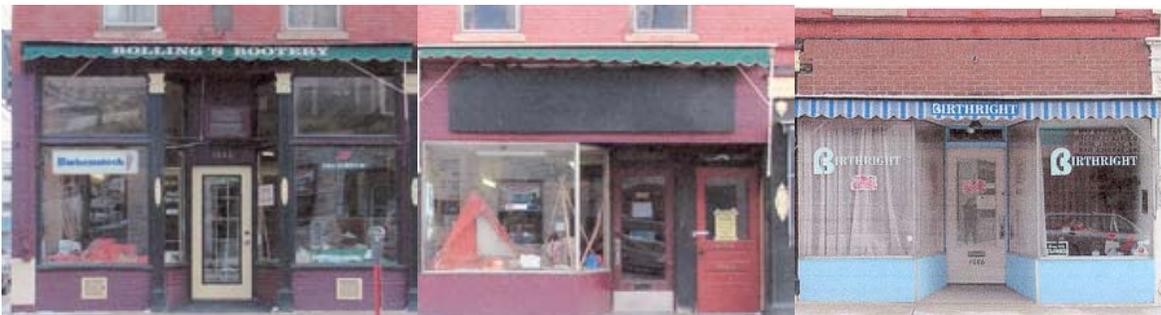
Details of existing storefronts prior to rehabilitation.

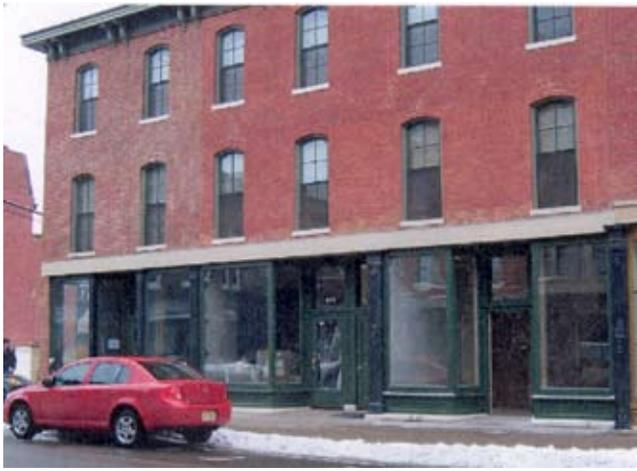
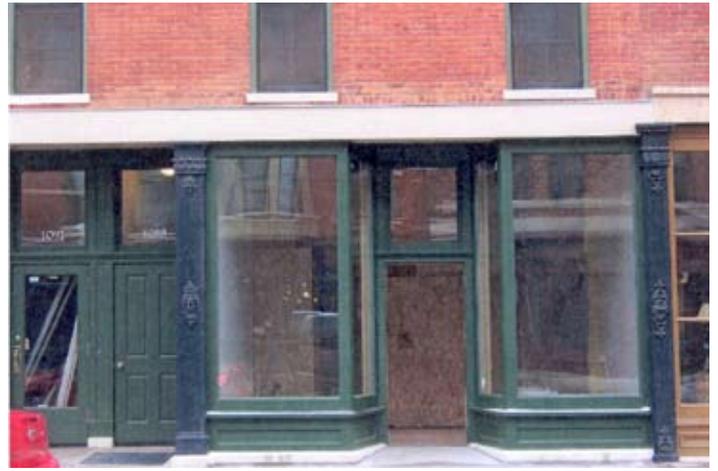
The buildings with compatible new storefronts after rehabilitation with detail of new storefronts.

The rehabilitation of these buildings for retail/commercial use on the first floors and residential use on the upper floors included installing compatible new storefronts. As part of the rehabilitation the original cast iron pilasters were retained and repaired. The new replacement storefronts are painted wood and consist of a lower panel and large glass display windows. The new doors are simple in design and feature transoms above. Although the original storefront windows could have included transoms, the new full height, undivided showcase windows without transoms are compatible with the historic character of these buildings. Accordingly, this rehabilitation project meets the Standards.

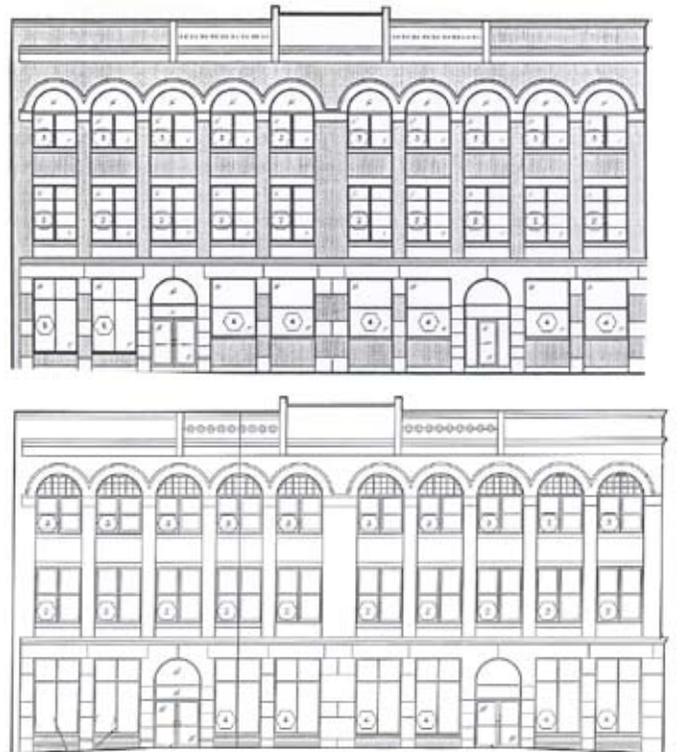
Above: Drawings of storefront elevation before (top) and after (center) rehabilitation. Below: The warehouse with compatible new storefronts after rehabilitation.

Compatible new storefronts were installed as part of the rehabilitation. Each of the storefront windows was replaced with a correctly-proportioned lower panel with a display window and a two-light transom above. Simply-designed double doors with a two-part transom were installed in the two entrances. This treatment meets the Standards.

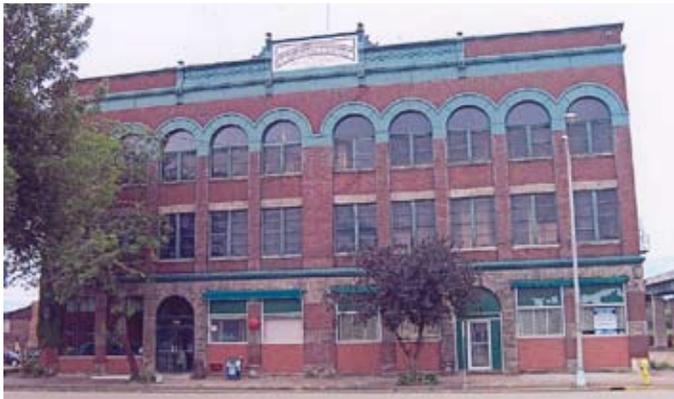
Above: The warehouse storefronts had been changed prior to rehabilitation.

Application 2 (Compatible treatment): This 1912 hardware warehouse was rehabilitated for low-income housing. Over the years, the first floor storefront openings had been altered. A single door, surrounded by green spandrel glass sidelights and transom, filled in the entrance. Brick infill had reduced the size of the window openings, especially those on the right side of the façade. The historic storefront windows themselves had been replaced with smaller unpainted aluminum windows with green spandrel glass transoms.
