ITS NUMBER 6

Interpreting The Secretary of the Interior's Standards for Rehabilitation

Subject: Preserving Historic Church Interiors

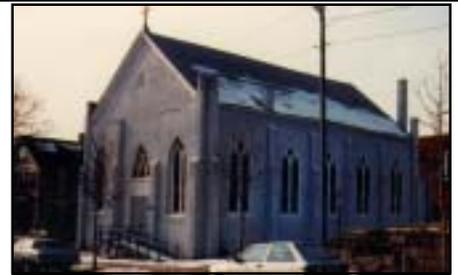
1858 Gothic Revival church building prior to rehabilitation.

Application 1 (*Incompatible treatment*): A simple Gothic Revival church constructed in 1858 was rehabilitated for combined office and residential apartment use. The interior still possessed a high degree of integrity before its rehabilitation with its tray ceiling, twelve large stained glass windows, choir loft, and the large, two-story space of the sanctuary itself. During the rehabilitation the choir loft was demolished, and the construction of a full second floor resulted in bisecting the two-story interior space horizontally. The combination of these treatments resulted in a loss of interior features and loss of the interior space itself in this historic church building. Inserting the new floor level removed the choir loft and, most importantly, resulted in the loss of the

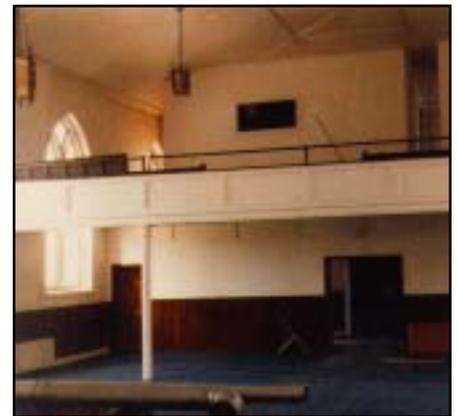
Sanctuary with choir loft prior to rehabilitation

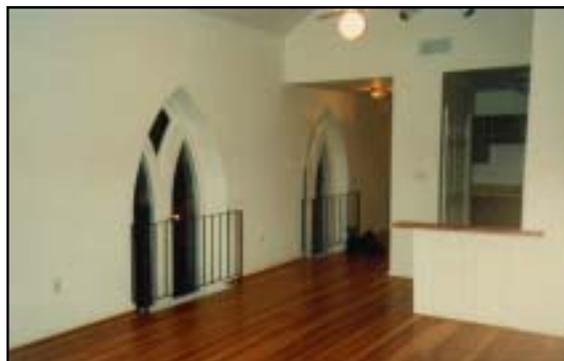
Sanctuary after rehabilitation with new floor and newly divided windows.

historic spatial volume so characteristic of church building interiors. The new second floor also negatively impacted the tall Gothic-arched windows by cutting across them, effectively re-proportioning them and reducing their appearance to smaller segments. This rehabilitation, because it did not preserve the integrity and historic character of the church interior, did not meet Standards 1, 2, 5 and 10. Although this particular rehabilitation was not successful, some subdivision may have been possible if a sense of the historic interior space and volume had been preserved, as was achieved in the second example.

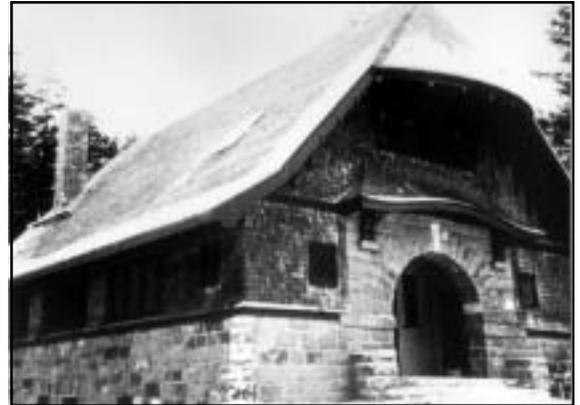
*Shingle-Style church.
North and east elevations after rehabilitation.*

Application 2 (Compatible treatment): In another example, a small, two-story, rectangular Shingle-style church, built in the late-19th century, was rehabilitated into a single-family dwelling. Prior to rehabilitation, the interior historic finishes still remained intact, as did the sanctuary space itself lit by original clear glass casement windows. As part of the rehabilitation, approximately a third of the first floor sanctuary space was partitioned off at the rear and modified for use as two bedrooms. The remaining two thirds of the sanctuary was retained intact as the living room, and the apse became the dining area. The corner rooms (the cloakroom, vestry and rear entry vestibule) were kept in their historic configuration and converted into a bathroom, kitchen and mudroom, respectively. To permit more light into the interior, plaster panels at the back of the apse were removed and replaced with clear, single-paned glass windows. The existing stairway provided access to the choir loft which was converted into a master bedroom and bath with only a minimal amount of alteration, even allowing retention of the historic church organ. This rehabilitation successfully preserved the primary, character defining features, finishes and spaces of this historic church interior.

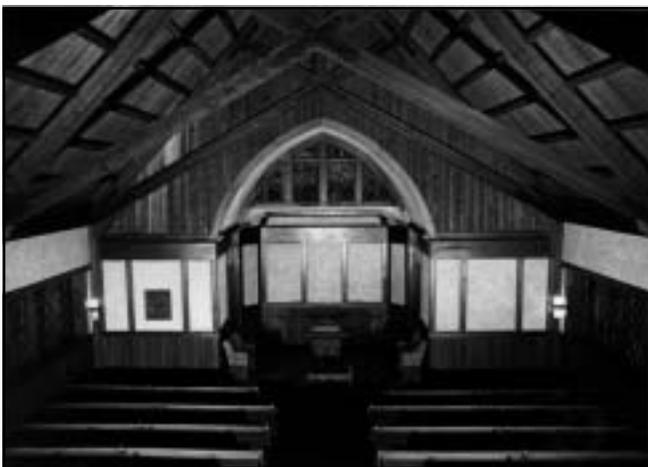
Sanctuary and apse before rehabilitation.

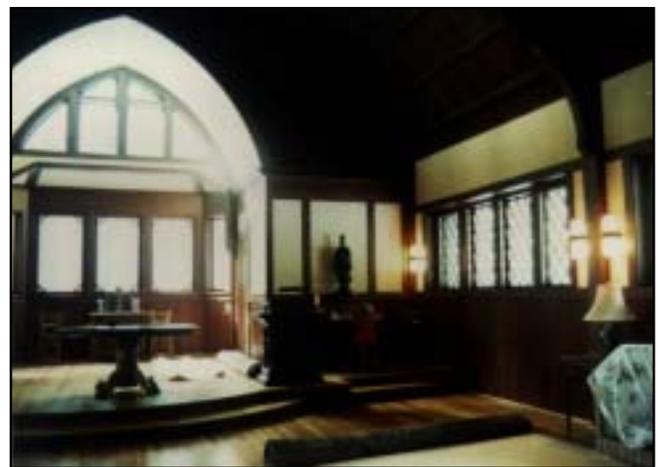
Sanctuary after rehabilitation. View toward kitchen and dining area from living space.

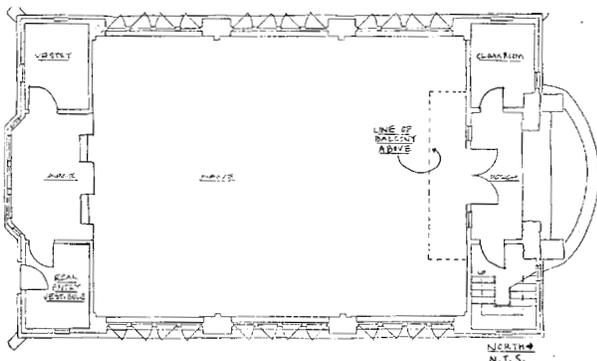
Before rehabilitation first floor plan with reflected line of balcony.

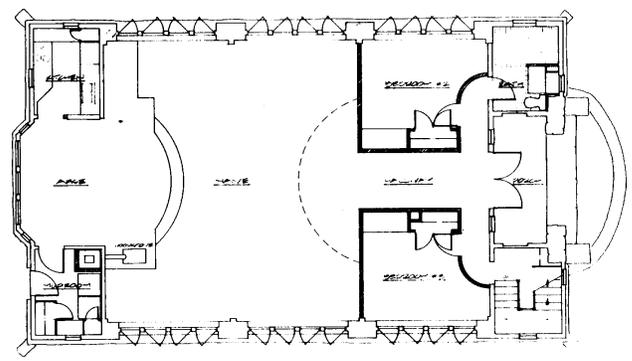
First floor plan after rehabilitation.
