# PEIRCE MILL COMPLEX

## Cultural Landscape Report

### CULTURAL LANDSCAPE REPORT

PREPARED BY:  
QUINN EVANS | ARCHITECTS  
1214 TWENTY-EIGHTH STREET, NW  
WASHINGTON, DC 20007

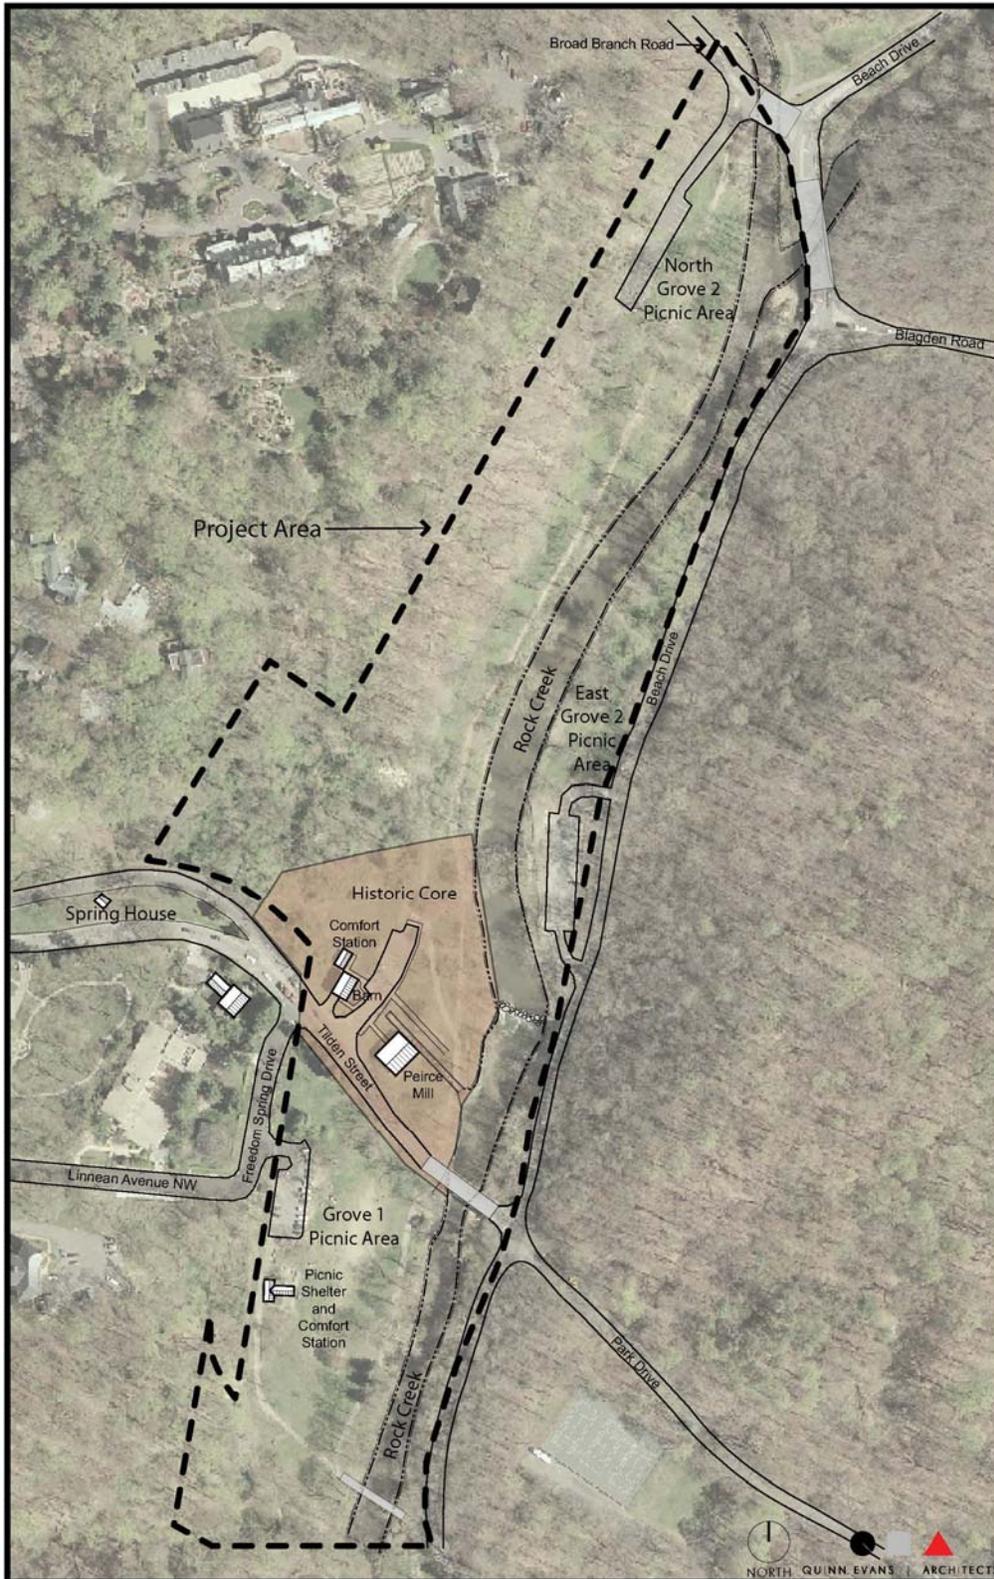
Figure 1- 3: Peirce Mill Project Area and Historic Core.

The historic core of the project area is defined as a hub including the primary resources associated with the Peirce Mill property. These are the Mill, barn, millrace, and the landscape immediately surrounding these resources, as illustrated in Figure 1-3. Throughout this report resources within the project area are addressed at two scales. At a broad scale, the overall project area boundary defines the area addressed. Resources within this area are evaluated and general management recommendations are provided. At a more detailed level resources within the historic core are considered. Figure 1-3 illustrates the boundaries of the project area and the location of the historic core.

The project area boundary is illustrated in Figure 1-3. The western edge of the project area is marked by woods that cover the steep east-facing slope. The northern and eastern edges are formed by roads, Broad Branch Road and Beach Drive respectively. The southern boundary of the landscape is defined by the edge of the woods and the Melvin Hazen tributary of Rock Creek. These boundaries are based loosely on the boundaries of three parcels (Acquisition Tracts 75, 76, and 77) purchased from Peirce Shoemaker by the Federal government in 1891 to create a portion of Rock Creek Park.

- *Peirce Mill Project Area*: the entire 20.7 acre area associated with the Peirce Mill Complex, illustrated in Figure 1-3.
- *Peirce Mill Historic Core*: The portion of the Peirce Mill project area that includes the primary historic resources associated with the Peirce Mill property, illustrated in Figure 1-3.

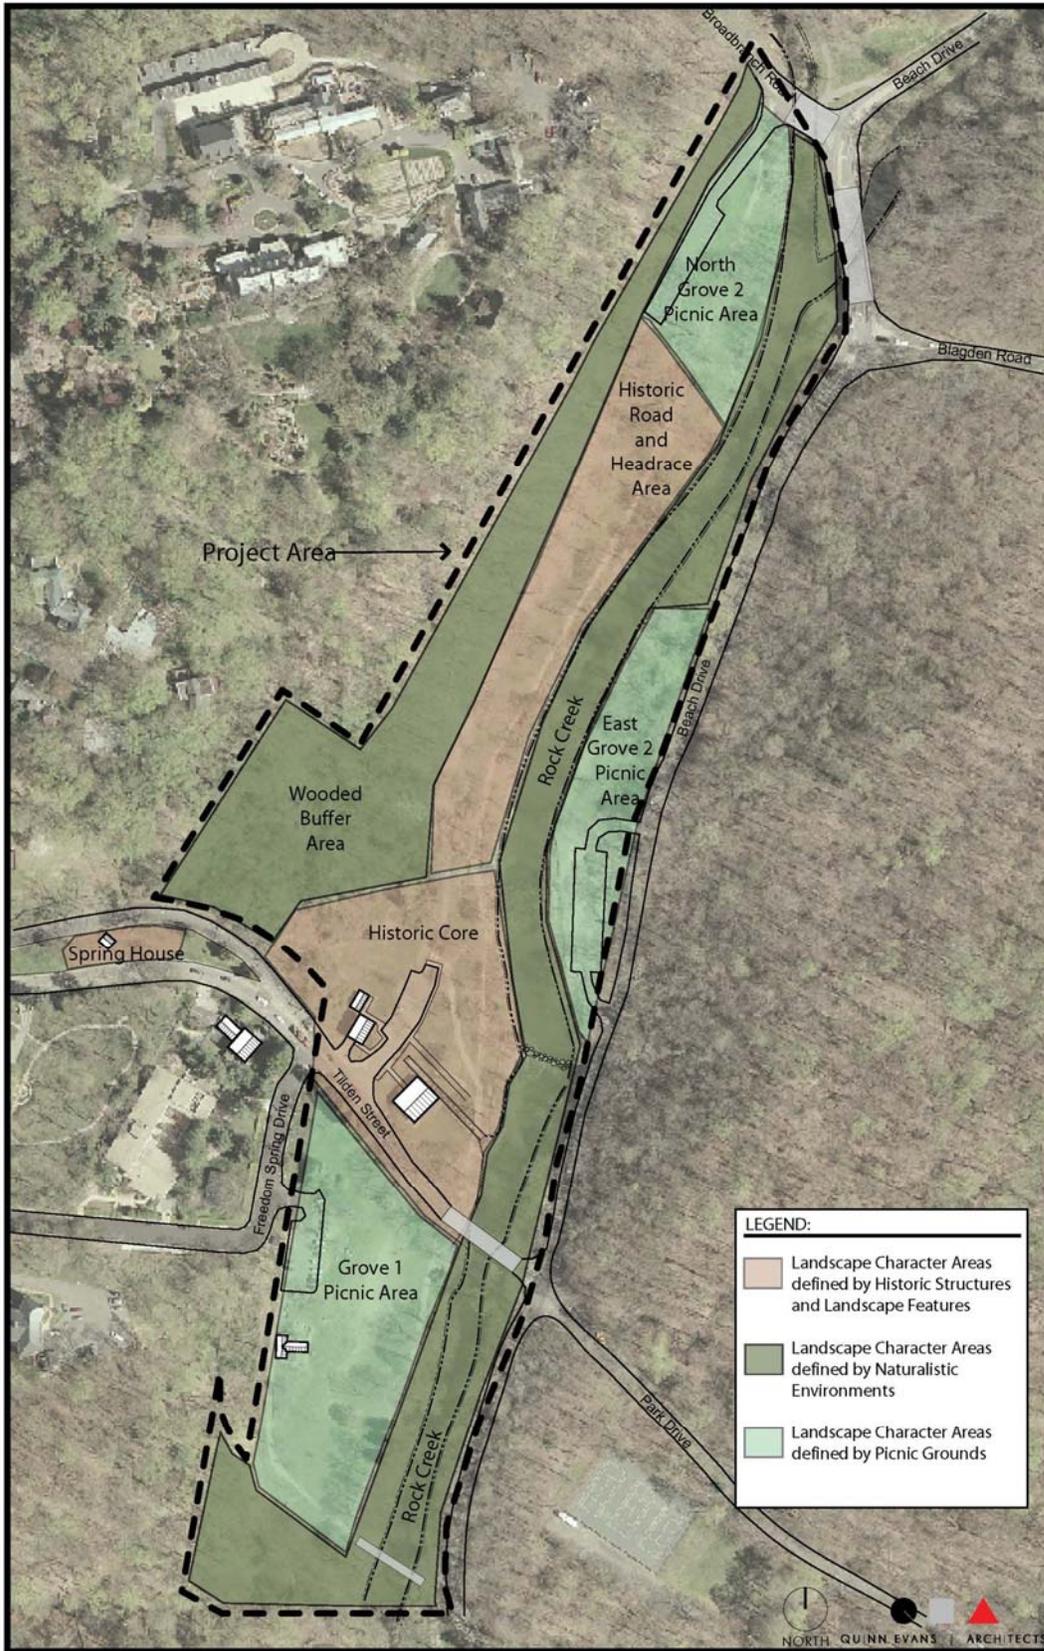
Figure 1- 4: Landscape Character Areas

The landscapes within the project area are described herein as landscape character areas that are defined by their physical qualities and the cultural resources present.<sup>2</sup> Three types of landscape character areas are found at Peirce Mill. They include landscapes defined by historic structures and landscape features; landscapes that include naturalistic environments, and landscapes used as picnic groves. Eight landscape character areas have been identified and are illustrated in Figure 1-4. The landscape character areas defined by historic resources include: 1) the historic core; 2) the spring house area; and 3) the historic road and headrace area. The landscape character areas defined by naturalistic environments include the wooded buffer area and the Rock Creek area. The landscape character areas utilized as picnic groves include the Grove 1 picnic, north Grove 2 area and east Grove 2 area. The Peirce Mill complex landscape character areas are described in this section.

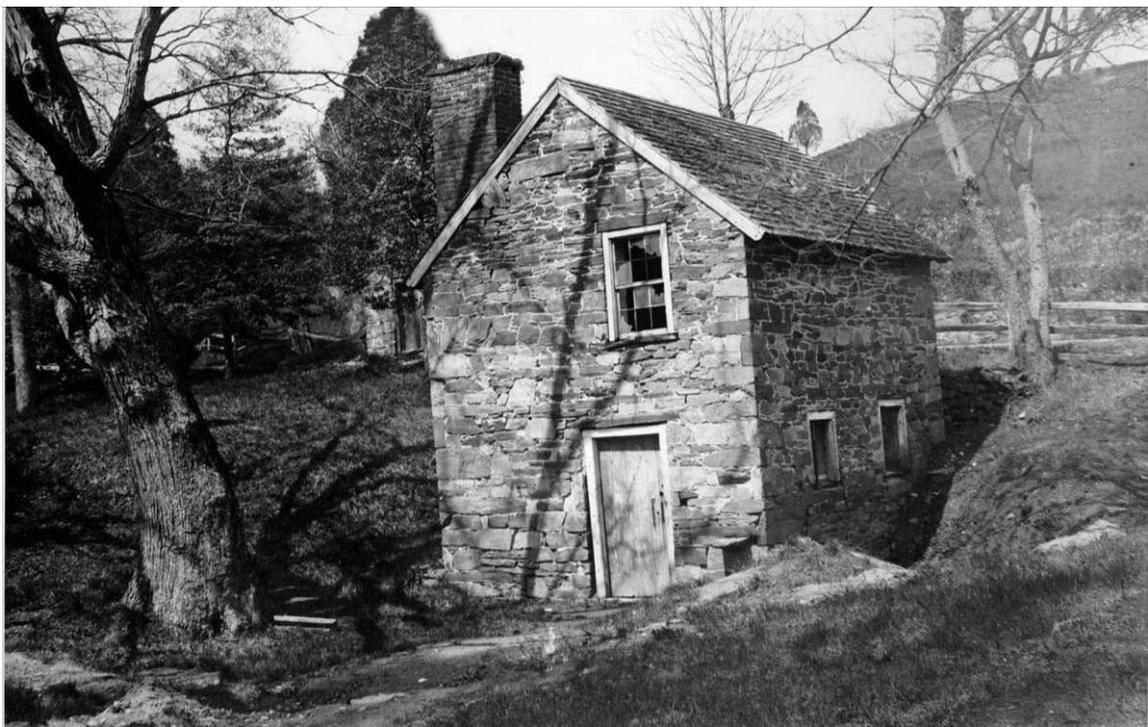
**Figure 2- 3: Peirce Mill Springhouse, south and east elevations, ca. 1897.** (Source: Rock Creek Park Historic Photograph Collection PM1-56)

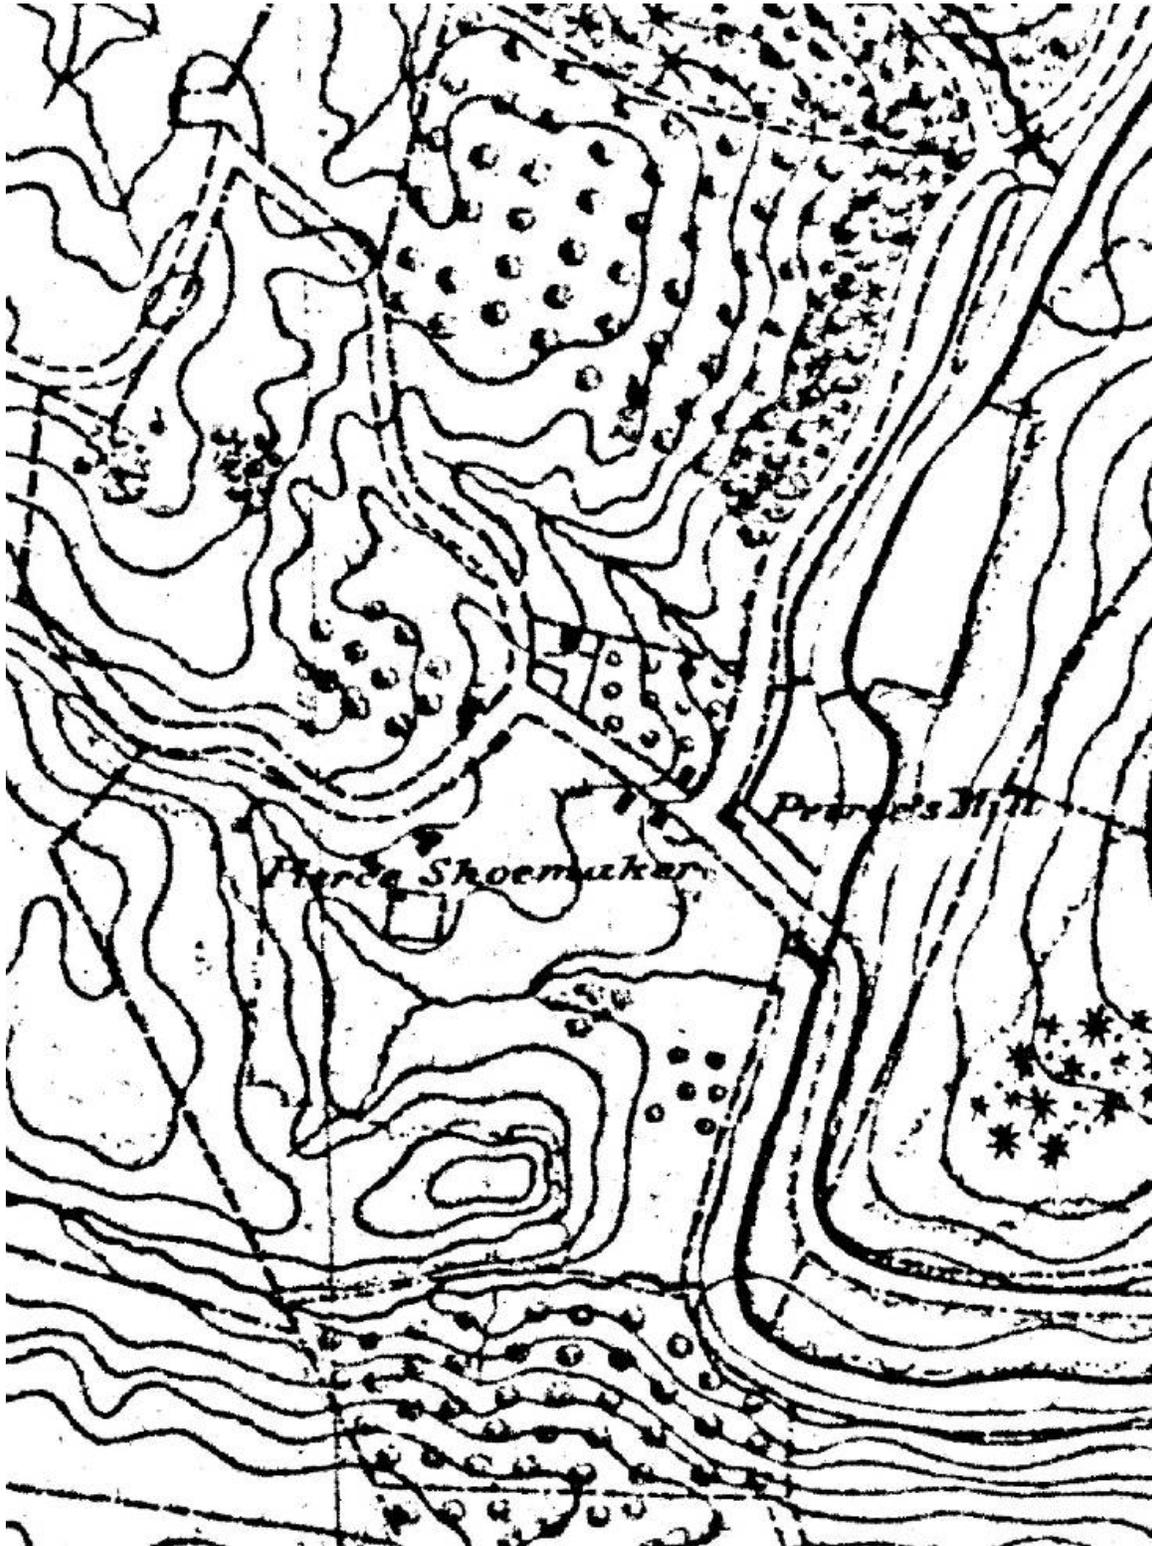
Figure 2- 4: The Boschke Map shows the cluster of buildings, the fields, orchards, and woodlands, 1861. (Source: excerpt from Boschke Topographical Map of Washington and its Environs, Library of Congress)

Consideration of Boschke's 1861 map (Figure 2-4), Carpenter's 1864 survey (Figure 2-6), Michler's 1866 map (Figure 2-5), and the 1893 District of Columbia Coast and Geodetic Survey (Figure 2-13), indicates that the differing scales, styles, and emphasis of these maps on landscape features makes comparison difficult. In fact, the alignment of Rock Creek differs markedly in the diagrams. Nevertheless, comparison of the diagrams to the 1930s planting plan provides some insight regarding the millrace. Of particular interest is the apparent existence of three connections between the millrace and creek in the Boschke and Michler plans. Particularly on the Michler plan, it appears that the headgate was farther upstream from the mill, and that the middle connection, which curved from the millrace to the southeast toward the creek, may have been an overflow route. The third connection is the tailrace. The Boschke map is less detailed and harder to decipher, but it appears that the raceway extends to Broad Branch, has a second connection to the creek in a similar location to that shown in the Michler plan, and a third at the tail race. A line shown across the creek just downstream of the second connection is likely to represent a dam.

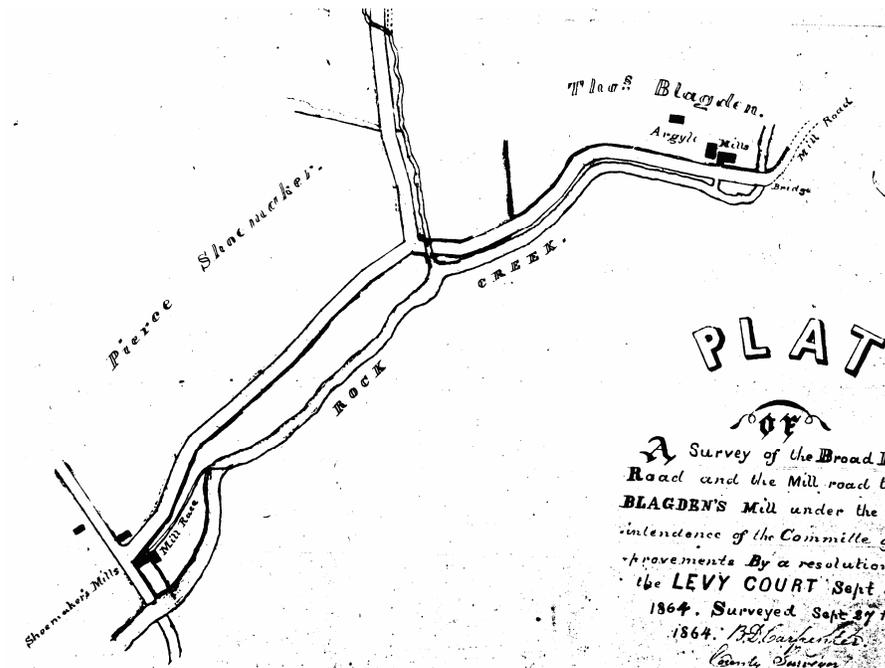
Figure 2- 5: B. D. Carpenter's Survey, dated 1864. (Source: Peirce Mill Historic Structure Report)

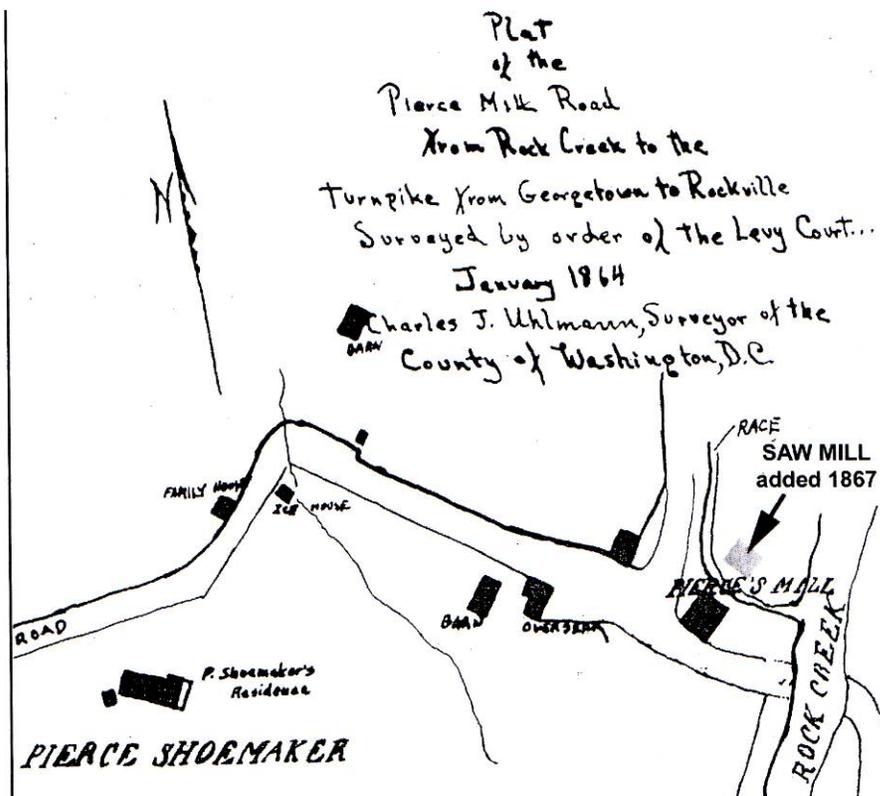
Figure 2- 6: Plat of Peirce Mill, 1864. (Source: McCormick, 1967)

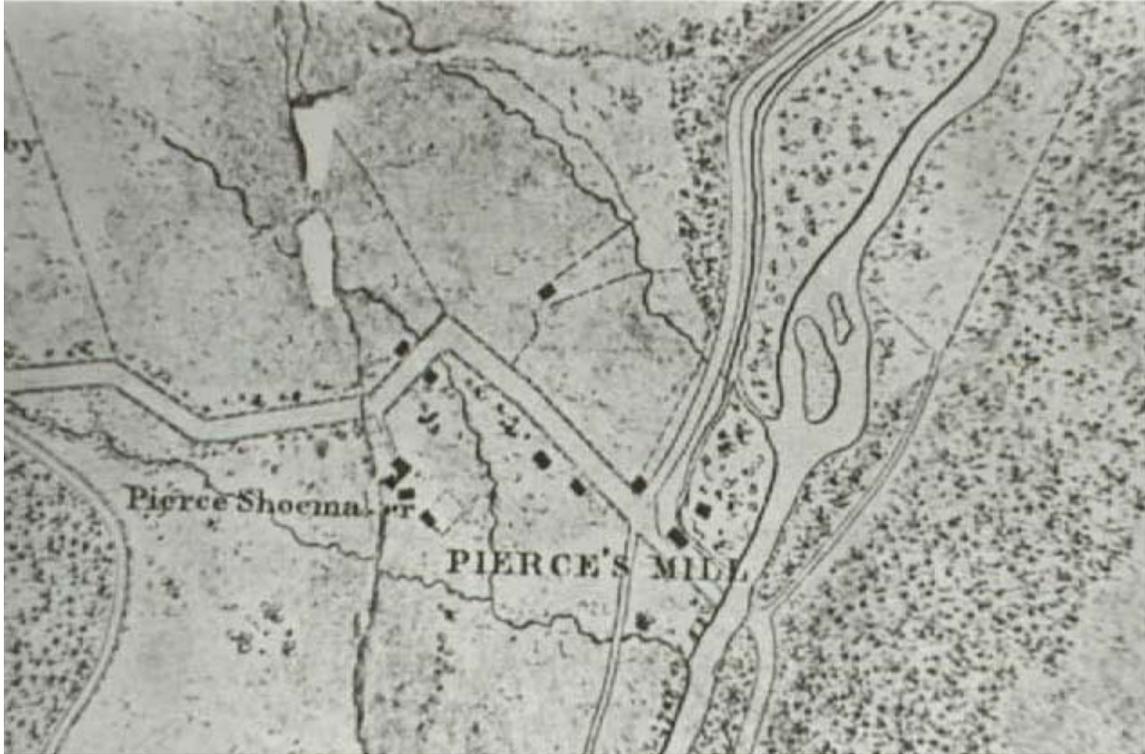
**Figure 2- 7: The mill and other structures and their relationship to the road system and Rock Creek are indicated on Michler's 1866 'Topographical Sketch of the Environs of Washington.'** (Source: National Archives)

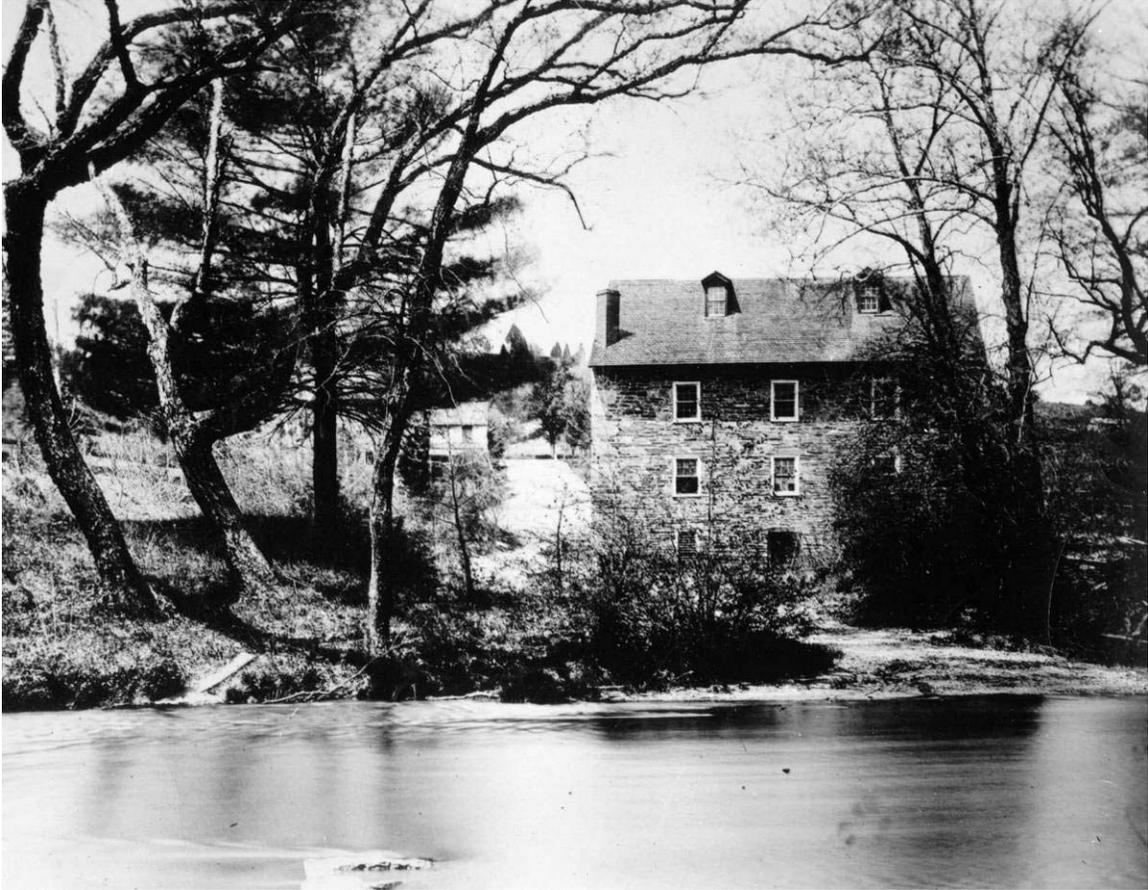
**Figure 2- 8: Peirce Mill, east elevation, ca. 1897, showing dormers.** (Source: Rock Creek Park Photograph Collection PM2-60)

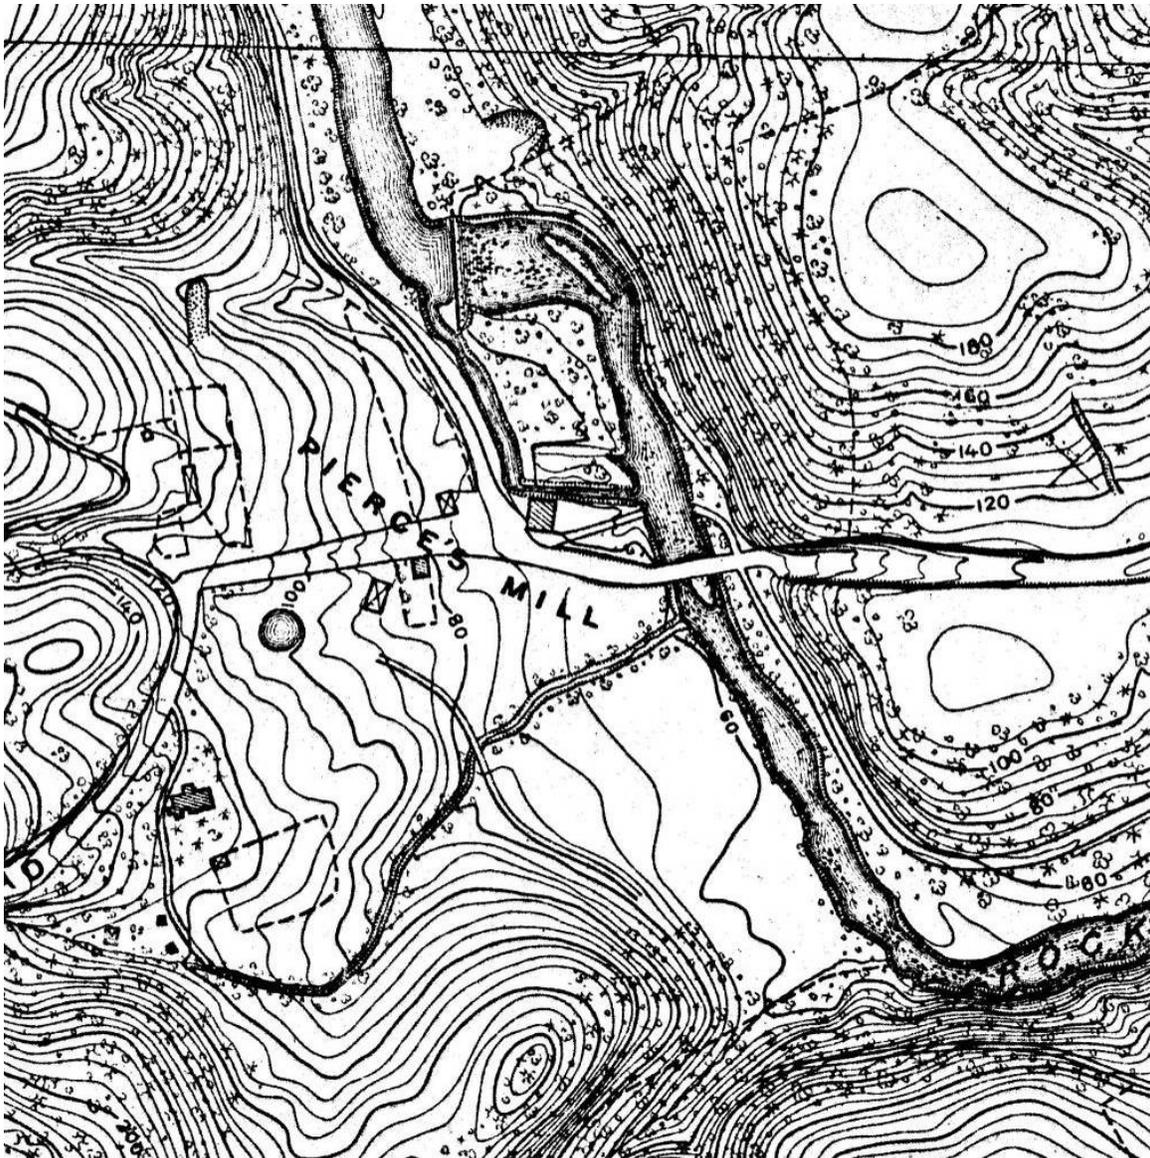
Figure 2- 10: Coast and Geodetic Survey, District of Columbia, 1893. (Source: Peirce Mill Historic Structures Report)

A major alteration to the landscape around the mill occurred in 1895 when the wood truss bridge across the creek was replaced with one constructed of steel girders faced with stone (see Figure 2-9). This new construction added a significant increase in grade of almost six feet at both ends of the bridge (see Figure 2-10). Stone wing walls were added in 1912 to contain the fill used in the grade adjustment at the bridge approaches. Because Peirce Mill Road was a public road, the District highway department, independent of the Rock Creek Board of Control (the administrative organization of the new park) made these changes to the bridge crossing.<sup>37</sup>

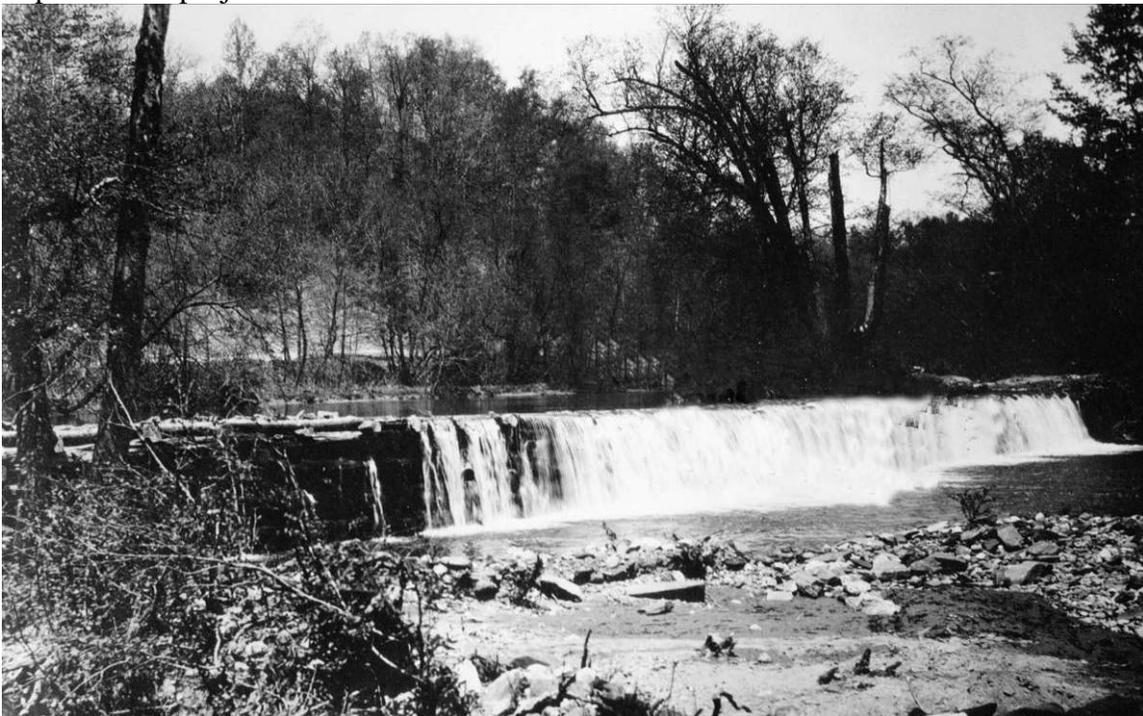
**Figure 2- 11: Peirce Mill dam, facing northeast, post 1904.** (Source: Rock Creek Historic Photograph Collection PM2-61)

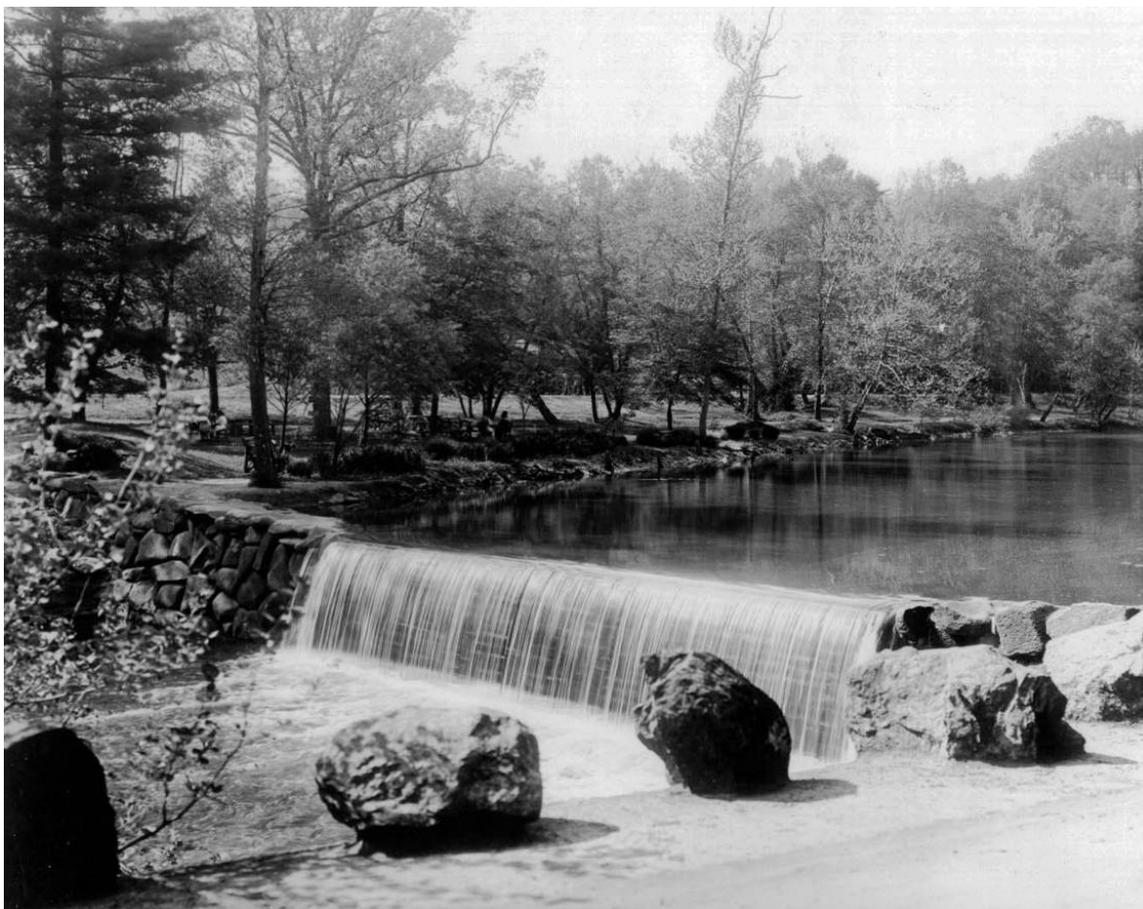
**Figure 2- 12: Peirce Mill dam facing northwest, taken by Olmsted Brothers, 1917.** (Source: CLI 2003)

In 1918 Rock Creek Park was transferred from the Board of Control to the park system of the District of Columbia under the jurisdiction of the Chief of Engineers. The management of the park fell under the Office of Public Buildings and Grounds (OPBG). Just prior to this transfer, the Board of Control commissioned the Olmsted Brothers, the notable landscape architecture firm from Brookline, Massachusetts, to study and prepare a report with recommendations on the future development of Rock Creek Park. In 1918, after extensive reconnaissance work and analysis and evaluation of the entire park, the firm submitted its report to the Office of Public Buildings and Grounds. A photograph of the dam at Peirce Mill during the reconnaissance is shown in Figure 2-12.

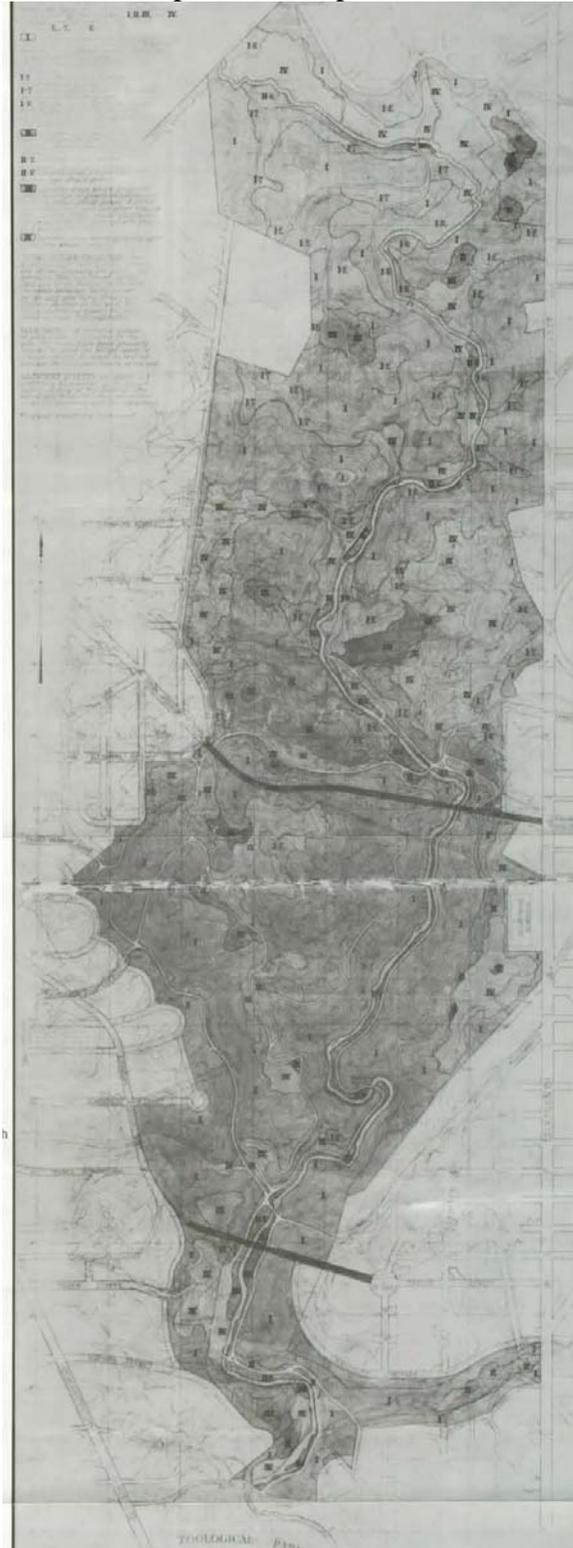
**Figure 2- 13: Olmsted Brothers Plan for Landscape Units at Rock Creek Park, December 1917.**  
(source: National Park Service, 821-25000-DSC-Sept 90)

While the Olmsted Report discussed the valley, meadowlands, and the development of picnic groves, the document did not specifically address the areas around existing historic structures such as Peirce Mill (see Figure 2-13). The area on the west side of the creek, north and south of the mill site fell into the landscape unit designated in the report as Type V, an area of "generally open grass land." The area lying directly along the west bank above the 1904 dam and on the east side of the creek above and below the bridge qualified as Type II-R, "where river bottom prevails."<sup>51</sup> The designations were based on the reconnaissance notes, which indicated that a "nice meadow" lay on the west side of the creek, south of the mill.<sup>52</sup>

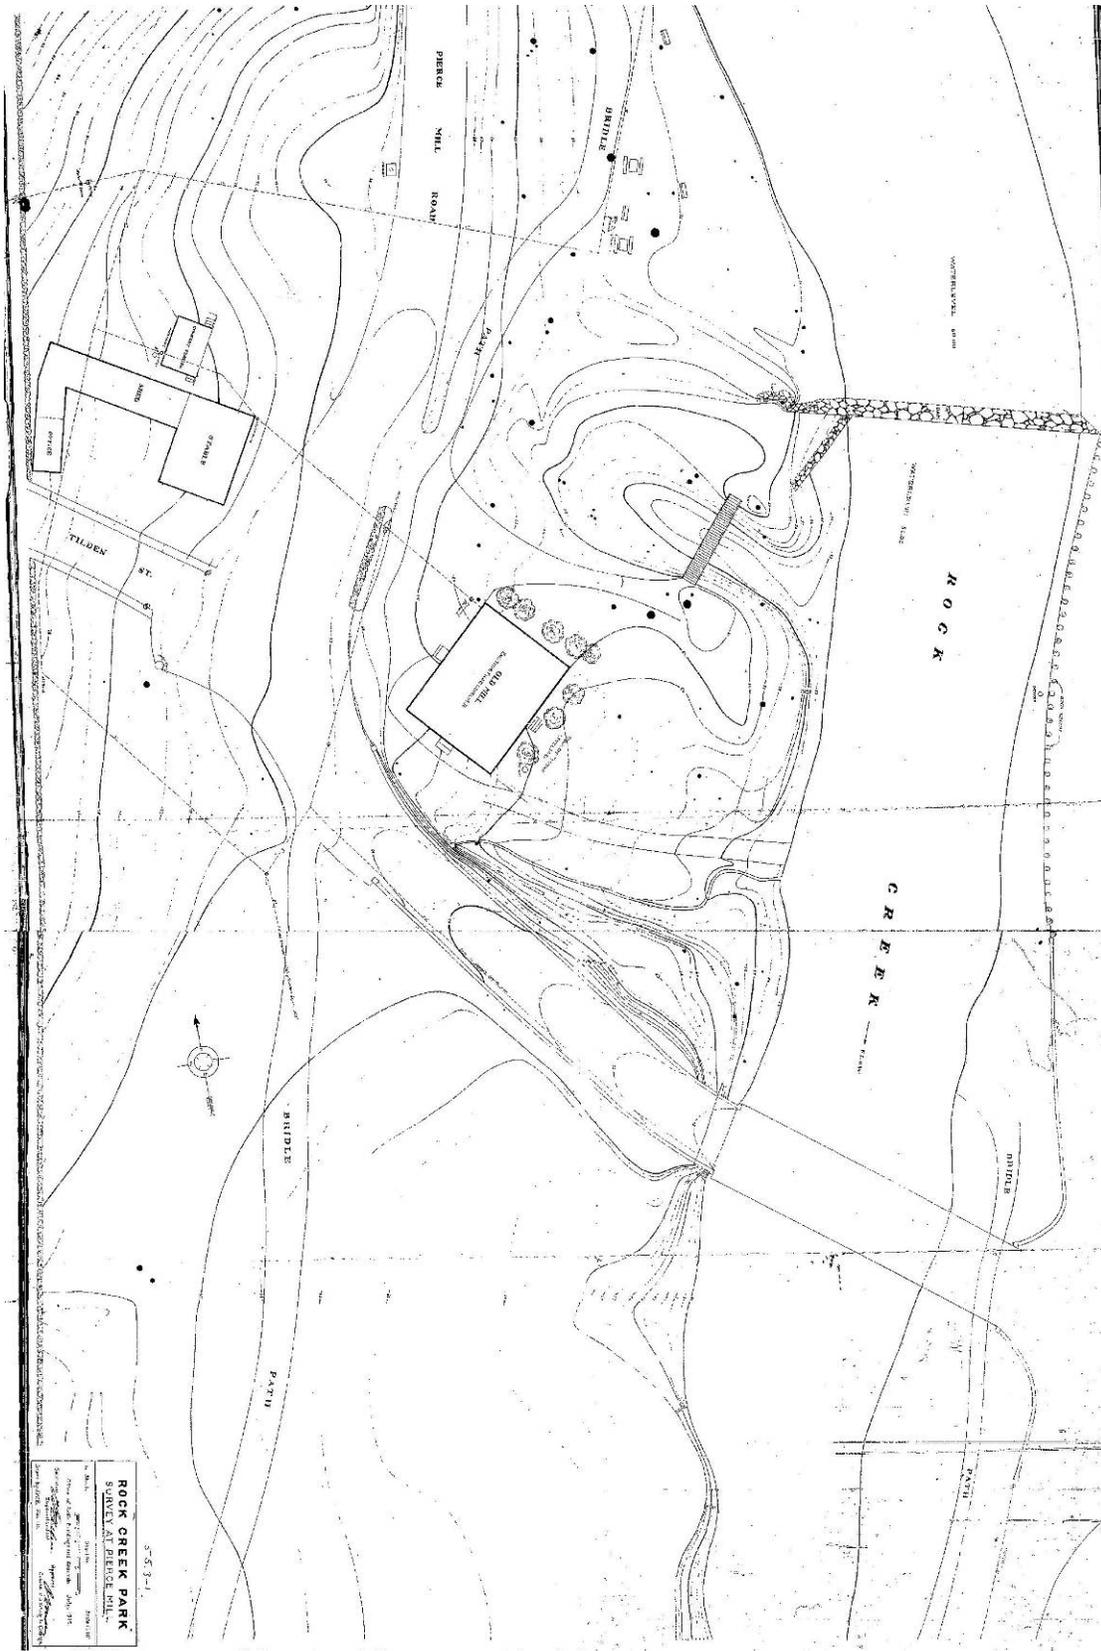
**Figure 2- 14: Survey of Peirce Mill Grounds, 1919** (source: National Park Service, Technical Information Center, ROCR 821\_83001) Note: the image is oriented so that north is to the top of the page.

In 1919 the Officer in Charge of the OPBG, Col. Ridley, directed the organization's architect, Horace Peaslee, to develop plans for the improvement of Pierce Mill. A survey completed in that year documents the existing conditions of the landscape (see Figure 2-14). Peaslee's preliminary assessment of the mill noted the deteriorated condition of the remaining structural elements and stated that what remained was "probably enough to materially help create the proper atmosphere within." Yet he questioned "whether or not it would be well to attempt, for the sake of historical record, to put back, without competing with the new function of the property, the essential parts of an old-time mill." In his final proposal, Peaslee included a water wheel restoration, rather than reusing the "unpicturesque turbine," to create the picturesque atmosphere needed for the adaptive use of the mill as inn or coffeehouse with outdoor dining.<sup>54</sup> His 1919 plans for the grounds showed a designed landscape that incorporated symmetrical formality with the "intrinsic charm of the naturalesque."<sup>55</sup> Although Peaslee's recommendations were not adopted, his proposal for the grounds underscored park priorities: the need for a unifying landscape design and separate circulation patterns (pedestrian, automobile and horseback riding) around the mill.<sup>56</sup>

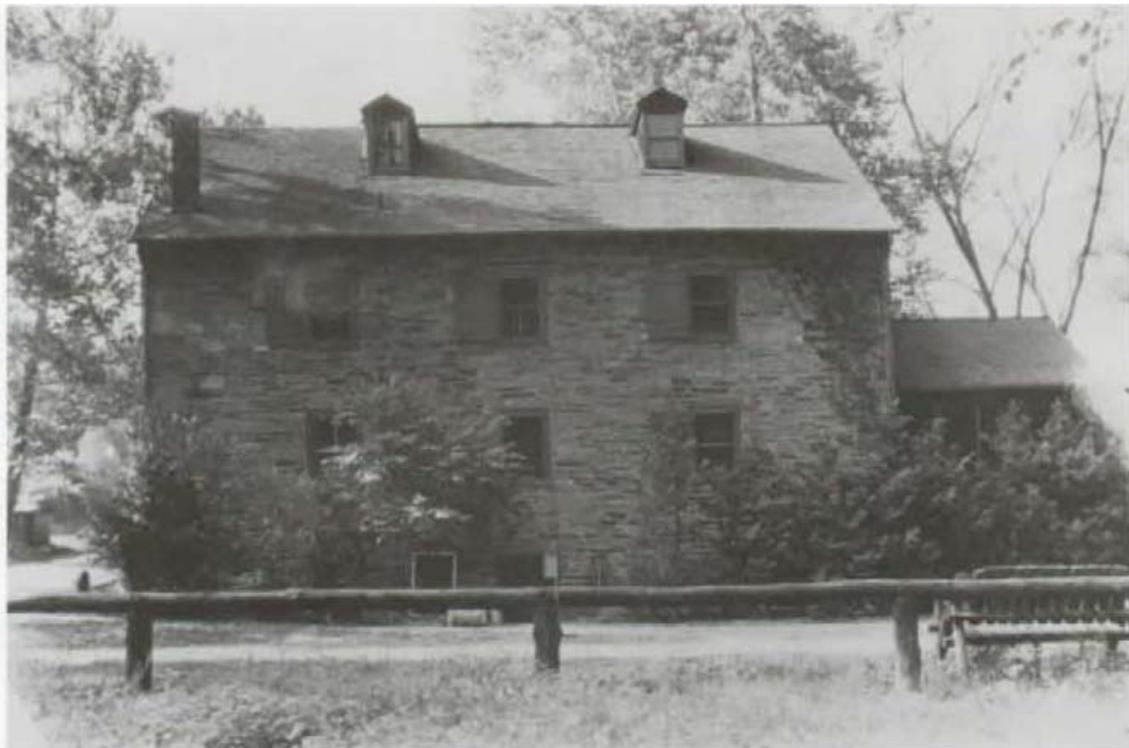
**Figure 2- 17: Peirce Mill, east elevation with simple rail fence and bench, 1933. Note the dormers and vegetation at the building foundation.** (source: National Archives)

The National Park Service brought new design and planning skills, as well as administrative expertise, to their stewardship of Rock Creek Park. National Park Service architects and landscape architects developed programs to improve or rebuild structures, roads, trails, footbridges and site furnishings using CCC labor and PWA funding. Charles Peterson, then chief of planning and design for the Eastern Division of the NPS, identified Peirce Mill as a structure worthy of restoration. The newly established Historic American Building Survey (HABS), also part of the National Park Service, initiated the survey and collection of historic documentation about the mill in 1934. A view of the east elevation of Peirce Mill in 1933 is provided in Figure 2-17.

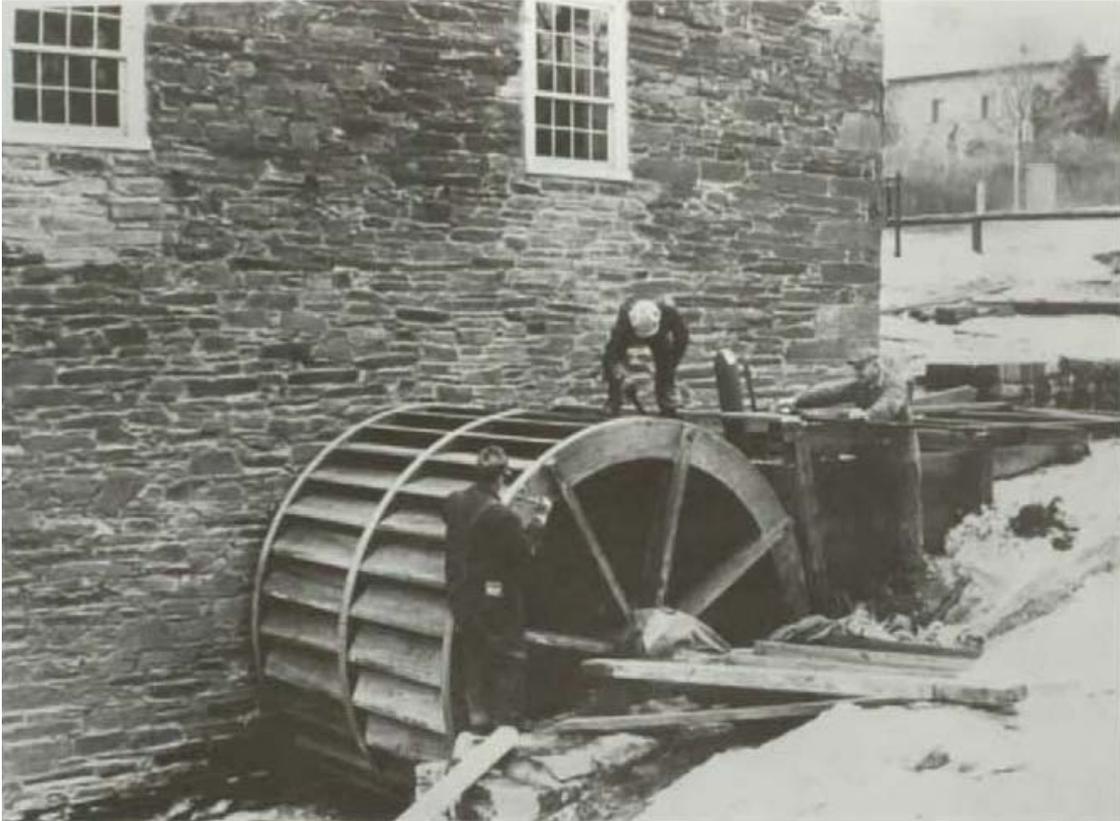
**Figure 2- 18: Restoration of the Peirce Mill wheel, 1936** (source: Library of Congress)

Work to restore Peirce Mill as a functioning example of a nineteenth-century gristmill began in 1934 and was completed by 1936 (see Figures 2-18 and 2-19). In November the tearoom porch was removed from the mill, so that a mill wheel could be replicated in the historically accurate location on the north facade. In 1935, J.S. Fitz of Hanover, Pennsylvania designed the replacement mill machinery using as much original and/or old material as possible. Fitz also consulted on the design for the forebay and penstock and on the width of the water wheel. While most aspects of the architectural restoration were relatively easy to execute, treatment of the mill's historic landscape features was more problematic. For instance, the original estimate of the cost to restore the mill had not included the expense of replicating the original dam.<sup>61</sup>

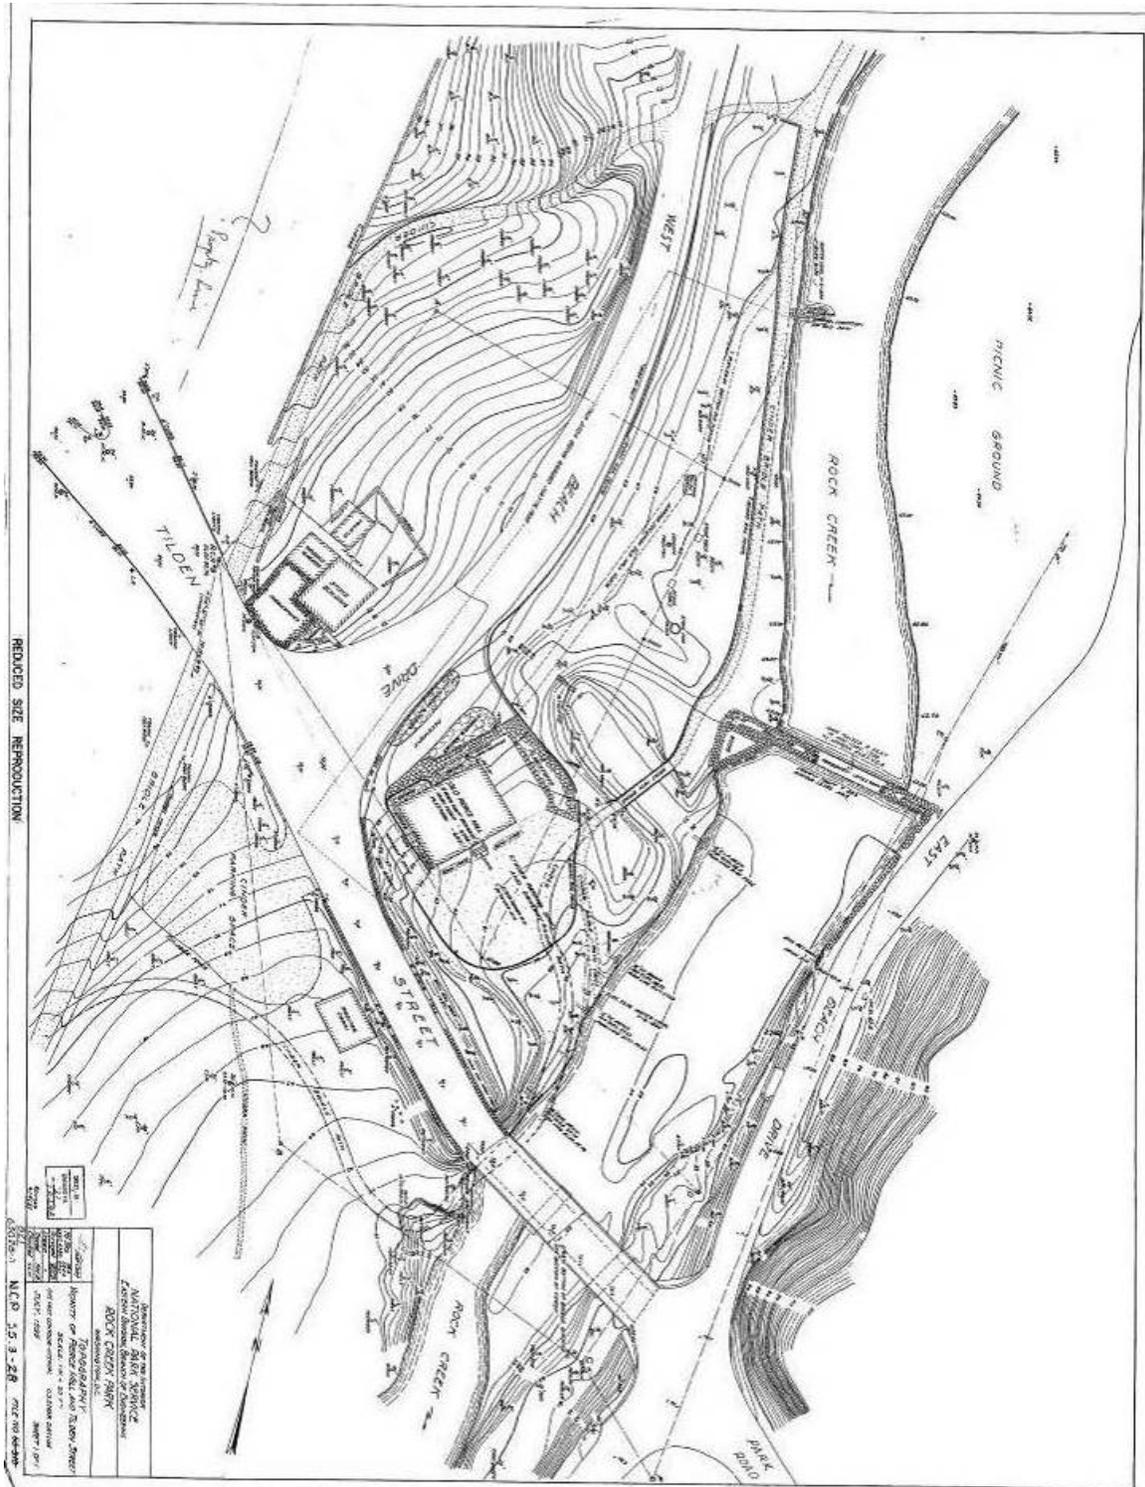
**Figure 2- 21: Topography at Peirce Mill and Tilden Street, 1935** (source: National Park Service, Technical Information Center, ROCR\_821\_83028A[350167])

Figure 2-21 is a topographic plan of Peirce Mill and Tilden Street prepared in July 1935. This plan illustrates the low area north of the tailrace that may have been related to the sawmill operation. Another design for the site is illustrated in Figure 2-22. Although the date is difficult to read, it appears the drawing was prepared in 1937. This drawing was prepared over the base illustrated in Figure 2-21, and illustrates several proposed changes to circulation routes, as well as a proposed mill yard between Peirce Mill and Peirce Barn.
