# PEIRCE MILL COMPLEX

## Cultural Landscape Report

### CULTURAL LANDSCAPE REPORT

PREPARED BY:  
QUINN EVANS | ARCHITECTS  
1214 TWENTY-EIGHTH STREET, NW  
WASHINGTON, DC 20007

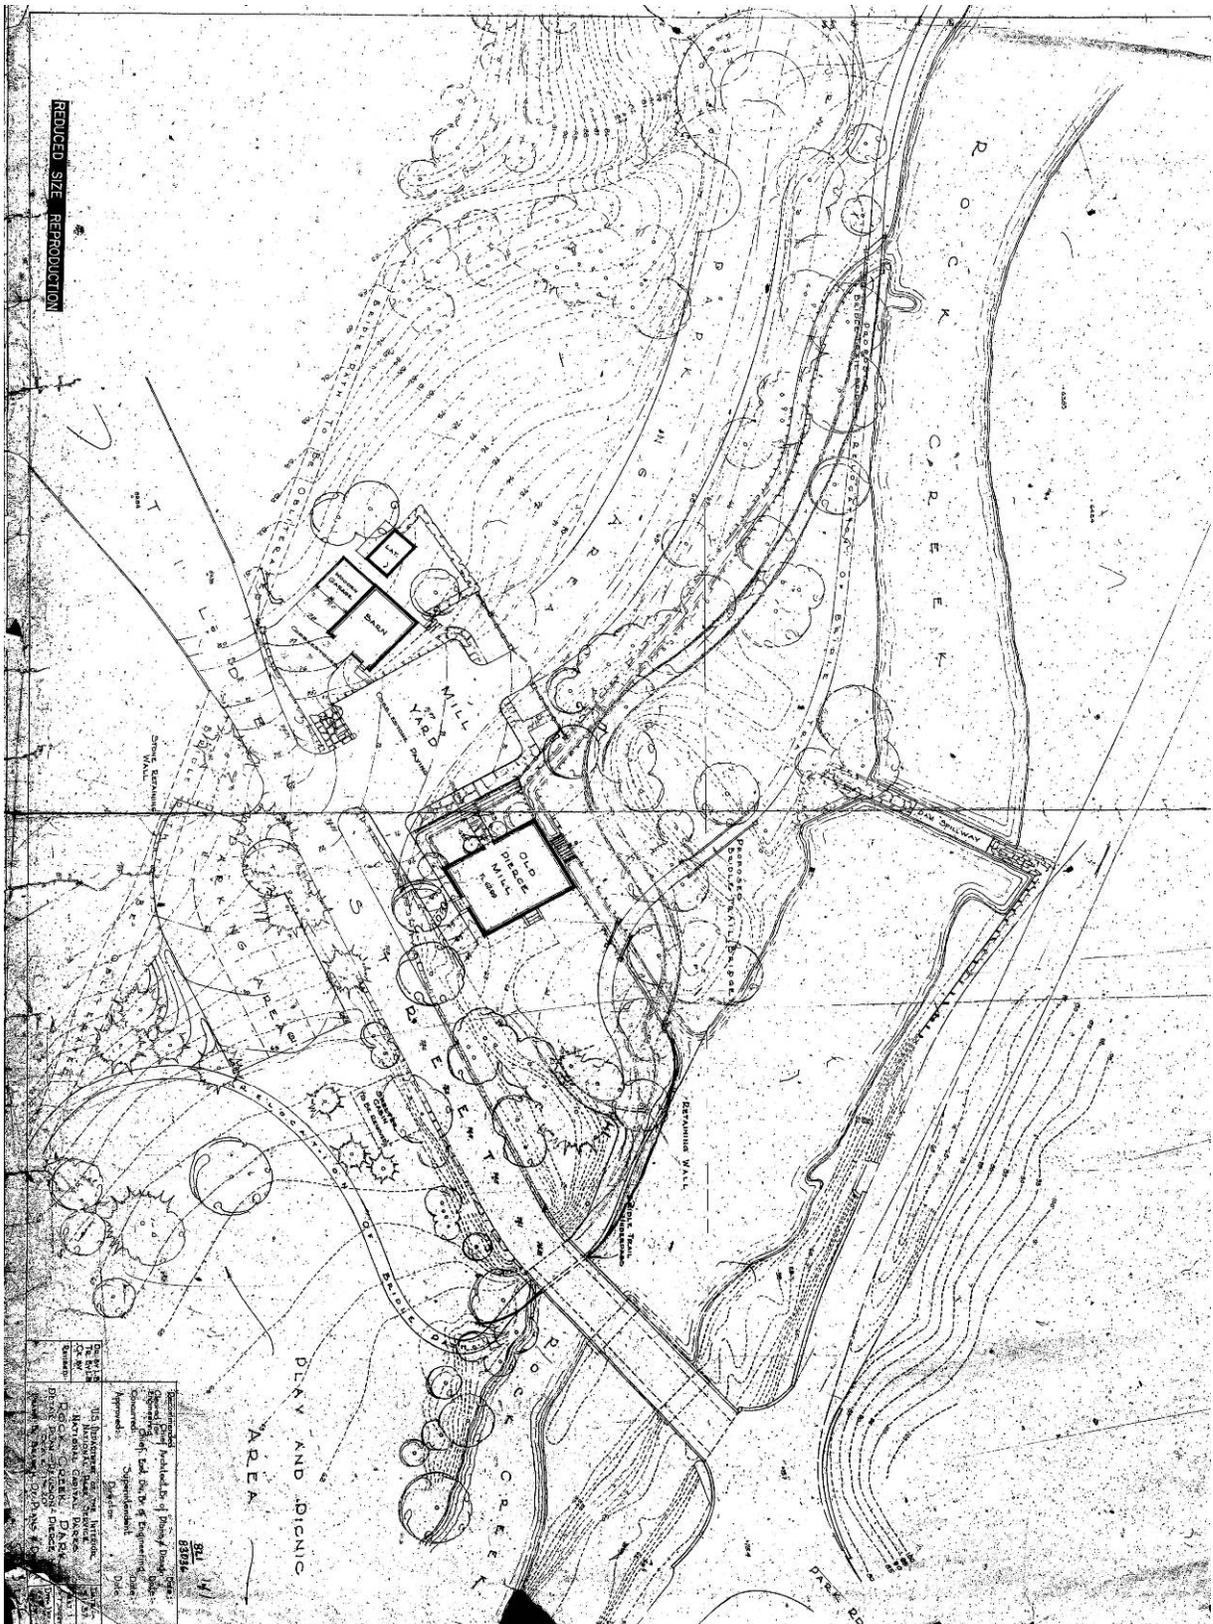
Figure 2- 22: Peirce Mill Site Plan (source: National Park Service, Technical Information Center, ROCR\_821\_83036[350163])

Figure 2-21 is a topographic plan of Peirce Mill and Tilden Street prepared in July 1935. This plan illustrates the low area north of the tailrace that may have been related to the sawmill operation. Another design for the site is illustrated in Figure 2-22. Although the date is difficult to read, it appears the drawing was prepared in 1937. This drawing was prepared over the base illustrated in Figure 2-21, and illustrates several proposed changes to circulation routes, as well as a proposed mill yard between Peirce Mill and Peirce Barn.

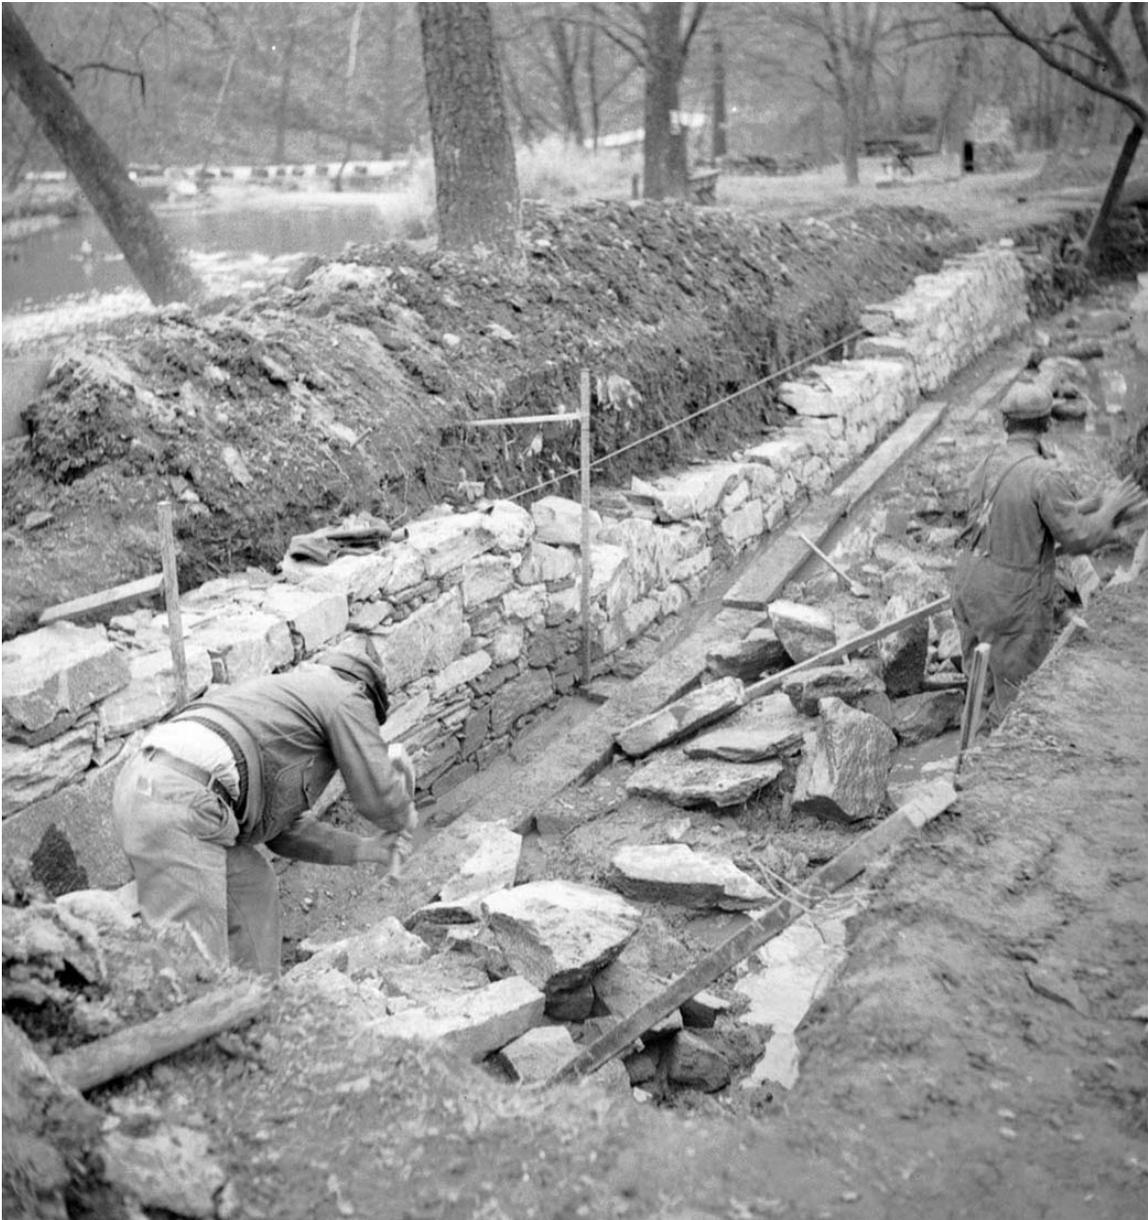
**Figure 2- 23: Construction of millrace, 1935.** (Source: Rock Creek Park Historic Photograph Collection PM1-12, 16.50-3, PW571)

The construction of the wall of the race required additional strengthening to counter the weakness in the area caused by the depression left from the old saw mill (see Figures 2-23 and 2-24).<sup>63</sup> Because of unique construction difficulties encountered in hidden portions of the raceway and in "weakened framing which was badly charred from a fire" in the mill, little money remained to finish the restoration, much less address the issue of the dam. Although the importance of the mill's restoration is underscored by the additional \$10,000 allocated to complete the project, funds were insufficient to restore the dam in a historically accurate way.<sup>64</sup>

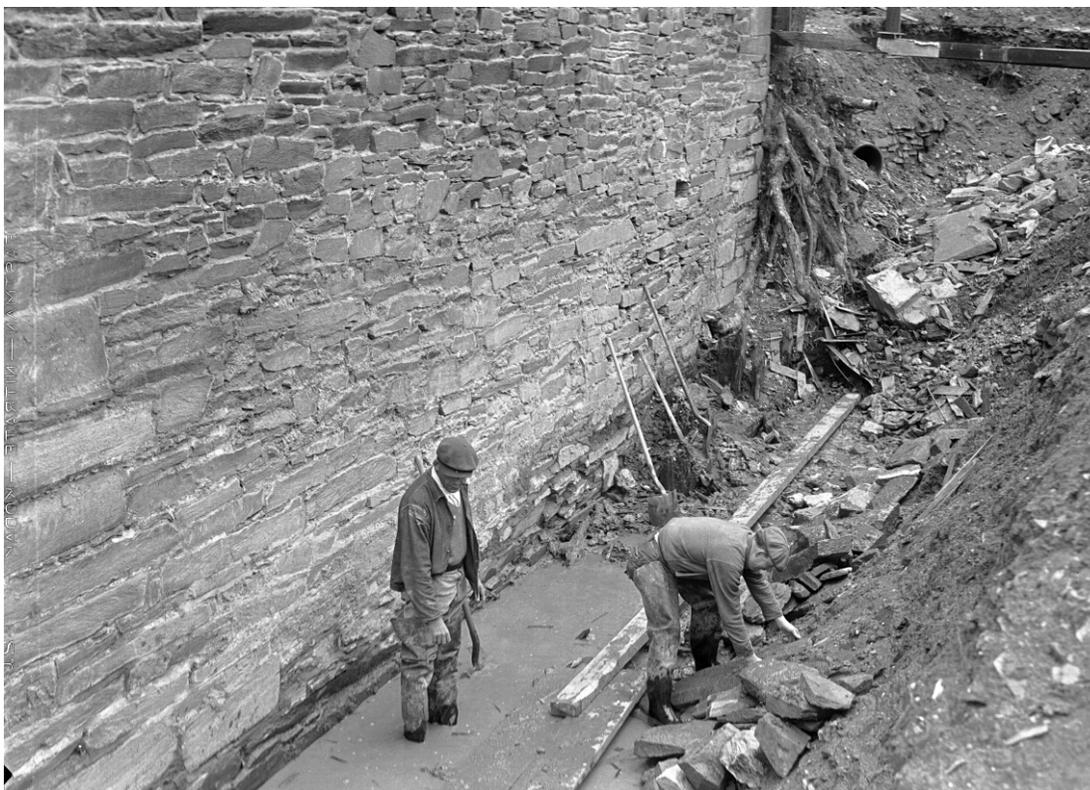
**Figure 2- 24: CCC Crews restoring mill race at mill wall, 1935.** (Source: Rock Creek Park Historic Photograph Collection PM1-21, 16.50-3)

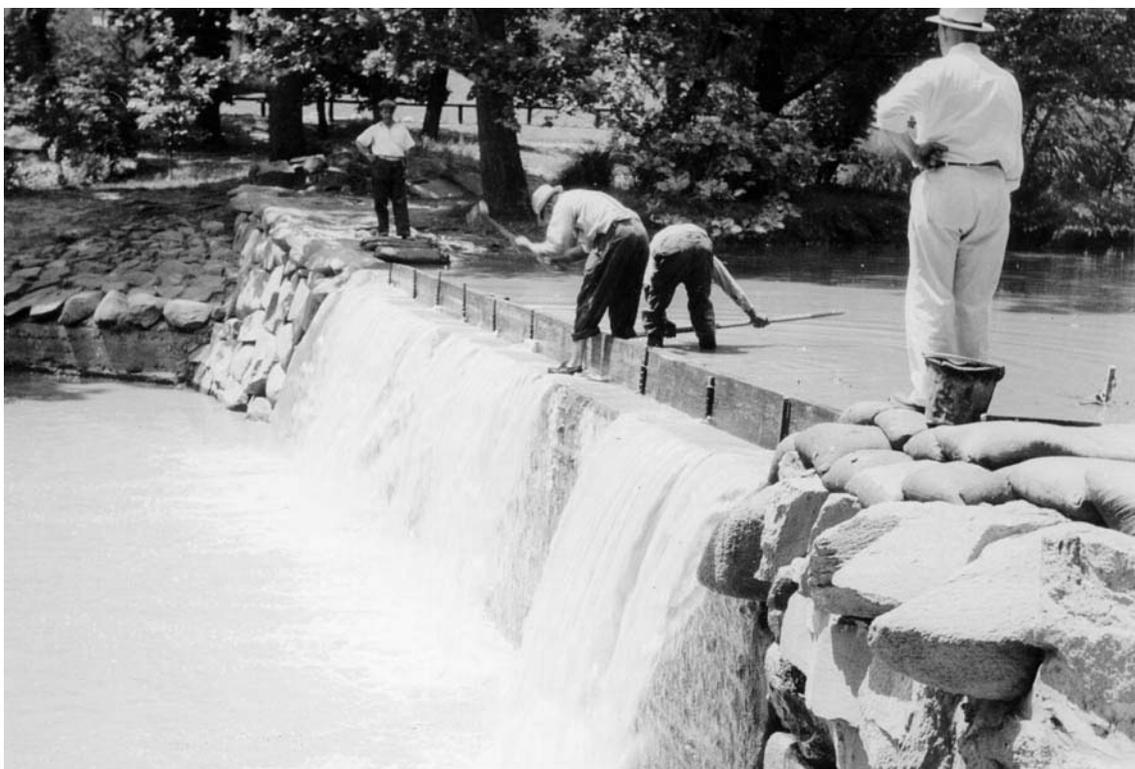
**Figure 2- 25: CCC crews raising the mill dam, 1936.** (Source: Rock Creek Park Historic Photograph Collection PM2-83, 16.50-3)

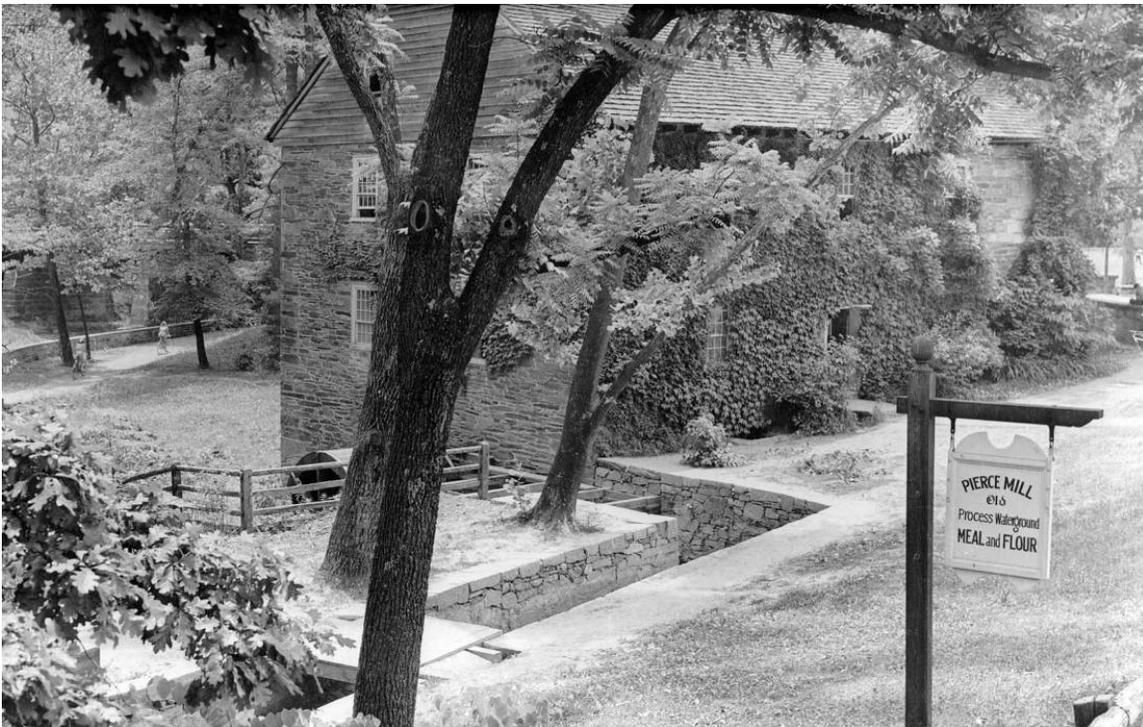
**Figure 2- 27: Peirce Mill after restoration, note sign, millrace, fence and plants, 1936. (Source: Rock Creek Park Historic Photograph Collection PM3-36)**

Not only did the restored mill attract park visitors to this part of Rock Creek, but the National Park Service interpretative programs did as well. The landscape around the mill provided opportunities for interpretation (see Figure 2-27). While the history program was centered inside the mill, outside the emphasis was on nature in the park. The Service prided itself on its educational and interpretative programs on the value of parks. Thus, Donald McHenry, the first Park Service naturalist assigned to National Capital Parks, began a series of traditional NPS Friday night campfire programs at the mill in June 1936.<sup>70</sup>

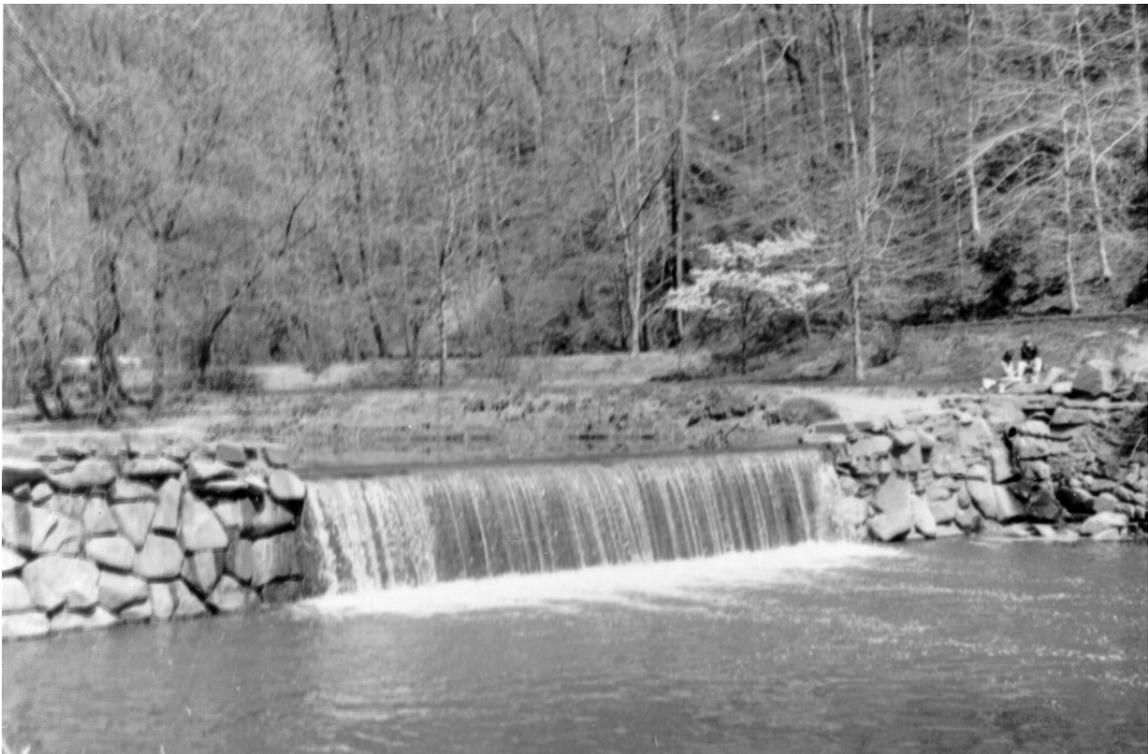
**Figure 2- 29: Peirce Mill Dam, facing northeast, note the picnic activity and topographic terraces on east bank of creek, 1968.** (Source: Rock Creek Park Historic Photograph Collection PM2-101, 4-12-48)

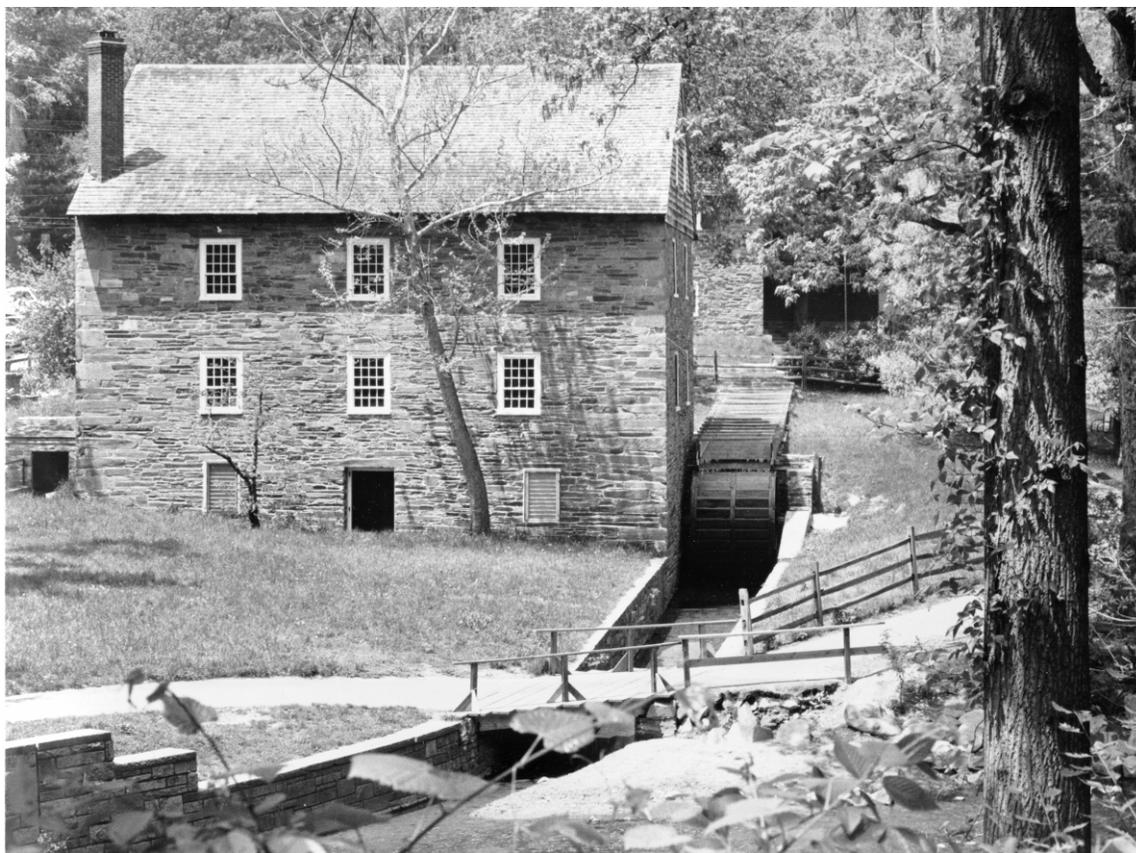
**Figure 2- 30: Peirce Mill east façade, 1979, showing overshoot wheel and infilled mill race.** (Source: Rock Creek Park Historic Photograph Collection PM2-72, 7A, William P. Clark photograph)

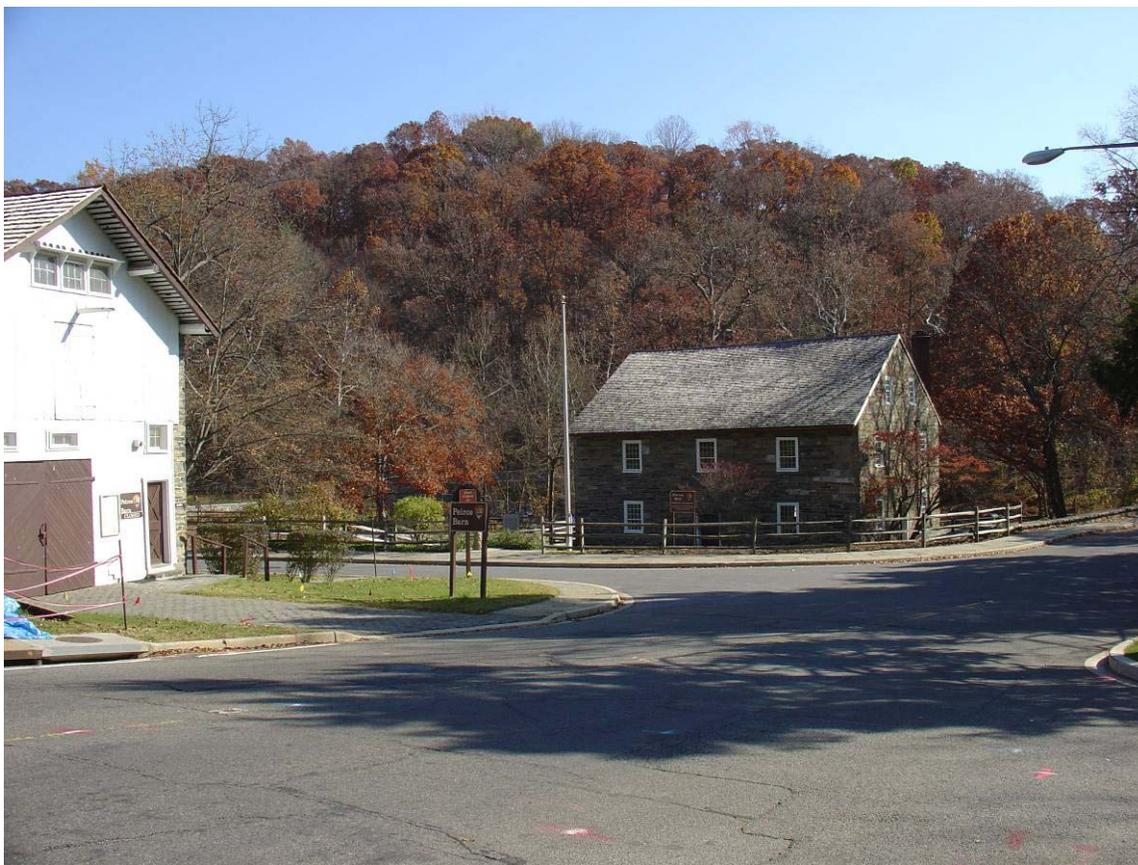
**Figure 3- 3: Raised roadbed between mill and barn facing northeast, 2008.** (Source: QE|A 2488)

Peirce Mill is situated on the western bank of Rock Creek, just north of the intersection of Tilden Street and Beach Drive. Built in 1820 or 1829, the front elevation of the mill faces west. A driveway and parking lot are located between the Mill and barn (see Figure 3-2). The driveway is elevated above the mill to meet Tilden Street. The elevation of Tilden Street has been raised several times. The resulting height of the street and the driveway and parking lot that are adjacent to the street, is considerably higher than the area was during the earliest period of significance. A consequence of this is the mill appears to lay in a depression (see Figure 3-3).

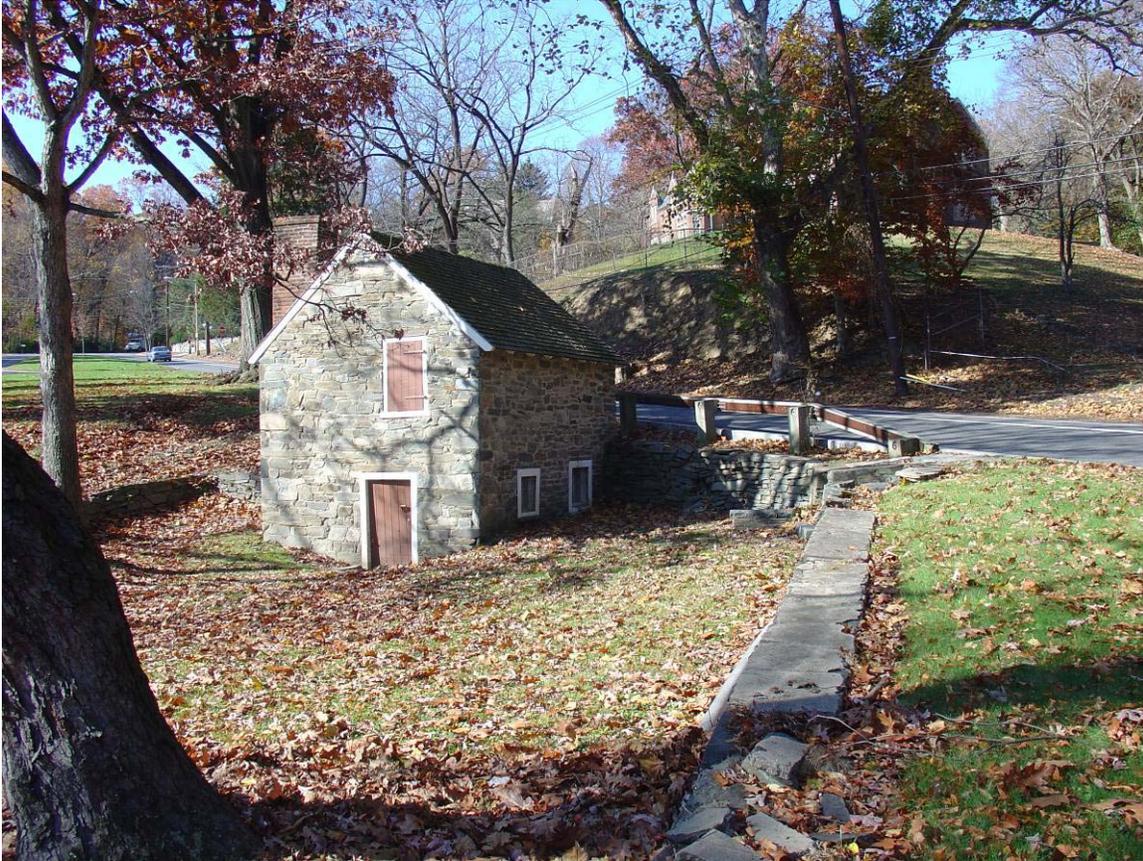
**Figure 3- 4: Banked springhouse, 2008** (Source: QE|A 2499)

The springhouse also contains a datestone in one of its gable ends, as well as keystone arches above the window and door openings--features commonly seen in domestic buildings in southeastern Pennsylvania. However, the most distinctive feature of the springhouse is its banked arrangement, which was frequently used in springhouse construction by both British and Germanic groups in the Delaware and Susquehanna valleys (see Figure 3-4).<sup>3</sup> While the predominant function of the springhouse was to protect the property's water supply from contamination as well as cool perishable food products, its ancillary functions included butter and cheese making, butchering, and washing clothes. Cheese and butter making often took place on the upper floor, which sometimes served as living quarters for tenant farmers.<sup>4</sup> The springhouse at Peirce Mill has two levels, and its brick chimney serves as evidence of its ancillary functions.

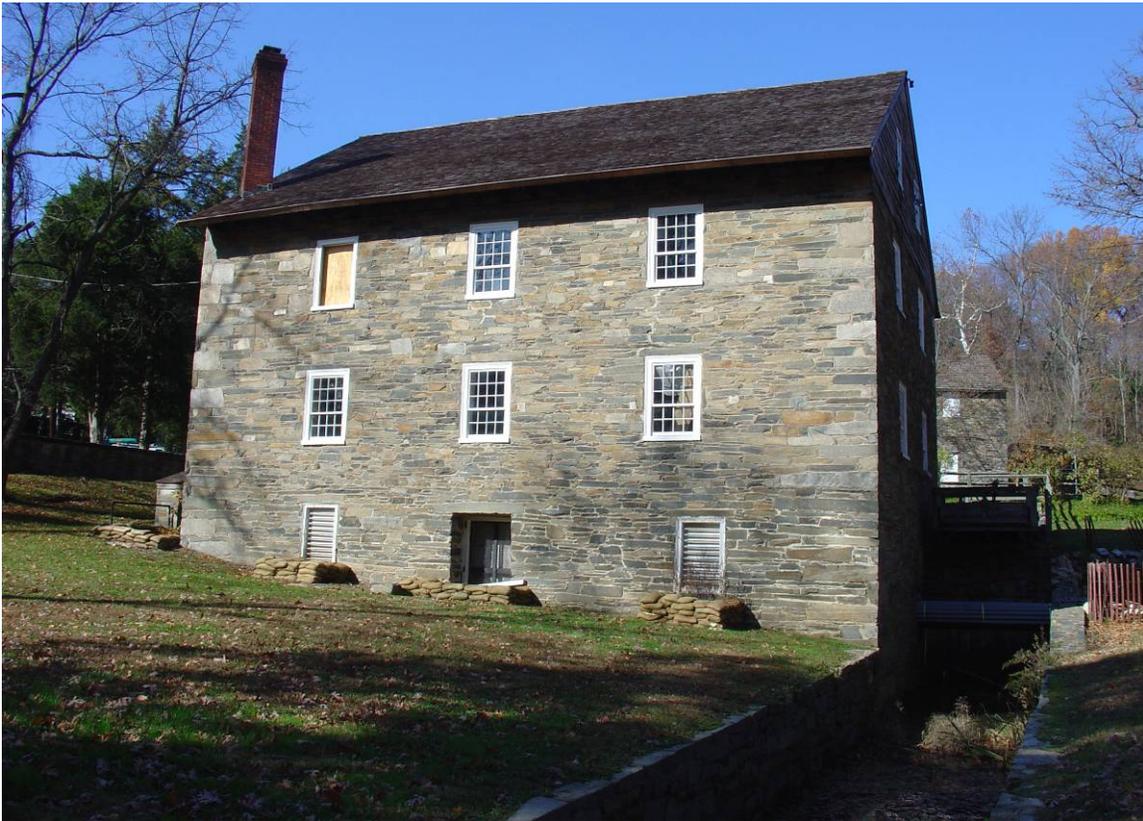
**Figure 3- 19: Peirce Mill, east elevation and millrace, 2008.** (Source: QE|A 2008 DSC02439)

Peirce Mill, which retains most of its exterior building fabric, is located upon its original foundation on the west bank of Rock Creek near the current junction of Tilden Street and Beach Drive (see Figures 3-19 and 3-20). The vernacular industrial building was constructed in 1829 according to a datestone located within its south gable. Peirce Mill, having undergone many rehabilitation campaigns throughout its history, possesses architectural elements from each of its developmental eras. The early nineteenth-century industrial building was constructed as a custom mill, milling grain for local residents. As such, the structure is relatively small in scale compared to area merchant mills which served a larger clientele. The principle façade (west) of Peirce Mill is two-and-one-half stories. The rear façade (east) is three-and-one-half stories due to its banked construction into the gently sloping western creek edge. The gable-roofed building is three bays wide, two rooms deep, with a rectangular floor plan. Constructed of large, blue and brown, cut granite, irregularly laid, Peirce Mill has flat stone lintels and sills. The window openings have unadorned frames with nine-over-six double hung sash, except on the gable ends and the rear basement level. The attic level windows on the gable ends have a six-over-six configuration and the rear basement windows have wooden louvered screens. The gable of the north façade has been covered in wood cladding. The north façade has a wheel pit and waterwheel on the ground level which dates to the late 1960s renovation of the structure.

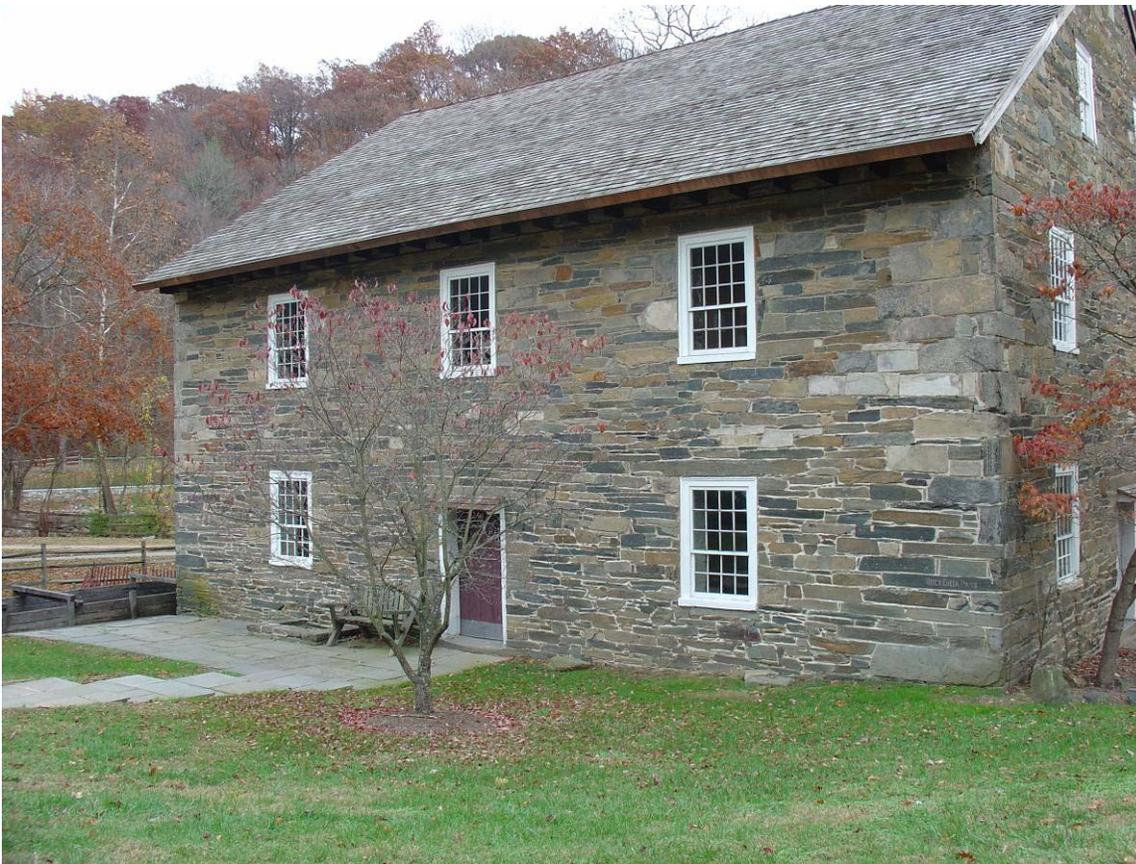
**Figure 3- 20: Peirce Mill, west elevation, 2008.** (Source: QE|A 2529)

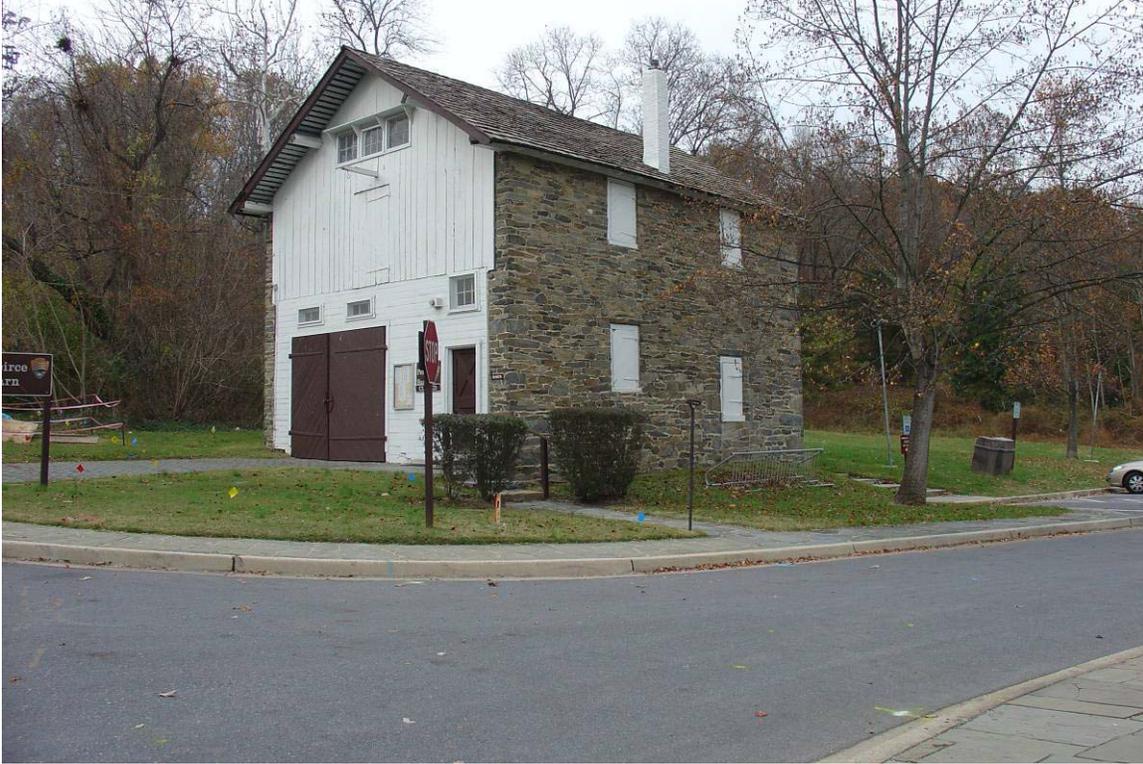
**Figure 3- 21: Barn, south and east elevations, 2008.** (Source: QE|A 2524)

To the west of the mill is the Peirce Barn, the former wagon barn/stable (see Figure 3-21). The two story vernacular stone building has a rectangular plan and measures approximately 26 feet wide by 35 feet long. Like the mill, the wood shingle gable-roofed structure is constructed of large, irregularly laid stone. The fenestration of the facades varies remarkably, however, reflecting changes in the use of the building. The east façade is characterized by symmetrically paired six-over-six sash on the second level. Due to alterations, the two windows on the lower level are irregularly placed. The opening for the window toward the rear of the barn was originally larger and accommodated a door. The west elevation has two centrally placed windows in each story. The north façade has a center gable window and two asymmetrical window openings to either side of a central axis. The building has shutters attached to the northern edge of each opening. The wood shingled roof is punctuated by a square, brick chimney on the east elevation. Typical of buildings used to house wagons and carriages, the building likely served as stables as well. As such, the upper story was frequently used for the storage of hay which appears to be the case with this structure.<sup>5</sup>

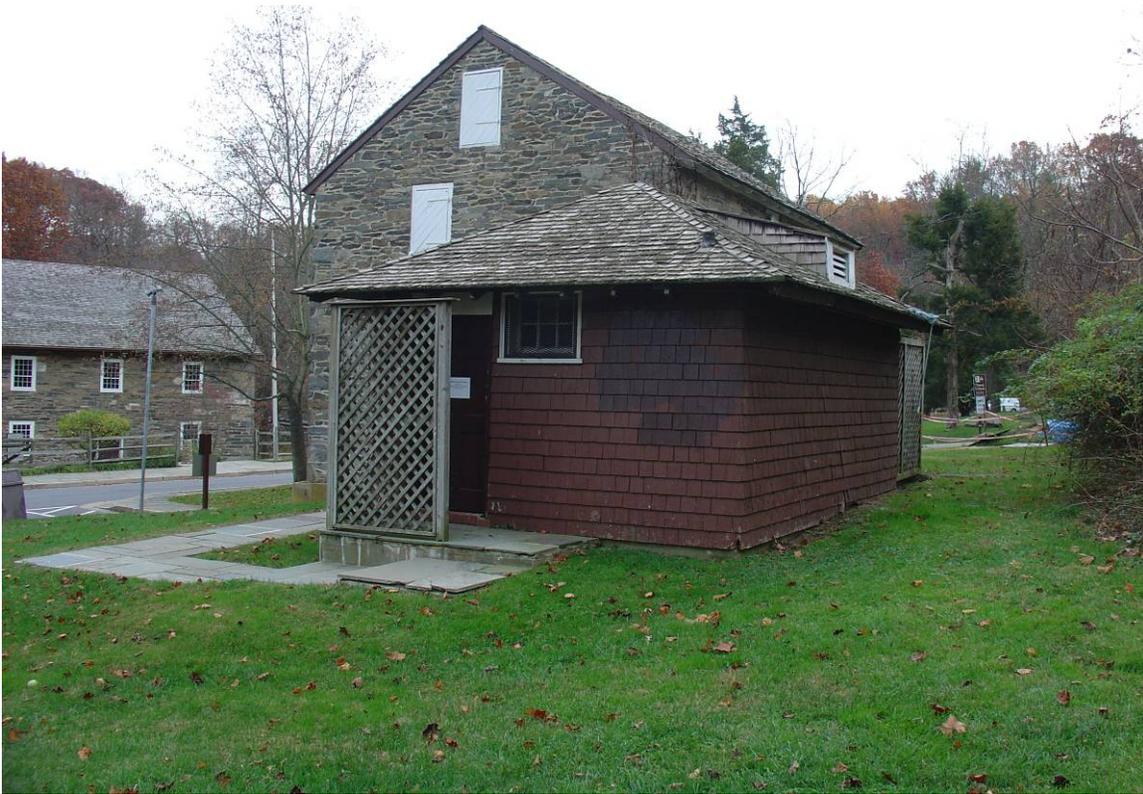
Figure 3- 22: Comfort station, looking southeast, 2008. (Source: QE|A 2553)

A one-story comfort station is located slightly to the north of the barn (see Figure 3-22). This structure, built in ca. 1920, according to secondary historic accounts, has been moved. The first relocation occurred with the construction of the parking area west of the mill. The second relocation occurred in 1950 when it was placed on its present site. The hipped roof structure is clad with brown painted wood shingles. Exposed joists accent the roof line. The building has a horizontal emphasis with a rectilinear footprint and shallow pitched roof line. Lattice trellis screens, recently added, extend from the north and south ends, shielding the entrances to the women's and men's bathrooms. Two six-light windows are located on the eastern façade of the building. The structure has been moved from its original foundation. It does not contribute to the Rock Creek Park Historic District.

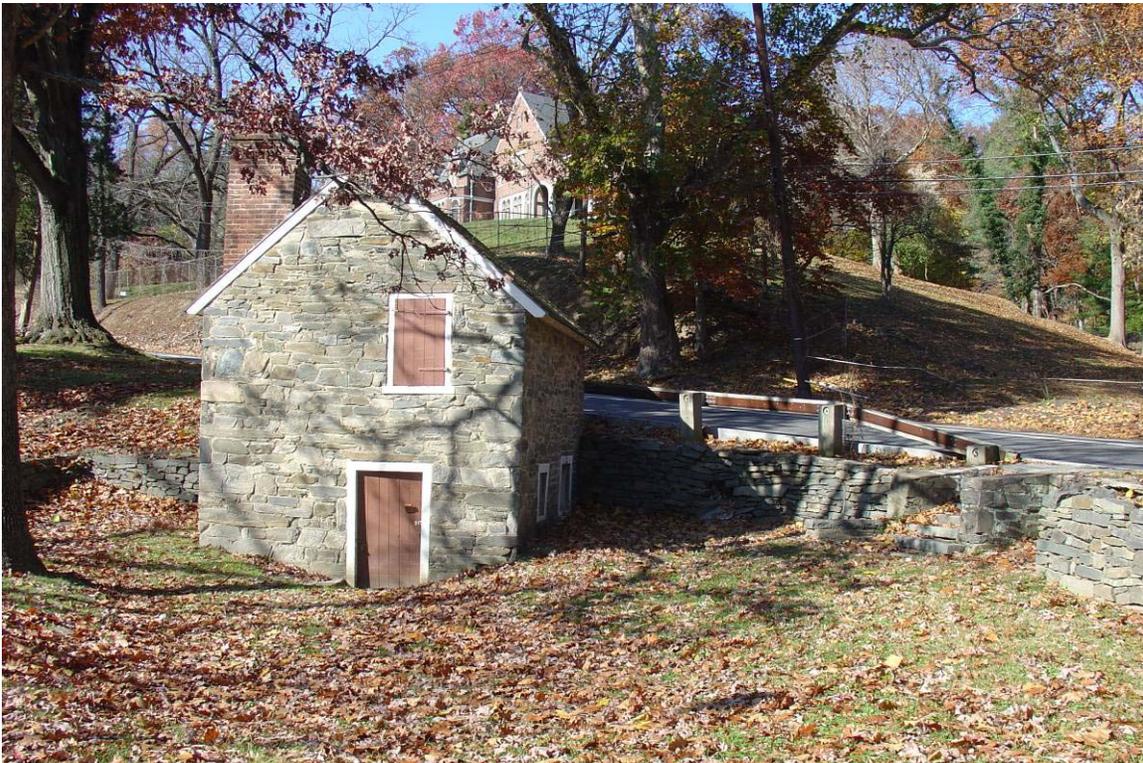
Figure 3- 23: Springhouse, looking northwest, 2008. (Source: QE|A 2500)

The final nineteenth-century structure which contributes to the historic significance of the Peirce Mill landscape is the springhouse (see Figure 3-23). The building is located in a triangular shaped hollow which is now part of a median strip between the dual lanes of Tilden Street, N.W. The one-and-a-half story, banked structure has a rectangular plan of approximately 15 feet by 19 feet. The moderately pitched gable roof is clad in wood shingles. A square brick exterior chimney is located on the western elevation. The lintels and sills, like those of the mill and wagon barn/stable, are constructed of stone. The primary entrance, a vertically paneled door, is on the east ground floor facade. The upper story has an entrance on the western façade. The interior of the upper floor of the springhouse, in contrast to the lower, has been finished for use as a residence.

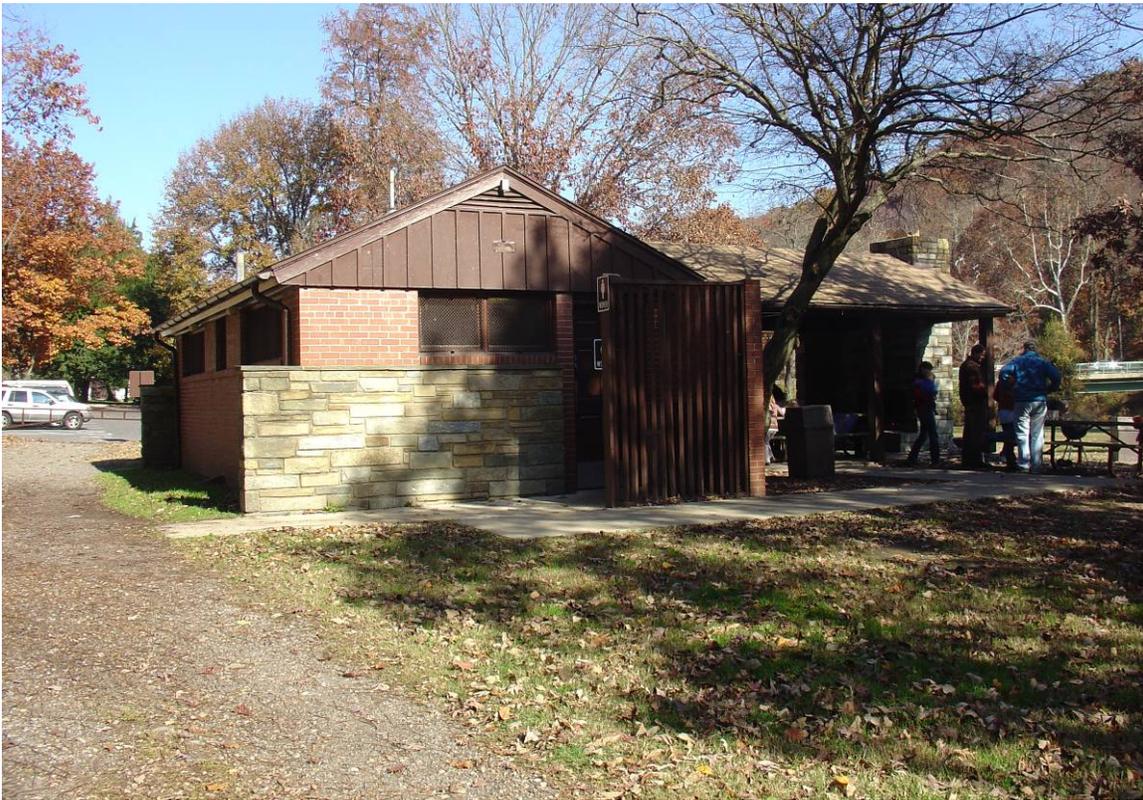
**Figure 3- 24: Grove 1 picnic pavilion and comfort station, looking north, 2008. (Source: QE|A 2476)**

A picnic pavilion was built during the Mission 66 era of National Park Service (see Figure 3-24). The Mission 66 buildings in Rock Creek Park have not yet been fully evaluated. The picnic pavilion does not contribute to the Rock Creek Park Historic District. The one-story stone and brick faced pavilion is characteristic of the International style of architecture.

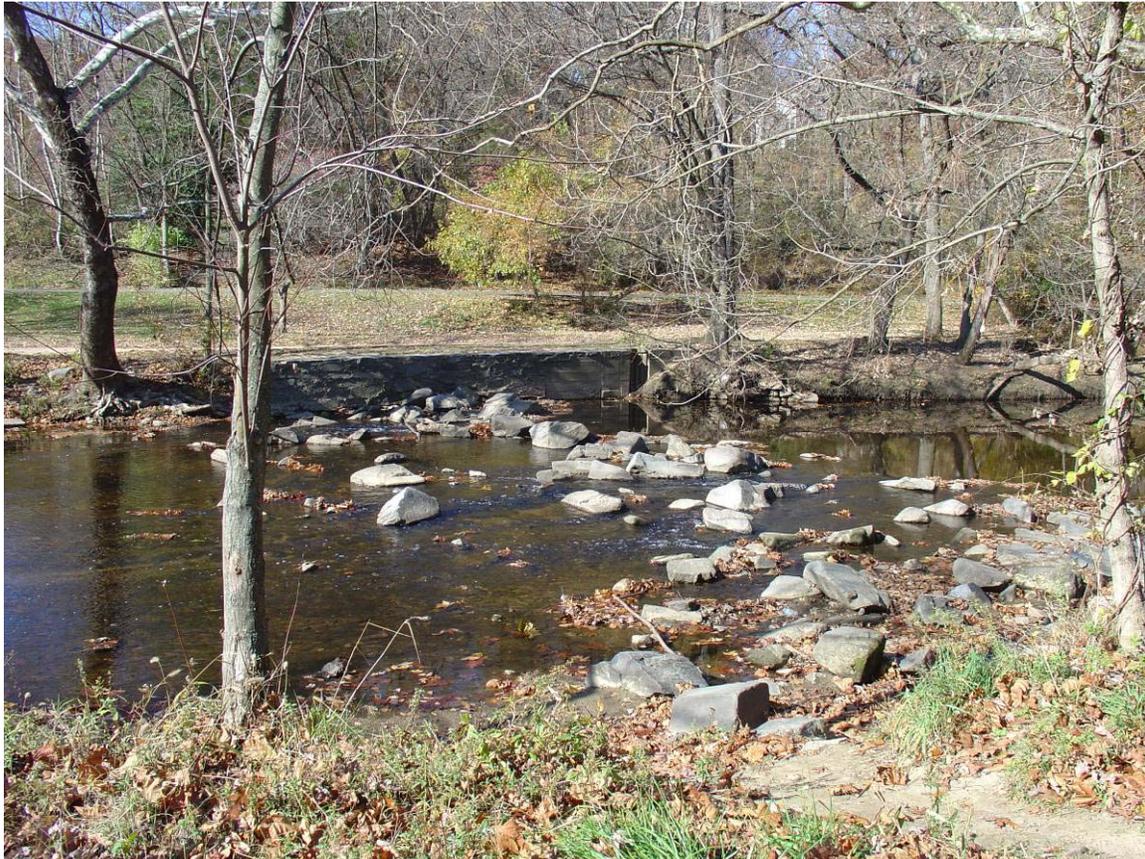
**Figure 3- 26: Crib dam remnants north of mill, facing west. 2008.** (Source: QE|A 2384)

There are three primary constructed water features which were integral to the development of the Peirce Mill landscape. These are the late nineteenth-century crib dam, the circa 1904 boulder dam and the 1935 millrace. Remnant rock piles of the crib dam cross Rock Creek at an angle approximately one hundred yards north of Peirce Mill.

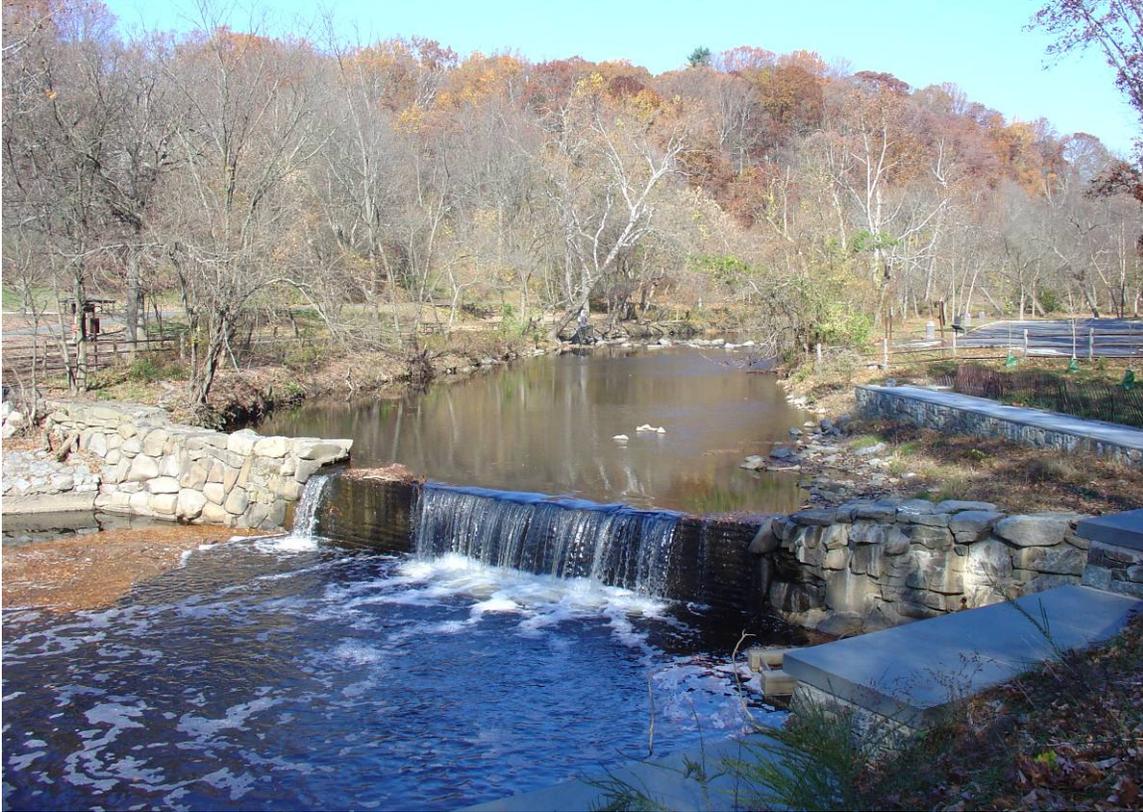
**Figure 3- 27: Boulder dam and spillway the fish ladder is at the lower right of the image with the stone retaining wall above that and the split-rail fence and east Grove 2 parking lot beyond, facing north, 2008. (Source: QE|A 2368)**

The boulder dam, built on a foundation of concrete with a field stone facing on the downstream side, remains in place. It is one hundred feet long and has a spillway of forty feet located in the center. Masonry wings were added to the dam in 1905. During the 1930s restoration of Peirce Mill, the height of the dam was increased and the boulders were repointed by the Civilian Conservation Corp. Depressions in the landscape are visible at the former locations of the crib dam millrace and the later 1930s millrace closer to the mill.

Recently, a stone fish ladder was constructed on the east bank of the creek directly south of the boulder dam. The fish ladder figures prominently in views from Peirce Mill to the east toward the creek and toward the boulder dam. Above the dam and fish ladder a stone retaining wall, split-rail fence, and metal safety rail painted green all also new additions related to the fish ladder.

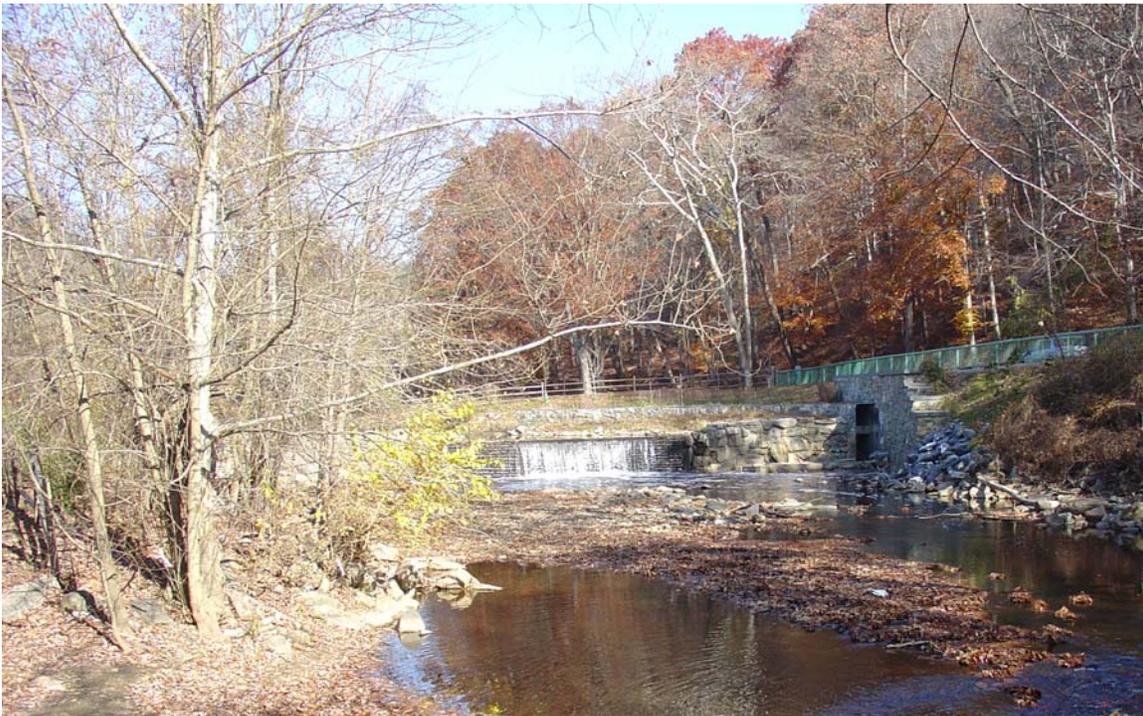
**Figure 3- 28: View of boulder dam, fish ladder, split-rail fence and metal handrail from multi-use trail at Peirce Mill, facing northeast, 2008 (source: QEA 2454)**

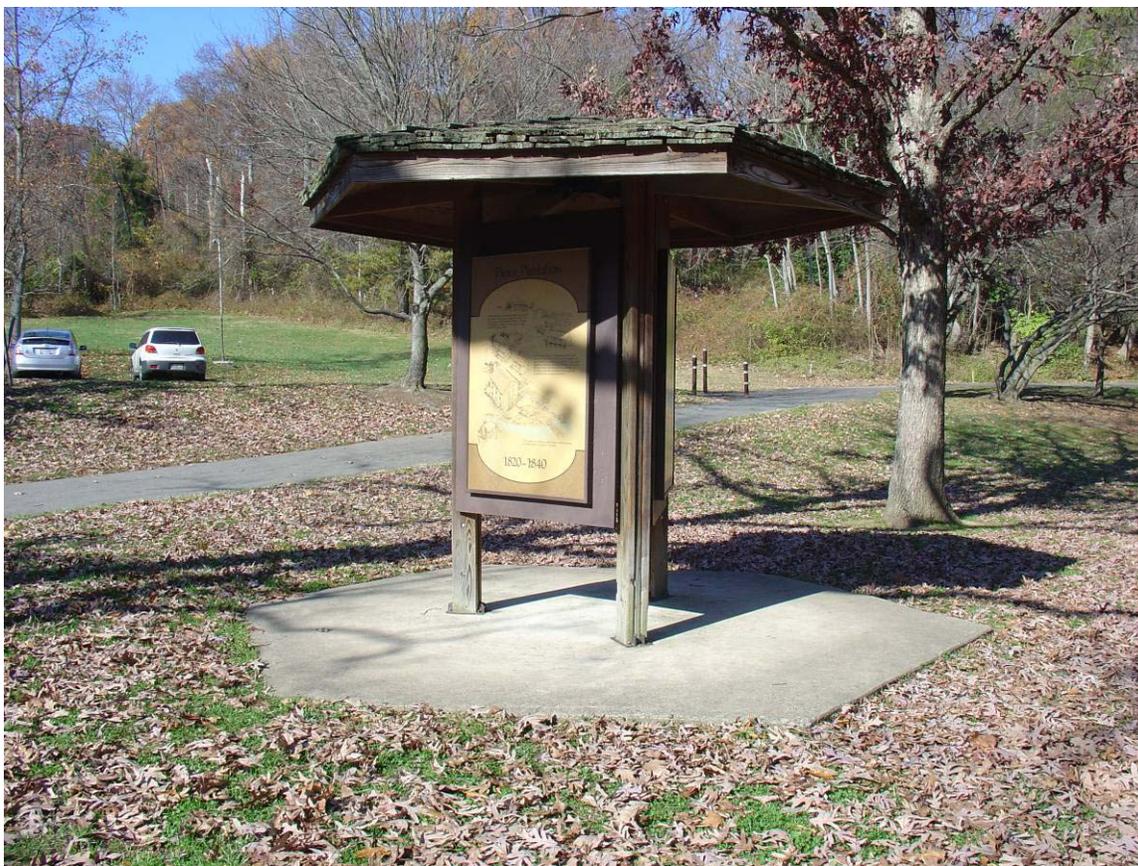
**Figure 3- 30: Interpretive kiosk north of mill, 2008.** (Source: QE|A 2425)

An interpretive kiosk is located to the north of the mill (see Figure 3-25). It is constructed of wood and metal with wood shingles. The kiosk includes an artist's rendering of the site.
