# PEIRCE MILL COMPLEX

## Cultural Landscape Report

### CULTURAL LANDSCAPE REPORT

PREPARED BY:  
QUINN EVANS | ARCHITECTS  
1214 TWENTY-EIGHTH STREET, NW  
WASHINGTON, DC 20007

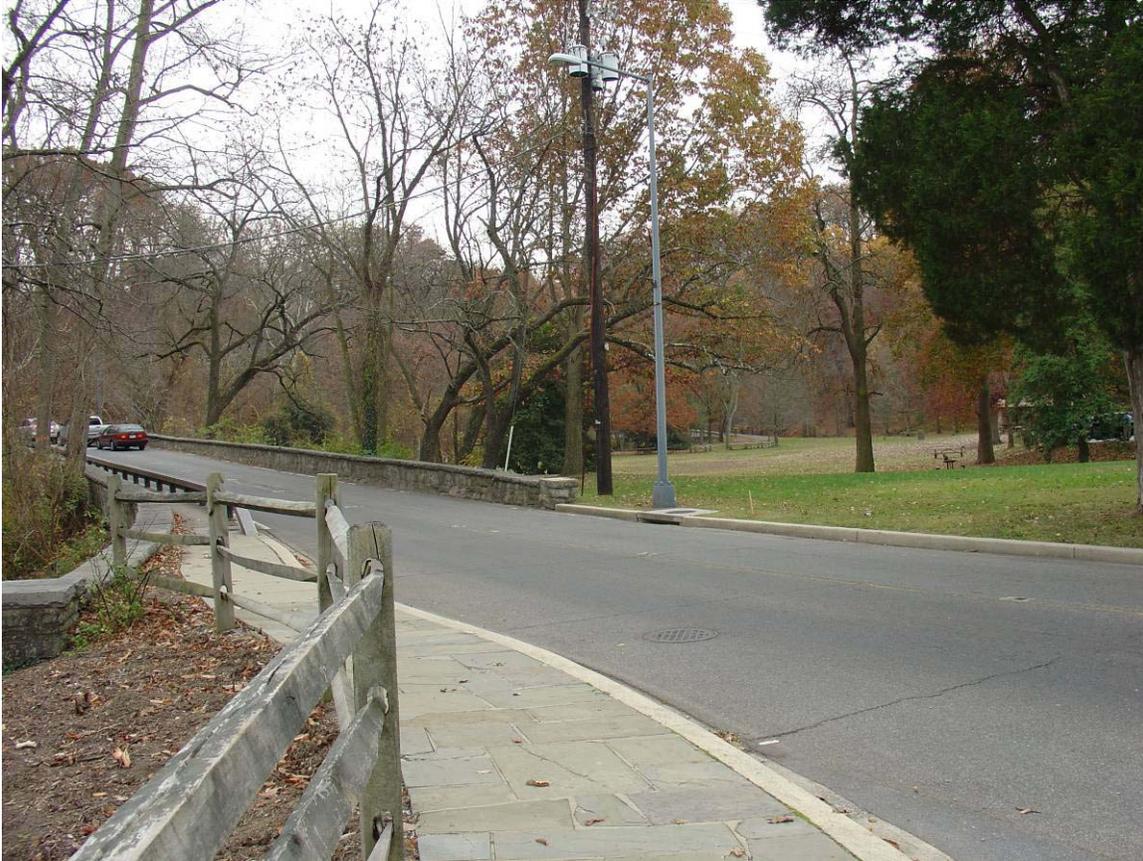
**Figure 3- 31: Light standard south of Tilden Street, 2008.** (Source: QE|A 2532)

The current lighting fixtures on site include various forms of light standards added to the site within the last thirty years. Along Tilden Street, light standards typical of current District of Columbia street lights, are placed at regular intervals. To the east of the comfort station are two light standards. Two metal poles painted gray, without ornament, have two floodlights each attached to their tops. The poles are sunk into a concrete base. In addition, two floodlights are attached to the north façade of the mill. One is located in the apex of the gable and the other is placed near the western most second story window.

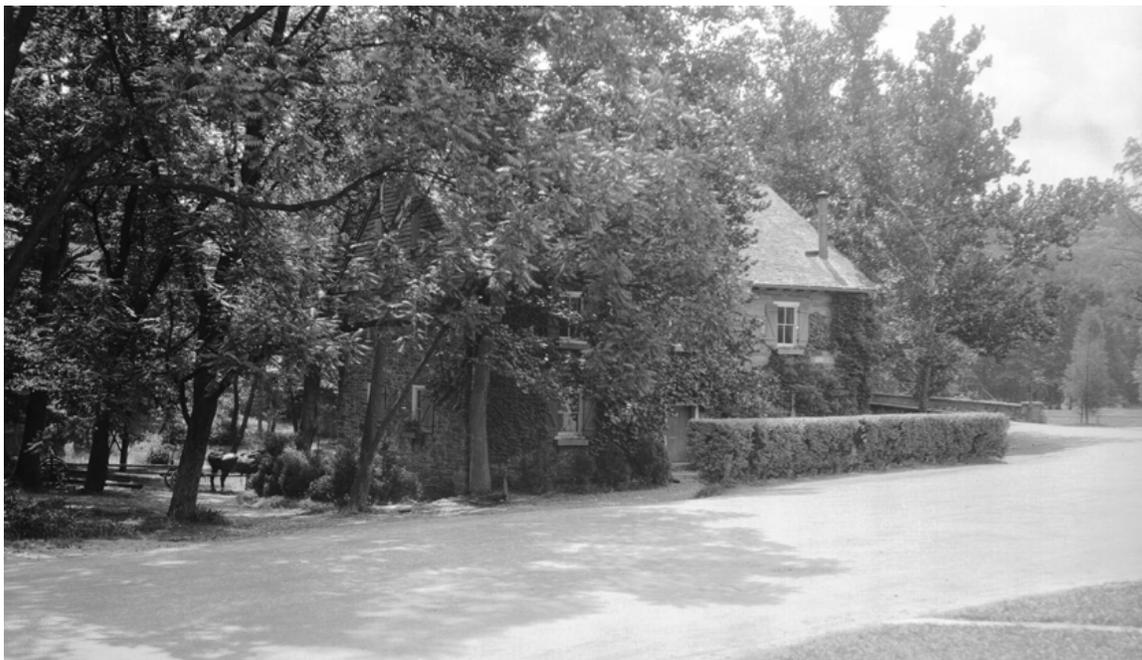
**Figure 4- 1:** In this image, a hedge is used to separate circulation systems. Foundation plantings include shrubs and trees, and the Mill walls are covered with ivy. (source: Rock Creek Park Historic Photograph Collection PM1-32, 224 written on image, 16.50-3)

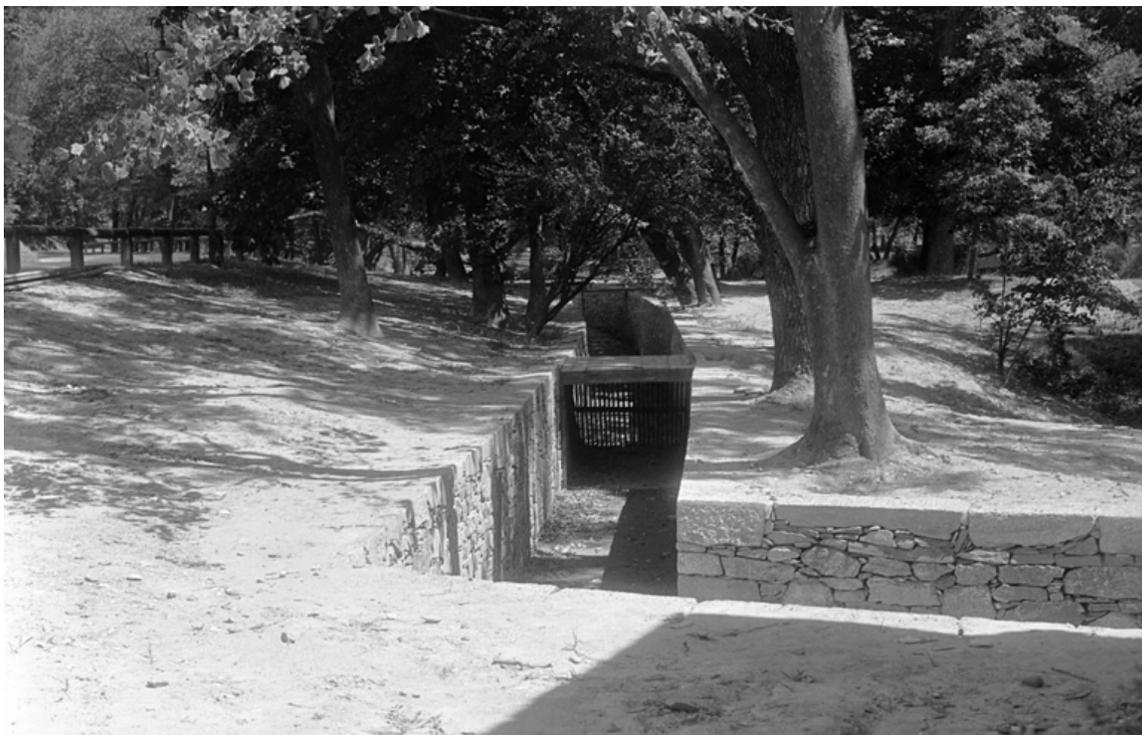
**Figure 4- 2:** The 1936 architectural restoration of Peirce Mill included excavation of the old Mill race and reconstruction of its stone walls. (source: Rock Creek Park Historic Photograph Collection, Peirce Mill finished but empty headrace, 8/5/35, 16.50-3)

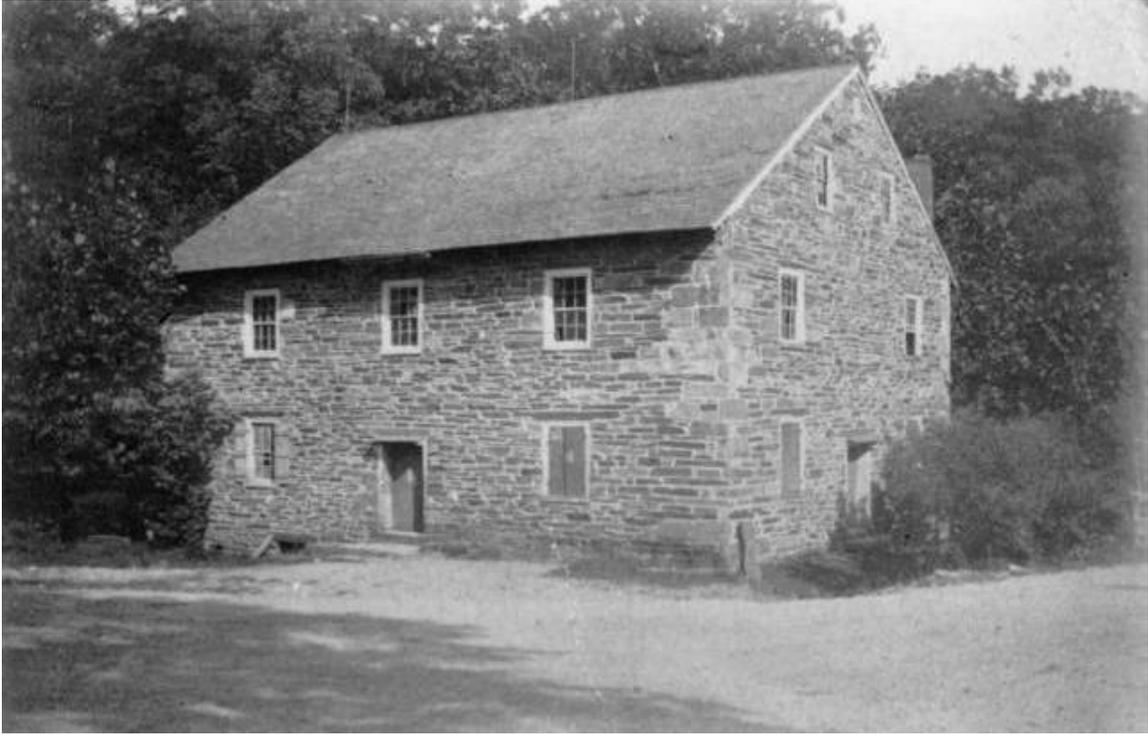
**Figure 4- 3: Peirce Mill, west façade, 1897.** (source: Rock Creek Park Historic Photograph Collection PM1-43, Peirce Mill, 16.50-3)

The early nineteenth-century circulation patterns also took advantage of the topography, following the creek as it cut north to south through the lower portion of the valley. The re-construction of the bridge at Tilden Street in 1905 raised the topography of the road, serving to separate the Peirce Mill site into two individual park areas. The area south of the bridge became identified as a picnic area and the area north of the bridge, the Peirce Mill tea house. What was once a unified, utilitarian site became a visually divided, recreational area. The creation of the Peirce Mill tea house also resulted in a regrading of the topography to enhance the grounds for picnicking and for the tea house. The millraces were filled in. The drive which led from Tilden Street to the ford at Rock Creek was reincorporated into the site as a drive to access the parking lot located to the east of the Mill. With the 1936 restoration of the Mill structure, the landscape was again regraded and the parking lot and the historic road, located to the immediate south of the Mill was removed. The late nineteenth-century millrace was reconstructed and the remnants of the sawmill race filled in. The elevation of the parking lot to the west of the Mill was raised to better intersect with the new bridge at Tilden Street. These two topographic alterations, the increased elevation of both the parking lot and the Tilden Street Bridge, served to further divide the visitor's experience of the Peirce Mill landscape. A series of images of the west elevation of the Mill help to illustrate these changes in topography (compare Figures 4-3, 4-4, 2-28, 4-5, and 4-6).

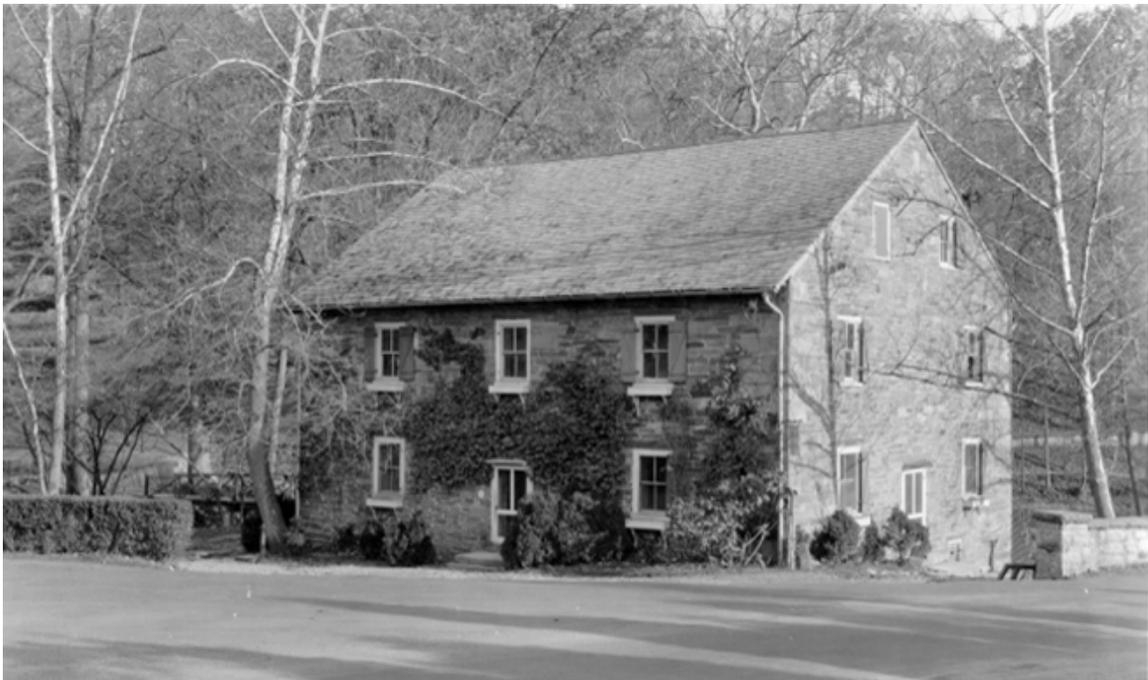
**Figure 4- 4: Peirce Mill, west and east elevations, note foundation plantings, vines on the Mill, retaining wall on the right, hedge on the left and rustic bridge behind the hedge on the left, date unknown.** (source: Rock Creek park Historic Photograph Collection PM2-66)

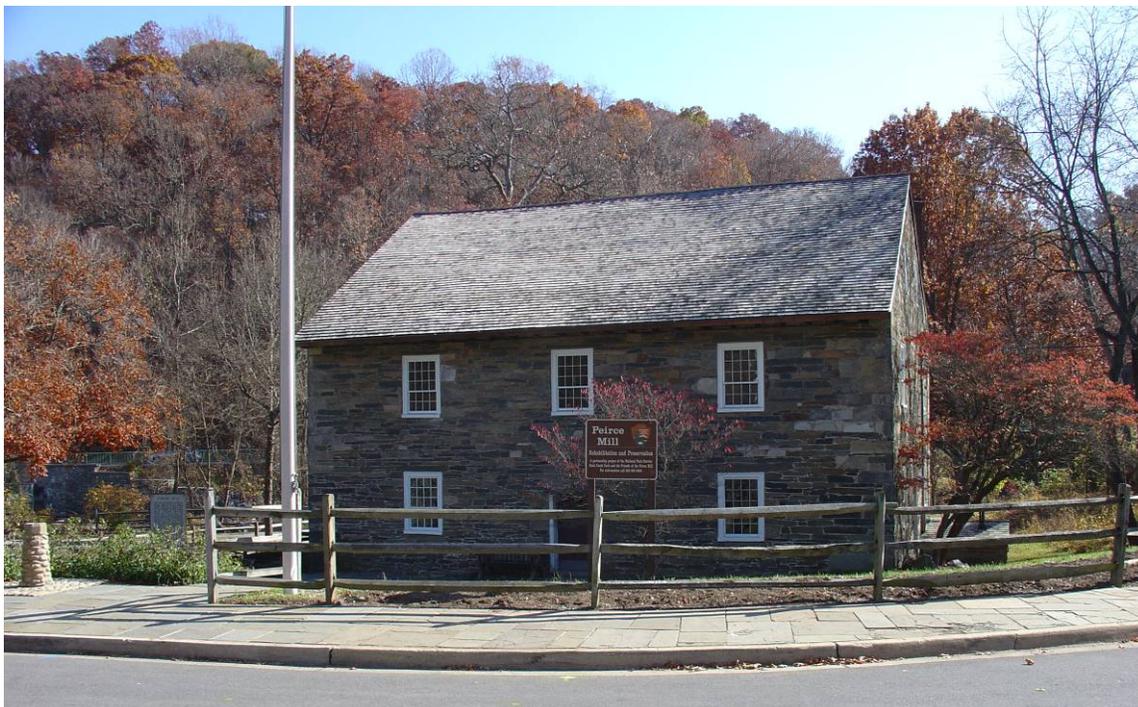
Figure 4- 5: Peirce Mill, west elevation, 2008. (source: QEA 2503)

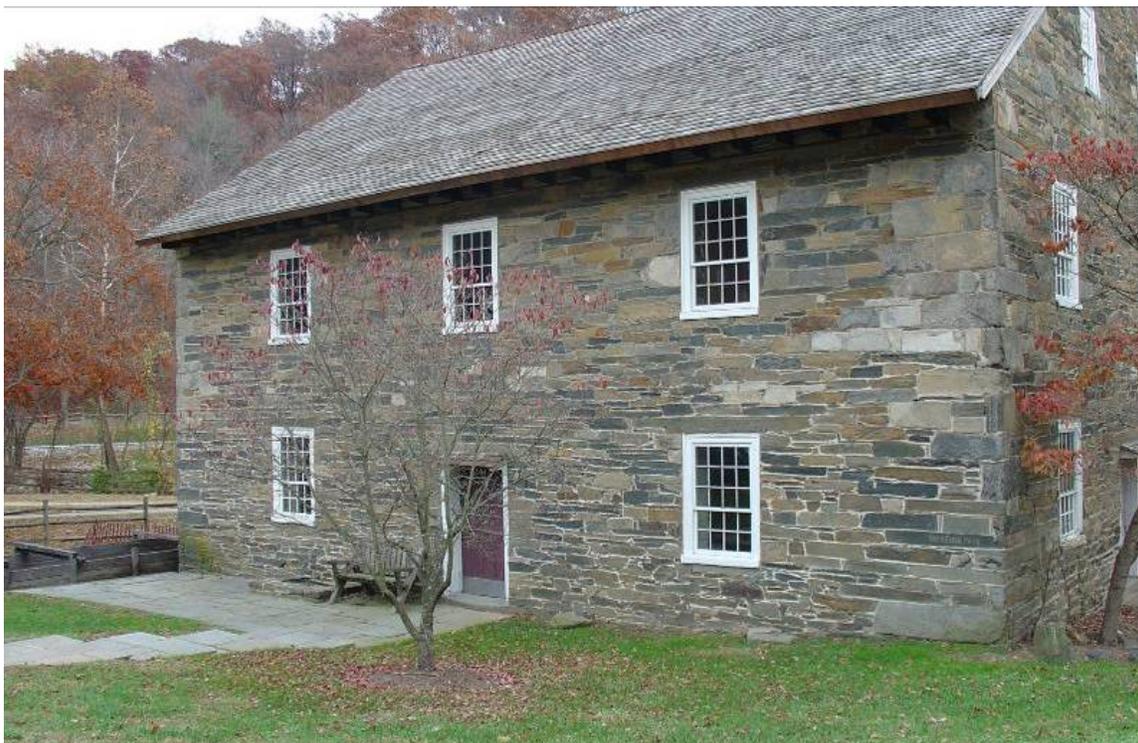
Figure 4- 6: Peirce Mill, west elevation, 2008. (source: QEA 2529)

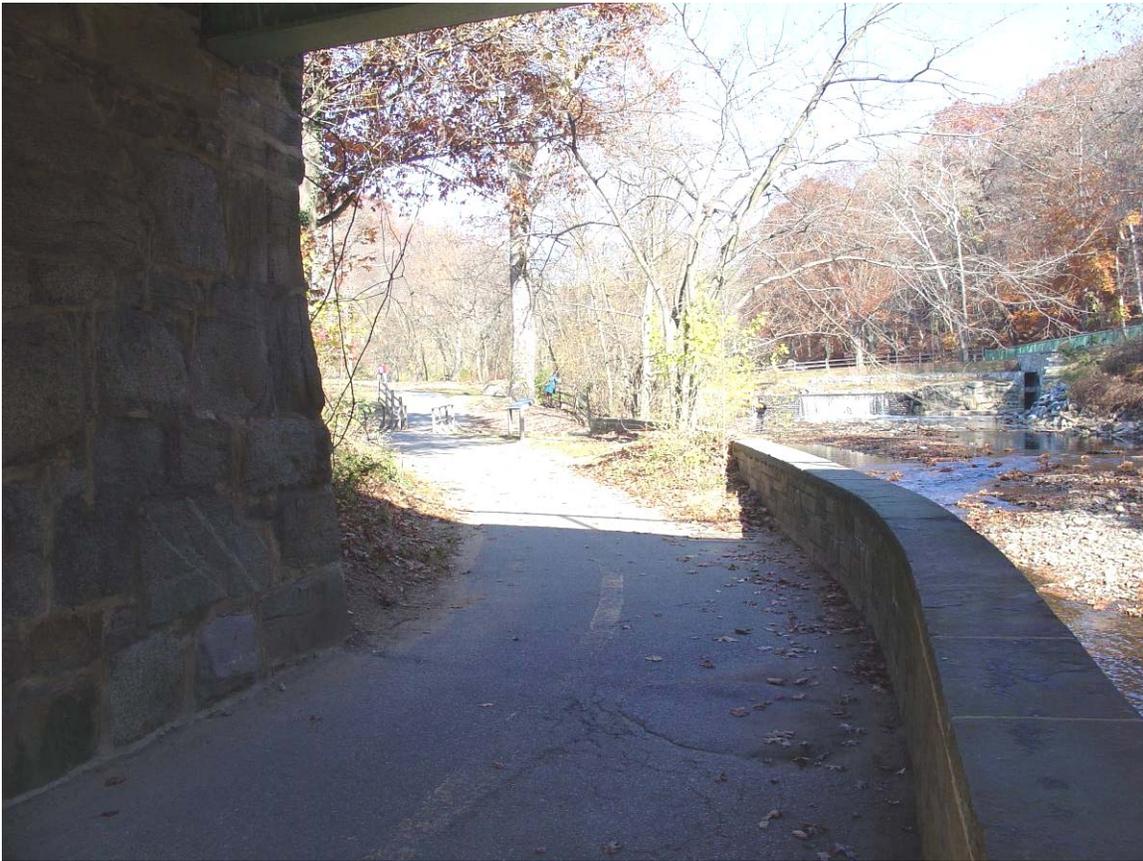
**Figure 4- 7: Underpass multi-use trail and retaining wall at Peirce Mill bridge, facing north, 2008**  
(source: QEA 2456)

underpass, however, required major regrading of the western creek bank, east of the Mill (see Figure 4-7). The result was a loss of the integrity of the nineteenth-century relationship between the Mill and the creek. In addition by the late 1960s, the circa 1936 re-construction of the millrace had been filled in. Work was begun on the construction of an abbreviated millrace which ran from the Mill, east to the creek and utilized city water. This millrace remains today, although the mill wheel was removed. The historic integrity of the nineteenth-century topography of the Peirce Mill landscape has been diminished due to alteration during the twentieth century, but integrity related to the later periods of significance is intact.

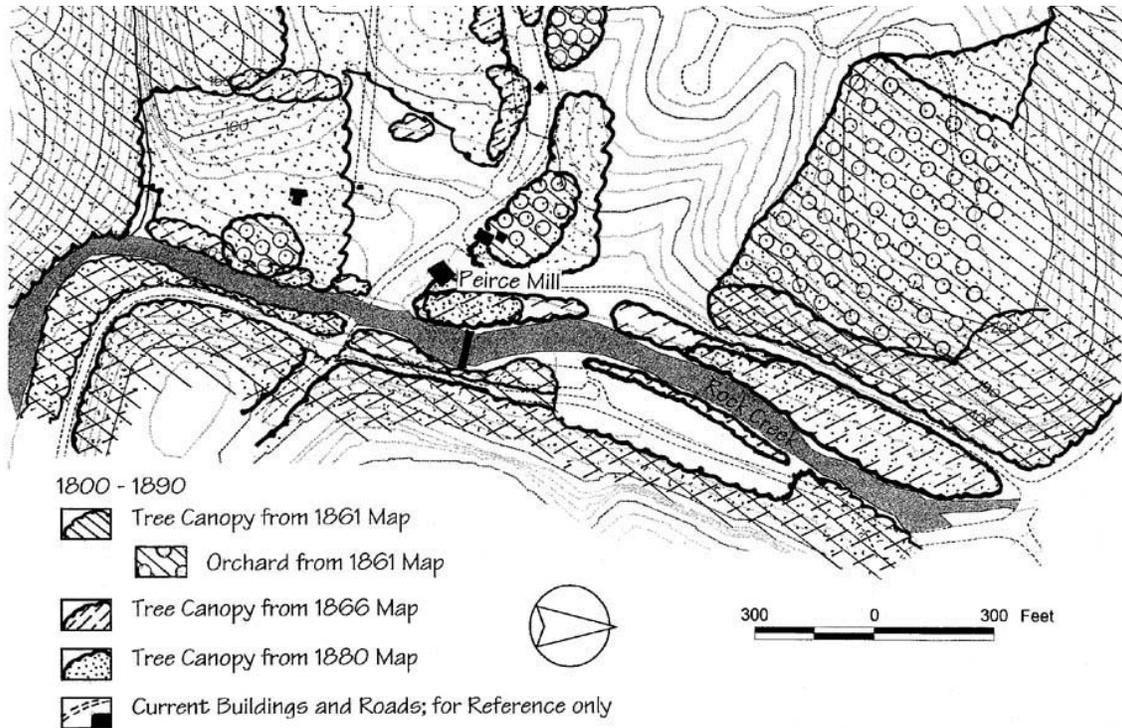
**Figure 4- 8: The tree canopy from 1800 to 1890 shows a definite pattern of open fields and meadows. The 1861 map detailed orchards from the period.** (source: Cultural Landscapes Inventory, Peirce Mill, Part 3a, page 16)

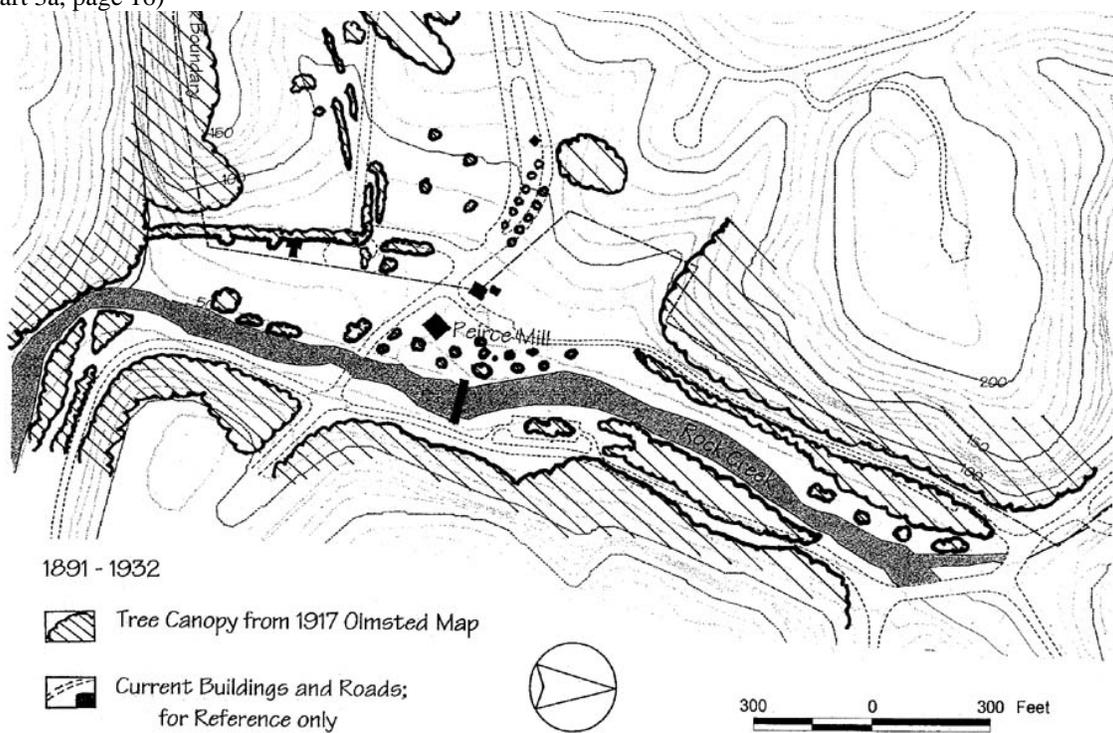
**Figure 4- 9: The 1917 Olmsted Firm reconnaissance maps show hedgerows near the park boundary and an allee along Tilden Street. The meadow south of the Mill is open, while the one to the north is lightly wooded.** (source: Cultural Landscapes Inventory, Peirce Mill, Part 3a, page 17)

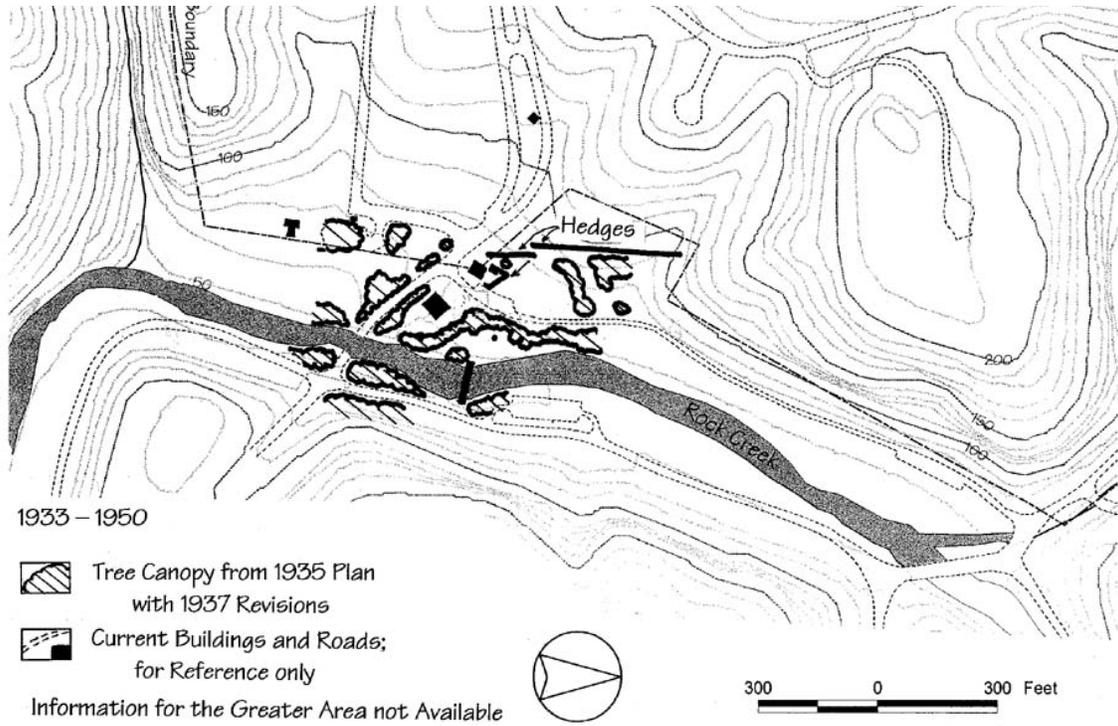
**Figure 4- 10: Little information is known for the greater area, but the area adjacent to the Mill is lightly wooded. Hedges were introduced close to Peirce Mill along the bridle trail. (source: Cultural Landscapes Inventory, Peirce Mill, Part 3a, page 17)**

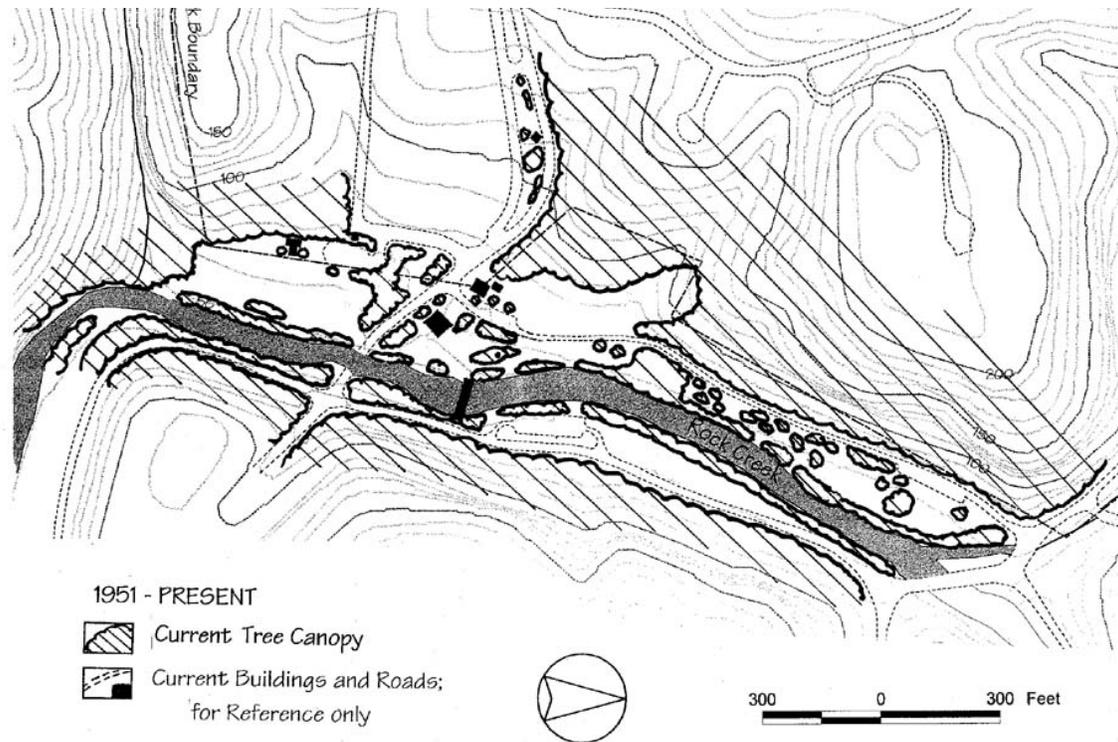
**Figure 4- 11: Approximate relationship between wooded areas and open areas currently. (source: Cultural Landscapes Inventory, Peirce Mill, Part 3a, page 18)**

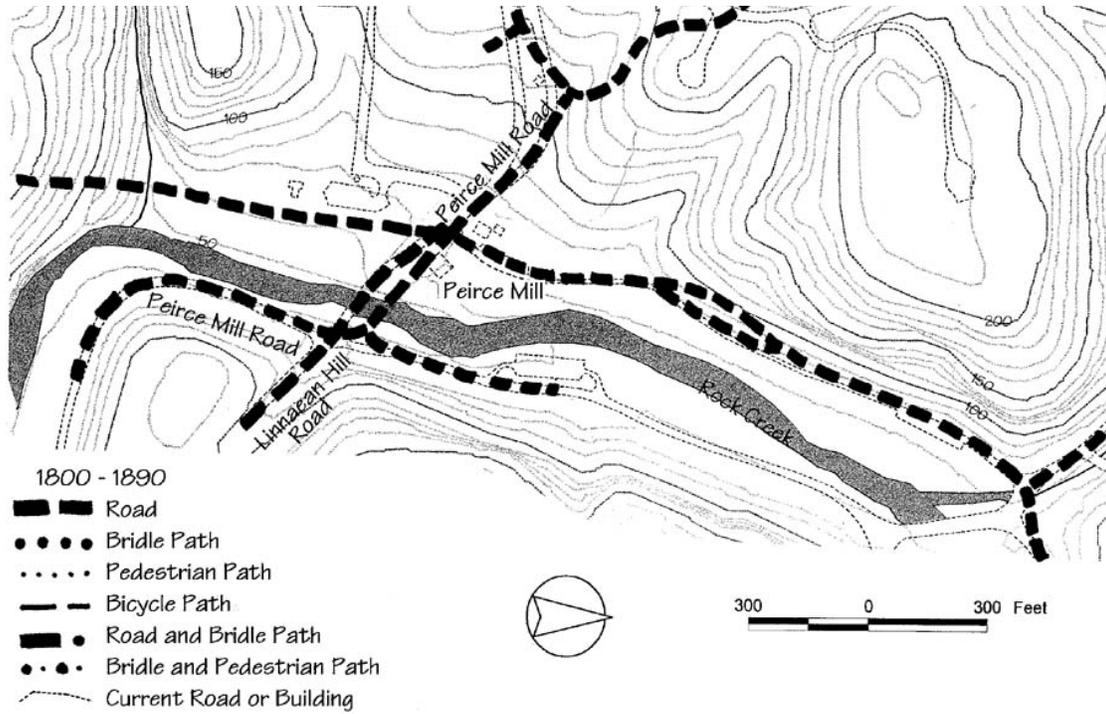
**Figure 4- 12: The diagram illustrates the simple circulation patters at the site from 1800-1900.**  
 (source: Cultural Landscapes Inventory, Peirce Mill, Part 3b, page 5)

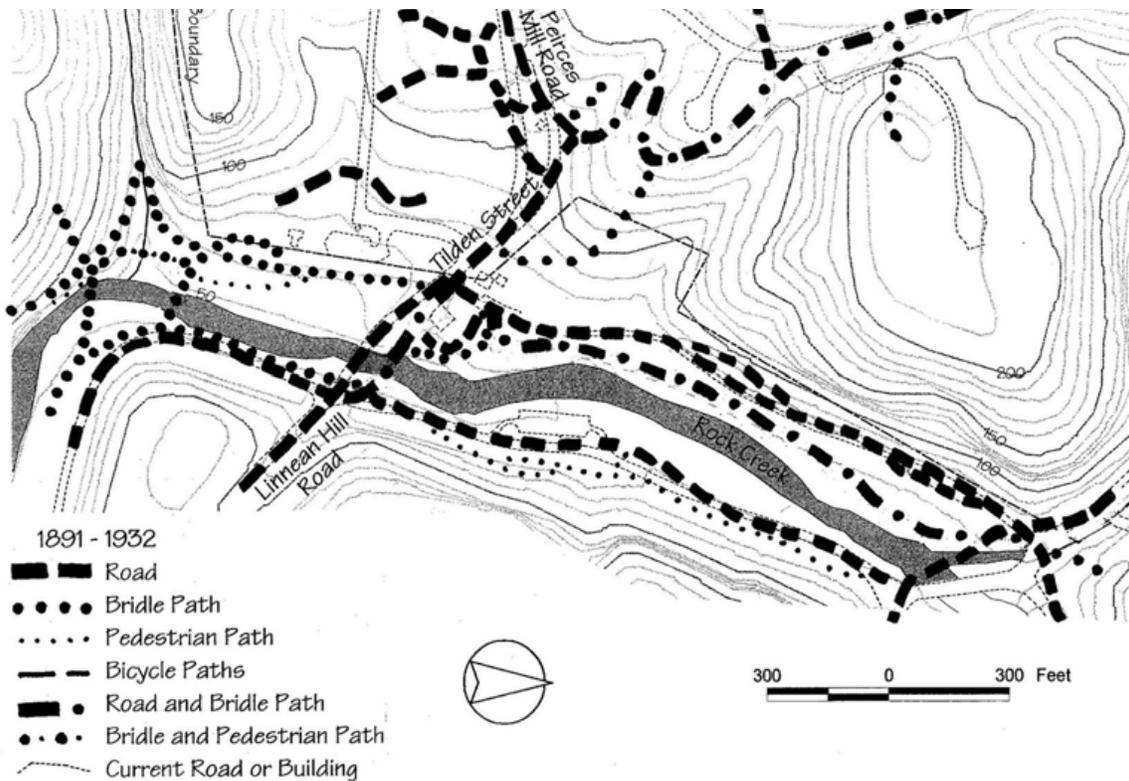
**Figure 4- 13: The complexity of circulation between 1891 and 1932 is evident in this illustration.**  
 (source: Cultural Landscapes Inventory, Peirce Mill, Part 3b, page 5)

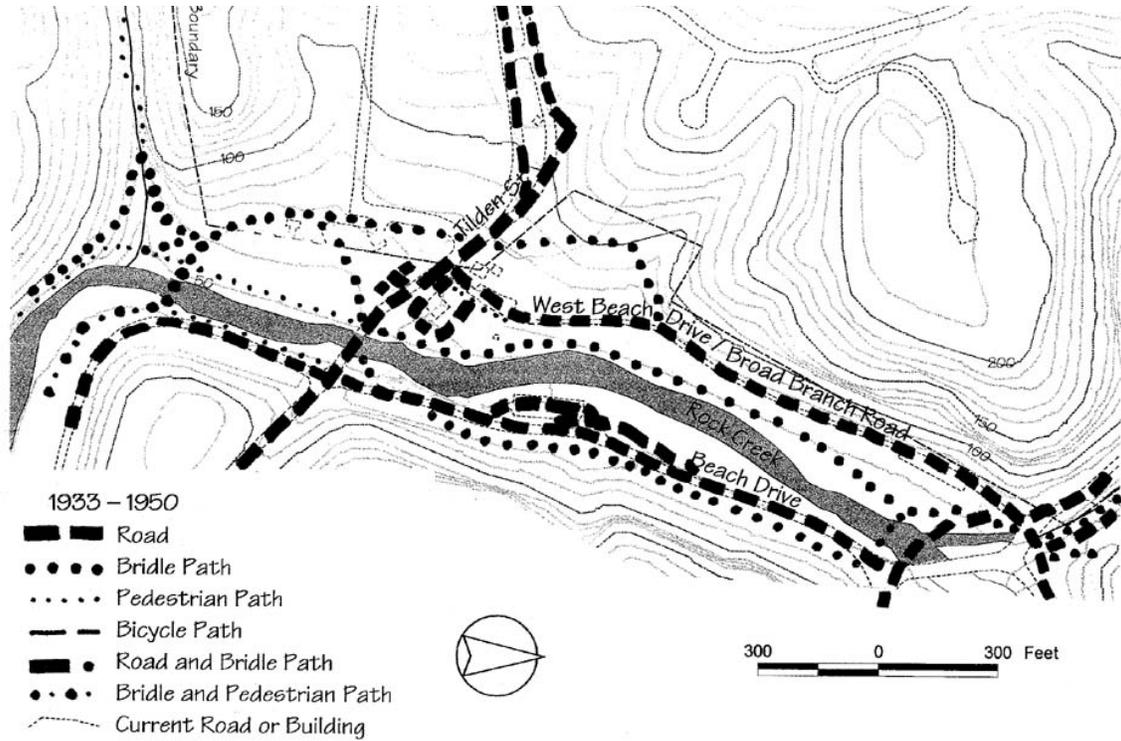
**Figure 4- 14: Here are the circulation patterns found at Peirce Mill from 1933 to 1950.**  
 (source: Cultural Landscapes Inventory, Peirce Mill, Part 3b, page 6)

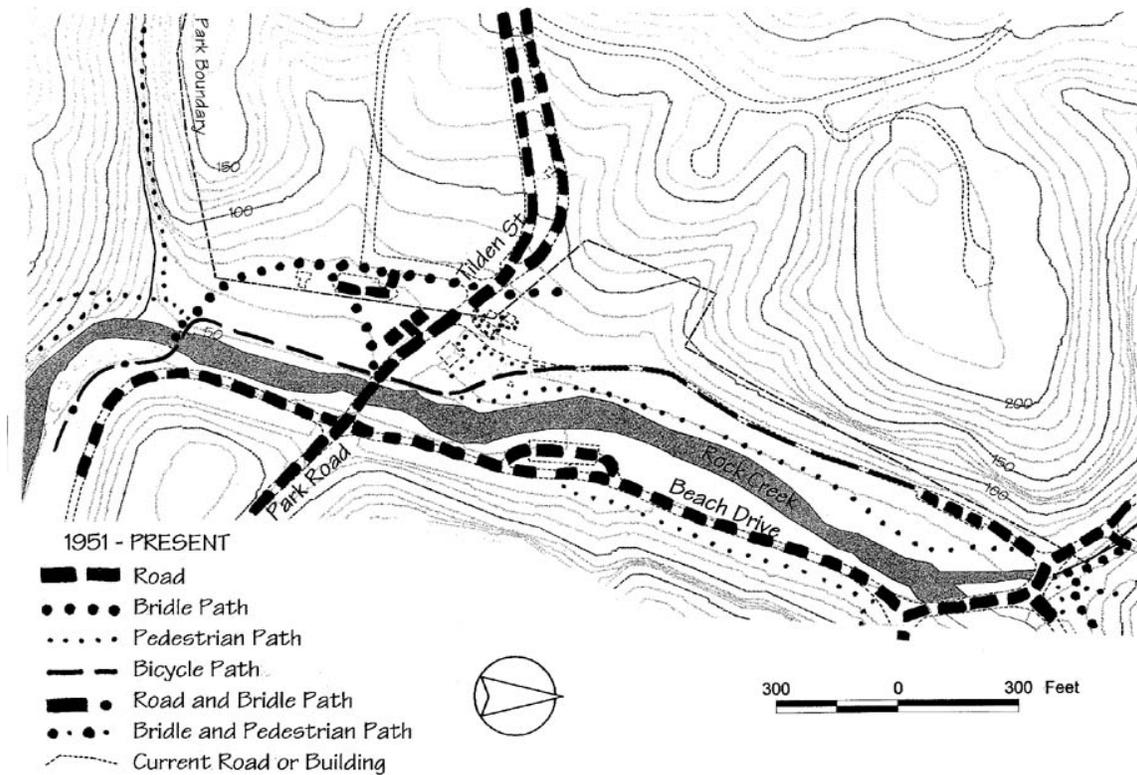
**Figure 4- 15: The circulation systems shown here represent the period from 1951 to the present.**  
 (source: Cultural Landscapes Inventory, Peirce Mill, Part 3b, page 6)

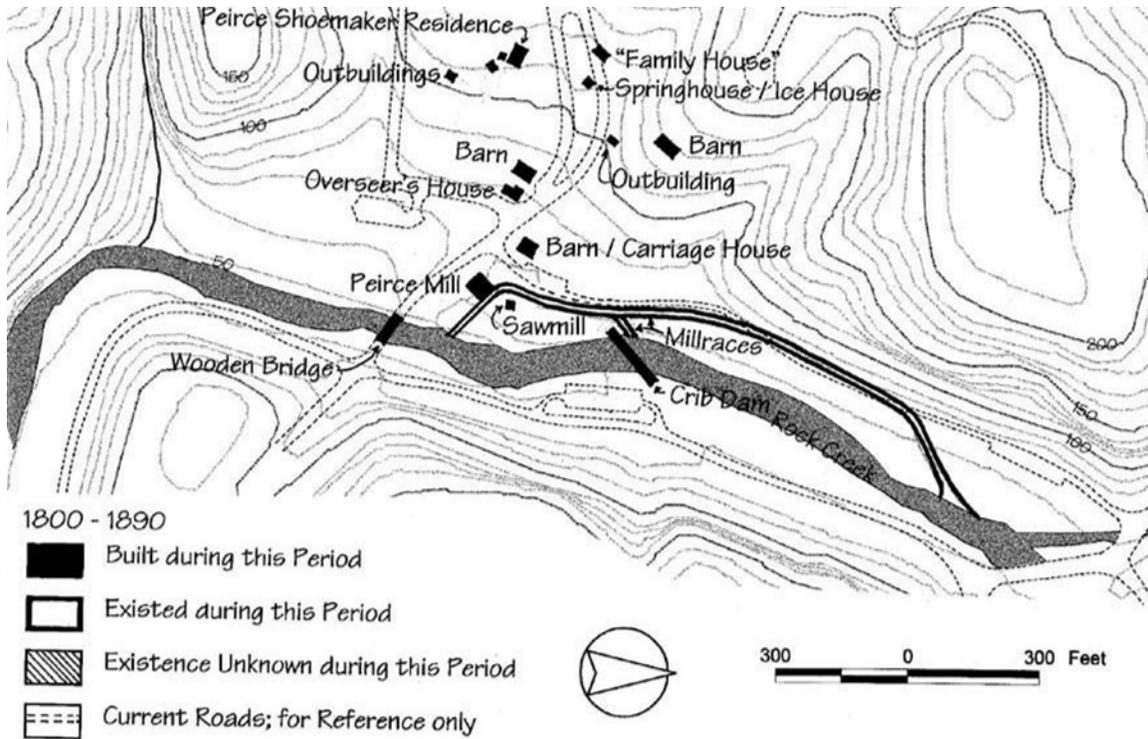
**Figure 4- 16: Structures built on the site between 1800 and 1890.** (source: Cultural Landscapes Inventory, Peirce Mill, Part 3b, page 13)

The land upon which Peirce Mill now stands was first settled in the late eighteenth-century. In 1794, according to written documentation, Isaac Peirce owned a frame house and two story timber frame mill in the Rock Creek valley. By 1810 he had constructed a new residence which was described by contemporaries as a building of oak timbers with a gable roof and vine-covered porch placed on a stone foundation. Peirce Shoemaker built his own house in the same location. The existence of several barns, outbuildings and a distillery/barn was also recorded. Due to the division of the Peirce Shoemaker property in 1890 for the creation of Rock Creek Park, the only nineteenth-century buildings contributing to the historic integrity of the landscape are the Mill, the wagon barn and the springhouse. These buildings were acquired by the government in the creation of Rock Creek Park. Many of the nineteenth-century structures associated with the milling and agricultural enterprises of Peirce Shoemaker's family, which remains private land, have been razed. Subsequent restoration and rehabilitation plans have altered the original appearance of the remaining structures. In addition, buildings have been constructed on the landscape to accommodate Rock Creek Park visitor needs. Conceptual diagrams illustrating broad changes to buildings and structures at the Peirce Mill complex are provided in Figures 4-16 through 4-19)

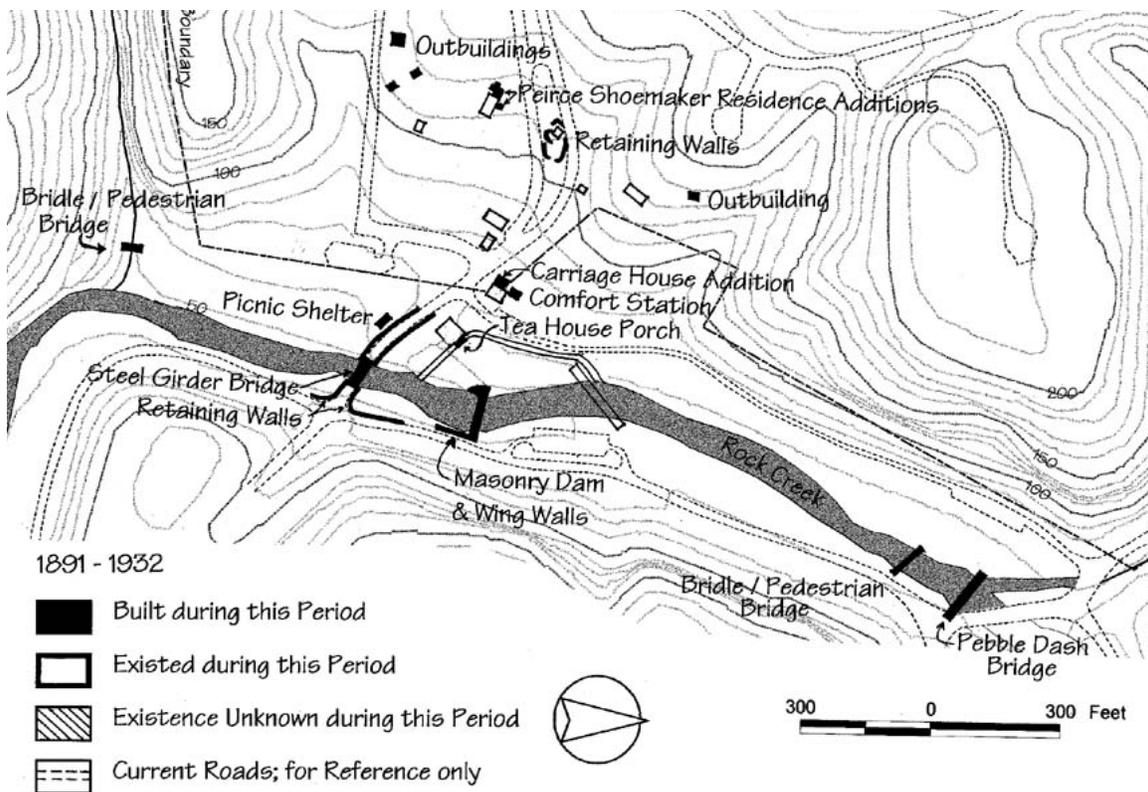
**Figure 4- 17: Structures present between 1891 and 1932.** (source: Cultural Landscapes Inventory, Peirce Mill, Part 3b, page 13)

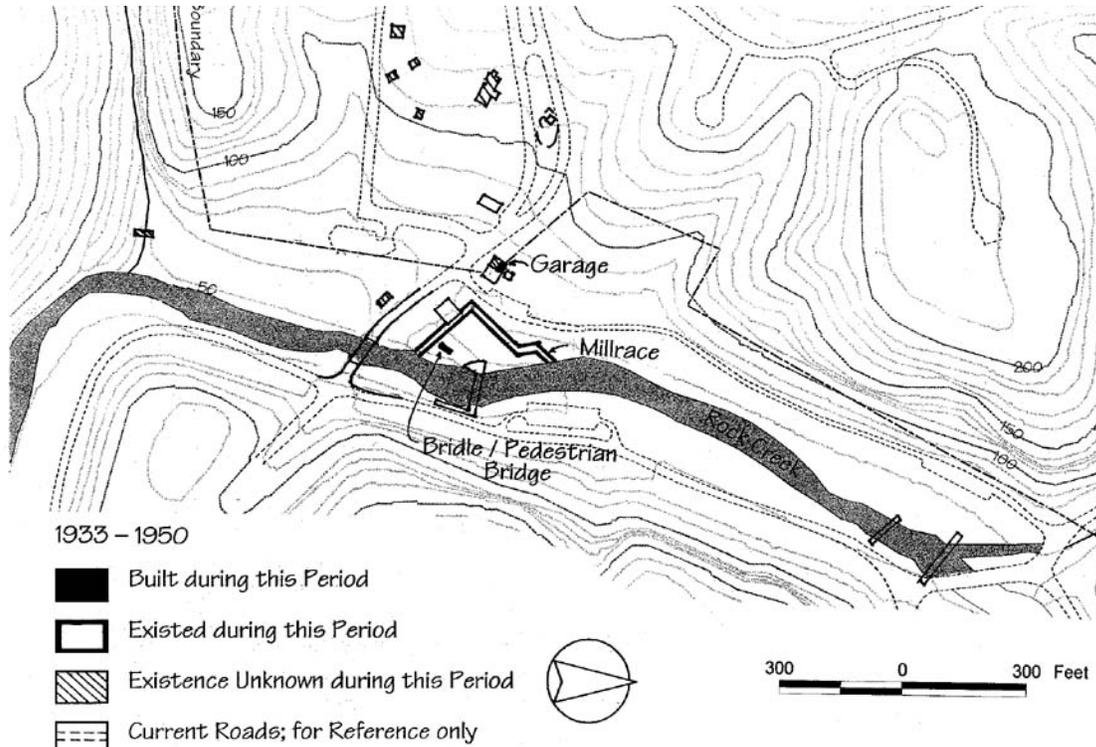
**Figure 4- 18: Structures present between 1933 to 1950.** (source: Cultural Landscapes Inventory, Peirce Mill, Part 3b, page 14)

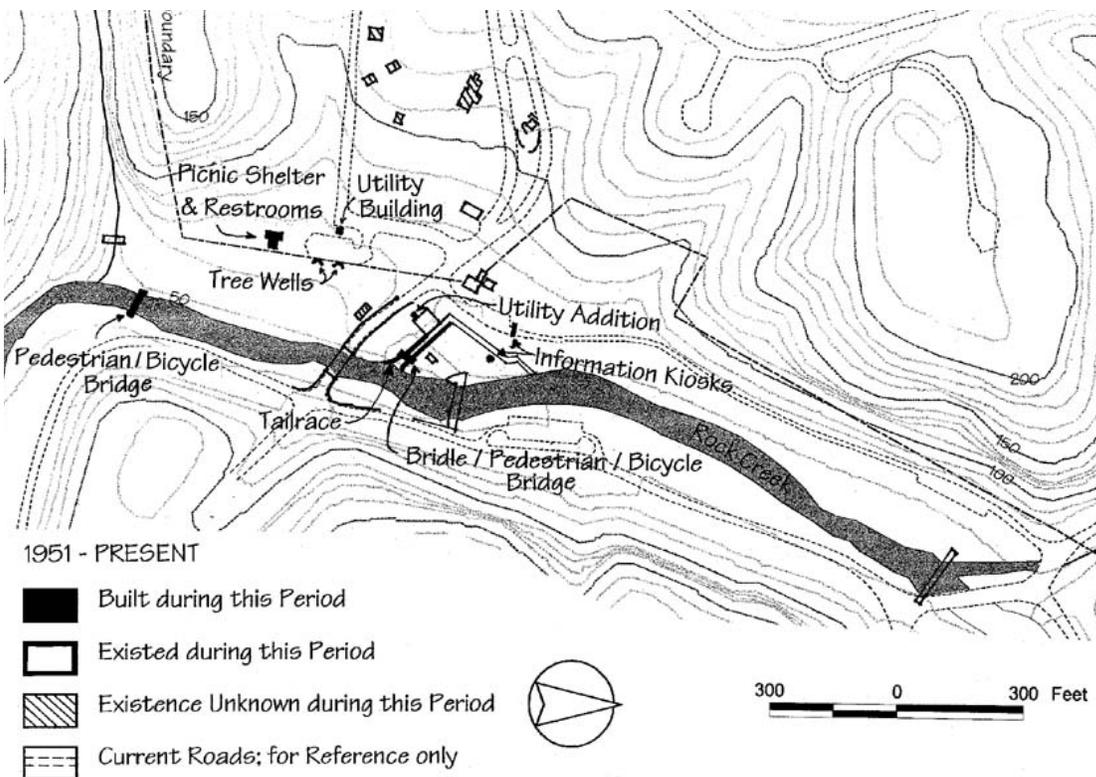
**Figure 4- 19: Structures present between 1951 and today.** (source: Cultural Landscapes Inventory, Peirce Mill, Part 3b, page 14)

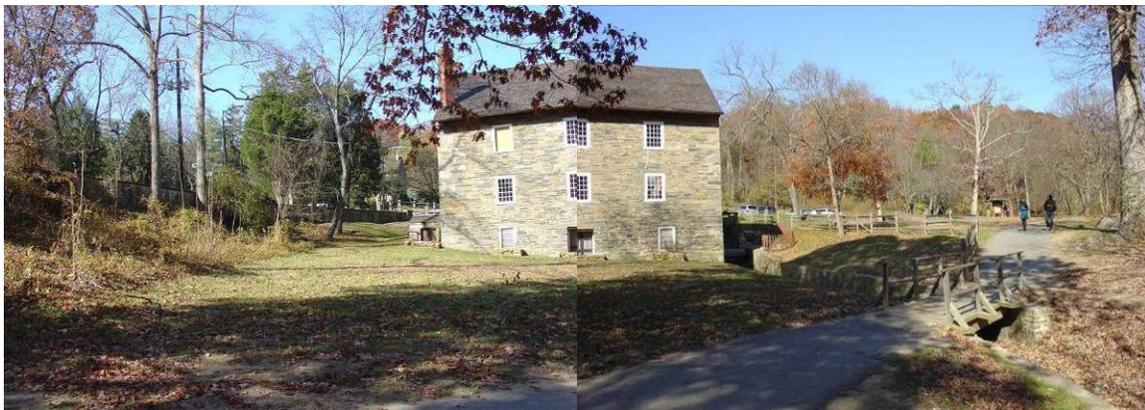
**Figure 4- 20: Peirce Mill, view from east, 2008.** (source: QE|A, 2449, 2450 and 2451)

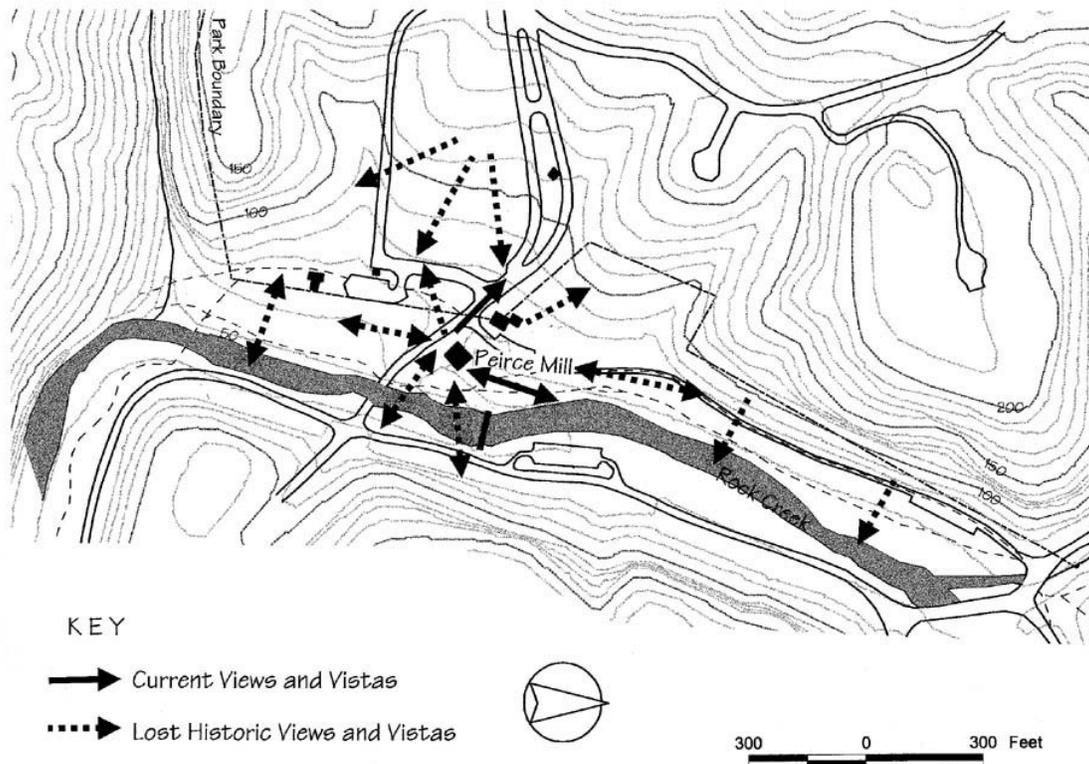
Figure 4- 21: Views and Vistas (Source: Cultural Landscape Inventory, Peirce Mill, Part 3b, page 20).

The views apparent during the nineteenth-century arose from the utilitarian nature of the landscape. Though most likely not consciously designed, the broad views available on the cleared land, from both the Peirce/Shoemaker residence and the Mill, served to connect various use areas. Beginning in the early twentieth-century, with the transfer of the property to the management of Rock Creek Park, views were designed to enhance the picturesque landscape—providing connections, not between utilitarian areas, but between Peirce Mill as a destination and the broader Rock Creek Park landscape. A conceptual diagram illustrates existing and non-extant views at the Peirce Mill complex (see Figure 4-21).

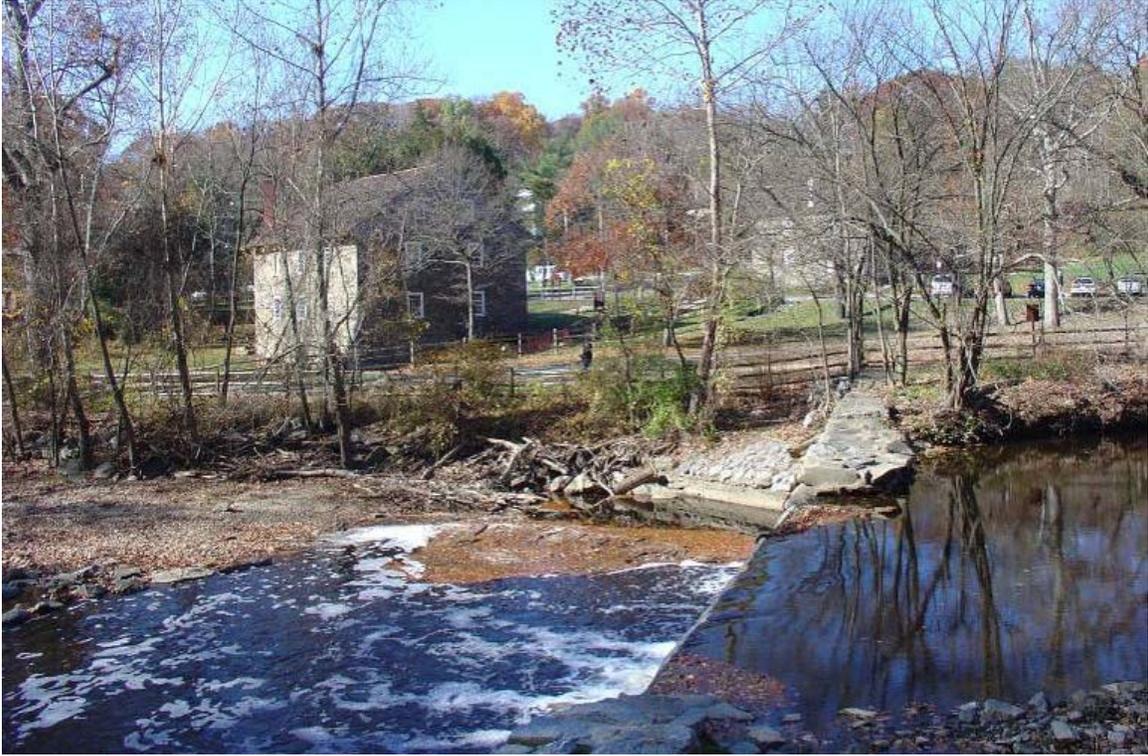
**Figure 4- 22: Dam with Mill and Barn in background facing west, 2008.** (source: QEA)

Beginning in the early years of the twentieth-century, the Peirce Mill landscape underwent drastic change, both programmatically and physically. Due to the division of the property with the formation of Rock Creek Park, adjacent land once visible from the Mill became blocked by woody vegetation (see Figure 4-22). Yet though the vegetation levels in the vicinity of the Mill were allowed to increase, their location was controlled to create vistas in the landscape. For instance, when the Peirce Mill dam was created in 1904, vistas framed by vegetation accented the picturesque qualities of its boulder structure (see Figure 4-23). New bridle and pedestrian paths were introduced. From these circulation routes, views were created, placing the Mill as a recreational destination within the park setting. While the Mill and wagon barn themselves were accented, the agricultural and horticultural aspects of the landscape were relatively ignored. Successionary vegetation and invasives continued to grow and partially hide views to the once open land east across the creek.

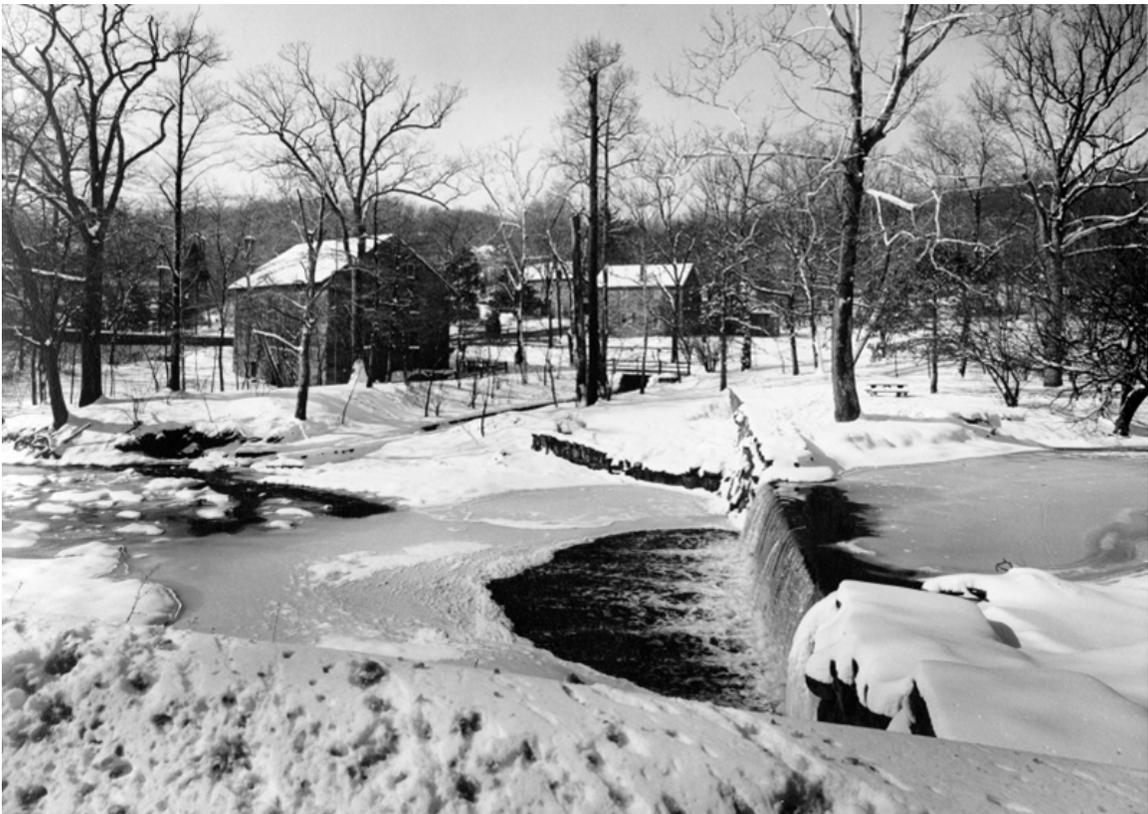
**Figure 4- 23: Dam with Mill and Barn in background, facing west, 1966.** (source: Rock Creek Park Historic Photograph Collection PM2-63, January 27, 1966, 9571-A)
