# PEIRCE MILL COMPLEX

## Cultural Landscape Report

### CULTURAL LANDSCAPE REPORT

PREPARED BY:  
QUINN EVANS | ARCHITECTS  
1214 TWENTY-EIGHTH STREET, NW  
WASHINGTON, DC 20007

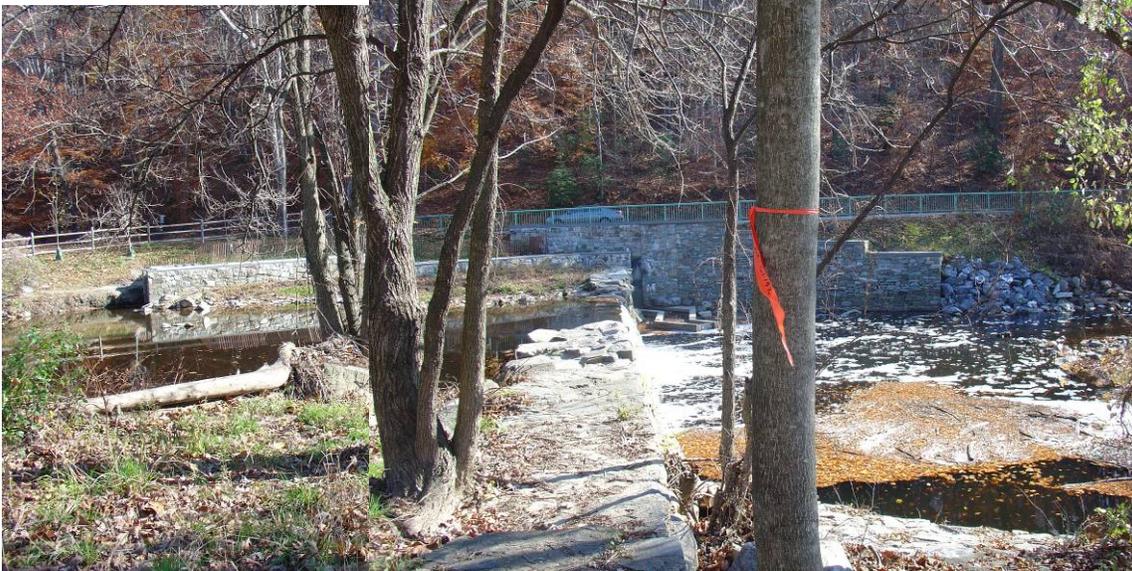
**Figure 4- 24: Dam from west, 2008.** (source: QE|A 2433 and 2434)

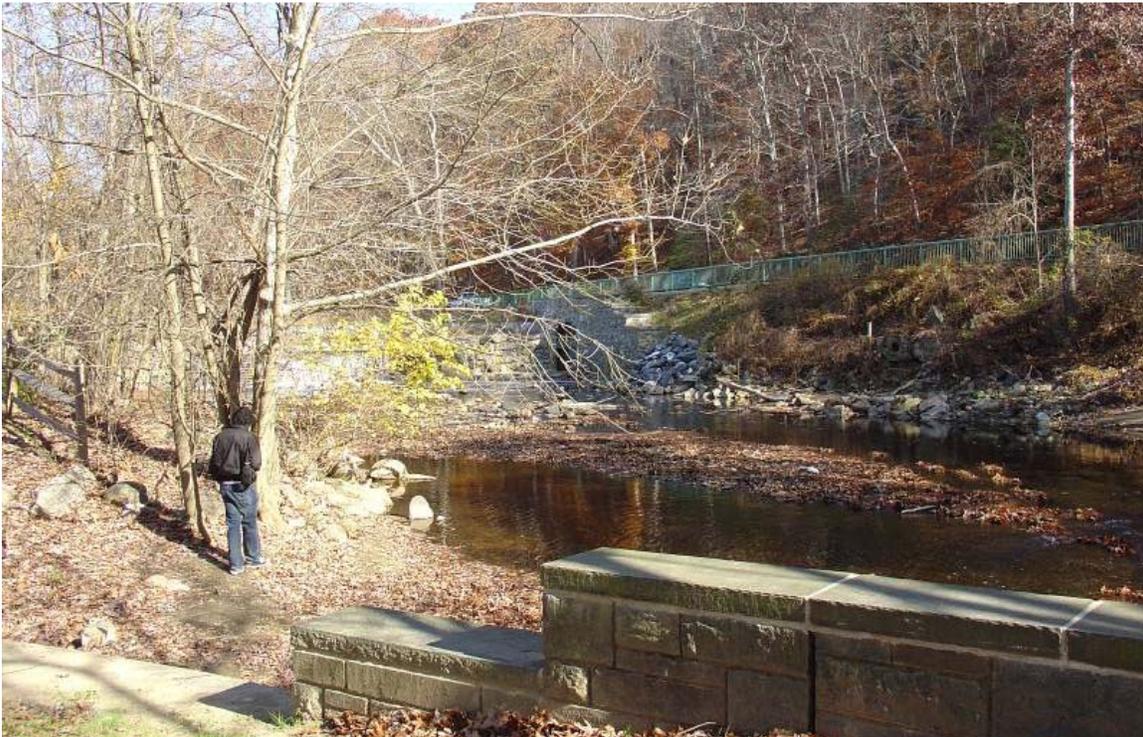
**Figure 4- 25: View of the Dam from the south is obscured by vegetation in some areas, 2008.** (source: QE|A 2452)

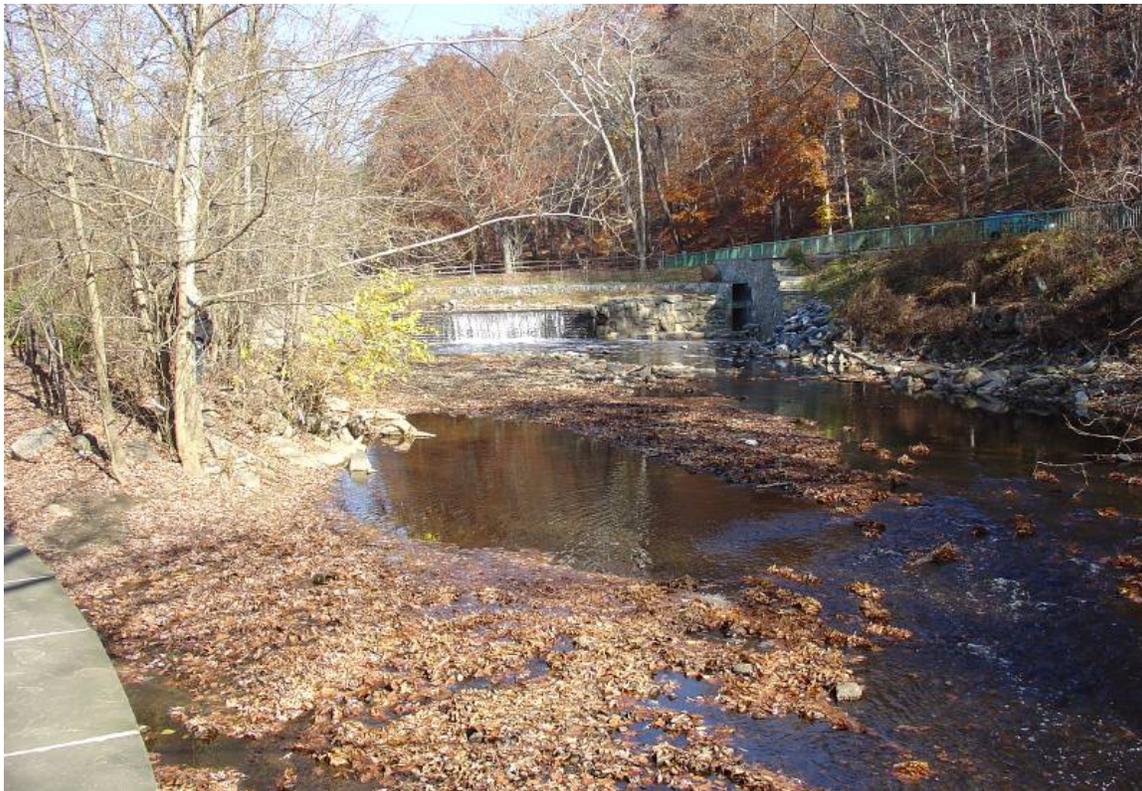
Figure 4- 26: Dam from south, 2008. (source: QE|A 2453)

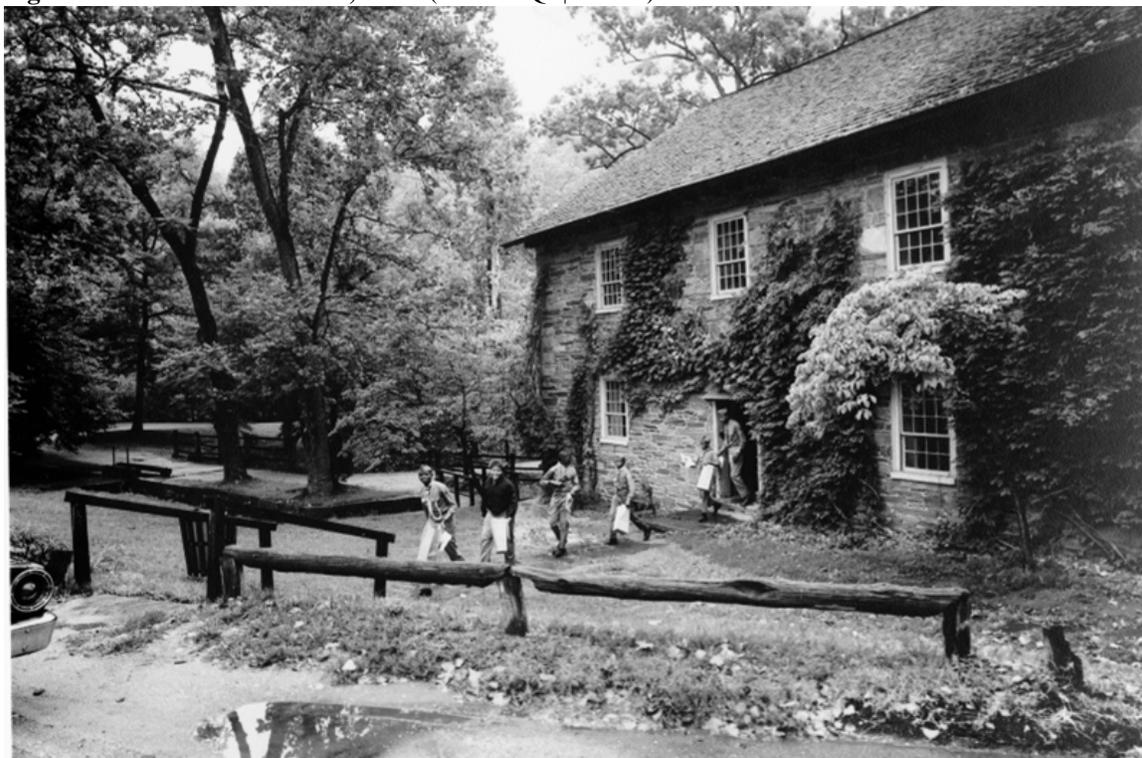
Figure 4- 27: West elevation of Peirce Mill and small scale features (note head race in middle left of image), 1965. (source: Rock Creek Park Historic Photograph Collection PM2-62, Peirce Mill, west façade, clean-up day, Boy Scouts, August 1, 1965, 9336-L)

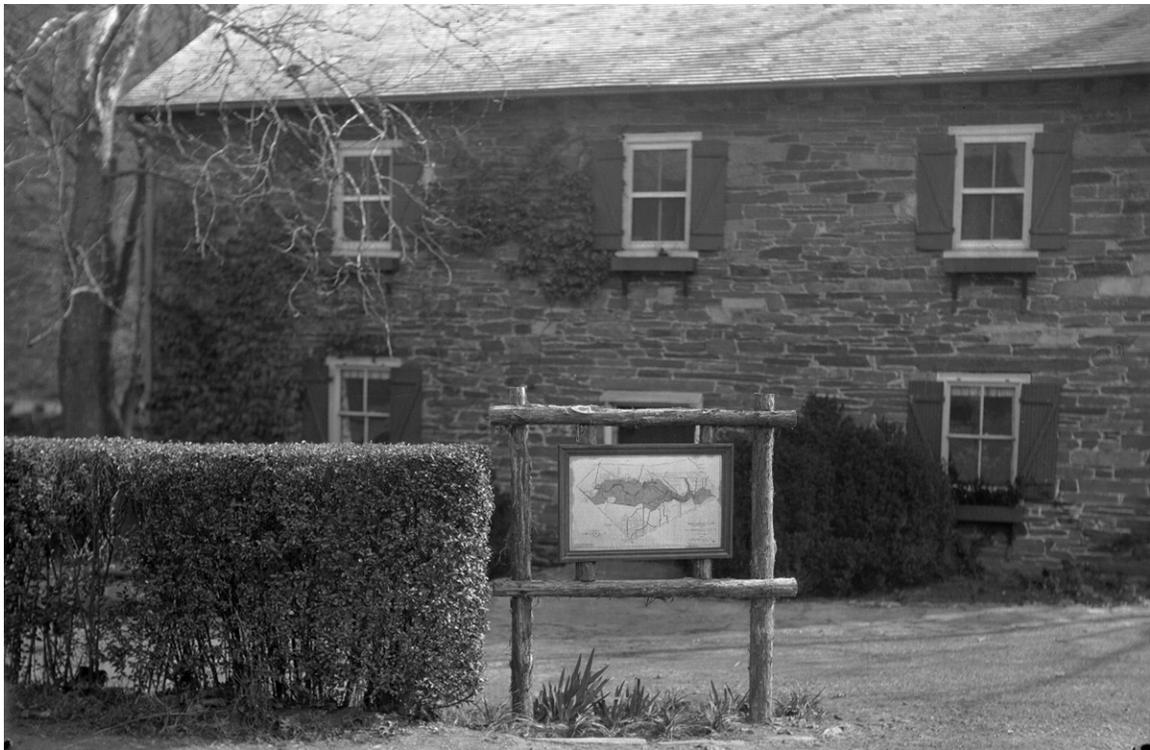
**Figure 4- 28: Rustic sign, window boxes, shutters, and hedge at Peirce Mill, post 1927.** (source: National Park Service, National Capital Regional Office, PM1-34)

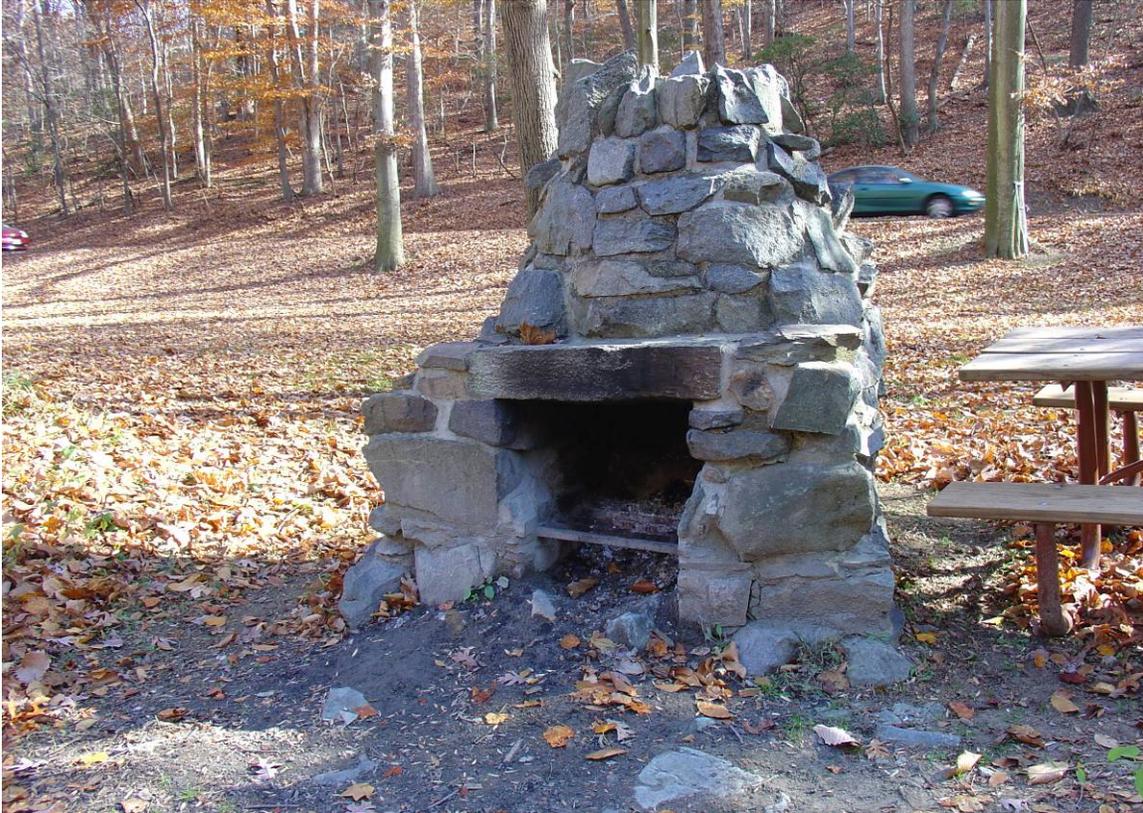
**Figure 4- 29: Rustic Fireplace at East Grove 2 Picnic Area, facing east, 2008 (source: QEA 2393)**

The introduction of small-scale features was also associated with the development of the picnic areas surrounding the Mill. North of the Mill, near the headrace of the late nineteenth-century dam, a stone fireplace was built during the 1920s. It is no longer extant. A stone fireplace and stone grill were also located on the eastern bank of the creek, in the picnic area north of Peirce Mill and are still extant (see Figures 4-29 and 4-30). The stone fireplaces were designed in the Rustic style and constructed throughout Rock Creek Park. Six remain in the park including the one at East Grove 2 as well as others at picnic areas 6a, 6b, 7, 8 and 13.<sup>2</sup> These structures exemplified the fireplace types advocated by Albert H. Good in the design source book, *Park and Recreation Structures*.<sup>3</sup>

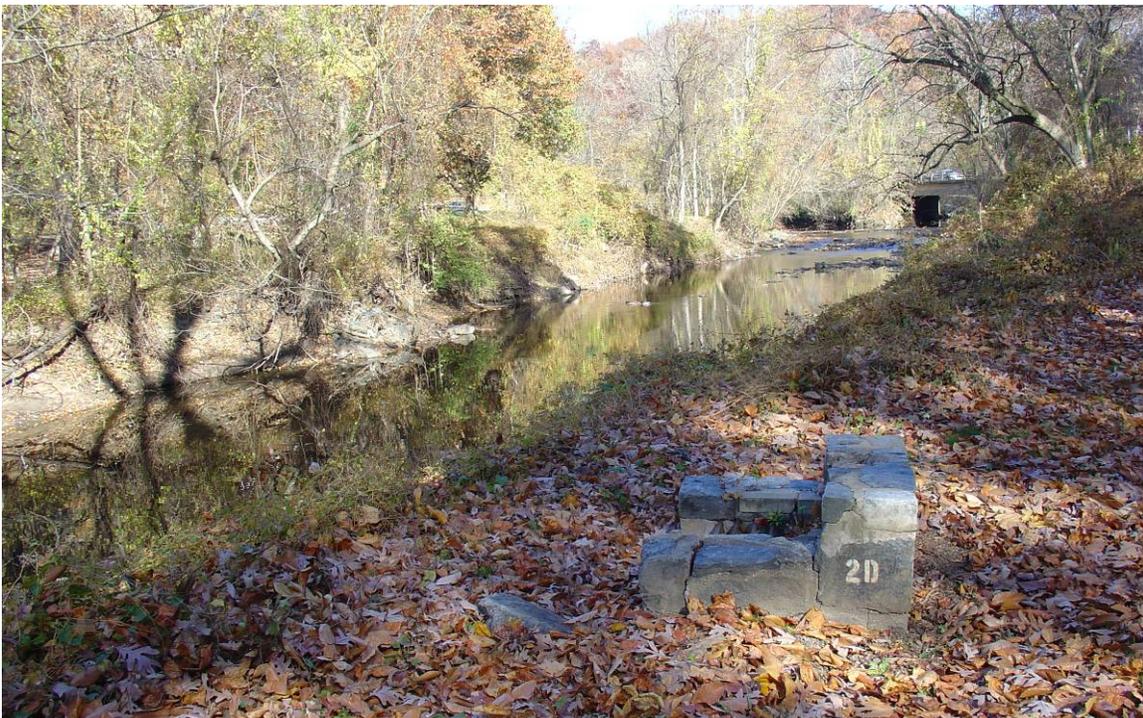
**Figure 4- 30: Stone Grill at East Grove 2 Picnic Area, facing north, note the close proximity to the creek bank, 2008 (source: QEA 2395)**

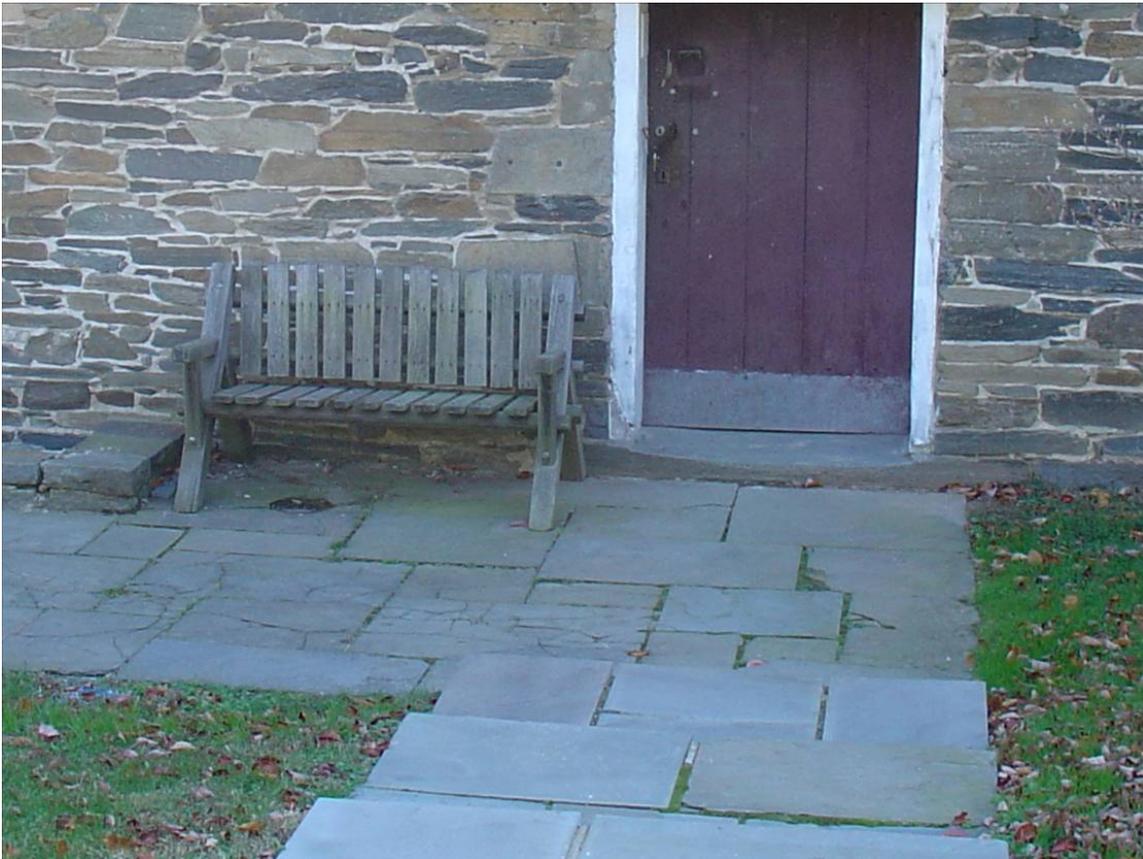
**Figure 4- 31: Washington Bench and flagstone steps and pavement at the west entrance to Peirce Mill, 2008.** (source: QEA 2505)

Wood picnic tables and benches were also associated with the picnic area development. The exact appearance of these early twentieth-century site furnishings is not known. In 1926 metal playground equipment, including a swing set and a teeter-totter, was installed, south of the Mill across Tilden Street. “Washington” benches were introduced to the site by the 1930s (see Figure 4-31). An iron drinking fountain was located near the northwest corner of the Mill during this time period, as was a trellis on the south end of the west façade. Following the rehabilitation of the Mill in the late 1960s, other additions were made. To the west of the Mill, bordering the eastern edge of the parking area, a drinking fountain was installed. Of uncut, mortared stone construction, this fountain is still extant. In the picnic area south of Peirce Mill, multiple container, brown painted metal waste receptacles in the “tulip” style were installed during the 1960s as well. These are no longer extant. Currently wood picnic tables with metal braces and recycled plastic tables are located in Grove 1 area, south of Peirce Mill. Picnic tables are also located at the other two picnic areas.

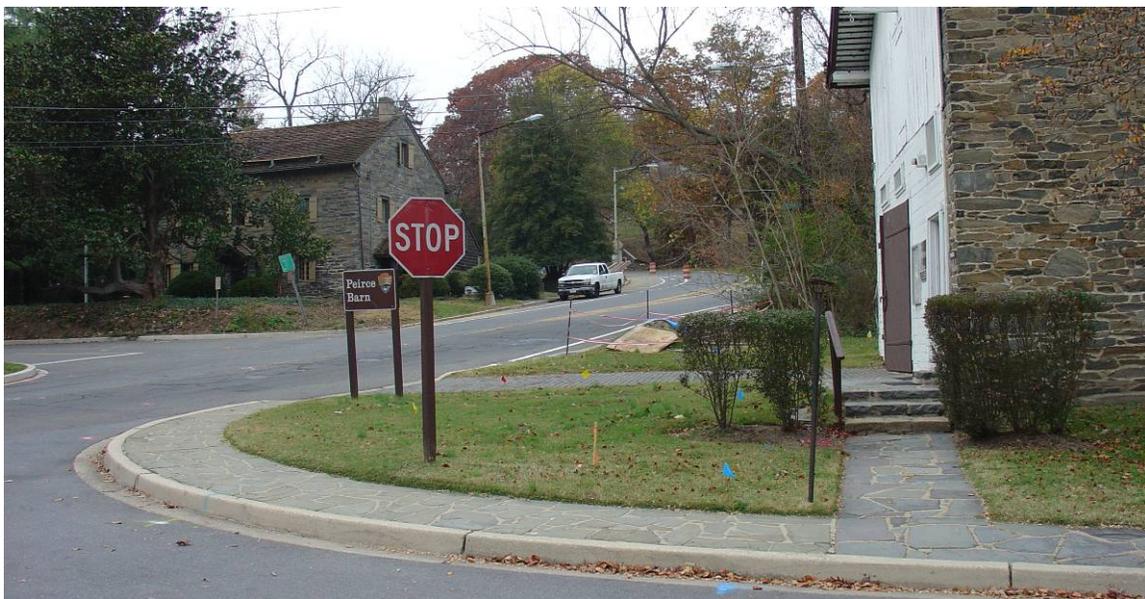
**Figure 4- 32: Informational and Regulatory signs at the Peirce Mill Barn, 2008.** (source: QEA 2522)

Additional signage was developed during the 1960-1980s to assist in the interpretation of the site. The current signage around the Peirce Mill landscape includes informational signs, regulatory signs, and interpretive signs and waysides. Informational signs are brown metal signs with white lettering, mounted on brown posts (see Figures 3-29 and 4-32). Regulatory signs are also mounted on brown posts and are metal signs, but their colors and symbols respond to standards for traffic and directional signs (see Figure 4-32). Interpretive signs and waysides vary to include the kiosk north of the Mill (see Figure 3-30), a simple interpretive sign with text on the west side of Peirce Mill (see Figure 4-33), and waysides with color graphics (see Figure 4-34).

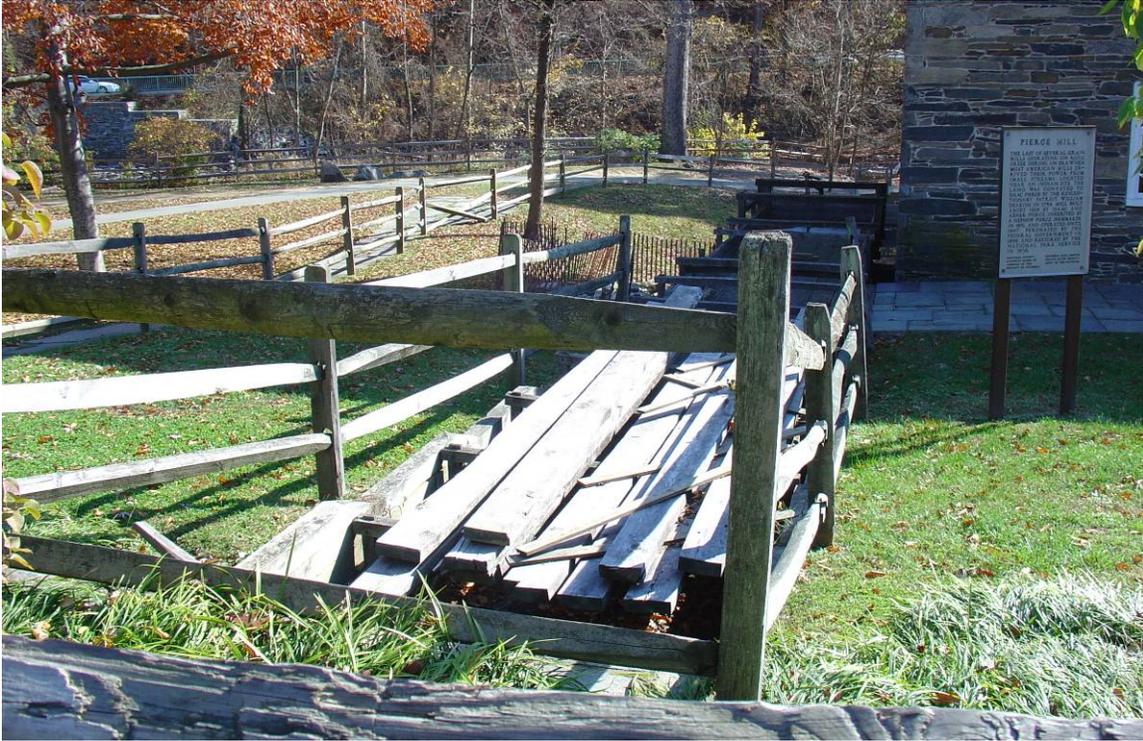
Figure 4- 33: Interpretive sign, headrace, and fences at Peirce Mill, facing east, 2008. (source: QEA 2511)

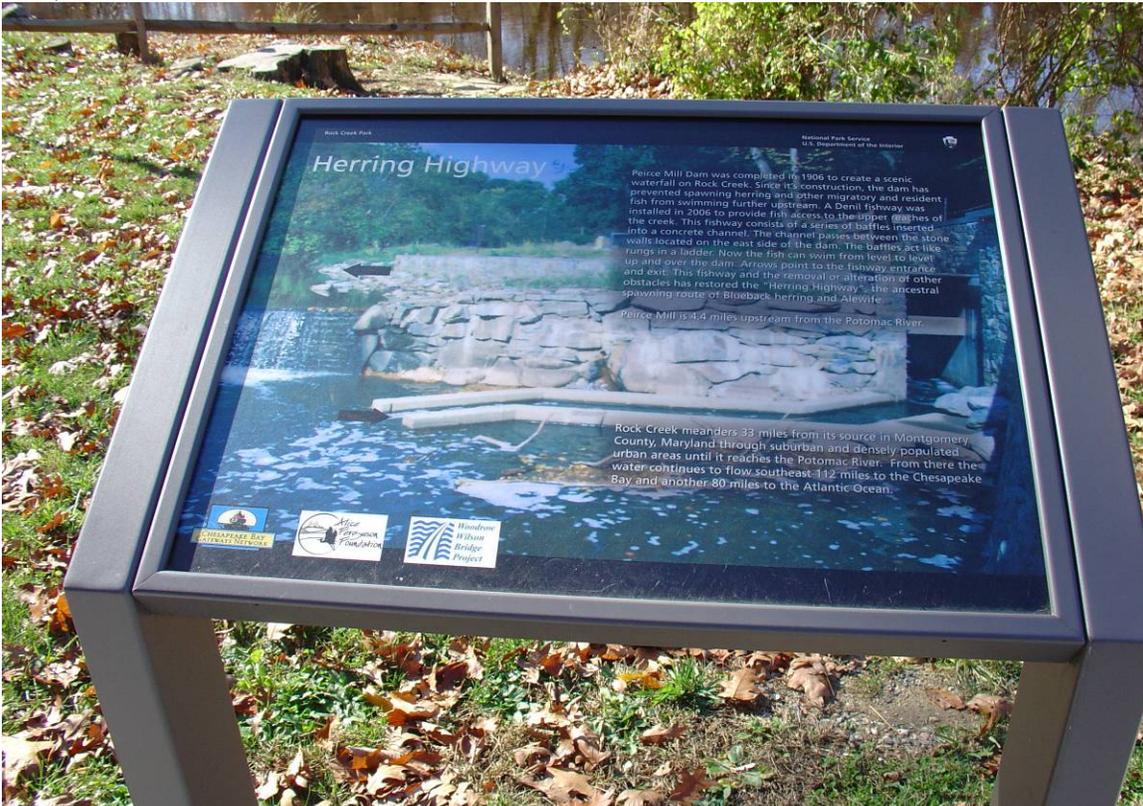
Figure 4- 34: Wayside with information about the fish ladder at Peirce Mill, 2008 (source: QEA 2381)

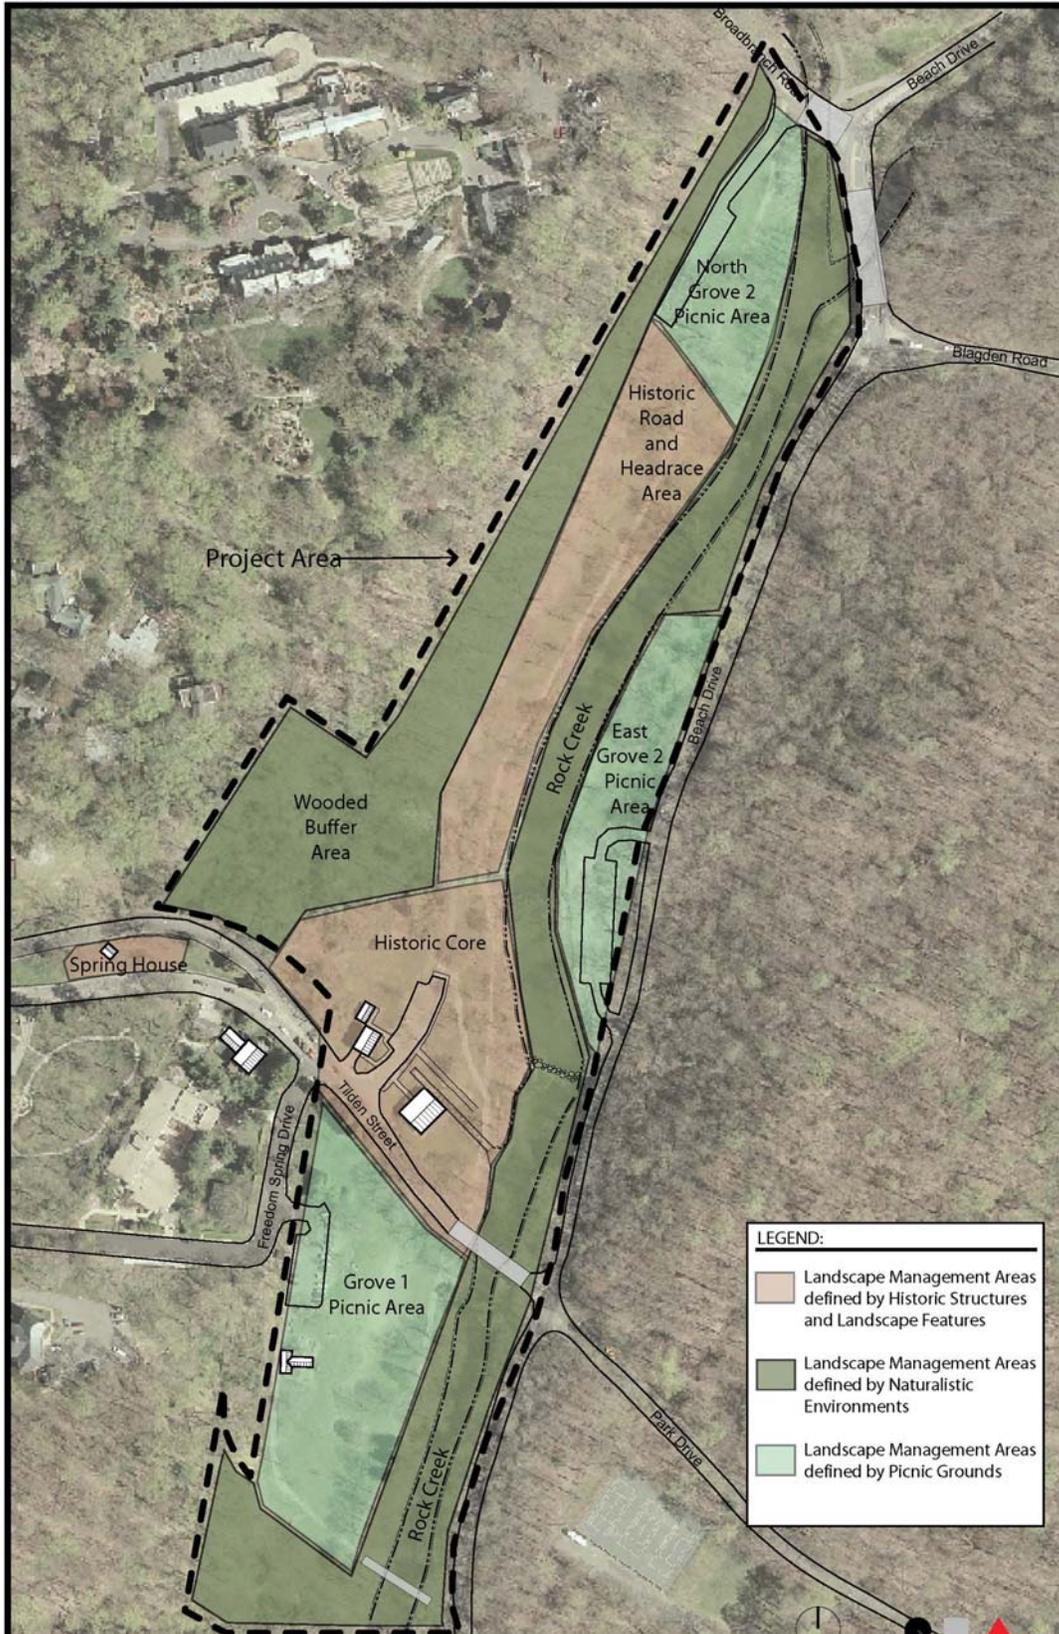
Figure 6- 1: Peirce Mill Landscape Management Areas.

Eight landscape management areas have been identified to organize the discussion of treatment alternatives. They are illustrated in Figure 6-1. Three landscape management areas are defined by historic resources. These include: 1) the historic core; 2) the springhouse area; and 3) the historic road and headrace area. Two landscape management areas are defined by naturalistic environments, including: 1) the wooded buffer area; and 2) the Rock Creek area. The three landscape management areas that are defined by picnic grounds are: 1) the north Grove 2 area; 2) the east Grove 2 area; and 3) the Grove 1 area.

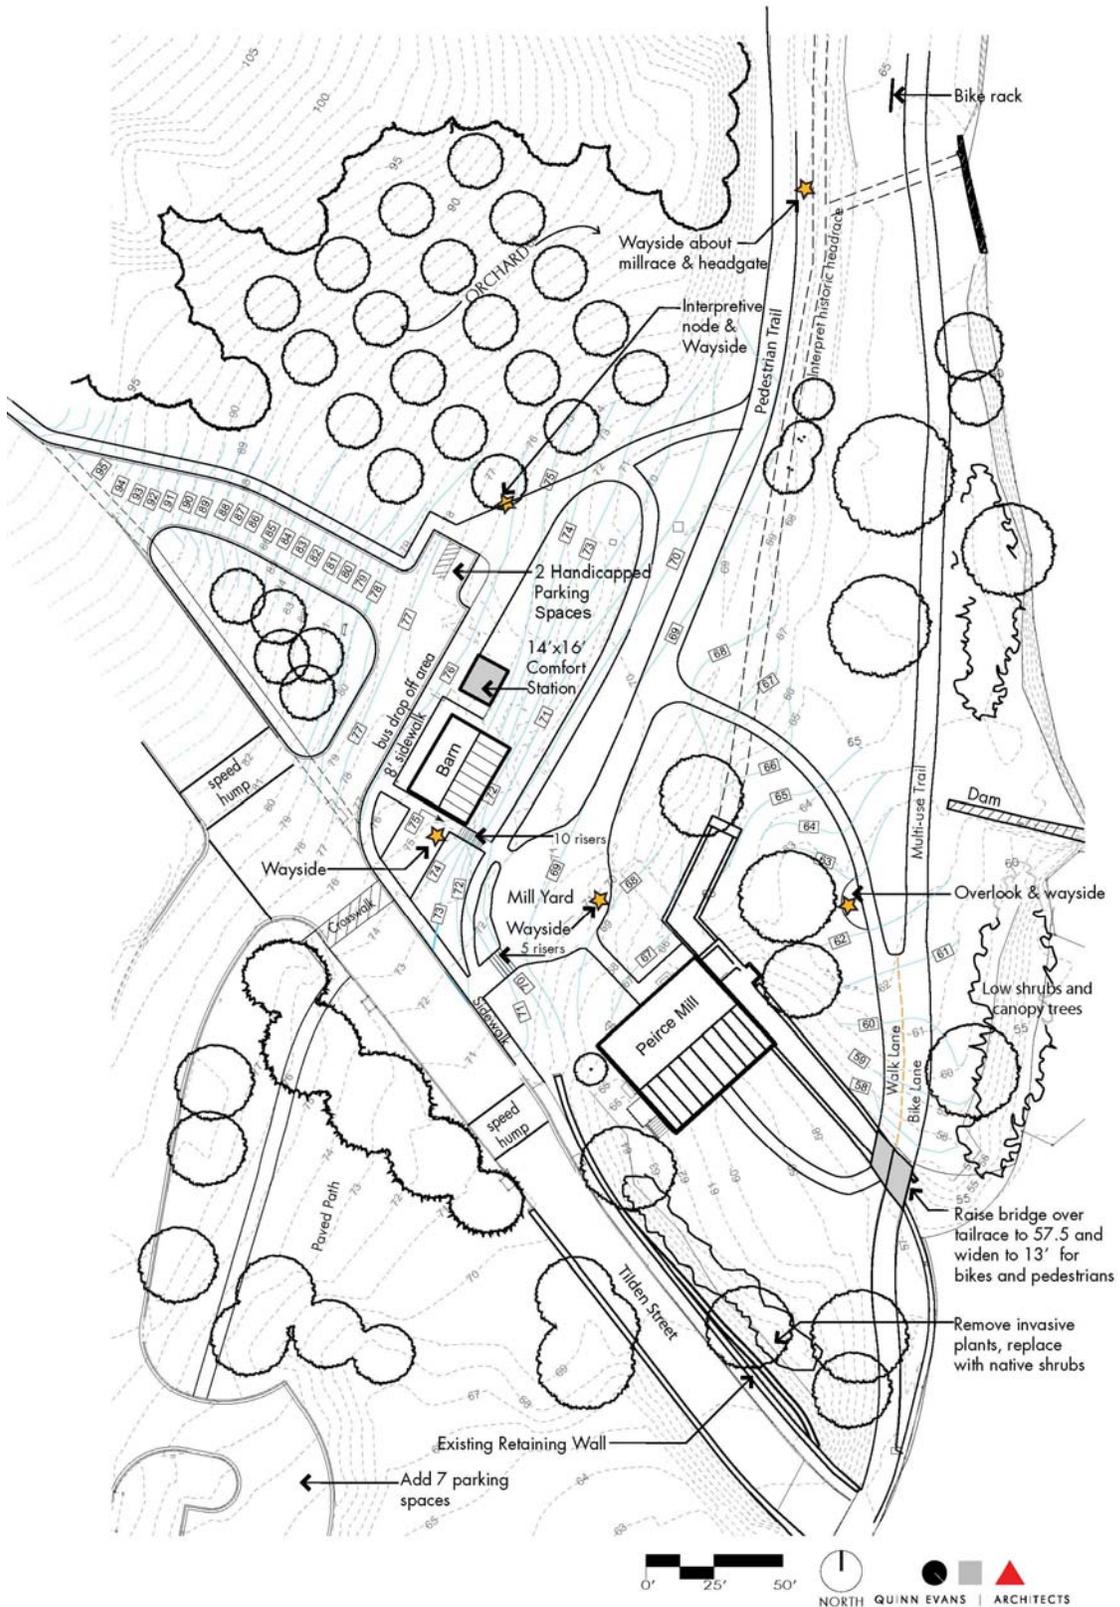
**Figure 8- 1: Historic Core Recommended Treatment Plan.**

The recommended treatment design for the historic core enhances the ability of the site to represent the historic activities and creates a pedestrian oriented experience for visitors. Appendix A provides an overview of the treatment alternatives that were developed and evaluated as part of the project process. The recommended treatment plan represents a combination and refinement of features presented in alternatives B, D, and E (see Appendix A).

A pedestrian gathering space, or mill yard, is established between the Mill and barn emphasizing a strong relationship between the Mill, mill yard, and the extant route of the historic road. Vehicular traffic and parking is removed from the area between the Mill and barn and replaced with a pedestrian gathering space with routes that are accessible for visitors with mobility impairments to the main and lower levels of the Mill, barn, new comfort station, parking, drop-off and all of the waysides. The grade at the mill yard is lowered to relate more directly to the Mill, as it would have before Tilden Street was raised. The elevation of the mill yard is approximately three feet lower than Tilden Street. An accessible route from the mill yard to Tilden slopes at 4-1/2% grade. In addition, steps lead down from Tilden Street to the mill yard following an alignment that reflects the general route of the historic road. An ADA accessible replacement comfort station, measuring approximately fourteen feet by sixteen feet, is located to the north of the barn near the visitor drop-off and accessible parking area.

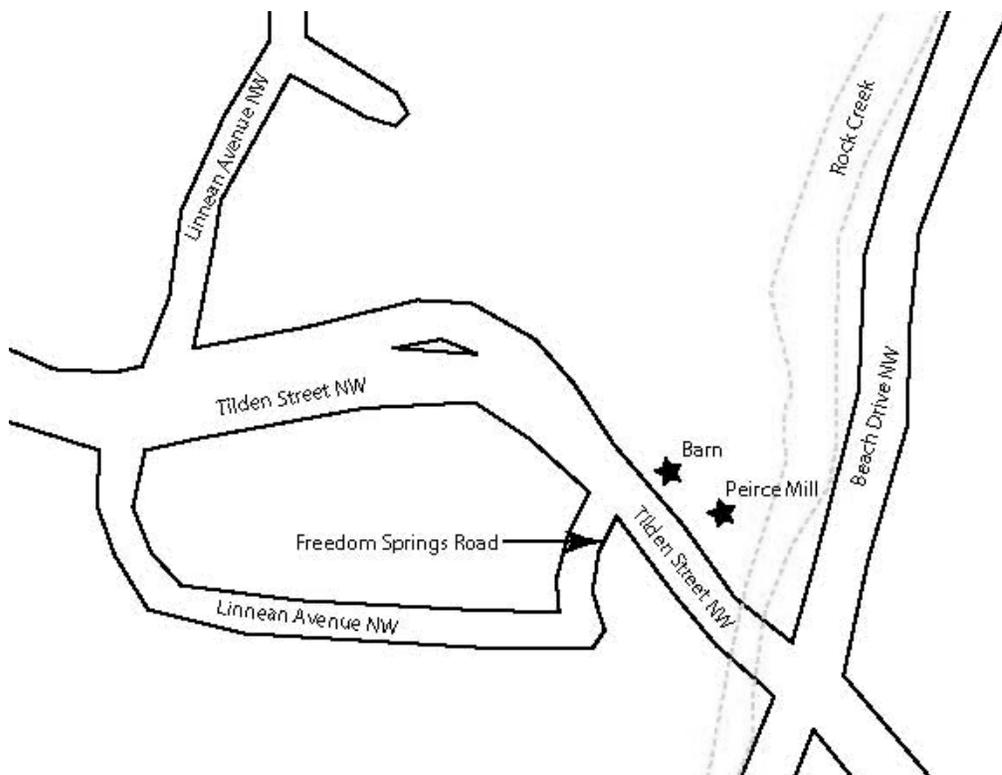
**Figure 7- 1: Streets used for bus circulation.**

Curb cuts are provided on Tilden Street to accommodate a bus drop-off loop road. Signs are provided on Tilden Street directing eastbound bus drivers to turn south onto Linnean Avenue NW and follow the loop drive past the Grove 1 area to its intersection with Tilden Street. A sign is provided directing bus drivers to turn left and use the drop-off lane. In coordination with DDOT, a bus pull-off parking lane is established along Linnean Avenue near the Grove 1 area and two pedestrian crosswalks are provided at Tilden Street with traffic calming measures along Tilden toward the bridge and up the hill on the west.

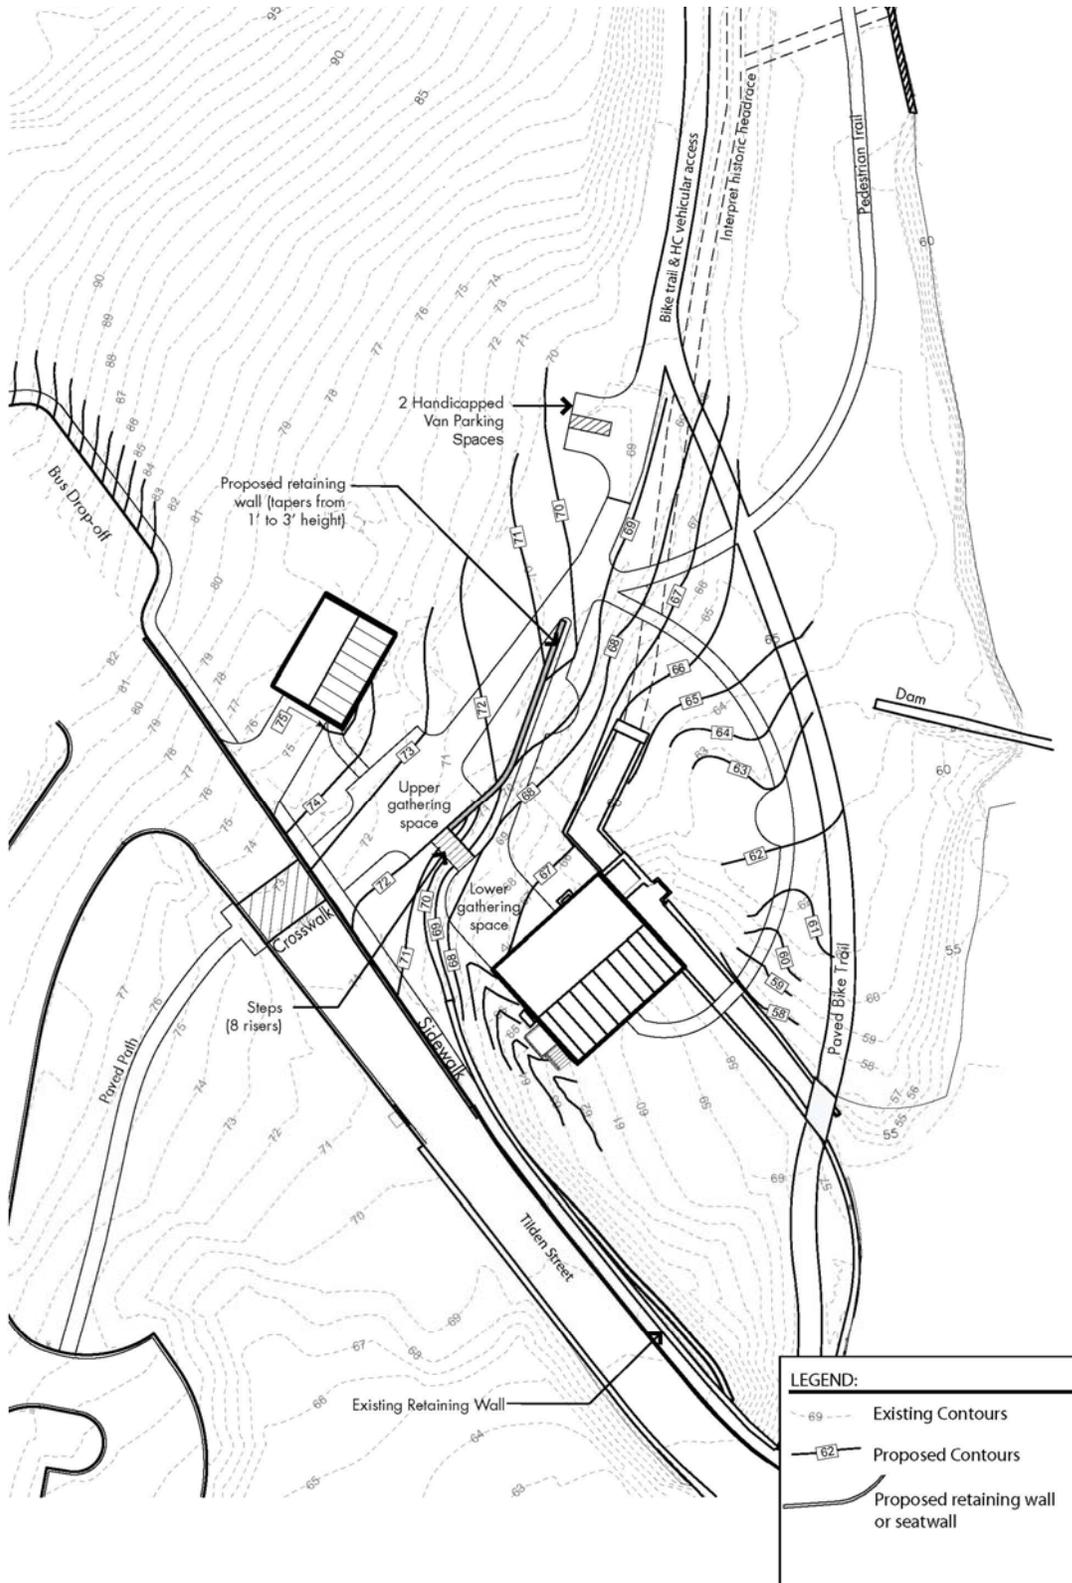
Figure 7- 2: Historic Core Site Design Alternative A, Conceptual Grading.

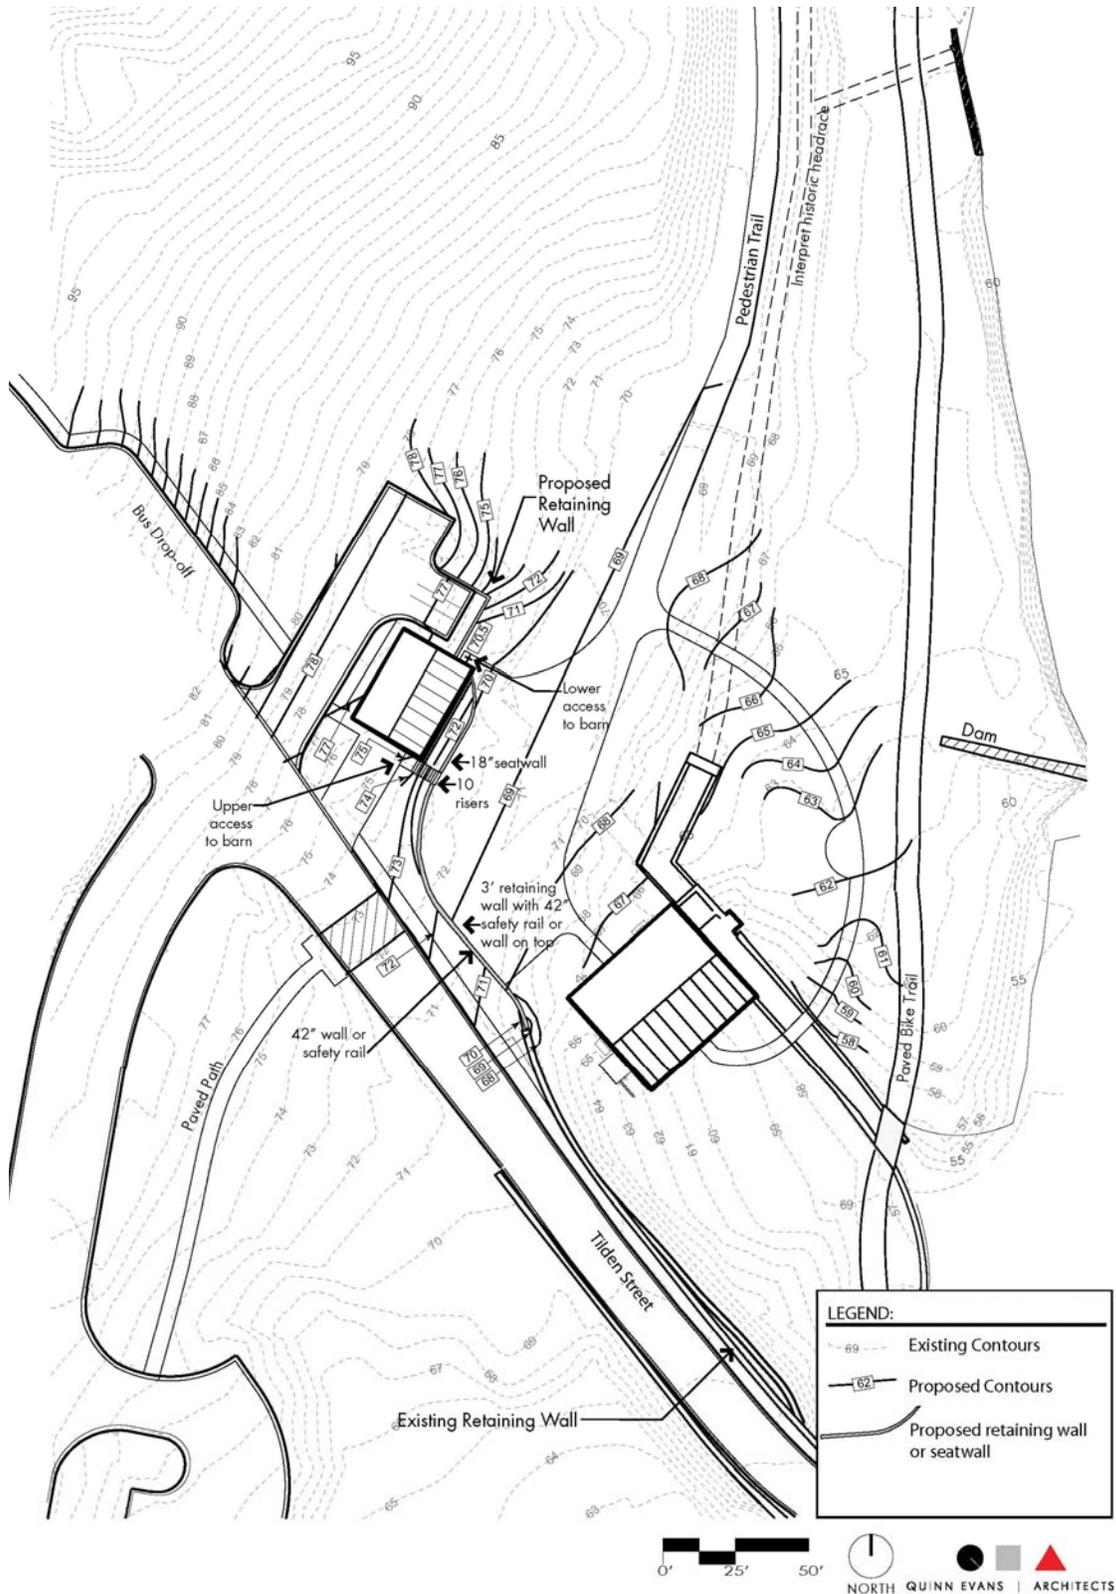
Figure 7- 4: Historic Core Site Design Alternative B, Conceptual Grading.

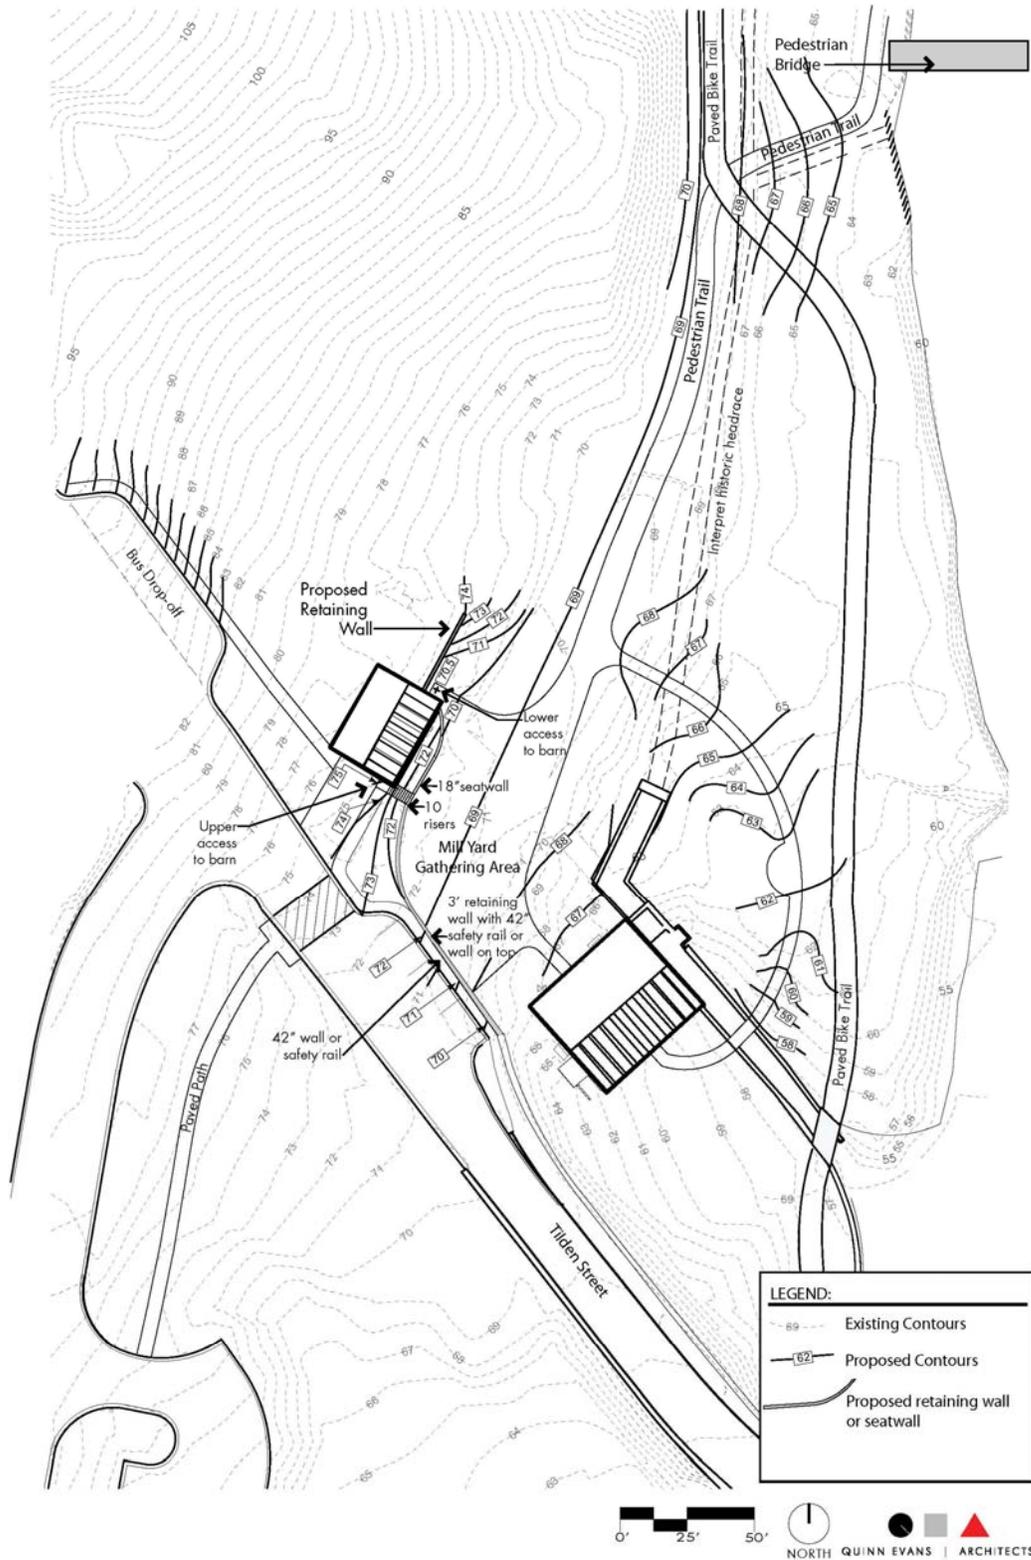
**Figure 7- 6: Historic Core Site Design Alternative C, Conceptual Grading.**

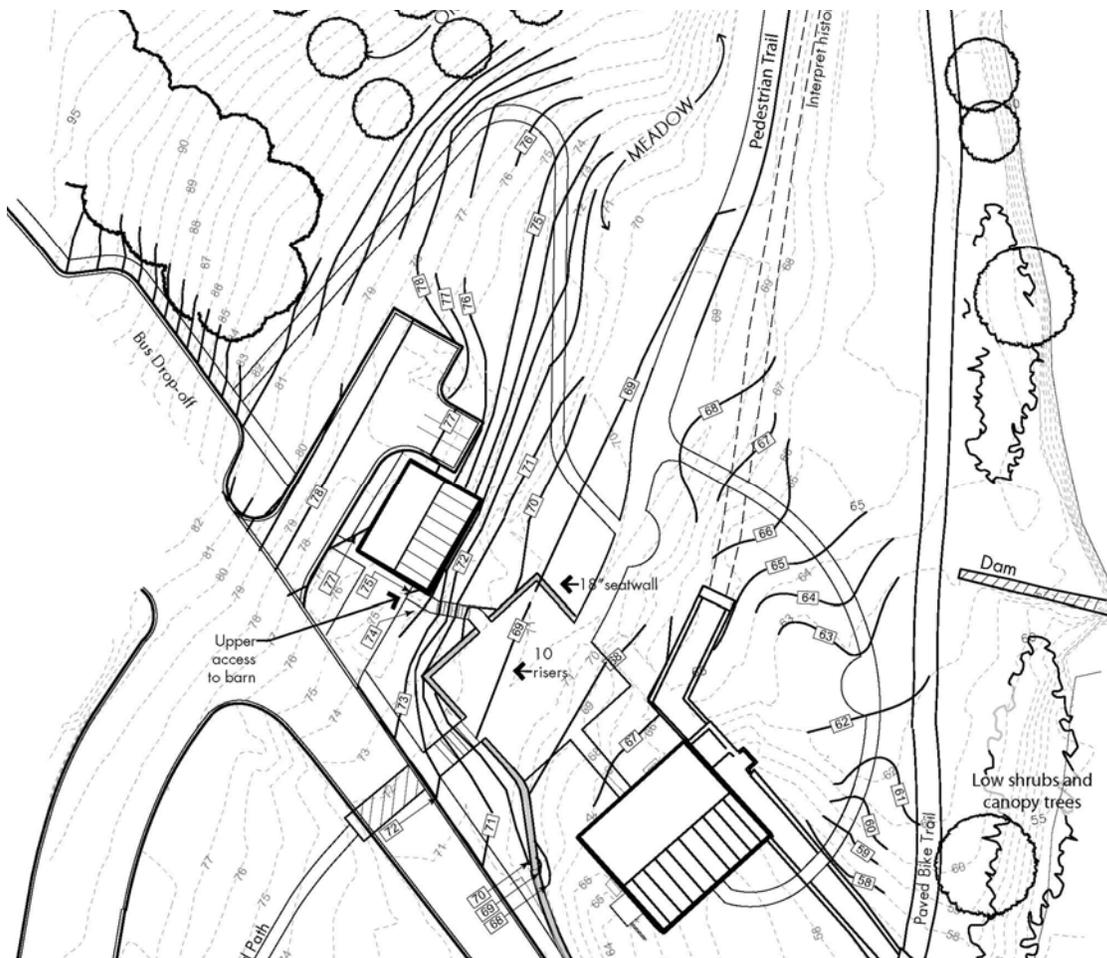
Figure 7-8: Historic Core Site Design Alternative D, Conceptual Grading.

Alternative D is illustrated in Figure 7-8. This design is similar to Alternative B with a few alterations to improve access for visitors with mobility impairments while limiting impacts to the historic landscape. A pedestrian route not exceeding 4-1/2 percent slope provides a link from the bus drop-off to the pedestrian trail at the level of the mill yard. This scenario was rejected because the bus drop-off area would need to be at the same grade as Tilden Street, approximately fourteen percent, and would limit the type of vehicle that could drop-off visitors with mobility impairments. In addition, this layout would require visitors parked in the handicap parking spaces to take a circuitous route to reach the mill yard and mill.
