# PEIRCE MILL COMPLEX

## Cultural Landscape Report

### CULTURAL LANDSCAPE REPORT

PREPARED BY:  
QUINN EVANS | ARCHITECTS  
1214 TWENTY-EIGHTH STREET, NW  
WASHINGTON, DC 20007

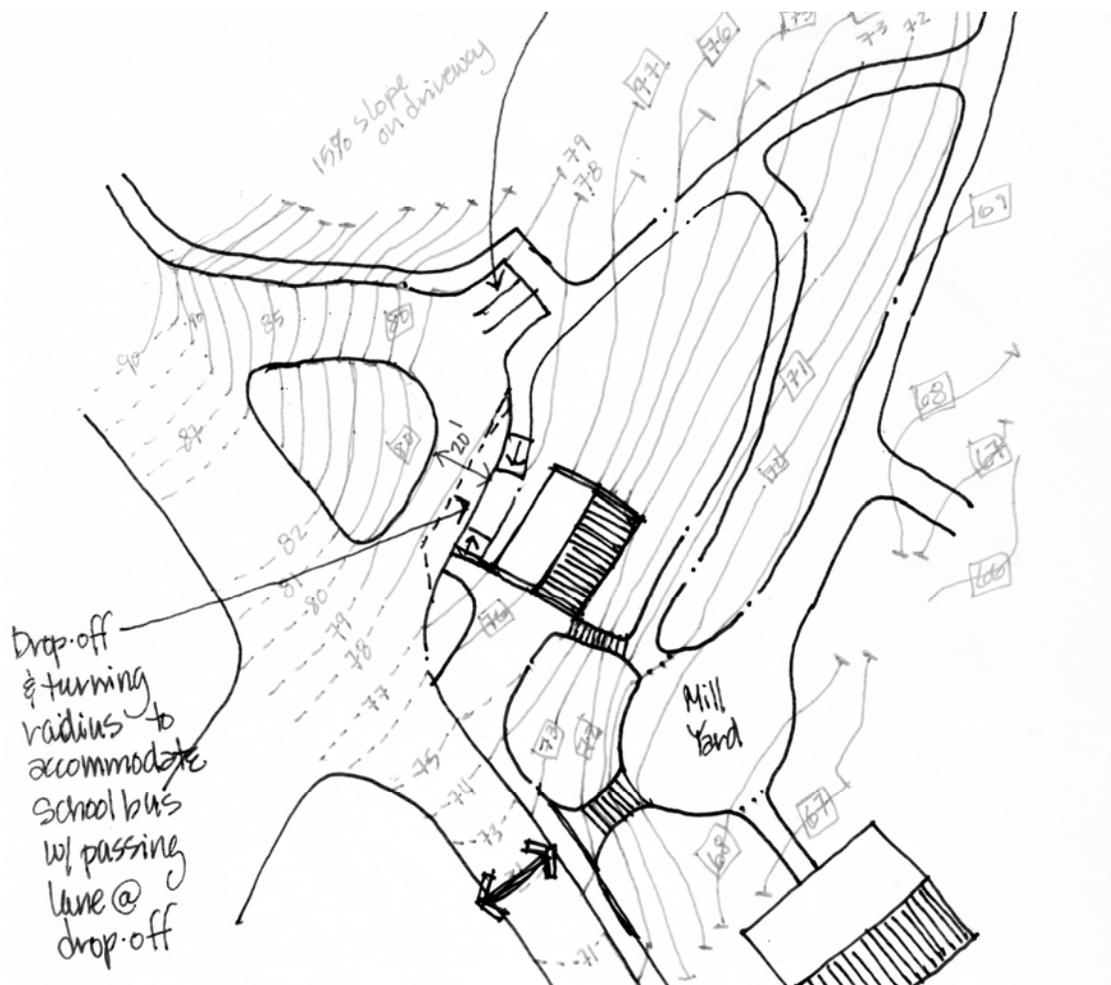
Figure 7- 9: Conceptual Drop-off Design Alternative E, Conceptual Grading.

In this alternative, illustrated in Figure 7-9, the bus drop-off area is designed to accommodate one school bus with room for a passenger vehicle to pass the bus. A loop road takes advantage of the existing topography to accommodate passenger drop-off. The drop-off area is adjacent to the west side of the barn and connected with paved walkways to the barn entrance and the mill yard area. The walkways do not exceed 4-1/2 percent slope. Two handicap accessible parking spaces are provided on the north end of the loop road, allowing easy access to the accessible walkways, buildings, and site features. Also, the size of the mill yard has been reduced, eliminating the need for retaining walls along its south and west sides, and better reflecting a possible historic size. The form of the mill yard was modified to soften the edges.

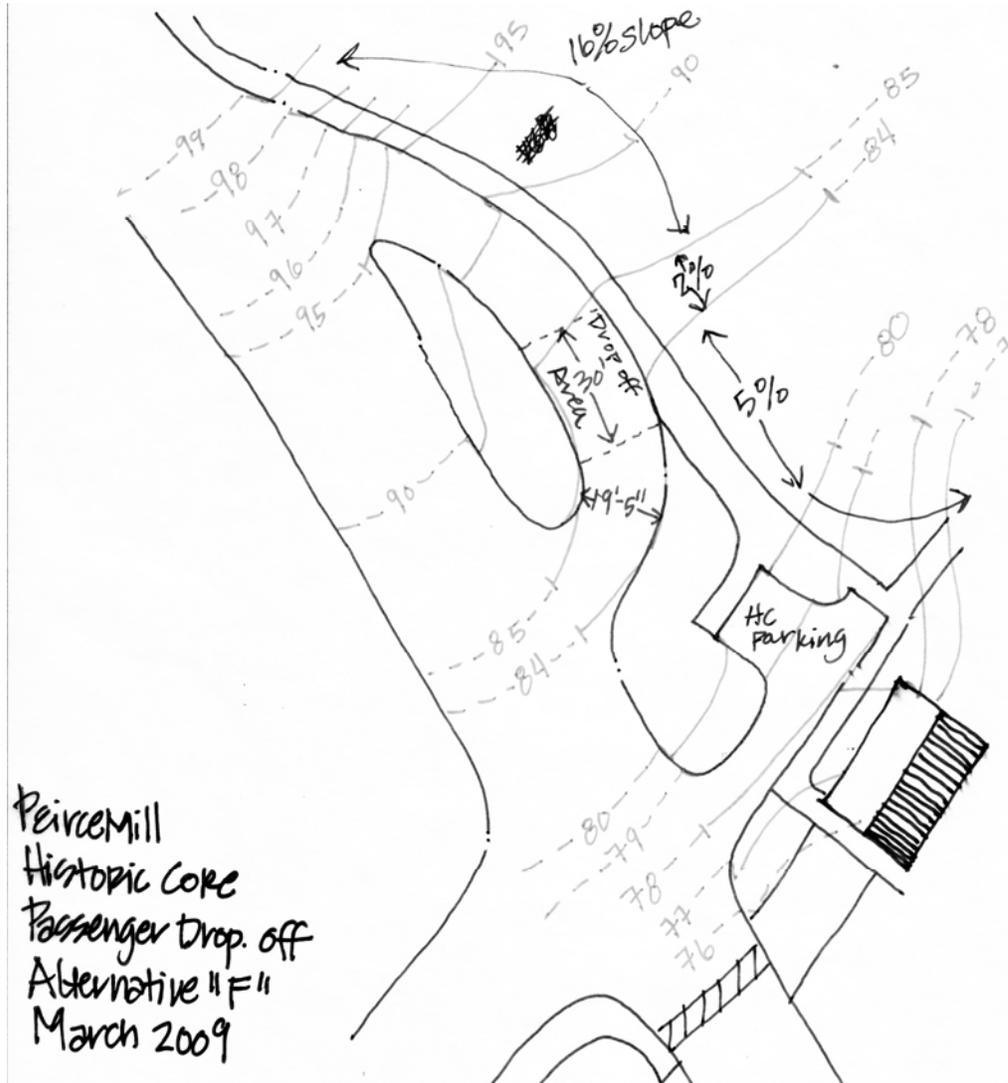
This scenario provides a bus drop-off to accommodate one school bus in a loop configuration parallel to Tilden Street. This scenario was rejected because it would require extensive grading and would not provide an optimal sequence for visitors.

Figure 7- 10: Conceptual Drop-off Design Alternative F, Conceptual Grading.

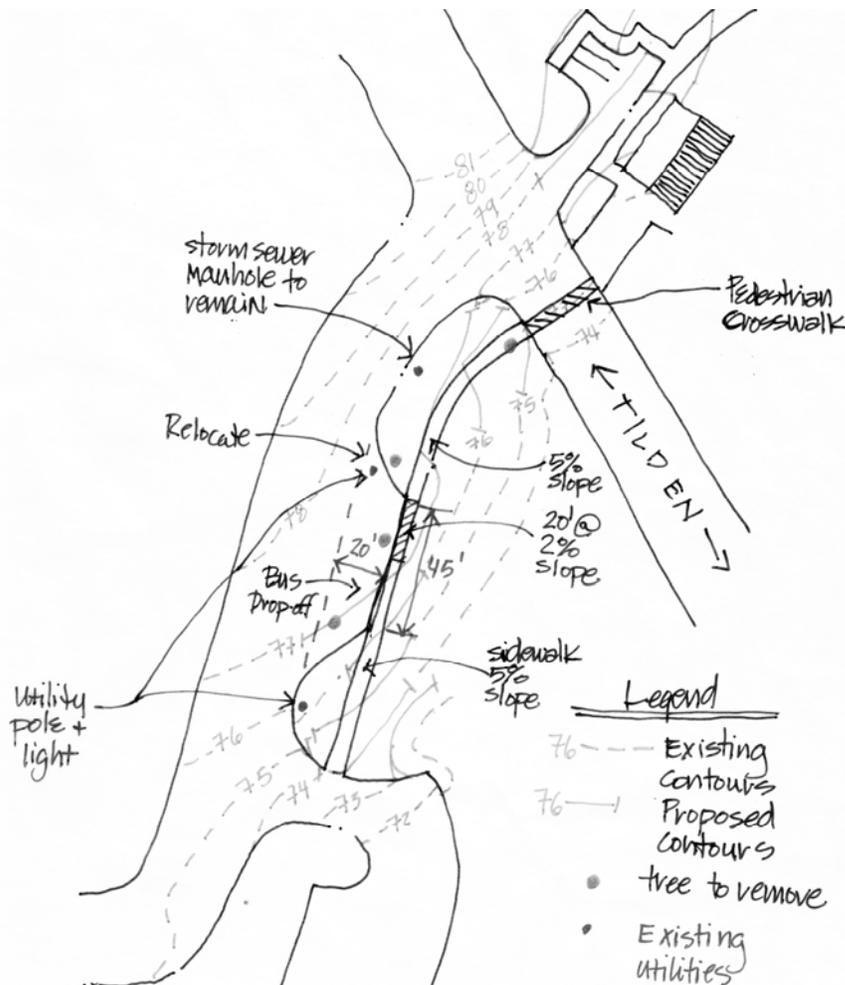
Figure 7- 11: Conceptual Drop-off Design Alternative G, Conceptual Grading.

Alternatives G and H explore the concept of providing the bus drop-off on Freedom Springs Road. The main difference between the two is that Alternative G, illustrated in Figure 7-11 provides a drop-off area for one school bus and Alternative H, seen in Figure 7-12, provides space for two school busses. After disembarking from the bus, visitors would go across Tilden Street to the Peirce Mill Complex via an accessible pedestrian route. The topography is better suited for pedestrians, as it is much less steep. However, Tilden Street accommodates many vehicles that move quickly with limited sight lines, making it a dangerous crossing location for pedestrians. The underpass at the bridge provides an option for able-bodied visitors, but does not accommodate visitors with mobility impairments. These alternatives were rejected due to concerns about requiring large groups of school children to cross Tilden Street.

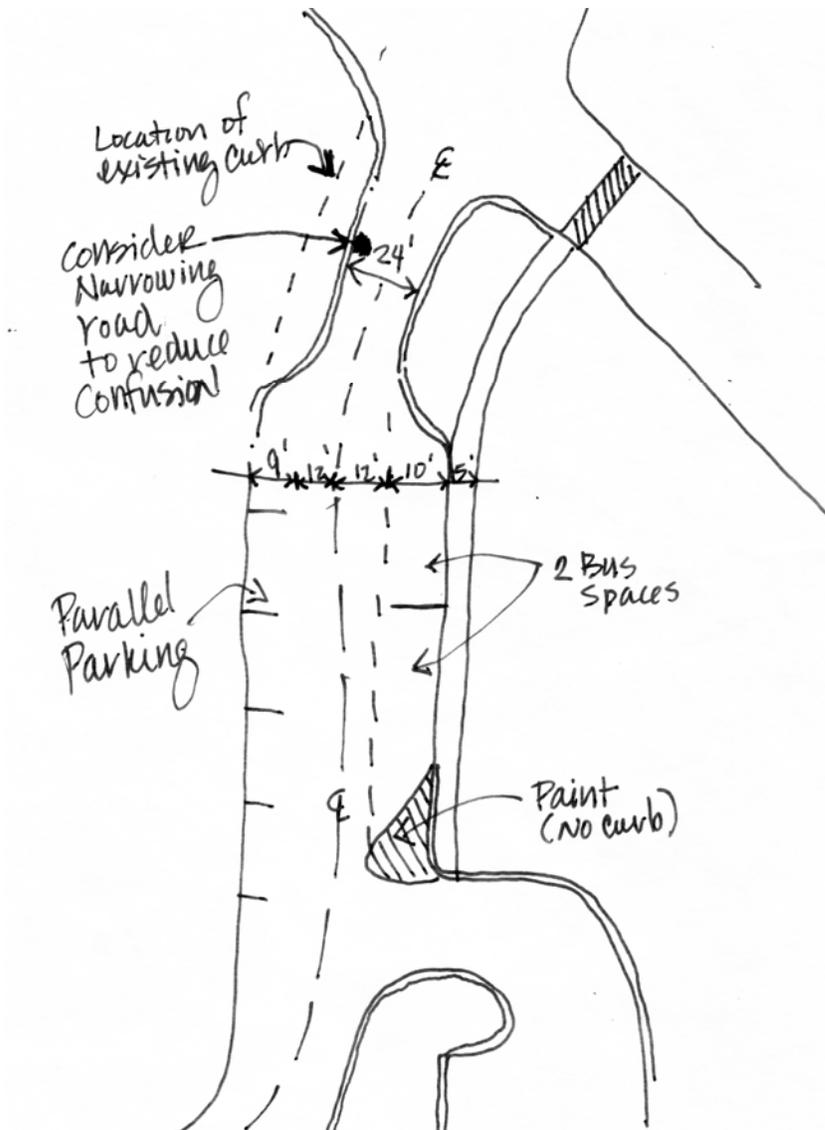
Figure 7- 12: Conceptual Drop-off Design Alternative H.
