Gray Cottage

Sagamore Hill National Historic Site
Oyster Bay, New York

HISTORIC STRUCTURE REPORT

**James J. Lee III
Architectural Conservator
Historic Architecture Program
Northeast Region, National Park Service
Lowell, Massachusetts**

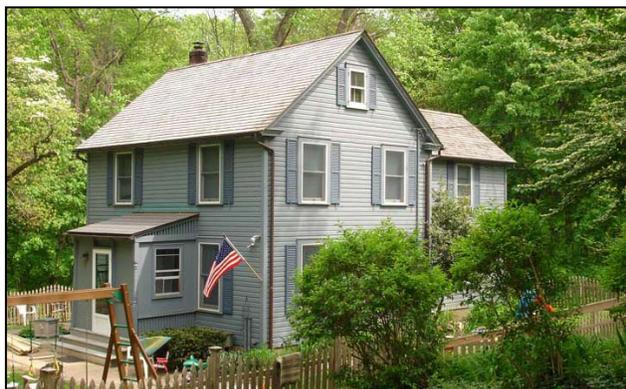
Figure 3. Gray Cottage looking southeast, 2009.

The current views of Gray Cottage depict the main/north block and south ell/1964 addition of the building (figs. 3 and 4). Gray Cottage is situated approximately 800 feet southeast of the main house in a low-lying wooded lot. The following information is selected and cited from the current LCS data for Gray Cottage.¹⁵

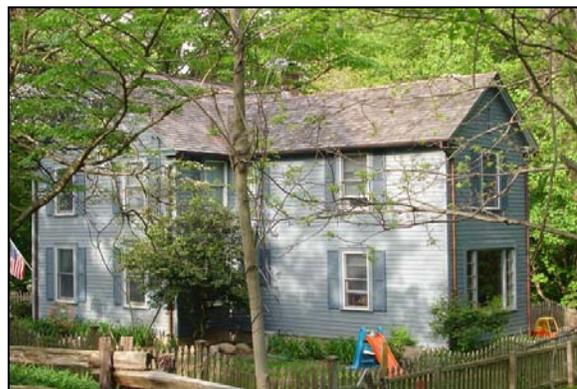
Figure 4. Gray Cottage looking northeast, 2009.

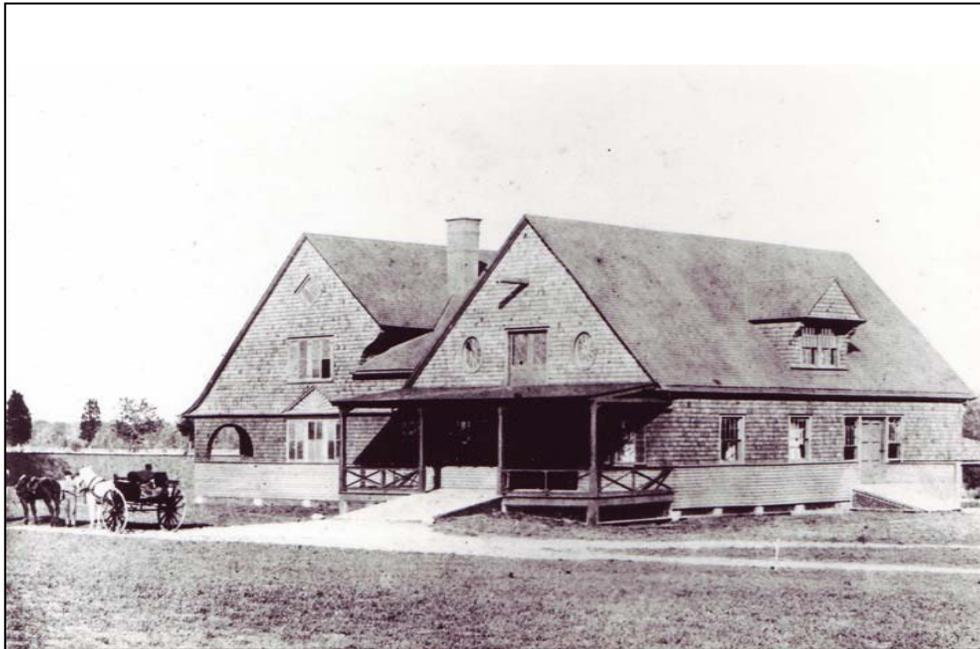
Figure 10. The west elevation of the Stable and Lodge at Sagamore Hill, circa 1905.

TR hired the architectural firm of Hugo Lamb and Charles A. Rich to design a stable and lodge for the property, in the Queen Anne style of the Victorian era. Local builders, John A. Wood & Son, were contracted to build the Stable and Lodge in 1883 (fig. 10).³²

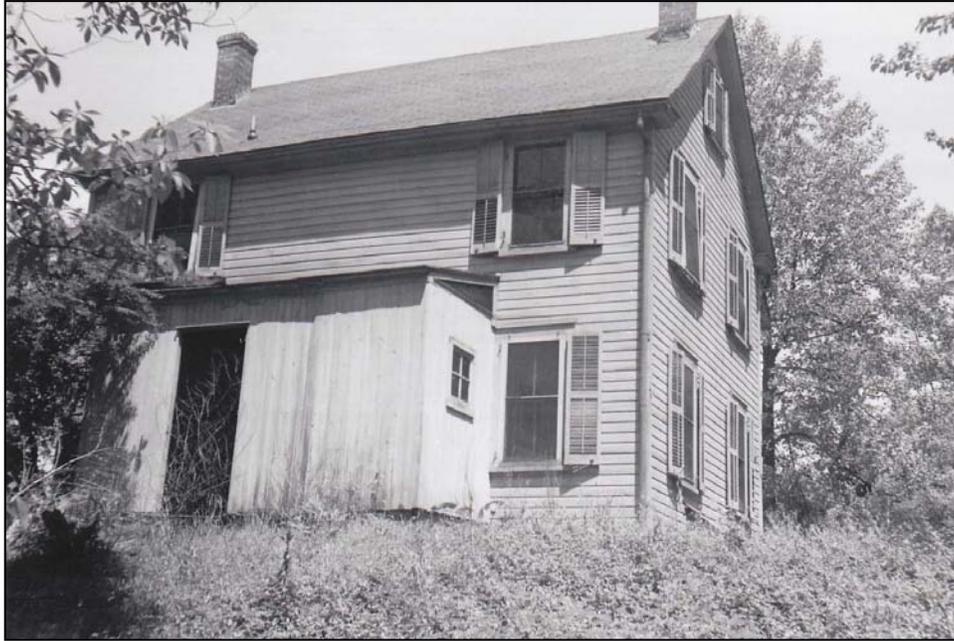
Figure 18. Gray Cottage, south and east elevations, 1950. The photograph depicts Gray Cottage prior to alterations by the TRA in the early 1950s, and is the earliest known photograph of the building.

Both the 1950 insurance photograph and description indicated that there was an enclosed porch on the south elevation at that time (fig. 18). The porch was later removed by the TRA, and no further documentation of the south porch exists. The south porch was probably constructed as an open porch and enclosed when the front porch was enclosed. However, there was no extant evidence of that porch to determine the original configuration.

Enclosing the front porch appeared to be the most significant exterior change during the historic period. The 1950 insurance photograph indicated that the back porch was also enclosed (fig. 18). That was evident from the presence of shutter hardware but the absence of the shutter on the first-story window opening (W104). The alterations to the back porch may have coincided with the work on the front porch. Paint evidence indicated that Gray Cottage was routinely painted on a schedule that probably coincided with the painting of other buildings on site (Appendix A, “Gray Cottage Exterior Paint Analysis”). The physical evidence suggested that there were no other significant alterations to the exterior of Gray Cottage during the Roosevelt period.

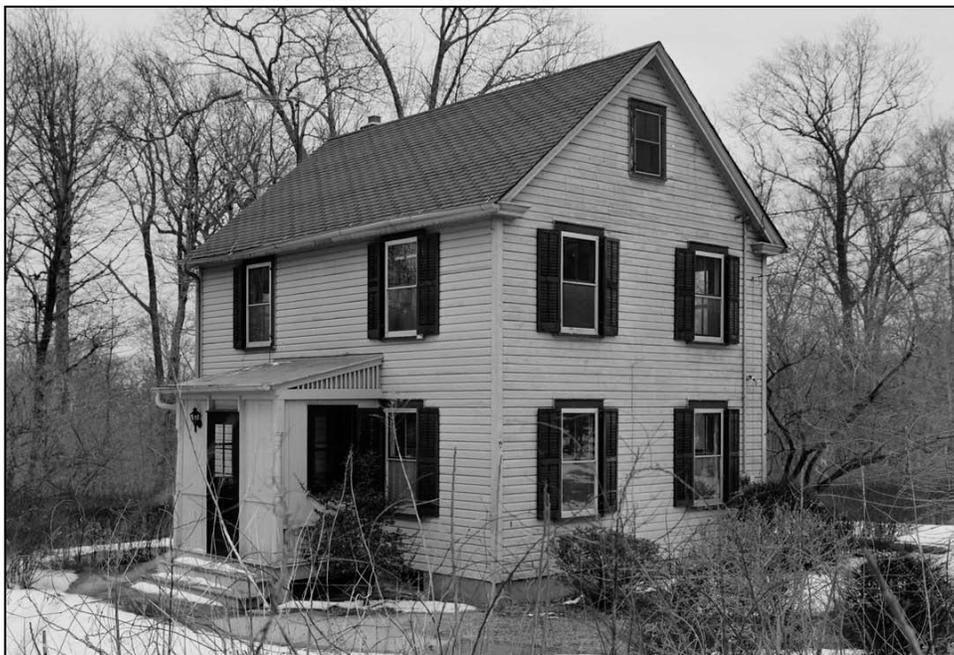
Figure 19. Gray Cottage, north and west elevations, 1963. The photograph depicts the original two-story, side-gabled structure with some alterations.

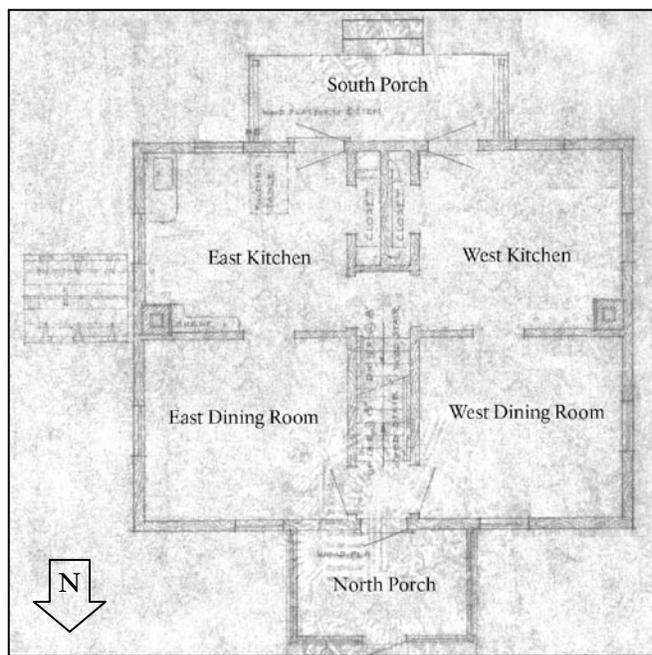
Figure 20. Gray Cottage, conjectural historic plan of first story.

Historical accounts and some physical evidence suggested that the first story of Gray Cottage was configured for two apartments. The front doorway (D102) opened into a small foyer that had a doorway on the east wall (D105), and one on the west wall leading to the respective apartments. The foyer also had access to the center staircase that ascended to the second-story hallway.

Since Gray Cottage was constructed for two families, it was conjectured that the west side of the first story was configured like the east side (fig. 20). However, the west side of the building was altered during the historic period, and the original

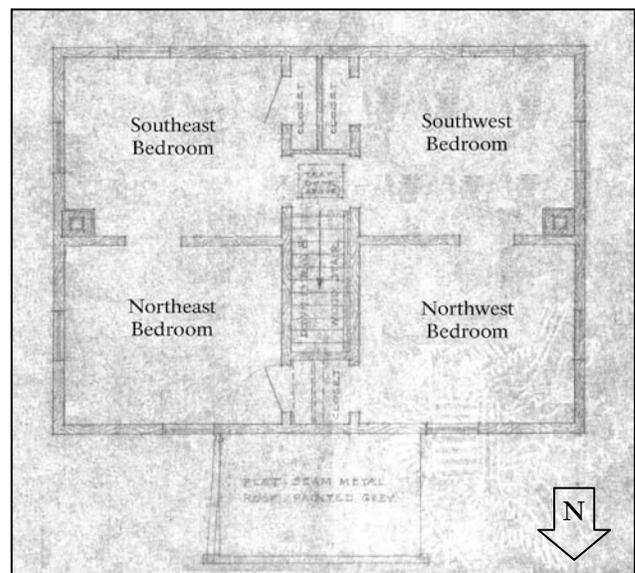
Figure 21. Gray Cottage, conjectural historic plan of second story, depicting a common hallway and staircase with separate bedrooms.

According to Lukens's description of the second story, the west side of the building retained the original two rooms with the addition of a bathroom in the southeast corner of the southwest room (fig. 21). The bathroom and associated partitions were added during the historic period, and were recorded in the 1950 and 1963 documents. The extant physical evidence indicated that the original layout of the west-side rooms included a closet doorway in the northeast corner that accessed a common closet (D205). It was conjectured that the east and west sides of the second story had a similar plan when first constructed, which was supported by Lukens's observations. However, the configuration of the living space on the second story was not documented prior to 1950.

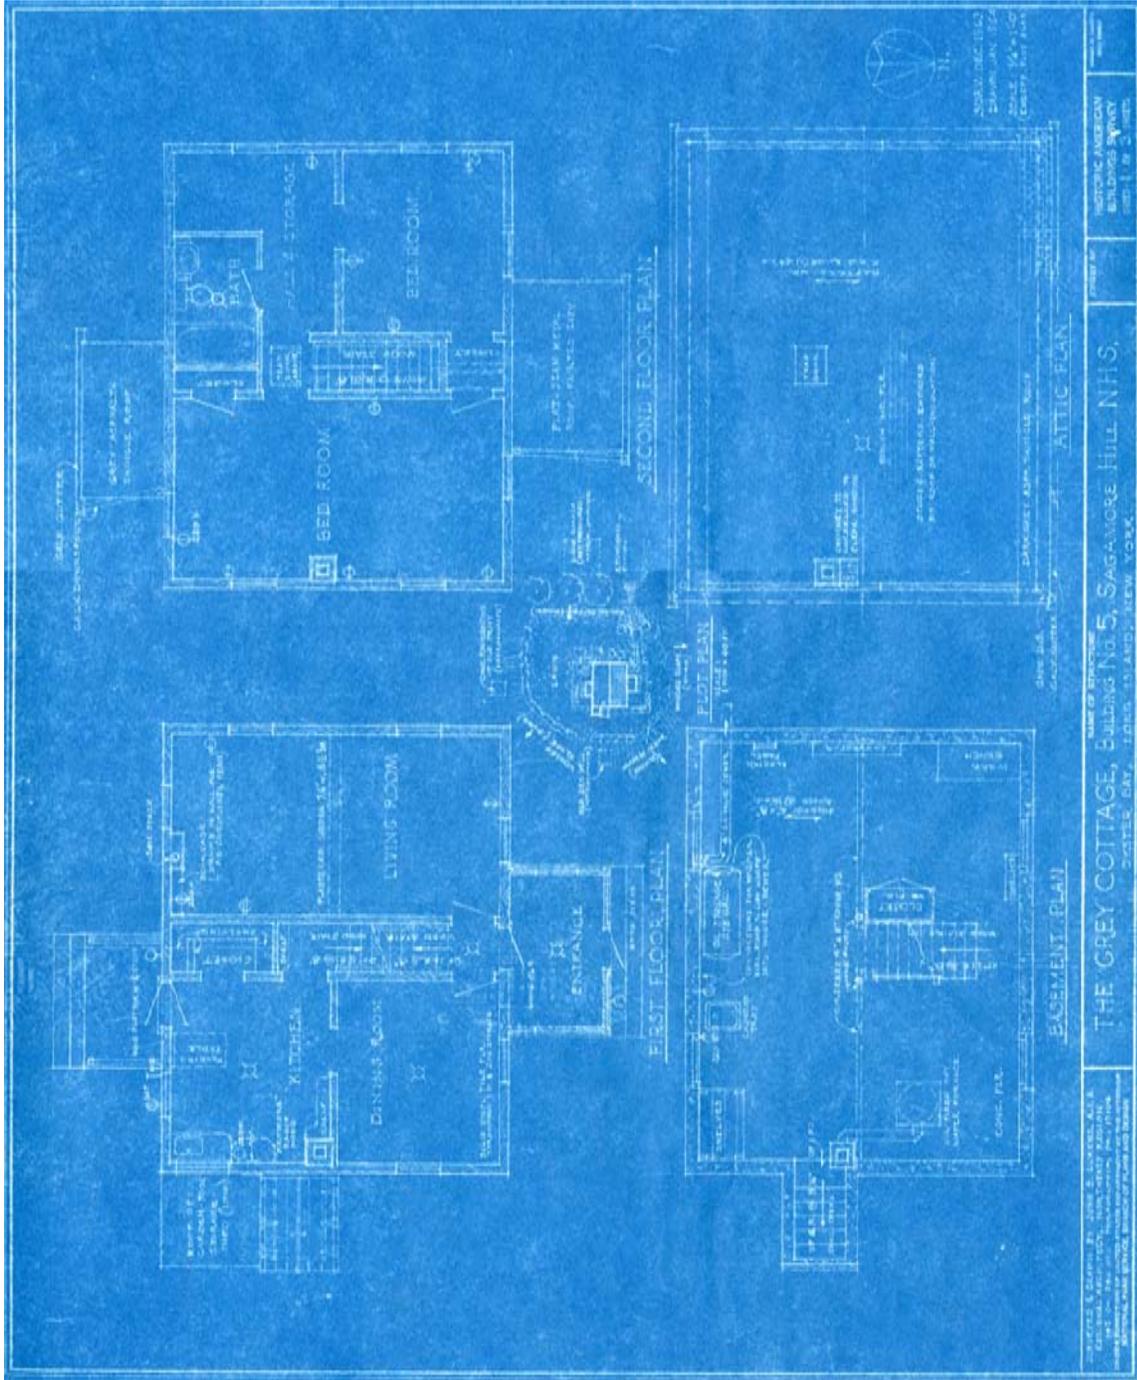
Figure 22. The Grey Cottage, Building No. 5, Sagamore Hill NHS, Historic American Buildings Survey, Sheet 1 of 3 sheets. Reproduced from full-size blueprint; not to scale.

The plan of the first story as a single-family residence was documented by the HABS drawings (fig. 22). The 1950 insurance description provided documentation of the building during the historic period and described a single-family home.⁹¹

The description of the building in 1950 does not vary significantly from the building depicted in the 1963–64 HABS plans. Thus it seemed likely that the floor plans depicted in the HABS drawings were similar to the historic layout after the earlier alteration of Gray Cottage from a two-family to a single-family residence. The HABS drawings and photograph documented the existing building when the NPS established Sagamore Hill NHS.

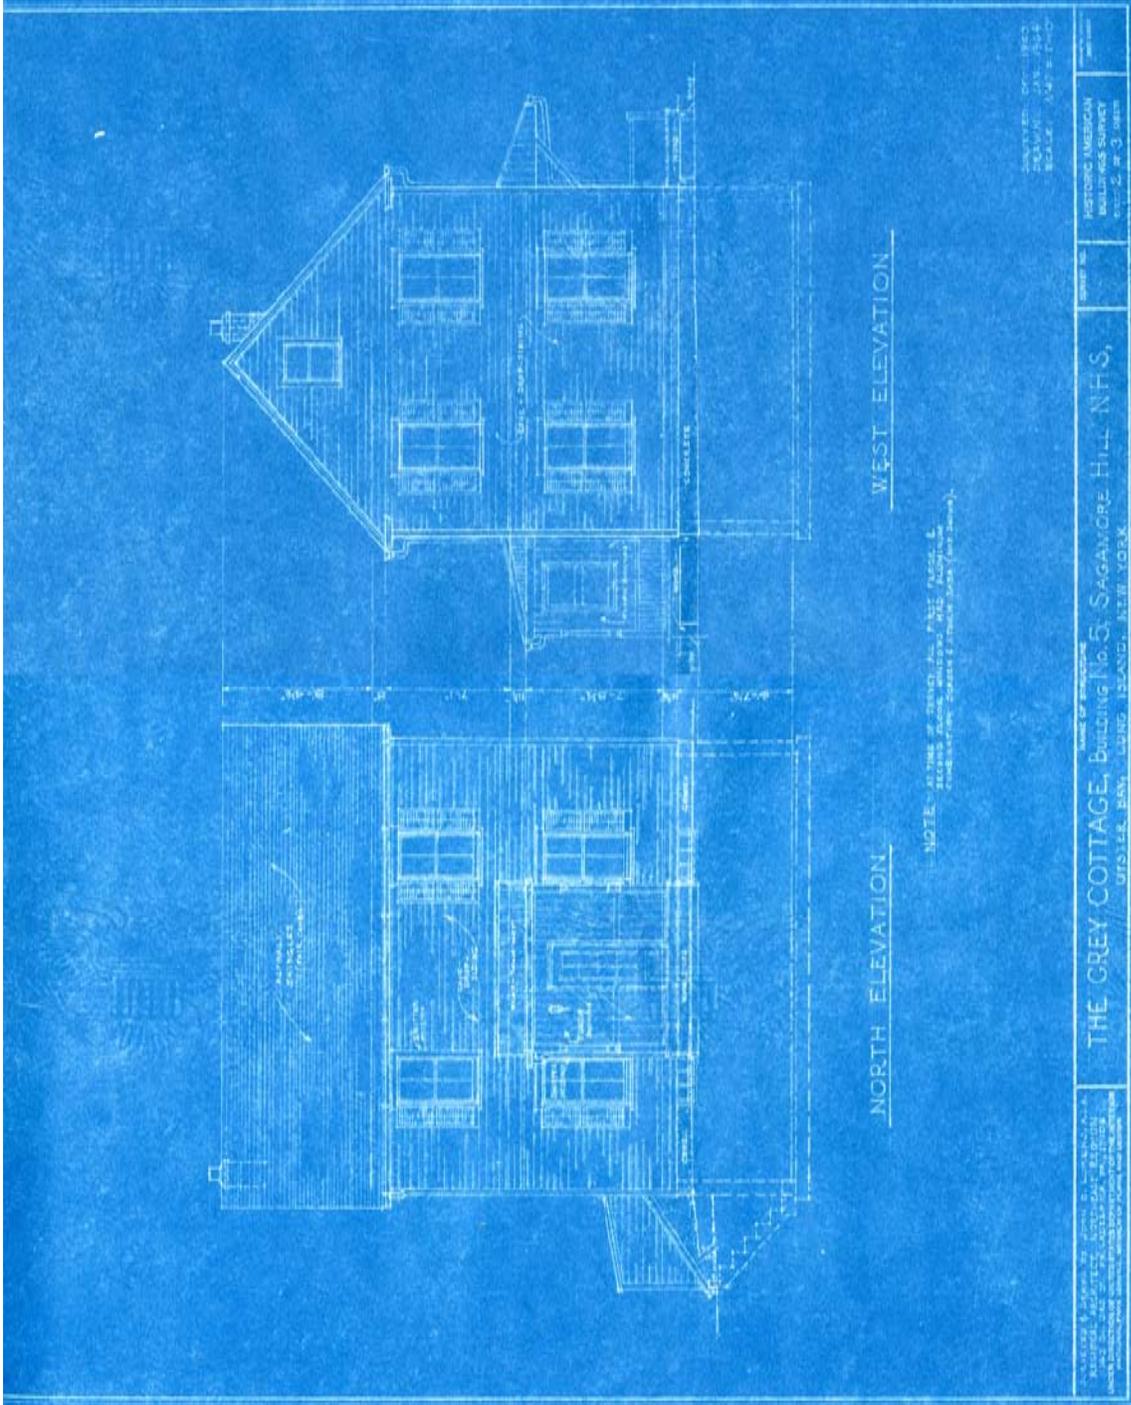
Figure 23. The Grey Cottage, Building No. 5, Sagamore Hill NHS, Historic American Buildings Survey, Sheet 2 of 3 sheets. Reproduced from full-size blueprint; not to scale.

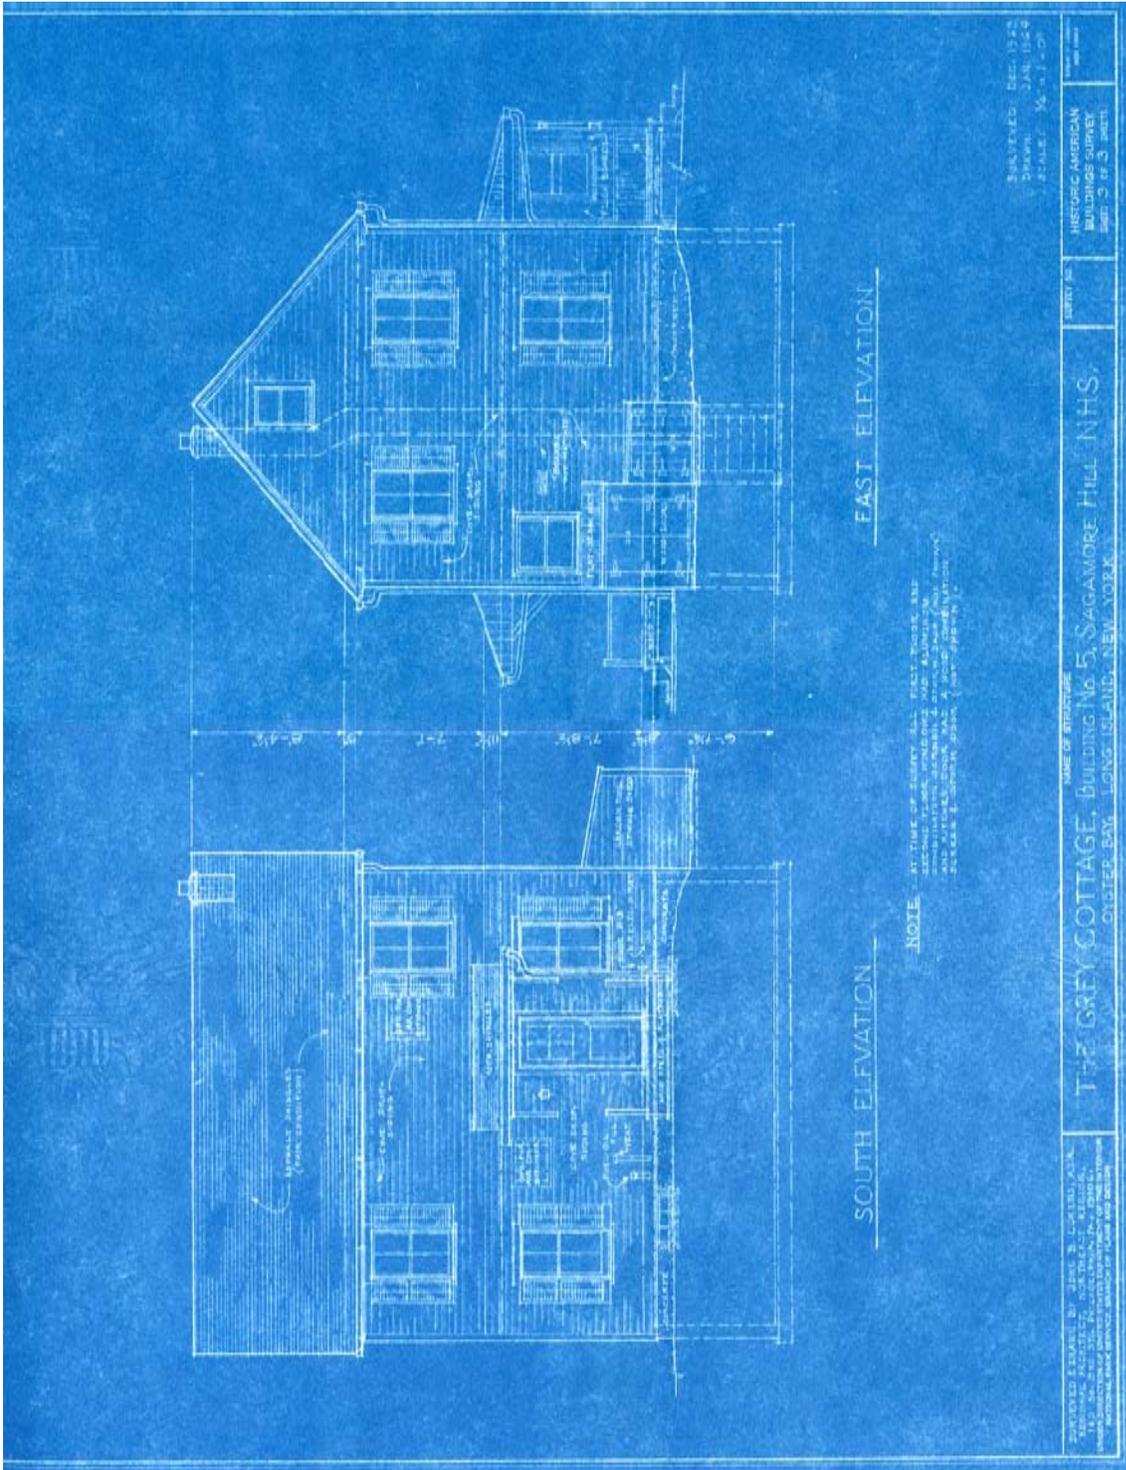
Figure 24. The Grey Cottage, Building No. 5, Sagamore Hill NHS, Historic American Buildings Survey, Sheet 3 of 3 sheets. Reproduced from full-size blueprint; not to scale.

The east side of the first story had two rooms that were described in the 1950 insurance report and documented in 1963–64 drawings (fig. 24). The same documents indicated that the historic use of the two rooms was as a dining room in the northeast room and a kitchen in the southeast room. It was conjectured that the historic use of the rooms as described in 1950 had not changed significantly from the original construction of the separate apartments. The northeast room was possibly used as both a dining room and sitting room when there were two separate apartments in Gray Cottage.

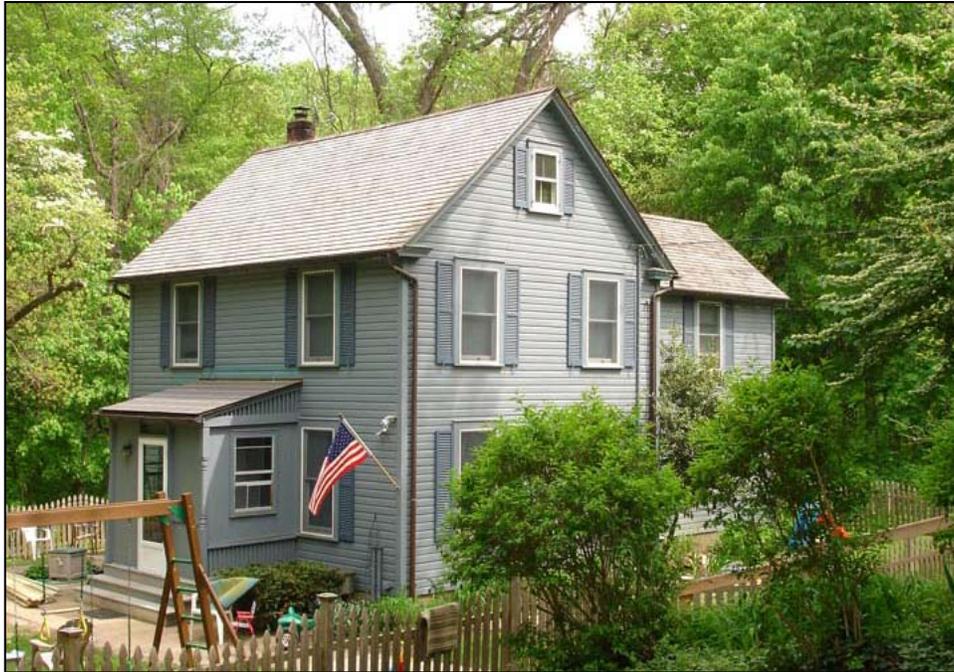
Figure 31. Gray Cottage, looking southeast, 2009.

The façade of the building is on the north elevation of the main block and retains historic elements (figs. 31 and 35). The façade has an enclosed one-story porch at the center of the elevation, portions of which date to the historic period. The east and west elevations of the main block form the gable ends (figs. 36 and 38), and the ell extends from the south elevation. The gable end of the ell faces south (fig. 37). A second enclosed porch was constructed at the southeast corner of the building where the main block and ell meet.

The records indicated that the front porch of Gray Cottage was enclosed during the historic period (figs. 31 and 35). The porch measures 6 feet wide by 9 feet 9 inches long and is one story high with a shed roof. The four corners of the porch are supported by piers that are currently concealed by plywood. The outside corners of the porch are constructed with turned posts that support the roof structure.

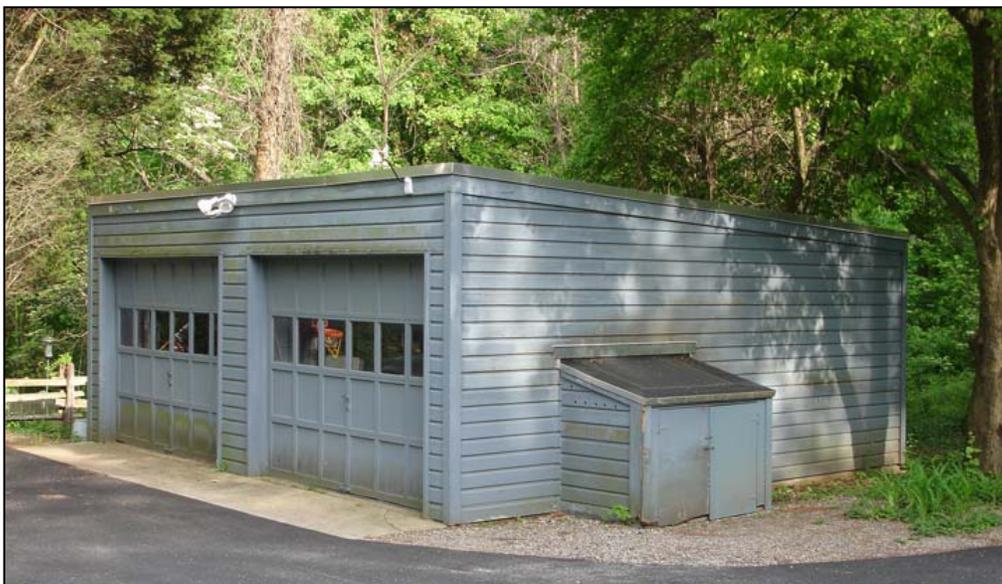
Figure 32. Gray Cottage Garage, looking southeast, 2009.

Approximately 50 feet west of Gray Cottage is a two-car garage adjacent to the paved parking area. The garage was constructed by the TRA in the 1950s to serve the parking needs of the Gray Cottage residents. The garage is set on a concrete pad and measures 22 feet 3 inches wide (east–west) by 20 feet 3 inches long (north–south). It is sided with drop siding and has sections of replacement siding on the south and east elevations up to the southeast corner. The replacement siding is constructed with textured plywood (T111) designed to resemble vertical siding. The garage is trimmed with plain boards at the corners and along the roof line. It has a shallow-pitched shed roof that is currently covered with membrane roofing material (EPDM) that was installed in 2008 and has an aluminum drip edge. Two overhead roll-up garage doors are located on the north elevation. These are four-section doors with stiles and rails forming six panels in each section and one section of fixed glass panes. A small storage shed constructed with similar materials is appended to the west elevation of the garage in 1967.

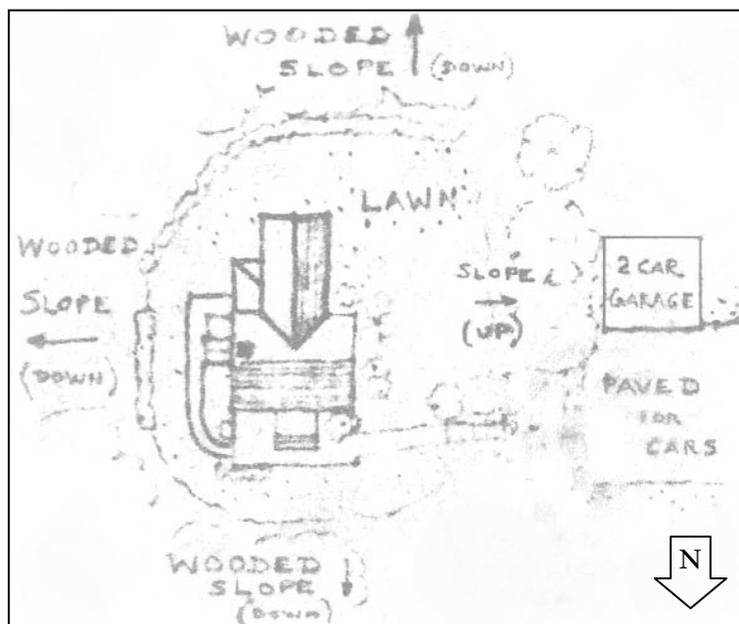
Figure 33. Gray Cottage plot plan depicting building, garage, paved parking area, and landscape features and slopes, 1964.

Gray Cottage is set on a low-lying wooded lot that slopes down from west to east. There is a paved driveway approaching the site that leads east from the visitor parking lot to a level paved parking area west of the building. Concrete steps with a wooden railing along the south side lead down to a concrete walkway and the yard. The yard at Gray Cottage is enclosed by a wooden picket fence with a gate near the base of the steps. Proceeding through the double gate, the concrete walkway leads to the north elevation of the building. A wide concrete pad spans the entire length of north elevation of the building, and extends from the foundation about 12 feet north into the yard. On the east side of the concrete pad, the concrete walkway continues around the east elevation of the building and leads to the east porch steps. A bluestone patio, portions of which are bordered by concrete curbing, is installed on the east side of the building.

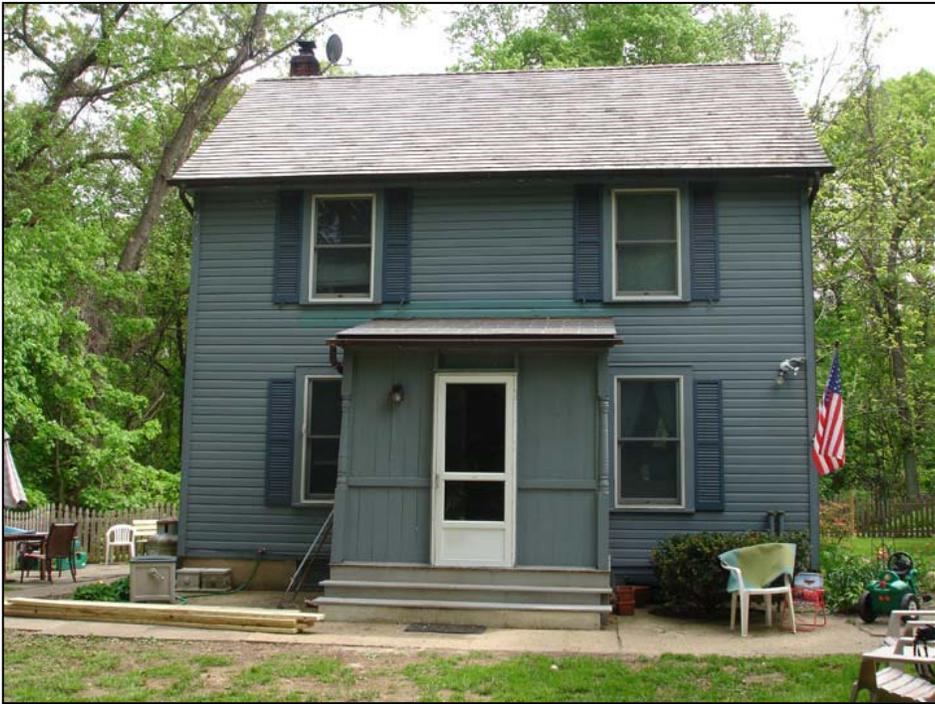
Figure 35. Gray Cottage, north elevation, 2009.

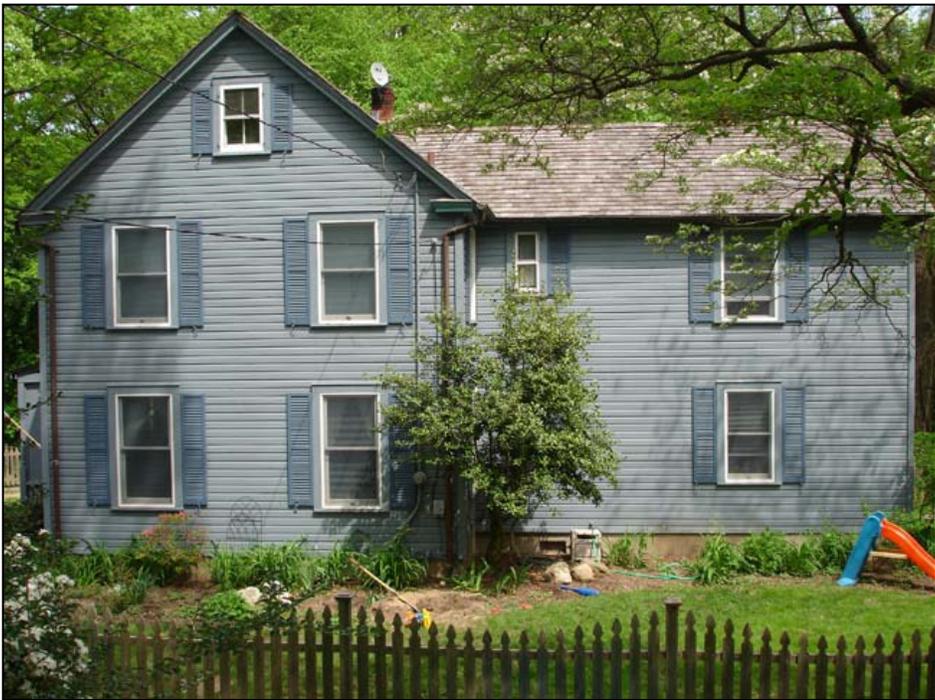
Figure 36. Gray Cottage, west elevation, 2009.

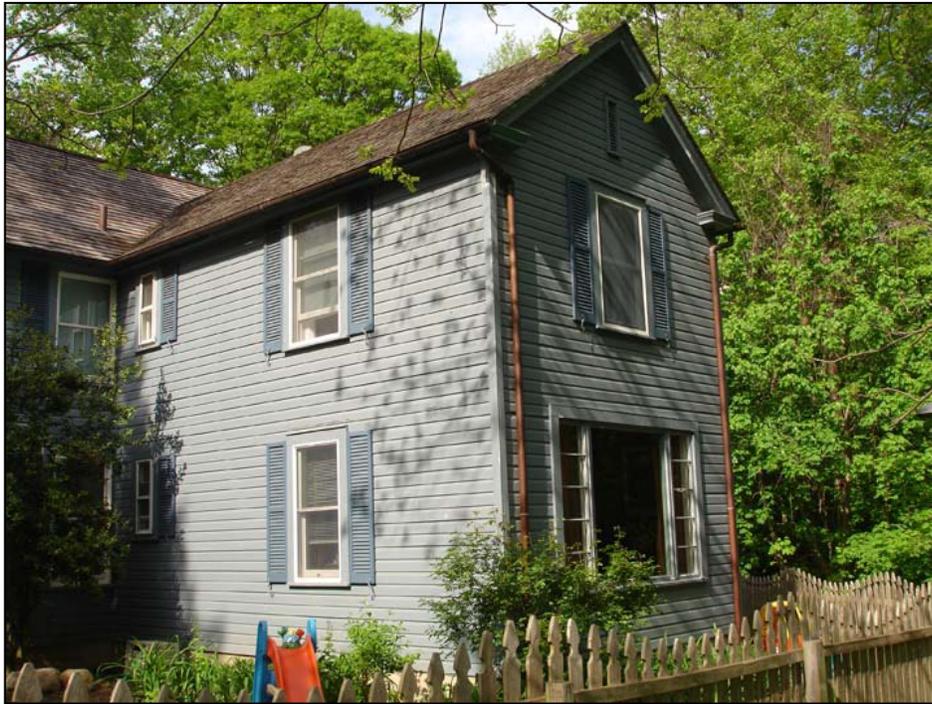
Figure 37. Gray Cottage, west and south elevations of ell, looking northeast, 2009.

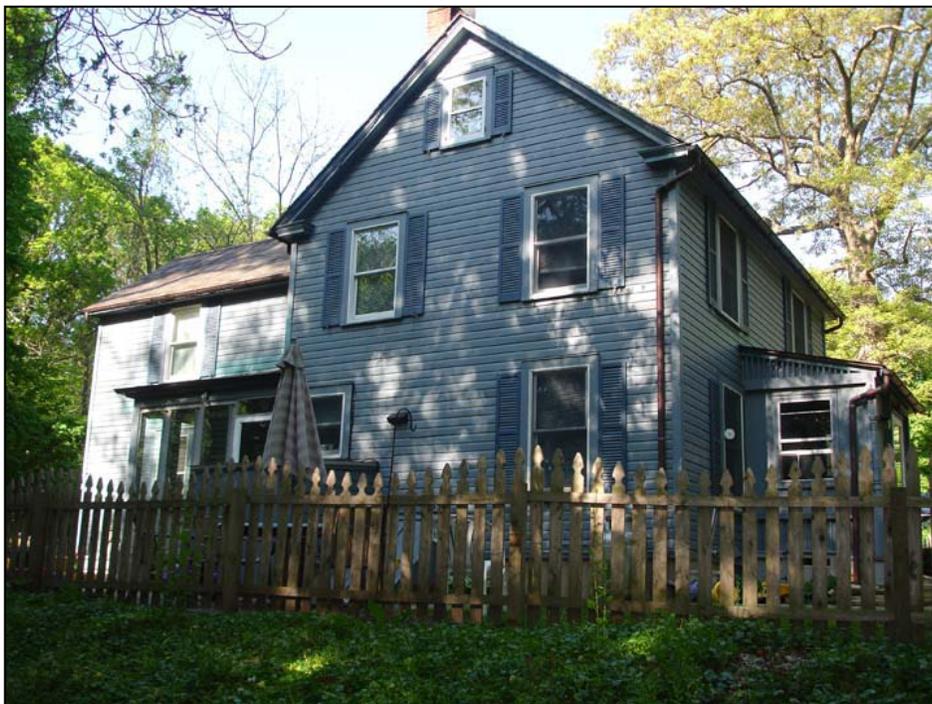
Figure 38. Gray Cottage, east elevation, 2009.

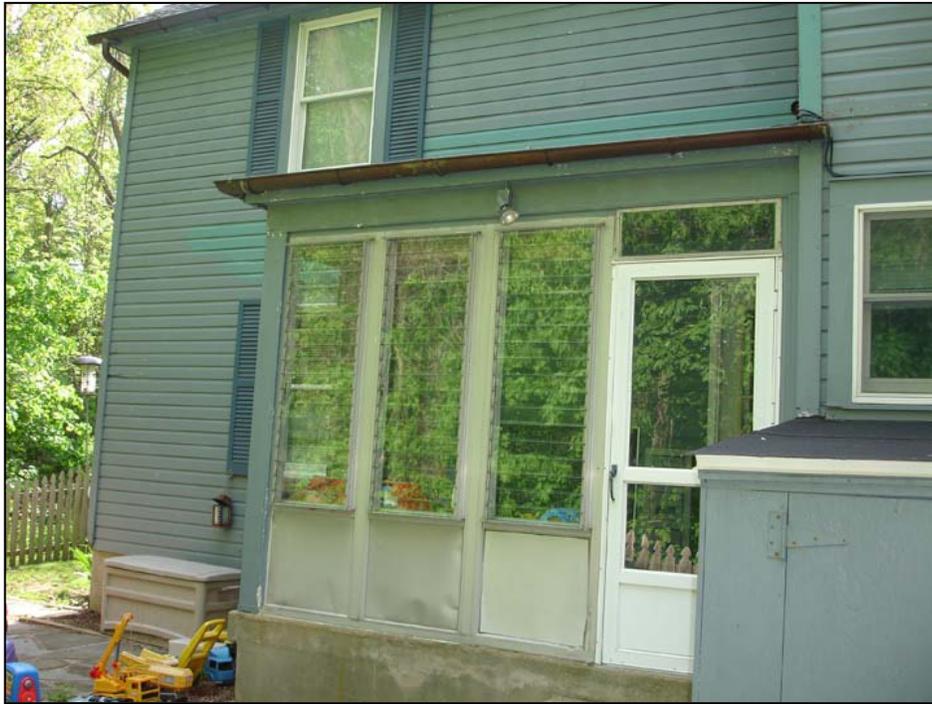
Figure 39. Gray Cottage, east-elevation enclosed porch, 2009.

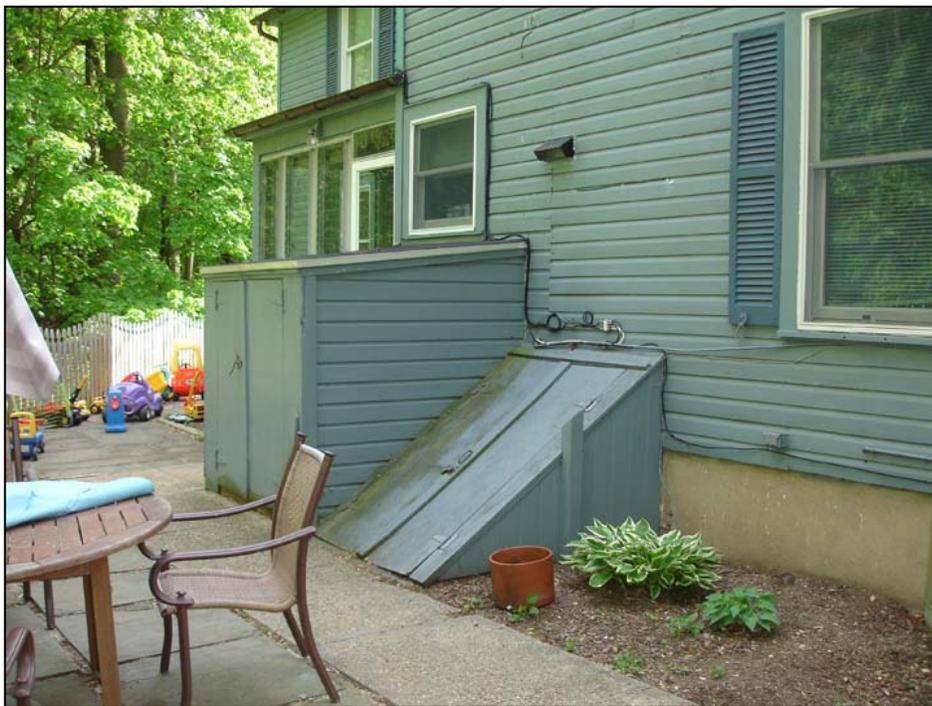
Figure 40. Gray Cottage, east-elevation bulkhead and storage shed, 2009.

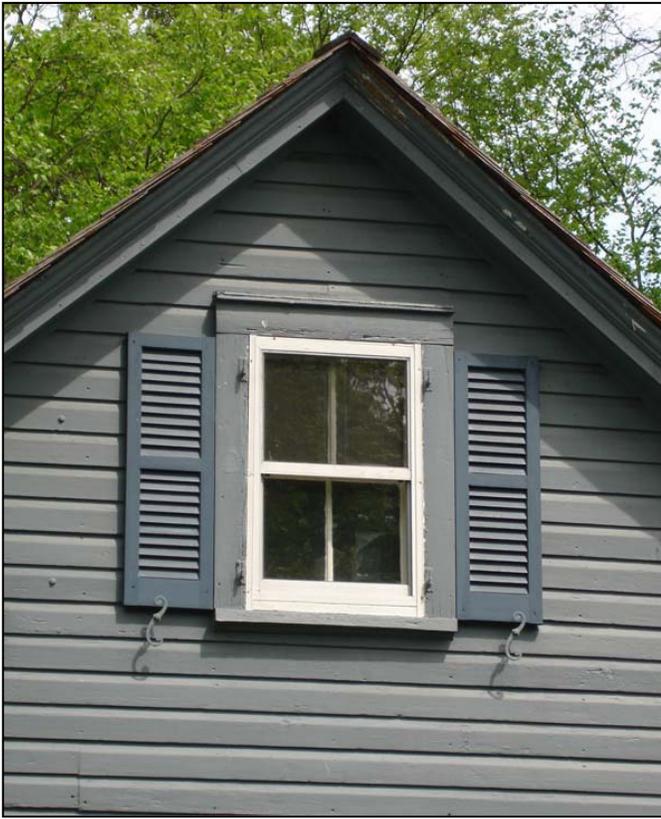
Figure 41. Gray Cottage, west-elevation gable window opening, 2009.

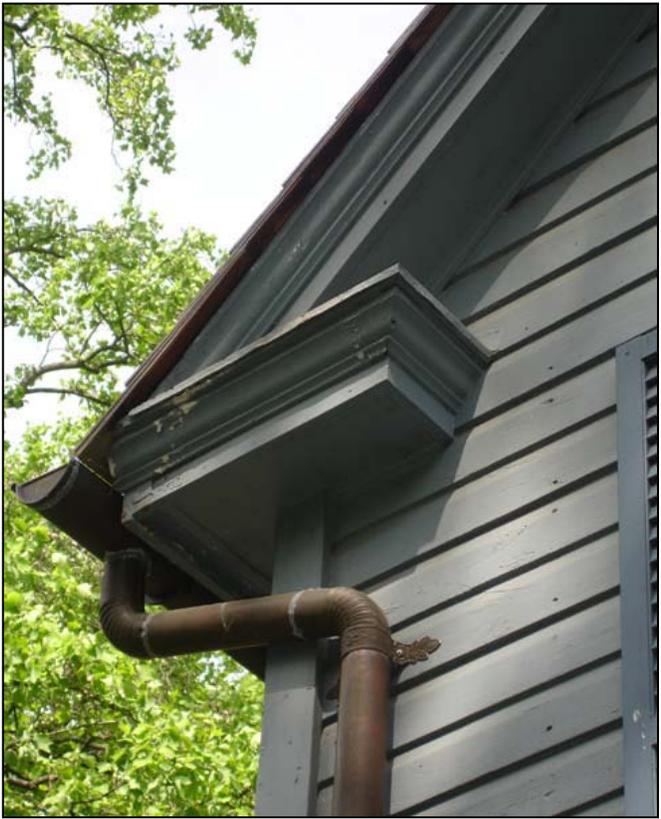
Figure 42. Gray Cottage, west-elevation cornice return and molded rake board, 2009.

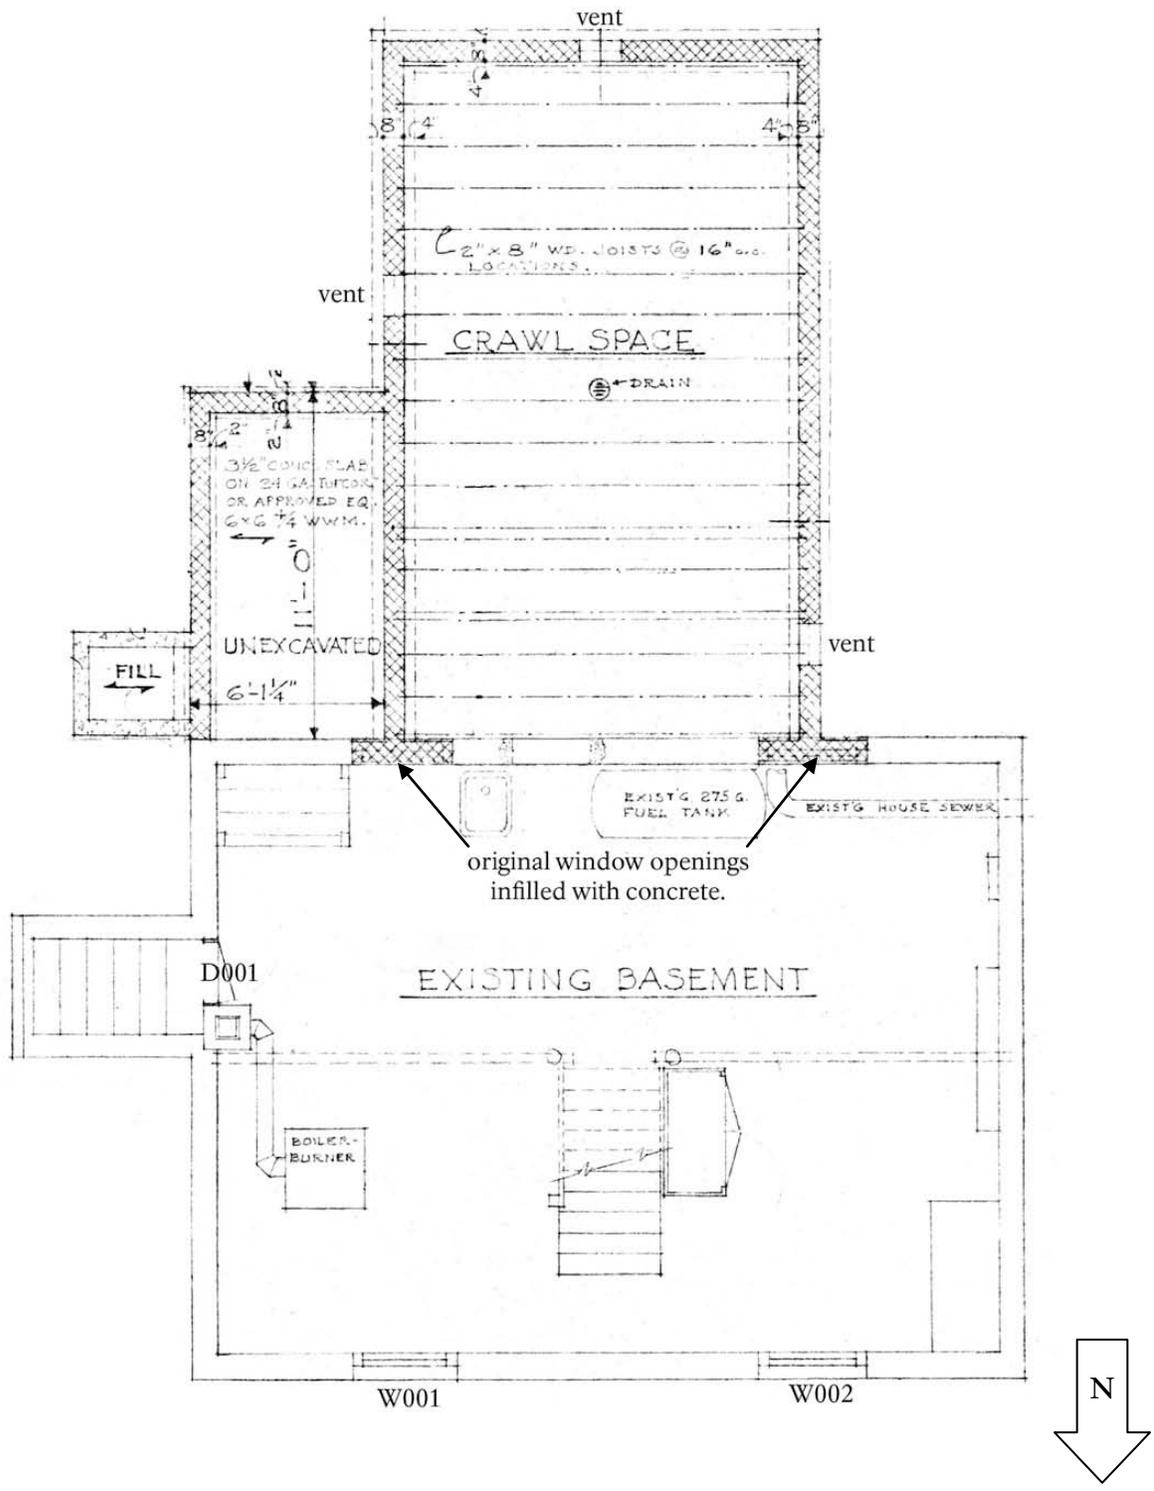
Figure 43. Gray Cottage, basement floor plan with doorway and window-opening numbers assigned for the current project.

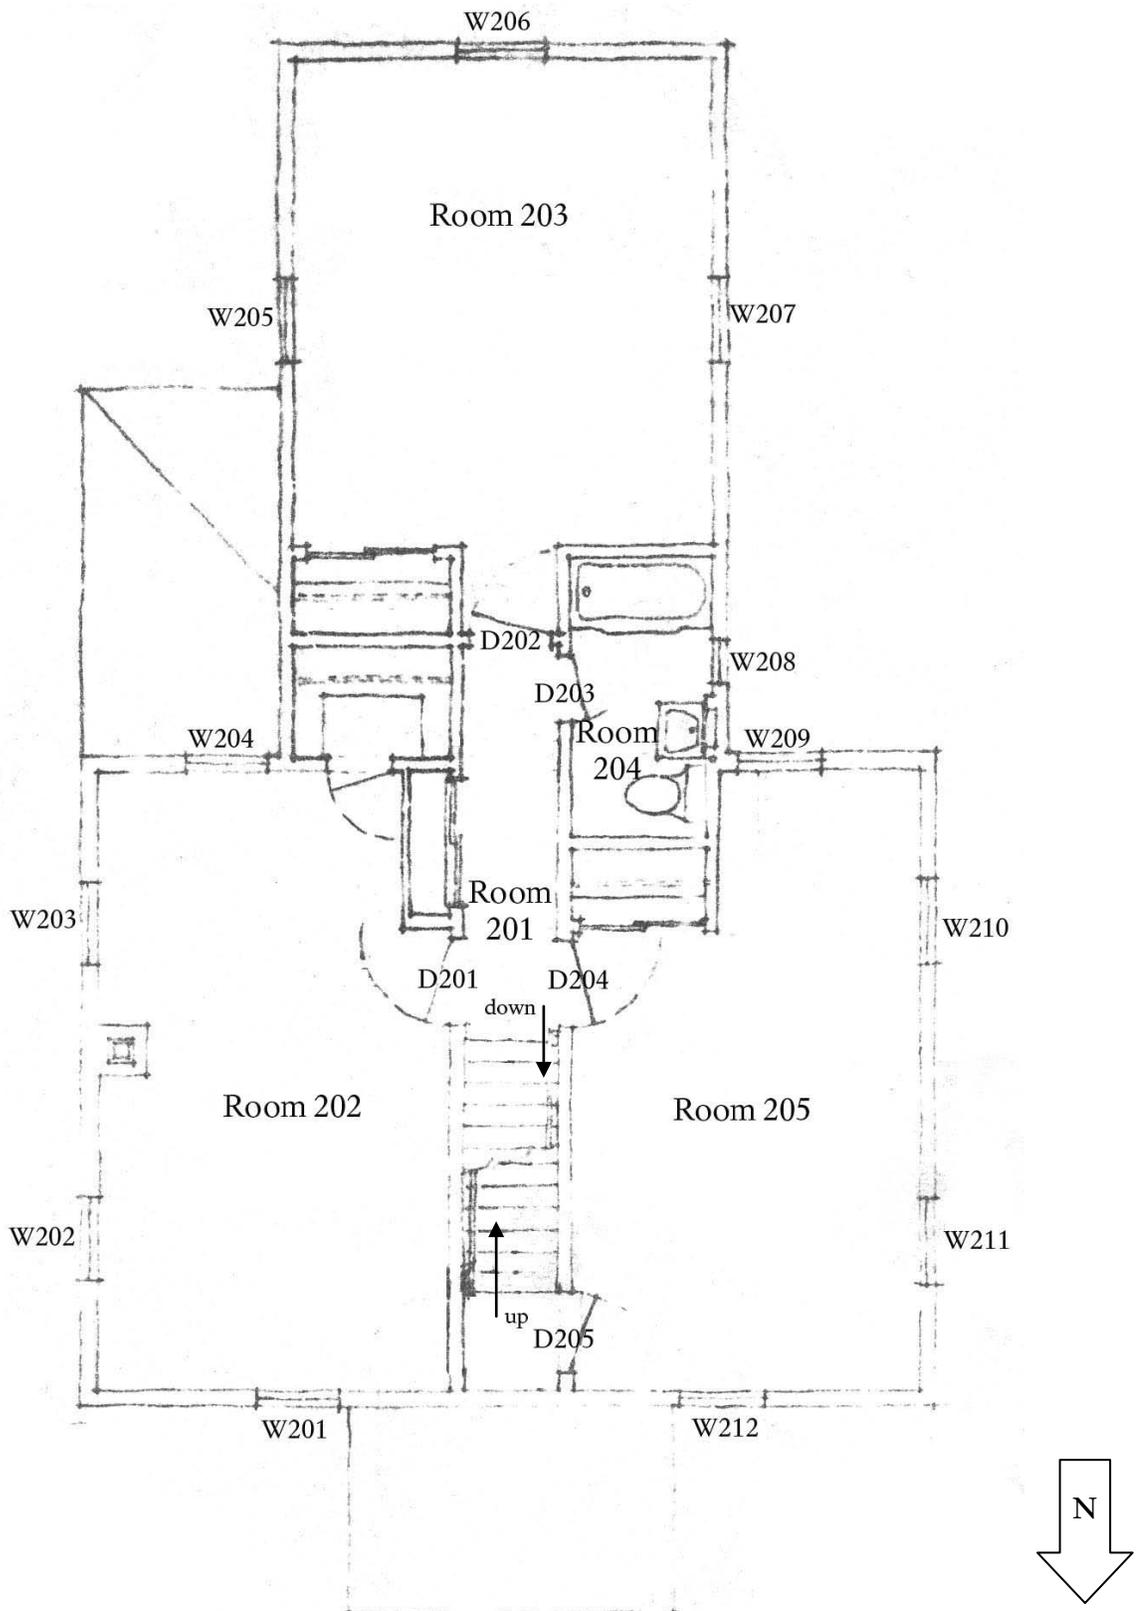
Figure 45. Gray Cottage, second-story floor plan with room, doorway, and window-opening numbers assigned for the current project.

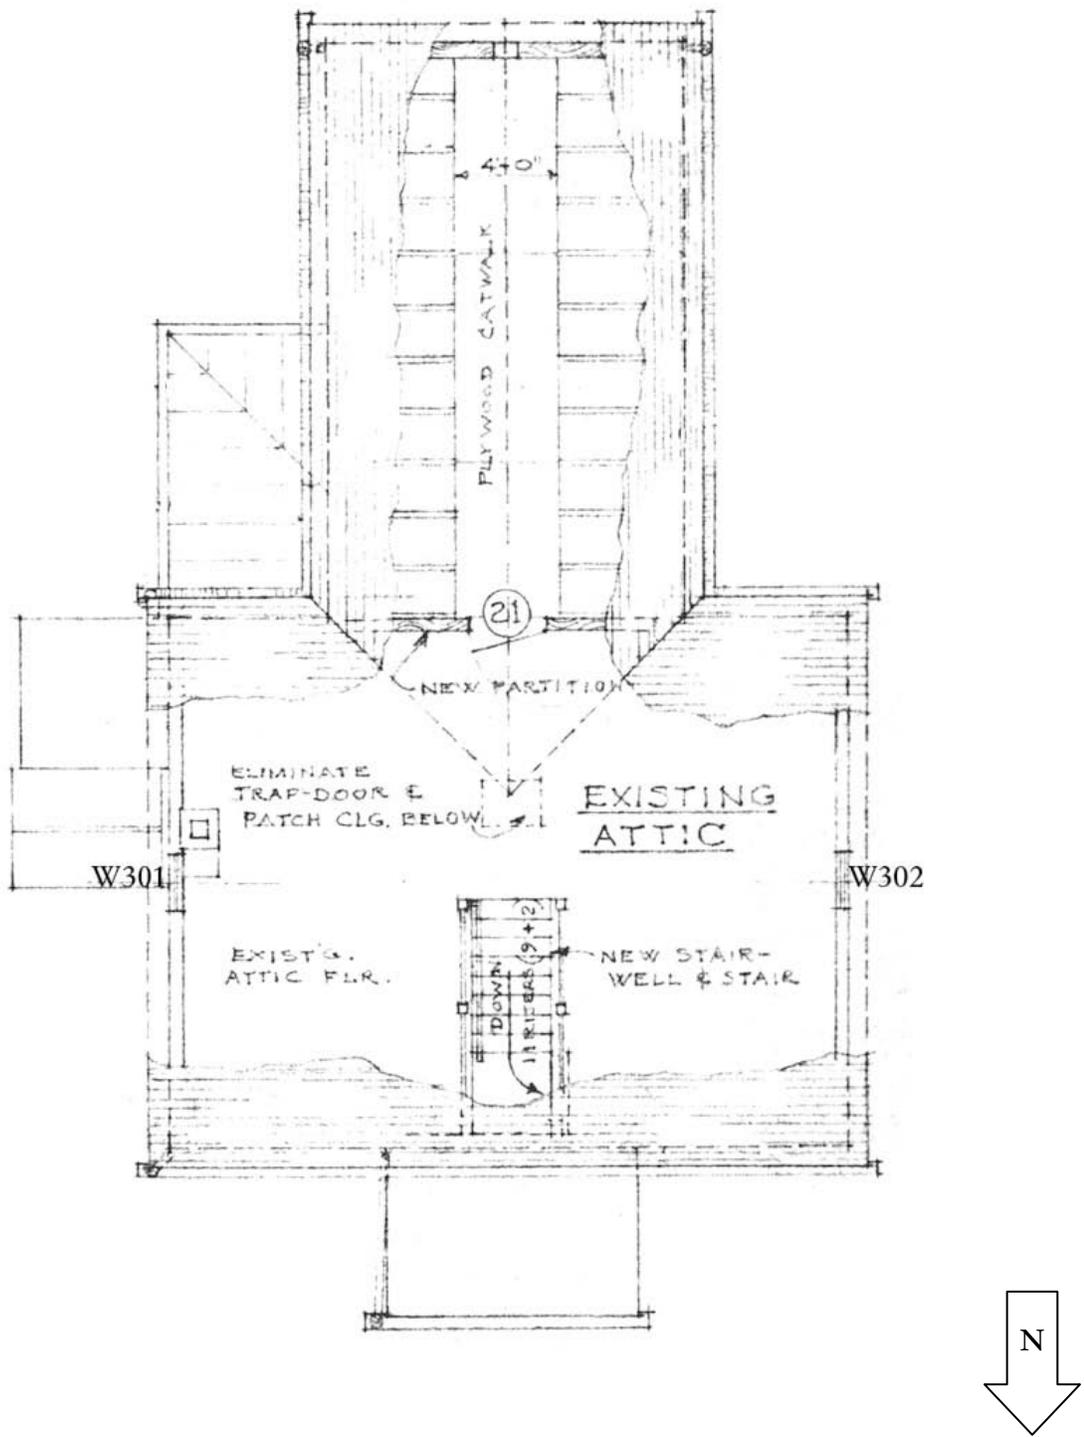
Figure 46. Gray Cottage, attic floor plan with window-opening numbers assigned for the current project.
